**DOT/FAA/AR-04/28**

# **Turbine Engine Fan Disk Crack Detection Test**

September 2004

Final Report

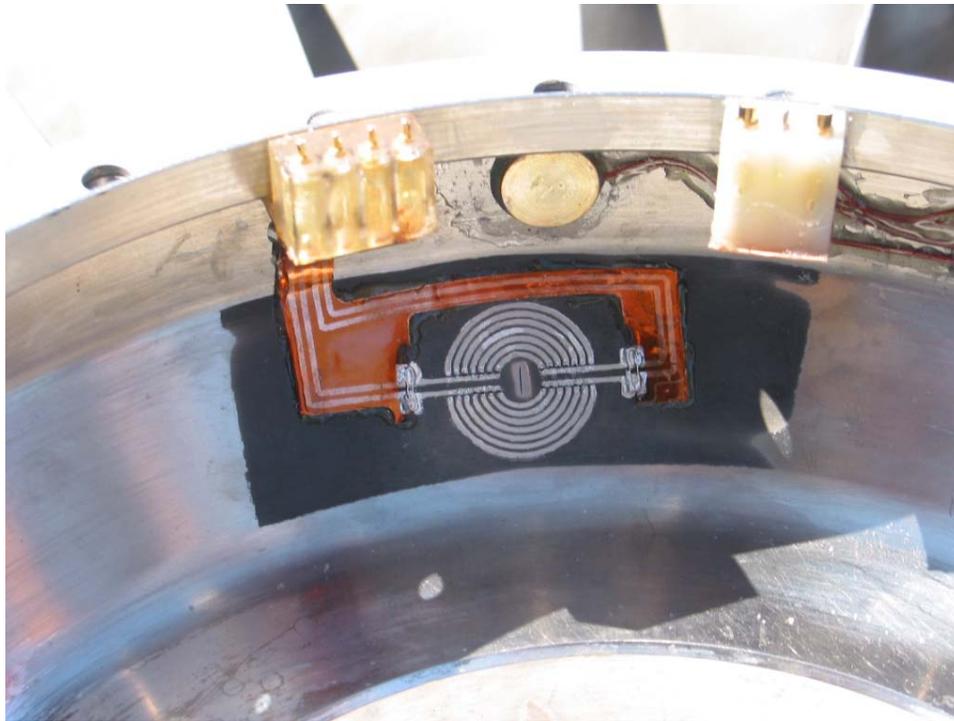
FIGURE 6. TF41-A-1B DISK WITH EDM CRACK  
(Shown with the IDINY crack wire sensor and AADC acoustic sensors in place.)

The initial EDM notch was a 0.100-inch radius electron discharge-machined half-penny slot (0.200" length at the surface) on the forward face of the first stage fan disk. The disk was subjected to a total of 20,140 cycles, each cycle ramping approximately from idle (3000 rpm) to 8500-8800 rpm in the Test Devices Inc. spin pit. These spin pit cycles were intended to initiate a crack in the disk to ensure further crack growth when the fan was on the engine. Fluorescent penetrant was used to periodically inspect the crack during spin pit testing. All inspections conducted with fluorescent penetrant inspection (FPI) were negative in the spin pit. It is important to note that sensors surrounded the EDM notch, therefore polishing was not possible. At 20,140 cycles, a small FPI indication was present in the crack growth sensor but not in the parent material. The team decided to have the disk eddy-current inspected.

The disk was shipped to the Air Force Research Laboratory/Materials Integrity Branch (AFRL/MLSA) where they conducted an FPI, revealing no visible cracks at each end of the EDM slot in the parent material. However, the eddy-current crack inspection revealed that the spin pit cycling of the disk resulted in cracks approximately  $0.100 \pm 0.010$  inch long, extending from each end of the EDM slot. The disk was then shipped to NAWC China Lake for full-scale engine testing.

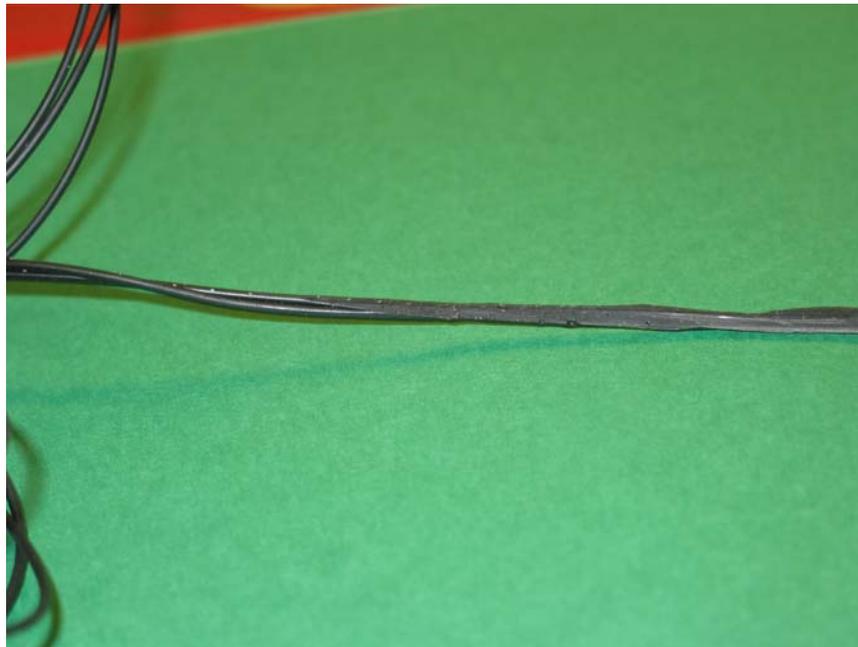
FIGURE 7. CREATIVE ENGINEERING CONCEPTS, INC., FIBER-OPTIC LINES FUSED TOGETHER

The technologies that were first evaluated in the test experienced some difficulties. The short lead-time for the development of TF-41 installations contributed to these difficulties. Had the systems been available for the earlier checkout runs, adjustments in the systems could have been implemented during the crack growth portion of the test. A posttest inspection discovered the fiber-optic lines for the torsional vibration measurement had been pulled taut across the top of the forward bearing. The coating on the fiber-optic lines had melted and had fused together (figure 7).

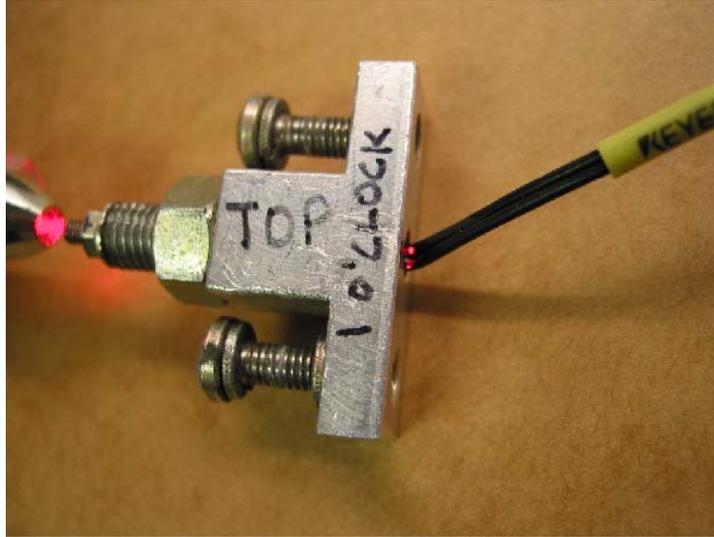
FIGURE 8. CREATIVE ENGINEERING CONCEPTS, INC., SENSOR AND SENSOR MOUNT WITH A RED LASER POINTER ILLUMINATING A BREAK IN THE LINES

The tension on the fiber-optic lines also pulled the line around a corner on the sensor mount and caused the fiber-optic lines to break (figure 8). A red laser pointer was used to detect any breaks in the fiber-optic lines.

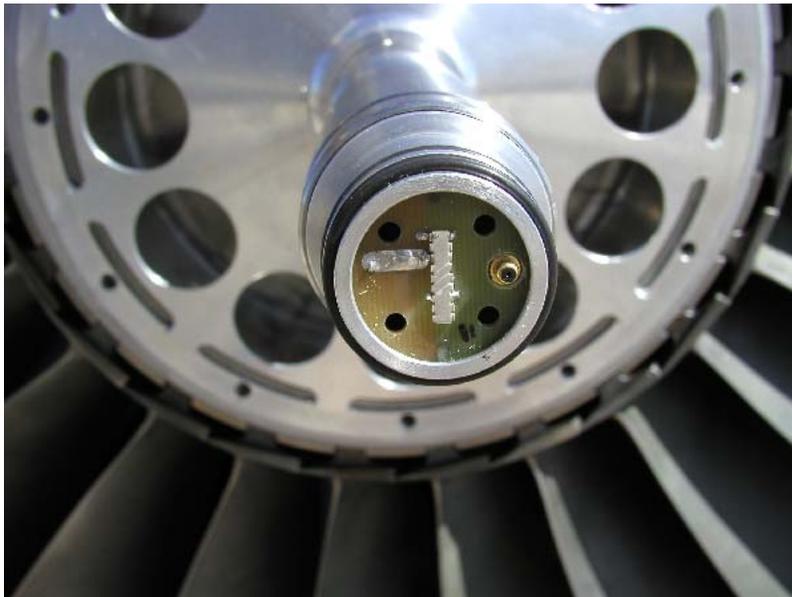
FIGURE 9. ALLISON ADVANCED DEVELOPMENT COMPANY AND IDINY TELEMETRY HARDWARE  
(Fan with the nose cone removed)

The AADC and IDINY wireless telemetry hardware (figure 9) installed in the nose cone also had some problems. Sand got into the electronics of the transmitter in the center post, and the battery seemed to have an intermittent connection. The nose cone was removed at the end of the first test day, and the exposed portion of the electronics was sealed with epoxy. The wiring connections in the electronics were checked and strengthened, and the nose cone was replaced.

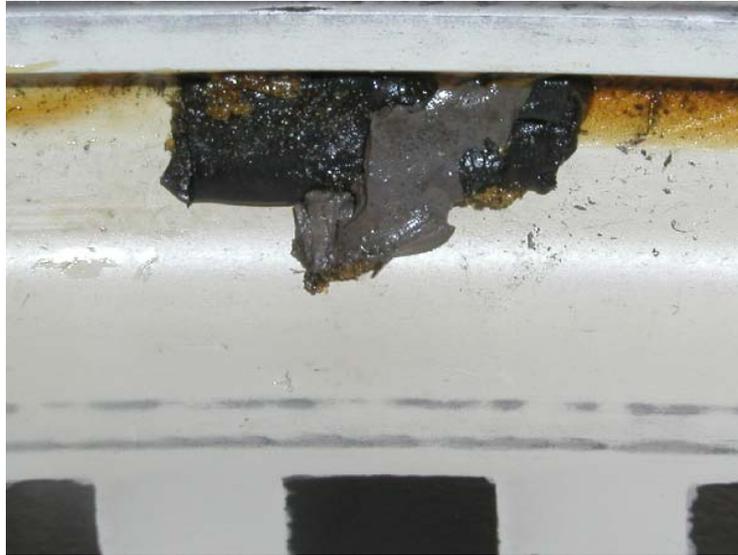
FIGURE 10. DEBRIS ON FAN AFT RETENTION PLATE

Upon disassembly of the engine, a small piece of debris was found on the aft retention plate on the fan (figure 10). The debris appeared to be a small piece of rubber or plastic that was sucked into the space between the fan and the first-stage stators through one of the hollowed-out vanes. The debris measured approximately 0.8 x 0.45 inch and weighed 5 grains (0.324 gram).

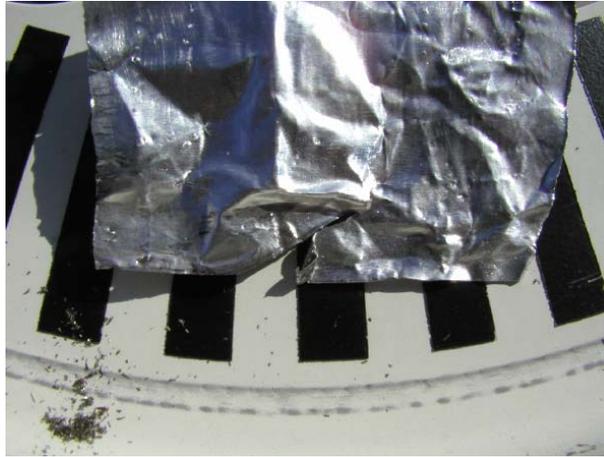
FIGURE 11. ALUMINUM TAPE RUBBED AGAINST THE TF41-A-1B FAN DISK BLADE RETENTION PLATE

During the engine checkout the week before the seeded fault test, the cutouts made in the static air seal plate were covered with aluminum tape. During this second engine checkout, the aluminum tape lifted up and rubbed against the fan aft retention plate (figure 11). The aluminum tape did not cause any damage to the retention plate, to any of the sensors on the instrumentation ring, or the static air seal plate. The aluminum tape was removed and replaced with thin strips of stainless steel spot-welded into place.

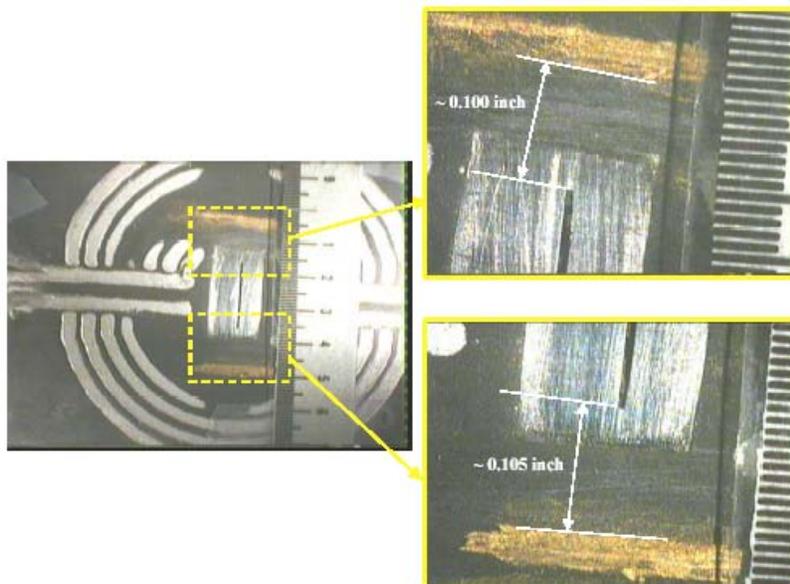
FIGURE 12. TF41-A-1B FAN DISK CRACK AFTER PRETEST SPIN-PIT GROWTH [13]

The TF41-A-1B fan survived 4474 engine power cycles with an initial crack radius measuring 0.205" on the front face of the first-stage engine fan without catastrophic failure (figure 12). The crack radius grew to approximately 0.225" (figure 13). These inspections were made with eddy current. The high residual stress disk exhibited very tight cracks that were not detected with FPI and were only partially visible with polishing and magnification. The visual crack growth was larger than the eddy-current growth, which is attributed to the amount of polishing and the fact that the growth sensor was chemically removed after the test and mechanically removed for the postspin pit inspection.

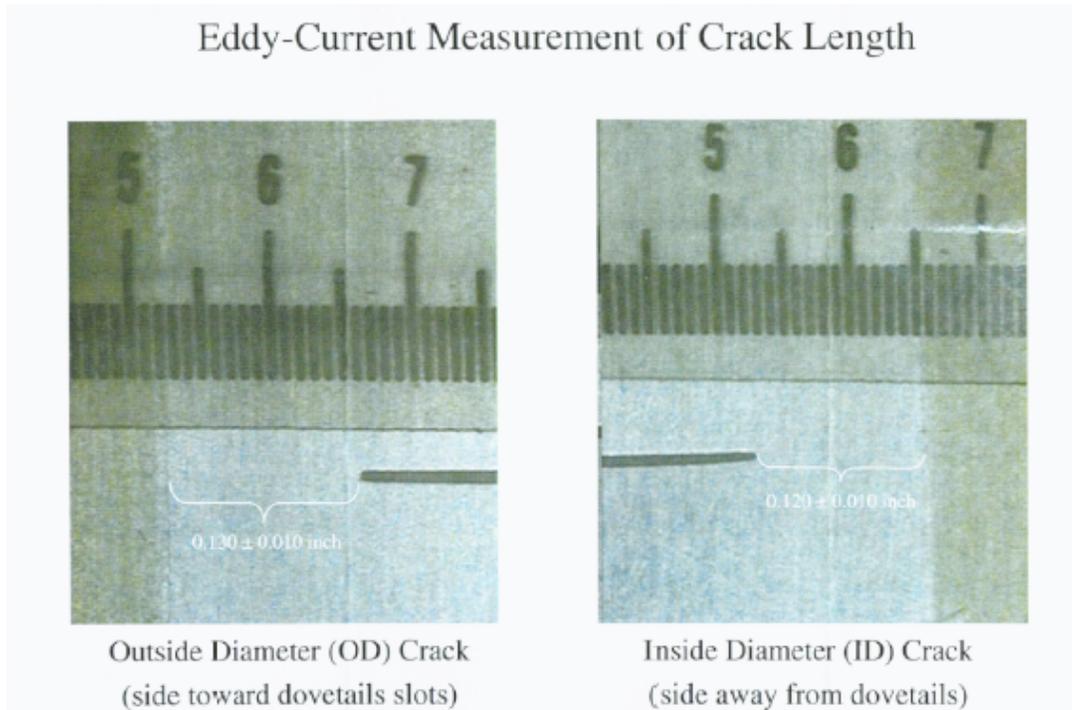
FIGURE 13. TF41-A-1B FAN DISK CRACK AFTER 4474 ON-ENGINE THROTTLE CYCLES [14]

The eddy-current inspection of the crack revealed a crack length of  $0.130 \pm 0.010$  inch beyond the EDM notch on the outer diameter side of the EDM notch and  $0.120 \pm 0.010$  inch beyond the inner diameter side of the EDM notch on the disk.

The crack grew less than predicted by the analysis. Table 3 describes the predicted crack growth.

The number of cycles performed exceeded the predicted number of cycles to failure of 50  $\text{ksi} \cdot \sqrt{\text{inch}}$  toughness titanium fan disk.

The limited growth of the crack may have been due to various factors. One was the fact that the growth occurred only at the higher low-speed shaft (N1) speeds. The spikes to 8816 rpm were of very short duration and may not have been sufficient to induce crack propagation. The maximum speed was not increased because doing so would have reduced the size of the critical crack length and may have caused the disk to fail rapidly, not providing the time to identify the trend preceding the failure. To provide a larger critical crack size and sufficient cycles to collect data, the crack was introduced in a moderate stress area. Other factors that could have contributed to the limited crack growth were aerodynamic loading from the fan blades and

After analyzing the test results, it was suggested that the crack growth rate be investigated by placing a Vishay crack grid on the disk and cycling the disk in a spin pit. However, the crack growth rate would not help to identify the disk toughness. The discussions also suggested that a better means of controlling the N1 speed needs to be developed to hold the desired rpm, rather than allow the spike seen during each cycle of the seeded fault test.
