**FULL-SCALE DYNAMIC CRASH TEST  
OF A  
DOUGLAS DC-7 AIRCRAFT**

**TECHNICAL REPORT**

**APRIL 1965**

**Aviation Safety Engineering and Research  
Division of Flight Safety Foundation, Inc.  
Phoenix, Arizona**

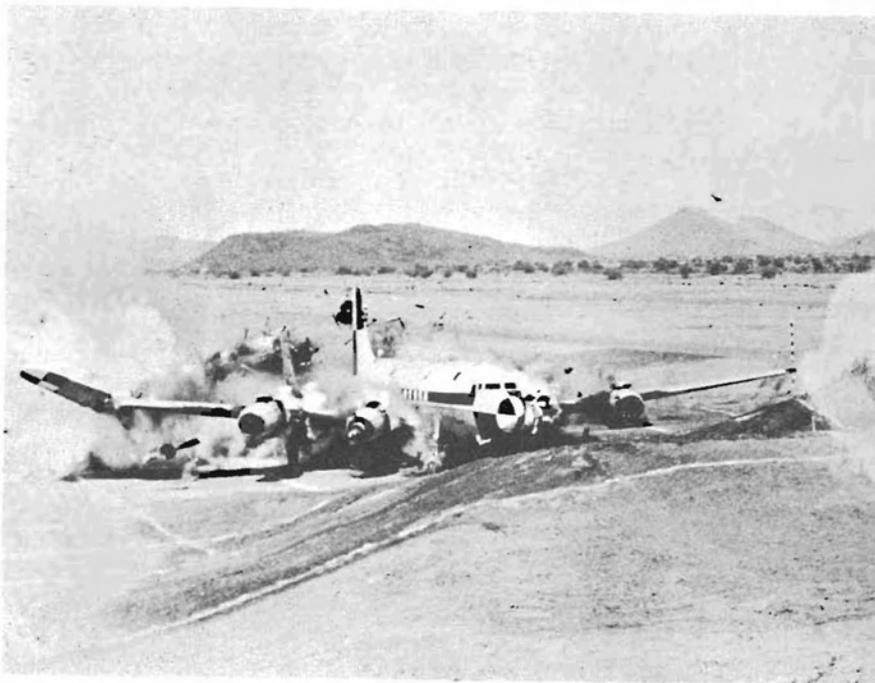
Figure 23 shows the initial contact with the outboard right wing barrier pole. The impact with the pole cut off the wing approximately 12 feet from the tip. This figure also shows the spray of simulated fuel issuing from No. 4 main tank, which was ruptured by the pole. Approximately 0.150 second after the first pole impact, the aircraft contacted the second pole barrier, which was placed to strike the wing between No. 3 and No. 4 engines. This pole crushed the wing leading edge structure back to the forward spar, and then the pole broke. The left wing tip scraped along the earthen wing barrier, suffering only slight flattening of the underside near the tip.

FIG. 23 IMPACT WITH RIGHT WING BARRIER POLES

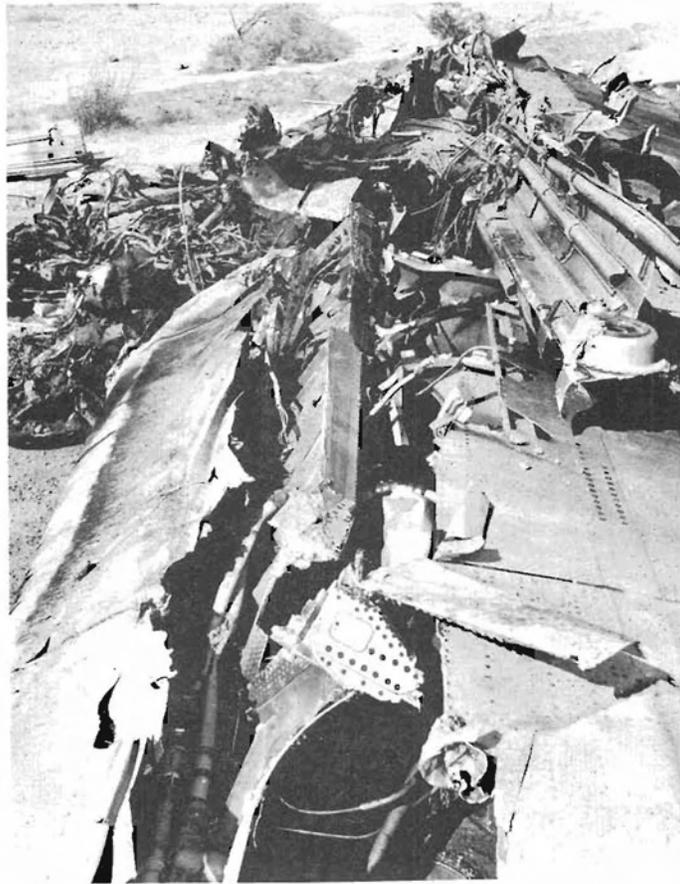
The bottom of No. 1 alternate tank had no visible punctures and was only slightly deformed. The top was in good condition with practically no deformation. The spar leading edge area separated for 28 inches, outboard to inboard, on the bottom and completely separated on top. This is shown in Figure 33. Just outboard from the No. 1 engine, the forward spar was bulged outward (forward). The arc formed in the spar between the top and the bottom edges had a radius of approximately 30 to 35 inches. This is shown in Figure 34.

FIG. 34 CLOSEUP VIEW OF FRONT OF LEFT MID-WING  
AREA (ALTERNATE TANK NO. 1) WHERE GELLED  
FUEL WAS CARRIED

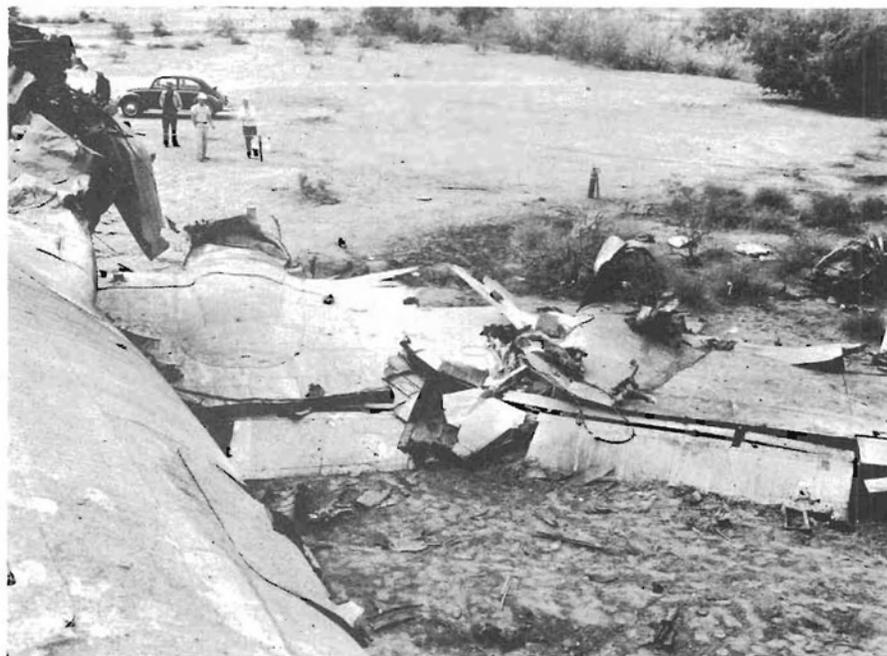
Jagged and torn metal was all that remained of the inboard wing section. Torn material from the bladder tank and laminated nylon chafing board were exposed along the line of separation from the fuselage. The top and bottom of the tank were practically all destroyed. The damage to this section is shown in Figure 38.

FIG. 38 POSTCRASH VIEW, RIGHT WING

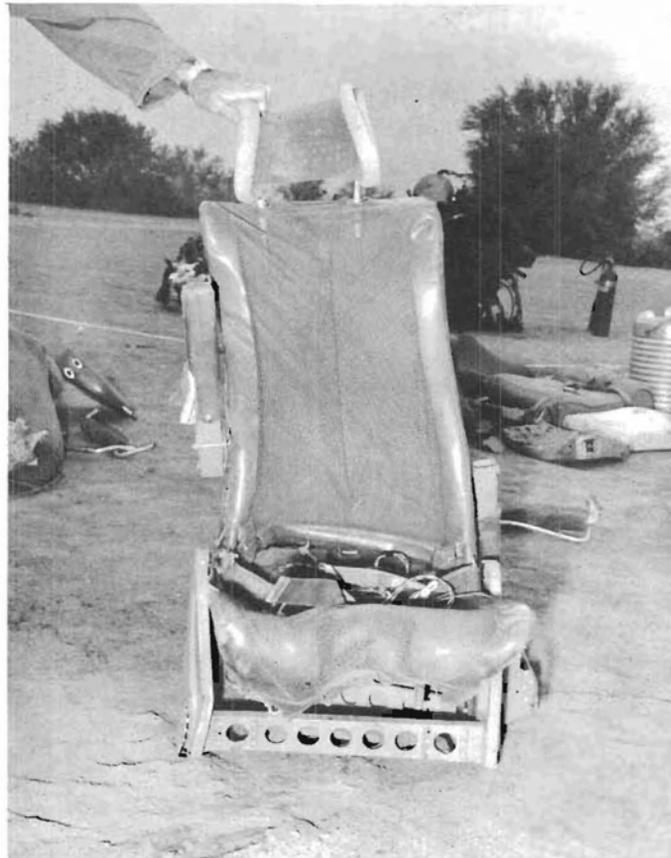
FIG. 46 REAR VIEW OF  
PILOT SEAT AFTER  
REMOVAL FROM  
WRECKAGE

During the crash, the floor attachment of the pilot's seat failed completely. The seat tracks remained attached to the floor structure, but the lower seat structure failed at the attachment to the tracks. The lap

belt and shoulder harness remained undamaged and attached throughout the crash. The overall condition of the seat after removal from the aircraft is shown in Figures 44, 45, and 46. The pilot vertical pelvic acceleration experienced was considerably lower in all impacts than the vertical acceleration in the copilot pelvic region, as shown in the accelerometer data, Appendix I.

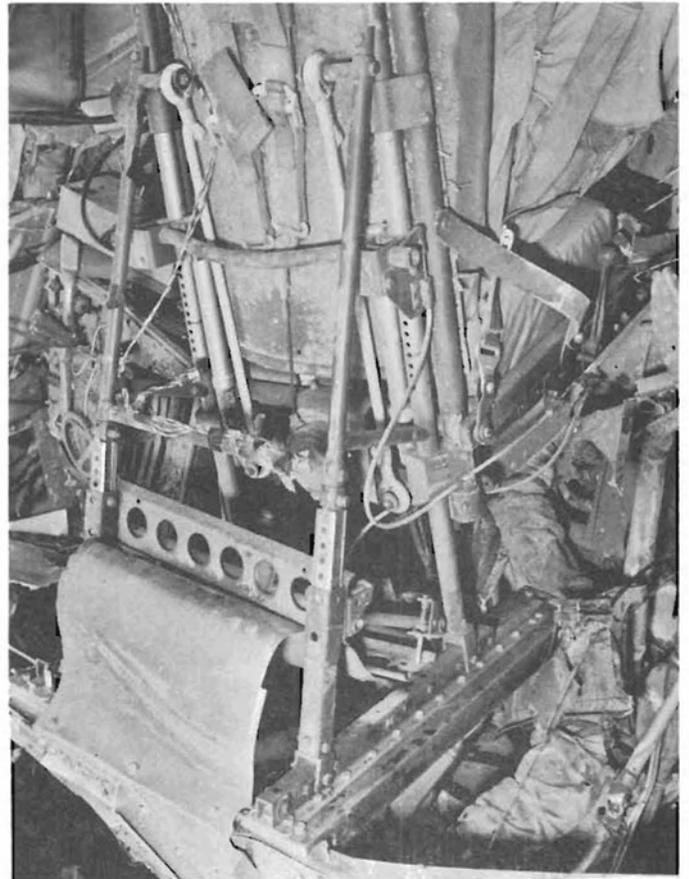
The copilot's seat remained attached to the aircraft structure, as shown in Figure 47. The seat track attachments remained intact, but the surrounding structure was badly damaged. The entire seat pan was bent upward with respect to the seat back, due to contact with forward and lower cockpit structure. The copilot dummy remained in the seat. The inertia reel was locked and the shoulder harness was still attached to the right side of the lap belt, which was still connected to the seat. The lap belt was broken on the left side of the adjustment fitting as shown in Figure 50. Neither of the vertical energy absorbers used in the seat extended. The postcrash condition of this seat is shown in Figures 48, 49, 50, and 51.

FIG. 48 RIGHT SIDE VIEW  
OF COPILOT SEAT  
SHOWING ANGLE  
OF SEAT PAN  
WITH RESPECT  
TO SEAT BACK

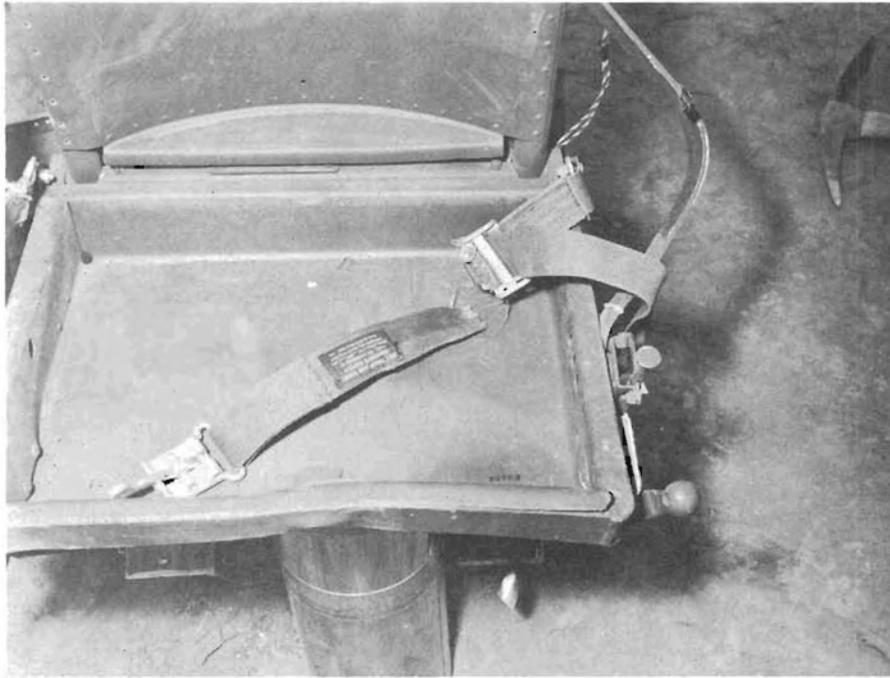
FIG. 50 VIEW OF COPILOT SEAT AFTER REMOVAL FROM WRECKAGE SHOWING SEAT PAN INDENTATION CAUSED BY CONTACT WITH OTHER STRUCTURE AND THE LAP BELT WHICH BROKE AT THE ADJUSTMENT FITTING

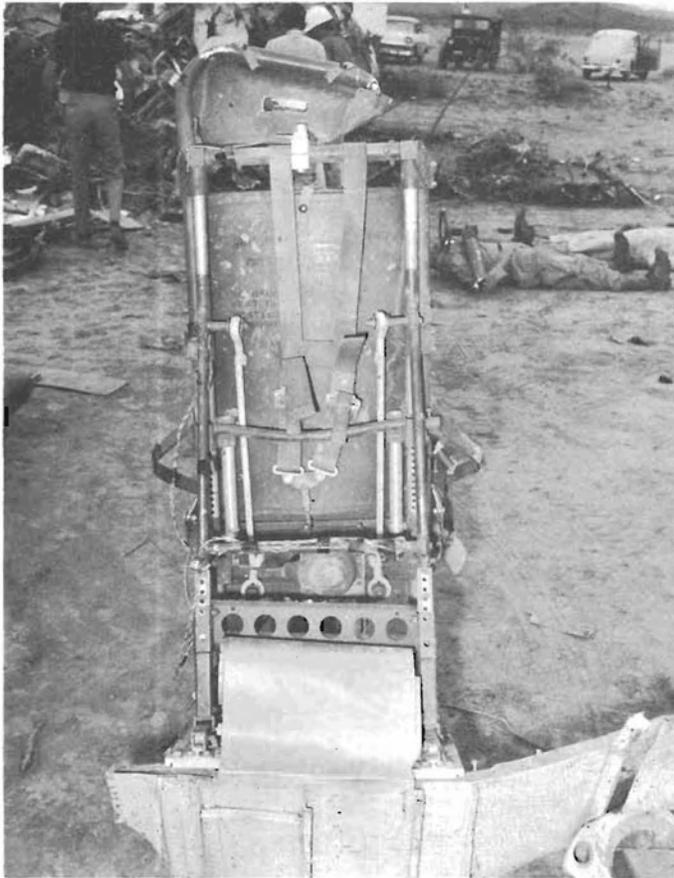
FIG. 51 REAR VIEW OF COPILOT SEAT AFTER REMOVAL FROM WRECKAGE, WITH PORTION OF FLOOR STRUCTURE STILL ATTACHED

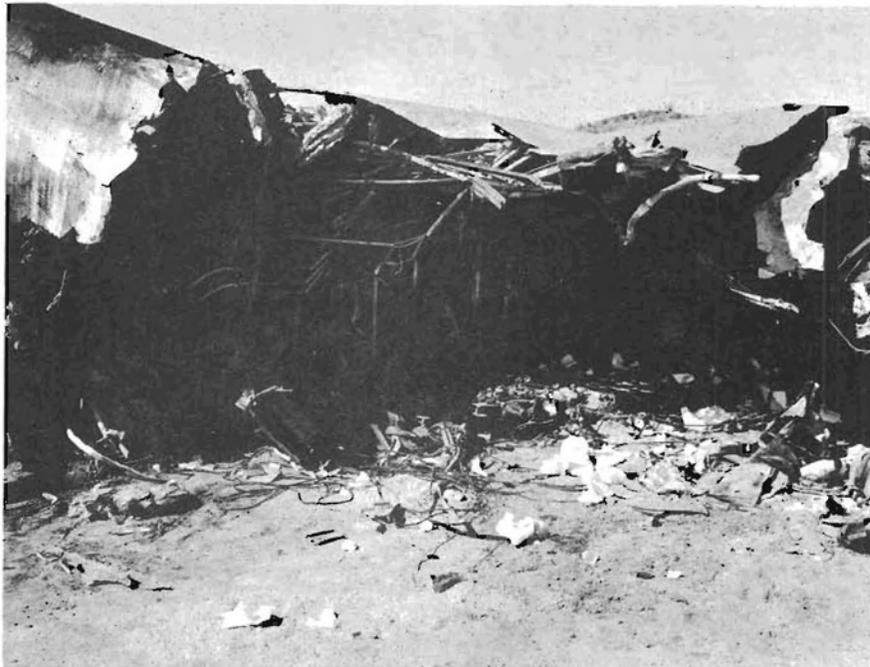
Neither pallet or cargo load completely separated from its original tiedown. Several failures did occur to each net and the pallet tiedown links, but the bulk of the cargo was effectively restrained by both systems. Figure 57 is a postcrash view of the cargo experiment section of the aircraft.

FIG. 57 POSTCRASH ENVIRONMENT OF CARGO EXPERIMENT

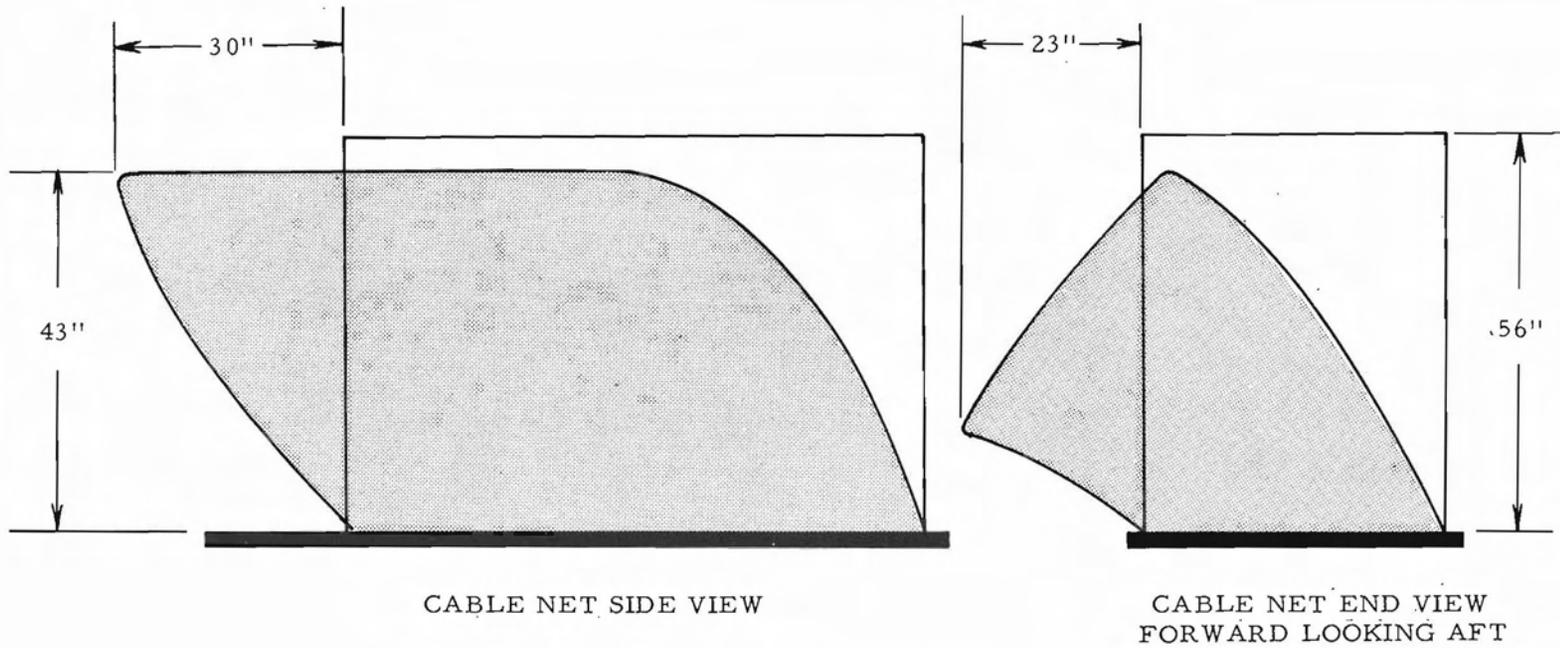
net failures were found where the engine impacted the cargo. However, the cargo was "chewed up" where the engine climbed the stack. Figure 60 is a sketch of the postcrash position of the shifted forward cargo. Nearly all of the boxes of simulated cargo on the forward cargo pallet were torn apart. Of the two cargo experiments, this cargo definitely sustained the most damage.

FIG. 60 POSTCRASH POSITION OF SHIFTED CARGO

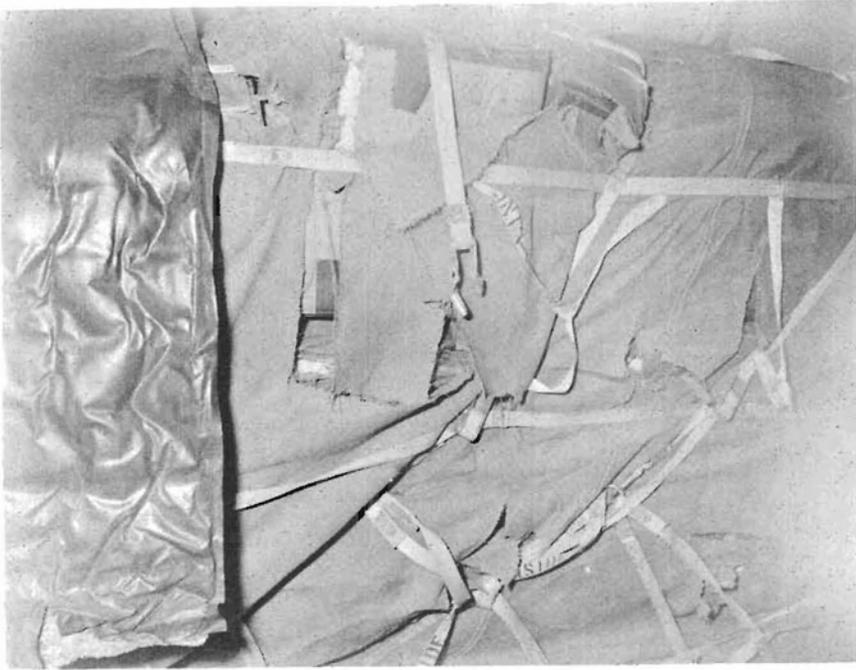
FIG. 62 FAILED LOAD CARRYING BUCKLE, SHOWN  
IN PHOTOGRAPH CENTER

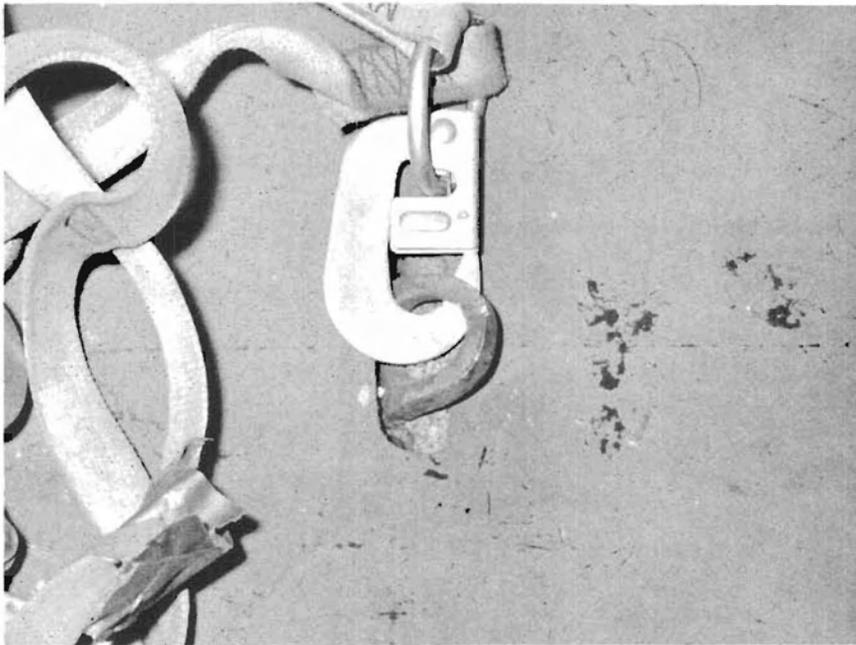
There was no evidence to indicate that any loads were applied to the cargo, cargo pallet or nylon net of the aft cargo experiment except the inertia loads of the cargo and pallet. The postcrash configuration of this cargo installation is shown in the sketch of Figure 61. Approximately one-fourth of the boxes of cargo used for this load suffered no damage whatsoever, while approximately one-half were torn but not destroyed. Only four boxes of cargo were completely ripped apart. One buckle on a load carrying strap, Figure 62, failed. Figure 63 shows the forward tiedown ring on the pallet which was deformed forward by the load applied to this strap.

FIG. 63 FORWARD DEFORMATION OF PALLET CARGO NET  
TIEDOWN RING SHOWN WITH NET HOOK STILL  
ATTACHED

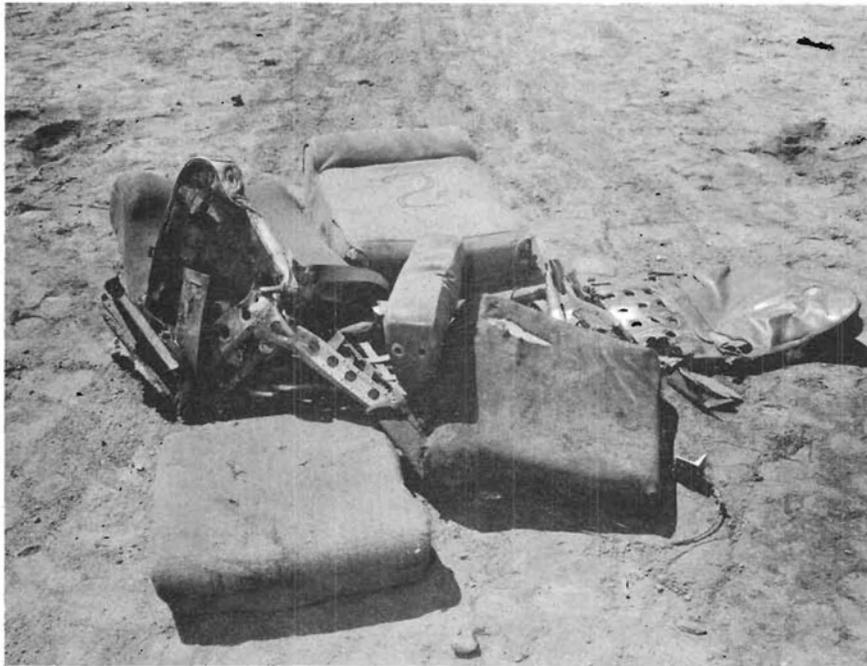
The two forward seats of this group of three were torn loose from their mountings and were found entangled in the wreckage of the forward fuselage section. The postcrash conditions of these seats is shown in Figures 66 and 67. The first seat was struck by the propeller blade from No. 3 engine. In addition, the fuselage broke just forward of the seat location and the walls of the fuselage, next to the seats, were buckled outward and crushed. The wall attachment for the forward seat pulled out of the wall fitting. The second seat ripped out the fitting and the intercostal to which it was attached.

FIG. 67 CENTER SEAT OF FORWARD CABIN DC-7  
PASSENGER SEAT EXPERIMENT

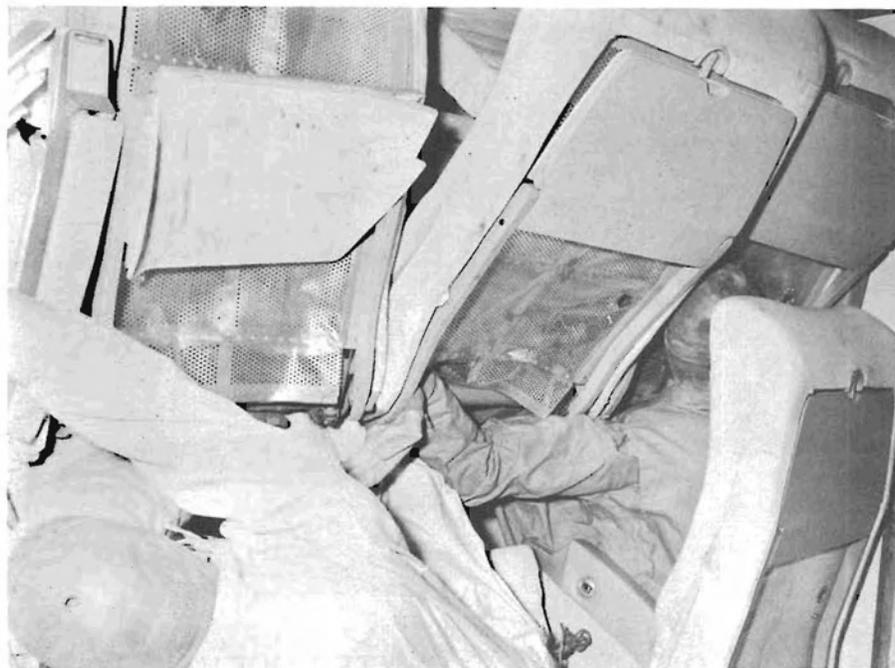
FIG. 69 VIEW SHOWING DAMAGE TO BACKS OF UN-OCCUPIED THREE PASSENGER FORWARD FACING SEATS CAUSED BY CONTACT WITH DUMMIES (PICTURE ROTATED 90° CLOCKWISE)

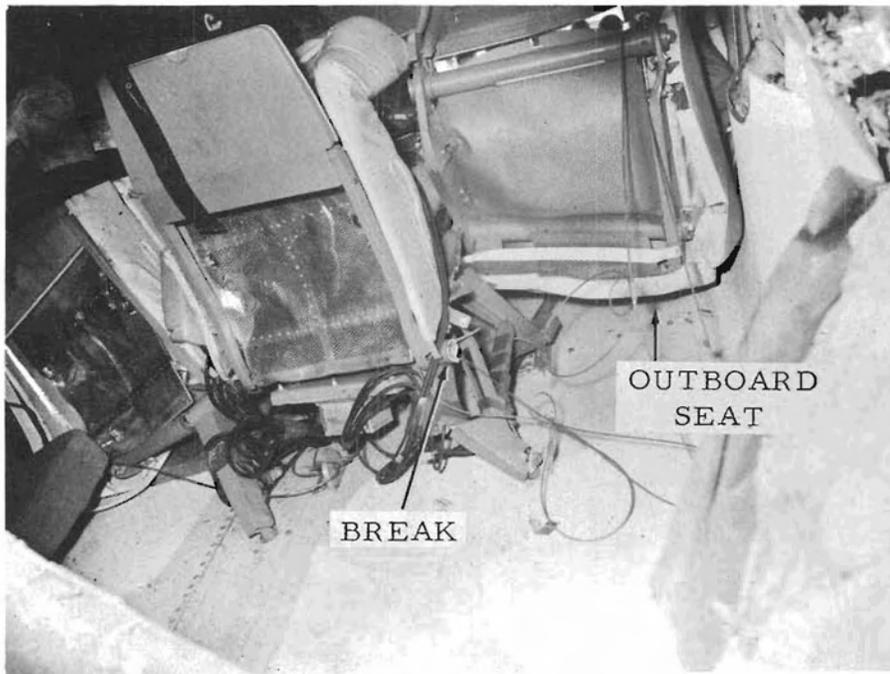
FIG. 70 POSTCRASH VIEW OF OCCUPIED THREE PASSENGER FORWARD FACING SEATS LOOKING FORWARD, SHOWING FORWARD ROTATION OF SEAT NEXT TO WALL

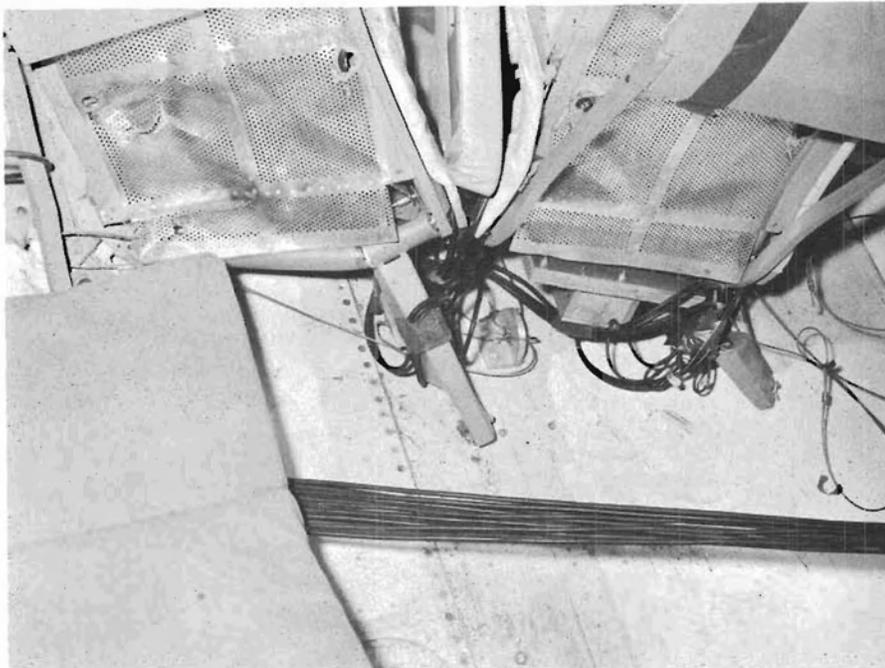
FIG. 71 REAR VIEW OF AISLE AND CENTER OCCUPIED THREE PASSENGER FORWARD FACING SEATS SHOWING FAILURE OF LATERAL TUBE THAT ALLOWED AISLE SEAT TO DEFLECT DOWNWARD TOWARD AISLE (PICTURE ROTATED 90° CLOCKWISE)

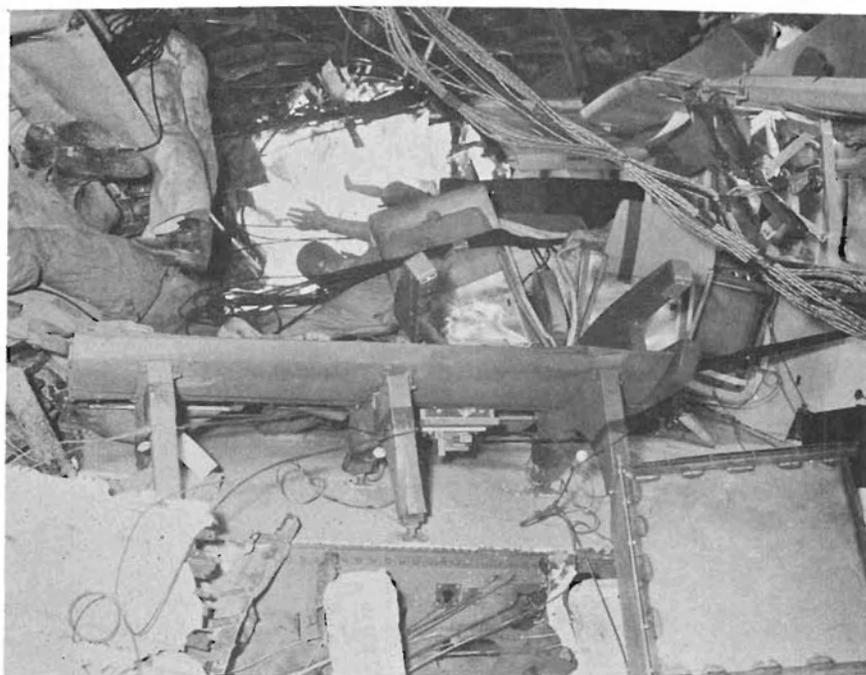
although all three lap belts remained fastened. The three seat back locks, small hydraulic cylinders, all failed in a similar manner - at the point indicated in Figure 79. The seat leg to floor attachments held throughout the crash and the energy absorbers located in the aft legs were attenuated. The general condition of the seat is shown in Figures 77 and 78.

FIG. 77 POSTCRASH CONDITION OF TRIPLE REARWARD FACING SEAT, LOOKING TOWARD THE FRONT OF THE AIRCRAFT (PICTURE ROTATED 90° CLOCKWISE)

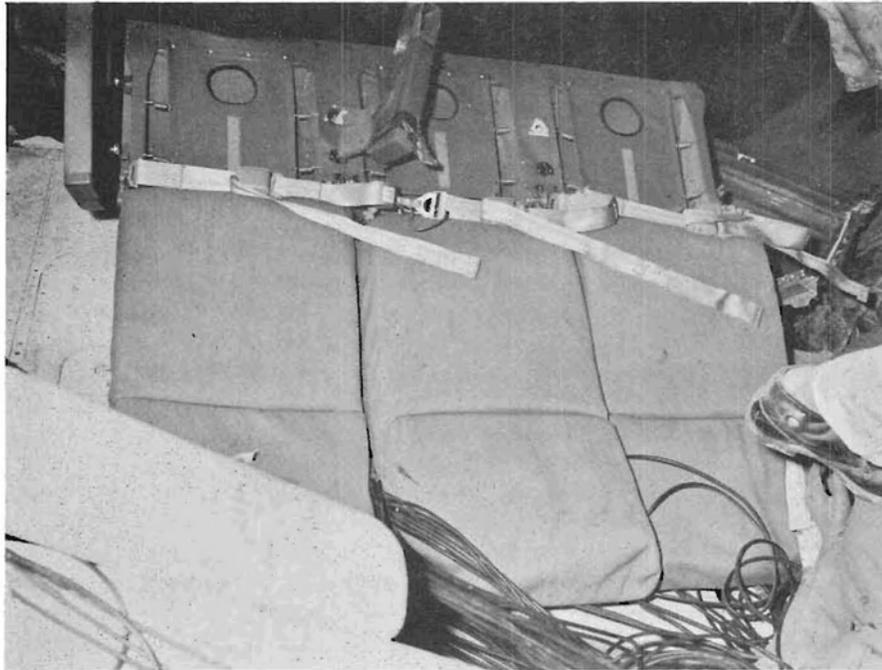
All three seat back locks failed during the crash, causing the backs to collapse and allowing the seat occupants to slide out of the seats,

FIG. 78 COLLAPSED POSITION OF SEAT BACKS OF REARWARD FACING SEAT, LOOKING AFT (PICTURE ROTATED 90° COUNTERCLOCKWISE)

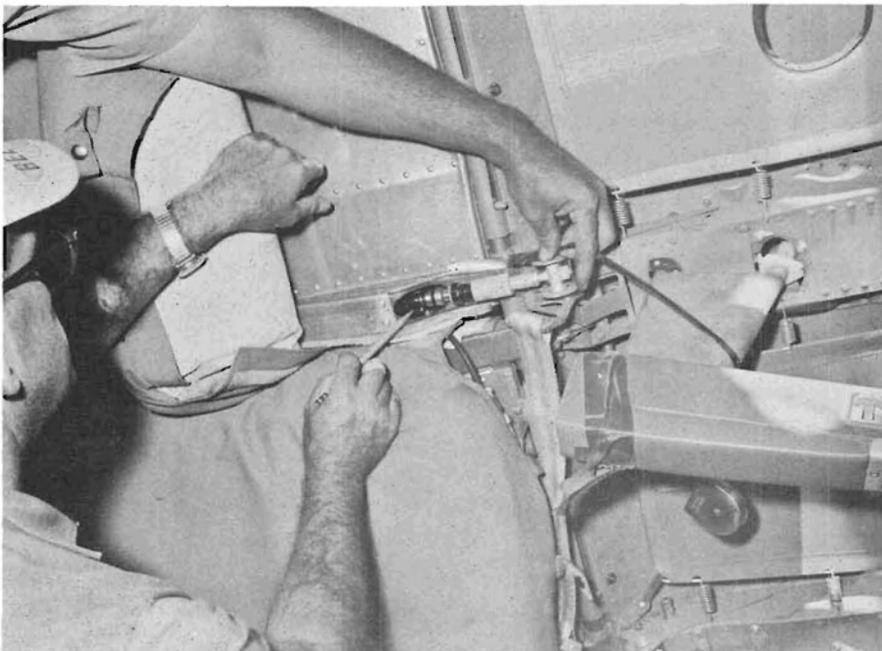
FIG. 79 EXAMINATION OF REARWARD FACING SEAT BACK LOCKS AFTER CRASH

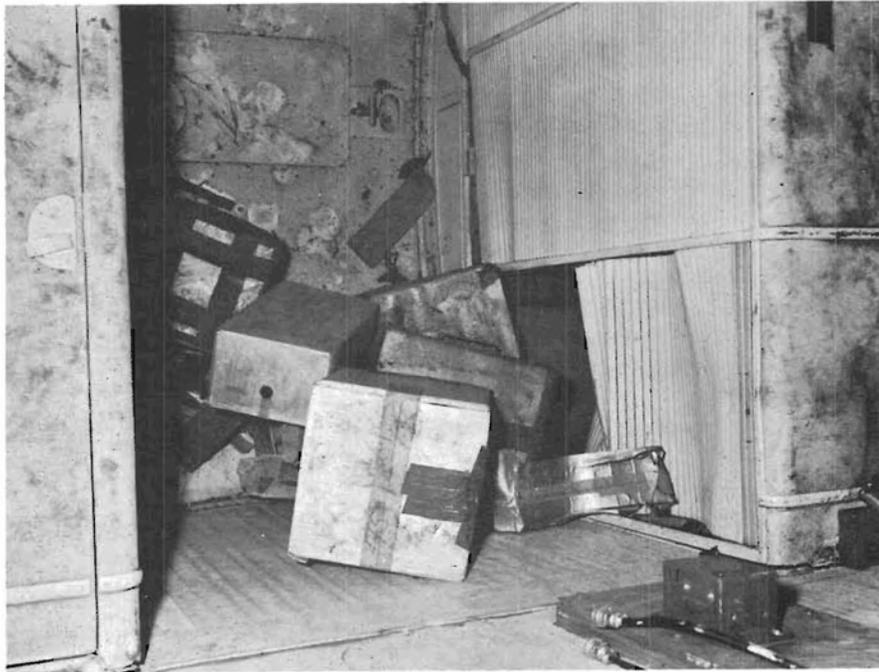
The aft section of the galley remained in place but the flexible sliding door failed when the aircraft impacted the 8 degree slope allowing the simulated galley equipment to eject and impact against the bottom of the forward galley section. All of the equipment remained in the galley area with the exception of the flexible door which moved forward to fuselage station 570. The forward galley, which was not loaded, remained in place; however, the forward bulkhead was loosened during the crash. Figures 81 and 82 show the postcrash condition of the galley and the spilled equipment.

FIG. 82 VIEW SHOWING IMPACTED FORWARD GALLEY SECTION

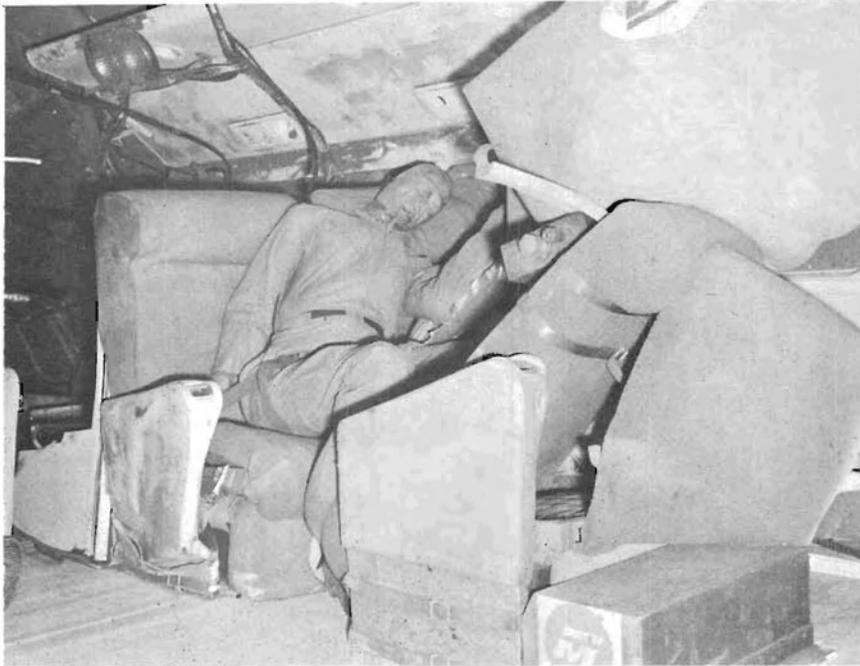
Both dummies remained in position in the aft seat, as shown in Figure 85. The lap belts were still attached and intact. The three rubber airbags that restrained the aisle dummy remained inflated. The two underseat bags restrained the dummy's feet in the normal position. The upper bag remained attached to the forward seat back, even though the seat back failed under the load applied by the dummy when the aircraft impacted the 8 degree slope. This failure allowed the chest bag to rotate out of position as shown in Figures 86 and 87.

FIG. 86 OVERALL VIEW OF AIRBAG RESTRAINT EXPERIMENT  
(PICTURE ROTATED 90° COUNTERCLOCKWISE)

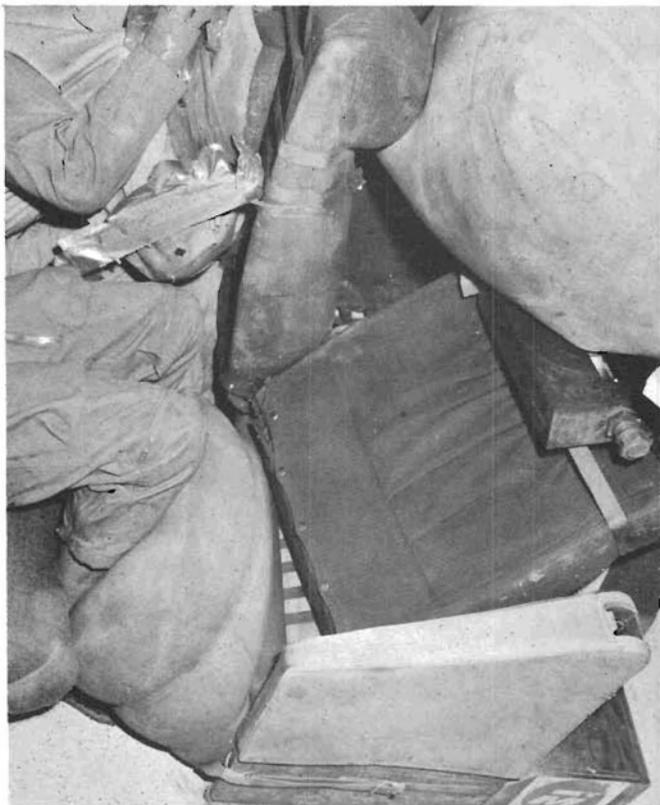
FIG. 87 SEAT BACK  
FAILURE THAT  
CAUSED CHEST  
AIRBAG TO  
ROTATE OUT OF  
POSITION

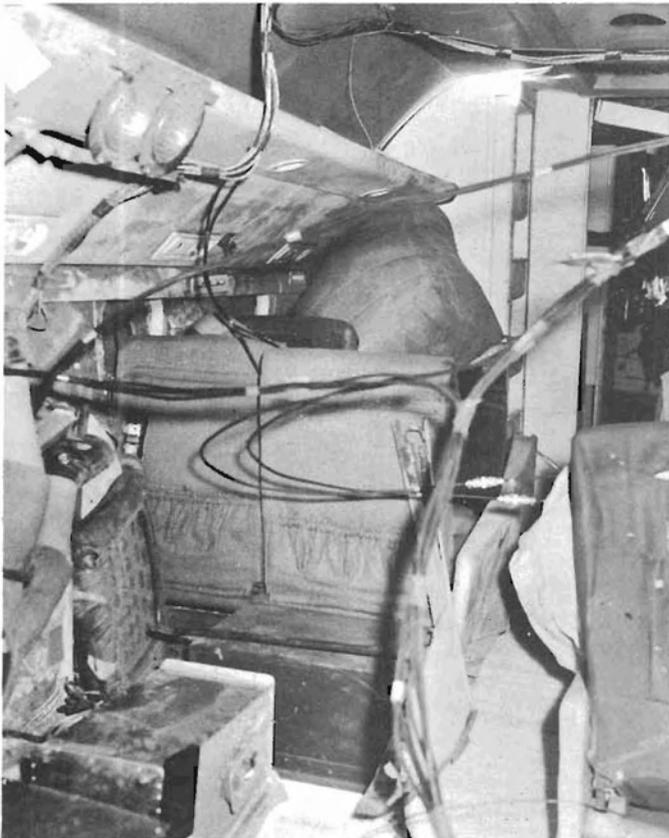
Figure 88 is a postcrash rear view of the airbag experiment, showing the rotated bag lodged against the aft galley partition. The plastic airbag installed in front of the dummy next to the wall split along the inboard aft seam during impact. This 15-inch tear allowed rapid deflation and allowed the dummy's head to strike the back of the seat ahead. Figure 85 shows the dummy after the crash with his head positioned against the fitting box for the clear plastic bag. The occupied seat remained attached to the floor. The aft wall attachment held; but the forward wall fitting failed, allowing the forward seat structure next to the wall to deflect downward.

FIG. 88 POSTCRASH REAR  
VIEW OF AIRBAG  
EXPERIMENT  
(PICTURE ROTA-  
TED 90° CLOCK-  
WISE)

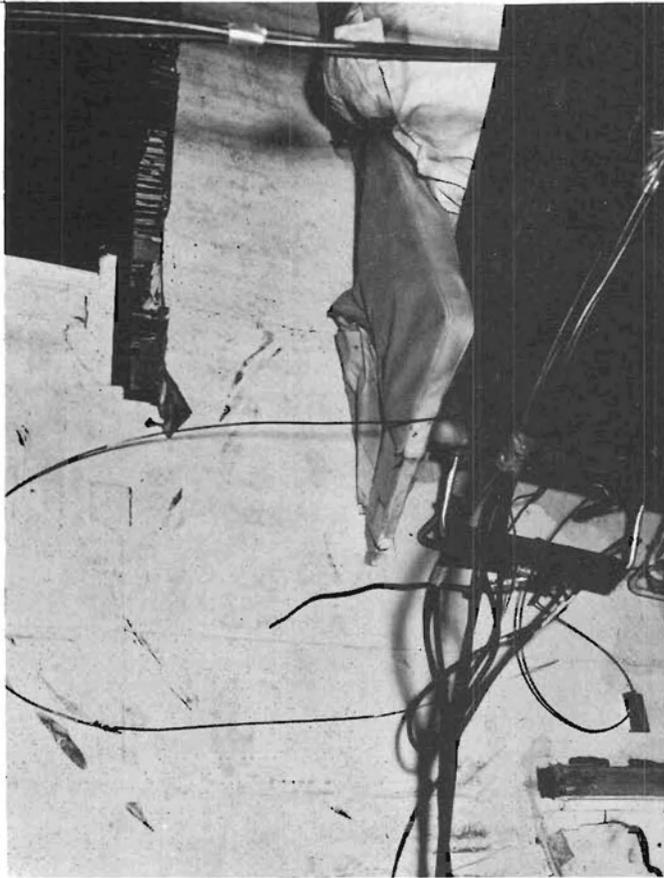
FIG. 90 FORWARD  
CRUSHING OF  
AISLE SEAT LEG  
STRUCTURE  
(PICTURE ROTA-  
TED 90° CLOCK-  
WISE)

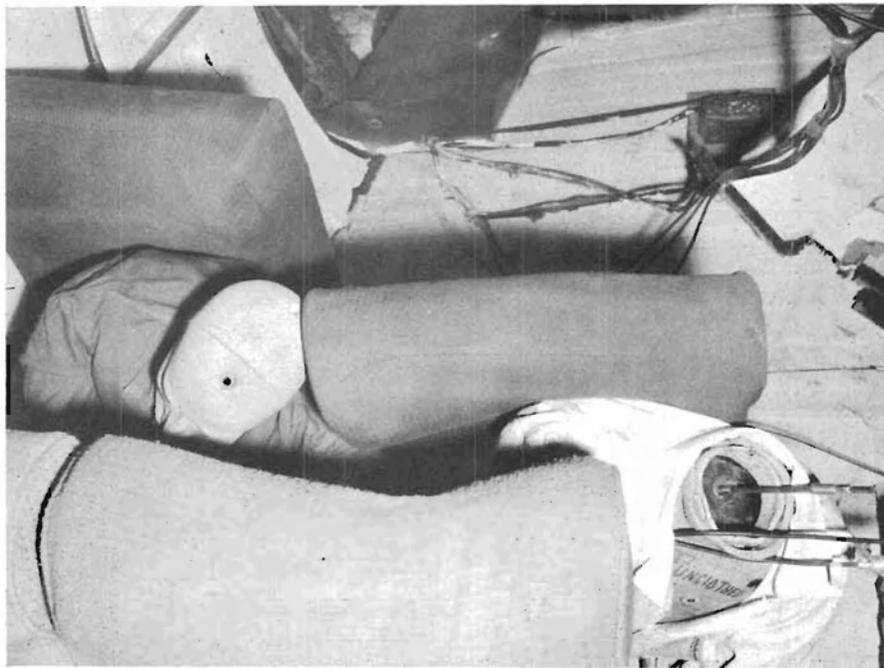
FIG. 91 HEAD LOSS EXPERIENCED BY AISLE DUMMY, LOOKING  
DOWN ON THE SEAT AND DUMMIES  
(PICTURE ROTATED 90° COUNTERCLOCKWISE)

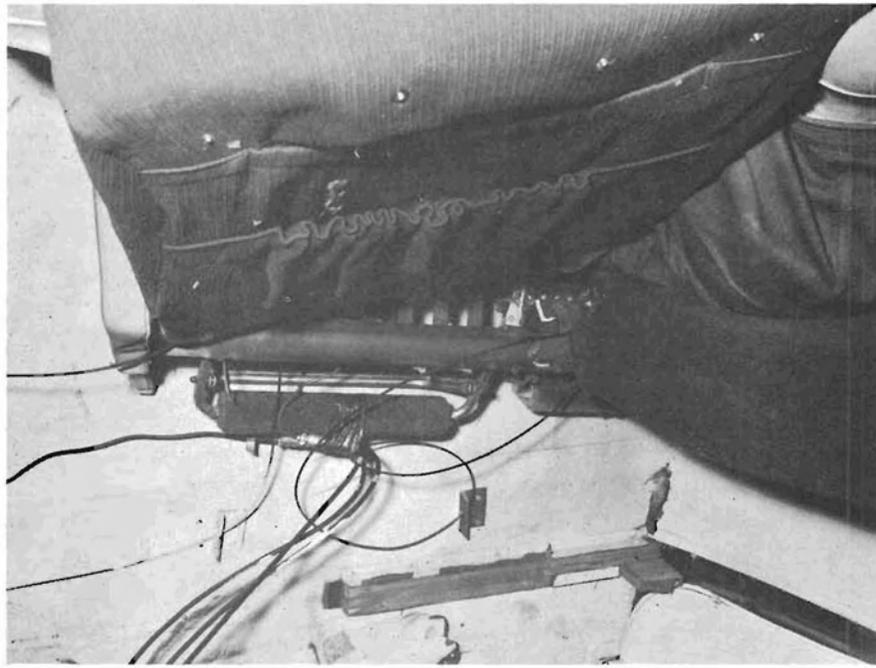
FIG. 92 SEAT BACK SEPARATION IN AISLE SEAT

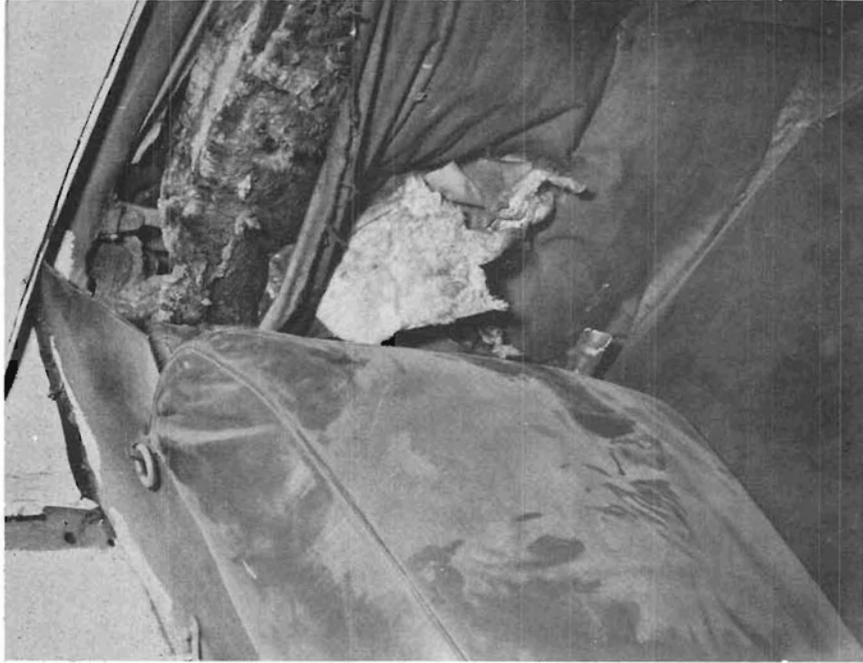
The seat was considerably deformed by the loading encountered during the crash. The forward wall attachment was bent upward, as the seat forward edge was forced downward. The forward edge of the seat contacted the floor and remained 1-1/2 to 2 inches from the floor. The aisle side of the seat collapsed due to the forward and downward loads, as shown in Figures 89 and 90. Both dummies remained in their seats throughout the crash even though the lap belt attachments for the aisle seat failed. The head of the aisle dummy struck the back of the seat in front of him causing a 3-inch deep dent in the metal structure which resulted in the loss of the dummy's head. (See Figure 91) Figure 92 shows that separation occurred between the seat back and the seat pan. The legs of both dummies extended under the forward seat. The legs of the aisle dummy extended under the seat up to his knees whereas the legs of the dummy next to the wall only extended under the forward seat midway between the ankles and the knees.

FIG. 94 POSTCRASH CONDITION OF SIDE FACING  
LOUNGE SEAT
