APPENDIX C—DESTRUCTIVE ANALYSIS OF JT9D TURBINE EXHAUST CASE (TEC)

Two JT9D-7 TECs (Turbine Exhaust Case) were available for this investigation (see section 2.1.4). Case S/N CD8893 was selected for cut up analysis. This case had been operated by Japan Airlines for 63,887 hours and 12,934 cycles. Metallographic samples were removed from the outer ring front flange, rails, mount lugs, and rear flange and from the case walls at the forward, middle, and rearward wall sections. Samples were also removed from one of the struts, the inner ring walls and inner ring flanges. Examples of the assembly welds were also examined. Besides examining general microstructure and possible defects, hardness measurements were made at several of the locations.

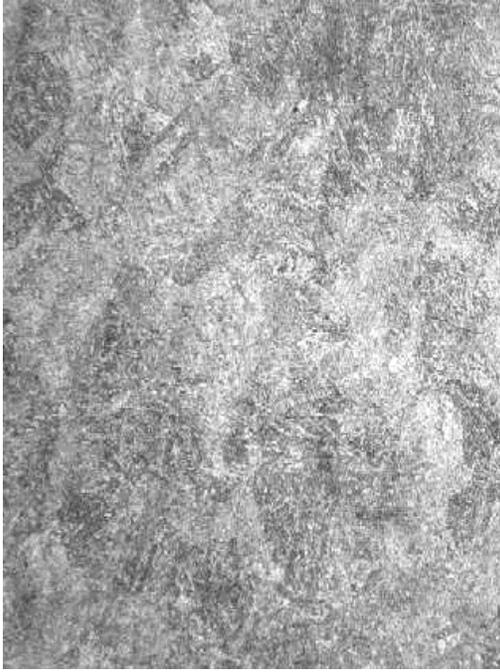
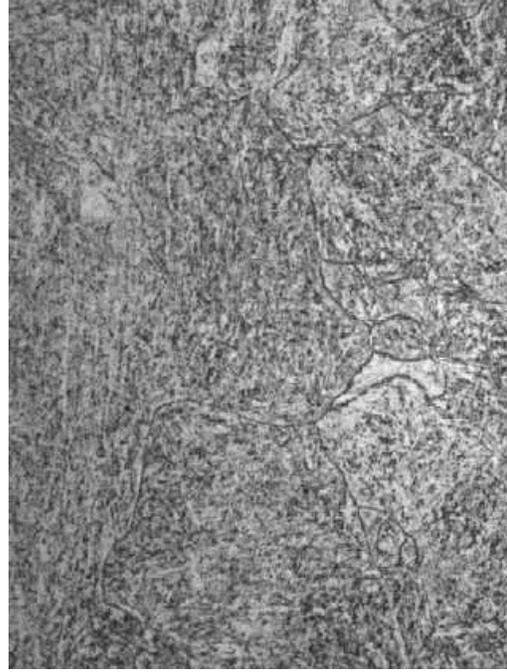
FIGURE C-1. GENERAL MICROSTRUCTURE OF JT9D TURBINE EXHAUST CASE OUTER FLANGE

The coarser grain and sensitized microstructure of the outer ring is attributed to its size and the heat treat procedures used with the case. The outer ring is substantially thicker in cross section than the inner ring and sheet metal struts. It would be expected that this hot-rolled ring forging would display a relative coarse grain relative to the thin sheet details and smaller thinner inner ring. Multiple tempers may lead to a sensitized microstructure, but the other case details would also be affected. The more probable cause is that the case experienced a more than typical slower cool from solution than experienced with test material. Most test material, including that used in this program, is hardened by a liquid quench from the solution temperature. However, large structural assemblies such as the TECs cannot be liquid quenched because they would experience severe distortion. Typically the TECs are solution heat treated followed by a forced gas cool, which is not as fast as a liquid quench. The forced gas cool most probably produced the sensitized microstructure. Quantitative metallography was not performed on the case samples, but qualitatively, the outer ring forward areas appeared to be more sensitized than the other case areas. These areas are the hottest operating and the microstructure may reflect this fact. Delta ferrite and other stringers were observed but not to any great degree.

Outer Ring Front Flange 100X

Outer Ring Front Flange 500X

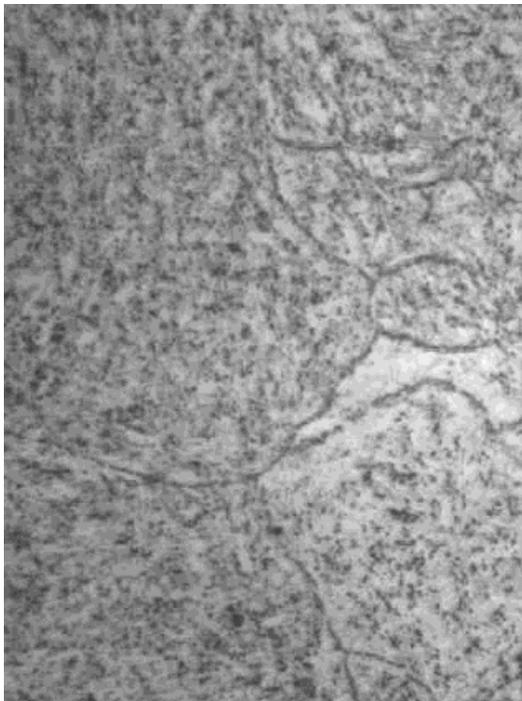
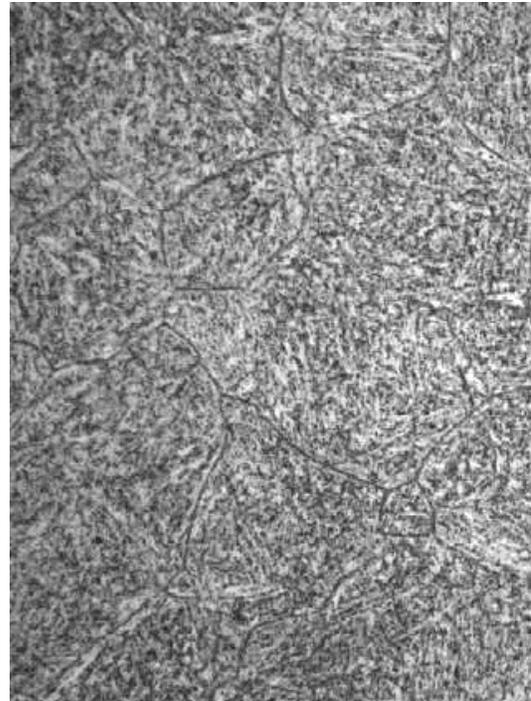
FIGURE C-2. GENERAL MICROSTRUCTURE OF JT9D TURBINE EXHAUST CASE OUTER RING FRONT FLANGE AND FRONT WALL

Outer Ring Front Flange 1000X

Outer Ring Front Wall 500X

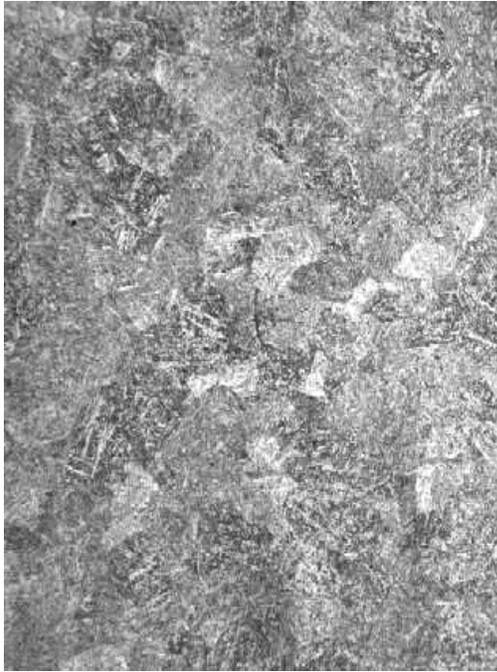
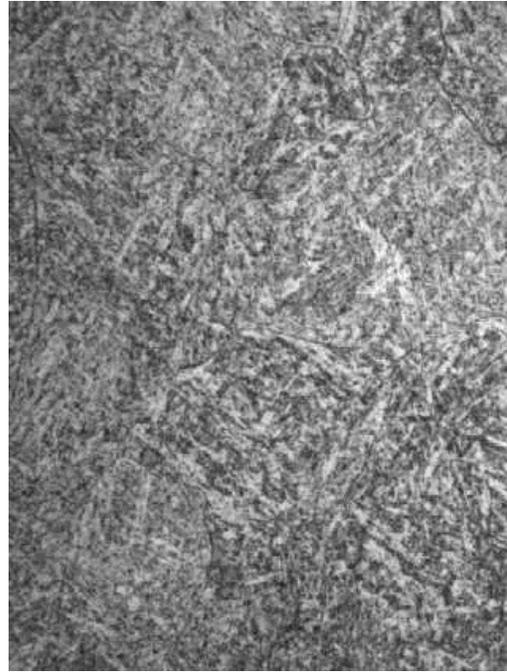
FIGURE C-3. GENERAL MICROSTRUCTURE OF JT9D TURBINE EXHAUST CASE OUTER RING MID-WALL

Outer Ring Mid-Wall 100X

Outer Ring Mid-Wall 500X

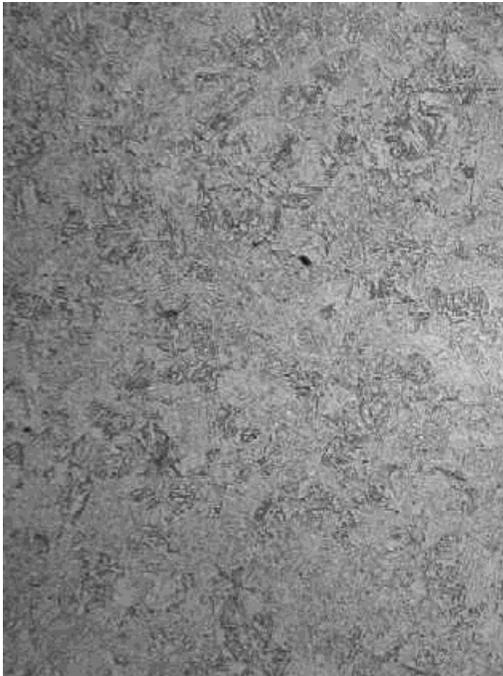
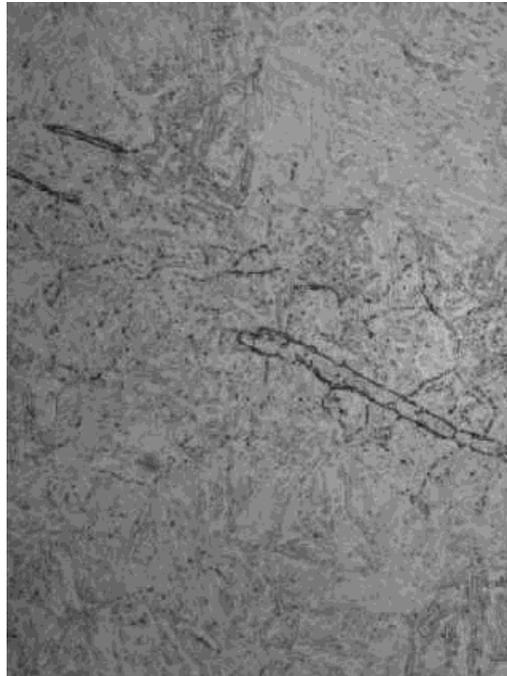
FIGURE C-4. GENERAL MICROSTRUCTURE OF JT9D TURBINE EXHAUST CASE OUTER RING REAR RAIL

Outer Ring Rear Rail 100X

Outer Ring Rear Rail 500X

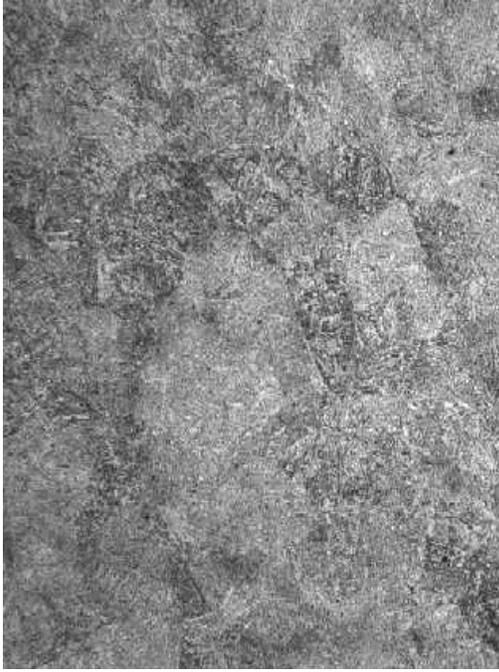
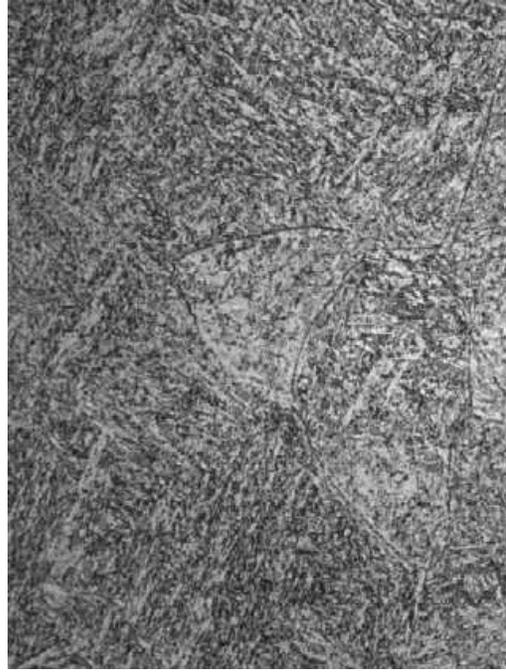
FIGURE C-5. GENERAL MICROSTRUCTURE OF JT9D TURBINE EXHAUST CASE OUTER RING MOUNT LUG

Outer Ring Mount Lug 100X

Outer Ring Mount Lug 500X

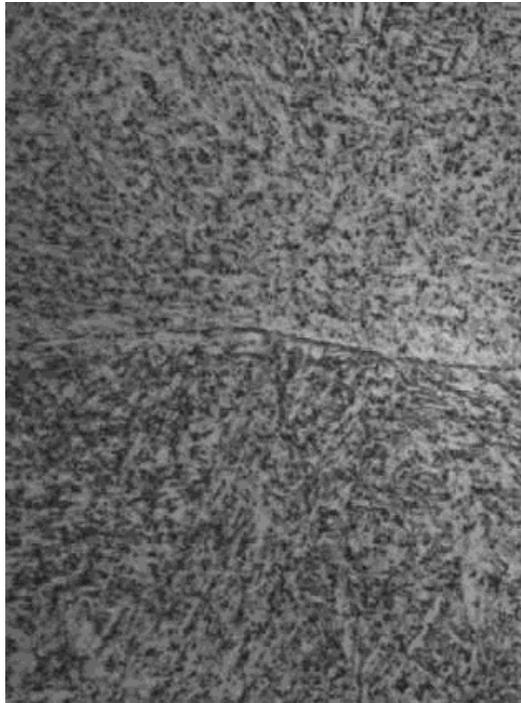
FIGURE C-6. GENERAL MICROSTRUCTURE OF JT9D TURBINE EXHAUST CASE OUTER RING MOUNT LUG

Outer Ring Mount Lug 1000X

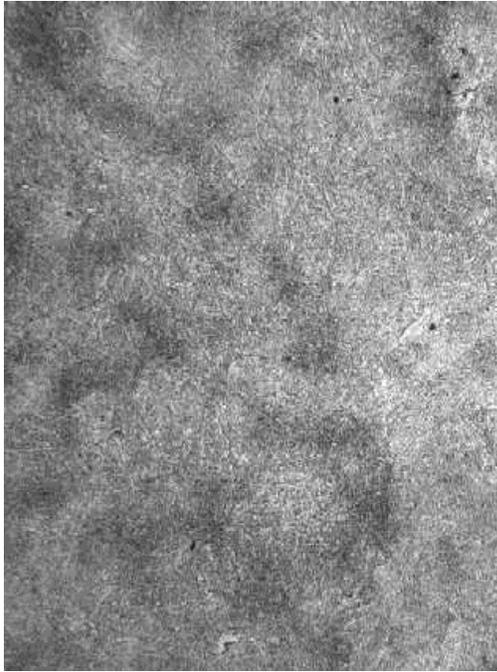
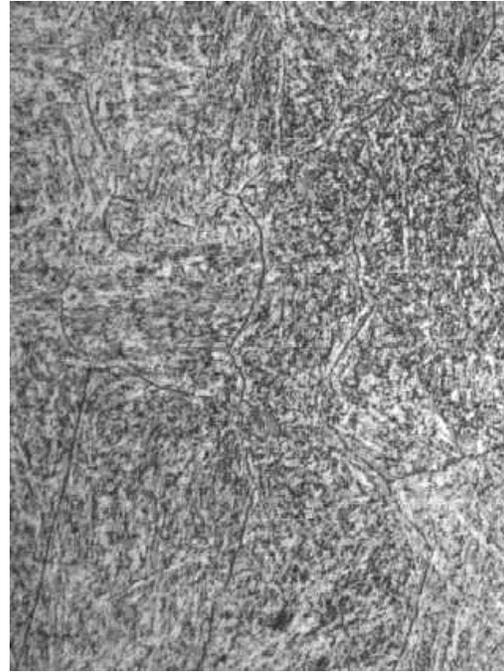
FIGURE C-7. GENERAL MICROSTRUCTURE OF JT9D TURBINE EXHAUST CASE OUTER RING REAR WALL

Outer Ring Rear Wall 100X

Outer Ring Rear Wall 500X

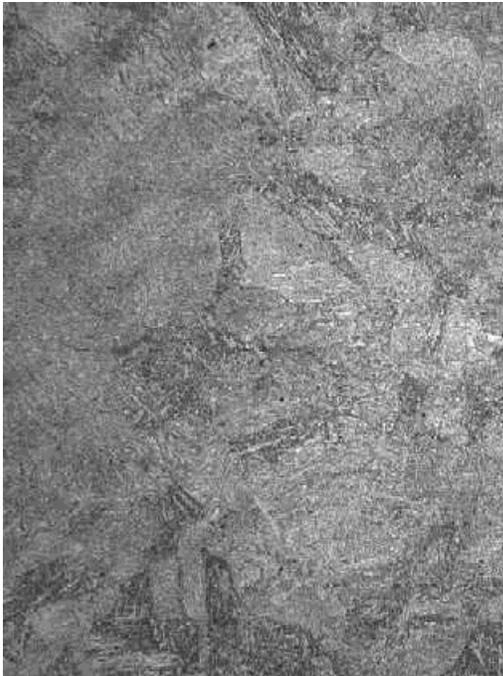
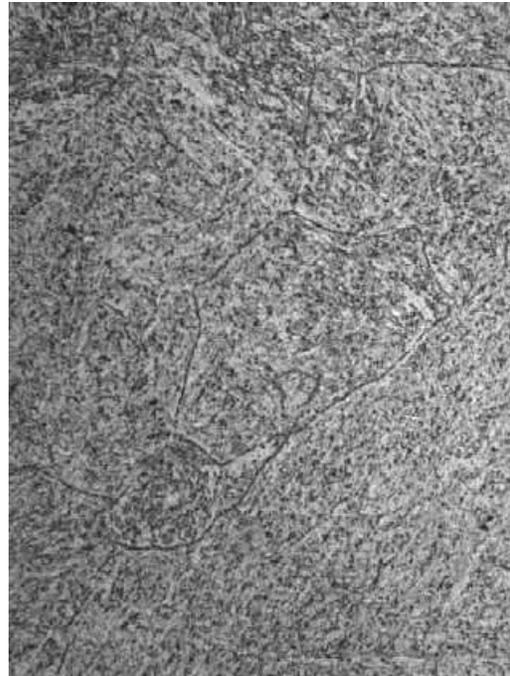
FIGURE C-8. GENERAL MICROSTRUCTURE OF JT9D TURBINE EXHAUST CASE OUTER RING REAR FLANGE

Outer Ring Rear Flange 100X

Outer Ring Rear Flange 500X

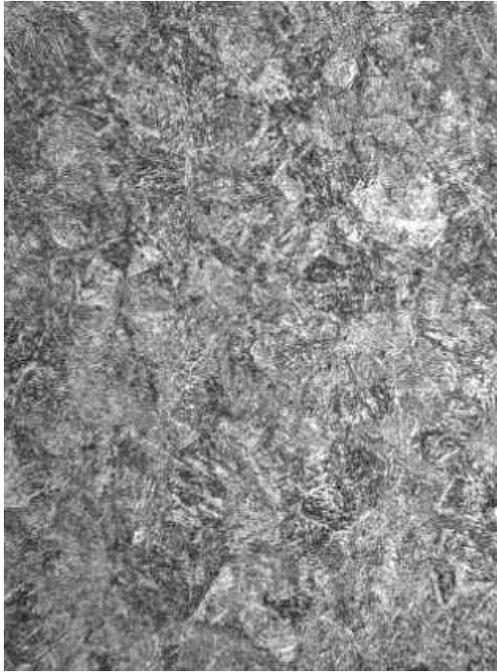
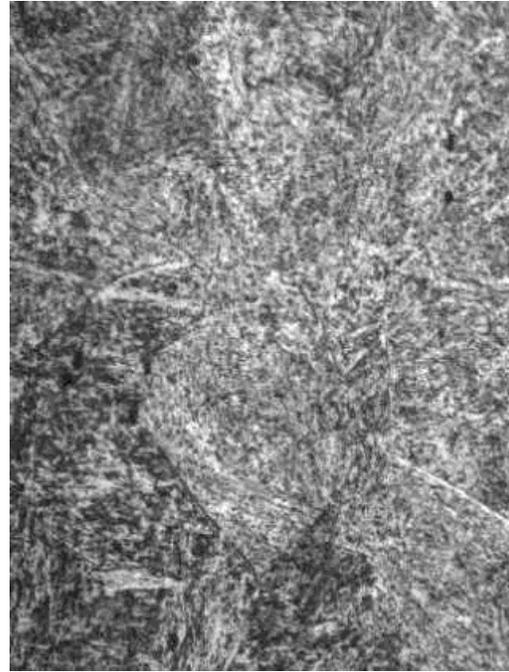
FIGURE C-9. GENERAL MICROSTRUCTURE OF JT9D TURBINE EXHAUST CASE INNER RING MID-WALL

The inner ring and struts displayed typical martensitic structure with the strut sheet material (AMS 5596) having a measurably finer grain size than the inner ring. Strut-to-case attachment welds were even finer grained. Deep notches were discovered at the strut/case attachment welds within the hollow struts. It is not known if these were present at completion of construction of the case as a new assembly or occurred subsequent to initiation of commercial service. The microstructure of the outer ring displayed a more sensitized like microstructure with grain boundaries that are heavily decorated with carbides. The grain structure of the outer ring was also coarser than the inner ring. No significant difference in microstructure was observed among different areas of the same detail, suggesting that whatever differences in temperature exposure that may have existed during engine operation, they were sufficiently similar as to not create microstructural differences.

Inner Ring Mid-Wall 100X

Inner Ring Mid-Wall 500X

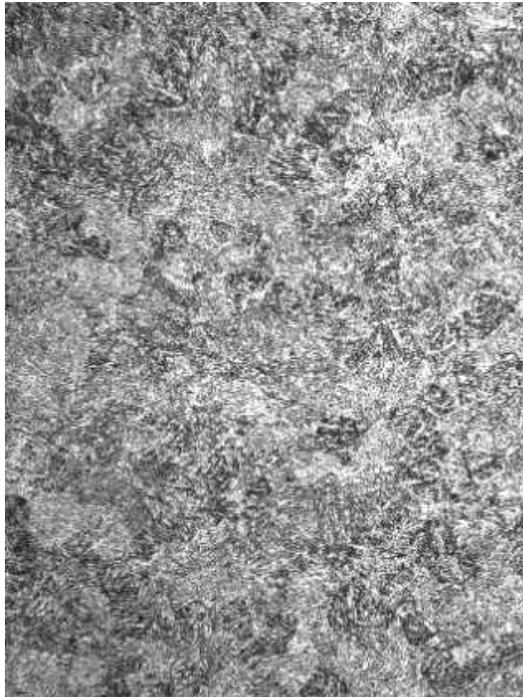
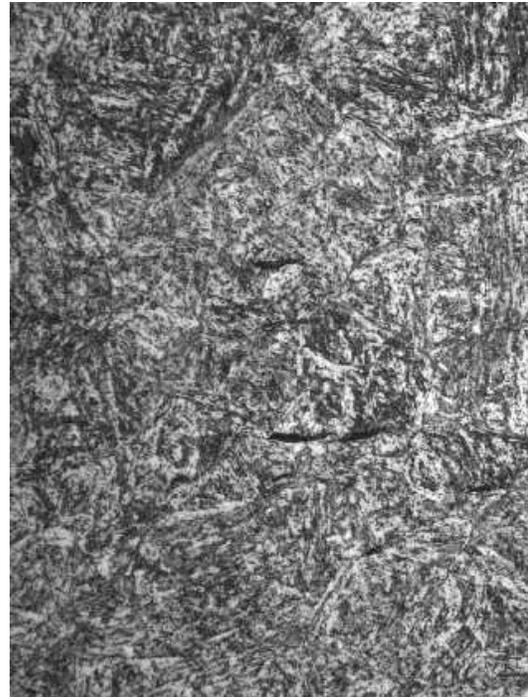
FIGURE C-10. GENERAL MICROSTRUCTURE OF JT9D TURBINE EXHAUST CASE OUTER RING REAR WALL

Inner Ring Rear Wall 100X

Inner Ring Rear Wall 500X

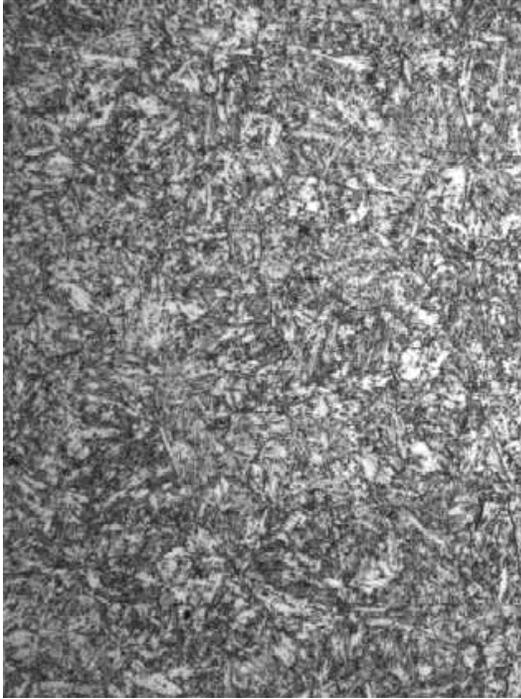
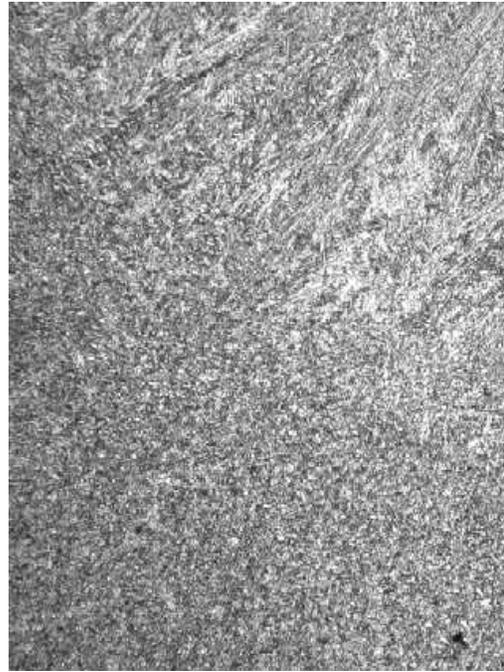
FIGURE C-11. GENERAL MICROSTRUCTURE OF JT9D TURBINE EXHAUST STRUT

Strut Sidewall 500X

Strut (lower left) Weld 100X

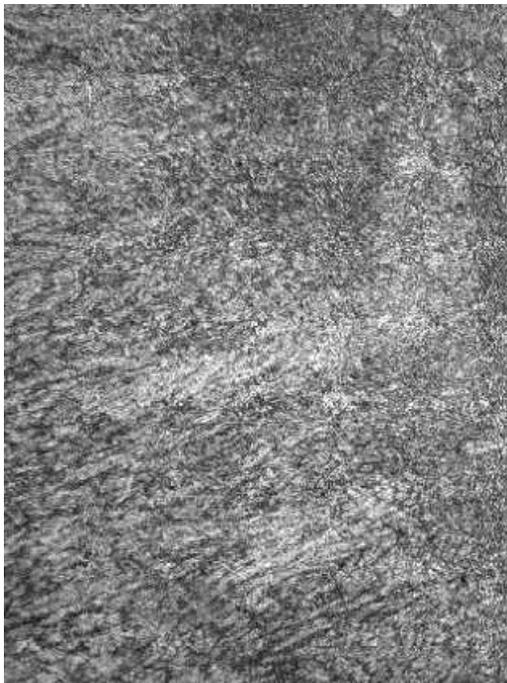
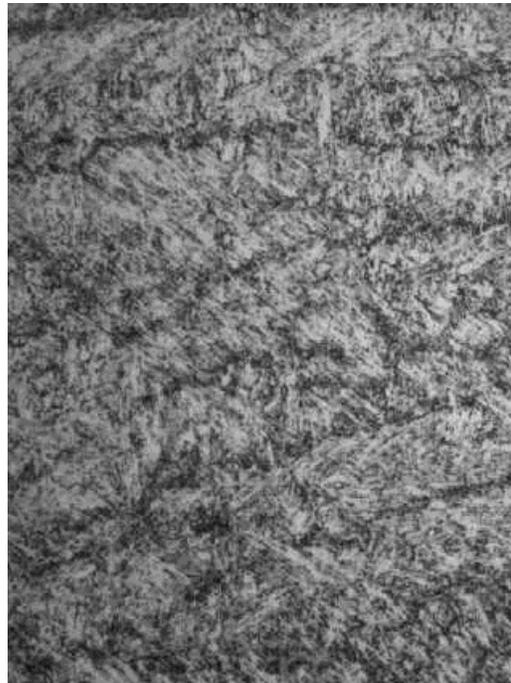
FIGURE C-12. GENERAL MICROSTRUCTURE OF JT9D TURBINE EXHAUST CASE WELD

Case (upper right) Weld 100X

Typical Weld 500X

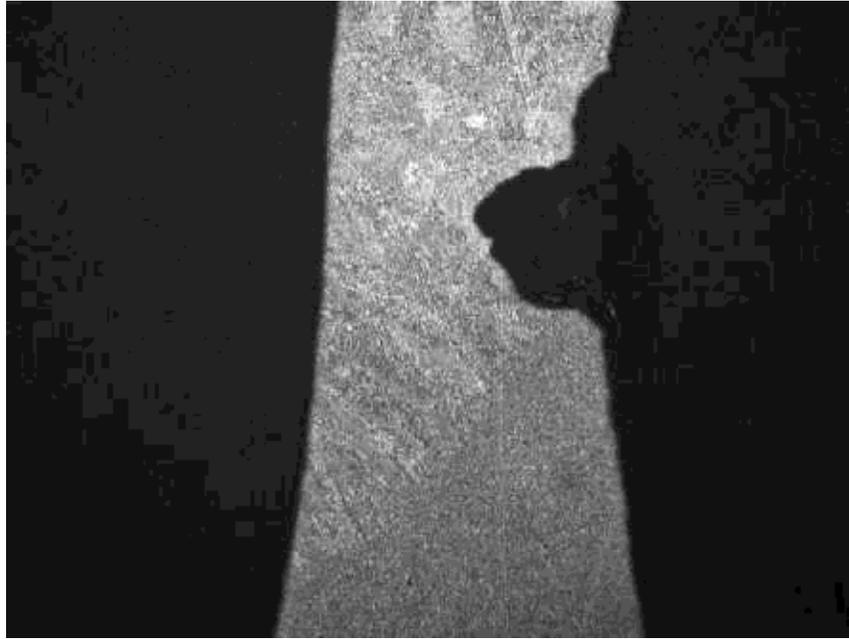
FIGURE C-13. GENERAL MICROSTRUCTURE OF JT9D TURBINE EXHAUST CASE LOWER STRUT/CASE WELD

Strut (lower)/Case Weld

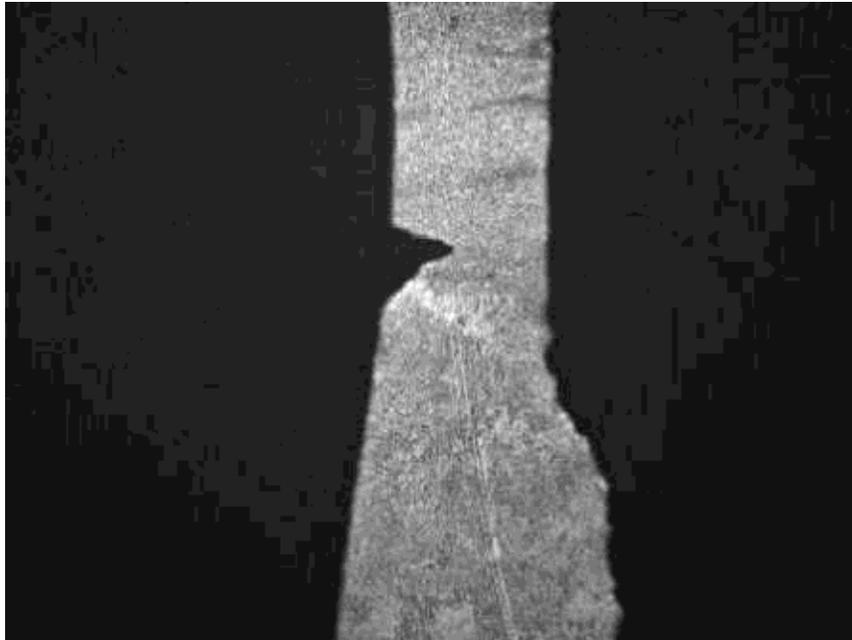
FIGURE C-14. GENERAL MICROSTRUCTURE OF JT9D TURBINE EXHAUST CASE UPPER STRUT/CASE WELD

Strut (Upper)/Case Weld
