DOT/FAA/AR-07/64

Teardown Evaluation of a 1975 Piper Navajo Chieftain Model PA31-350 Airplane

March 2008

Final Report

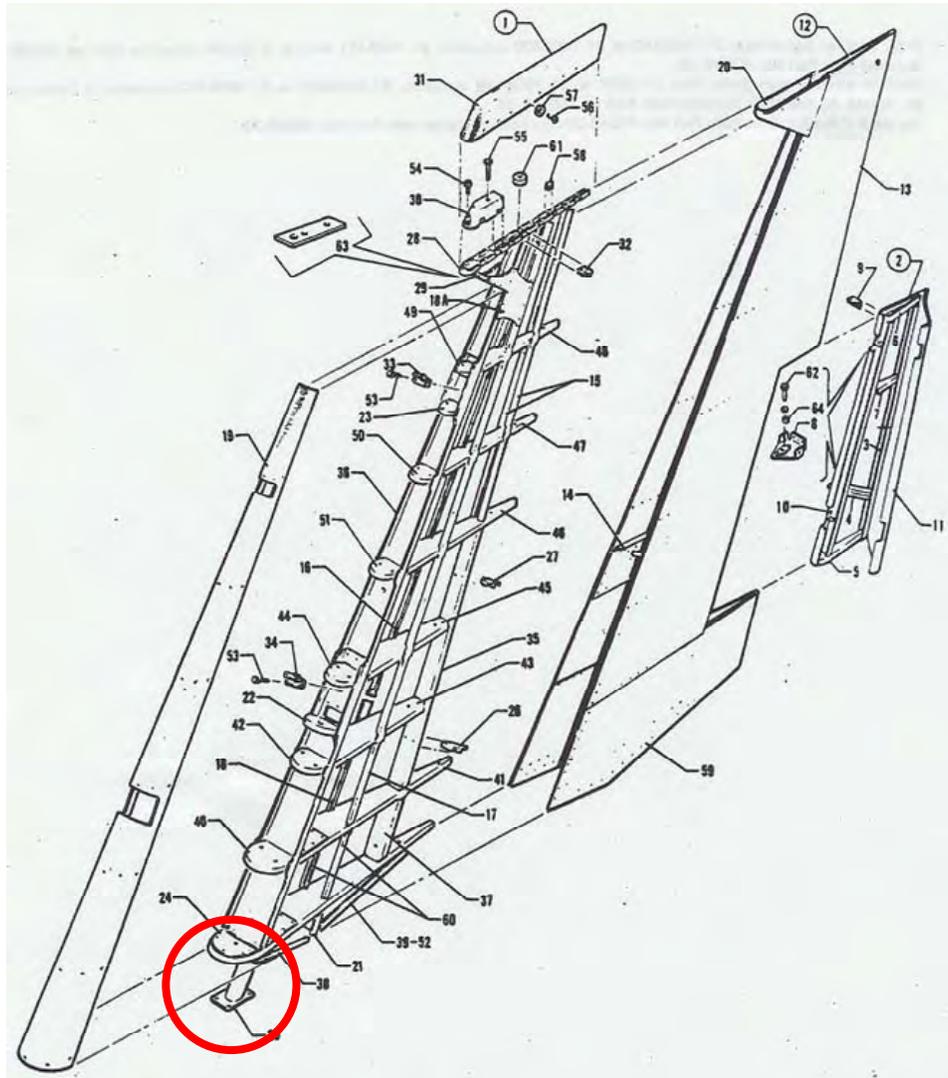
Figure 19. Location of the Rudder Torque Tube

The location of the rudder torque tube, part number 40040-09, is shown in figure 19. Figure 20 shows corrosion of the rudder torque tube at FS 342.25, WL 20, and BL 0. Figure 21 shows the location of a chafed coaxial cable, while figure 22 shows chafing of the coaxial cable by the aileron trim tab control cables at FS 84, WL 17, and BL 0. The location of the nose landing gear oleo strut housing, part number 40273-00, is shown in figure 23. A 1-inch crack, located at FS 25, WL 32, and RBL 2, began near the steering stop, as shown in figure 24. The survey of the airplane maintenance records revealed that numerous reports have been made of similar damage fleet-wide due to improper towing procedures and exceeding the turn limitations of the airplane.

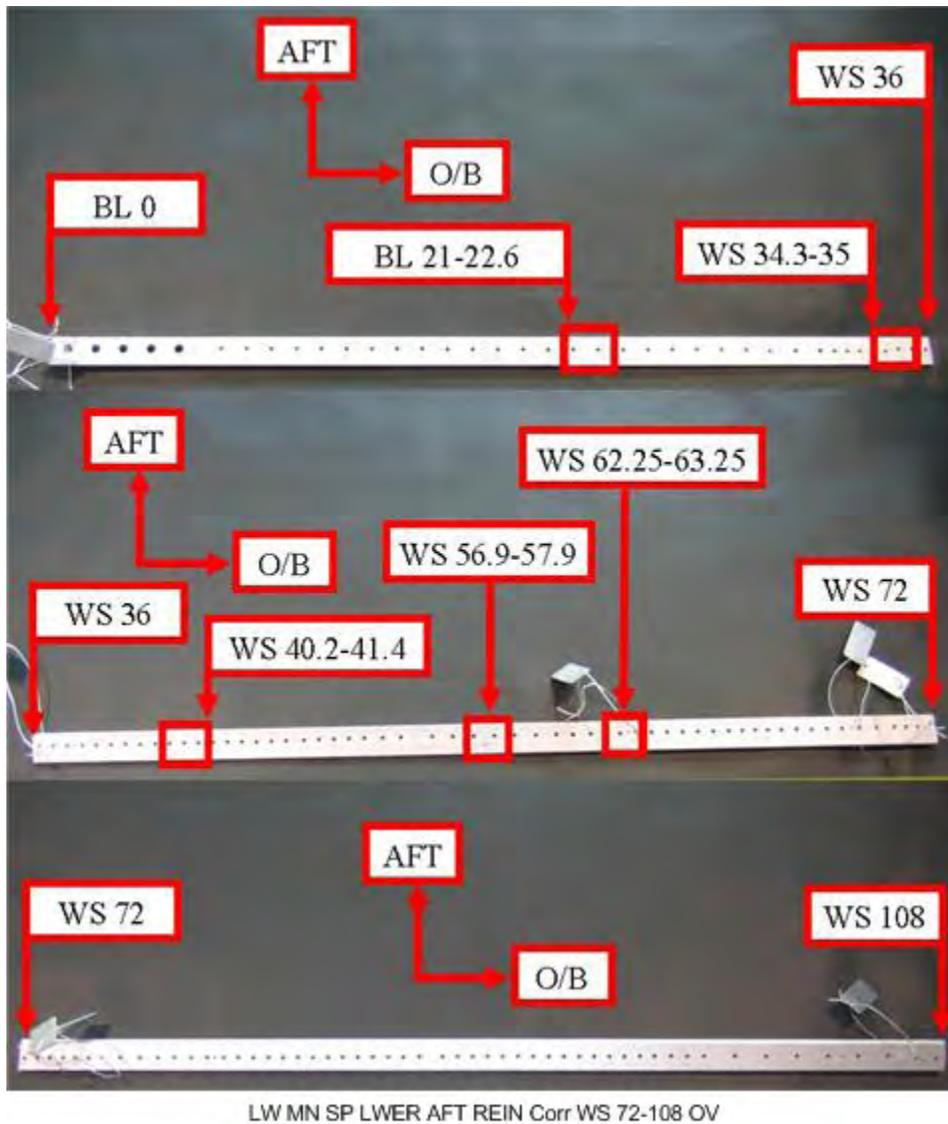
Figure 122. Locations of Moderate and Moderate-Severe Corrosion and Overview of Left Wing Main Spar Lower Aft Reinforcement BL 0 Through WS 108

in thickness of 7%. Another area of moderate-severe corrosion, causing 7% thickness loss, was observed on the lower aft reinforcement from WS 62.25 to WS 63.25. Figure 127 shows this 0.5-square-inch area of corrosion.

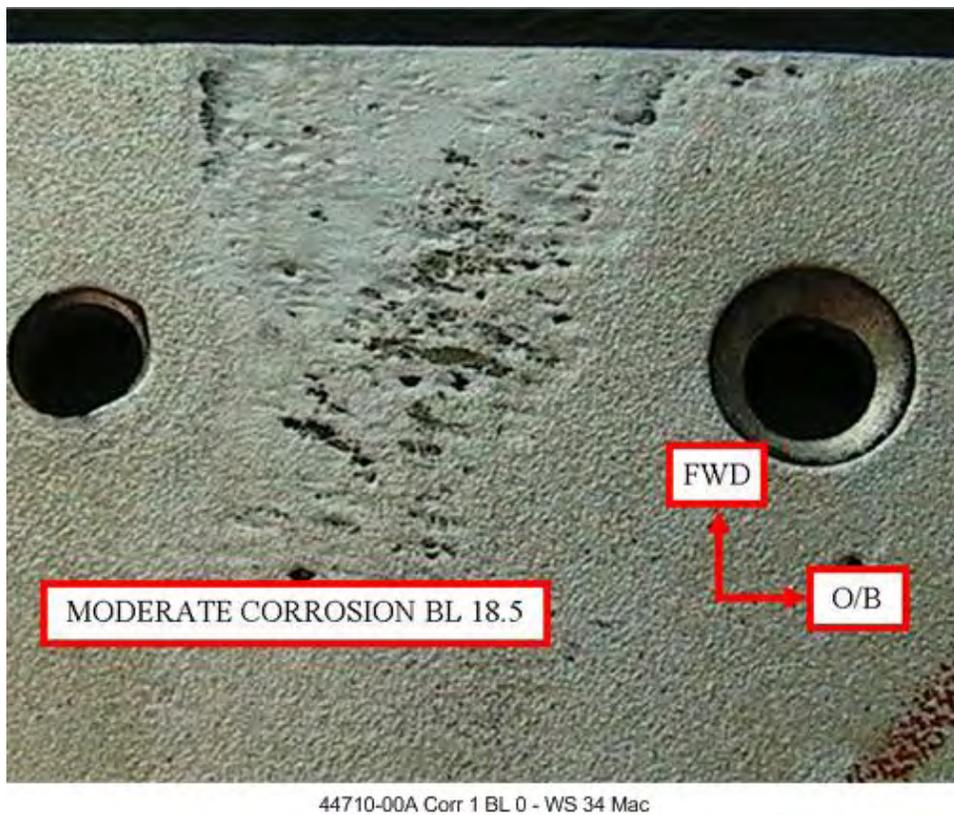
Figure 141. Macroscopic View of Moderate Corrosion on the Left Wing Plate Wing Panel Reinforcement Assembly BL 18.5

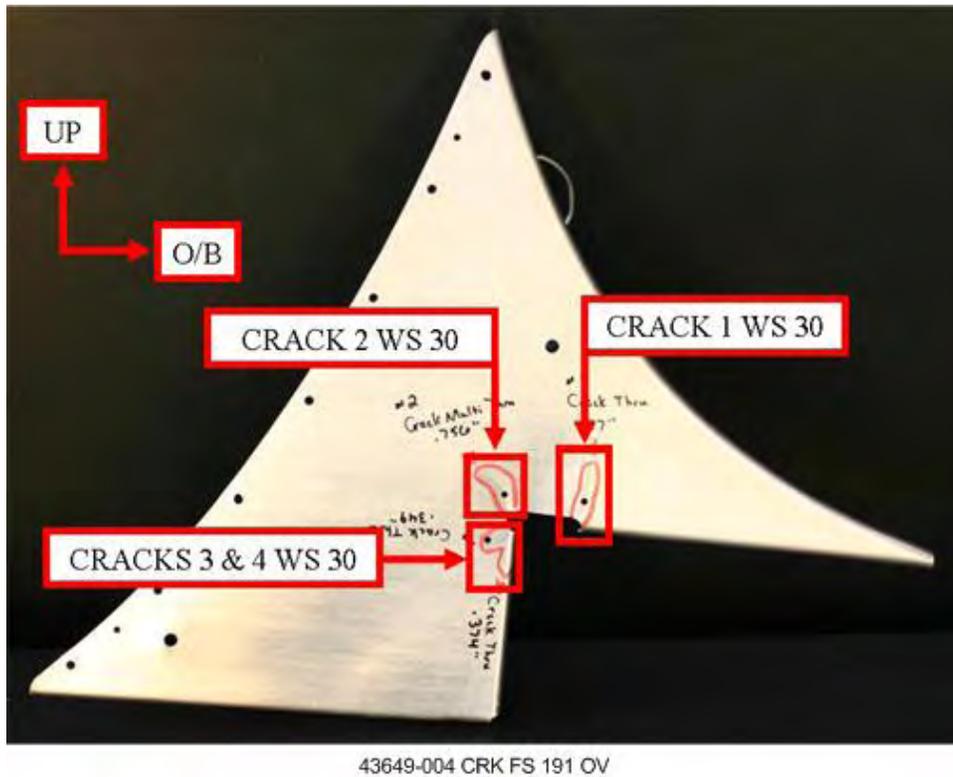
Figure 156. Location of Cracks on Left Wing Bulkhead Wing Fillet WS 30 FS 191.7

The location of four cracks on the left wing bulkhead wing fillet at WS 30 FS 191.7, part number 43646-04, is shown in figure 156. A macroscopic view of crack 1, which originated from both sides of a fastener hole and grew to a final total length of 0.77 inch, is shown in figure 157. Figures 158 and 159 show microscopic views of both branches of the crack. The macroscopic view of multiple cracks, grouped together and identified as crack 2, is shown in figure 160. This crack also occurs on both sides of a fastener hole and has a total length of 0.756 inch. Microscopic views of this crack are shown in figures 161 and 162. Figure 163 provides the macroscopic view for cracks 3 and 4. A microscopic view of crack 3, which measured 0.349 inch, is shown in figure 164, and the microscopic view of crack 4, which measured 0.374 inch, is shown in figure 165.

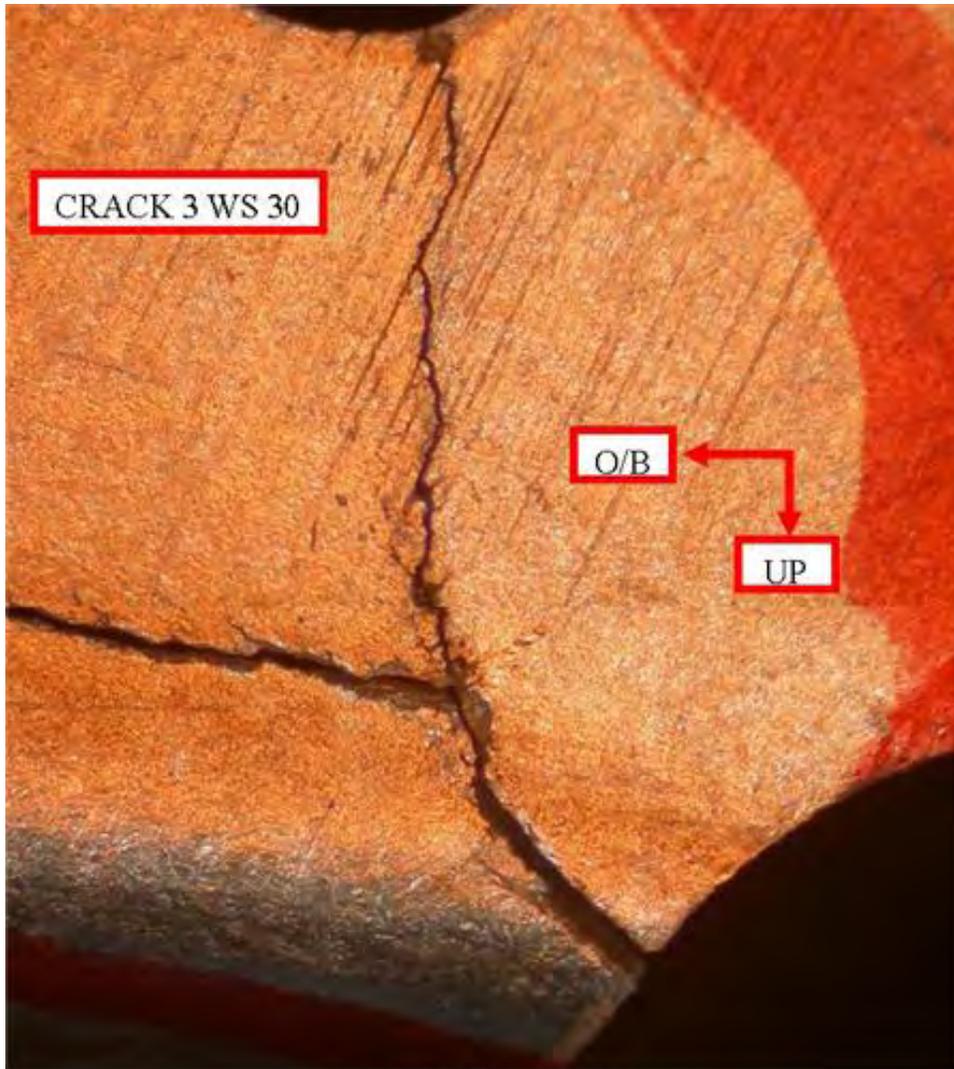
43649-004 CRK 3 FS 191 Mic

Figure 164. Microscopic View of Crack 3 on the Left Wing Bulkhead Wing Fillet
WS 30 FS 191.7

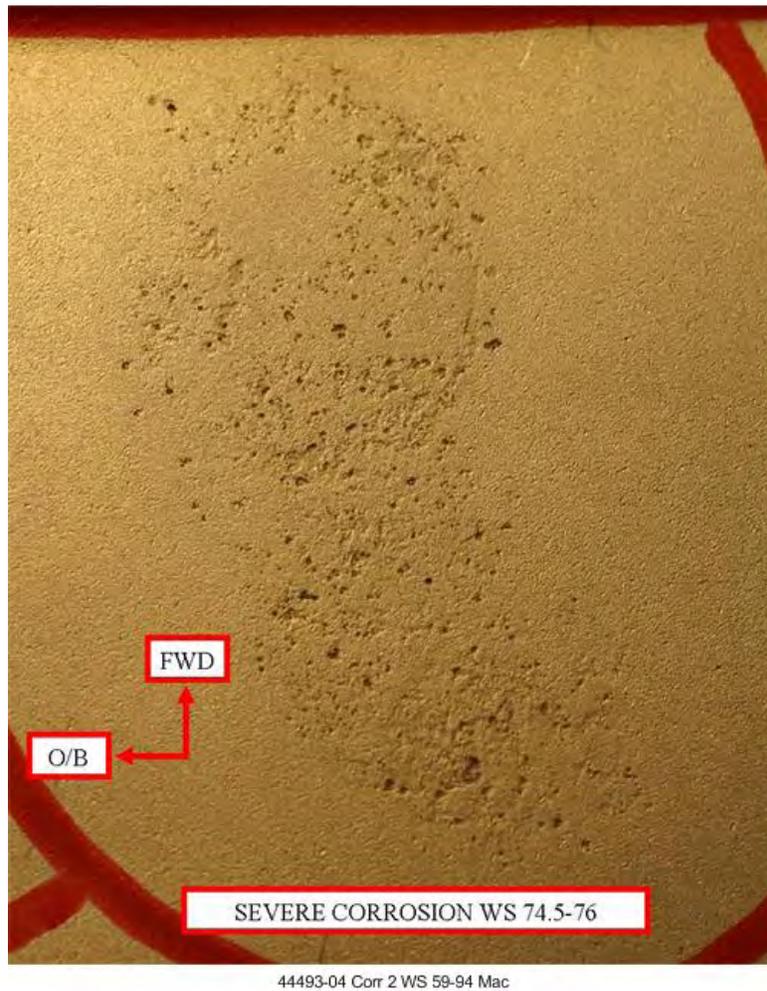
Figure 187. Macroscopic View of Severe Corrosion on the Left Nacelle Front Locker Floor WS 74.5 Through WS 76

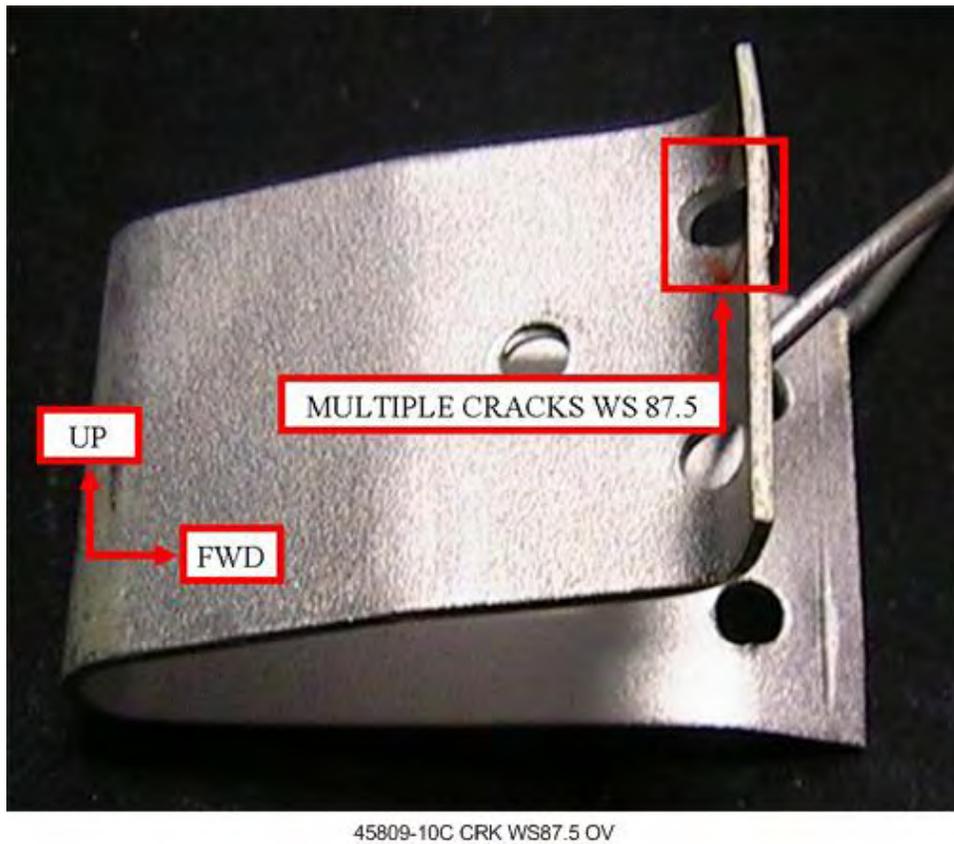
Figure 211. Location of Cracks on the Left Wing Flap Track WS 87.5

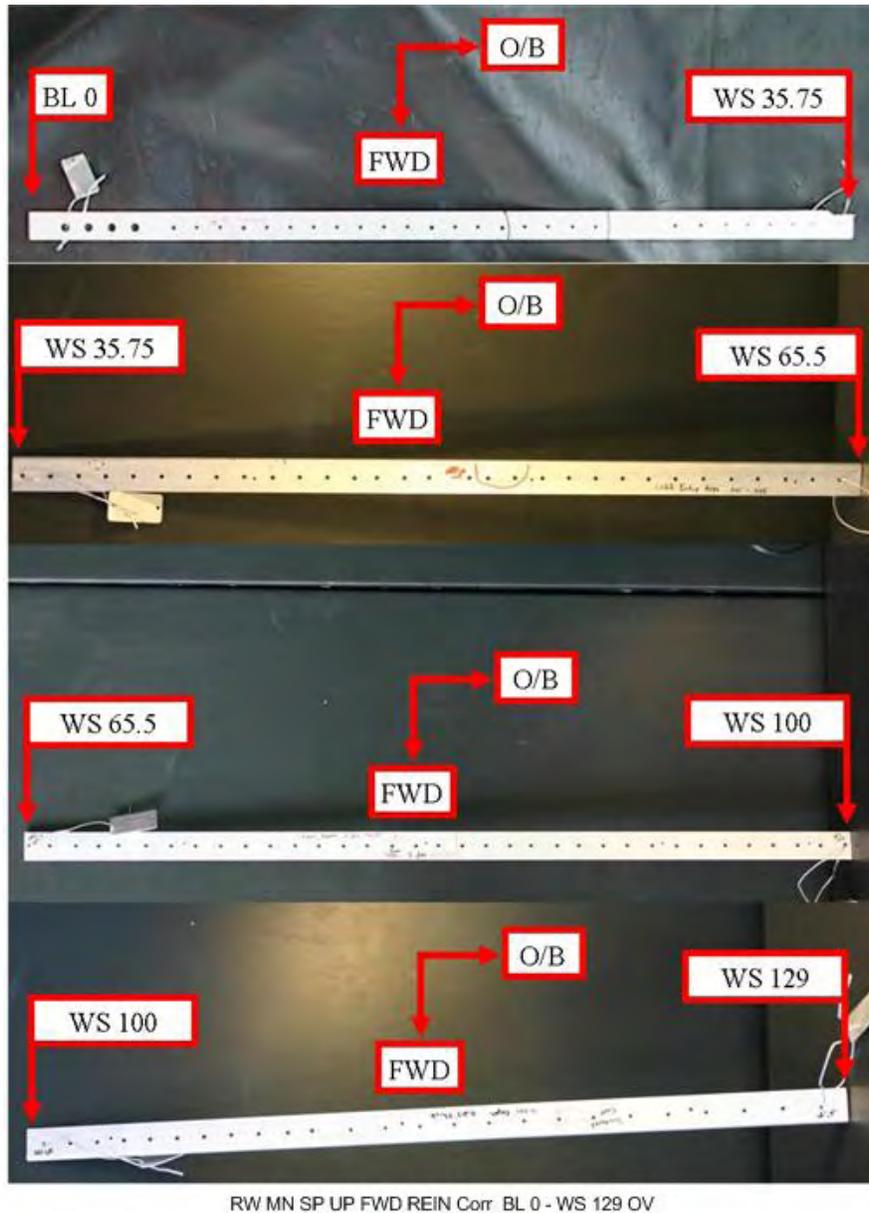
Figure 237. Overview of Right Wing Main Spar Upper Forward Reinforcement BL 0 Through WS 129

Figure 237 shows an overview of light corrosion scattered over the entire right wing main spar upper forward reinforcement from BL 0 to WS 129. This corrosion caused a localized reduction in thickness of only 1%. The location of scattered light corrosion and two areas of moderate corrosion on the right wing main spar upper aft reinforcement are shown in figure 238. The scattered light corrosion covered the surface of the aft reinforcement from WS 65.5 to WS 149.5 and caused a maximum localized thickness loss of less than 1%. A macroscopic view of a 9.75-square-inch area of moderate corrosion, located from BL 10.5 to 17, is shown in figure 239. Figure 240 shows a macroscopic view of another moderate area of corrosion, covering a surface area of 1.75 square inches, on the aft reinforcement, located from BL 27.5 to BL 29.25. Both areas of corrosion caused a maximum localized reduction in thickness of 5.5%.

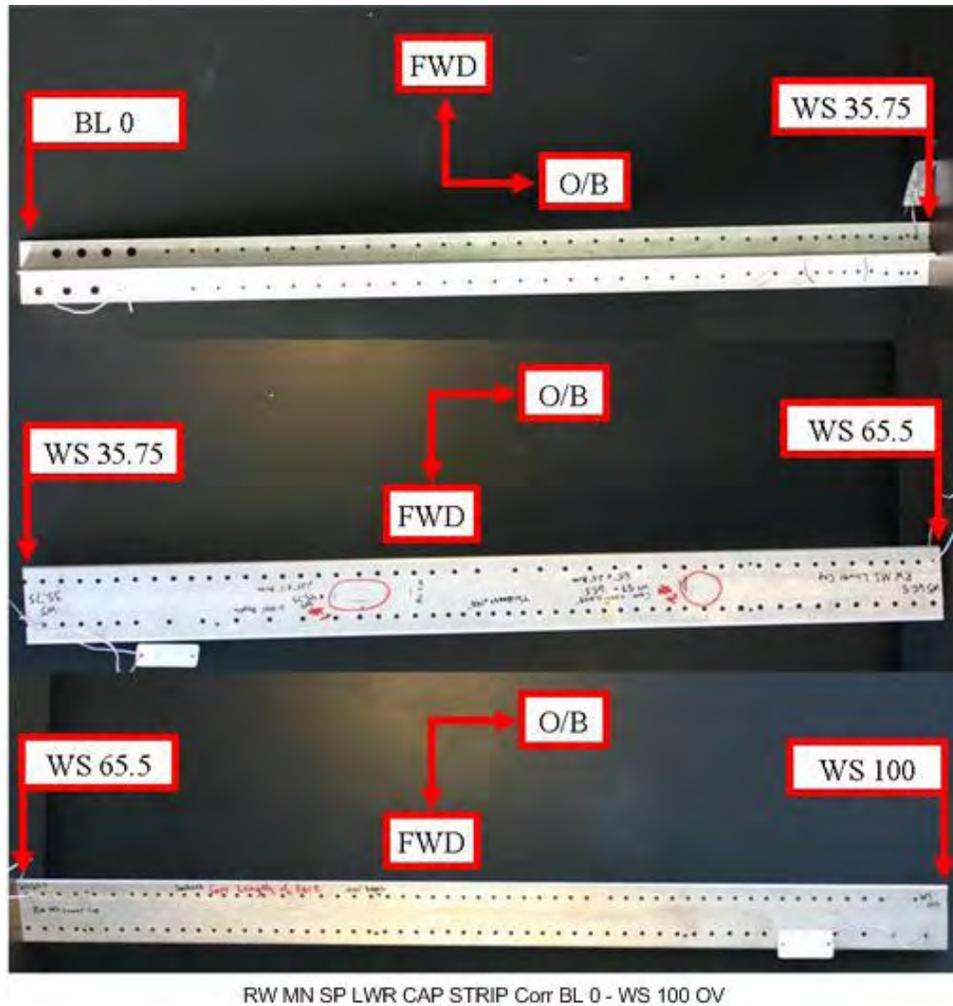
Figure 247. Location of Light-Moderate Corrosion on the Right Wing Main Spar Lower Cap Strip BL 0 Through WS 100

The location of scattered light-moderate corrosion, located from BL 0 to WS 100, on the lower cap strip is shown in figure 247. This scattered corrosion caused a maximum localized thickness loss of 4.5%. Scattered light corrosion was also found on the lower forward reinforcement from BL 0 to WS 100, as shown in figure 248. This corrosion caused a maximum localized thickness loss of less than 1%. Scattered light corrosion, which caused a localized reduction in thickness of 1.4%, was also found on the lower aft reinforcement, scattered from BL 0 to WS 65.5, as shown in figure 249.

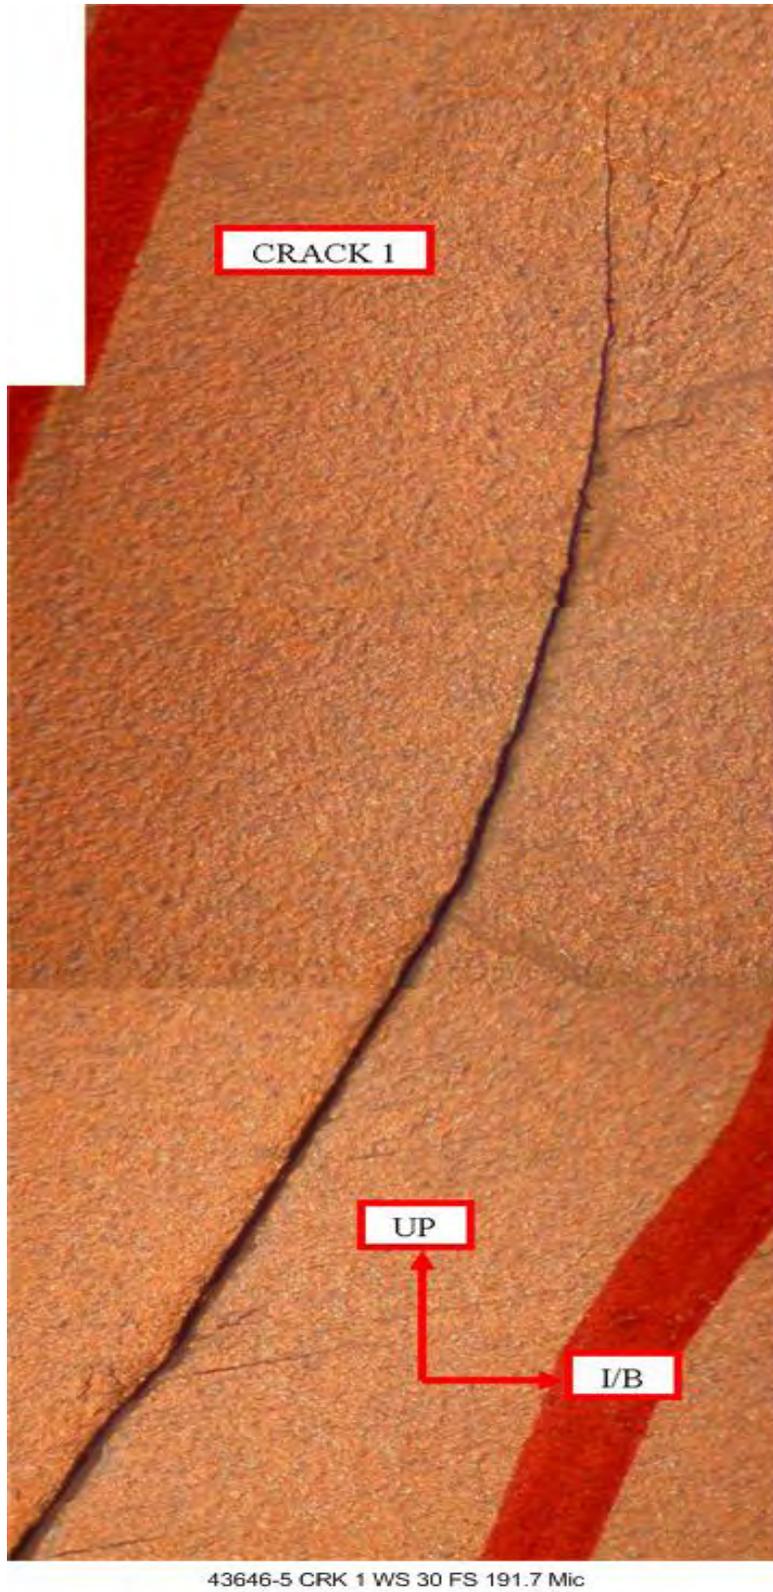
Figure 265. Microscopic View of Crack 1 on the Right Wing Bulkhead Wing Fillet
WS 30 FS 191.7

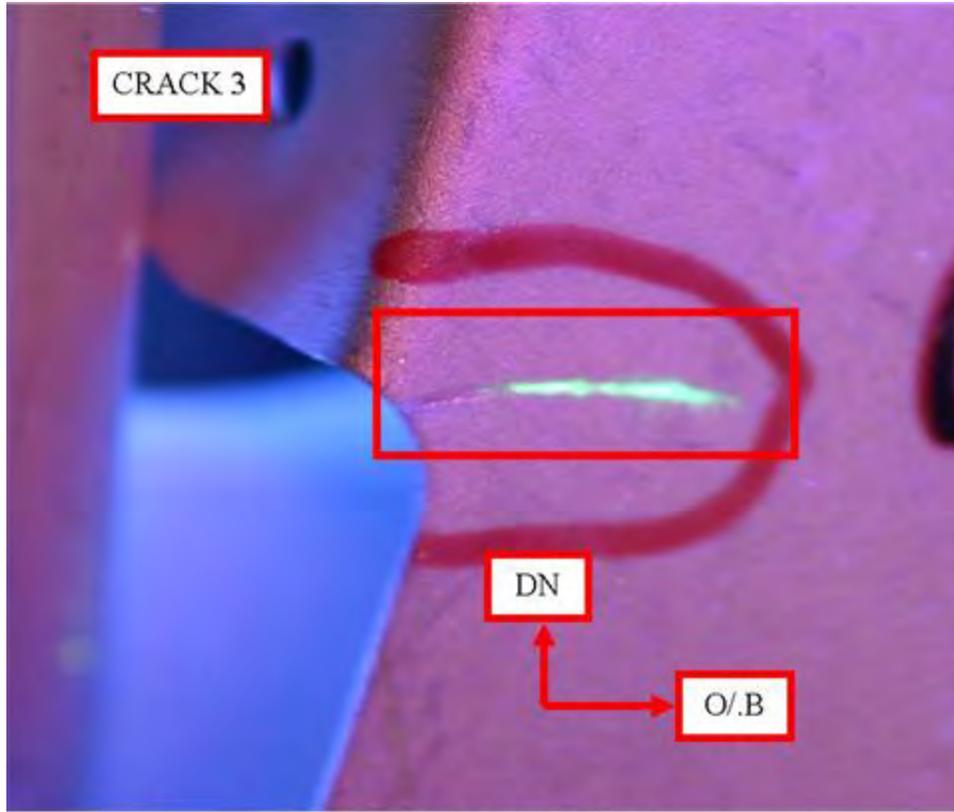
43646-5 CRK 3 WS 30 FS 191.7 FLP

Figure 270. Fluorescent Liquid Penetrant Indication of Crack 3 on the Right Wing Bulkhead Wing Fillet WS 30 FS 191.7

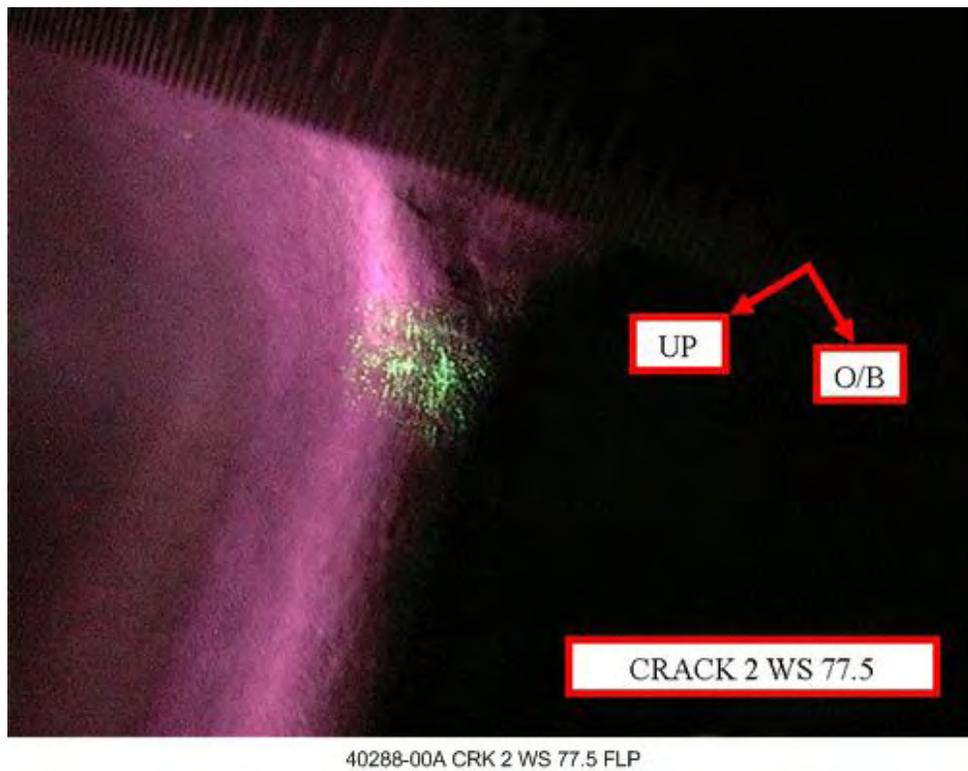
Figure 335. Fluorescent Liquid Penetrant Indication of Crack 2 on the Right Wing Trunnion Landing Gear Aft WS 77.5

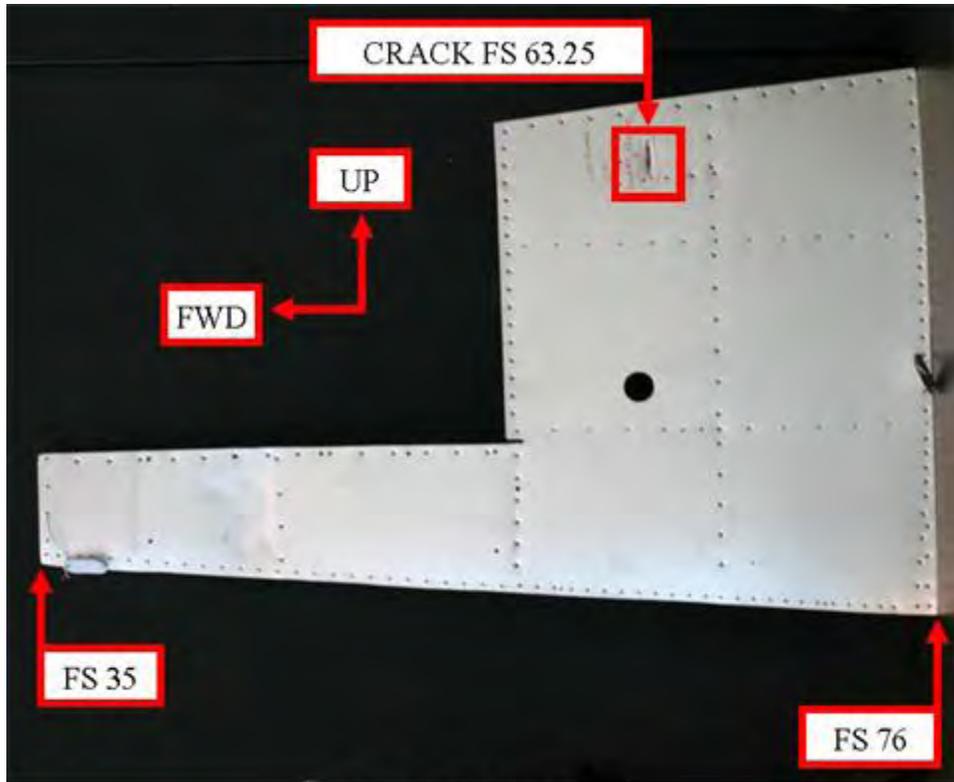
52118-00 CRK FS63.25 OV

The location of a 1.691-inch crack on the fuselage upper forward skin, part number 52118-00, is shown in figure 398, and a macroscopic view of this crack is shown in figure 399. Figure 400 shows the location of a 0.262-inch crack on the fuselage bulkhead assembly, part number 40962-3. A macroscopic view of this crack, which occurs at FS 66.5, is shown in figure 401. The location of three areas of damage on the fuselage bulkhead assembly, located at FS 87.5, is shown in figure 402. Figure 403 shows a macroscopic view of damage 1 and 2 on the bulkhead assembly, part number 52157-6. Damage 1, which covered a surface area of 0.24 square inch, and damage 2, which covered 0.1 square inch, both resulted in localized areas of complete thickness loss. A macroscopic picture of damage 3 is shown in figure 404. This damage covered a surface area of 0.07 square inch and caused a maximum localized reduction in thickness of 100%. The fluorescent liquid penetrant indication for this damage is shown in figure 405.

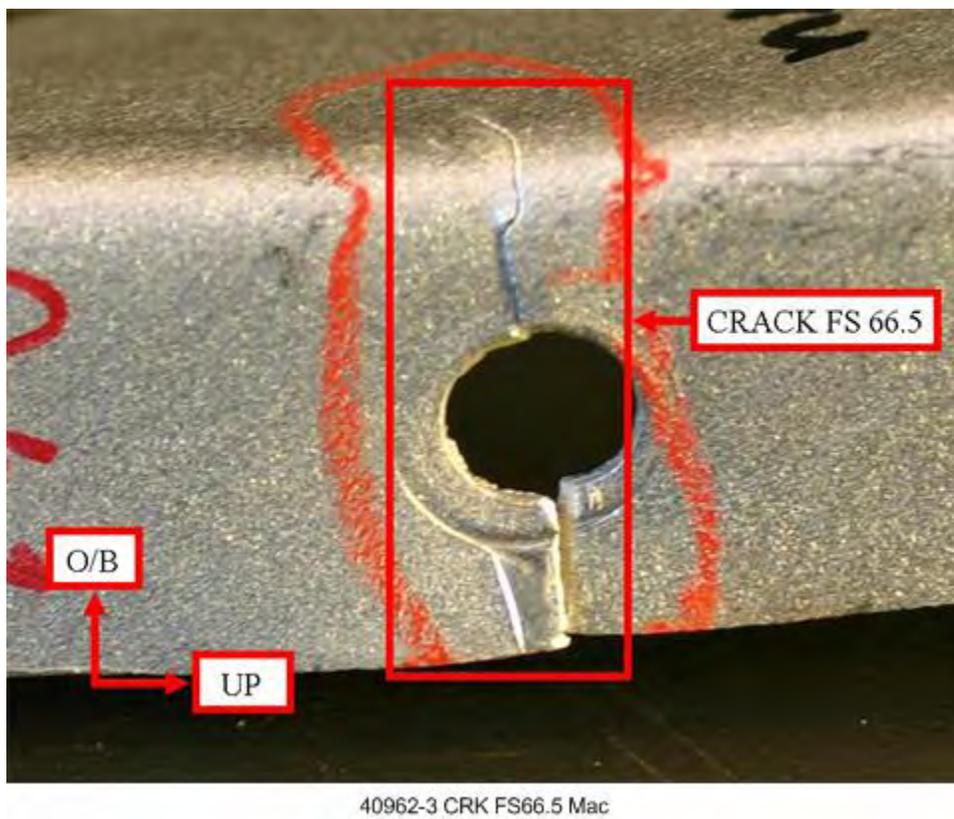
Figure 401. Macroscopic View of Crack on the Fuselage Bulkhead Assembly FS 66.5

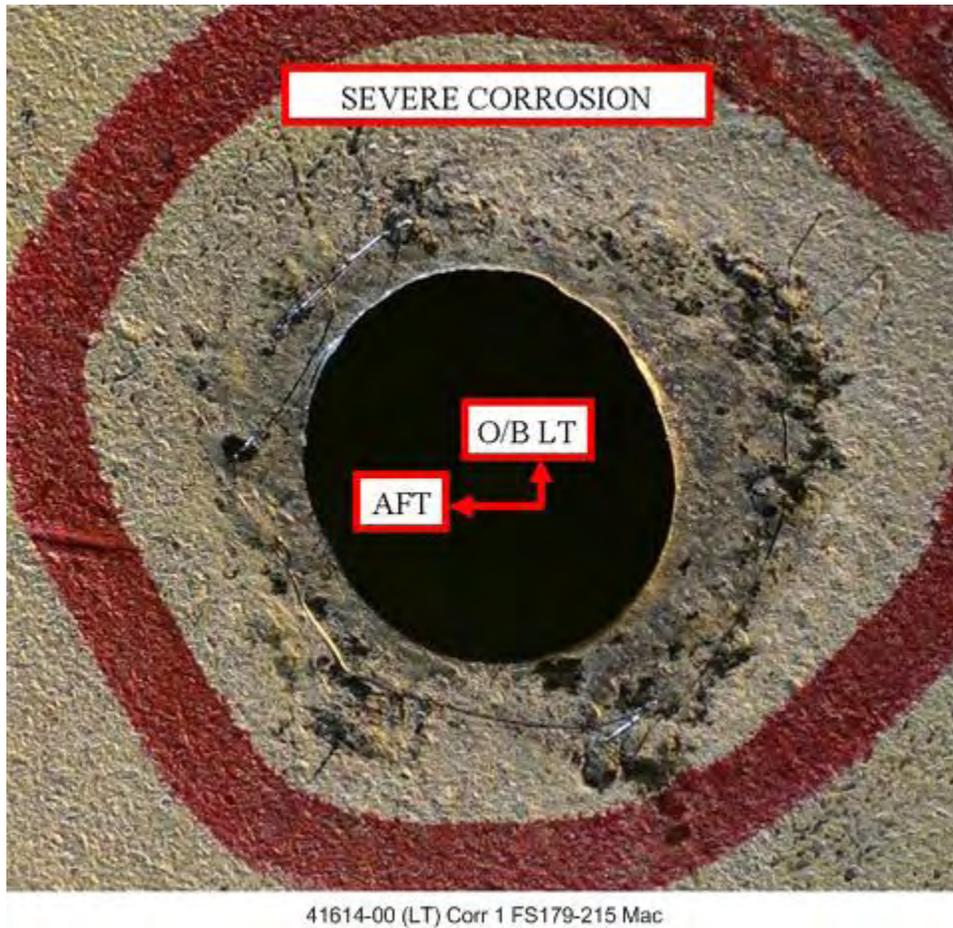
Figure 478. Macroscopic View of Severe Corrosion on the Left Floorboard Support FS 204.5

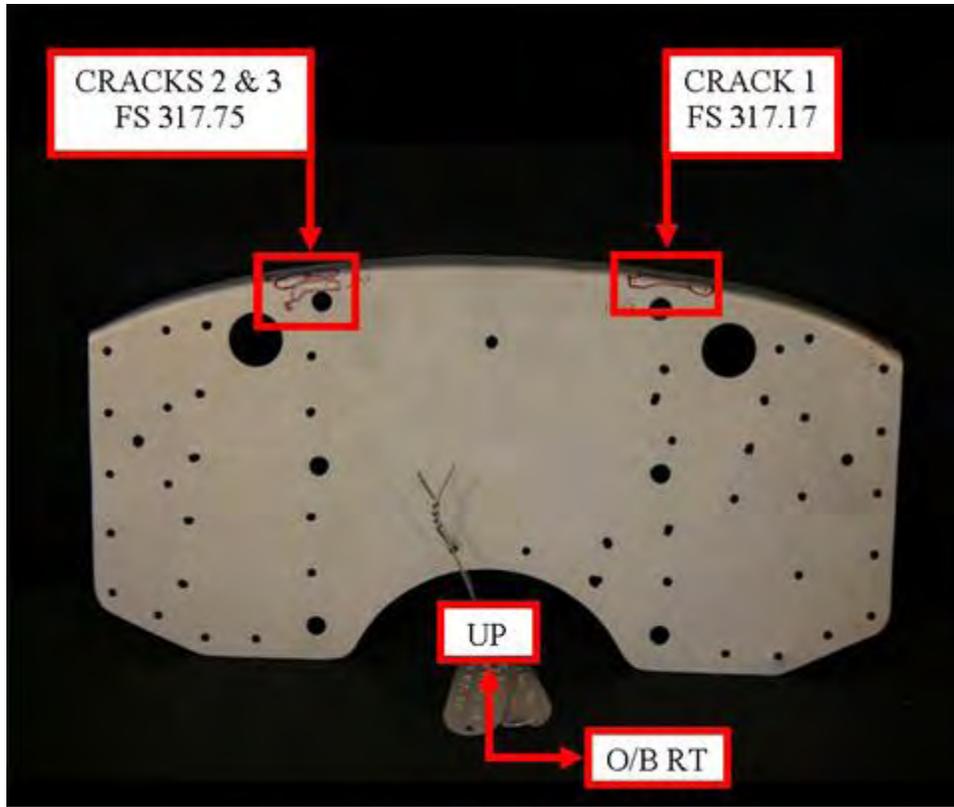
40682-08(1 of 2) CRK FS317.75 OV

The location of three cracks on the aft fuselage bulkhead assembly (1 of 2), part number 40682-08, is shown in figure 524. Figure 525 shows a macroscopic view of crack 1, which measured 1.165 inches and was located at FS 317.75. A macroscopic view of crack 2, which measured 0.75 inch and was located at FS 317.75, is shown in figure 526, and figure 527 shows a macroscopic view of crack 3. Crack 3 measured 0.55 inch and was also located at FS 317.75.

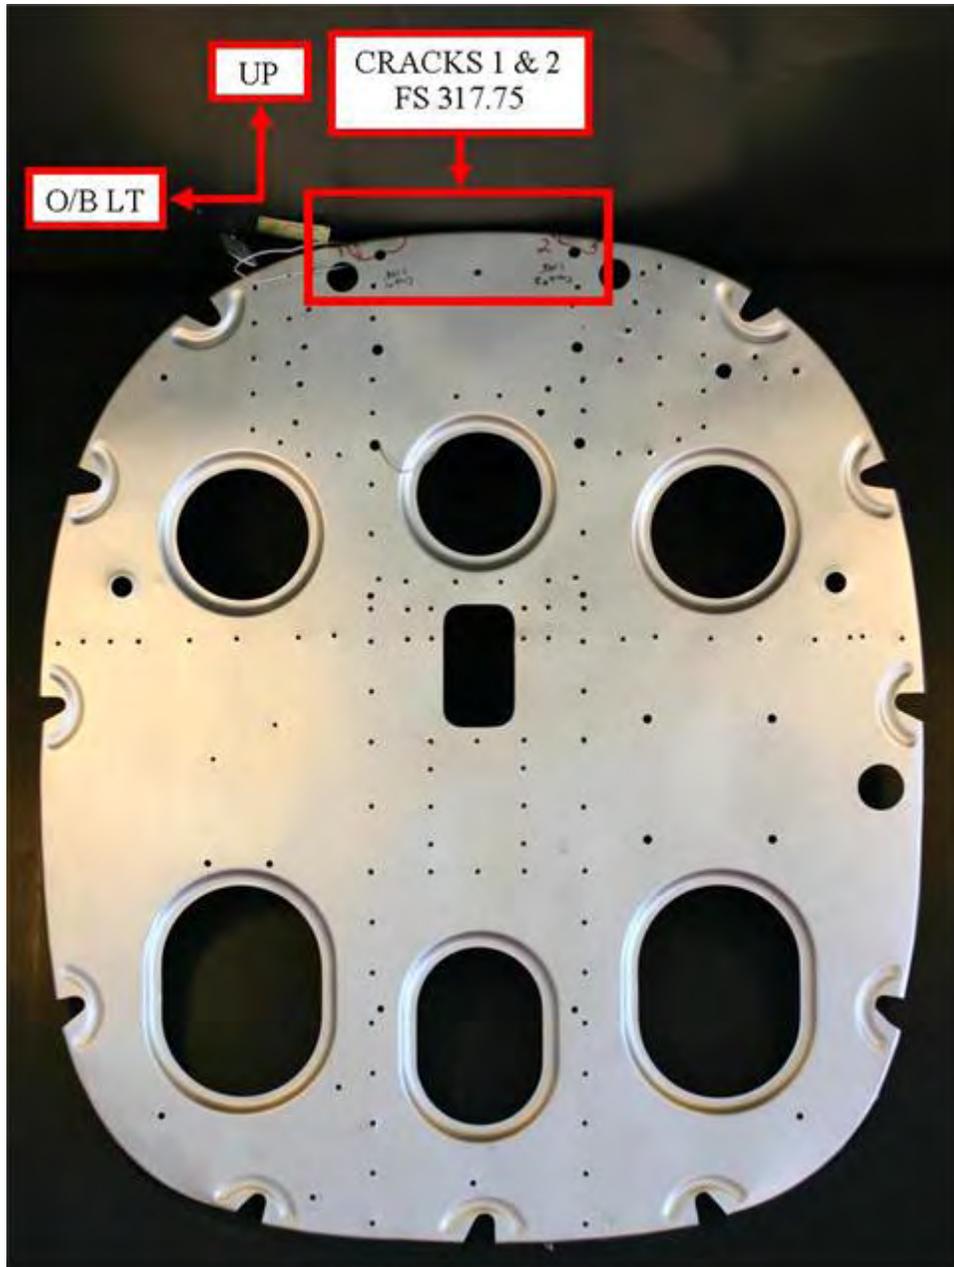
40682-08(2 of 2) CRK FS317.75 OV

Figure 528 shows the location of two cracks on the aft fuselage bulkhead assembly (2 of 2) at FS 317.75, part number 40682-08. A macroscopic view of crack 1, which measures 1.138 inches, is shown in figure 529. Figure 530 shows a macroscopic view of crack 2, which measures 1.192 inches. Figure 531 shows the location of a 0.48-inch crack on the aft fuselage bulkhead assembly, part number 40682-4. A macroscopic view of this crack is shown in figure 532, and a microscopic view of the crack is shown in figure 533.

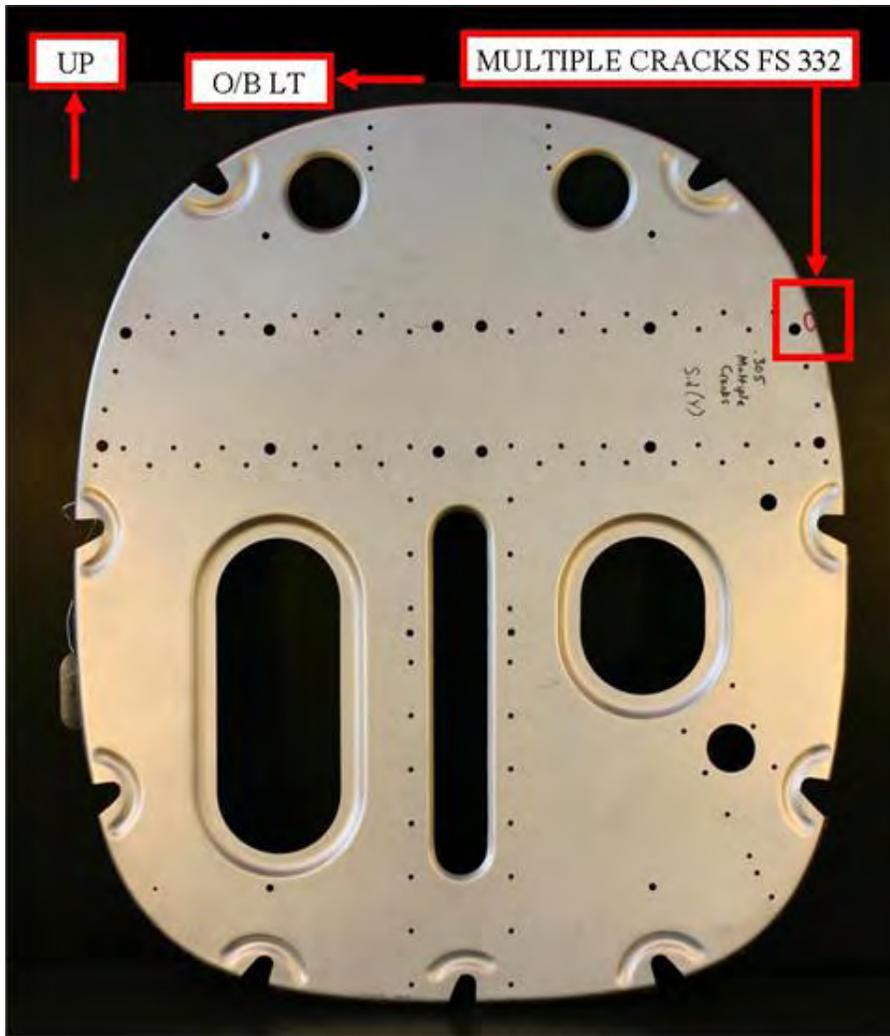
40655-00 (1 of 5) CRK FS 332 OV

Figure 534 shows the location of multiple part-through cracks on the fuselage bulkhead assembly, part number 40655-00. These cracks, which are shown macroscopically in figure 535 had a maximum length of 0.305 inch and were located at FS 332. A microscopic view of these cracks is shown in figure 536. The location of multiple part-through cracks on the bulkhead assembly, part number 40639-004, is shown in figure 537. These cracks had a maximum length of 0.437 inch and were located at FS 342.25. A macroscopic view of these cracks is shown in figure 538, and a microscopic view is shown in figure 539.

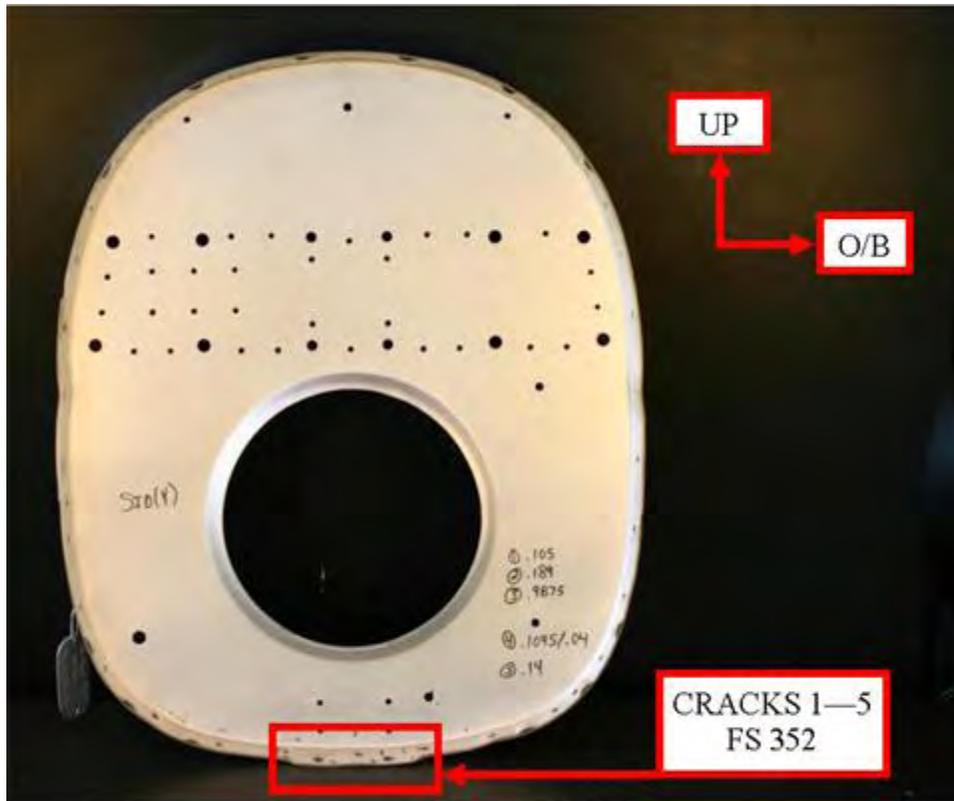
40638-00 CRK FS352 OV

An overview of the location of five cracks on the fuselage bulkhead assembly, part number 40638-00, at FS 352, is shown in figure 551, and a detailed overview is shown in figure 552. A macroscopic view of crack 1, which measured 0.105 inch, is shown in figure 553. A macroscopic view of crack 2, which measured 0.189 inch in length, is shown in figure 554. A microscopic view of crack 2 is shown in figure 555. Figure 556 shows a macroscopic view of crack 3, which measured 0.9875 inch, and figure 557 shows a microscopic view of this crack. Crack 4, which measured 0.1095 inch in length, is shown macroscopically in figure 558 and microscopically in figure 559. Figure 560 shows a macroscopic view of crack 5, and figure 561 shows a microscopic view of this 0.14-inch-long crack.

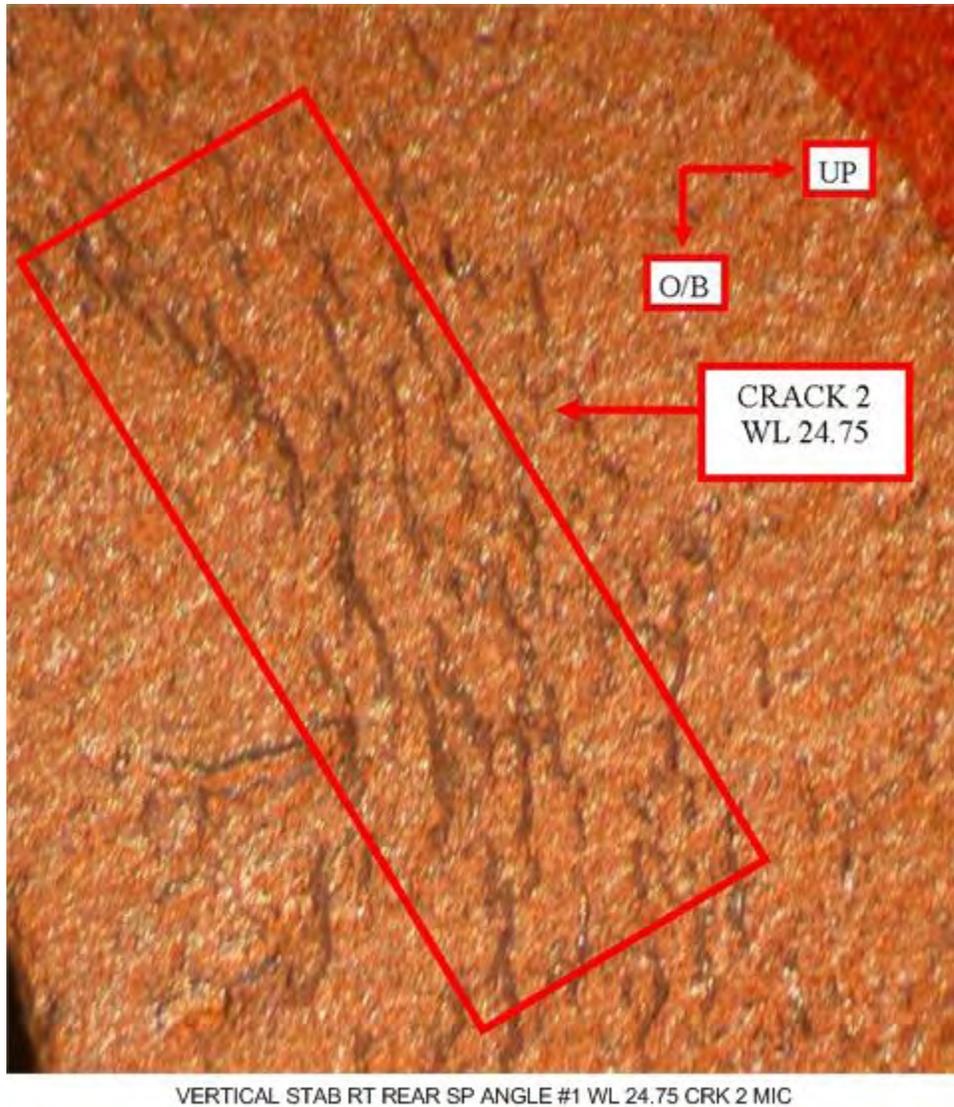
Figure 615. Microscopic View of Crack 2 on the Vertical Stabilizer Rear Spar Right
Angle WL 24.75

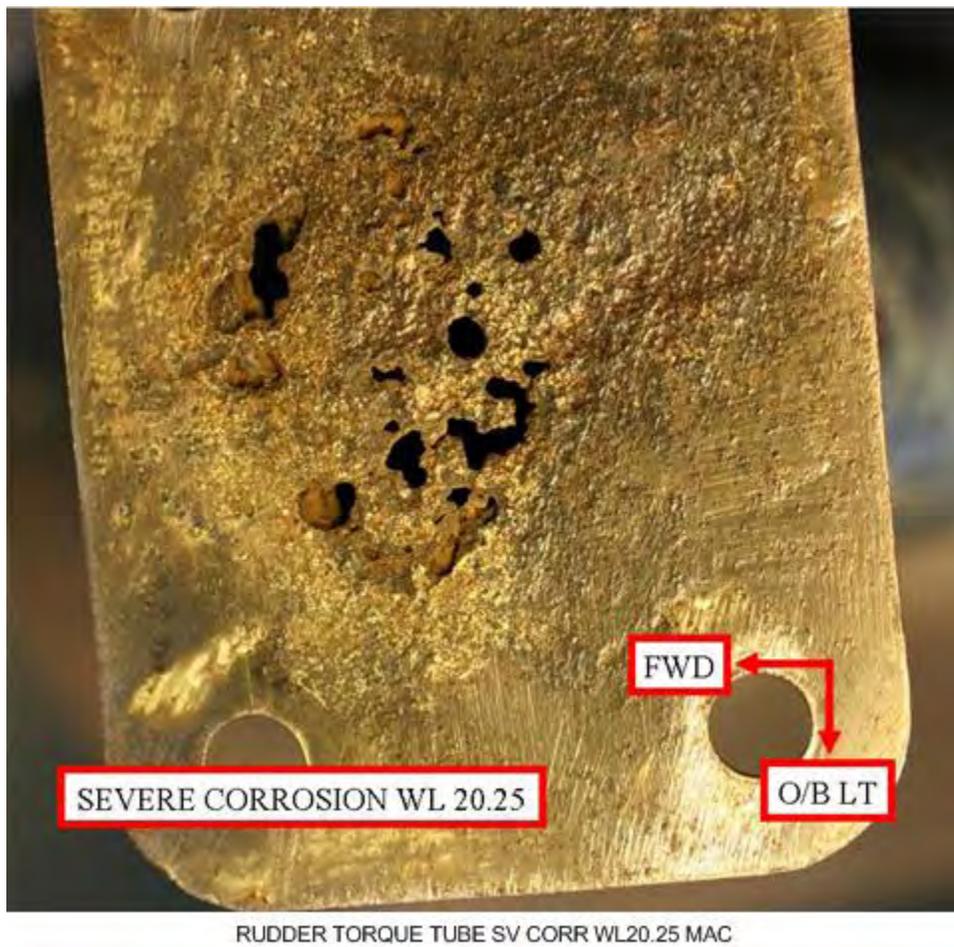
Figure 624. Macroscopic View of Severe Corrosion on the Rudder Torque Tube Assembly WL 20.25

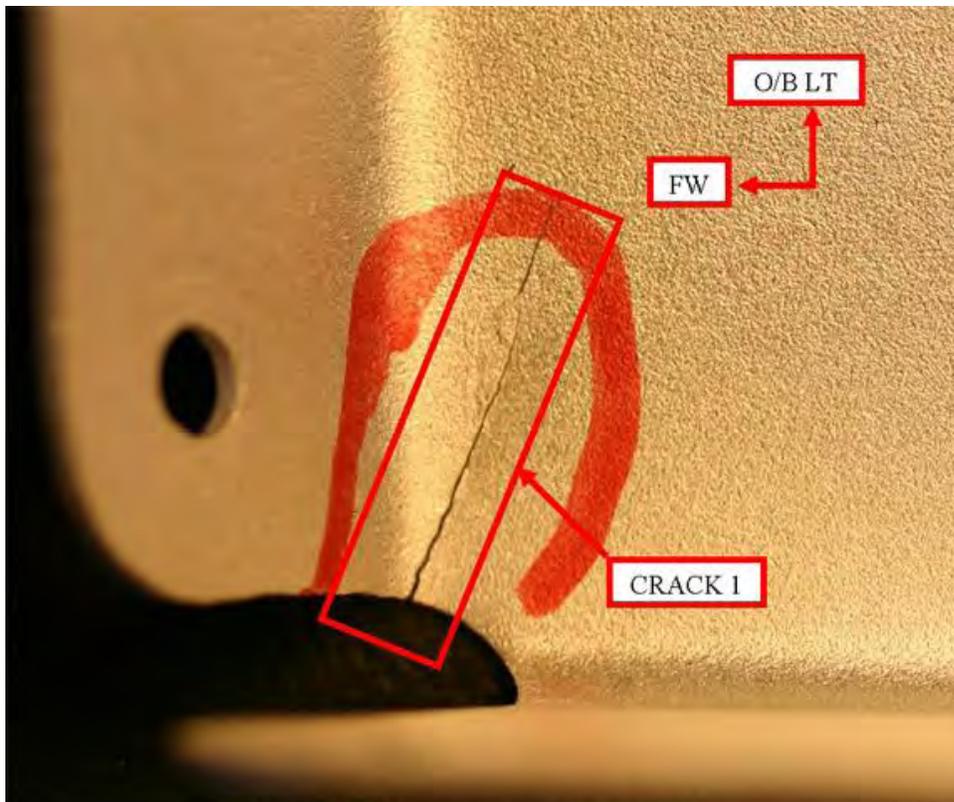
VERTICAL STAB MAIN BOTTOM RIB WL25.75 Crk1 Mac

Figure 638. Macroscopic View of Crack 1 on the Vertical Stabilizer Main Bottom Rib Assembly WL 25.75
