DOT/FAA/AR-11/28

Flight-Critical Systems Design Assurance

Final Report

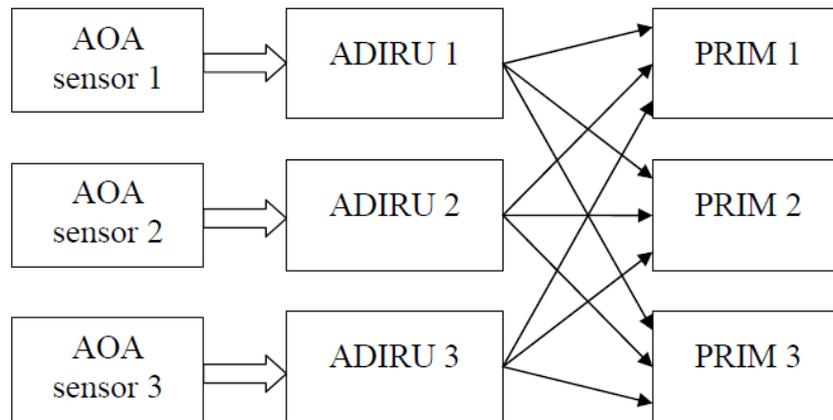
Figure 1. The ADIRU to Autopilot Data Flow

On October 7, 2008, an Airbus 330-303 (operated by Qantas) on a flight from Singapore to Perth, Western Australia, experienced violent pitch-up and pitch-down maneuvers that left 12 people seriously injured and over 100 less seriously [6]. The cause was traced to faulty data from one of the Air Data Inertial Reference Units (ADIRU).

The Qantas A330 was equipped with three ADIRUs manufactured by Litton Industries, Inc., now a part of Northrop Grumman Corporation (NGC). The data flow from the ADIRUs to the three primary flight control computers (PRIM) is shown in figure 1.

Each AOA sensor utilised two identical outputs (A and B for each sensor) for redundancy. The relevant ADIRU checked the A and B signals to ensure that they agreed. If they agreed, the data was passed on to other systems.

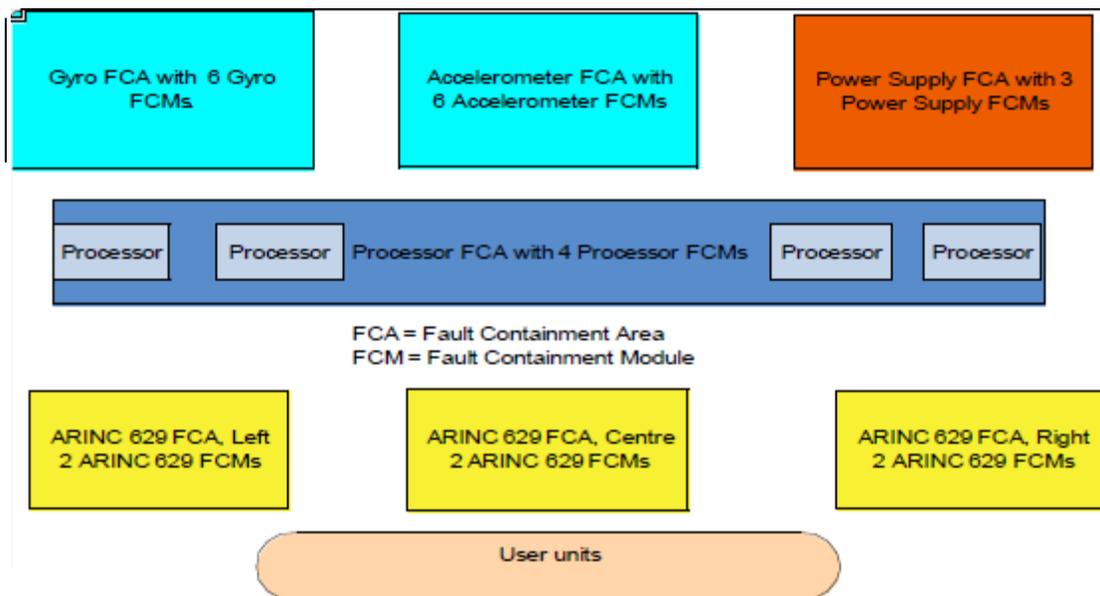
Figure 2. Redundancy in Honeywell ADIRU

The flight from Perth to Kuala Lumpur had reached 37,000 ft when it experienced a violent uncommanded, pitch-up maneuver [7]. The no. 5 accelerometer in the ADIRU failed, but such a single failure could be tolerated by the ADIRU, which was specifically designed to require minimum maintenance. The failure event was recorded in a register of the ADIRU but was not visible to the pilot.

The redundancy here is implemented in a single ADIRU, as shown in figure 2. Fault containment areas (FCA) are functions with internal redundancy.

During the flight event in August 2005, the no. 6 accelerometer malfunctioned, and a software error allowed the output of the previously failed no. 5 accelerometer to be substituted. This caused a rapid climb of the aircraft with loss of airspeed and incipient stall. The pilots disconnected the autopilot and were able to return the aircraft to Perth. The passengers were not injured.

The accelerometer FCA is comprised of six accelerometers in a nonorthogonal orientation. Theoretically, this should permit it to compute the correct acceleration data as long as three accelerometers remain operational. The computation of the valid inertial orientation after failure of an instrument in a nonorthogonal array has been recognized as a challenging software problem for several decades. It was selected as the sample problem when, as part of a fault-tolerant software project in the late 1980s [8], National Aeronautics and Space Administration (NASA) wanted to investigate whether failure modes of independently developed software were, in fact, independent. A well-vetted specification was given to five teams (2 graduate students each) at each of five leading software engineering schools at that time. The 20 resulting versions were then subjected to over 800,000 tests. Table 2, based on table 1 of reference 5, shows excerpts for the test cases in which a new failure was introduced. Thus, the entries in the first row represent a first failure, those in the second row, a second failure, etc.

These data showed more than a tenfold increase in overall failure probability after a first instrument failure, which was hardly a basis for permitting a nonorthogonal array with one failed accelerometer to be flown for 4 years without repair. Thus, the Maint cause code was assigned. The RM cause code was assigned because the explicit requirement for the ADIRU was that it would continue operating after a second failure.

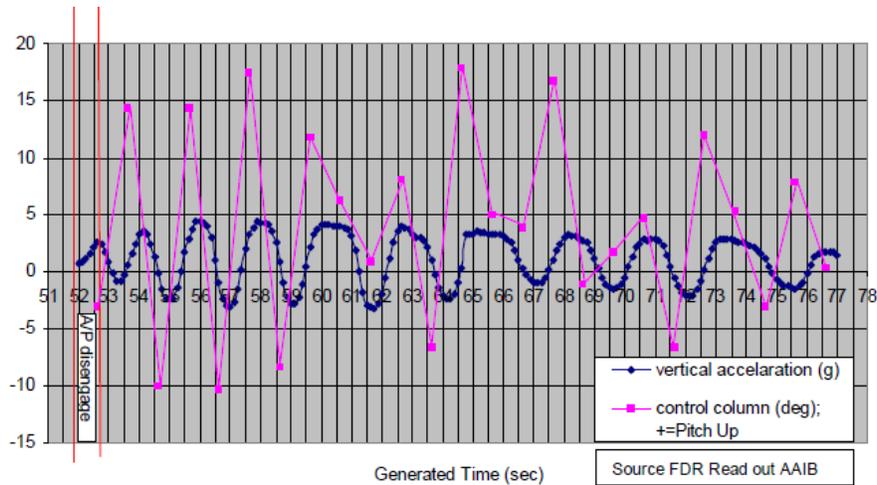
Figure 3. Column Movement and Vertical Acceleration

In September 1999, a Falcon 900 operated by Olympic Airways for the Greek government experienced severe pitch oscillations during the final stages of a flight from Athens to Bucharest, Romania [11]. Shortly after takeoff, when flaps and slats were retracted, a pitch feel warning light illuminated and remained on for most of the flight. On descent into Bucharest the autopilot disengaged, apparently without deliberate crew action, probably as a result of the pilot pulling on the control column.

From this point, there were ten major oscillations, which lasted for about 2 seconds and caused vertical accelerations of almost +5 and -3 g's, as shown in figure 3.

Although the aircraft was nearing its destination, most of the passengers did not have their seatbelts fastened and were violently thrown about during the oscillations. Seven passengers were killed, the flight attendant and one passenger were seriously injured, and two passengers and the cockpit crew sustained minor injuries. The oscillations subsided when the airspeed was reduced, and the aircraft was able to land normally.
