DOT/FAA/AR-95/81

Corrosion of Aluminum Alloys in the Presence of Fire-Retardant Aircraft Interior Materials

October 1995

Final Report

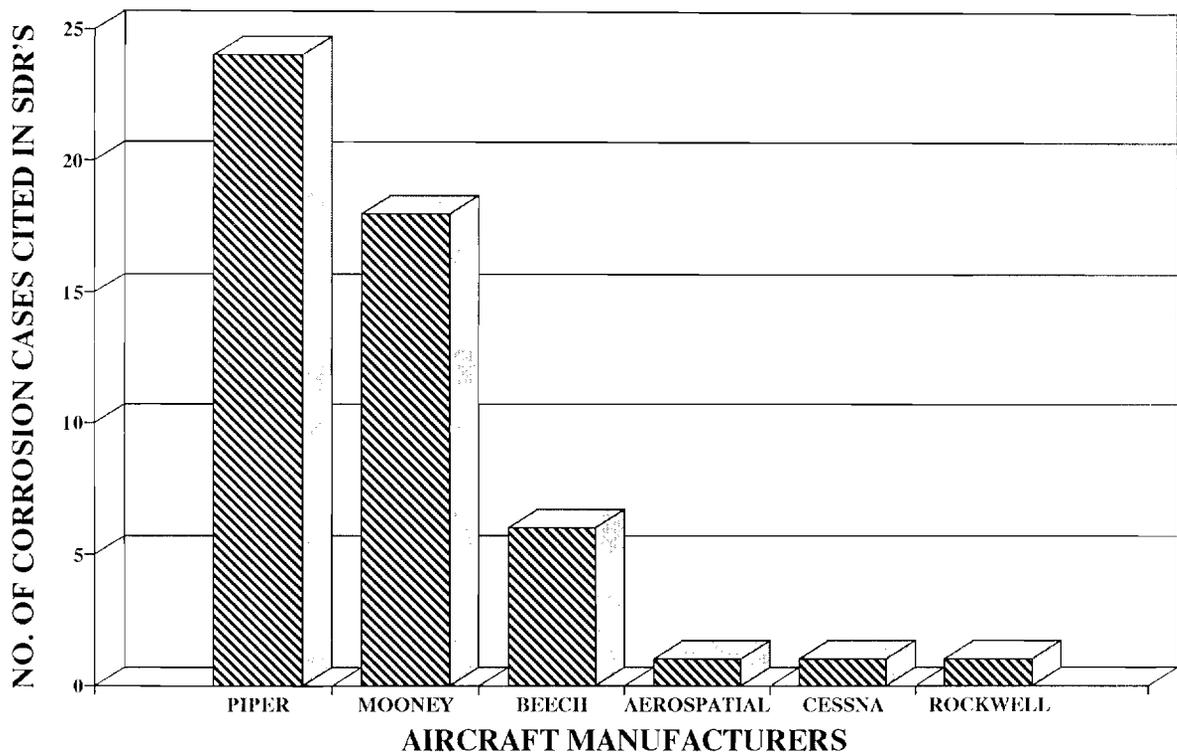
FIGURE 1. CORROSION CASES FROM SERVICE DIFFICULTY REPORTS

Figure 1 presents a histogram representation of various corrosion cases from SDR's with respect to the aircraft manufacturers. Figure 2 presents the locations at which corrosion was reported in SDR's. This graph illustrates that the most frequently observed corrosion was in the fuselage, with especially high occurrences near windows and frames.

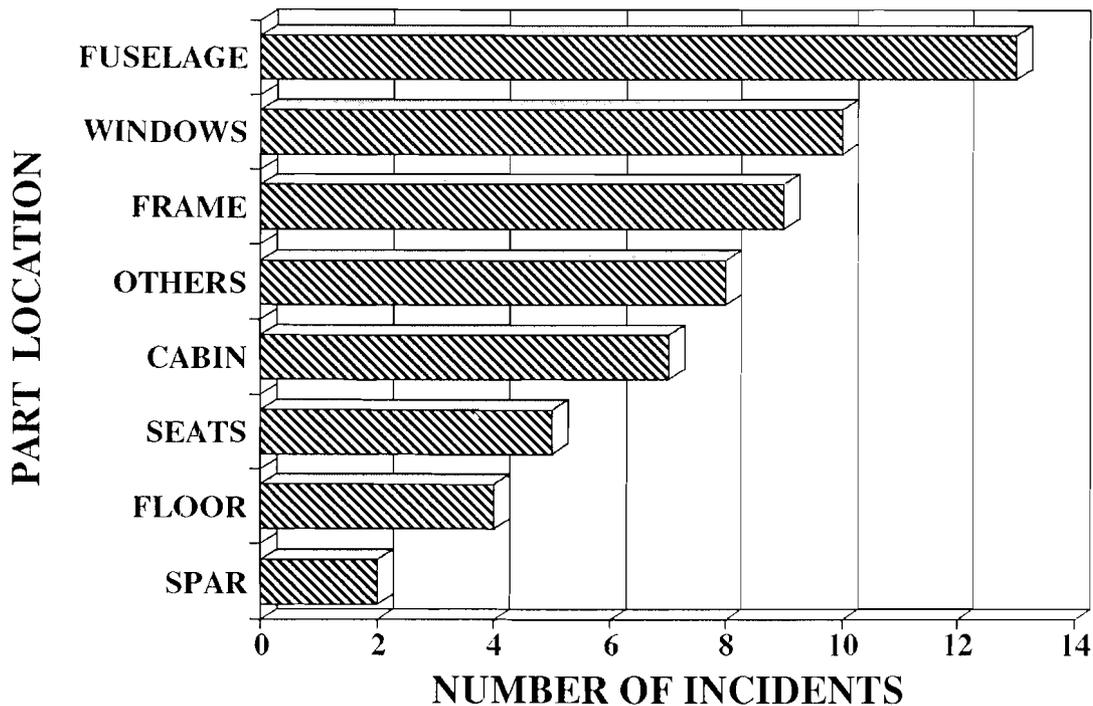
FIGURE 2. CORROSION INCIDENTS BY LOCATION

Reports stated that most of the corrosion was due to the presence of moisture in the fire-retardant insulation. In many of these cases the presence of moisture was due to window leaks, saturation by galley fluids, deterioration of cabin window sealant, and leaking door seals. Following are a series of suggested practices based on review of the SDR's:

- Windows should be leak proof and there should be no deterioration of window sealants.
- Insulation should be contained in a plastic bag so that it does not rest directly against the aircraft skin or structure.
- Interior of the aircraft should be coated with primer.
- Regular visual inspections should be conducted of the insulation in areas that can retain water.
- Insulation should be removed and dried if moisture gets in. It should not come in contact with metallic parts [7,8].

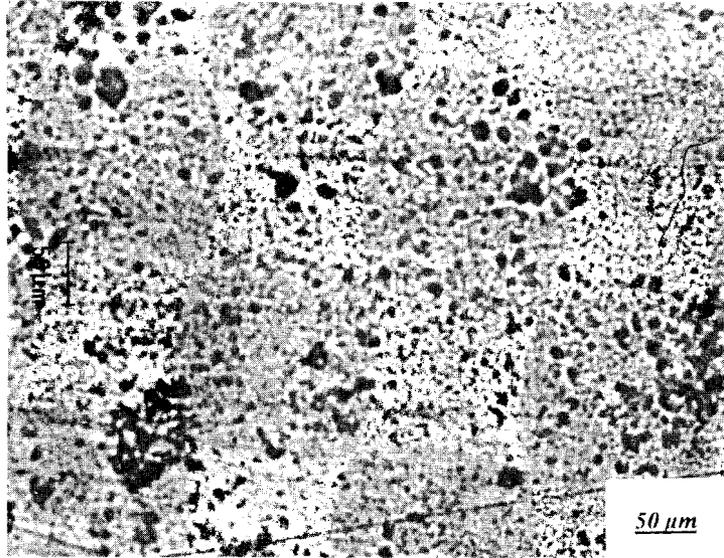
FIGURE 5. MICROGRAPH OF AL 2024-T3 WITH GLENLIVIT, 100°F, 90% RH, 14 DAYS (MODERATE CORROSION, 50 POINTS)

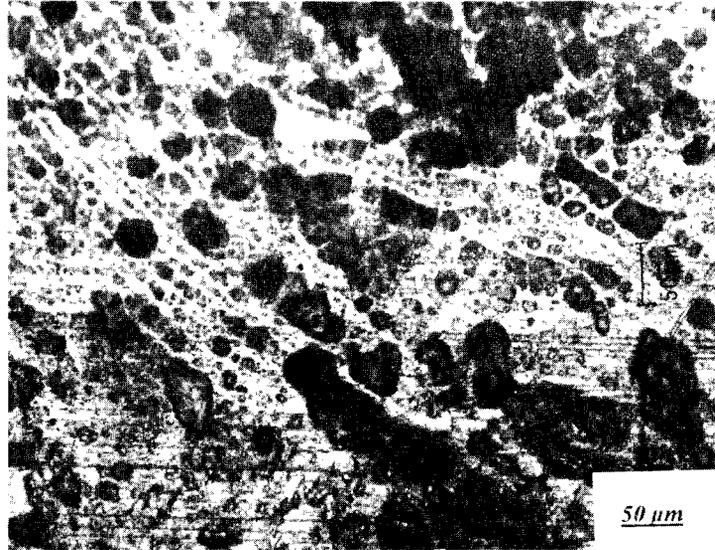
FIGURE 8. AL 2024-T3 WITH ULTRASUEDE, 130°F, 90% RH, 14 DAYS
(80 POINTS)

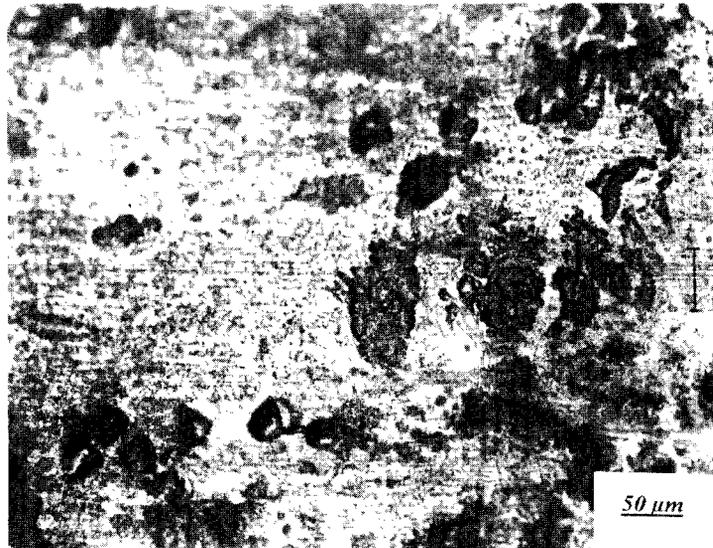
FIGURE 9. AL 7075-T6 WITH ULTRASUEDE, 70°F, 50% RH, 21 DAYS
(40 POINTS)

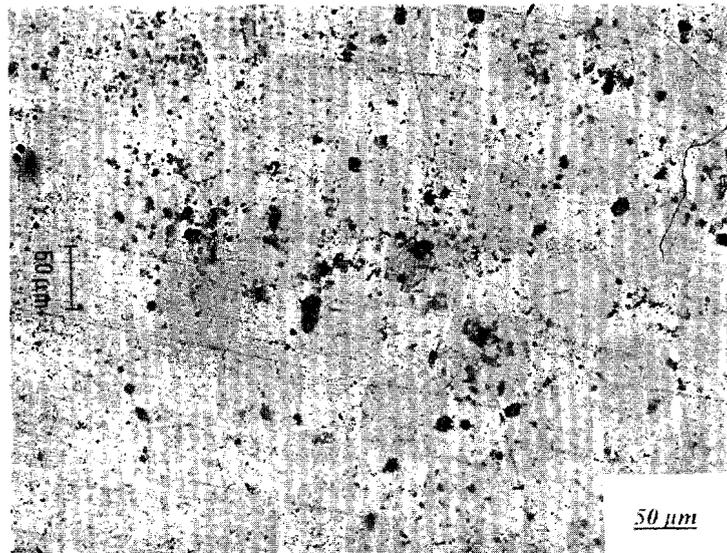
FIGURE 11. AL 2024-T3 WITH GLENLIVIT, 100°F, 90% RH, 21 DAYS
(65 POINTS)

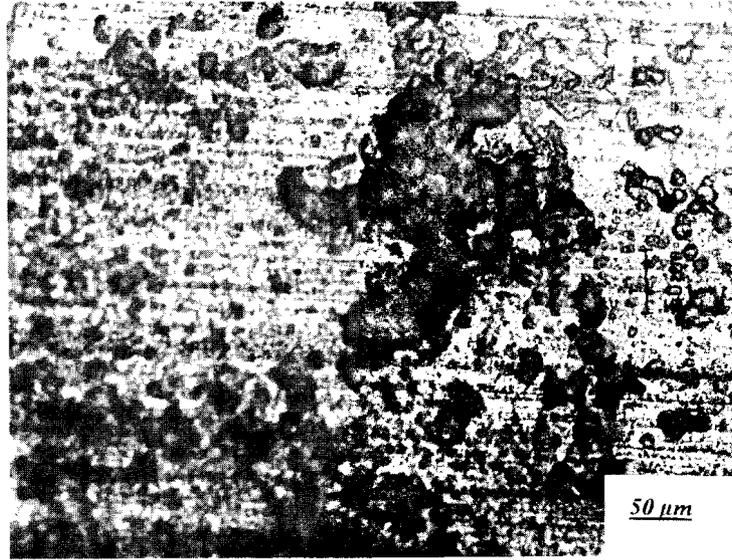
FIGURE 12. AL 2024-T3 ALCLAD WITH GLENLIVIT, 130°F, 50% RH, 14 DAYS
(80 POINTS)
