DOT/FAA/AR-98/22

FAA T53-L-13L Turbine Fragment Containment Test

June 1998

Final Report

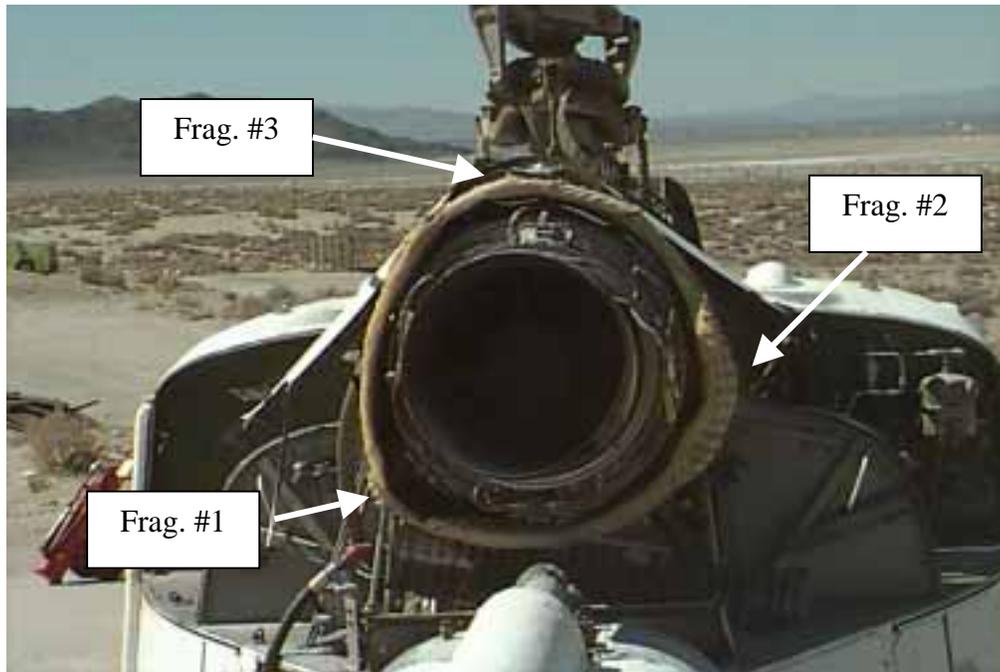
FIGURE 8. POSTTEST ENGINE

The test was completed as planned. The cameras were triggered as N_p passed through 14,000 rpm. The disk released at 19,629 rpm. Test data are provided in figures 5 through 7. The disk ruptured into three nearly equal sections that were contained by the containment ring. The outer titanium shell split due to the tensile load resulting from the disk fragments pulling the Kevlar into a triangular shape. All three disk fragments penetrated the engine combustor case. The fuel lines located between the containment ring and combustor case were penetrated, resulting in a small fire. Secondary blade fragments exited the engine exhaust nozzle and a few fragments

appeared to exit through the holes created by the disk fragments. These fragments were low-energy releases. Post event pictures are provided in figures 8 through 11.

The engine stayed within its mounts, with little apparent duress caused from the disk fragment energy being absorbed. The only noticeable sign of high vibration or loading was a broken throttle linkage.

All three fragments penetrated through the combustor case and were embedded inside the containment ring. Minimum interactions between the immediate engine components and fragments were observed.

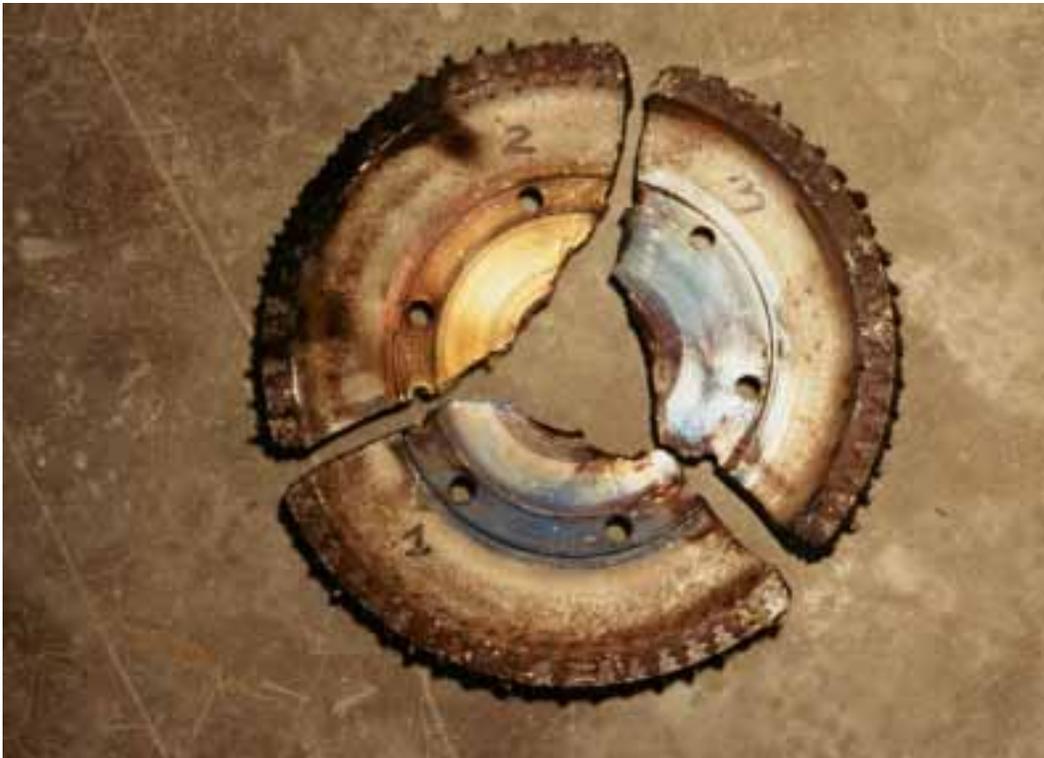
FIGURE 11. DISK FRAGMENTS

The disk fragments were recovered and weighed (table 1). The original weight of 10.8 lbs included blades which were broken off during impact. Approximately 2.65 lbs of debris was released.

Disk Fragment Number	Fragment Weight After Burst (lbs)
1	2.66
2	2.70
3	2.79
Total Large Disk Fragments	8.15
