Evaluation of Wind-Loading on Airport Signs

Keith Bagot

June 2000

DOT/FAA/AR-TN00/32

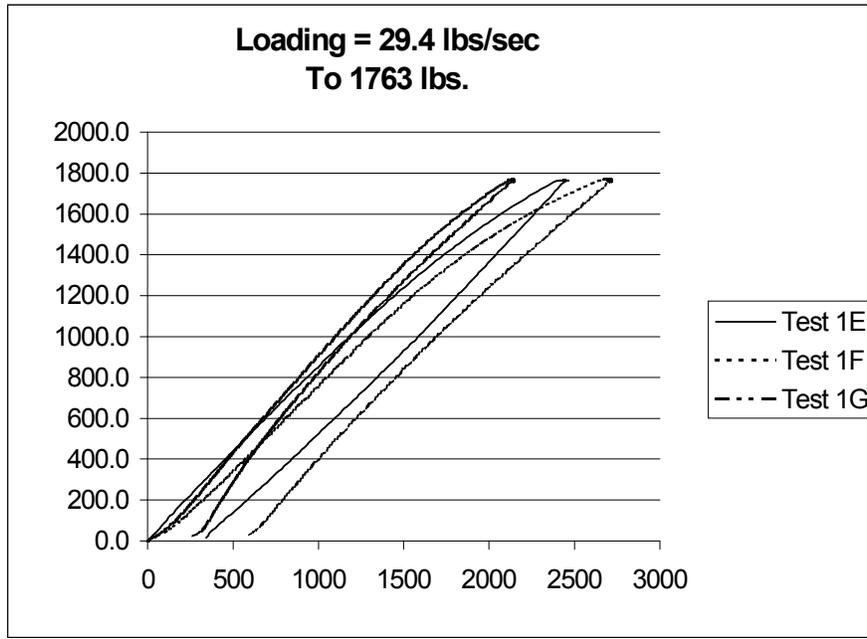
FIGURE 5. MTS COUPLING (STANDARD RATE) LOADING TO 0.9 psi

The MTS test data indicated that the couplings remained, for the most part, elastic through loads of approximately 1800 lb. (slightly greater than 0.9 psi) although there was some indication that 0.9 psi (minimum design load) was at the very fringe of the elastic limit of some of the couplings.

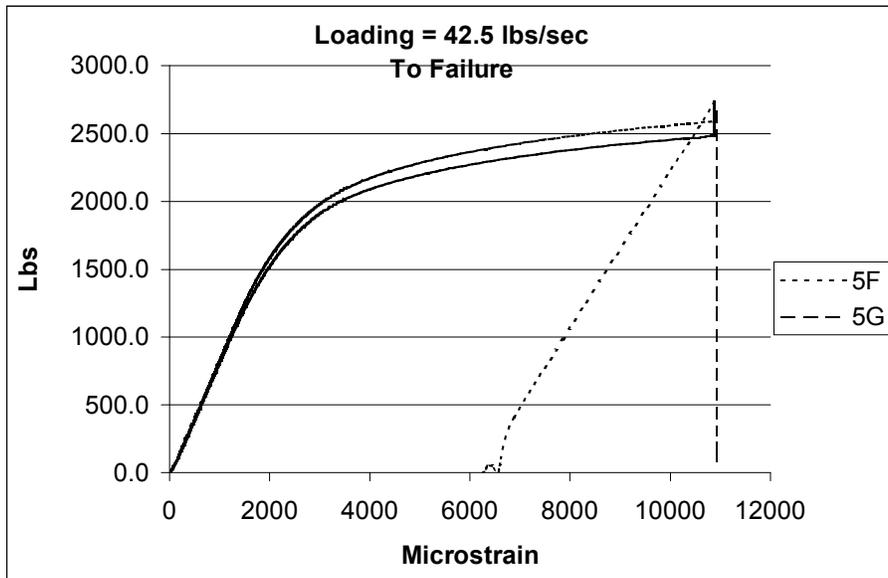
FIGURE 7. MTS LOADING TO 1.3 psi (OR FAILURE)

The MTS test data also indicated that the couplings failed with loads of more than the maximum design load (2600 lb. or 1.3 psi) on the sign face. The results of the tests also demonstrated that the elastic limit and failure point of the couplings are independent of the rate of loading. Sample results for the standard and highest load rates are illustrated in figures 5 through 8.

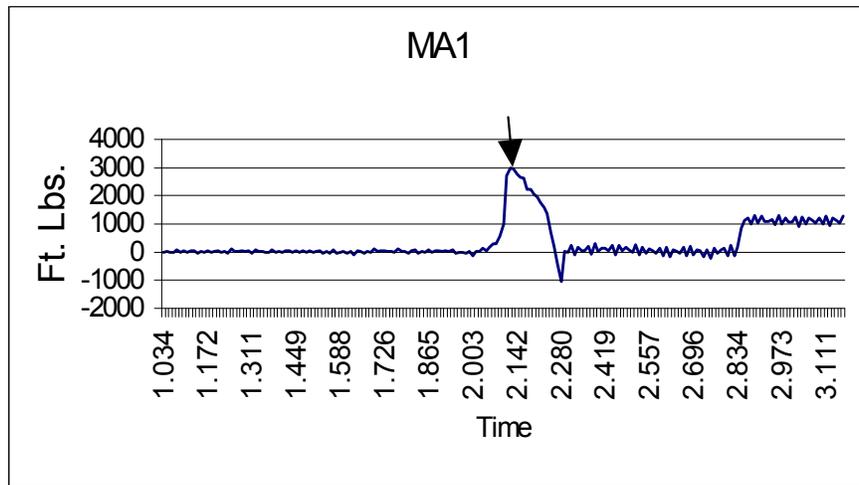
FIGURE 11. FRANGIBLE COUPLING 1, MA1

The sign was installed and data were collected for 3 months before the first sign was destroyed by the jet blast of a B747-200 which rotated adjacent to the sign. The sign failed at the frangible couplings as intended. The sign couplings broke between 2.12 and 2.13 seconds into the incident, which was consistent with the data obtained from the strain gauges on each of the couplings (MA1 and MA2). The force (from the wind) increased for 0.7 second; however, during the first 0.12 second of increased wind velocity, the measured force on coupling MA1 rose to 3,000 ft-lb. and dropped to zero. Similar conditions were observed on coupling MA1, 2248 ft-lb. and dropping to zero, within one hundredth of a second. Readings from the pressure and strain gauge clusters on the face (5A, B, C and 10A, B, C) of the sign did not record any significant change during the event.

The measured moments at MA1 and MA2 differed in magnitude by 20% indicating that there was some bending (twisting) about the horizontal plane. The values for MA1 and MA2 in figures 11 through 18 were zeroed (MA2 values are absolute) for comparison.

The data also showed that the sign failed at the frangible point (couplings) under a load of only approximately 0.62 psi; which is less than the minimum frangibility requirements of the Advisory Circular. Moreover, the failure appeared to occur within the elastic limits of the laboratory tested couplings. It should be noted that the loading was applied to the sign over a time frame of less than 0.05 second, almost 200 times faster than in the laboratory tests. Although the measured wind speed was only 14.95 and 19.43 mph respectively, the data are considered to be unreliable since it was measured with a mechanical device that is not capable of providing accurate measurements over such a short period of time.

Further investigation of events prior to the total failure of the frangible couplings showed loads that exceeded the elastic limits of the couplings, causing permanent deformation of the couplings and actual failure (cracking) of the couplings well before the sign broke completely free of the couplings.
