Evaluation of In-Pavement Runway Guard Lights

December 2004

DOT/FAA/AR-TN04/49

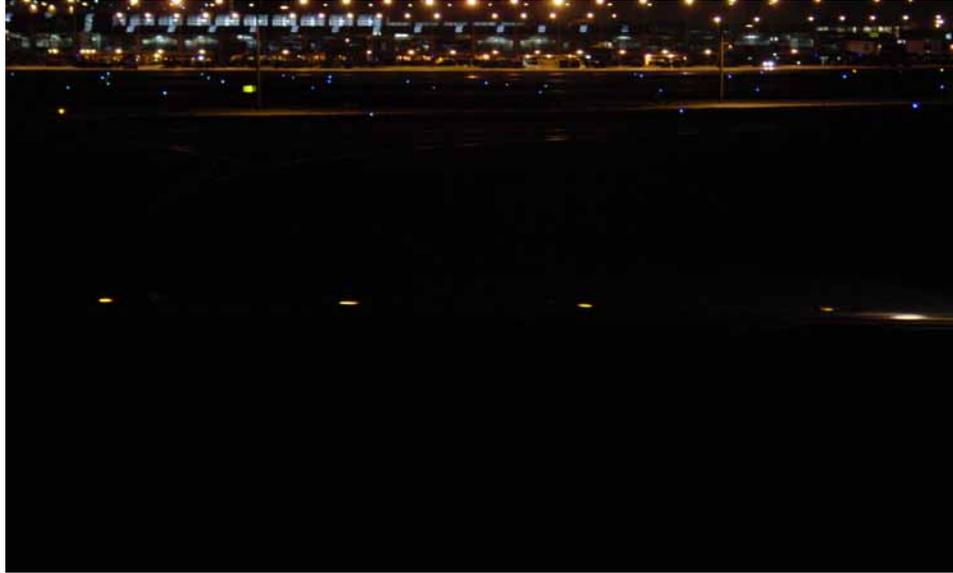
Upon ORD's activation of the in-pavement RGL system, pilots began reporting that the flashing yellow lights created a confusing situation. The pilots saw the RGL lights from the runway side and interpreted the yellow flashing lights to be those of flashing barricade lights (see figure 2). The pilot, believing that the taxiway was closed due to the yellow construction barricade lights, proceeded to the next taxiway and found the same situation. The pilot contacted ATC who assured the pilot that there were no barricades in that area, and it was safe to proceed. Several other pilots encountered the same situation, refusing to exit the runway under the assumption that there were barricades in the way. This problem delayed arrivals and departures and forced other aircraft to go around.

FIGURE 2. VIEW OF RGL BAR FROM RUNWAY SIDE

Through discussions with the pilots, it was learned that the cause of the pilot's confusion came from viewing the in-pavement RGL from the runway side, which gave the same appearance as random flashing yellow barricade lights that are typically used to identify nonaccessible construction areas. When viewed from the runway side, the flashing pattern of the in-pavement RGLs appeared to be random rather than the alternating pattern that is visible from the front of the in-pavement RGL, thus creating a false signal to the rear of the fixtures.

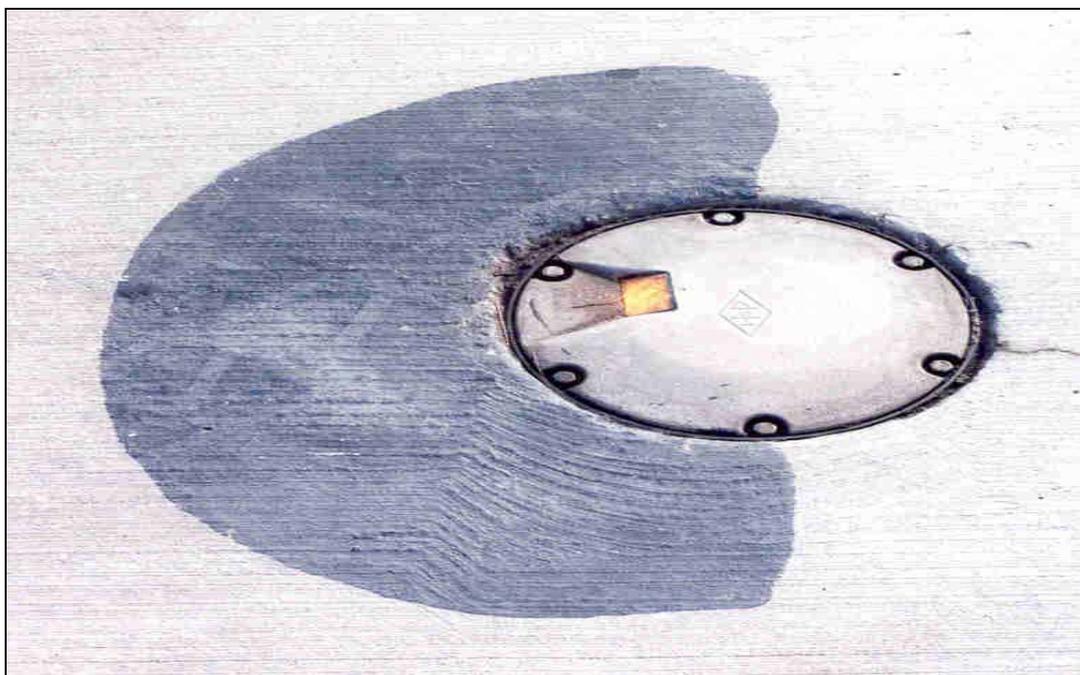
FIGURE 3. CHAMFER PAINTED BLACK IN AN EFFORT TO ABSORB AND REFLECT THE LIGHT UPWARD

1. Chamfer the concrete lip where light strikes it to direct most of the reflected light upward and away from the runway. The concrete surface within this chamfer must be very smooth to reduce any reflections.
2. Increase the smoothness of the chamfer by applying a durable, glossy, polyurethane paint to the surface.
3. Paint the chamfer black to absorb and reflect the light upward (see figure 3).
4. Raise the fixture with spacer rings. Depending on how level the concrete is, grinding may also be needed.

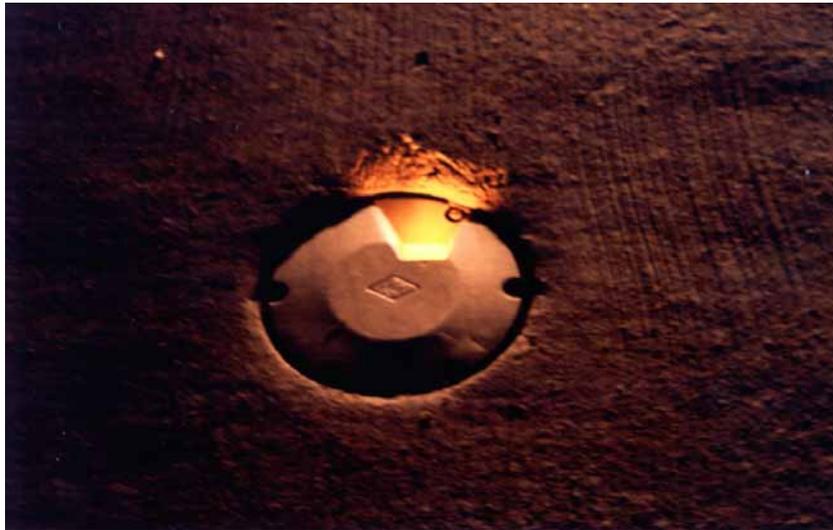
The fixtures, as produced by all major airport lighting manufacturers (Crouse-Hinds, ADB, Honeywell, etc.), were derived from the standard L-850 and L852 series of fixtures, and in most cases, the same casting as runway centerline and touchdown zone (L-850A&B) fixtures. These fixtures will, as determined by the William J. Hughes Technical Center testing, project a significant amount of light below the horizontal level because the lens are raised higher than the front edge of the fixture port or ramp, which projects the light to negative angles of 2 to 3 degrees. By design, this type of fixture will always illuminate the surrounding surface in front of the fixture and create reflections in the reverse direction (see figure 4).

FIGURE 4. AN RGL FIXTURE WITH LIGHT REFLECTING OFF THE EDGE OF THE CONCRETE

The L-852G fixtures presently installed at ORD are provided with a single 105-watt lamp, and project a relatively high-intensity beam of light. This, unfortunately, also produces higher-intensity reflections and may be contributing to the problem. It was determined that no matter which lamp wattage or brightness/intensity setting was used, it was possible that pilots would still confuse the RGL installation with random flashing yellow barricade lights.

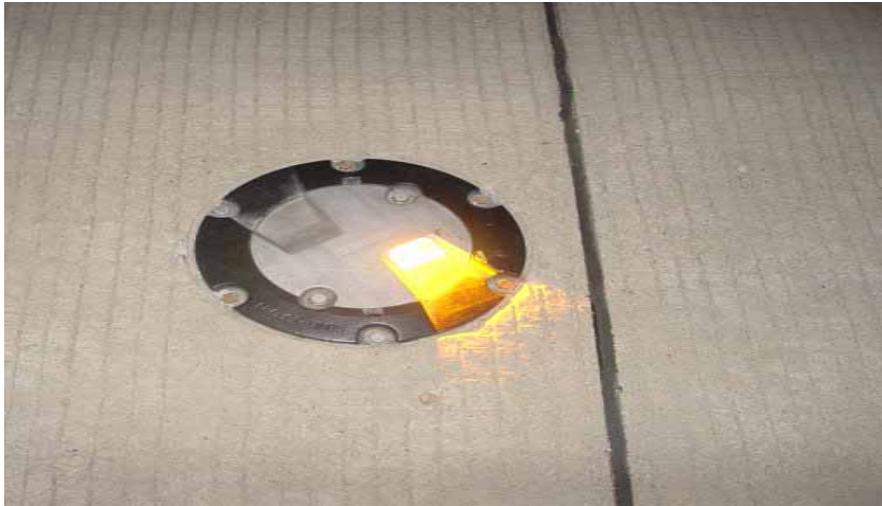
In addition to the design of the fixtures, the fixtures at ORD were installed at such a low level that the outer edge of the fixture, which is also at the same level as the front of the light, impinges directly upon the vertical wall (or in some cases slope) of the saw cut hole. The primary reason for this low setting is to prevent the fixtures from being struck by snowplows or blades. This low installation creates an even more intense rearward reflection. AC 150/5340-30 specifies that the outer edge of the fixture be level with the surrounding taxiway surface or, at most, a maximum of 1/16 inch (1.5 mm) below the pavement surface. Paragraph 11.1, page 75 of AC 150/5340-30 reads:

During a site visit, these fixtures were elevated using the appropriate spacer rings to bring the edge of the fixture up to the same level as the concrete lip. However, by raising the fixture, the glare was moved from the edge of the concrete wall to the top surface of the concrete, creating a teardrop pattern of concentrated light on the pavement in front of the fixture (see figure 5).

FIGURE 5. AN RGL FIXTURE WITH LIGHT REFLECTING OFF THE SURFACE PAVEMENT

6. The final solution to the problem encountered at Chicago O'Hare International Airport was to reconfigure the flash pattern of the in-pavement RGL system so that it flashes in unison, eliminating the confusing random yellow flashing pattern that is viewed from the runway side of the fixture, while still maintaining the intended integrity of the system when viewed from the taxiway side.
