Effects of Concentrated Hydrochloric Acid Spills on Aircraft Aluminum Skin

July 1998

DOT/FAA/AR-TN97/108

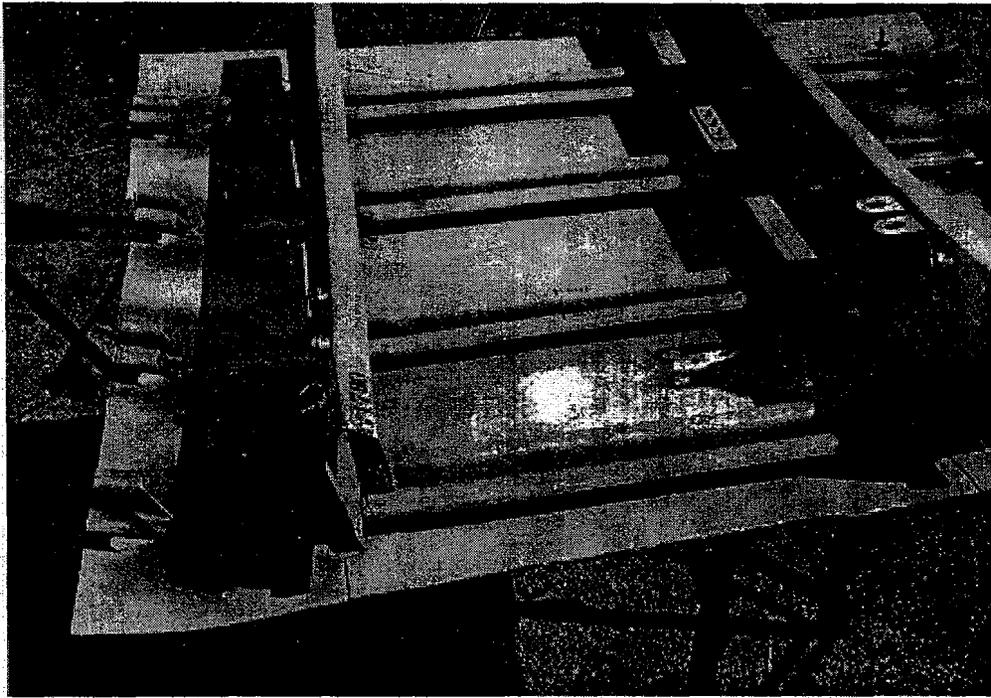
The first test was the largest, a 3- by 3-foot section with a 1-liter acid spill (figures 1 and 2). The edges of the skin were bent upwards to contain the acid. In the process of bending the skin and cutting notches in the ribs to allow the bending of the frame, scrapes and breaks in the surface coating of the aluminum skin were produced. There was no treatment of the marred surfaces in this test. The acid contacted not only the interior skin surface but also the bulkhead plates and fittings and the ribs and attaching grommets.

FIGURE 1. TEST ARTICLE FOR TEST 1: 3- BY 3-FOOT SIDEWALL OF A BOEING 747

Test No.	Test Article Description	Location of Failure	Time to Failure (min.)	Comments	Figure No.
1	3' x 3' section of fuselage	At scratched surfaces and at bends in skin	47, 65, and 80	Acid created hole in skin at scratched and bent surfaces.	1, 2
		At rivets	No failure	Rivets partially decomposed, but still intact.	
2	6" x 6" section of aluminum skin in a 7" x 7" Pyrex pan	At rivets	50	Three rivets eaten away below surface of skin.	3
		At ribs	70	Side of rib eaten 1/2 inch through the length of rib. Severe corrosion.	
			80	All submerged surfaces of unpainted rib completely gone.	
		At rivets	85	Only white exterior paint remained where rivets were.	
3	7" x 7" section of aluminum skin as base of pressurized box, 0-2.5 psi. Silicone caulk used as a seal.	At rivets	N/A	Severe corrosion. Rivets eaten through below surface of the skin.	4, 5, 6
		At ribs	90	Rib disconnected from aluminum skin. All submerged surfaces of unpainted rib completely gone. Base seal remained intact. Pressure not maintained during the test due to failure of lid seal.

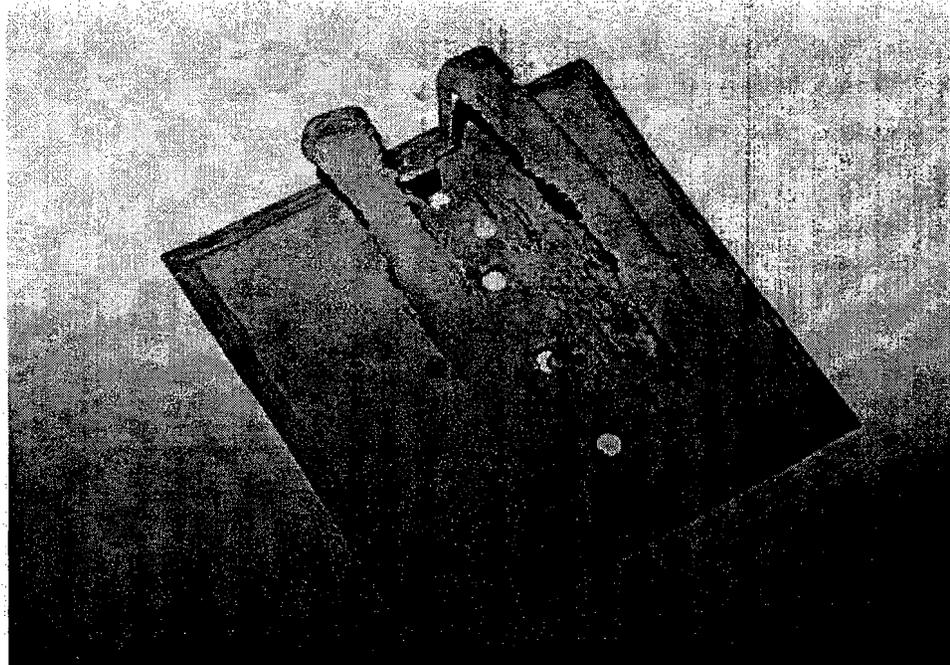
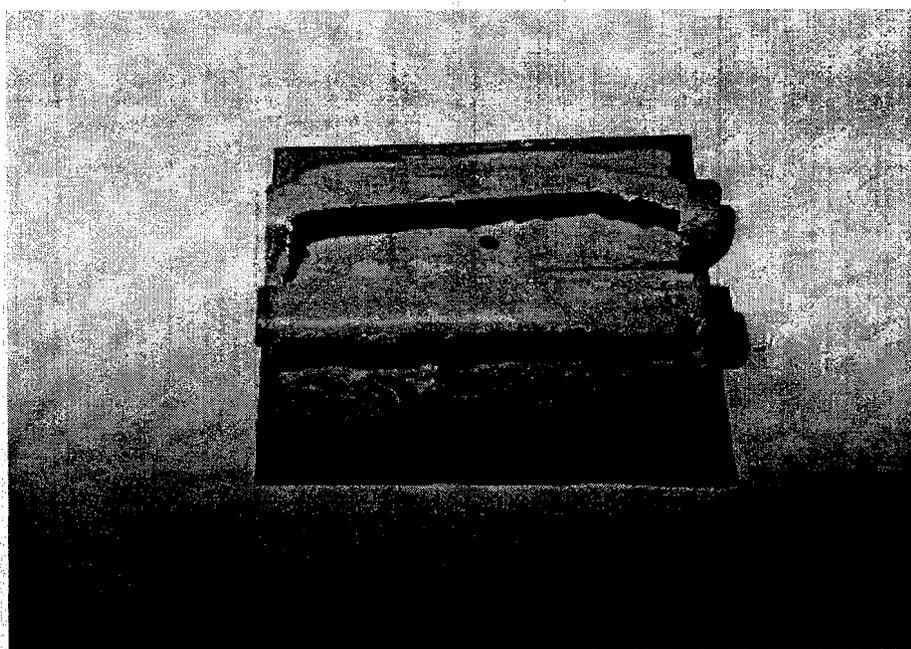
A 6- by 6-inch section of the skin, including the frame material, was placed in a Pyrex pan with the outside surface of the skin face down. All cut edges of the test sample were covered with epoxy paint. One liter of concentrated HCl was spilled into the Pyrex pan. The depth of acid was 1 1/4 inches. Periodically the section of skin was lifted out of the solution with metal tongs to visually evaluate the damage as a function of exposure time. The test specimen was rinsed with tap water at the conclusion of the test and photographed (figure 3).

FIGURE 3. TEST ARTICLE FOR TEST 2 AFTER REMOVAL FROM PYREX PAN CONTAINING 1 LITER OF CONCENTRATED HYDROCHLORIC ACID, TWO VIEWS

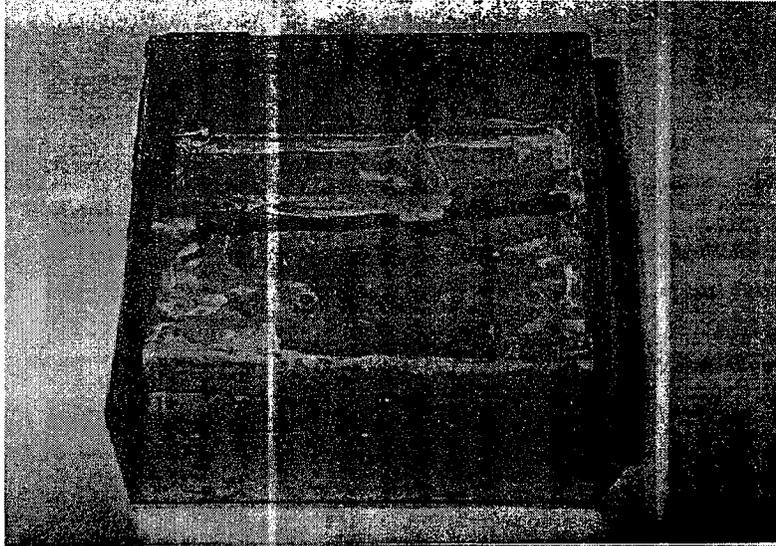
FIGURE 6. TEST ARTICLE FOR TEST 3 AFTER A 90-MINUTE CONTACT WITH SPILLED CONCENTRATED HYDROCHLORIC ACID. TOP OF TEST CONTAINER REMOVED.

A 2.5 psi box pressure simulates the ΔP_{skin} at 15,000 feet altitude. A small ΔP may result in the blowout of the white exterior epoxy paint on the bottom of the box when the rivets fail, giving a visual indication of failure. However, the silicone lid seal failed early into the test and pressure fell to ambient.
