DOT/FAA/CT-86/42

Statistics on Aircraft Gas Turbine Engine Rotor Failures that Occurred in U.S. Commercial Aviation During 1981

March 1987

Final Report

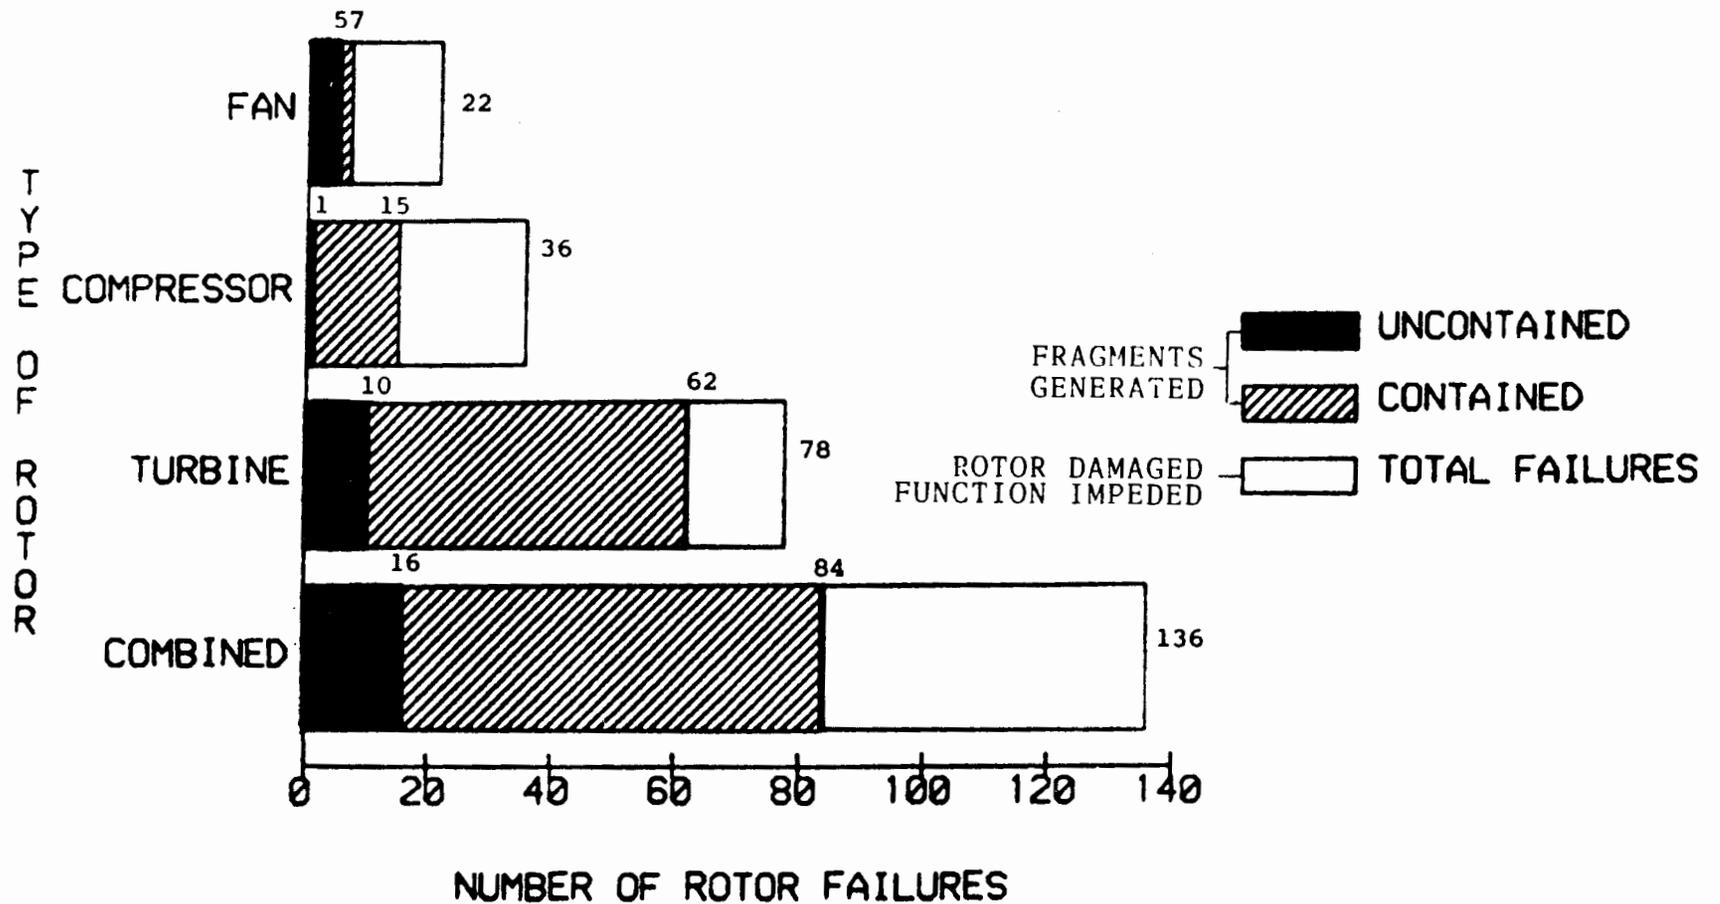
FIGURE 1: INCIDENCE OF ENGINE ROTOR FAILURE
IN U. S. COMMERCIAL AVIATION 1981

a. Figure 1 shows that 136 rotor failures occurred in 1981. These rotor failures accounted for approximately 2.7 percent of the 5095 shutdowns experienced by the gas turbine powered U. S. commercial aircraft fleet during 1981. Rotor fragments were generated in 84 of the failures experienced and, of these, 16 (19.0 percent of the fragment producing failures) were uncontained. This represents an uncontained failure rate of 2.1 per million gas turbine engine powered aircraft flight hours, or 0.8 per million engine operating hours. Approximately 7.5 million and 20.7 million aircraft flight and engine operating hours, respectively, were logged by the U. S. commercial aviation fleet in 1981. Gas turbine engine fleet

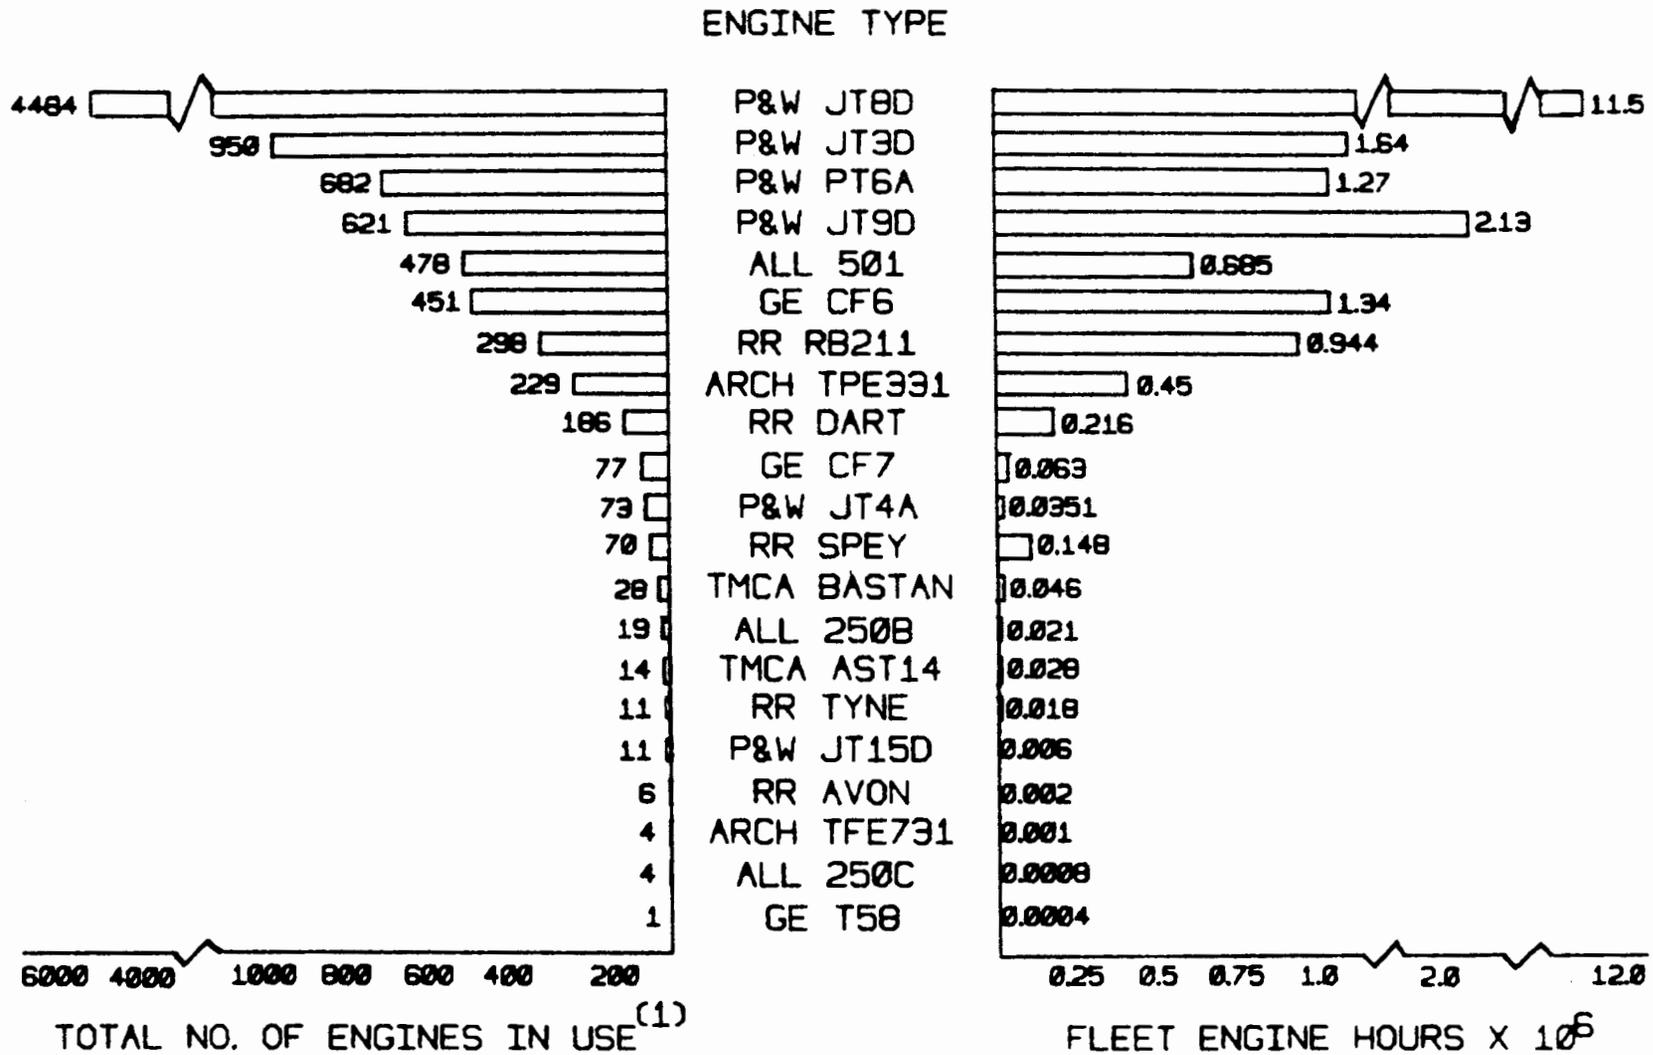
FIGURE 2: GAS TURBINE ENGINE FLEET OPERATING HOURS IN U.S. COMMERCIAL AVIATION ACCORDING TO NUMBER OF ENGINES IN SERVICE - 1981

operating hours according to the number and type of engines in use is shown in Figure 2.

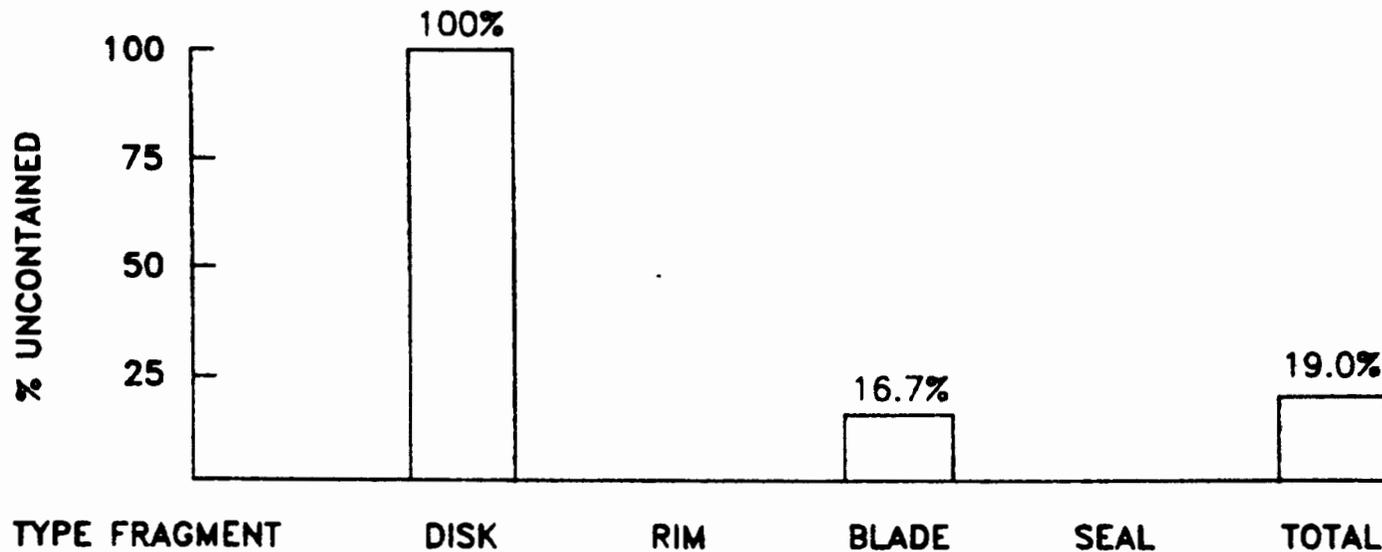
FIGURE 3: COMPONENT AND FRAGMENT TYPE DISTRIBUTIONS FOR CONTAINED AND UNCONTAINED ROTOR ENGINE FAILURES (FAILURES THAT PRODUCED FRAGMENTS) - 1981

b. Figure 3 shows the distribution of rotor failures that produced fragments according to the engine component involved (fan, compressor, turbine), the types of fragments that were generated, and the percentage of uncontained failures according to the type of fragment generated. These data indicate that:

(1) The incidence of turbine rotor fragment producing failures was approximately four times greater than that of the compressor rotor fragment producing failures; these corresponded to 62 (73.8 percent) and 15 (17.9 percent), respectively, of the total number of rotor failures. Fan rotor failures accounted for 7 (8.3 percent) of the fragment producing failures experienced.

(2) Blade fragments were generated in 78 (92.9 percent) of the rotor failures; 13 (16.7 percent) of these were uncontained. The remaining 6 (7.1 percent) rotor fragment failures were produced by disk, rim, or seal.

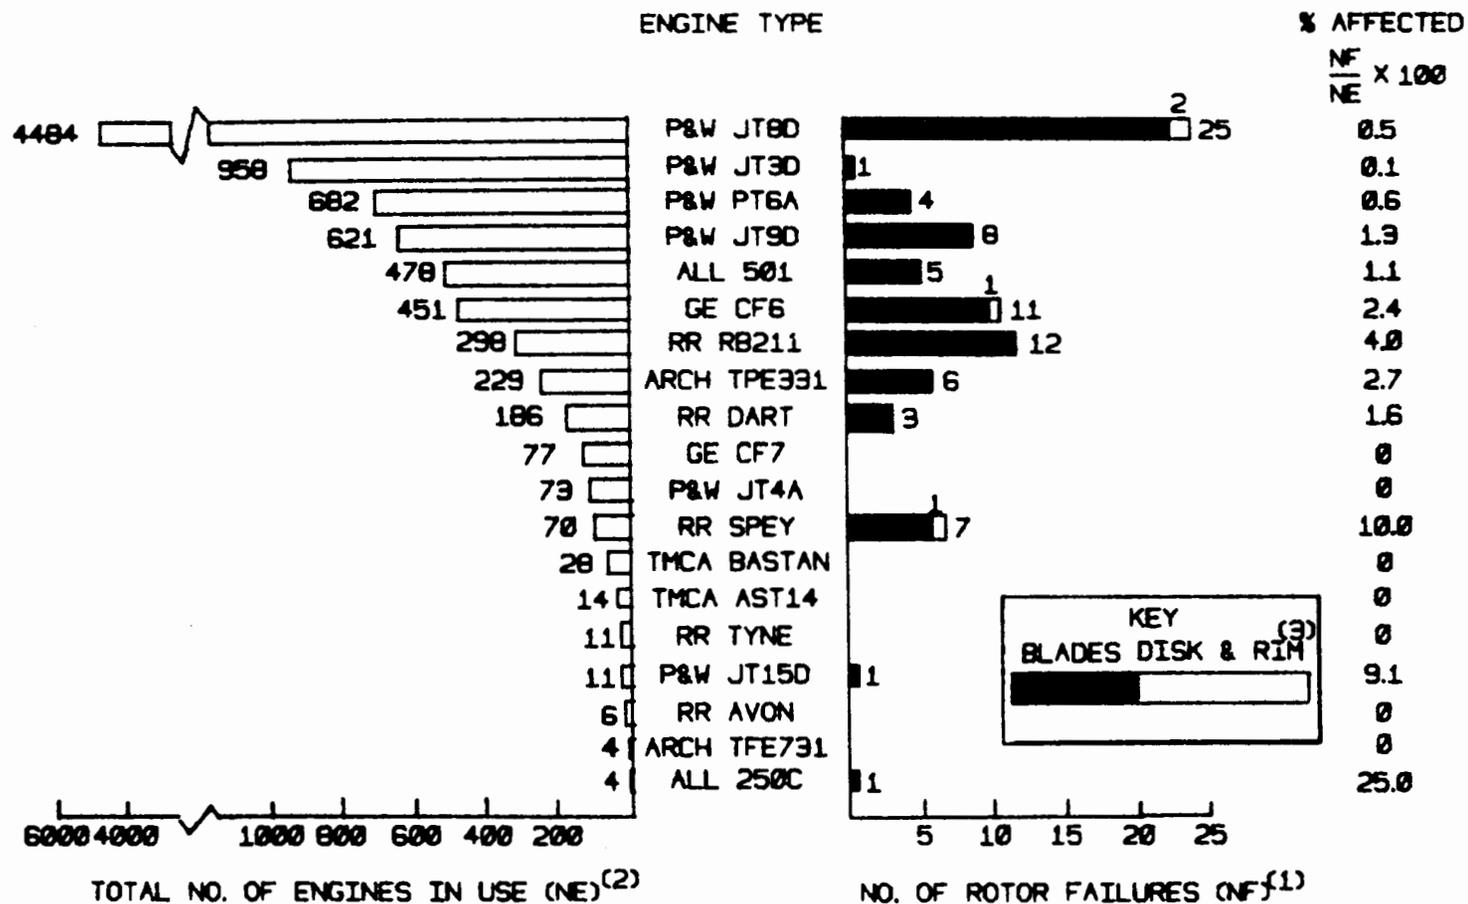
FIGURE 4: THE INCIDENCE OF ENGINE ROTOR FAILURE IN U.S. COMMERCIAL AVIATION ACCORDING TO ENGINE TYPE AFFECTED - 1981

c. Figure 4 shows the rotor failure distribution among the engine models that were affected, and the total number of the models in use.

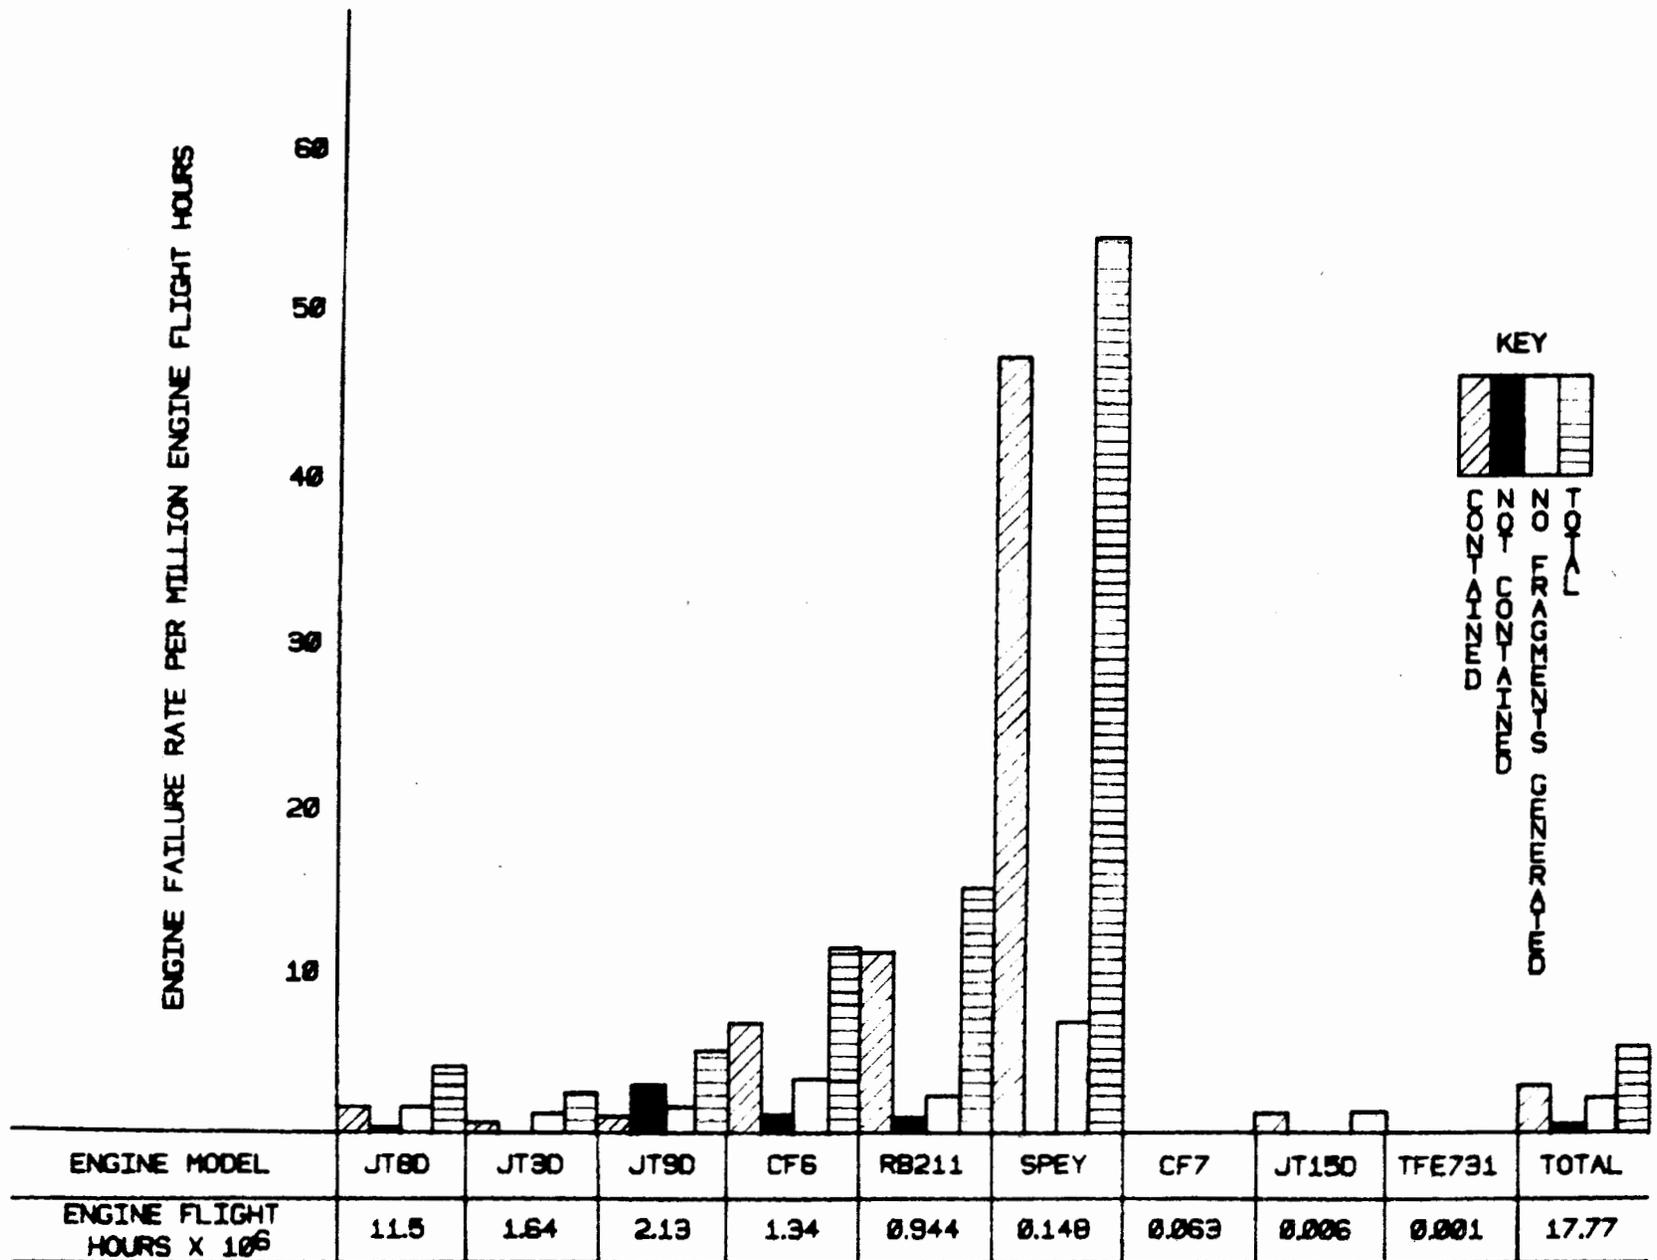
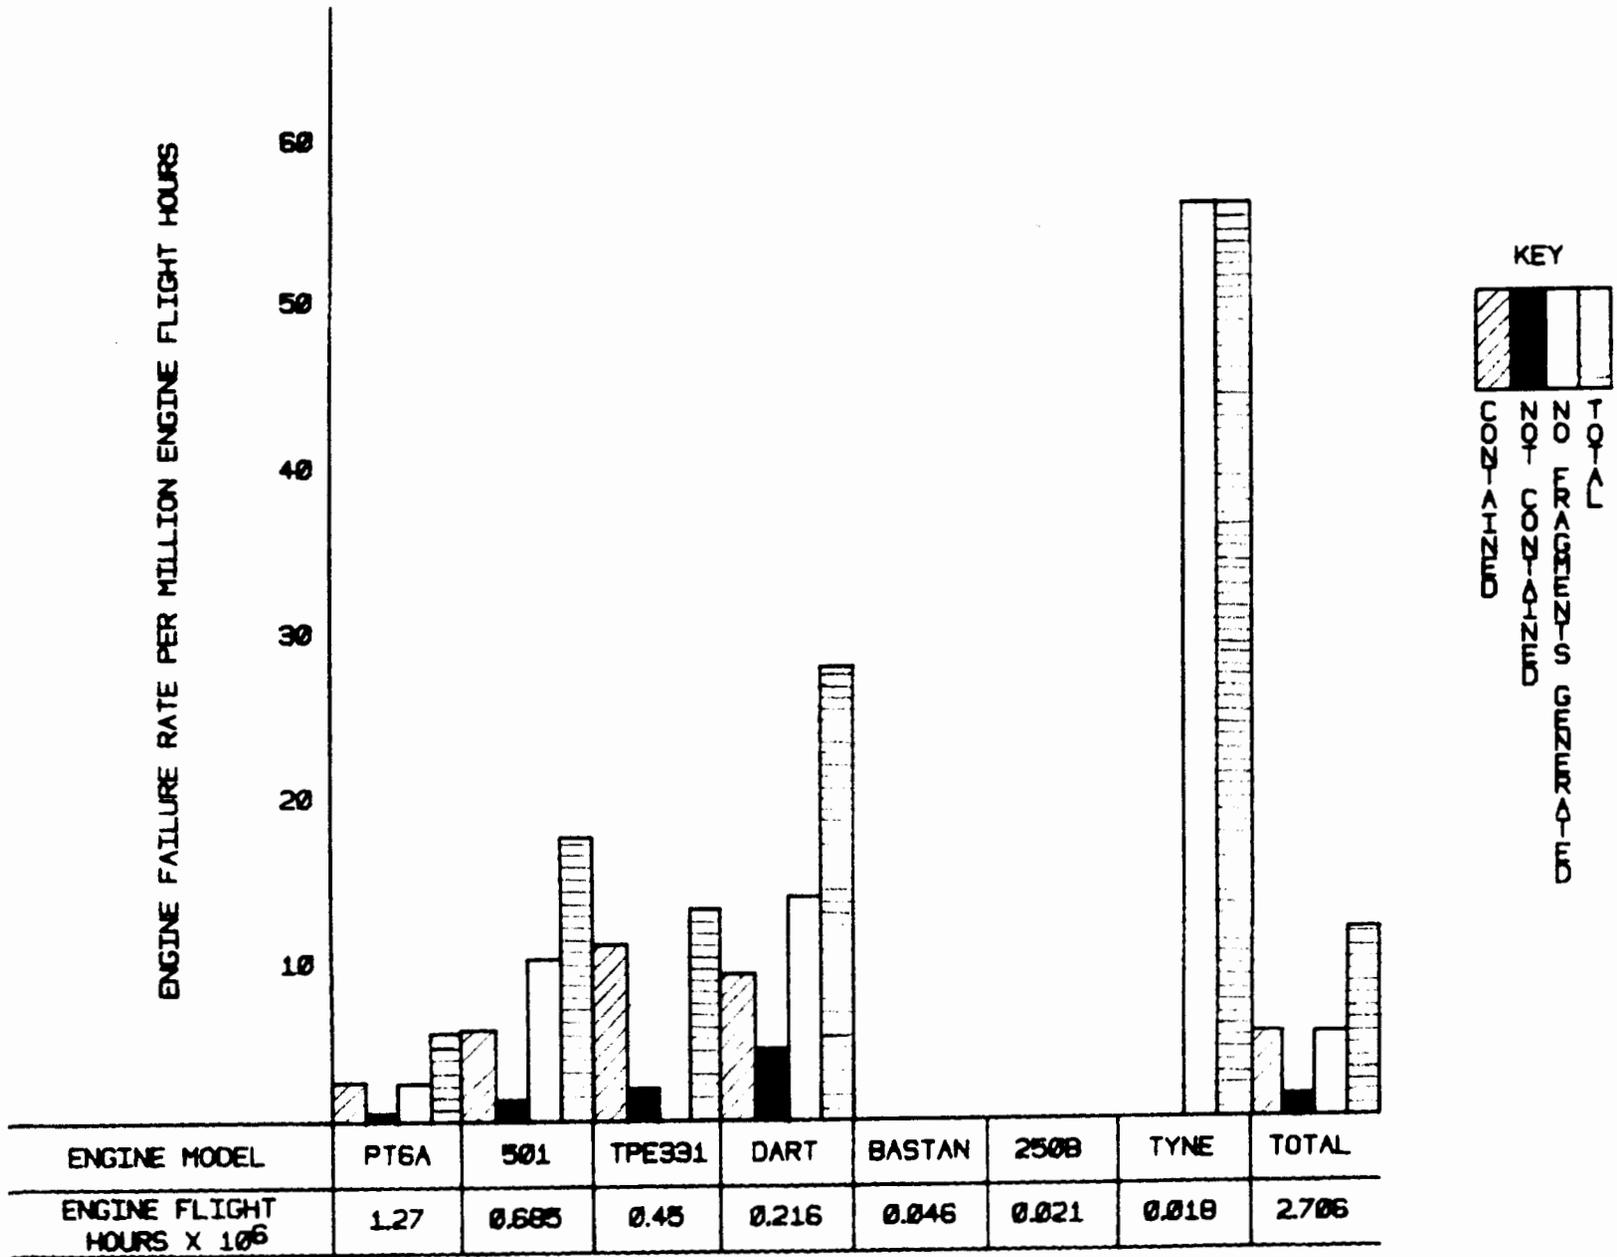
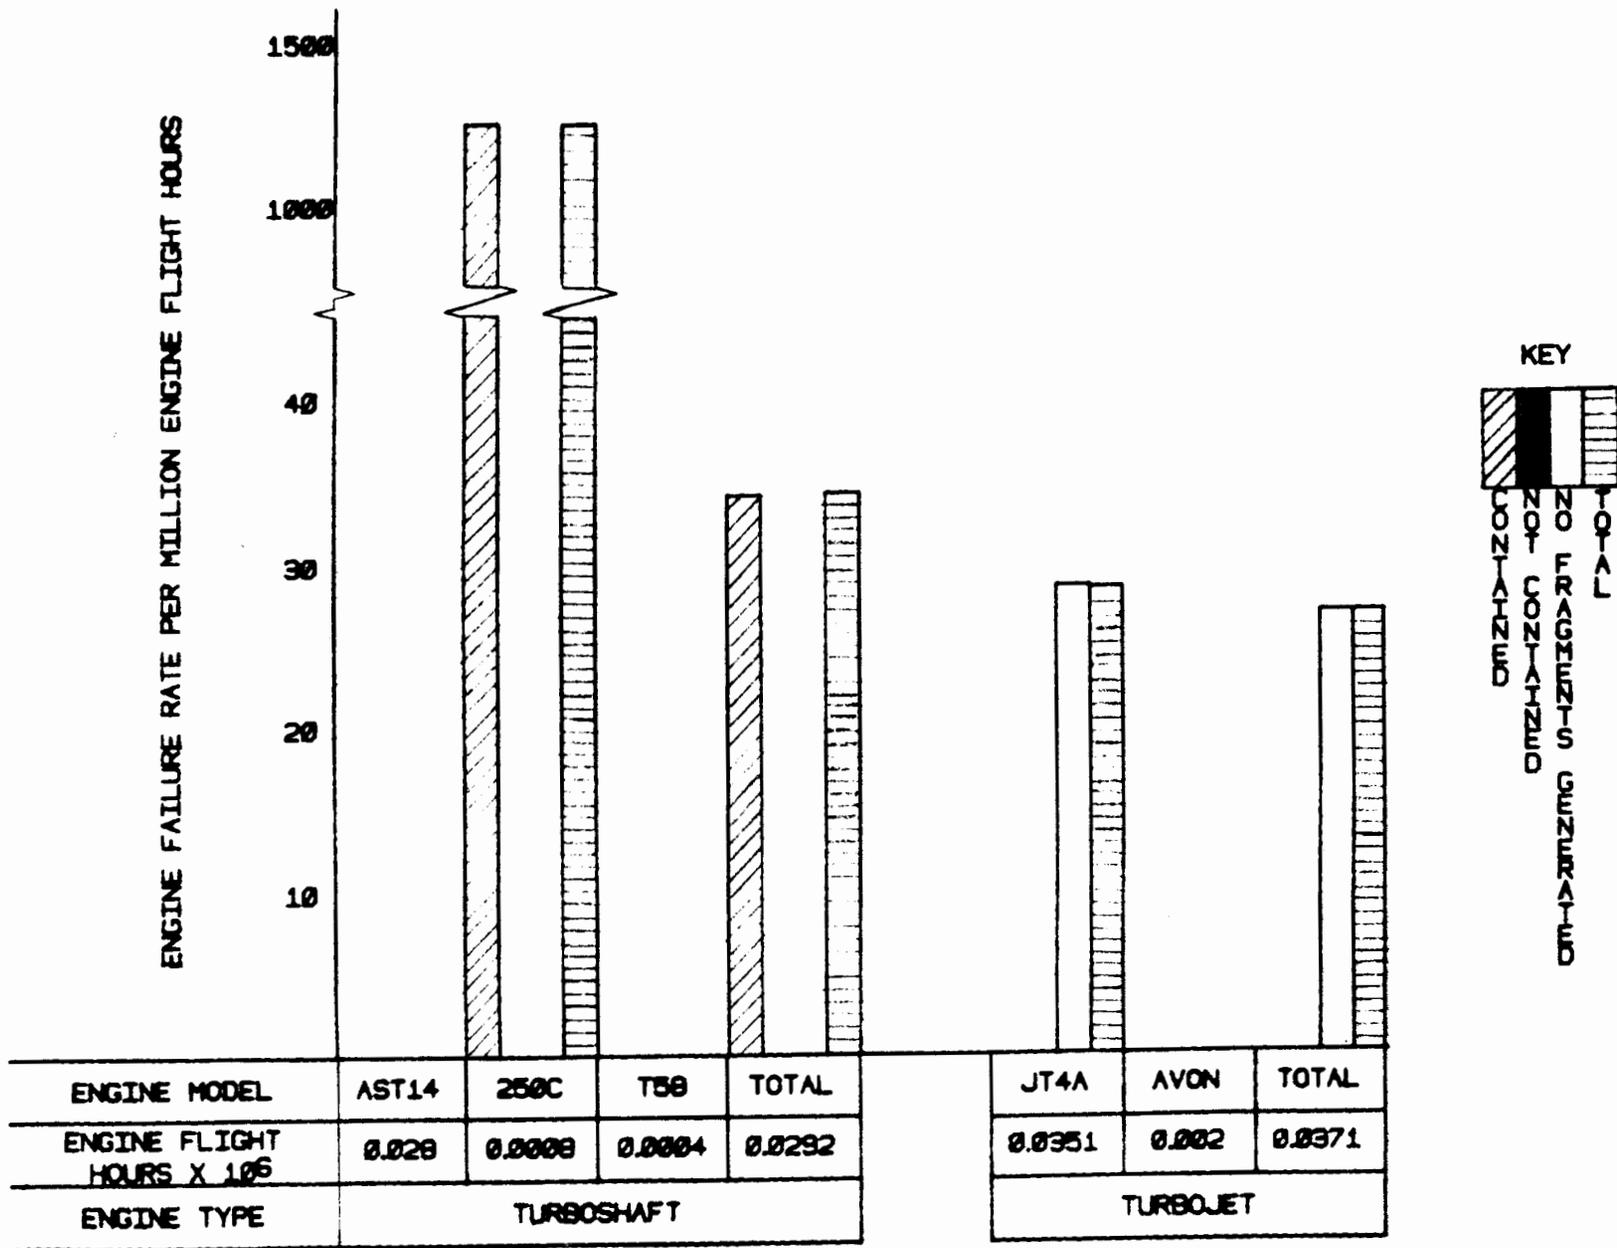
d. Figures 5, 6, and 7 illustrate engine failure rates per million engine flight hours according to engine model, engine type, and containment condition. The total engine failure rate per million engine type flight hours are: turbofan 5.7, turboprop 11.8, turboshaft 34.2, and turbojet 27.0. Total uncontained engine failure rates per million engine type flight hours were: turbofan 0.7 and turboprop 1.5. No uncontained rotor failures were reported for turboshaft and turbojet engines in 1981.

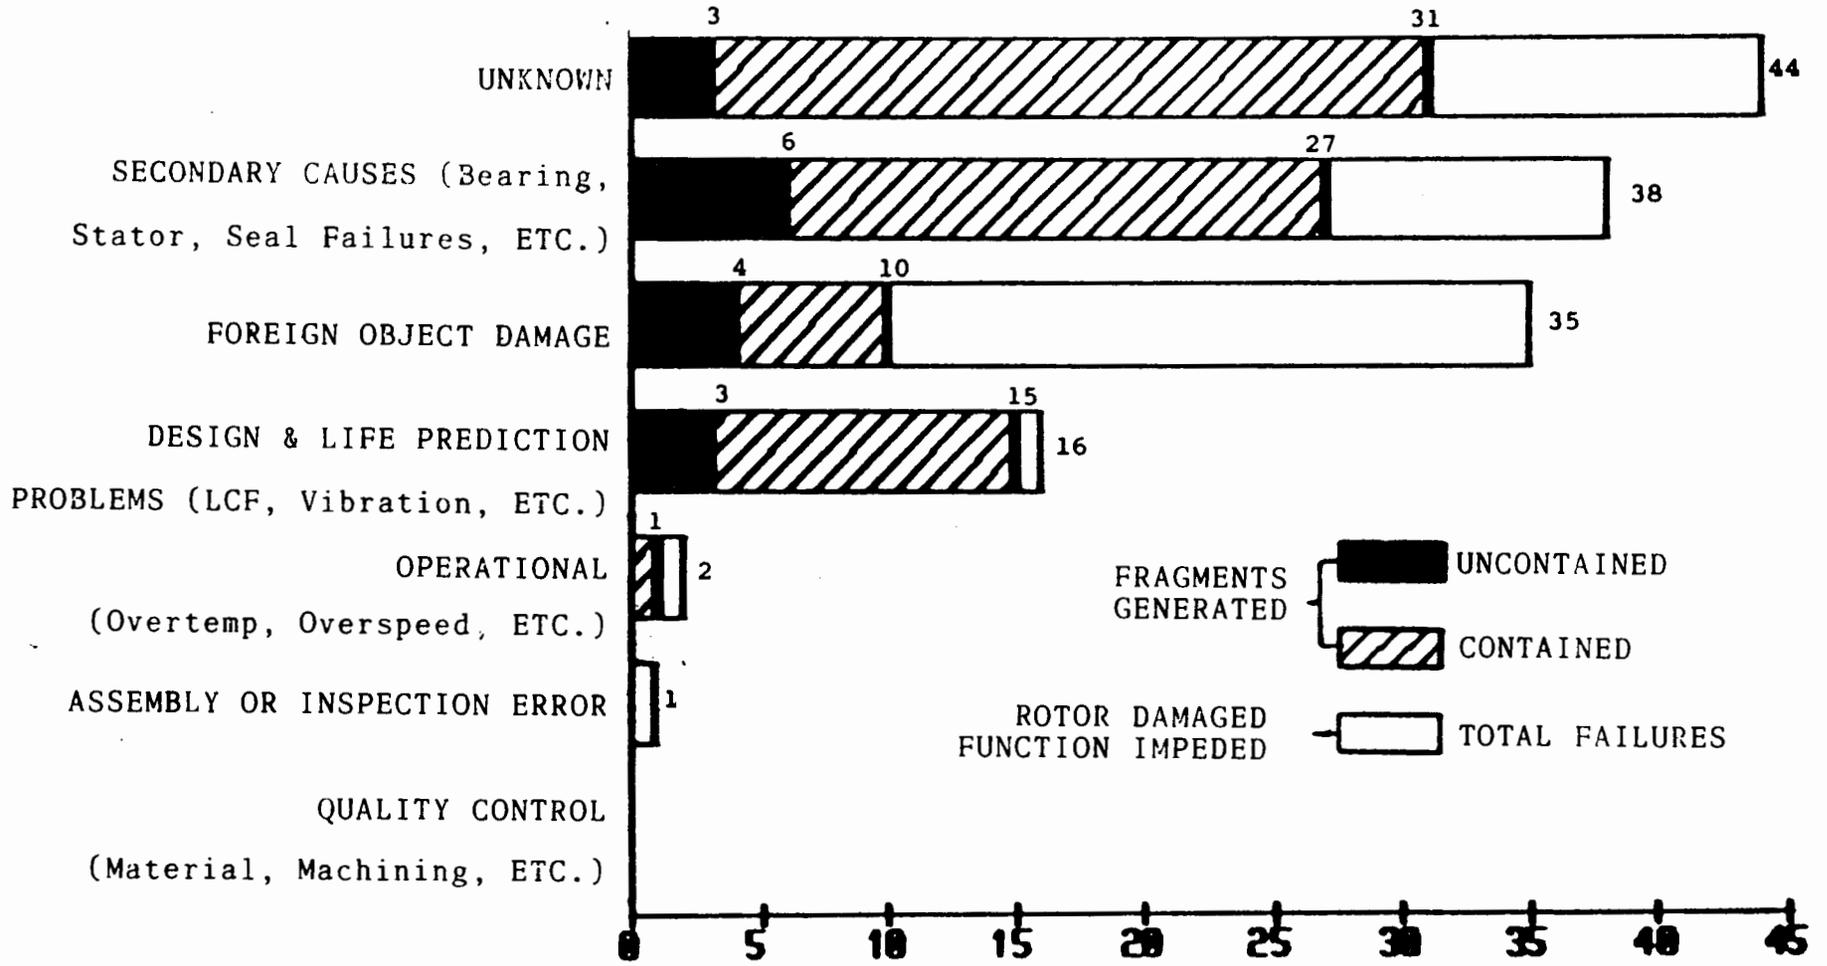
FIGURE 8: ENGINE ROTOR FAILURE CAUSE CATEGORIES - 1981

e. Figure 8 shows what caused the rotor failures to occur. Of the 92 known causes of failure (because of the high percentage of unknown causes of rotor failure, the percentages were based on the total number of known causes), the causal factors were: (1) Secondary Causes 38 (41.3 percent); (2) Foreign Object Damage 35 (38.0 percent); (3) Design and Life Prediction Problems 16 (17.4 percent); and Other 3 (3.3 percent).

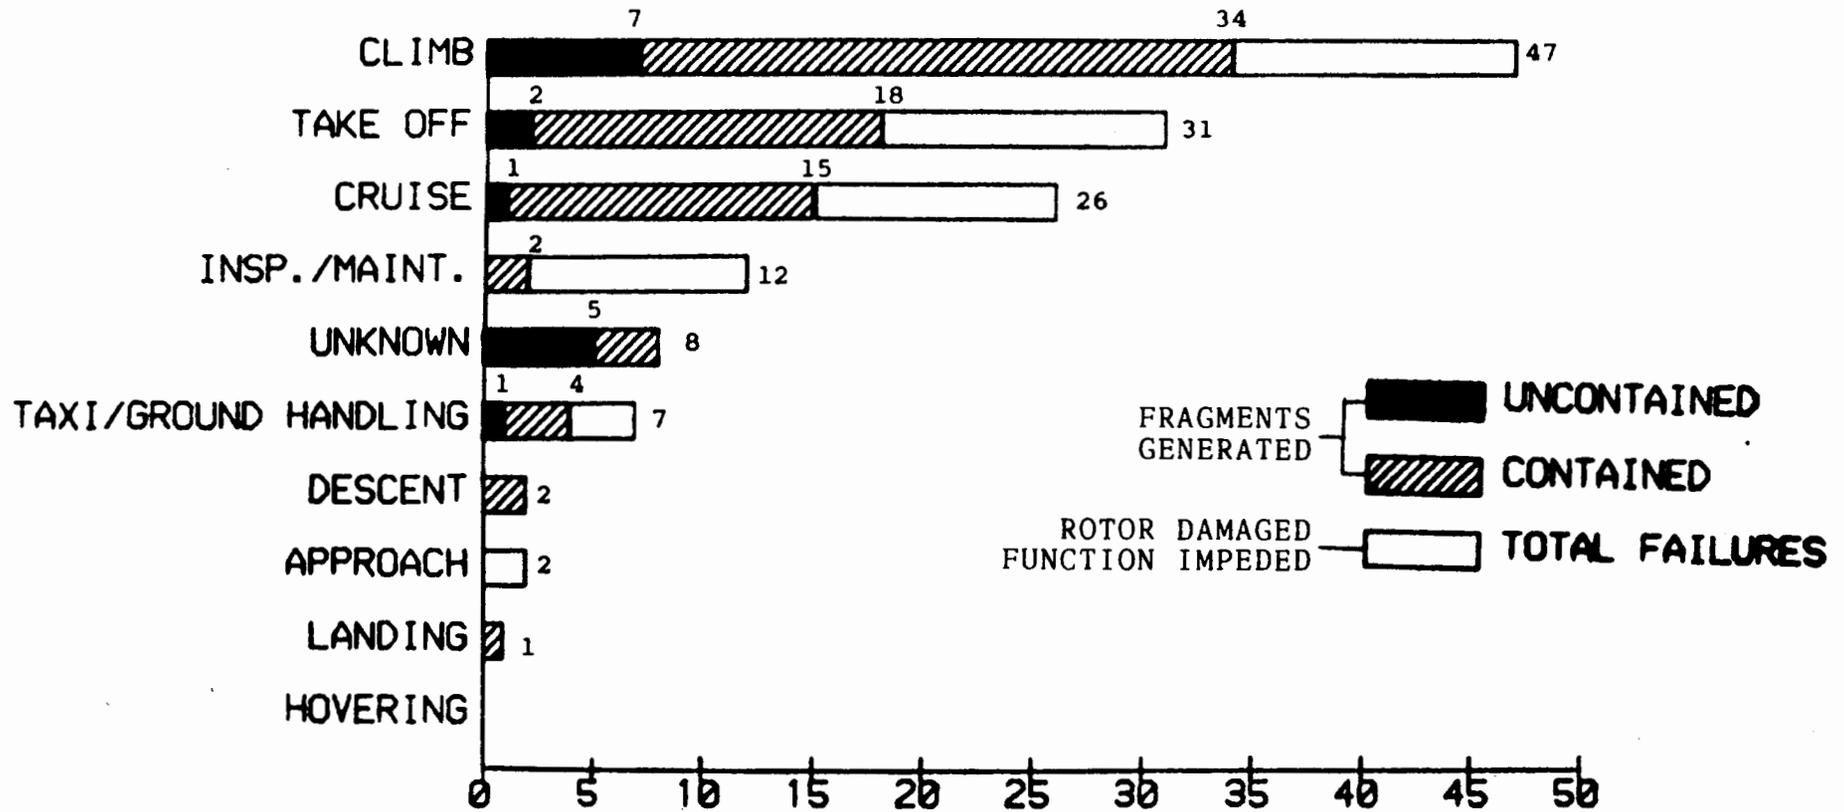
FIGURE 9: FLIGHT CONDITION AT ENGINE ROTOR FAILURE - 1981

f. Figure 9 indicates the flight conditions that existed when the various rotor failures occurred. Seventy-eight (57.4 percent) of the 136 rotor failures occurred during the takeoff and climb stages of flight. Fifty-two (61.9 percent) of the rotor fragment producing failures and 9 (56.3 percent) of the uncontained rotor failures occurred during these same stages of flight. The highest number of uncontained rotor failures, 7 (43.8 percent) was experienced during climb.

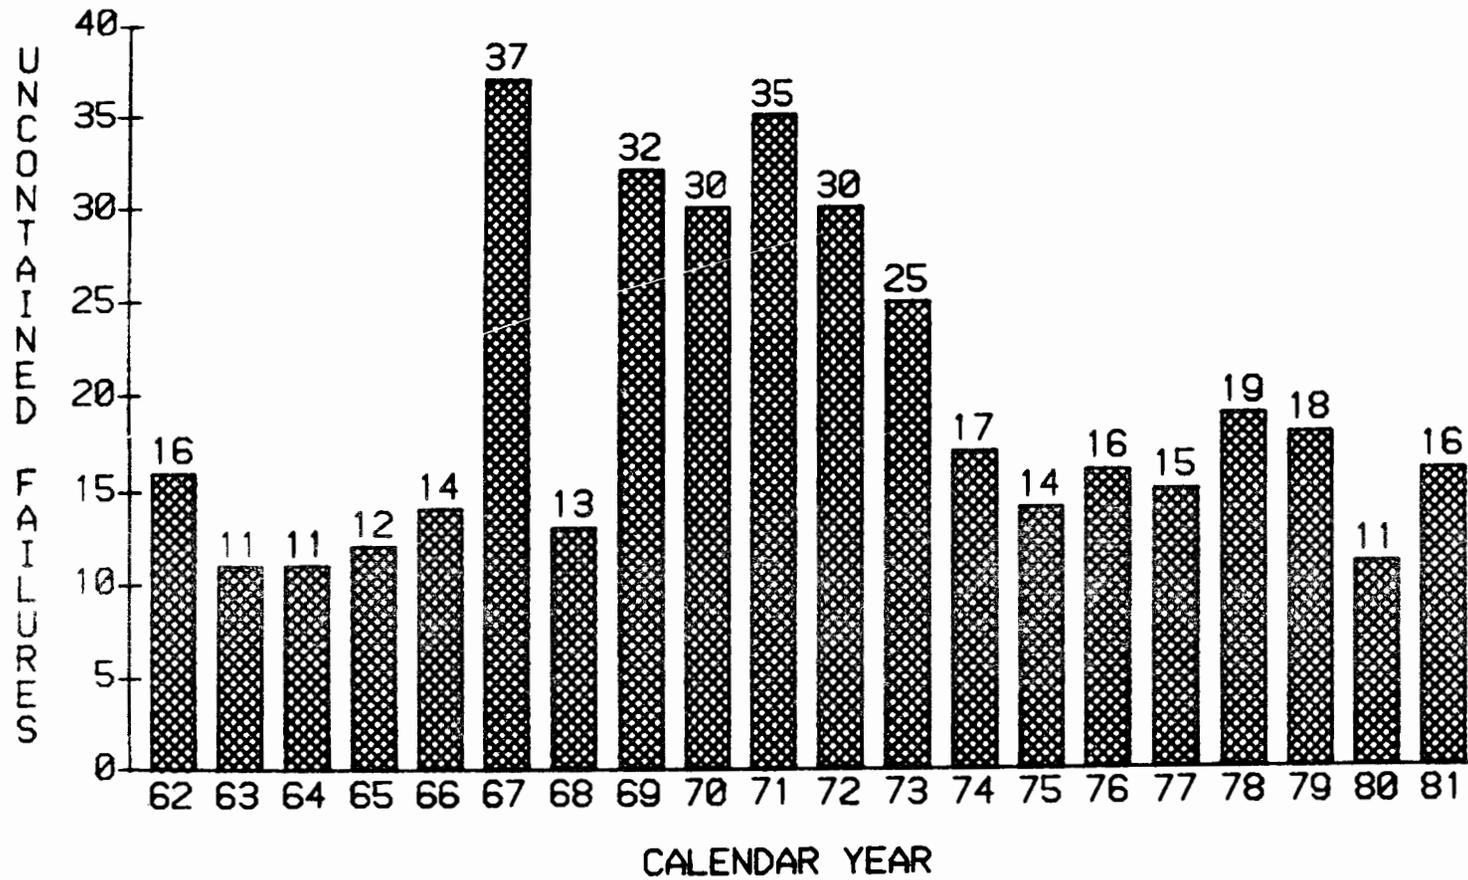
FIGURE 11: THE INCIDENCE OF UNCONTAINED ENGINE ROTOR FAILURE IN U.S. COMMERCIAL AVIATION 1962 - 1981

h. Figure 11 shows the annual incidence of uncontained rotor failures in commercial aviation for the years 1962 through 1981. During 1981, the incidence of uncontained rotor failure increased by five over the previous year, 1980. Over the past six years, 1976 through 1981, an average of 16 uncontained rotor failures per year have occurred. During the same time period, the rate of uncontained rotor failures has remained relatively constant at an average of approximately one per million engine operating hours.

The high incidences of uncontained rotor failures in calendar years 1967 through 1973 (except for 1968) were probably due to the introduction of newly developed engines entering the commercial aviation fleet such as the JT9D and CF6 engines.

Structural life prediction and verification is being improved by the increased use of spin chamber testing by government and industry as a means of obtaining failure data for statistically significant samples. In addition, increased development and application of high sensitivity non-destructive inspection methods, should increase the probability of cracks being detected prior to failure. The capability to reduce the causes of failures from secondary effects, also is being addressed through technology development programs. However, causes due to foreign object damage still appear to be beyond the control or scope of present technology.
