DOT/FAA/CT-88/23

Statistics on Aircraft Gas Turbine Engine Rotor Failures that Occurred in U. S. Commercial Aviation During 1982

R.A. DeLucia
J.T. Salvino

July 1988

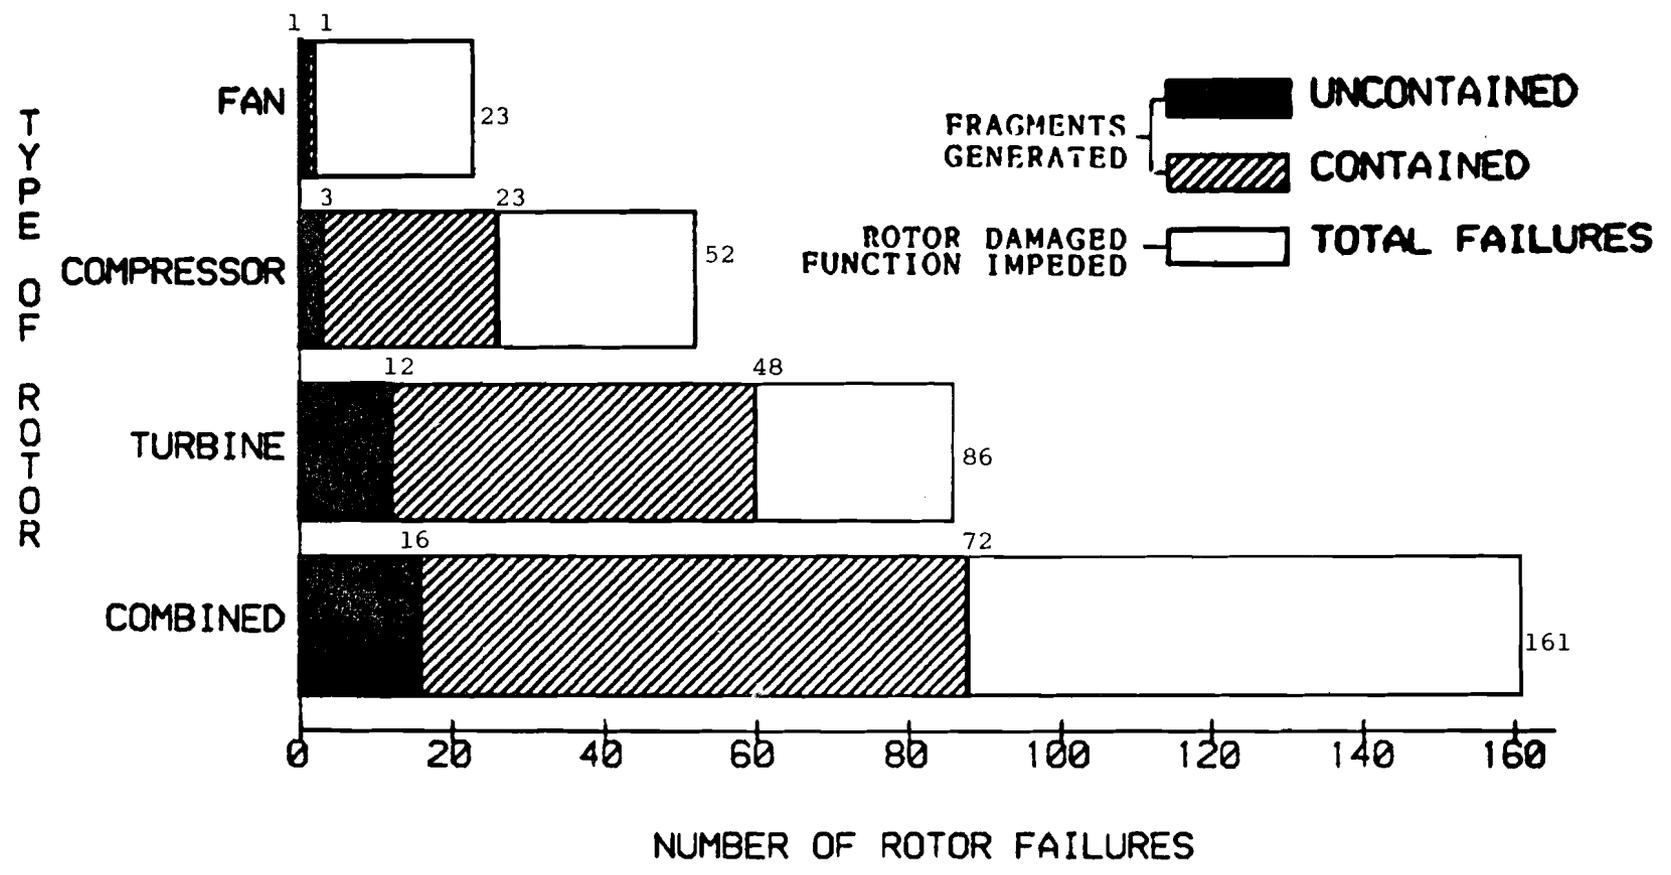
FIGURE 1. INCIDENCE OF ENGINE ROTOR FAILURES IN U.S. COMMERCIAL AVIATION - 1982

Figure 1 shows that 161 rotor failures occurred in 1982. These rotor failures accounted for approximately 9.3 percent of the 1722 shutdowns experienced by the U.S. commercial gas turbine powered aircraft fleet during 1982. Rotor fragments were generated in 88 of the failures experienced and, of these, 16 (18.2 percent of the fragment-producing failures) were uncontained. This represents an uncontained failure rate of 2.1 per million gas turbine engine powered aircraft flight hours, or 1.3 per million engine operating hours.

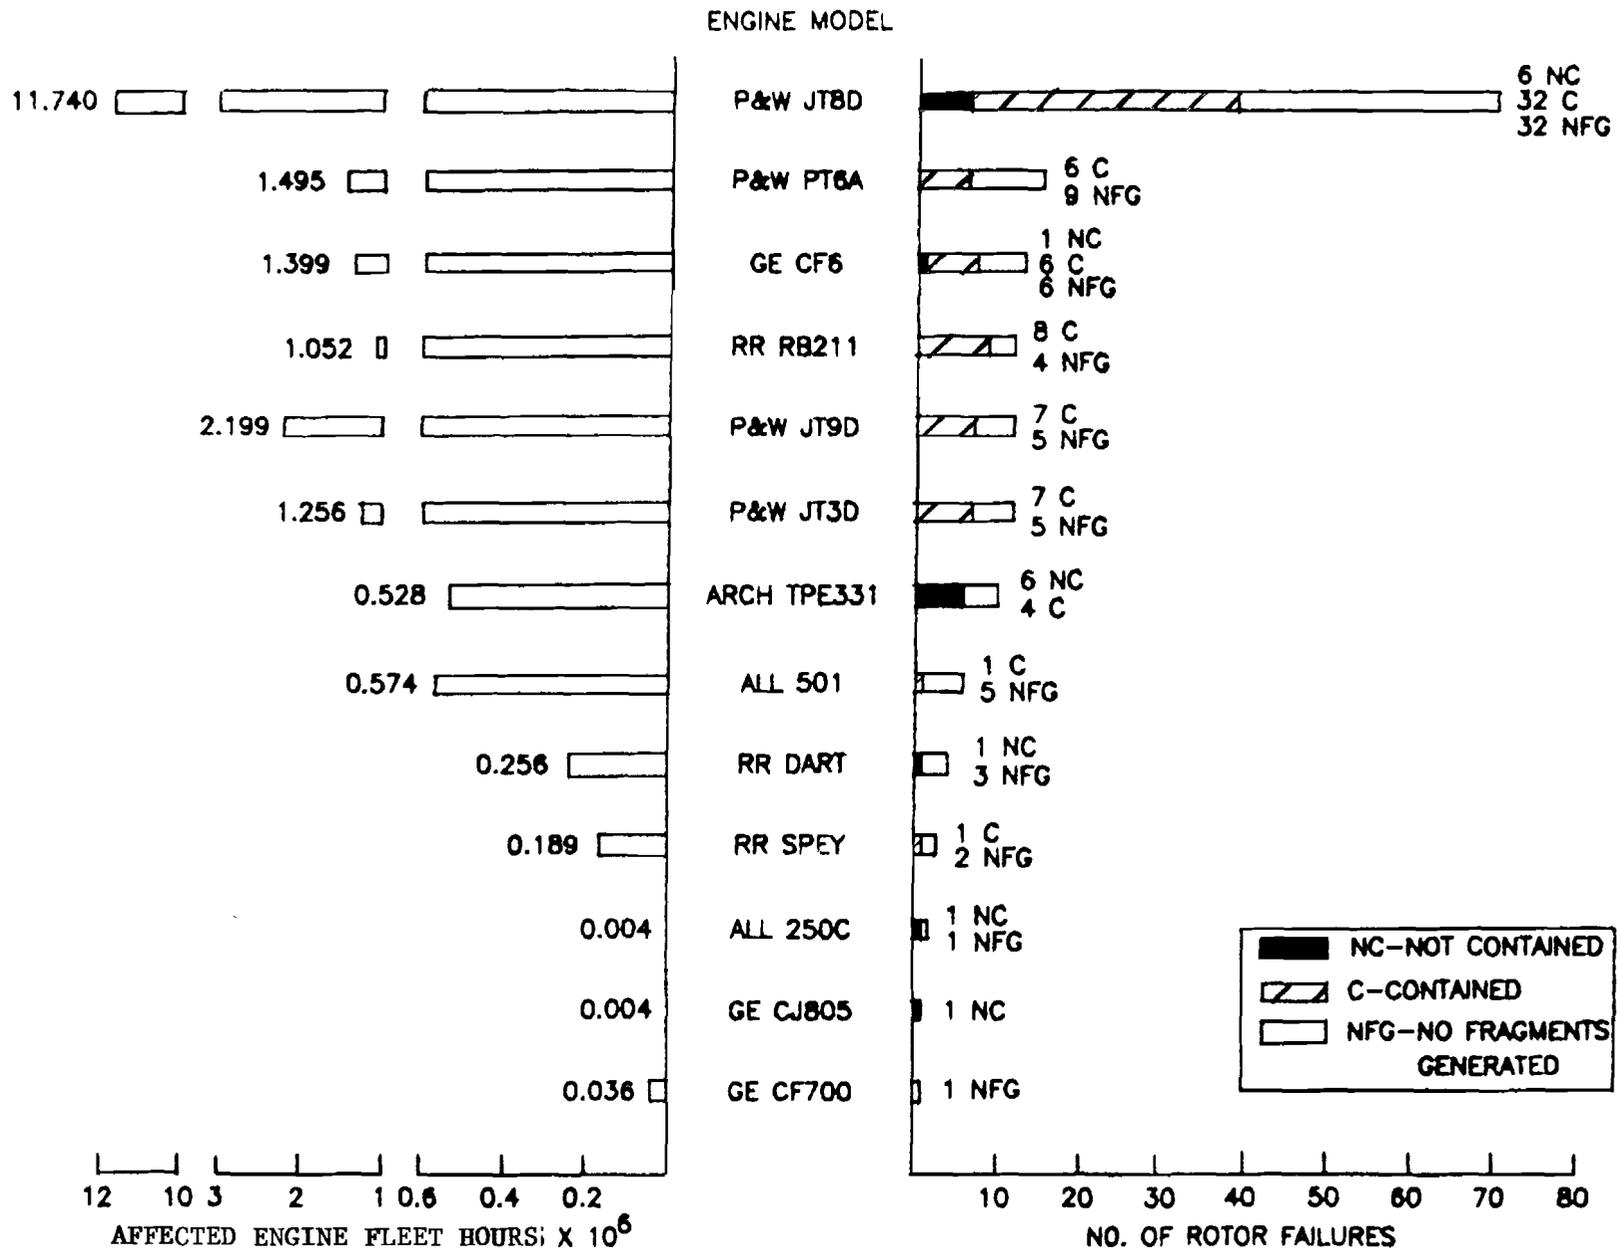
FIGURE 2. THE INCIDENCE OF ENGINE ROTOR FAILURES IN U.S. COMMERCIAL AVIATION ACCORDING TO AFFECTED ENGINE FLEET HOURS FOR EACH ENGINE MODEL - 1982

Approximately 7.6 million aircraft flight hours and 20.8 million engine operating hours were logged by the U.S. commercial aviation fleet in 1982. Gas turbine engine fleet operating hours relative to the number of rotor failures and type of engines in use are shown in figure 2.

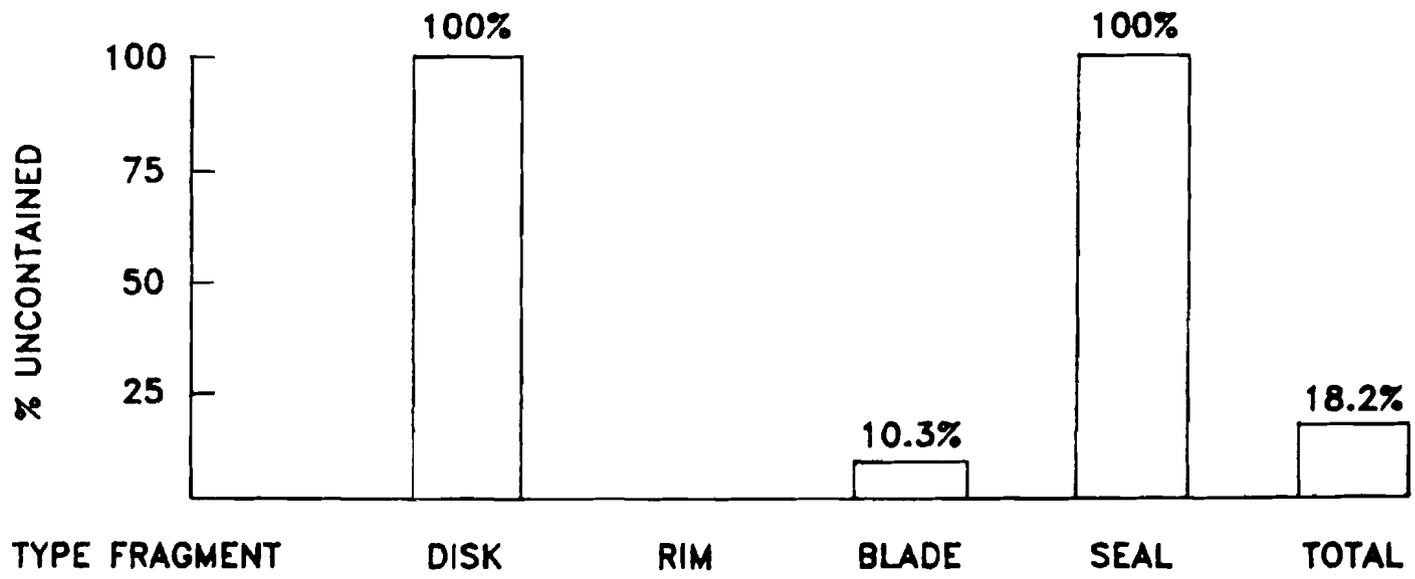
FIGURE 3. COMPONENT AND FRAGMENT TYPE DISTRIBUTIONS FOR CONTAINED AND UNCONTAINED ROTOR ENGINE FAILURES (FAILURES THAT PRODUCED FRAGMENTS) - 1982

Figure 3 shows the distribution of rotor failures that produced fragments according to the engine component involved (fan, compressor, turbine), the types of fragments that were generated, and the percentage of uncontained failures according to the type of fragment generated. These data indicate that:

1. The incidence of turbine rotor fragment-producing failures was approximately two times greater than that of the compressor rotor fragment-producing failures; these corresponded to 60 (68.2 percent) and 26 (29.5 percent), respectively, of the total number of rotor failures. Fan rotor failures accounted for two (2.3 percent) of the fragment-producing failures experienced.

2. Blade fragments were generated in 78 (88.6 percent) of the rotor failures; eight (10.3 percent) of these were uncontained. The remaining 10 (11.4 percent) rotor fragment failures were produced by disk, rim, and seal. While the disk and seal failures were a relatively small percentage of the total failures, all of the disk and seal failures were uncontained.

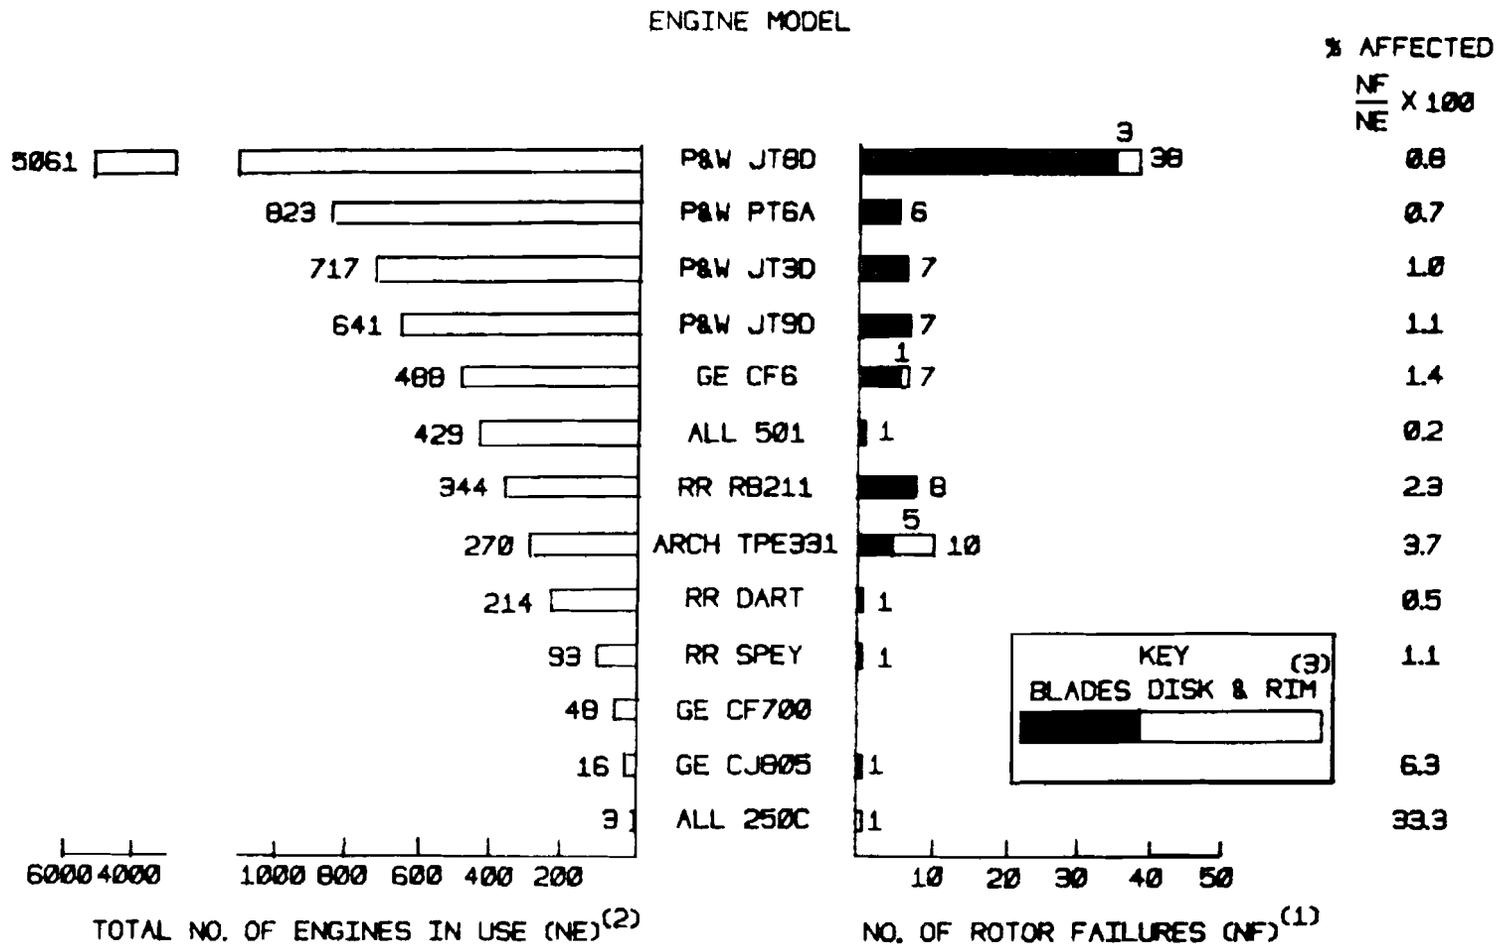
FIGURE 4. THE INCIDENCE OF ENGINE ROTOR FAILURES IN U.S. COMMERCIAL AVIATION ACCORDING TO ENGINE TYPE AFFECTED - 1982

Figure 4 shows the rotor failure distribution among the engine models that were affected and the total number of models in use.

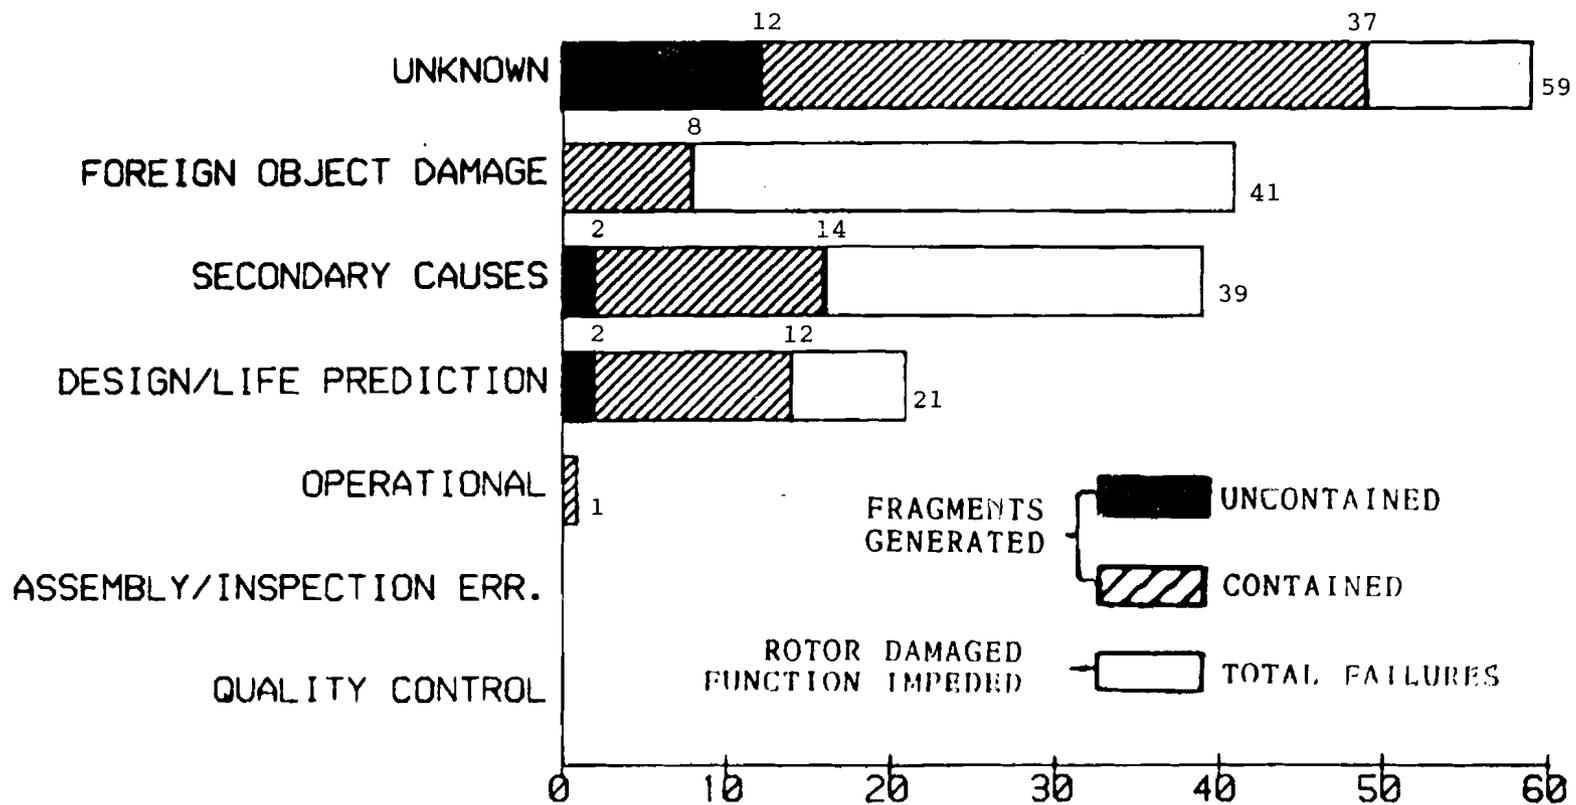
FIGURE 6. ENGINE ROTOR FAILURE CAUSE CATEGORIES - 1982

Figure 6 shows what caused the rotor failures to occur. Of the 102 known causes of failure (because of the high percentage of unknown causes of rotor failure, the percentages were based on the total number of known causes), the causal factors were (1) foreign object damage--41 (40.2 percent); (2) secondary causes--39 (38.2 percent); (3) design and life prediction problems--21 (20.6 percent); and operational--1 (1.0 percent).

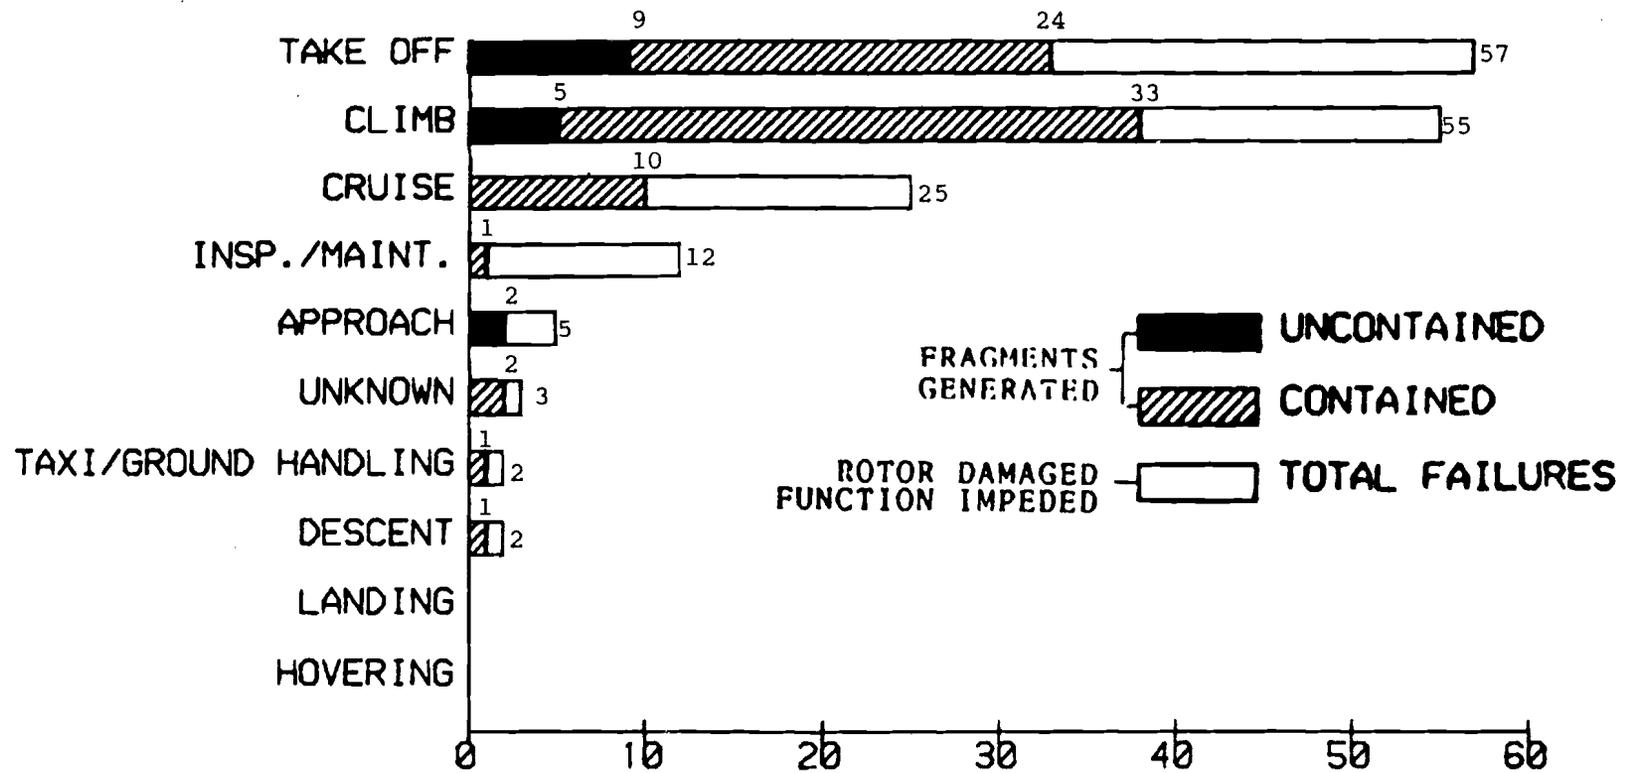
FIGURE 7. FLIGHT CONDITION AT ENGINE ROTOR FAILURE - 1982

Figure 7 indicates the flight conditions that existed when the various rotor failures occurred. One-hundred and twelve (69.6 percent) of the 161 rotor failures occurred during the takeoff and climb stages of flight. Seventy-one (80.7 percent) of the rotor fragment-producing failures and 14 (87.5 percent) of the uncontained rotor failures occurred during these same stages of flight. The highest number of uncontained rotor failures, nine (56.3 percent), happened during takeoff.

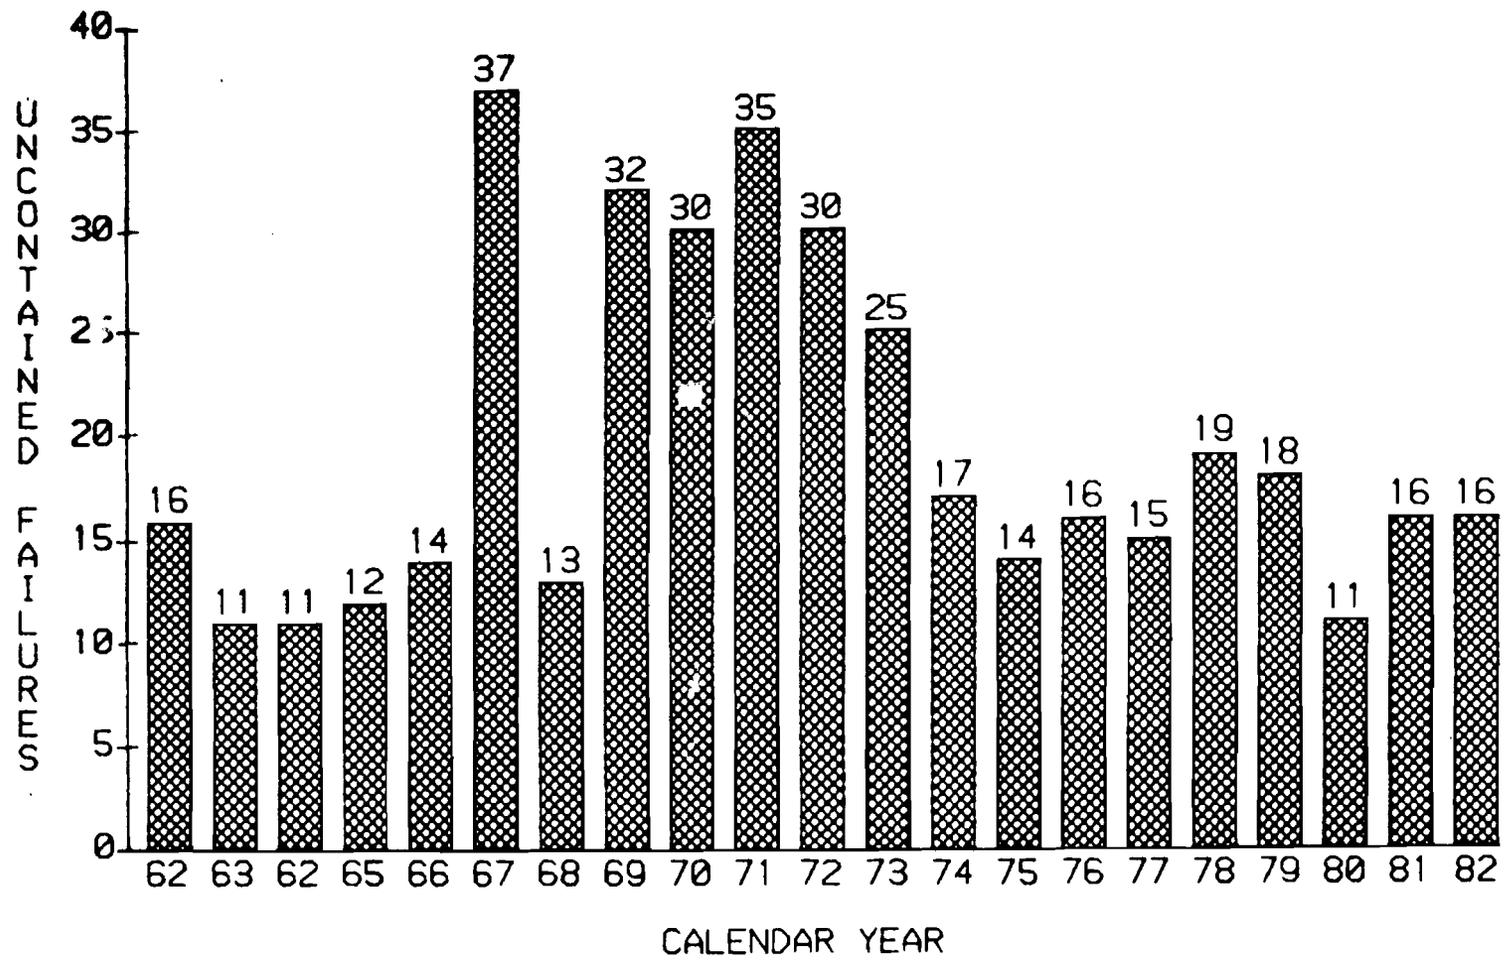
FIGURE 9. THE INCIDENCE OF UNCONTAINED ENGINE ROTOR FAILURES IN U.S. COMMERCIAL AVIATION - 1962 THROUGH 1982

Figure 9 shows the annual incidence of uncontained rotor failures in commercial aviation for the years 1962 through 1982. During 1982, the incidence of uncontained rotor failures (16) was identical to those reported the previous year, 1981. Over the past 7 years, 1976 through 1982, an average of 16 uncontained rotor failures per year have occurred. During the same time period, the rate of uncontained rotor failures has remained relatively constant at an average of approximately one per million engine operating hours.
