DOT/FAA/CT-92/04

Commuter/Air Taxi Ditchings and Water-Related Impacts that Occurred from 1979 to 1989

July 1994

Final Report

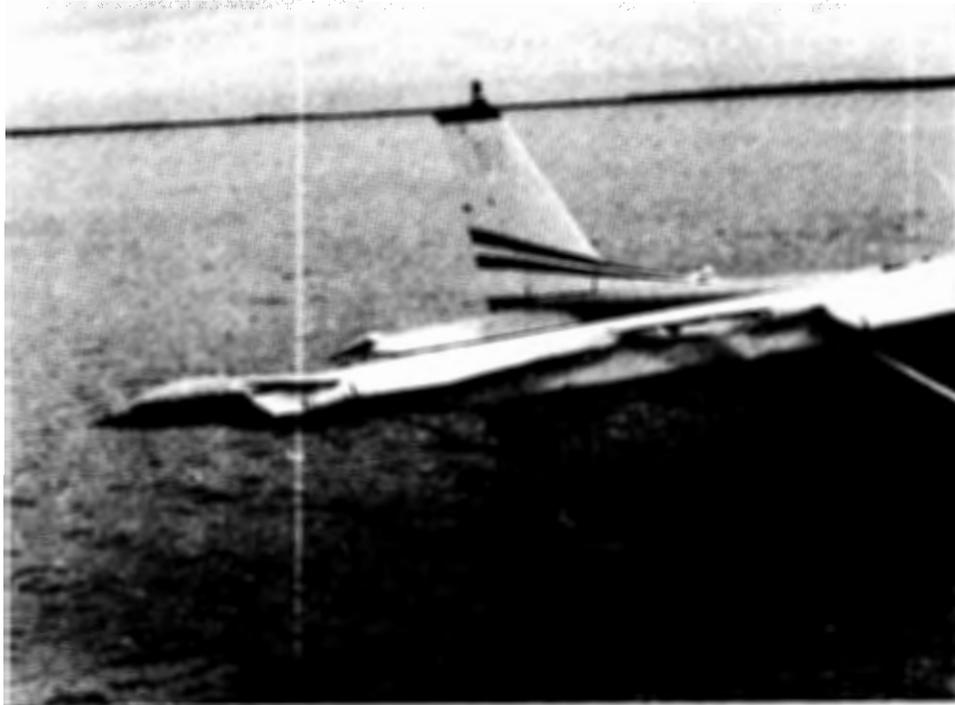
FIGURE 4.1. CASE STUDY 3, DAMAGED LEADING EDGE OF RIGHT WING

- a. Right wing substantially damaged (figures 4.1, 4.2).
- b. Right wing flap slightly displaced (figure 4.3).
- c. Propeller blade bent.

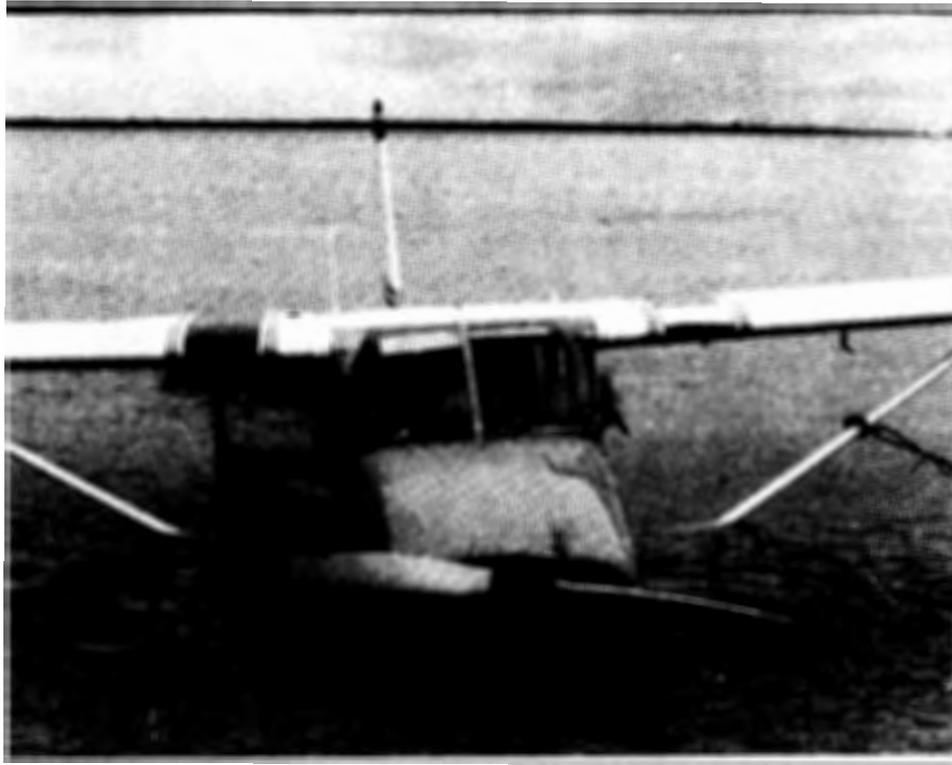
FIGURE 4.4. CASE STUDY 3, FRONT VIEW OF AIRCRAFT

This accident again illustrates the hazards presented by the post water impact environment in an apparently successful ditching. Post-crash examination of the aircraft revealed no significant damage to the occupiable volume. In addition, the open cockpit door and the unfastened pilot restraint seem to indicate that the pilot, the sole occupant, egressed

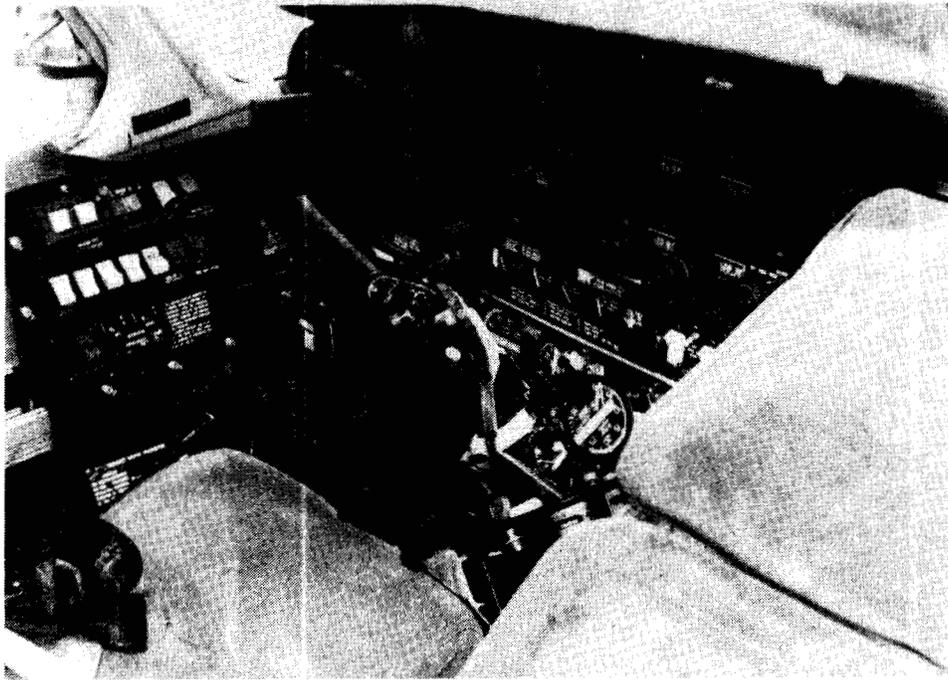
FIGURE 4.9. CASE STUDY 6, FRONT LEFT VIEW OF COCKPIT

The aircraft in this case was recovered. Two views of the cockpit interior are given in figures 4.9 and 4.10. Major aircraft damage is listed below:

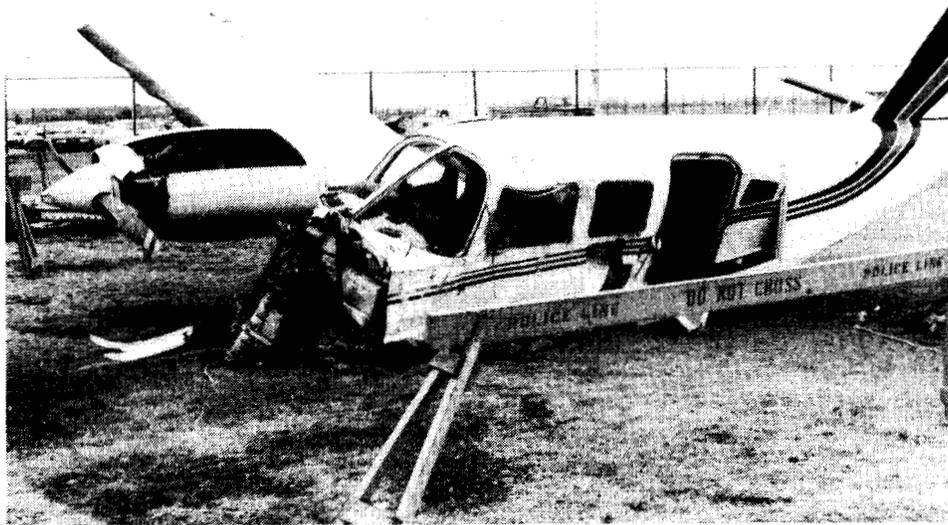
FIGURE 4.11. CASE STUDY 6, FULL VIEW OF LEFT FUSELAGE DAMAGE

- a. Left wing completely separated from fuselage and inverted (figure 4.11).
- b. Forward upper left fuselage side indentation resembling left wing tip (figure 4.11).
- c. Fuselage door under the wing (figure 4.11).
- d. Left, right, and nose gear in down position (figure 4.12).
- e. Nose wheel and lower part of nose strut missing (figure 4.11).
- f. Right wing tip missing (figure 4.12).
- g. Rudder slightly wrinkled.
- h. Nose crush damage (figure 4.11).
