Shearographic Inspection of a Boeing 737

July 1992

DOT/FAA/CT-TN92/19

An inspection for disbonds was conducted on a Boeing 737-200 aircraft at the carrier's repair station at Winston-Salem, NC, from August 21 to 23, 1991. The inspection concentrated on comparing the effectiveness of shearography with currently mandated methods in detecting disbonds in the fuselage.

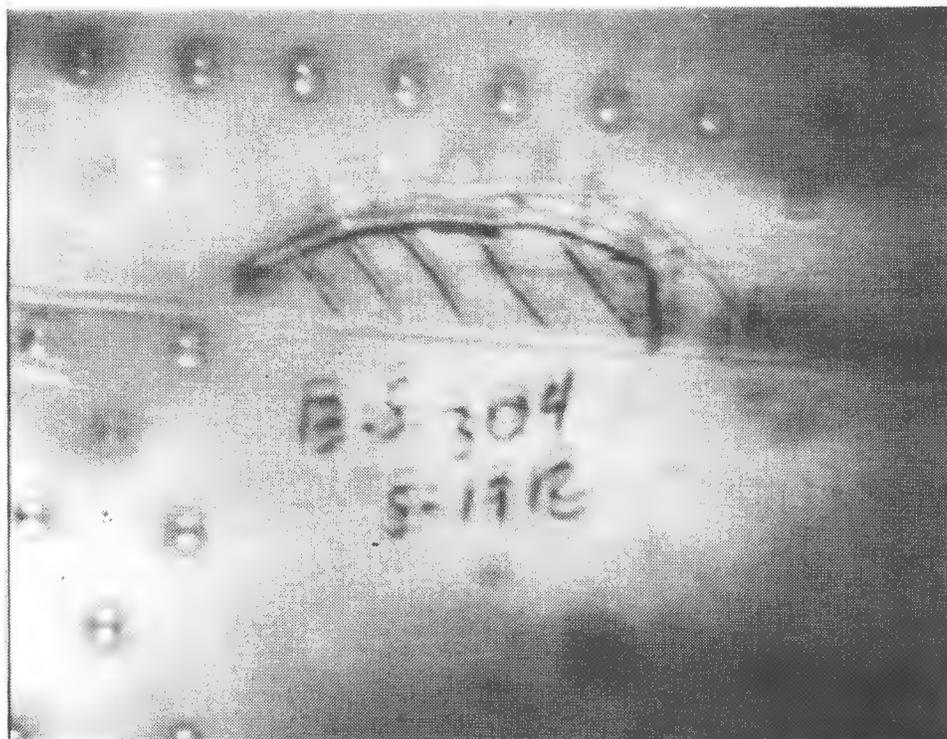
Figure 4 Disbond in Repaired Area.

Most observed disbonds were related to repairs where the top row of rivets of a lap joint had been replaced, leaving the two adjacent rows of rivets intact. In such a case, disbonds frequently extended from the panel edge into the lap, as in Figure 4.

Sometimes the disbonds extended all the way to the other side of the lap; at other times, only the upper row of rivets was affected. Correlation between shearography (outer double line) and ultrasound (cross-hatched area) is also indicated in Figure 4. The fringe pattern from which the disbond in Figure 4 was determined is shown in Figure 5. Since the Sondicator could not detect disbonds shorter than one inch, only disbonds longer than this are reported here for comparison between shearography and ultrasound.

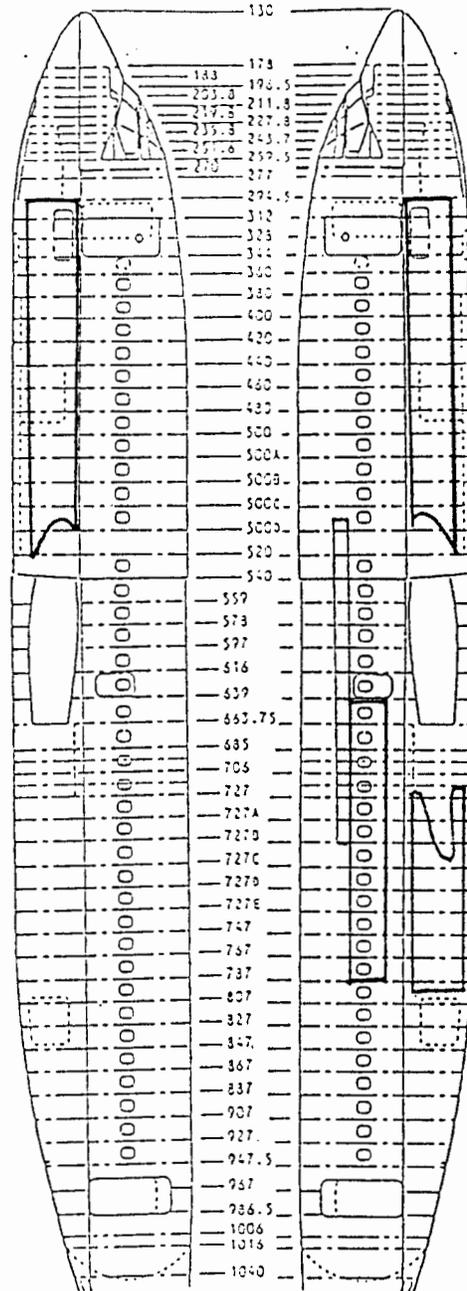
Figure 6 Left and Right Side of the Aircraft Showing Inspection Coverage

The inspection was intended to cover as much of the aircraft as possible during the available 24-hour period. The fixed-focus system could cover an area of about 14x11 inches, whereas the coverage of the tripod-mounted system was proportional to the distance from the target with maximum distance being governed by the intensity of the illumination and the ambient background. Parts of the window belt and upper stringers on the right-hand side of the aircraft were inspected using the fixed-focus system. Parts of the left- and right-hand side and bottom of the aircraft were inspected using the tripod-mounted system with two fields of view: 30x24 inches for coarse real-time observation, 10x8 inches for recording. Figure 6 shows inspection coverage of the aircraft during the 24-hour period was approximately twenty percent.
