Mark 20 Category II/III Instrument Landing System Operational Test and Evaluation, Functional and Performance Test Report

DOT/FAA/CT-TN95/44

U.S. Department of Transportation
Federal Aviation Administration
Technical Center
Atlantic City Airport, NJ 08405

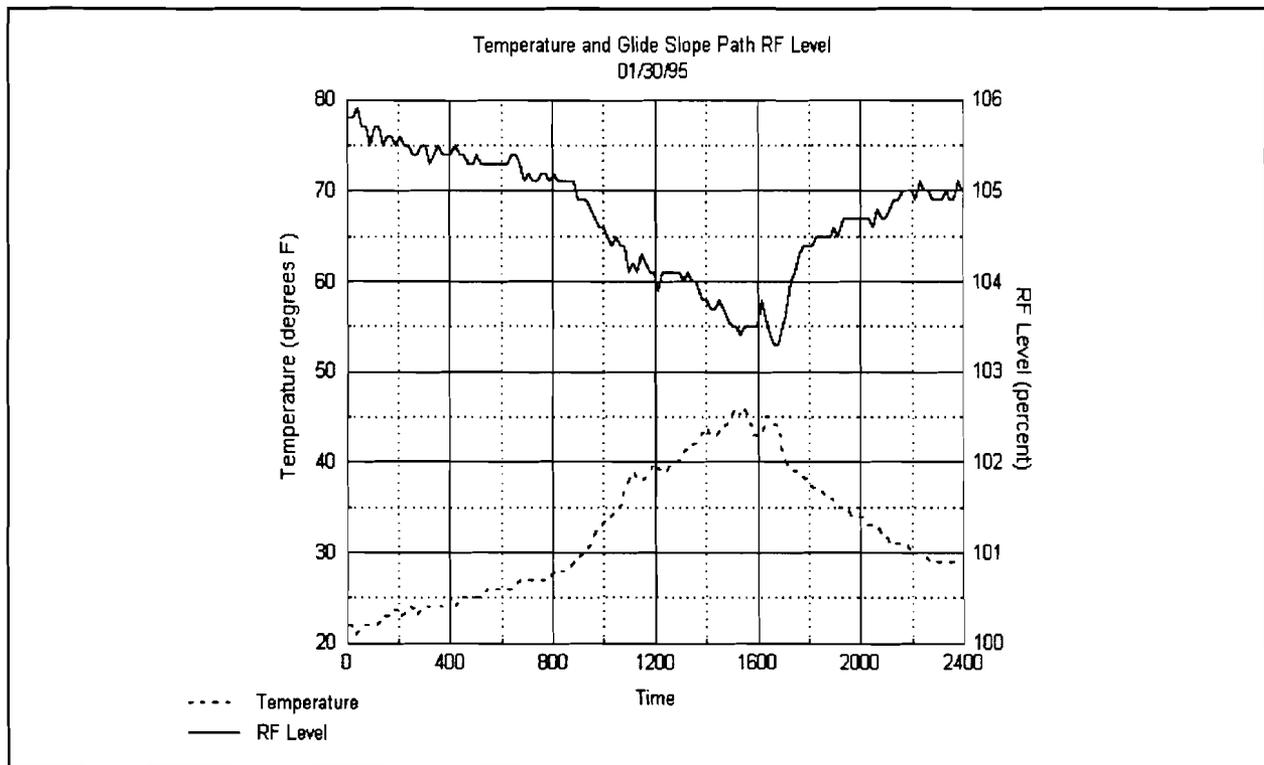
FIGURE 8. CORRELATION OF TEMPERATURE AND MONITORED GLIDE SLOPE PATH RF LEVEL FOR JANUARY 30, 1995

The only observed correlation between weather and the Mark 20 performance was temperature, and the course and clearance RF power for the localizer and glide slope. This correlation shows an approximate 2 percent change in RF level to a 20° Fahrenheit change in temperature. This change is relatively insignificant but could be a problem depending on the recalibration schedule. The monitors were calibrated at the test site during the summer months. Due to the change in average temperature during the winter months, the average RF levels were in the vicinity of 104 percent. The daily fluctuation in temperature varied the RF levels between 103 percent and 106 percent. At facilities with colder winter temperatures, a subsystem calibrated during the summer may drift out of RF level tolerance during the winter and vice versa. Only output power of the subsystem is affected as the impedance characteristics of exposed cable and antennas change with the temperature. This condition will not affect the quality of guidance because Carrier and Sidebands (CSB) and SBO signals are attenuated at the same rate, but some outages could occur due to RF levels exceeding alarm limits. Figure 8 shows the temperature and glide slope path RF level for January 30, 1995. The monitored weather and Mark 20 parameters for the month of January 1995 are contained in appendix C.

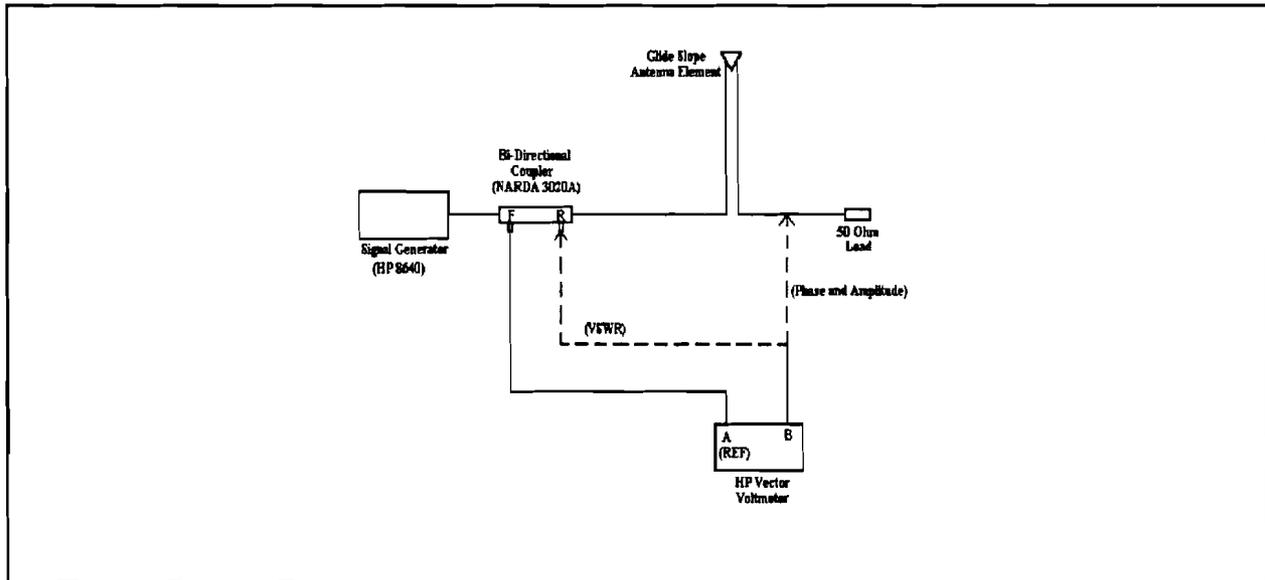
FIGURE 9. TEST CONFIGURATION FOR MEASURING VSWR, PHASE, AND AMPLITUDE OF GLIDE SLOPE ANTENNAS DURING ICE LOADING TESTING

Figure 9 shows the configuration for testing ice loading effects. Table 1 indicates the date, time, conditions, VSWR, phase, and magnitude of the measurements made on the antennas. This data indicates that no significant changes in measured parameters were observed during ice loading or antenna heater operation. The maximum variations from the baseline measurements were: VSWR: 0.03, Phase: 1.3°, and magnitude: 0.28 dB. Based on these measurements, it appears that the antenna heaters are not required. The data collected also indicates that antenna heater operation does not affect the radiated signal. During this testing period (8 months) no antenna heater failures occurred. Because the glide slope electronic equipment had not been delivered at the time of this test, these measurements were obtained using a signal generator for the provided signal, thus no signal in space measurements were possible and no determination of actual provided guidance can be made.
