DOT/FAA/RD-91/1

Composite Profiles of Helicopter Mishaps at Heliports and Airports

January 1992

Final Report

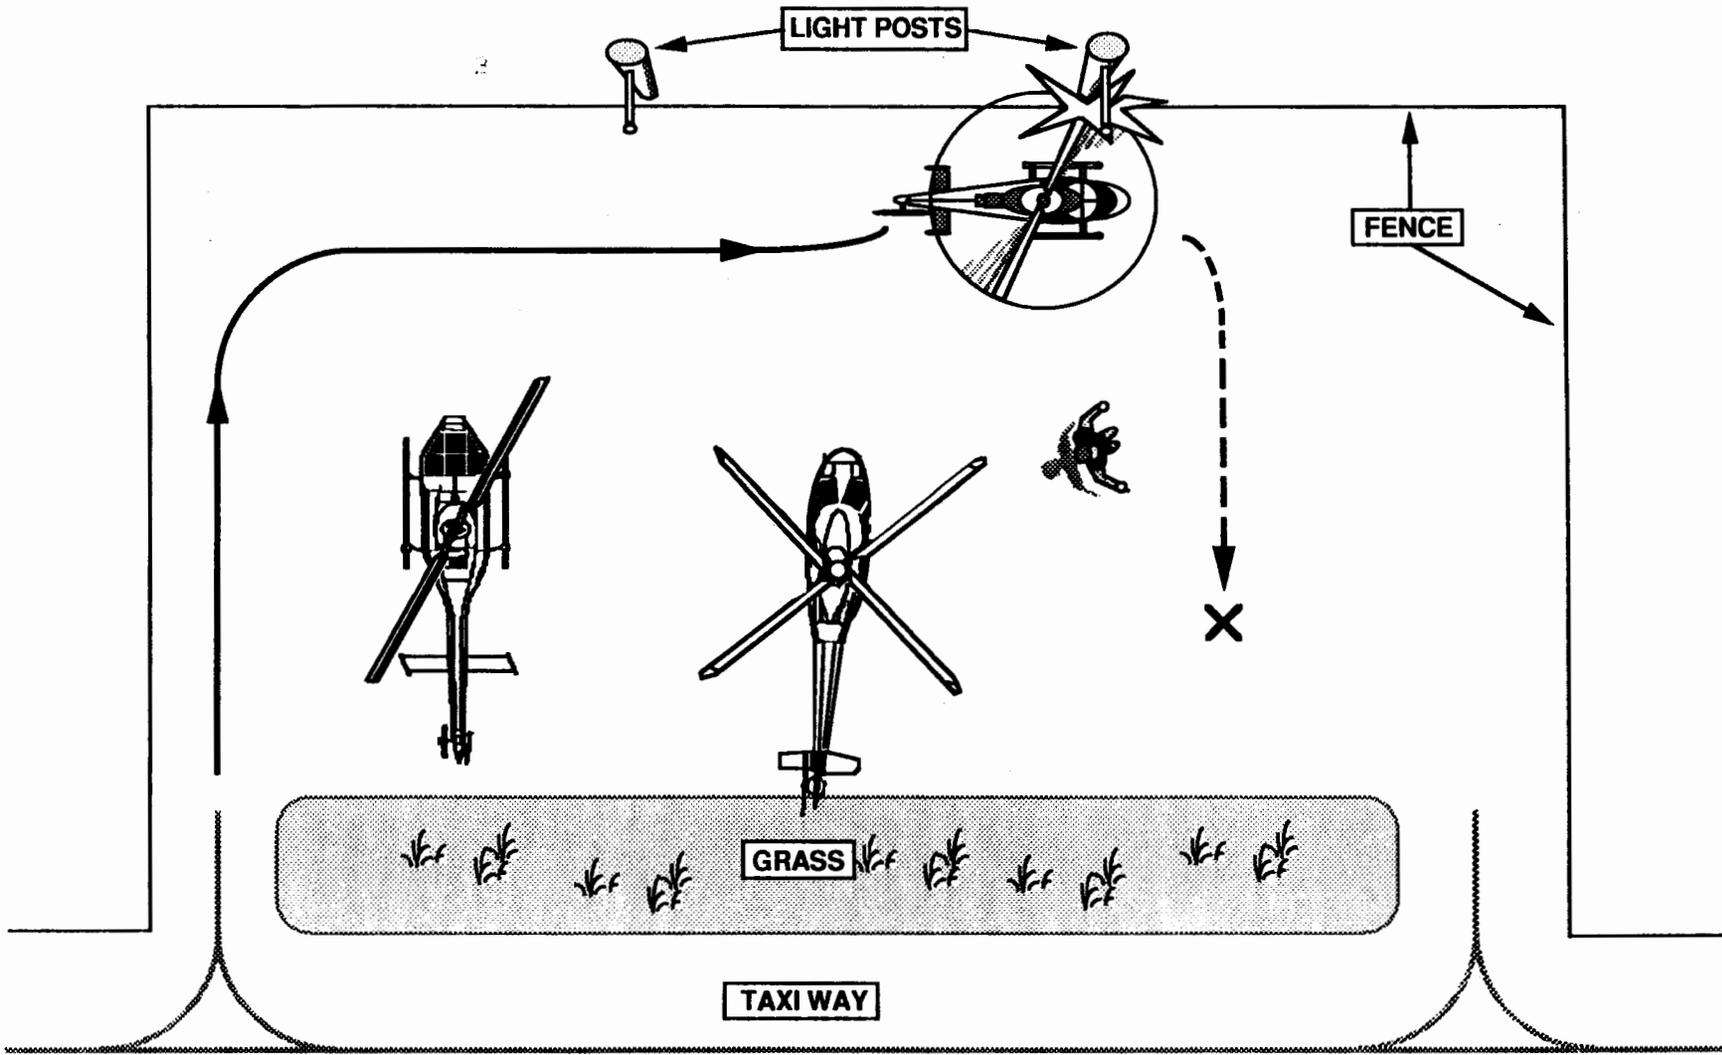
FIGURE 2 OBSTACLE STRIKE - LIGHT POLE

Obstacle Marking - Marking obstacles that lie in or near operational areas is an extremely important consideration. This is particularly true when the obstacle may blend in with the background under certain conditions. Heliport designers should consider marking obstacles with reflective materials, flood lights, or obstruction lights (reference 8). Using reflective tape or paint to place stripes on an obstacle may be the simplest means of making obstacles more visible.

Weather - The weather was definitely a contributing factor in this mishap. The gray metal light pole blended in with the gray overcast skies. Even though pilots are aware of the hazard that obstacles represent, individuals may momentarily let down their guard if an obstacle does not stand out sufficiently from the surroundings. This is more likely to occur when the pilot is hungry, tired, stressed, or distracted.

Obstacle Location - Operational areas may contain obstacles such as fences, poles, or other aircraft. Placing permanent obstacles in or near operating areas must be done with care and consideration. At airports, helicopters typically operate in areas designed primarily for fixed-wing use (parking, fuel, taxi). These areas are often designed without considering any special needs of helicopters. A suggestion for installing lights in this

instance is to mount them low on the fence itself, thereby combining two obstacles into one. Groups of obstacles are usually more noticeable than individual obstacles.

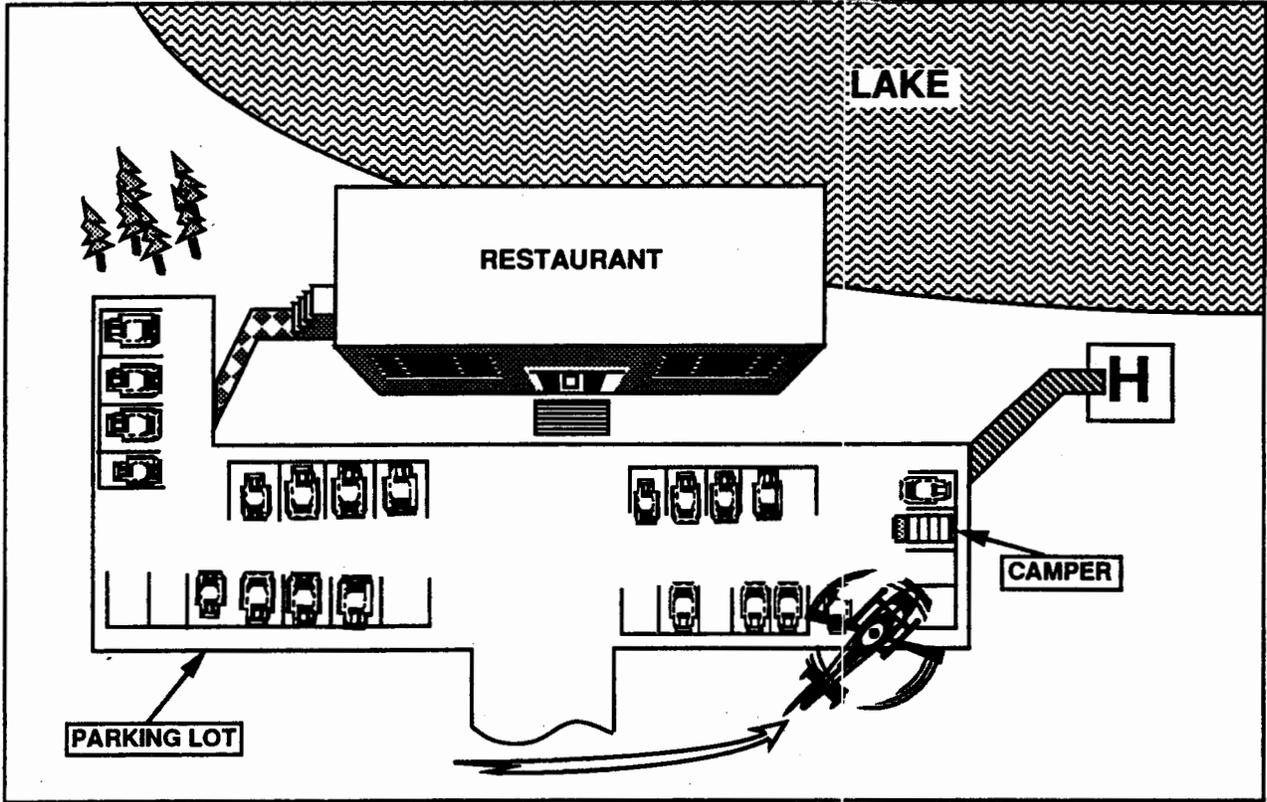
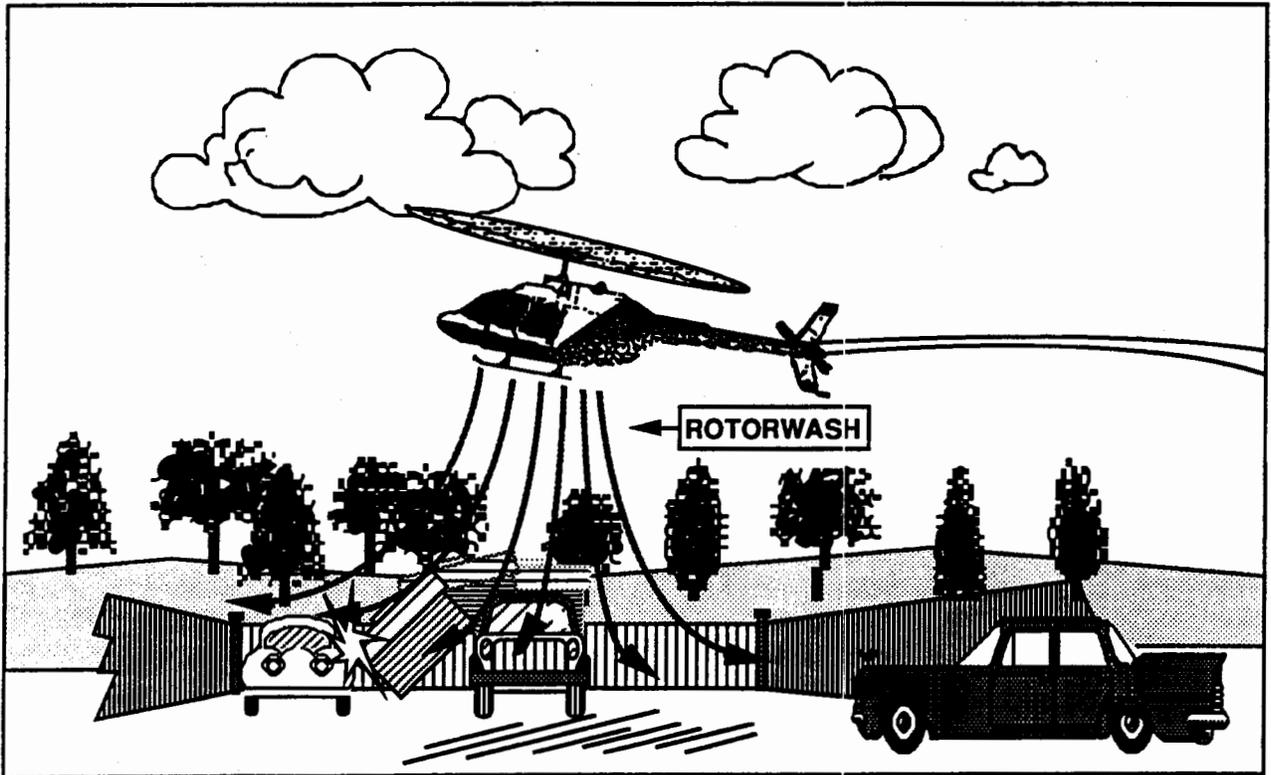
FIGURE 4 ROTORWASH DAMAGE

Clear Groundspace - Rotorwash has been the cause of personnel injury and property damage in a number of mishaps. It is important to control the groundspace under the approach/departure path to at least the recommended distance of 280 feet from the edge of the primary surface (reference 3). In addition, as was shown in the mishap presented above, the approach/departure path that a pilot will choose cannot be guaranteed. Therefore, the facility operator may wish to ensure that, where possible, groundspaces under other potential approach/departure paths have limited access because of the possibility of mishaps due to rotorwash.

Approach/Departure Paths - Pilots should attempt to adhere to the recommended approach/departure path whenever conditions allow for such procedures. At times, it may seem easy to put aside established procedures when there appears to be plenty of clear space surrounding a heliport. When the wind is not a significant factor, a pilot may choose to approach a heliport from a direction other than that prescribed by the heliport markings. However, judicious approach/departure paths are designed based on several factors, not just prevailing wind. Helicopter performance, safety, noise, obstacles, and objects underlying the approach/departure paths must be considered. Whenever possible, avoid flying over people, vehicles, and structures, particularly during takeoffs and landings. Figure 5 depicts the proper approach.

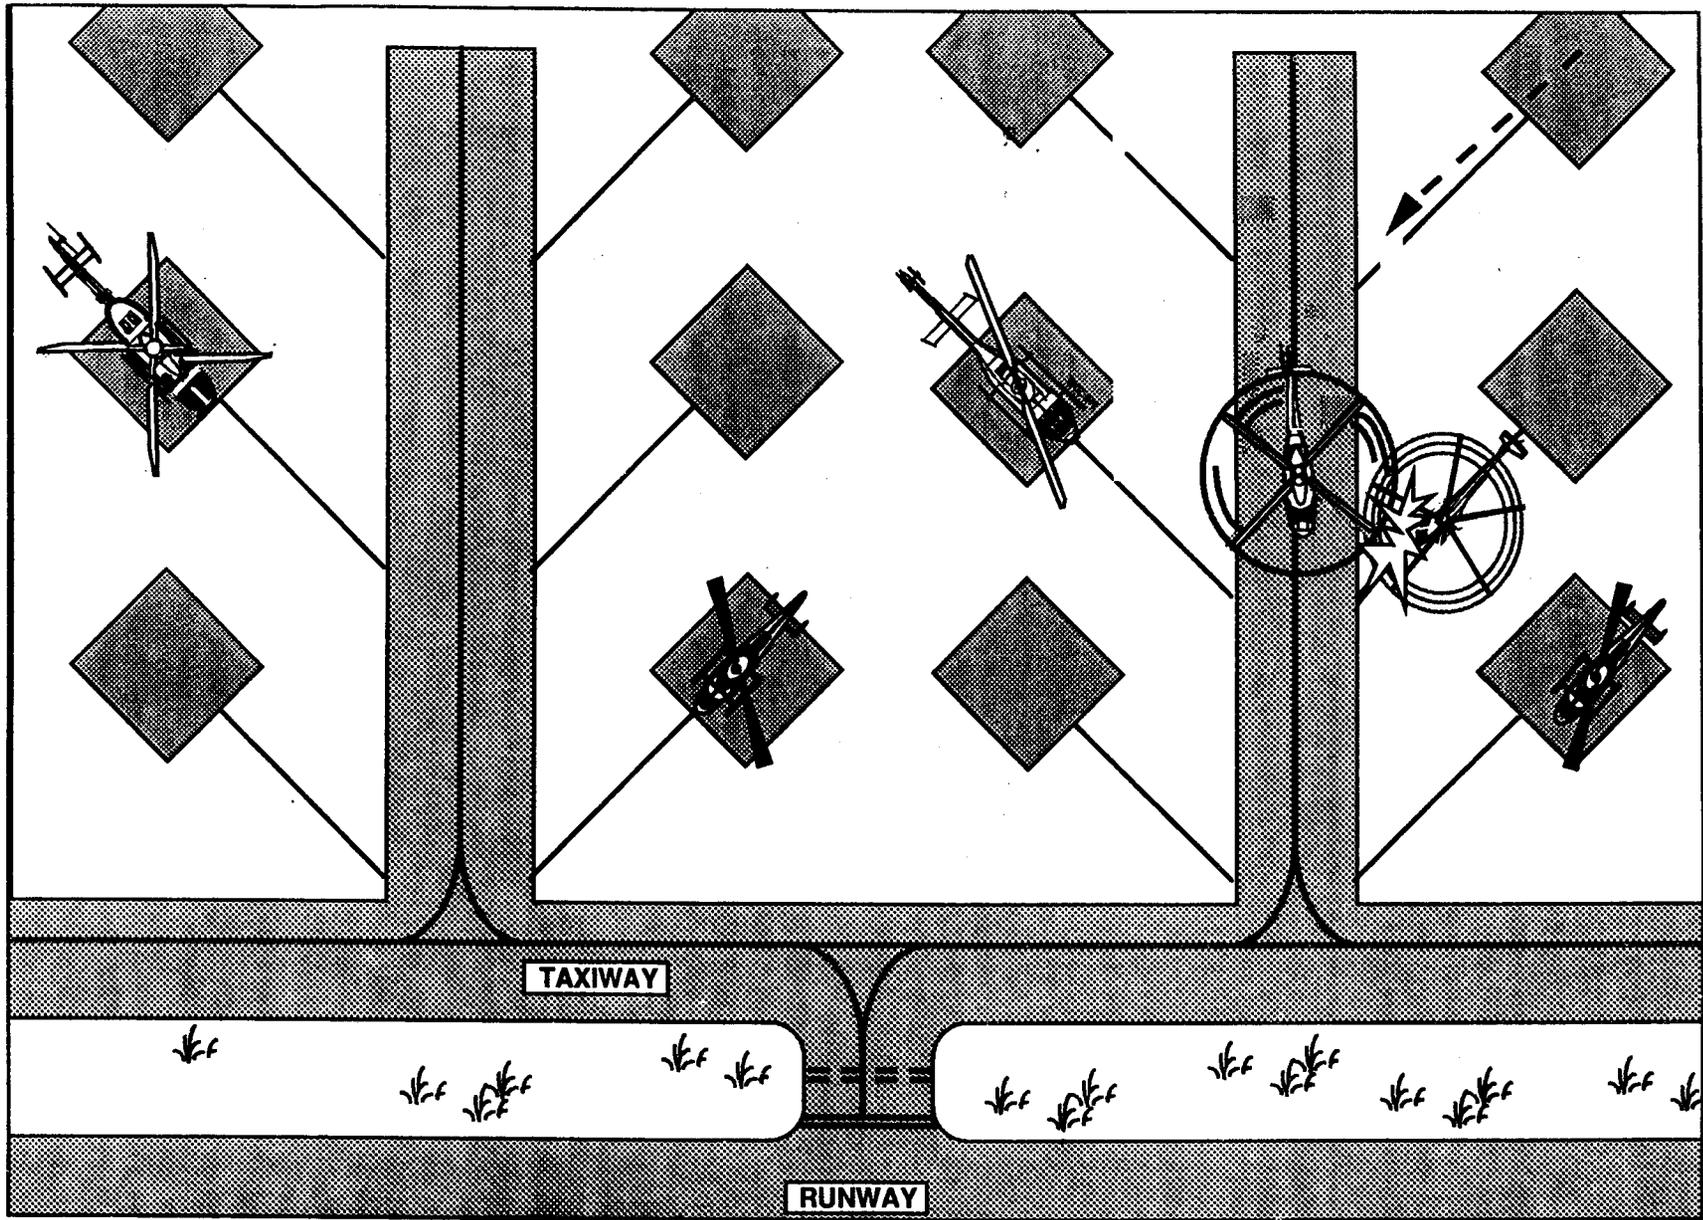
FIGURE 6 OBSTACLE STRIKE - MULTIPLE AIRCRAFT ON-GROUND COLLISION

Visual Obstacles - The single-turbine pilot's visibility was hampered by the curtain that separated the cockpit from the cabin. In most operational situations, the curtain may not have presented a hindrance to the pilot.

However, in this particular instance the design of the parking area necessitated that the pilot be able to see more than 90 degrees to his right.

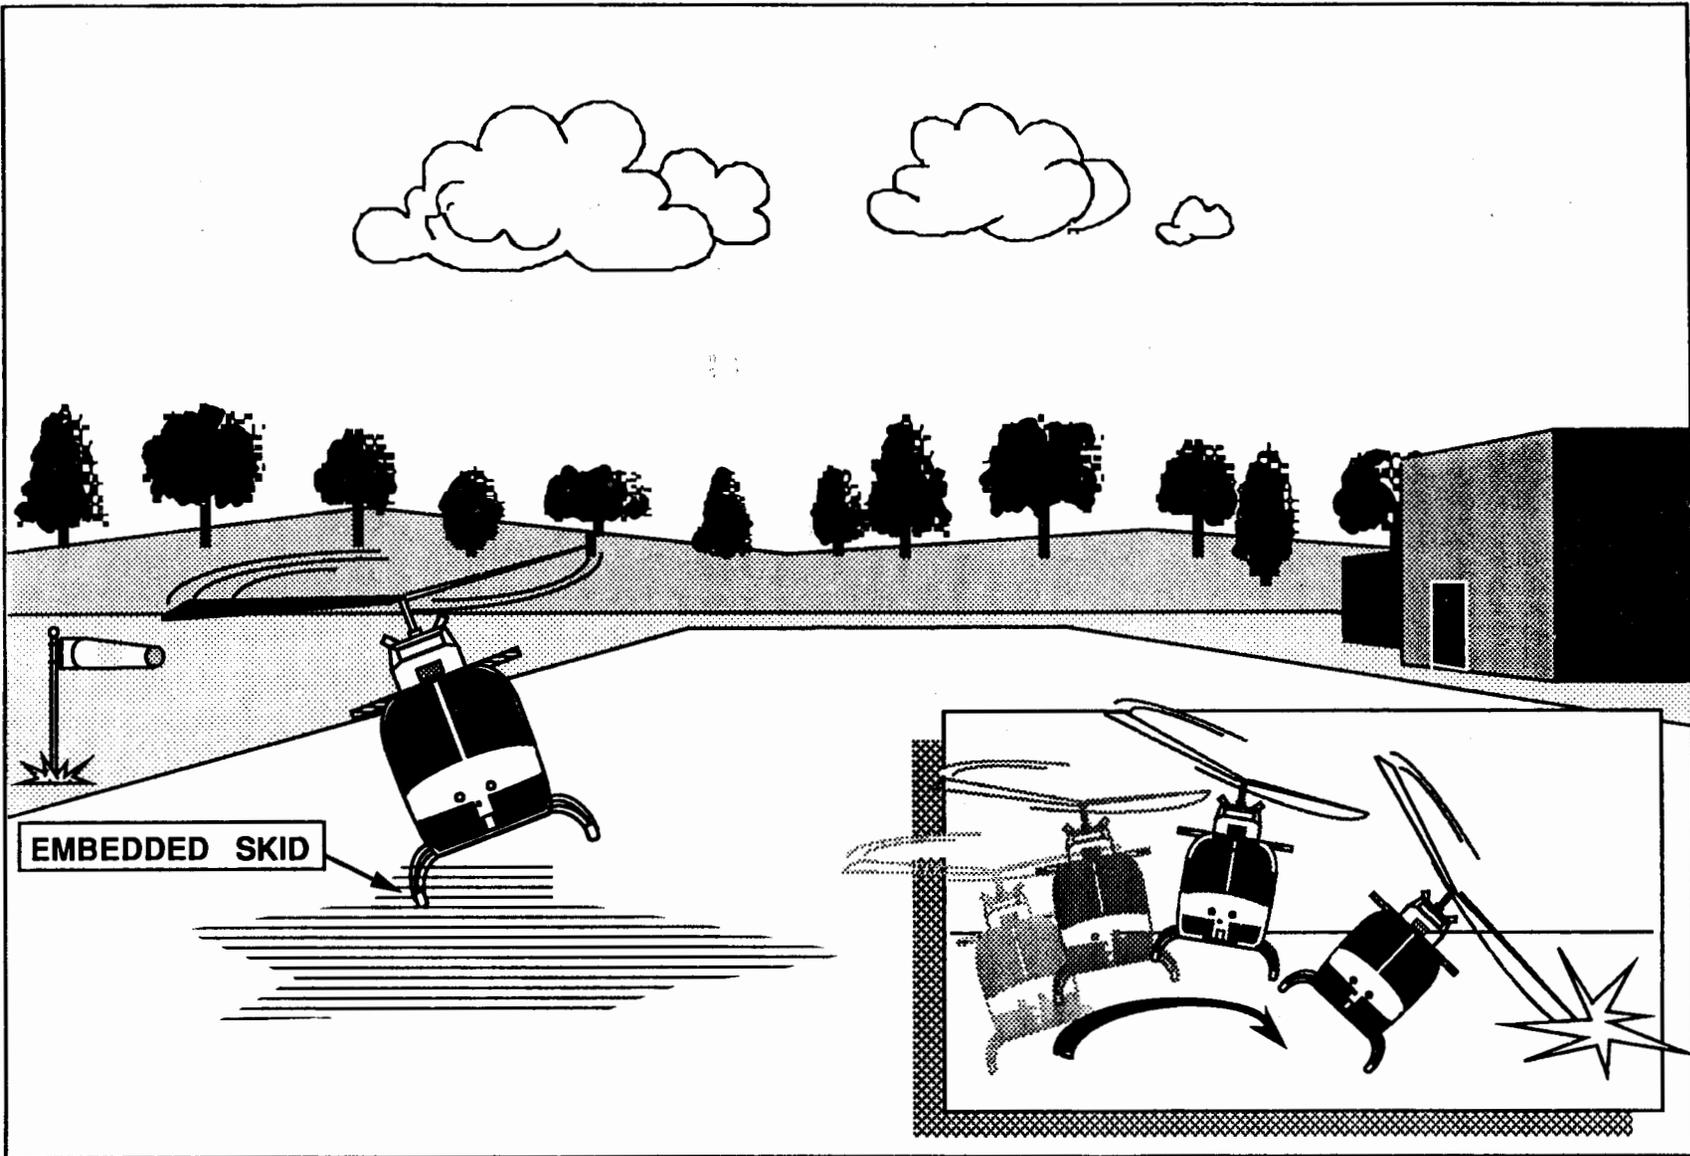
FIGURE 8 GROUND MISHAP (STUCK SKID)

Preflight Procedure - The pilot's preflight procedure was obviously inadequate because he failed to notice that the skid had sunk into the asphalt. The condition of the surface around the skids should always be checked. Any cracks, bumps, or indentations can lead to mishaps.

Pilot Technique - A contributing factor to this mishap was pilot technique. The pilot attempted to free the skid by pulling collective and using the helicopter to fly out of the asphalt. This is not recommended at any time. The best solution to the problem is to physically loosen the landing gear with the engine off during the preflight inspection. Ground handling equipment can be helpful in this regard. Depending on aircraft model, it may also be possible to free the landing gear by moving the tail boom.

Surface Material - It is important that operational areas be capable of supporting the full weight of the aircraft. These areas include FATOs, refueling areas, and parking pads. Concrete is preferable to asphalt. This is particularly true for locations that experience high daytime temperatures during the year. Figure 9 depicts the heliport with design improvements that enhance safety.

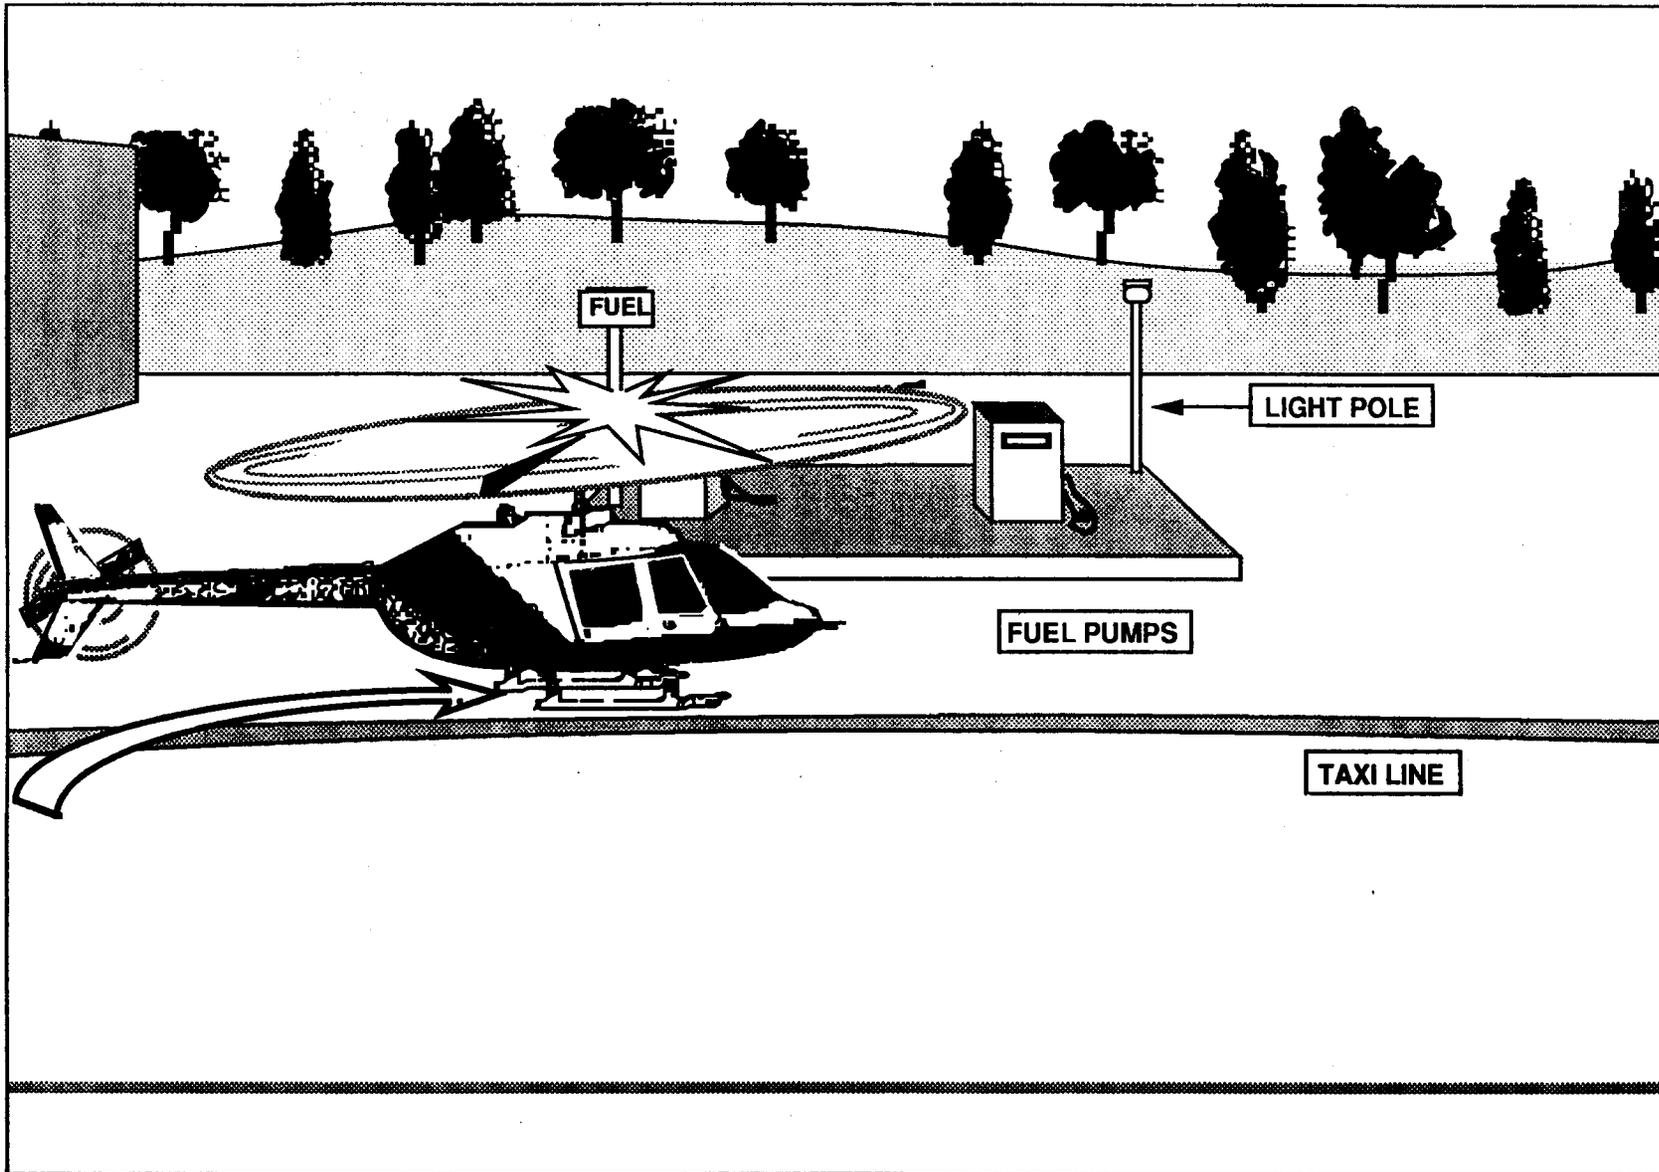
FIGURE 10 OBSTACLE STRIKE - SIGN POLE

Refueling Hoses - Pilots have stated in mishap investigations that their concern over the length of fuel hoses has been a definite contributing factor to mishaps. In their attempt to get close enough to the fuel pumps,

their helicopters have struck objects in refueling areas. Refueling hoses should be adequate in length so that an aircraft centered on the taxi line can be refueled. Pilots should not have to concern themselves with the length of a fuel hose. Taxi lines adequate to handle the largest type of helicopter should be marked. However, for the uninitiated, a short sign could be posted, "Fuel - 40 Foot Hose."

Ground Markings - At refueling areas that include service for helicopters, taxi lines must clearly provide adequate clearance for safe operations. That is, if large helicopters may not operate safely in these areas, it should be clearly indicated as such. One method may be to post the largest rotor diameter accommodated on the taxi line. If taxi lines are meant as a guide to fixed-wing aircraft only and are not meant for helicopters, then it should be noted as such. Figure 11 depicts the heliport with design improvements that enhance safety.

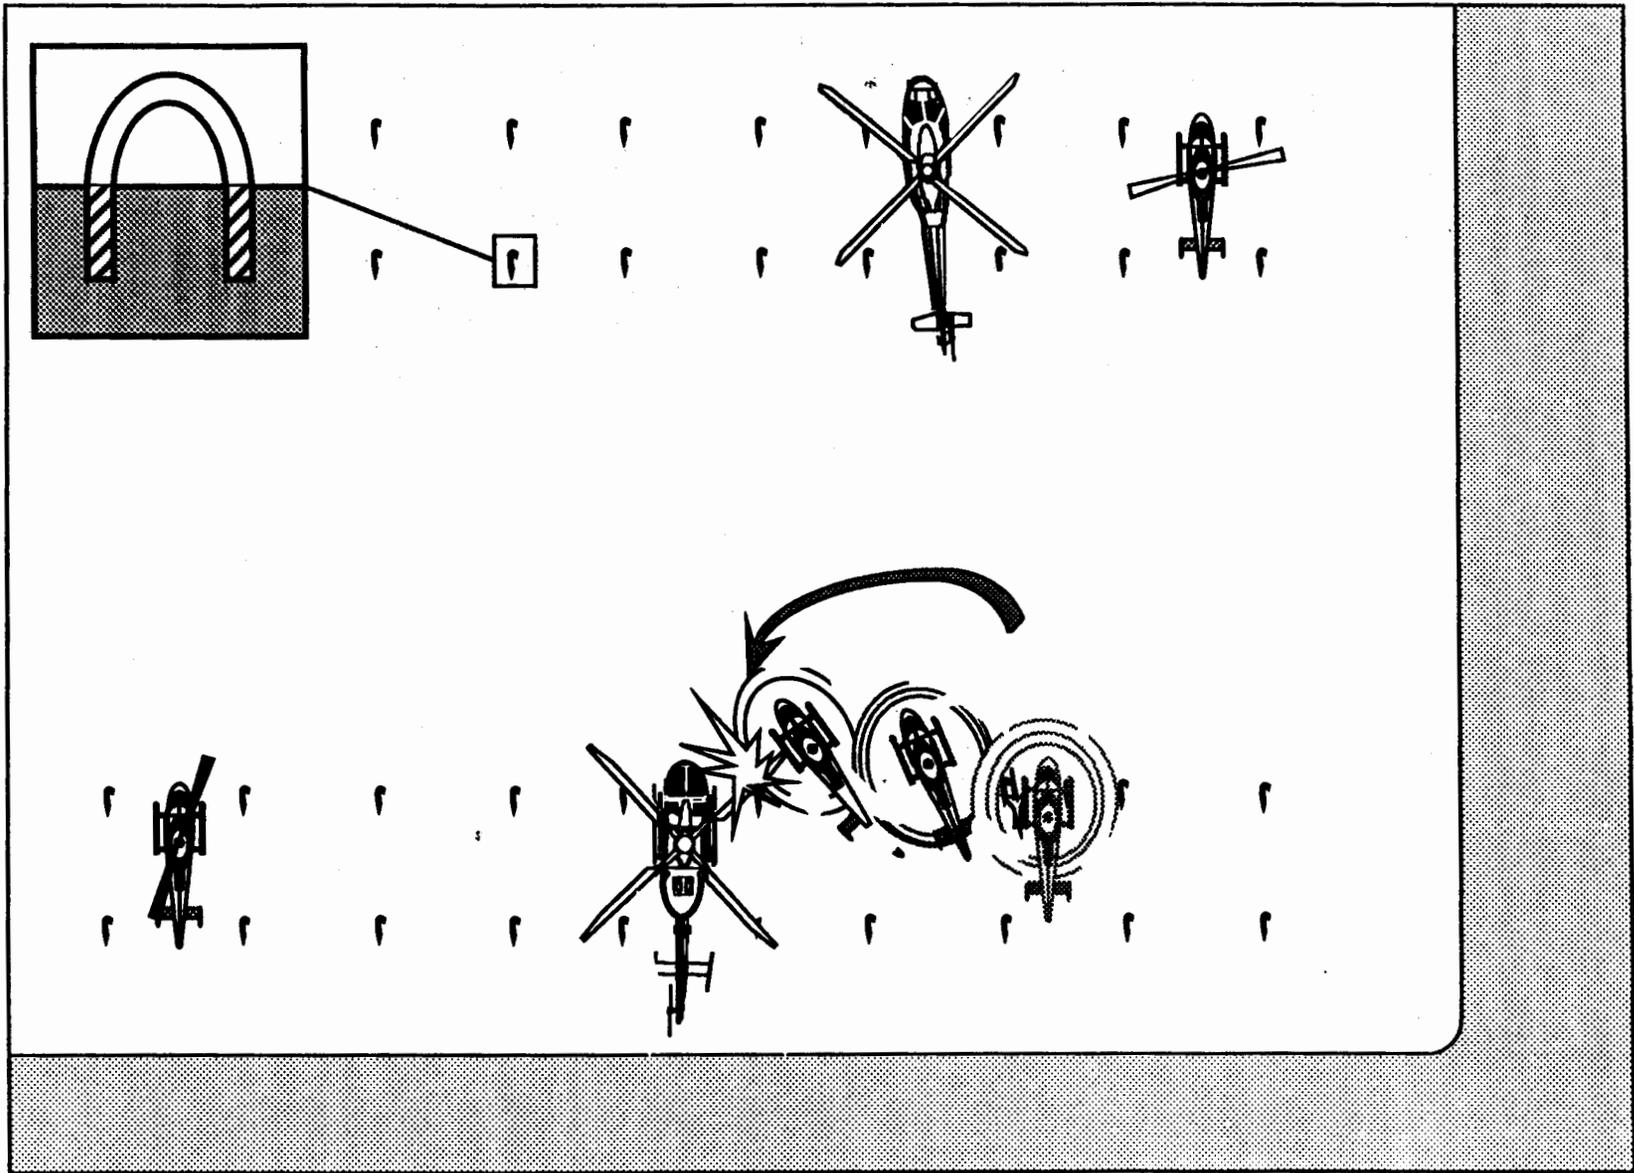
FIGURE 12 OBSTACLE STRIKE - TIE-DOWN ANCHOR

In post-mishap interviews, the pilot stated that because of the excitement of taking her friend for a helicopter ride, she forgot about the anchor bolts. She also stated that the bolts were not easily visible at night. The owner of the FBO stated that he didn't consider the anchors to be a real hazard, because they only "stuck up about 2 inches above the parking ramp."

Lighting - The parking area was not well lit. Had the area contained better lighting, this mishap may not have occurred. Lighting was especially important in this mishap, since the parking area contained obstacles (anchor bolts) that were not easily seen at night.

Flat Operating Surfaces - Helicopters require flat operating surfaces. Mishap data shows that just about any object protruding above the operating surface has the potential for causing a mishap. Helicopters have caught landing gear on objects such as grounding eyes, bolts, drainage grates, perimeter lights, and helipad lips. Although an object may not appear to be a hazard, it is important to recognize that any object that protrudes above the operating surface represents a potential cause for a mishap. This design consideration is important even when the helicopters using the facility are equipped with wheeled landing gear. Figure 13 depicts the heliport with design improvements that enhance safety.

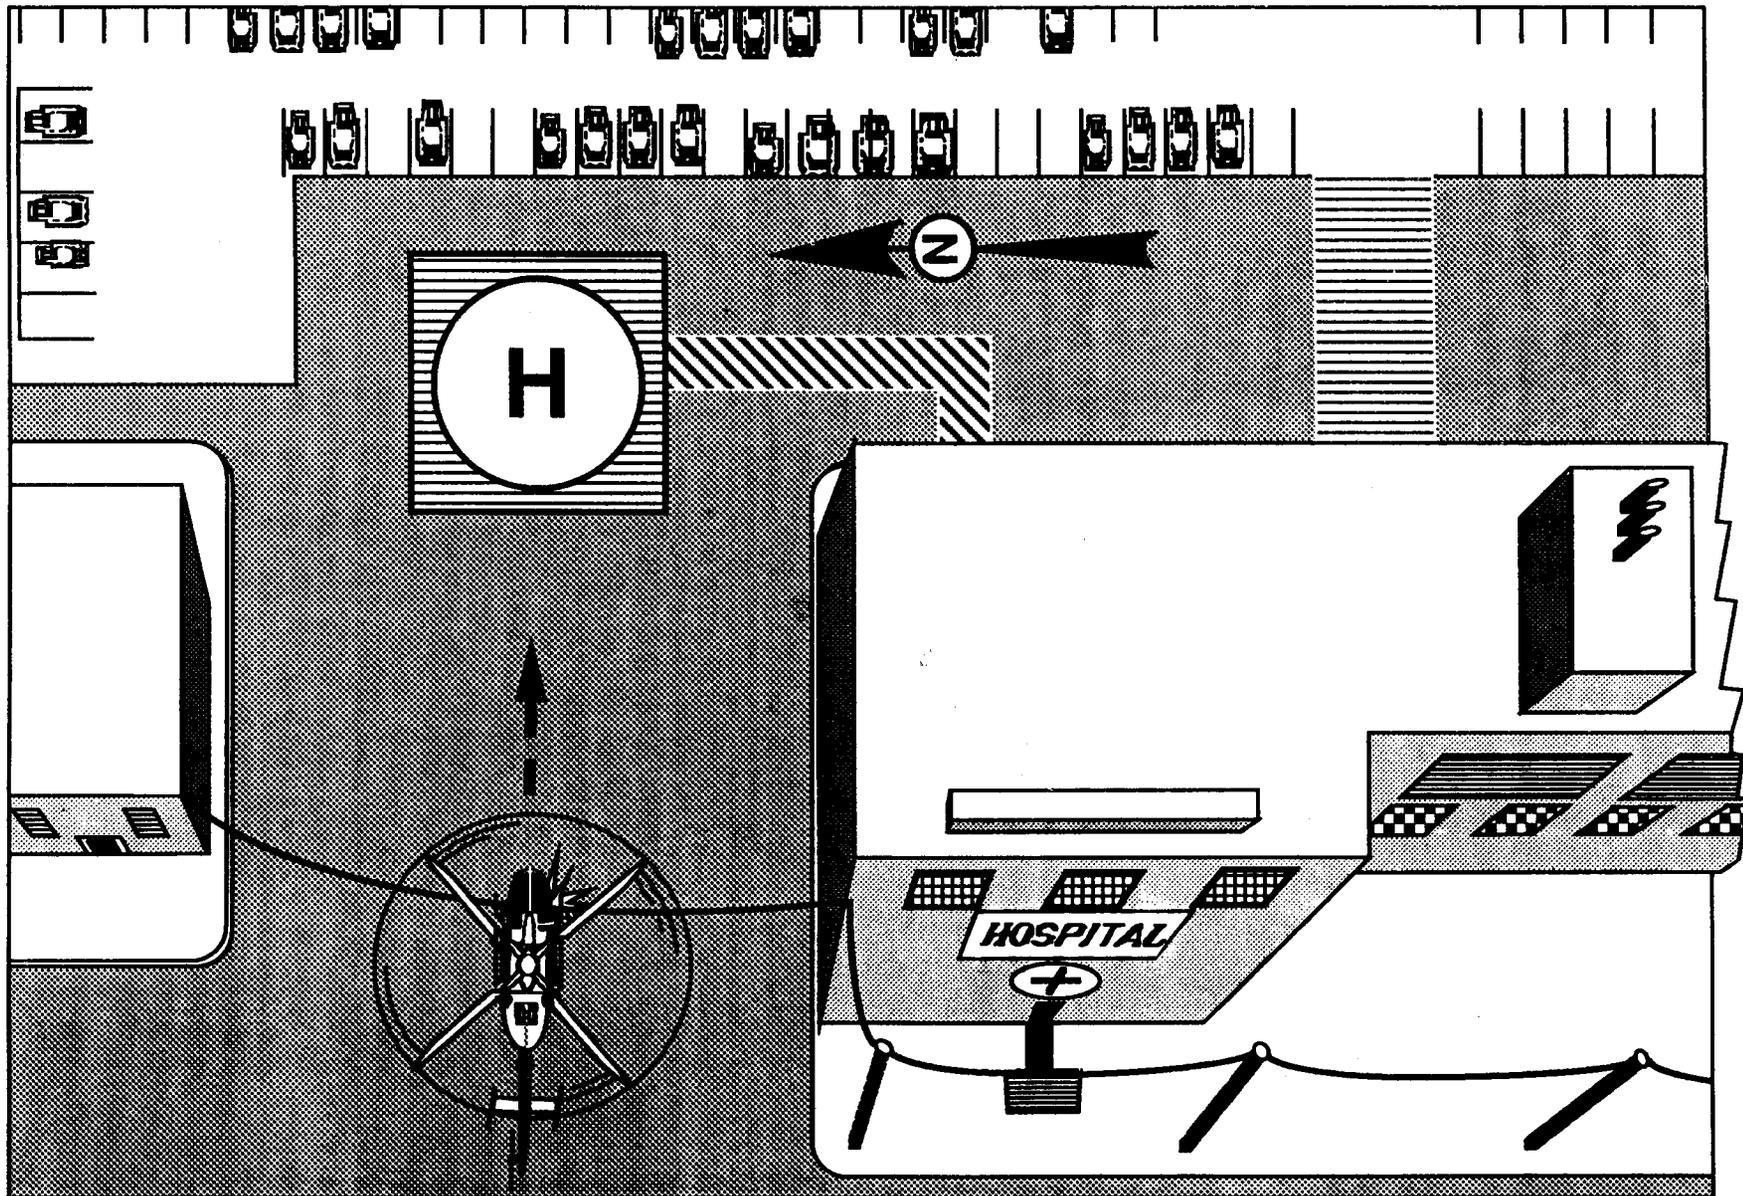
FIGURE 14 OBSTACLE STRIKE - WIRES

Obstacle Marking - Although the wires were located below the 8:1 protected airspace surface, they remained hazardous to operations. They were difficult to see because they blended in with the background. The mishap analysis report (reference 1) provides guidance for marking wires near heliports which lie below the 8:1 protected surfaces.

Obstacle Location - The fact that the powerlines were located below the approach/departure protected airspace surface did not preclude them from being a hazard to operations. Mishap reports indicate that wires located near heliports have contributed to many helicopter mishaps. Installation

of wires near heliports should not be done without giving serious consideration to the alternatives. Figure 15 depicts the heliport with design improvements that enhance safety.

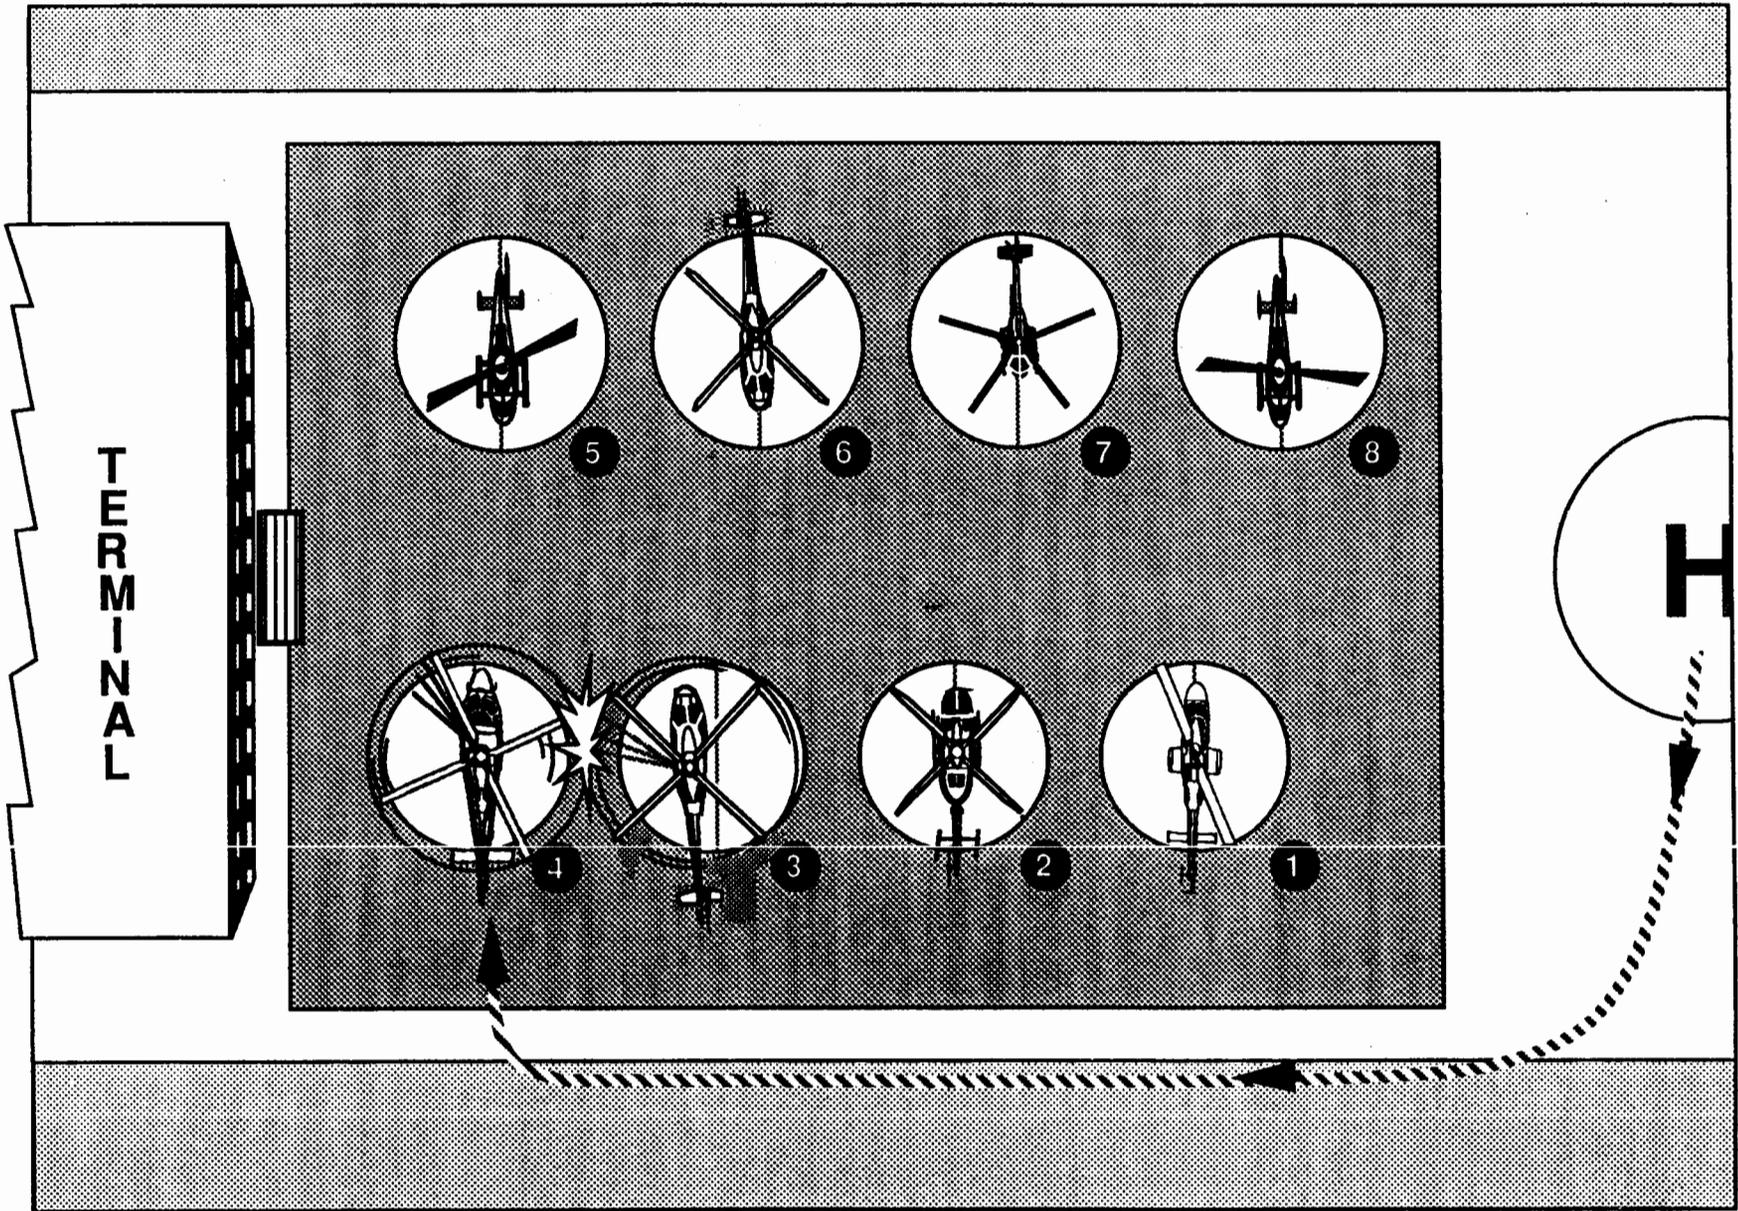
FIGURE 16 MULTIPLE AIRCRAFT - MAIN ROTOR BLADE CONTACT (ON-GROUND)

After the blade contact, the first helicopter was observed to be about 5 feet left of the parking space centerline and the second helicopter was about 1 foot to the right of its designated parking centerline. Both helicopters incurred substantial damage. There were no injuries to the crewmembers, passengers, or line personnel. There was no fire and no other damage as a result of the mishap.

Parking Area Clearances - The helicopter parking area should allow adequate clearance for adjacent parking of the largest design helicopters. The current Heliport Design Advisory Circular 150/5390-2 (reference 3) recommends "at least 1/3 rotor diameter but not less than 10 feet (3 meters) clearance from a takeoff and landing area or a fixed or movable object." This indicates the need for a clearance between the edges of parking spaces of 1/3 rotor diameter of the largest helicopter expected to use the heliport. As illustrated by this mishap, parking safety can be compromised even with specified parking space/aircraft assignments.

Marking - The fact that both helicopters parked off the parking space centerline contributed to the cause of the accident. To facilitate placement of the aircraft at the center of the parking space, centerlines and cross lines need to be clearly marked and visible to the pilot of a taxiing helicopter. Figure 17 depicts the heliport with design improvements that enhance safety.

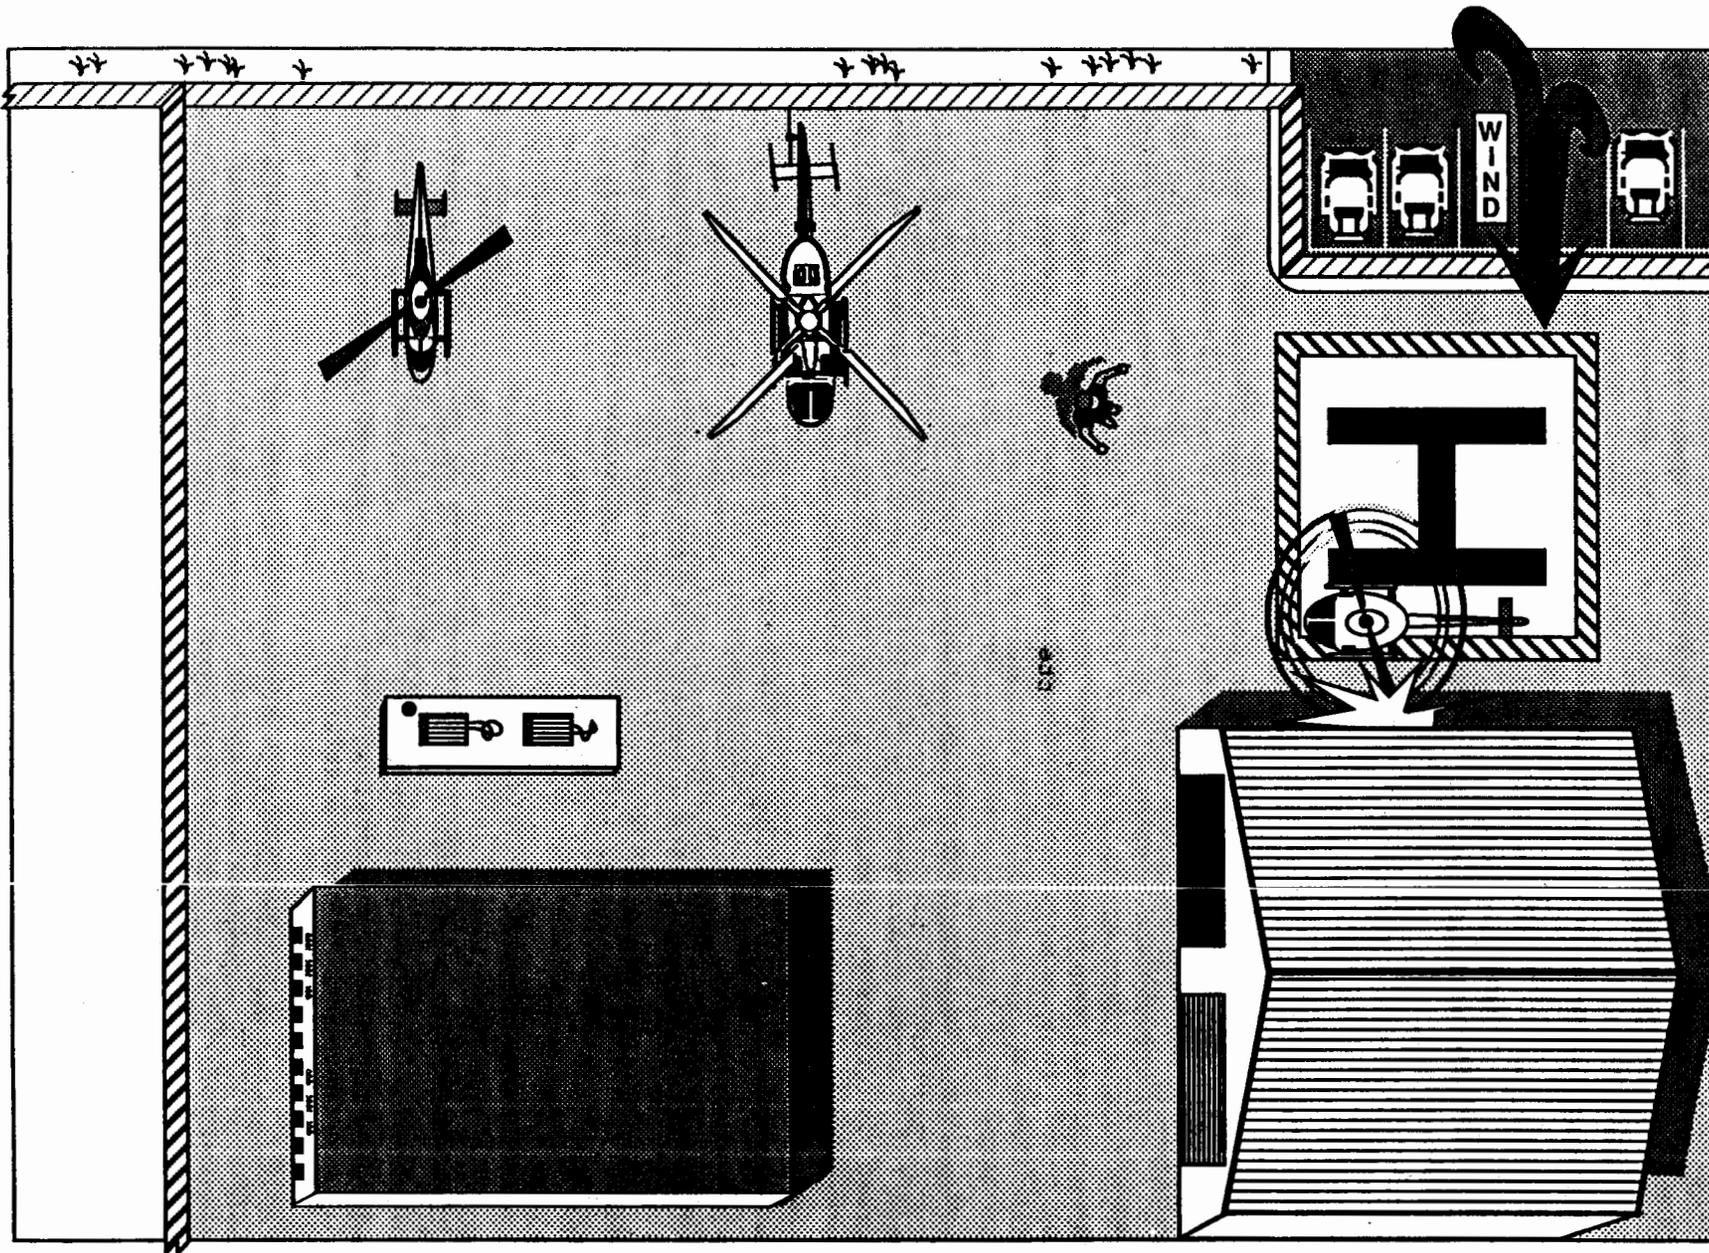
FIGURE 18 OBSTACLE STRIKE - BUILDING

Upon liftoff from the FATO, the pilot reported that his attention was diverted by the proximity of parked automobiles and the activity in the parking area. A sudden gust of wind blew the helicopter into the hangar (see figure 18). Flying debris struck a ground support crewman standing nearby. He was taken to a local hospital in critical condition with head and leg injuries. The pilot exited the helicopter uninjured, although the helicopter was substantially damaged.

FATO Size - The operation occurred in an area that was well below recommended design standards. As previously mentioned, the edge of the FATO should be located at least 1/3 rotor diameter, but not less than 20 feet, from structures. Recent FAA analysis has raised questions whether the 1/3 rotor diameter tip clearance is adequate for small helicopters. The helicopter requiring the largest tip clearance may be the small, light helicopter that is more easily affected by wind gusts than larger, heavier helicopters.

Takeoff and Landing Area - Unobstructed takeoff and landing areas are recommended for both private and public use heliport facilities. This area should provide at least 1/3 rotor diameter tip clearance, but not less than 20 feet horizontally from buildings, fences, fueling facilities, windsocks, earth berms, or any other objects that could present a hazard to flight. This is particularly important with light helicopters that are more likely to be affected by gusting winds. Additional clearance can be used to increase the safety margin of such operations. The current advisory circular (reference 3) recommends that the size of the takeoff and landing area be at least twice the rotor diameter (of the design helicopter) in both length and width.
