DOT/FAA/RD-91/1

Composite Profiles of Helicopter Mishaps at Heliports and Airports

January 1992

Final Report

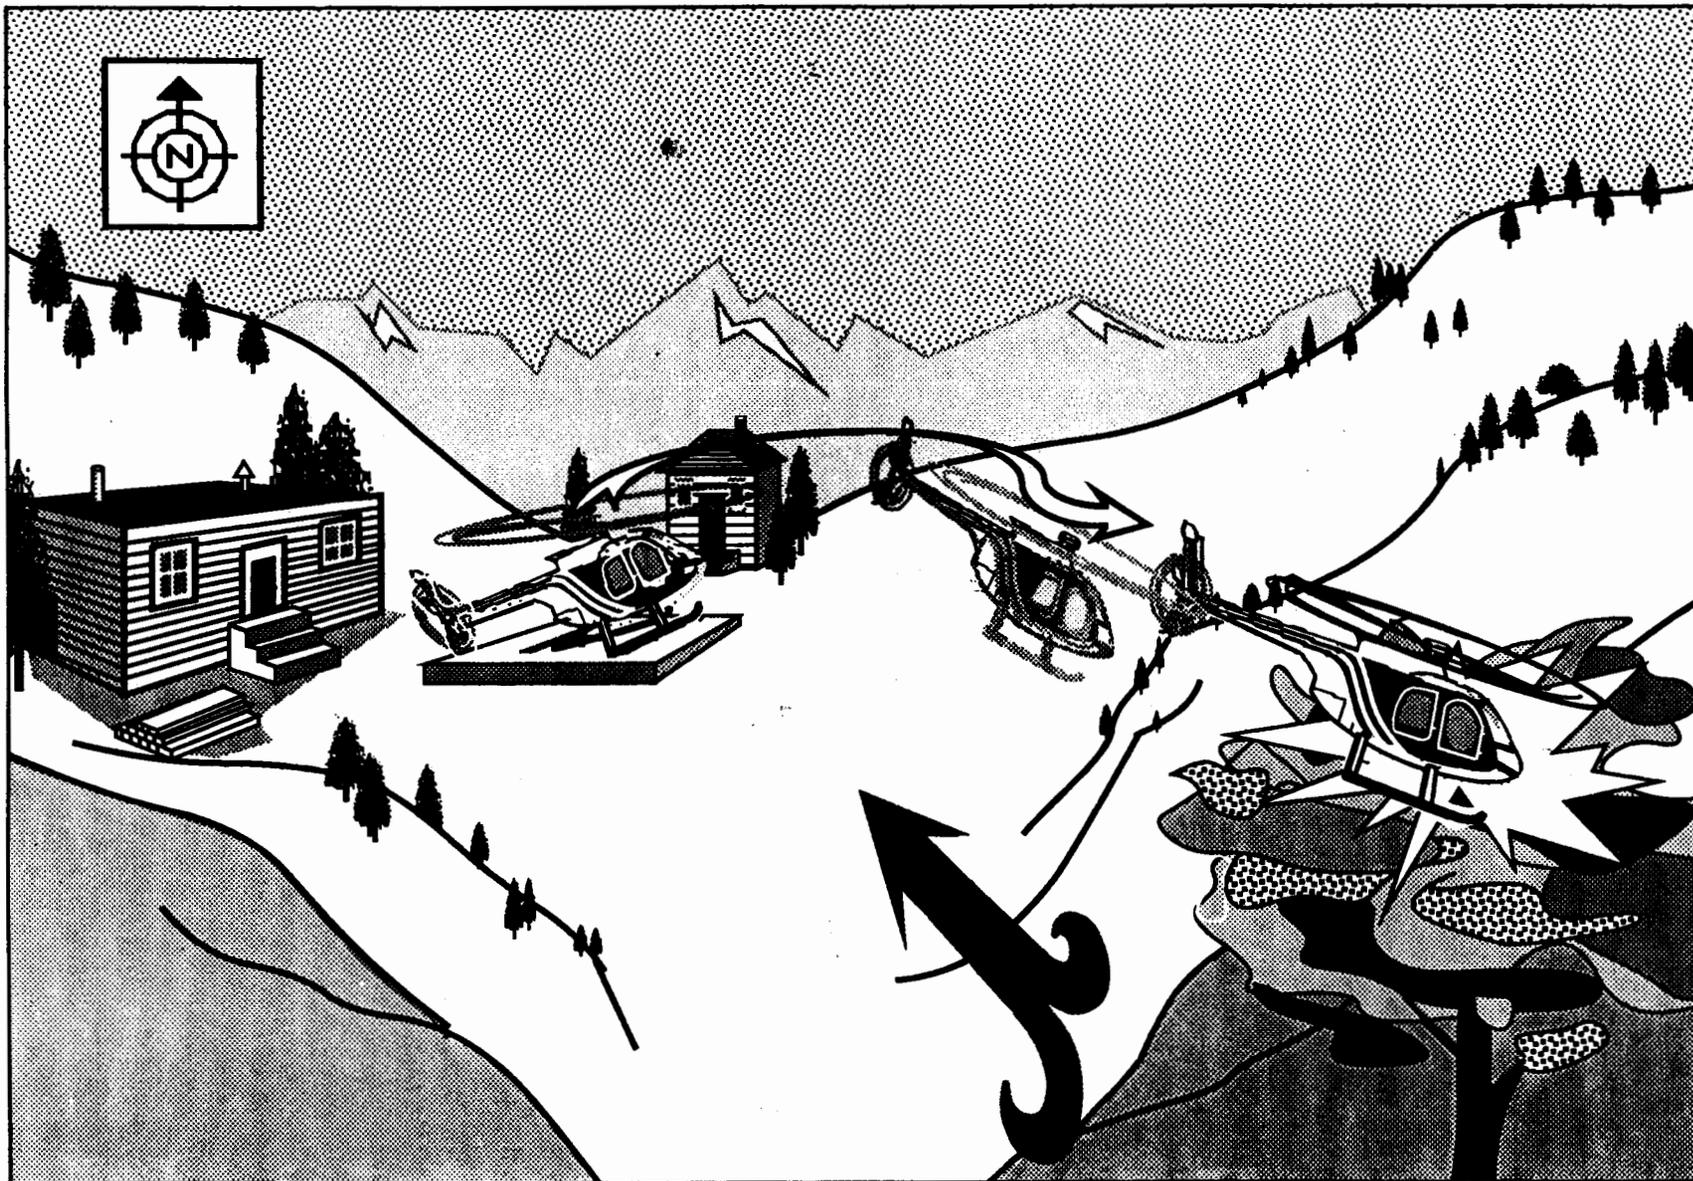
FIGURE 20 INSUFFICIENT POWER FOR TAKEOFF - DENSITY ALTITUDE

As the takeoff began, the helicopter did not climb. The pilot added power up to the maximum takeoff manifold pressure and increased collective in an attempt to climb away from the oak tree. As the helicopter was about to clear the tree, rotor rpm began decreasing and the pilot observed the tach needles passing through the "bottom of the green." He could not return to the takeoff spot, because rotor rpm was insufficient to control a 180 degree turn and the area was too narrow for any margin of error. According to passengers and observers, the engine's response to the power demand was a gradual power fade until it quit altogether. Due to the steep slope surrounding the area, the pilot elected to land in the oak tree to prevent a downhill roll. He did not flare in order to prevent ballooning over the tree. There was no perceptible bounce and the tree held the helicopter (see figure 20). The time from first branch strike to stop was about 1 second. The helicopter was demolished, but there were no serious injuries.

Assuming the pilot-observed outside air temperature of 60 degrees and approximated heliport elevation of 7,000 feet were correct, the investigators calculated that the density altitude was actually 9,010 feet. The flight manual for the aircraft at the estimated aircraft weight and density altitude showed a hover in-ground effect ceiling (HIGE) of 13,000 feet and a hover out-of-ground effect ceiling (HOGE) of 7,500 feet.

Pilot Technique - The pilot's takeoff procedures in this situation contributed to the mishap. The operating area was rather tight and the density altitude was questionable. In this situation, the pilot should have been near maximum takeoff power at takeoff, rather than waiting to apply full power.

Rejected Takeoff Groundspace - Rejected takeoff mishaps may occur at any altitude; however, the likelihood of this occurring is increased at high

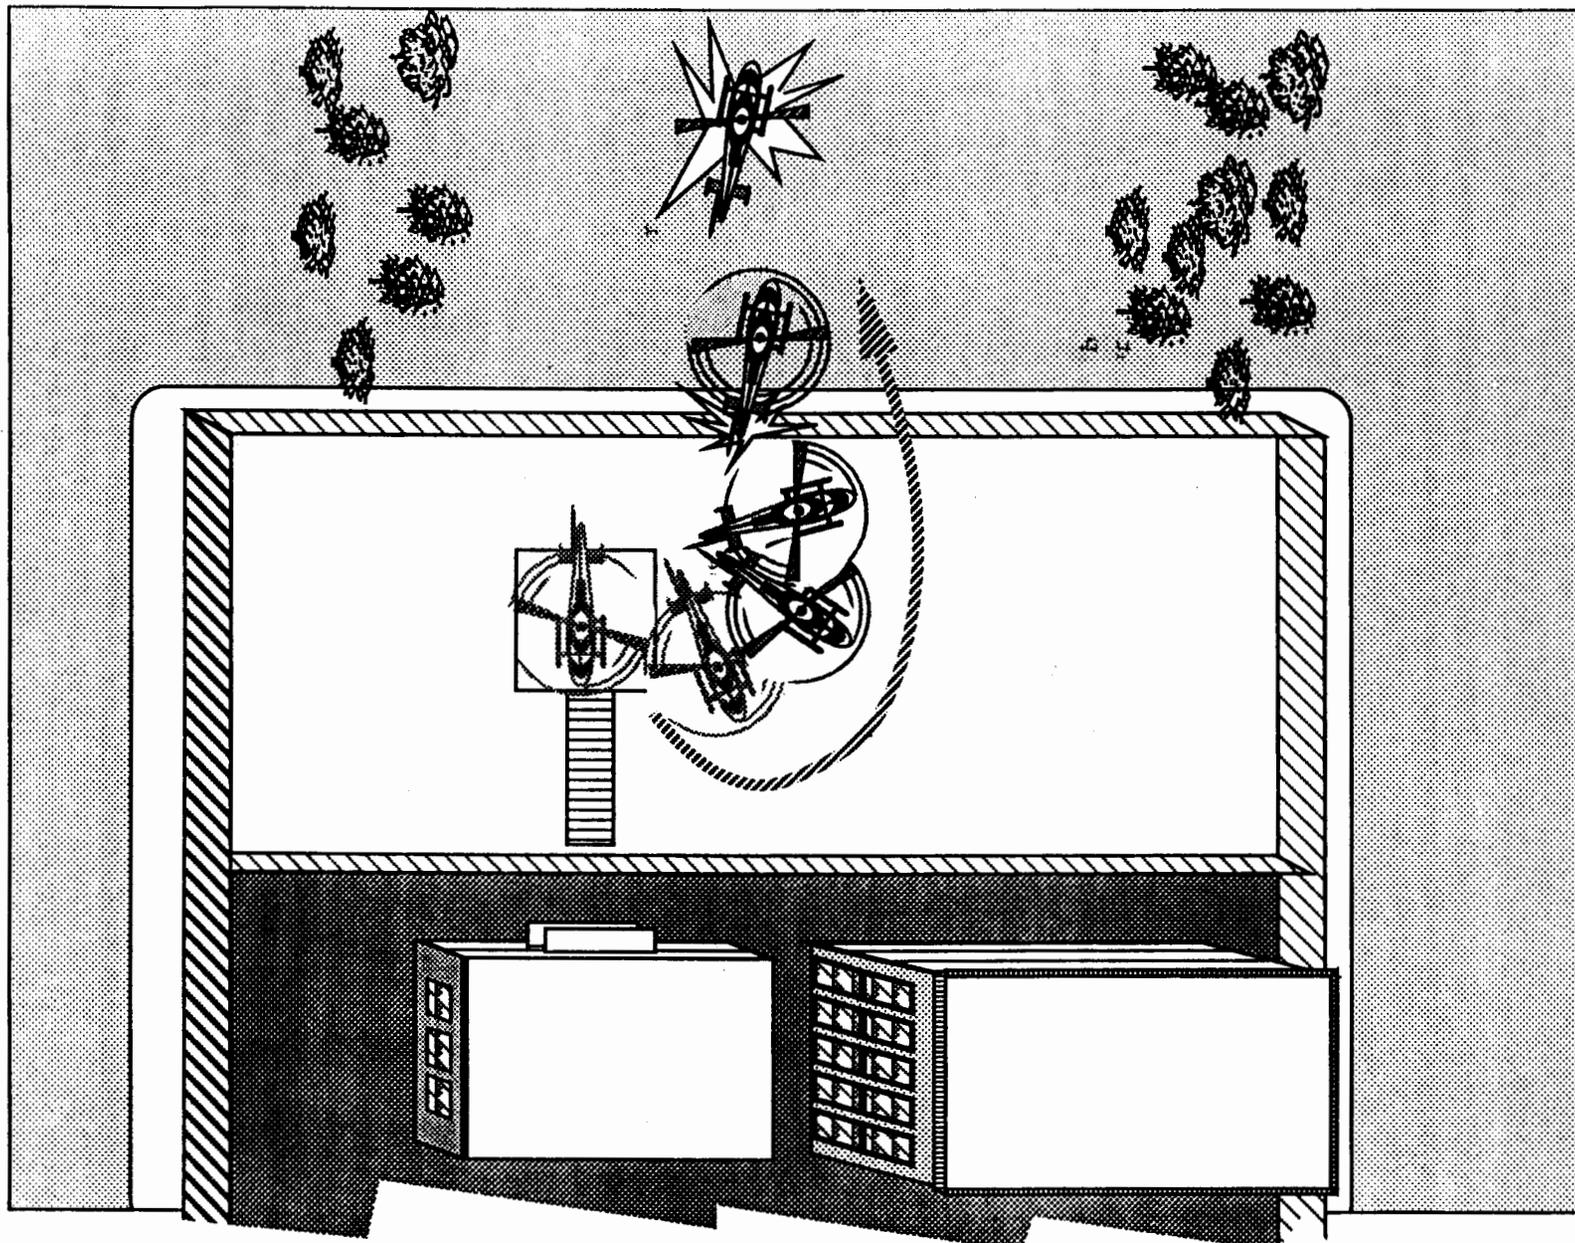
FIGURE 22 ENGINE FAILURE ON TAKEOFF

Approach/Departure Path - At first glance, the takeoff flight path chosen by the pilot and depicted in figure 22 seems unreasonable. Even though a departure path perpendicular to that flown would have given the pilot more room, mishap data shows that pilots do not always choose the most appropriate approach/departure path. The obvious lesson here is that pilots should give themselves as much leeway as possible in all situations. A good rule of thumb to remember is that "short cuts generally short cut safety."

Rejected Takeoff Groundspace - Mechanical failures do sometimes occur on takeoff. Even though this event is rare, having clear groundspace below the departure path will help to minimize the effects of such a mishap. Historic mishap data shows that safety measures, lighting, environmental (noise reduction) measures, etc. taken to protect the operator and the

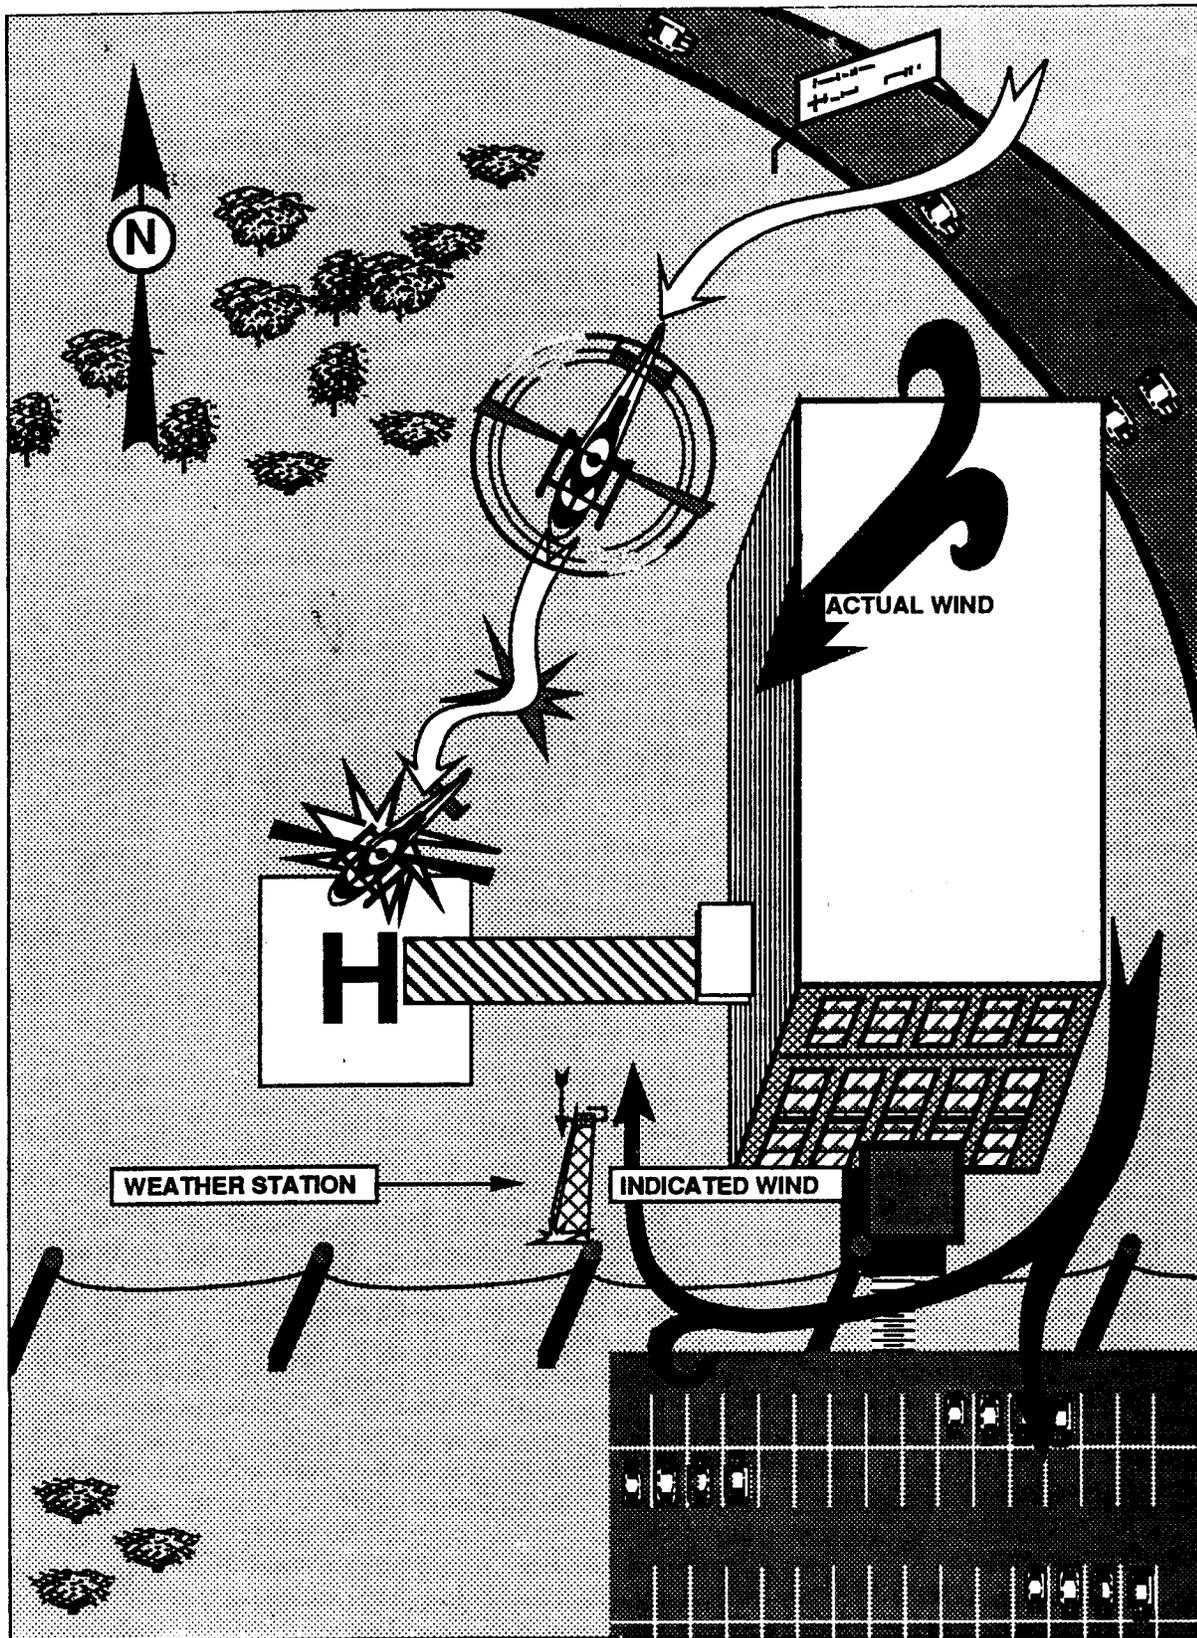
FIGURE 24 INSUFFICIENT POWER - DOWNWIND LANDING

Wind Indicator Placement - This mishap may have been prevented by adhering to the recommendations of the Heliport Design Advisory Circular (reference 3) regarding wind indicator placement. The advisory circular states that the wind indicator should be located "adjacent to the takeoff and landing area, but not interfere with helicopter operations or be shielded by buildings or other objects that prevent it from showing a true indication of the wind's relative direction and magnitude." Several accidents and incidents analyzed were characterized by helicopters not being able to achieve translational lift, and, in general, not being able to attain/maintain sufficient rotor rpm to continue the intended maneuver. These mishaps frequently resulted in collisions with buildings, porches, light stanchions, fences, etc. in the vicinity of the heliport or airport helicopter facility. A document entitled "Evaluating Wind Flow Around Buildings on Heliport Placement," DOT/FAA/PM-84/25 (reference 6)

Approach Procedures - When pilots find it necessary to use facilities not optimally located or without adequate wind indicators, they should take all possible sources of wind information into consideration, such as trees in the vicinity of the facility, ripples on nearby ponds or lakes, flags near office buildings, etc. If possible, a low reconnaissance orbit should be performed, especially when reported winds indicate a tentative situation or an undesirable one. The safe pilot is one who uses superior judgment to avoid situations which might require the use of skill beyond his/her or the aircraft's capabilities.

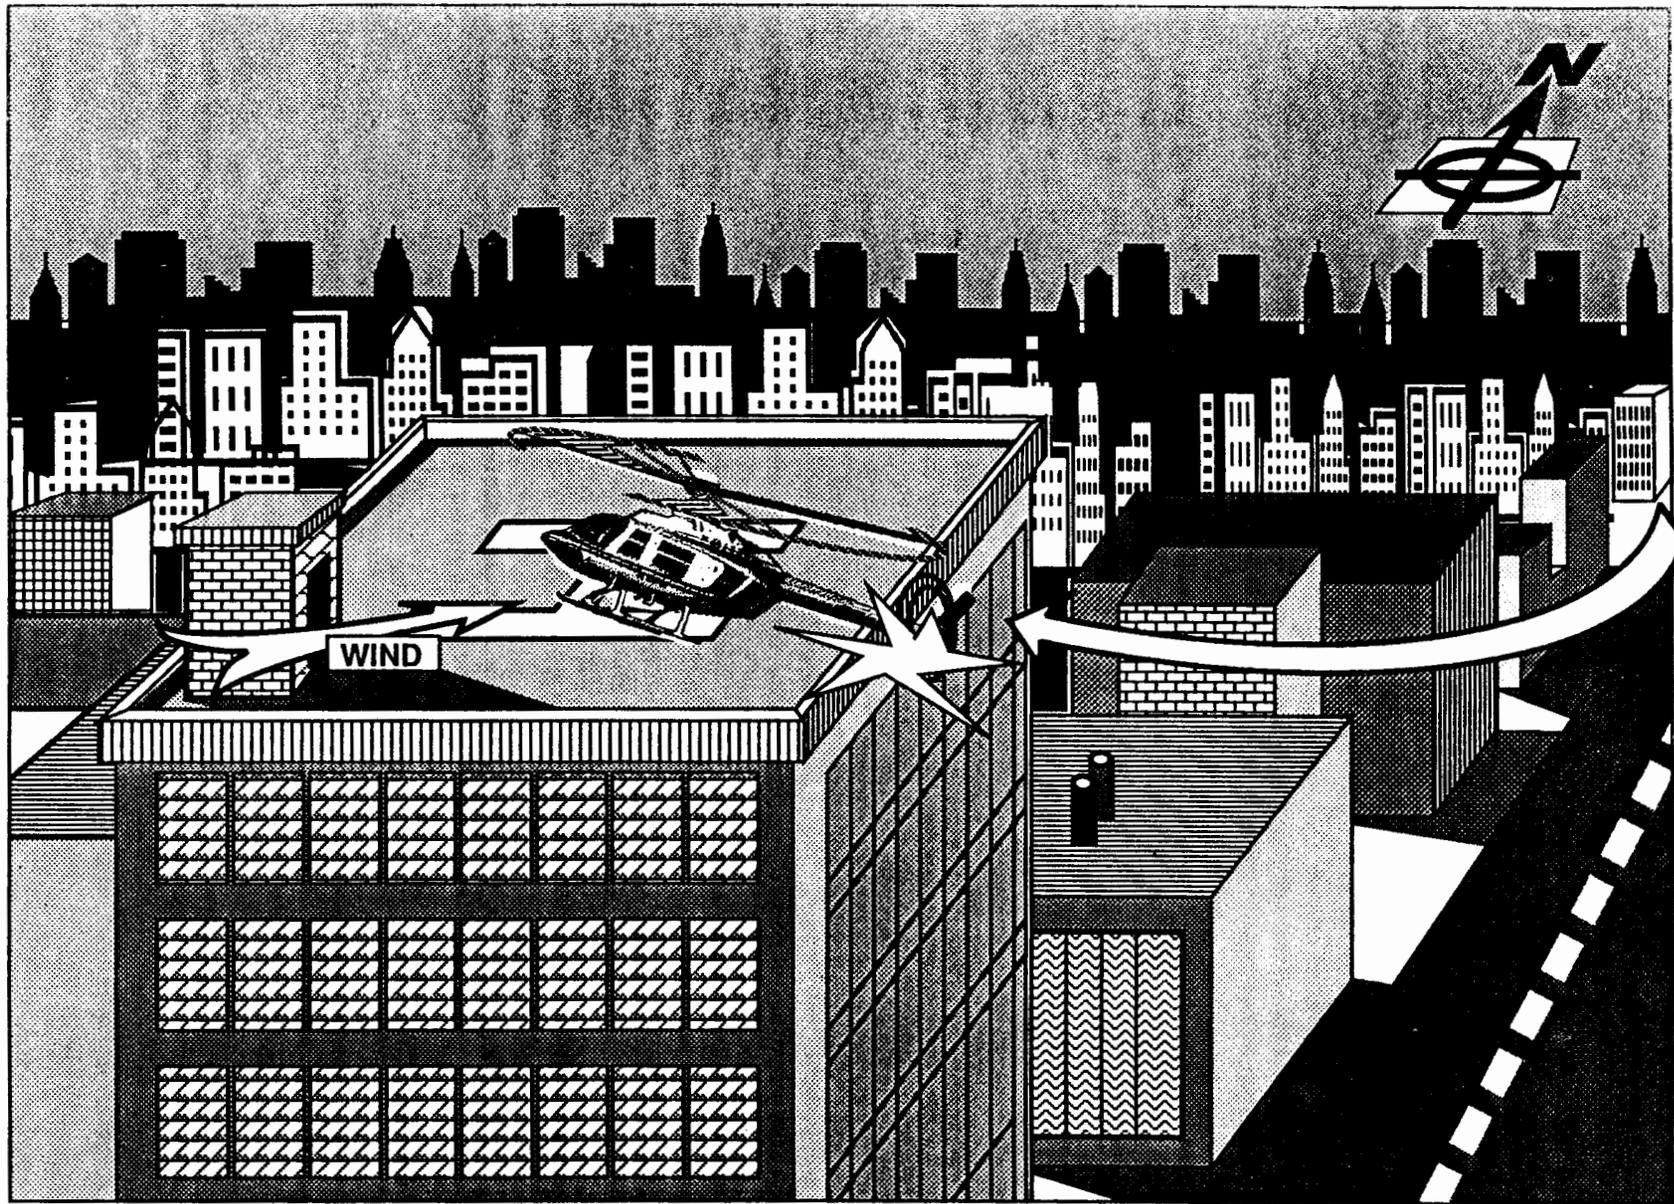
FIGURE 26 OBSTACLE STRIKE - PARAPET

In this mishap, the pilot did not have a VASI-type guidance system to assist him in executing an approach at the proper angle. Visual guidance

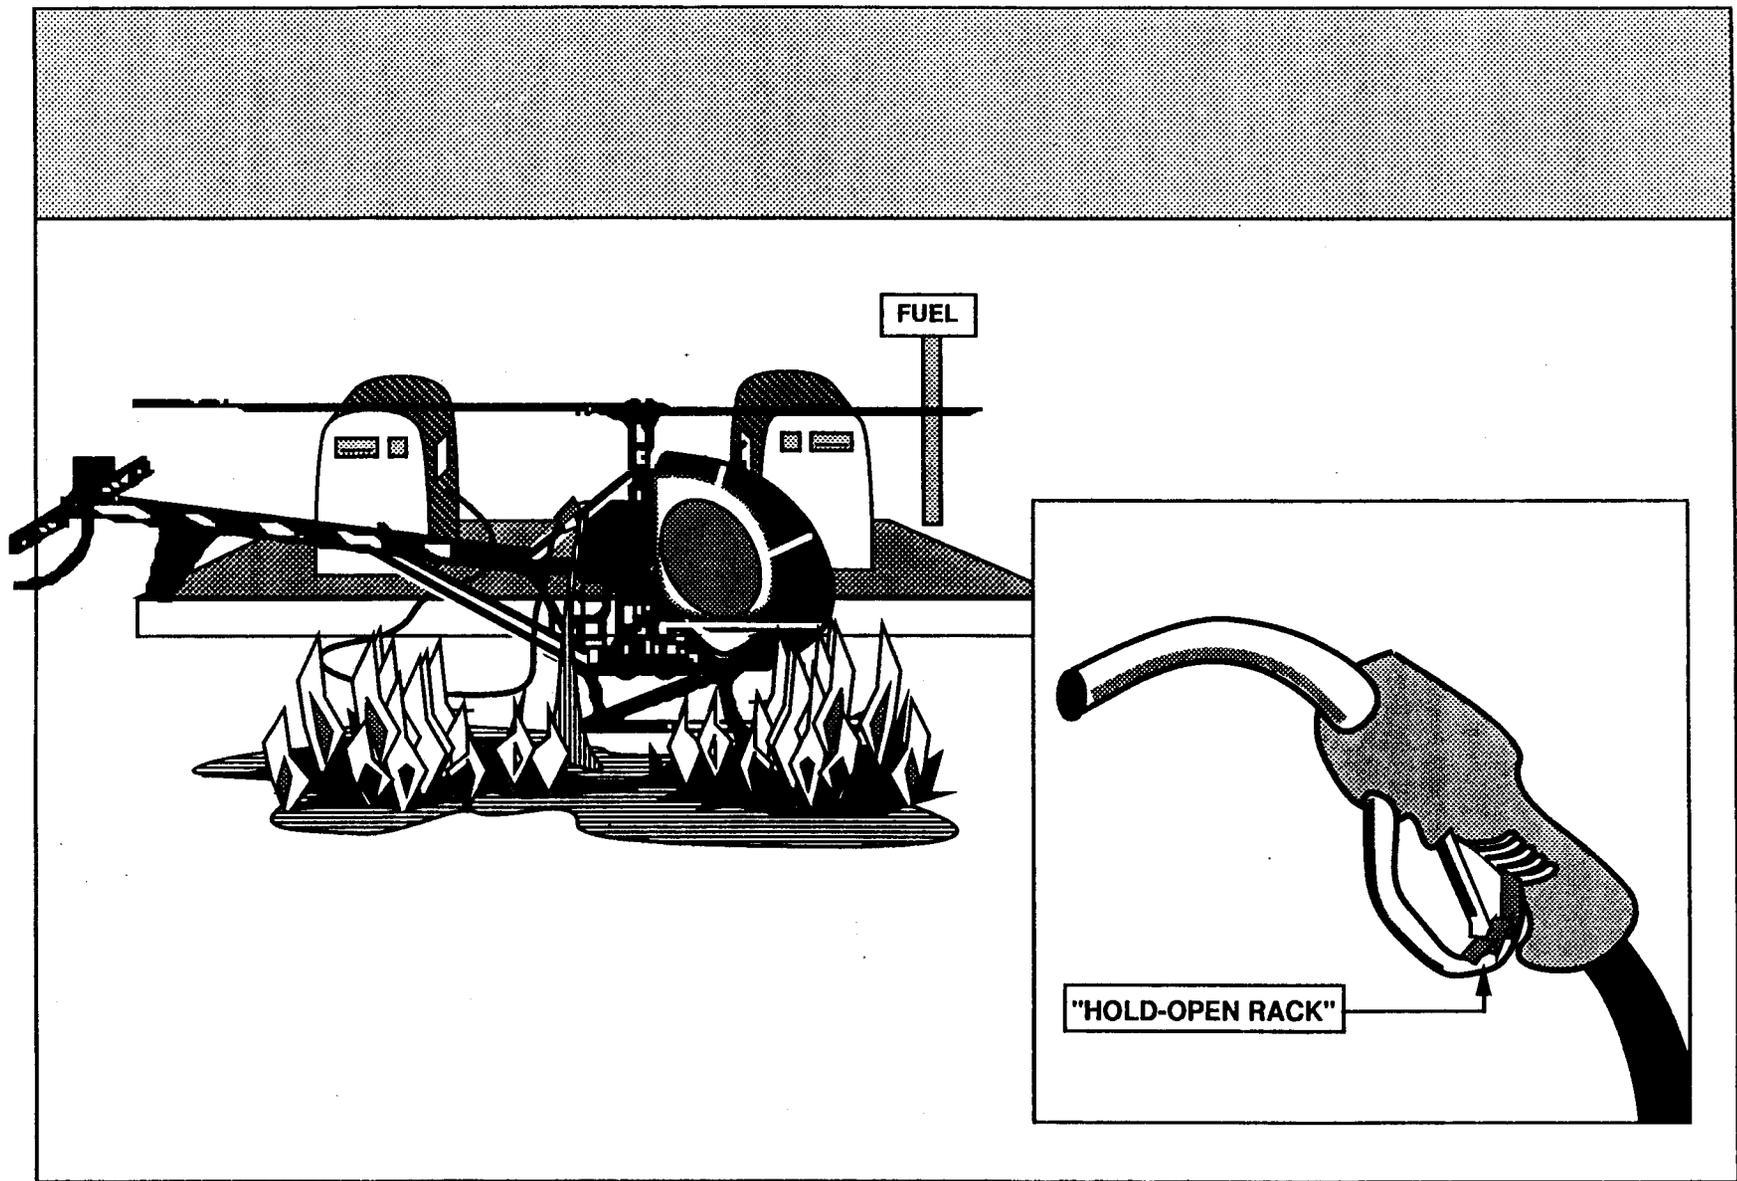
FIGURE 28 REFUELING FIRE

Fuel Nozzle - The pilot engaged the hold-open rack feature during refueling. Advisory Circular No. 00-34A (reference 10) addresses the subject of "Aircraft Ground Handling and Servicing." It states that fuel nozzle lever stop notches (hold-open racks) should be removed to avoid the possibility of an inadvertent blocking-open of the valve. The advisory circular further states "...never block the nozzle lever in the open position." Even if these nozzles have automatic fuel shut-off features there is no guarantee that it would preclude a fuel spill. The advisory circular states that: "Fuel-dispensing vehicles and stationary facilities should be equipped with appropriate fire extinguishers, fire blankets, static grounding cables, explosive proof flashlights, and ladders. Fire

extinguishers should be located so they are accessible from either side of the vehicle (or stationary pump, etc.) and remote from the probable fire hazard."

Pilot Procedures - Pilots should set all switches to the "off" position following engine shutdown. Also, whenever possible, pilots should watch over refueling procedures to contribute to safety in refueling operations.

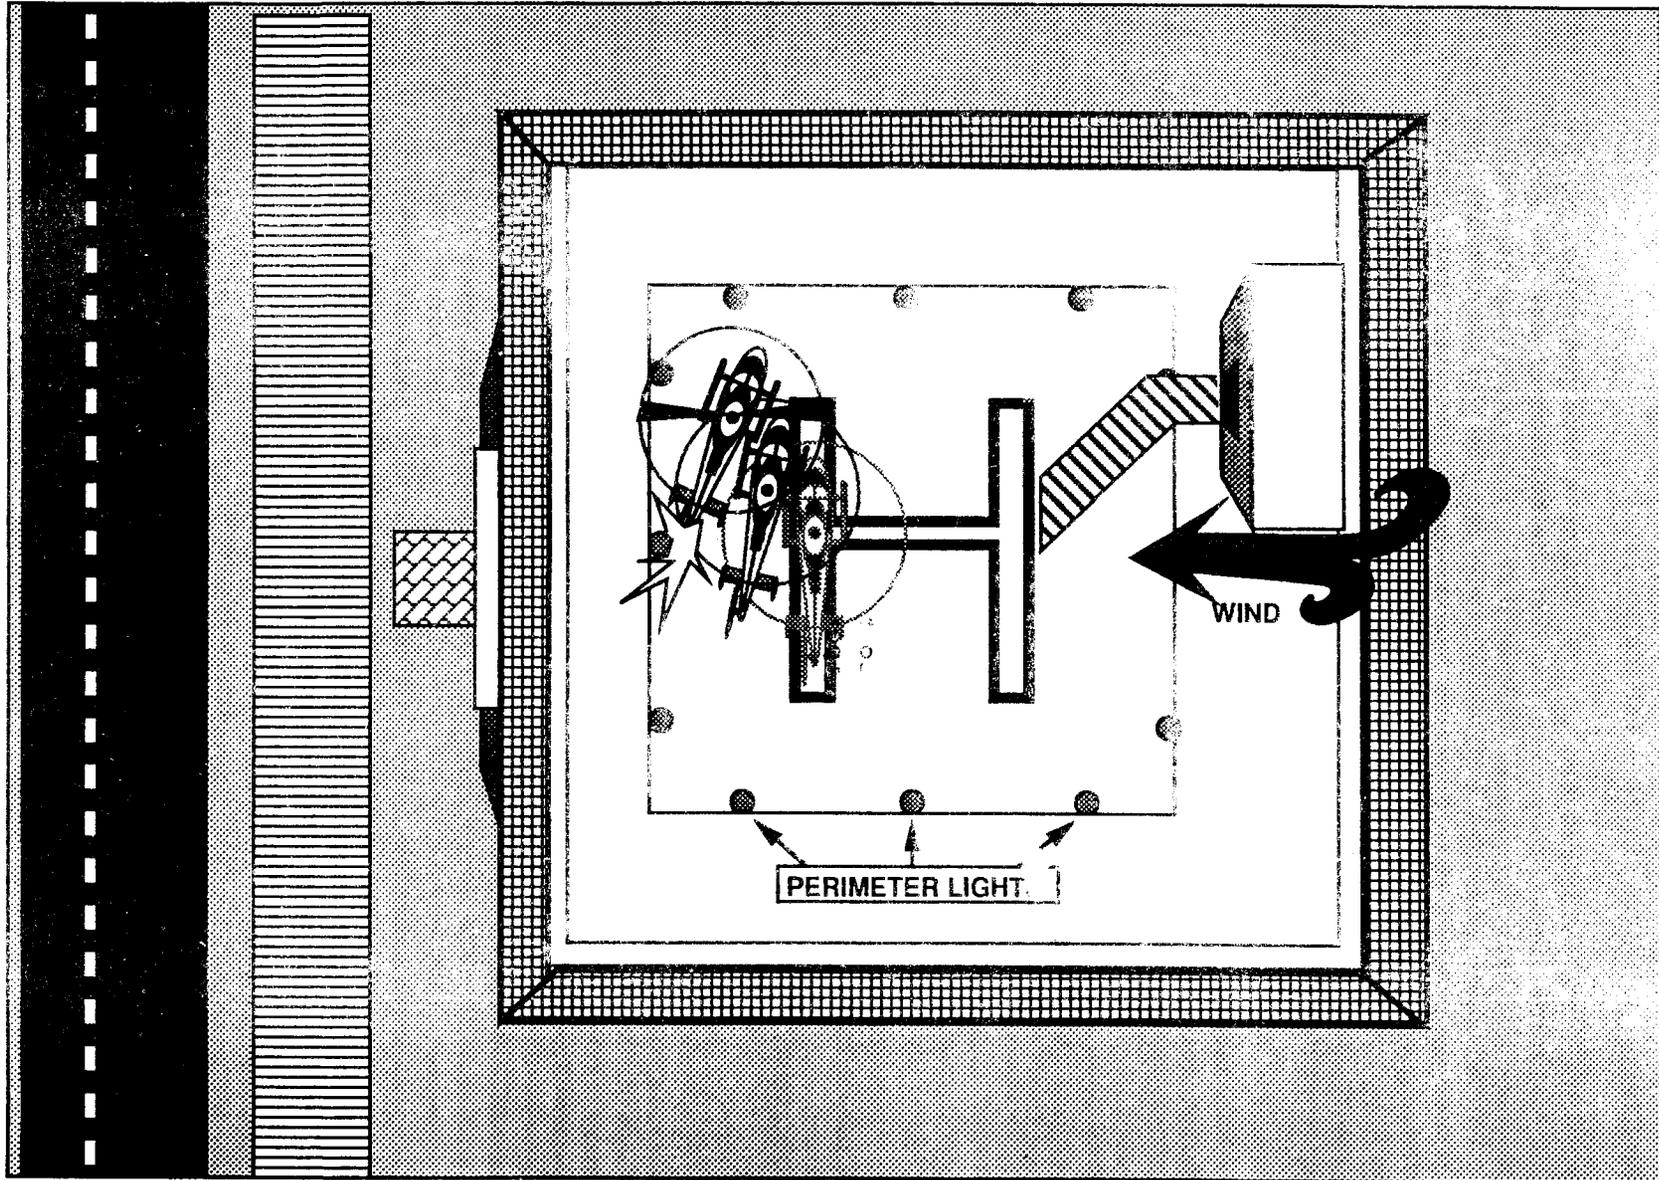
FIGURE 30 OBSTACLE STRIKE - PERIMETER LIGHT

Publicized Information - Several perimeter light strikes have involved operations to new heliports or first time operations to an unfamiliar location. Considering the need for lighting and the fact that these occurrences do happen, it is recommended that both pilots and heliport

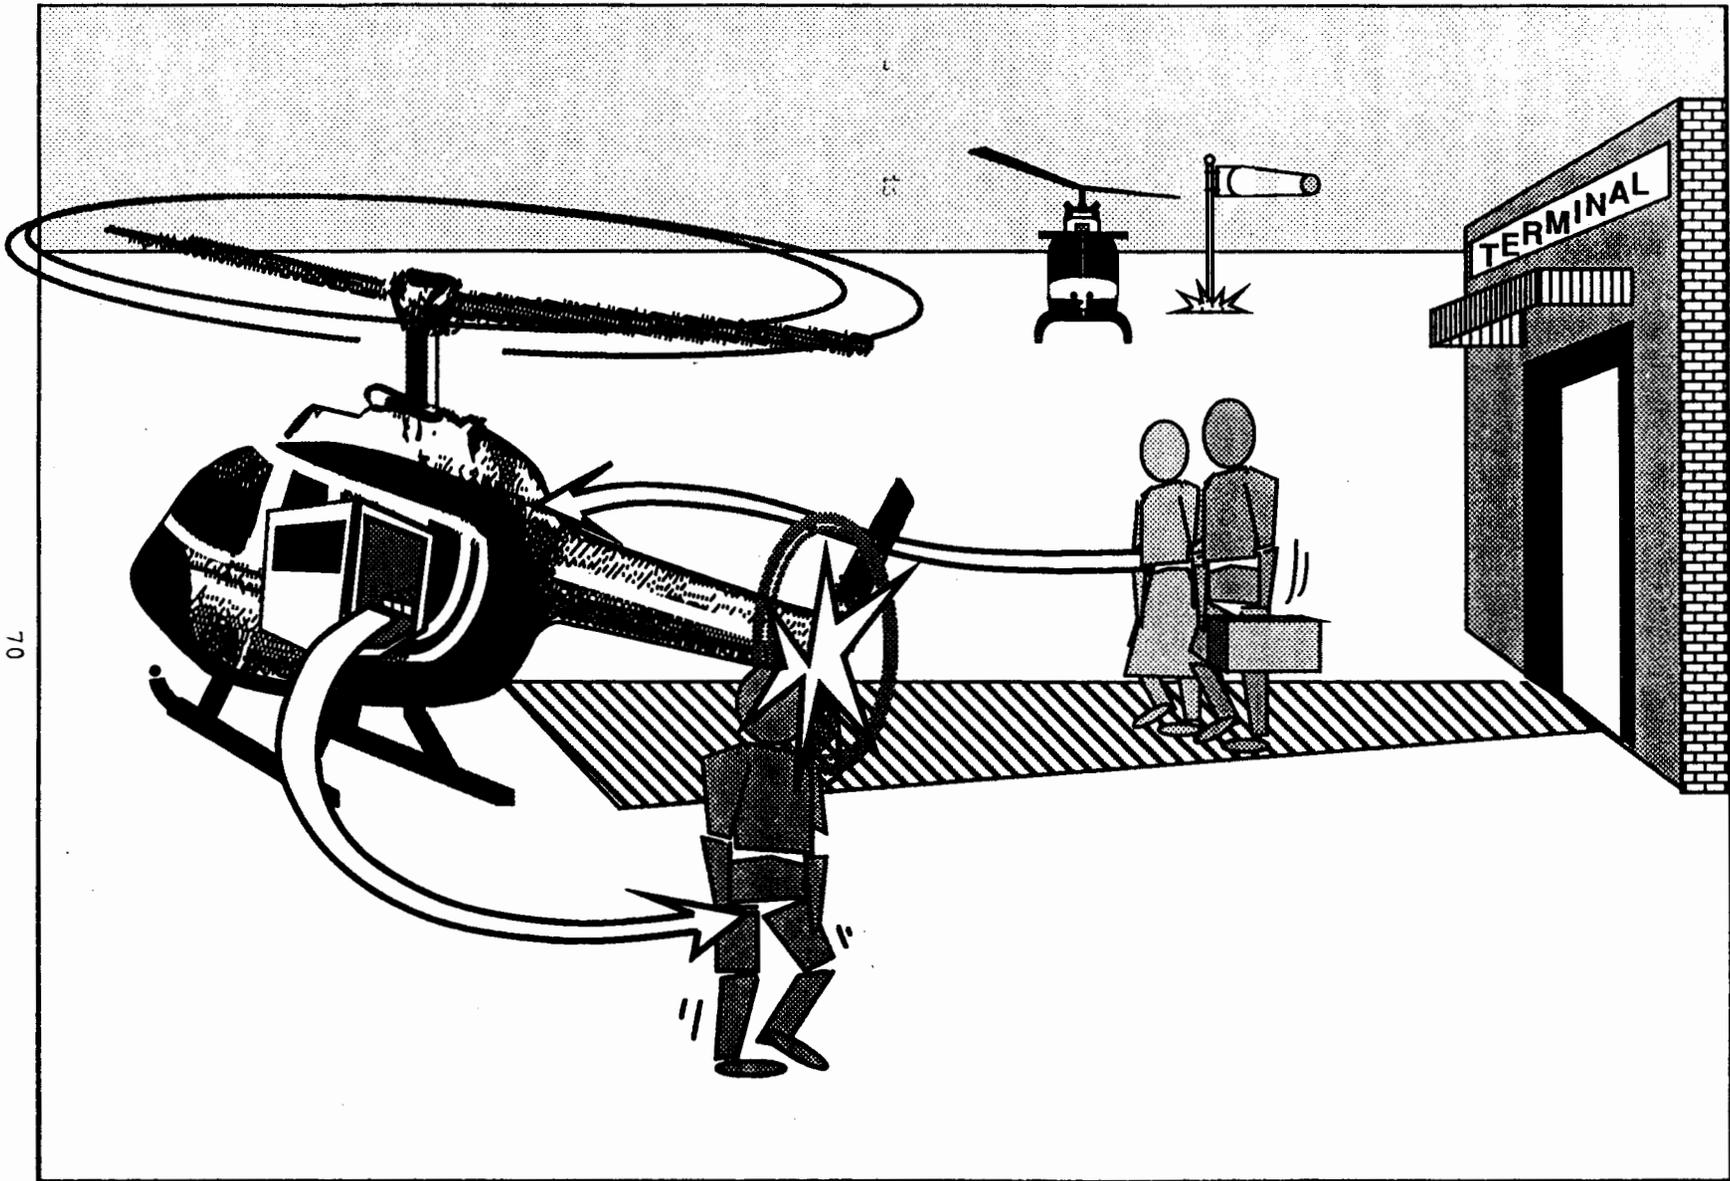
FIGURE 32 TAIL ROTOR STRIKE - PERSONNEL

Ground Marking - Mishap reports show that even passengers who have ridden on helicopters on a number of occasions may walk into a turning tail rotor. The seriousness of this type of mishap requires that every effort be made to ensure its prevention. When helicopter flights carrying passengers occur on a regular basis from a location, specific ground markings to guide passengers should be considered. Ground marking guidance is provided in the Heliport Design Advisory Circular (reference 3). Figure 33 depicts the ground markings which enhance the safety of embarking and disembarking passengers.
