**DOT/FAA/TC-14/20**

# **Nonconforming Composite Repairs: Case Study Analysis**

November 2014

Final Report

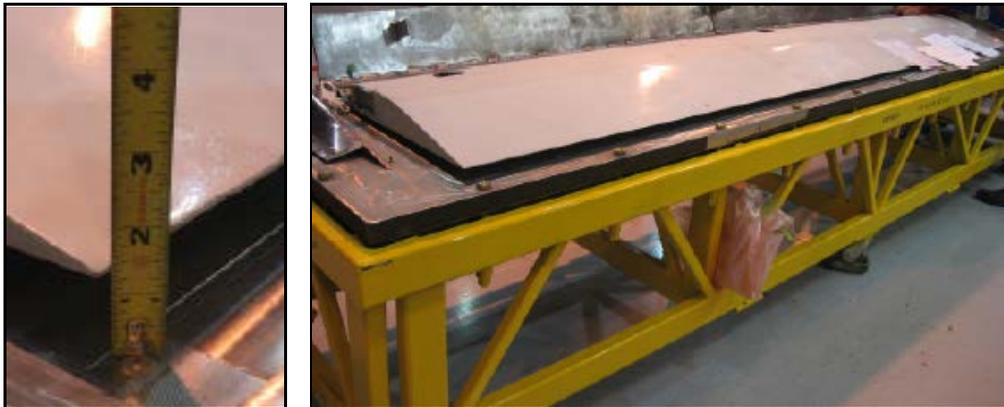
After receipt of an overhauled flap assembly, the airline observed that the assembly did not fit properly. Maintenance personnel indicated that the issue was due to the part's contour. A different contractor was selected to fabricate check inspection tooling to confirm the discrepant contour. The tooling was based on OEM data and was compared against a digital model of the OEM loft using a Coordinate Measuring Machine device, and also checked against a good part. When the overhauled flap assembly was placed on the tool, the trailing edge was out of contour at the outboard end by over 1.5 inches (figure 1).

Figure 1. Overhauled Flap Assembly Placed on Tooling That Served as a Check Fixture

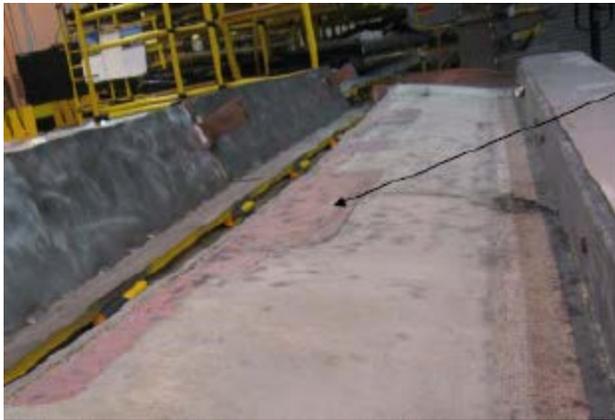
- A prior MRO had removed and replaced large sections of honeycomb, including 20-inch segments that spanned the leading and trailing edges of the part, which were outside the SRM limitations.
- It was observed that the repairs used 250°F instead of 350°F prepreg repair materials and that the repaired areas exceeded the SRM limits on size (figure 2).

250°F prepreg repair material well over 6" diameter

Figure 2. Repair That Incorrectly Used 250°F Prepreg Repair Material

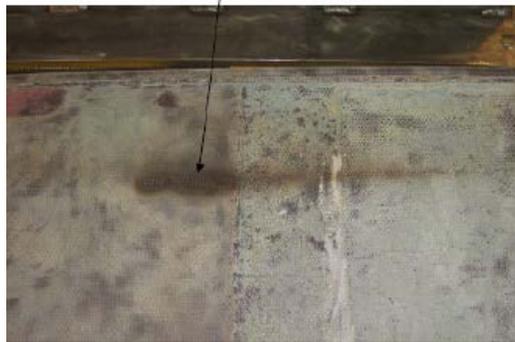
- It was concluded that a previous repair had been performed by improperly using a hot bonder and heat blanket for part cure. This conclusion was reached by observing what appeared to be burn marks on the skin caused by heat blanket overheating (figure 3). This is frequently caused by the improper use of the hot bonder or placement of the thermocouples.

Burn marks on upper skin from overtemping during hot bond repairs.

Figure 3. Skin Burn Marks Caused by Heat Blanket Overheating

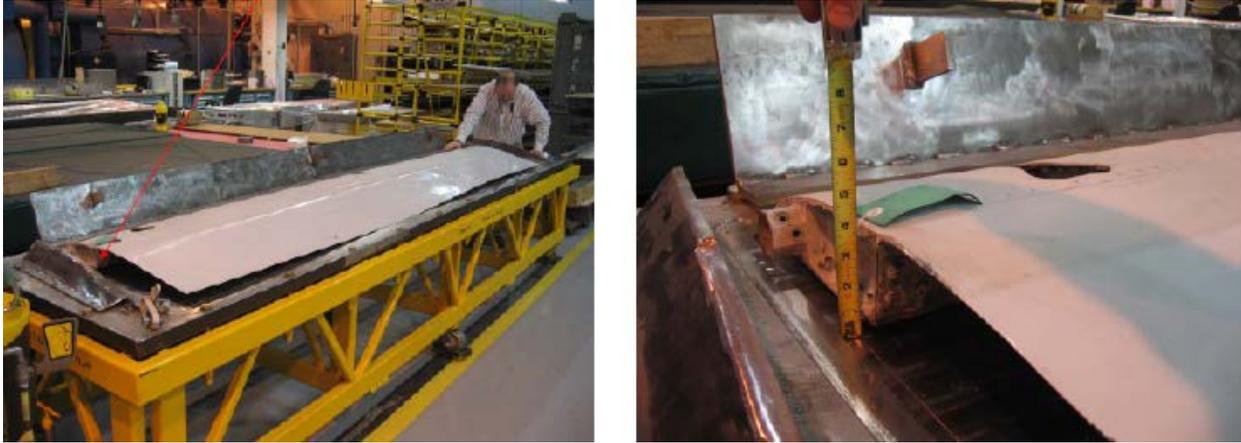
- Not using tooling, or using tooling with incorrect contours during the repair, caused a warp condition on the spar. In figure 4, the lower skin and honeycomb had been removed and the spar would not conform to the tooling contour, even with substantial pressure on both ends of the part.

Figure 4. Out-of-Contour Condition of the Spar Resulting From the Use of Improper Tooling

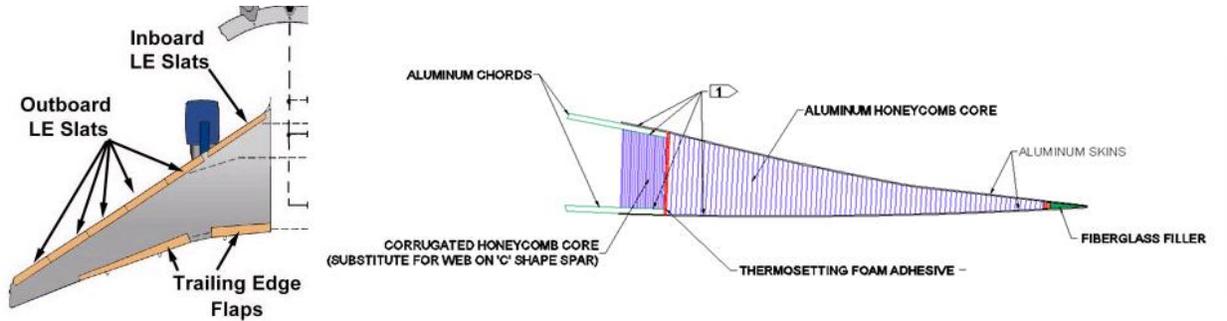
Figure 5. Schematics of Slat Locations and Cross-Section

A leading edge (LE) slat (figures 5 and 6) was removed for inspection because of hail damage that extended the length of the slat. A tap test was performed, followed by ultrasonic inspection, which revealed core damage in addition to skin damage caused by hail.

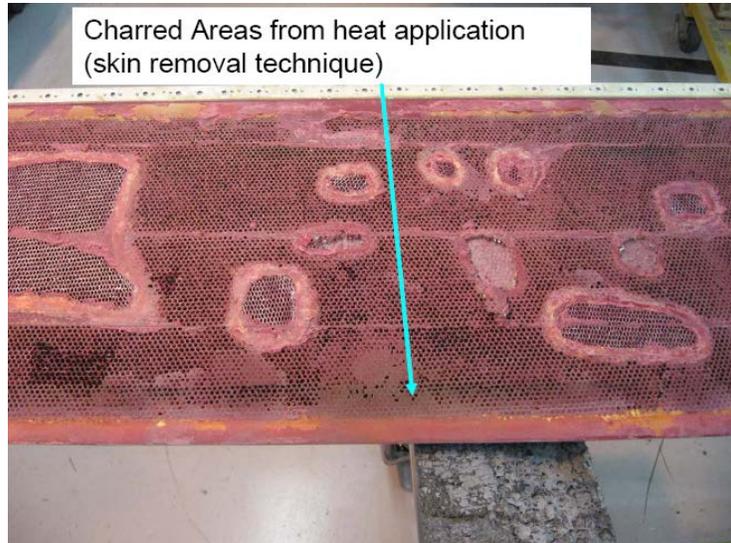
1. Burn marks on the honeycomb core showed that the heat application during skin removal exposed the part to temperatures above acceptable limits (figure 7).

Figure 7. Damaged Honeycomb Core From Excessive Heating

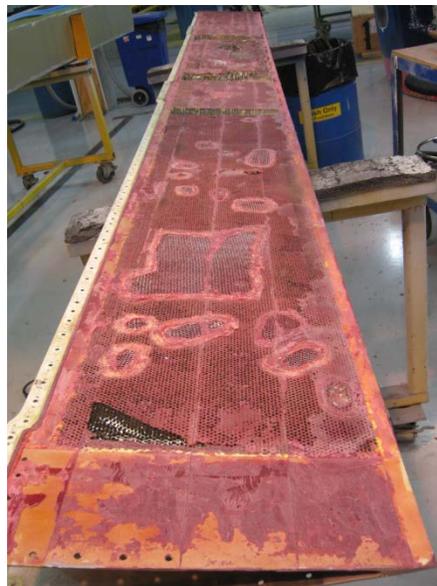
2. There were areas at the inboard and outboard ends that had evidence of film adhesive porosity (small voids), which indicated that the BMS5-101 film adhesive had a thickness that exceeded OEM tolerances. This suggested that the tool used in the repair did not match the flap assembly correctly (figure 8).

Figure 8. Uneven Film Adhesive Thicknesses May Have Been Caused by Tooling Contour Inaccuracies

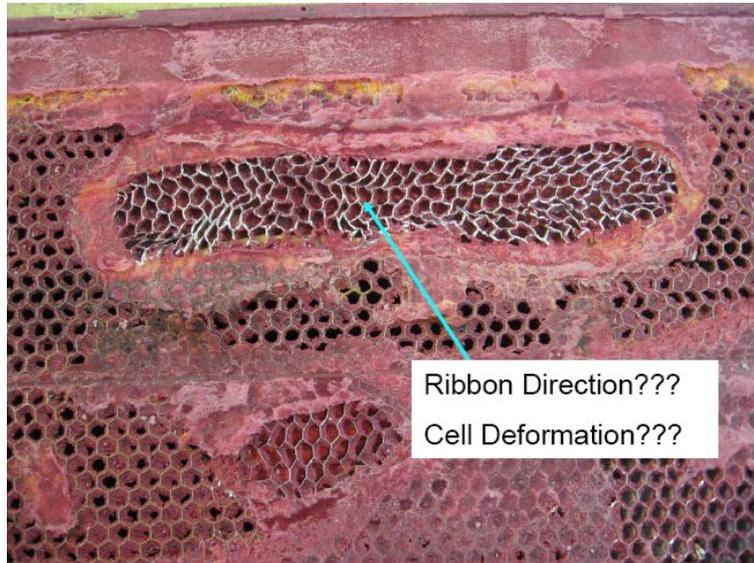
3. Several issues were discovered that related to improper ribbon direction of the replacement honeycomb core areas, SRM repair proximity limits, and honeycomb replacement core type (figure 9). The technician may have squeezed replacement core into the cut out area without regard to orientation, shape, and cell wall condition.

Figure 9. Poor Workmanship Resulted in Distorted Honeycomb Core

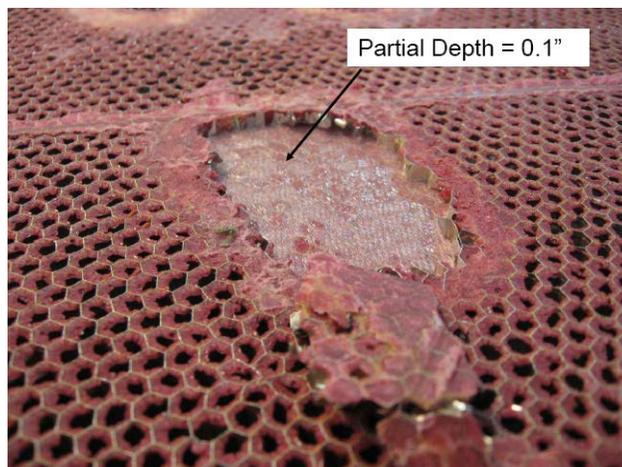
4. The core plug depth for all repair areas shown in figure 10 were 0.100-inch deep, which is far shallower than the SRM allows (The SRM requires that core plugs are greater than 1/3 of the full depth of the core, locally, to both skins). The repair station did not have access to full-depth shaped core replacement sections, and the technicians were forced to improvise.

Figure 10. Incorrect Honeycomb Plug Dimensions Violated SRM Requirements

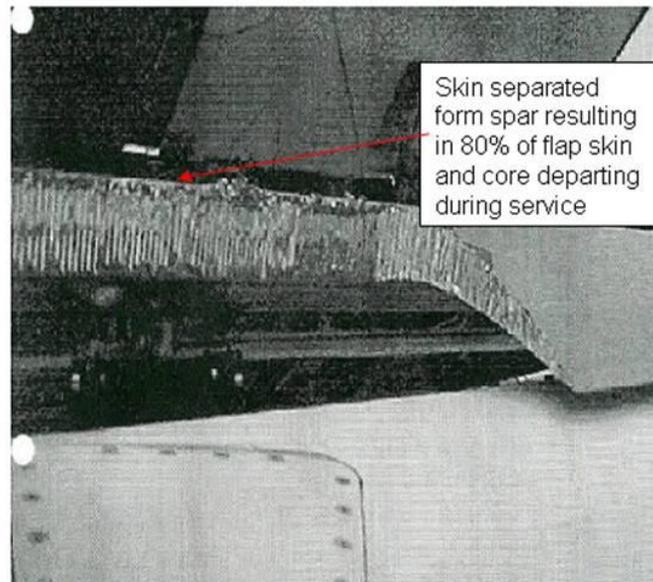
During an approach, a passenger looked out a window and observed severe damage to an outboard flap. Upon landing, it was discovered that approximately 80% of the trailing edge wedge assembly was missing. Investigation revealed that the skins had disbonded from the spar, which had not been adequately treated in the original bond process performed at the MRO (figure 11). After assessment of the defective assembly for damage, it was discovered that the primer had stuck to the adhesive and separated with the skins, leaving a scuff sanded spar surface exposed.

Figure 11. Disbonding Between Skin and Spar Following Repair

The MRO had implemented the substitute procedure that allowed the technician to scuff sand, perform CCC, and apply adhesive primer to areas of the original OEM-built components that were previously anodized with phosphoric acid. These areas consisted of the entire spar and the upper and lower skin mating flanges where the skins were bonded to the spar by using the hot bond autoclave process. The repair procedure was not approved by the OEM for this assembly repair scenario.

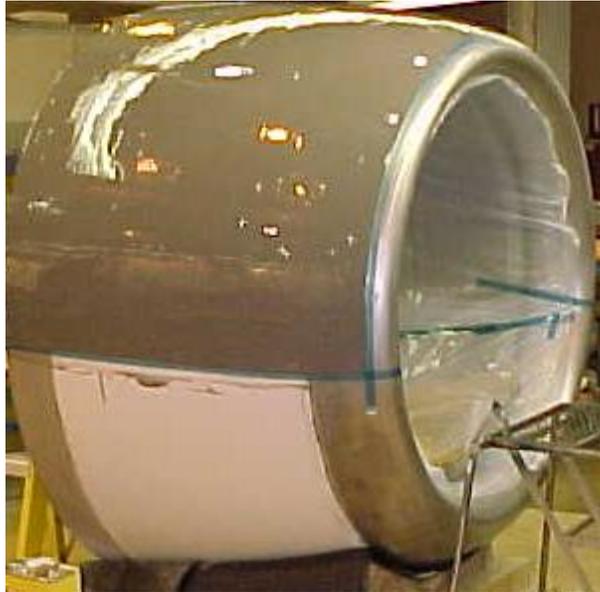
Figure 12. Typical Nose Cowl Dispositioned for Repair

With its exposed location, an engine nose cowl often suffers foreign-object damage, such as bird strikes, which can take an aircraft out of service while the damage is repaired. A typical nose cowling is shown in figure 12.

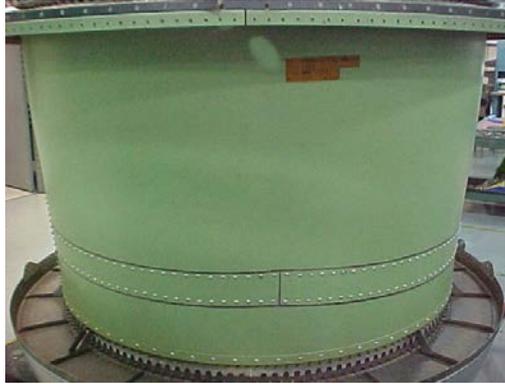
After partial disassembly, the inner barrel appeared visually to be correct (figure 13), but experienced technicians recommended further evaluation of the nose cowl assembly. During this evaluation, airline repair technicians and inspectors noticed an irregular repair to the inner barrel back skin. Further investigation revealed that poor workmanship and a lack of adherence to proper repair procedures were the causes for the significant underlying discrepancies.

Figure 13. Inner Barrel Prior to Disassembly and Further Investigation

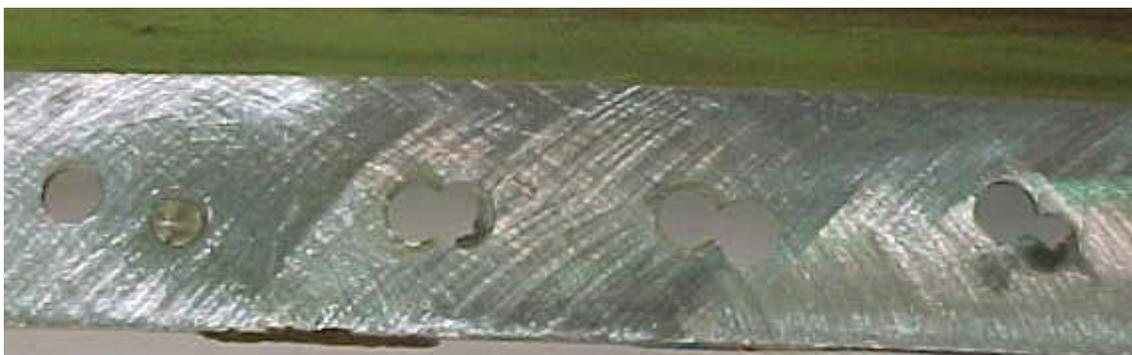
1. After removing access panels' outer barrel skins, it was observed that the repair to the inner barrel exceeded the circumference limitation of 25 inches imposed by the OEM's SRM. This was not annotated in FAA Form 8130-3, nor was the repair accomplished with approved data that should have been required for exceeding the SRM limitations.
2. The outer skins were removed for examination, revealing further issues:
  - a. There were double-drilled attach holes that were partially filled with sealant/adhesive to plug old holes (figure 14). Glass fabric was applied to one side of the sealant/adhesive to create an aesthetically pleasing finish. It appeared that the vendor repair station had double-drilled holes and had filled these holes with paste adhesive to hide the double drilling.

Figure 14. Improper Drilling Workmanship and Failure to Follow Correct Repair Procedure

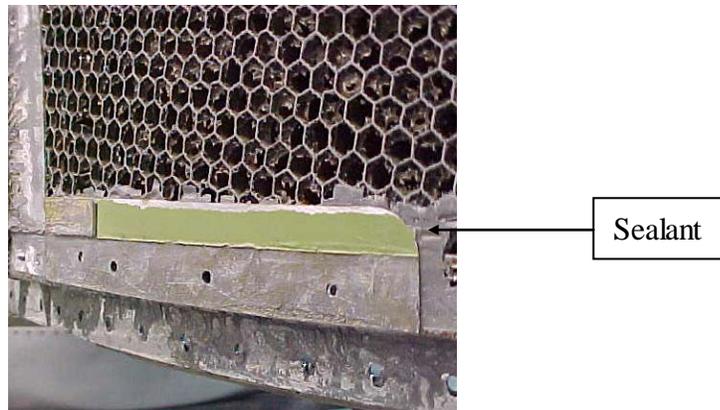
- b. Large cracks had been covered with sealant at the edges where erosion or sanding had caused outer-ply damage (figure 15). This damage was extended completely through all layers of carbon.

Figure 15. Example of Improper Use of Sealant During Repair

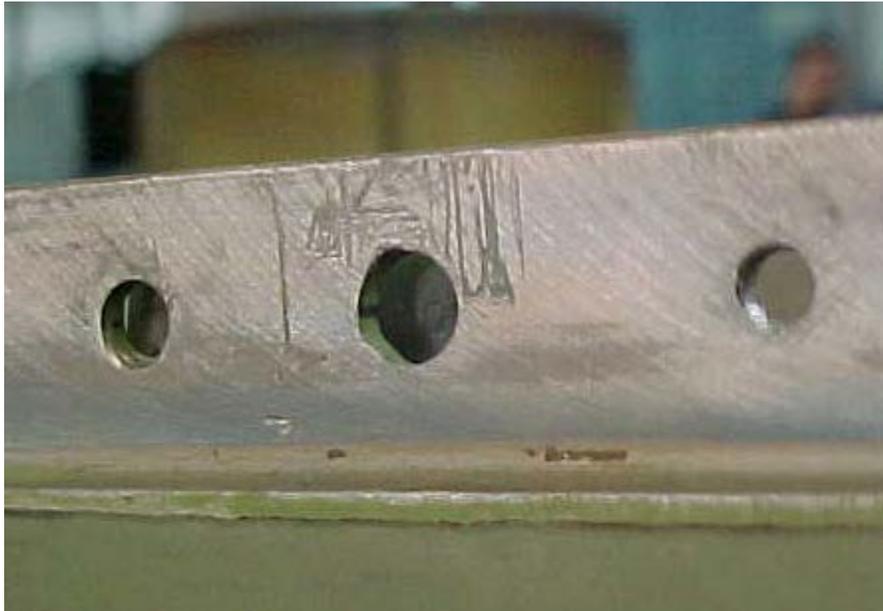
- c. Fastener scoring damage at attachment locations was extensive (figure 16).

Figure 16. Fastener Scoring Damage
