# The Response of Aircraft Oxygen Generators Exposed to Elevated Temperatures

April 2003

DOT/FAA/AR-TN03/35

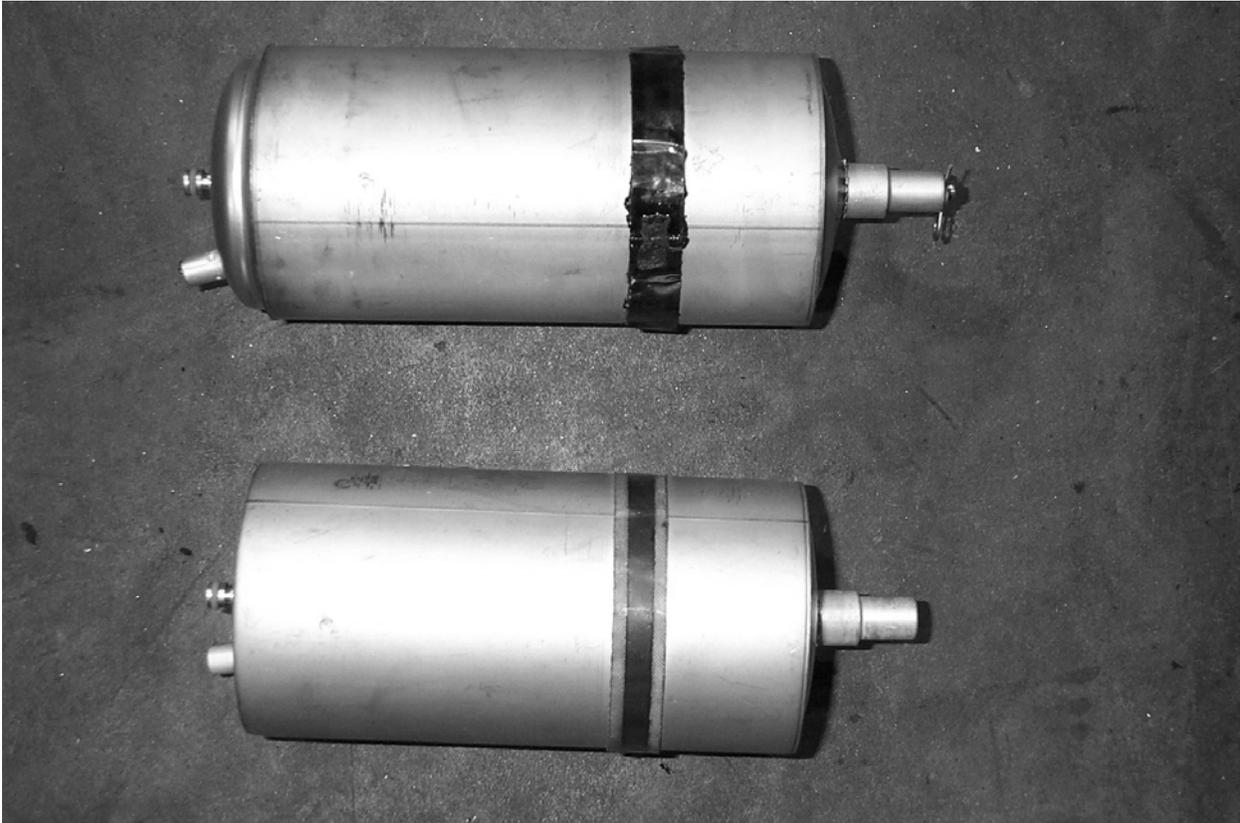
than could be discharged from the generator, and the outer case was significantly bulged outward due to internal pressure. Figure 2 shows the outwardly bulged generator from test 18 next to a normal generator. All of the generators that activated in the furnace were disassembled and the primer caps were examined. In all cases, the primer caps had activated. Table 1 summarizes the results of the testing.

FIGURE 2. OUTWARDLY BULGED GENERATOR (TOP) AND NORMAL GENERATOR (BOTTOM)

1. Exposure to furnace temperatures at or above 600°F was necessary to cause the self-activation of sodium chlorate oxygen generators.
2. Exposure to a furnace temperature of 500°F for 3 hours did not cause activation of the particular generator designs used in this test project.
3. Due to the uncertainty of the self-activation temperature of primer caps or electrically activated ignition squibs in other generator designs not tested in this project and the literature data stating that decomposition could occur as low as 482°F, it is recommended that generators not be exposed to ambient temperatures above 400°F.
