DOT/FAA/AR-99/8,IV

Improved Barriers to Turbine Engine Fragments: Interim Report IV

June 2002

Interim Report

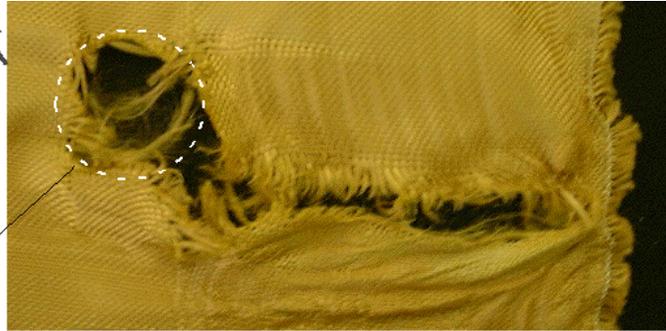
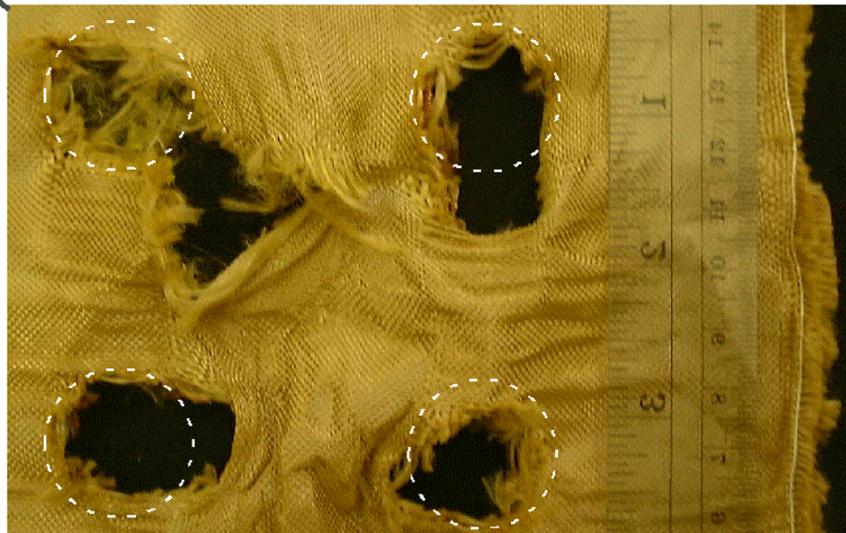
Closest Hole to Impact Region of a Doubled Pair

Second Hole of Pair (4 in. below Hole Shown) Exhibited Only Moderate Enlargement and No Tearing Towards Edge

Quadrupled Group of Holes

FIGURE 16. FABRIC DEFORMATION AND FAILURE AROUND PEGGED HOLES NEAR FABRIC BARRIER CORNERS THAT DID NOT COMPLETELY FAIL

The energy-absorbing mechanisms include fabric distortion, yarn stretching, yarn tensile failure, and yarn pullout (as shown in figure 16, for cases of significant fabric damage around holes but where the corners did not fail).
