DOT/FAA/AR-03/73

Engineering Studies of Cleaning and Drying Processes in Preparation for Fluorescent Penetrant Inspection

January 2004

Final Report

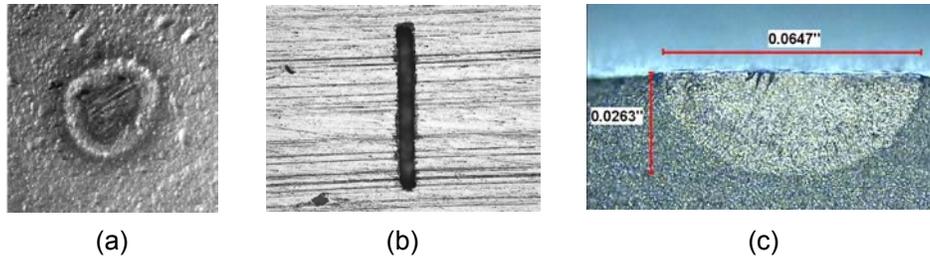
FIGURE 2. (a) TYPICAL SPOT WELD, (b) EDM NOTCH USED AS STRESS RISERS TO INITIATE CRACKING IN LCF SAMPLES, AND (c) TYPICAL CRACK ASPECT RATIO

One of the 1-inch wide areas was chosen for the fatigue crack, and a belt sander with 50-grit aluminum oxide sandpaper was used to remove the rough mill finish. Each sample was then sanded by hand using silicon dioxide abrasive paper to obtain a surface finish that made visually finding small fatigue cracks easier. A stress riser was introduced near the center of the sanded surface on each specimen so that a crack would initiate in a desired location. The stress risers were either small spot welds or electrodischarge-machined (EDM) notches with typical examples shown in figures 2(a) and 2(b) respectively. The spot weld diameters were approximately 0.125", and the EDM notches were approximately 0.050 inch long, 0.005 inch wide, and 0.002 inch deep. The sample with the stress riser was then placed into a three-point bending fixture on ISU's MTS machine, shown in figure 3, and cycled at approximately 80% of its yield strength. A load ratio of 0.1 was used during the LCF process, and yield strengths of 104 ksi for Ti and 120 ksi for Inconel were assumed. Sample width and thickness and the span between the bottom bending supports were used to determine the exact load settings required.

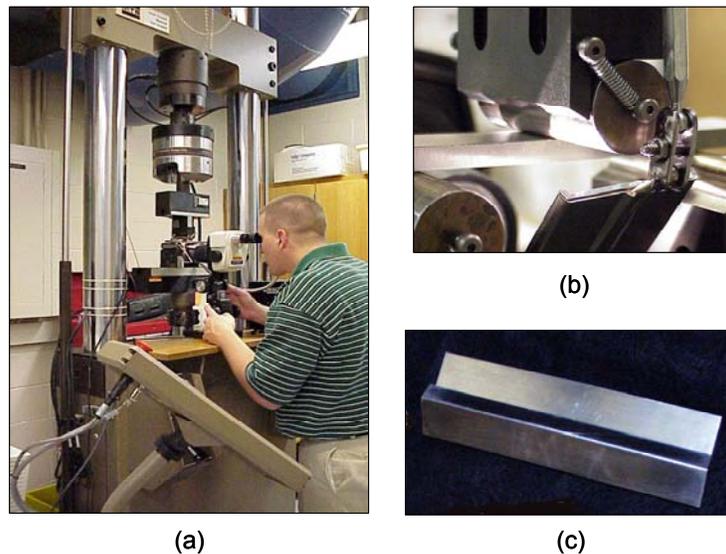
FIGURE 3. (a) FATIGUE TESTING MACHINE THAT INCLUDES THE ABILITY TO MAKE OPTICAL CHECKS ON CRACK GROWTH WITHOUT SAMPLE REMOVAL, (b) CLOSE-UP OF THE SAMPLE IN THE THREE-POINT BEND FIXTURE, AND (c) SAMPLE GEOMETRY

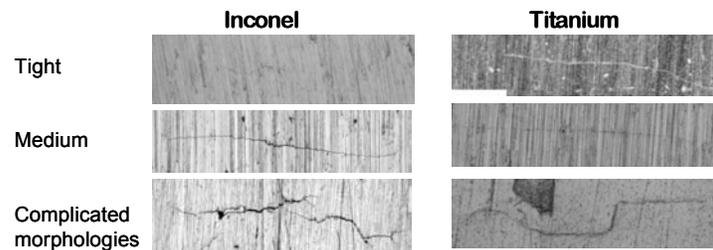
FIGURE 4. TYPICAL CRACK MORPHOLOGIES FOR IN-718 (LEFT) AND Ti-6Al-4V (RIGHT) SAMPLES (Crack morphologies could be categorized as tightly closed (shown at top), medium or somewhat open (shown in the middle), or of complicated morphology with visible surface branching and twisting.)

Digital optical photographs were recorded for each of the samples prior to the cleaning studies. Typical examples are shown in figure 4 for both Ti and Ni. Note that remnant surface sanding marks are also visible on some samples.

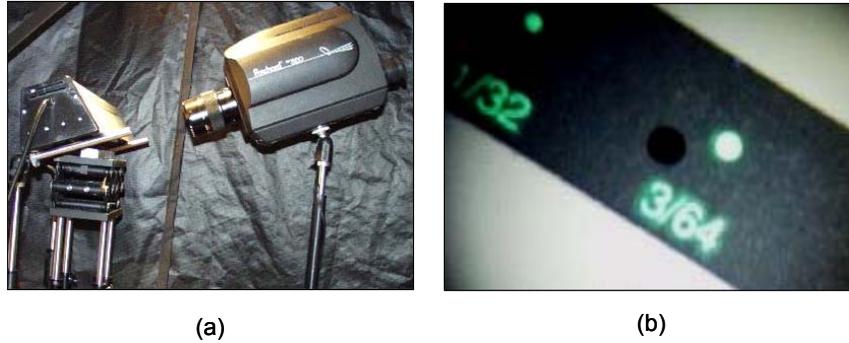
FIGURE 6. PHOTOMETER SETUP AND FLUORESCENT INTENSITY CARD
 (a) PHOTOMETER SETUP. PHOTOMETER IS SHOWN ON THE RIGHT WITH SAMPLE POSITIONING FIXTURE AND HIGH-INTENSITY BLACK LIGHT SHOWN ON THE LEFT. (b) FLUORESCENT INTENSITY CARD USED AS PART OF SETUP VERIFICATION. THE BLACK SPOT SHOWN IN THE IMAGE INDICATES THE FOCAL SPOT OVER WHICH THE BRIGHTNESS READING IS AVERAGED. NOTE COMPARISON TO THE 3/64" SPOT

background reading was made with the focal spot just to the side of the crack in a representative area. The corrected brightness was arrived at by subtracting the background from the brightness reading. All values of brightness used in the evaluation and in the plots shown in this report are of the corrected brightness and are reported in foot-Lamberts.

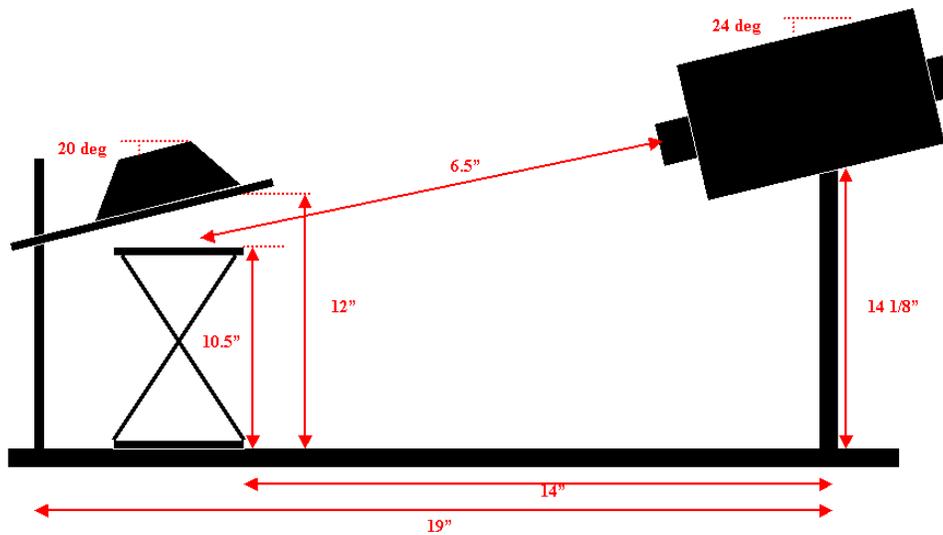
FIGURE 7. SCHEMATIC OF THE SPOTMETER AND SAMPLE POSITIONING SETUP
 (Diagram not to scale)

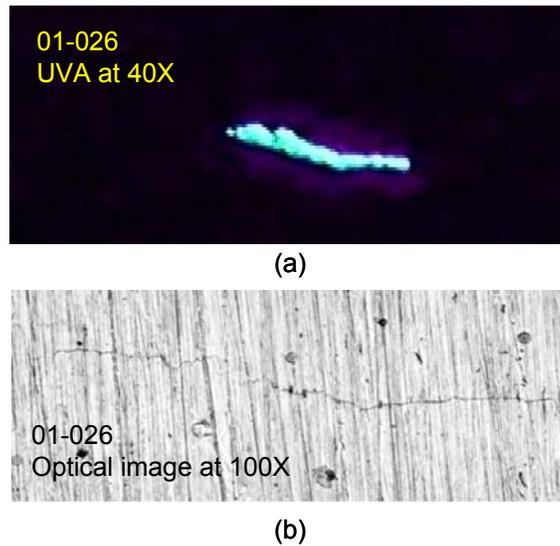
FIGURE 8. ULTRAVIOLET-A IMAGE OF CHARACTERIZATION FOR 0.055" LCF CRACK SAMPLE (a) UVA IMAGE OF CHARACTERIZATION RUN FOR SAMPLE 01-026 WHICH IS A 0.055" LCF CRACK IN Ni AND (b) OPTICAL IMAGE OF SAME CRACK TAKEN PRIOR TO ANY CLEANING STUDIES THAT WOULD IMPACT THE SURFACE OR CRACK CONDITION. THE ORIGINAL OPTICAL IMAGE WAS TAKEN AT 100X. BOTH UVA AND OPTICAL RESULTS ARE TYPICAL OF THE SAMPLE SET USED FOR THIS STUDY

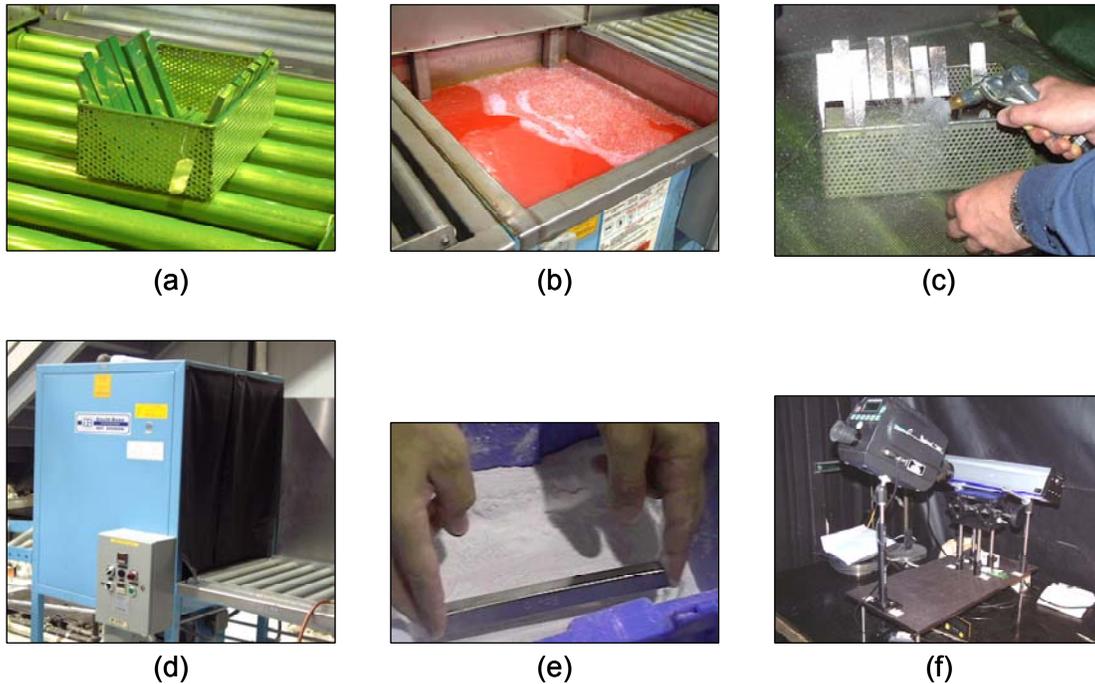
FIGURE 10. FLUORESCENT PENETRANT INSPECTION PROCESS (a) SAMPLE BATCH CONSISTING OF 20 SAMPLES IN A SINGLE BASKET FOR PROCESSING, (b) EMULSIFIER TANK USED FOR THE STUDY, (c) SAMPLES BEING RINSED AFTER EMULSIFICATION, (d) DRYER OVEN USED PRIOR TO DEVELOPER APPLICATION, (e) DRY DEVELOPER APPLIED TO SAMPLES INDIVIDUALLY, AND (f) SPOTMETER MEASUREMENT SETUP IN THE INSPECTION AREA

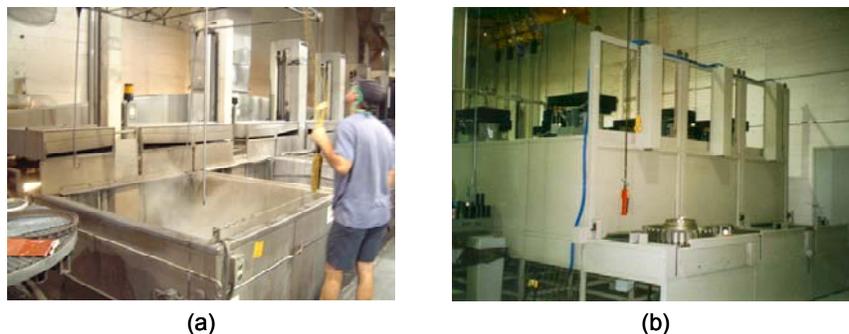
FIGURE 11. (a) HOT-WATER RINSE TANK USED TO FLASH-DRY PARTS AND (b) OVEN-DRY FACILITY, SHOWING THREE SEPARATE, INDEPENDENTLY CONTROLLED, AUTOMATED OVENS

The ETC team decided to use parameters from AMS 2647B [1]. The minimum flash-dry temperature of 150°F (65.5°C) and an oven-dry temperature of 225°F (107°C) were selected for this study. The lowest flash-dry temperature and the highest oven-dry temperature were selected, providing the largest parameter difference in the hope of revealing differences between the two methods. The Delta Air Lines facility was selected for these studies because they have part-drying ovens in the FPI area and flash-dry capabilities as part of their cleaning line. Figure 11(a) shows the hot-water rinse tank that is used for flash-drying parts at the Delta facility. For the duration of the flash-dry study, the flash-dry tank temperature was lowered to 150°F (65.5°C) from Delta's normal operating temperature of 185°F (85°C). Figure 11(b) shows the oven-drying facility, which includes three independently controlled ovens. One of the ovens was made available for the study and was set at 225°F (107°C) throughout the three studies. Samples are placed at the entry point of the oven and automatically pulled into the furnace through a conveyor belt. They are cycled through the full length of the furnace over a 30-minute duration and exit the furnace at the point shown in figure 11(b).

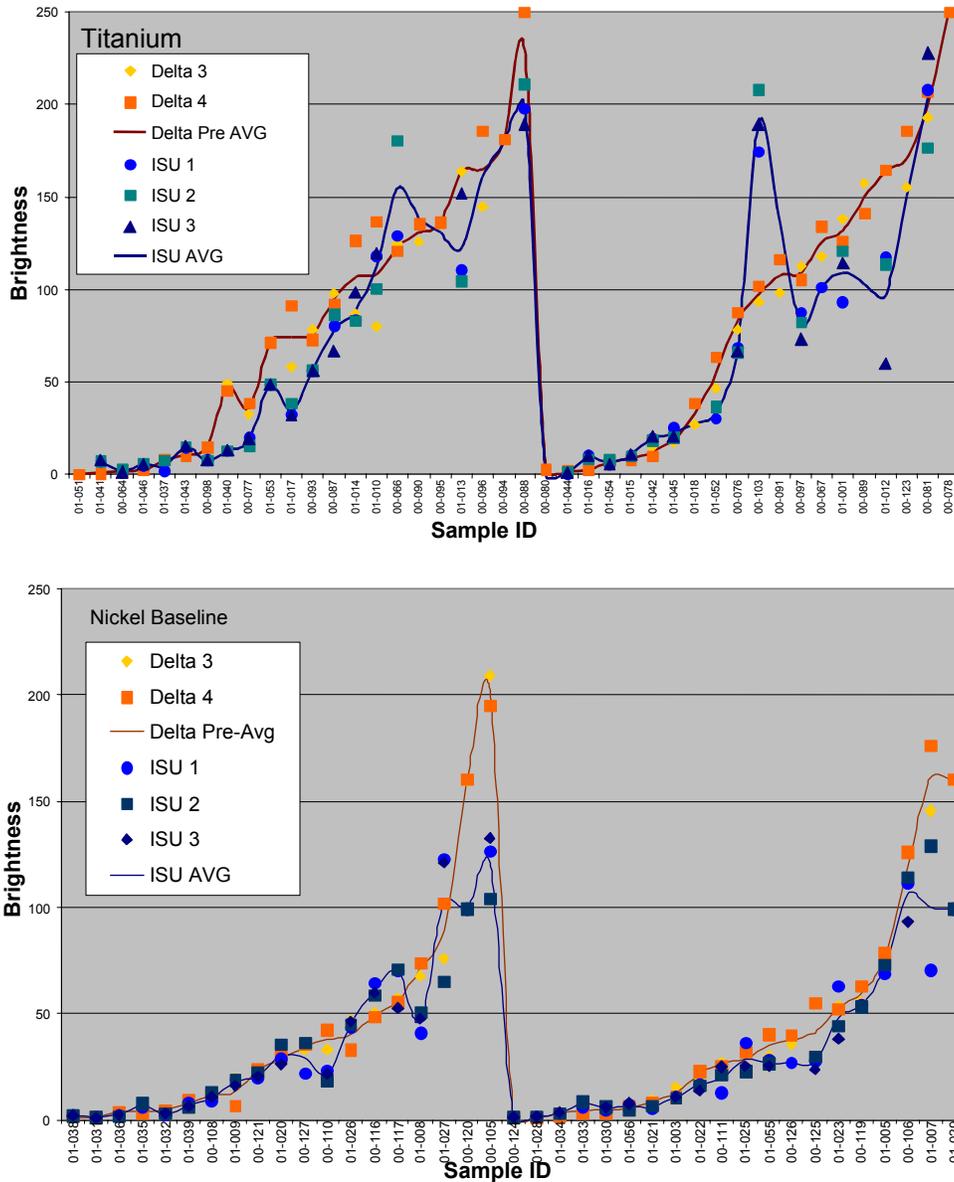
FIGURE 13. COMPARISON OF ISU CHARACTERIZATION DATA SHOWN IN BLUE AND DELTA BASELINE SHOWN IN ORANGE (The points represent brightness values for the individual runs and the lines are the average at each of the locations. Data is shown for Ti (above) and Ni (below).)

Based on the brightness values, the 40 Ti and 40 Ni samples were both subdivided into two separate sets of 20 samples each and results are plotted in figure 13 for each of the sets. This was done to accommodate the processing constraints, i.e., not exceeding recommended developer dwell time before analysis, limited an individual run to 20 samples. The data shown in figure 13 has been sorted to show the two separate sample sets for each material. Note that there was somewhat more variability with the Ti samples than the Ni. This has been attributed to the surface finish differences that led to some bleedout on the Ti samples, which was not observed with the Ni samples.

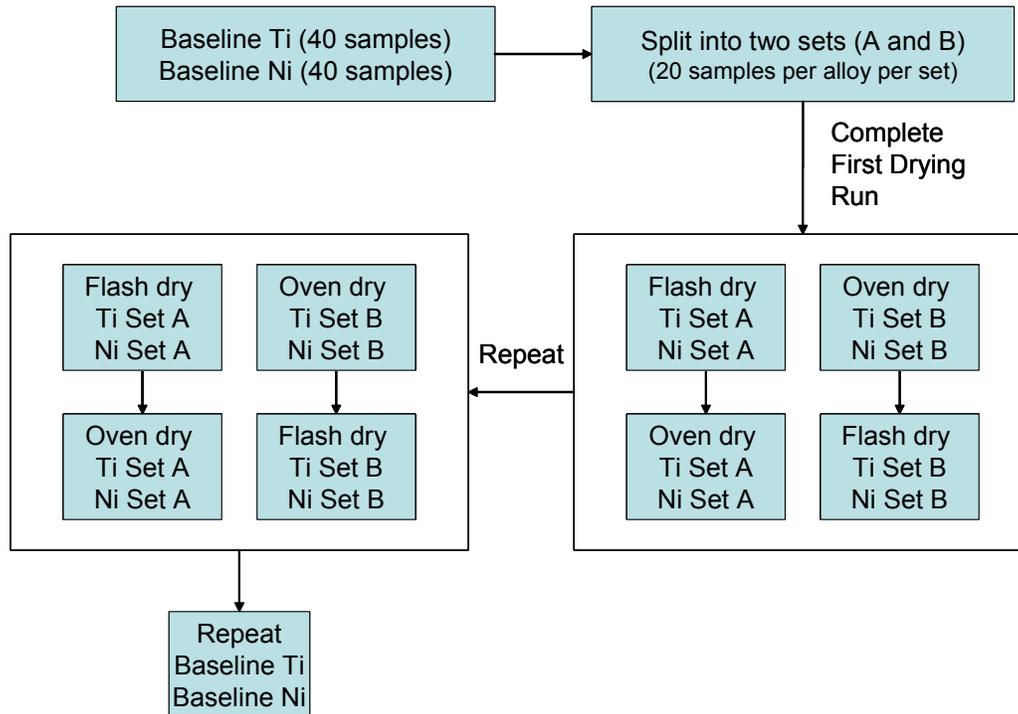
FIGURE 14. FLOWCHART OF THE EXPERIMENTAL STEPS USED IN THE DRYING STUDY

made so that two data points were generated for every sample for both drying methods. The final step was to repeat the baseline run twice for comparison to the original baseline.

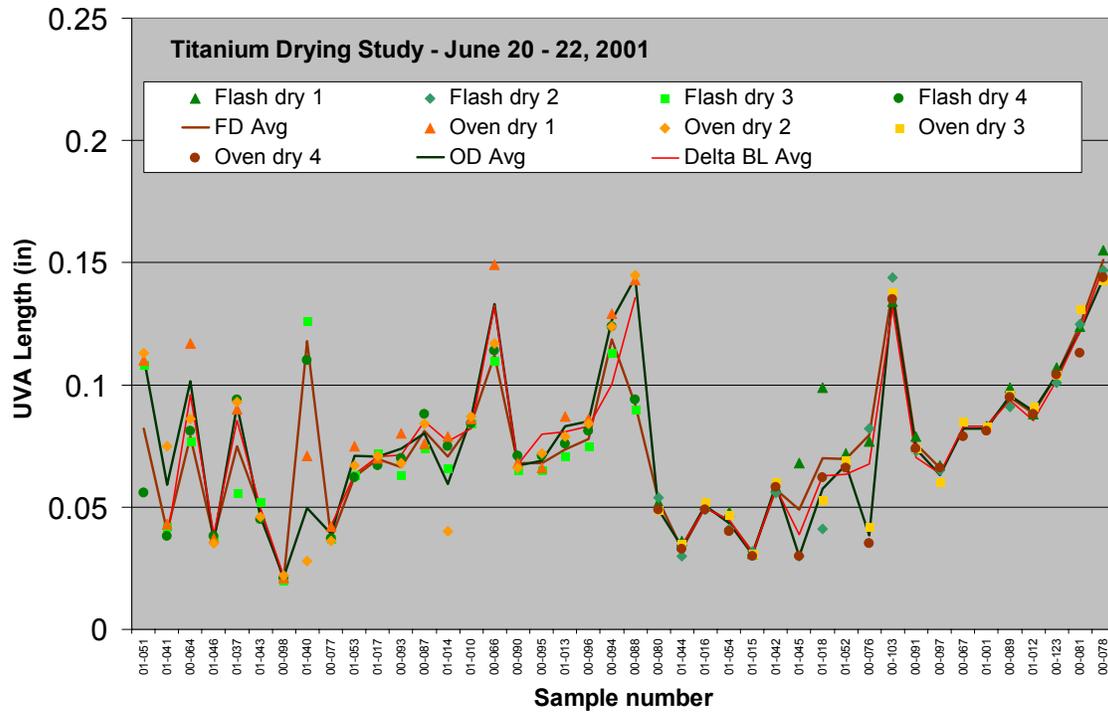
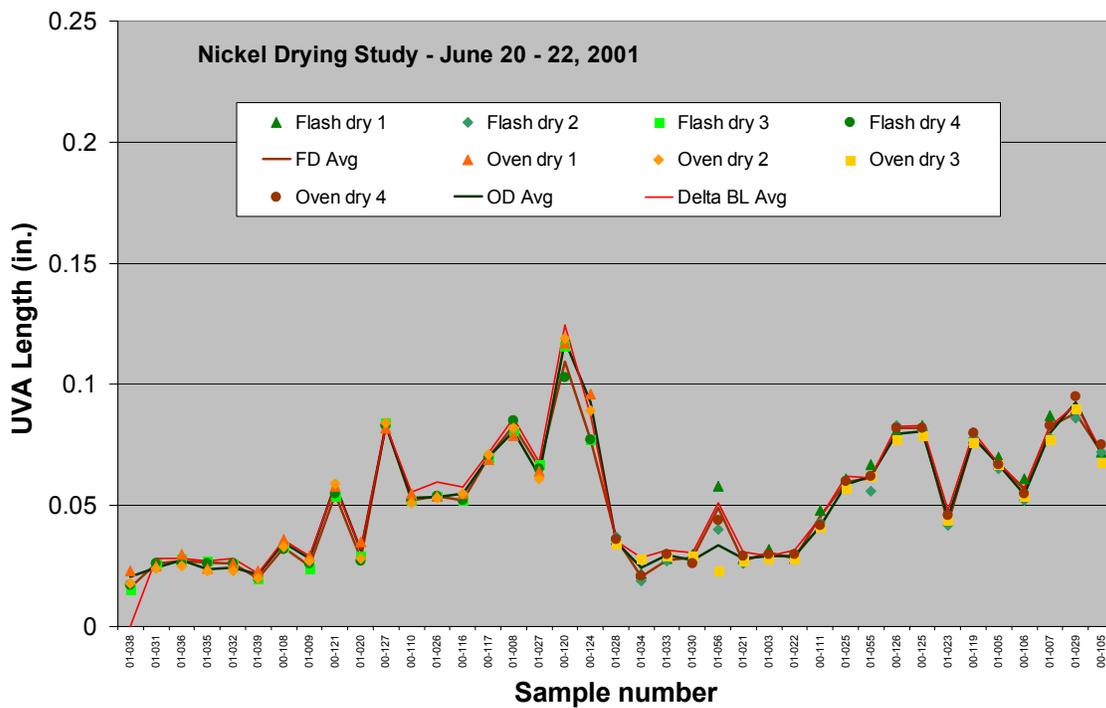
FIGURE 16. ULTRAVIOLET-A LENGTH RESULTS FOR Ti AND Ni (Flash-dry points are shown in green and oven-dry points are shown in orange. Note that two flash-dry runs and two oven-dry runs were completed for each sample. The average of the baseline results are shown by the solid red line.)

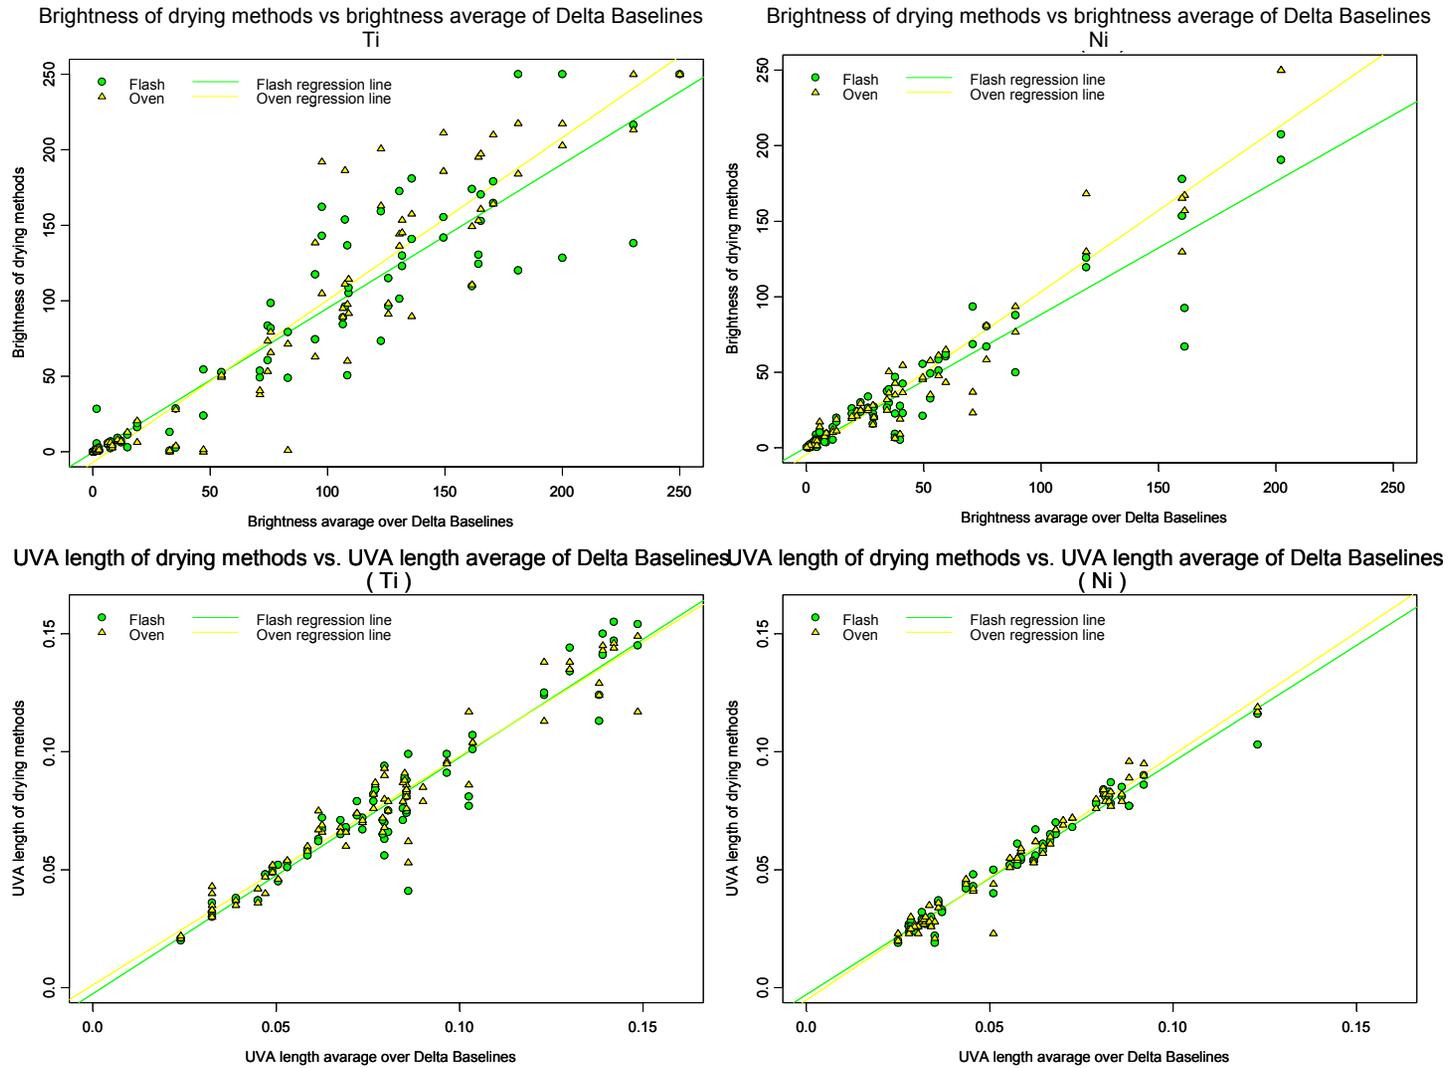
FIGURE 17. BRIGHTNESS (TOP) AND UVA LENGTH (BOTTOM) PLOTTED AGAINST AVERAGE VALUES FOR Ti (LEFT) AND Ni (RIGHT) ALLOYS USING FLASH- AND OVEN-DRY METHODS

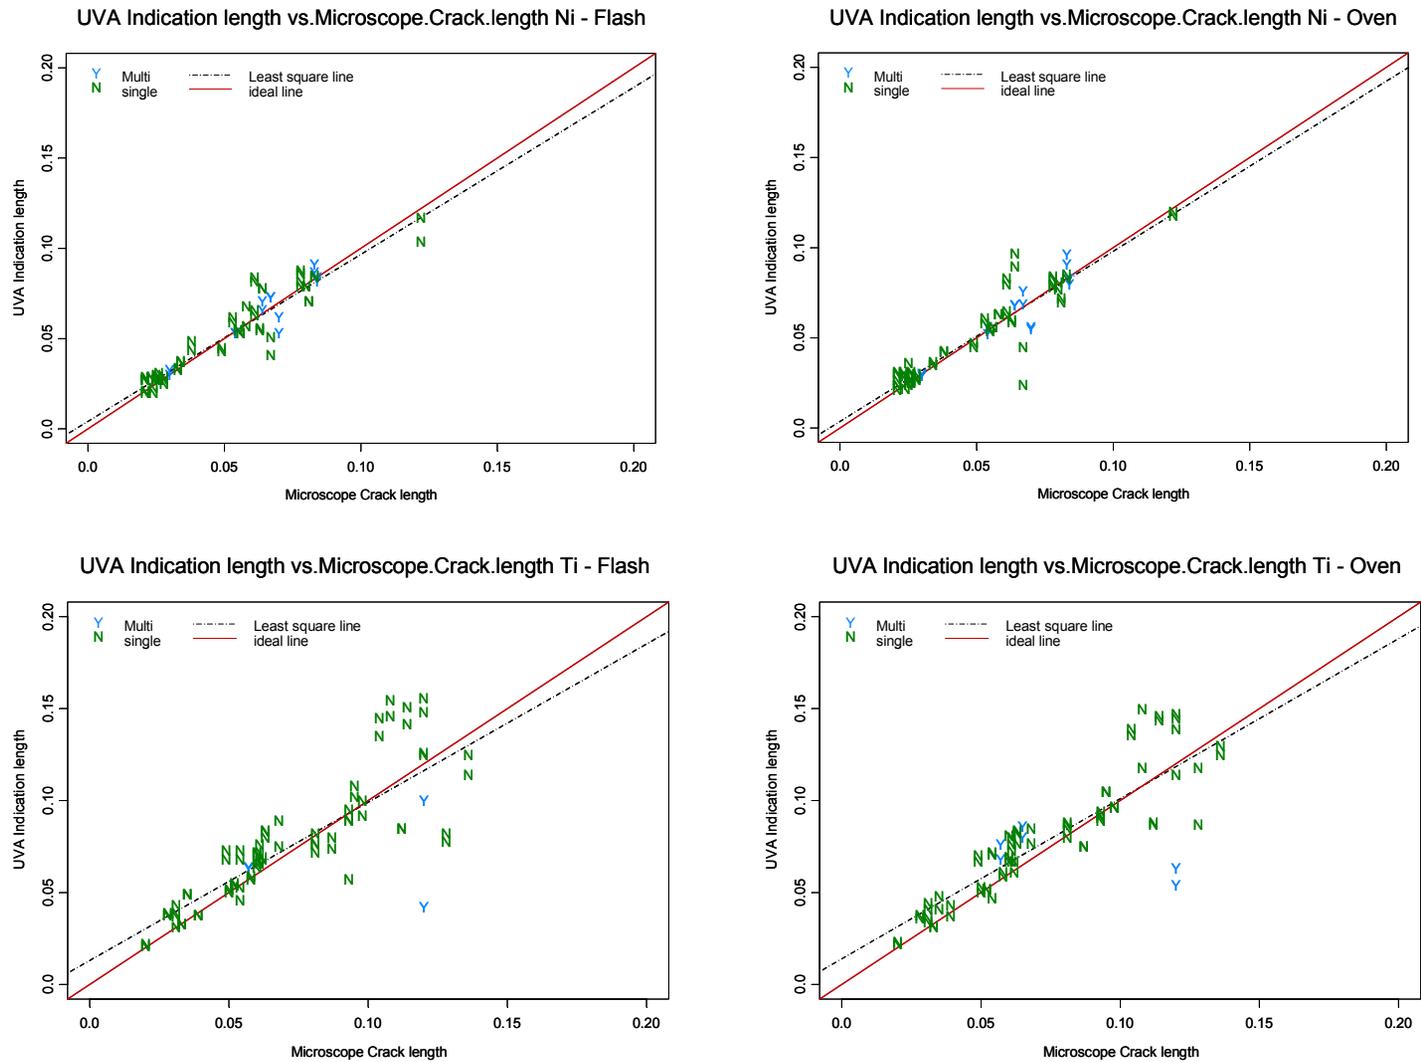
FIGURE 18. RESULTS OF STATISTICAL ANALYSIS (UVA lengths were compared to the optical lengths for each sample type and drying method.)

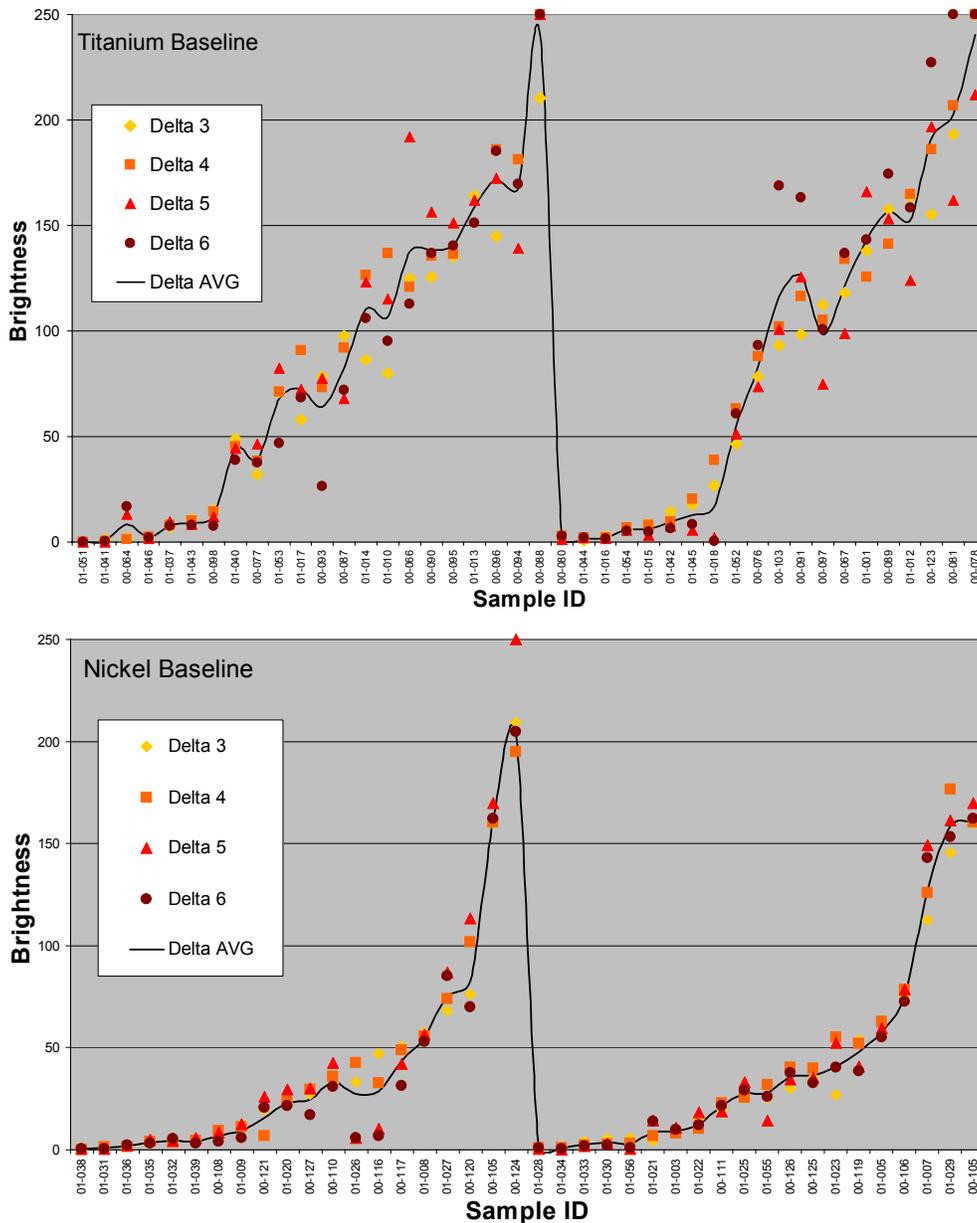
FIGURE 19. PREBASELINE (RUNS 3 AND 4) AND POSTBASELINE (RUNS 5 AND 6) COMPARISON OF BRIGHTNESS RESULTS FOR Ti AND Ni

The final step of the drying study in June 2001 was to repeat the original baseline measurements. This was done to ensure that the samples had not changed over the course of the week-long study, i.e., the cracks did not become contaminated through their use in evaluating the drying parameters. In general, the brightness values were consistent, with the Ti samples showing somewhat more variability than the Ni. The results are shown in figure 19. After completion of the study, the samples were shipped back to ISU for thorough UT cleaning in acetone prior to continuation of the program.

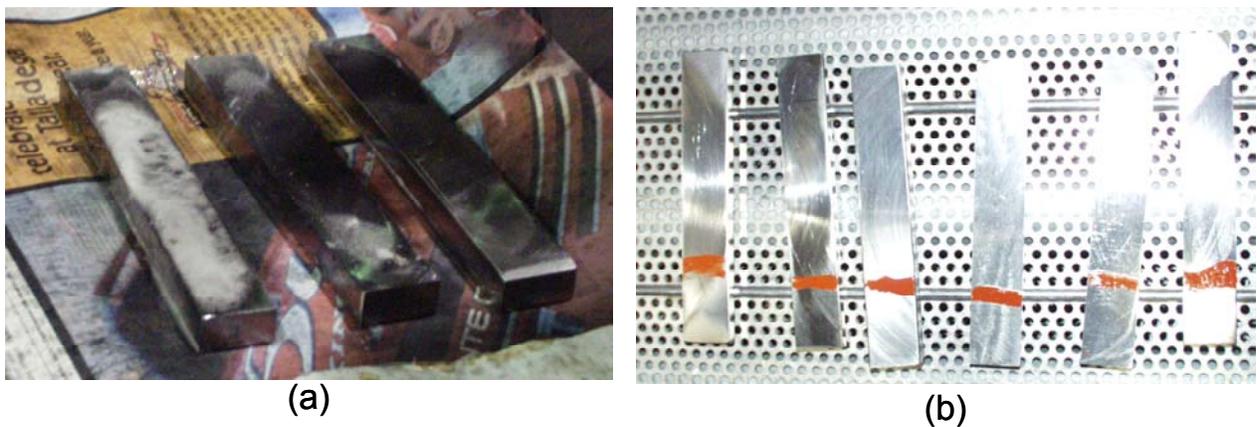
FIGURE 20. (a) PENETRATING OIL APPLIED DIRECTLY OVER CRACKS AND (b) RTV APPLIED TO ONE SIDE OF THE CRACKS

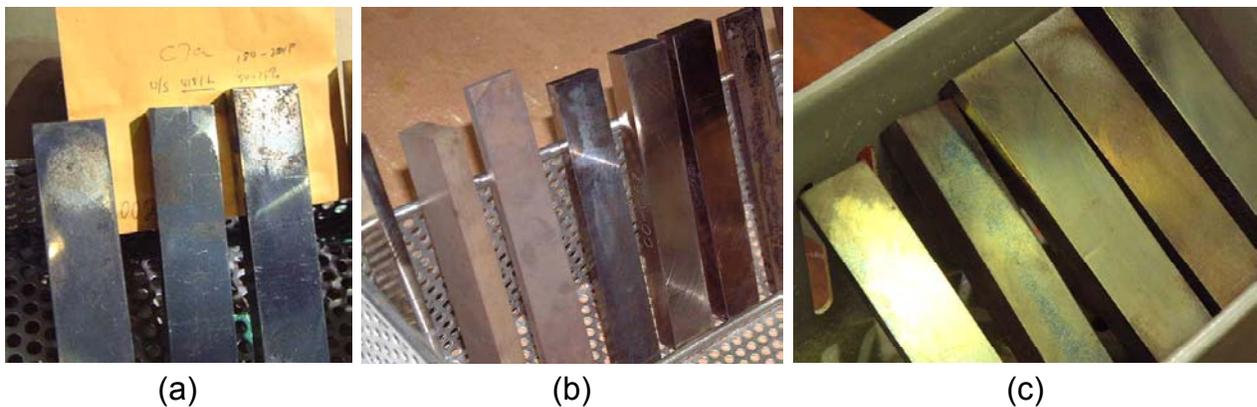
FIGURE 21. (a) OXIDATION AND SCALE, (b) SOOT, AND (c) VARNISH

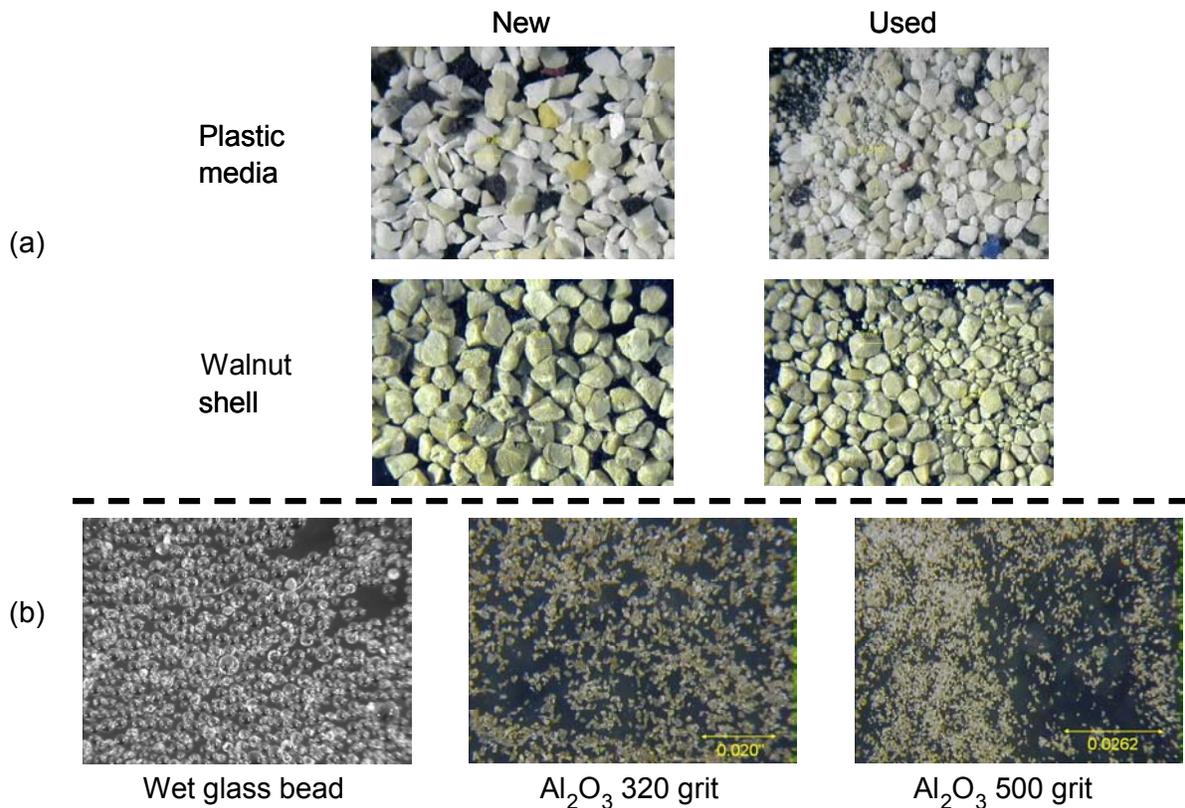
FIGURE 22. VARIOUS MEDIA USED DURING THE STUDY (a) AS-RECEIVED AND USED MEDIA FOR PLASTIC MEDIA AND WALNUT SHELLS AND (b) AS-RECEIVED MEDIA FOR WET GLASS BEAD AND TWO Al_2O_3 GRIT SIZES

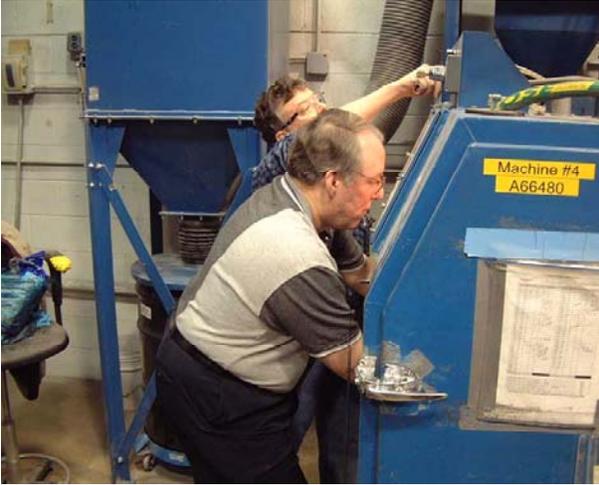
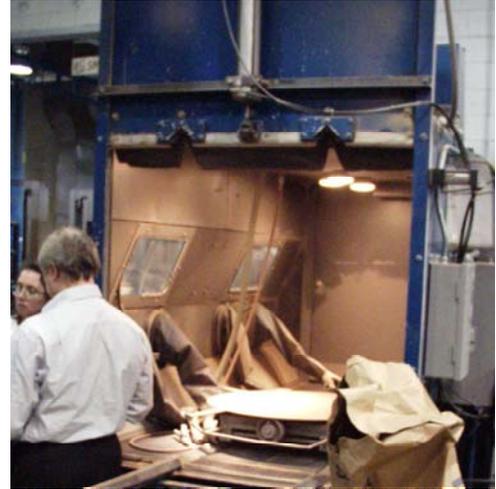
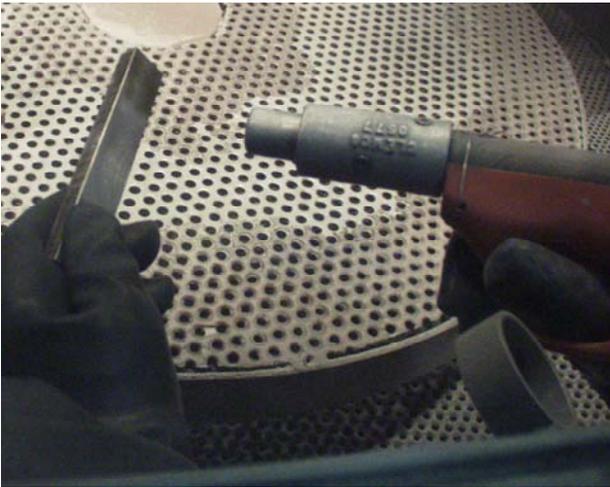
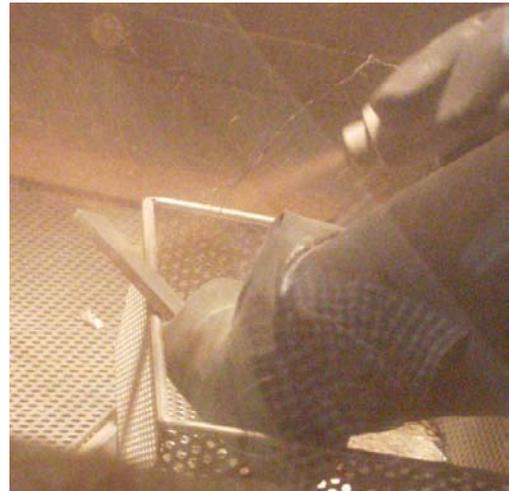
FIGURE 23. (a) PRESSURE CABINET USED FOR PLASTIC MEDIA BLASTING, (b) INTERIOR VIEW OF THE PRESSURE CABINET USED FOR WALNUT SHELL BLASTING, (c) SAMPLE AND MEDIA GUN SHOWN PRIOR TO MEDIA BLASTING, AND (d) VIEW OF THE CLEANING PROCESS WITH MEDIA SHOWN BEING APPLIED TO THE SAMPLE

used in the wet glass bead process and two grit sizes of Al_2O_3 . With the exception of the wet glass bead process, all mechanical blasting processes were performed in the cleaning shop at Delta Air Lines in Atlanta. Wet glass bead processes were not available at Delta so arrangements were made with Northwest Airlines to use their facilities, also located in Atlanta. Figure 23(a) shows the pressure cabinet used for plastic media blasting. In the study performed at the Delta facility, adjustments to the pressure were made using the dial gauges on the cabinet. Two different pressures were evaluated: 40 psi, which is the recommended pressure in OEM standard practices manuals for pressure-type cabinets, and 80 psi. Figure 23(b) shows the interior of the pressure cabinet used for walnut shell blasting, and figures 23(c) and 23(d) provide a closer view of the sample before and during the cleaning process. The sample is held in one hand and the media gun is held in the other. The media is applied with a sweeping motion for the time durations shown in table 11 for each of the media types. A distance of 3 to 4 inches (76 to 102 mm) was used for the nozzle-to-part distance and a 45 to 60 degree angle was maintained to the work surface. The sweeping motion was perpendicular to the crack direction.

Plastic media blast (PMB (B1)) (Plasti-Grit (60-120 mil)) is used to remove detrimental surface conditions or coatings that could affect the sensitivity of FPI. The media is applied using the equipment shown in figure 23. For this study, a pressure cabinet was used. A comparison was made of the recommended pressures of 40 psi, as read at the cabinet gage, and at 80 psi. The angle, which is also an important variable, was held constant in all PMB studies performed as part of this program. The results are shown in tables 26 and 27 respectively. As indicated earlier, several types of coatings, including RTV, were applied to the side of the crack. Media application time was established on one sample and maintained as a constant throughout the study. For plastic media, that time was standardized at 30 sec. for removing coatings and baked-on contaminants.

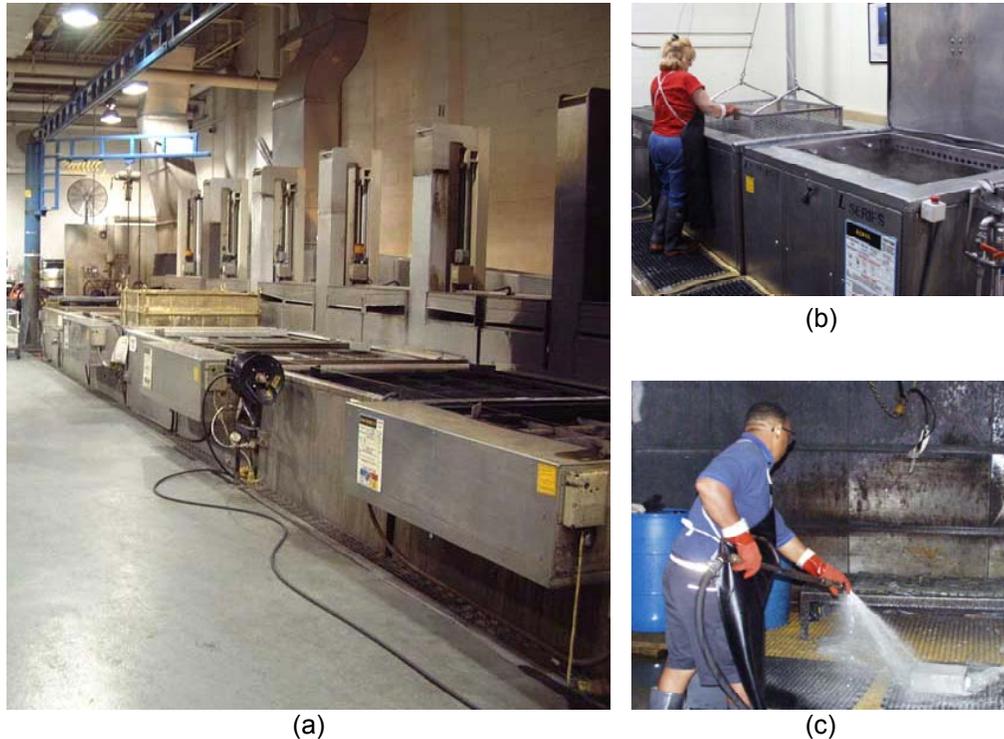
FIGURE 24. (a) CLEANING LINE, (b) ULTRASONIC-ASSISTED CLEANING PROCESSES, AND (c) SPRAY CLEANING REMOVAL OF ALKALINE GEL

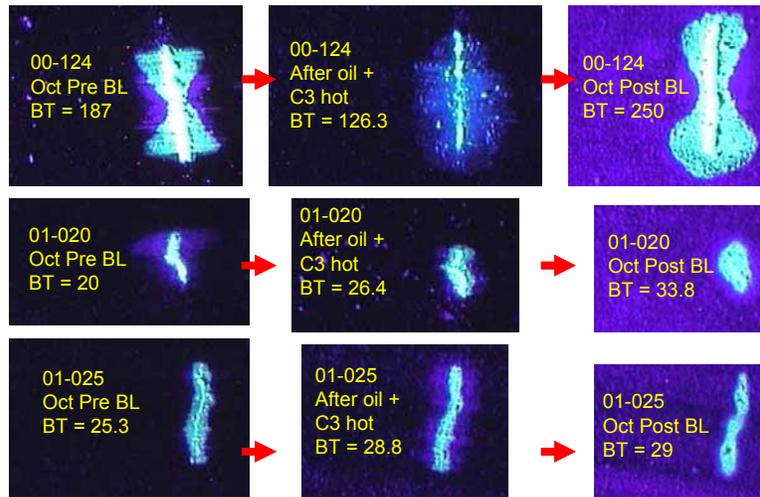
FIGURE 32. COMPARISON OF UVA IMAGES OF OIL-CONTAMINATED Ni SAMPLES CLEANED WITH C3 FOLLOWED BY A HOT-WATER RINSE (Images for three samples are shown, including a prebaseline image in the left column, an image of the cleaned sample in the center, and a postbaseline image in the right column.)

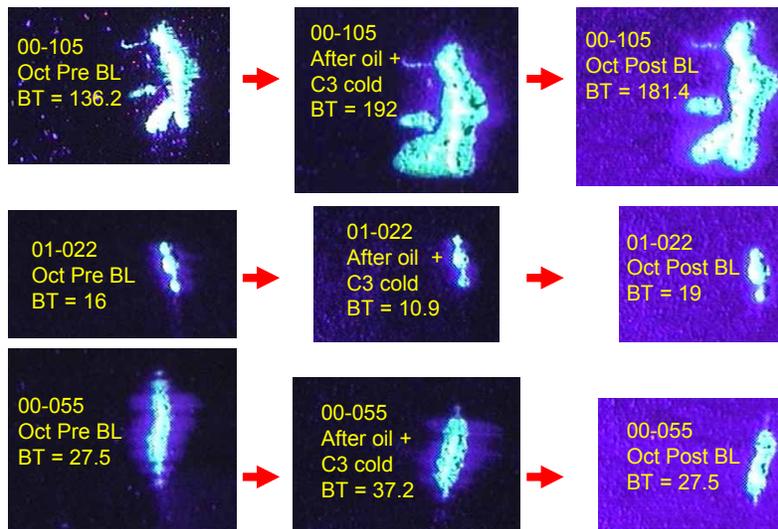
FIGURE 33. COMPARISON OF UVA IMAGES OF OIL-CONTAMINATED Ni SAMPLES CLEANED WITH C3 FOLLOWED BY A COLD-WATER RINSE (Images for three samples are shown, including a prebaseline image in the left column, an image of the cleaned sample in the center, and a postbaseline image in the right column.)

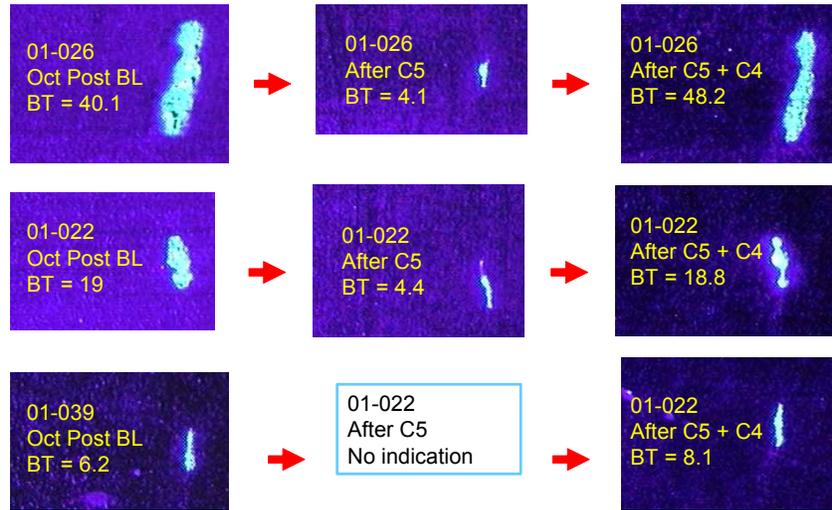
FIGURE 35. ULTRAVIOLET-A IMAGES OF COKE AND VARNISH Ni SAMPLES (The left column shows baseline images for three samples prior to the coke and varnish process. Results for the C5 process are shown in the center. Note the marked improvement after using the C4 process shown in the images on the right.)

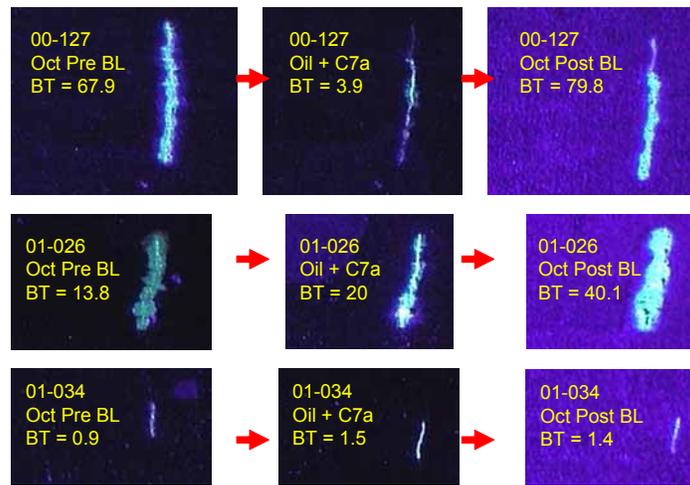
FIGURE 37. ULTRAVIOLET-A IMAGES OF SAMPLES CONTAMINATED WITH PENETRATING OIL (The outer columns show the pre- and postbaseline results respectively. The center column shows the results after applying the penetrating oil and subsequent removal with C7a.)

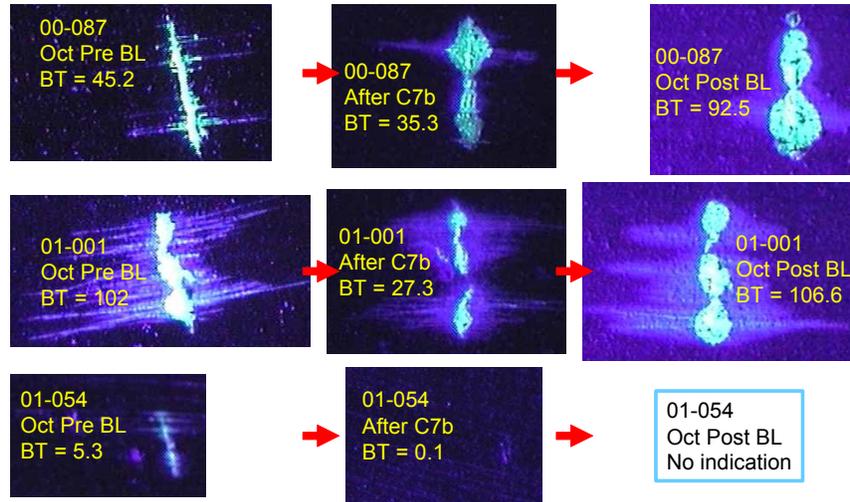
FIGURE 38. ULTRAVIOLET-A IMAGES OF SAMPLES WITH AN APPLICATION OF ANTIGALLANT COMPOUND TO Ti SAMPLES (The outer columns show the pre- and postbaseline results respectively. The center column shows the results after application of antigallant compound and subsequent removal with C7b.)

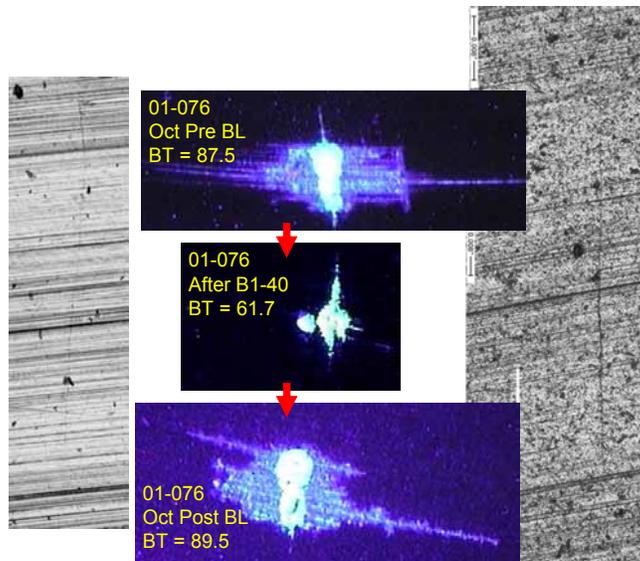
FIGURE 39. RESULTS FOR THE 01-076 Ti SAMPLE (The optical image for the pristine crack is shown at the left and the final surface condition after PMB is shown to the right. UVA images for prebaseline, after PMB and postbaseline are also shown.)

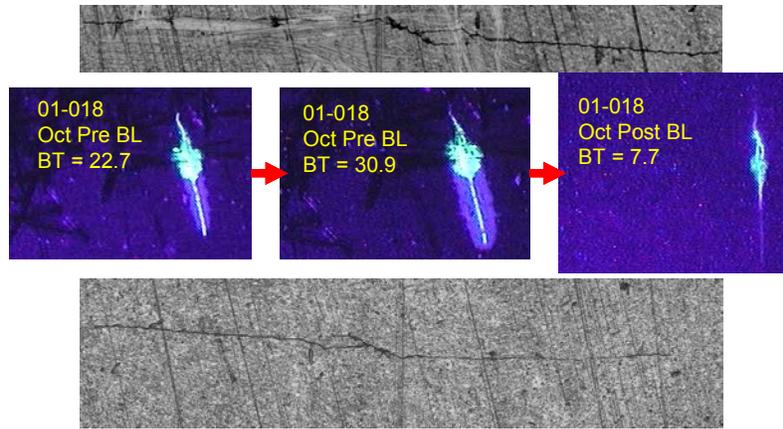
FIGURE 40. RESULTS FOR THE 01-018 Ti SAMPLE (Note that UVA indication was not available for the B1-80 treatment until after subsequent processing with acetone, as shown in the October postbaseline image.)

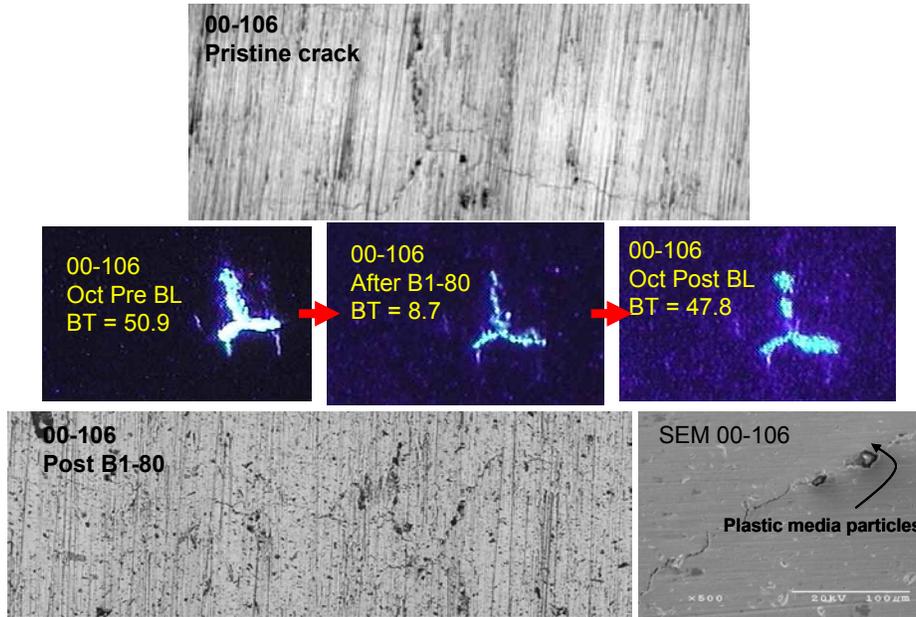
FIGURE 42. RESULTS FOR THE 00-106 Ni SAMPLE, PROCESSED WITH PMB AT 80 psi (Note the plastic media particles visible with SEM.)

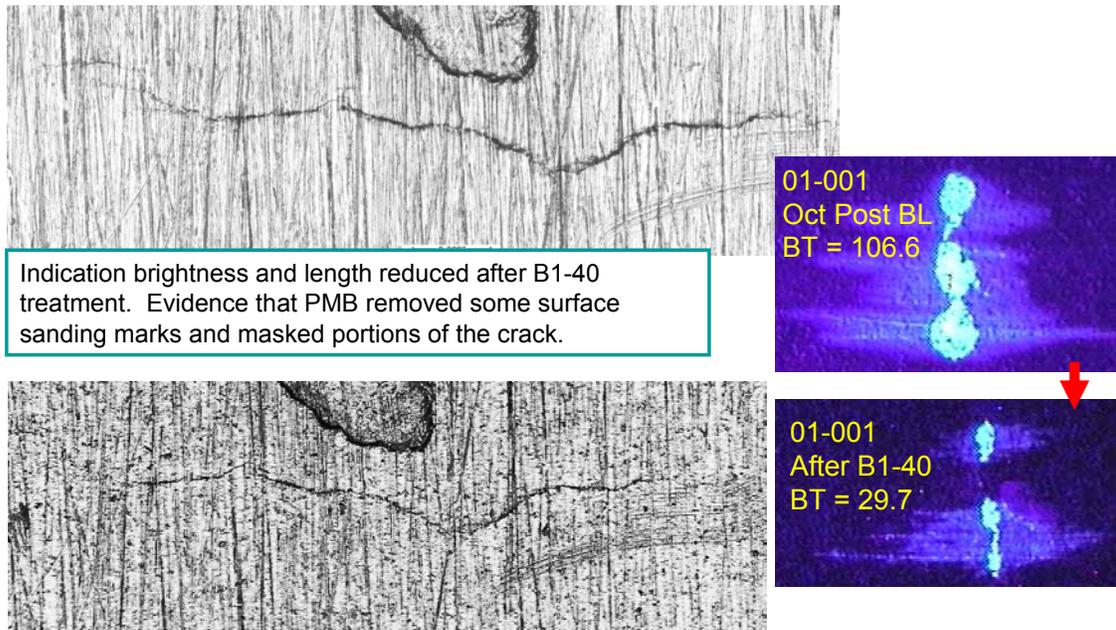
FIGURE 44. RESULTS FOR THE 01-001 Ti SAMPLE (The top image shows the surface condition prior to PMB and the lower image shows the surface condition after soot and PMB. The UVA images are also provided. Note the discontinuous nature of the UVA indication after the PMB treatment.)

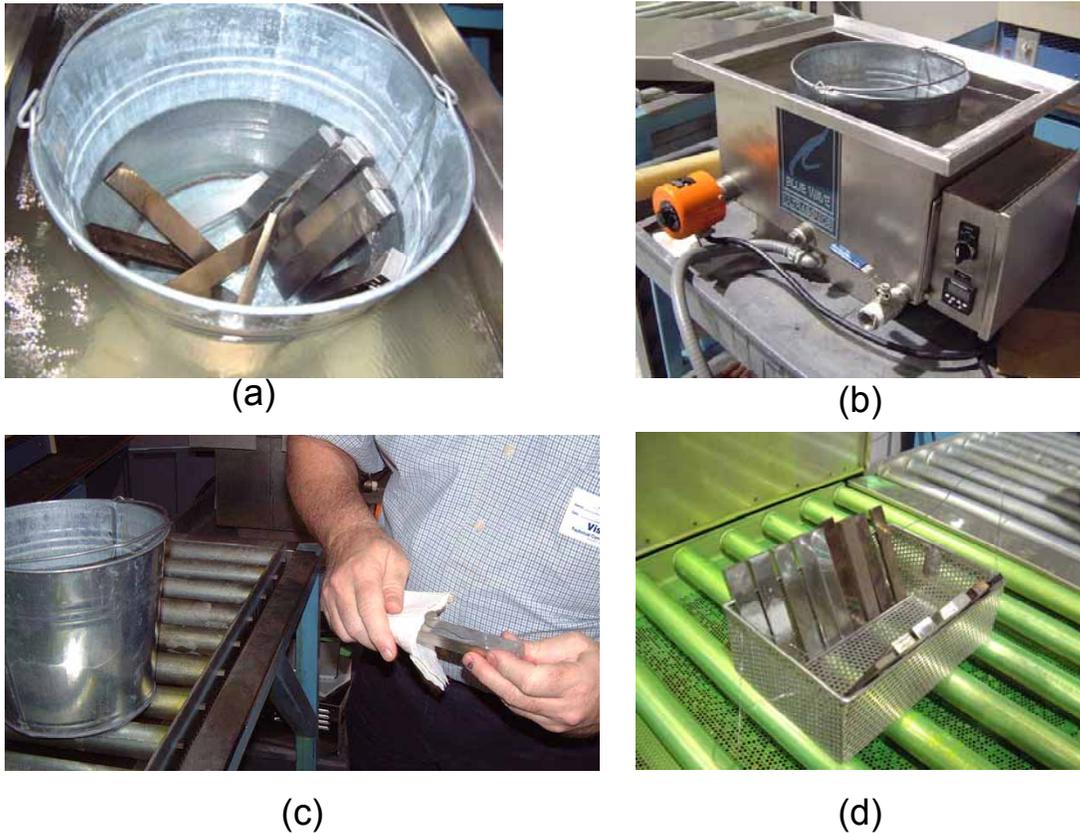
FIGURE 63. PROCEDURE FOR WATER CONTAMINATION TEST (a) SAMPLES IN 70° WATER, (b) SAMPLES IN ULTRASONIC CLEANER, (c) EXCESS WATER IS BLOTTED FROM THE SURFACE, AND (d) SAMPLES READY FOR FPI
