DOT/FAA/AR-03/73

Engineering Studies of Cleaning and Drying Processes in Preparation for Fluorescent Penetrant Inspection

January 2004

Final Report

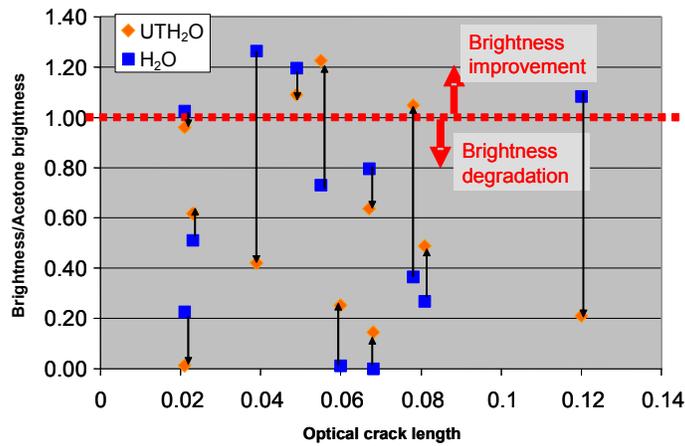
FIGURE 64. COMPARISON OF BRIGHTNESS AFTER WATER CONTAMINATION TO BASELINE AS A FUNCTION OF THE OPTICAL CRACK LENGTH

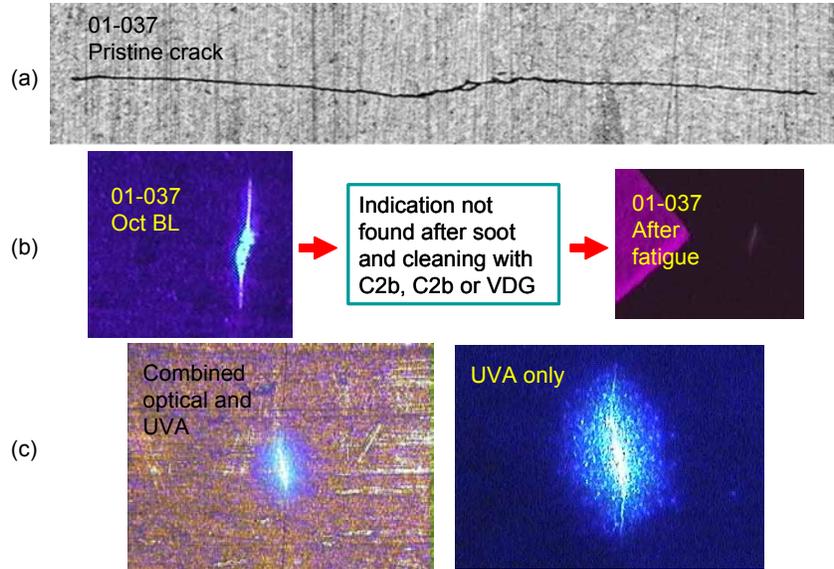
FIGURE 67. TRANSITION OF AN OPTICAL IMAGE TO A UVA IMAGE FOR THE 01-037 Ti SAMPLE (a) OPTICAL IMAGE OF A CRACK PRIOR TO STUDIES, (b) COMPARISON OF UVA IMAGE FROM OCTOBER BASELINE AND AFTER FATIGUE. NOTE THAT NO INDICATION WAS VISIBLE AFTER SOOT AND CLEANING, AND (c) COMBINED OPTICAL AND UVA IMAGE AND UVA-ONLY IMAGE

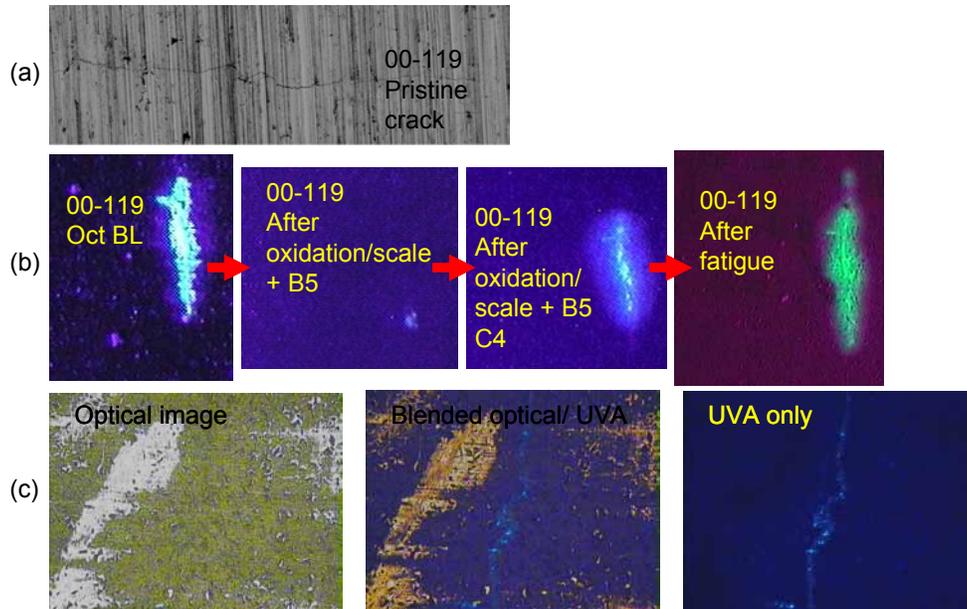
FIGURE 68. TRANSITION OF AN OPTICAL IMAGE TO A UVA IMAGE FOR THE 00-119 Ni SAMPLE (a) OPTICAL IMAGE OF A CRACK PRIOR TO STUDIES; (b) COMPARISON OF UVA IMAGE FROM OCTOBER BASELINE, FEBRUARY CLEANING STEPS, AND AFTER FATIGUE; AND (c) COMBINED OPTICAL AND UVA IMAGE AND UVA-ONLY IMAGE

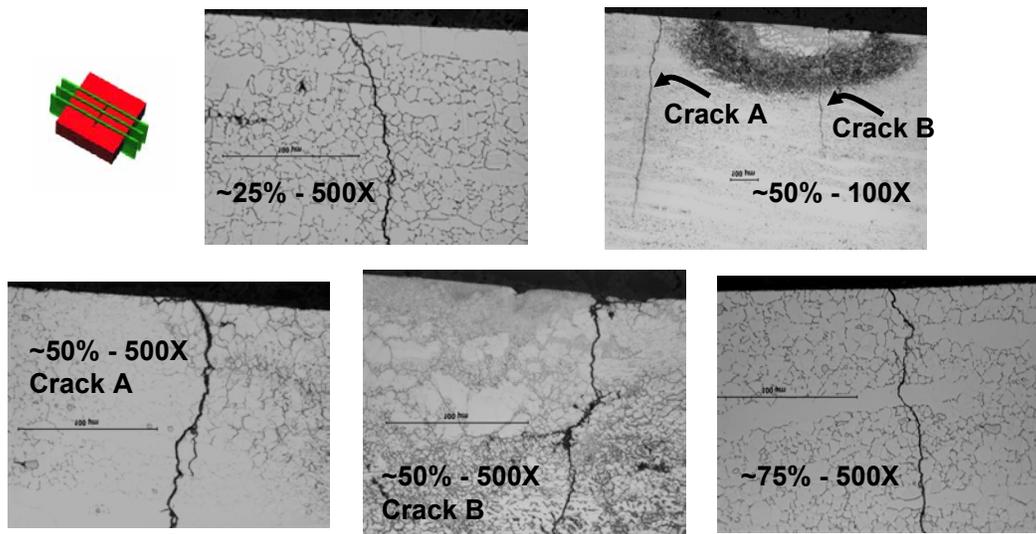
FIGURE 71. TRANSVERSE SECTIONING RESULTS FOR THE 01-110 Ni SAMPLE (Note that the crack showed branching at the 50% section. Higher magnification is shown of the two branches.)

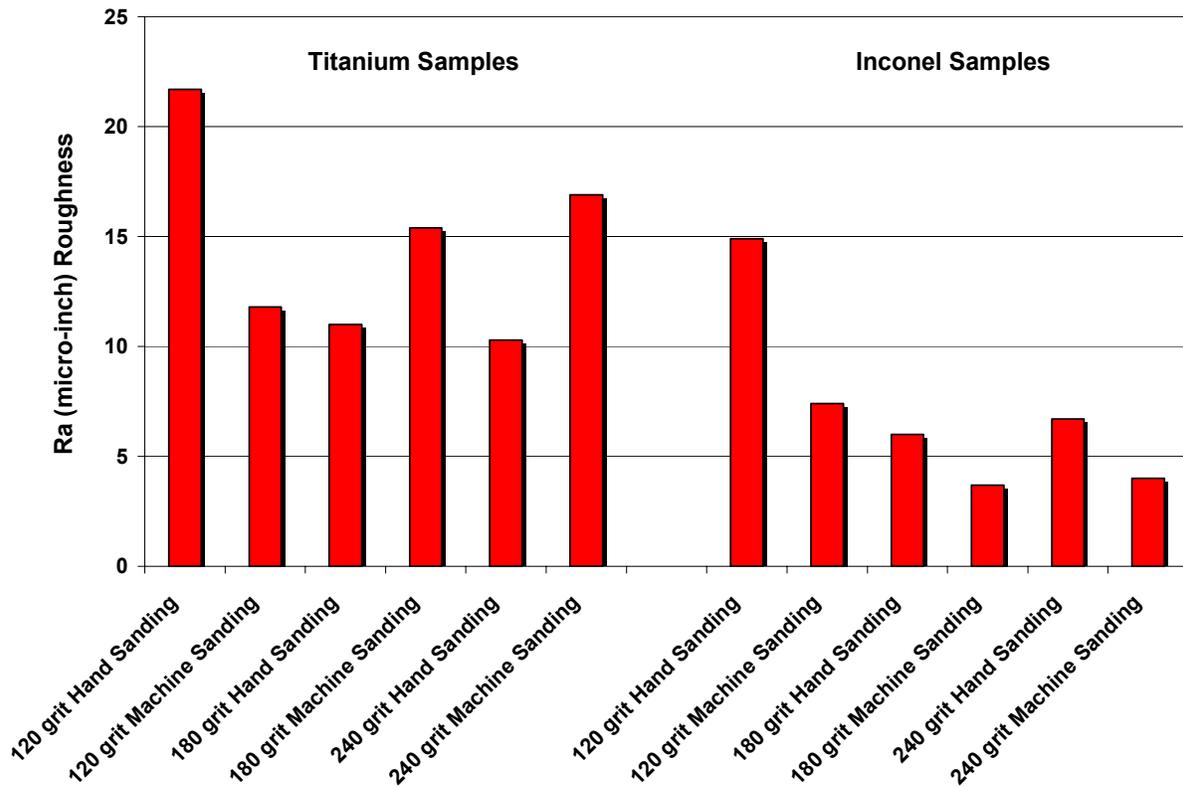
FIGURE 77. SURFACE ROUGHNESS DATA SHOWING THE EFFECT OF SANDING METHODS

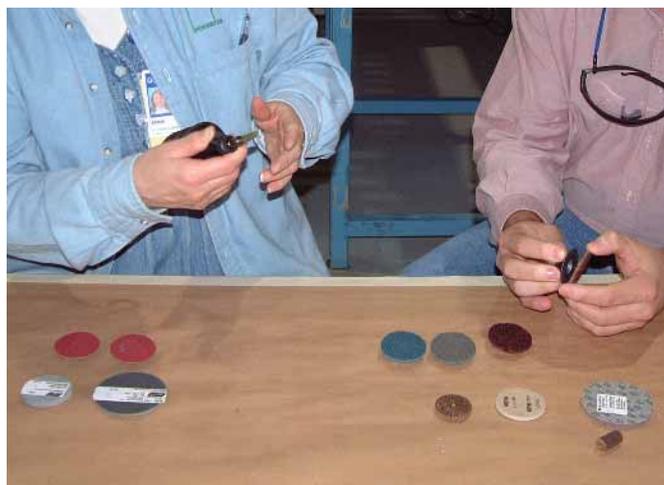
FIGURE 80. A VARIETY OF BLENDING MEDIA USED TO REMOVE STRESS CONCENTRATION

Current OEM standard practices define the approved tooling and blending operations used to remove stress concentrations caused by nicks, dents, and scratches to provide a surface favorable to FPI. These operations used manual or power tool techniques using media ranging from coarse-grade abrasives and files to fine-grade abrasives and crocus cloths to obtain a surface finish as similar to the original finish as possible. For this study, the blending of samples would be conducted using a power tool (electric or air) with abrasive-impregnated wheels, stones, or pads, which are commonly used in the aviation industry. Available blending media included Cratex abrasive-impregnated rubber points, Norton Al₂O₃, SiC wheels available in a typical Dremel tool kit, to a wide variety of media currently used at the Delta facility. The coarsest available abrasive media was 80 grit. Figure 80 shows a variety of blending media used to smear metal over the fatigue crack samples.

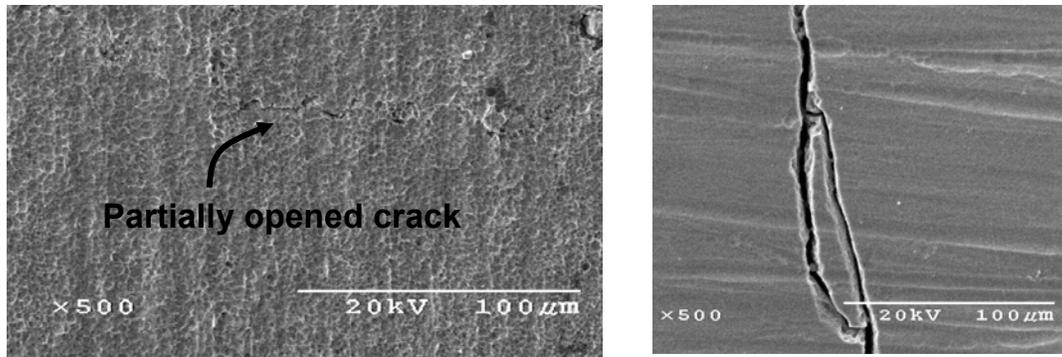
FIGURE 81. SURFACES OF INCONEL (LEFT) AND Ti (RIGHT) SAMPLES AFTER BLENDING AND SUBSEQUENT ACID ETCH (500X MAGNIFICATION). (The Inconel fatigue crack was not reopened by etching, while the Ti crack was recovered.)
