**DOT/FAA/AR-04/12**

# **Aircraft Wiring Harness Shield Degradation Study**

August 2004

Final Report

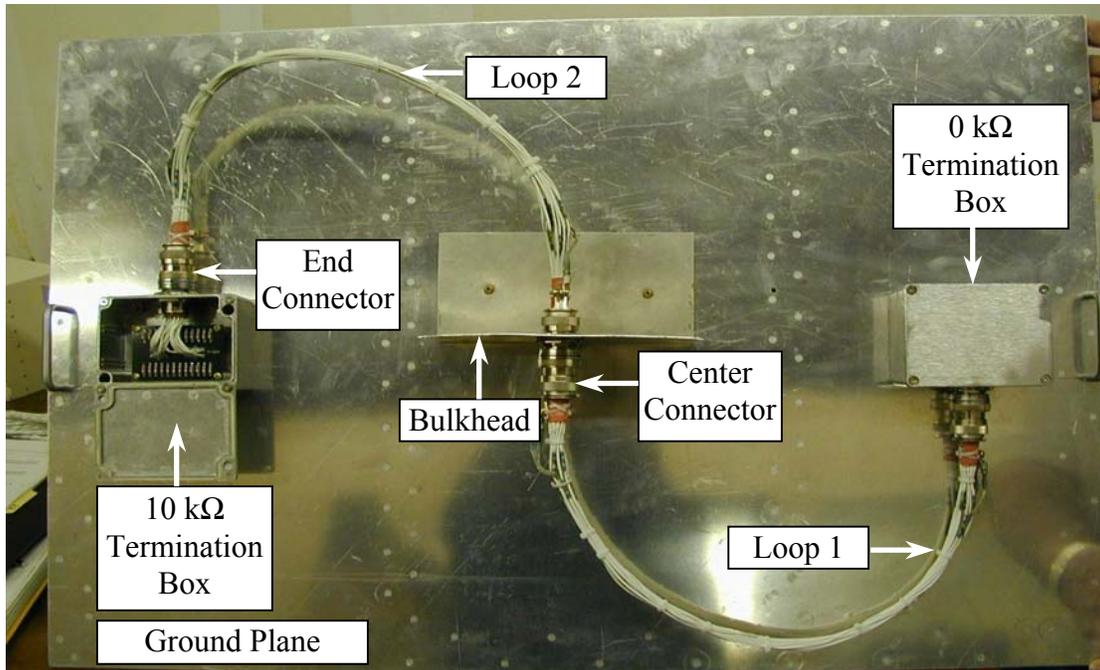
Simulating an aircraft wiring harness, a 24-inch-long wire bundle with P/N MS3475L16-26P end connectors using Sunbank P/N S4785S16C12 backshells is connected to the receptacle on each termination box and to a center bulkhead receptacle. Each wire bundle was made up of 12 unshielded wires (P/N M81044/12-22) and 12 woven-braid shielded wires (P/N M27500-22-ML-1T08), secured along its length with plastic tie wraps and forming a standard wire bundle configuration. Where each end of the wire bundle enters its backshell, the woven shields were separated from their insulated wires and soldered to a common ground lug terminal that is bolted to the backshell.

FIGURE 1. REGULAR BULKHEAD (TEST PANEL TYPE A)

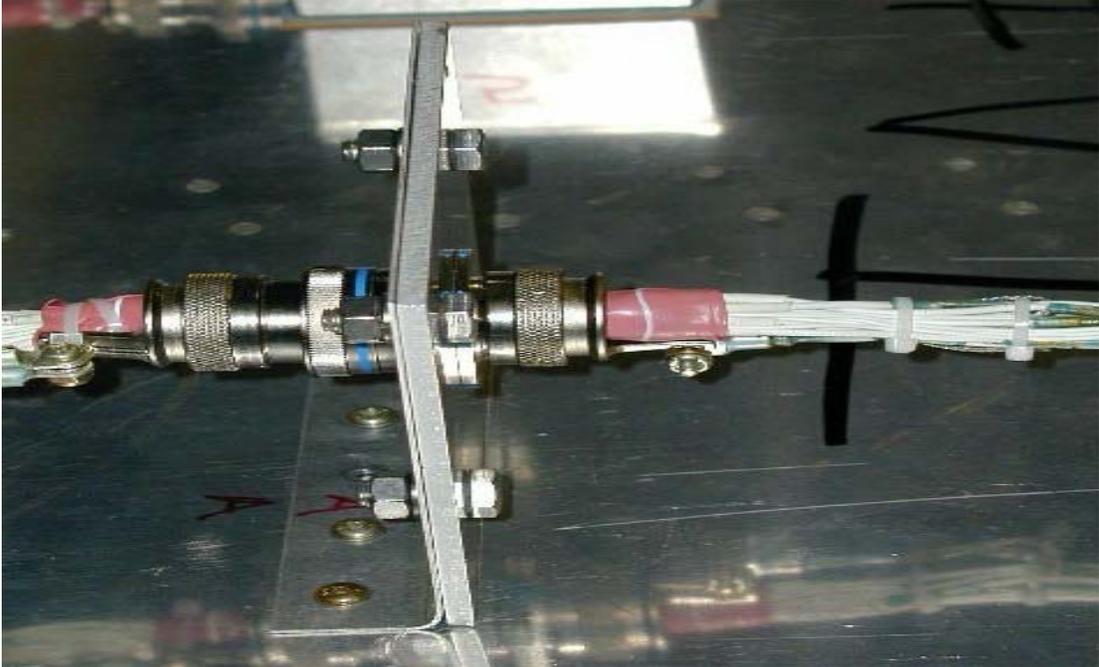
FIGURE 2. CENTER BULKHEAD MODIFIED FOR VIBRATION TEST  
(TEST PANEL TYPE A)

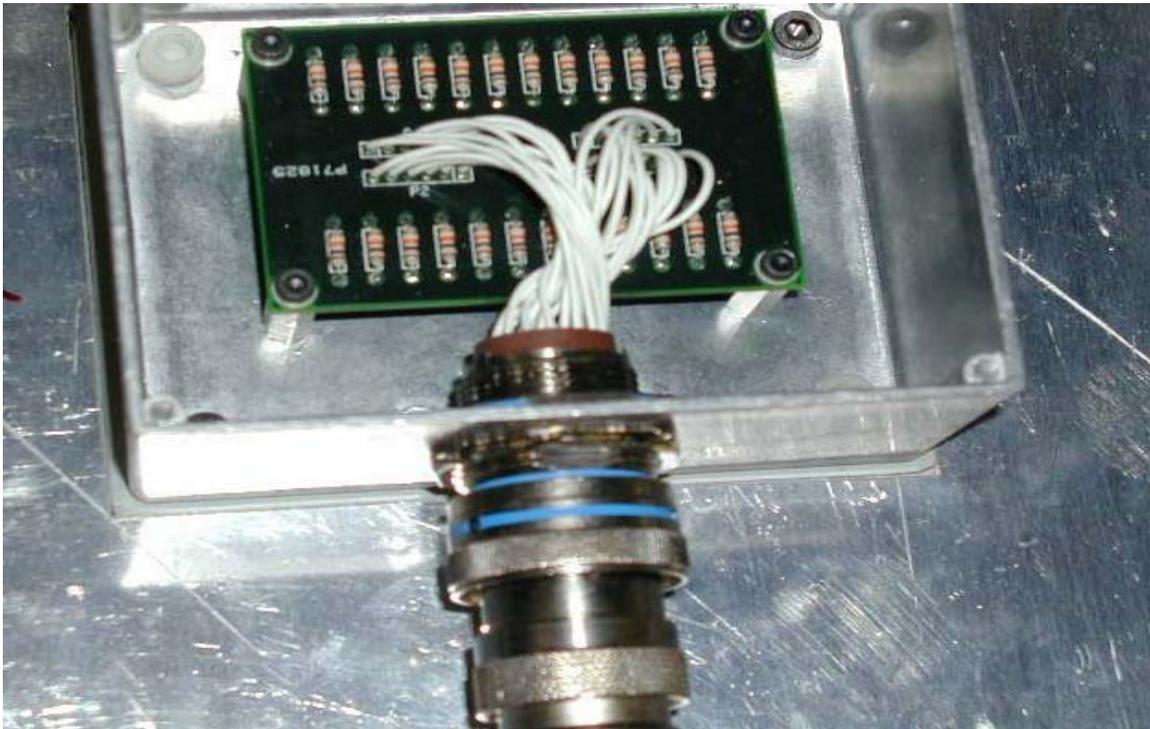
One aluminum box, called the 0 kΩ termination box, had all the inner conductors from the cable receptacle shorted together to the ground plane. Figure 3 shows the other termination box with 10 kΩ resistances mounted on a circuit board and the flange receptacle mounted on the side of the box. All 24 inner conductors are linked individually from the flange receptacle through a resistor to the box mounted on the ground plane. A wire bundle connector is shown attached to the outer part of the box flange receptacle.

FIGURE 3. TERMINATION BOX WITH END CONNECTOR (TEST PANEL TYPE A)

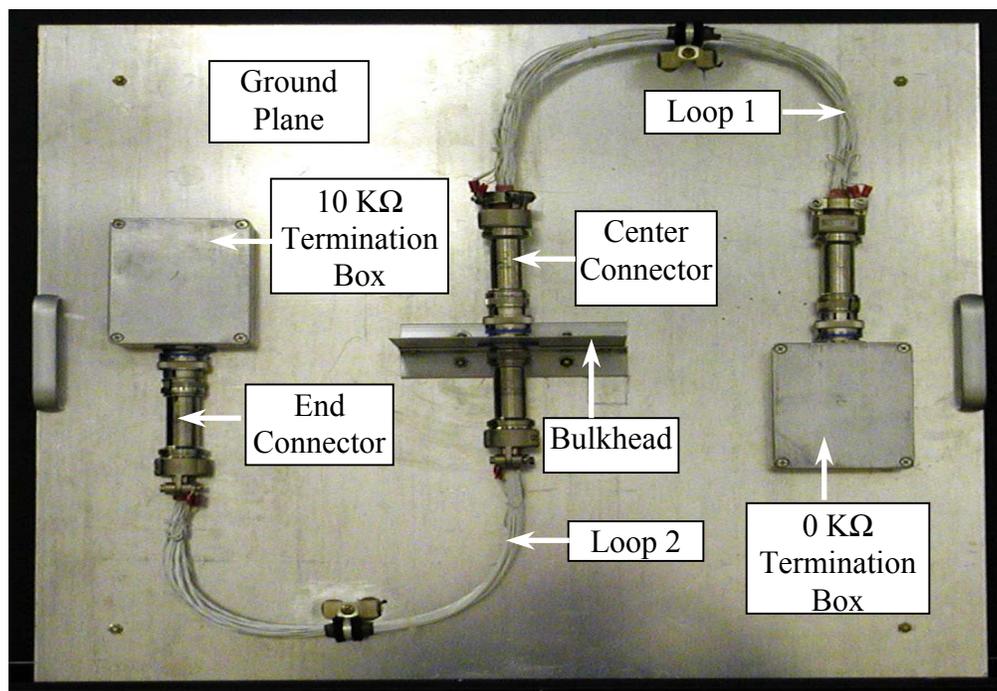
Figure 4 shows test panel type B with a regular center bulkhead. All six type B test panels were designed and built the same way, except that test panels B4 and B5 had specially designed bulkheads for the vibration test. Each test panel type B was designed to have two 24-inch-long wire bundles of standard configuration with 12 unshielded wires (P/N M22759/16-22 27478) and 6 strands of twisted pair (M27500.22 ML1T08) 85% coverage shielded wire. Each test panel had 0 k $\Omega$  and 10 k $\Omega$  termination boxes similar to the configuration of type A test panels. The two end connectors (P/N MS3475L16-26P) of the wire bundle were connected to termination boxes. Sunbank (P/N M85049/25-22N) backshells were used for test panel type B. The bulkhead not only provided support to the center connector, but also provided a ground path to the panel ground plane.

FIGURE 4. REGULAR CENTER BULKHEAD (TEST PANEL TYPE B)

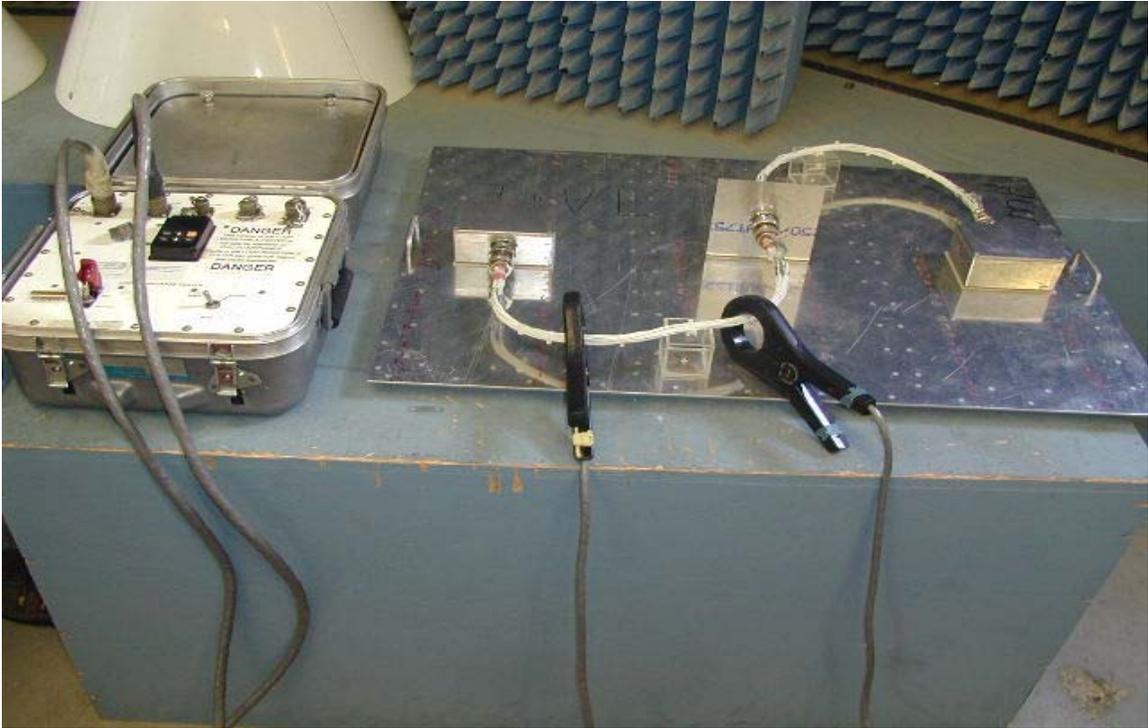
Figure 5 shows the LRT measuring the resistance of loop 1 of test panel type A, while figure 6 shows the LRT measuring the total shield loop resistance (loops 1 and 2). The shield resistance measurements were taken at each degradation level.

FIGURE 5. LOOP 1 RESISTANCE MEASUREMENT USING THE BOEING LRT (TEST PANEL TYPE A)

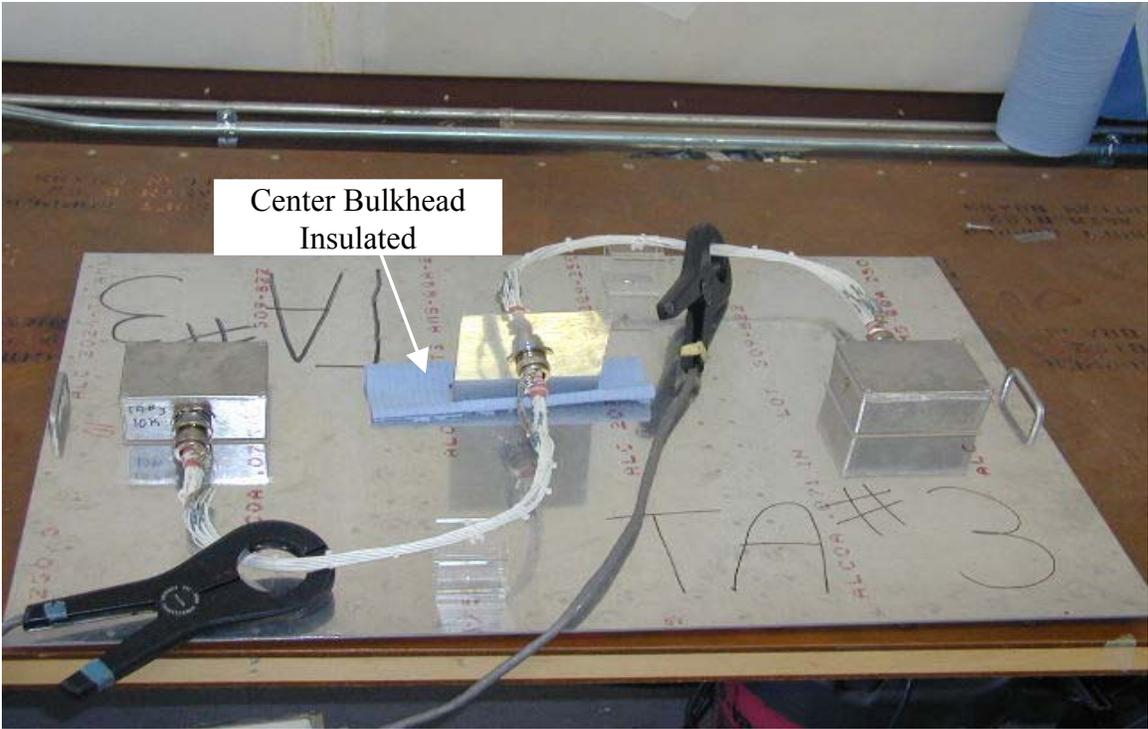
FIGURE 6. TOTAL LOOP RESISTANCE MEASUREMENT USING THE BOEING LRT (TEST PANEL TYPE A)

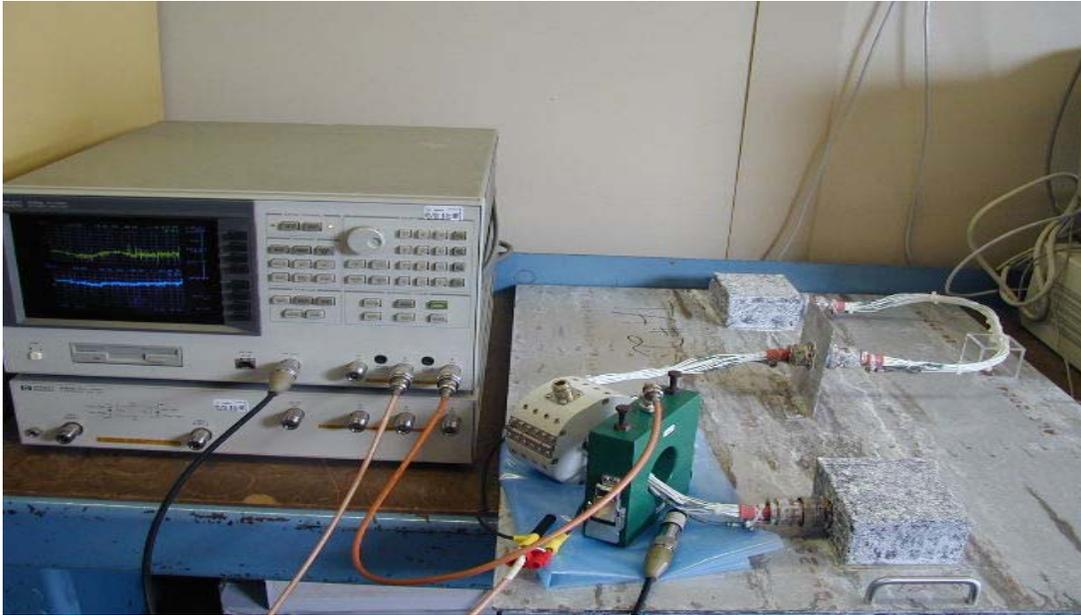
Figure 7 shows the setup for impedance measurement of loops 1 or 2, and figure 8 shows the measurement setup for the total loop. The center bulkhead bracket was lifted from the ground plane so that the impedance of total loop could be measured.

FIGURE 7. NETWORK ANALYZER SETUP FOR INDIVIDUAL LOOP IMPEDANCE MEASUREMENT

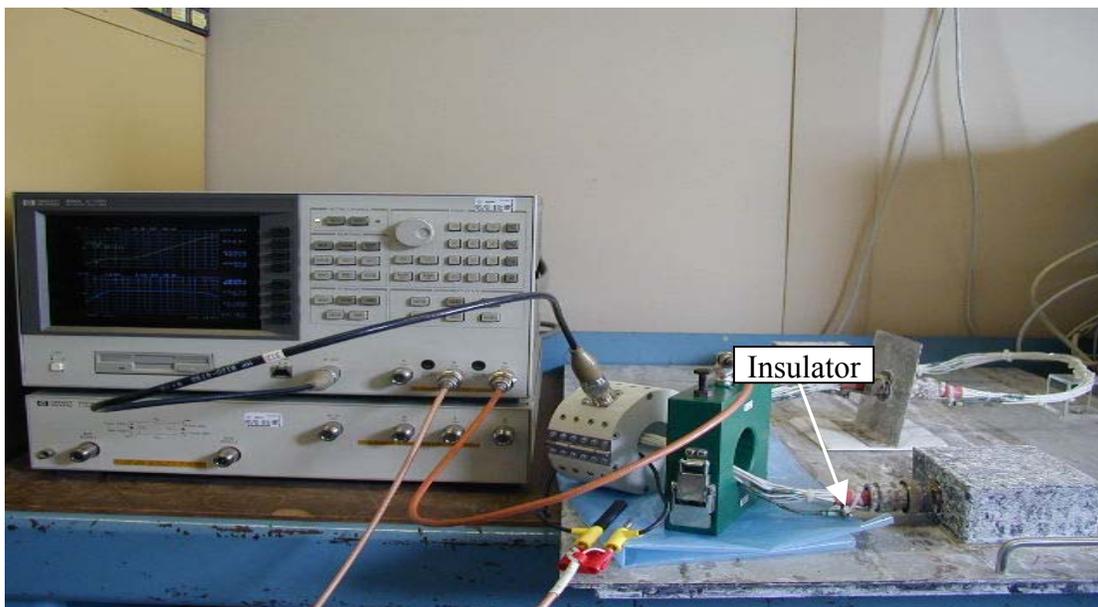
FIGURE 8. NETWORK ANALYZER SETUP FOR TOTAL LOOP IMPEDANCE MEASUREMENT

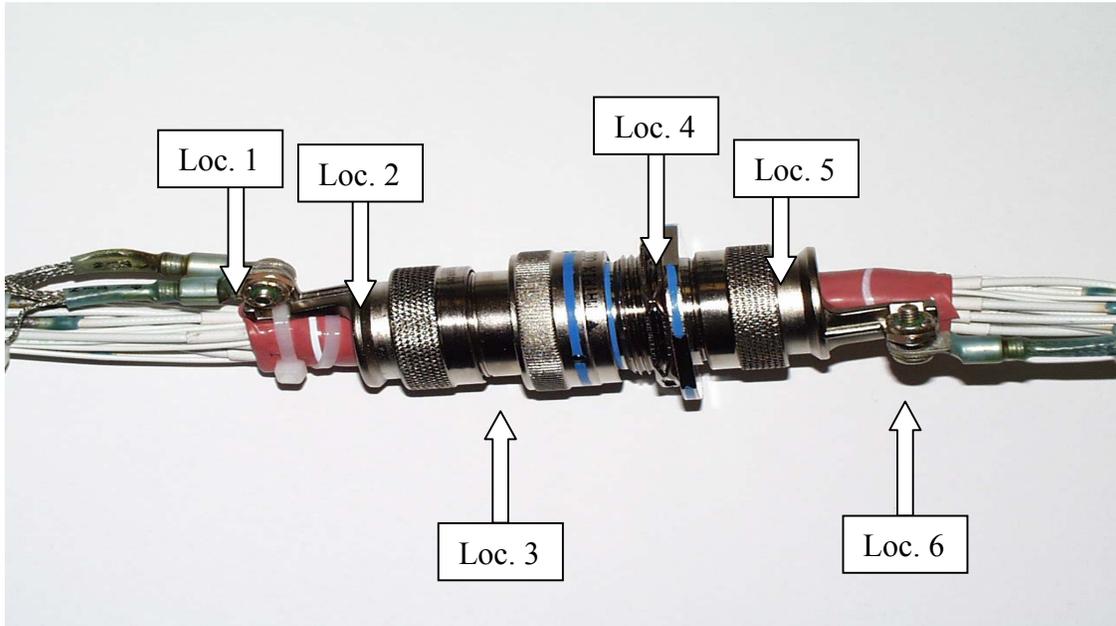
Figure 9 shows the center bulkhead flange receptacle (Loc. 4) with the center bulkhead bracket removed and wire bundle connectors (Loc. 3 and Loc. 5) attached to both sides of the flange receptacle.

FIGURE 9. DIRECT CURRENT RESISTANCE TEST LOCATIONS (CENTER CONNECTOR)

To verify that the increase in loop resistance was not due to the changes in the joint resistances of different electrical contacts of wire harnesses (figures 9 and 10), the dc measurements were recorded using a Keithley model 580 micro-ohmmeter at each degradation level for test panel A1 (table 7). A very small change was observed between baseline resistance values and high-level resistance values of the electrical contacts. Therefore, any increase found in the loop resistance value was assumed not to be due to change in contact resistance.

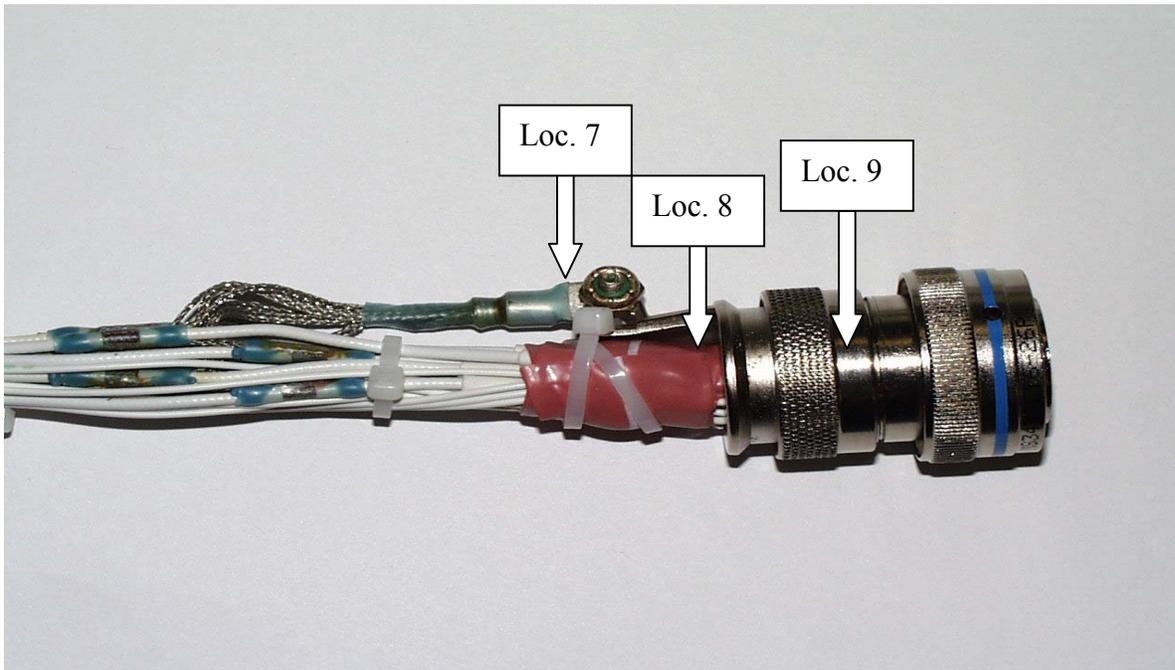
- Measurement 6 was taken between the shield termination (Loc. 7) and the backshell (Loc. 8) of the connector.
- Measurement 7 was taken between the backshell (Loc. 8) and the body (Loc. 9) of the connector.
- Measurement 8 was taken between the body (Loc. 9) of the connector and the termination box flange receptacle (not shown in figure 10).

FIGURE 10. DIRECT CURRENT RESISTANCE TEST LOCATIONS  
(END CONNECTOR)

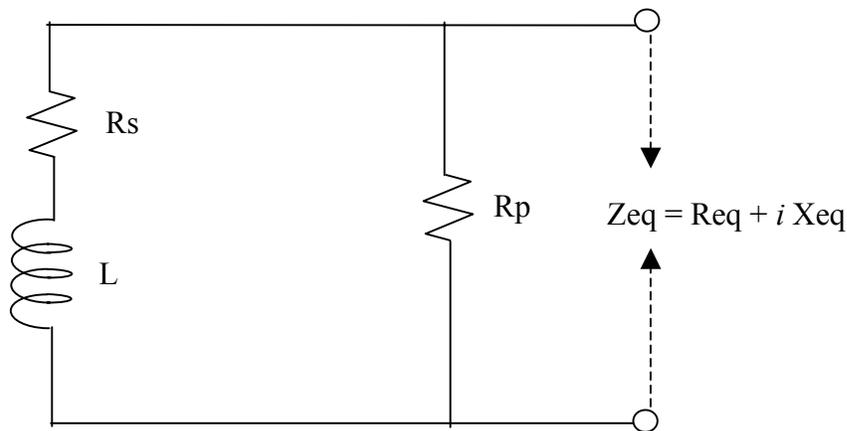
The loop impedance values for all test panels, as measured by the network analyzer, were modeled with a passive circuit consisting of two resistors and an inductor. The passive circuit was designed with a small resistance in series with an inductor, both in parallel with a relatively large resistor, as shown in figure 11. The series resistance ( $R_s$ ) was chosen close to the measured loop impedance values at lower frequencies (10 Hz to 1 kHz). The parallel resistor ( $R_p$ ) was selected to reduce the minimal variation between the experimental impedance values and the model values at higher frequencies. The resistance values of this model (figure 11) was kept at less than 5% over the entire range of frequencies compared to the actual panels.

FIGURE 11. CIRCUIT DIAGRAM FOR R-L-R MODELING

The loop impedance values, measured at baseline and after degradation testing, were modeled with the resistance-inductance-resistance (R-L-R) circuit. The impedance ( $Z_{eq}$ ) was calculated as follows:

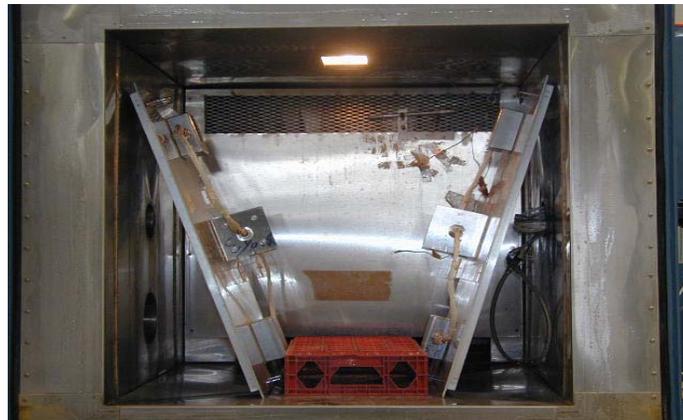
This test was performed to evaluate the level of degradation on aircraft wiring harness shield characteristics when exposed to various temperature and pressure extremes that are usually associated with altitude change during normal flight operations. The test setup and parameters were in accordance with the guidance material for a combined test described in section 5 of RTCA/DO-160D [1] on temperature variation. The test setup, with test panels A1 and A5 in the environmental chamber, is shown in figure 12.

FIGURE 12. TEMPERATUTE AND ALTITUDE CHAMBER TEST SETUP

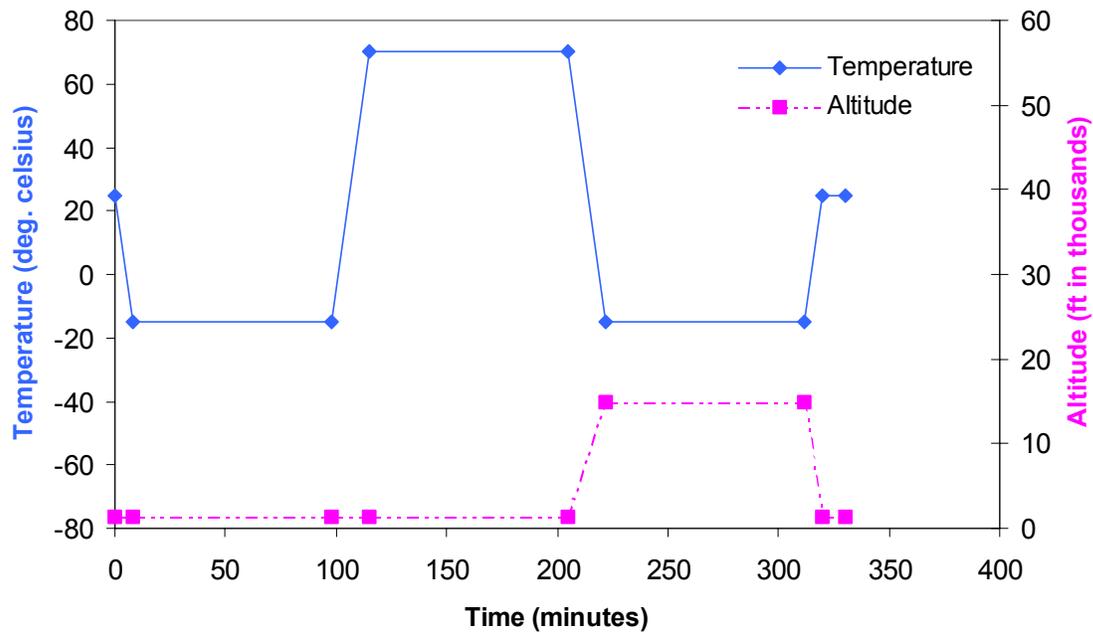
Figure 13 diagrams the low-level test procedure for temperature and altitude variation. With the altitude held constant at ground level (1333 ft), the temperature in the test chamber (figure 12) was reduced from 25° to -15°C during an 8-minute period. This temperature was maintained for 90 minutes. The temperature was then increased from -15° to 70°C for the next 17 minutes. The temperature was held at 70°C for 90 minutes, simulating an aircraft parked on the ramp in bright sunlight.

FIGURE 13. LOW-LEVEL TEMPERATURE AND ALTITUDE VARIATION TEST

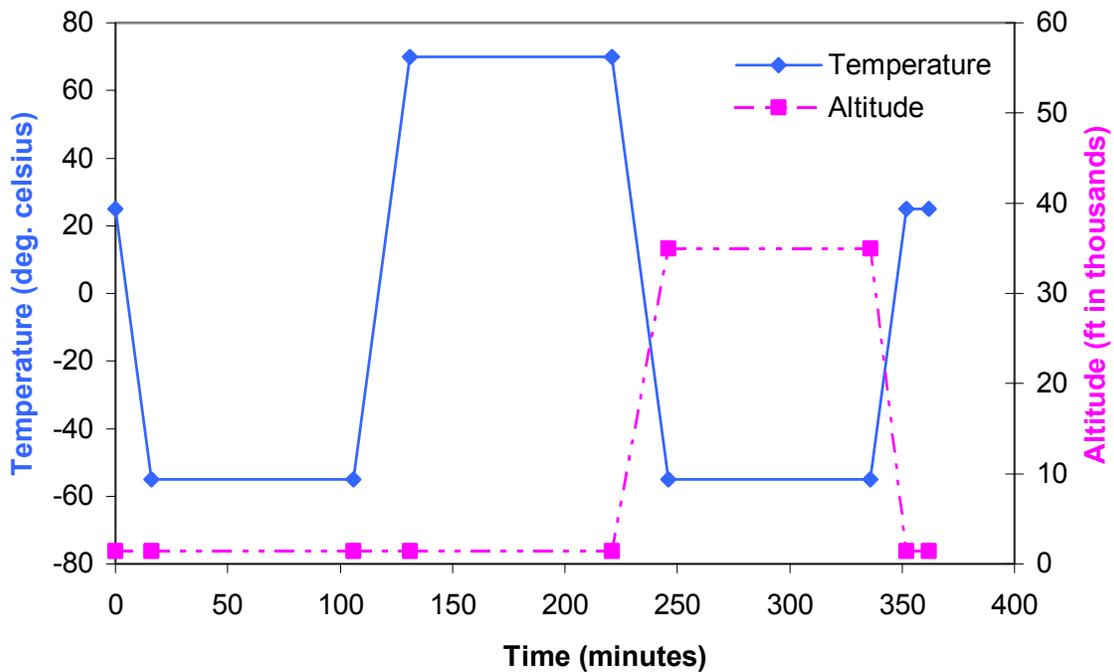
During the next 25 minutes the temperature was reduced from 70° to -55°C, while the chamber pressure was simultaneously reduced to simulate a change in altitude from 1,333 to 35,000 feet. This flight altitude and temperature was maintained for the next 90 minutes. Then the air pressure and temperature were increased over a 16-minute period, simulating a descent from 35,000 to 1,333 feet and a temperature increase from -55° to 25°C. This altitude and temperature were maintained for another 10 minutes, completing the 362-minute, medium-level test period.

FIGURE 14. MEDIUM-LEVEL TEMPERATURE AND ALTITUDE VARIATION TEST

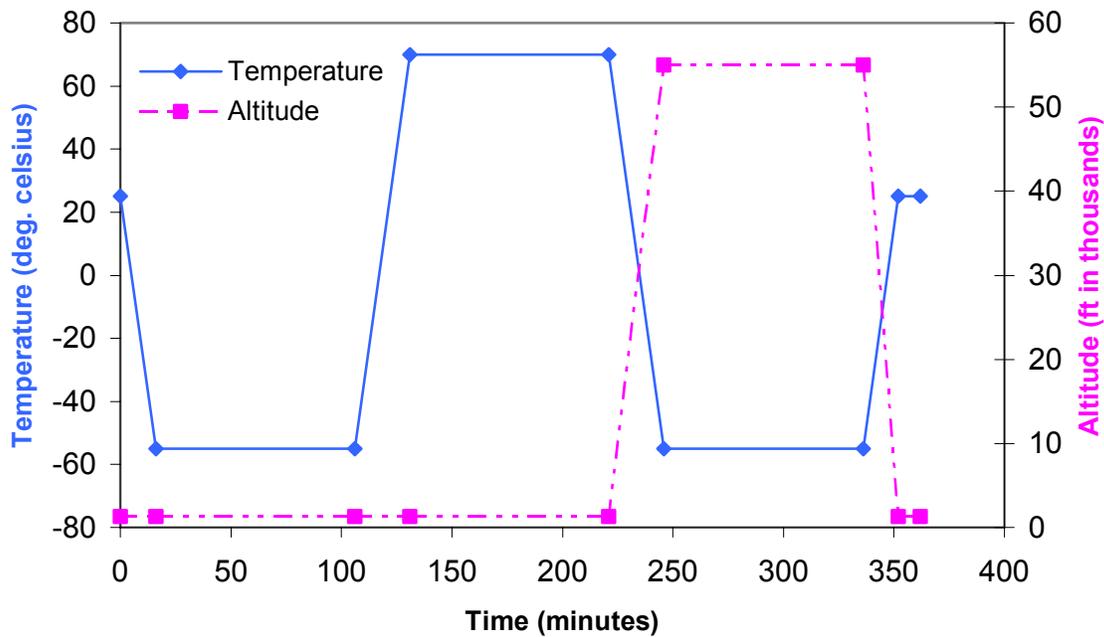
During the next 25 minutes the temperature was reduced from 70° to -55°C while the chamber pressure was simultaneously reduced to simulate a change in altitude from 1,333 to 55,000 feet. This flight altitude and temperature was maintained for the next 90 minutes. Then the air pressure and temperature were increased over a 16-minute period, simulating a descent from 55,000 to 1,333 feet and a temperature increase from -55° to 25°C. This altitude and temperature were maintained for another 10 minutes, completing the 362-minute, high-level test period.

FIGURE 15. HIGH-LEVEL TEMPERATURE AND ALTITUDE VARIATION TEST

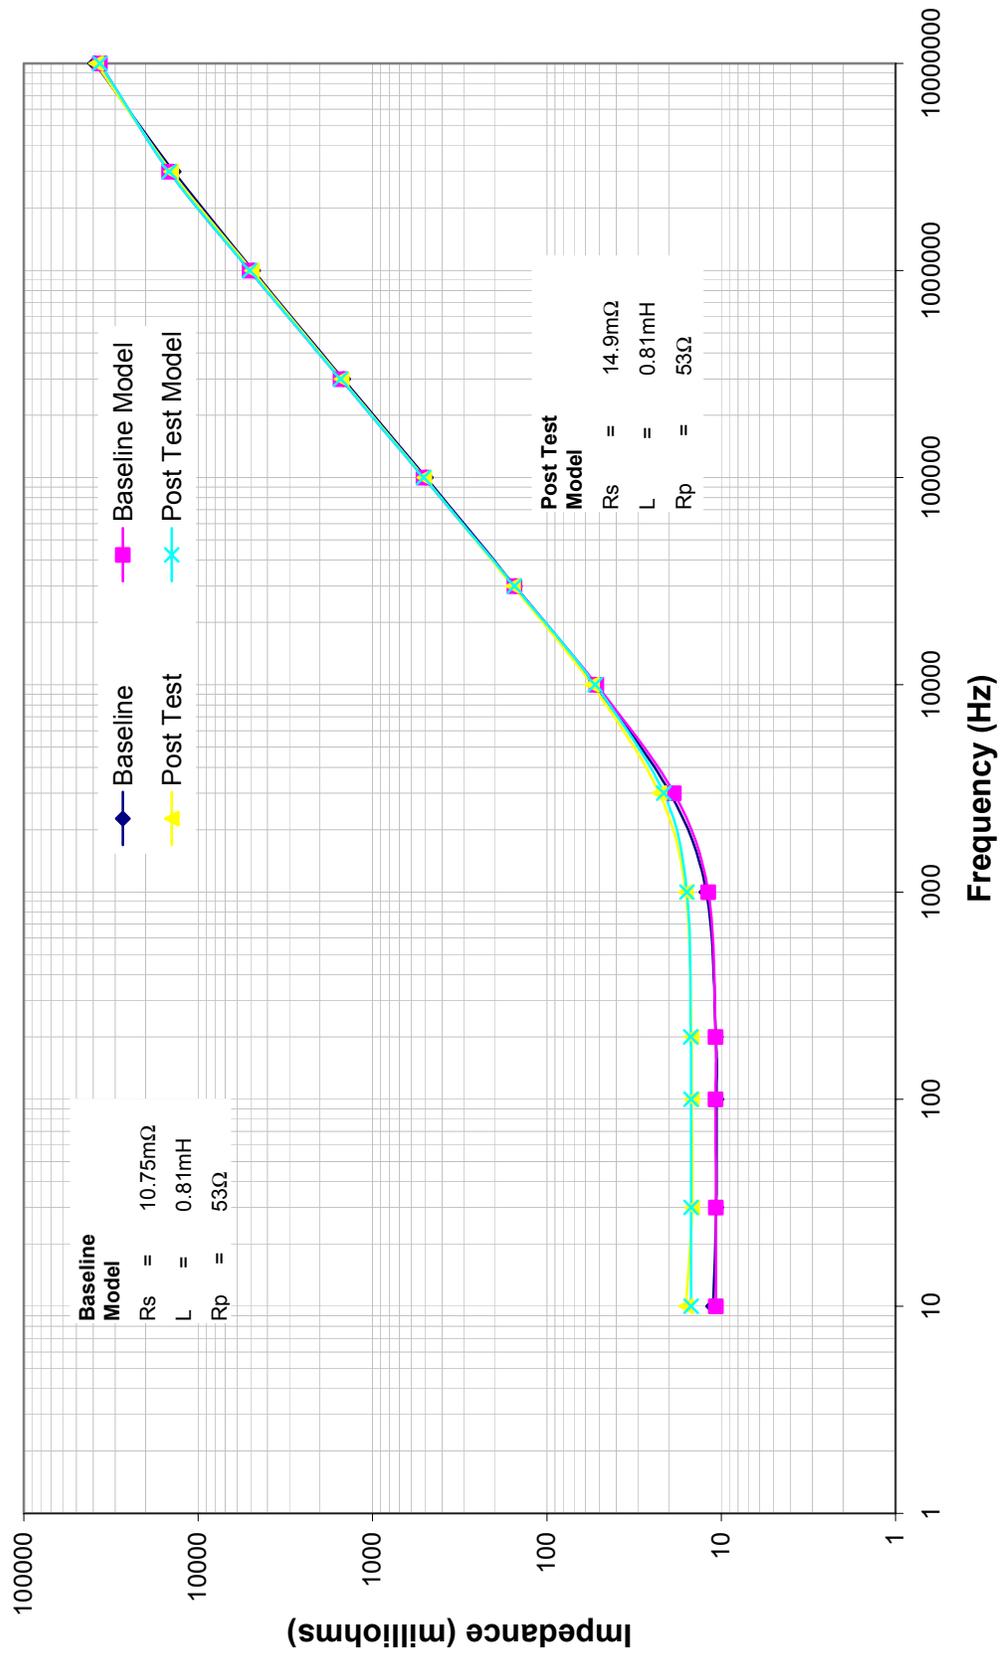
FIGURE 16. TOTAL LOOP IMPEDANCE CHARACTERISTICS BEFORE AND AFTER TEMPERATURE AND ALTITUDE TEST (TEST PANEL A1)

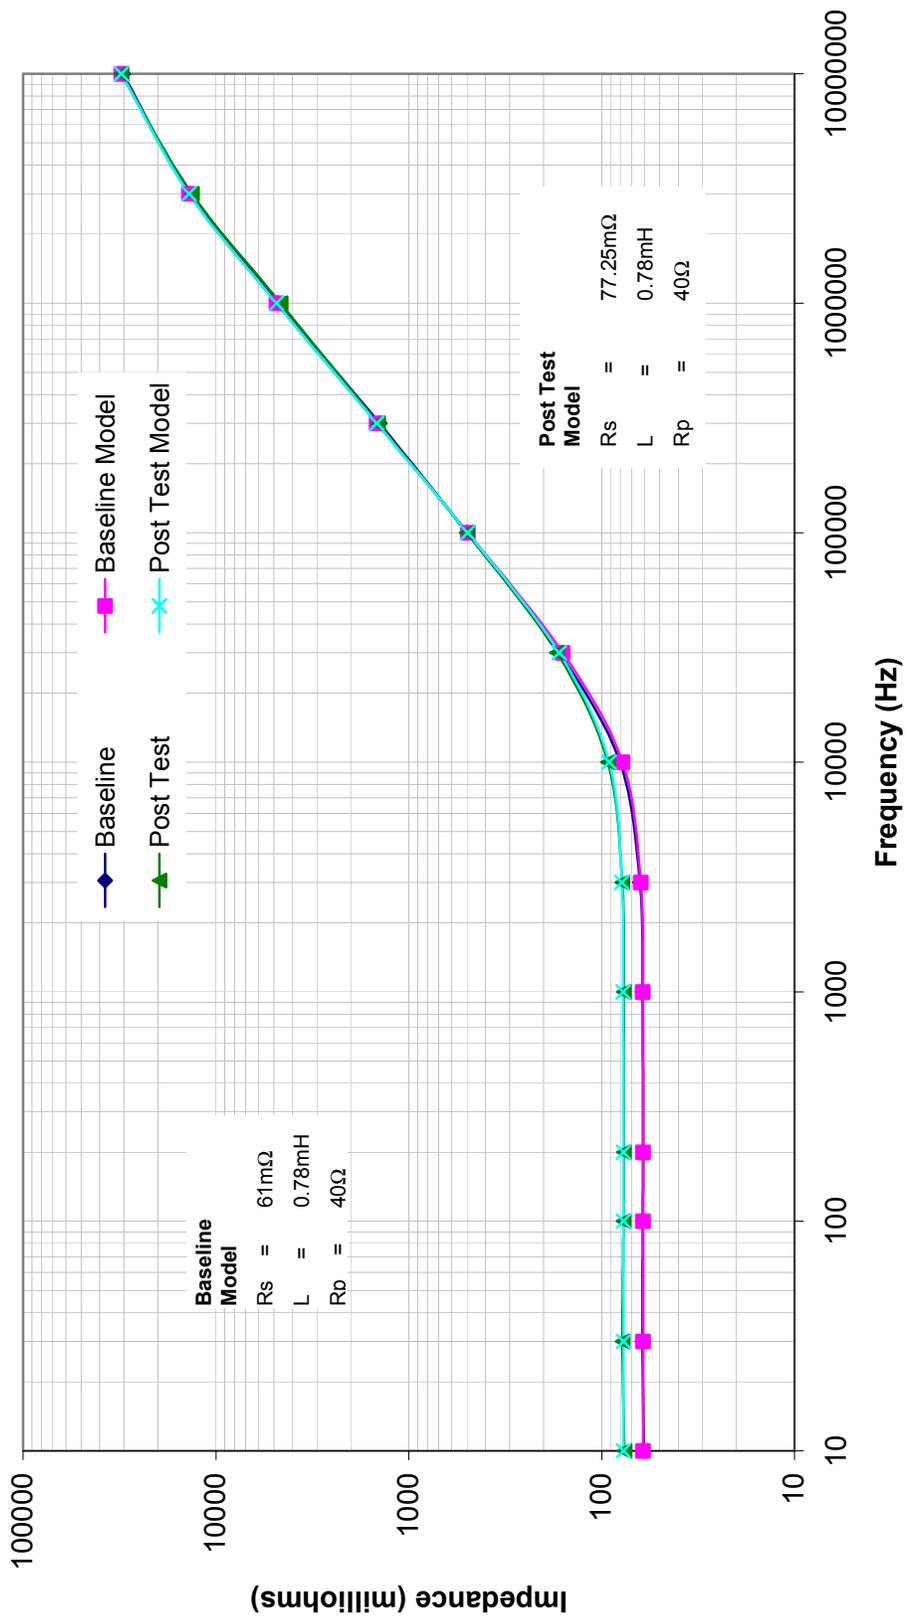
FIGURE 17. TOTAL LOOP IMPEDANCE CHARACTERISTICS BEFORE AND AFTER TEMPERATURE AND ALTITUDE TEST (TEST PANEL B1)

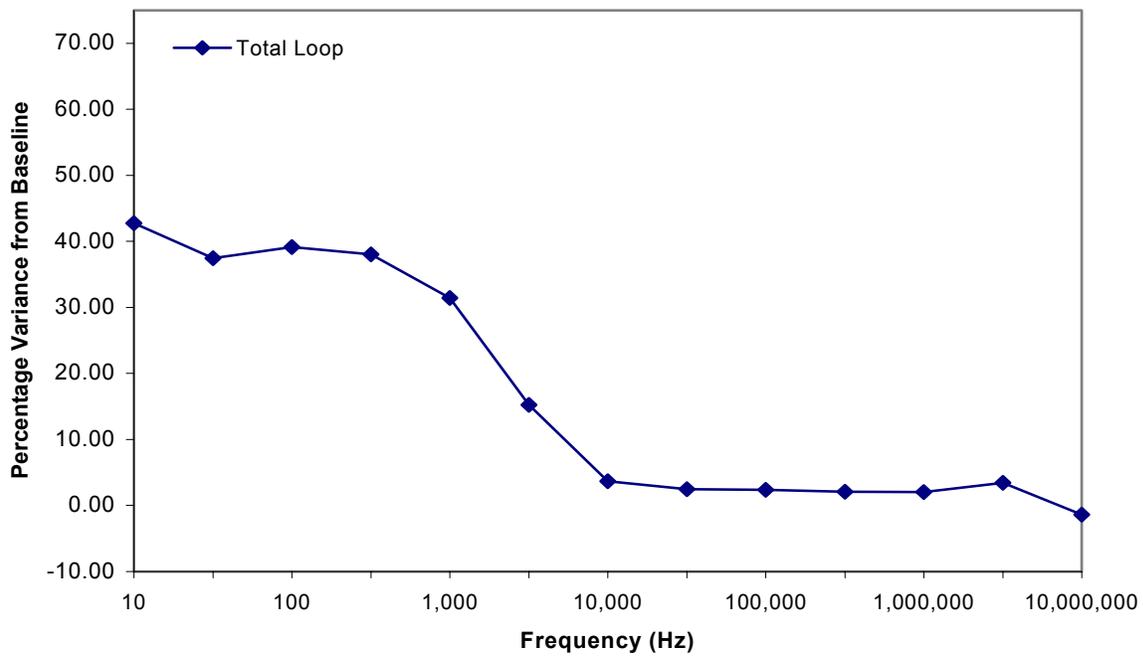
FIGURE 18. PERCENTAGE LOOP IMPEDANCE VARIATION AFTER TEMPERATURE AND ALTITUDE TEST (TEST PANEL A1)

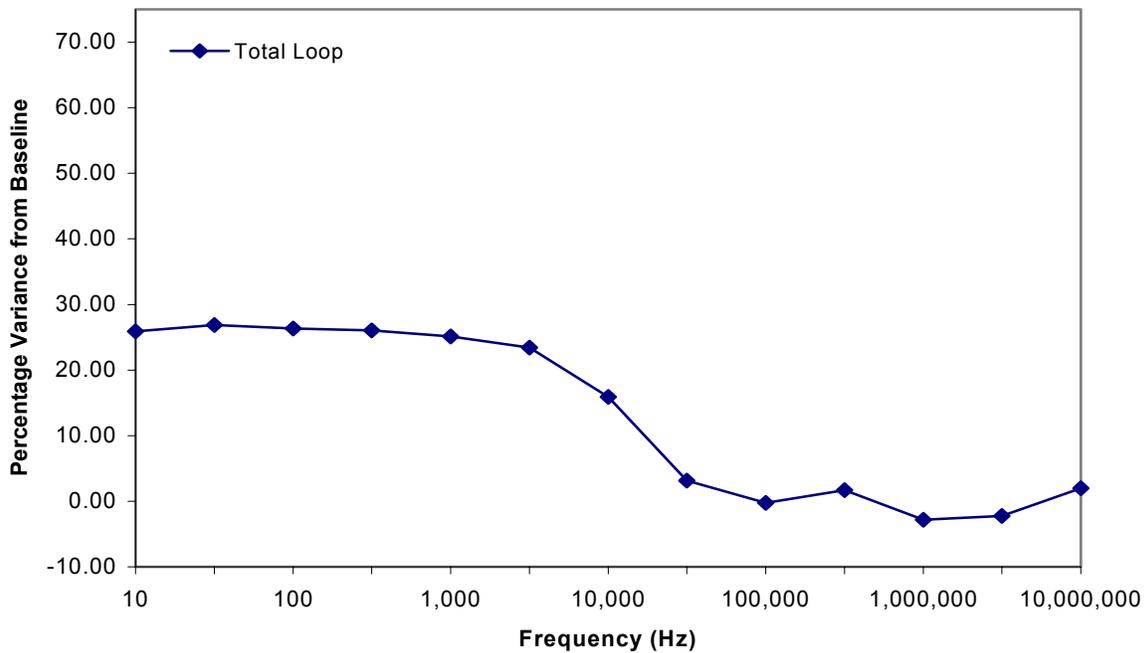
FIGURE 19. PERCENTAGE LOOP IMPEDANCE VARIATION AFTER TEMPERATURE AND ALTITUDE TEST (TEST PANEL B1)

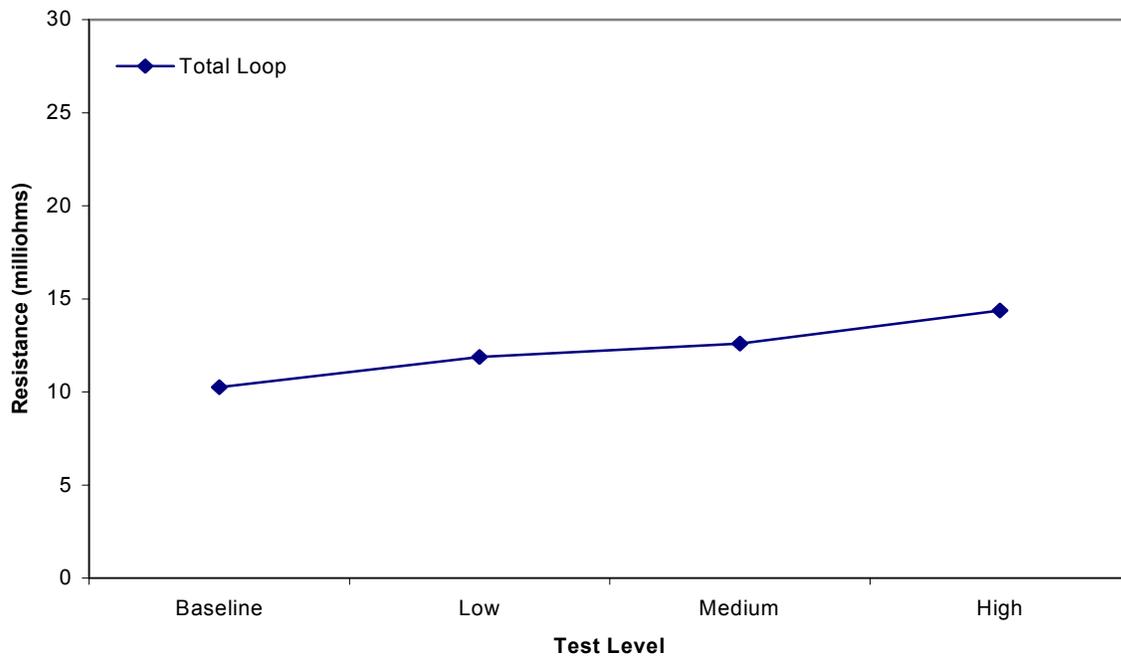
FIGURE 20. TOTAL LOOP RESISTANCE VALUES FOR TEMPERATURE AND ALTITUDE TEST USING THE BOEING LRT (TEST PANEL A1)

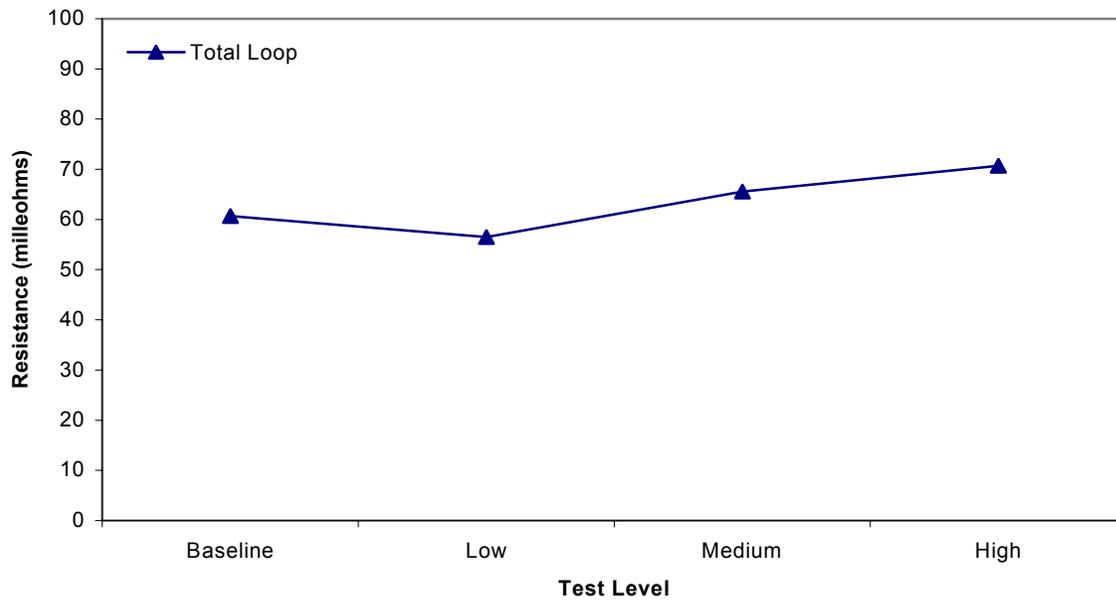
FIGURE 21. TOTAL LOOP RESISTANCE VALUES FOR TEMPERATURE AND ALTITUDE TEST USING THE BOEING LRT (TEST PANEL B1)

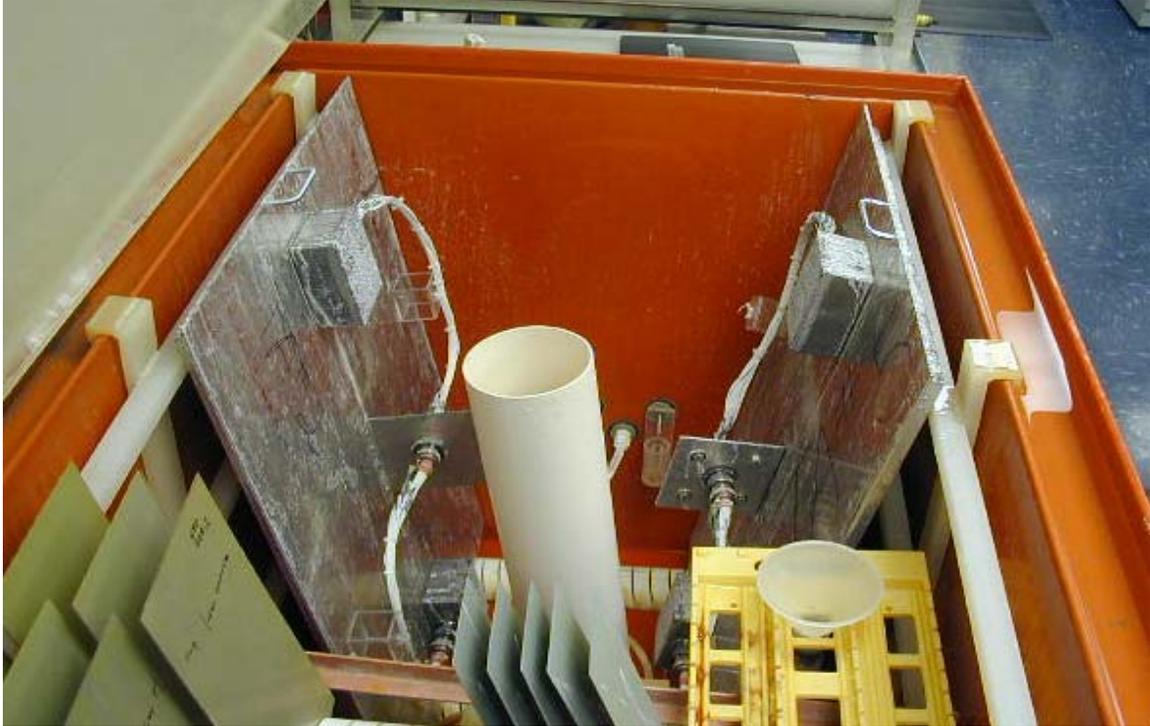
The test setup used for this test was in accordance with the guidance material provided in ASTM B 117 [2] titled “Standard Practice for Operating Salt Spray (Fog) Apparatus.” The test setup with test panels A2 and A5 in the salt spray chamber is shown in figure 22. The levels set for this part of the experiment are shown in table 8. The exposure times used for low, medium, and high levels of degradation were 24, 48, and 120 hours, respectively.

FIGURE 22. SALT SPRAY CHAMBER TEST SETUP

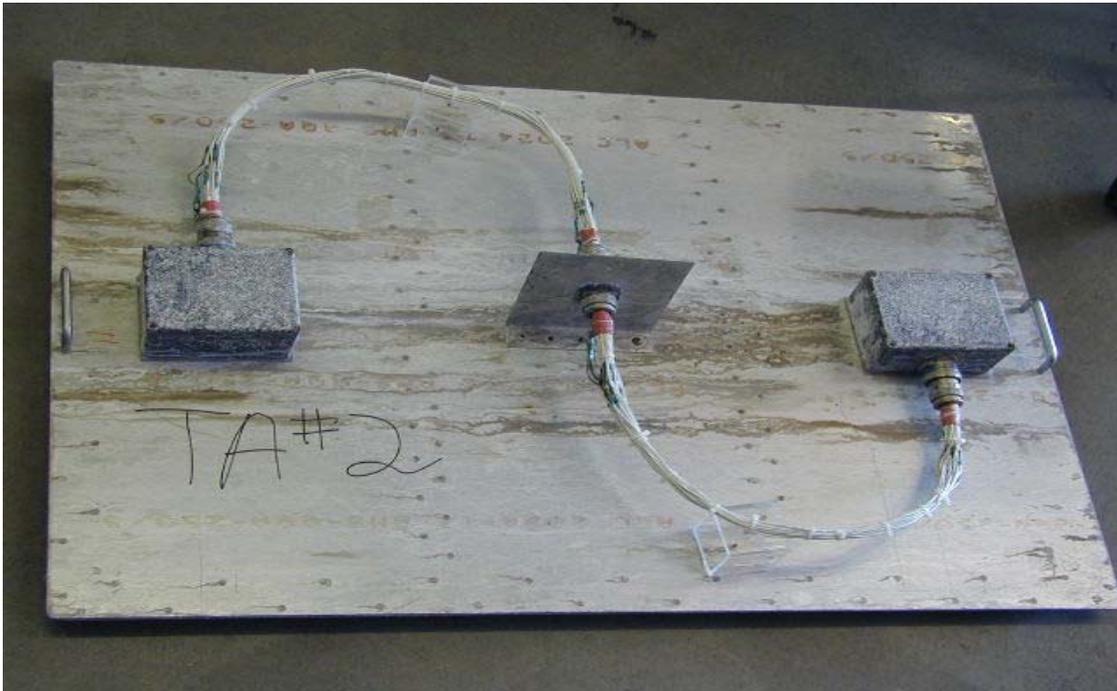
Figure 23 shows test panel type A and figure 24 shows test panel type B after the high-level salt spray and humidity test. Corrosion is visible on the shield termination screws and on the screws joining the bulkhead to the ground plane test panel type A, as shown in figure 25. The results obtained after the salt and humidity test, using the network analyzer, are given in table 9 for test panel A2 and in table 10 for test panel B2. The loop resistance calculated over a range of frequencies (10 Hz to 10 MHz) is tabulated for loops 1 and 2 and total loop. These measurements were recorded at baseline (initial readings) and after the high-level test (final readings).

FIGURE 23. TEST PANEL TYPE A AFTER SALT AND HUMIDITY TEST

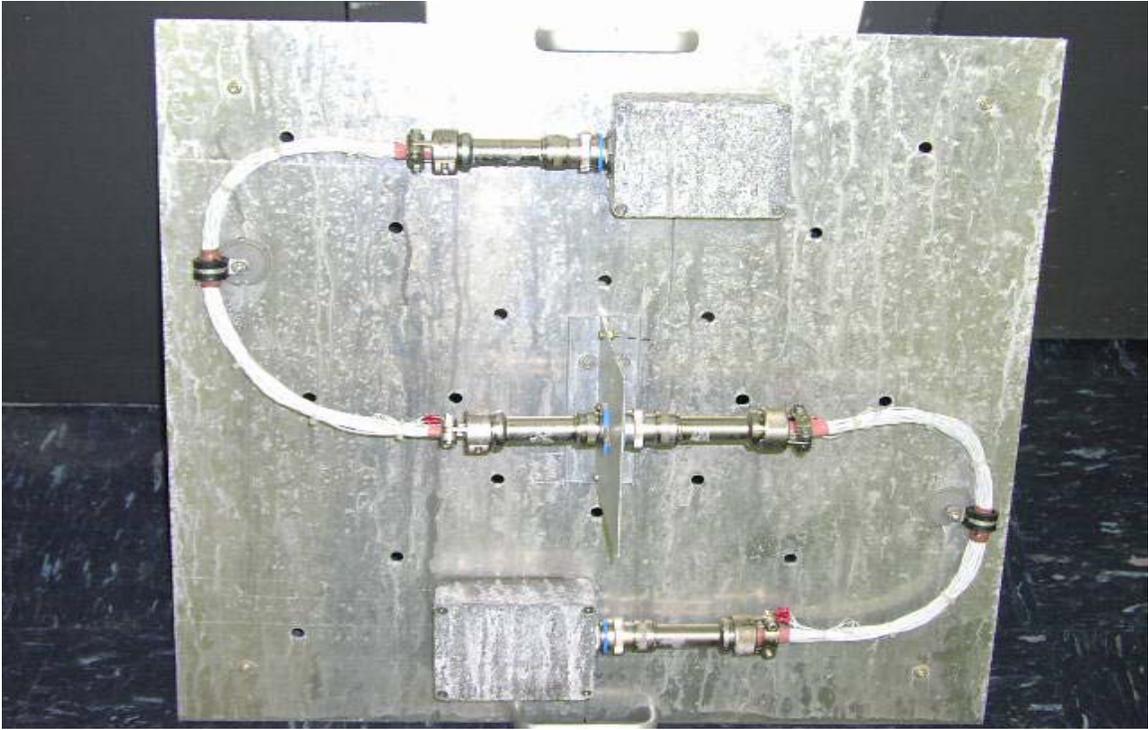
FIGURE 24. TEST PANEL TYPE B AFTER SALT AND HUMIDITY TEST

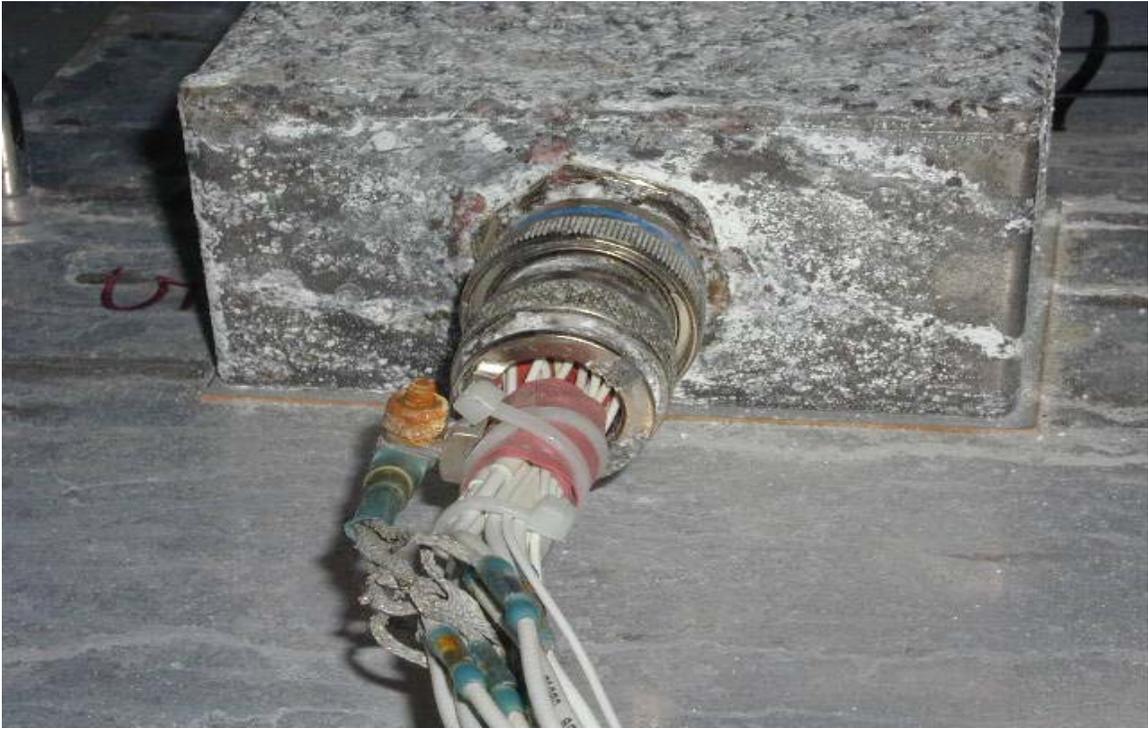
FIGURE 25. VISIBLE CORROSION AFTER SALT AND HUMIDITY TEST
