**DOT/FAA/AR-04/12**

# **Aircraft Wiring Harness Shield Degradation Study**

August 2004

Final Report

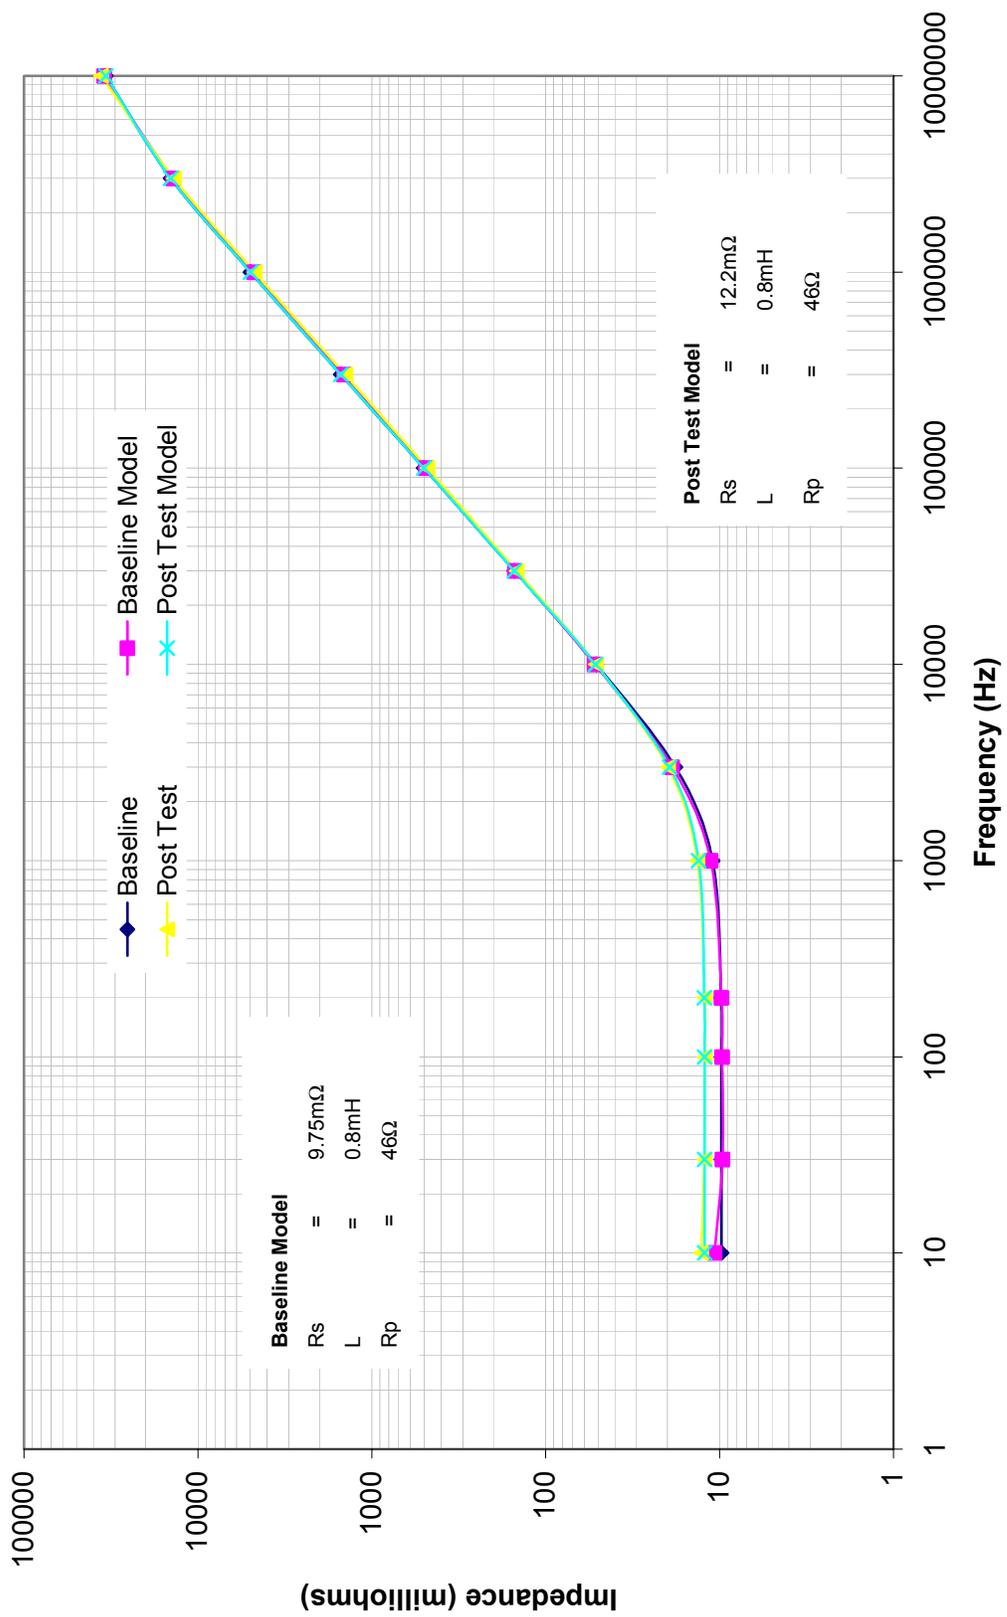
FIGURE 26. TOTAL LOOP IMPEDANCE CHARACTERISTICS BEFORE AND AFTER SALT AND HUMIDITY TEST (TEST PANEL A2)

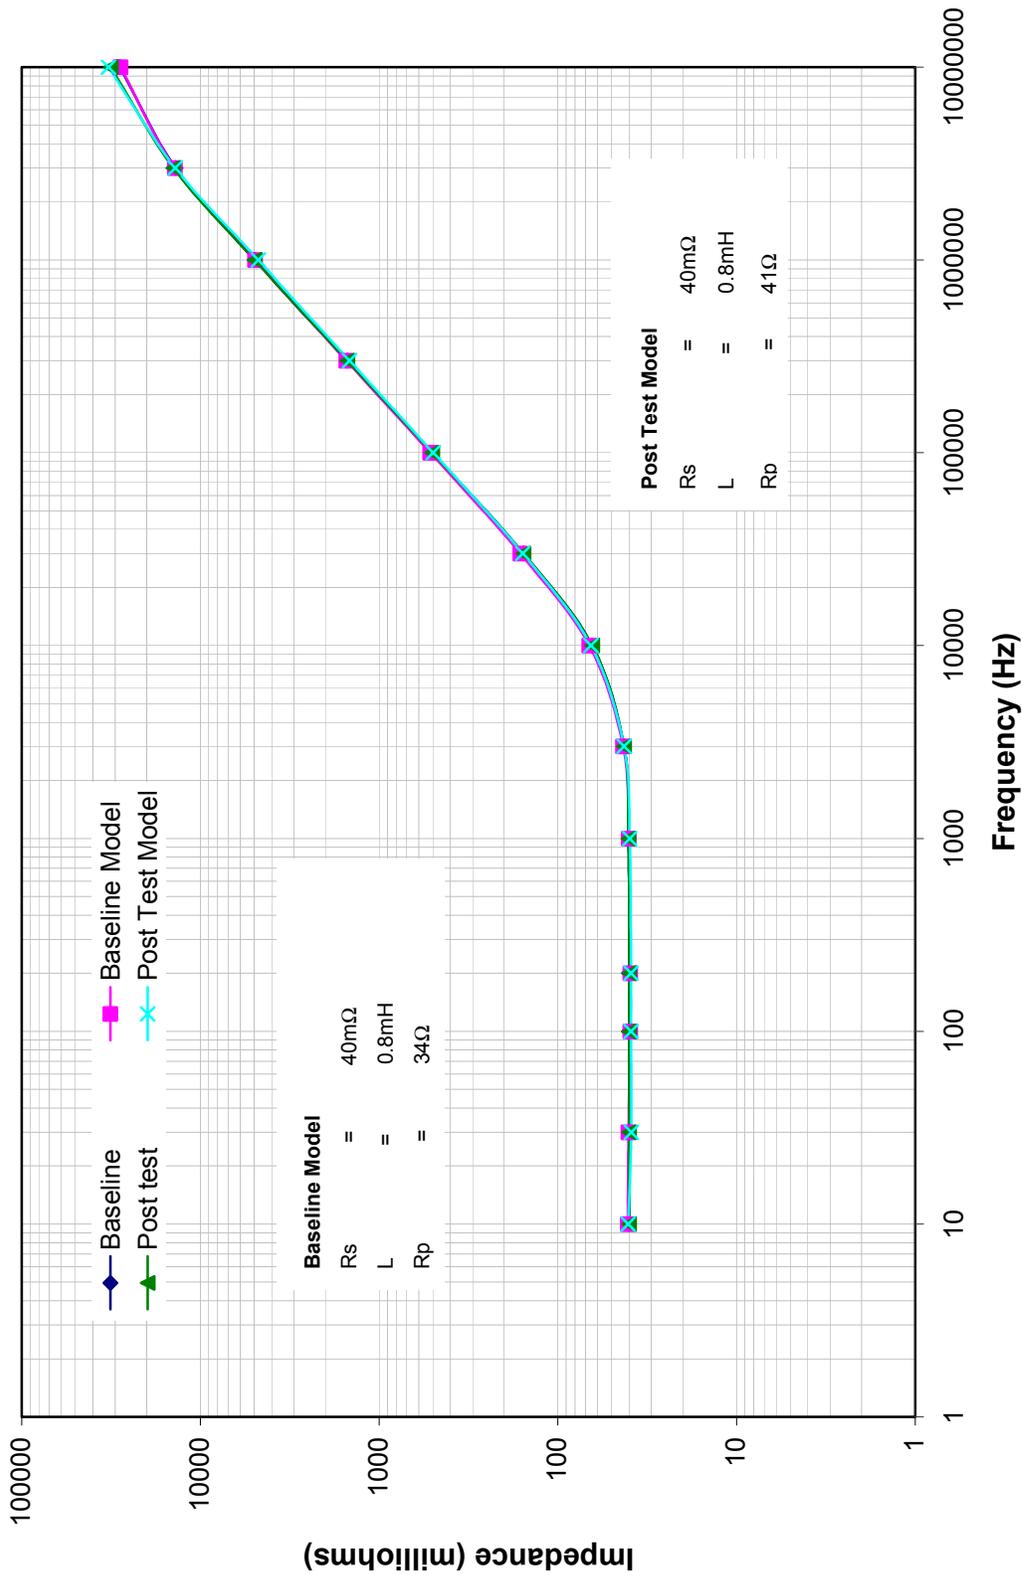
FIGURE 27. TOTAL LOOP IMPEDANCE CHARACTERISTICS BEFORE AND AFTER SALT AND HUMIDITY TEST (TEST PANEL B2)

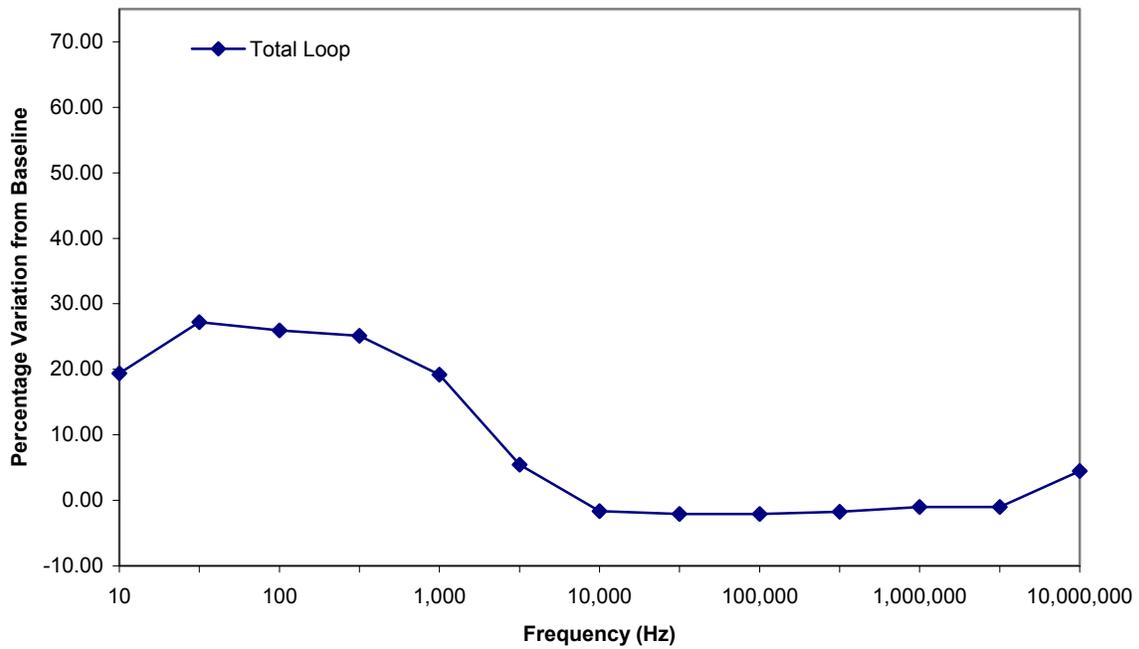
FIGURE 28. PERCENTAGE LOOP IMPEDANCE VARIATION AFTER SALT AND HUMIDITY TEST (TEST PANEL A2)

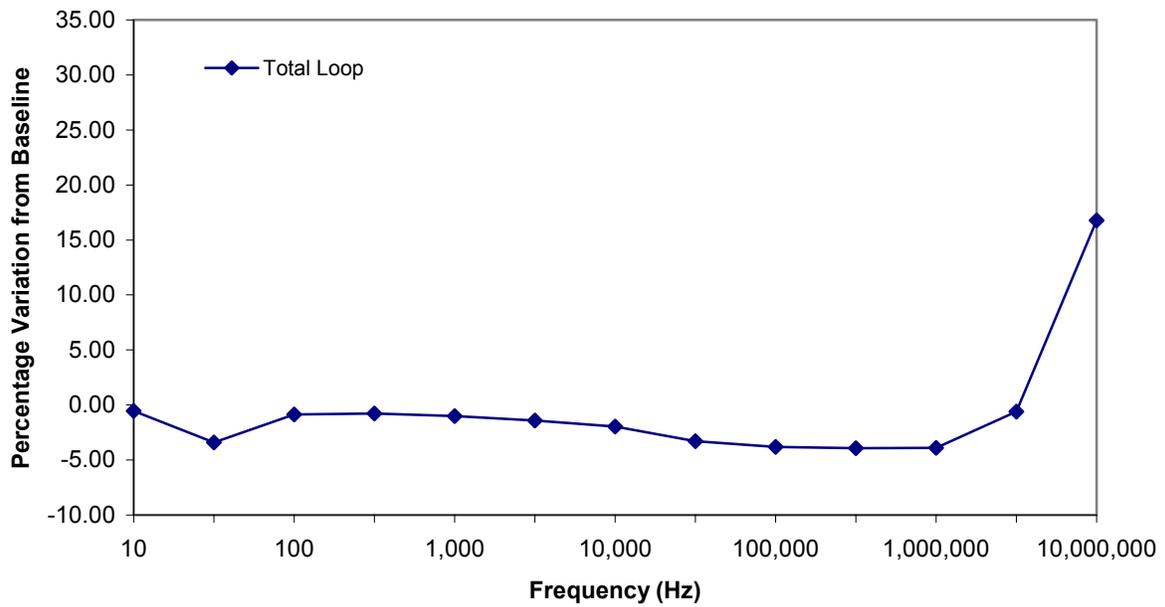
FIGURE 29. PERCENTAGE LOOP IMPEDANCE VARIATION AFTER SALT AND HUMIDITY TEST (TEST PANEL B2)

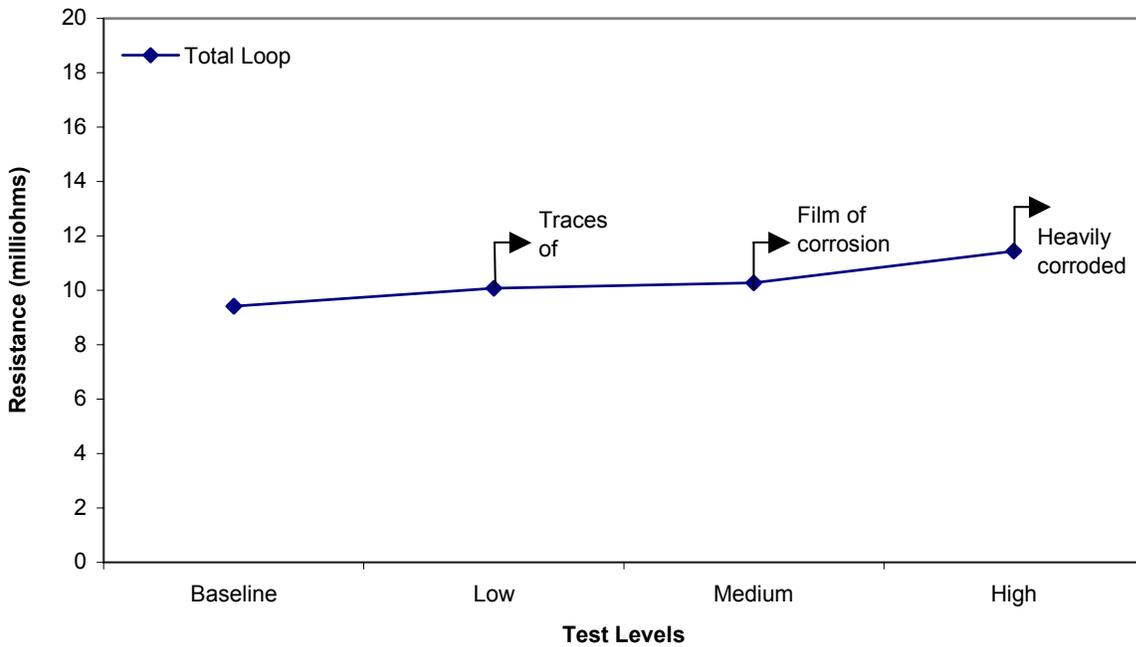
FIGURE 30. TOTAL LOOP RESISTANCE VALUES FOR SALT AND HUMIDITY TEST  
USING THE BOEING LRT (TEST PANEL A2)

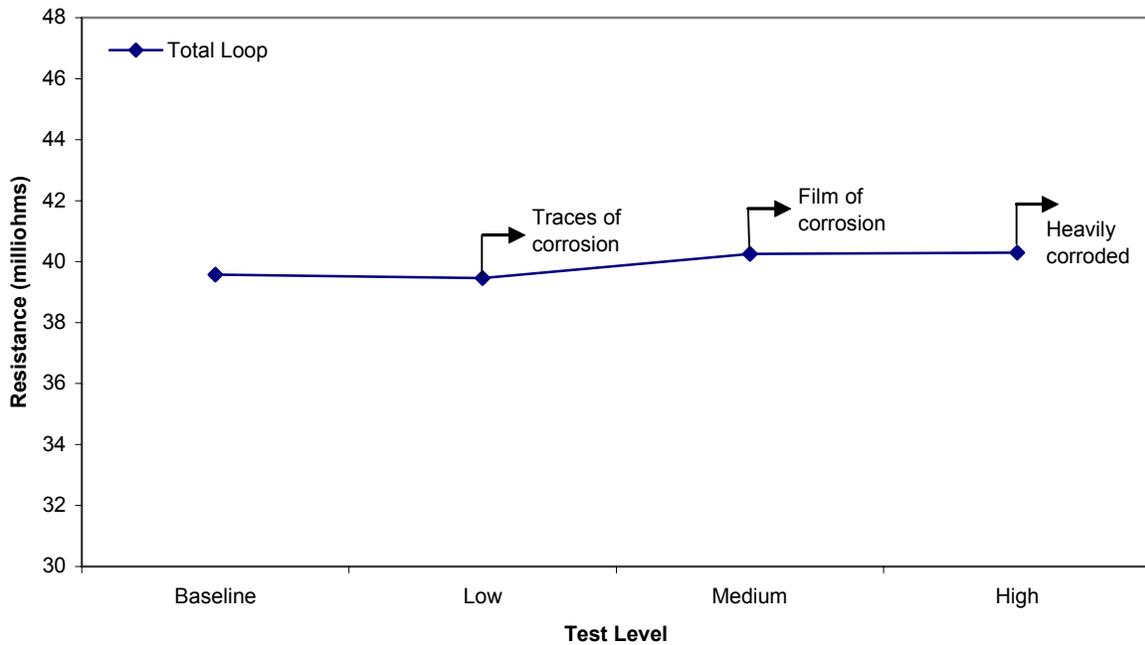
FIGURE 31. TOTAL LOOP RESISTANCE VALUES FOR SALT AND HUMIDITY TEST USING THE BOEING LRT (TEST PANEL B2)

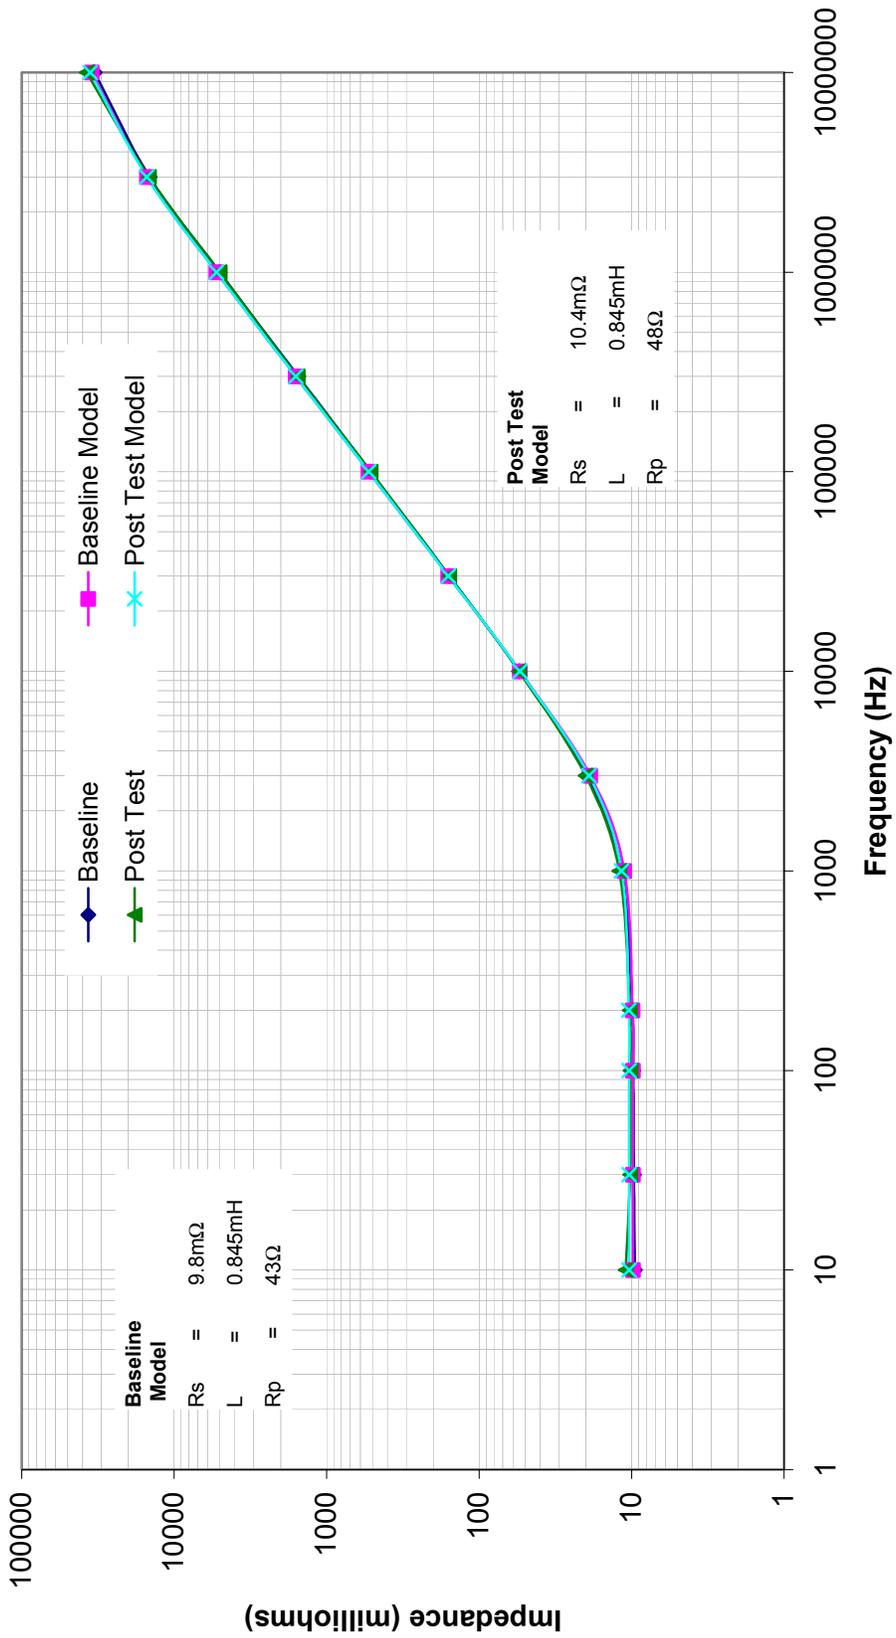
FIGURE 34. TOTAL LOOP IMPEDANCE CHARACTERISTICS BEFORE AND AFTER VIBRATION TEST (TEST PANEL A4)

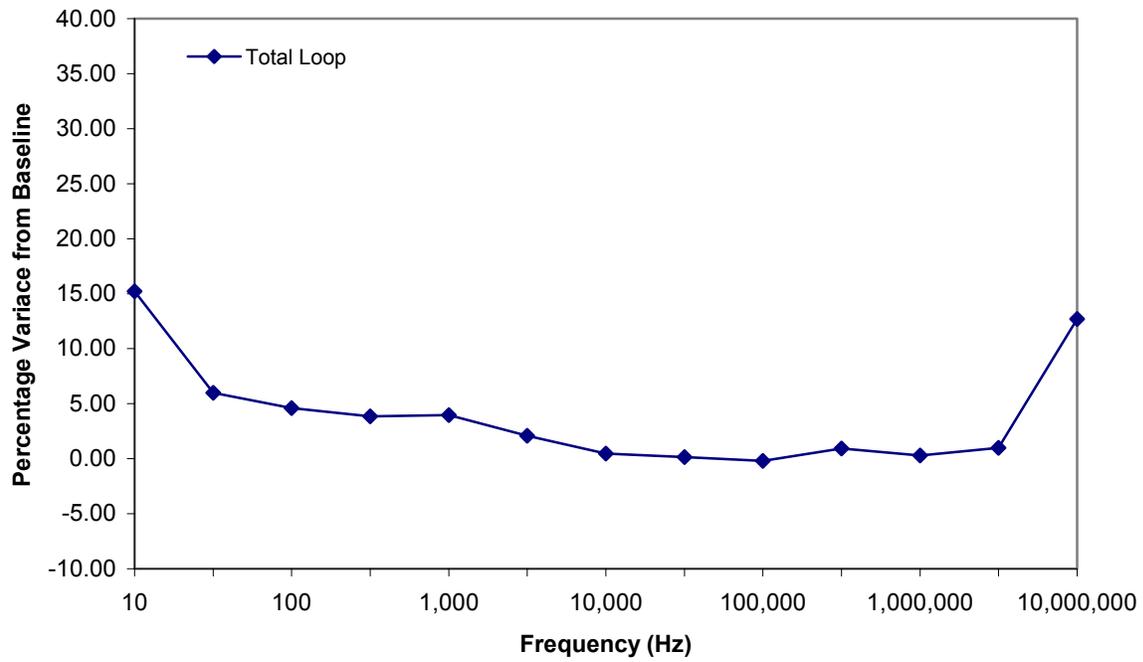
FIGURE 35. PERCENTAGE LOOP IMPEDANCE VARIATION AFTER VIBRATION TEST (TEST PANEL A4)

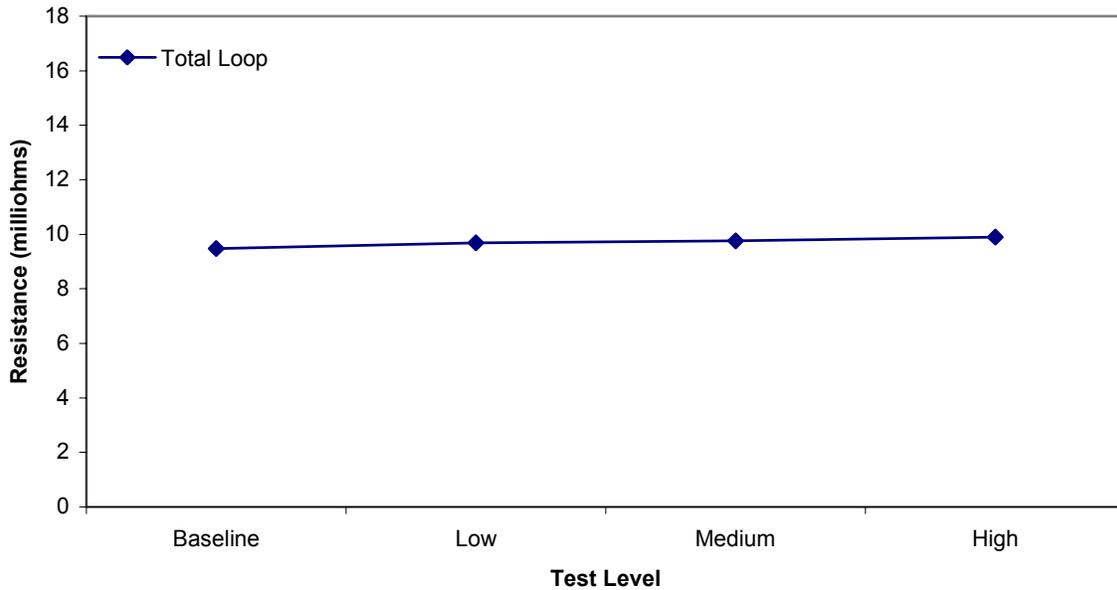
FIGURE 36. TOTAL LOOP RESISTANCE VALUES FOR VIBRATION TEST USING THE BOEING LRT (TEST PANEL A4)

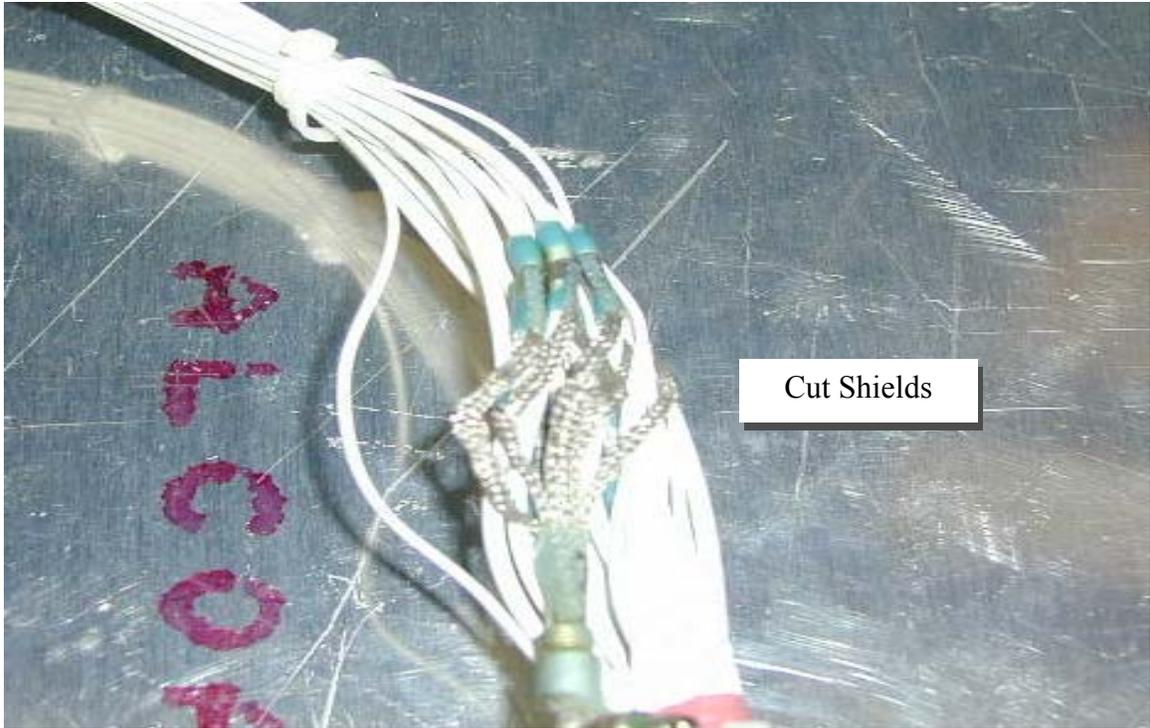
The shields of test panel A3 were stretched and loosened with pliers for the low-severity level test. Figure 37 shows the low-level mechanical degradation for test panel A3. For test panel B1, two of six shield wires were disconnected for the low-level degradation, as shown in figure 38.

FIGURE 37. LOW-LEVEL MECHANICAL DEGRADATION (TEST PANEL TYPE A)

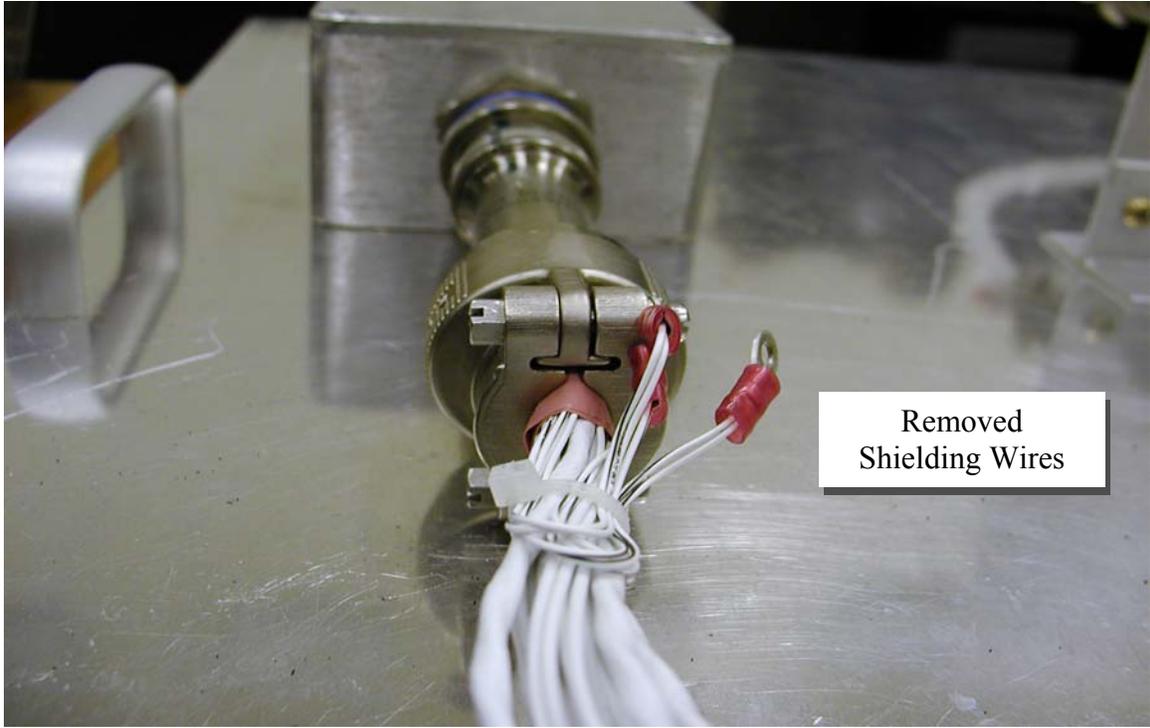
FIGURE 38. LOW-LEVEL MECHANICAL DEGRADATION (TEST PANEL TYPE B)

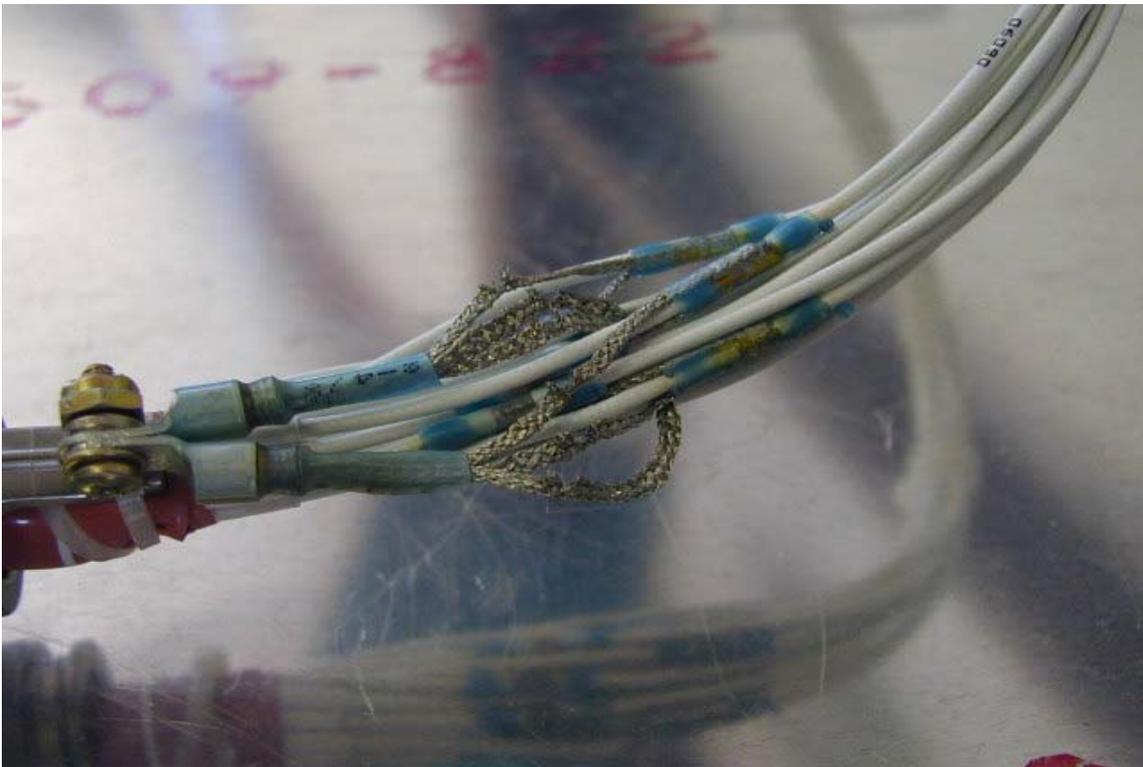
FIGURE 39. MEDIUM-LEVEL MECHANICAL DEGRADATION (TEST PANEL TYPE A)

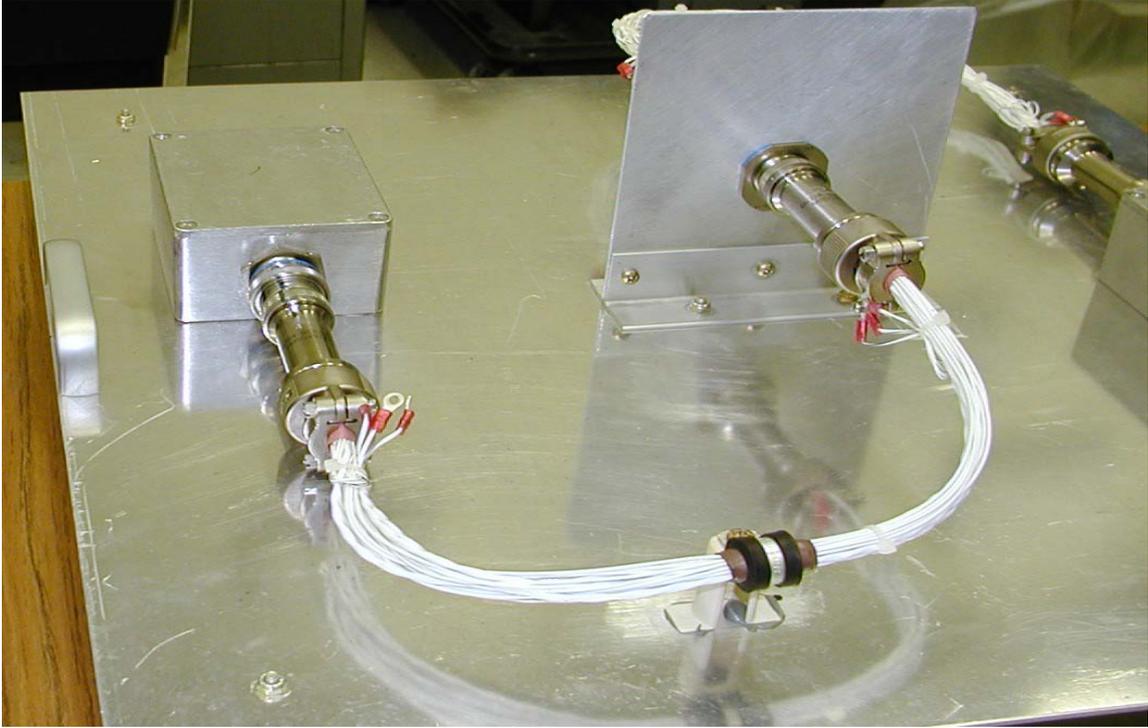
FIGURE 40. MEDIUM-LEVEL MECHANICAL DEGRADATION (TEST PANEL TYPE B)

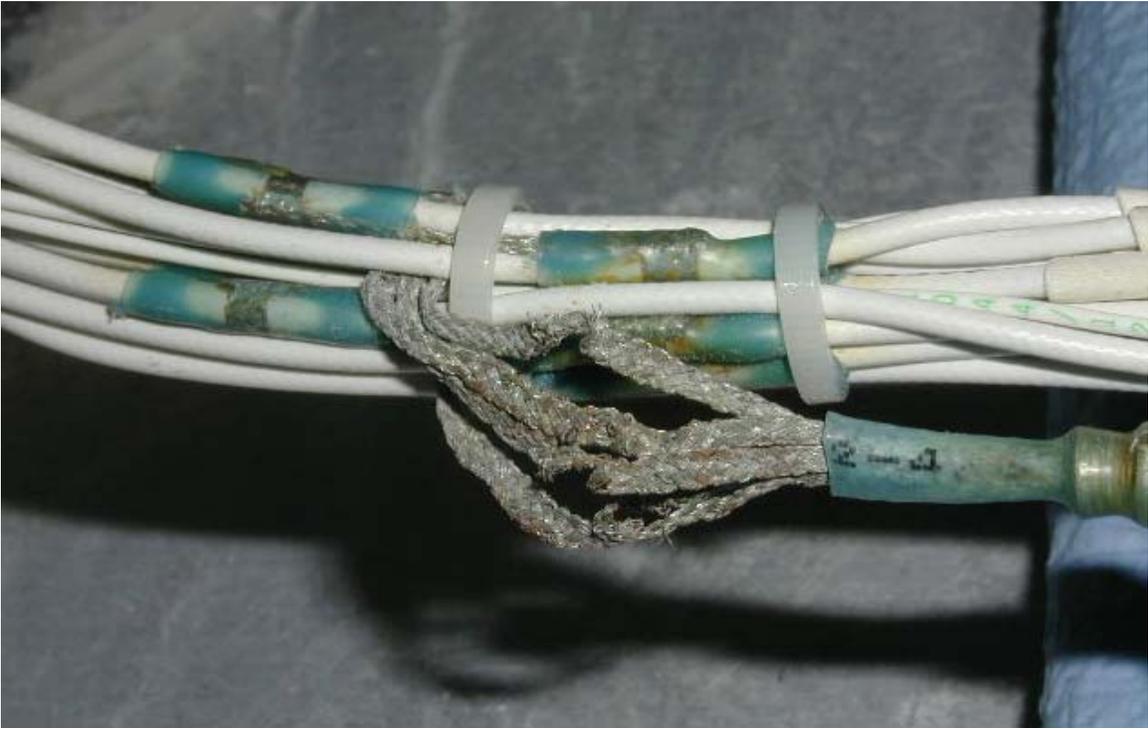
The half cut shields of test panel A3 were further severed for the maximum severity level. Figure 41 shows the severed braid shields for the high-level mechanical degradation. For test panel B1, five of six shield wires were disconnected for high-level degradation, as shown in figure 42. Visual inspection, loop resistance, and dc resistance measurements were recorded initially and after mechanical degradation was performed at each severity level.

FIGURE 41. HIGH-LEVEL MECHANICAL DEGRADATION (TEST PANEL TYPE A)

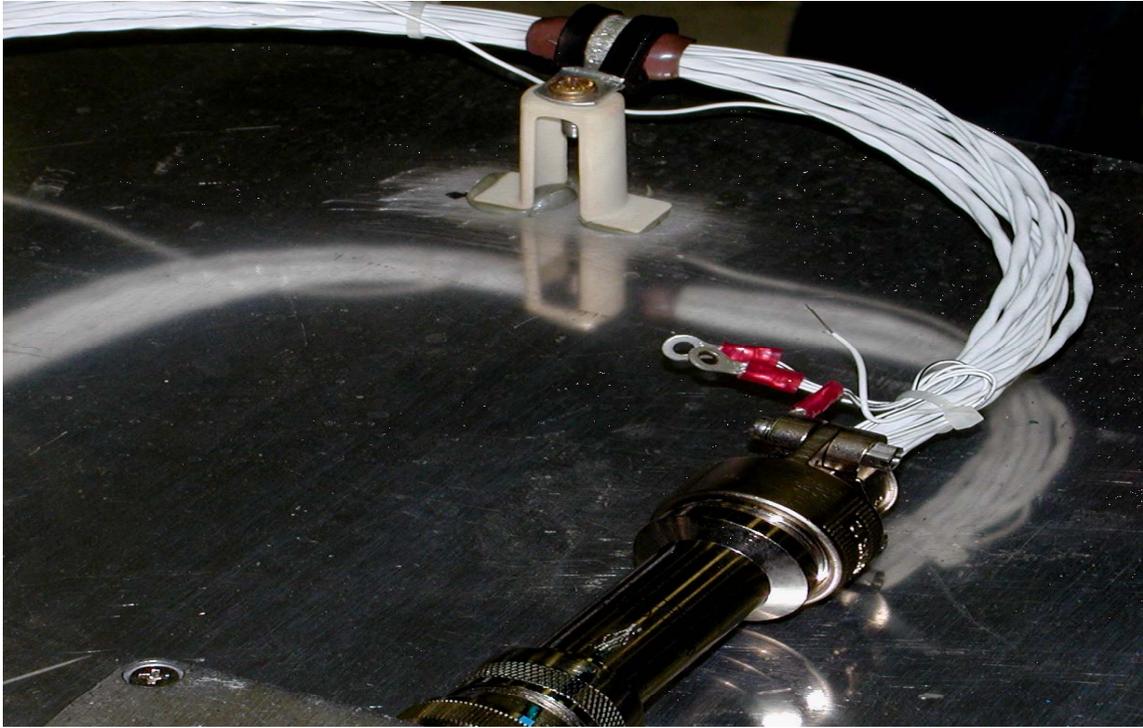
FIGURE 42. HIGH-LEVEL MECHANICAL DEGRADATION (TEST PANEL TYPE B)

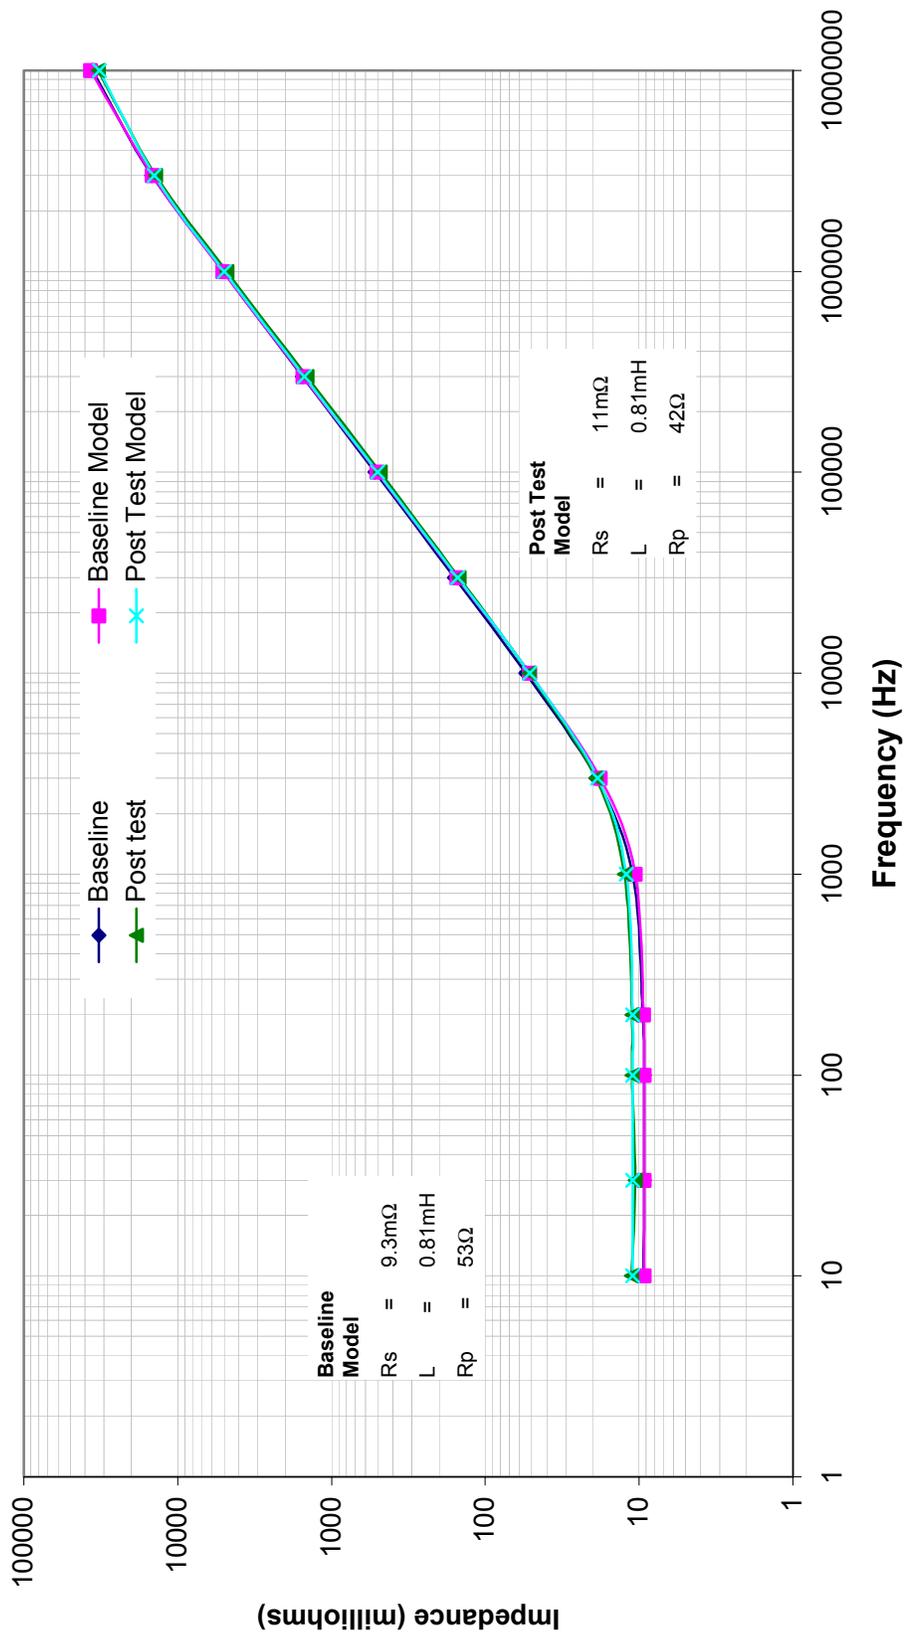
FIGURE 43. TOTAL LOOP IMPEDANCE CHARACTERISTICS BEFORE AND AFTER MECHANICAL DEGRADATION TEST (TEST PANEL A3)

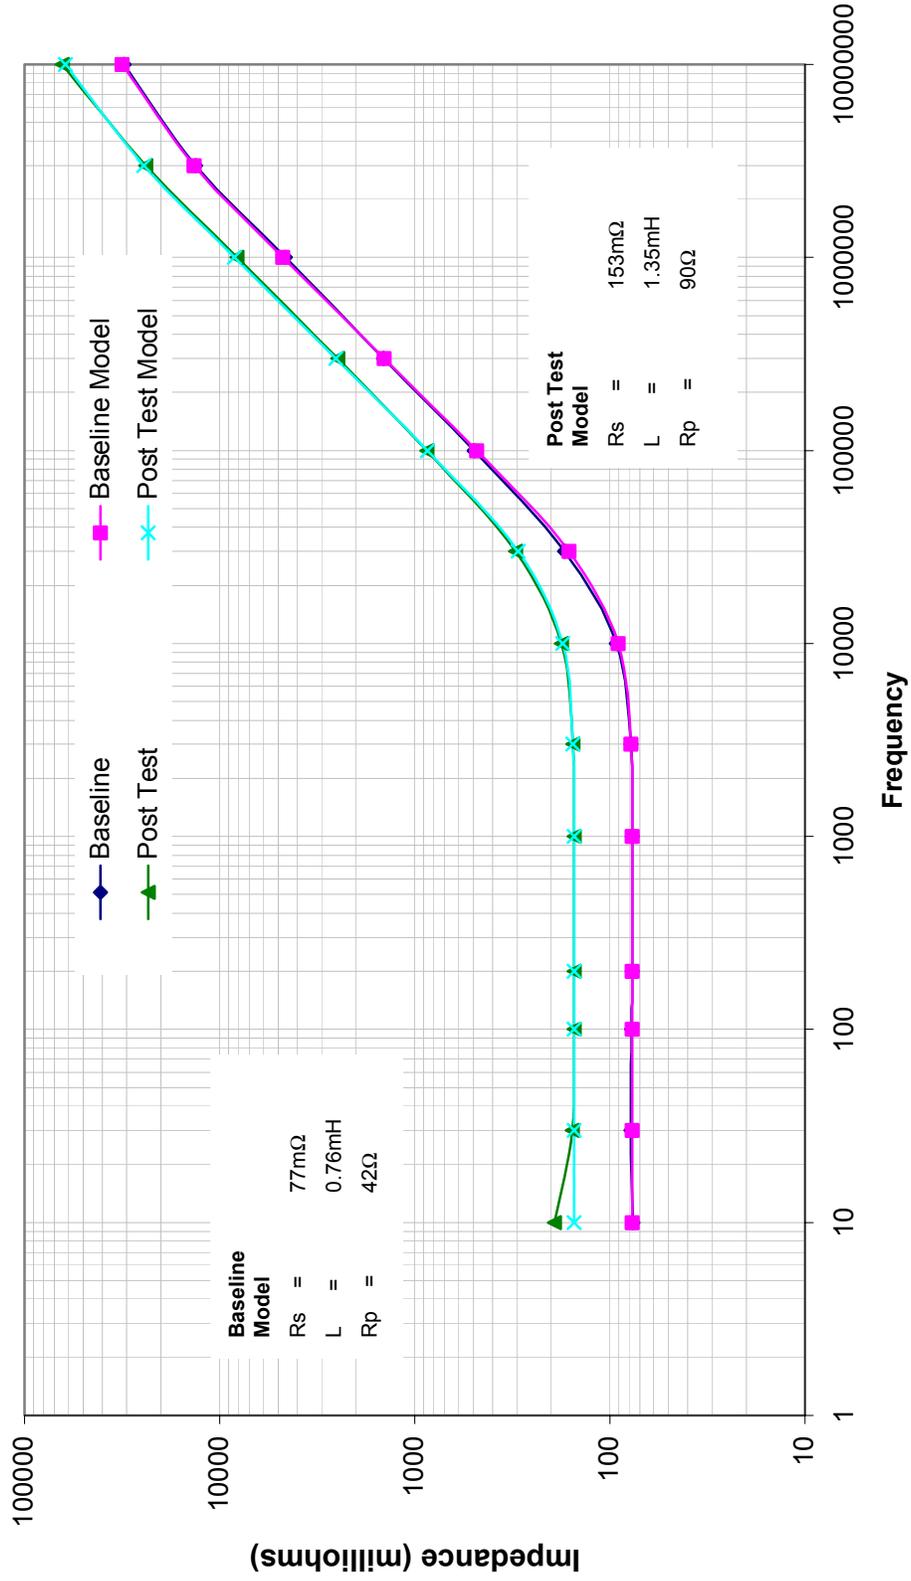
FIGURE 44. TOTAL LOOP IMPEDANCE CHARACTERISTICS BEFORE AND AFTER MECHANICAL DEGRADATION TEST (TEST PANEL B1)

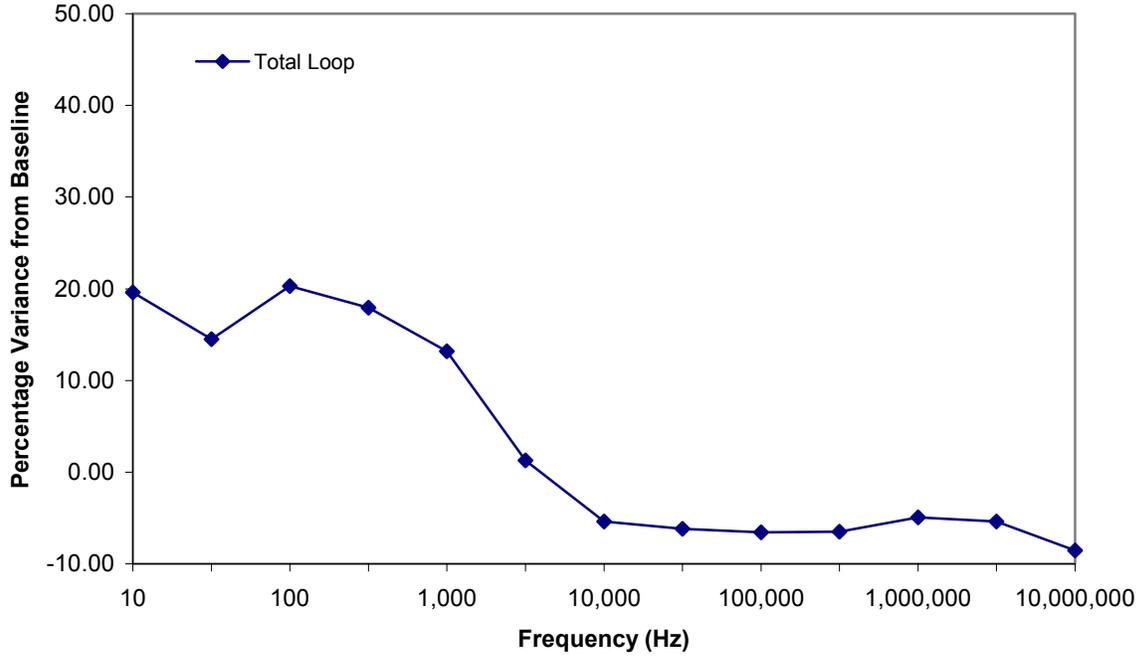
FIGURE 45. PERCENTAGE LOOP IMPEDANCE VARIATION AFTER MECHANICAL DEGRADATION TEST (TEST PANEL A3)

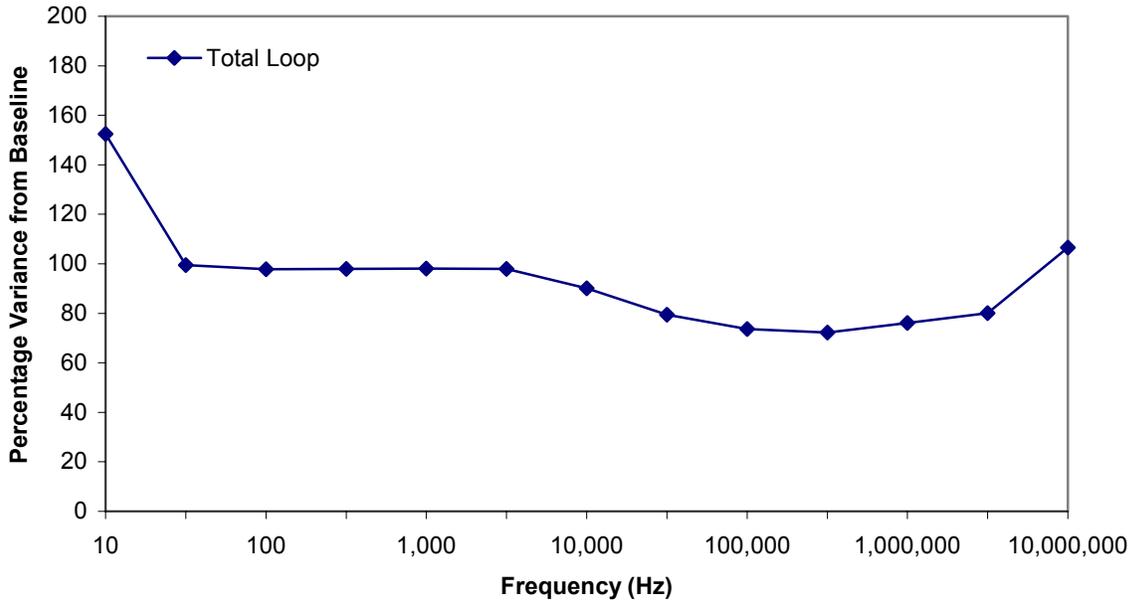
FIGURE 46. PERCENTAGE LOOP IMPEDANCE VARIATION AFTER MECHANICAL DEGRADATION TEST (TEST PANEL B1)

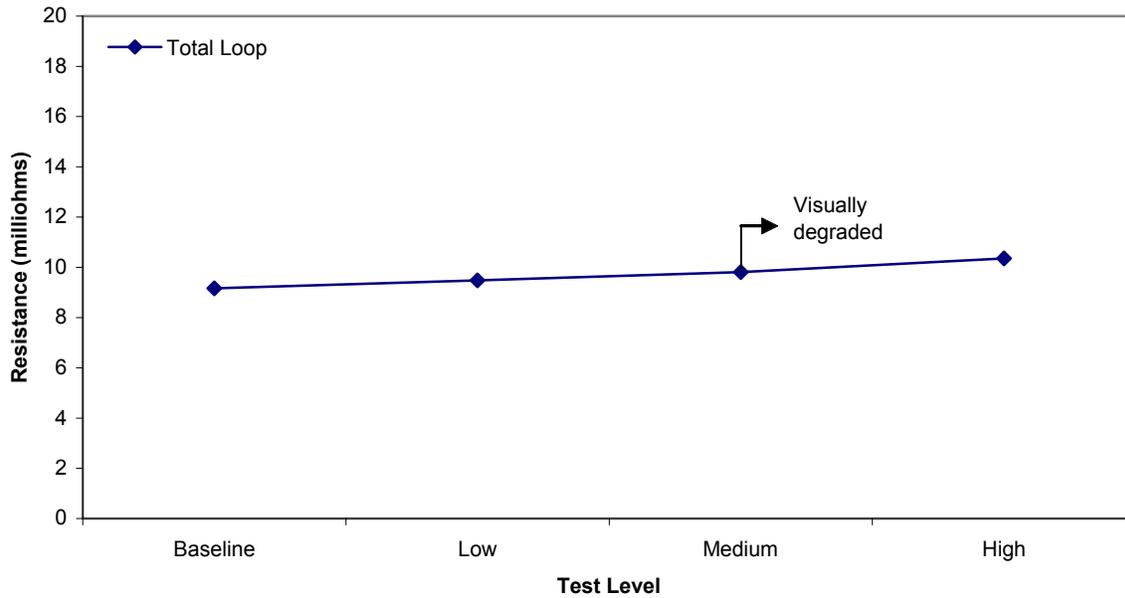
FIGURE 47. TOTAL LOOP RESISTANCE VALUES FOR MECHANICAL DEGRADATION TEST USING THE BOEING LRT (TEST PANEL A3)

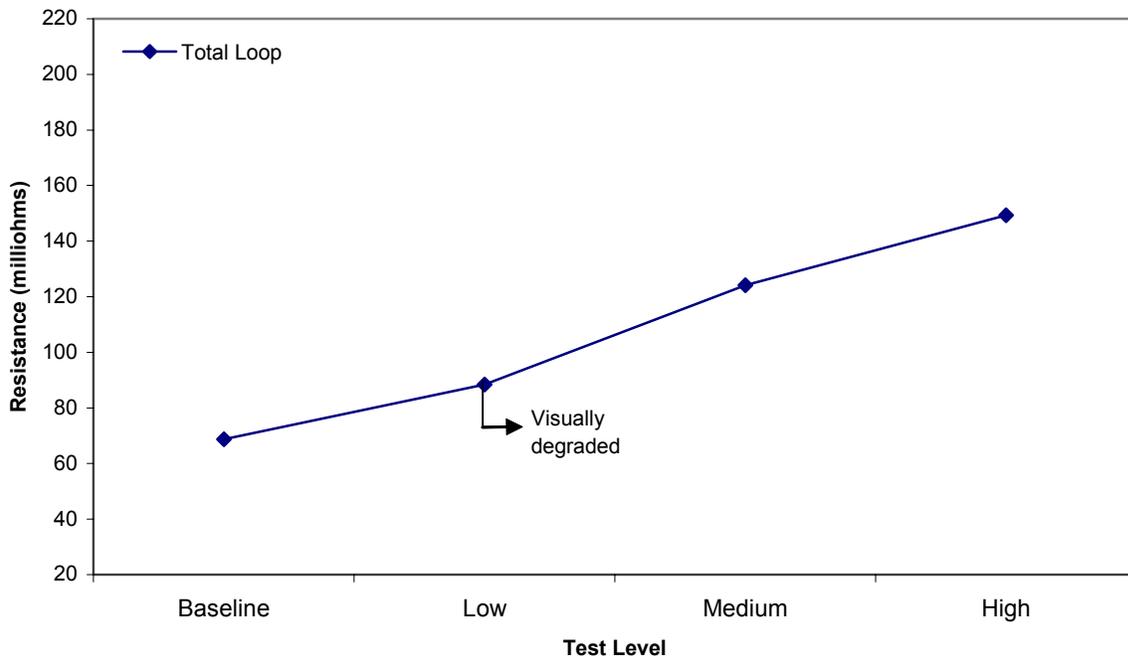
FIGURE 48. TOTAL LOOP RESISTANCE VALUES FOR MECHANICAL DEGRADATION TEST USING THE BOEING LRT (TEST PANEL B1)

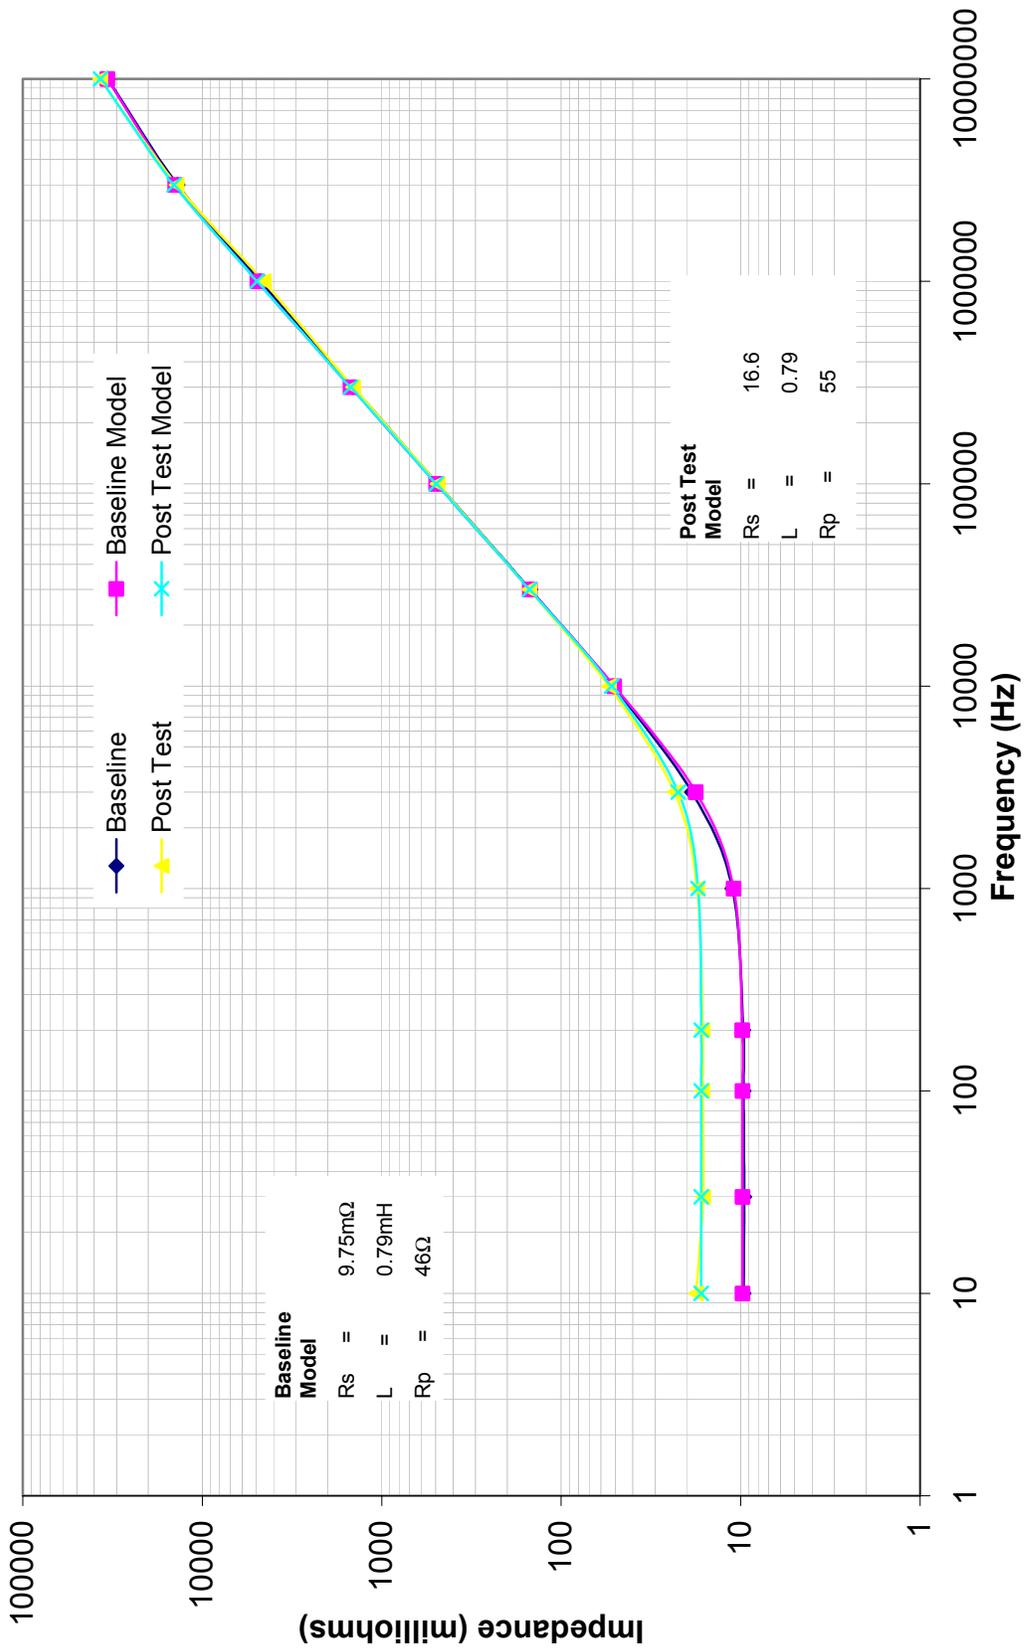
FIGURE 49. TOTAL LOOP IMPEDANCE CHARACTERISTICS BEFORE AND AFTER COMBINATION TESTS (TEST PANEL A5)

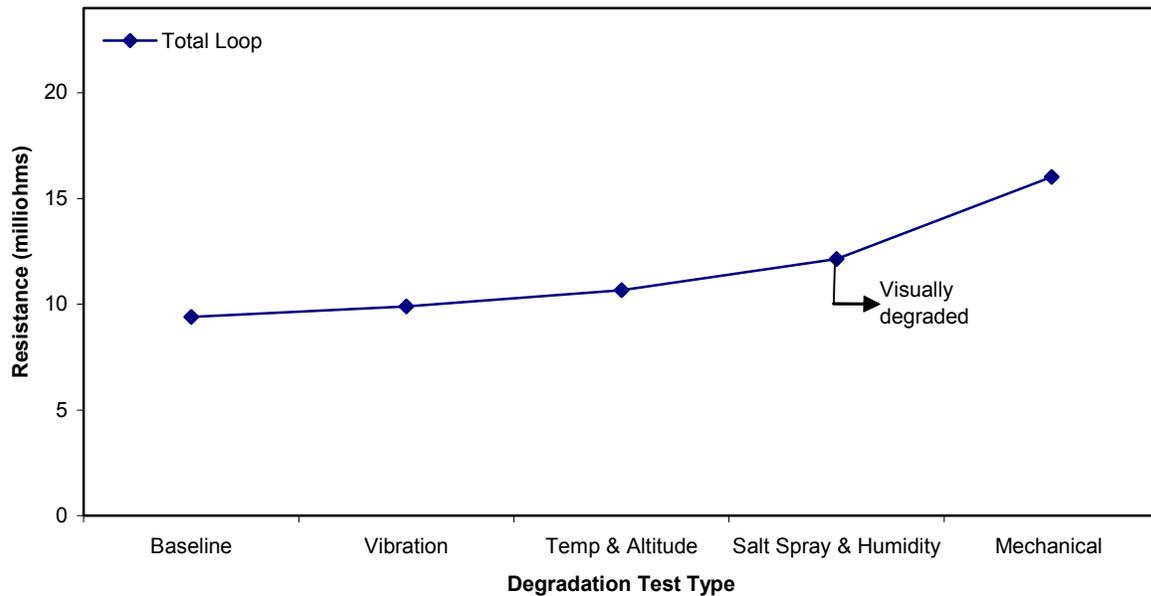
FIGURE 50. TOTAL LOOP RESISTANCE VALUES FOR COMBINATION TESTS USING THE BOEING LRT (TEST PANEL A5)
