**DOT/FAA/AR-04/12**

# **Aircraft Wiring Harness Shield Degradation Study**

August 2004

Final Report

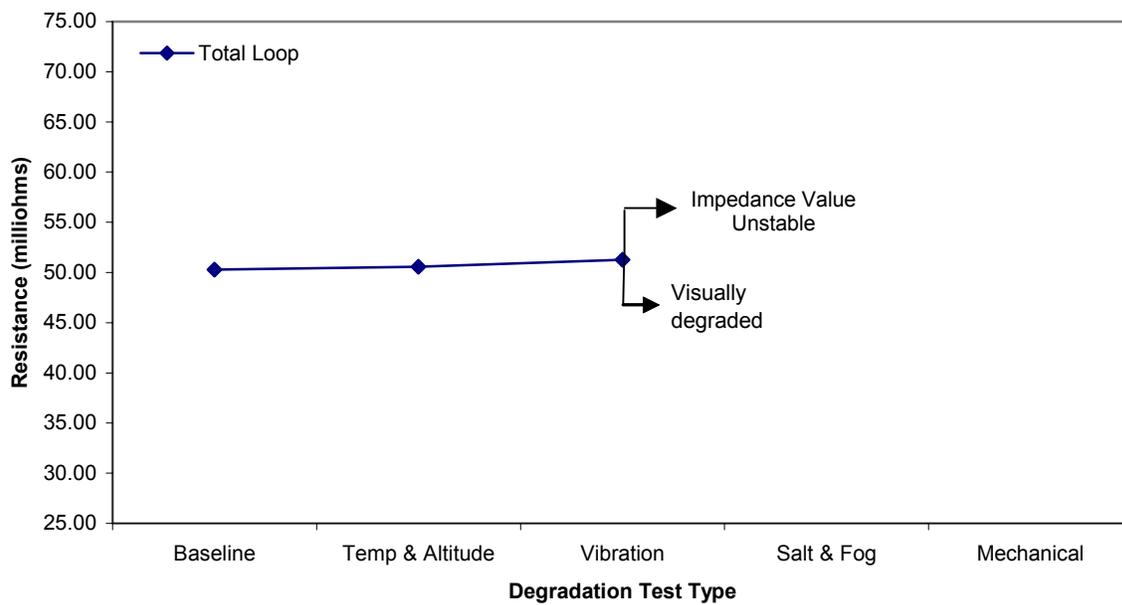
FIGURE 51. TOTAL LOOP RESISTANCE VALUES FOR COMBINATION TESTS USING THE BOEING LRT (TEST PANEL B5)

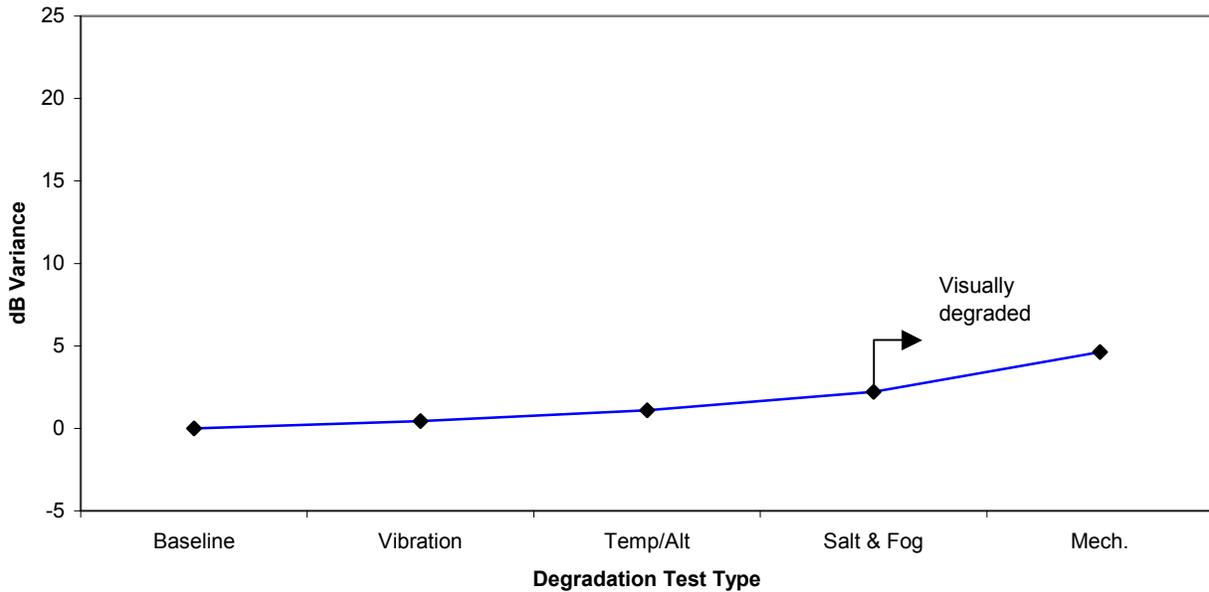
- Variation in loop resistance was within acceptable tolerance limits after all the degradation tests. Figure 52 shows the dB variance in loop resistance value after each degradation test on panel A5 (combination).
- Mechanical degradation has a more degrading effect on the loop impedance than any other environmental test.
- No significant change was measured in bonding, grounding, and connection resistances after all the degradation tests.

FIGURE 52. LOOP RESISTANCE VARIATION AFTER EACH DEGRADATION TEST

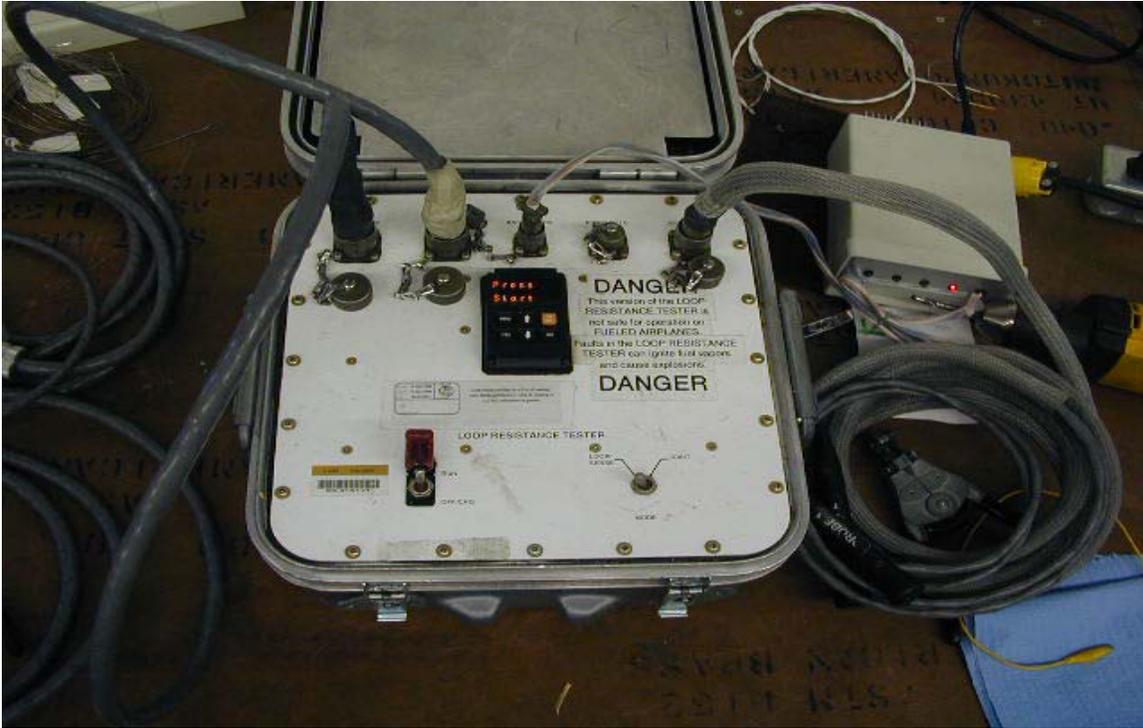
- Turn on the tester.
- Lift up the red protective cover and place the switch in the RUN position.
- Press the ON/OFF button on the center display. The loop impedance device will now run through a startup self-check.
- Connect the coupler probes to the LRT and place the other end on the wires to be tested.
- Place the mode switch into the loop mode.
- After the self-test is completed, the display will read BATTERY # # % showing the percentage charge on the battery; recharge the battery if needed. The display will then read PRESS START.
- Press the start button from either of the two couplers attached to the coupler probes to the start loop impedance measurement.

FIGURE A-1. LOOP RESISTANCE TESTER

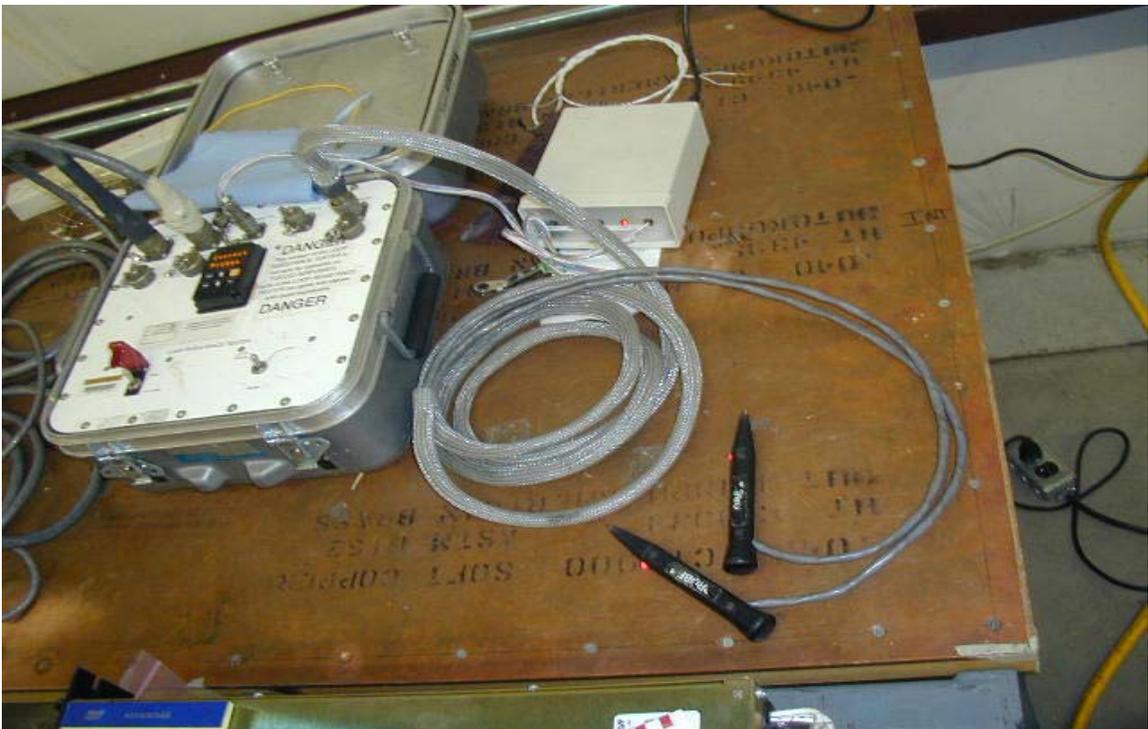
- Place the mode switch to joint mode.
- Connect the joint probes to isolate the bad joint, where the change in resistance occurred. (The tips of the joint probes are spring loaded.) While taking a measurement, press down on the probes for proper contact. Note that the coupler probes stay connected in the joint mode also.
- The LEDs will turn from red to green and the measurement will be displayed.

FIGURE A-3. JOINT PROBES ATTACHED TO THE LRT

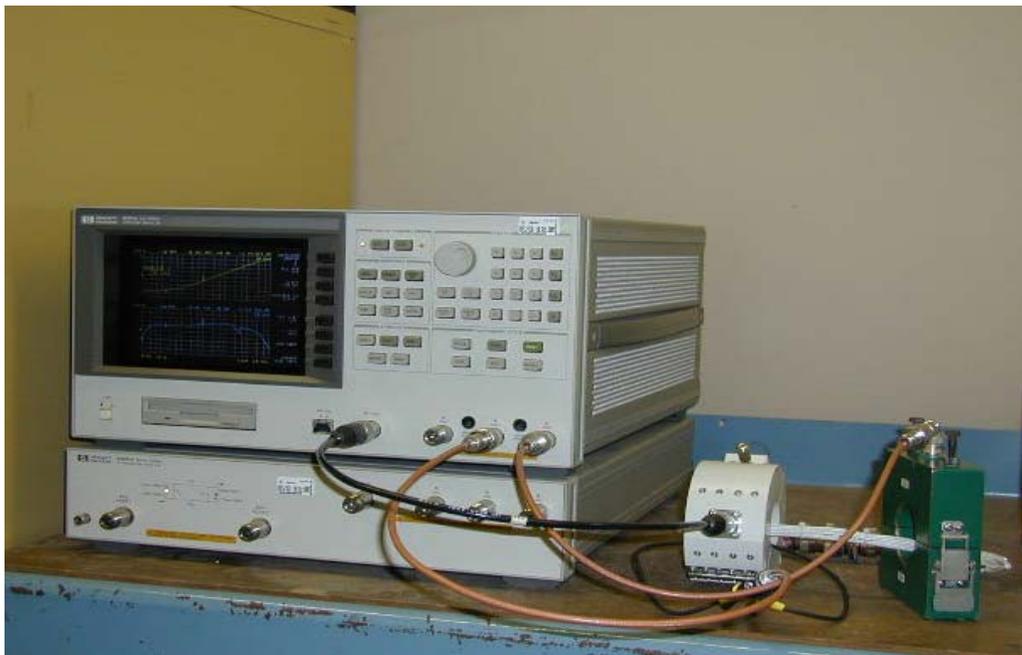
FIGURE B-1. TEST SETUP FOR IMPEDANCE MEASUREMENT

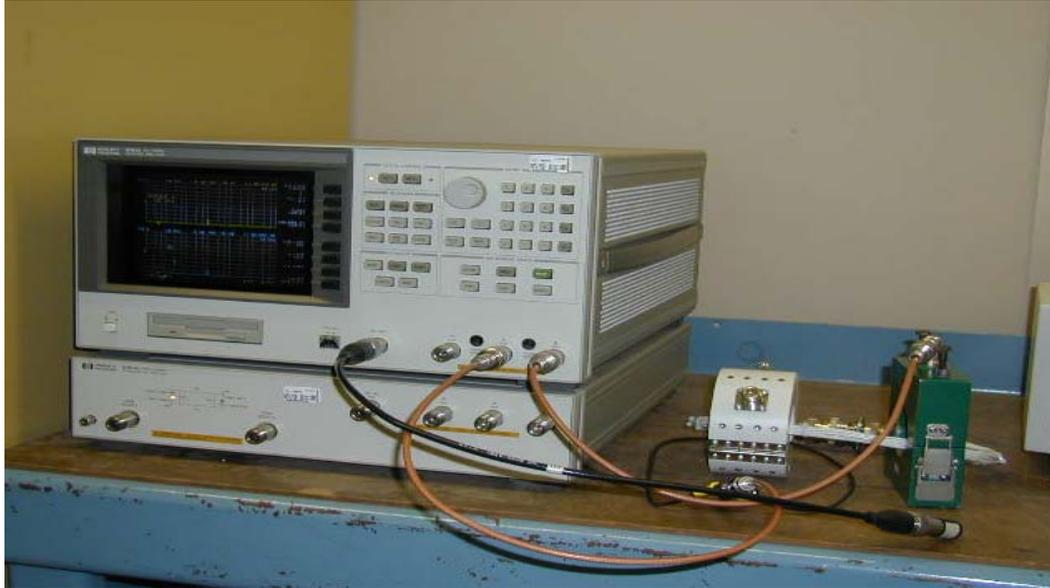
FIGURE B-2. NOISE REDUCTION SETUP

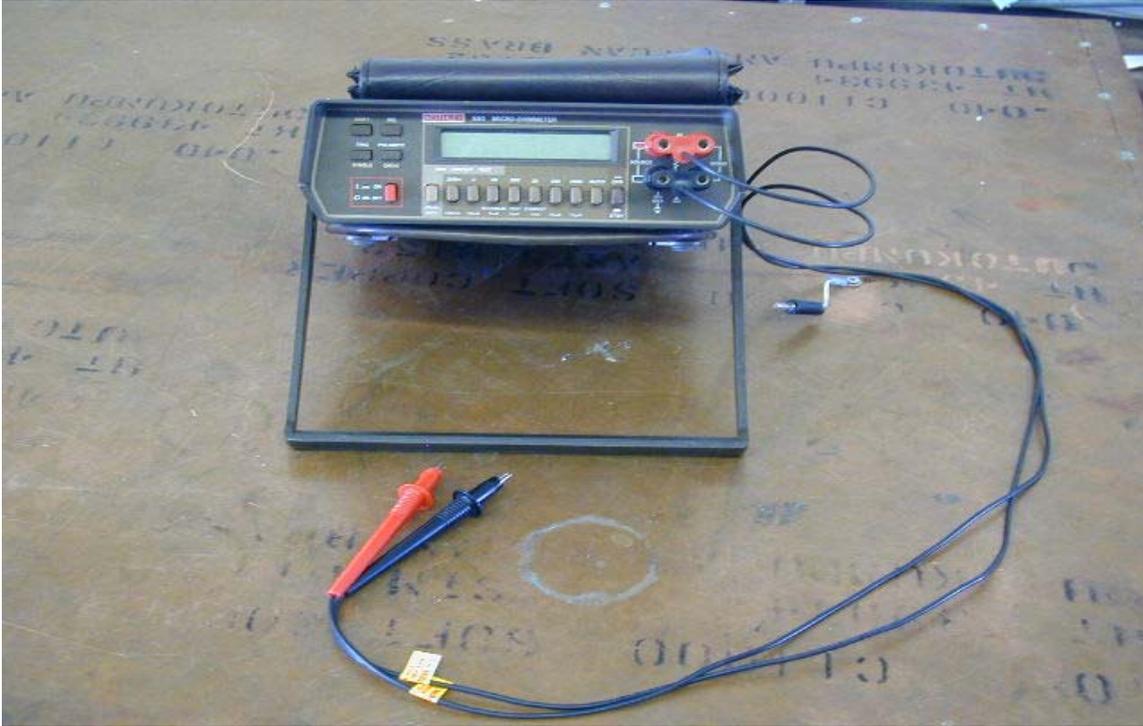
FIGURE C-1. KEITHLEY MODEL 580 MICRO-OHMMETER

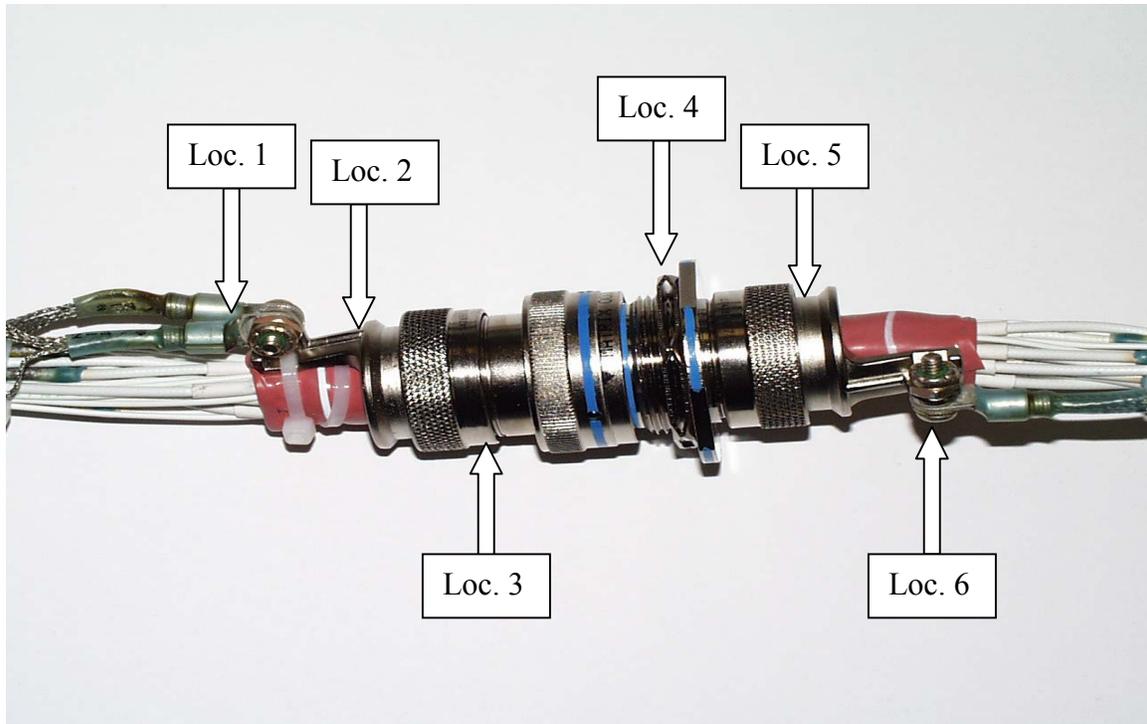
FIGURE C-2. DIRECT CURRENT RESISTANCE TEST LOCATIONS  
(CENTER CONNECTOR, TEST PANEL TYPE A)

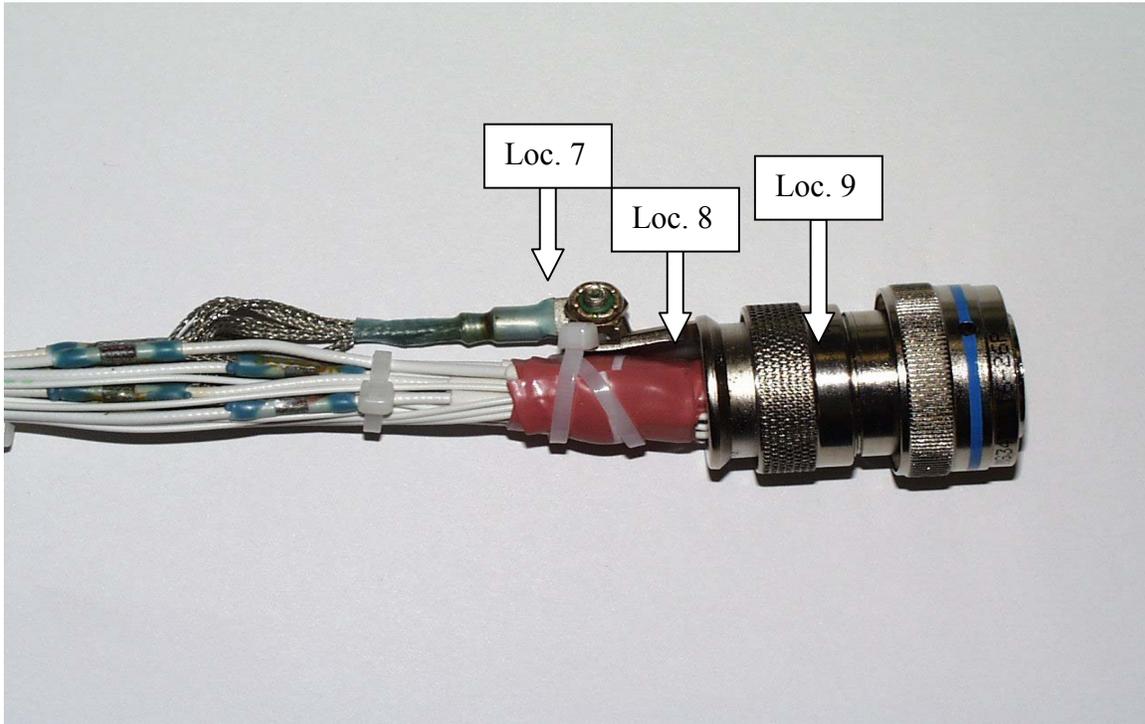
FIGURE C-3. DIRECT CURRENT RESISTANCE TEST LOCATIONS  
(END CONNECTOR, TEST PANEL TYPE A)

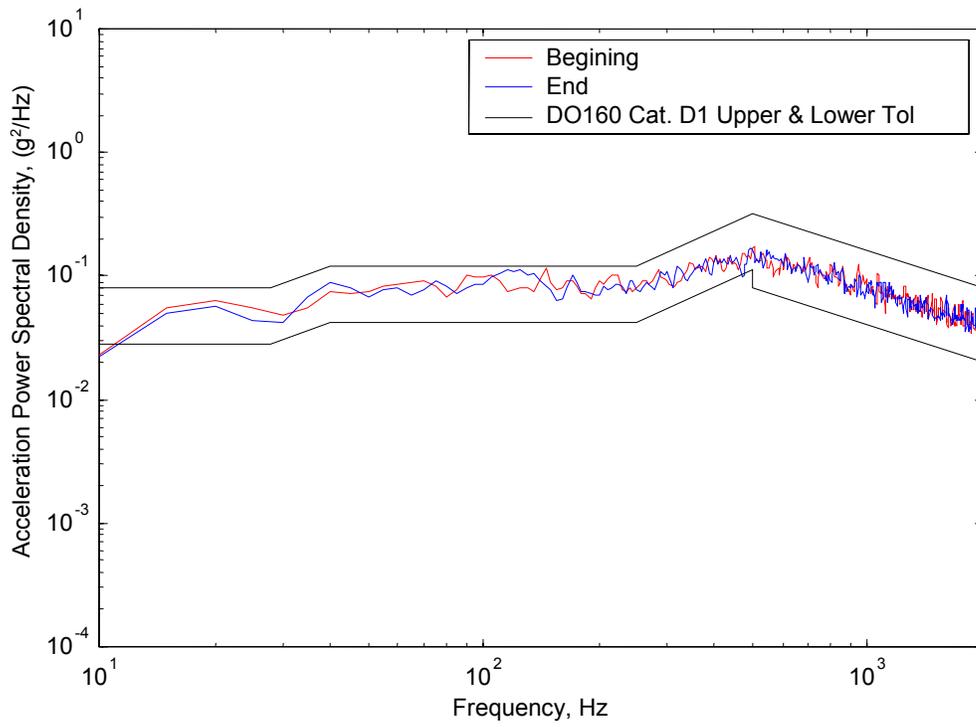
FIGURE D-1. TEST PANEL A4—X AXIS—CONTROL ACCELEROMETER

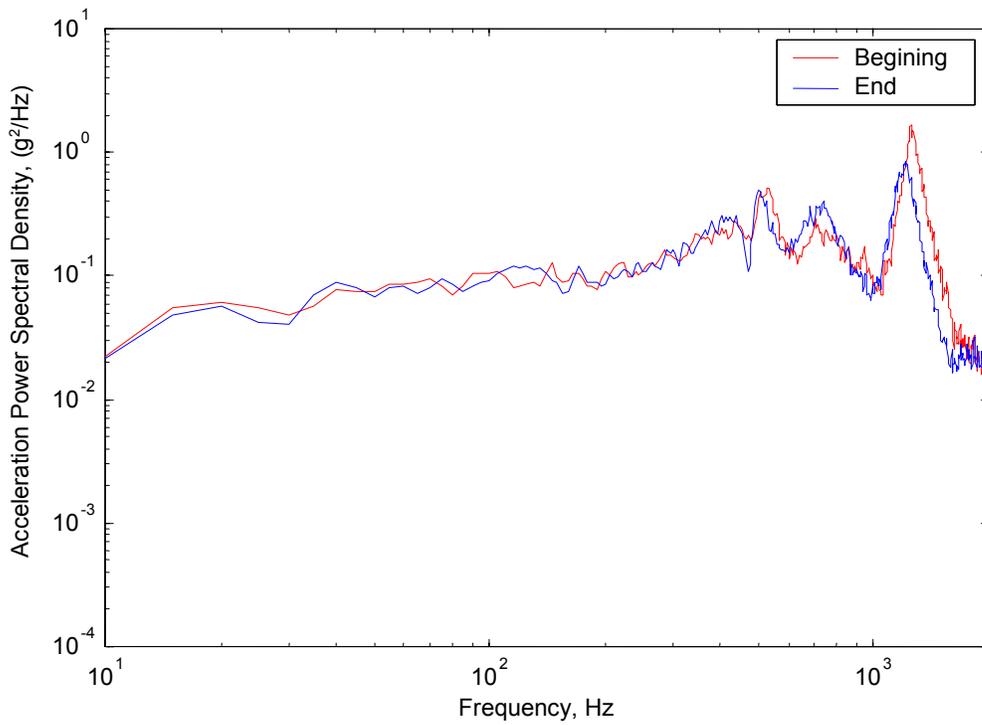
FIGURE D-2. TEST PANEL A4—X AXIS—RESPONSE ACCELEROMETER

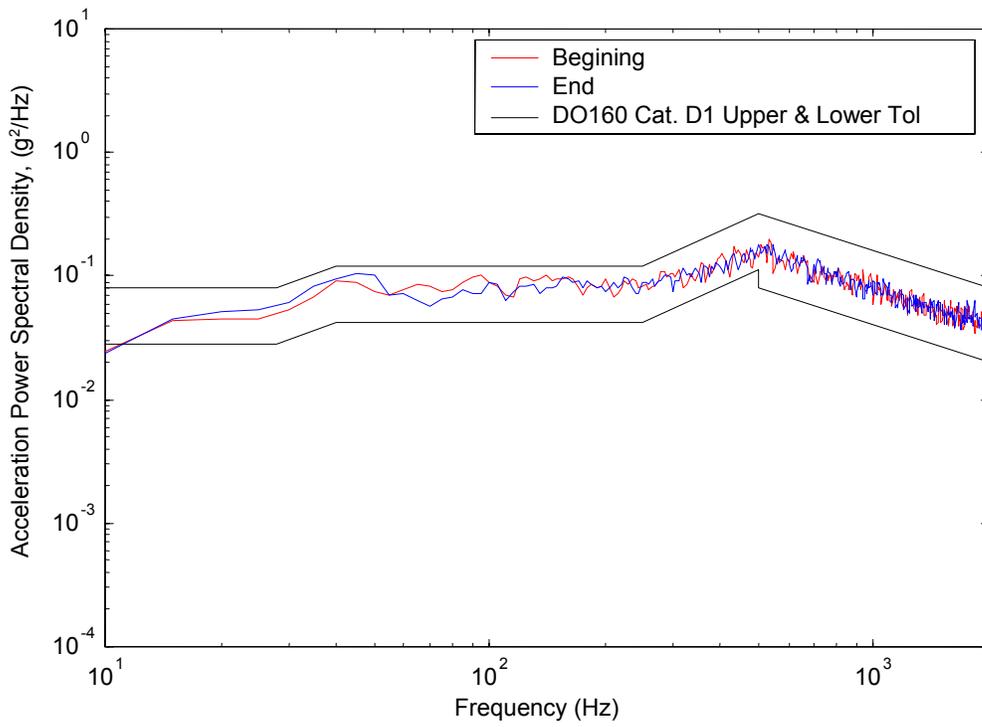
FIGURE D-3. TEST PANEL A4—Y AXIS—CONTROL ACCELEROMETER

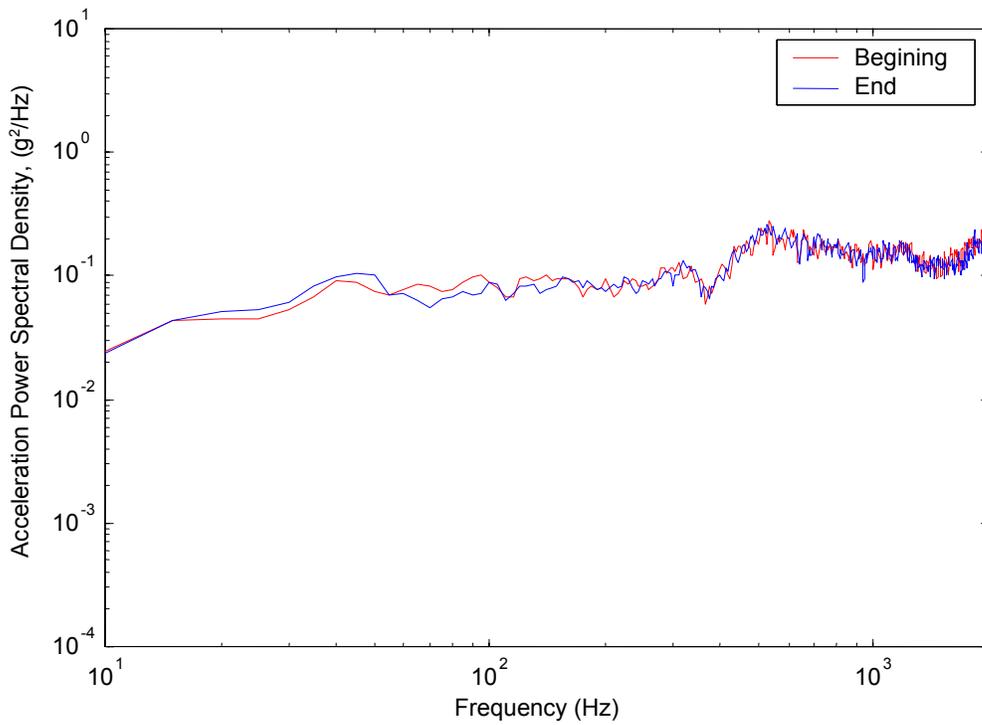
FIGURE D-4. TEST PANEL A4—Y AXIS—RESPONSE ACCELEROMETER

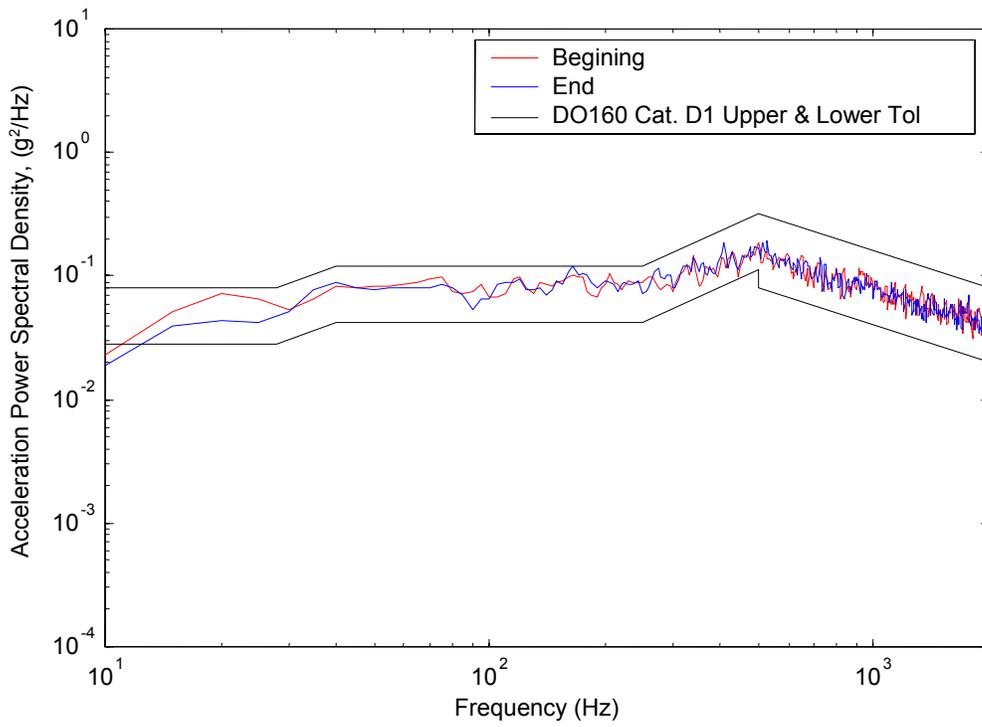
FIGURE D-5. TEST PANEL A4—Z AXIS—CONTROL ACCELEROMETER

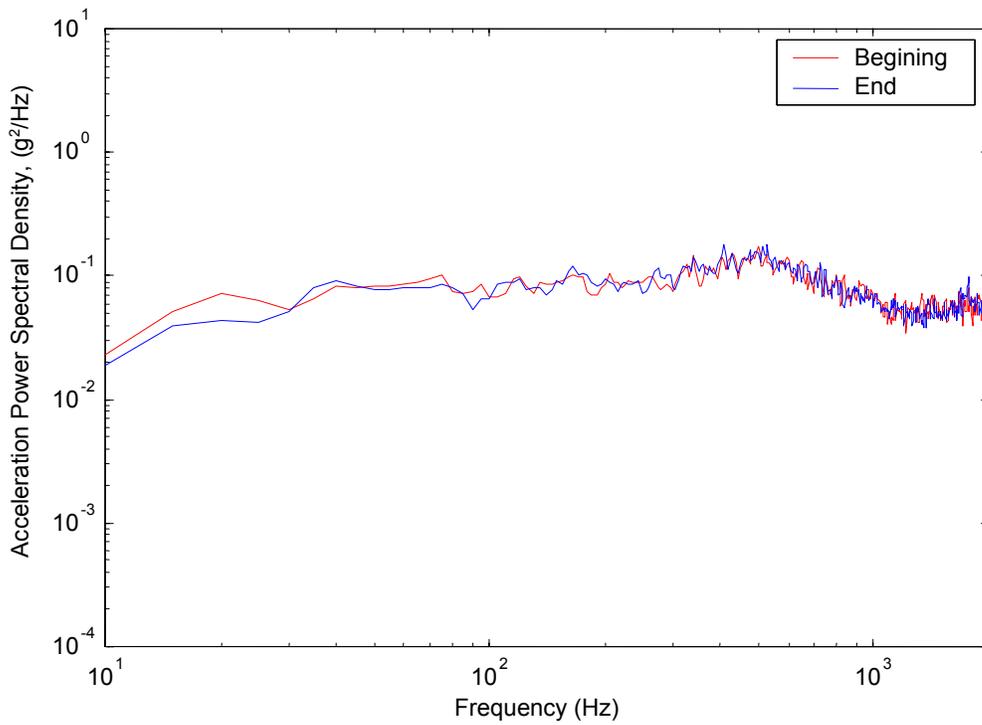
FIGURE D-6. TEST PANEL A4—Z AXIS—RESPONSE ACCELEROMETER

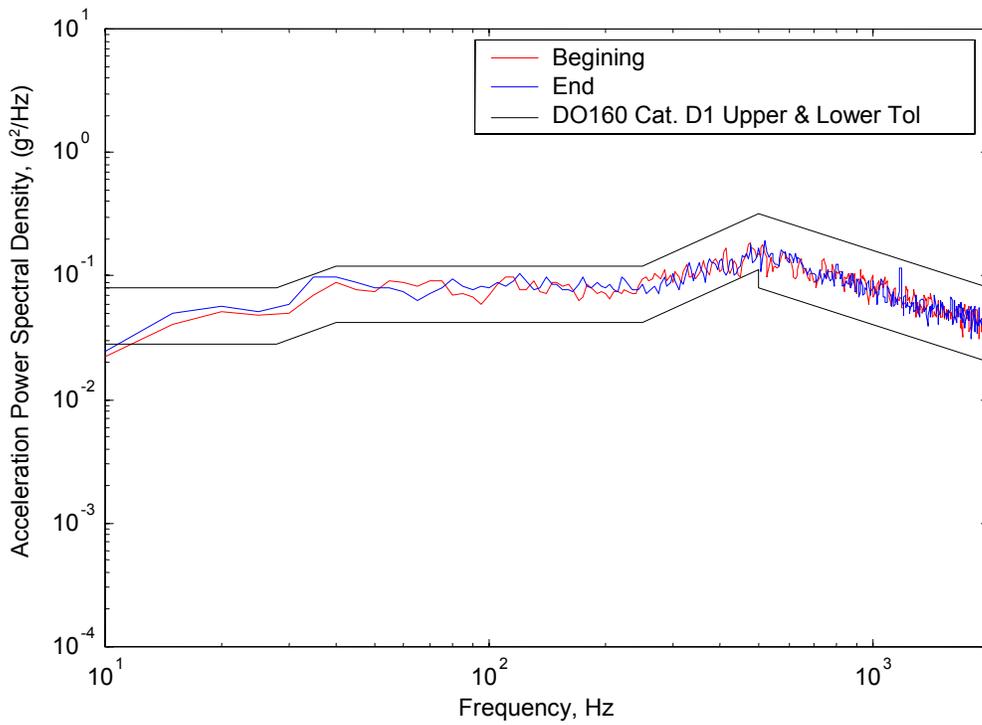
FIGURE D-7. TEST PANEL A5—X AXIS—CONTROL ACCELEROMETER

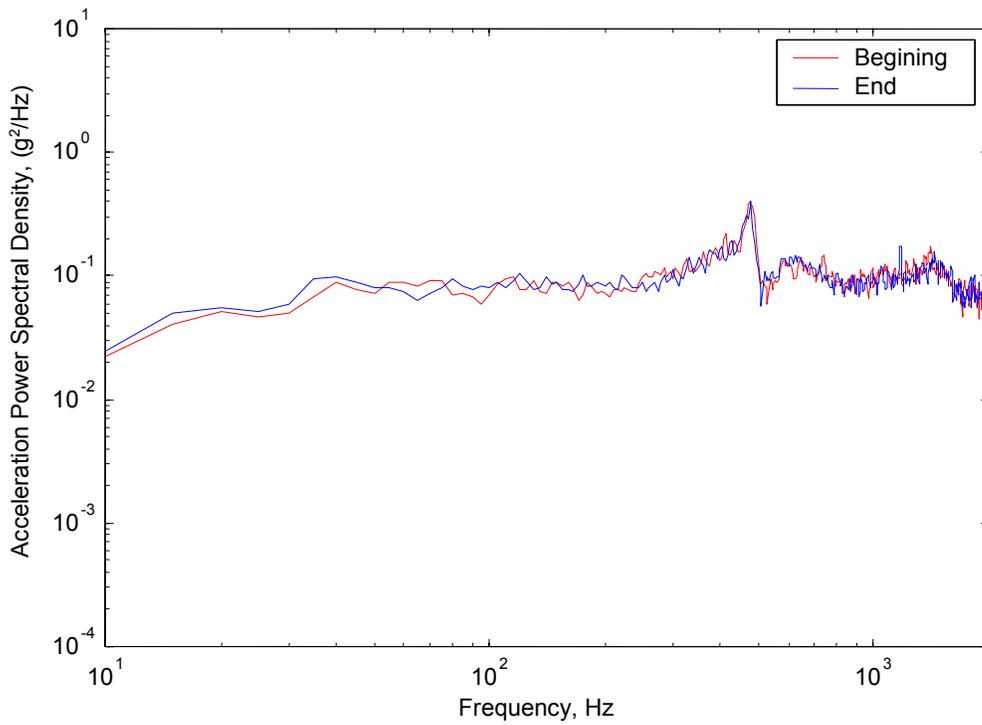
FIGURE D-8. TEST PANEL A5—X AXIS—RESPONSE ACCELEROMETER

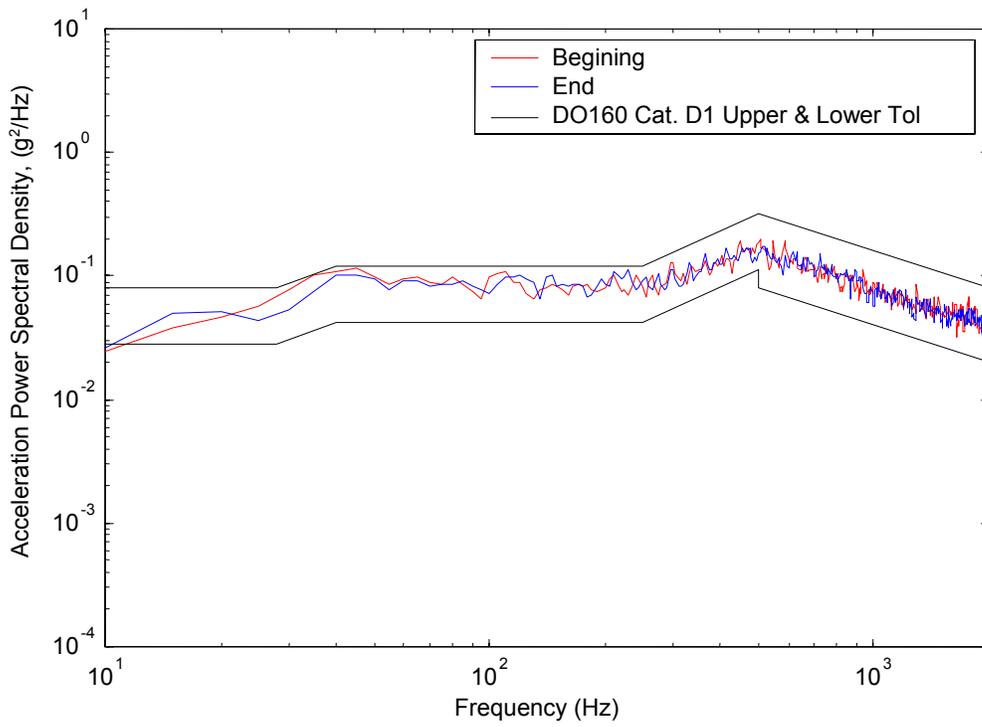
FIGURE D-9. TEST PANEL A5—Y AXIS—CONTROL ACCELEROMETER

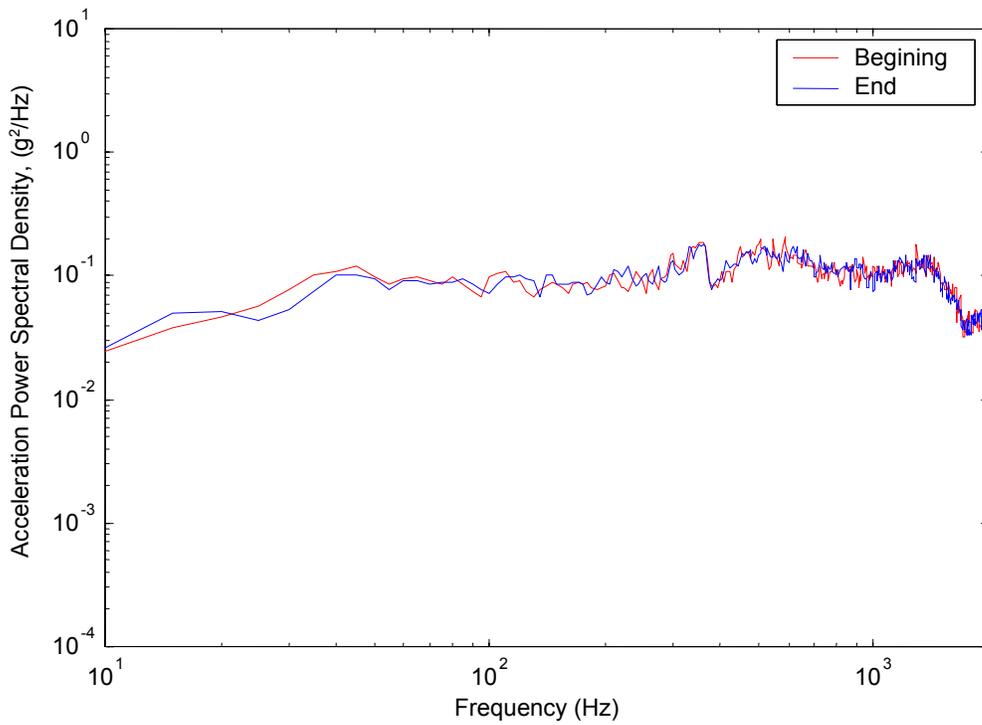
FIGURE D-10. TEST PANEL A5—Y AXIS—RESPONSE ACCELEROMETER

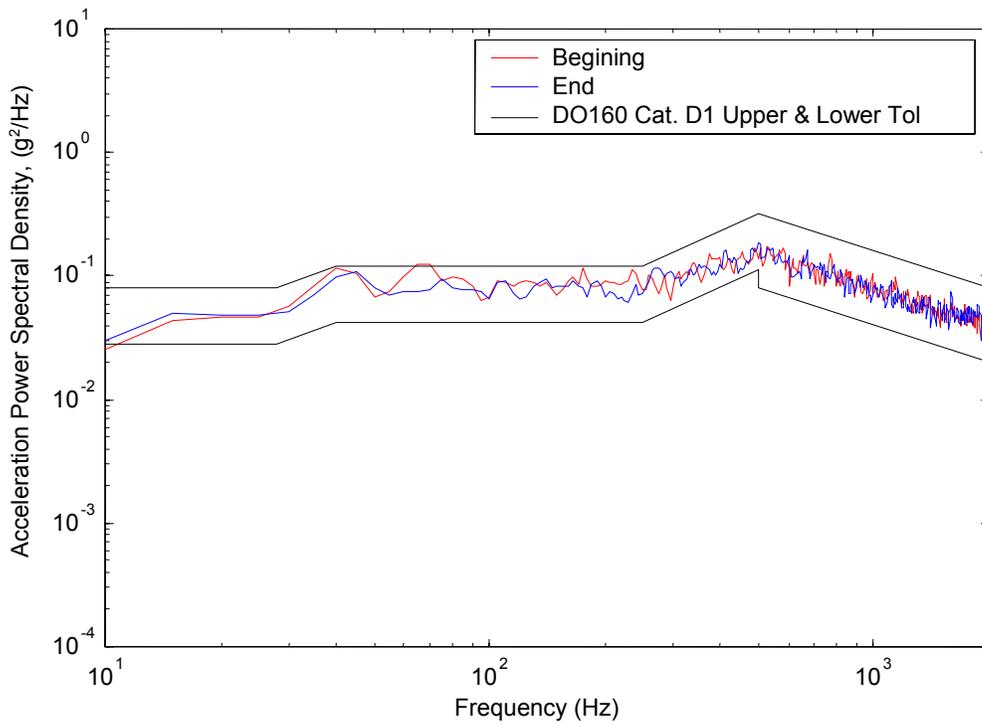
FIGURE D-11. TEST PANEL A5—Z AXIS—CONTROL ACCELEROMETER

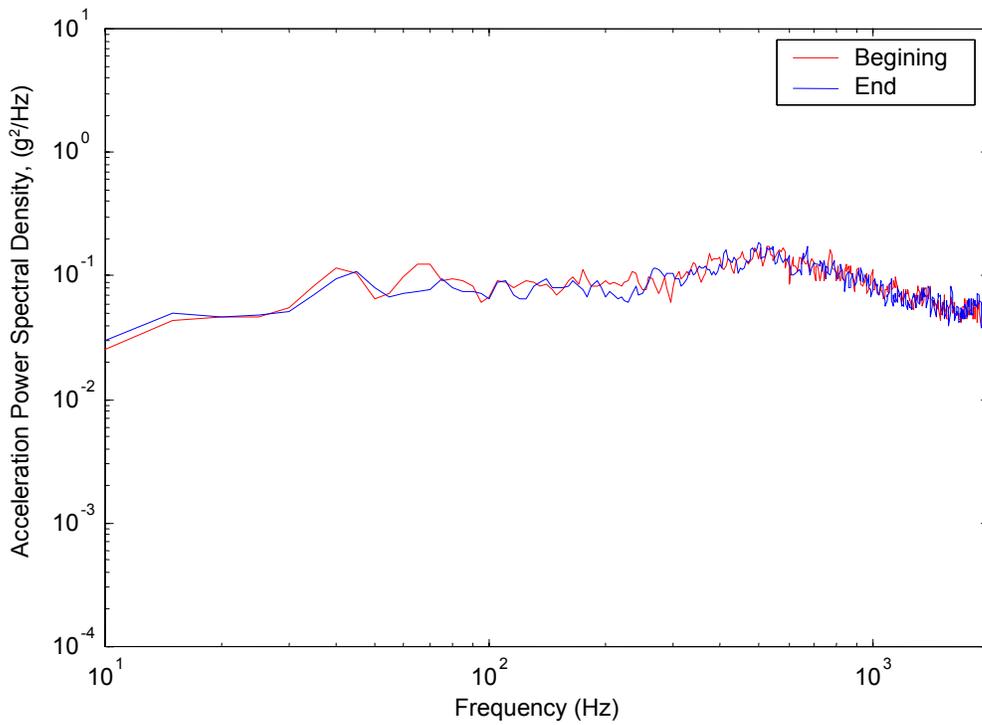
FIGURE D-12. TEST PANEL A5—Z AXIS—RESPONSE ACCELEROMETER
