**DOT/FAA/AR-05/26**

# **The Effects of Mixed Wire Types in Aircraft Electrical Wiring Interconnection Systems**

September 2005

Final Report

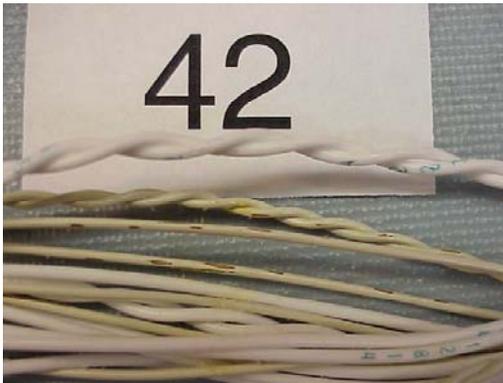
FIGURE 12. MODERATE WIRE-TO-WIRE WEAR ON GROUP I XPI IN BUNDLE MIXED WITH PTFE

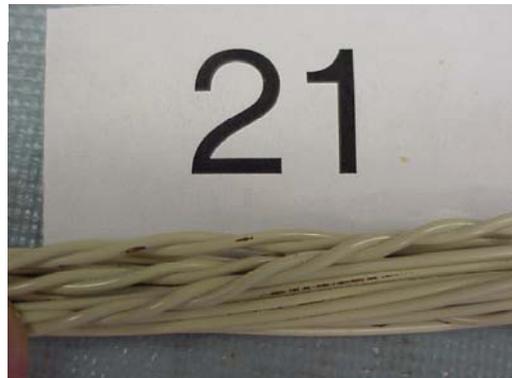
FIGURE 13. MODERATE WIRE-TO-WIRE WEAR IN GROUP I NONMIXED XPI BUNDLE

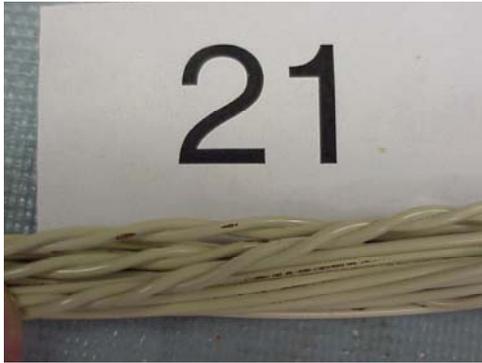
The one XPI wire that failed the wet DWV test was determined to be from a combination of wear from wire-to-wire interaction and wear from the clamps in the nonmixed bundle (see figure 14).

FIGURE 14. MODERATE WIRE WEAR FROM CLAMPS ON NONMIXED XPI BUNDLE IN GROUP I

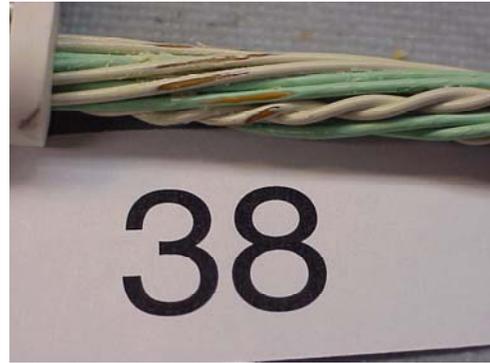
FIGURE 15. MODERATE WIRE WEAR FROM CLAMP ON PI/PTFE AND XPI IN GROUP I

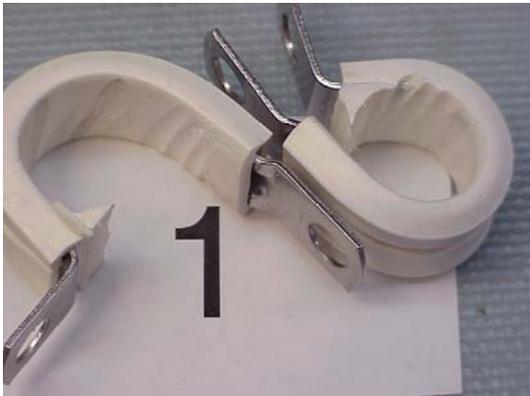
The clamps were the only support components (clamps, straps, and lacing string) that exhibited moderate wear. In these cases, either PVC/glass/nylon or PTFE/glass wires were in the bundles (see figures 18 and 19). This might be explained by the abrasive nature of the glass component within the PTFE/glass insulation and the slightly harder outer coating of the PVC/glass/nylon wire.

FIGURE 18. MODERATE WEAR ON CLAMP FROM PVC/GLASS/NYLON AND MF-PTFE GROUP I BUNDLE

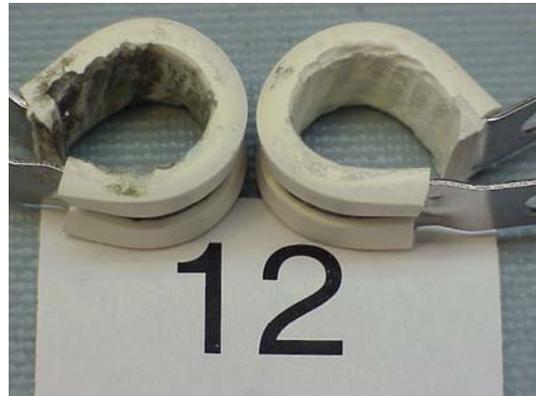
FIGURE 19. MODERATE WEAR OF CLAMP FROM NONMIXED PTFE/GLASS BUNDLE IN GROUP I

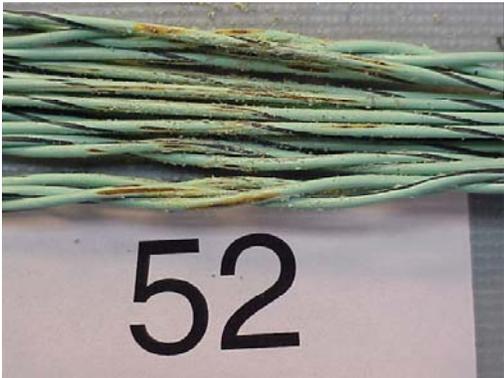
FIGURE 29. MODERATE WIRE-TO-WIRE WEAR IN GROUP IIF NONMIXED PI BUNDLE

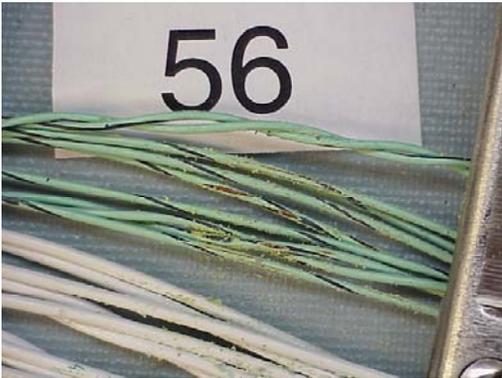
FIGURE 30. MODERATE WIRE-TO-WIRE WEAR ON PI WHEN MIXED WITH MF-PTFE IN GROUP IIF

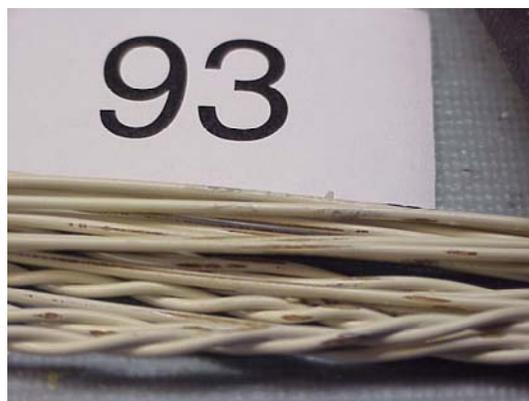
FIGURE 40. MODERATE WIRE-TO-WIRE WEAR ON XPI IN NONMIXED GROUP IIM BUNDLE

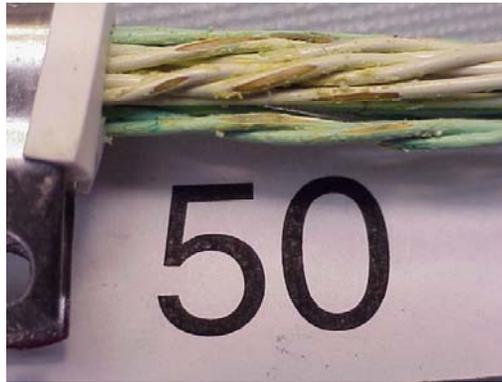
The only electrical failures detected in a fluid-contaminated bundle were on PI/PTFE wires (code 10) that were mixed with XPI wires (code 3). Although a little wire-to-wire and wire-to-fixture plate wear was noted, the failures were attributed to the severe wear from the clamps, as shown in figure 41.

FIGURE 41. SEVERE WEAR ON PI/PTFE FROM CLAMP WHEN MIXED WITH XPI IN GROUP IIF

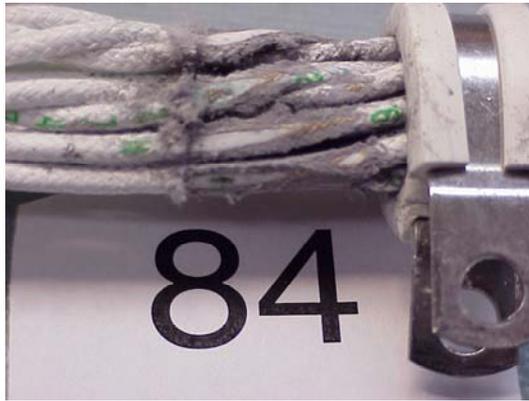
The only wet electrical failures on the bundles contaminated with the metal shavings were on a nonmixed bundle of PTFE/glass wires (code 9). This bundle exhibited severe wear from the clamps (see figure 44), and showed signs of a little wear from the vibration plate and wire-to-wire interaction.

FIGURE 44. SEVERE WEAR OF PTFE/GLASS WIRE FROM CLAMP IN GROUP IIM  
NONMIXED BUNDLE

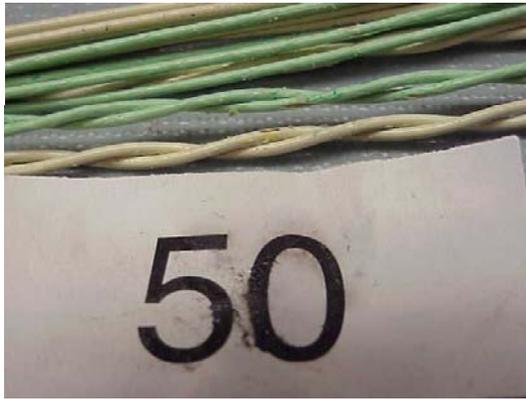
PI/PTFE wires (code 10) showed less wear in the nonmixed bundle than in bundles mixed with XPI and MF-PTFE (see figures 47 and 48).

FIGURE 47. MODERATE WEAR OF XPI AND PI/PTFE FROM STRAP IN GROUP IIF

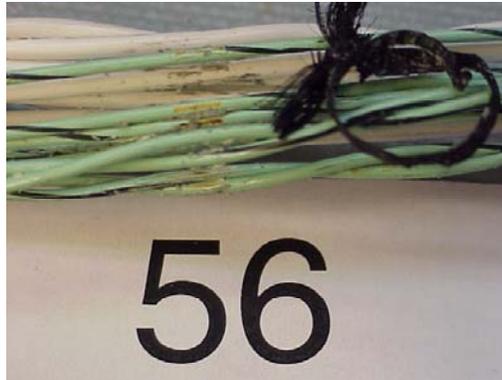
FIGURE 49. MODERATE WEAR ON PI FROM LACING STRING WHEN MIXED WITH MF-PTFE IN GROUP IIF

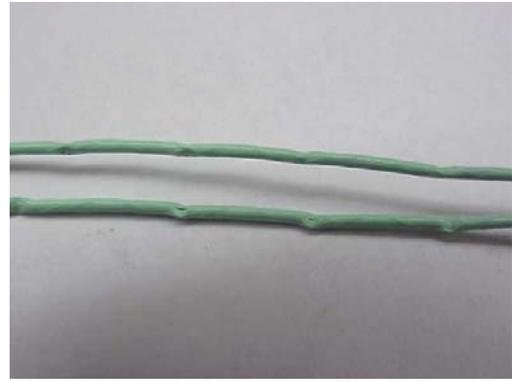
FIGURE 51. PI/PTFE ALLOY WIRE  
DAMAGED FROM PI/PTFE WIRE IN  
THE 80-POUND CRUSH TEST

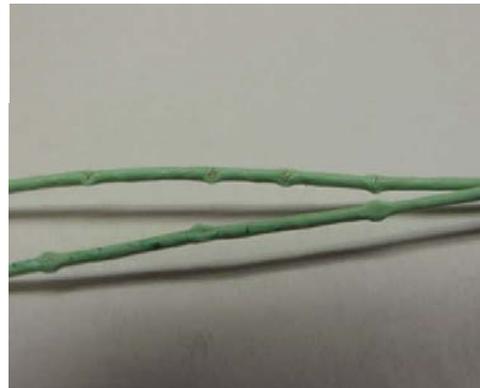
FIGURE 53. PI/PTFE ALLOY WIRE  
DAMAGED BY SAME WIRE TYPE IN  
THE 120-POUND CRUSH TEST

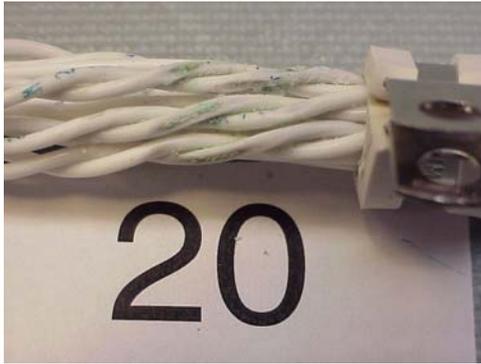
FIGURE D-1. SEVERE WIRE WEAR FROM CLAMP IN GROUP I PTFE WIRE NONMIXED BUNDLE

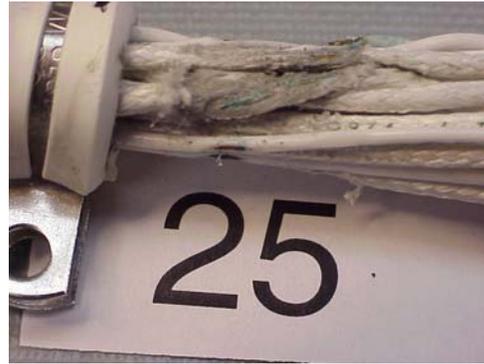
FIGURE D-2. SEVERE WEAR OF PTFE AND PTFE/GLASS WIRES FROM CLAMP IN GROUP I

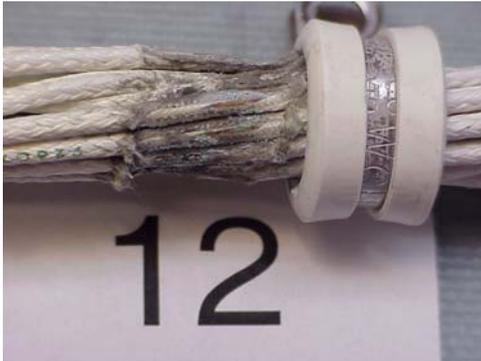
FIGURE D-3. SEVERE WEAR OF PTFE/GLASS WIRE FROM CLAMP IN NONMIXED GROUP I BUNDLE

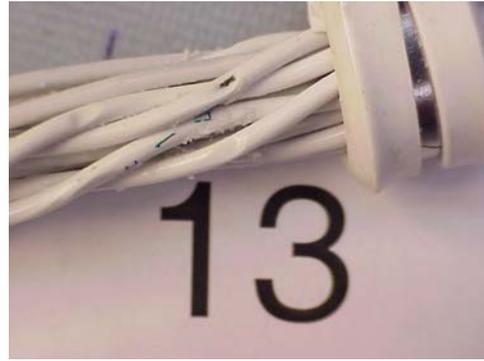
FIGURE D-4. SEVERE WEAR OF MF-PTFE WIRE FROM CLAMP IN GROUP I NONMIXED BUNDLE

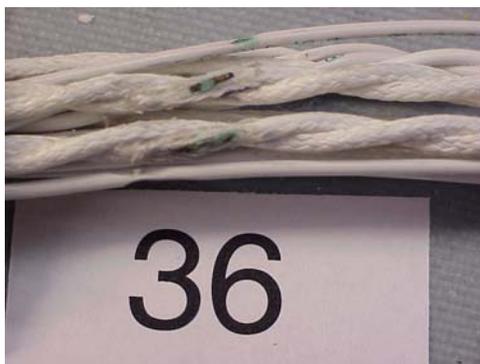
FIGURE D-5. SEVERE WEAR OF PTFE/GLASS AND MF-PTFE WIRES FROM CLAMP IN GROUP I

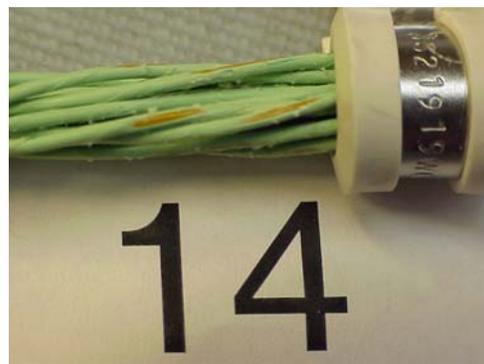
FIGURE D-6. MODERATE WEAR OF PI/PTFE ALLOY FROM CLAMP IN GROUP I NONMIXED BUNDLE

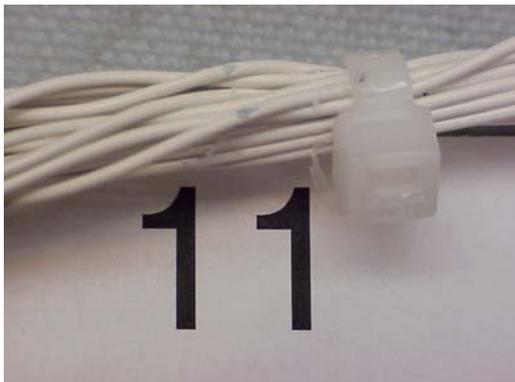
FIGURE D-9. SEVERE WEAR OF XLETFE ALLOY WIRE FROM PLATE IN GROUP I NONMIXED BUNDLE

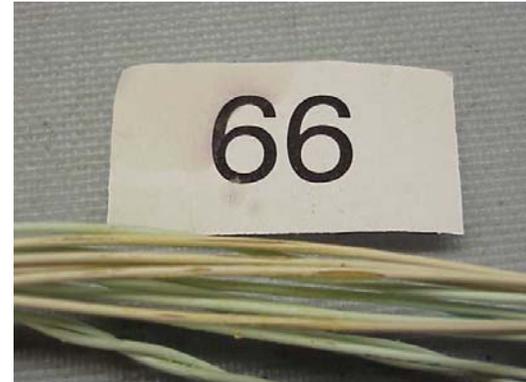
FIGURE D-10. MODERATE WIRE-TO-WIRE WEAR ON XPI WIRE WHEN MIXED WITH XLETFE GROUP IIF BUNDLE

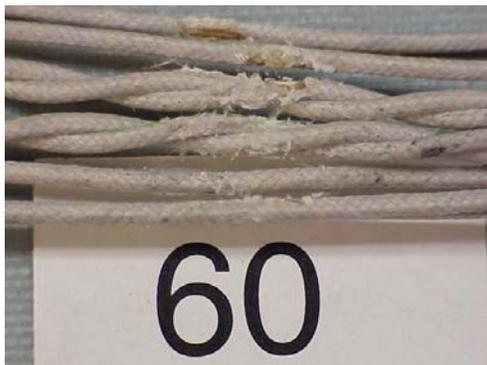
FIGURE D-11. MODERATE WIRE-TO-WIRE WEAR ON PTFE/GLASS IN NONMIXED GROUP IIF BUNDLE

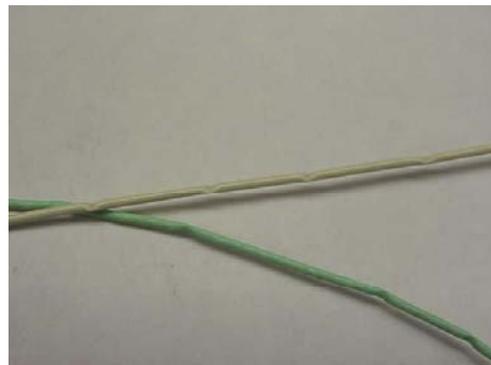
FIGURE D-12. XPI WIRE DAMAGED FROM PI/PTFE WIRE IN THE 80-POUND CRUSH TEST

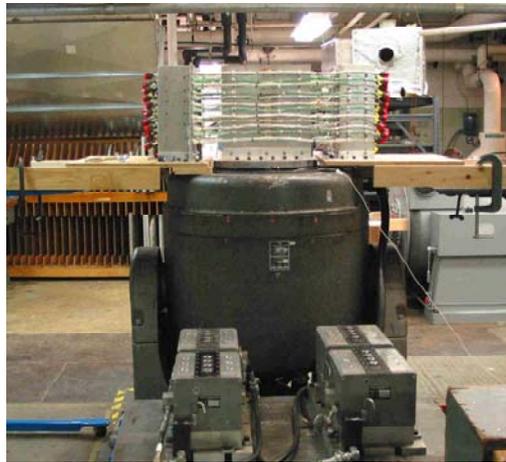
FIGURE D-15. FIXTURES MOUNTED ON VIBRATION TABLE
