DOT/FAA/AR-05/49

Development and Validation of a Microenergy High-Voltage Technology for Aircraft Wiring

October 2005

Final Report

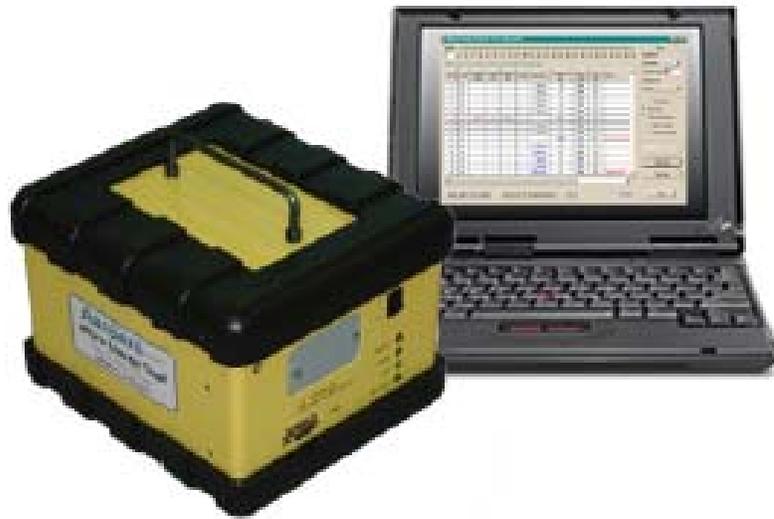
The MET (figure 2-1) uses a new approach to identify and locate breaches in wiring insulation. It identifies insulation breaches that are nearing or have already degraded to the point of arcing from conductor to conductor or to another low impedance path such as the aircraft frame. It identifies these breaches in a manner similar to high potential (Hi-pot) testing; however, the energy available to dissipate at a breach is limited to a value much lower than what occurs using traditional Hi-pot methods. When the breach arcs over, the voltage at the breach collapses and initiates a traveling wave that echoes back and forth between the ends of the cable and the breach location. The MET analyzes the resulting waveform and estimates the length of wire between the MET and the breach in a way that is similar to that used by time-domain reflectometry (TDR).

FIGURE 2-1. MICRO-ENERGY TOOL

Although the MET is similar to Hi-pot and TDR, it has some major differences. The MET addresses the problem of insulation breach detection and location, as discussed below.

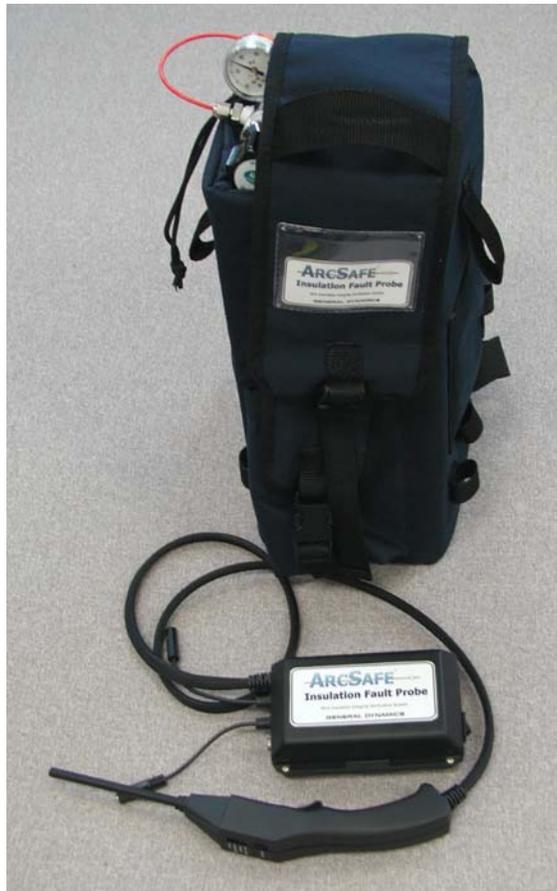
The IFP (figure 2-3) uses the principle of electron streaming through pure helium gas to detect and locate exposed conductors in a cable harness. When the trigger on the probe is actuated, a current-limited (<5 μ A), high-voltage (1-6 kV adjustable) source is applied to the pointed needle in the probe tip and pure helium gas flows past the tip into the intervening space between the needle and the harness. Electron streamers are emitted from the probe tip through the helium. If these streamers find any exposed conductors, a minute current will flow across the physical gap. The amount of current that flows is approximately proportional to the distance traversed. The operating range is from several inches of separation between the probe tip and exposed conductor all the way to direct contact with the exposed conductor.

FIGURE 2-3. INSULATION FAULT PROBE

The IFP's principle of operation is similar to that of an ohmmeter. However, the use of high voltage (with current limited to less than 5 μ A) and helium gas allows the tool to find breaches in insulation without direct galvanic contact. The IFP functions as a fine-tune (sniffer) fault locator. It also uses a high-voltage source in conjunction with helium flow to induce electron streaming across an air gap into an insulation crack. With the cable under test grounded, the IFP induces current flow through the wire and a return path back to the IFP, giving both audible and visual feedback to the user.

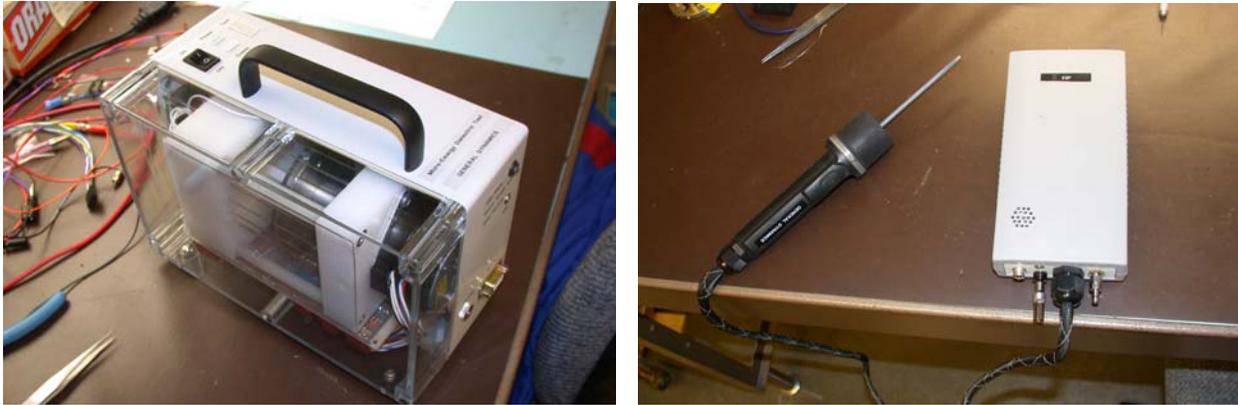
Prior to this research, GD was engaged in independently investigating MEHV and arc fault detection technology. MEHV technology development was under development for several years by RB Labs (under a license agreement with General Dynamics-Airborne Electronic Systems). Several prototype configurations for the MET and IFP tools were manufactured. Early laboratory tests, using the MEHV breadboards, showed promise in detecting and locating breaches in harness insulation.

FIGURE 3-1. THE MET AND IFP PROTOTYPE CONFIGURATIONS PRIOR TO THIS RESEARCH

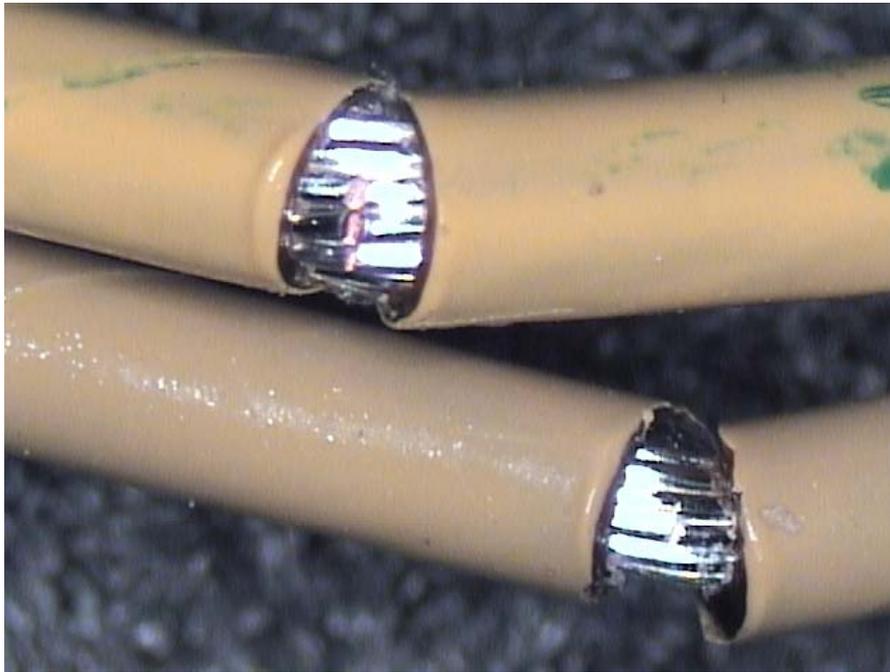
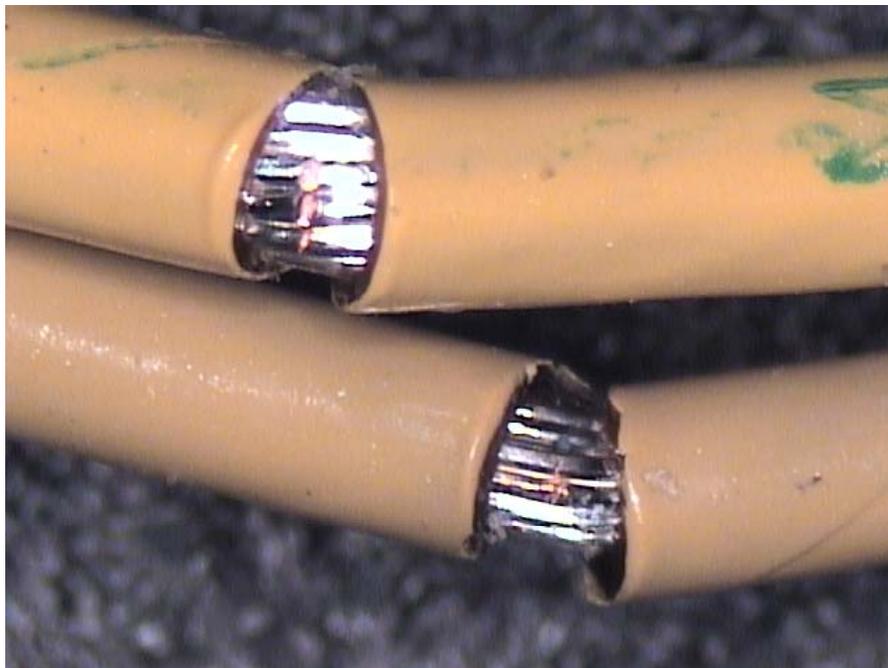
After 10 and 100 events, no carbon film deposits or visible melting of the insulation was observed. Note that this insulation type is dark in color; therefore, carbon film may not be as noticeable as it would be for white ETFE (M22759/34).

FIGURE 5-2. POLYIMIDE (M81381/11)—200-ft LENGTH—INITIAL CONDITION

FIGURE 5-3. POLYIMIDE (M81381/11)—200-ft LENGTH—AFTER 126 QUALIFYING ARCS

FIGURE 5-4. POLYIMIDE (M81381/11)—200-ft LENGTH—AFTER 627 QUALIFYING ARCS

FIGURE 5-5. POLYIMIDE (M81381/11)—200-ft LENGTH—TYPICAL ARC
(Note: At this separation, it took 4000-5000 V to initiate an arc.)

After 500 events, some minor melting of the polyimide film on the very outside jacket was noticed on the 200-ft specimen, as in figure 5-4. This specimen was situated so that the arc had to travel along the surface of the conductor insulation. No visible effects were noted on the 100- and 10-ft specimens. This was, primarily, a cosmetic effect and does not create a condition that would cause the breach to arc-over at a lower voltage.

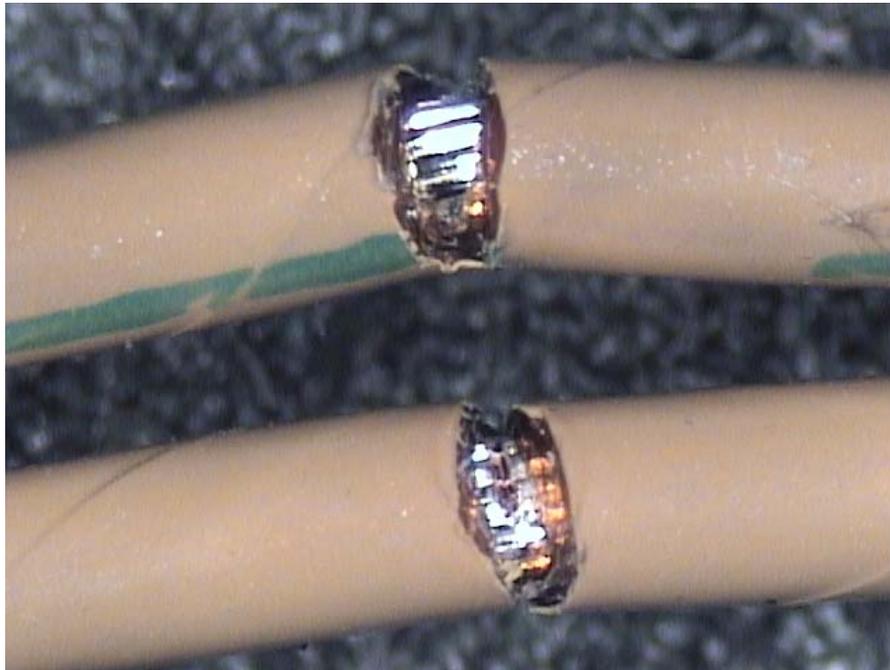
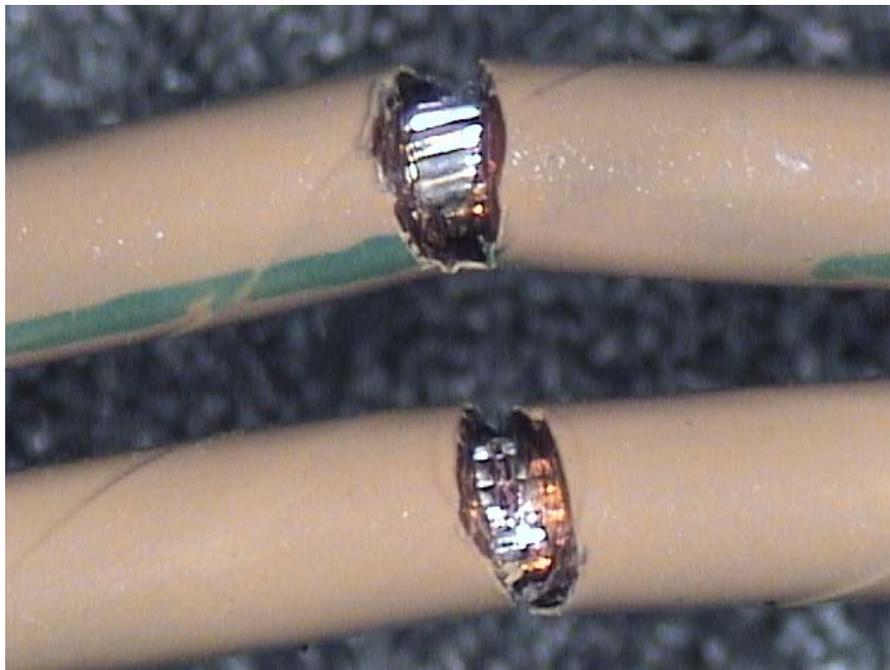
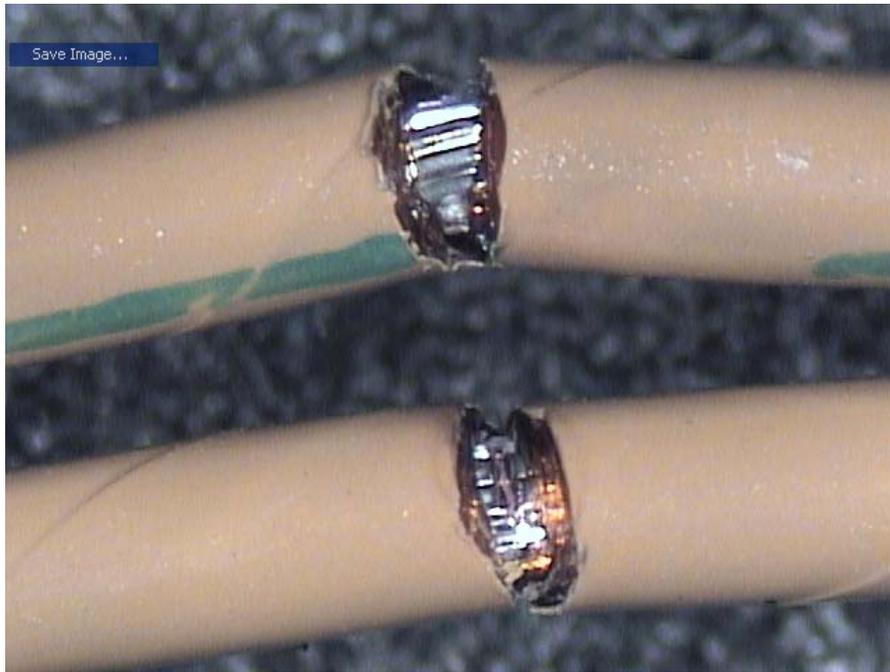
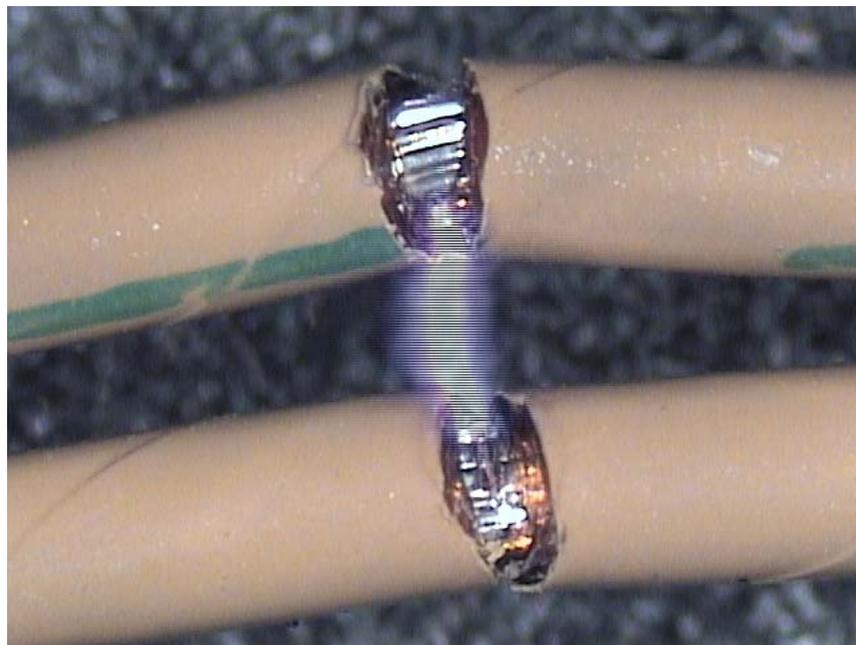
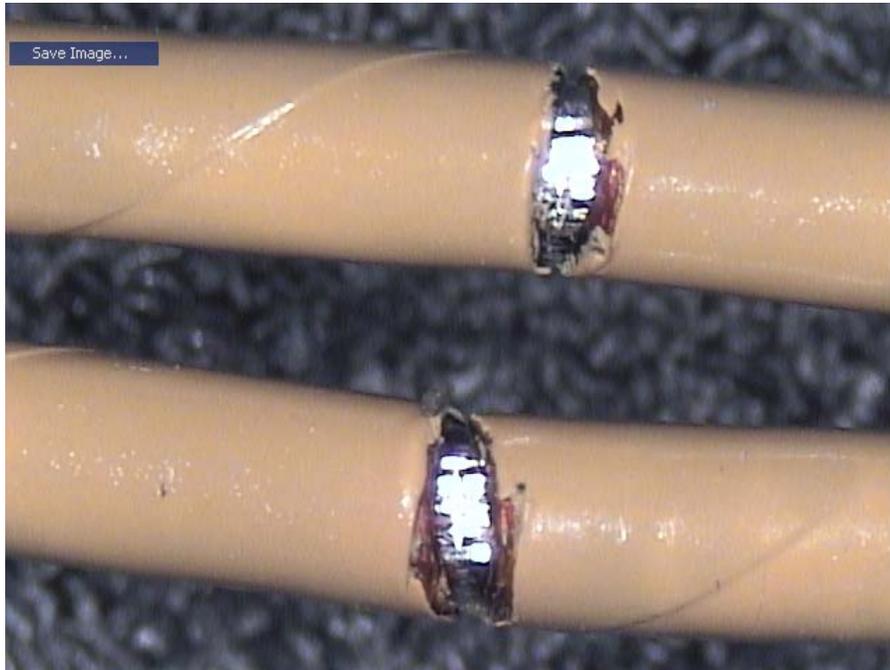
FIGURE 5-6. POLYIMIDE (M81381/11)—100-ft LENGTH—INITIAL CONDITION (MET TESTING)

FIGURE 5-7. POLYIMIDE (M81381/11)—100-ft LENGTH—AFTER 179 QUALIFYING ARCS

FIGURE 5-8. POLYIMIDE (M81381/11)—100-ft LENGTH—AFTER 642 QUALIFYING ARCS

FIGURE 5-9. POLYIMIDE (M81381/11)—100-ft LENGTH—TYPICAL ARC
(Note: At this separation, it took 4000-5000 V to initiate an arc.)

FIGURE 5-10. POLYIMIDE (M81381/11)—10-ft LENGTH—INITIAL CONDITION

FIGURE 5-11. POLYIMIDE (M81381/11)—10-ft LENGTH—AFTER 128 QUALIFYING ARCS

FIGURE 5-12. POLYIMIDE (M81381/11)—10-ft LENGTH—AFTER 617 QUALIFYING ARCS

FIGURE 5-13. POLYIMIDE (M81381/11)—10-ft LENGTH—TYPICAL ARC
(Note: At this separation, it took 4000-5000 V to initiate an arc.)

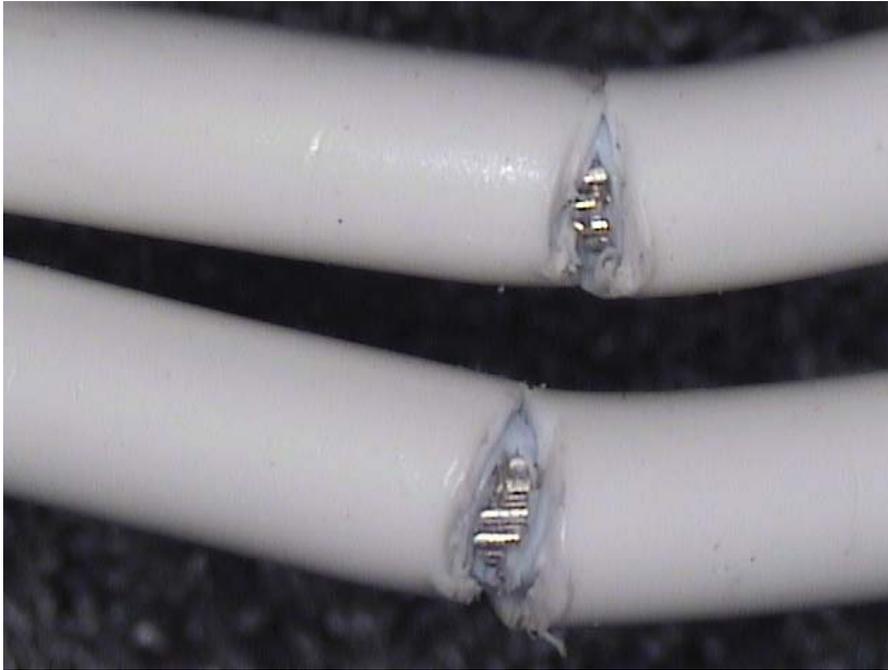
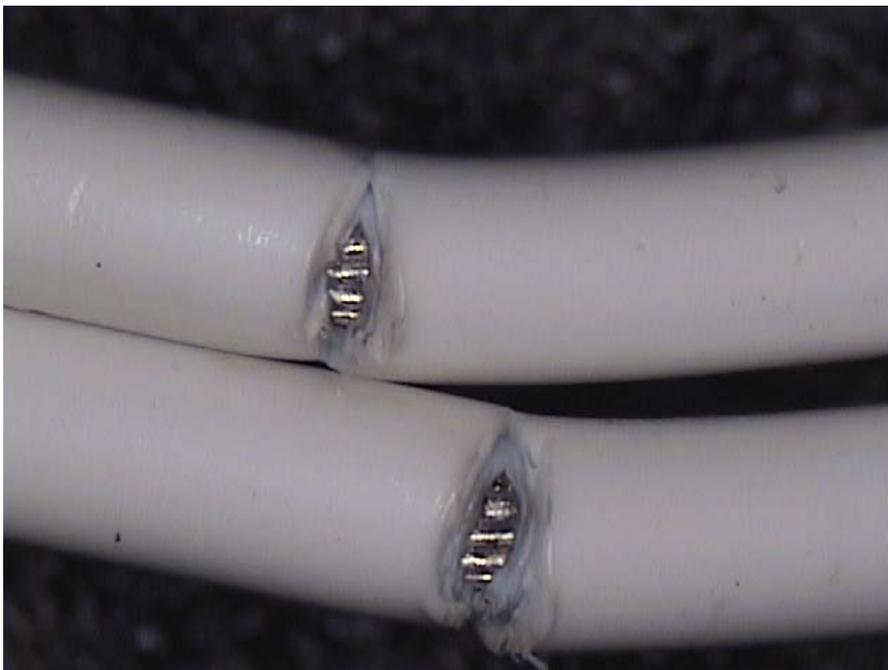
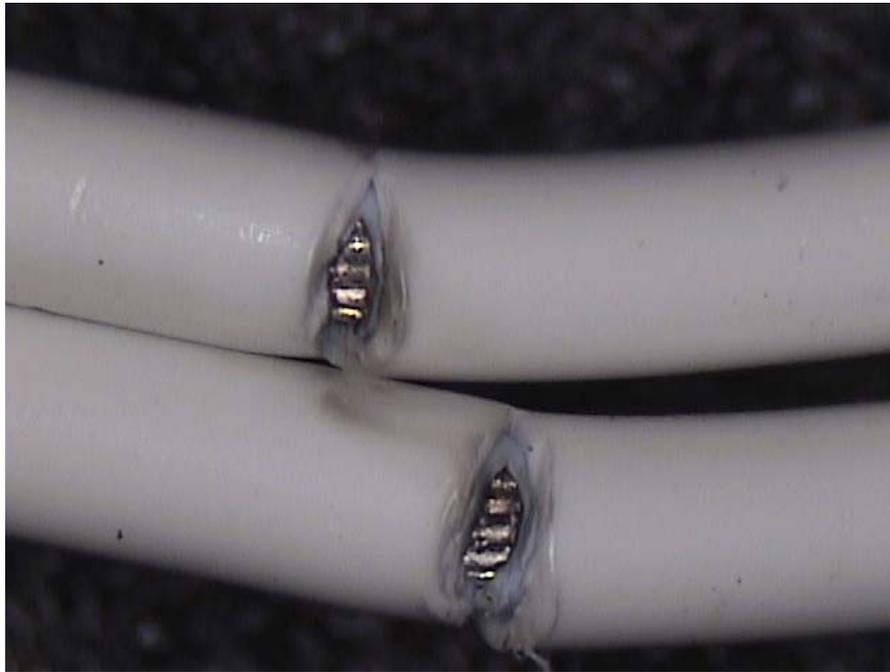
FIGURE 5-14. ETFE (M22759/34)—200-ft LENGTH—INITIAL CONDITION

FIGURE 5-15. ETFE (M22759/34)—200-ft LENGTH—AFTER 131 QUALIFYING ARCS

FIGURE 5-16. ETFE (M22759/34)—200-ft LENGTH—AFTER 652 QUALIFYING ARCS

FIGURE 5-17. ETFE (M22759/34)—200-ft LENGTH—TYPICAL ARC—AFTER 500 EVENTS

(Note. At this separation, it took 4000-5000 V to initiate an arc.)

After 10 to 100 events, it was possible to see an extremely faint carbon film deposited at some locations on the inside edges of the fault cut into the insulation. This effect was more prevalent on the 200-ft specimen than on the 100- and 10-ft specimens and was only visible under a microscope. This effect can be seen by comparing figures 5-14 (200-ft length, initial condition) and 5-15 (200-ft length after 131 qualifying arcs).

After 500 events, a heavier carbon film deposit was noticeable. This can be seen in figures 5-16 and 5-17. It is important to note that the film did not cause a decrease in the arc-over voltage, indicating no further breakdown in conductor insulation.

The results of the ETFE (M22759/34) tests are shown in figures 5-14 through 5-24.

No visible melting of the insulation or effect, other than a thin carbon film, was observed for any of the ETFE (M22759/34) specimens.

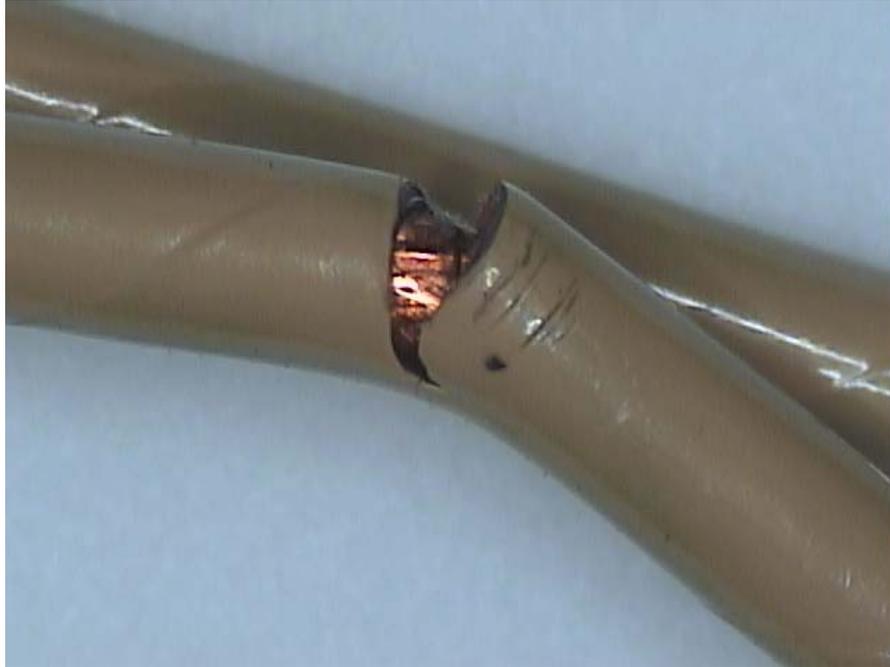
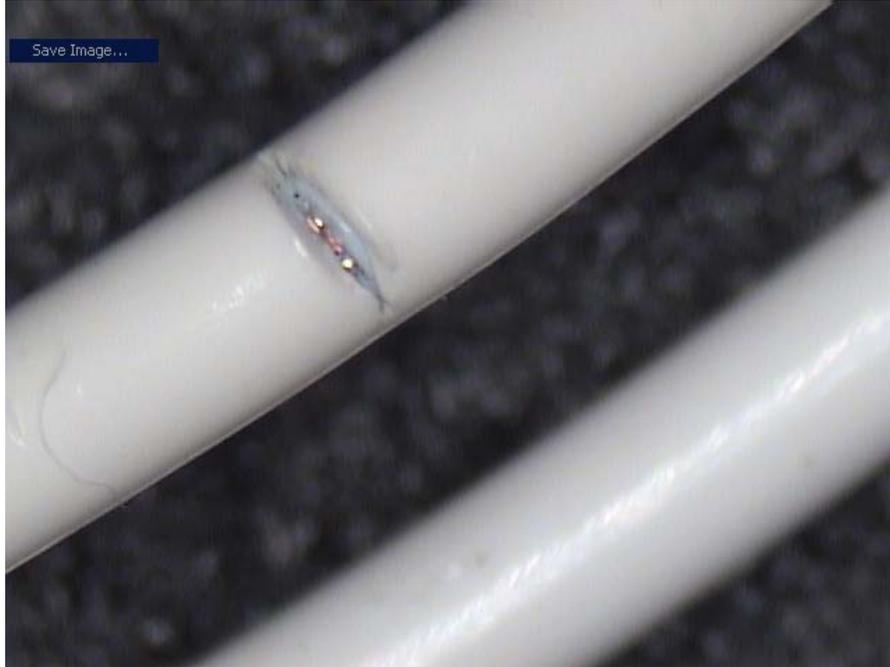
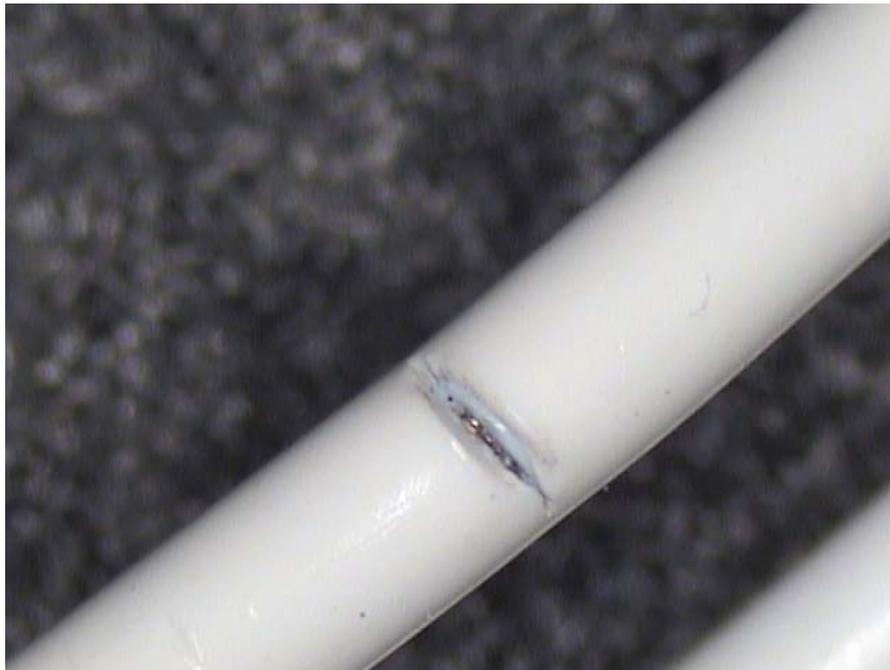
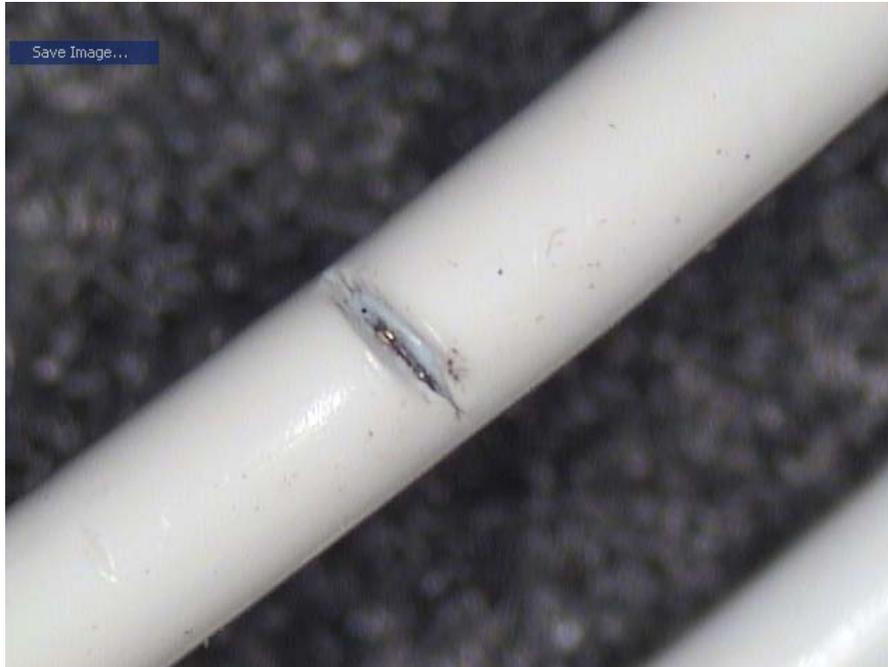
The voltage at which the probe stream initiates and the magnitude of the resulting current stream are independent of the length of the wire under test. Figures 5-27 through 5-32 show the results of the tests.

FIGURE 5-27. POLYIMIDE (M81381/11)—100-ft LENGTH—INITIAL CONDITION (IFP TESTING)

FIGURE 5-28. POLYIMIDE (M81381/11)—100-ft LENGTH—AFTER 120 REPETITIONS

FIGURE 5-29. POLYIMIDE (M81381/11)—100-ft LENGTH—AFTER 370 REPETITIONS

FIGURE 5-30. ETFE (M22759/34)—75-ft LENGTH—INITIAL CONDITION

FIGURE 5-31. ETFE (M22759/34)—75-ft LENGTH—AFTER 120 REPETITIONS

FIGURE 5-32. ETFE (M22759/34)—75-ft LENGTH—AFTER 370 REPETITIONS

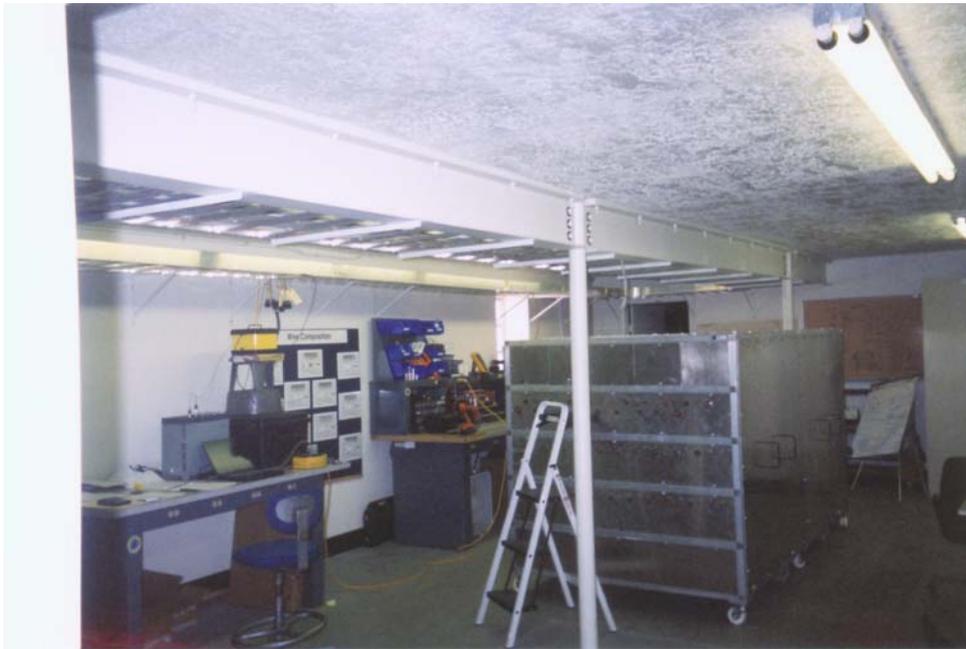
FIGURE 5-33. MICRO-ENERGY TOOL DETECTION AND IDENTIFICATION TEST SETUP

(All the harnesses are installed in a rectangular cable tray at ceiling level.)

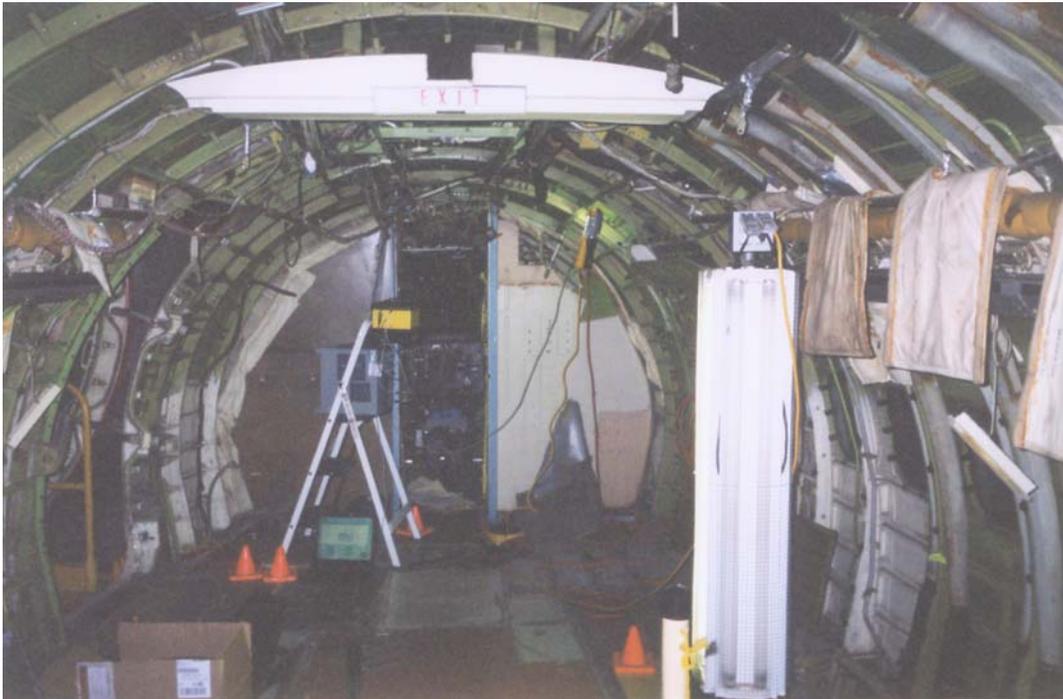
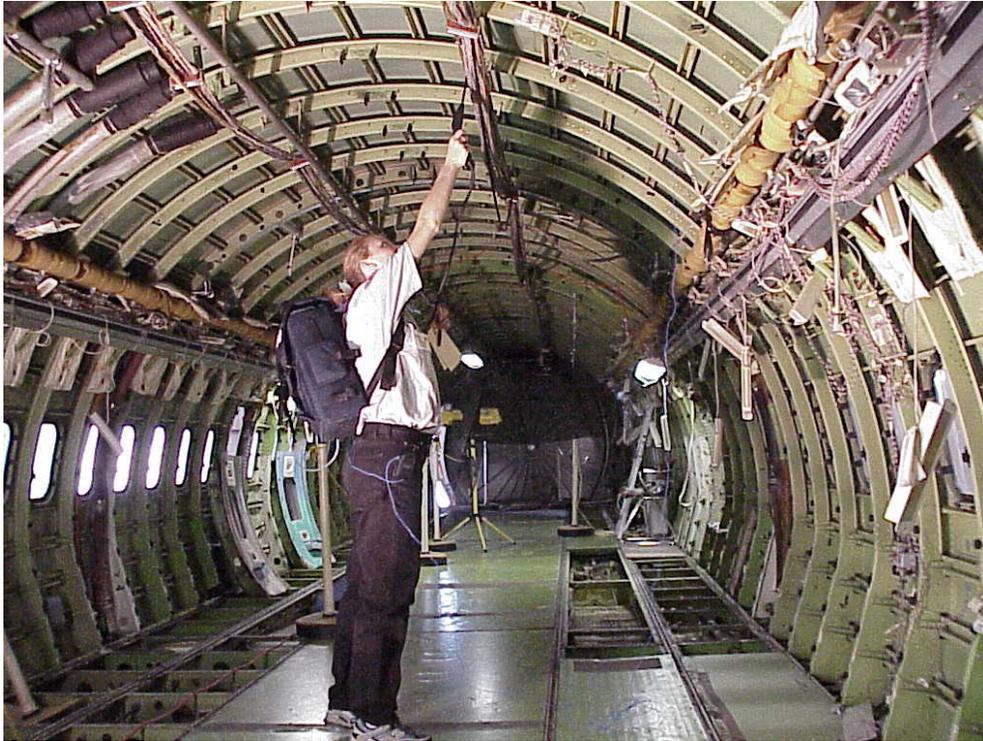
Figures 5-37 and 5-38 show the MET and IFP being used during this test.

FIGURE 5-37. USING THE MET TO SCAN THE TEST HARNESSSES

FIGURE 5-38. USING THE IFP TO SCAN THE TEST HARNESSSES
