DOT/FAA/AR-06/61

Commercial Off-the-Shelf Wiring System Diagnostics Evaluations

January 2007

Final Report

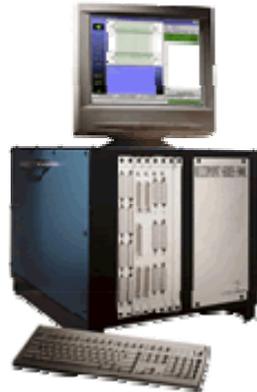
Figure 2. Cable Test MPT5000L

The Cable Test MPT5000L is a resistive-capacitive tester with an added high-voltage, high-potentiometer (HiPOT) insulation tester. The equipment reads precision resistances of the wires in a cable and flags any that exceed a programmable threshold. The MPT5000L also runs a low-voltage insulation current leakage test and reports the integrity of the insulation. The HiPOT test routine consists of charging one conductor to a high voltage (2000 volts direct current (Vdc) in this equipment's configuration) while grounding the remaining conductors in the cable. The analyzer then monitors for excessive current flow that would indicate an arc from this conductor. This type of test provides electrical stress on the insulation and then tests its voltage hold-off capability.

This may be a concern for flight line situations where the equipment usage could be intermittent. Cable Test has a new software interface (not evaluated in this test) that was designed to make the operator interface more intuitive. The tester is shown in figure 2.

The MPT5000L demonstrated an ability to detect opens and shorts by measuring current flow. It located opens by measuring the capacitance of each end of the wire and then calculating a ratio comprised of the smaller of the two capacitances divided by the sum of the two capacitances. The manufacturer claimed the ability to locate an open within 10% of the length of the cable. Although it was originally stated by the manufacturer that the equipment was able to locate shorts, it performed this task somewhat differently. It identified the connector closest to the shorted location, but there was no real distance-to-the-fault capability in the equipment that was tested.

The MPT5000L used a sensitive resistive measurement system to locate opens and shorts. It measured resistance between a particular test wire and all other referenced wires and ground surfaces, and compared that to the programmed expected value. The insulation defects were found by two different tests. The first was a low-voltage test that detected gross insulation defects and monitored leakage currents. The second was a HiPOT test that charged the wire to 2000 Vdc and monitored it for an arc signature. This stressed the insulation and broke down insulation defects that were in the vicinity of a conducting return path.

The MPT5000L detected all hard opens and shorts. It located 83.3% (10/12) of the hard opens to within the 10% tolerance, as specified by the company. The short locations were reported as the nearest connector to the defect, but since they were not specified with any particular accuracy, they were not evaluated.

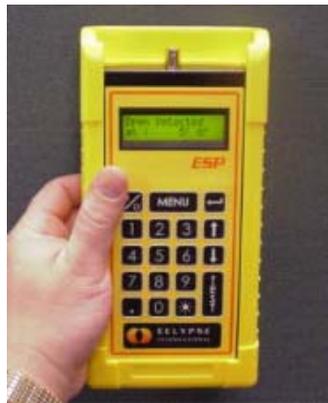
Figure 3. Eclipse ESP Wiring Analyzer

The Eclipse ESP Plus (ESP) utilizes standing-wave reflectometry (SWR) to test the condition of aircraft wiring systems. The ESP basically uses transmission line impedance discontinuity reflection properties to set up standing waves with a low-power signal. The ESP then uses this information to report whether the discontinuity is an open or a short, as well as the distance to the defect. Two separate tests were performed with this analyzer. An airline inspector performed one test in June 2004 using the equipment with version 1.07D software. Technical staff from the U.S. Air Force Research Laboratory performed the second test in August 2004 using the equipment running version 1.04A software. The ESP is shown in figure 3.

The ESP was intuitive to use and was relatively simple to operate, especially when the operator had training and experience in wire integrity testing. There was a customizable menu that provided several different wire types for testing. Once the wire type was selected, the test button was pressed, and the ESP performed the wire test automatically. The potential drawback lies in the velocity of propagation (VOP) programming, which, according to the manufacturer, was vital to its ability to accurately locate the defects and was determined differently than when using a typical time-domain reflectometry (TDR)-based system. The ESP features an automatic VOP detection algorithm, but was inoperative on both tested ESPs. Subsequent to completion of testing, the manufacturer indicated that installation of a new procedure would alleviate the problem and provide accurate VOP measures appropriate for use in the SWR-based equipment. This was not achieved due to time constraints. The ESP was capable of detecting opens and

The documentation on the ESP claimed that it can detect and locate opens and shorts to within 1 inch. No capabilities in locating insulation defects or installation defects were noted. Based on this information, the ESP was expected to detect and locate DT9 open wires and DT10 shorted wires (common and differential modes). An airline avionics maintenance technician with experience using the ESP conducted the tests at the AANC wiring laboratory. Although a formal response from the manufacturer as to what defects their equipment could detect was not provided, the maintenance technician stated that the ESP was capable of open and short detection as well as the location of those defects. Detection of all other defects was not expected, and the set of wire harnesses tested was limited based on this expectation.

The ESP detected all opens and shorts in the test bed. The location was reported accurately on several defects where the correct VOP value was used. The test monitor noted that four open defects were detected and displayed by the ESP; however, the technician did not interpret the results as a defect. The ESP reported every test as either an open or a short. Open is, therefore, a normal condition on a disconnected cable. Thus, the operator must know the wire's length to determine whether there is a defect or not. To further complicate the issue, in cases where a wire was shorted to another wire or to ground, the length of the cable was often reported inaccurately, presumably due to the impedance discontinuity. Thus, the ESP reported the wire as longer than its actual length. Possible solutions are to connect the system to both ends of the wire, or to test each wire pair with its far end in both open and shorted conditions.

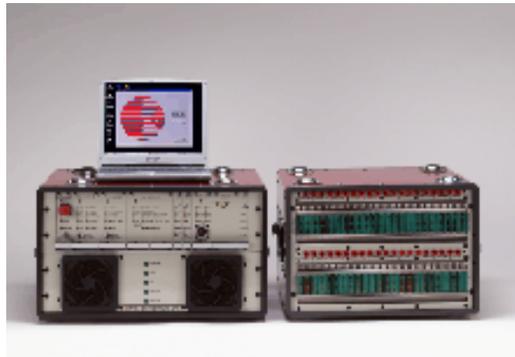
Figure 4. CKT1175-10 High-Voltage Circuit Analyzer

The CKT 1175-10, shown in figure 4, is a resistive-capacitive wire tester. Opens and shorts were tested precisely with the continuity test feature. The CKT detected short-circuit conditions by applying a programmed voltage potential to a particular wire and then monitoring the remaining wires and ground for current. The capacitance of a cable's wiring was used to locate an open condition. A ratio of the capacitance between the two ends of the wire was used to calculate the distance to the open from either end. A HiPOT test feature allowed the unit to

apply a high-voltage stress to the wire to probe more subtle insulation faults. (Note: Up to 1500 Vdc and up to 5 amps could provide a lethal shock if used improperly.)

The CKT was expected to detect open and short conditions in both wire-to-wire (differential mode) and wire-to-ground (common mode) wiring. The CKT was expected to locate (as opposed to detect) only opens at a distance down the wire.

The CKT was capable of detecting opens and shorts in the tested aircraft wiring systems. No other defects were detected with the system other than those that exhibited symptoms of opens and shorts. The CKT did not perform very well at locating the defects. The CKT claimed to be

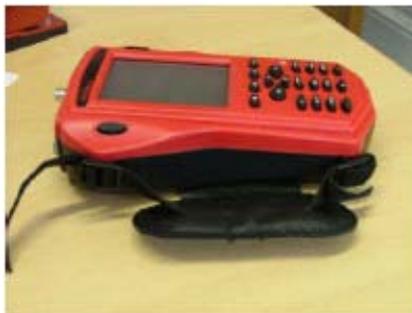
Figure 6. Phoenix Aviation ARCMAS

The Phoenix Aviation ARCMAS aircraft wiring analyzer, shown in figure 6, is a TDR-based system. The ARCMAS is a hand-held device with a Microsoft Windows-based software platform that was very simple to operate and required only 30 minutes of training. The ARCMAS provided a display of the TDR waveform, as well as a summary page, to communicate the interpretation of the TDR waveform. Opens and shorts, as well as the distance to the defect, were communicated on the summary page.

The ARCMAS was expected to detect and locate continuity defects (opens and shorts). The Phoenix Aviation representatives that provided the training on the equipment did not expect detection of insulation or installation defects. Although Phoenix Aviation provided training, the ARCMAS came with adequate documentation in the operator's manual to operate it without formal training.

The ARCMAS performed very well at detecting continuity (open and short) defects, as well as having the ability to locate both opens and shorts. The ARCMAS was able to detect one installation defect, a DT7 faulty splice that exhibited an open condition, but was unable to detect any other installation or insulation defects. There were a few occasions where the TDR waveform displayed indications of impedance changes that might correlate with certain types of defects; however, many other false indications were present throughout the testing.

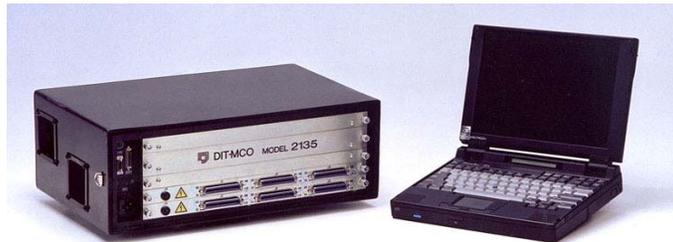
Figure 7. DIT-MCO Model 2135 Wiring Analyzer

The DIT-MCO Model 2135 wiring analyzer, shown in figure 7, is a resistive-capacitive wiring diagnostic tool with a built-in HiPOT capability. The DIT-MCO has a switching system that allows the testing of whole cable harnesses in a single test routine. The DIT-MCO was capable of running many different testing algorithms. But for the testing, it was advised to run the insulation leakage test, a continuity test, and a HiPOT test at 1000 volts. The software for the DIT-MCO was customizable to different configuration schemes due to its programming system. Any wiring harness scheme could be configured and then tested. The algorithm software allowed for customization of the test run.

The DIT-MCO was expected to detect and locate open and short (DT9 and DT10) defects reliably based on its technology. Installation and insulation defects would be detected only if they exhibited open or short characteristics, or if the insulation defect was severe enough that the HiPOT test can function. At 1000 volts, this would require a very close conducting return path to the insulation defect.

The DIT-MCO was able to detect most of the continuity (open and short) defects. The cause of the detectable defects that were not detected is unknown. The operator mentioned difficulties

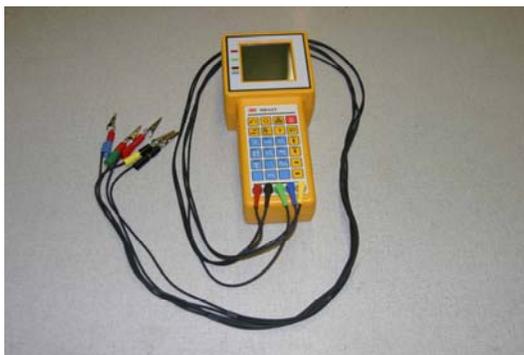
Figure 8. 3M 900AST

The 3M 900AST is a TDR-based wiring tester, shown in figure 8. The 900AST uses a short pulse to probe the wire under test. Defects in the wire cause changes to the characteristic impedance seen by the electromagnetic pulse and generates a reflection that is monitored at the injection end of the cable.

The 900AST was expected to detect open and short conditions in both wire-to-wire (differential mode) as well as wire-to-ground (common mode), wiring. The 900AST had a short location function known as a resistance fault location (RFL). The open wiring faults are located with the TDR function. All other insulation defects were not within the capabilities of the system unless they exhibited symptoms similar to those of an open or short condition.

bed. Of those 20 defects, 6 were opens and 14 were shorts. The 900AST located 9 of the 14 documented shorts accurately with the RFL and all 6 open faults with the TDR function. However, the system was not able to detect any of the insulation and installation non-key defects. The breakdown of the results for the 900AST is shown below:

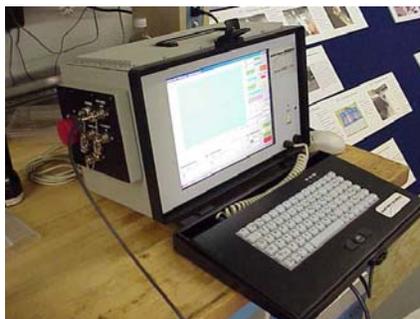
Figure 9. The AMWIT 1000

The Northrop Grumman AMWIT 1000, shown in figure 9, is a TDR-based aircraft wiring diagnostic system. The AMWIT 1000 injects a short pulse width onto the wire under test and monitors the injection point for reflections of that pulse. These reflections indicate changes in characteristic impedance on the line that are symptomatic of defects in the wiring. The roundtrip time of these pulses was used to calculate the distance to the defect down the wire. The system also features an automatic dielectric constant generator. The dielectric constant is the key to determining the VOP of a pulse down any wire and is a critical parameter to the location detection capability of any TDR-based equipment.
