DOT/FAA/AR-09/14

EMAS Cold Weather Performance Investigations

September 2009

Final Report

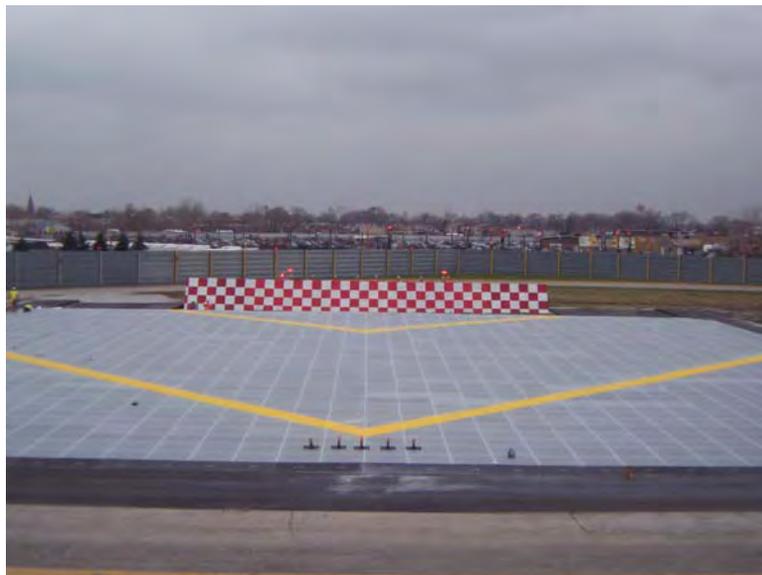
Figure 1. EMAS bed at Chicago Midway Airport. (Photo courtesy of ESCO.)

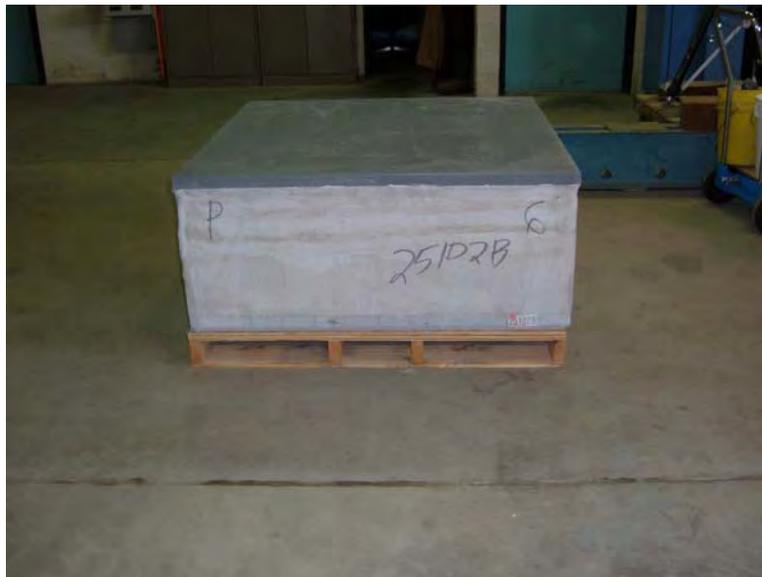
Figure 2. EMAS 4-ft × 4-ft × 20-inch-thick block.

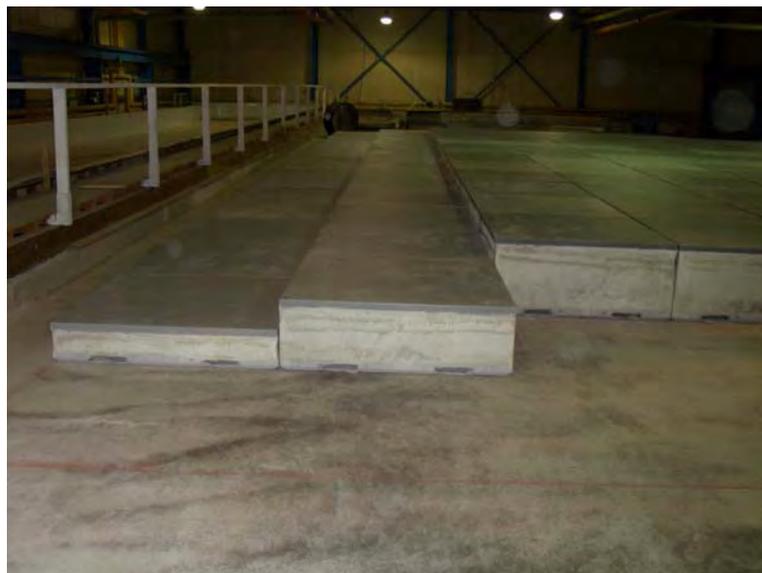
Figure 3. Side view of EMAS bed being installed for testing at CRREL.

The blocks are adhered to the pavement side by side with a 0.5-inch gap between blocks to form the arrestment bed (Figure 3). The gaps between blocks are covered with a sealing tape and the exterior block edges with a silicone flashing to waterproof the system. This test bed was initially installed with a butyl/Tedlar tape combination as shown in Figure 4.

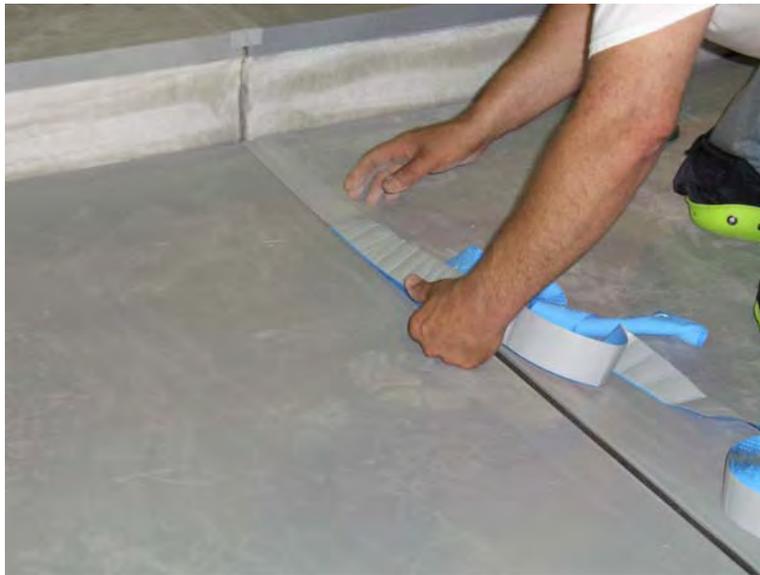
Figure 4. Butyl and tedlar tape being applied to gap between blocks.

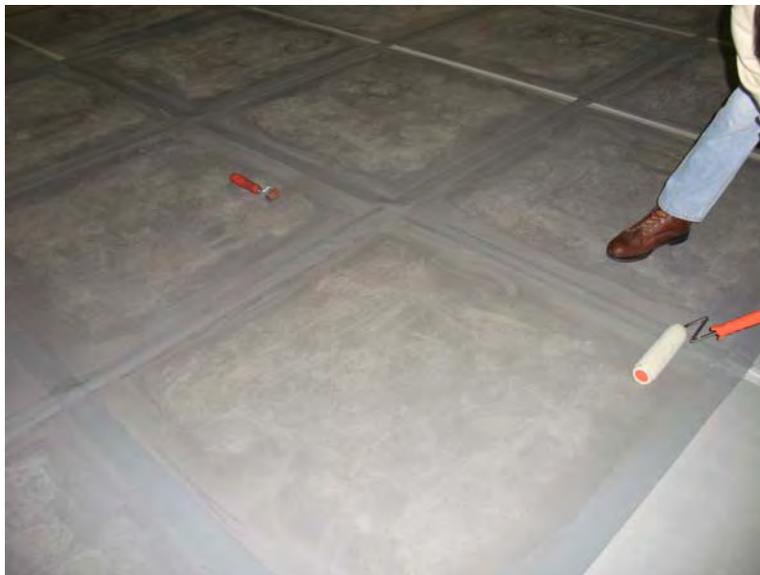
Figure 5. Silicone seam tape applied to gaps between EMAS boards.

After about five months of cycling, a portion of the bed's tape was overlain with a silicone tape that ESCO had switched to as shown in Figure 5. Figure 6 shows the side flashing.

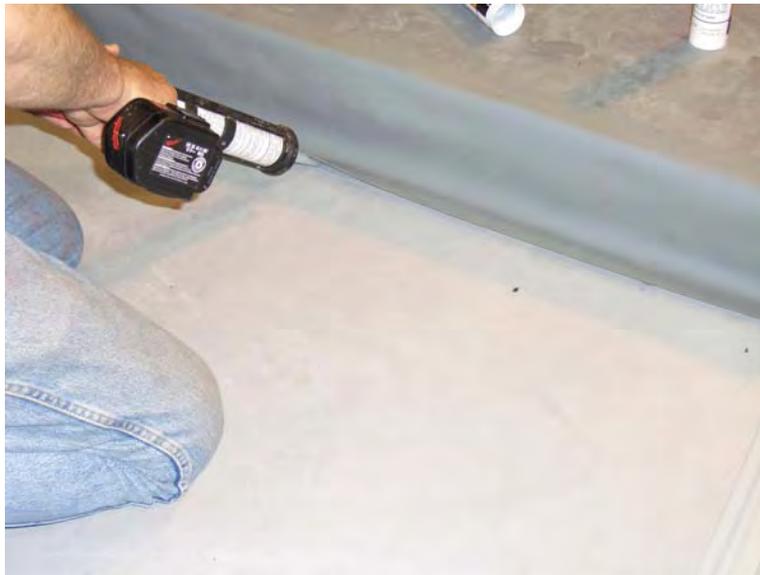
Figure 6. Side flashing applied to exposed side of EMAS.

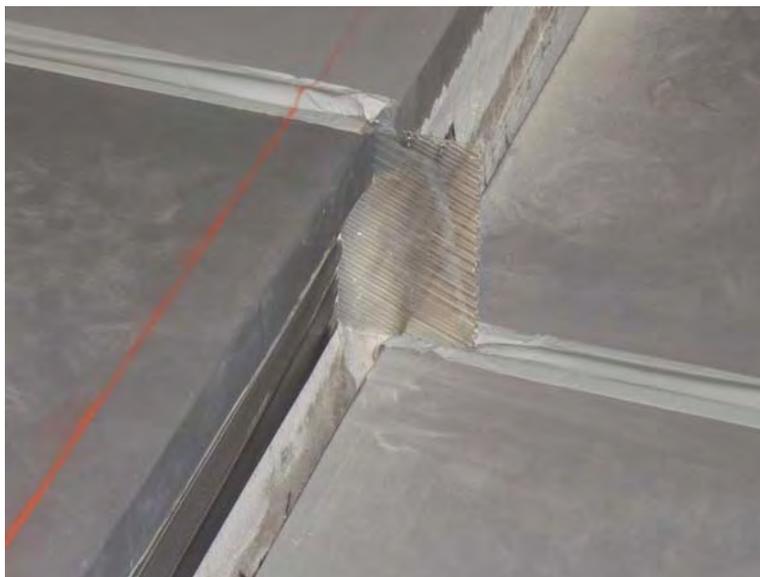
Figure 7. Plastic vent in vertical part of gap between EMAS blocks. Note the side flashing has not been applied yet to the exposed EMAS edge.

Plastic vents (Figure 7) are inserted between blocks at the exterior edges to promote moisture vapor dissipation from inside the bed.

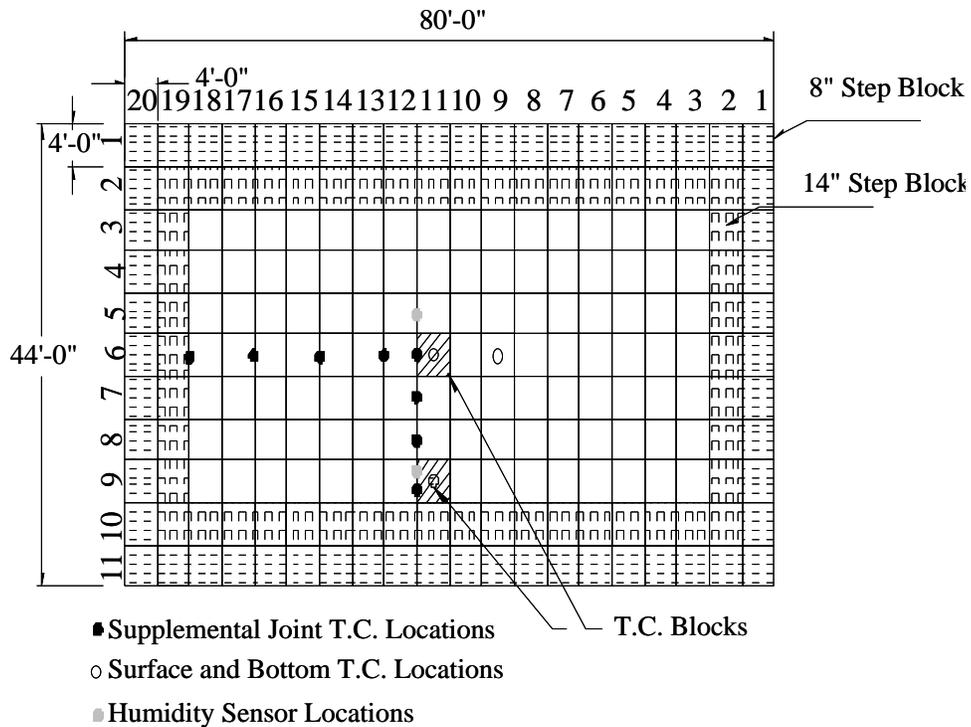
Figure 8. Overall EMAS bed layout with row and column numbers and sensor locations.

Figure 8 shows the overall EMAS layout with row and column numbers and locations of the temperature thermocouples and dual relative humidity/temperature sensors. Figure 9 is a closer view of the sensor locations with the sensor labels. "RH1" is a combined RH/temperature sensor as were the sensors at the locations named "Vent," which were installed directly behind a vent located in the seam. The temperature sensors labeled F1–F8 were type-T thermocouples with a temperature accuracy of less

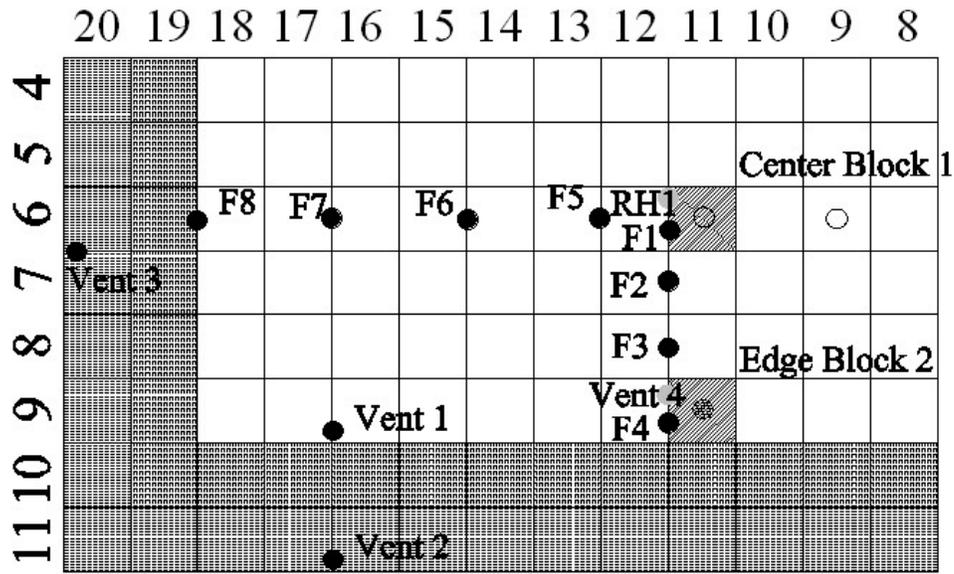
Dual Temp and RH sensors		"Fly" Thermocouples (TC)	
Name	Location	Name	Location
RH1	Seam adjacent to center block 1	F1	Row 6, col 11-12
Vent 1	Row 9, col 16-17 at 20" block	F2	Row 7, col 11-12
Vent 2	Row 11, col 16-17 at 8" block	F3	Row 8, col 11-12
Vent 3	Row 6-7, col 20 at 8" block	F4	Row 9, col 11-12
Vent 4	Row 9, col 11-12 at 20" block	F5	Row 6, col 12-13
		F6	Row 6, col 14-15
		F7	Row 6, col 16-17
		F8	Row 6, col 18-19

Figure 9. Detail view of the EMAS bed sensor layout with sensor labels.

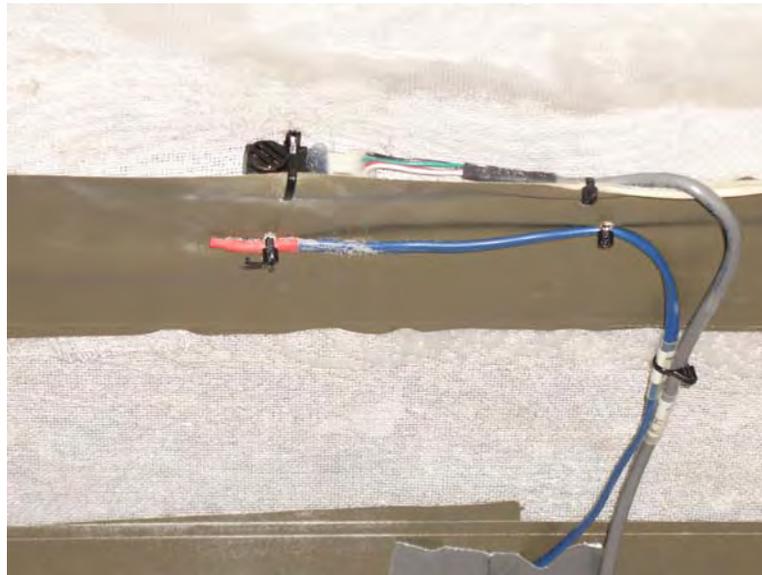
Figure 10. Precon temperature/RH sensor and a thermocouple (red tip) mounted on the side of a block.

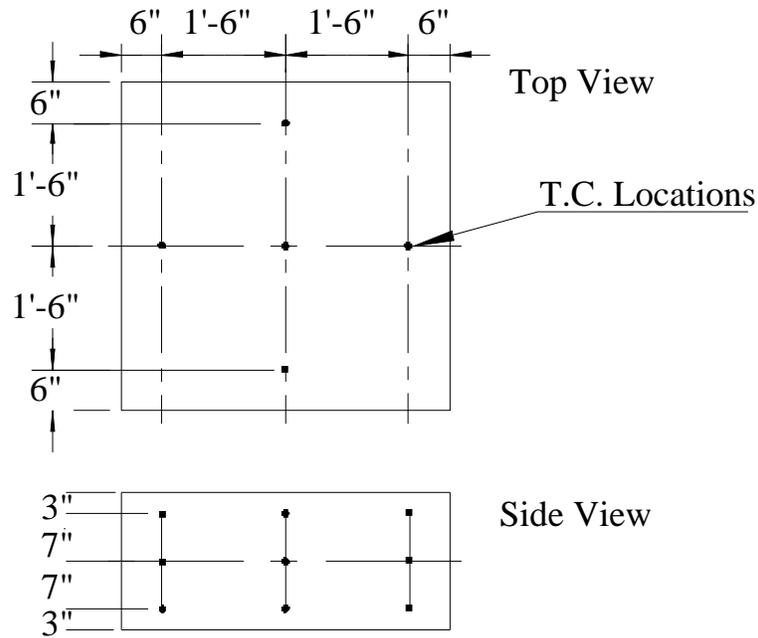
Figure 11. Thermocouple layout used in instrumented center and edge blocks.

Two blocks, called Center Block 1 and Edge Block 2, were instrumented with thermocouples at three levels to monitor internal temperatures as shown in Figure 11. The sensors were automatically read by a Campbell CR 10X datalogger at one sample every fifteen minutes (Figure 12).

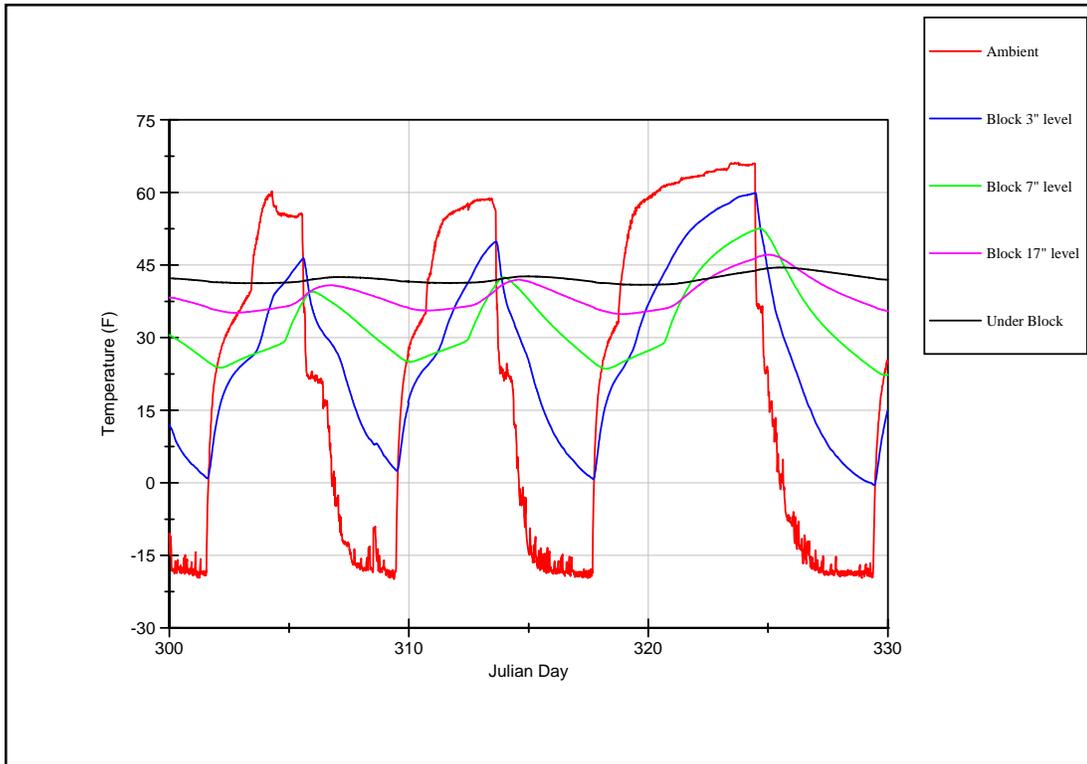
Figure 13. Ambient, in-block, and beneath-block temperatures for Julian days 300–330.

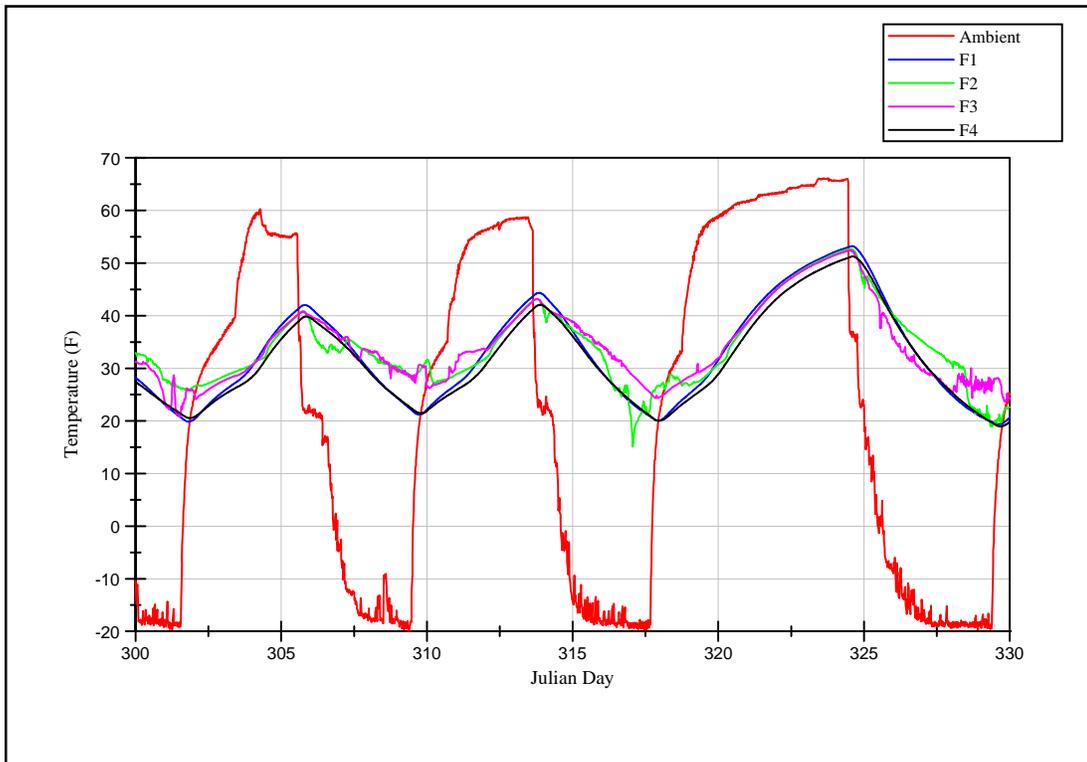
Figure 14. Seam temperatures from thermocouples F1–F4, Julian days 300–330.

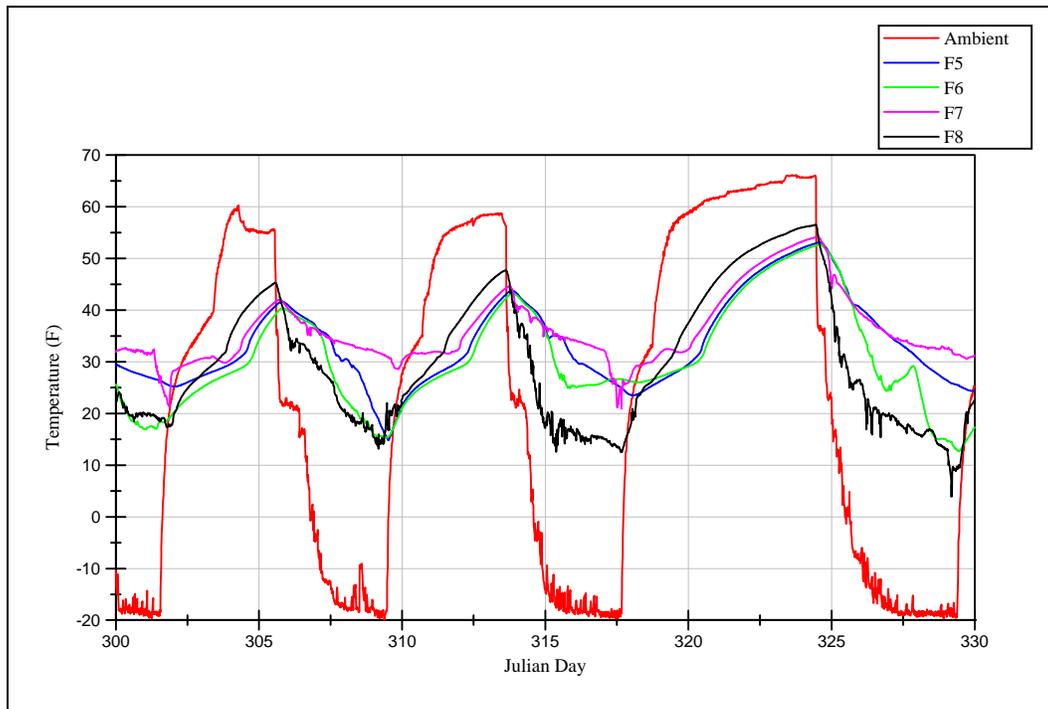
Figure 15. Seam temperatures from thermocouples F5-F8 for Julian days 300-330.

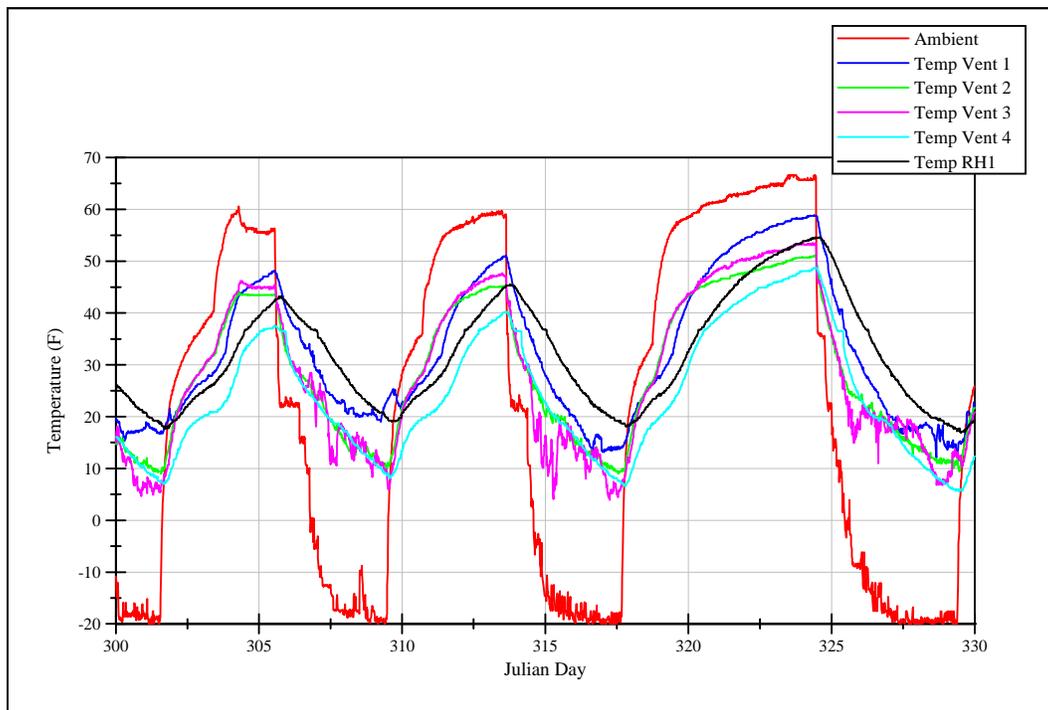
Figure 16. Temperatures measured by the Precon sensors at four vent locations and an interior seam, Julian days 300-330.

The four vent mean temperatures average out to 27.5° F, which is colder than the average mean temperature of all the other seam thermocouples (F1–F8) at 33.6° F. The vent temperature measurements were taken directly behind the vent and slightly higher than the seam thermocouples, which were placed halfway down the block, as shown in Figure 17.

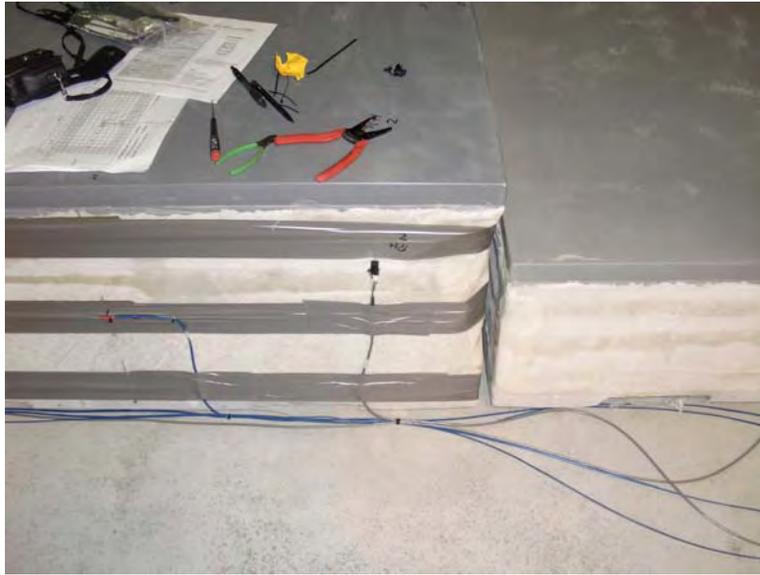
Figure 17. EMAS block being installed showing locations of thermocouple (at left) and Precon temperature/relative humidity sensor nearer where the vent eventually will be installed.

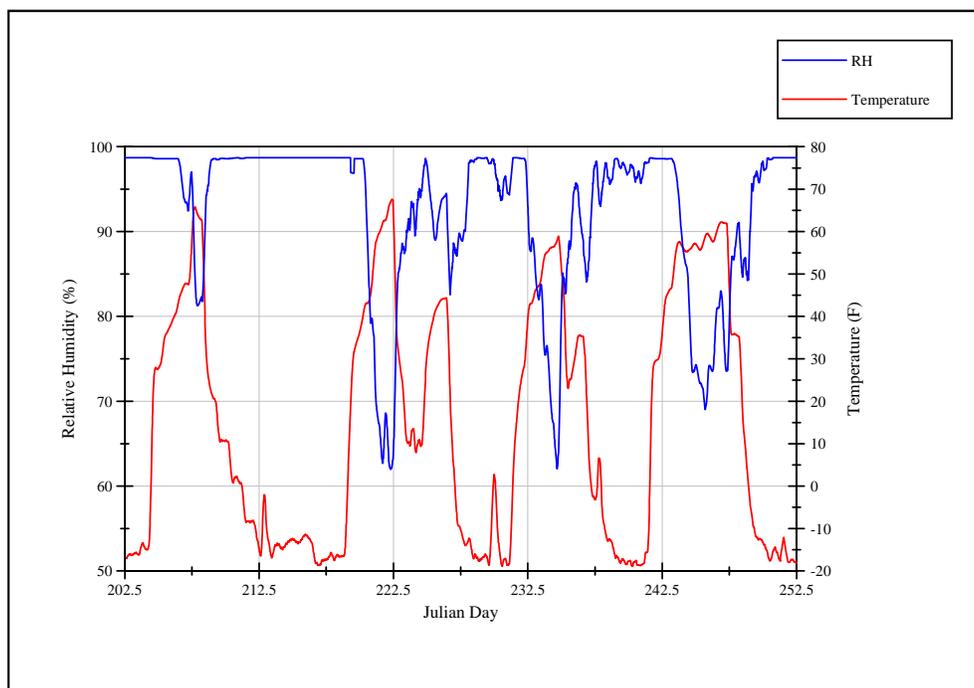
Figure 18. Ambient temperature and RH over EMAS bed during cycling.

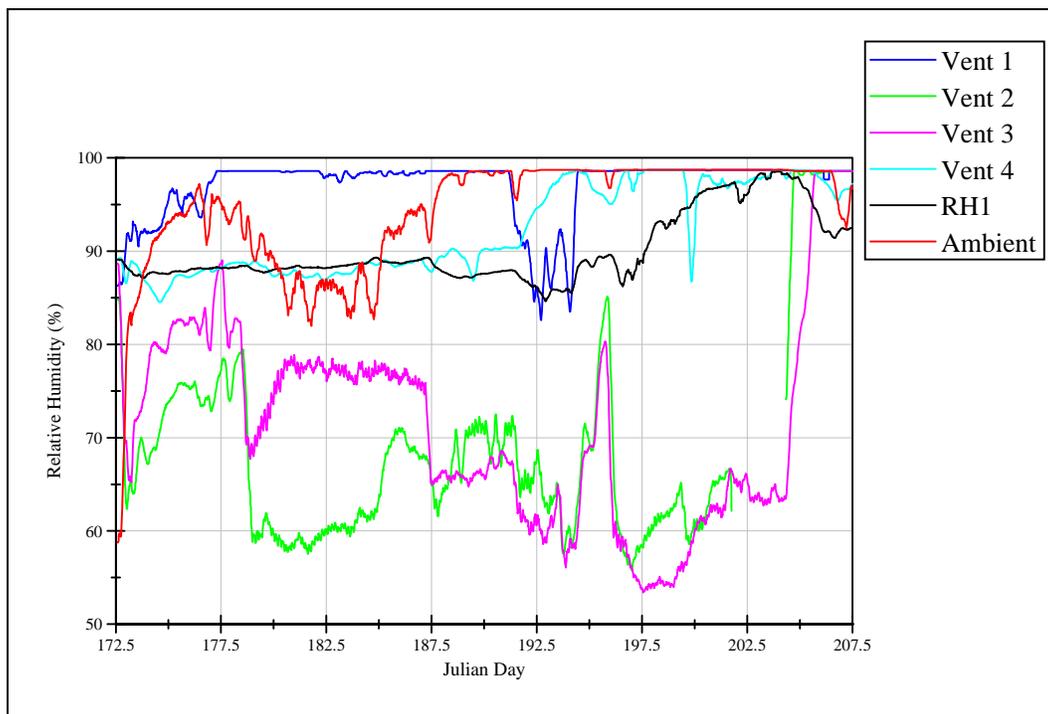
Figure 19. Smoothed relative humidity at the start of cycling.

99% at about Julian day 190. Figure 20 shows the ambient temperature was slowly dropping from the start of cycling to about Julian day 197, where it leveled off at -20° F. The RH behind Vent 2 and Vent 3 initially remained substantially lower than at the other locations, even though the temperatures at the two vents were similar to Vent 4 and colder than at Vent 1 and RH1. It was almost Julian day 206 before the RH at Vents 2 and 3 increased rapidly to nearly 100%. This coincided with the beginning of a warming portion of the cycle. Vents 2 and 3 are physically the lowest vents in the bed.

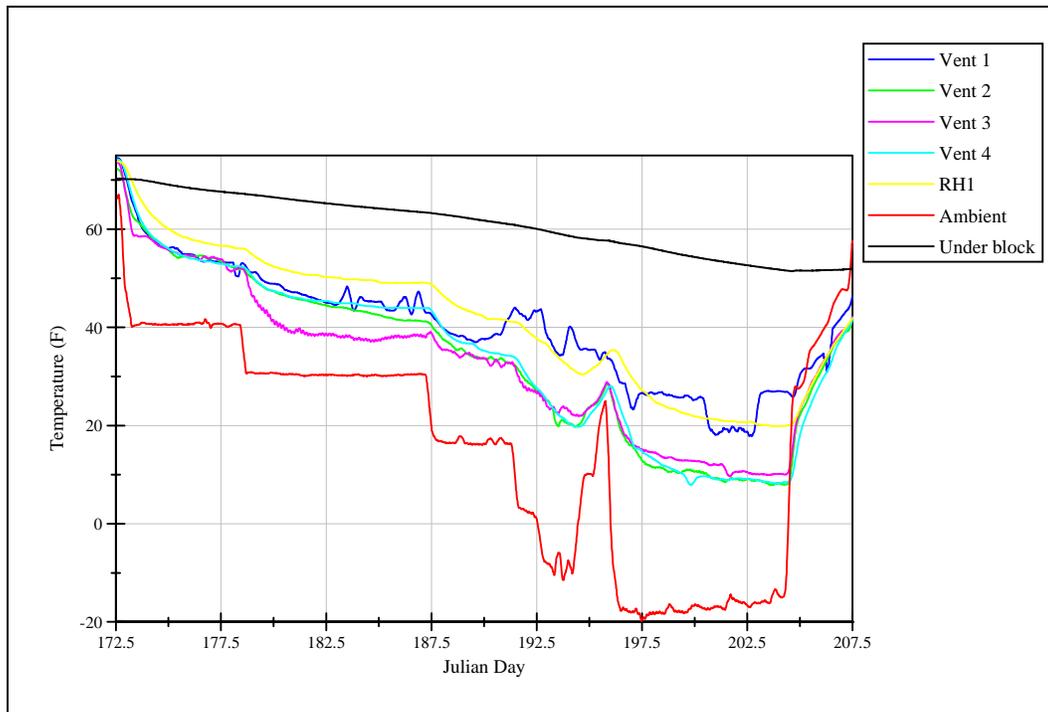
Figure 20. Temperatures measured by the temp/RH sensors Vent 1–Vent 4, RH1 and under a block at the beginning of cycling.

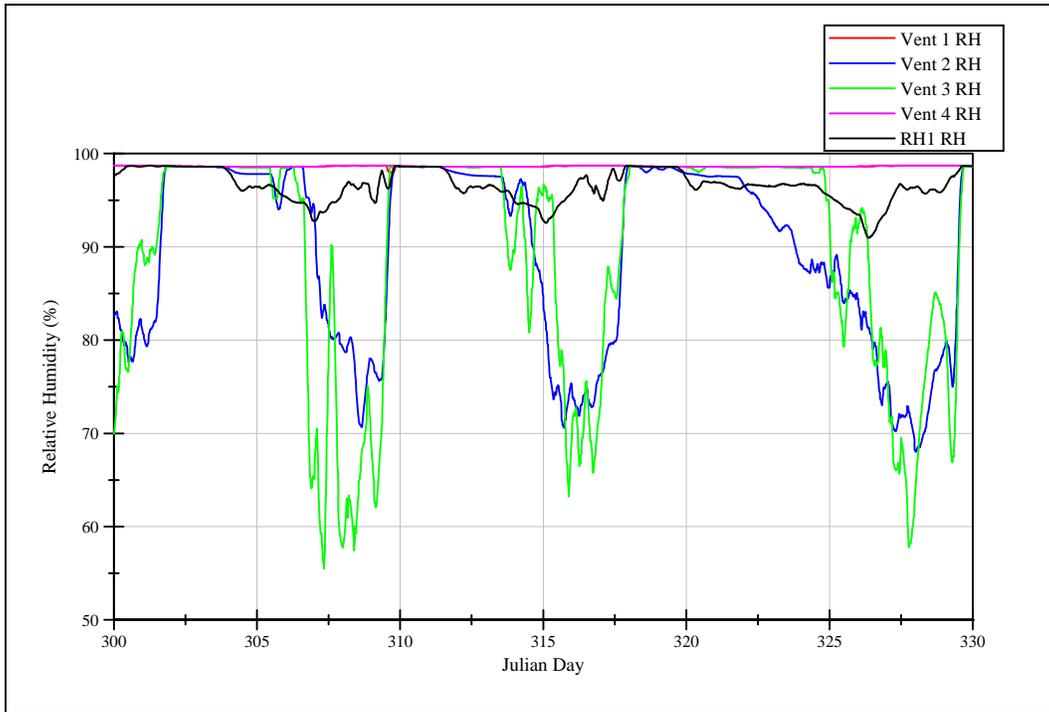
Figure 21. Smoothed relative humidity data, Julian days 300–330.

Figure 21 illustrates some typical seam RH trends during cycling with smoothed data from the five seam RH sensors for Julian days 300–330. It shows the RH change was most active behind the lower Vents 2 and 3 with a little change noticeable in RH1, located in an interior seam. Vents 1 and 4 remain pegged at nearly 100% relative humidity. Figure 22 shows the temperatures from the same sensors.

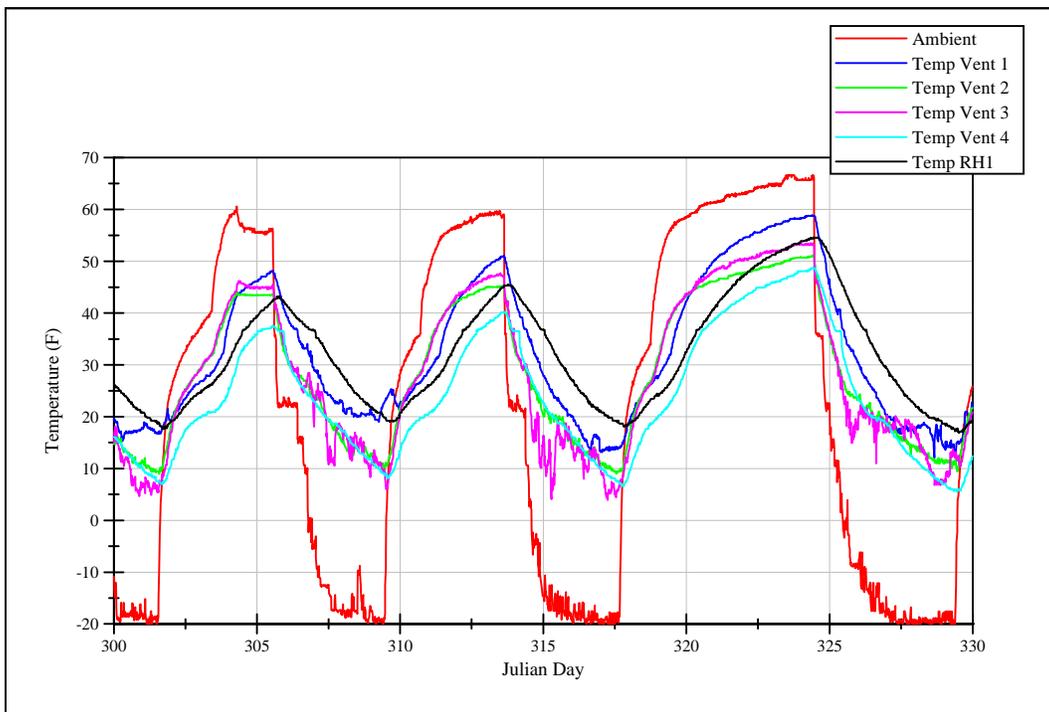
Figure 22. Five seam temperatures with ambient for Julian days 300–330.

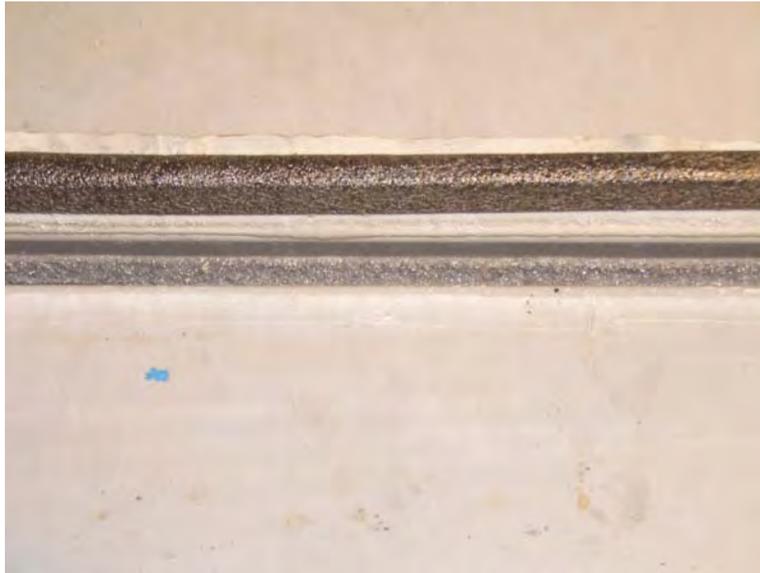
Figure 23. Small amount of frost along underside of sealing tape, row 5, column 20.

At the end of the cold cycling, several blocks were removed from the bed and inspected while the ambient temperature was still below freezing. This cold “forensics” allowed us to literally freeze any moisture that might be present in place to help explain the humidity data. During the cold forensics, several blocks were removed from Row 5 starting at Column 20 and continuing into the bed until Column 15. Small amounts of frost were found in the upper section of the seam between the lowest 8-inch-thick blocks in Column 20 as shown in Figure 23. More frost was found under the flashing in the seam between Column 20 and Column 19, where the 8-inch block met the 14-inch block as shown in Figure 24. The seams between the 14-inch-thick blocks (Column 19) generally had more frost than what was found between the 8-inch-thick blocks (Figure 25). The seam between the 14-inch- and 20-inch-thick blocks had more frost than the seam between the 8-inch- and 14-inch-thick blocks, as shown in Figure 26. Continuing into the bed, the seams between the 20-inch blocks had frost along most of their length down to variable depths along the block sides. Figure 27 shows a typical pattern for the frost distribution on the sides of the blocks. The frost pattern on the sides generally was deeper in the middle of the block, arching upward toward the sides until it would sometimes increase at the corners and other times decrease, as shown in Figures 28 and 29. In the bed interior, when viewed from above, the frost in the seams generally appeared thicker at the block corner intersections (Figure 30).

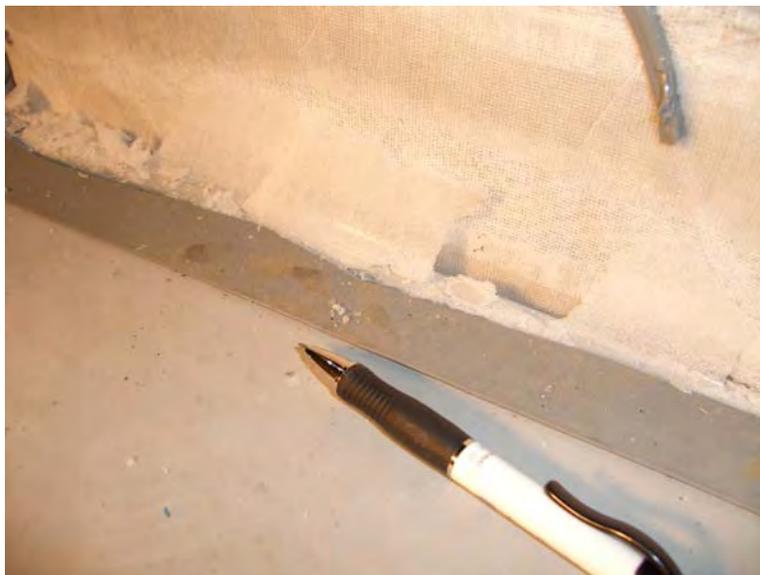
Figure 24. Frost where the 8-inch and 14-inch blocks meet.

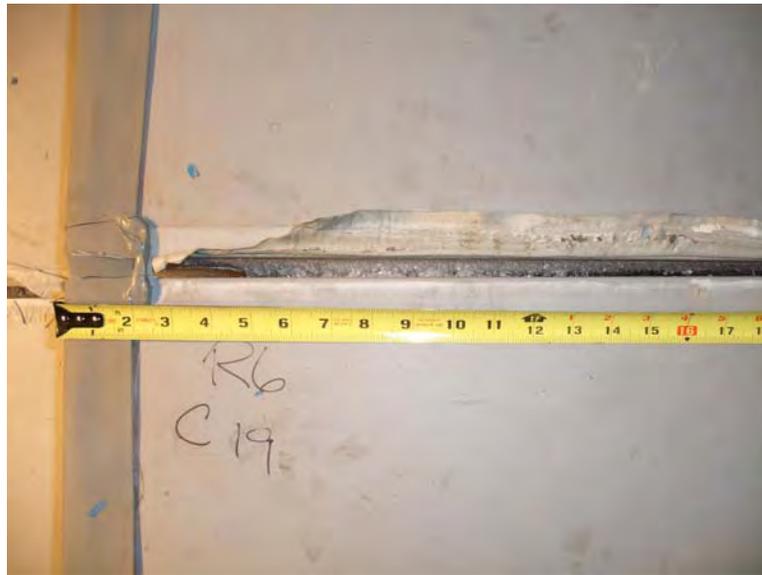
Figure 25. Slightly more frost between 14-inch-thick blocks in column 19 than found in column 20.

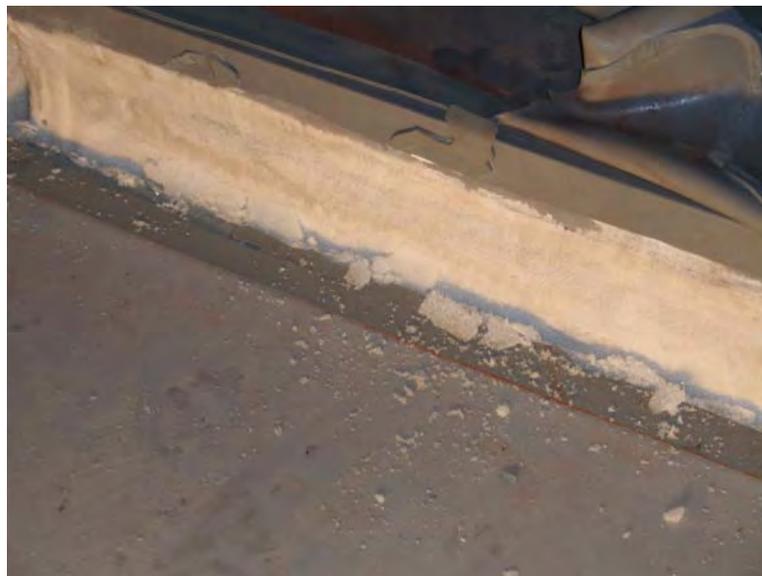
Figure 26. Frost between 14-inch- and 20-inch-thick blocks.

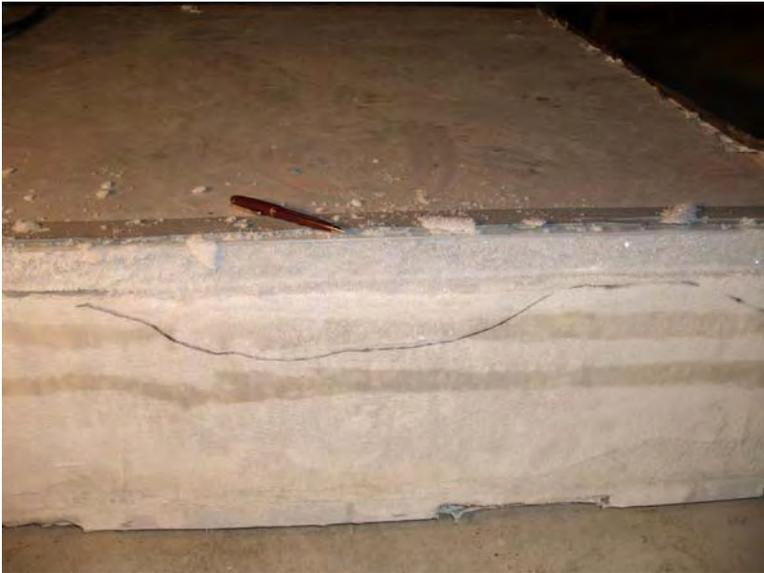
Figure 27. Typical frost pattern on the side of a block.

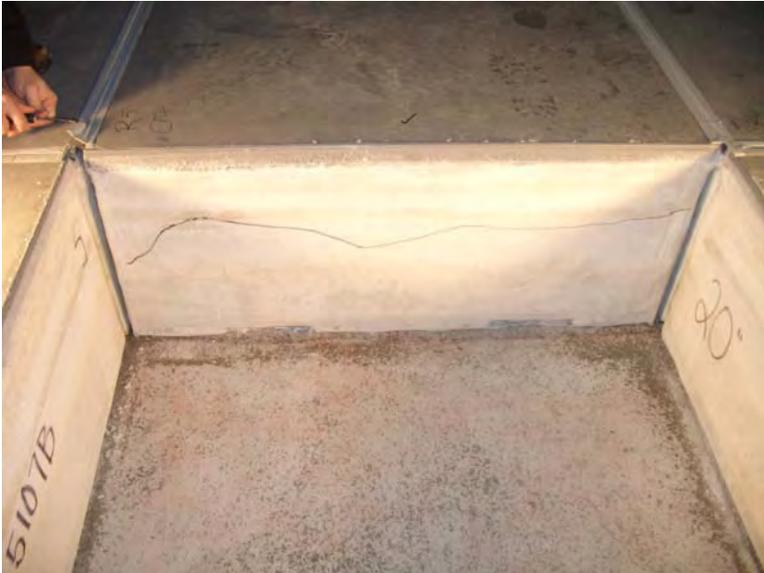
Figure 28. Frost distribution shows an increase at the corners.

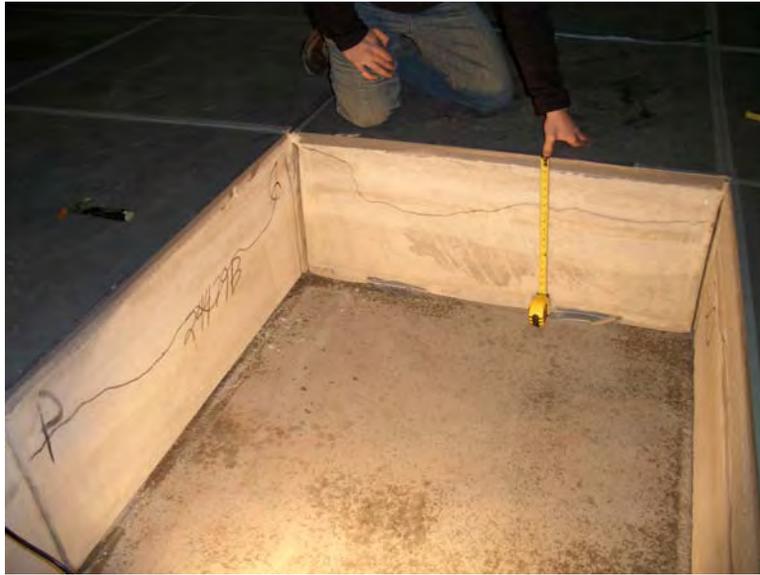
Figure 29. Decreasing frost at some corners.

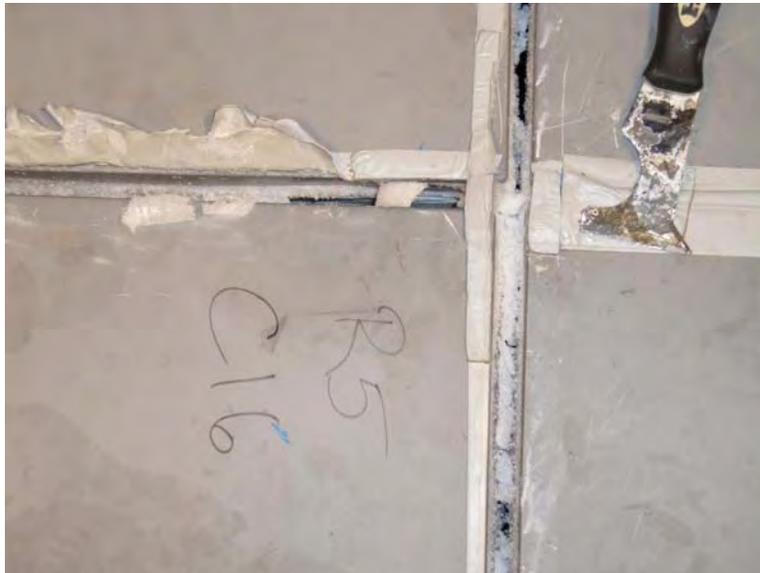
Figure 30. Thicker frost at the intersection of four blocks.

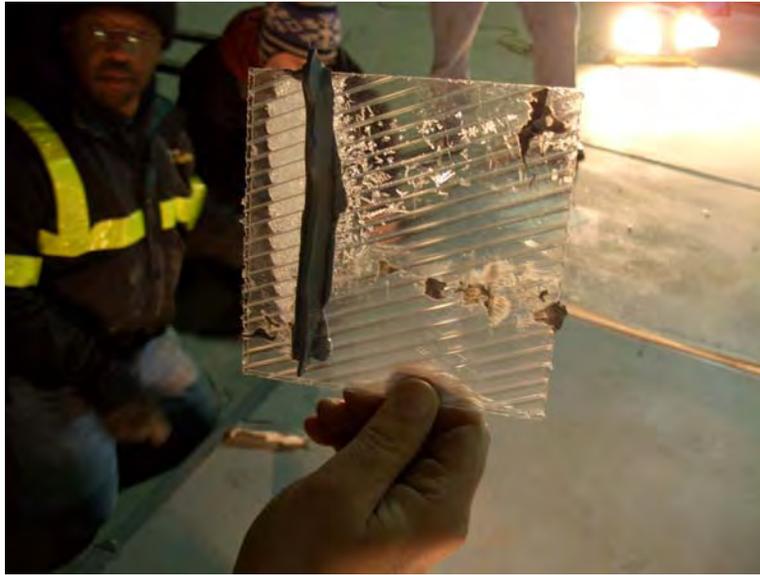
Figure 31. Frost in a vent from the first level of 8-inch-thick blocks.

Nearly all the vents showed frost buildup during the cold portion of the cycling. Figure 31 shows a vent from the lowest 8-inch-thick block. The material stuck on the side of the vent is silicone flashing and marks how far the vent protruded from the block. Figure 32 shows the vent from the second level of step blocks. Note that frost extends the entire length of the vents.

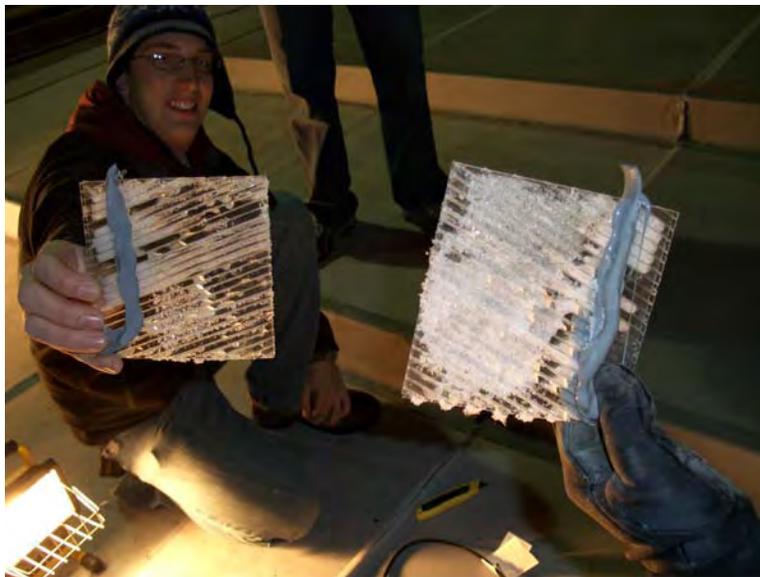
Figure 32. Frost in the second-level vents.

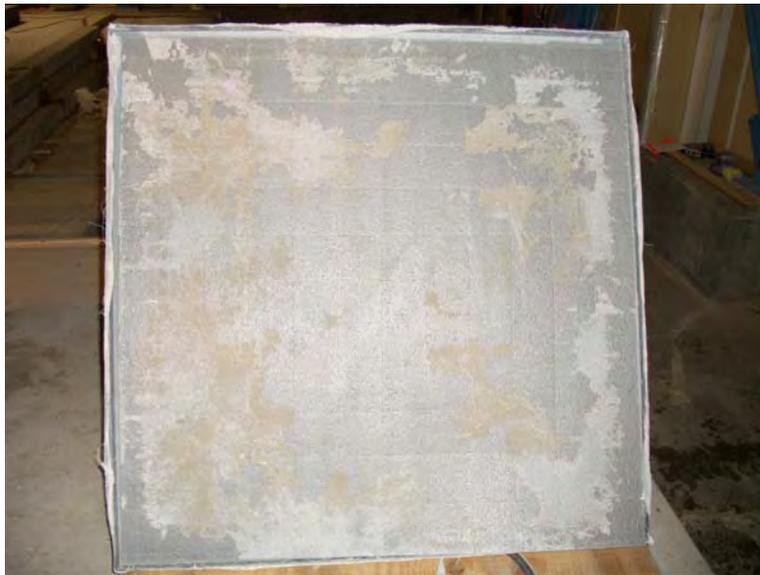
Figure 33. Underside of block top with frost traces.

A block top was removed during the cold forensics to inspect the condition of the block beneath it. Figure 33 shows the underside of the top with some frost traces visible. The block was dug into with a portion removed as shown in Figure 34. The concrete appeared to be competent with a normal consistency similar to what is found in new blocks, and the cut face profile didn't show any signs of deterioration or voids other than what was caused by the sample removal.

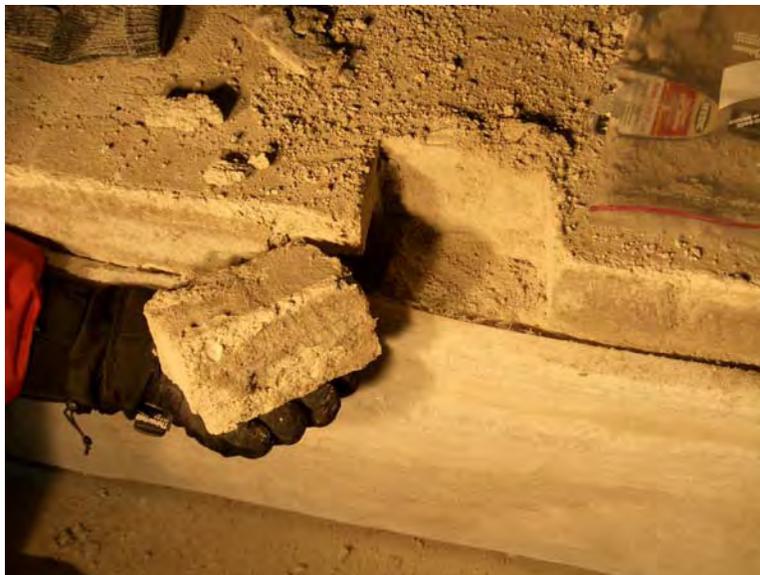
Figure 34. Sample removed from material directly under the block top.

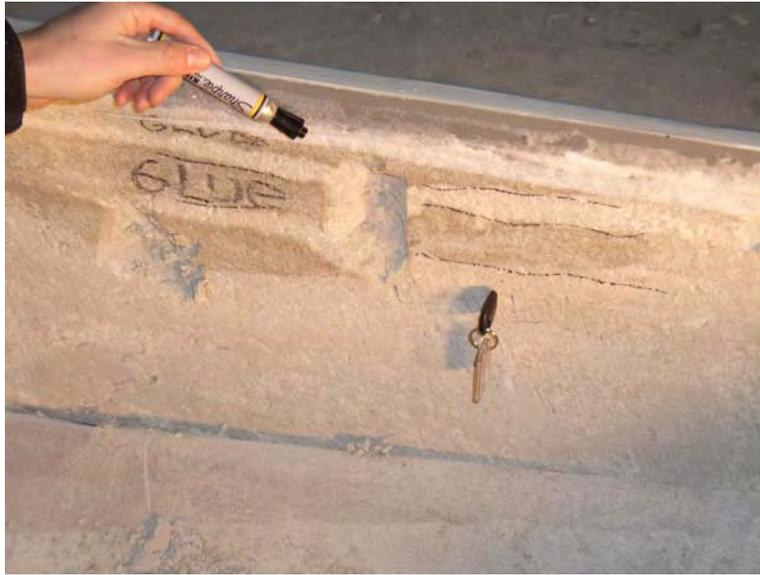
Figure 35. Sample cutout from a block side that had surface frost on it. The darker areas are from glue used to hold a scrim material that fastens the plastic block top to the plastic bottom.

A similar process was performed on an interior block directly behind where there had been surface frost in the seam as shown in Figure 35. Again the block consistency was normal with no signs of moisture deterioration behind the frost.

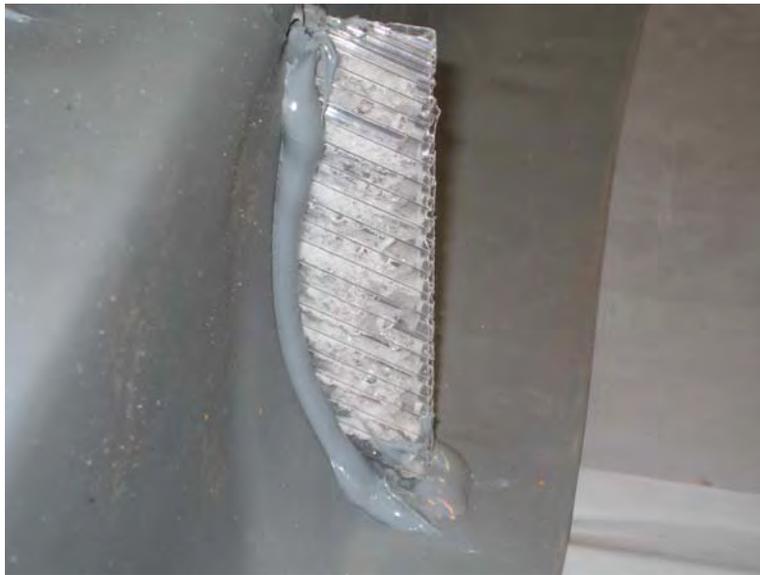
Figure 36. Vent frosting completely plugging the vent.

As mentioned above, the vents showed frost buildup during the below-freezing temperatures. This was severe enough in a large number of vents to completely plug the vent, as shown in Figures 36 and 37.

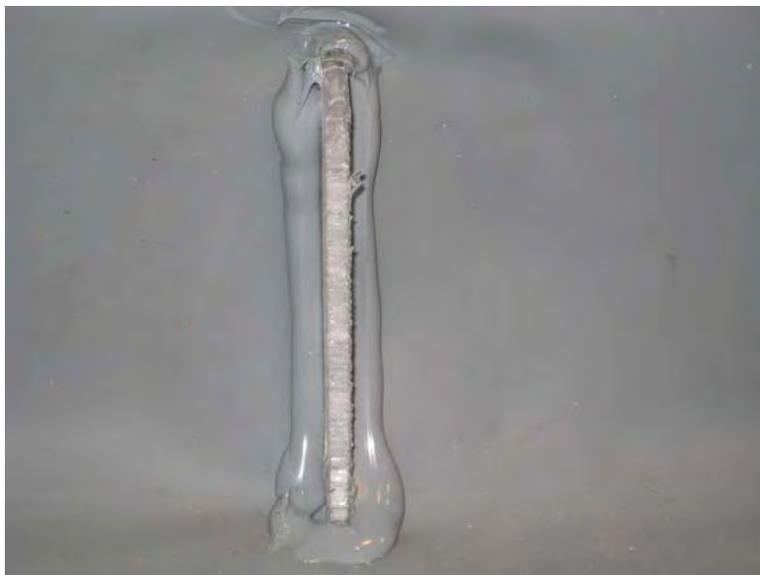
Figure 37. Front view of vent shown in Figure 36 with frost plugging holes.

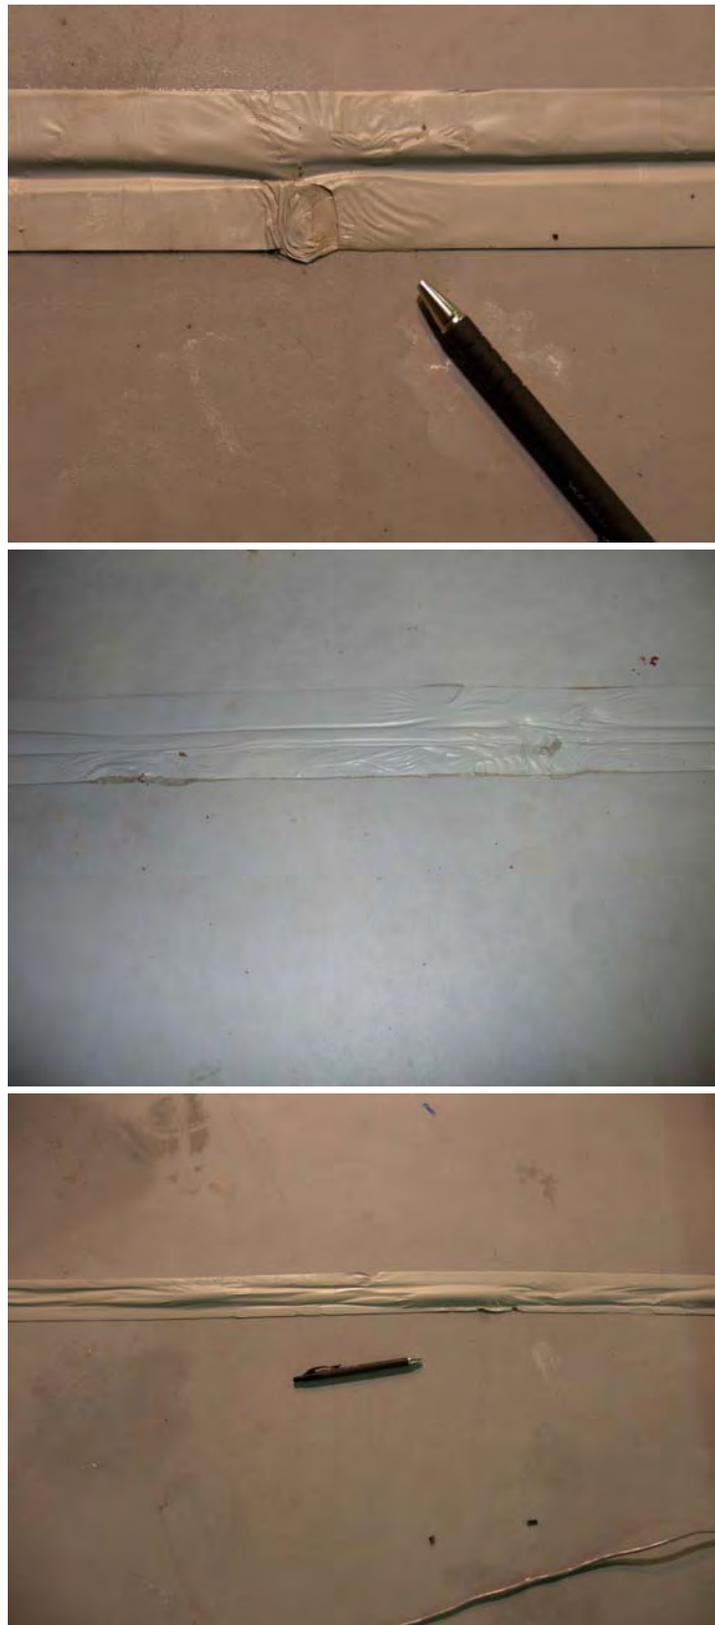
Figure 38 a, b and c. Tedlar/butyl tape showing some splitting and shrinkage.

About three months into the cycling, several areas of the Tedlar/butyl seam tape showed signs of distress. It appeared to be shrinking and in some cases splitting, as shown in Figure 38a, b, and c. ESCO has since replaced this tape with an all-silicone tape made of the same material as their side flashing that is applied with a silicone adhesive. A section of the EMAS was retrofitted with this tape on 19 November 2007. The new tape went through eight temperature cycles and showed no signs of deterioration from that number of cycles.
