DOT/FAA/AR-09/14

EMAS Cold Weather Performance Investigations

September 2009

Final Report

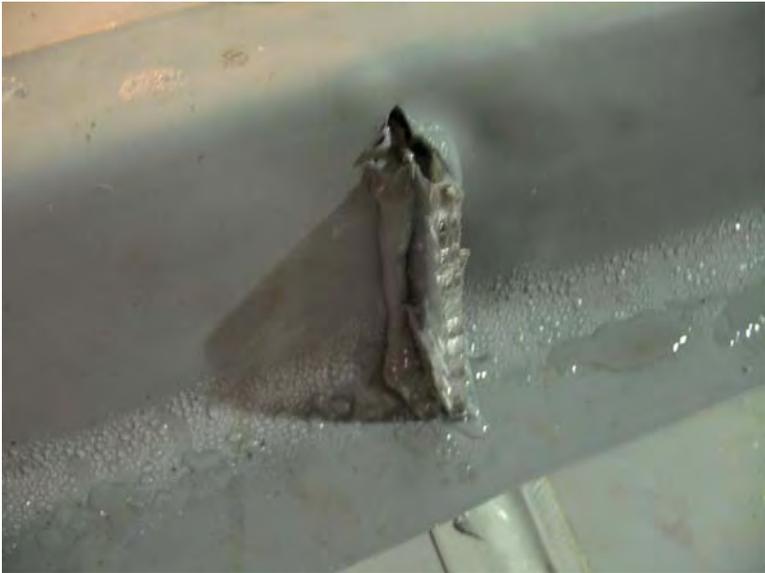
Figure 39. Flashing tearing above vent.

The most prevalent issue noted was the sealant around the vents. After several cycles, either the flashing at the vents started to tear, as shown in Figure 39, or the sealant at the vents started to pull away from the flashing (Figures 40 and 41). These openings could provide a direct moisture path into the seams.

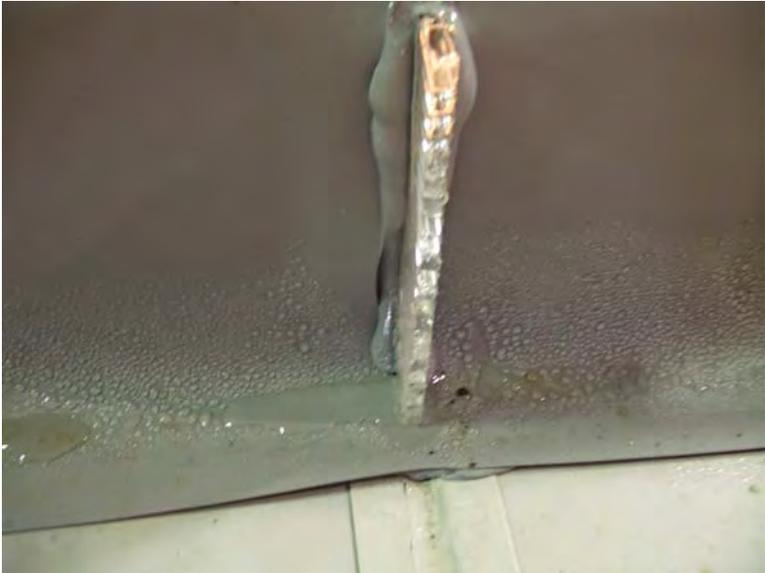
Figure 40. Vent sealant pulling away from flashing.

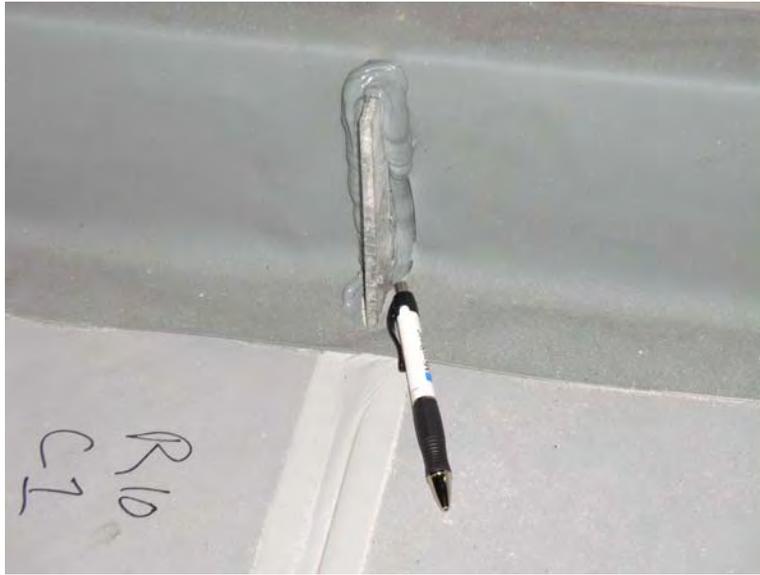
Figure 41. Sealant at vent pulling from flashing.

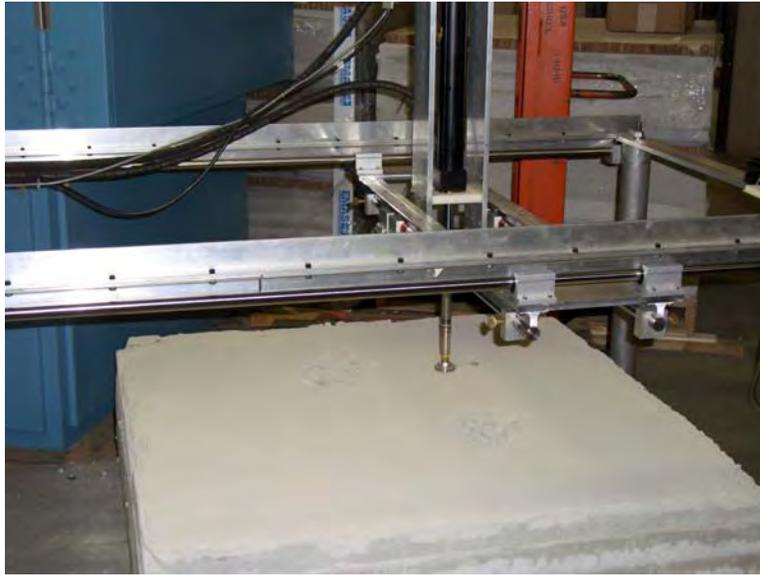
Figure 42. CRREL Punch Tester with an EMAS block in place.

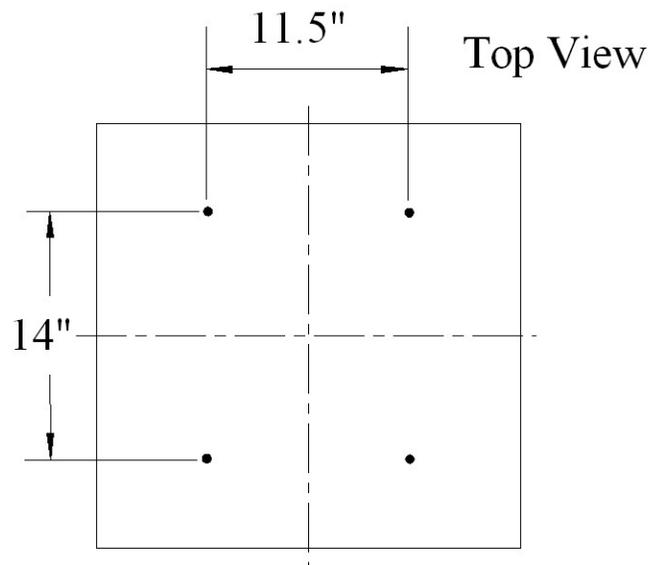
Figure 43. Top view of EMAS block showing punch test locations.

Each block except one had two punches done by ESCO and two by CRREL in the same relative block positions to avoid strength differences caused by cure location. Figure 43 shows the general punch locations in the block. The punch tests were performed with a 2-inch-diameter punch head at a rate of approximately 1 inch/second on blocks without the plastic top.

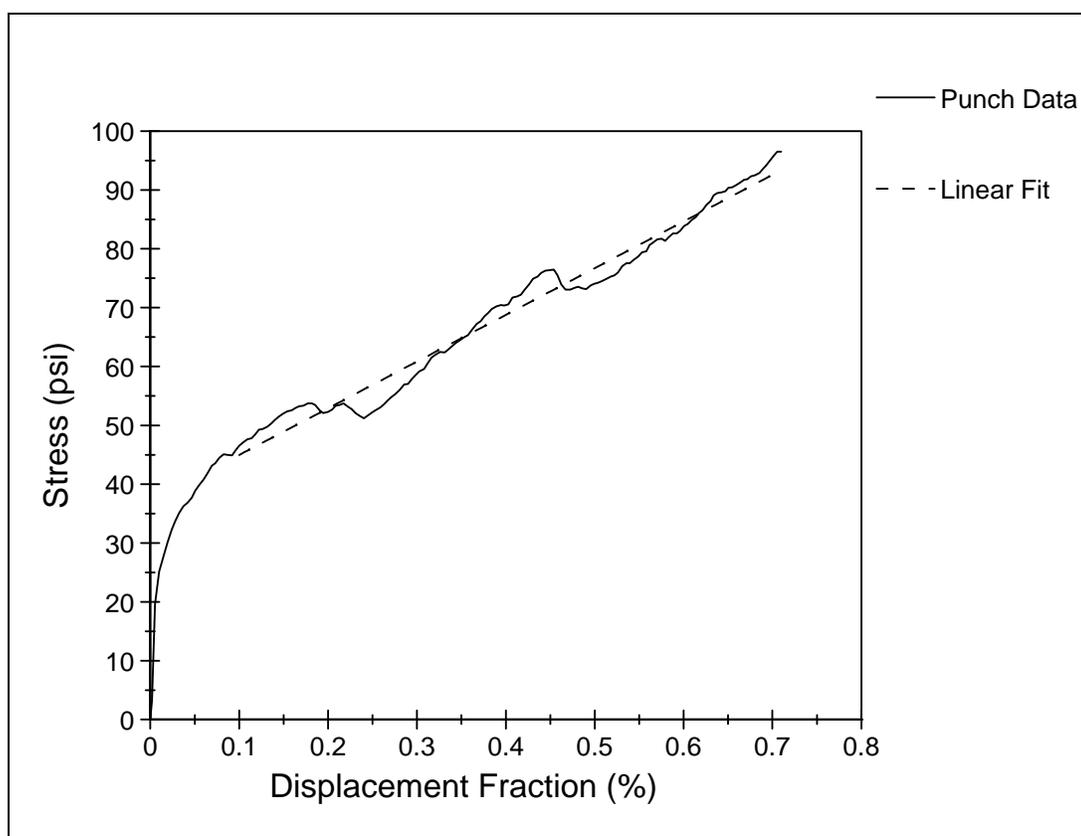
Figure 44. Typical stress versus displacement fraction curve from the block punch data.

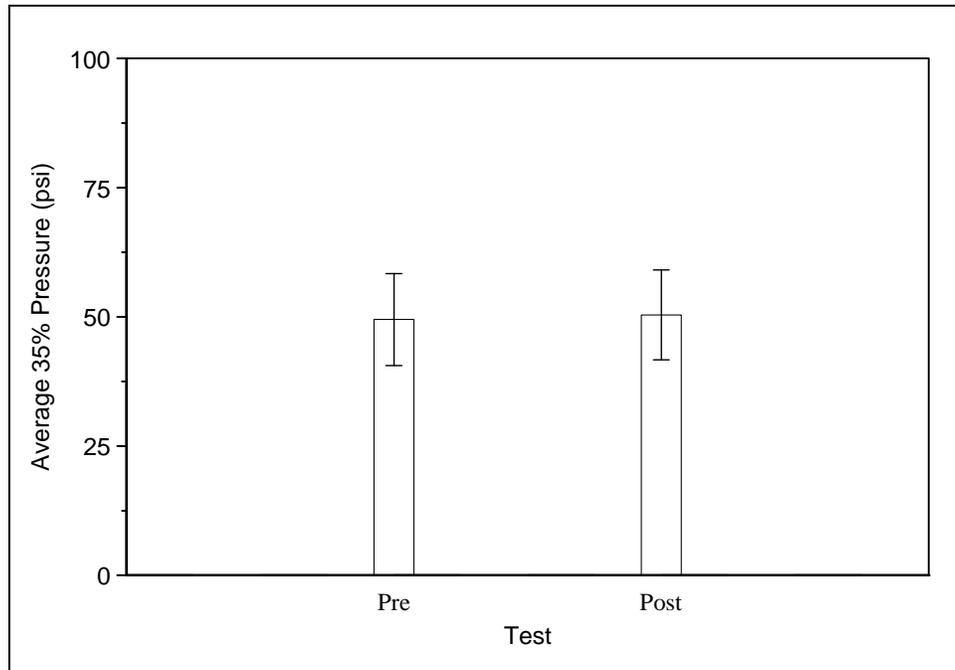
Figure 45. Average stress at 35% displacement fraction pre- and post-thermal cycling comparison.

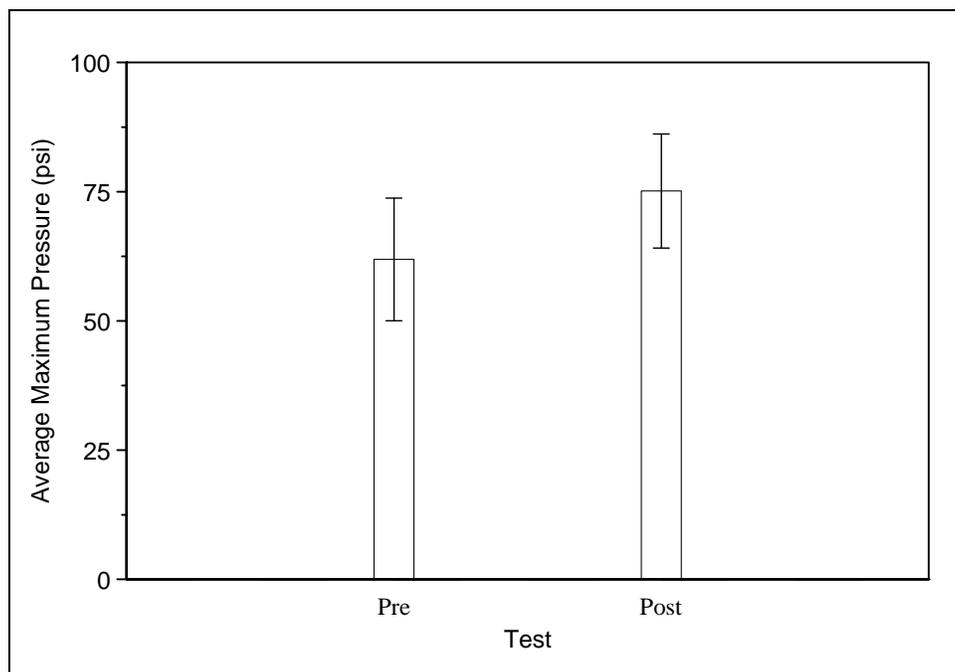
Figure 46. Average maximum stress pre- and post-thermal cycling comparison.

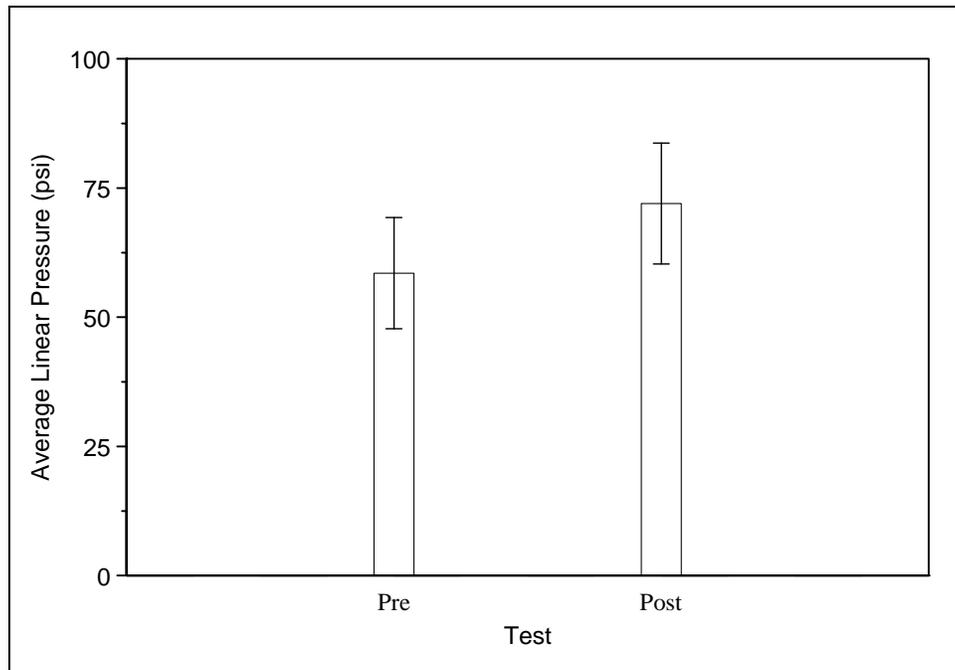
Figure 47. Average maximum linear stress pre- and post-thermal cycling comparison.

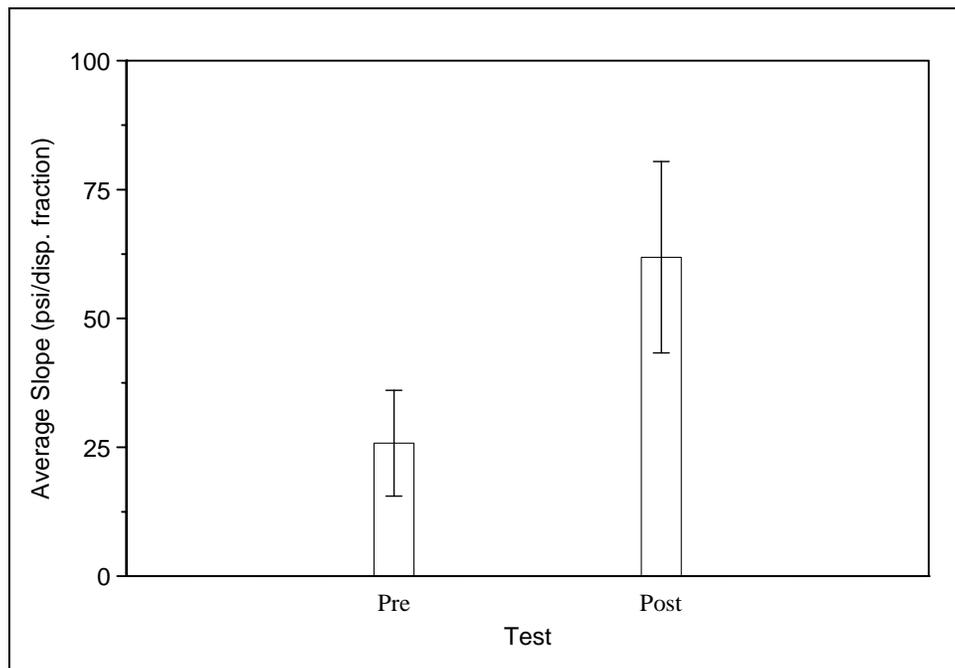
Figure 48. Average linear fit slope pre- and post-thermal cycling comparison.

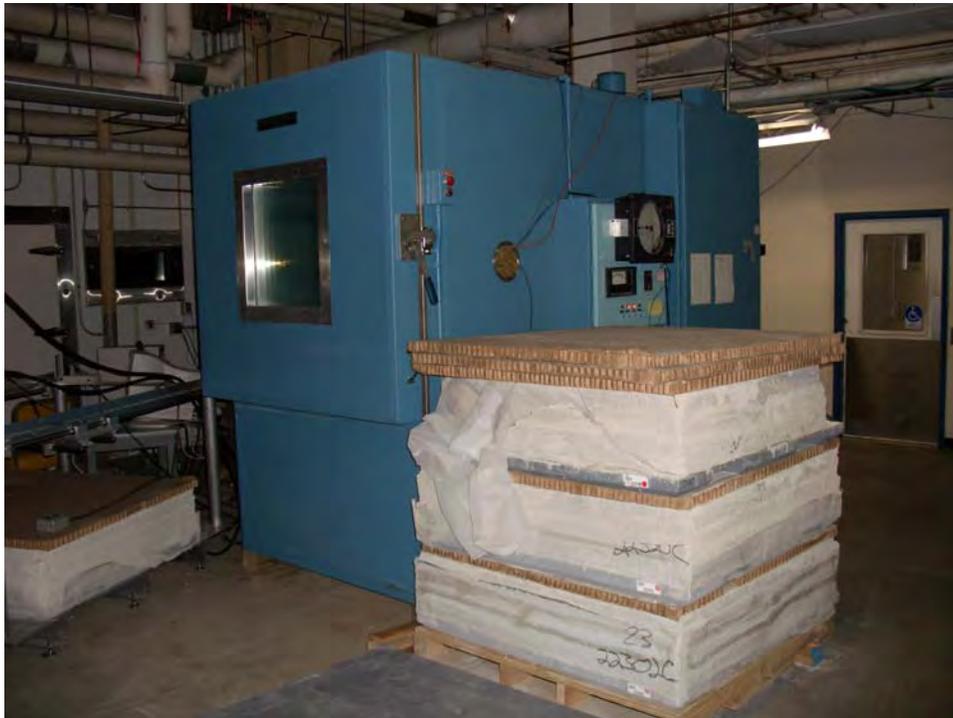
Figure 49. CRREL temperature chamber.

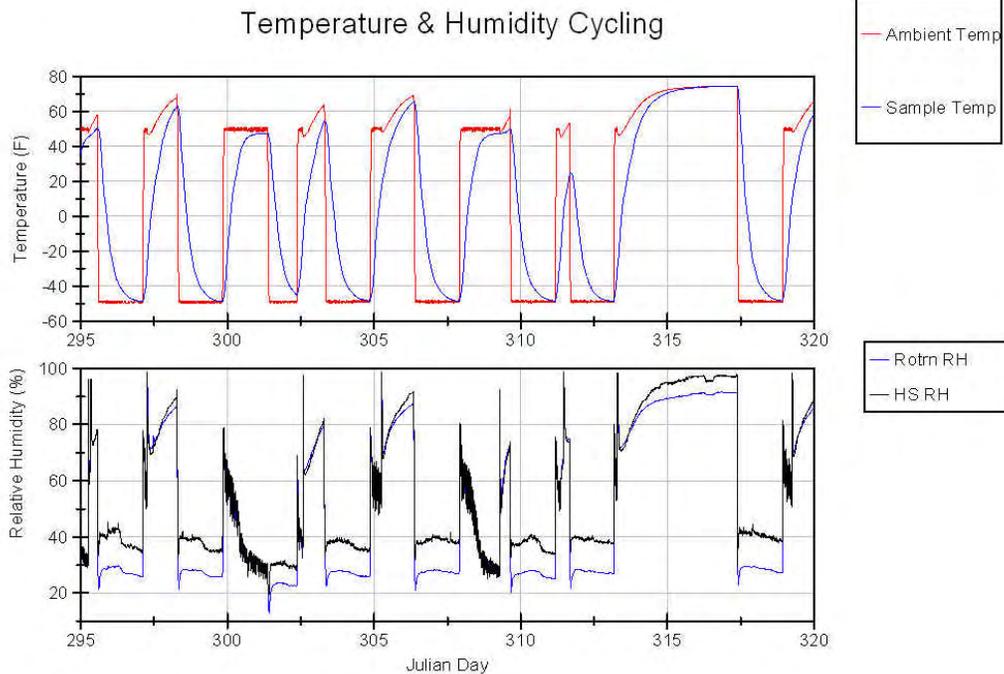
Figure 50. Temperature and humidity example. The temperature graph shows the ambient and internal sample temperature. The bottom humidity graph shows readings from two separate humidity sensors.

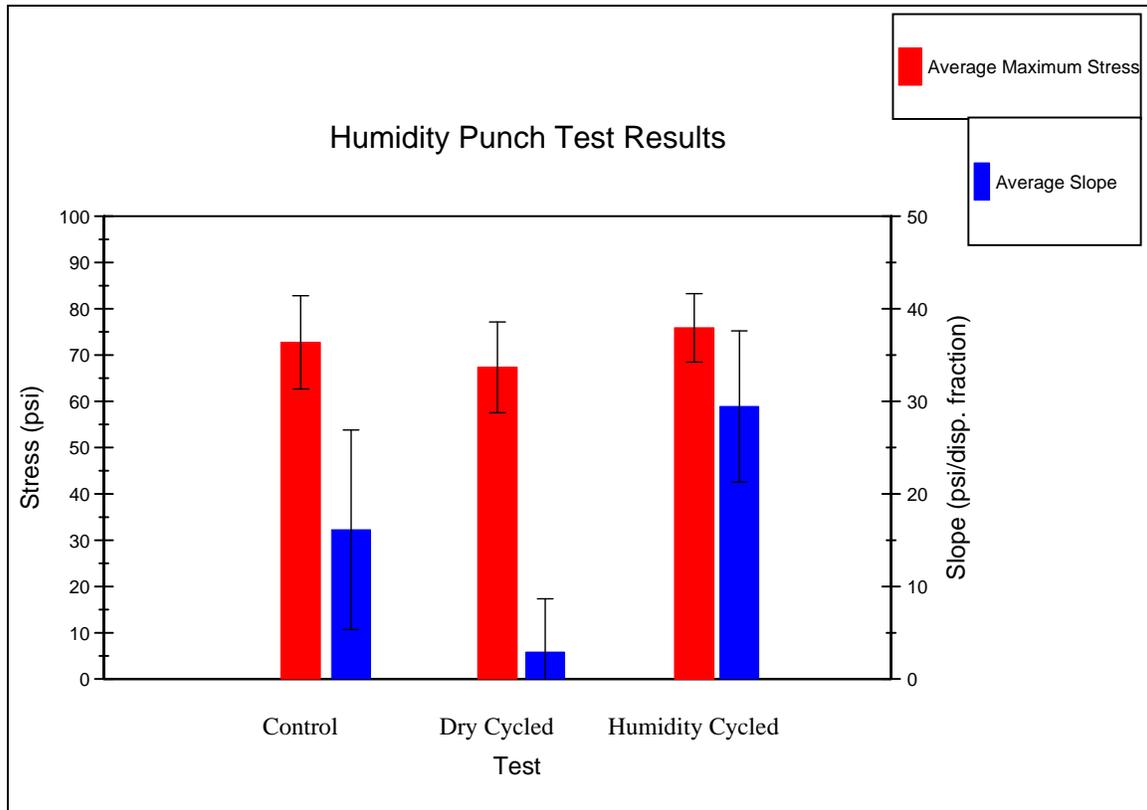
Figure 51. Punch test results for the temperature and humidity testing.

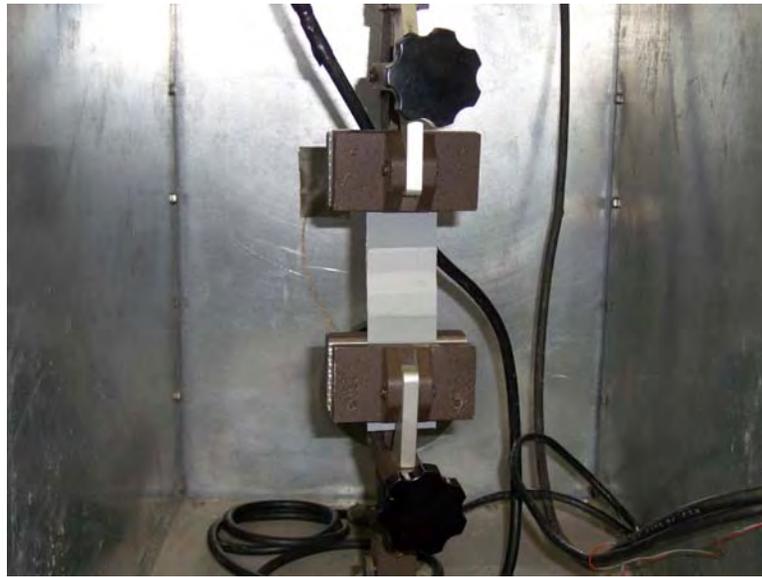
Figure 52. Sealing tape coupon mounted in test fixture.

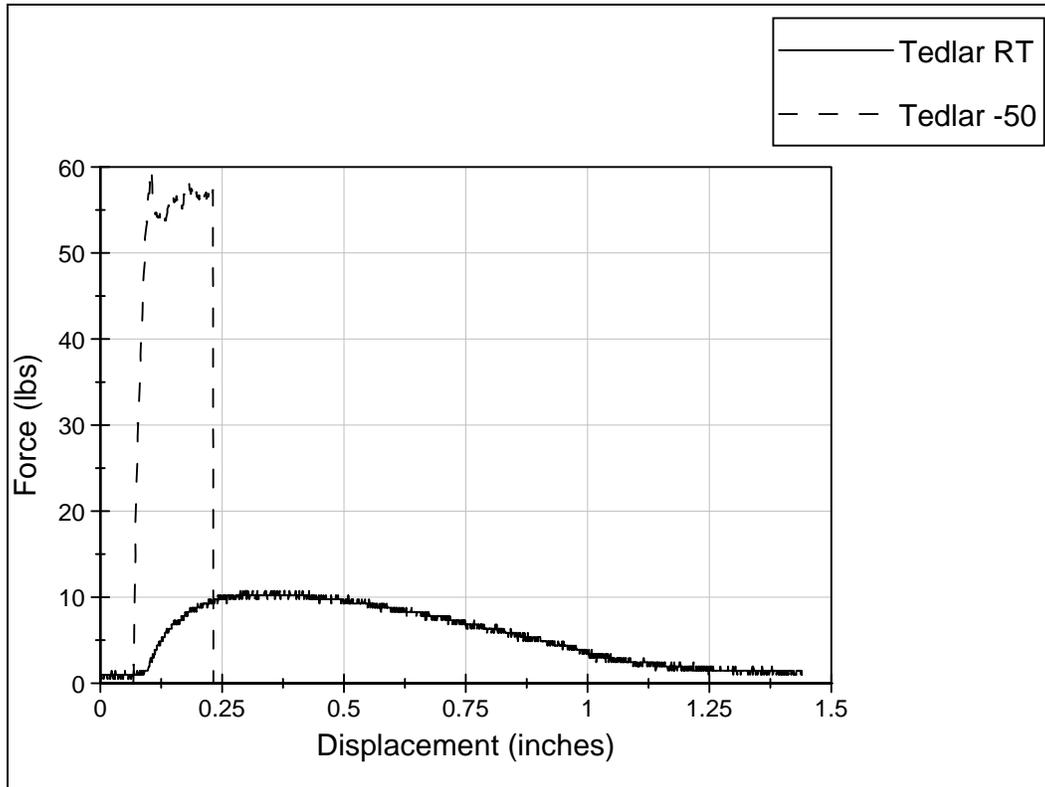
Figure 53. Tedlar/butyl force displacement plot for room temp and - 50° F.

elongation than the Tedlar/butyl did, as shown in Figures 53 and 57, where even the -50° F silicone elongation is greater than the Tedlar room temperature elongation. The silicone tape remained attached to the top material during the tests and failed within the silicone itself, as shown in Figure 59. Overall, the results show there is an increase in the seam tape strength with decreasing temperature in both tapes. This effect is minimal in the newer silicone tape, but that tape is stronger at room temperatures than the older Tedlar/silicone. The silicone has better top adhesion at all temperatures.

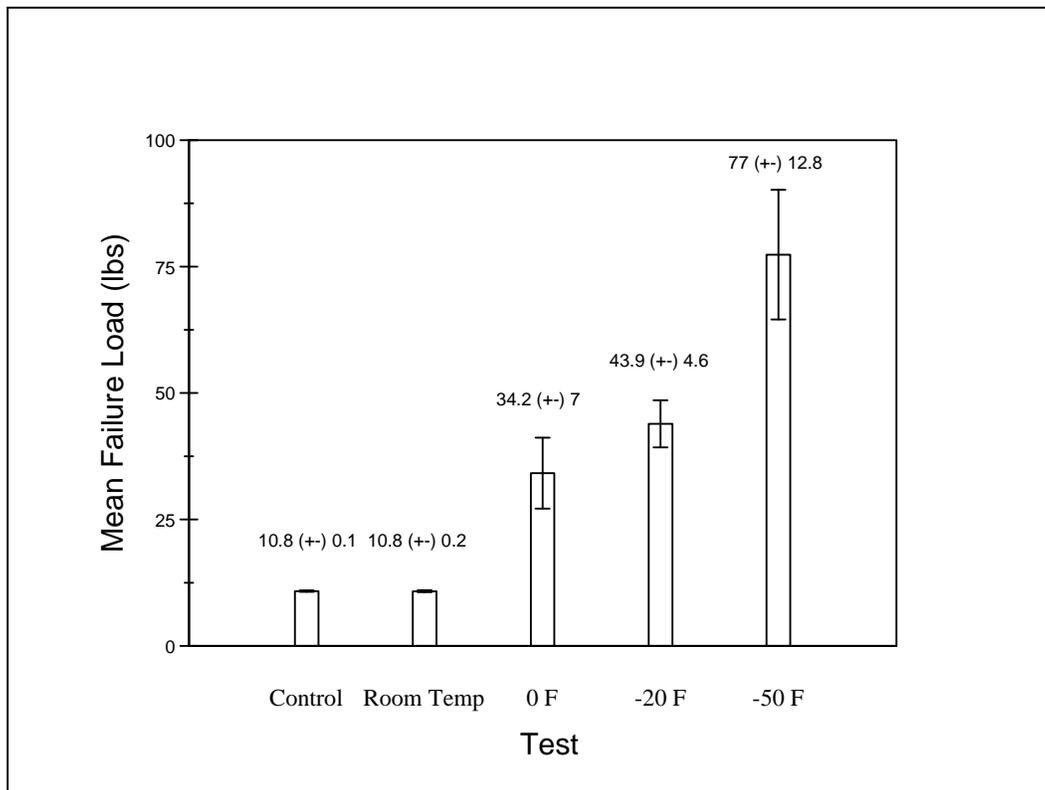
Figure 54. Summary of all Tedlar/butyl tape tests.

The first item to note in Figure 54 is that the control and the room temp strengths are identical. This suggests there is not a detrimental effect to tape shear strength from being temperature-cycled. It also can be seen from the figure that the shear strength of the tape increased as the test temperature dropped. This tape is a two-part tape consisting of a Tedlar film on top of a butyl mastic. At room temperature, the failure was usually because the Tedlar slid off the mastic while the mastic would remain attached to the top, as shown in Figure 55. At cold temperatures, the two parts would remain together, creating a stronger entity, and the failure would occur within the Tedlar, as shown in the -20°F test in Figure 56.

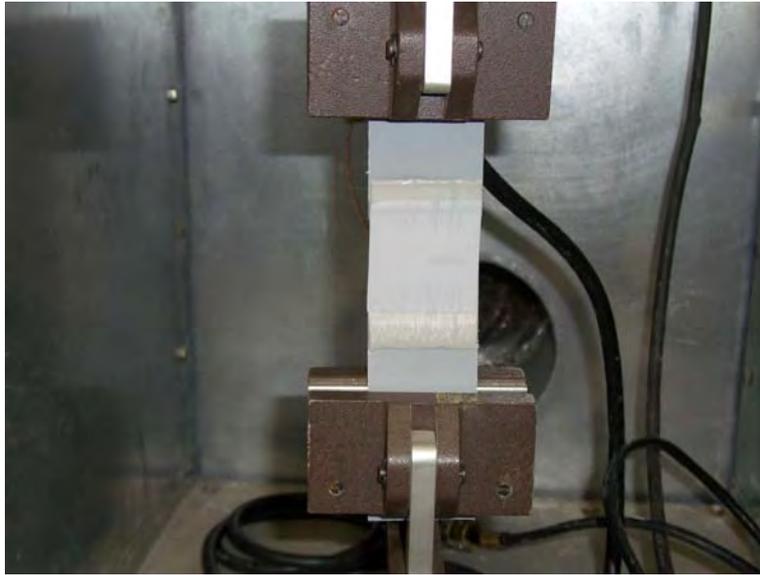
Figure 55. Tedlar/butyl tested at room temperature shows the Tedlar sliding from the butyl mastic.

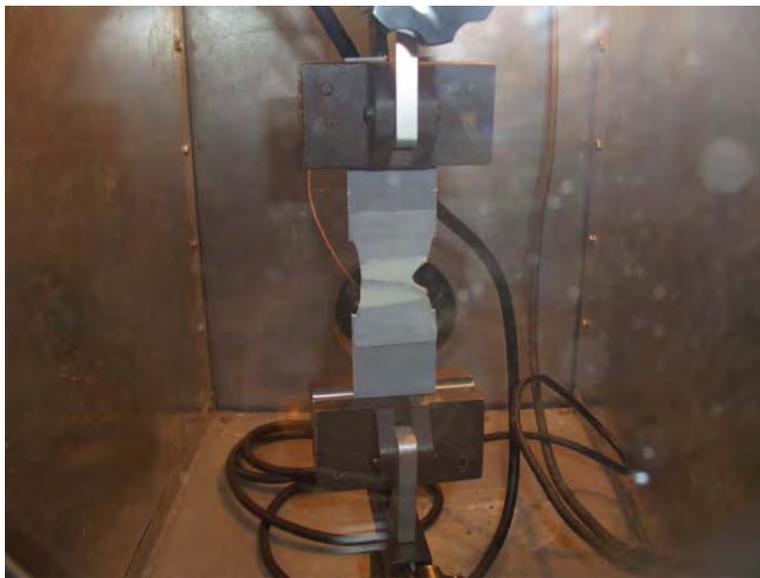
Figure 56. Tedlar/butyl tape tested at a cold temperature showing failure within the Tedlar film and no evidence of sliding off the mastic.

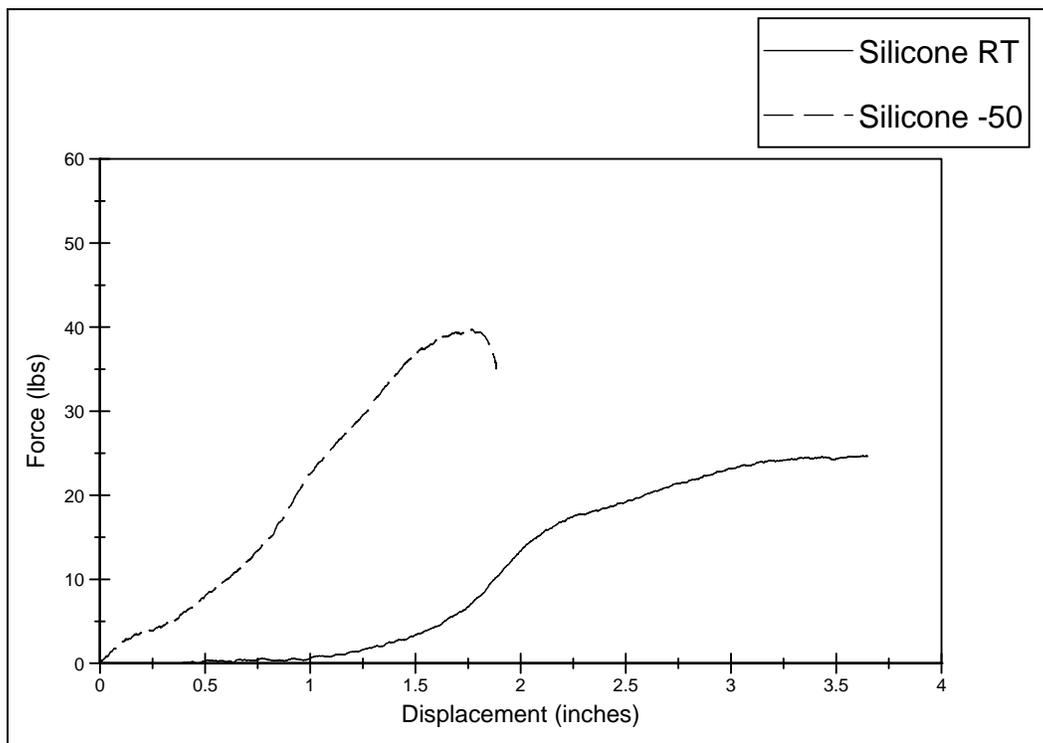
Figure 57. Silicone sealing tape force/displacement graph for room and -50° F temperatures.

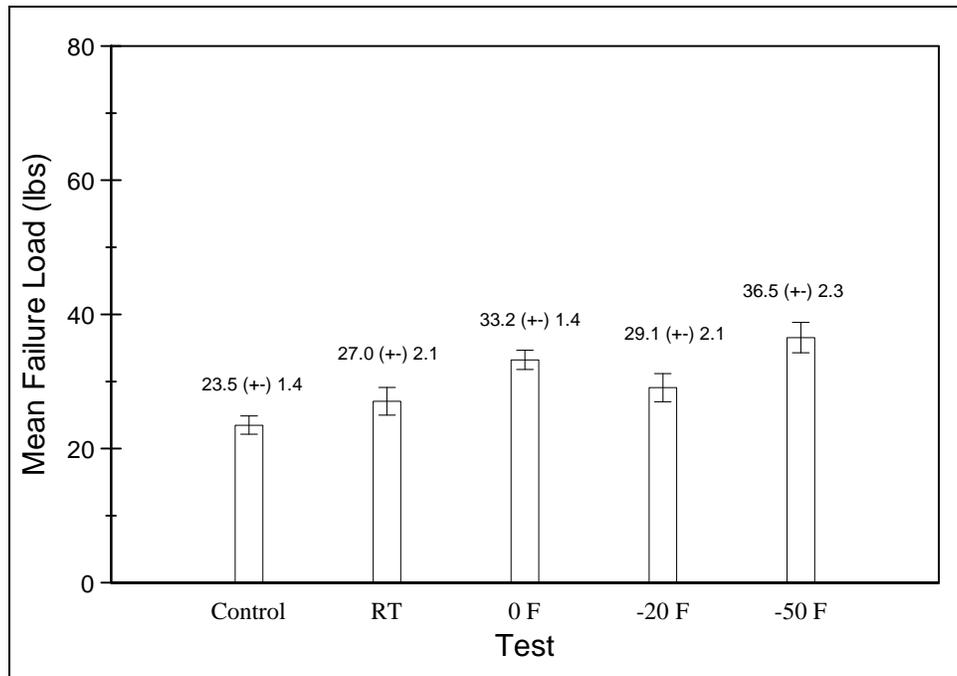
Figure 58. Silicone seam tape summary for all temperatures.

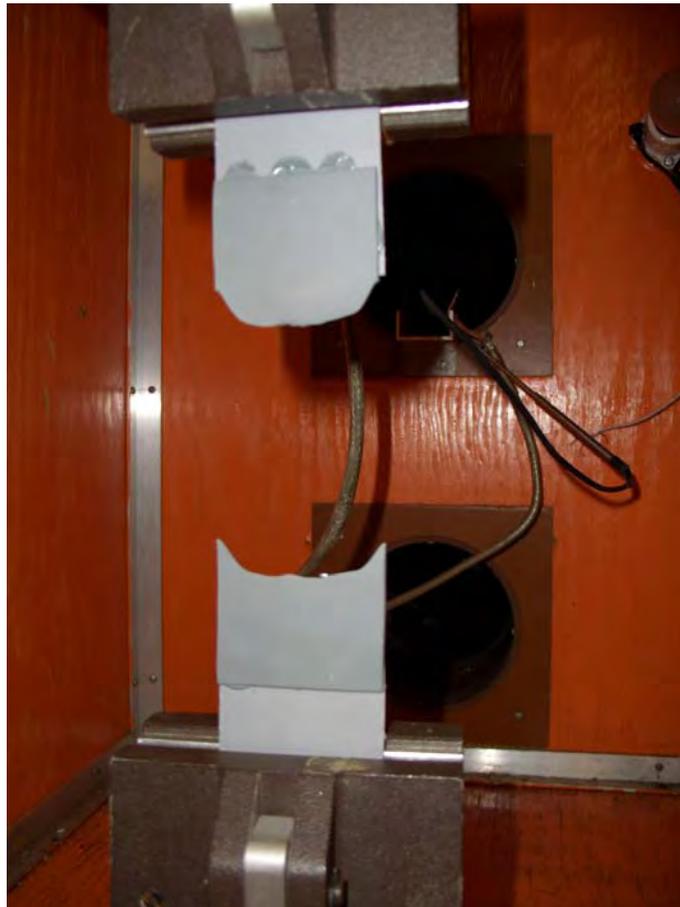
Figure 59. Silicone seam tape at failure. There is no tape slippage from the top material.

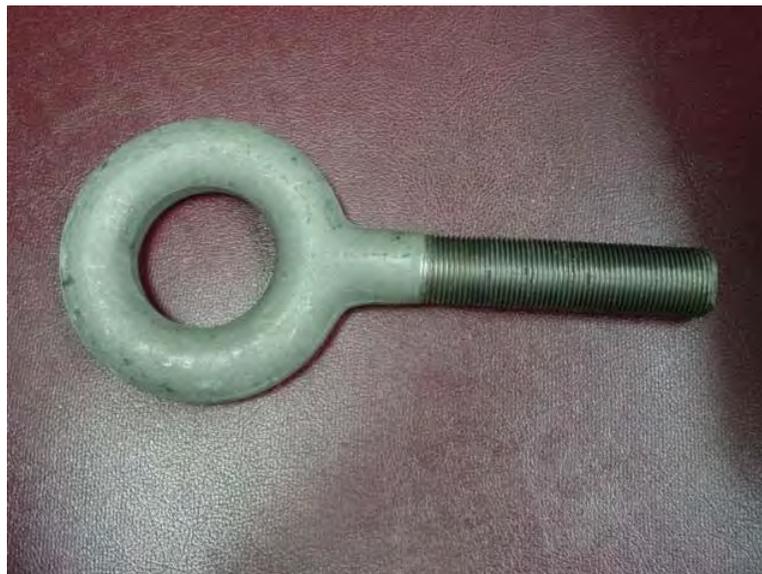
Figure 60. Eyebolt drop Indenter.

The indenters are shown in Figures 60 and 61. One was an eye-bolt, dropped ring down, with a somewhat tapered outside diameter to the ring, and one was a purpose-built round ball. The eyebolt had a sharper surface that impacted the top, whereas the ball was much smoother and less pointed. The dimensions and weights of the indenters are listed in Table 6.

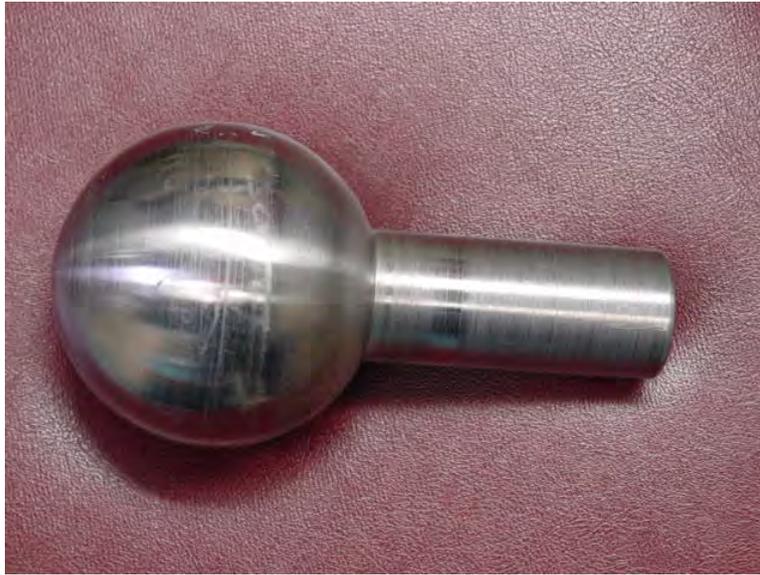
Figure 61. Spherical drop indenter.

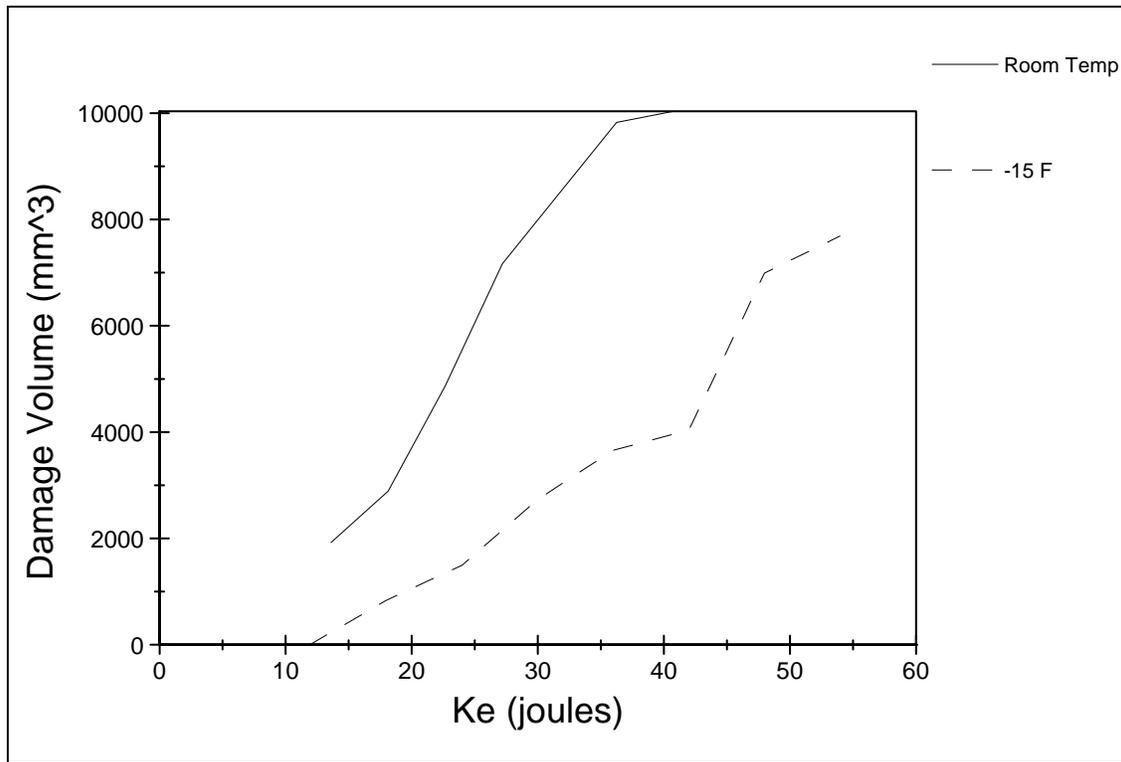
Figure 62. Damage volume versus drop energy for the eyebolt indenter.

Overall, the data show there is slightly less damage to the top with decreasing temperature.

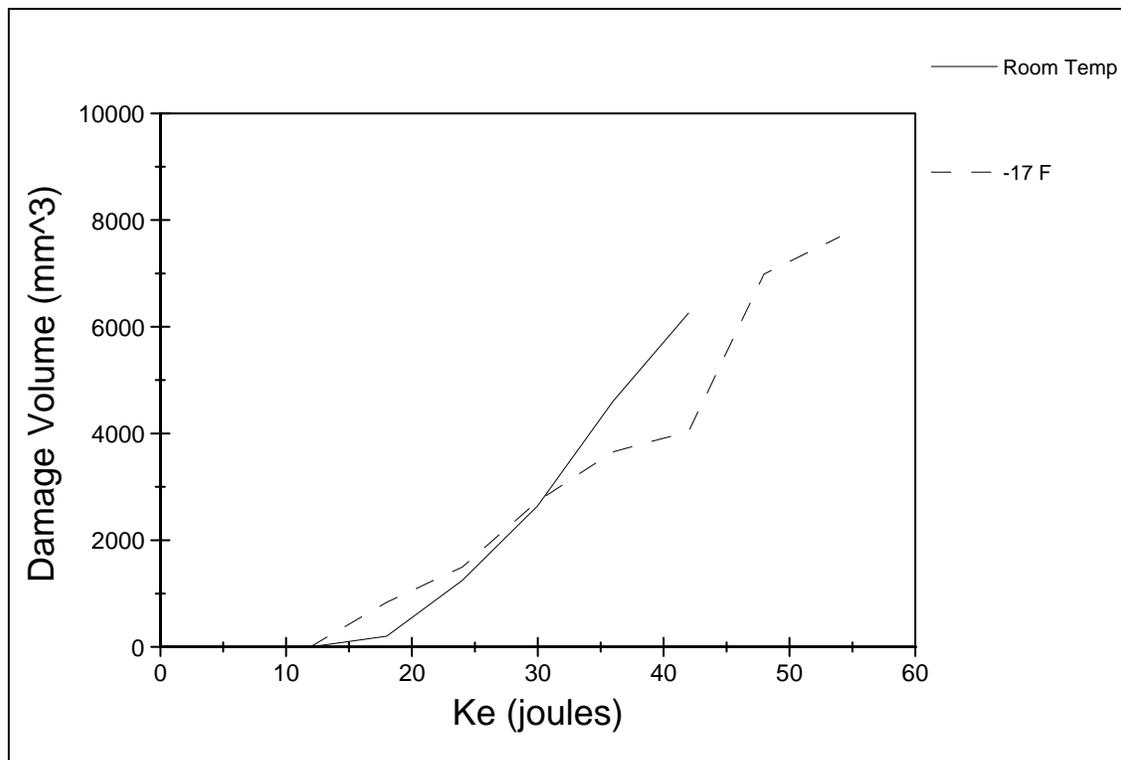
Figure 63. Damage volume versus drop energy for the spherical indenter.
