DOT/FAA/AR-97/65

Stabilized Base Courses for Advanced Pavement Design Report 1: Literature Review and Field Performance Data

September 1999

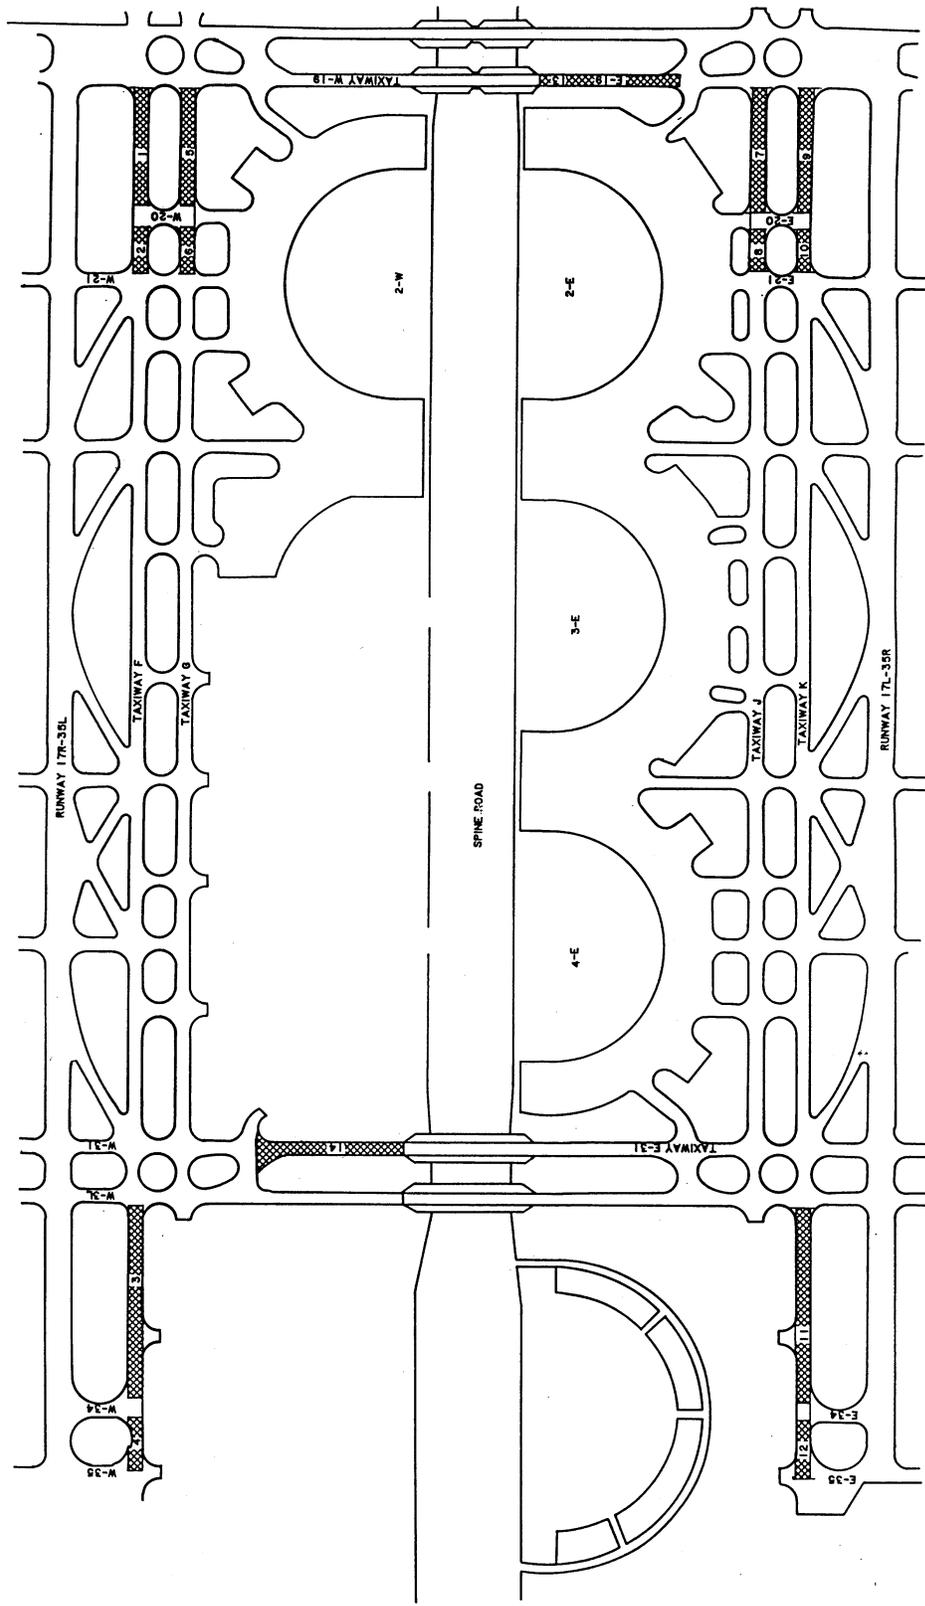
FIGURE C-2. LAYOUT OF DALLAS/FORT WORTH INTERNATIONAL AIRPORT

Schematic Drawing—Not to Scale

Dallas/Fort Worth (DFW) was opened to aircraft traffic in 1974. Therefore, at the time of this study the pavements were approximately 21 years old, 1 year older than their design life. The pavements are all rigid, designed as jointed reinforced-concrete slabs. The original design called for doweled joints spaced at 15-m (50-ft) intervals. After construction commenced, the design was changed due to regular cracking being observed at approximately 7.5-m (25-ft) spacings (mid-slab). The remaining pavements were constructed with doweled joints at 15-m (50-ft) spacings and contraction joints were sawed at 7.5-m (25-ft) spacings. The longitudinal joints were drilled and epoxy doweled. The slabs contained approximately 0.07 percent temperature

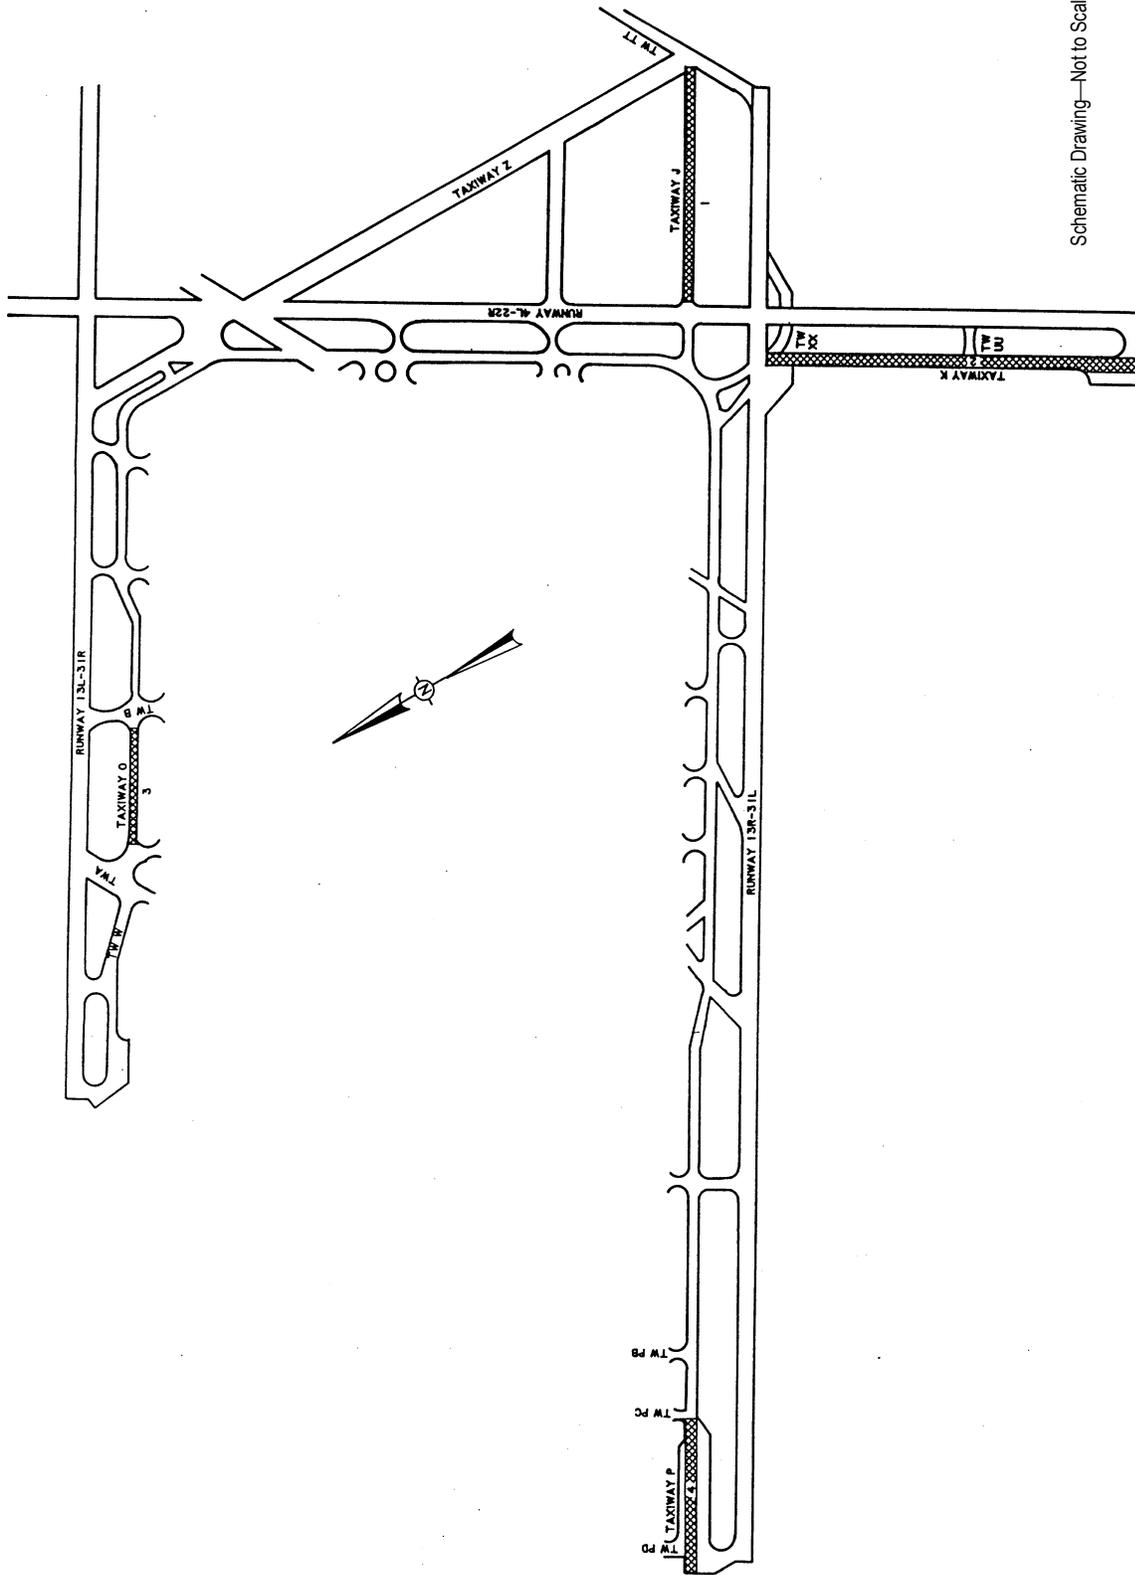
FIGURE C-3. LAYOUT OF JOHN F. KENNEDY INTERNATIONAL AIRPORT

Schematic Drawing—Not to Scale

The data used for evaluating the pavements at JFK were provided by the Port Authority of New York and New Jersey. The Port Authority has personnel on staff that conduct periodic condition surveys. The Port Authority contracts NDT data collection and analysis. The Port Authority provided the most recently collected NDT data. The unprocessed NDT data were evaluated using the procedure in reference 22.

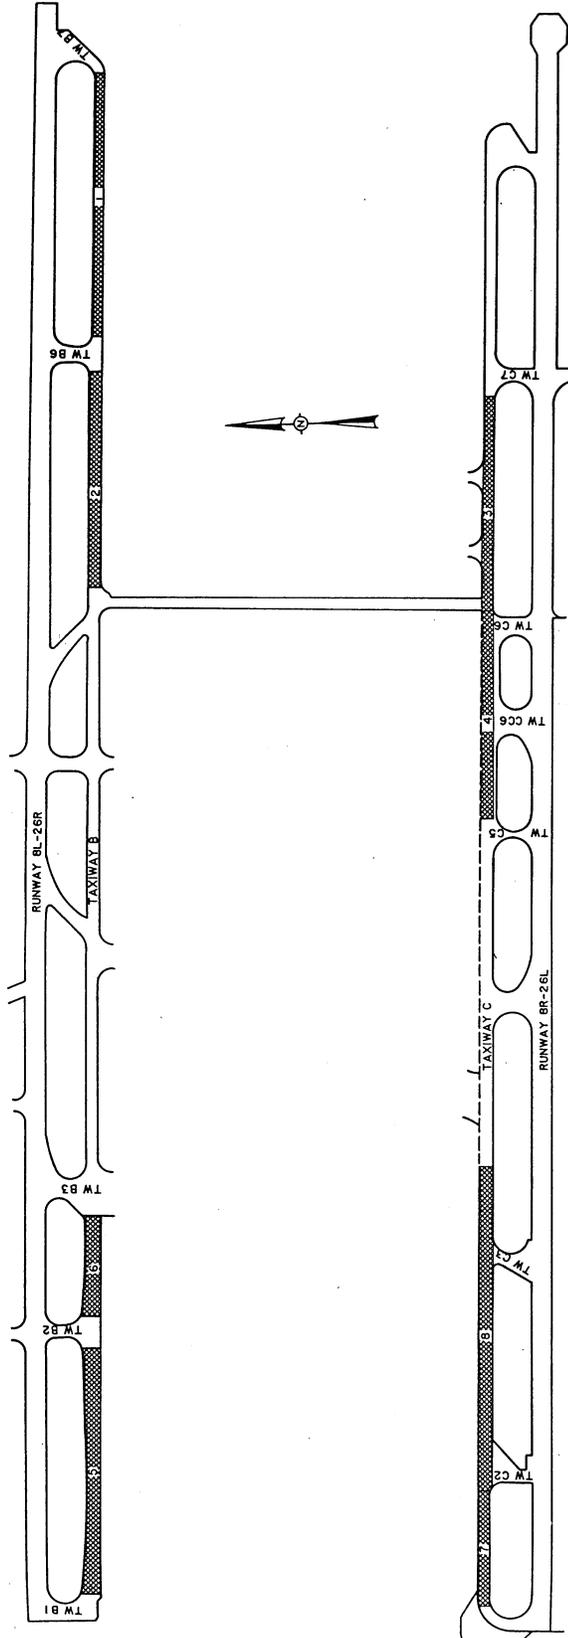
FIGURE C-4. LAYOUT OF PHOENIX SKY HARBOR INTERNATIONAL AIRPORT

Schematic Drawing—Not to Scale

The pavements that were evaluated for the high-volume study [20] at Phoenix were all flexible pavements. Only four of the original eight sections evaluated in the high-volume study were still conventional flexible pavements at the time of this study. The other four sections have been reconstructed and are now PCC. Half of two of the remaining four flexible sections have also been reconstructed with PCC. All of the remaining flexible pavement sections had approximately 2 in. of AC milled off and replaced with a new HMAC surface course in 1991. The ages of the pavements tested for this report were 14 to 28 years.
