DOT/FAA/AR-99/34

Characterization of Early Stages of Corrosion Fatigue in Aircraft Skin

Phase II: Interpretation of Corrosion-Fatigue Fracture Surfaces in Alclad 2024-T3 Aluminum Alloy Sheet

Phase II Report

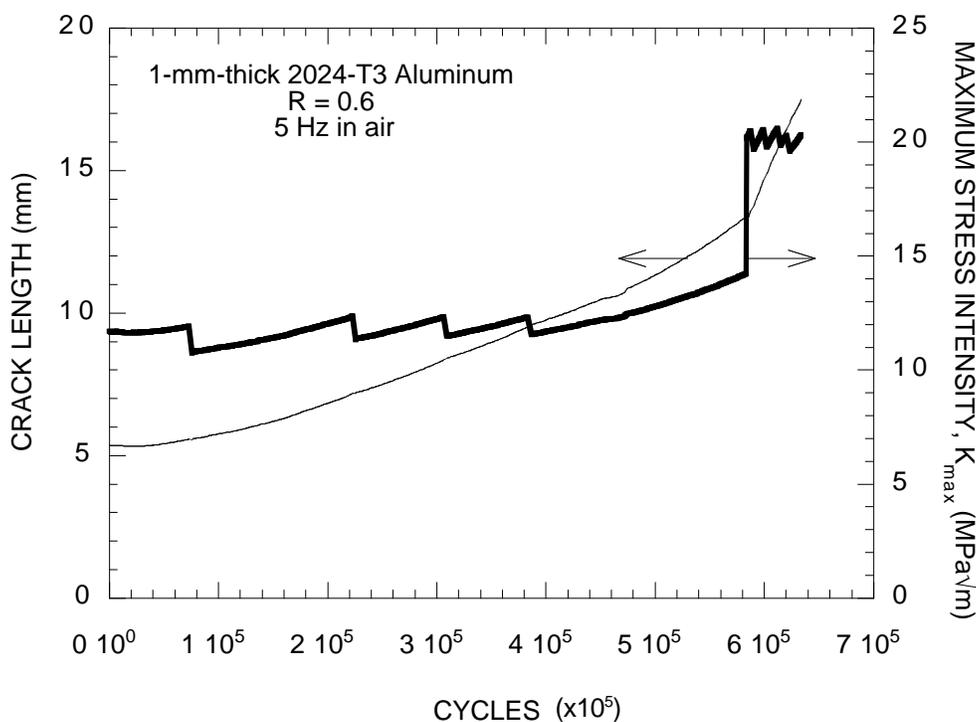
FIGURE 1. EFFECTS OF MAXIMUM STRESS INTENSITY CHANGE ON CRACK GROWTH RATE.

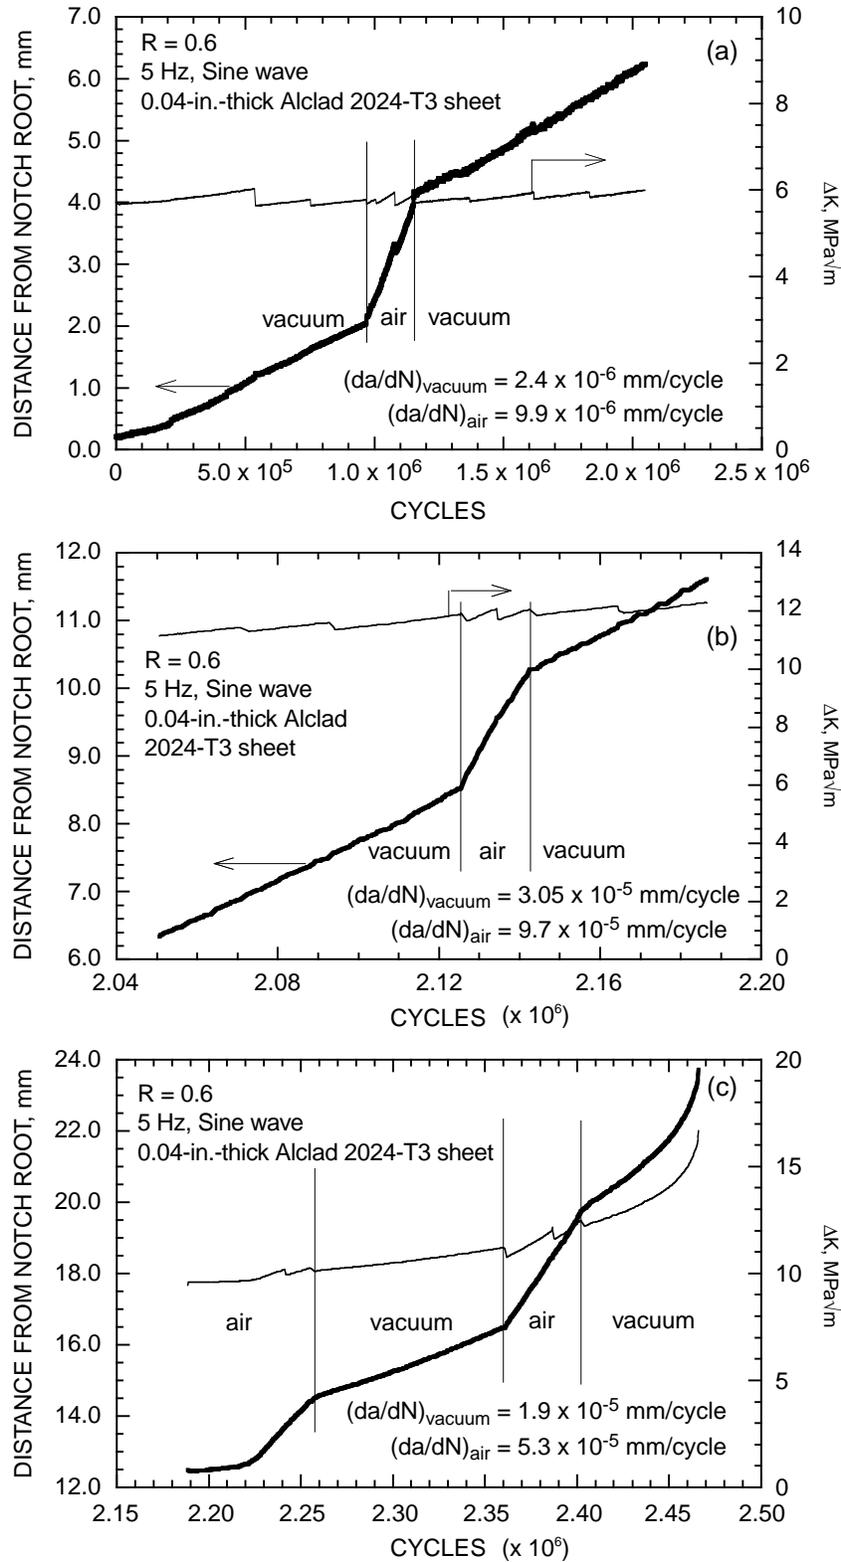
In these experiments, a vacuum of about 10^{-6} torr was imposed while the fatigue crack propagated a few millimeters. Then, the environment was suddenly changed to laboratory air as cyclic loading continued. Several changes in environment were imposed in this way under a range of loading conditions. The changes in environment immediately and reproducibly changed the crack growth rate such that the rate in air was about three times the rate under vacuum, as shown in figure 2(a), (b), and (c). The stress ratio, R , was constant at 0.6, and the load cycle frequency was 5 Hz in all tests.

FIGURE 2. CRACK GROWTH HISTORY OF A CYCLICALLY LOADED CENTER-CRACKED PANEL OF 2034-T3 ALUMINUM IN AIR AND UNDER VACUUM.

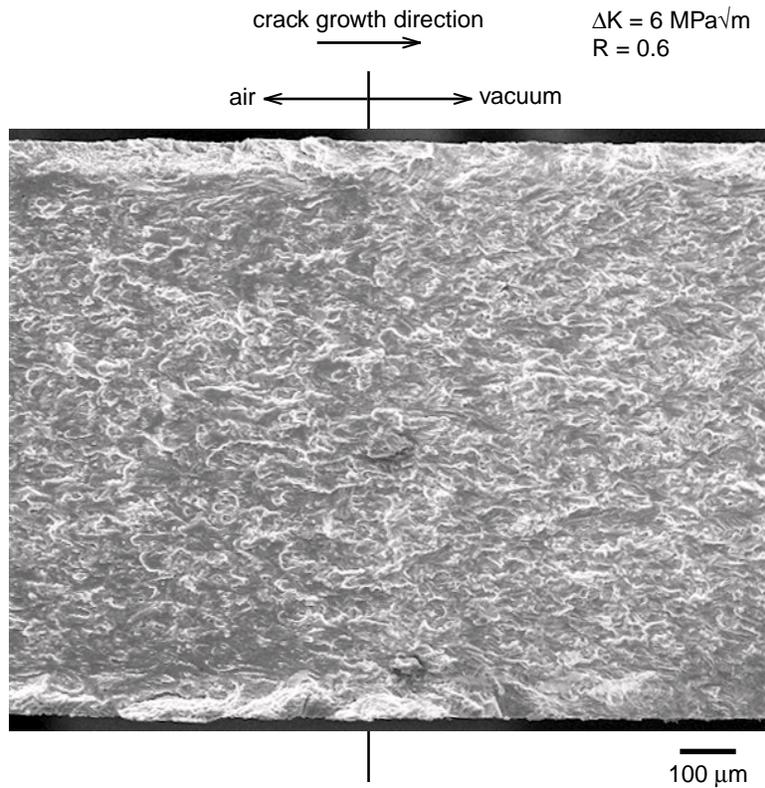
Figure 3 shows an example of the change in fracture surface appearance at the transition between crack propagation under vacuum and in air. There is a suggestion of denser features on the fracture surface generated in air; however, the difference is barely detectable by visual inspection. Examination of high-magnification SEM micrographs (see figure 4 for an example) shows no discernible difference in the fracture surface features for air and vacuum crack growth environments. We will show that Fourier analysis and FRASTA are capable of detecting and quantifying differences in fracture surface characteristics that are almost undetected by conventional SEM examination.

FIGURE 3. SEM MICROGRAPH SHOWING THE FATIGUE FRACTURE SURFACE MORPHOLOGY PRODUCED IN AIR AND UNDER VACUUM.

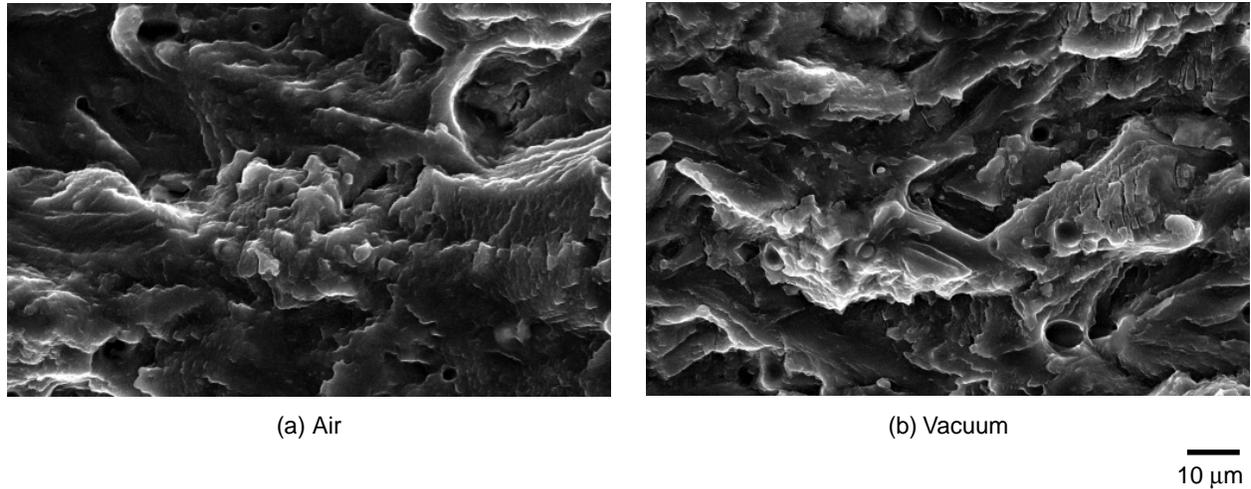
FIGURE 4. HIGH-MAGNIFICATION SEM MICROGRAPHS OF A FATIGUE FRACTURE SURFACE CREATED IN AIR AND UNDER VACUUM.

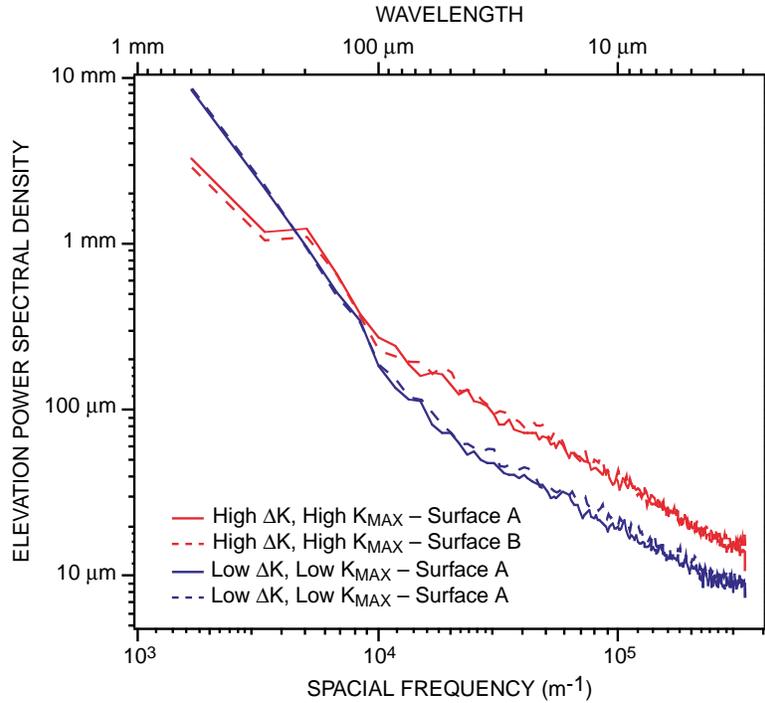
FIGURE 6. FAST FOURIER TRANSFORM ELEVATION POWER SPECTRAL DENSITY CURVES FOR CONJUGATE FATIGUE FAILURE SURFACES PRODUCED UNDER HIGH AND LOW ΔK AND K_{max} FATIGUE CONDITIONS.

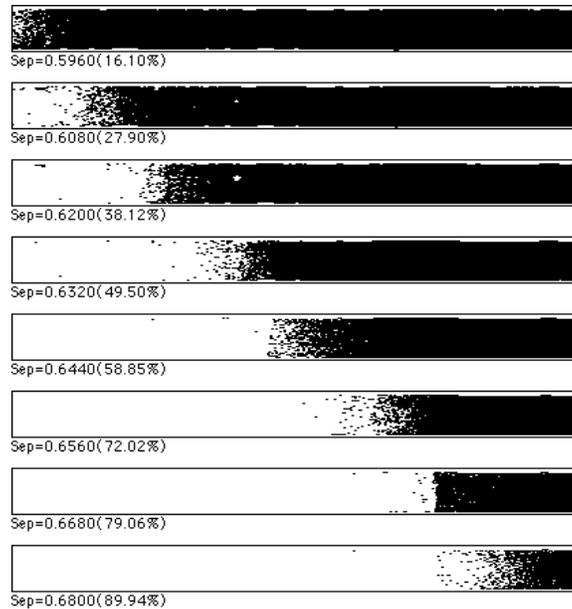
When the topographs are displaced normal to the crack plane, the line of intersection moves and crack growth is simulated. Figure 9 is a series of plan projection views of the crack at increasing topograph displacements. The transition between the white area and black area is a zone, rather than a line, and results from our choice of a large elevation range to characterize a large area of fracture surface. Better crack front definition can be obtained if a smaller area with a concomitant smaller elevation range is selected. Nevertheless, an average crack front can be defined by calculating the percentage of white (fractured) area in a plot and dividing by the plot height, and an effective crack growth rate (with respect to topograph displacement) can be obtained by plotting the percent fractured area against topograph displacement. This curve may be thought of as a fracture progression curve (FPC), indicating the relative (to crack opening displacement) growth history of a crack.

FIGURE 9. A SERIES OF PLAN VIEWS OF A CRACK FRONT AT INCREASING TOPOGRAPH DISPLACEMENTS. WHITE AREAS INDICATE SEPERATED MATERIAL; BLACK AREAS INDICATE INTACT MATERIAL

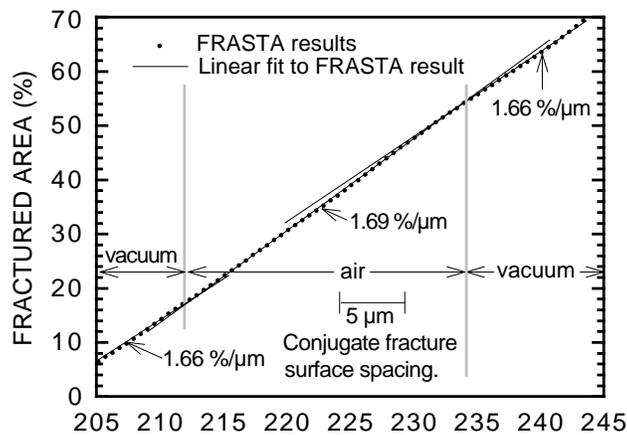
Results from the previous specimens showed that, under steady state fatigue loading, the area increase rate varies monotonically and the FPC is linear or a smoothly varying function without inflections. However, figure 10 shows that, when a change in environment is imposed (i.e., a change from vacuum to air back to vacuum), a deviation from the steady state slope is produced. The slopes for vacuum and air environments were measured to be $1.66\%/ \mu\text{m}^{**}$ and $1.69\%/ \mu\text{m}$ in vacuum and air, respectively.

FIGURE 10. EFFECT OF ENVIRONMENT ON FRACTURE PROGRESSION CURVE (FPC).

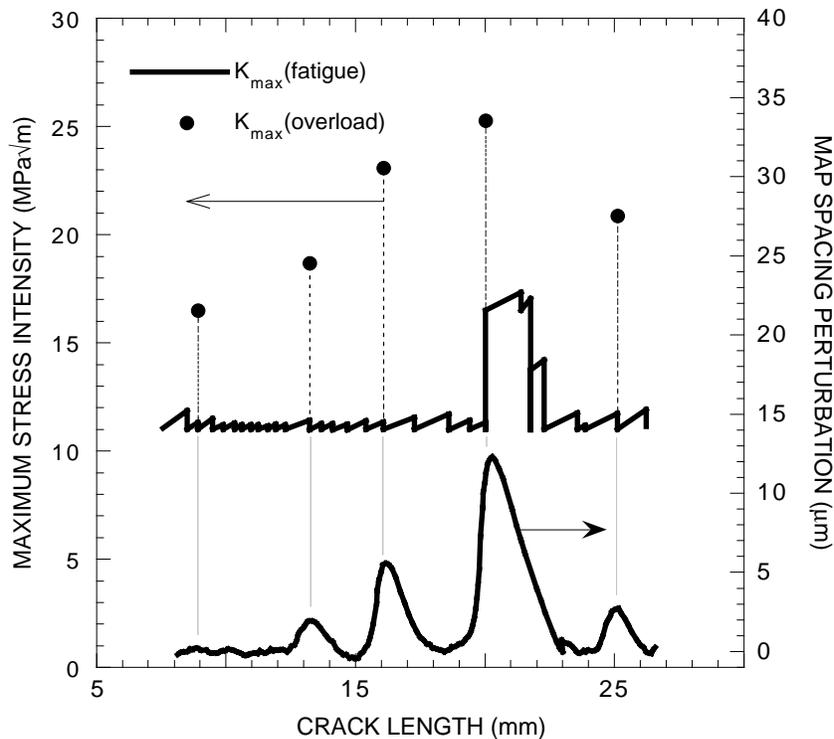
The positions of the overloads, as a function of half crack length, are shown by data points corresponding to the left ordinate of figure 11. The figure compares K_{max} during the cyclic loading intervals with K_{max} imposed by the overload. The small variations in K_{max} during the cyclic loading are a consequence of small amounts of crack growth under intervals of constant load cycling. Fatigue crack propagation could not be reinitiated at 11 MPa \sqrt{m} after the overload to 25.5 MPa \sqrt{m} , so higher stress intensity levels (17 and 14 MPa \sqrt{m}) were used to restart fatigue crack growth.

FIGURE 11. COMPARISON OF OVERLOAD HISTORY TO PERTURBATIONS IN FRACTURE PROGRESSION CURVE (FPC).

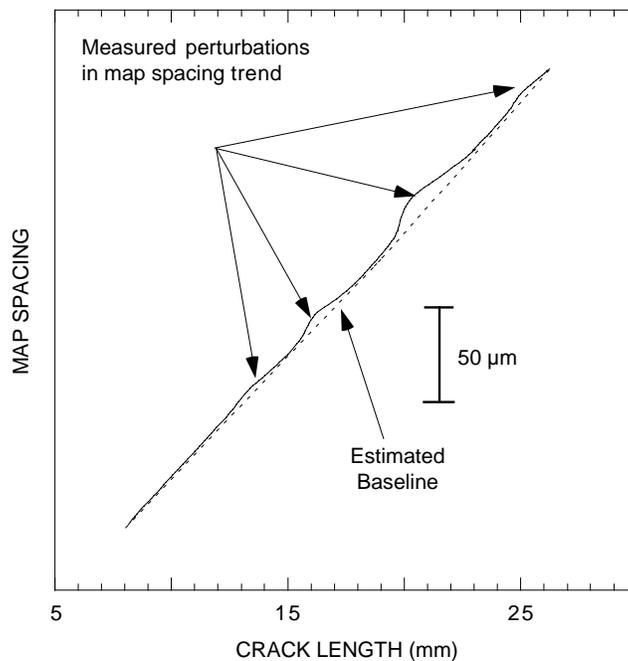
Figure 12 shows that overloads above $16.5 \text{ MPa}\sqrt{\text{m}}$ produce a perturbation from the steady-state slope. The FPC slope initially decreases, then increases, and then returns to the baseline slope. The positions of the peaks in the perturbations correspond to the crack lengths at which the overloads were applied. These deviations begin before the overload is applied, as shown in figure 11.

FIGURE 12. FRACTURE PROGRESSION CURVE (FPC) WITH BASELINE.

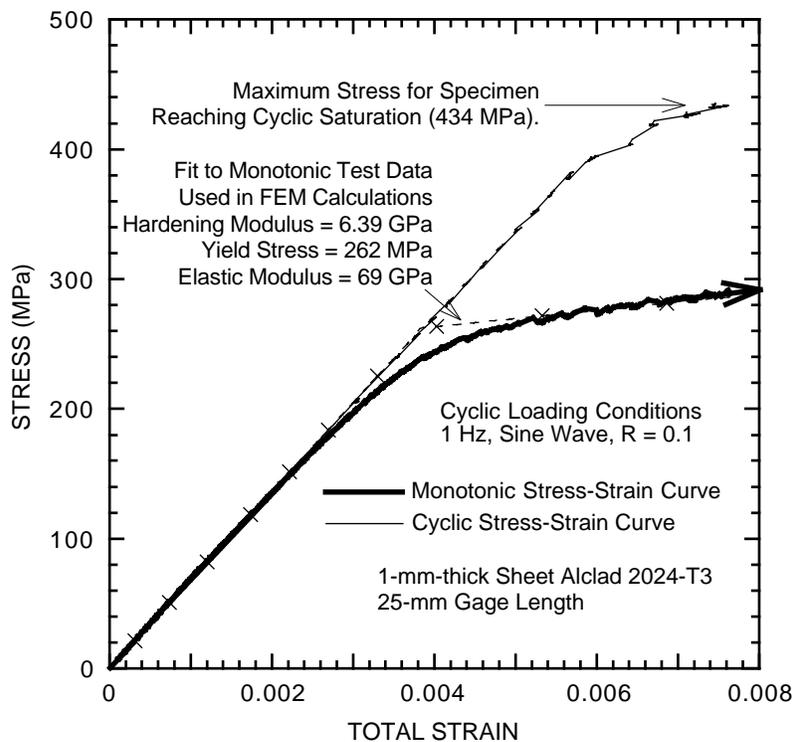
Finite element method simulations of the crack tip response require appropriate constitutive models that describe the nonelastic deformation behavior. Figure 13 compares the cyclic stress-strain response with the monotonic stress-strain response at low strain levels. These results show substantial cyclic strain hardening. The results in figure 13 formed the basis of the constitutive equations used in the finite element method (FEM) calculations described in section 3.5.

FIGURE 13. MONOTONIC AND CYCLIC STRESS-STRAIN BEHAVIOR OF 2024-T3 ALUMINUM ALLOY.

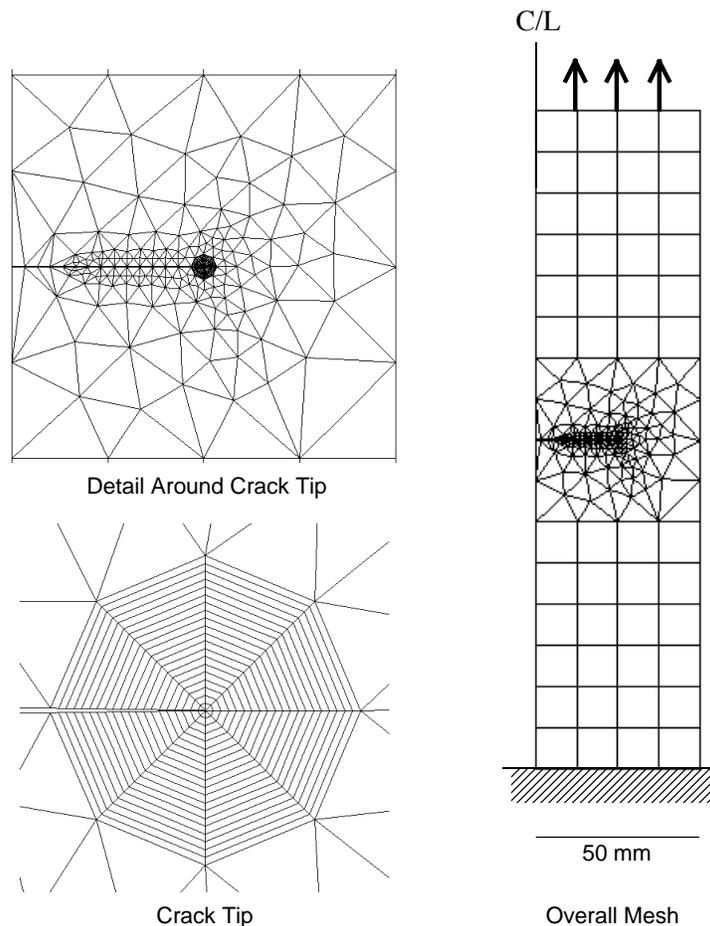
FIGURE 14. FINITE ELEMENT MESH AROUND CRACK TIP IN CENTER-CRACKED PANEL SPECIMEN.

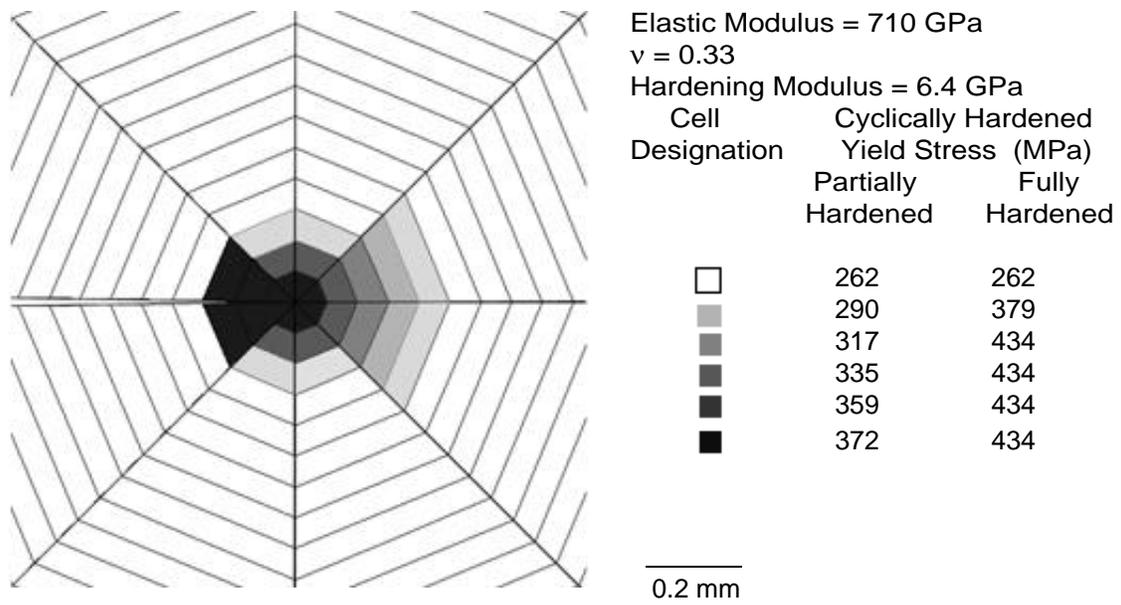
FIGURE 15. CYCLICALLY HARDENED AREAS NEAR CRACK TIP.

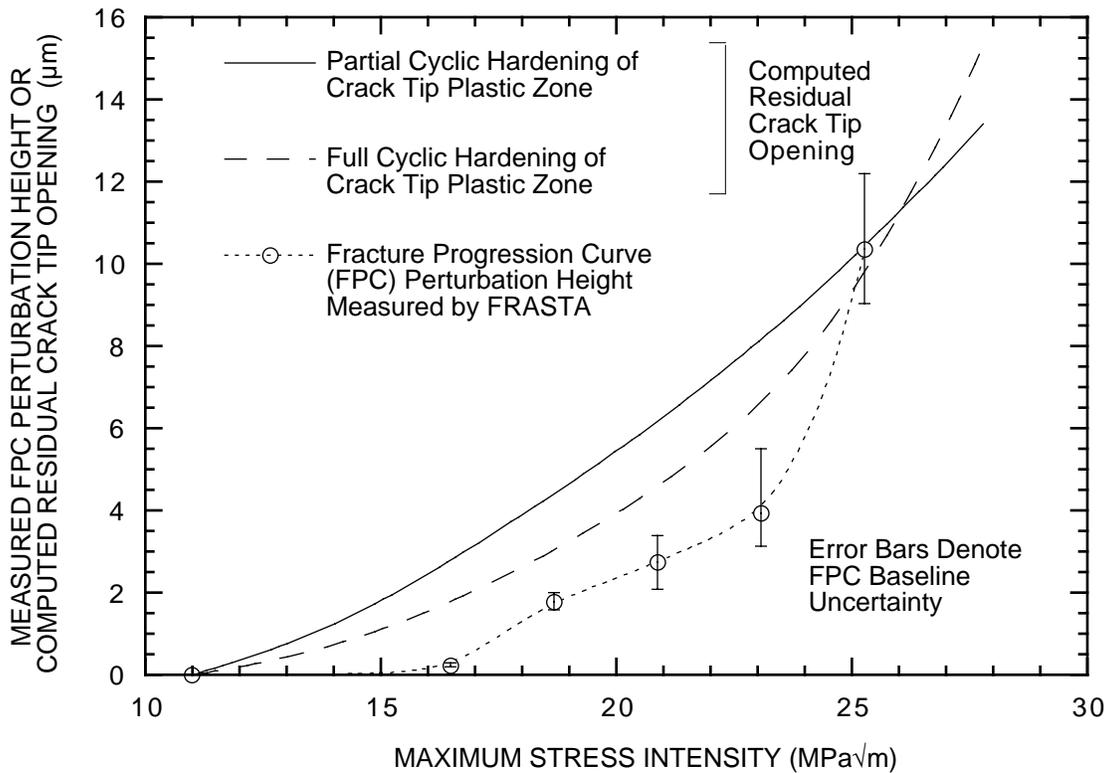
The computational procedure and the interpretation of computational results must be refined to more accurately predict the effect of overloads on fracture surface topography. Nevertheless, when the measurement and computational difficulties created by the small magnitude ($\leq 10 \mu\text{m}$) of fracture surface topography perturbations are considered, the present computational results show remarkable agreement with the measurements of fracture surface topography.

FIGURE 17. COMPARISON OF COMPUTED AND MEASURED FPC PERTURBATION HEIGHTS RESULTING FROM OVERLOADS.

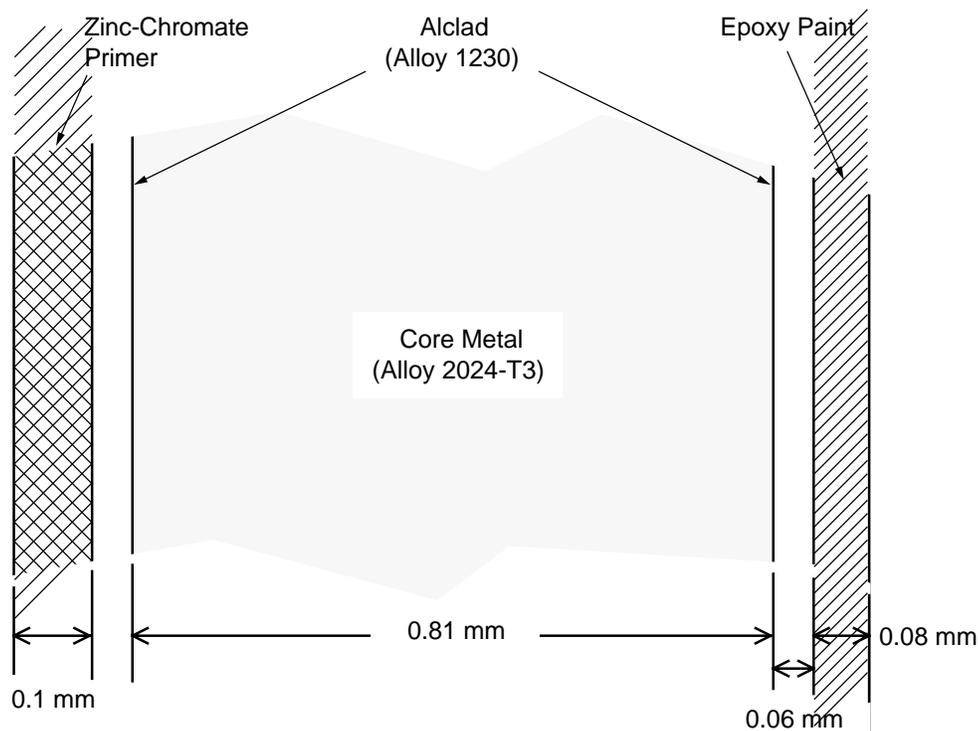
A tapered tensile coupon was cut from Section 360 (above the windows) of a Boeing 737 aircraft that had been retired from service in 1992 after 56,228 flight hours. The skin consisted of a 0.81-mm-thick (0.032-in.) core of 2024-T3 aluminum alloy, clad layers on both sides that were about 0.06 mm thick (0.002 in.), a paint layer on the outer surface about 0.08 mm thick (0.003 in.), and a corrosion inhibitor layer on the inside that was about 0.10 mm thick (0.004 in.), as sketched in figure 18. Microhardness tests showed that the core and the clad had Vickers hardnesses of 120.4 ± 1.5 and 32.2 ± 2.3 kg/mm², respectively.

FIGURE 18. CROSS SECTION OF REPRESENTATIVE AIRCRAFT SKIN.

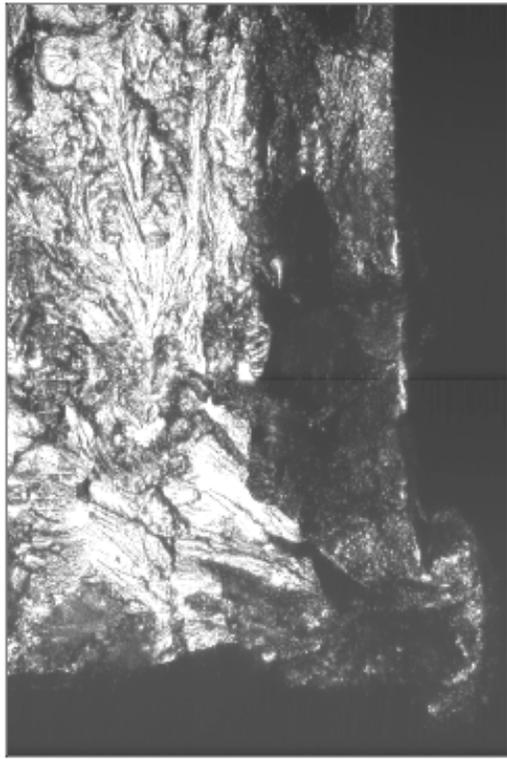
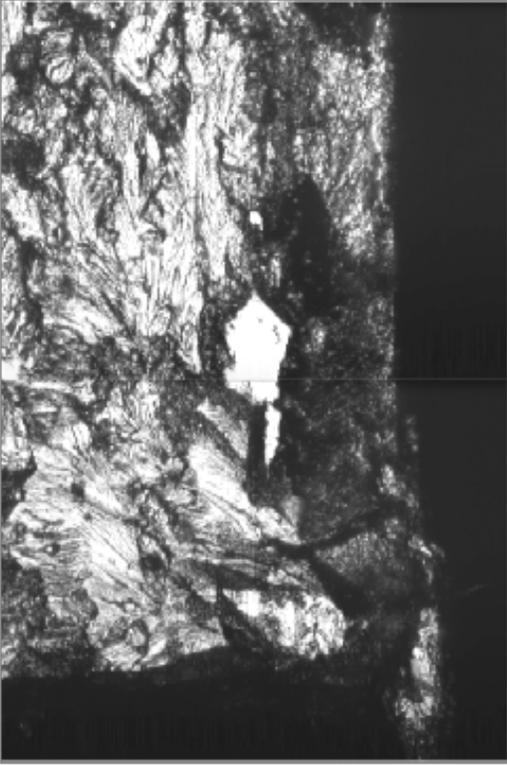
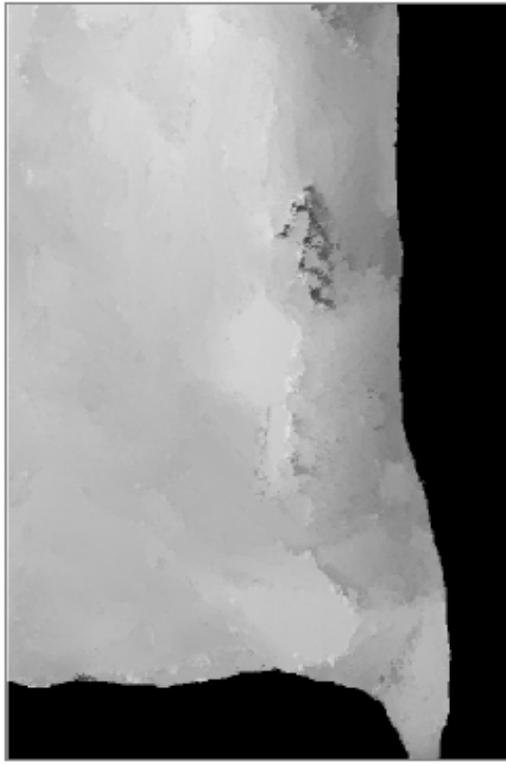
FIGURE 21. CONTRAST AND GRAY-SCALE TOPOGRAPHY IMAGES OF CONJUGATE SURFACES OF THE CRACK INITIATION SITE. (IMAGES OF SURFACE B WERE HORIZONTALLY FLIPPED TO SHOW THE CORRESPONDENCE BETWEEN THE CONJUGATE SURFACES.)

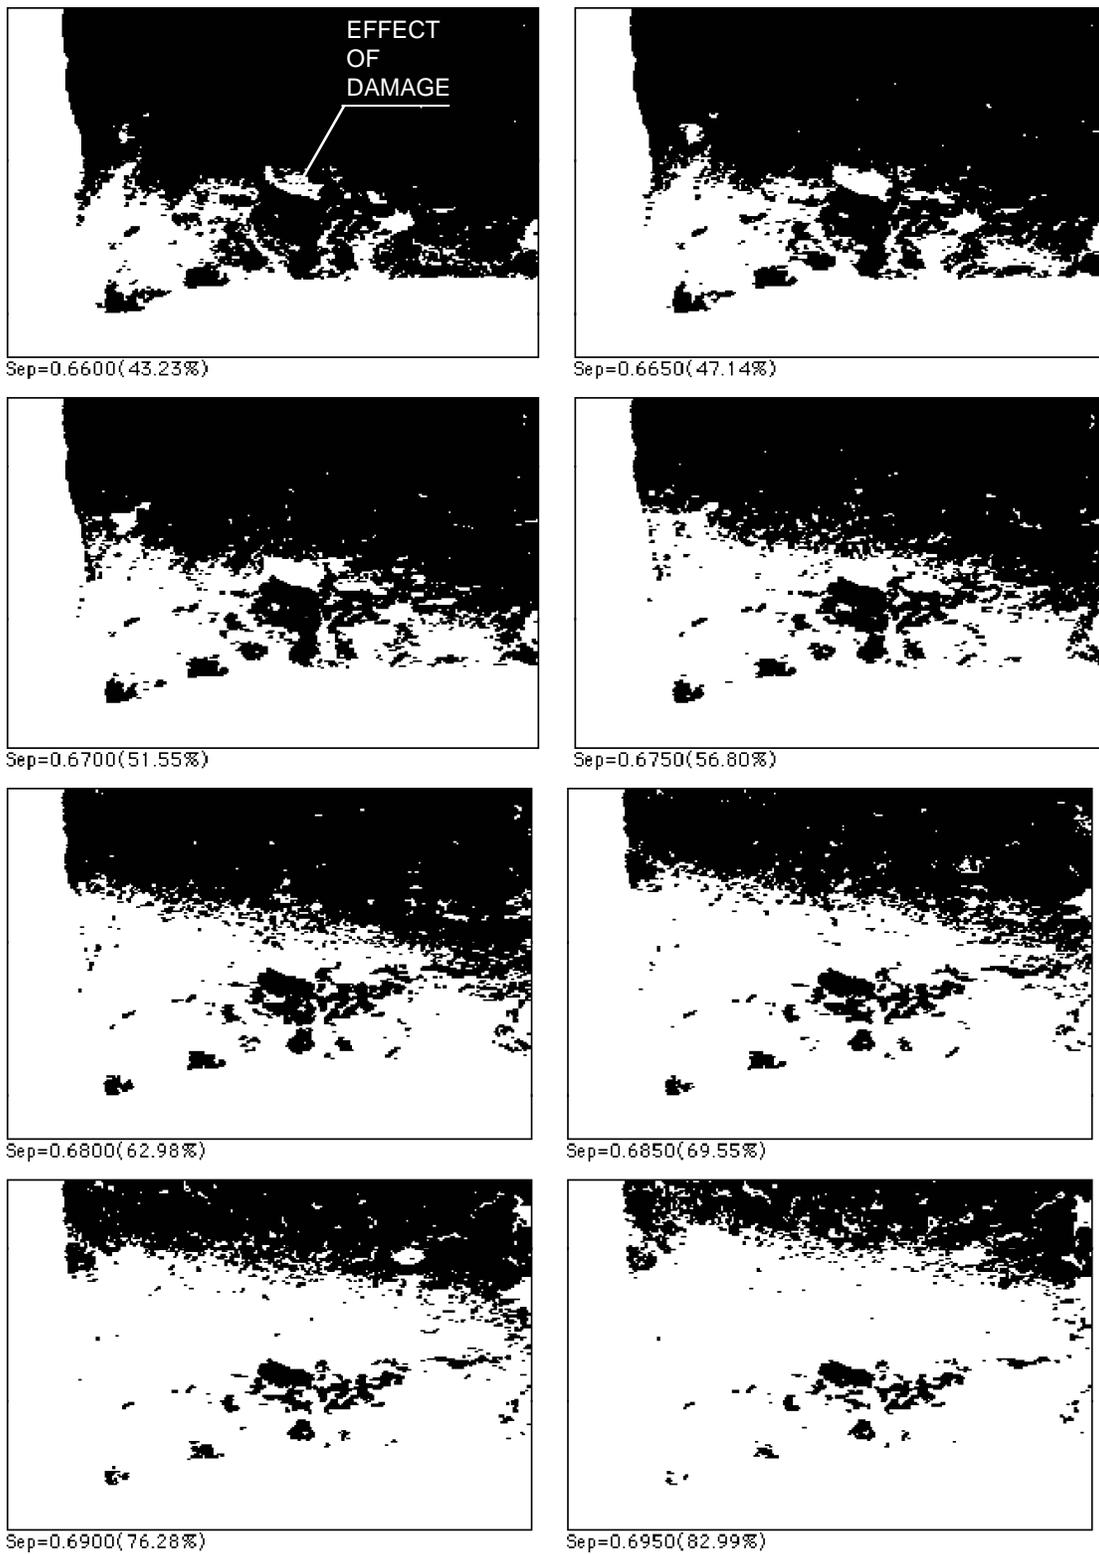
FIGURE 22. A SERIES OF FAPPS PRODUCED BY FRASTA SHOWING CRACK FORMATION AND GROWTH PROCESS (CONTINUED).

FIGURE 22. A SERIES OF FAPPS PRODUCED BY FRASTA SHOWING CRACK FORMATION AND GROWTH PROCESS (CONCLUDED).

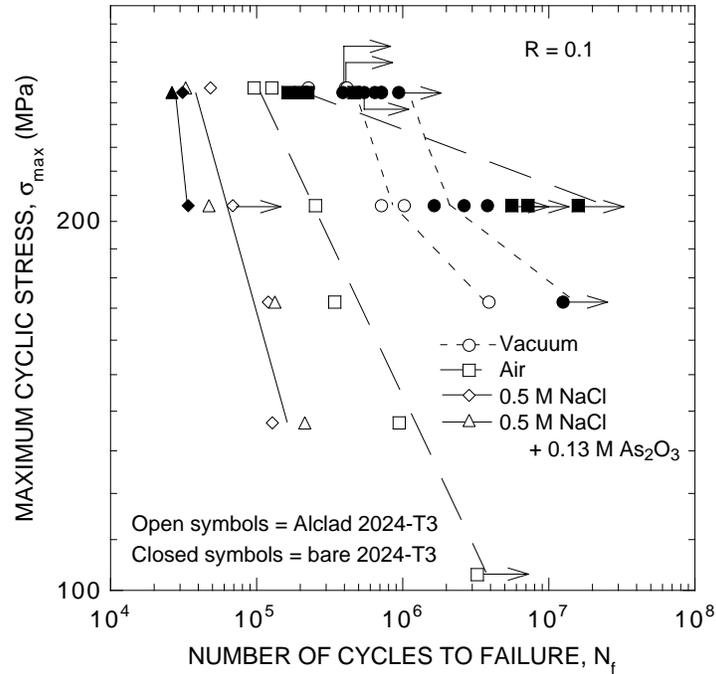
the trends of the stress dependence of fatigue life of bare material in air and under vacuum. The fatigue life in air was a factor of 3 less than the fatigue life under vacuum at a maximum fatigue stress of 255 MPa; however, at 207 MPa, the relative magnitudes of the fatigue life were reversed.

FIGURE 27. EFFECTS OF STRESS, CLADDING, AND ENVIRONMENT ON THE FATIGUE LIFE OF 2024-T3 ALUMINUM.

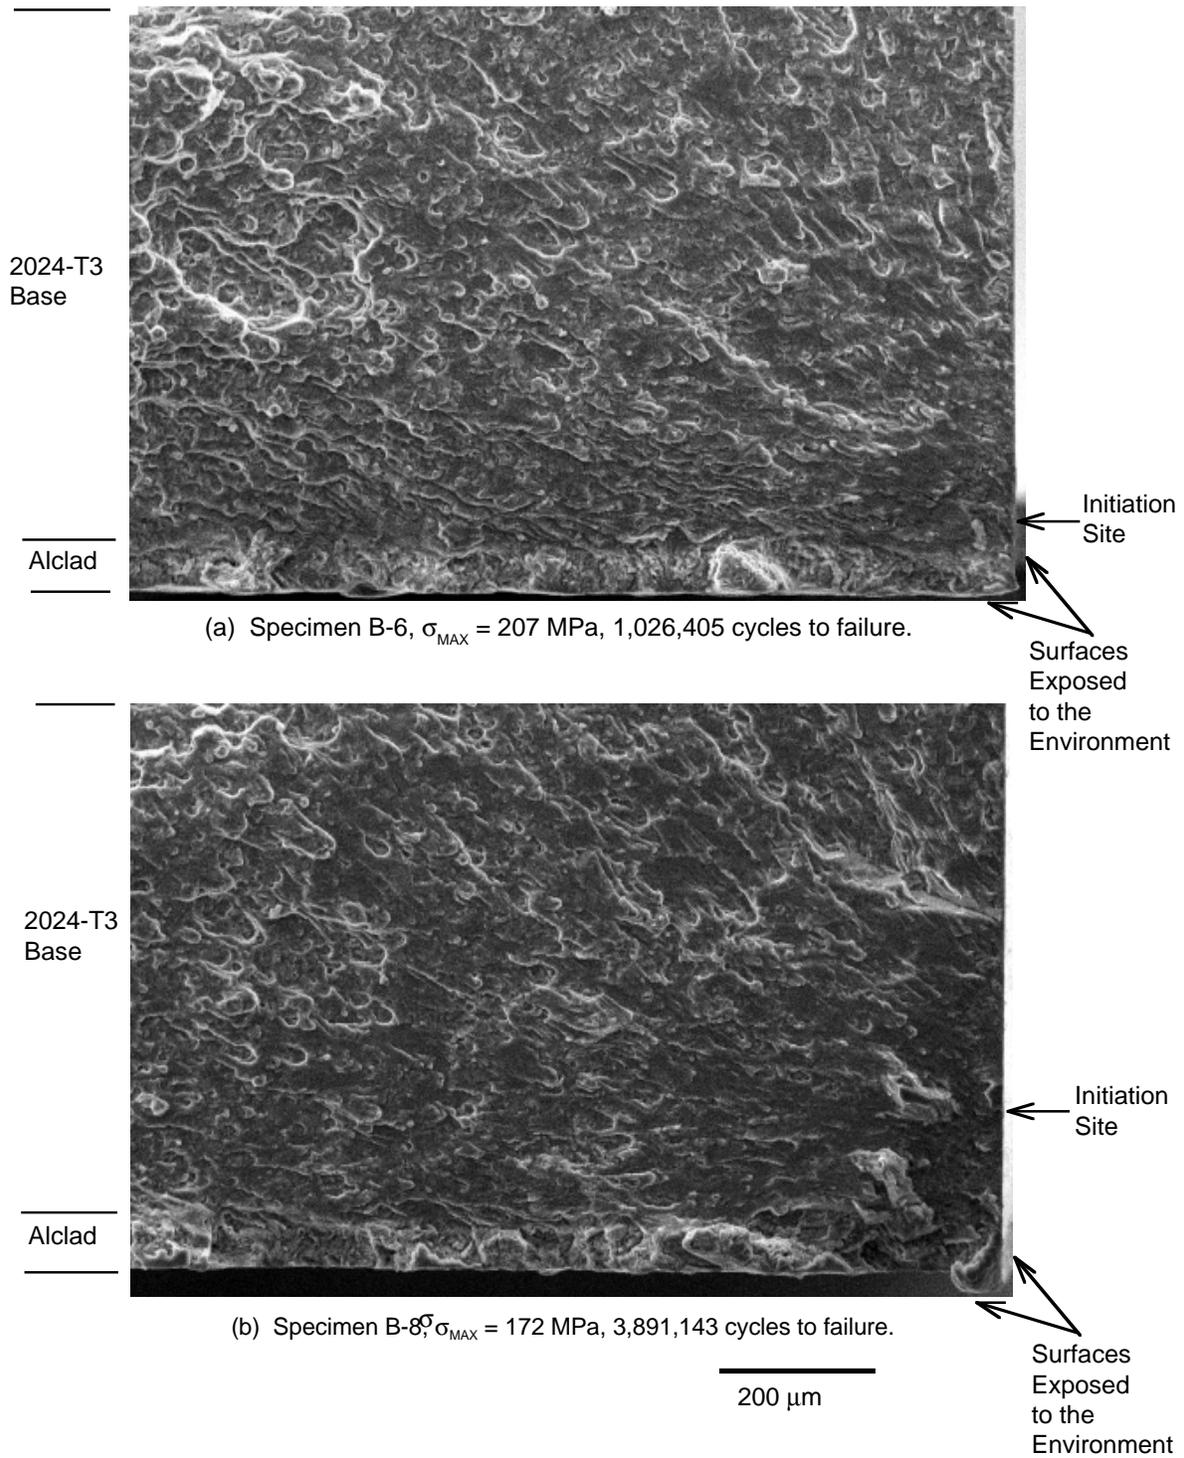
FIGURE 28. FRACTURE SURFACE APPEARANCE OF ALCLAD 2024-T3 FATIGUE SPECIMENS TESTED IN VACUUM.

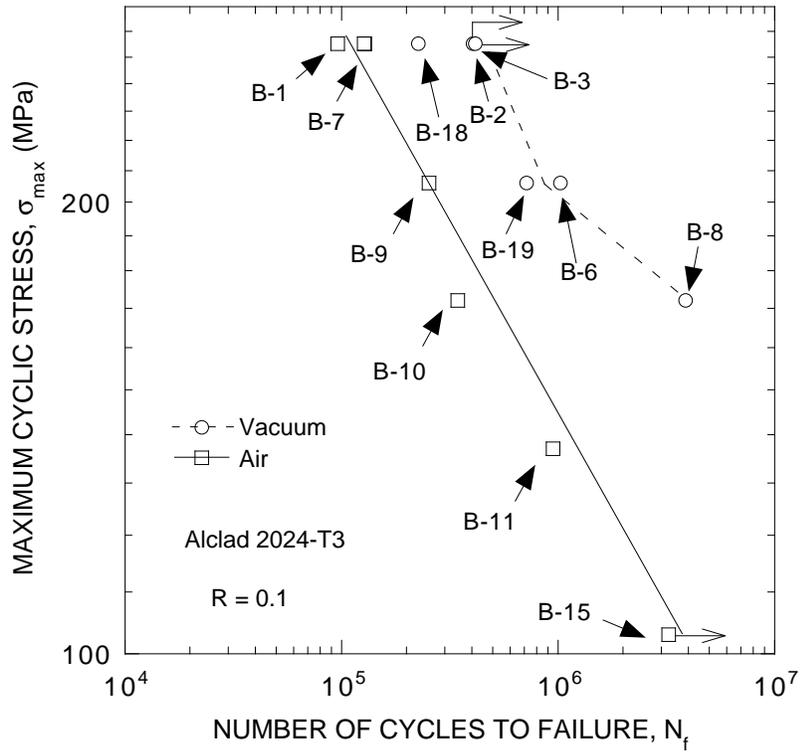
FIGURE 29. COMPARISON OF FATIGUE LIFE OF ALCLAD 2024-T3 ALUMINUM UNDER VACUUM AND IN AIR.

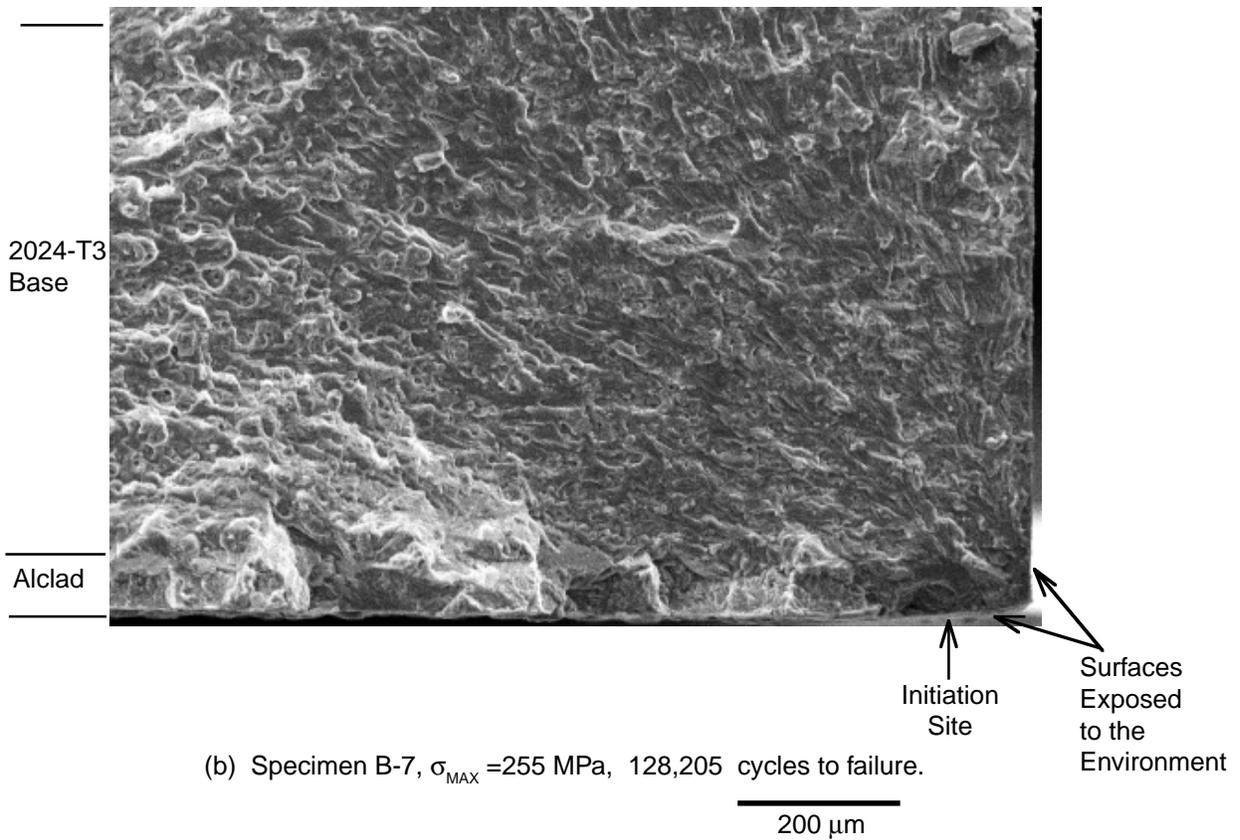
FIGURE 30. FRACTURE SURFACE APPEARANCE OF ALCLAD 2024-T3 FATIGUE SPECIMENS TESTED IN AIR.

(c) Specimen B-9, $\sigma_{MAX} = 207$ MPa, 253,201 cycles to failure.

(d) Specimen B-10, $\sigma_{MAX} = 172$ MPa, 344,564 cycles to failure.

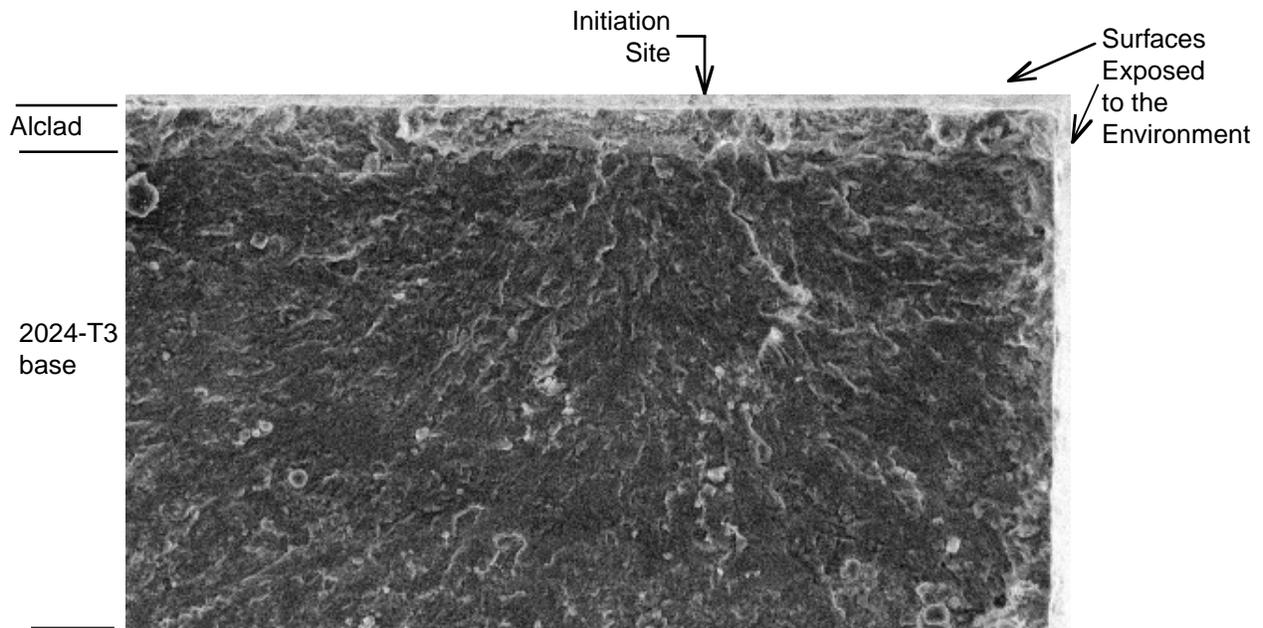
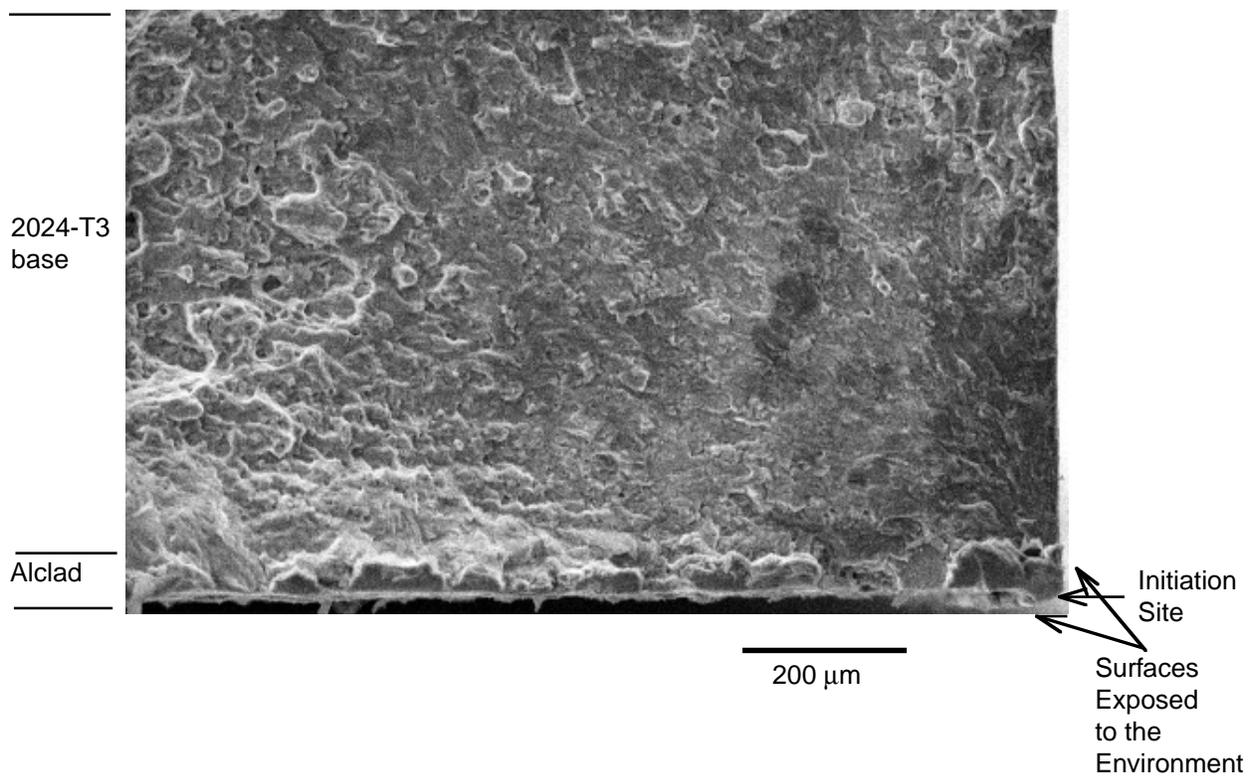
(a) Specimen B-22, $\sigma_{MAX} = 138$ MPa, 214,108 cycles to failure.

(b) Specimen B-20, $\sigma_{MAX} = 172$ MPa, 133,278 cycles to failure.

FIGURE 32. FRACTURE SURFACE APPEARANCE OF ALCLAD 2024-T3 FATIGUE SPECIMENS TESTED IN 0.5 M NaCl SOLUTION + 0.13 M As_2O_3 .

specimens tested under the same conditions (compare the cycles to failure of Specimen B-18 with the cycles for Specimen B-2 and B-3 in figure 32).
