# Beechcraft 1900C Vertical Impact Test

May 1999

DOT/FAA/AR-TN99/25

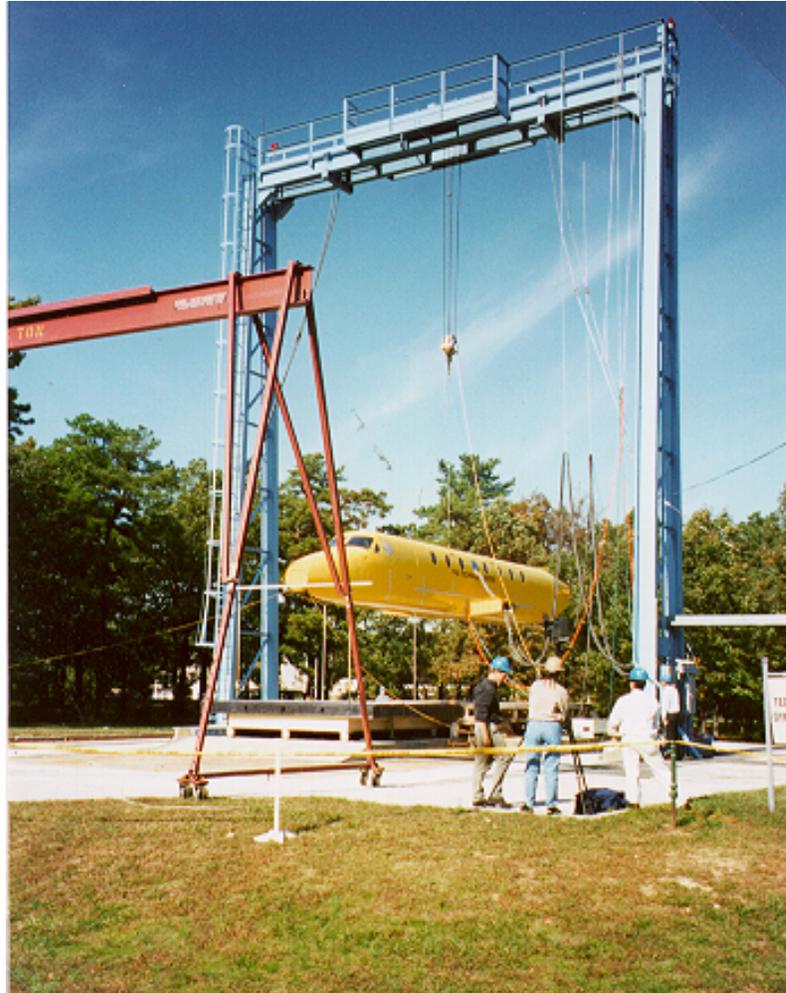
FIGURE 1. DROP TEST FACILITY

The William J. Hughes Technical Center drop test facility, shown in figure 1, is comprised of two 50-foot vertical steel towers connected at the top by a horizontal platform. An electrically powered winch, mounted on the platform, is used to raise or lower the test article and is controlled from the base of one of the tower legs. The current lifting capacity of the winch is 13,600 pounds. Attached to the winch is a reeved hoisting cable which is used to raise the test article. A sheave block assembly hanging from the free end of the reeved cable is engaged to a solenoid operated release hook. The release hook is connected to the airframe by a cable/turnbuckle assembly with hooks bolted to the fuselage section at four locations. Located below the winch cable assembly and between the tower legs is a 15- by 36-foot wooden platform which rests upon I-beams and is supported by 12 independent load cells.

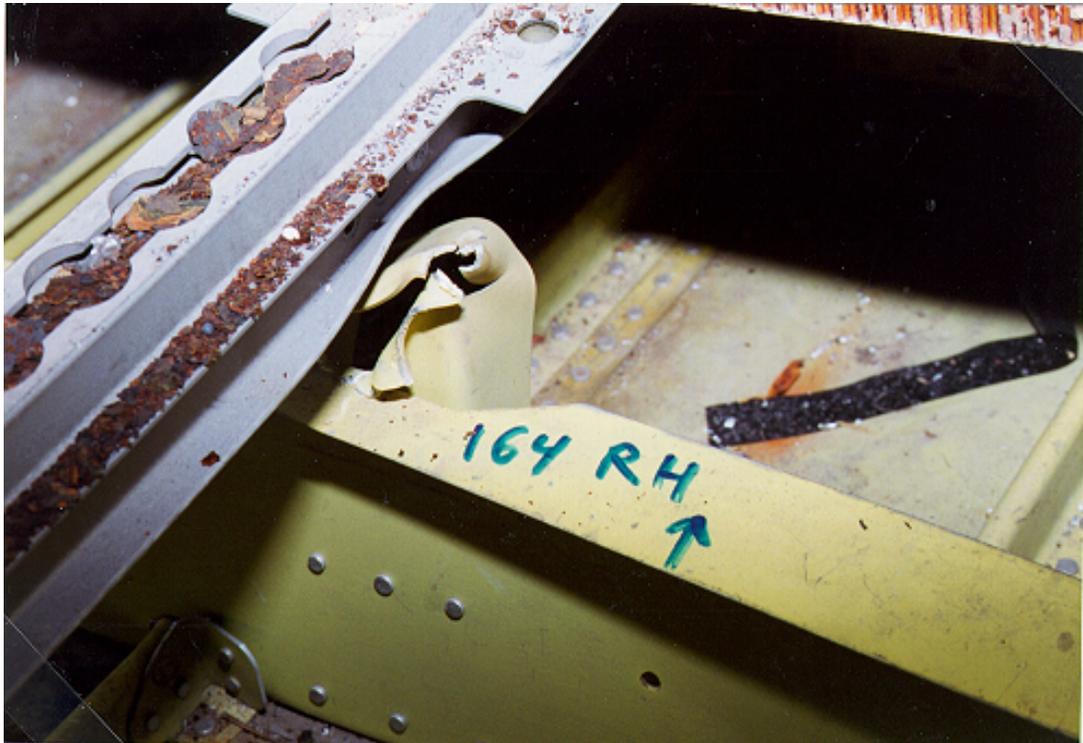
FIGURE 6. UNDERFLOOR BUCKLING RIGHT-HAND SIDE AFTER IMPACT

INTERNAL. The structural deformation experienced on the inside of the test article was minimal. The seat tracks remained intact and in place. Minor buckling was seen along the fuselage underfloor and side walls (see figure 6).

The still photographs in this report were taken with a 35-mm camera both prior to and following the drop test. Examples of these photographs are seen in figures 5 through 7.
