DOT/FAA/CT-94/120

# Evaluation of Retro-Reflective Beads in Airport Pavement Markings

December 1994

Final Report

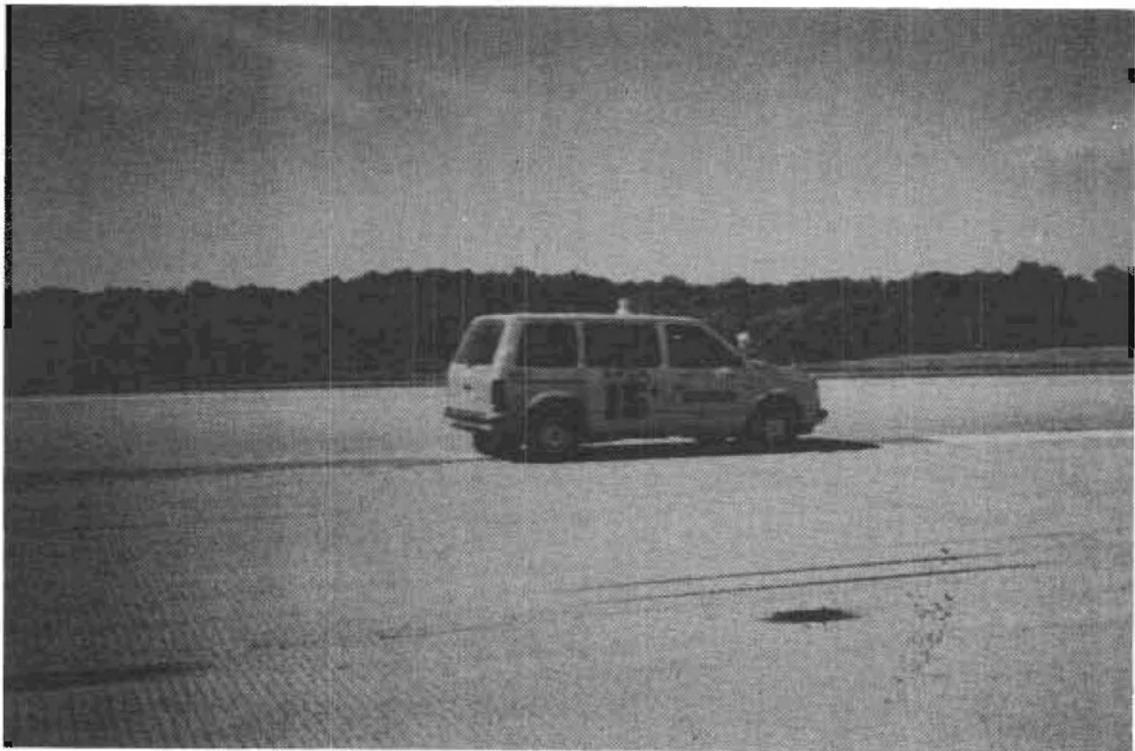
FIGURE A-44. FRICTION TESTING AT PITTSBURGH

Friction testing was conducted at two of the three selected airports. The Atlantic City and Pittsburgh airports possessed the friction testing equipment to collect the skid resistance data necessary for this test. Data were collected initially upon application and quarterly using the RFT Friction Test vehicle. Refer to figure A-44 for a depiction of the vehicle in operation.

Friction data obtained from the various materials indicated that certain marking materials exhibit positive friction benefits as compared with others. A reduction in friction readings would indicate that the abrasiveness of the material had degraded. Refer to figures A-45 and A-46 for the materials tested and friction data for the Atlantic City and Pittsburgh airports. In general the friction readings for the two beaded stripes (#6 & #7) were equivalent or better than those for the unbeaded materials. At the Pittsburgh test site the ambient pavement

friction was determined to be 0.75 mu. The #6 and #7 stripes (with beads and silica) provided average friction readings of 0.55 and 0.56 mu, slightly lower than that of the unbeaded #5 stripe with the silica additive, but well above that of the older existing paint markings (0.2 mu) and the minimum maintenance level of 0.41 (at 60 mph) as specified in the FAA Advisory Circular 150/5320-12B, Measurement, Construction, and Maintenance of Skid-Resistant Airport Pavement Surfaces<sup>6</sup>.
