DOT/FAA/CT-95/25  
DOT-VNTSC-FAA-95-10

# Strain Fields in Boeing 737 Fuselage Lap Splices: Field and Laboratory Measurements with Analytical Correlations

Final Report  
June 1995

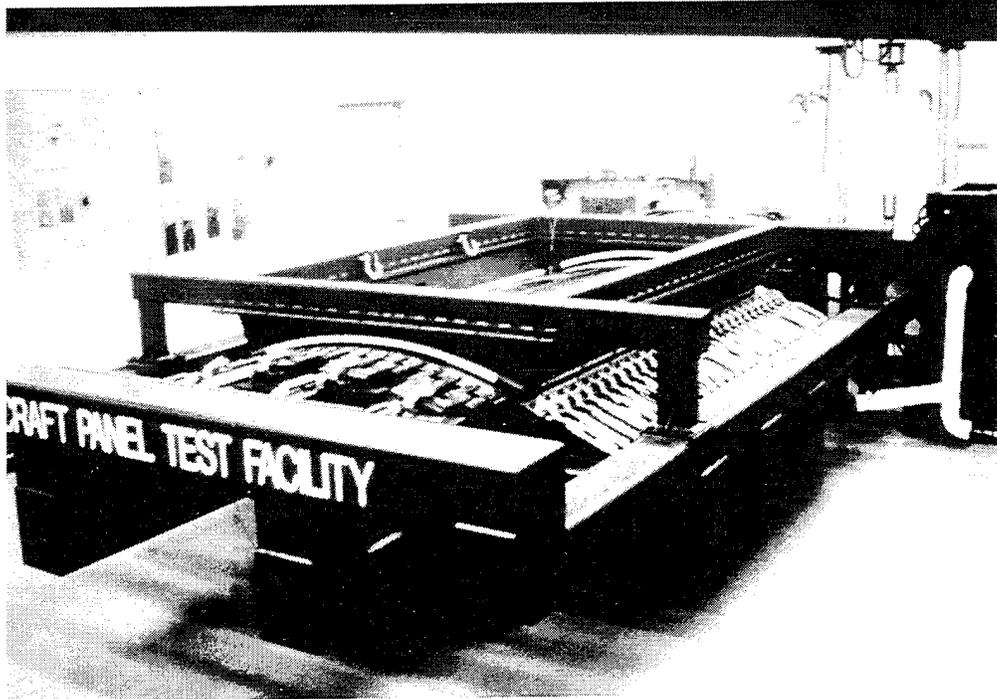
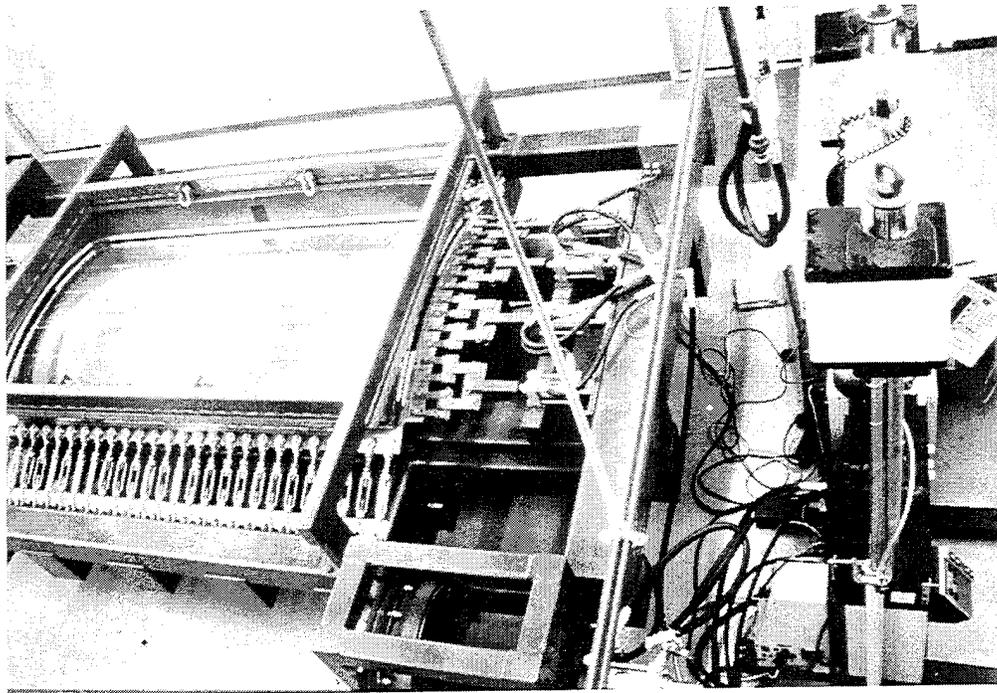
Figure 1.1. Full-Scale Panel Test Facility.

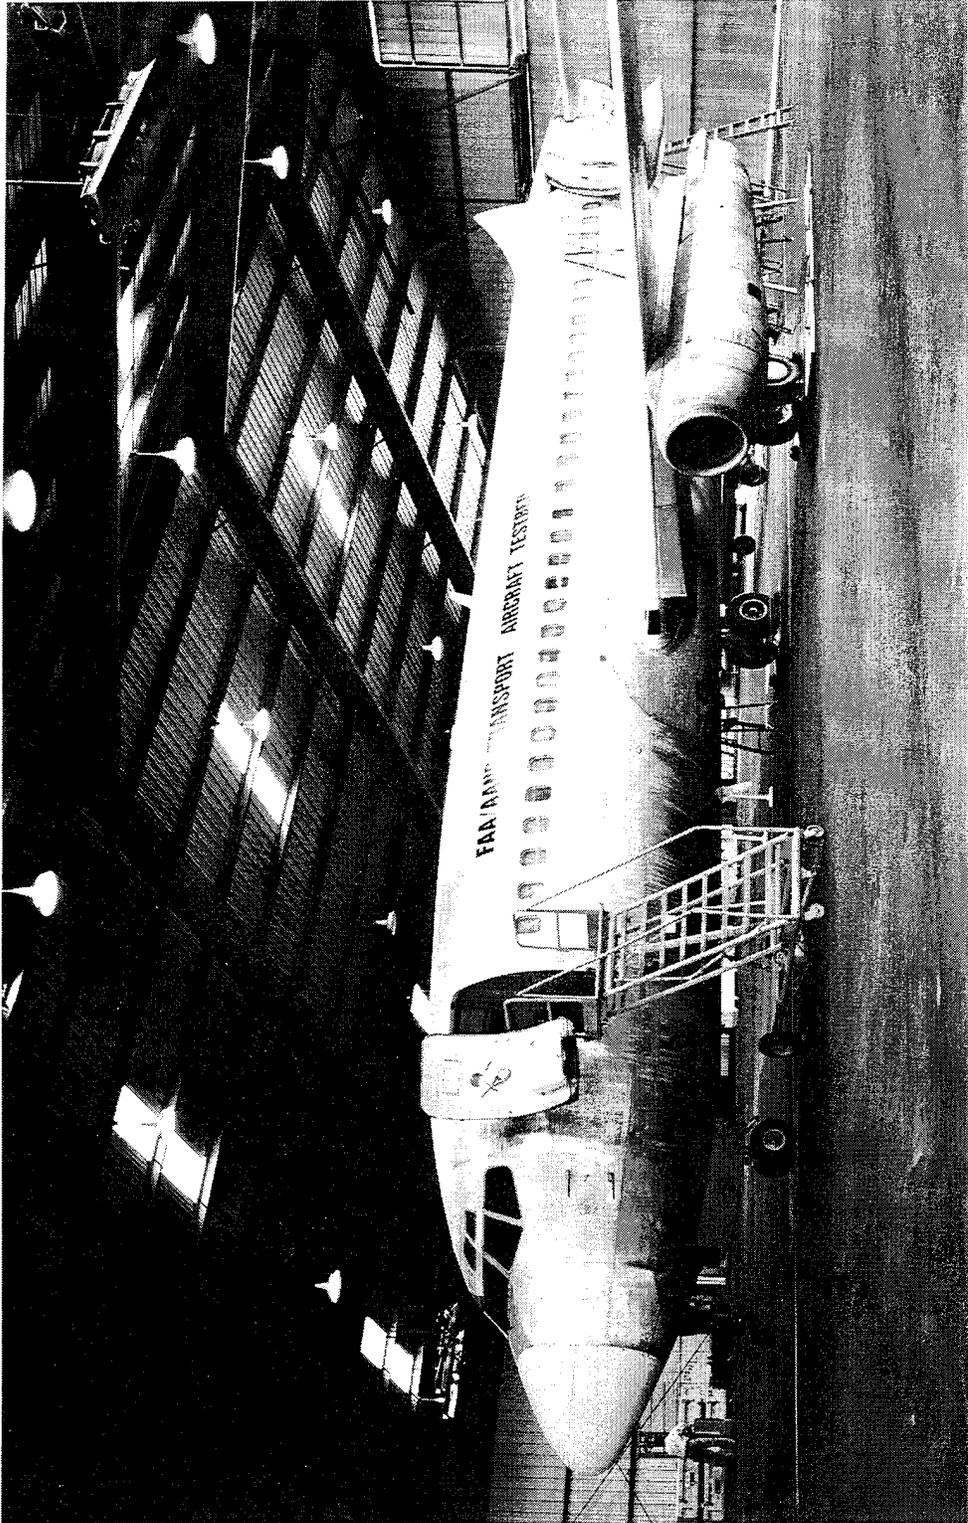
Figure 1.3. Photograph of FAA/AANC Boeing 737 Airplane Test Bed.

The airplane acquired by the AANC is a Boeing 737-200, Serial Number 19058, Line Number 49. A photograph of the AANC B737 airplane is shown in Figure 1.3. According to the Aircraft Utilization Database [6], this airplane was in service between August 1968 and February 1992. During these dates, the airplane accumulated 46,358 cycles in 38,342 flight hours. The most important structural feature pertinent to this test was that the lap splice joints were not altered with the terminating action. The terminating action is a remedial repair which entails the replacement of shear head countersunk rivets with universal head rivets that have a larger shank diameter<sup>2</sup>. In this context, the upper rivet rows on the lap joints on the AANC aircraft all contained shear head countersunk rivets.

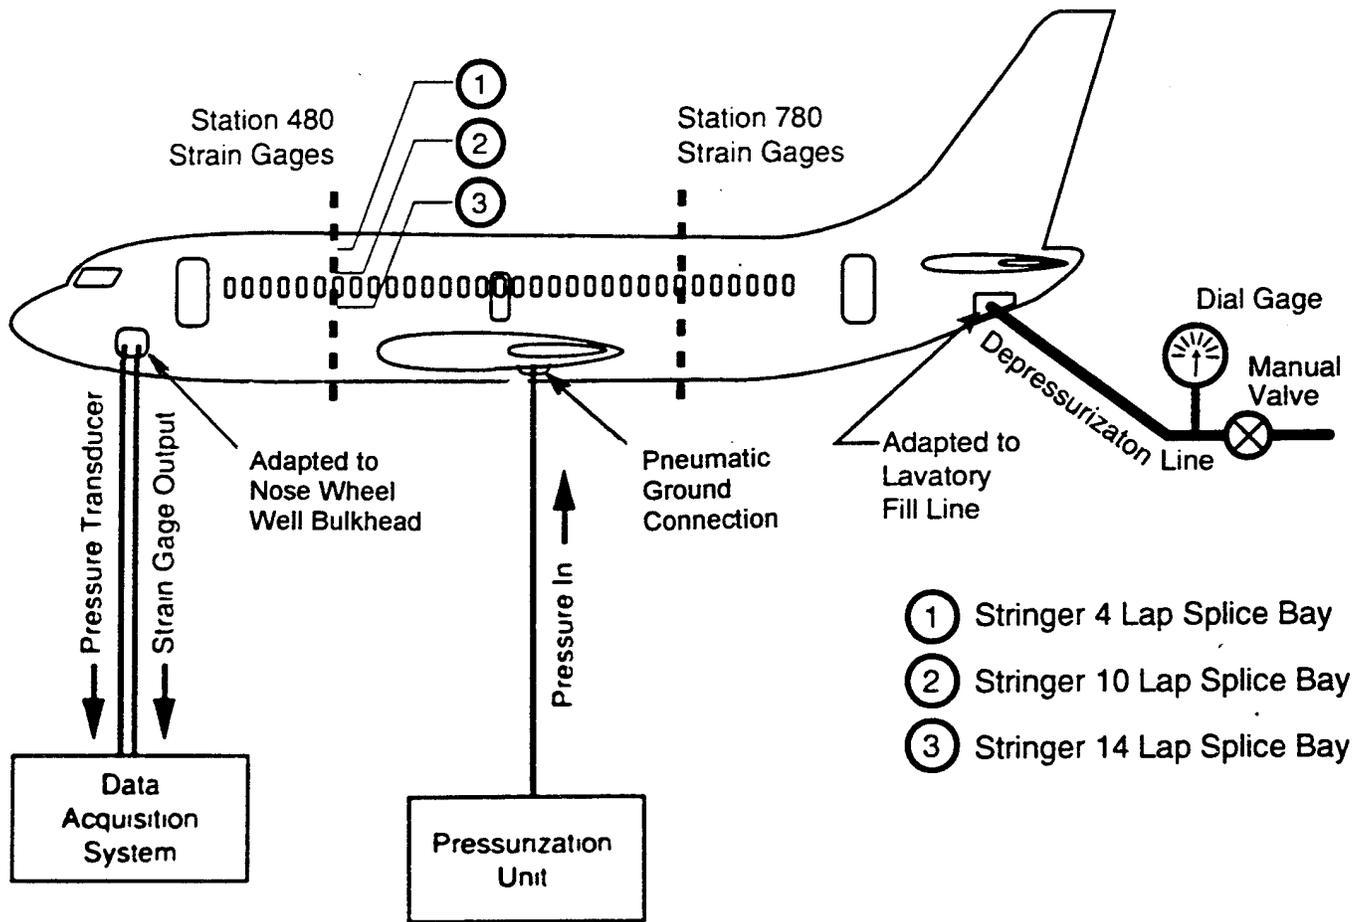
Figure 2.1. AANC 737 Strain Monitoring Test Set-Up.

For reference during the following discussion, a schematic of the entire test set-up is shown in Figure 2.1.

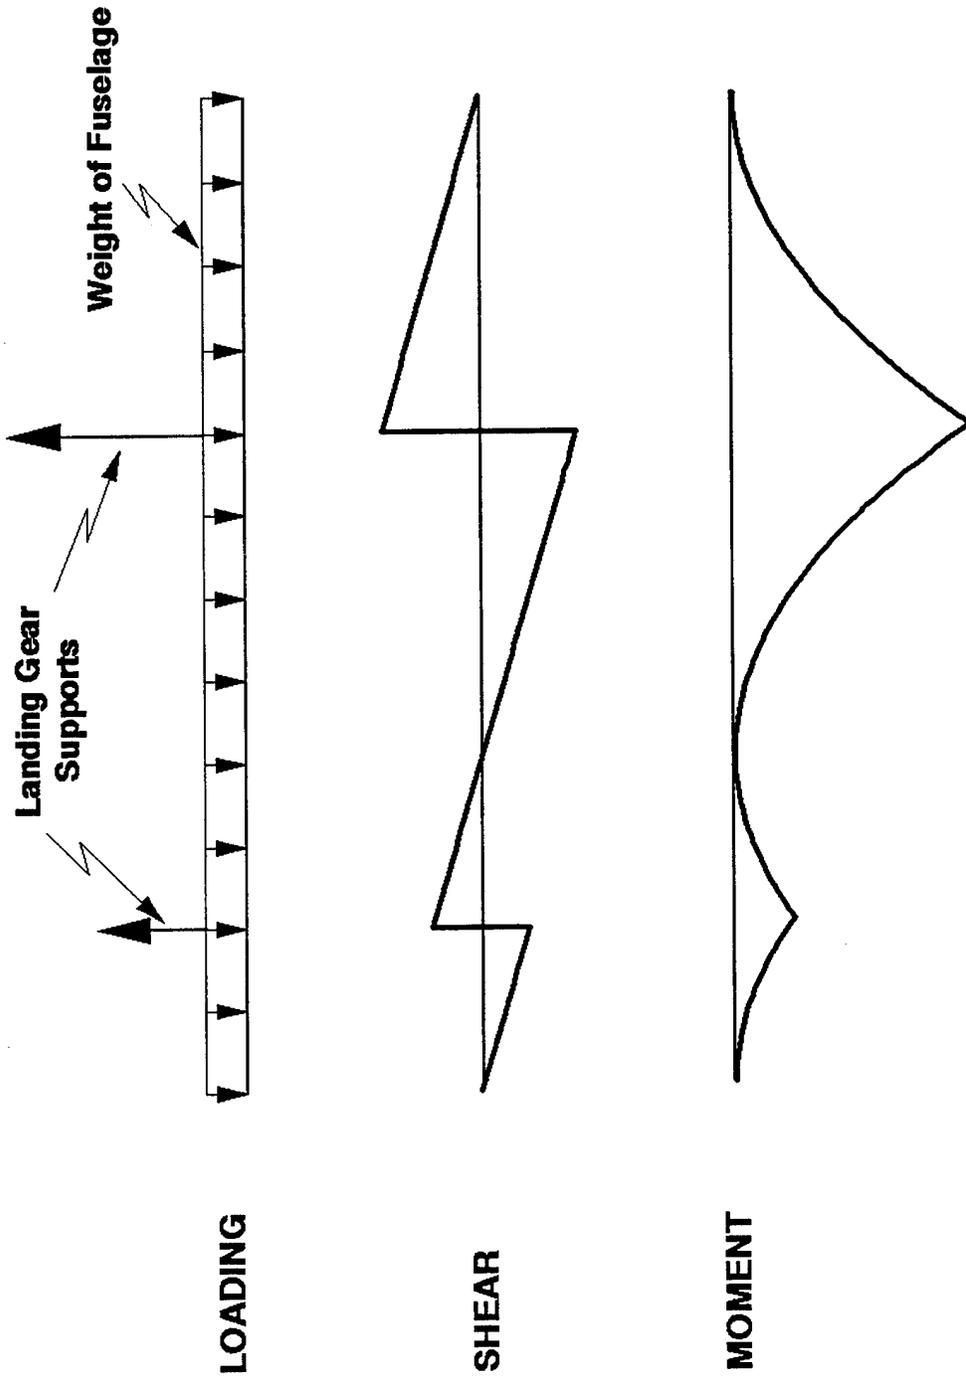
Figure 2.4. Generic Shear and Moment Diagrams for Fuselage Supported by Two Sets of Landing Gear.

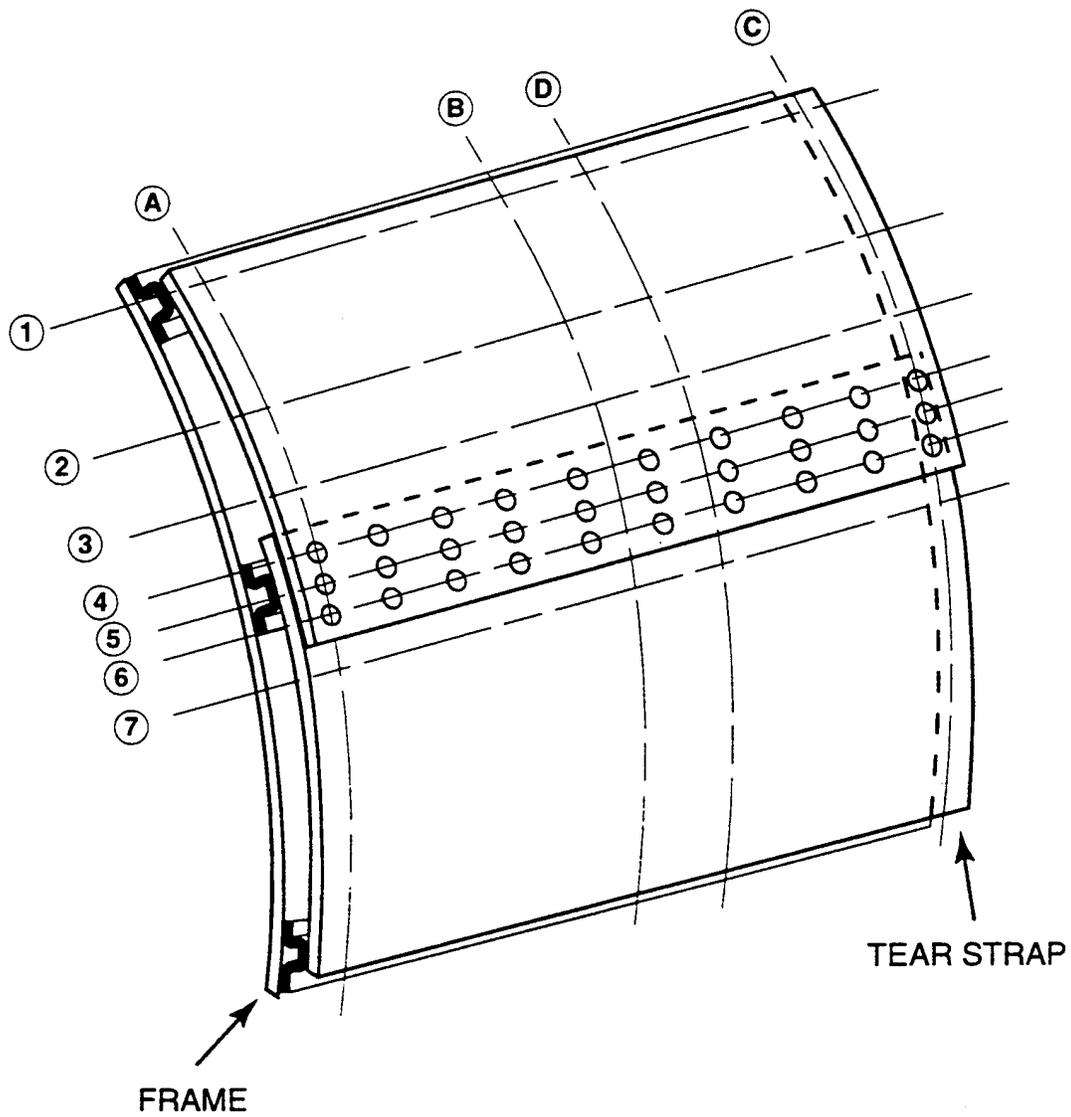
Figure 2.5. Specific Strain Gage Locations Within Selected Lap Splice Bays.

Specific strain gage locations were selected within a given lap splice bay to resemble the strain gage layouts in the Foster-Miller [4] and NASA [5] tests which allowed for direct comparisons of strains. Seven (7) circumferential positions were identified (refer to Figure 2.5):

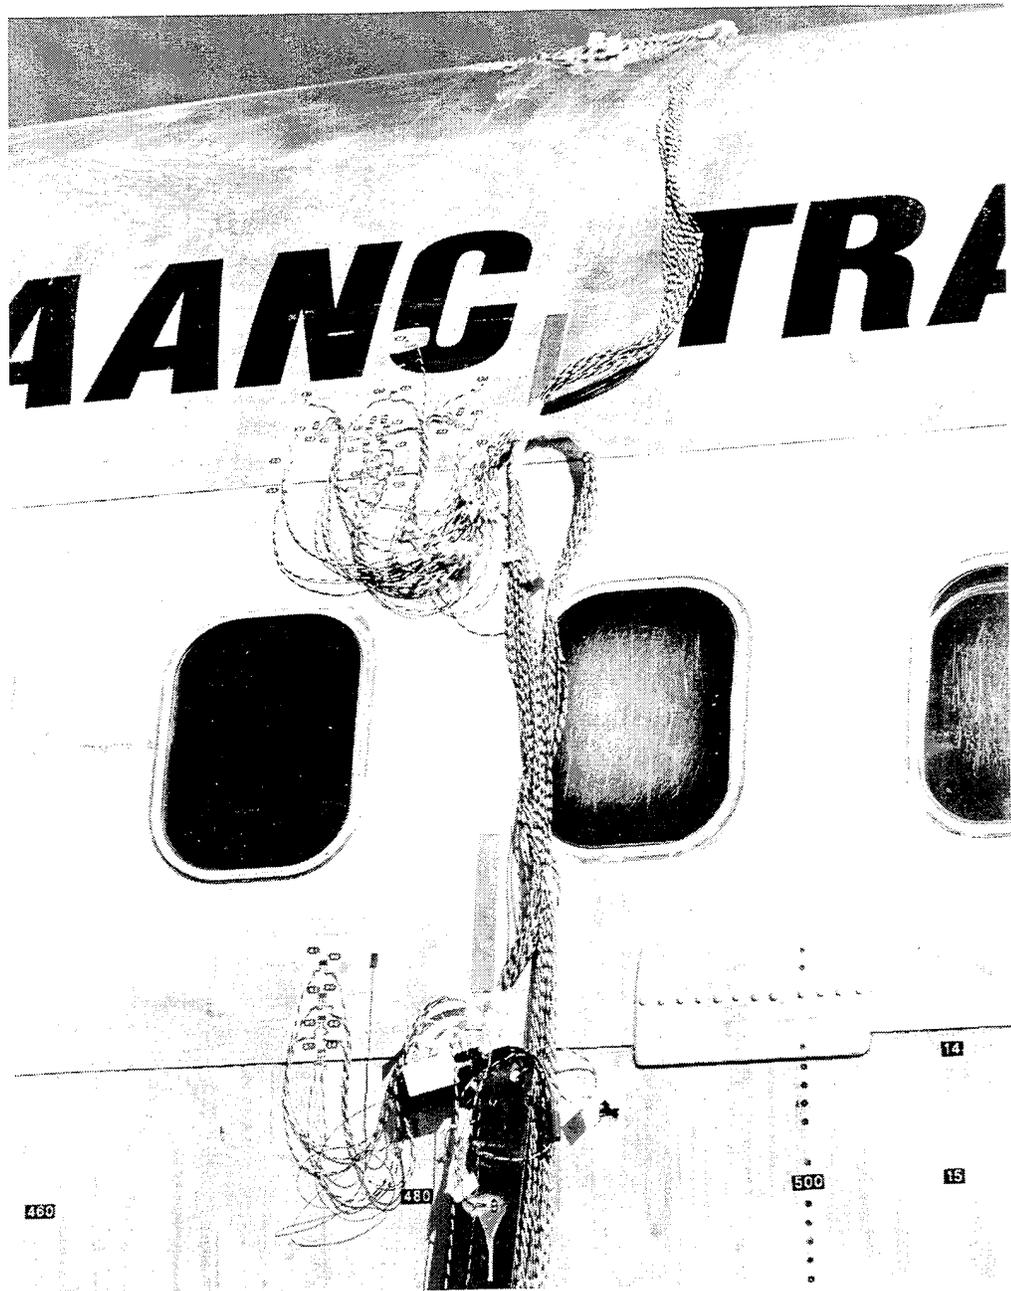
*Figure 2.7. View of Instrumented Lap Splice Bays Above and Below the Window Between Body Stations 470 and 480.*

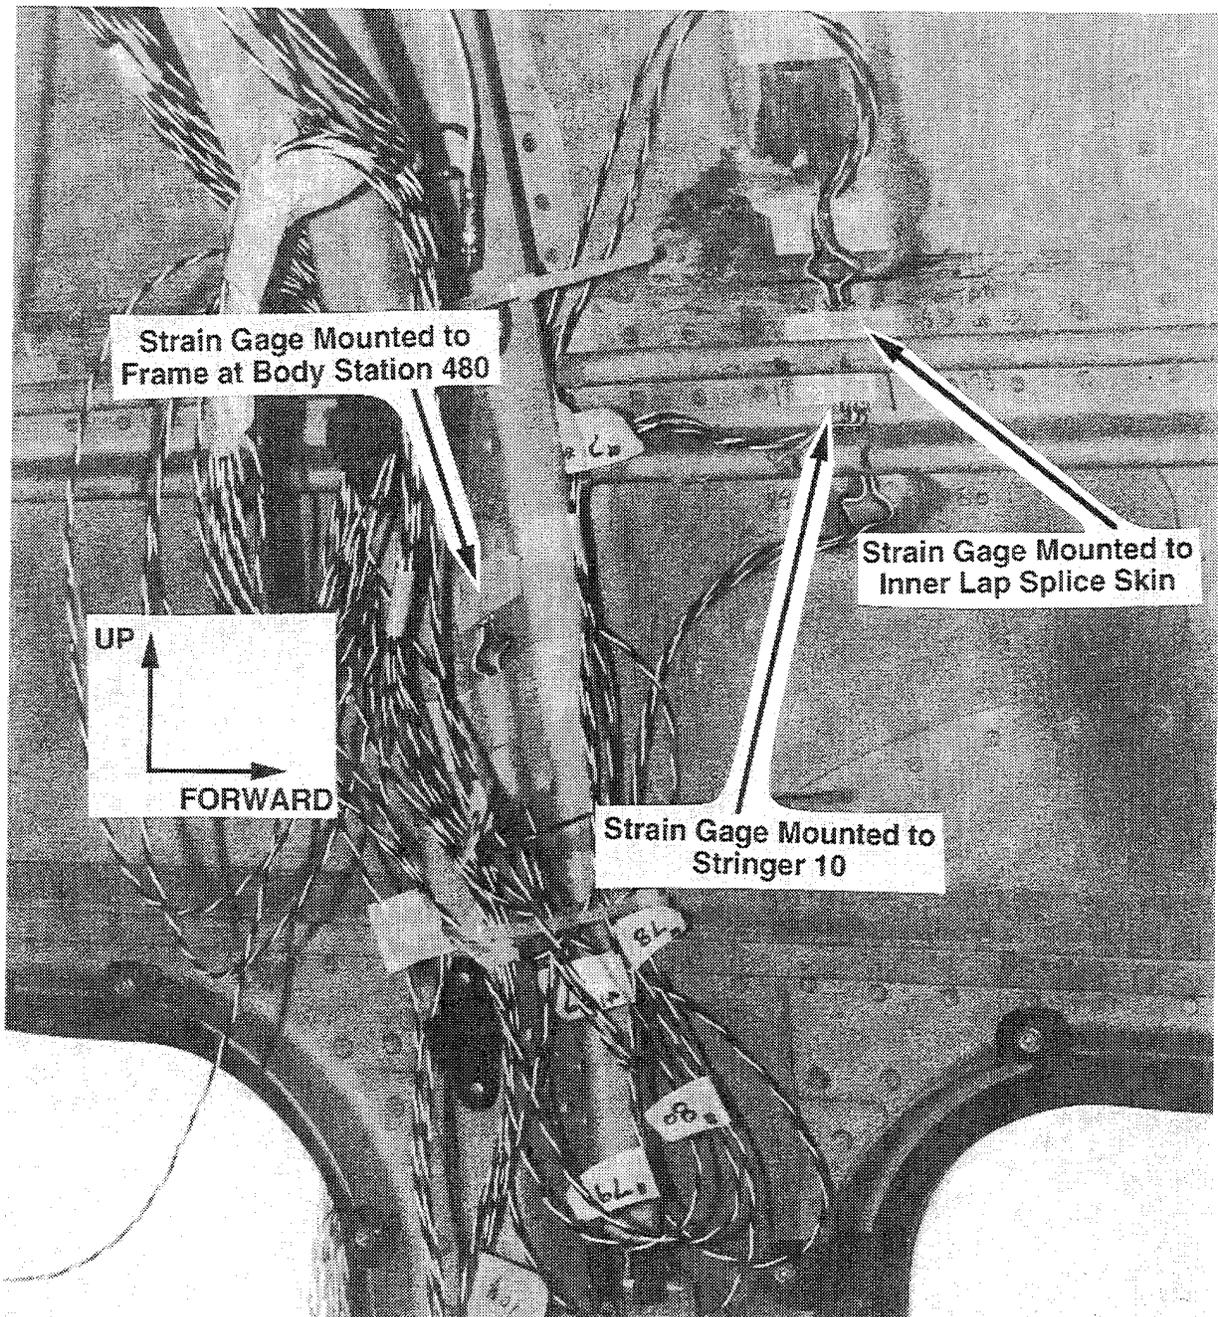
Figure 2.9. Strain Gage Installations on the Interior of AANC B737 Around Stringer S-10L.

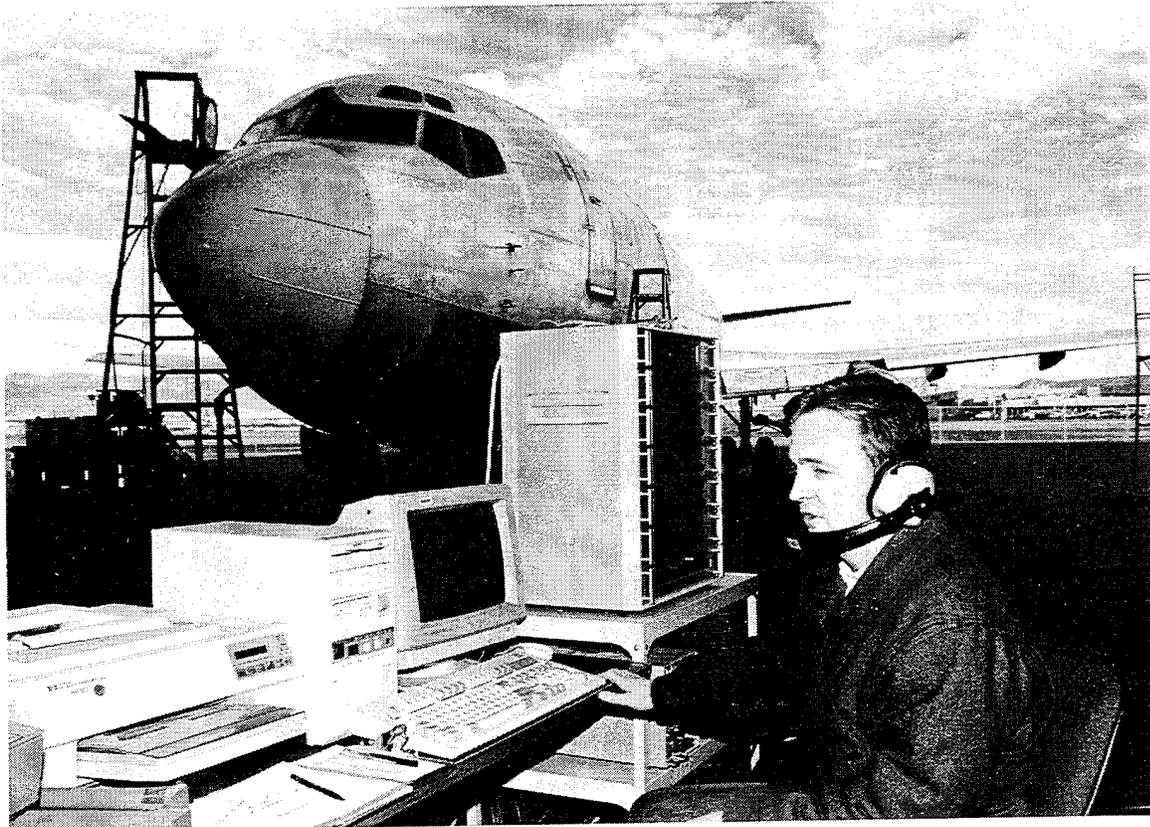
*Figure 2.10. Portable Data Acquisition System.*

The hardware for data acquisition was controlled by a personal computer with Disk Operating System (DOS). The system provided power up to 100 strain gage channels - in quarter, full- or half-bridge configurations - and 20 full-bridge transducers. The system also contained a controller to provide logic and timing commands to the data scanner and to digitize the signal received from the scanner. The data acquisition system was capable of scanning 30 channels per second. Entry of all test data was automated using manufacturer supplied software. Figure 2.10 shows a photograph of the data acquisition system positioned next to the AANC B737 aircraft. The computer operator shown in the photograph is using an intercom system which linked the data acquisition personnel with the cockpit personnel (fuselage pressure control) and the test equipment personnel (Ground Power and Airstart Unit control).

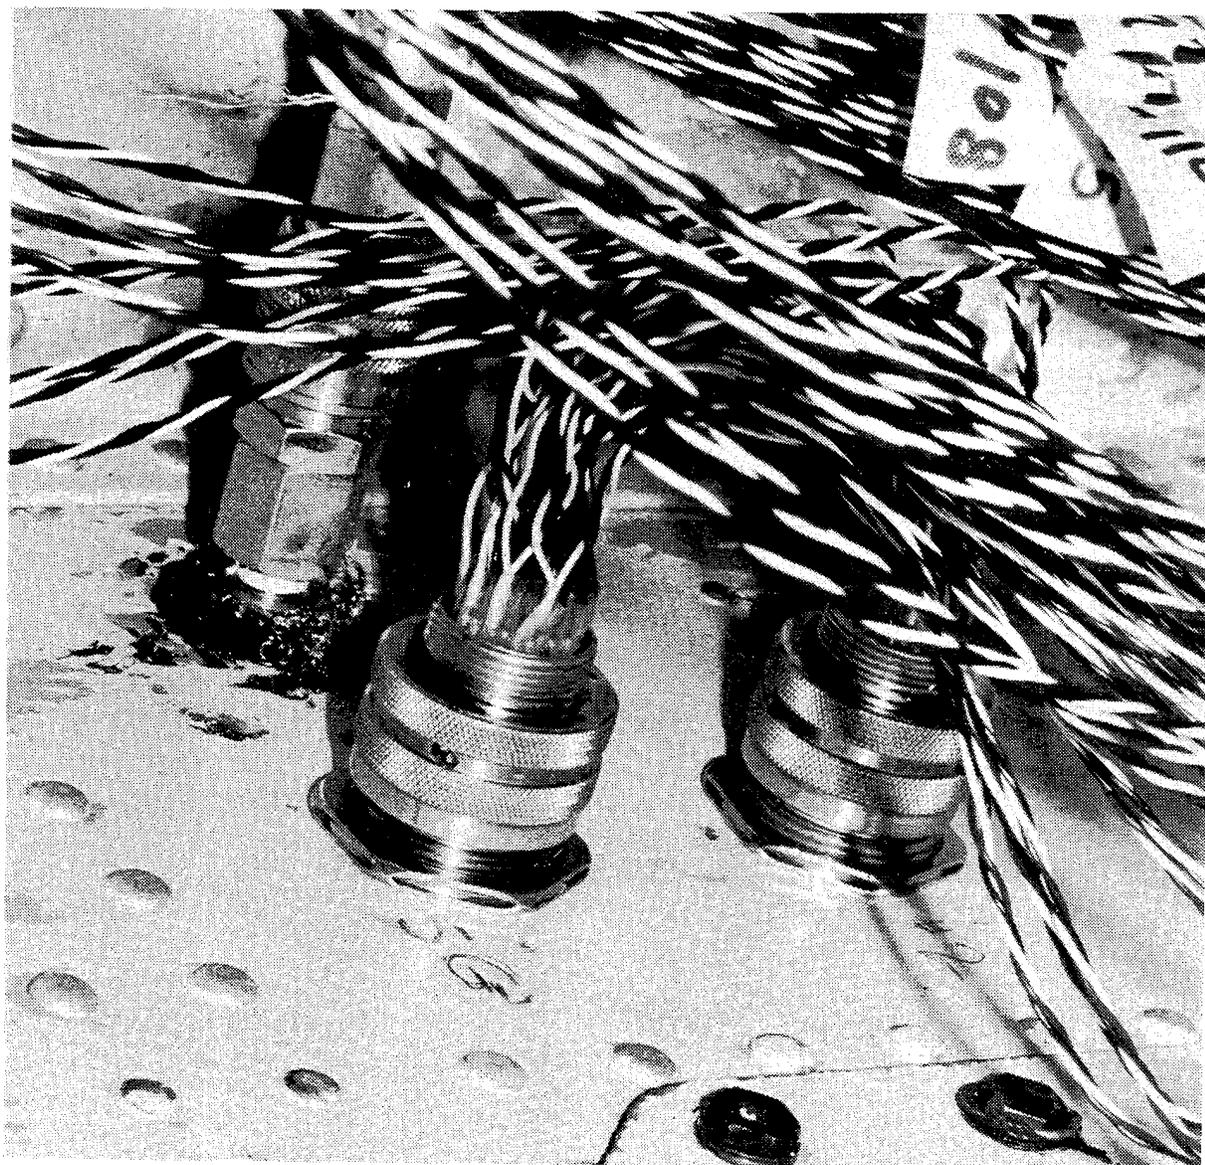
*Figure 2.11. Two 26-Pin Electrical Connectors and Pressure Pass-Through Sealed Against the Nose Wheel Well Bulkhead.*

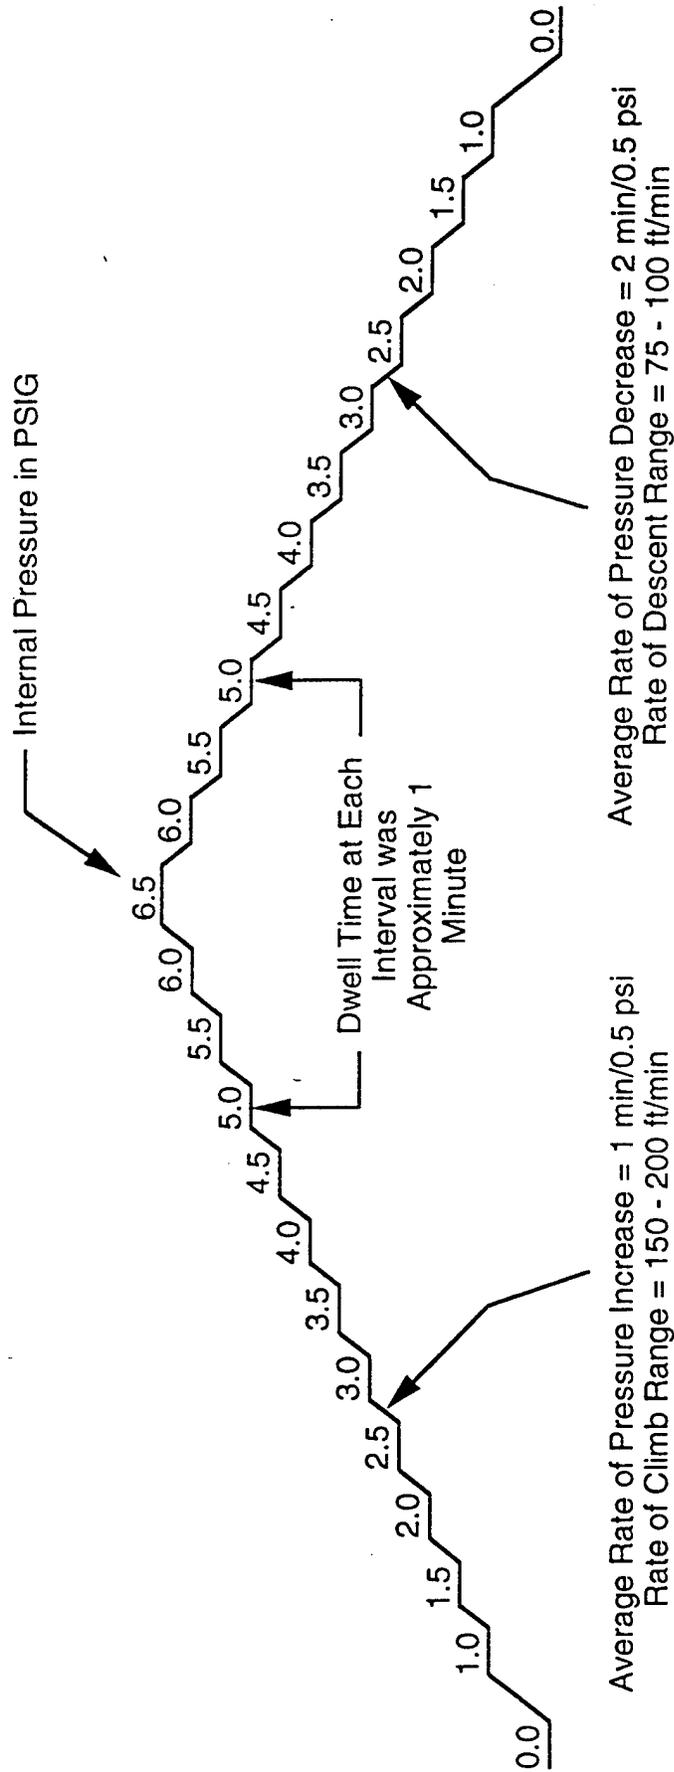
Figure 2.13. Typical Fuselage Pressure Profile.

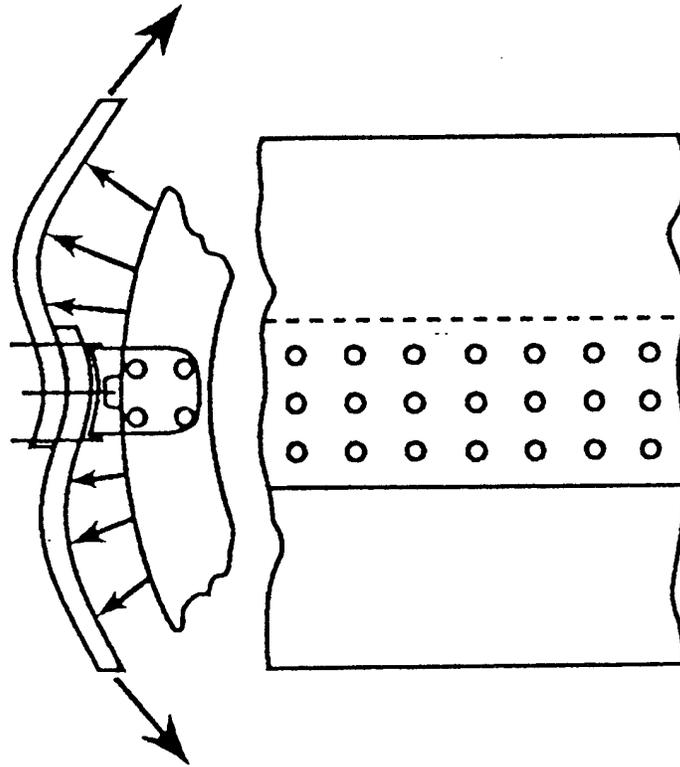
*Figure 3.6. Deformation of Lap Splice Joint Due to Internal Pressurization.*

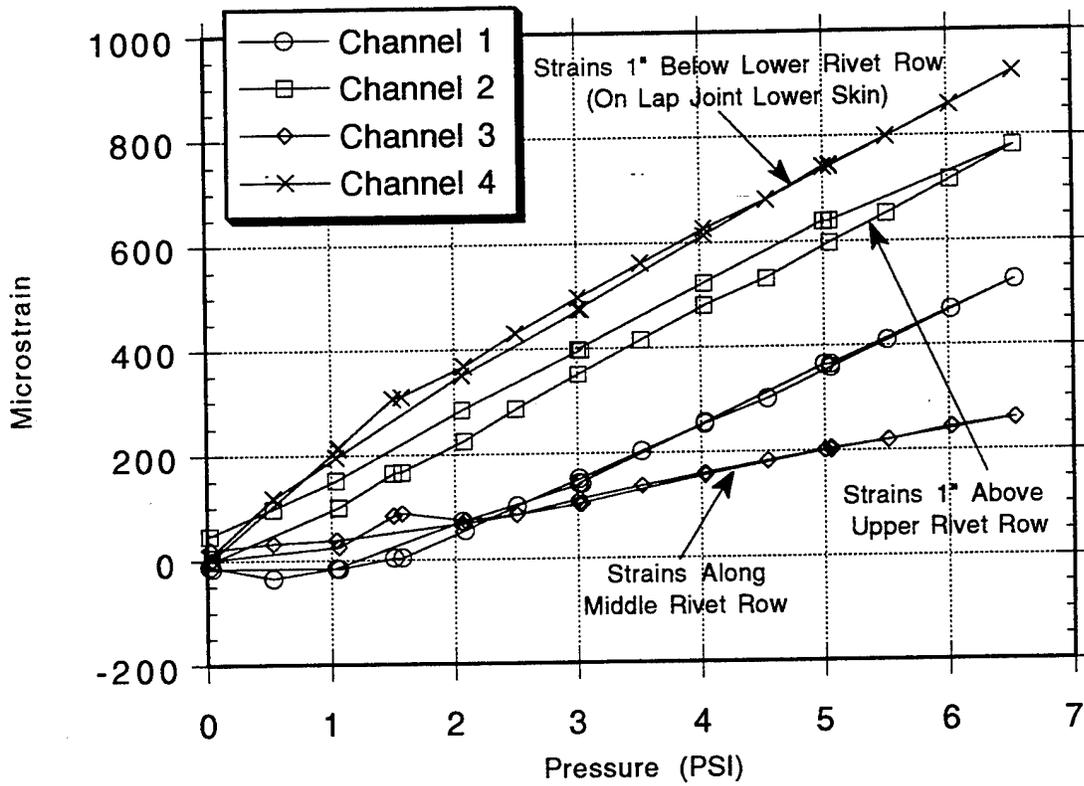
Figure 3.7. External Skin Hoop Strains Along Tear Strap at S-4L, BS470. (Refer to Figure A.4.)

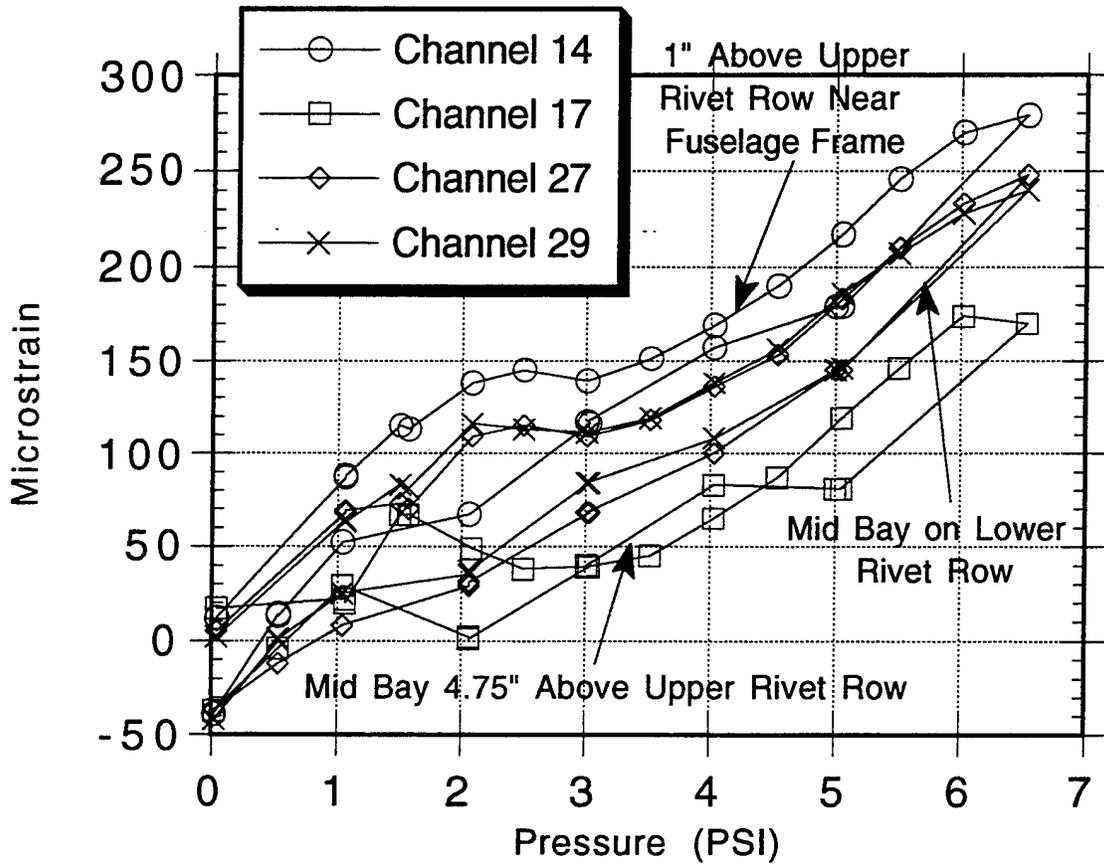
Figure 3.19. External Skin Longitudinal Strains at S-4L, BS475.  
 (Refer to Figure A.4.)

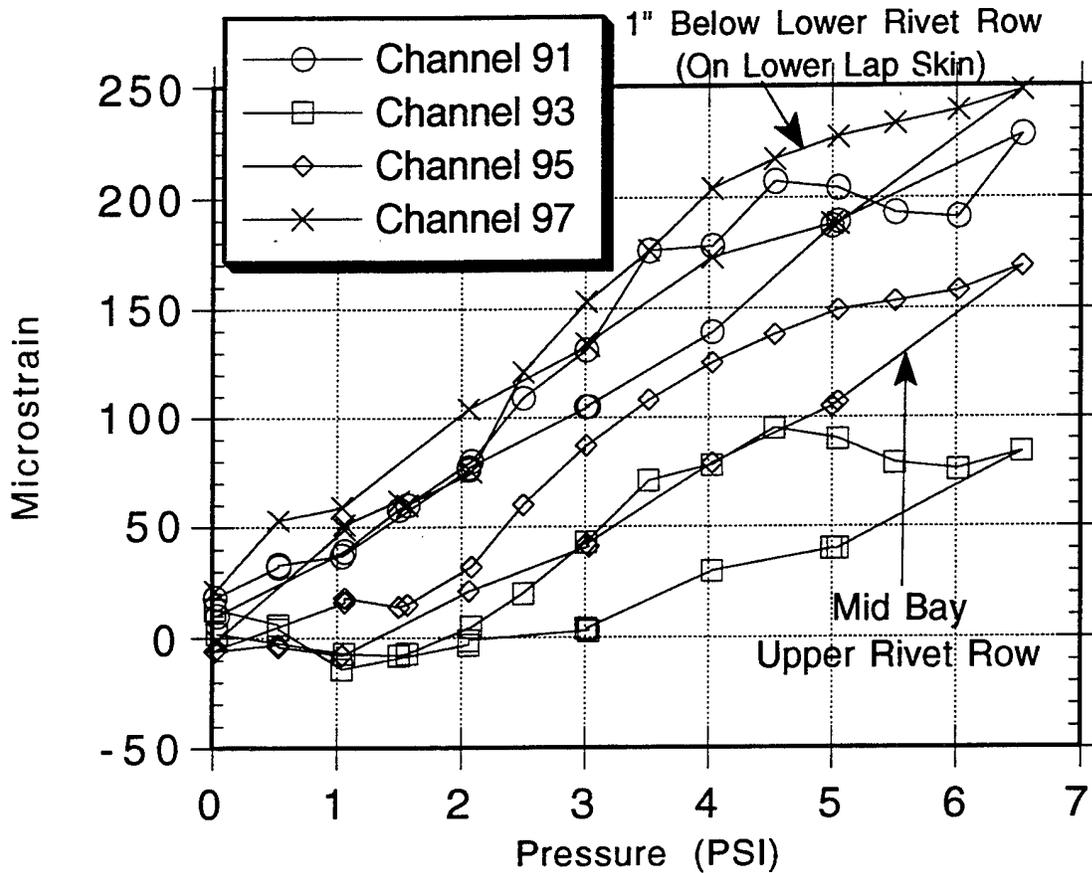
NOTE: In this figure, "midbay" refers to the longitudinal location halfway between the tear strap and the frame. In the text, this location is referred to as the "midline."

Figure 3.23. External Skin Longitudinal Strains at S-10L, BS785.  
(Refer to Figure A.11.)

- (3) Figures 3.21 to 3.23 compare the longitudinal strains measured along the midline in three different lap splice bays. The general strain profiles and magnitudes were the same forward and aft of the wing, and above and below the window. Otherwise, no significant trends were observed.

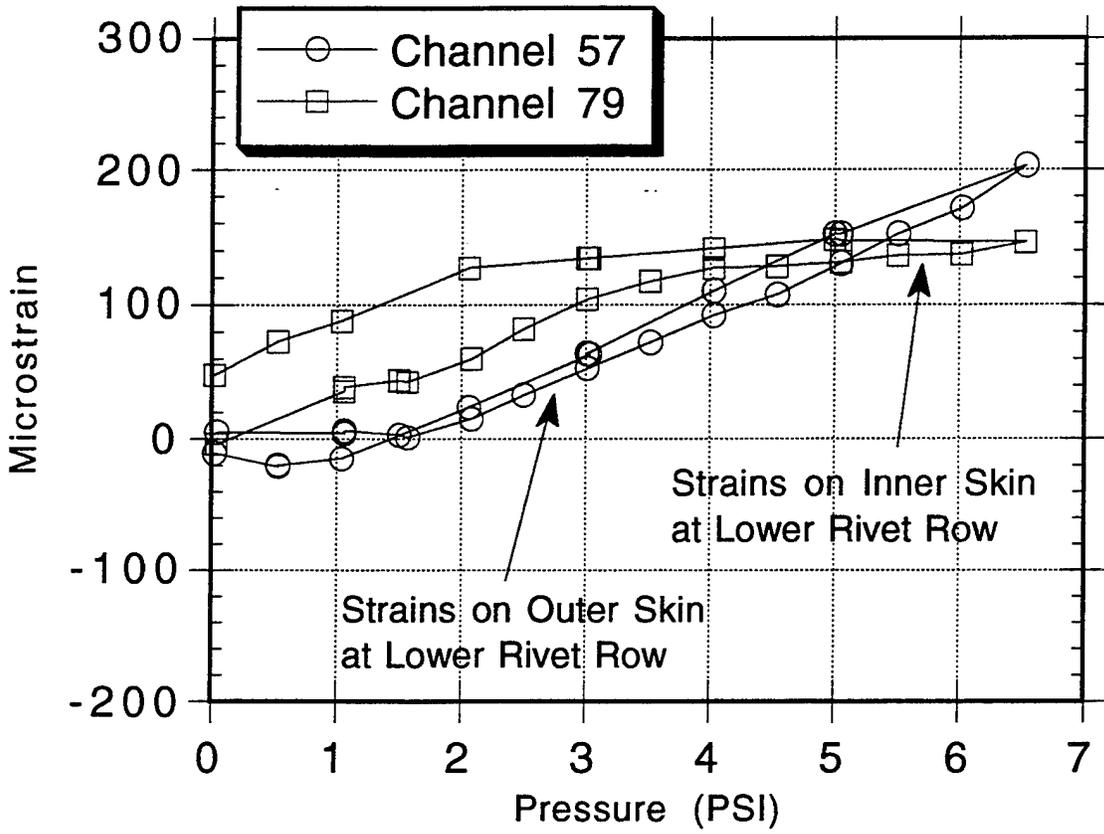
Figure 3.34. Longitudinal Strains in Lower Rivet Row on Inner and Outer Lap Skins at S-10L, BS475. (Refer to Figure A.5 and A.8.)

The maximum strains are approximately 900  $\mu\epsilon$  in the hoop direction and 250  $\mu\epsilon$  in the longitudinal direction. These results show that the lower rivet row of the inner skin experiences the same peak strains as the upper rivet row of the outer skin. Thus, these two areas should be treated similarly in fatigue and damage tolerance analyses.

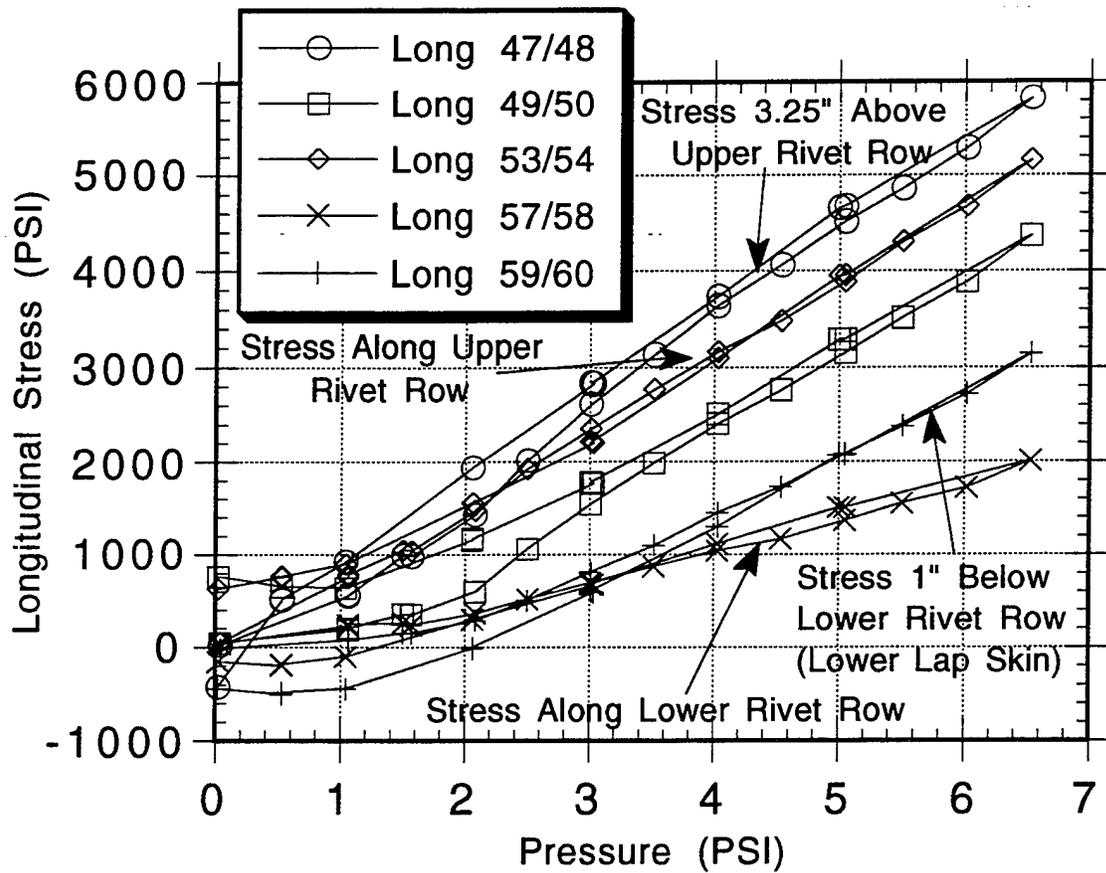
Figure 3.44. External Longitudinal Stresses at S-10L, BS475.  
(Refer to Figure A.5.)

Hoop and longitudinal stresses in the substructure elements were also calculated using equations (3.2) and (3.3). The longitudinal stresses in the S-10L stringer at BS475 and the S-4L stringer at BS475 are plotted in Figure 3.49. The peak longitudinal stresses in the stringers vary between 1300 and 2400 psi at a differential pressure of 6.5 psi. These values are approximately one-third of those in the mating lap splice skin.

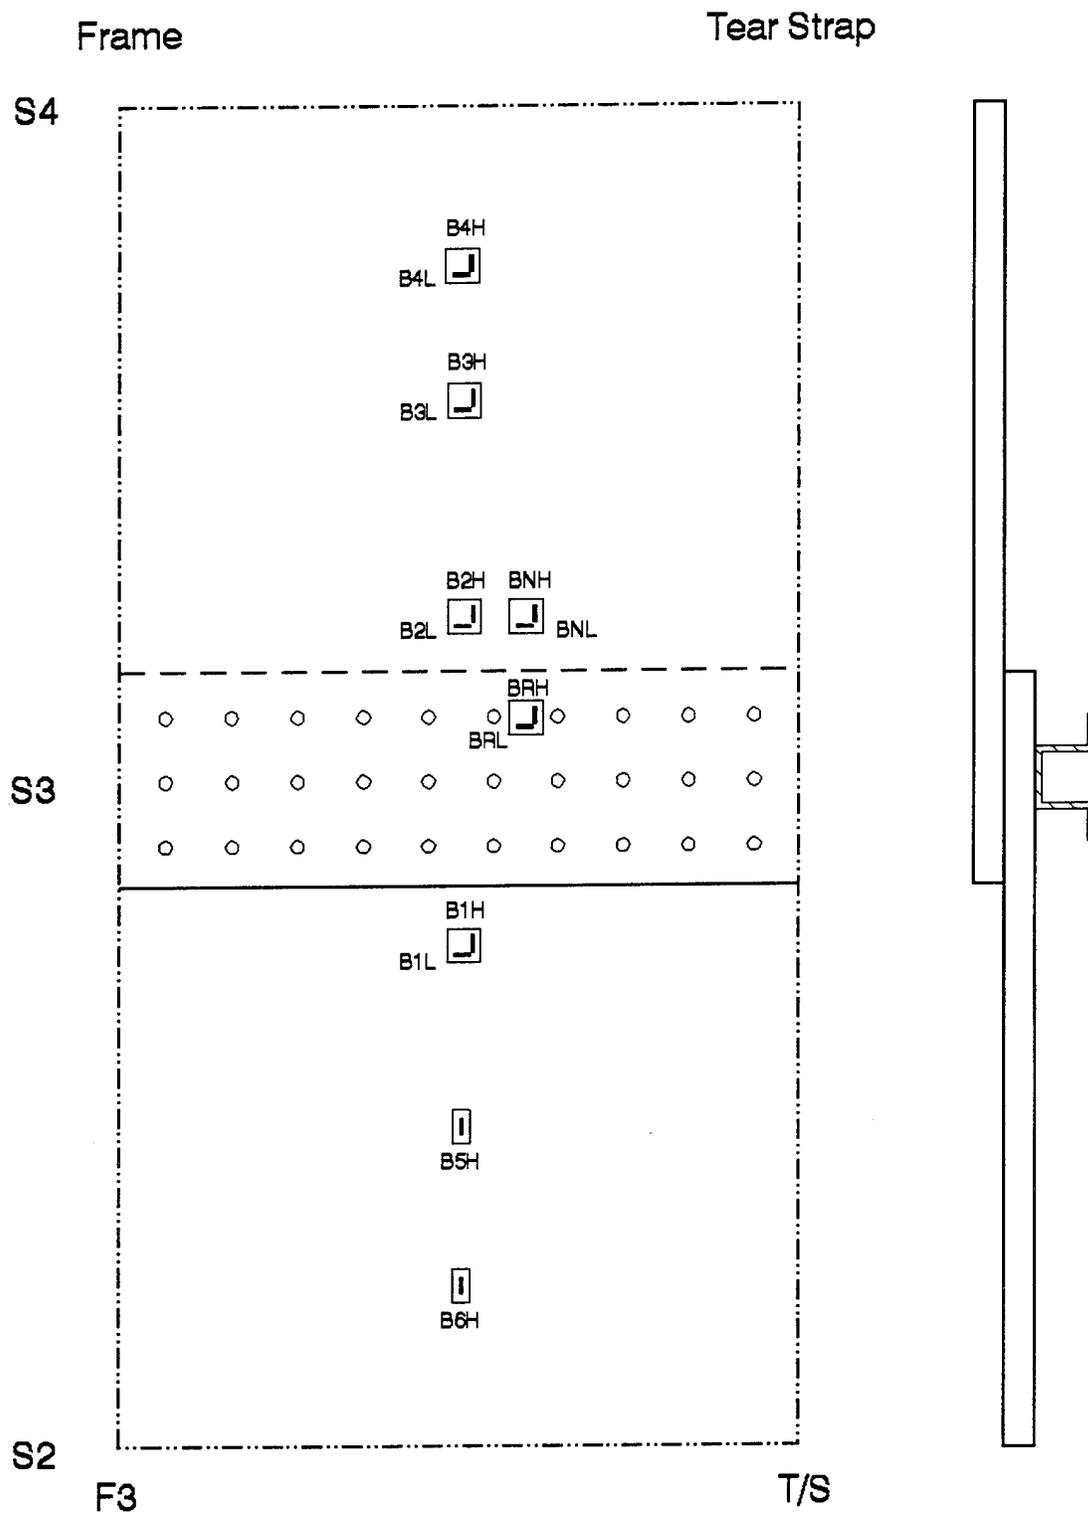
Figure 4.1. Strain Gage Deployment for FMI Panel (Exterior Gages).

Designations for the various gages used in the FMI panel are indicated on the strain gage layouts shown in Figures 4.1 and 4.2. Figure 4.1 corresponds to the exterior of the panel; Figure 4.2 corresponds to the interior. The last letter in the FMI strain gage designation refers to the component of strain being measured: "H" refers to the hoop direction and "L" refers to the longitudinal direction. Gages installed on the underside or interior of the panel can be identified by "U" in the first letter of the strain gage designation. For example, UB3H refers to a gage measuring hoop strain on the interior of the panel at a circumferential location midbay between stringers and a longitudinal location at the midline between the frame and tear strap (see Figure 4.2).
