DOT/FAA/CT-95/25  
DOT-VNTSC-FAA-95-10

# Strain Fields in Boeing 737 Fuselage Lap Splices: Field and Laboratory Measurements with Analytical Correlations

Final Report  
June 1995

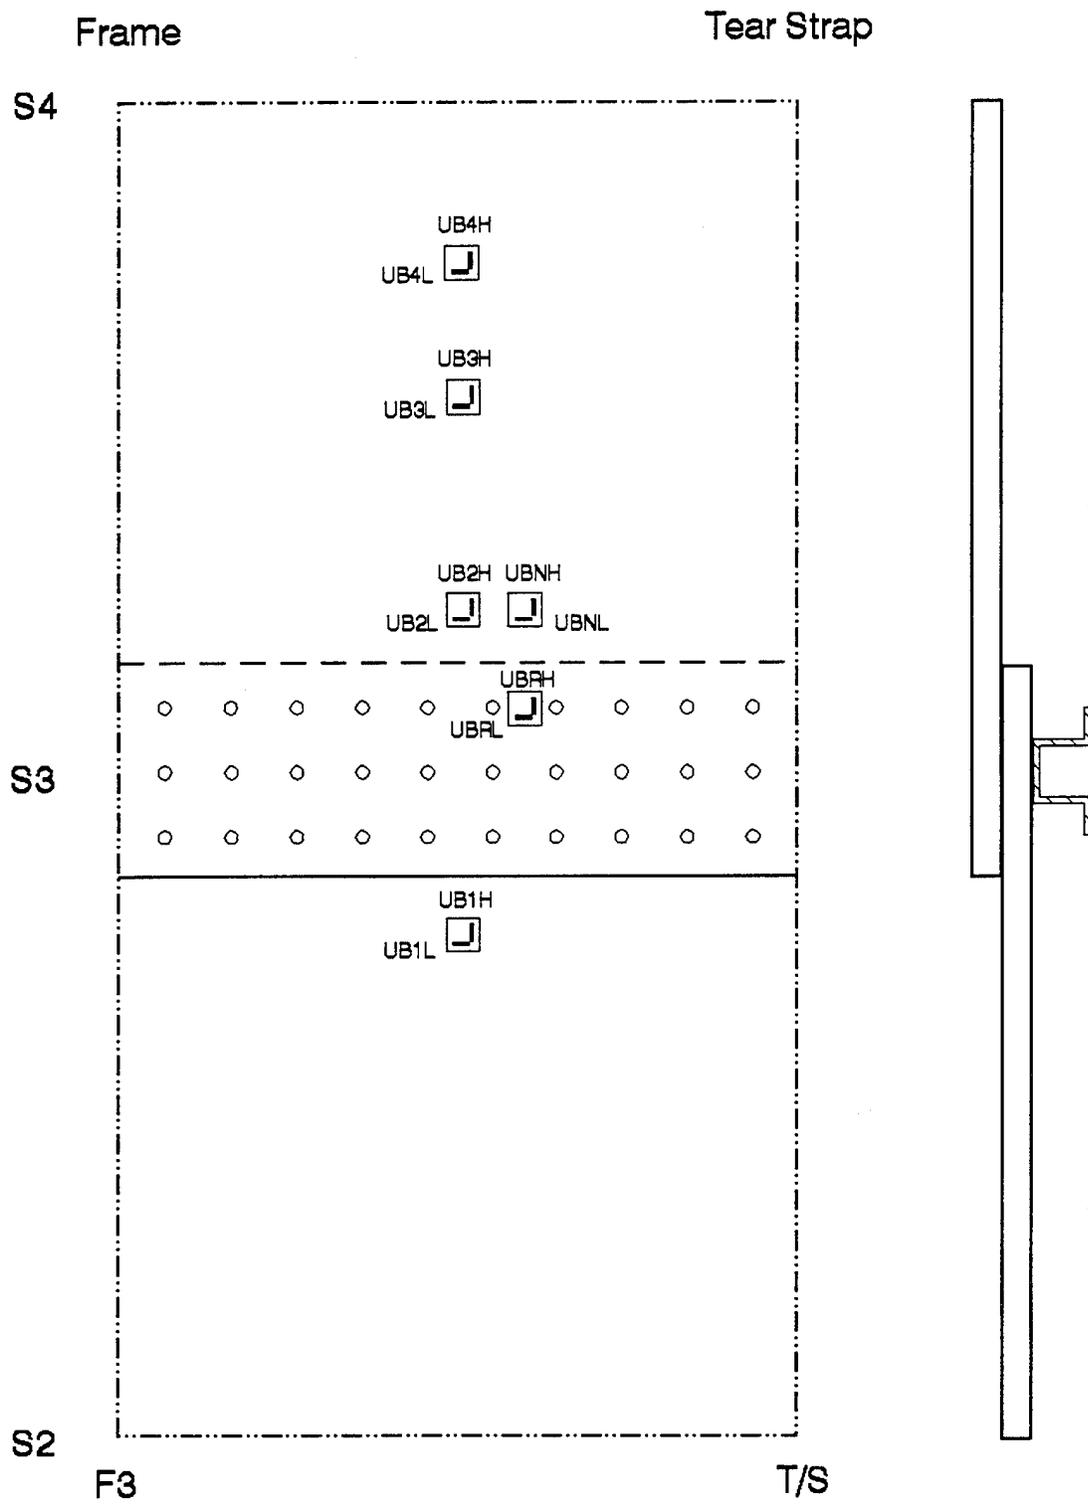
Figure 4.2. Strain Gage Deployment for FMI Panel (Interior Gages).

Designations for the various gages used in the FMI panel are indicated on the strain gage layouts shown in Figures 4.1 and 4.2. Figure 4.1 corresponds to the exterior of the panel; Figure 4.2 corresponds to the interior. The last letter in the FMI strain gage designation refers to the component of strain being measured: "H" refers to the hoop direction and "L" refers to the longitudinal direction. Gages installed on the underside or interior of the panel can be identified by "U" in the first letter of the strain gage designation. For example, UB3H refers to a gage measuring hoop strain on the interior of the panel at a circumferential location midbay between stringers and a longitudinal location at the midline between the frame and tear strap (see Figure 4.2).

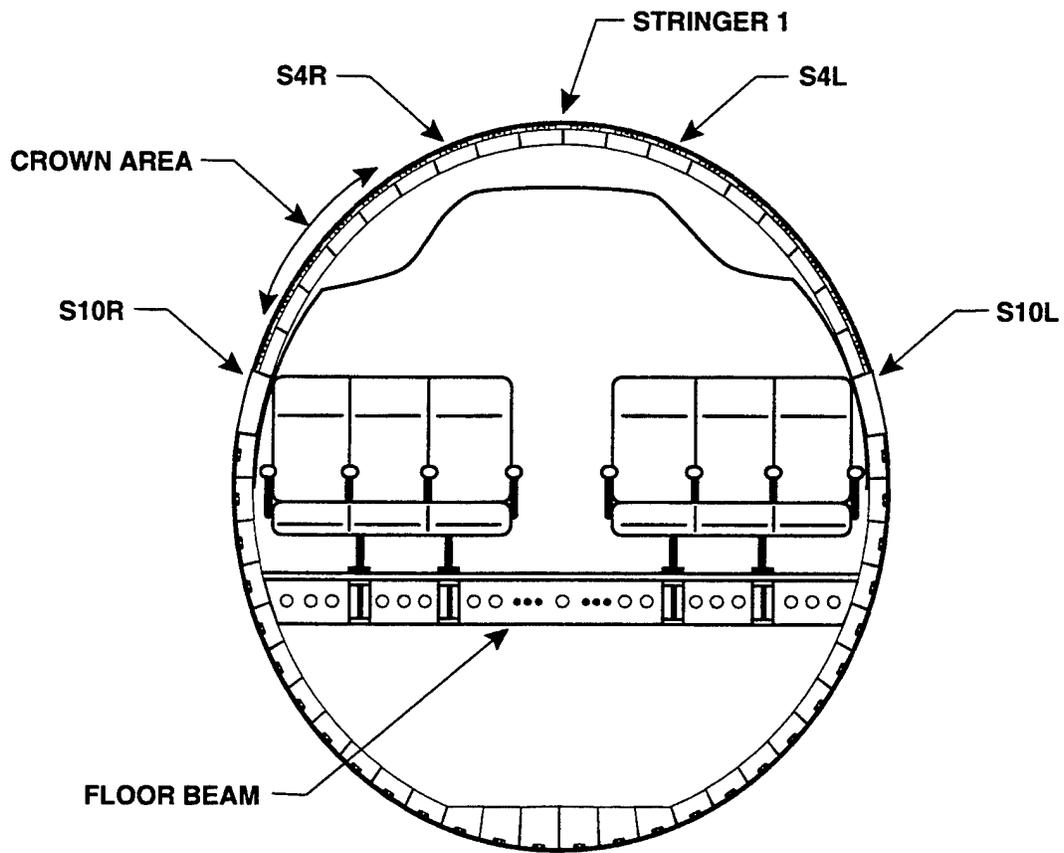
Figure 4.3. Cross Section of Boeing 737 Airplane.

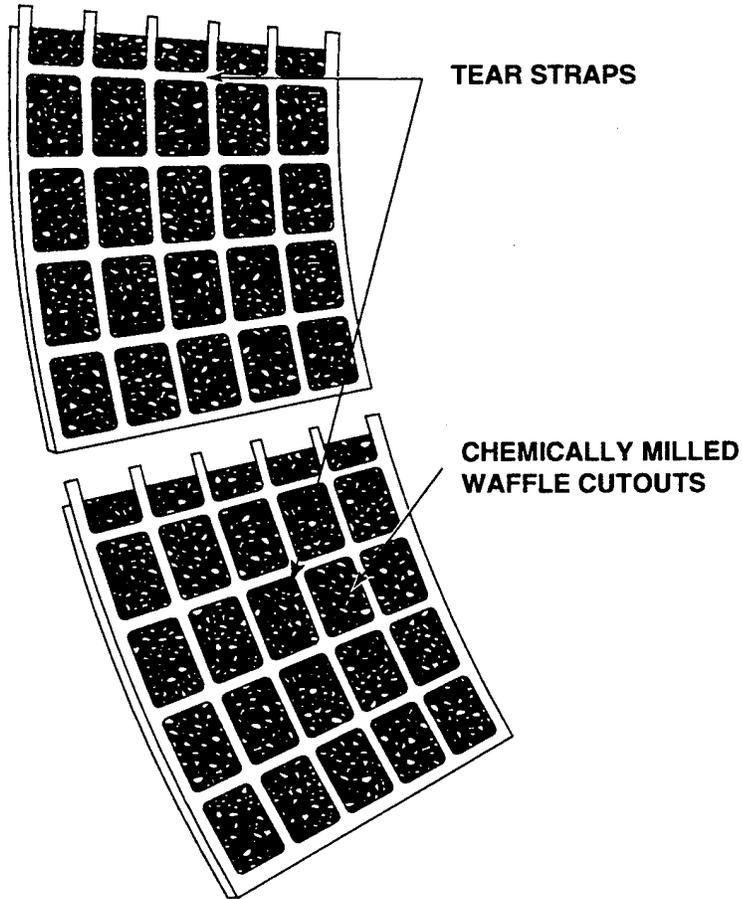
- (5) The FMI panel is constructed with a tear strap and filler strip arrangement rather than the waffle doubler design found in actual aircraft. Typical aircraft construction consists of bonding two pieces of skin together, and then chemically removing all the material that is not a tear strap or does not lie over a stringer. Thus, a continuous waffle-pattern doubler is produced beneath the skin, see Figure 4.4. In the FMI panels, continuous tear straps are bonded to the skin and longitudinal filler strips were attached between the skin and stringers. This deviation in panel construction was employed to simplify manufacturing and to reduce the cost of the test panels. It is believed that this modification in construction does not impact structural performance of the fuselage panels. The strain gage correlations between the FMI and AANC data can be used to assess this assertion.

*Figure 4.4. Waffle Doubler Tear Strap Design in Boeing 737 Airplane.*

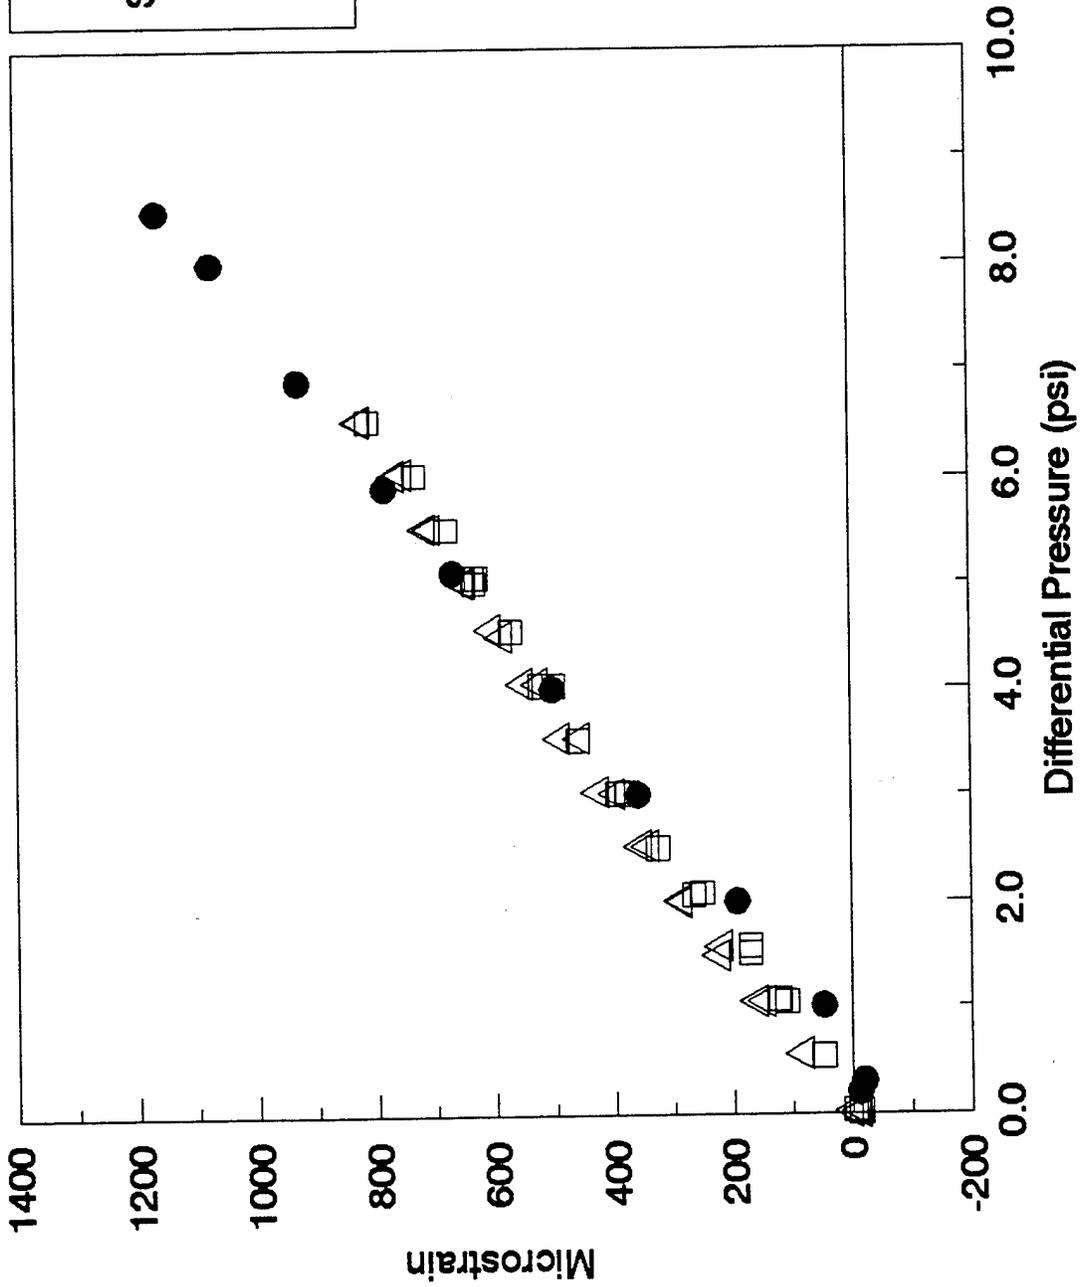
Figure 4.5. Comparison Between AANC Channel 18 and FMI Gage B3H.

Individual measurements from the FMI and AANC strain gage tests are compared in Figures 4.5 to 4.16. These comparisons are presented in the form of plots showing measured microstrain as a function of applied pressure. Each figure includes a schematic of a lap splice bay indicating the location of the measured strains. Table 4.2 lists the figure numbers that correspond to the plots comparing the various strain gage measurements from each test.

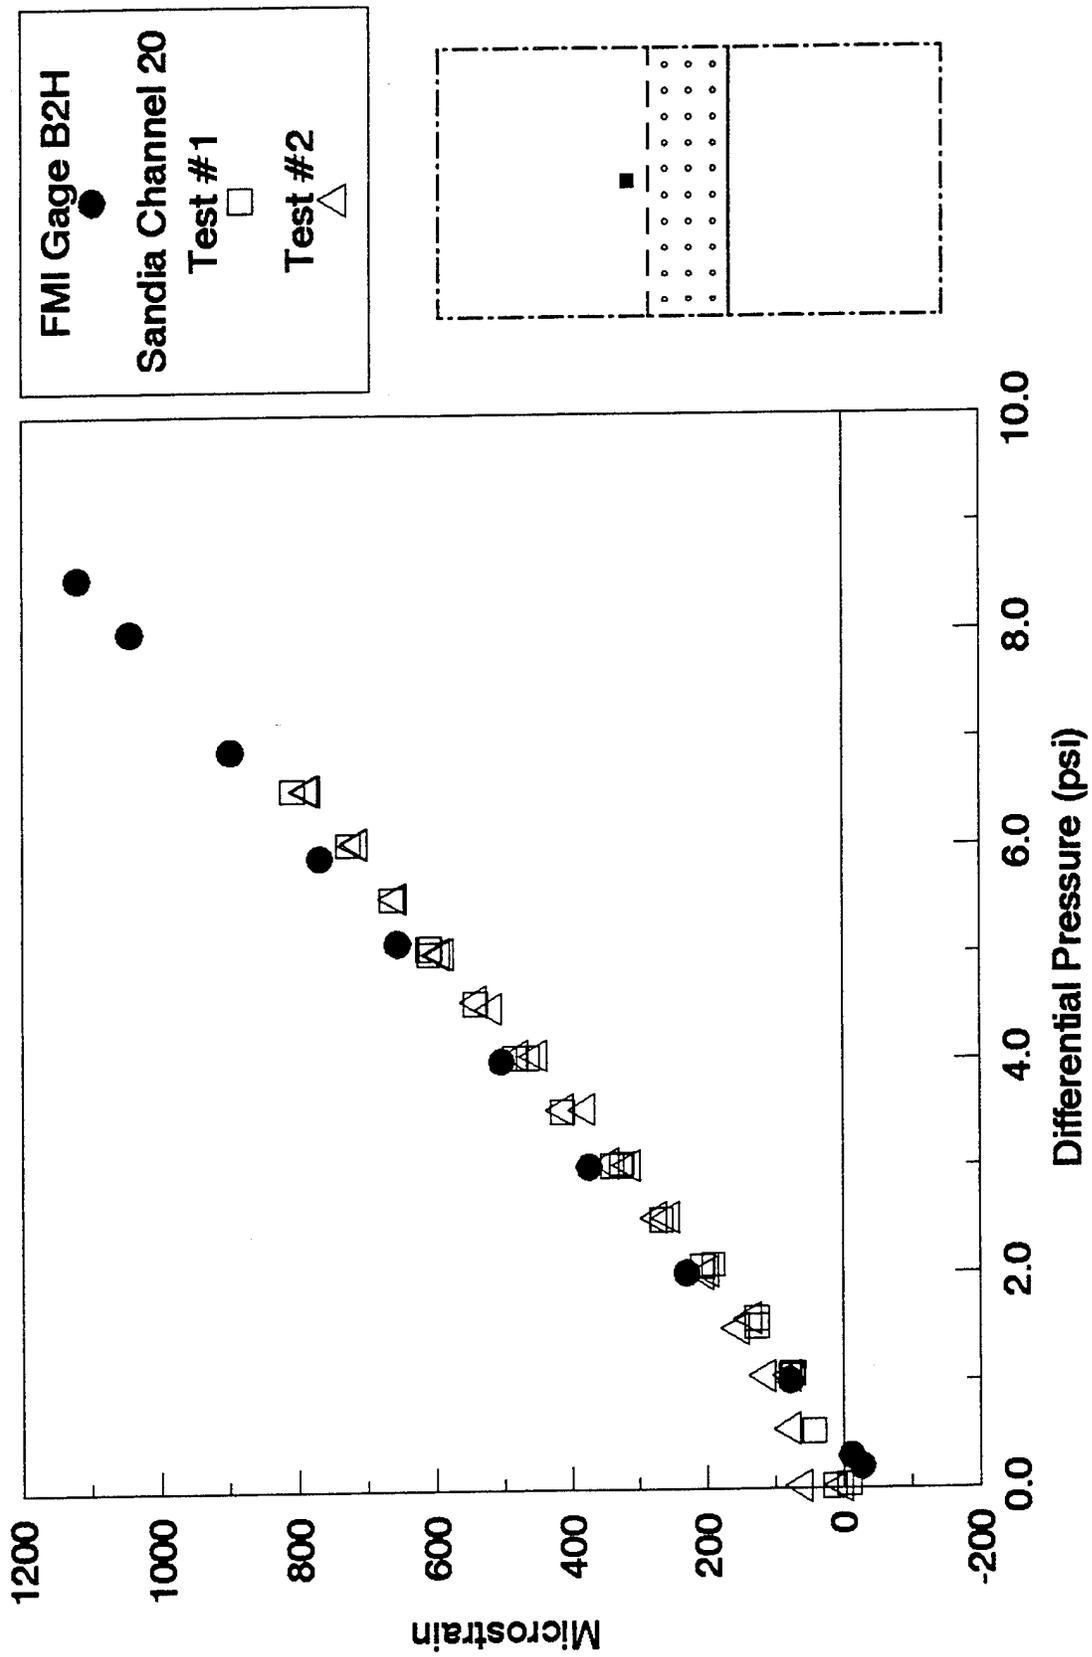
Figure 4.6. Comparison Between AANC Channel 20 and FMI Gage B2H.

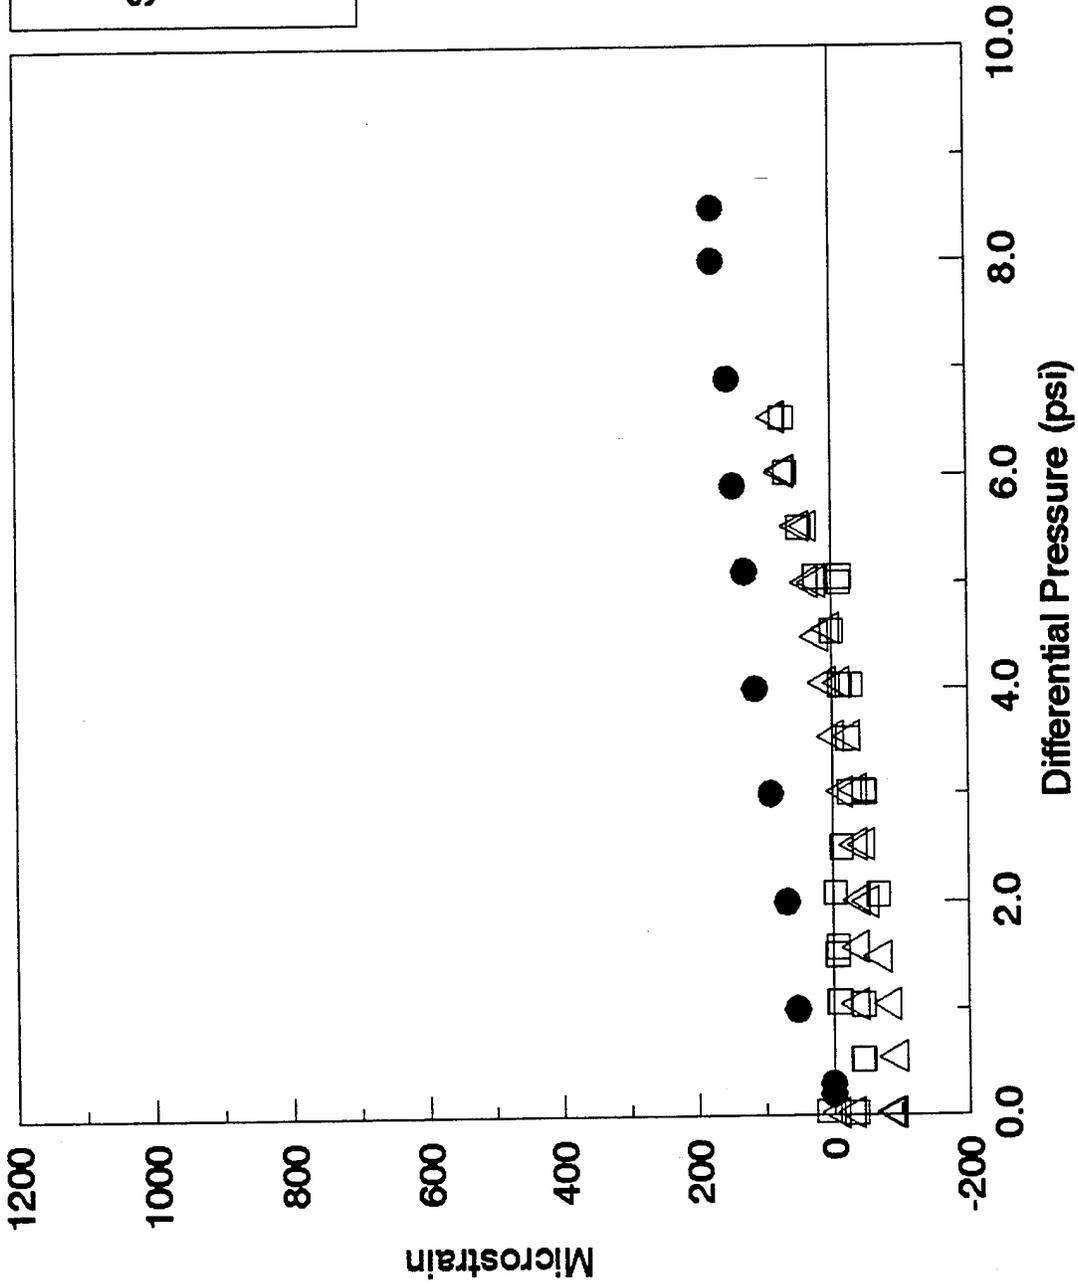
Figure 4.7. Comparison Between AANC Channel 21 and FMI Gage BNL.

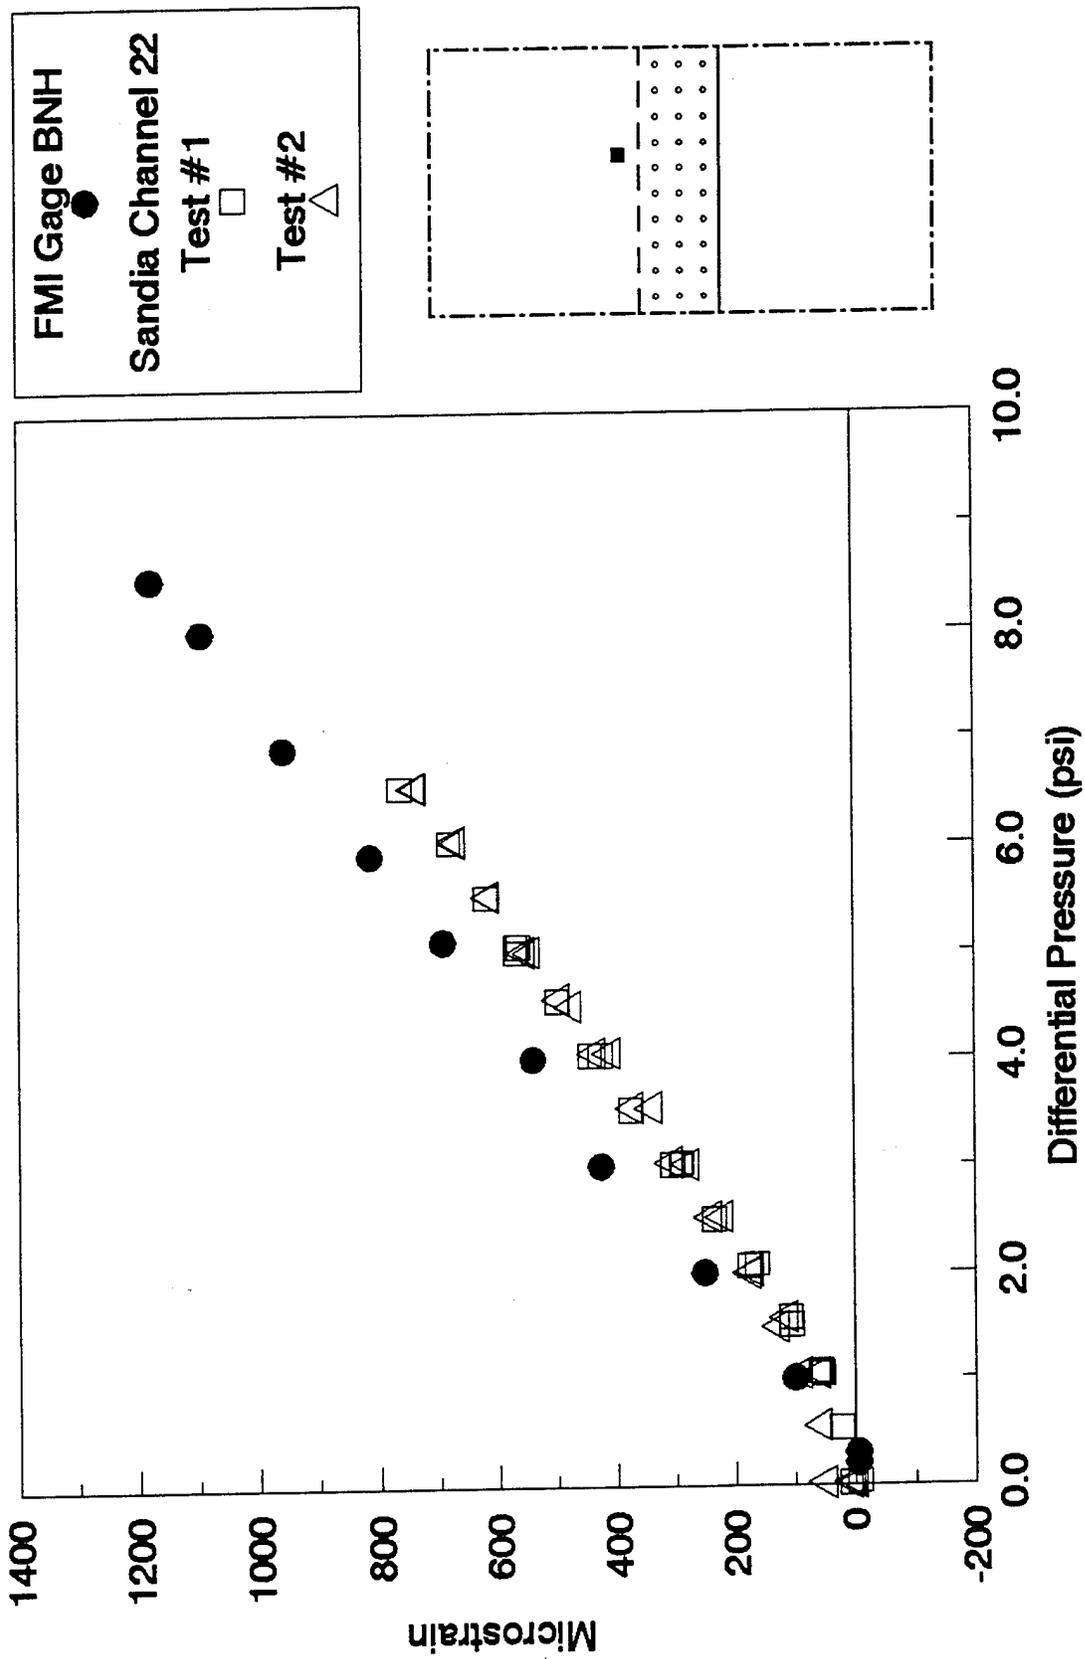
Figure 4.8. Comparison Between AANC Channel 22 and FMI Gage BNH.

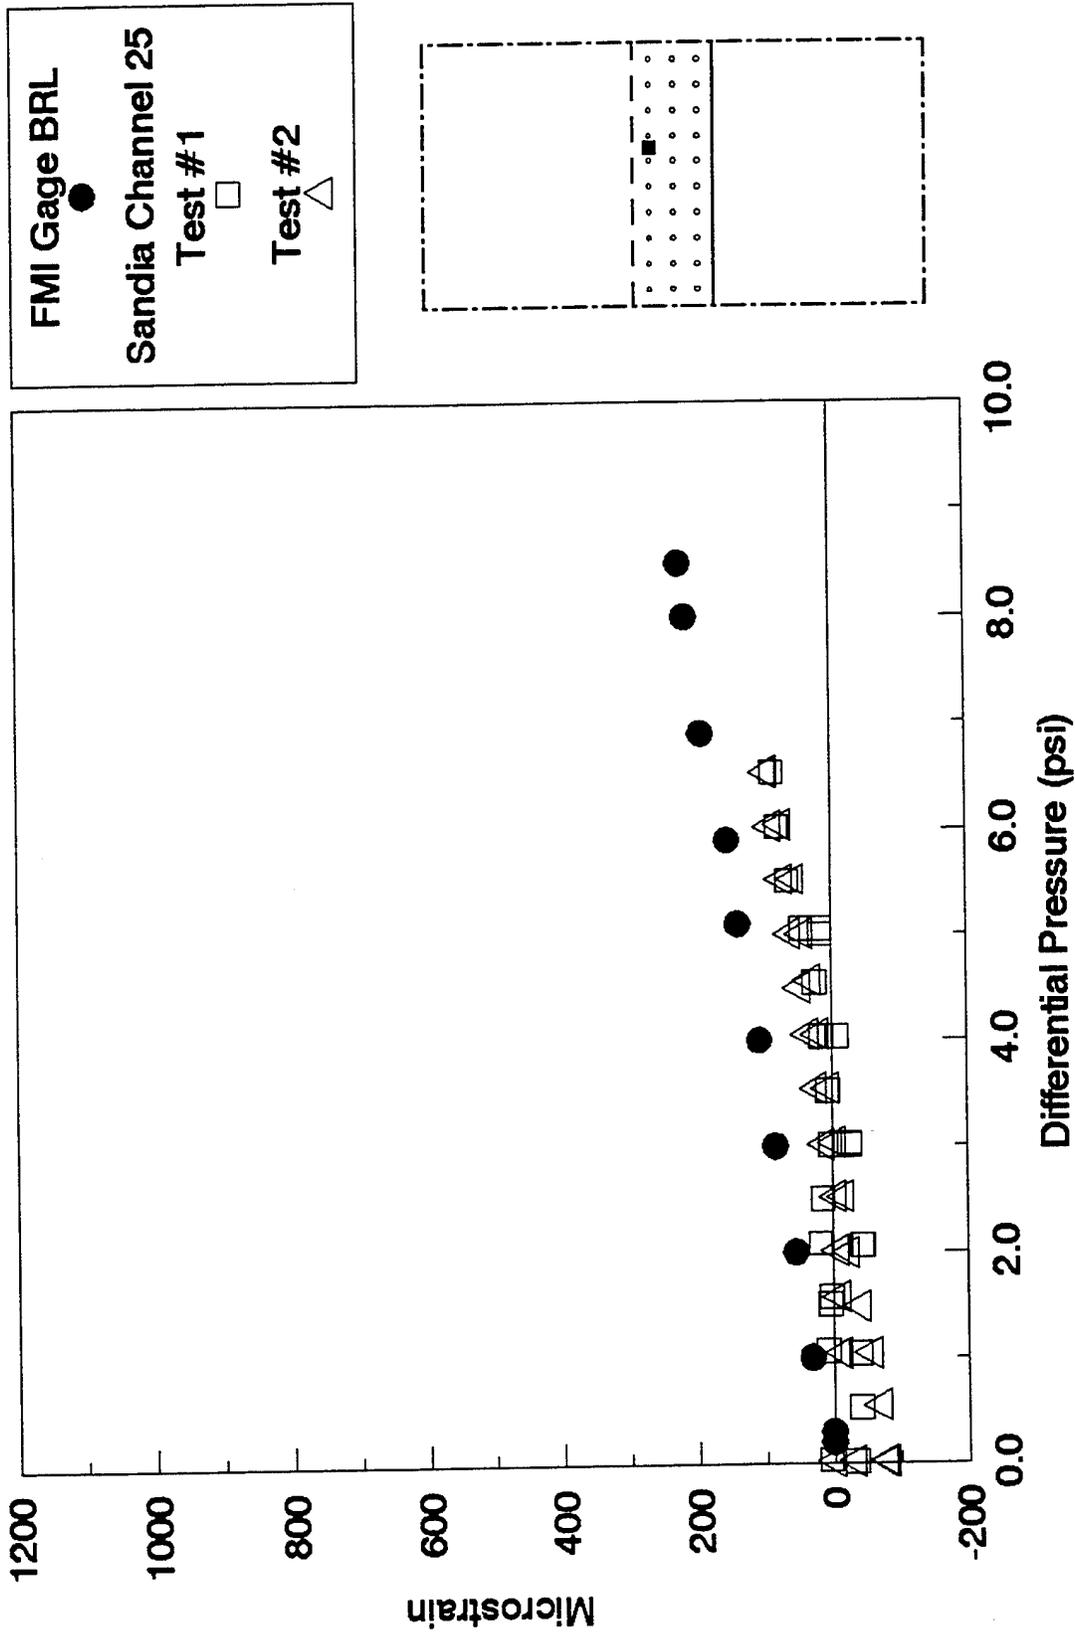
Figure 4.9. Comparison Between AANC Channel 25 and FMI Gage BRL.

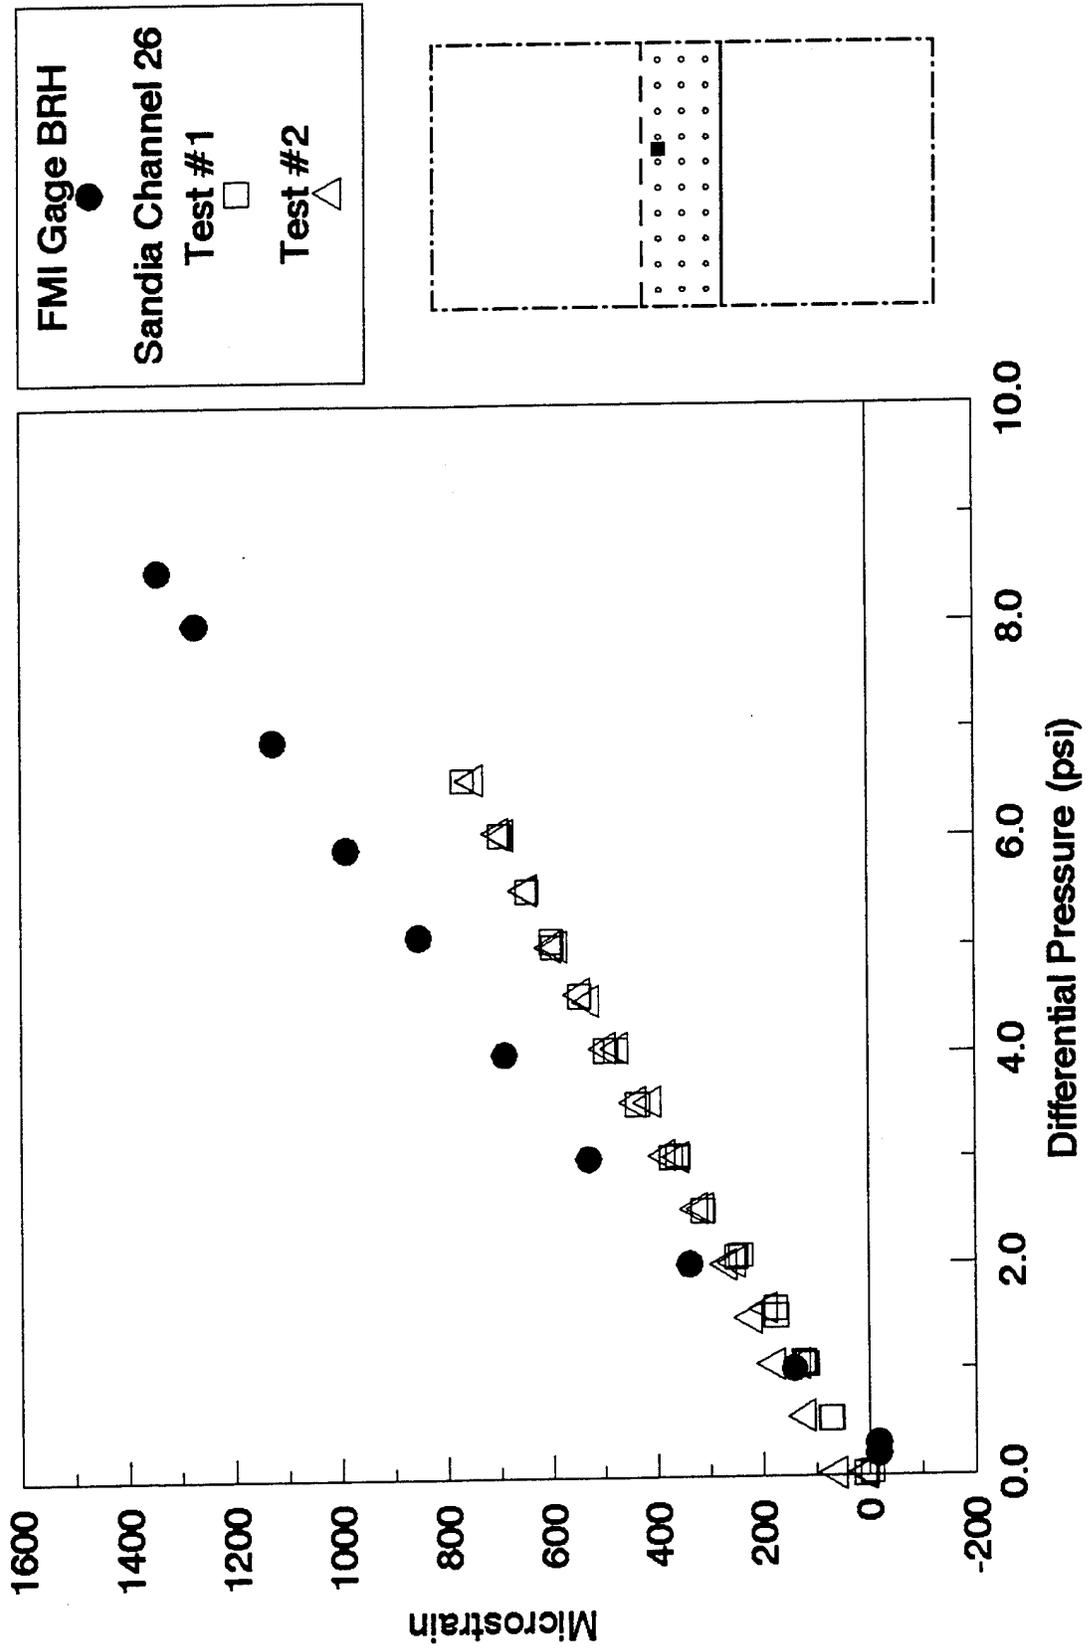
Figure 4.10. Comparison Between AANC Channel 26 and FMI Gage BRH.

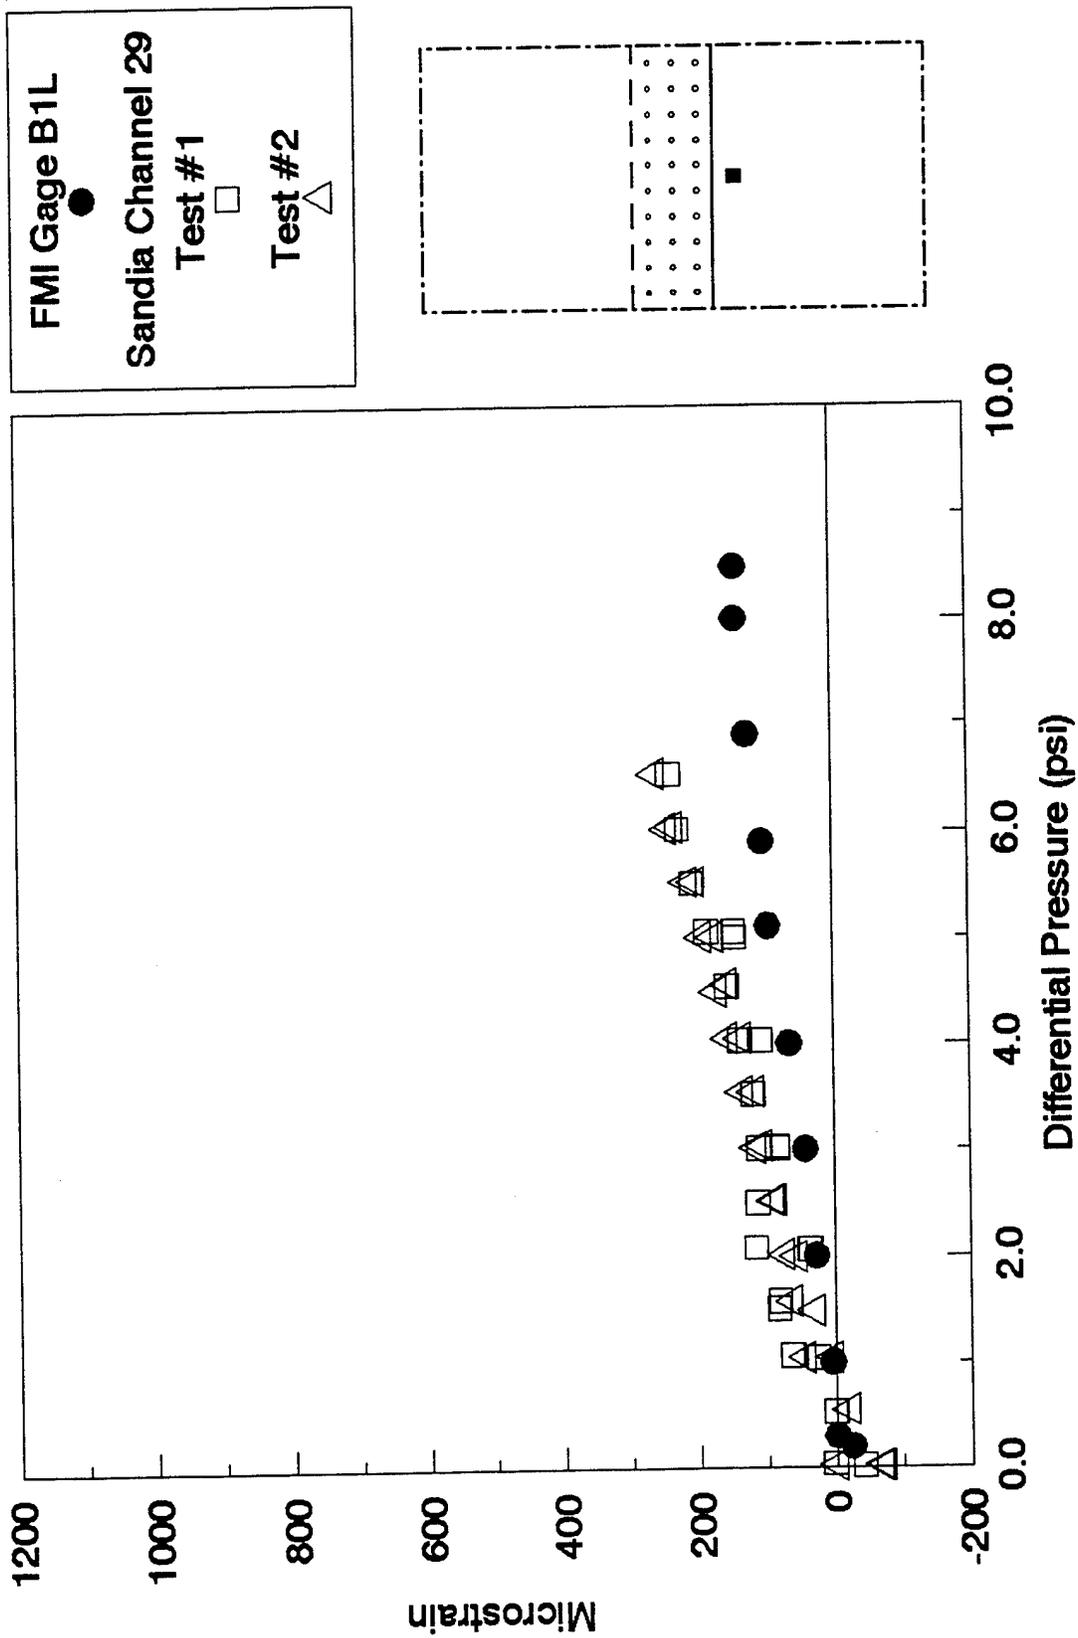
Figure 4.11. Comparison Between AANC Channel 29 and FMI Gage B1L.

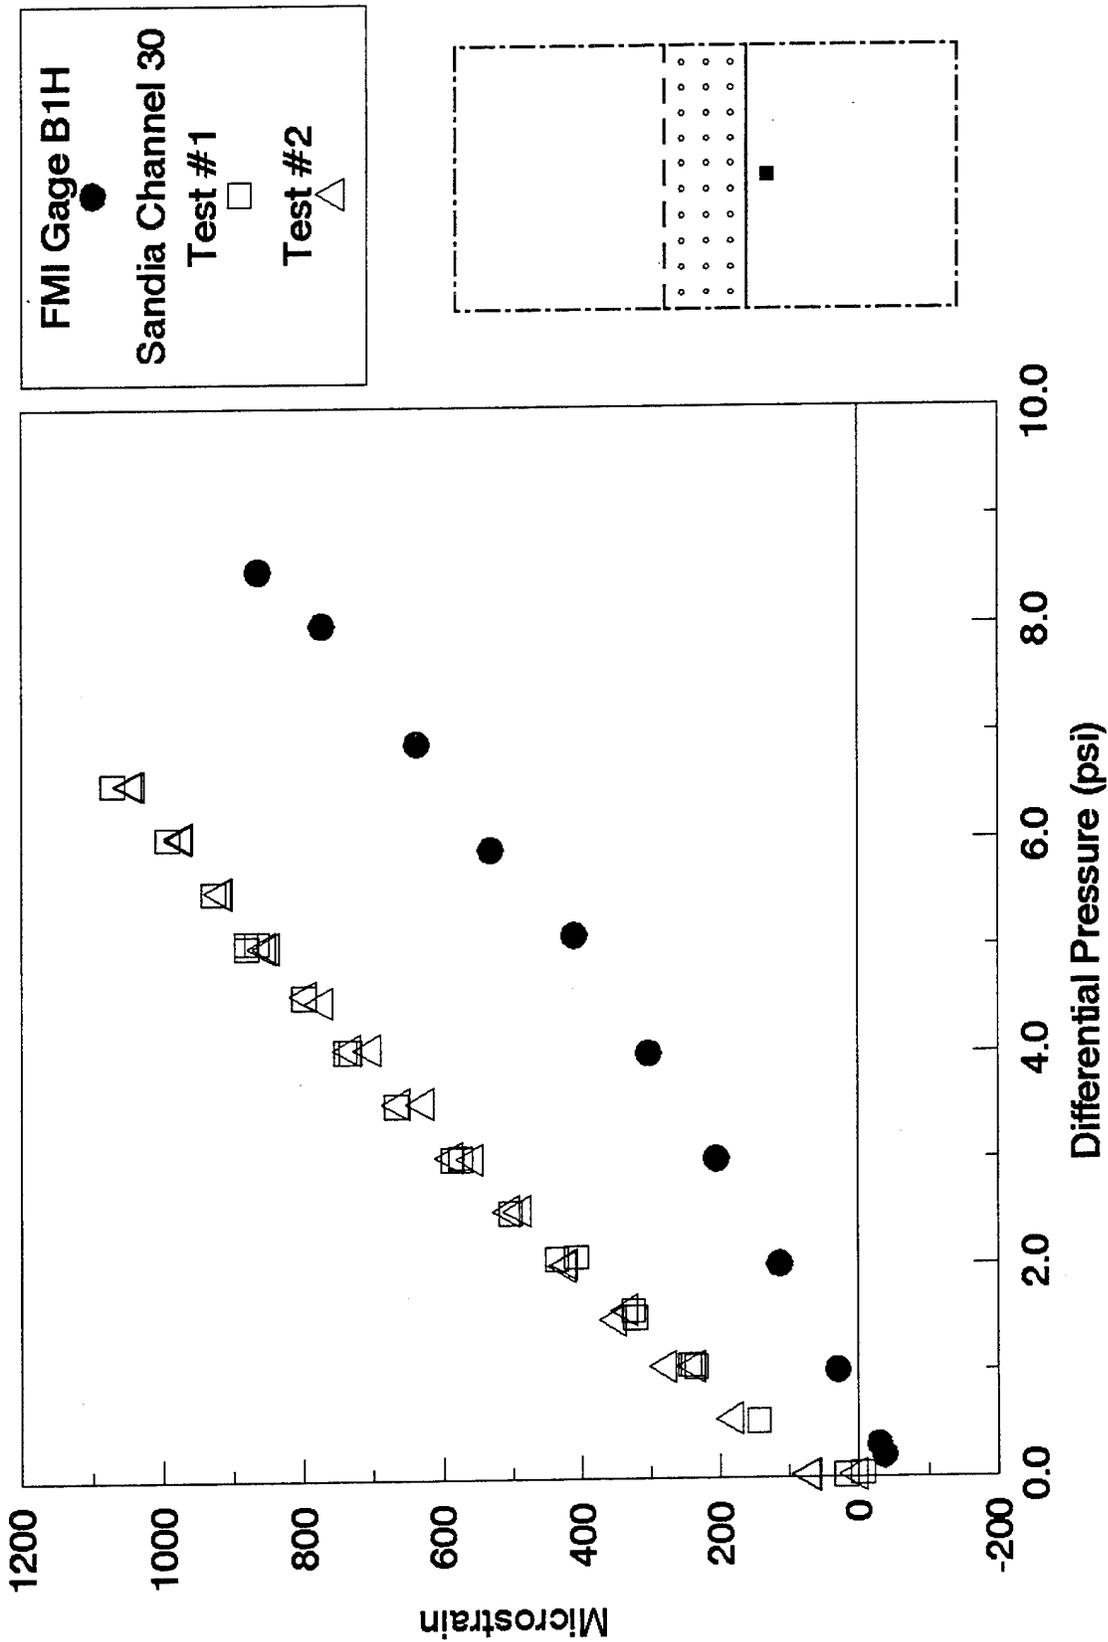
Figure 4.12. Comparison Between AANC Channel 30 and FMI Gage B1H.

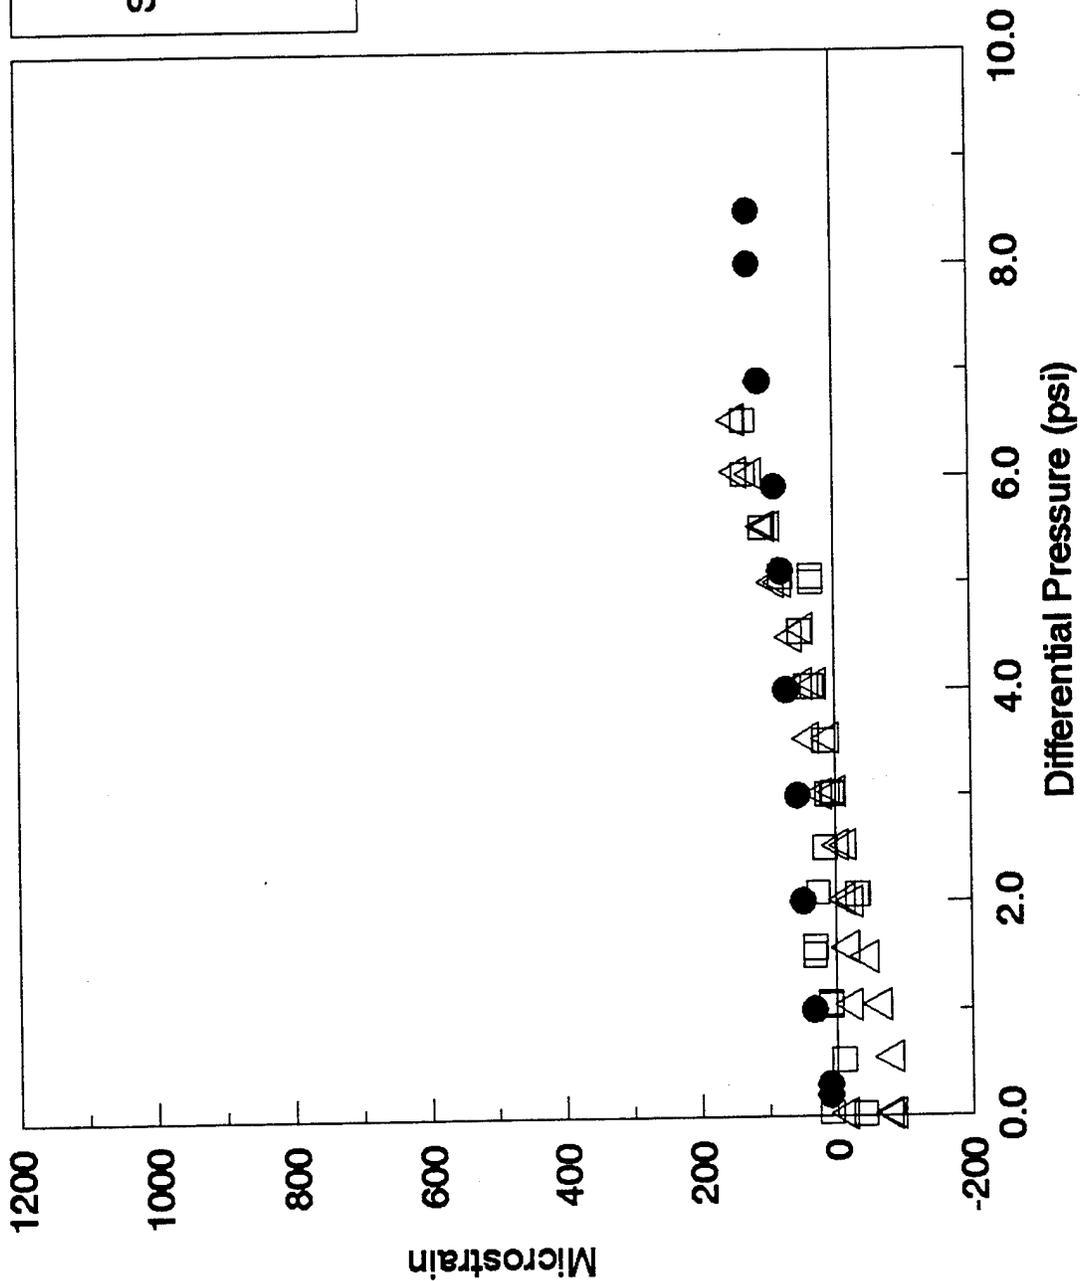
Figure 4.13. Comparison Between AANC Channel 69 and FMI Gage UB3L.

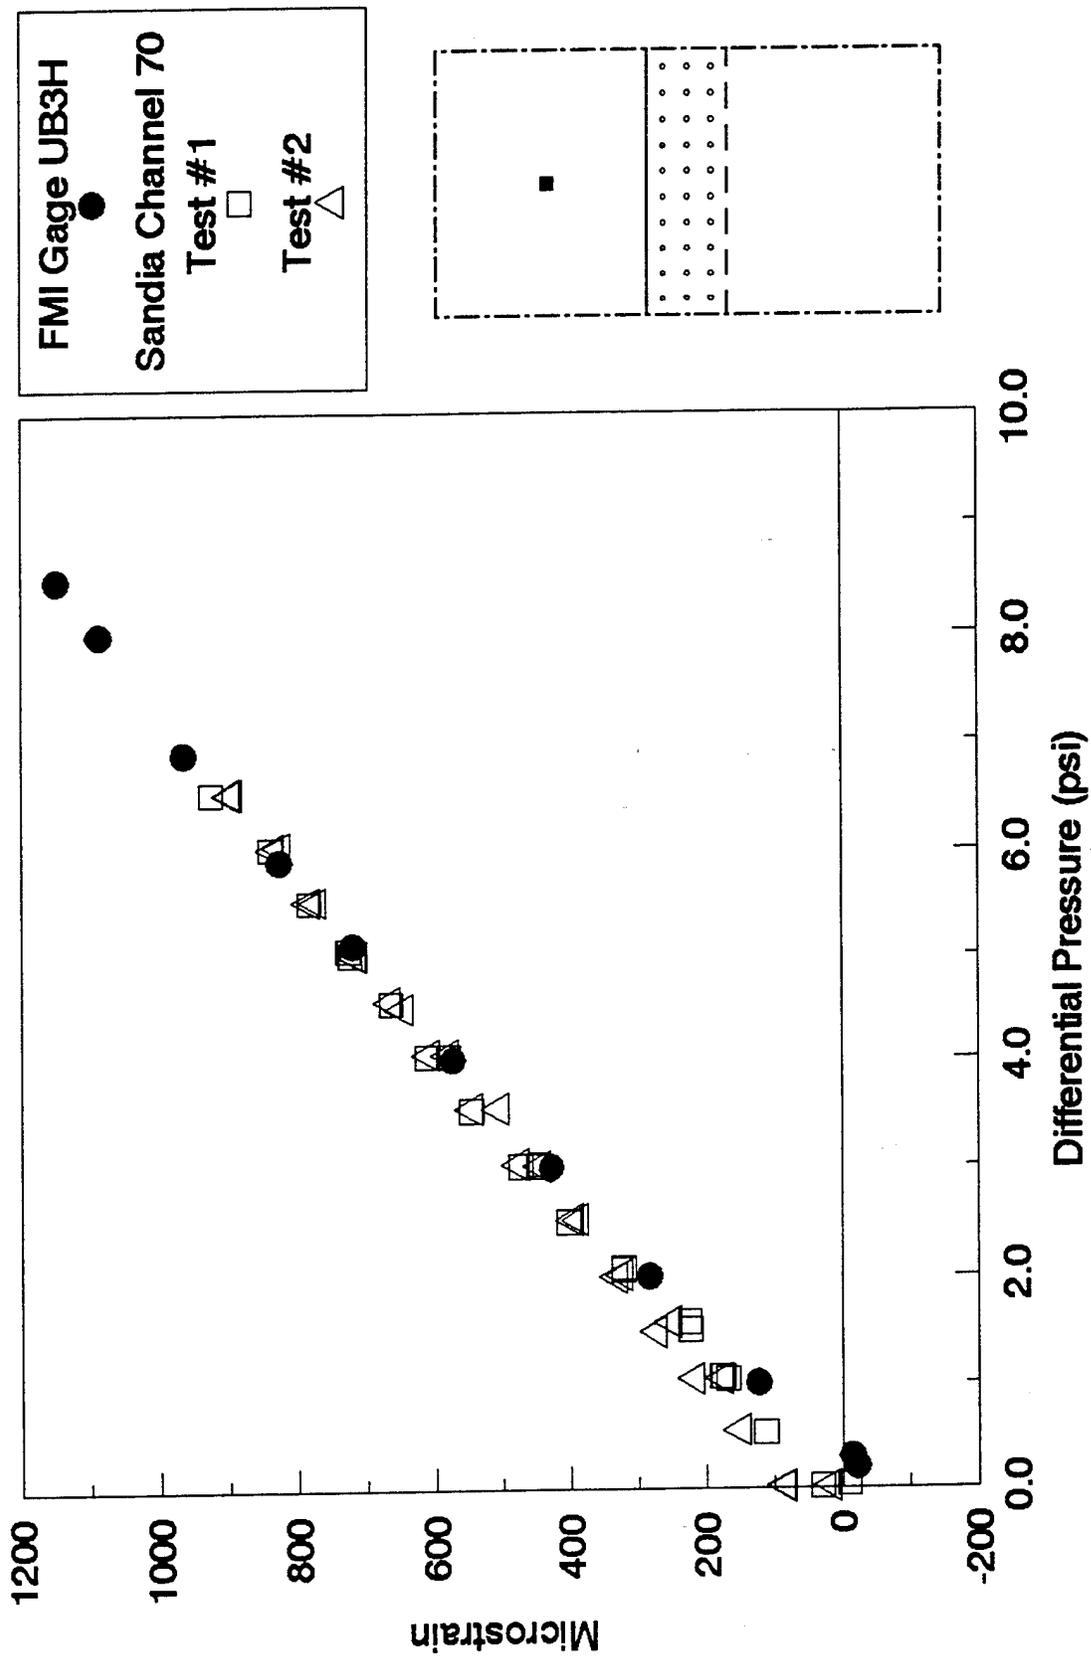
Figure 4.14. Comparison Between AANC Channel 70 and FMI Gage UB3H.

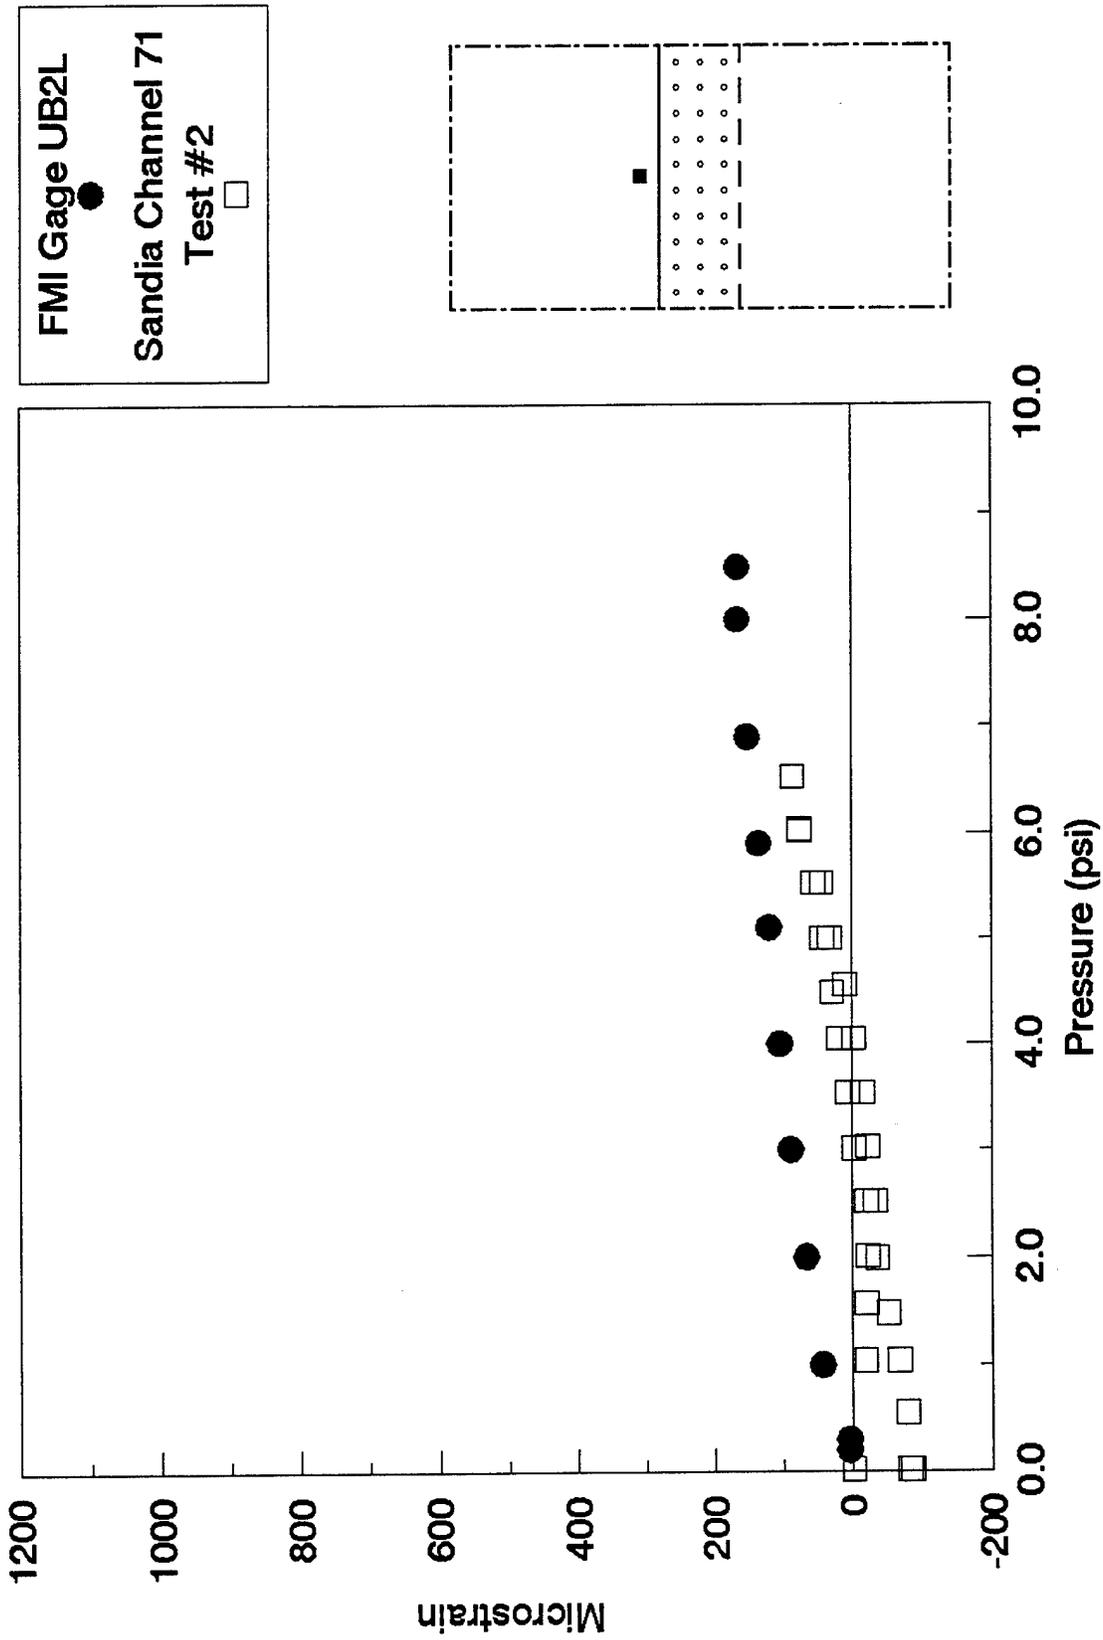
Figure 4.15. Comparison Between AANC Channel 71 and FMI Gage UB2L.
