DOT/FAA/CT-95/25  
DOT-VNTSC-FAA-95-10

# Strain Fields in Boeing 737 Fuselage Lap Splices: Field and Laboratory Measurements with Analytical Correlations

Final Report  
June 1995

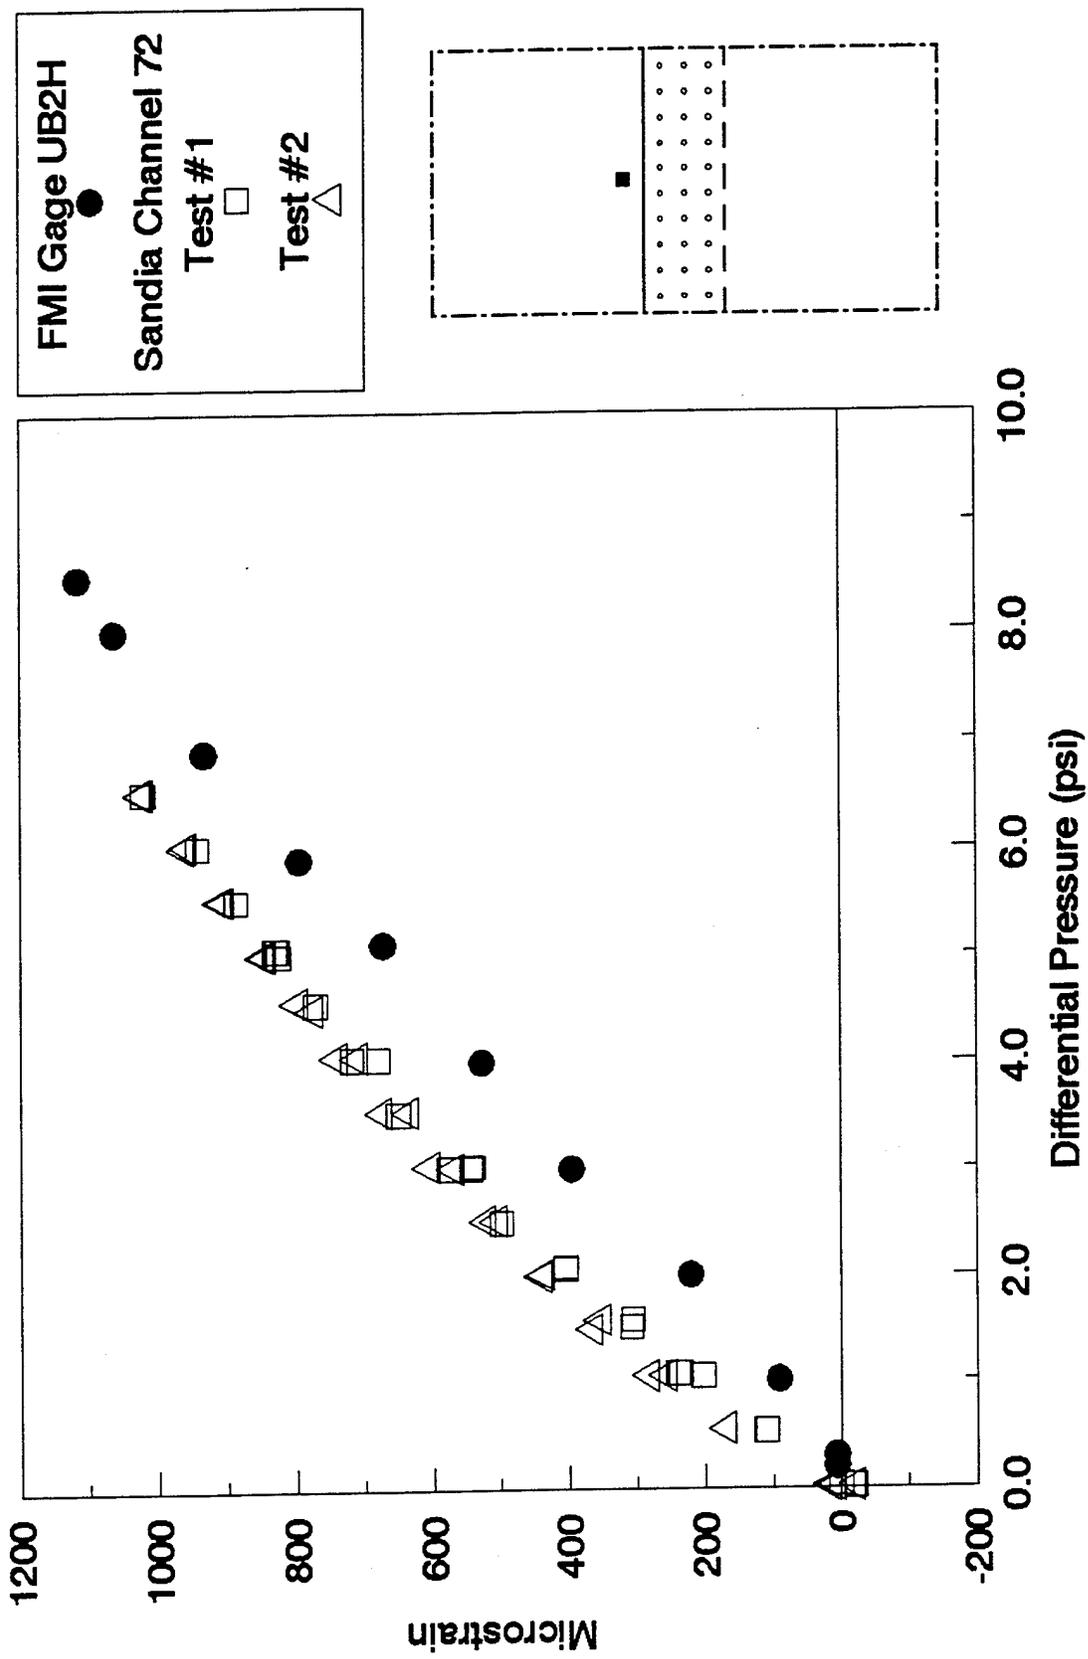
Figure 4.16. Comparison Between AANC Channel 72 and FMI Gage UB2H.

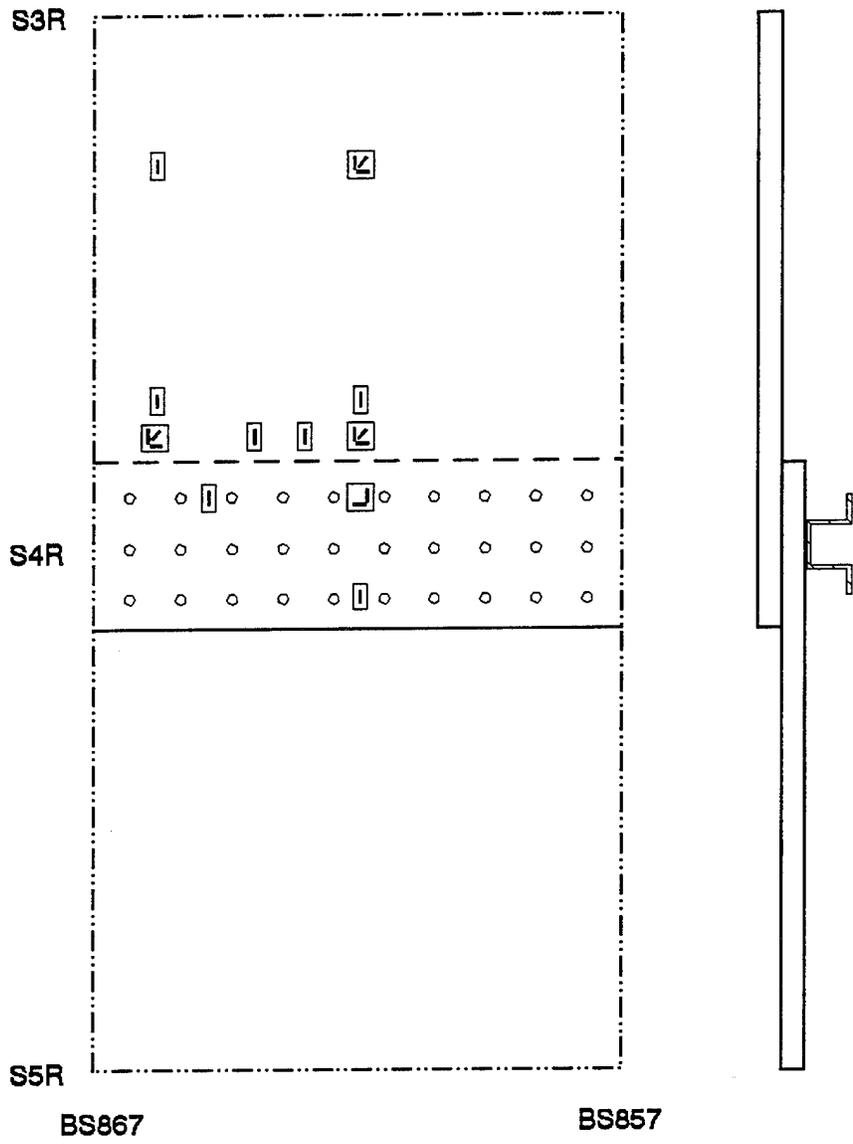
*Figure 4.17. Strain Gage Deployment for NASA Boeing 737 Test.*

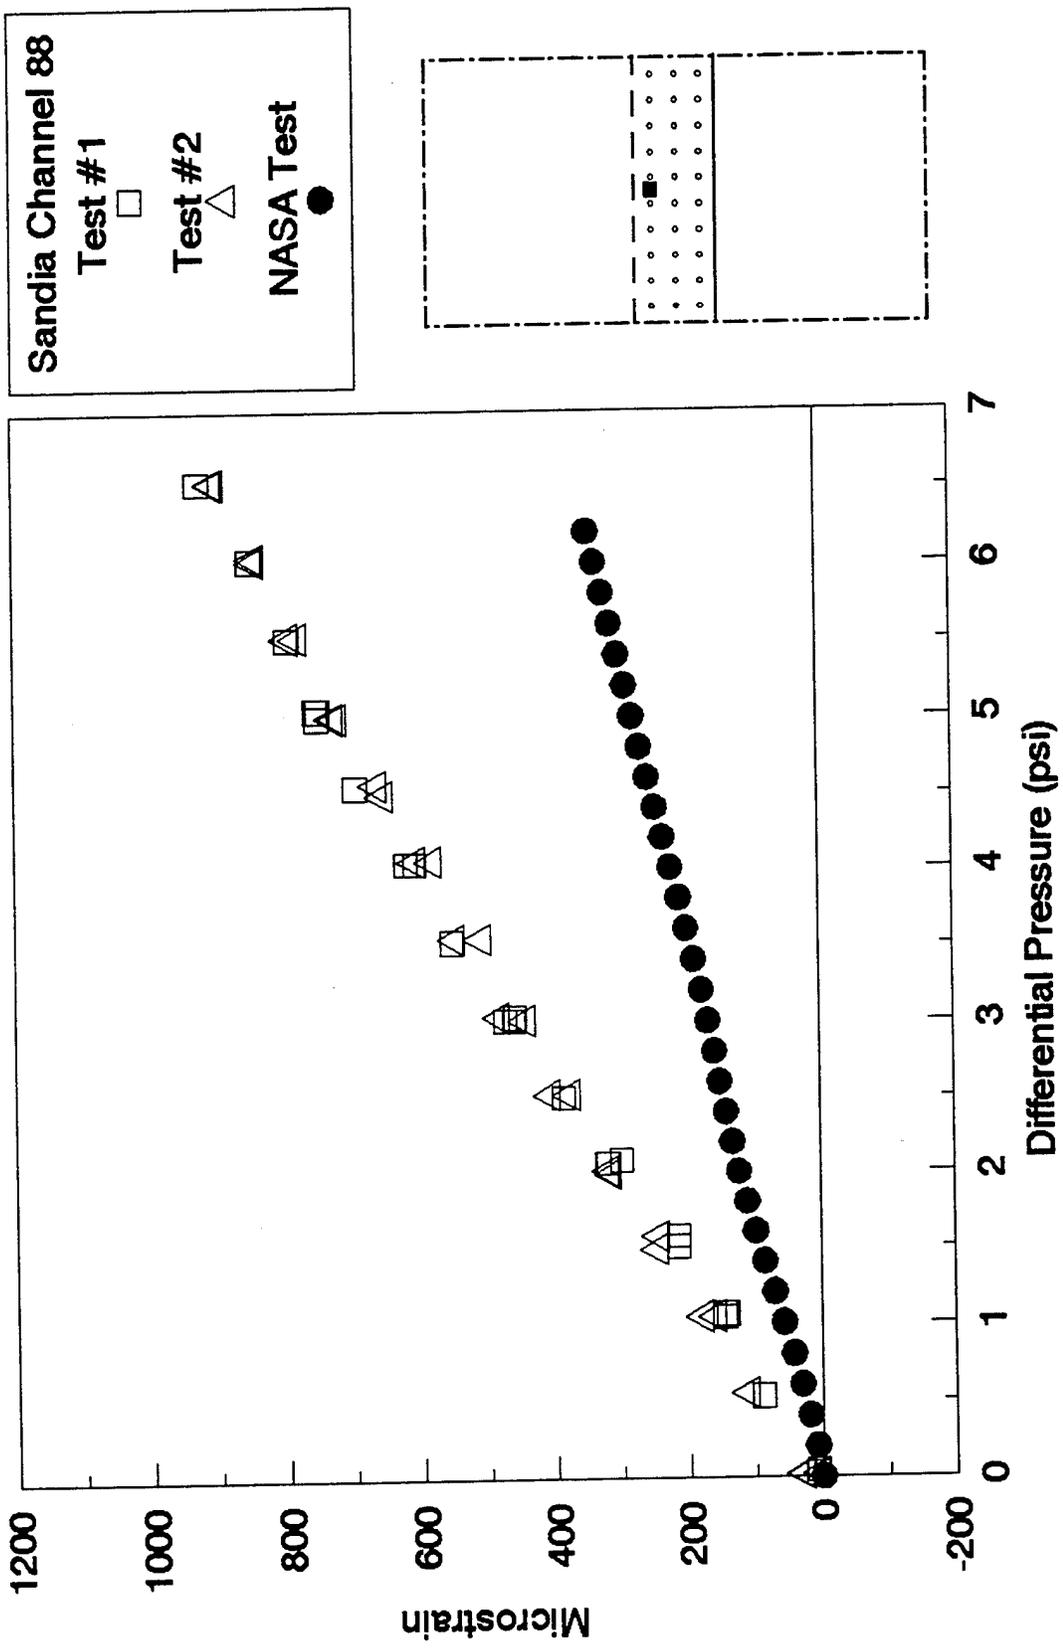
Figure 4.18. Comparison of Hoop Strains in Upper Rivet Row.

Figure 4.18 compares the hoop strain measured in the upper rivet row from both tests. The hoop strain measured in the AANC test is approximately 2.5 times higher than the strain measured in the NASA test at 6.0 psi. Figure 4.19 shows a comparison of the longitudinal strains at the same location. The longitudinal strain measured in the AANC test is about 40% higher than the strain obtained in the NASA test at a differential pressure of 6.0 psi. Figures 4.20 and 4.21 compare the hoop and longitudinal strains at the midbay-midline position from both tests. The strains from both tests at this location are within 20% of each other at a differential pressure of 6.0 psi.

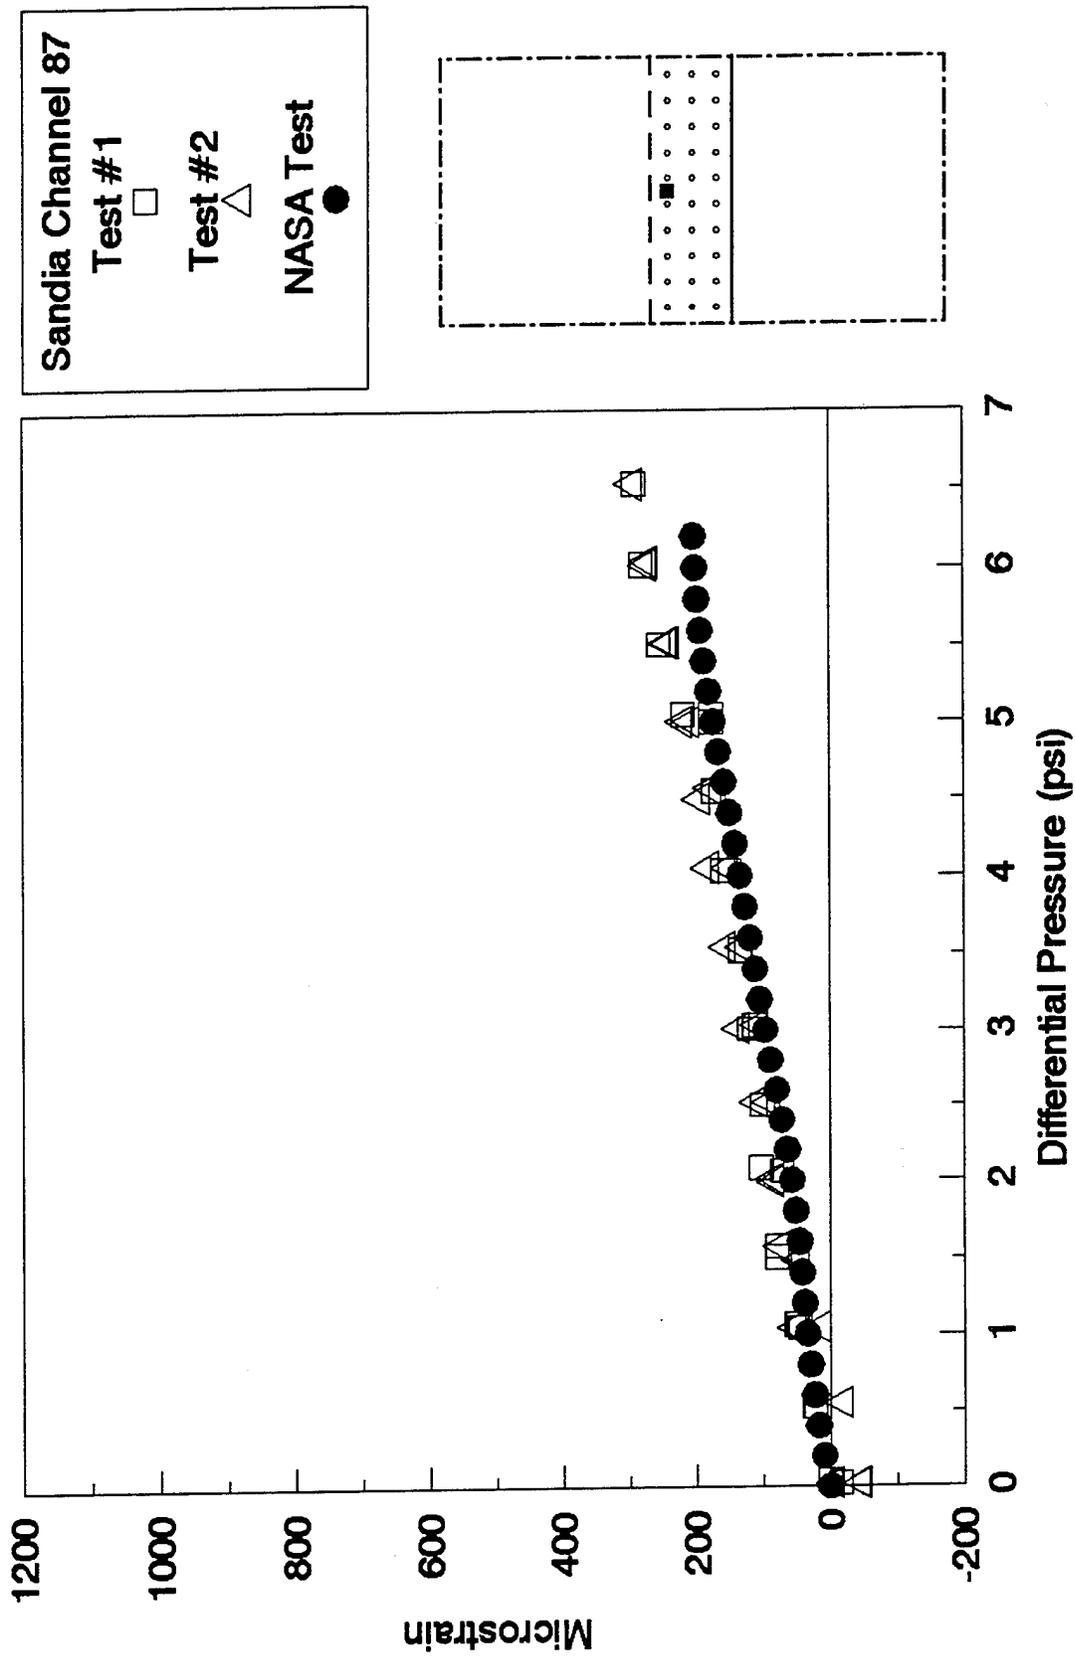
Figure 4.19. Comparison of Longitudinal Strains in Upper Rivet Row.

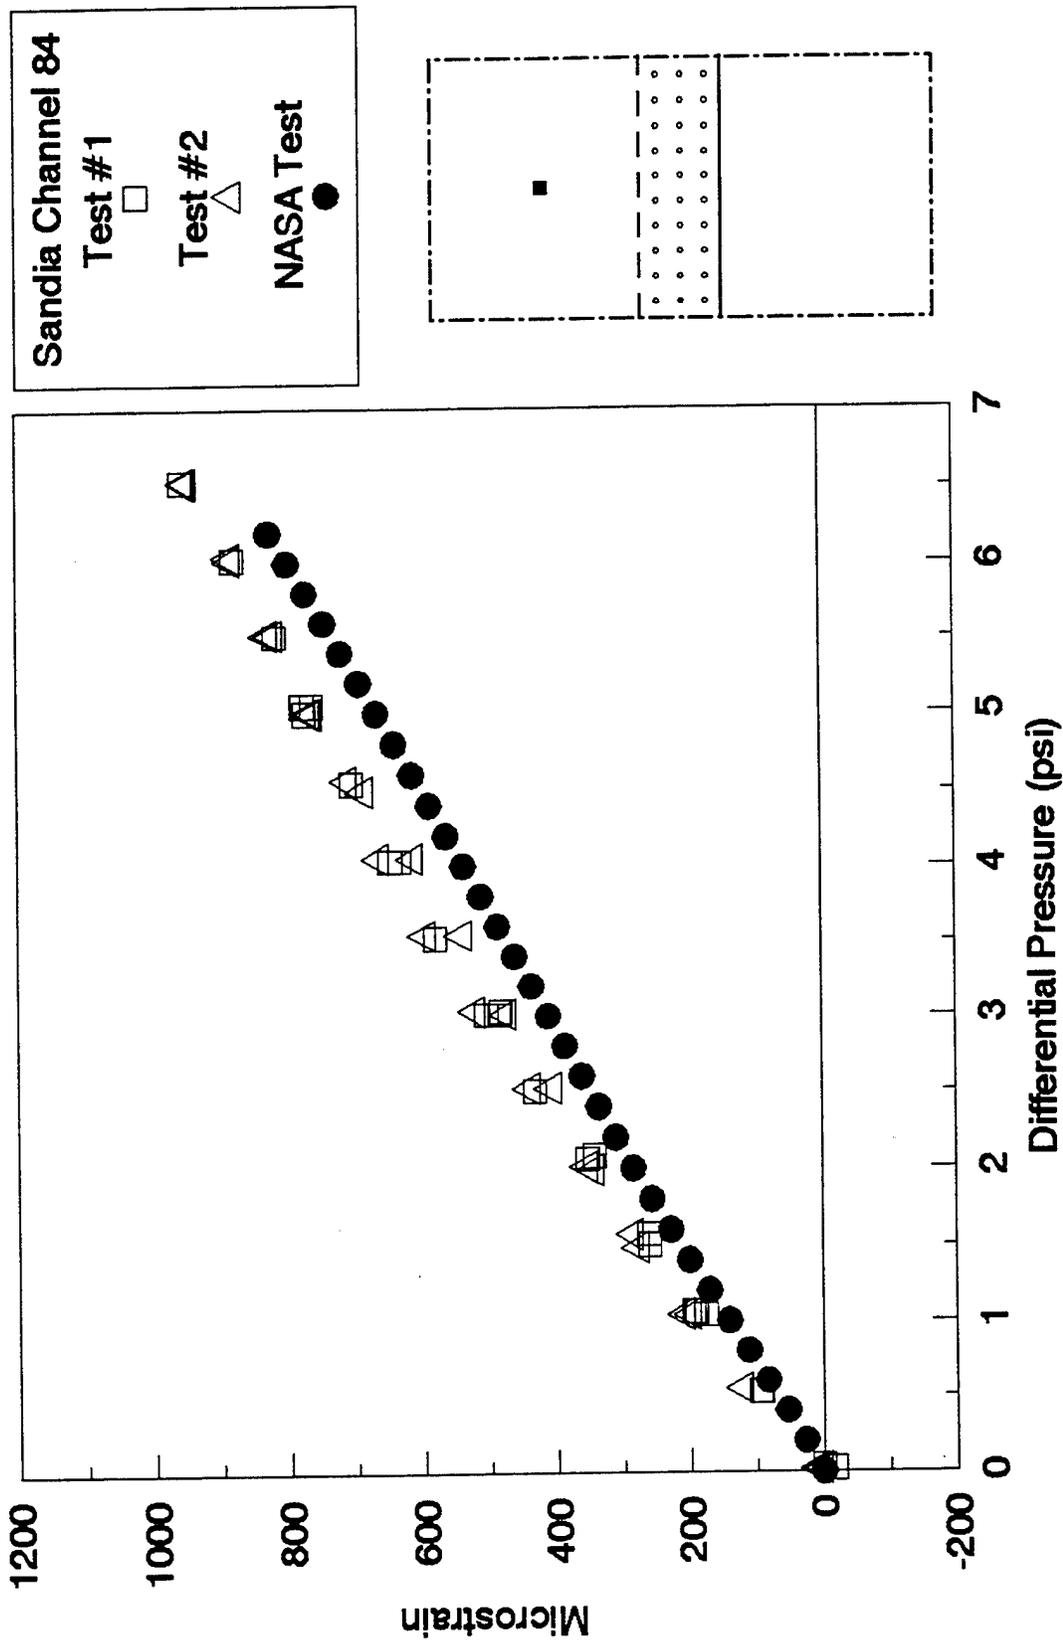
Figure 4.20. Comparison of Hoop Strains at Midbay/Midline Location.

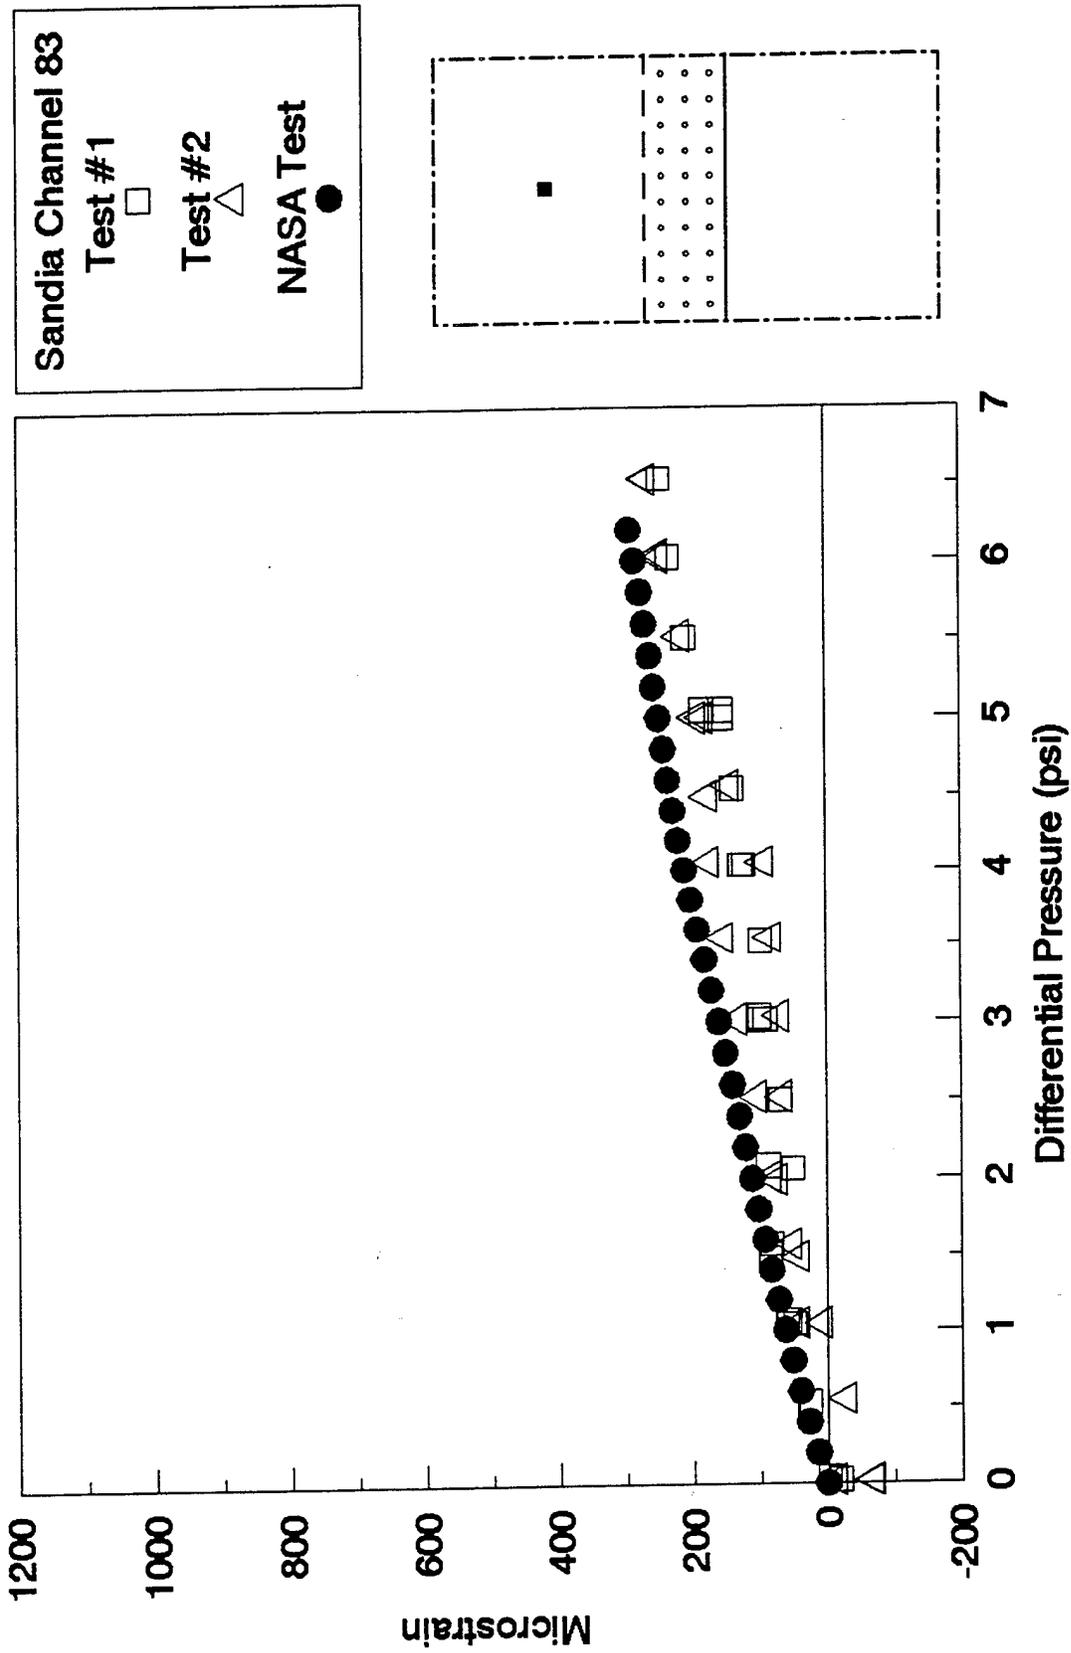
Figure 4.21. Comparison of Longitudinal Strains at Midbay/Midline Location.

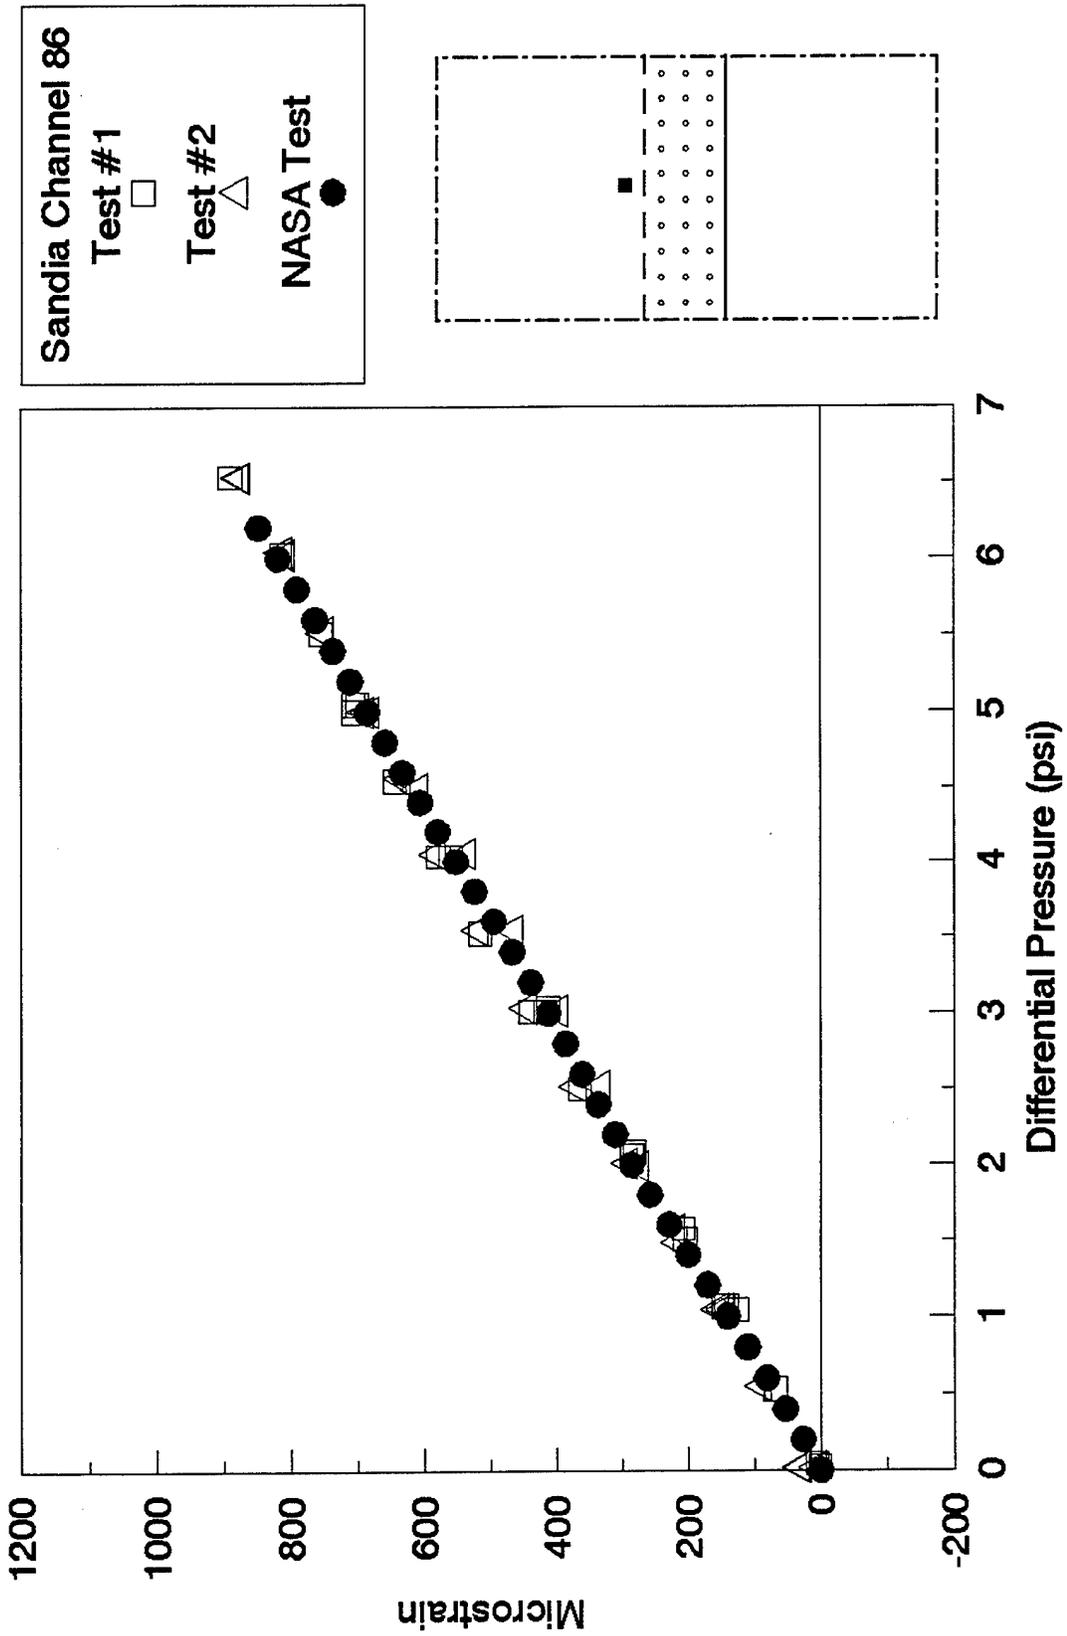
Figure 4.22. Comparison of Hoop Strains Near Top Edge of Lap Joint at Midbay.

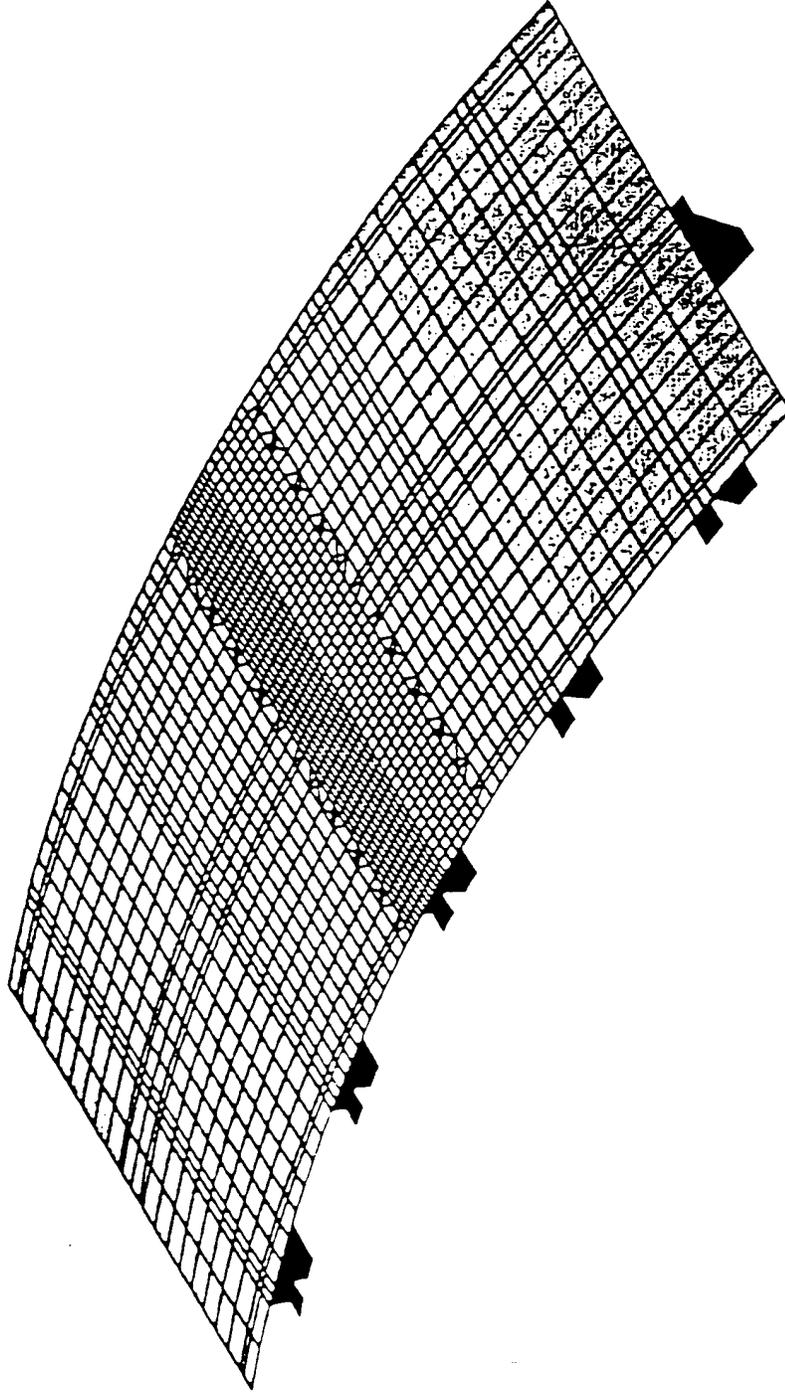
Figure 4.23. Finite Element Mesh Pattern for Pressurized Aircraft Section.

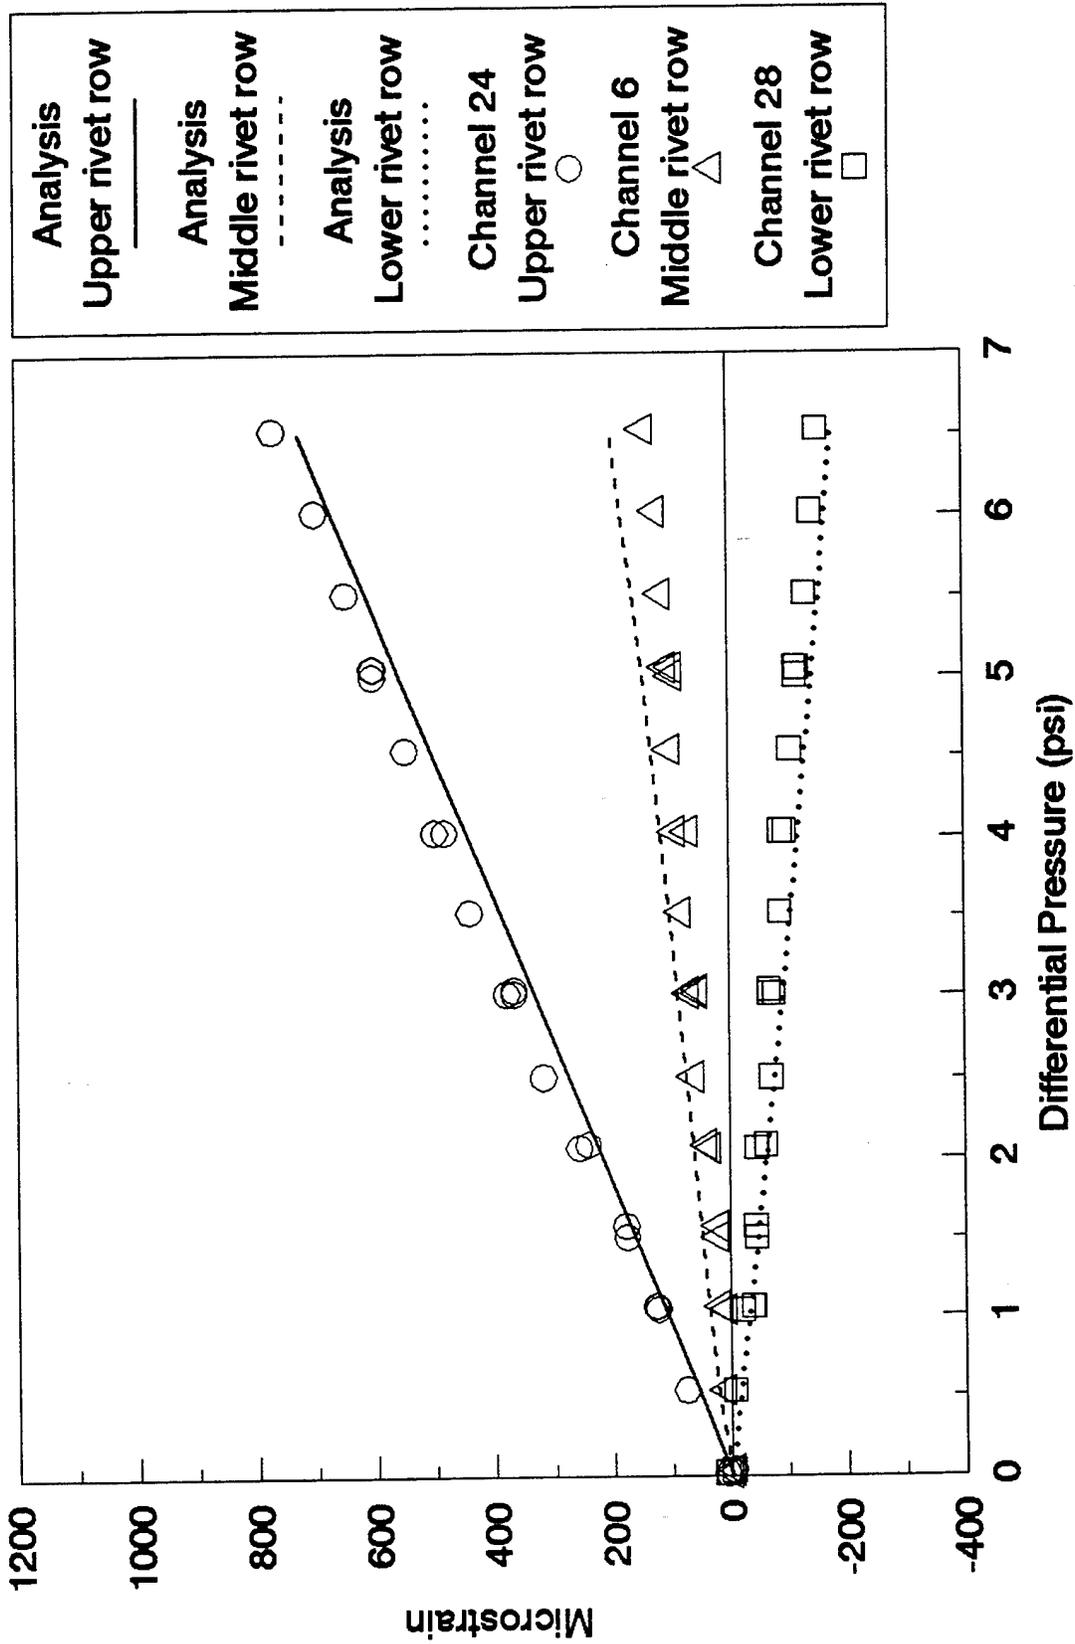
Figure 4.24. Comparison of Strains Across Lap Splice at S-4L, BS475  
(Riveted Lap Splice Model).

Figure 4.24 compares measured hoop strains at various locations across the lap splice at Body Station 475, stringer S-4L, with results from the riveted lap splice model. The solid, dotted, and dashed lines in the figure represent results from the finite element models; the symbols indicate the measured strain gage data. Similarly, Figure 4.25 shows the same comparison for the adhesive lap splice model. Clearly, the strain data are characterized more accurately by the riveted lap splice model, especially in the upper rivet row, suggesting that the cold-bond adhesive has substantially degraded at that location in the AANC airplane. This result was confirmed when nondestructive inspection detected extensive corrosion and debonds in the lap joints.

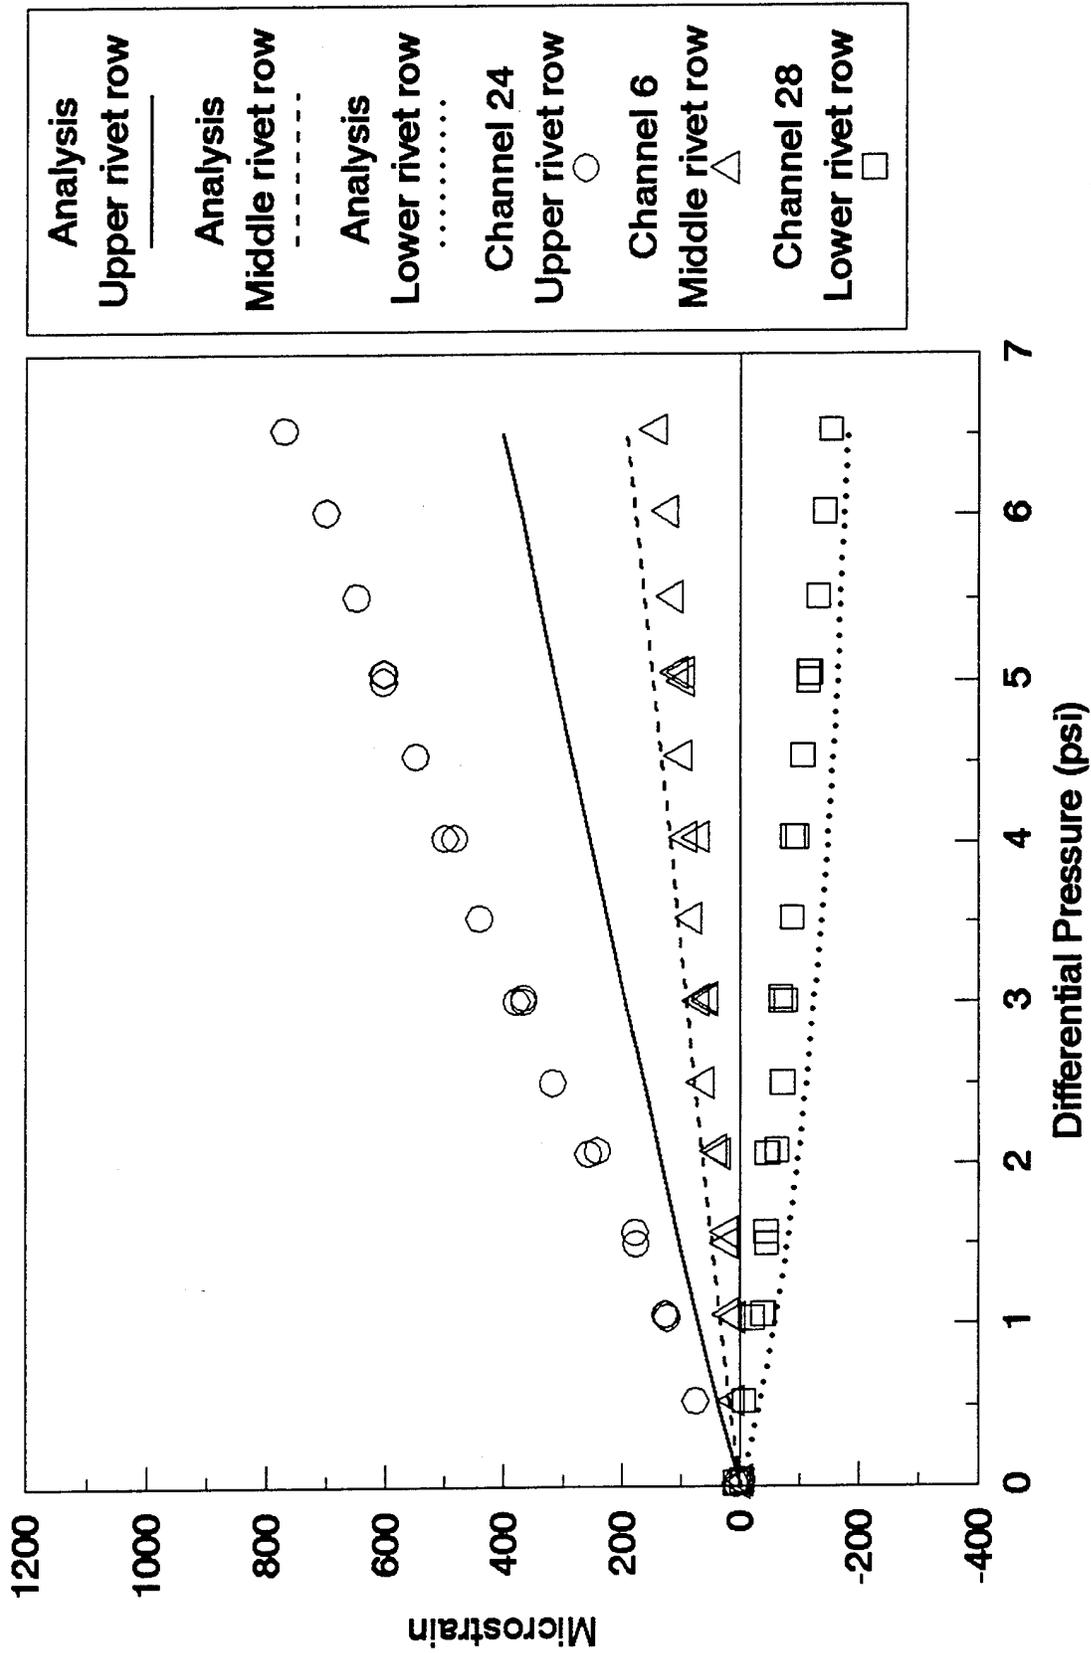
Figure 4.25. Comparison of Strains Across Lap Splice at S-4L, BS475  
(Adhesively Bonded Lap Splice Model).

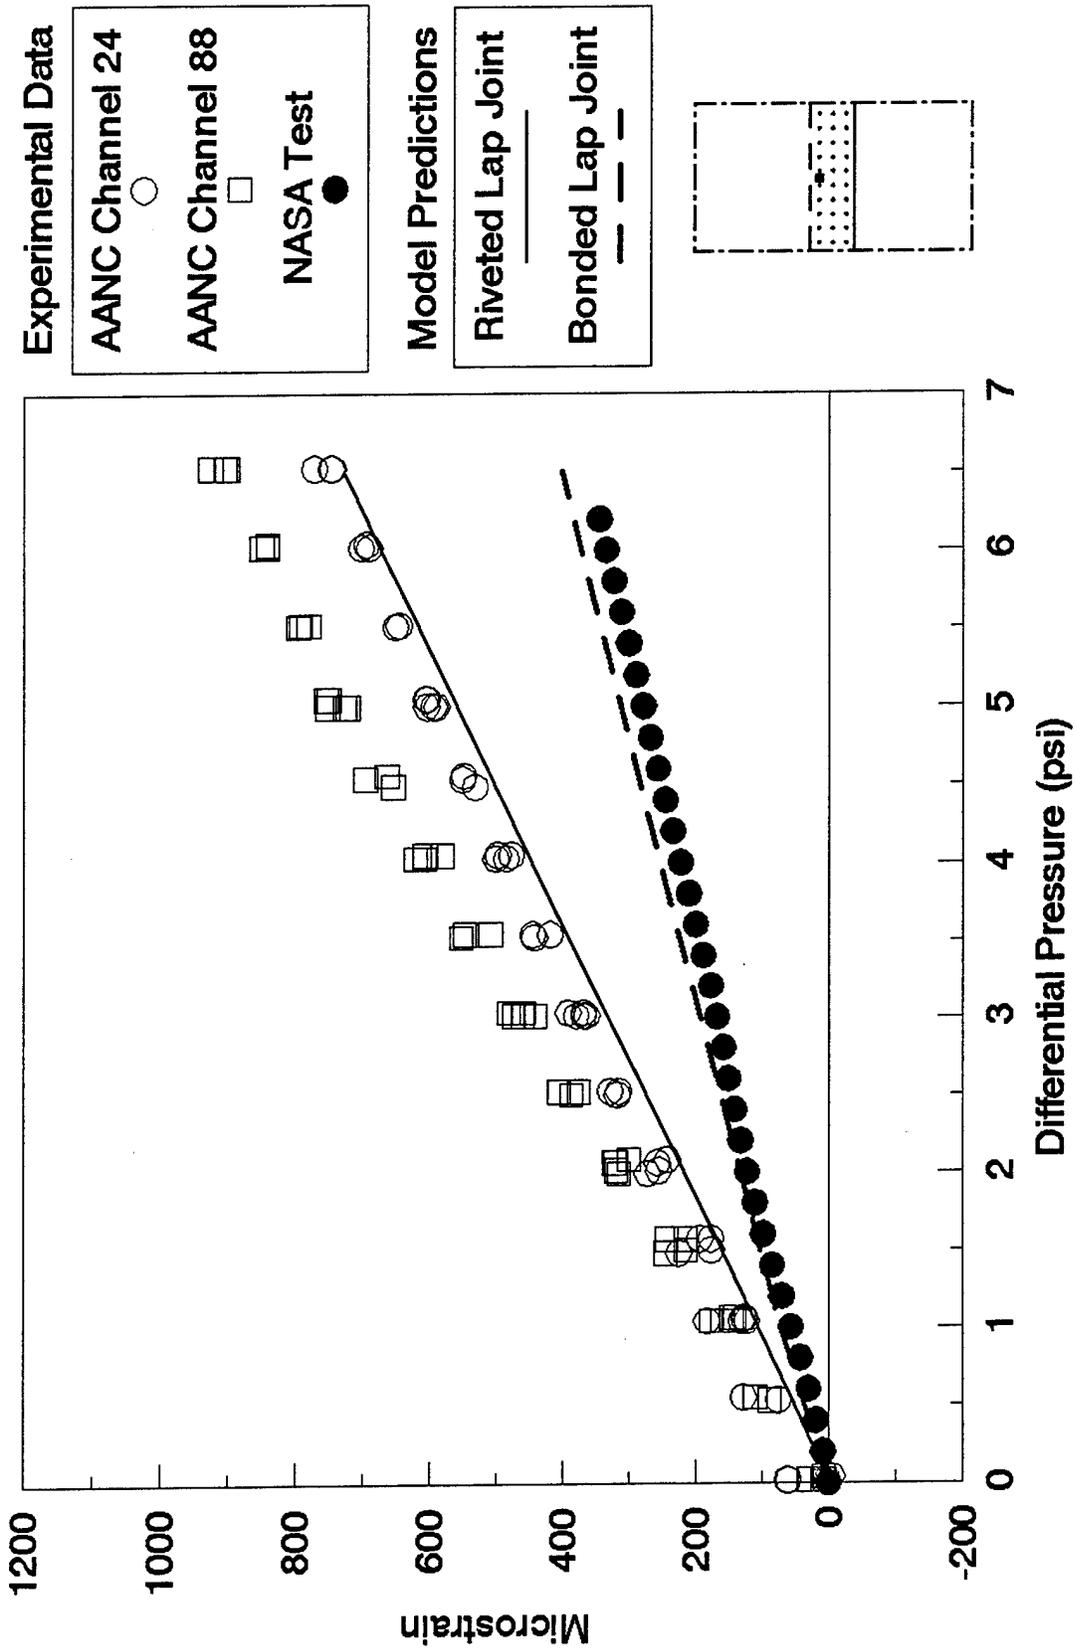
Figure 4.26. Comparison of Strains in Upper Rivet Row of AANC and NASA B737 Lap Splices with Results from Finite Element Models.

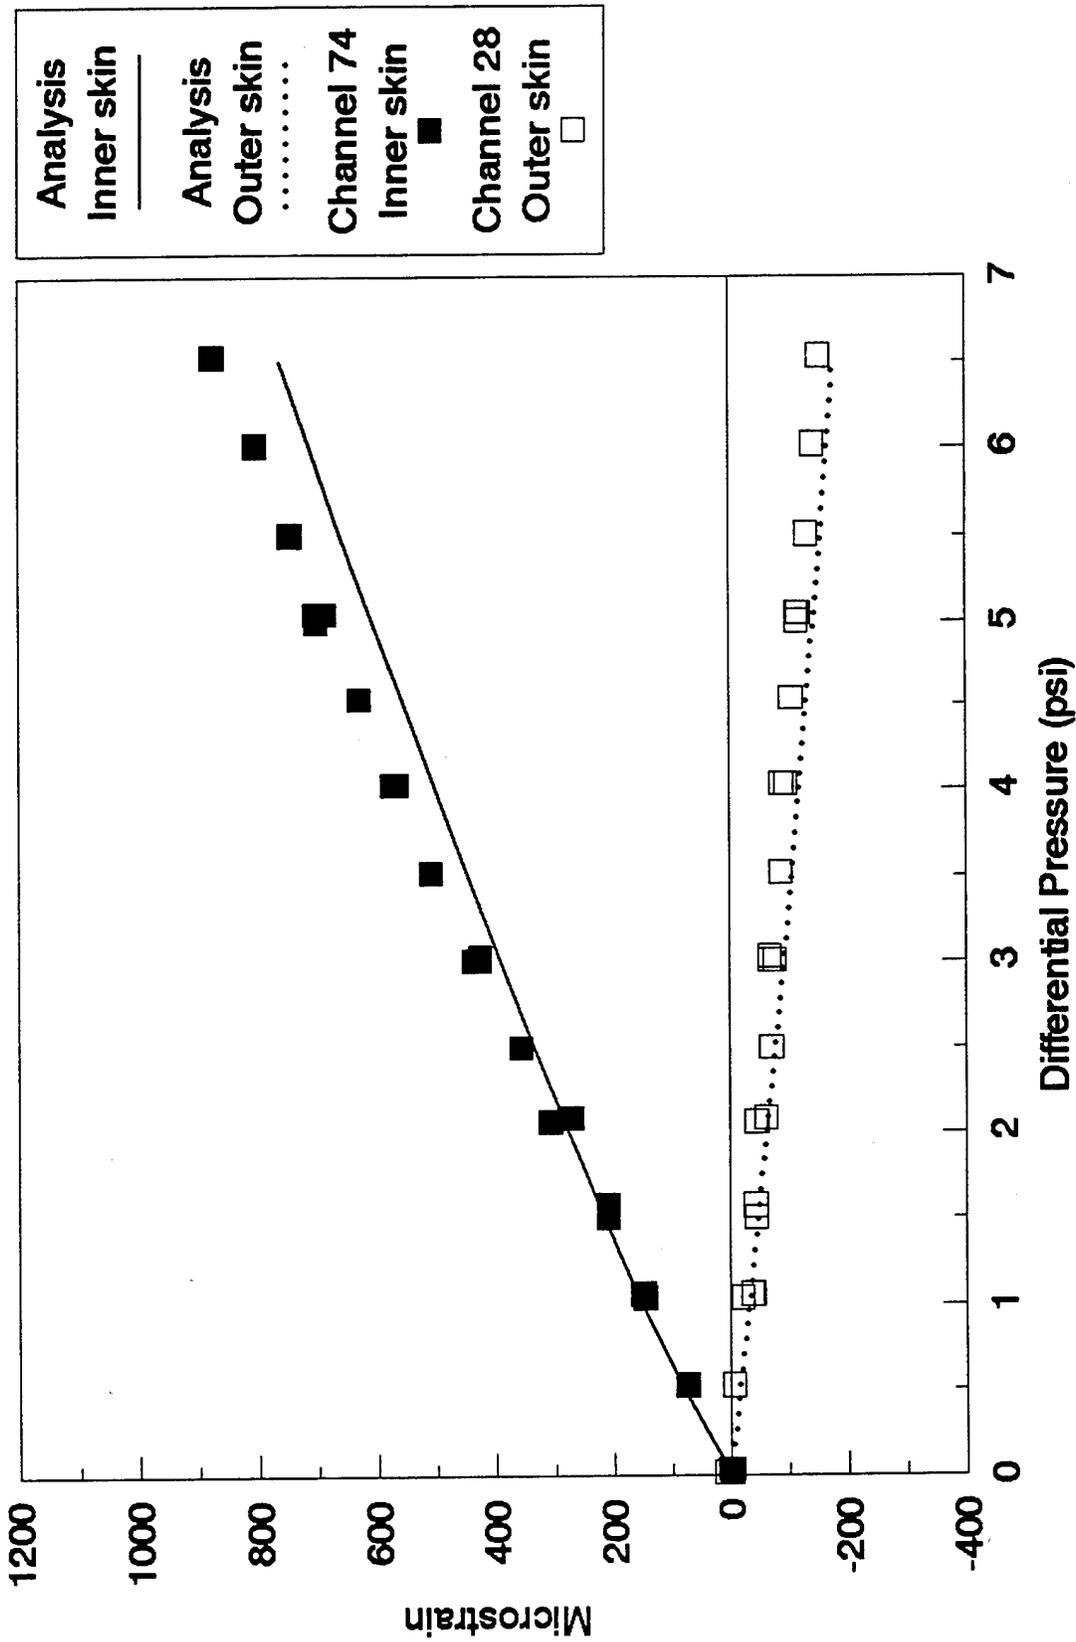
Figure 4.27. Comparison of Strains in Inner and Outer Skin at S-4L, BS475 (Riveted Lap Splice Model).

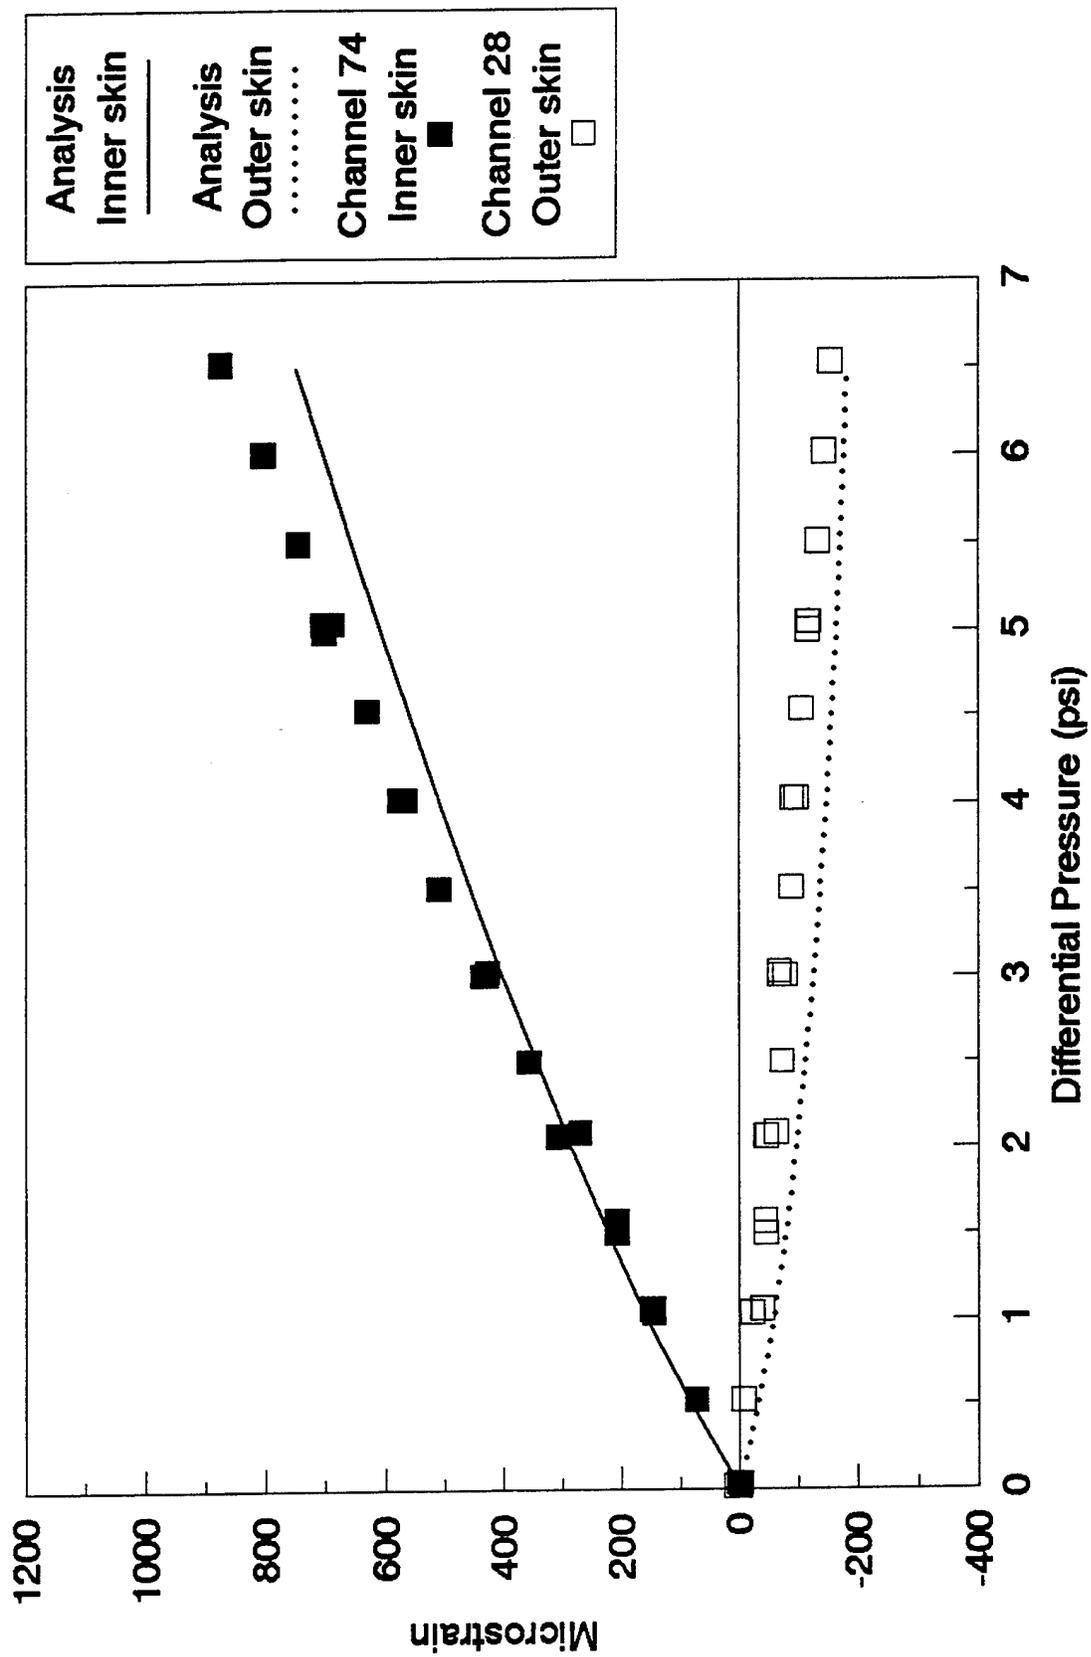
Figure 4.28. Comparison of Strains in Inner and Outer Skin at S-4L, BS475 (Adhesively Bonded Lap Splice Model).
