DOT/FAA/CT-95/25  
DOT-VNTSC-FAA-95-10

# Strain Fields in Boeing 737 Fuselage Lap Splices: Field and Laboratory Measurements with Analytical Correlations

Final Report  
June 1995

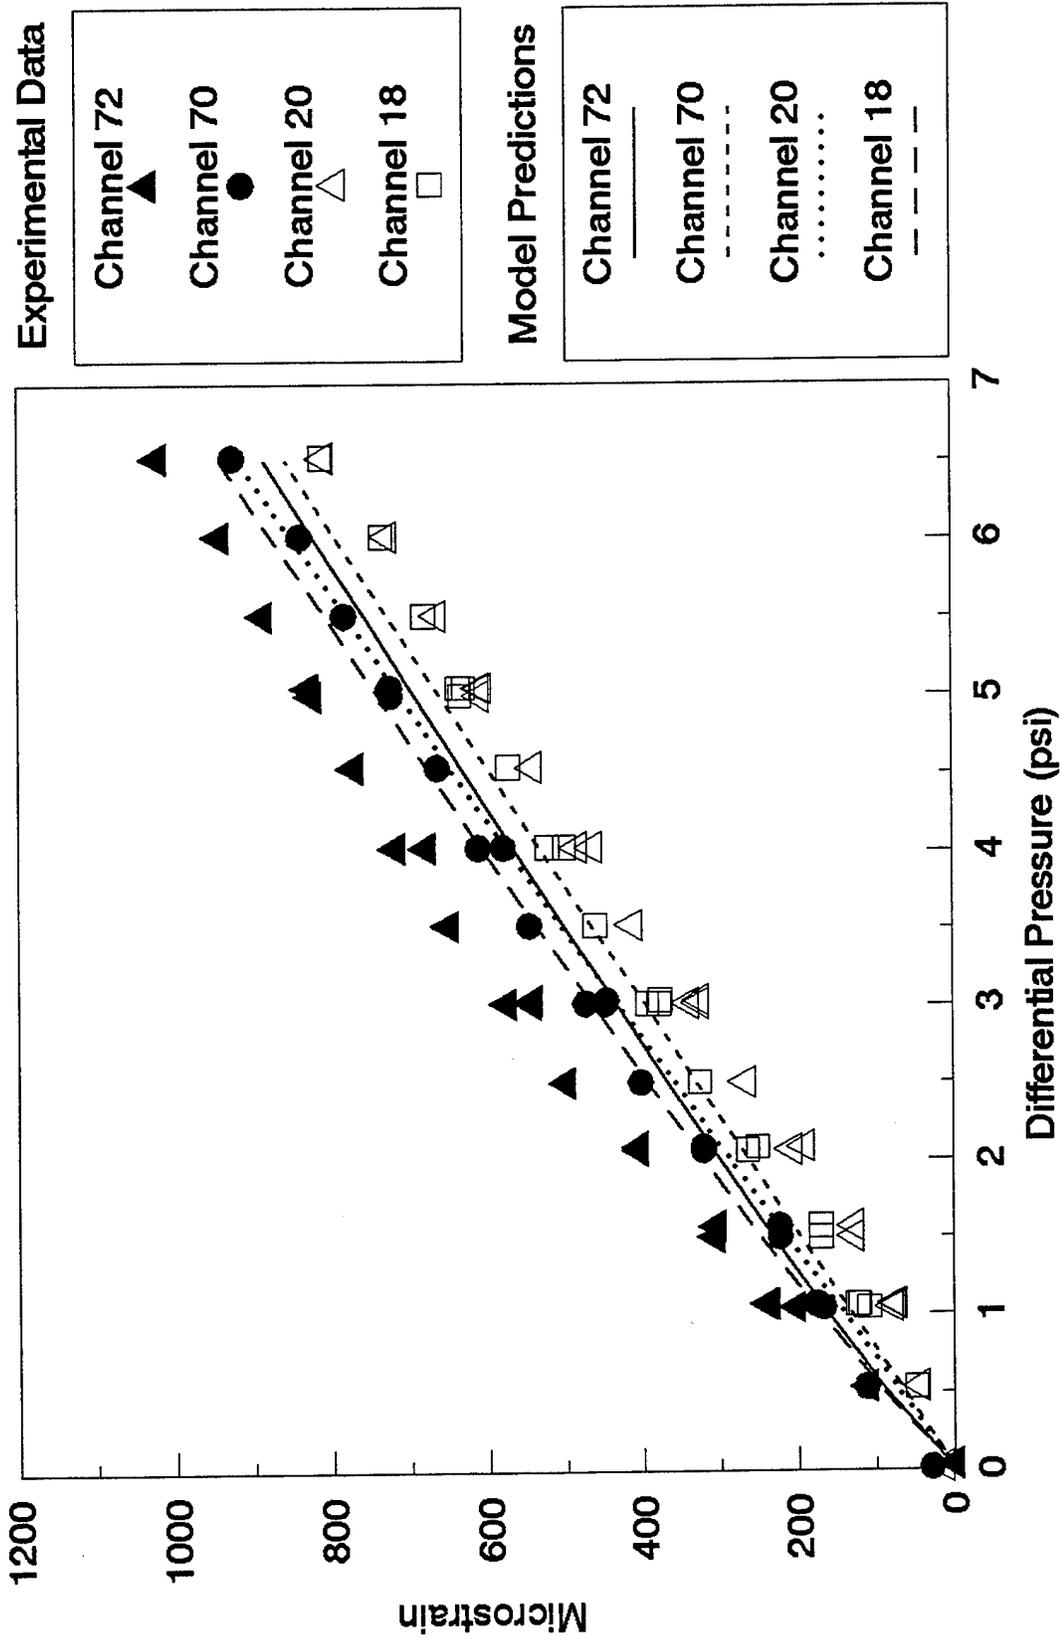
Figure 4.29. Comparison of Internal and External Strains on the Same Skin at S-4L, BS475 (Riveted Lap Splice Model).

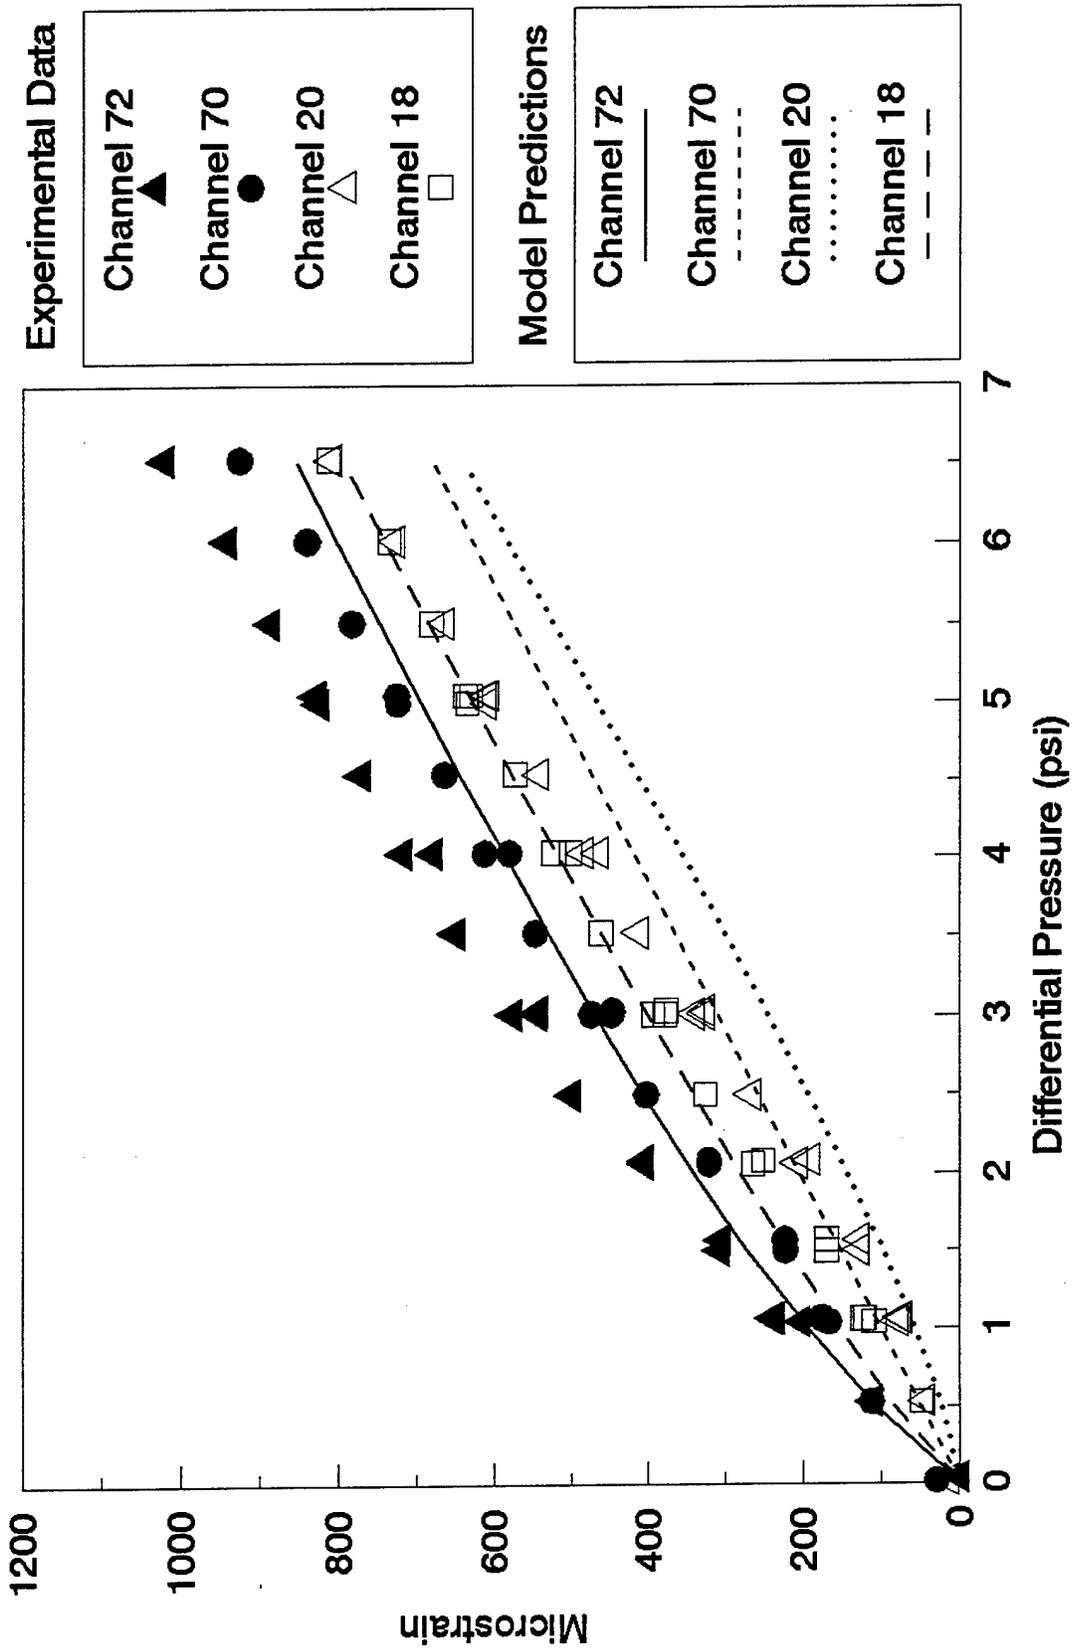
Figure 4.30. Comparison of Internal and External Strains on the Same Skin at S-4L, BS475 (Adhesively Bonded Lap Splice Model).

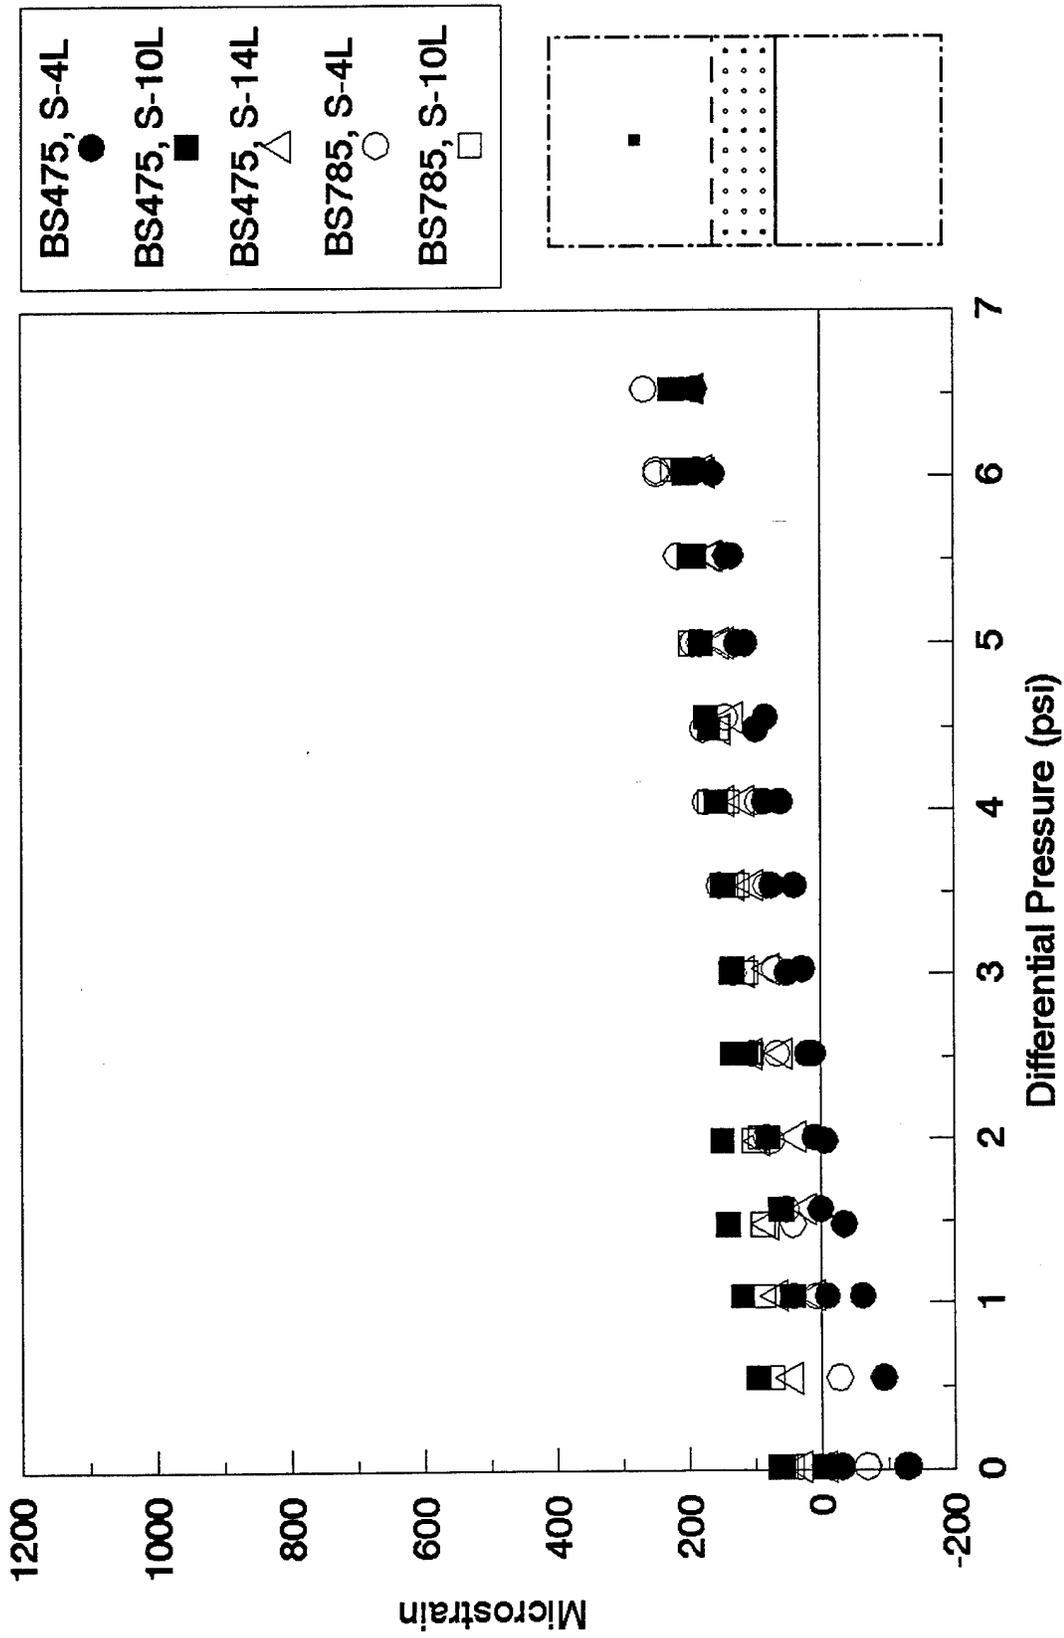
Figure 4.32. Comparison of Longitudinal Strains at Midbay Locations in AANC Airplane.

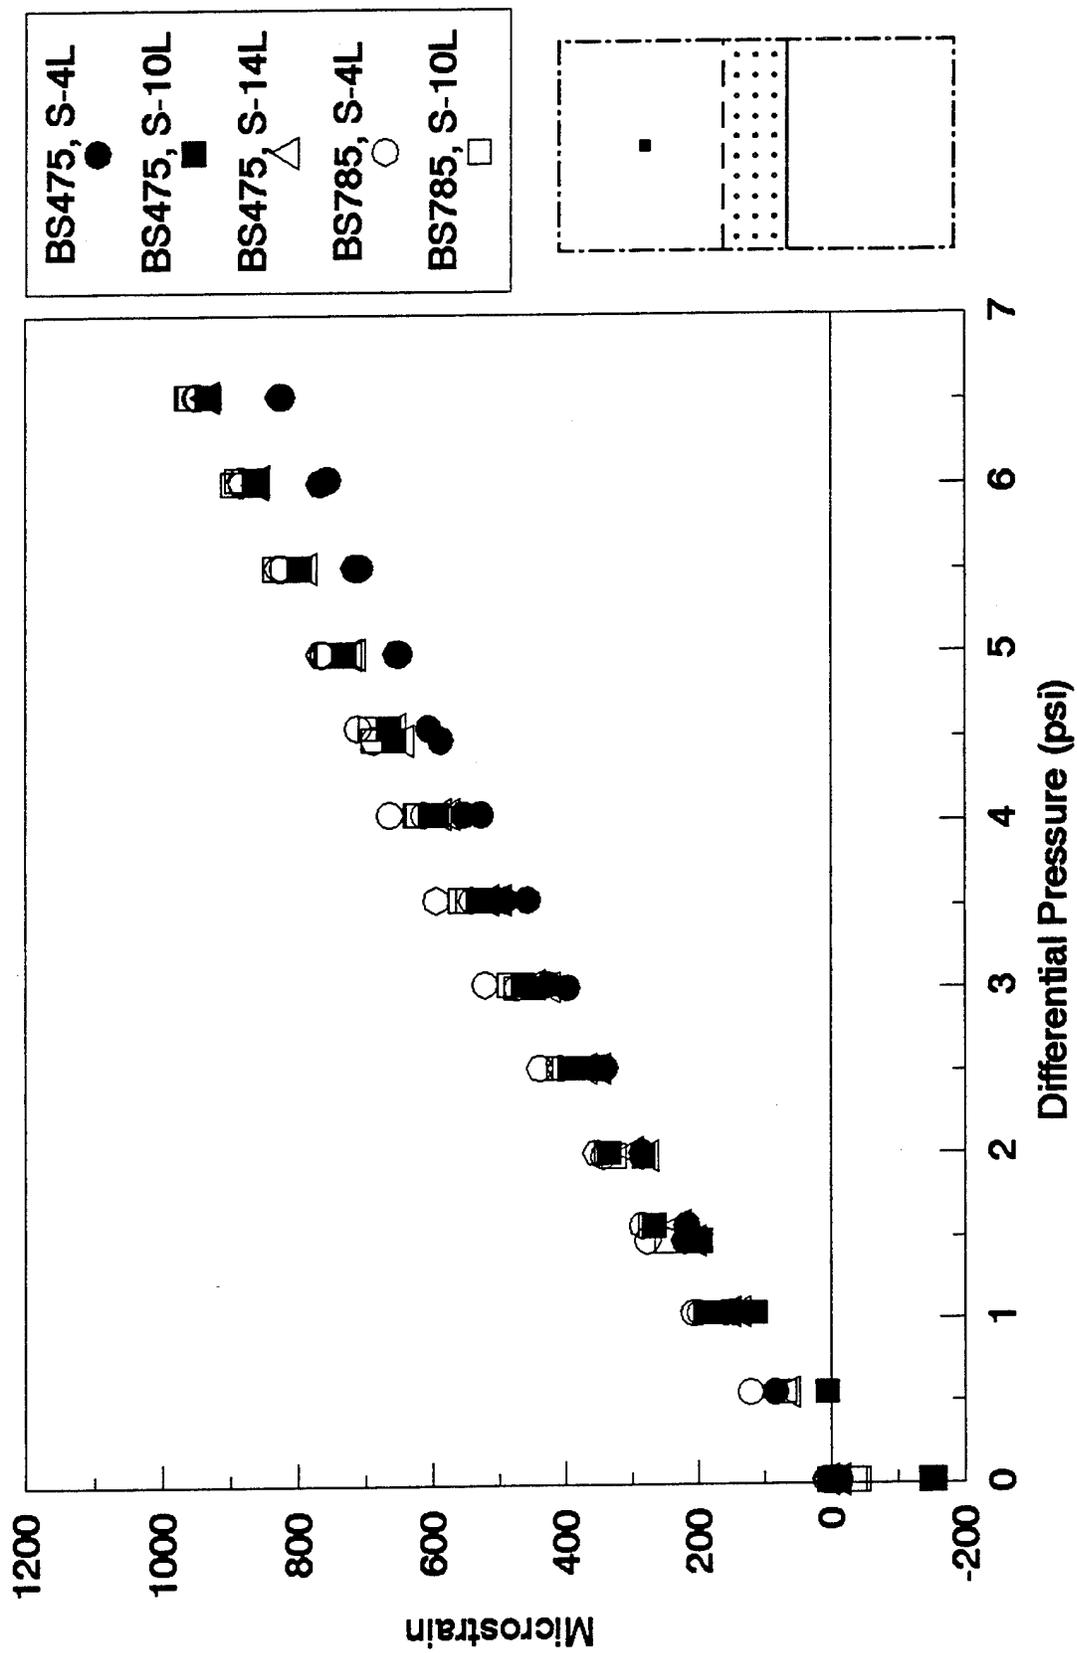
Figure 4.33. Comparison of Hoop Strains at Midbay Locations in AANC Airplane.

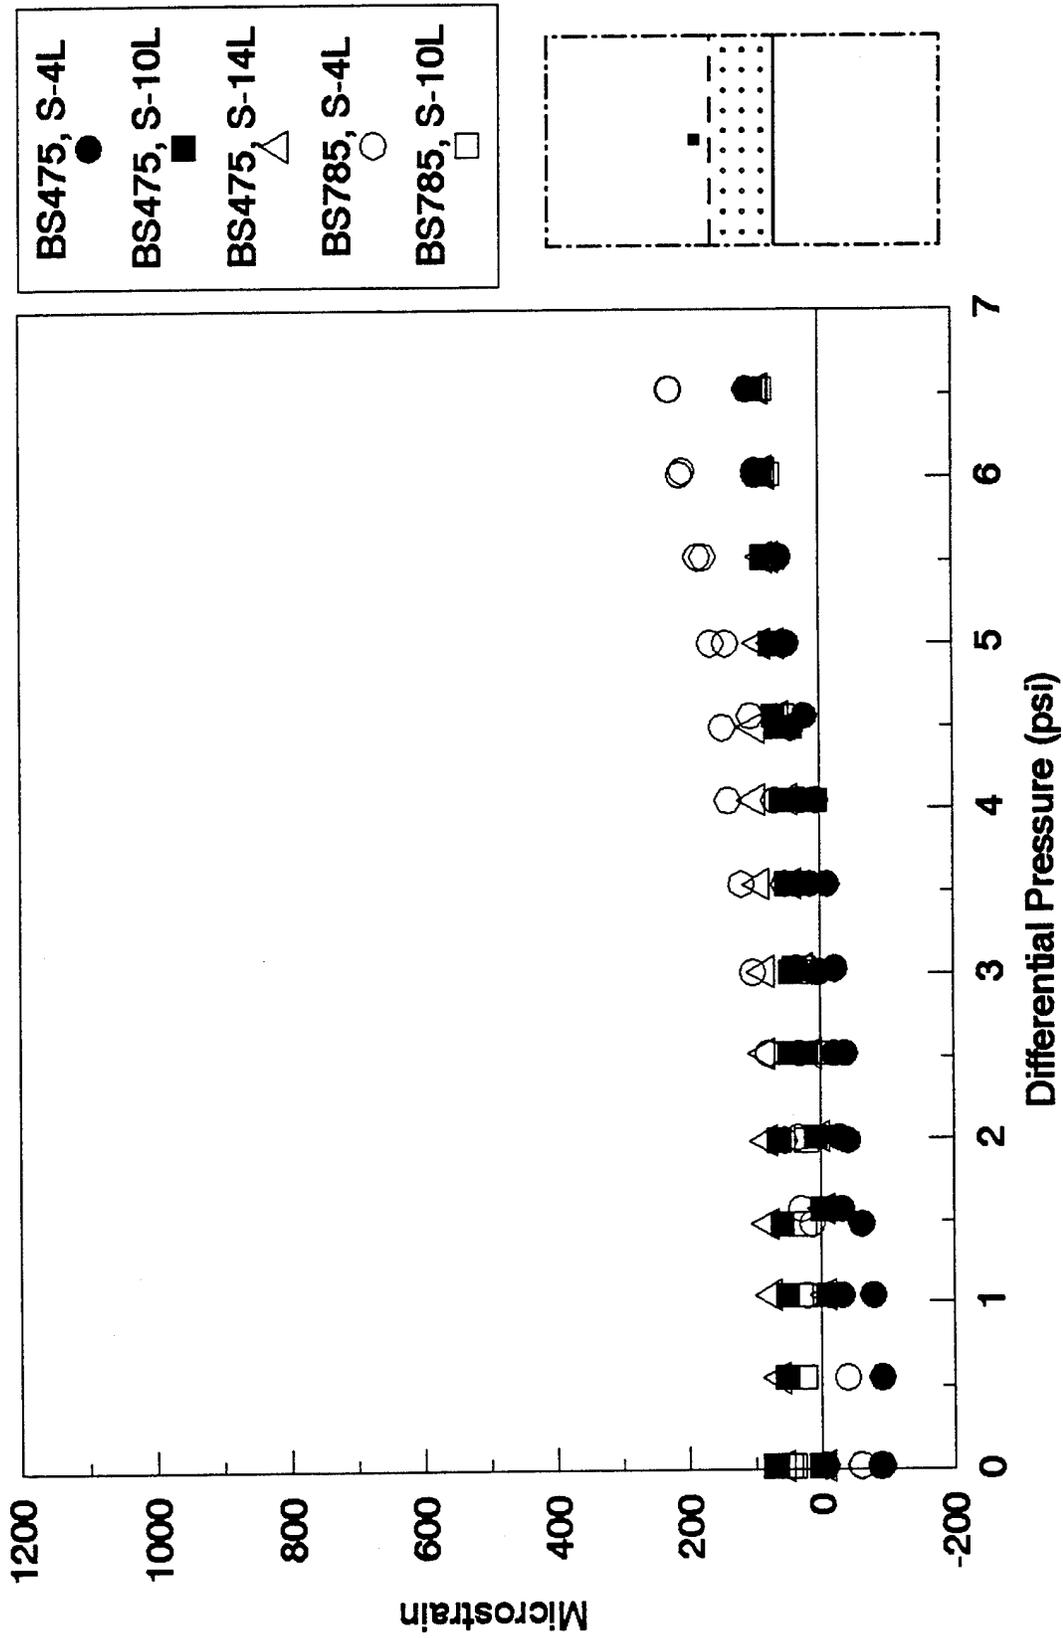
Figure 4.34. Comparison of Longitudinal Strains Near Top Edge of Lap Joint in AANC Airplane.

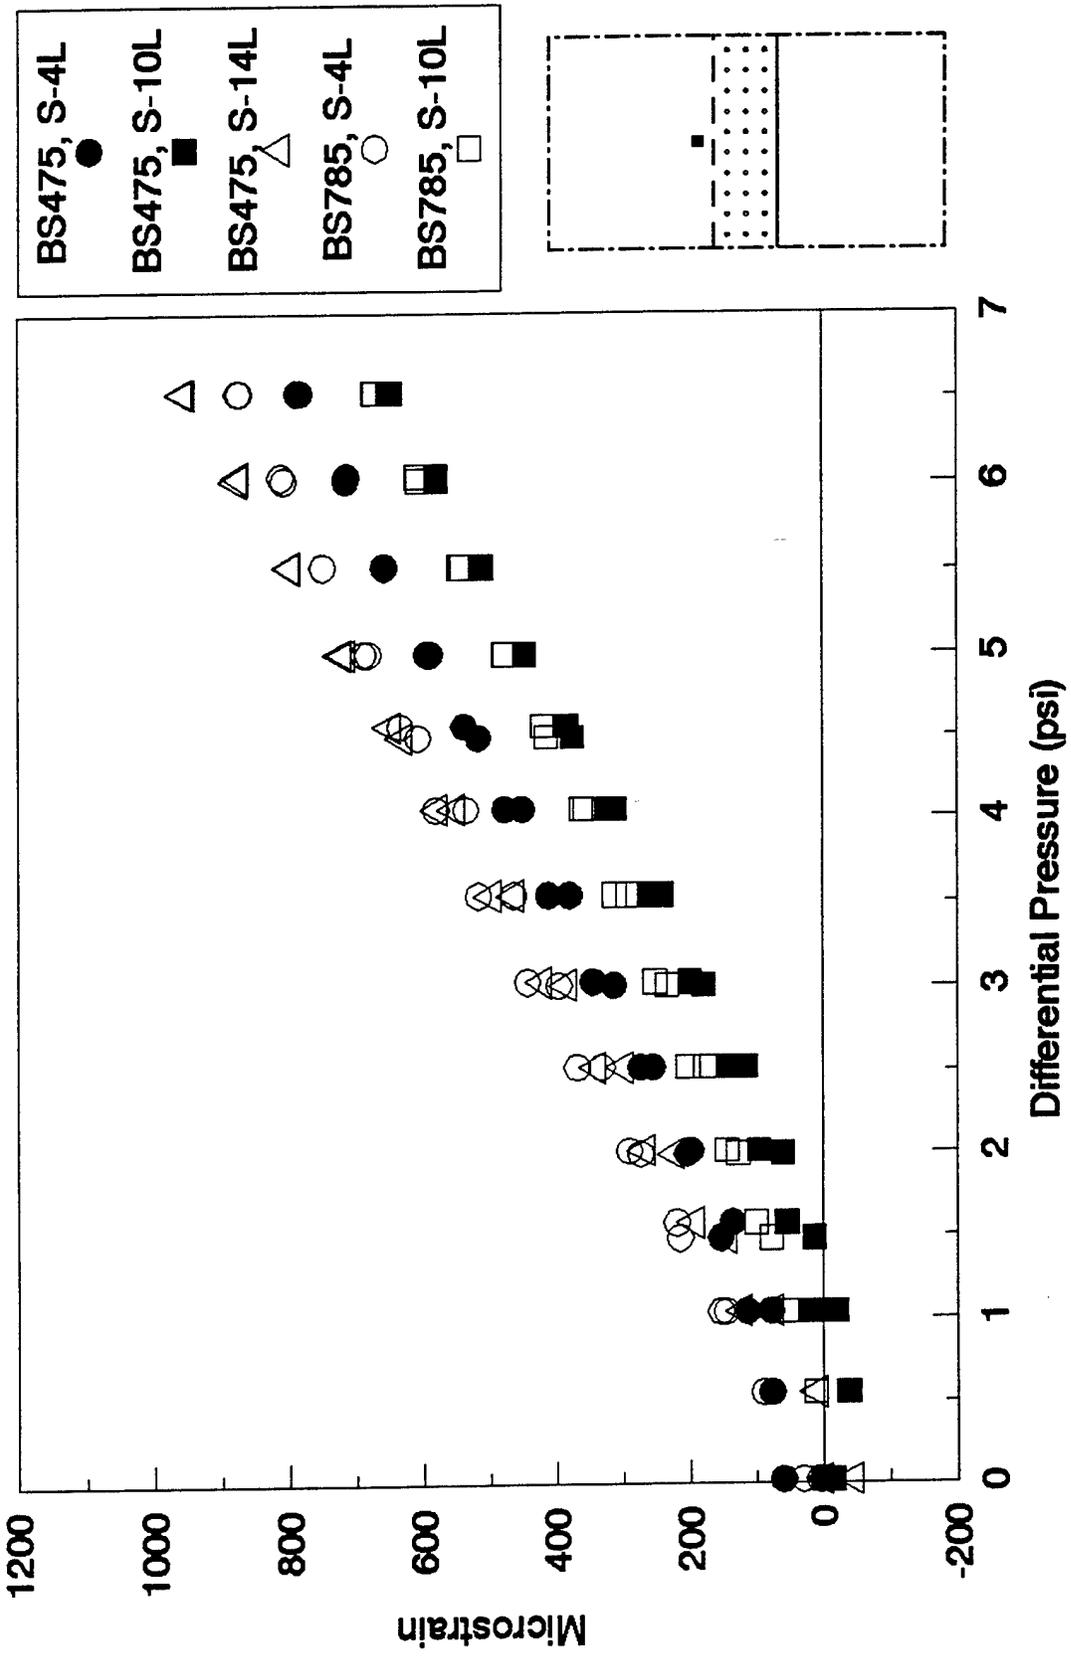
Figure 4.35. Comparison of Hoop Strains Near Top Edge of Lap Joint in AANC Airplane.

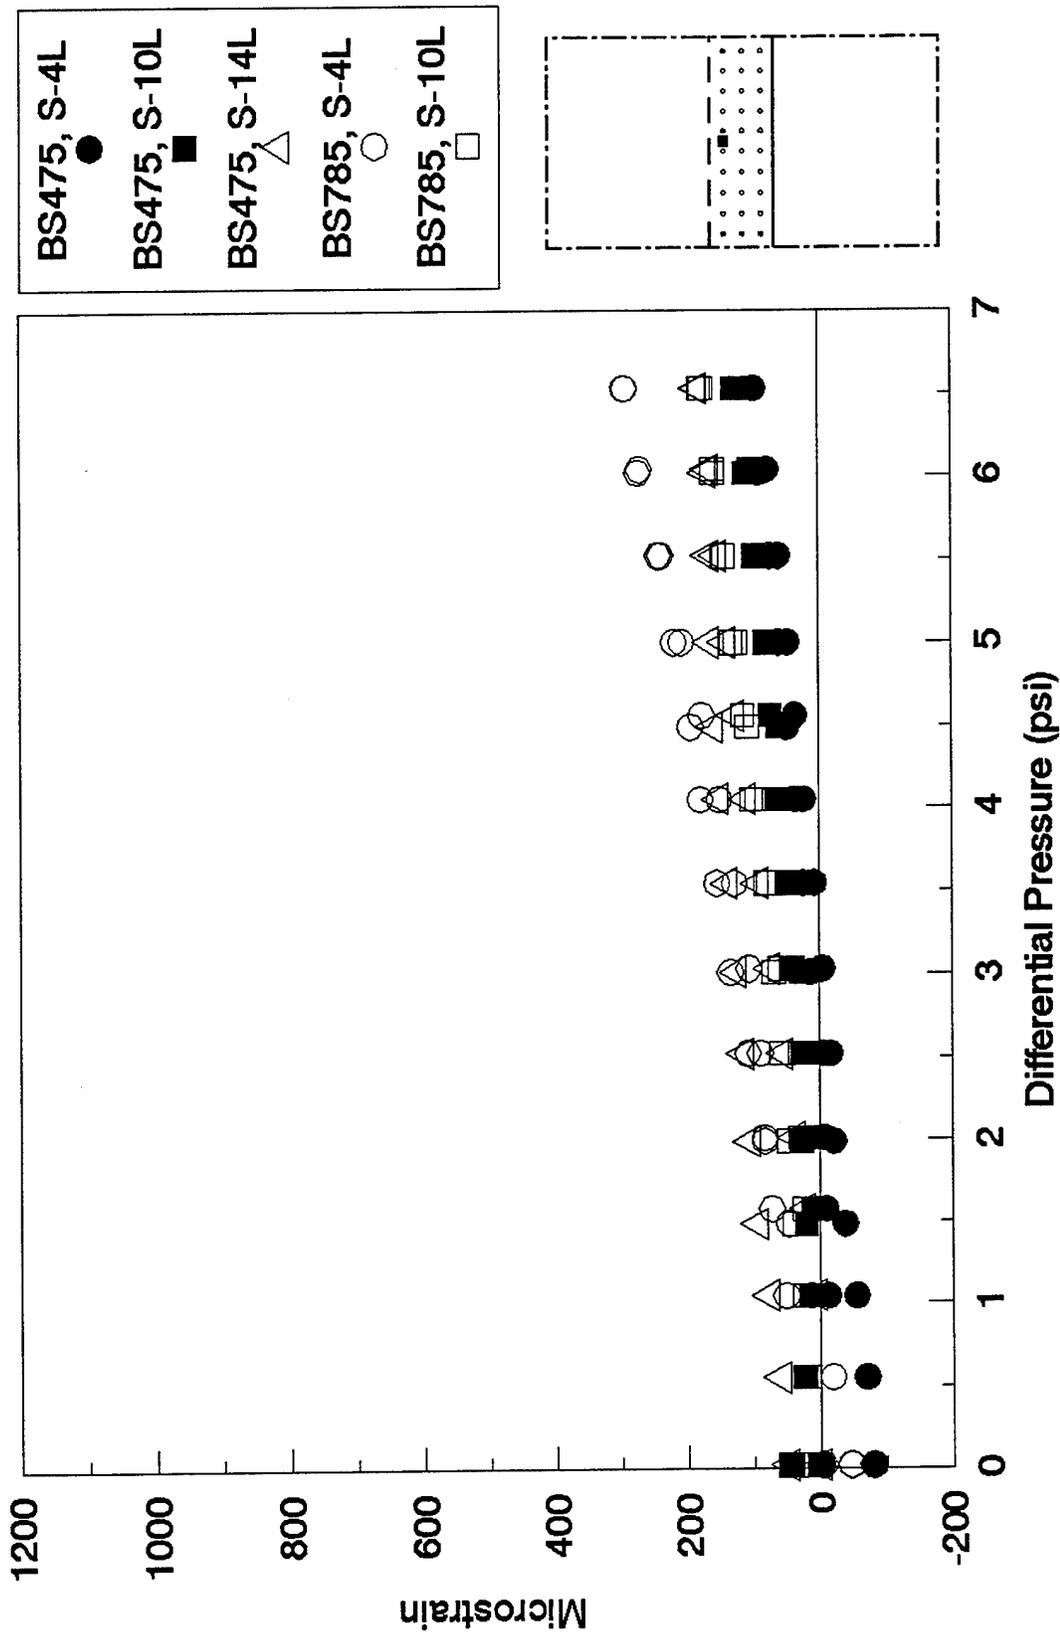
Figure 4.36. Comparison of Longitudinal Strains in Upper Rivet Row in AANC Airplane.

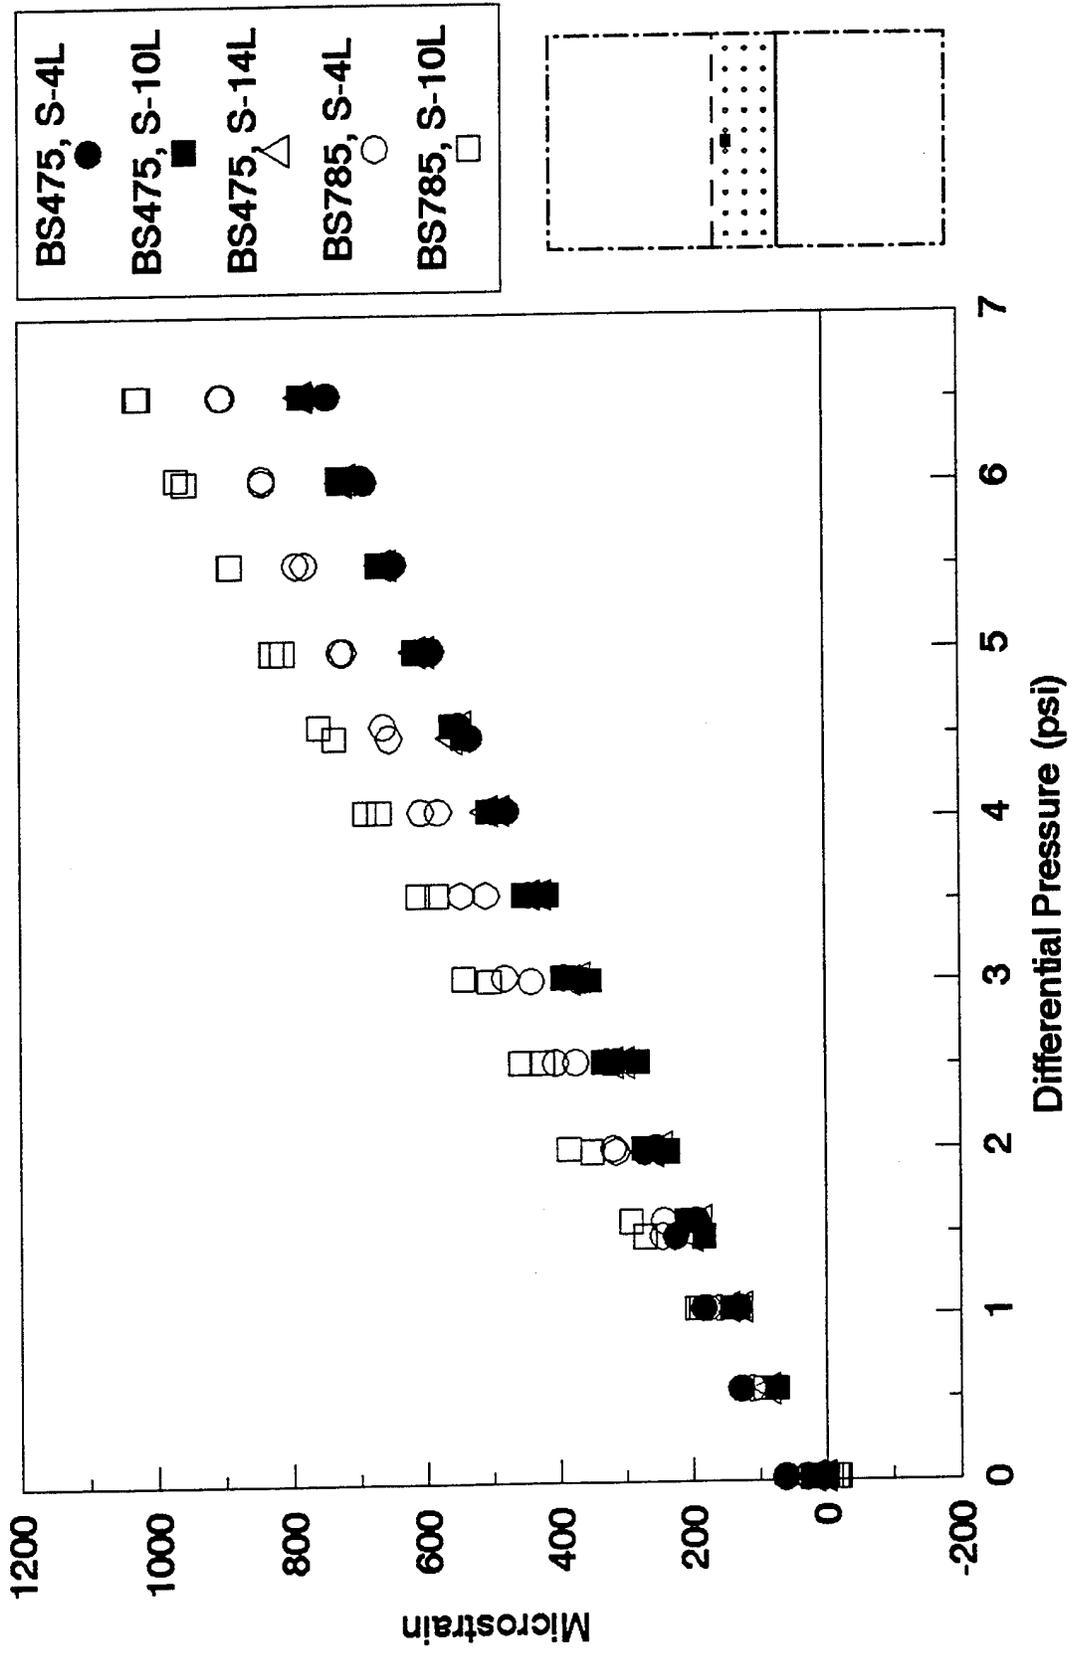
Figure 4.37. Comparison of Hoop Strains in Upper Rivet Row in AANC Airplane.

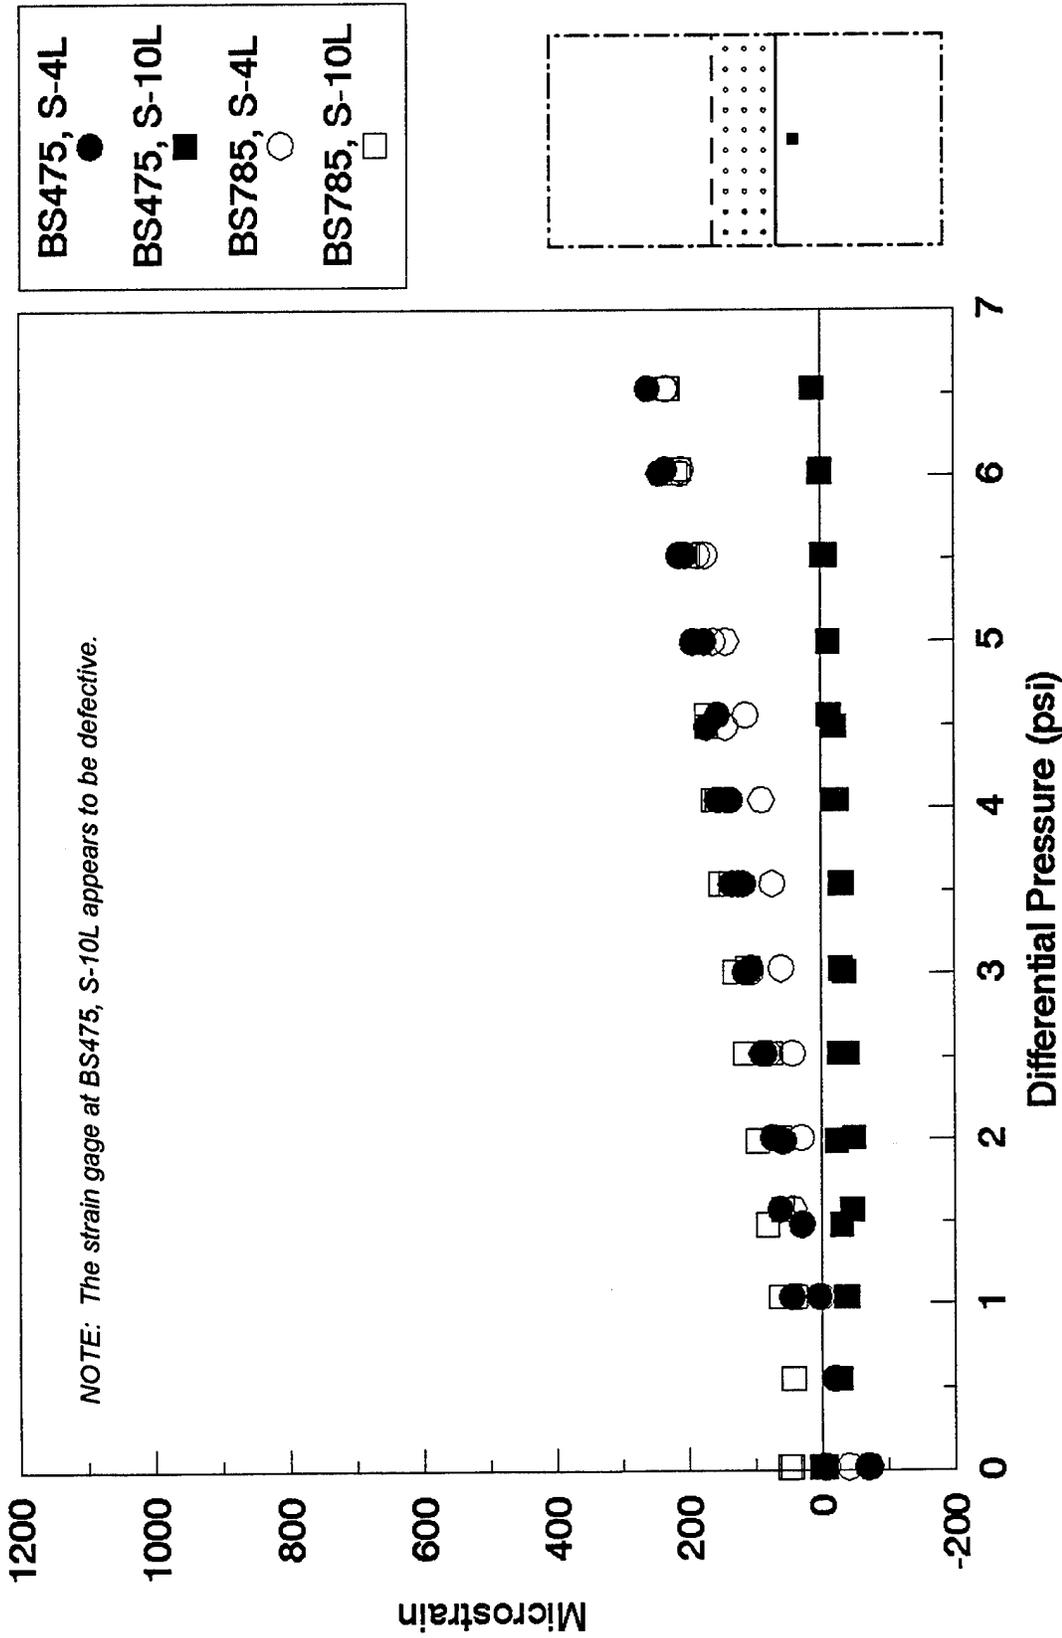
Figure 4.38. Comparison of Longitudinal Strains Near Bottom Edge of Lap Joint in AANC Airplane.

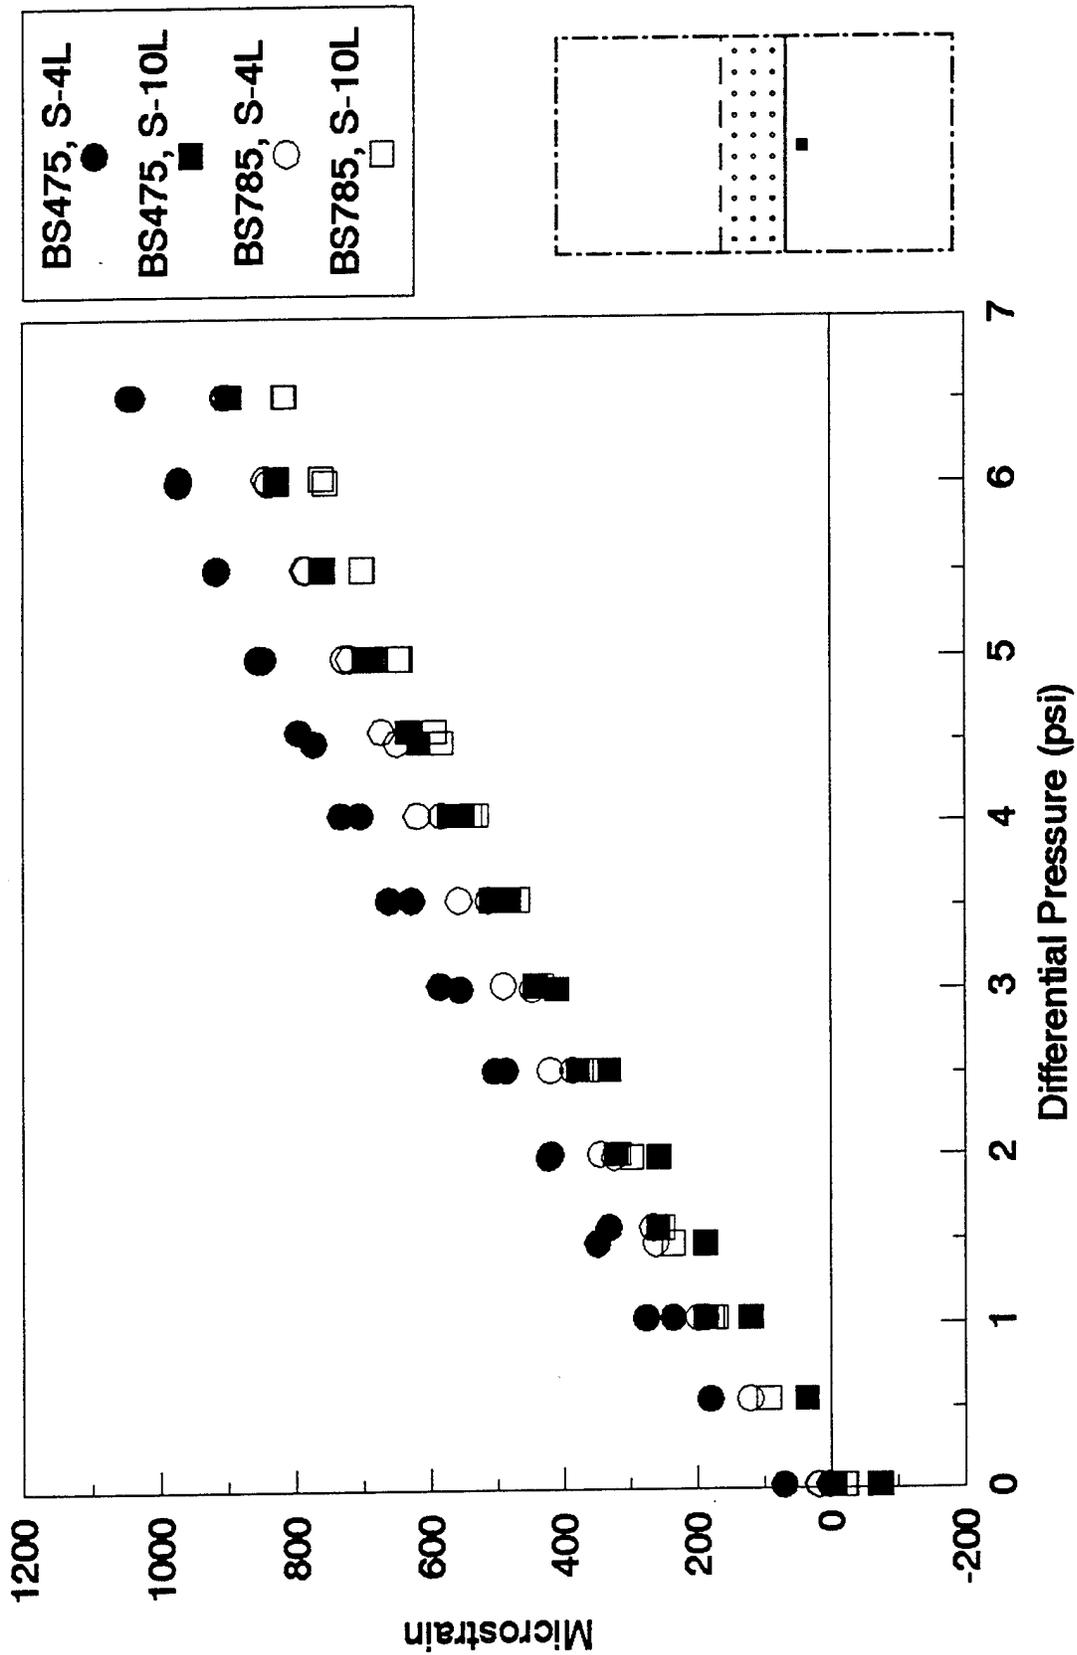
Figure 4.39. Comparison of Hoop Strains Near Bottom Edge of Lap Joint in AANC Airplane.

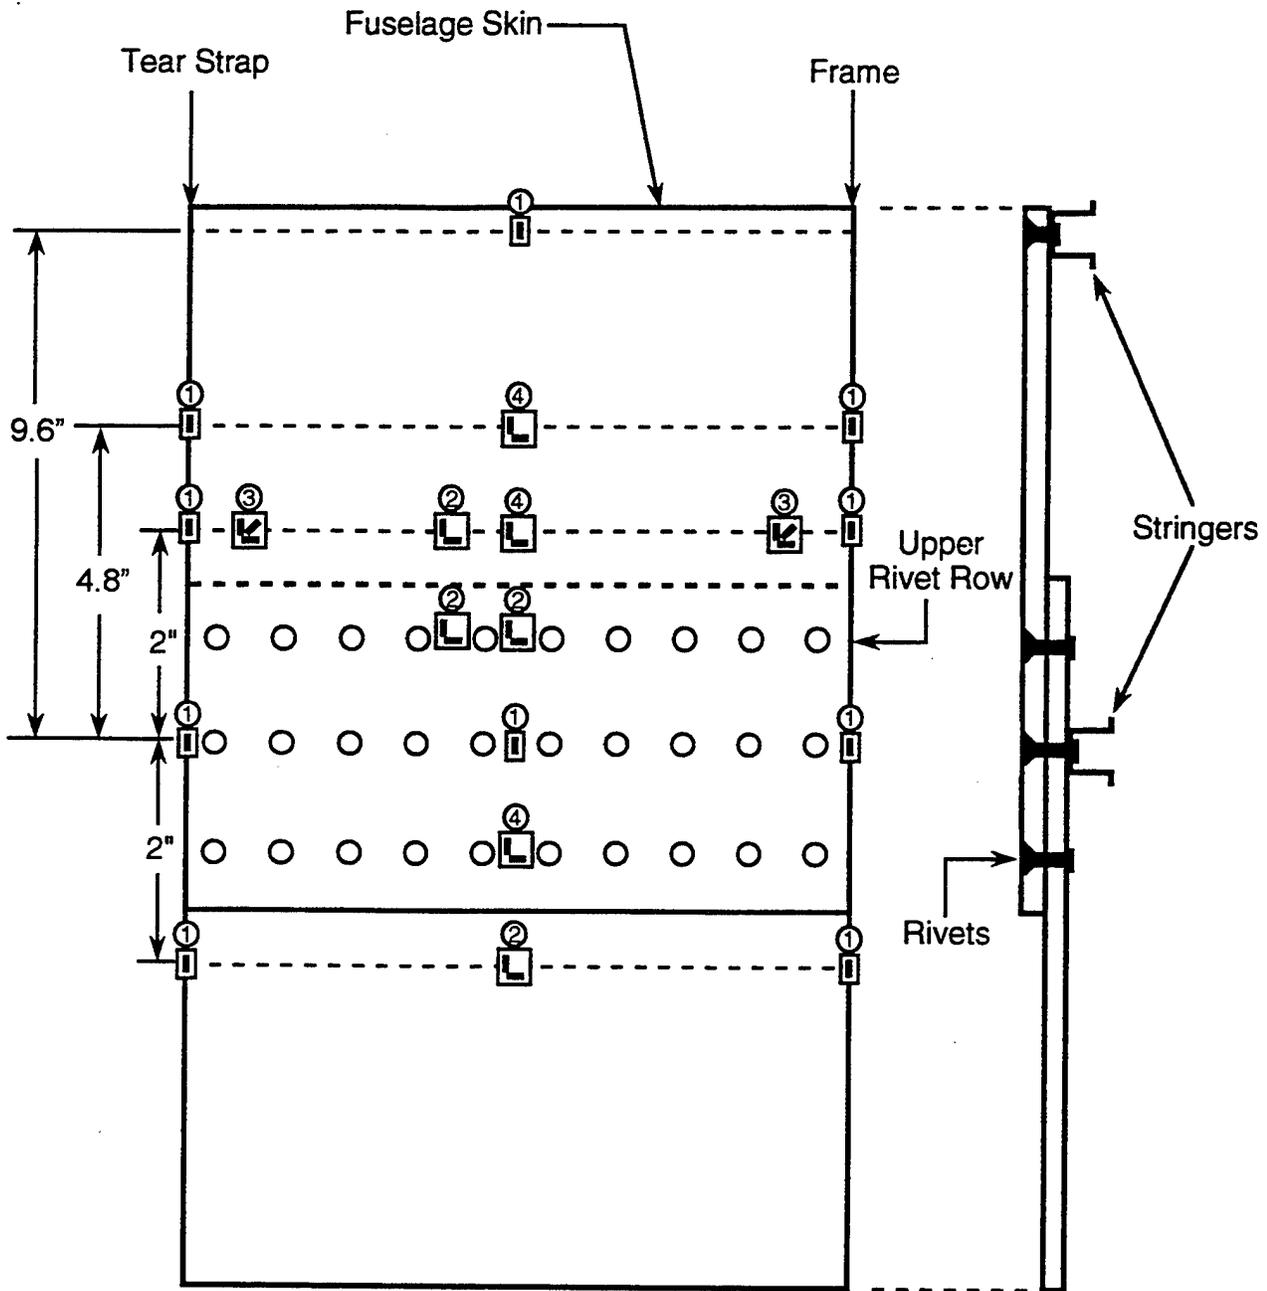
- ① Uniaxial Strain Gage - Hoop Direction, Exterior
- ② 0° / 90° Biaxial Strain Gage - Exterior
- ③ Rosette Strain Gage - Exterior
- ④ 0° / 90° Biaxial Strain Gage - Interior and Exterior

Figure A.1. Strain Gage Layout for Lap Joints Around Stringers S-4L and S-10L; Body Stations 470-480 (36 Gage Configuration).

The lap joint bays around stringers S-4 (on crown) and S-10 (above window) were instrumented with the 36-gage array. Four gages in this array measured hoop strains along the circumference at the tear strap and frame locations. Most of the gages in this array were located along the midline of the bay; i.e., midway between the tear strap and the frame. Biaxial gages were used to measure strains in the longitudinal and hoop directions. Several of these gages were mounted on the interior to monitor the circumferential bending of the joint and load transfer across the rivets. Several triaxial (rosette) gages were mounted near structural reinforcements (tear strap and frame) to determine shearing strains in this area (i.e., orientation of the principal strains).

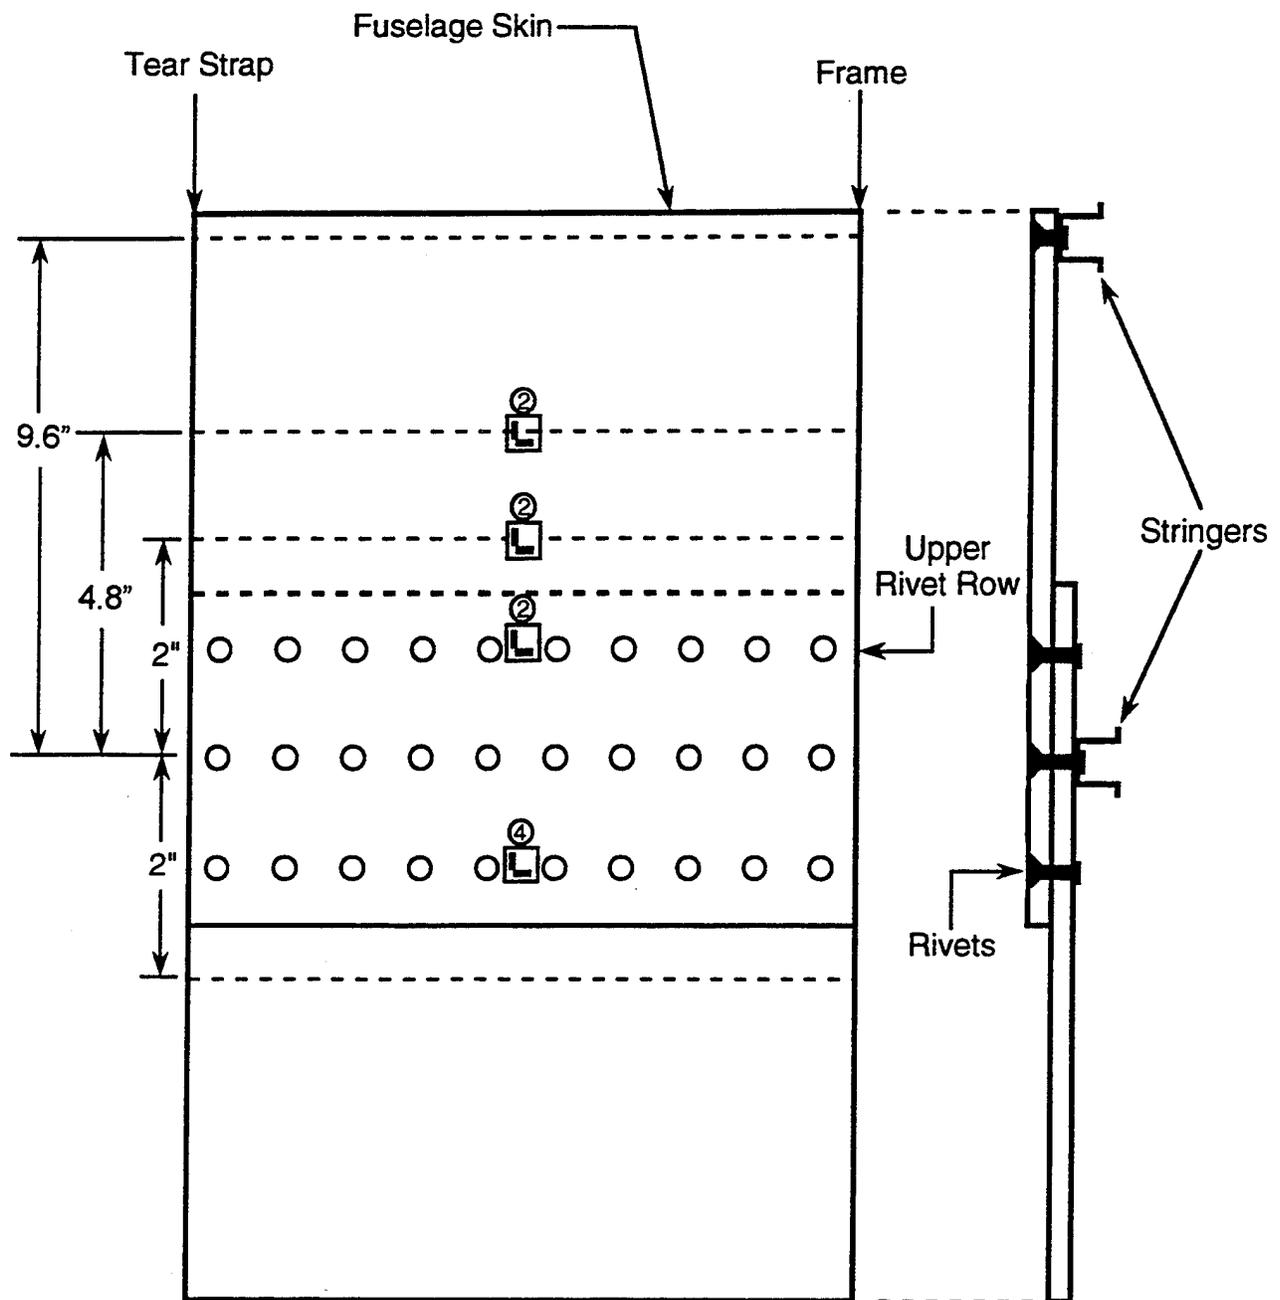
② 0° / 90° Biaxial Strain Gage - Exterior

Figure A.2. Strain Gage Layout for Lap Joint Around Stringer S-14L; Body Stations 470-480 (10 Gage Configuration).

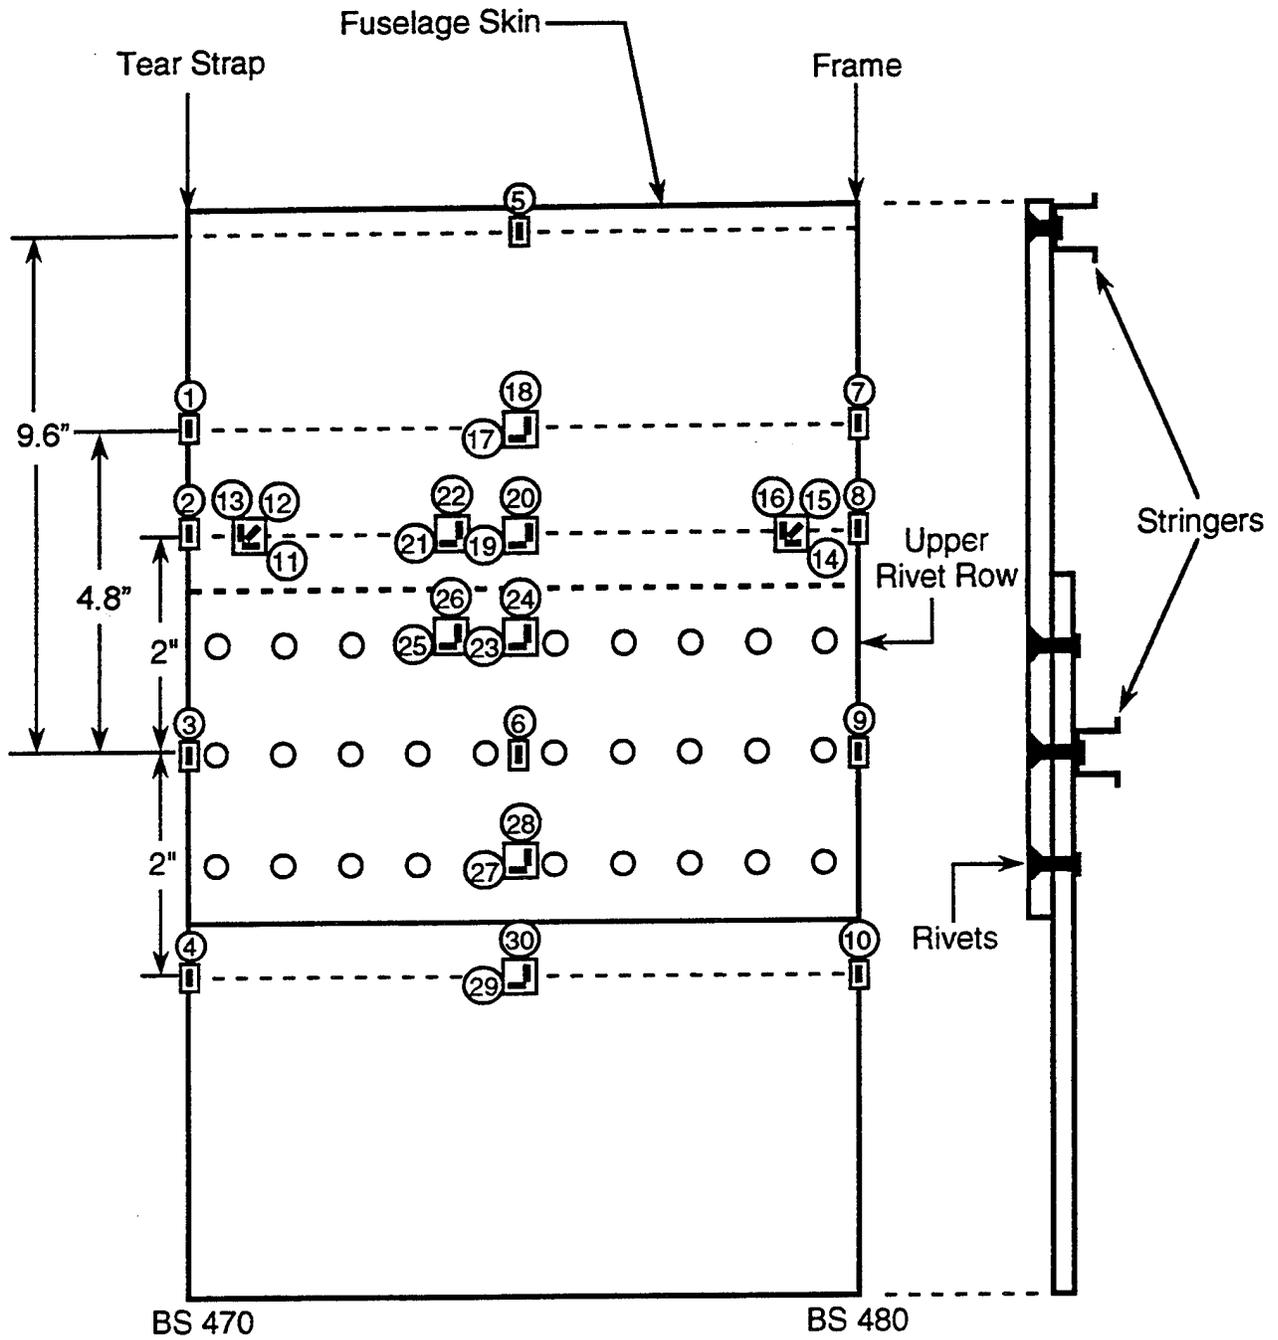
Figure A.4. Strain Gage Numbers for Lap Joint at Stringer S-4L; Body Stations 470-480; External (30 Gages).
