DOT/FAA/CT-95/25  
DOT-VNTSC-FAA-95-10

# Strain Fields in Boeing 737 Fuselage Lap Splices: Field and Laboratory Measurements with Analytical Correlations

Final Report  
June 1995

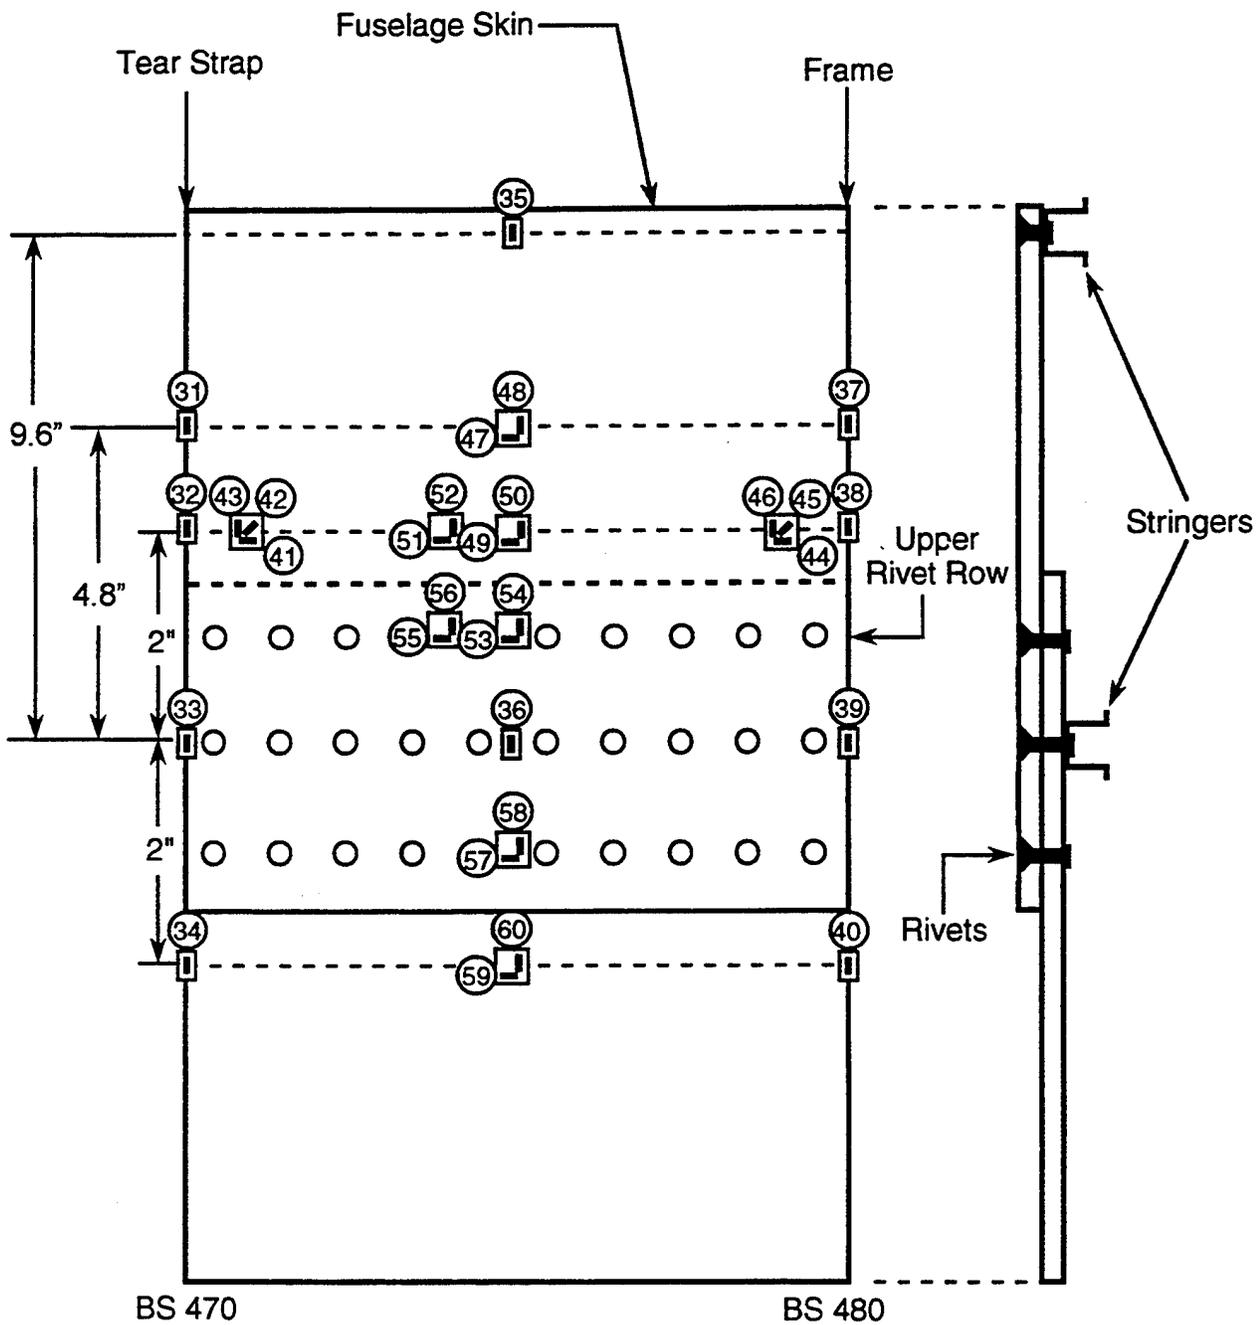
Figure A.5. Strain Gage Numbers for Lap Joint at Stringer S-10L; Body Stations 470-480; External (30 Gages).

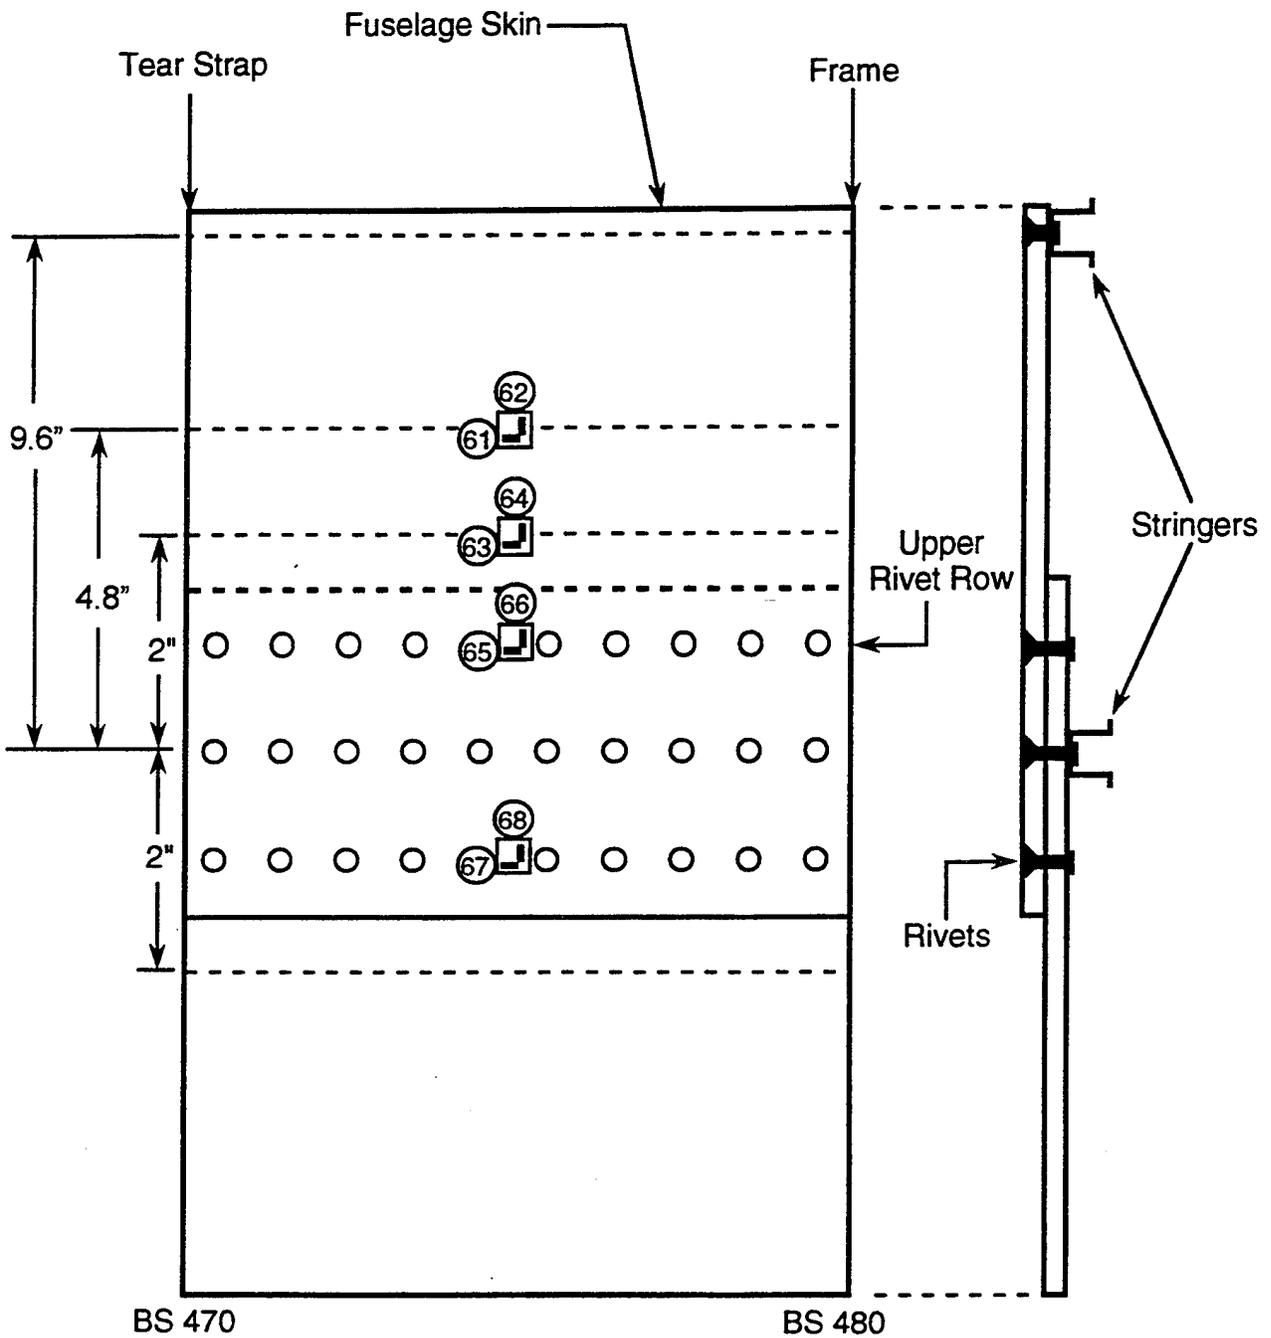
Figure A.6. Strain Gage Numbers for Lap Joint at Stringer S-14L; Body Stations 470-480; External (8 Gages).

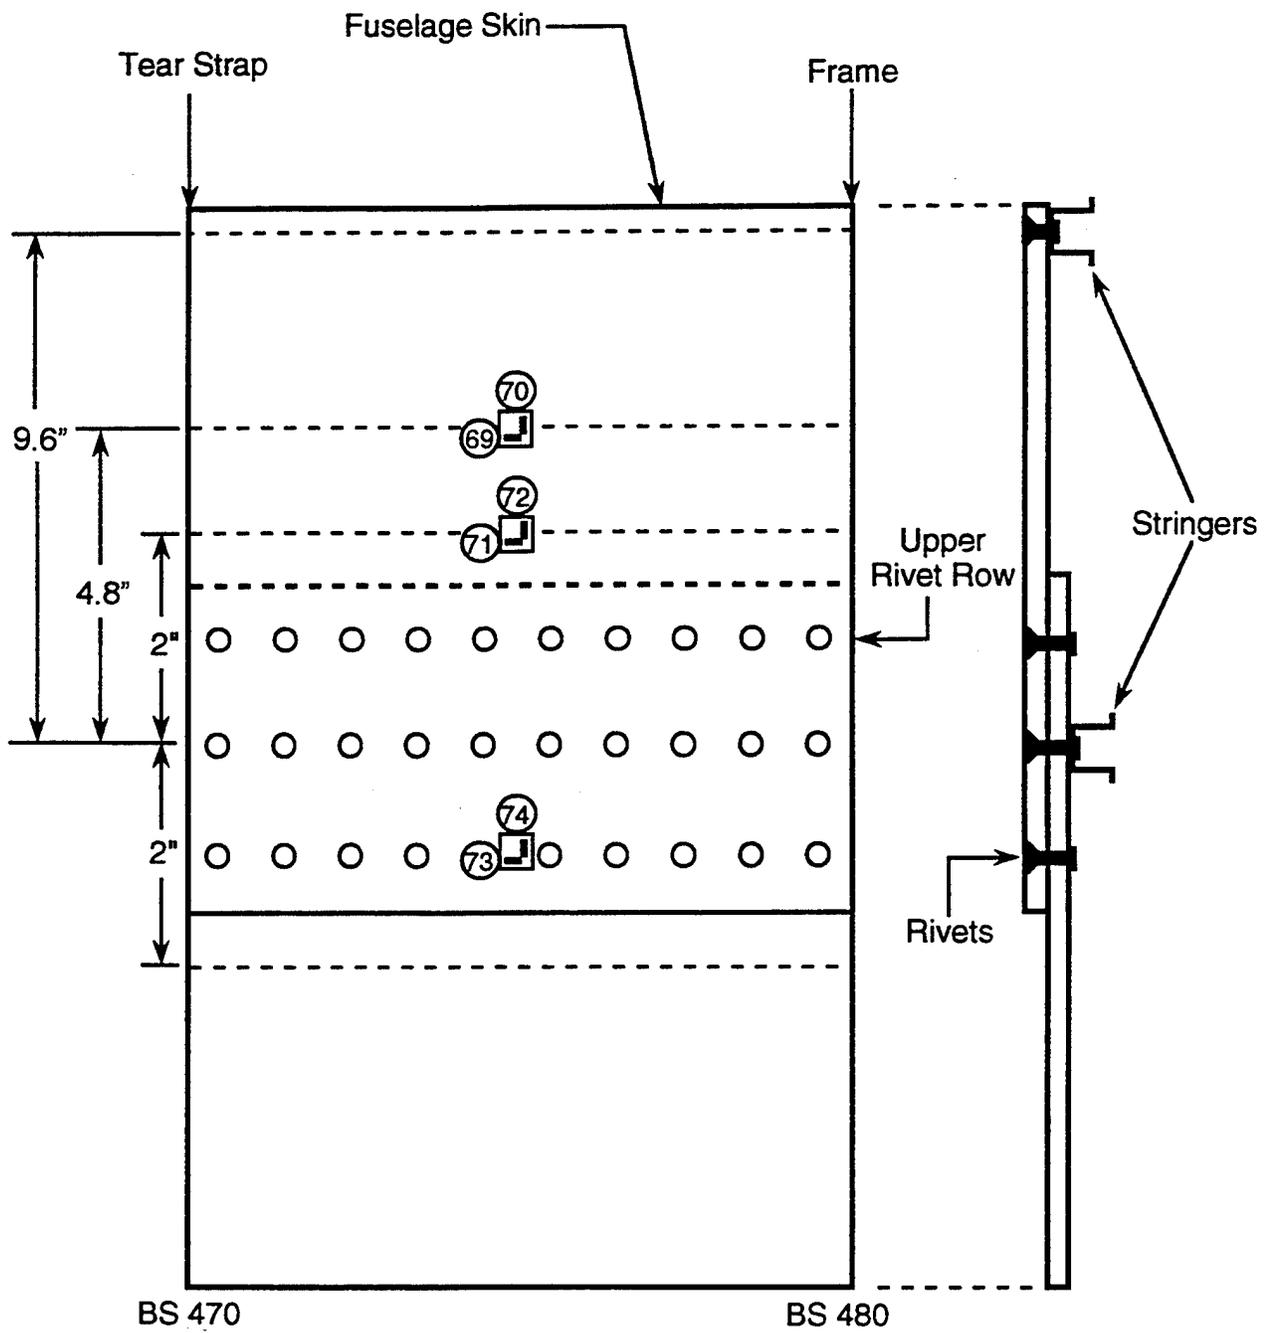
Figure A.7. Strain Gage Numbers for Lap Joint at Stringer S-4L; Body Stations 470-480; Internal (6 Gages).

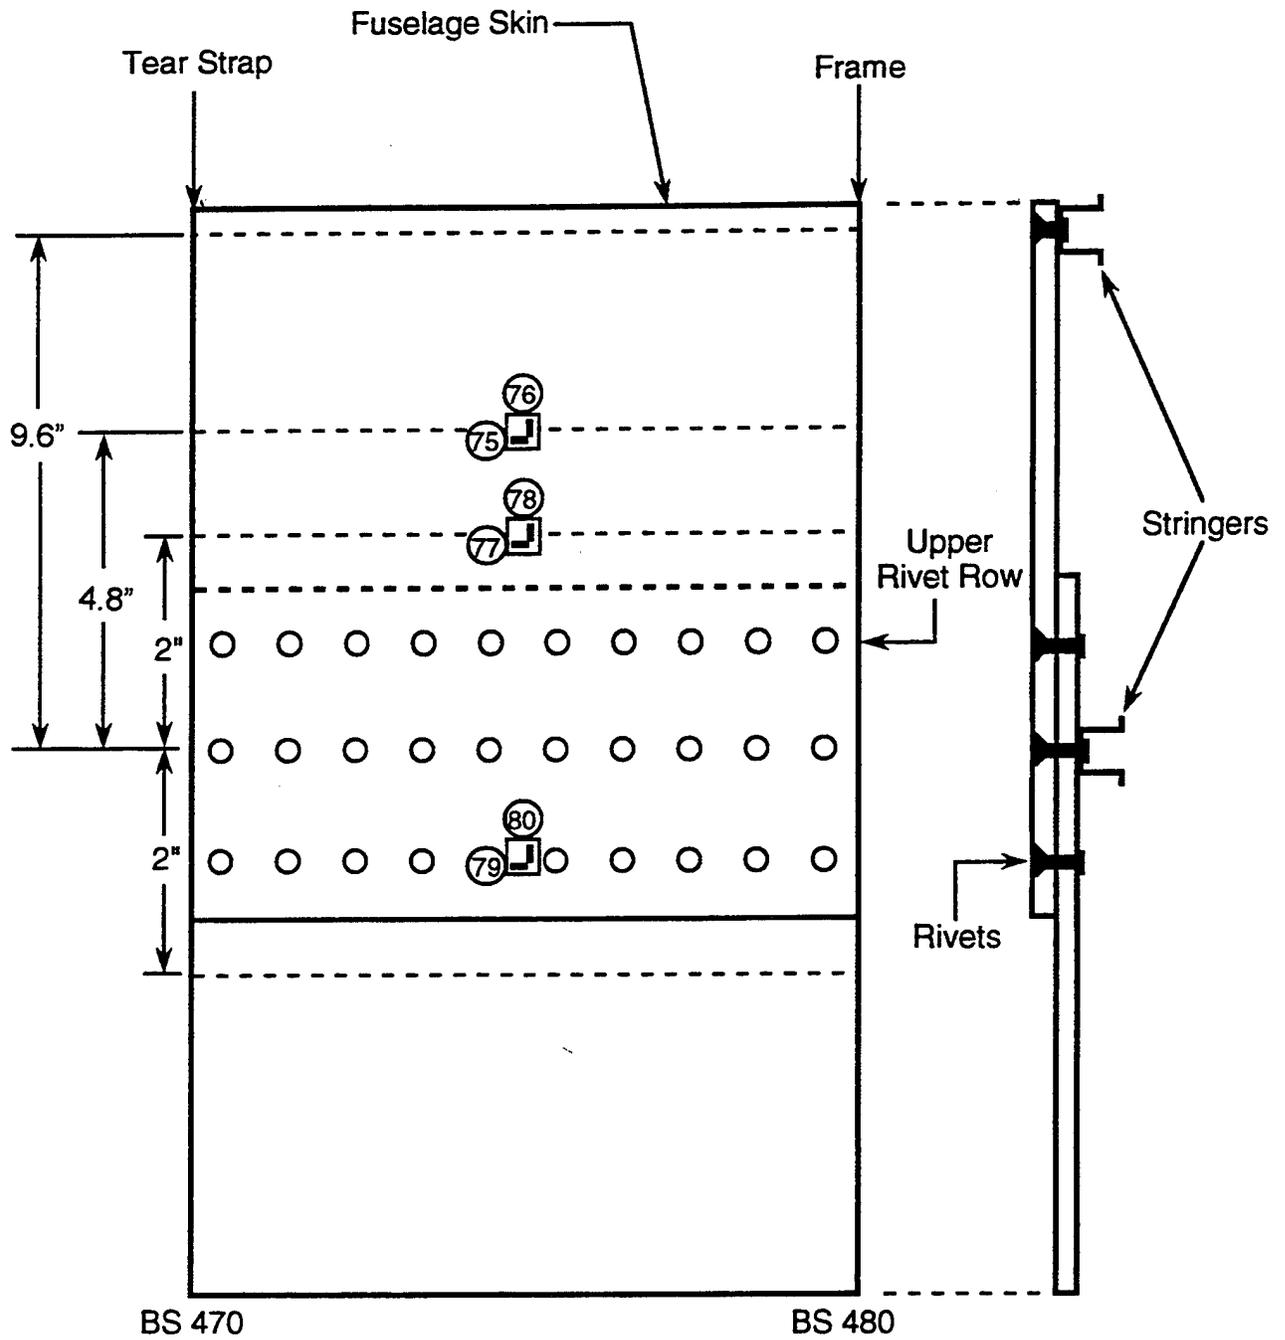
Figure A.8. Strain Gage Numbers for Lap Joint at Stringer S-10L; Body Stations 470-480; Internal (6 Gages).

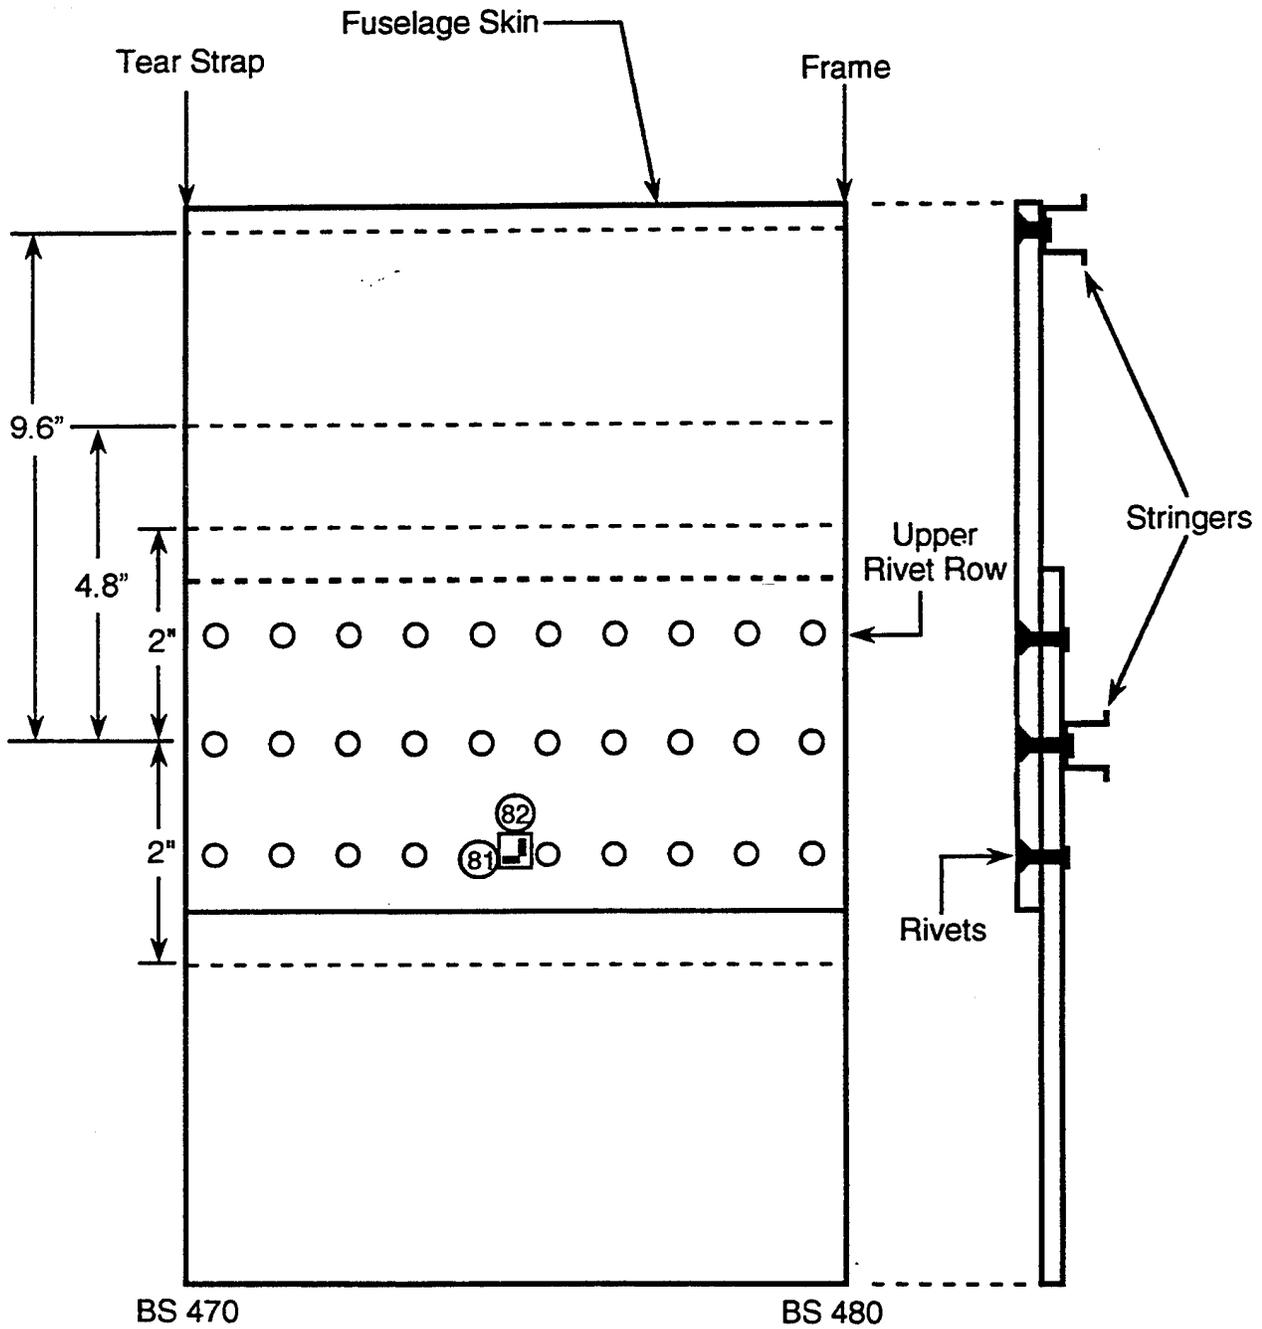
Figure A.9. Strain Gage Numbers for Lap Joint at Stringer S-14L; Body Stations 470-480; Internal (2 Gages).

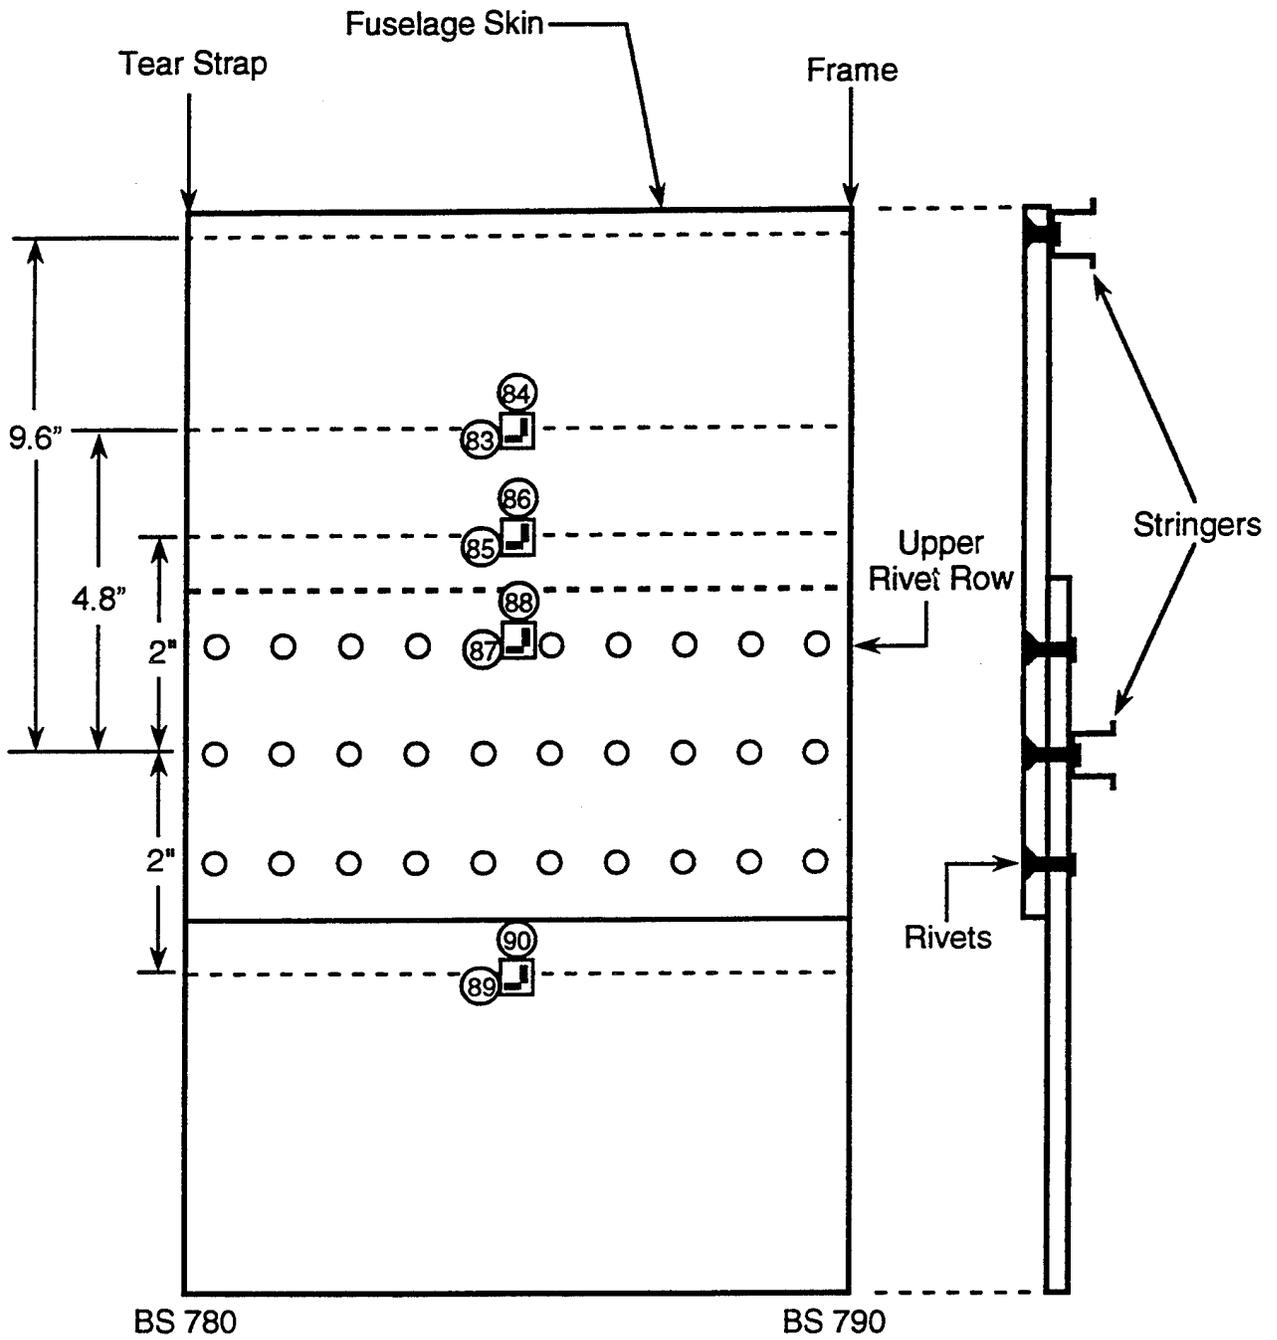
Figure A.10. Strain Gage Numbers for Lap Joint at Stringer S-4L; Body Stations 780-790; External (8 Gages).

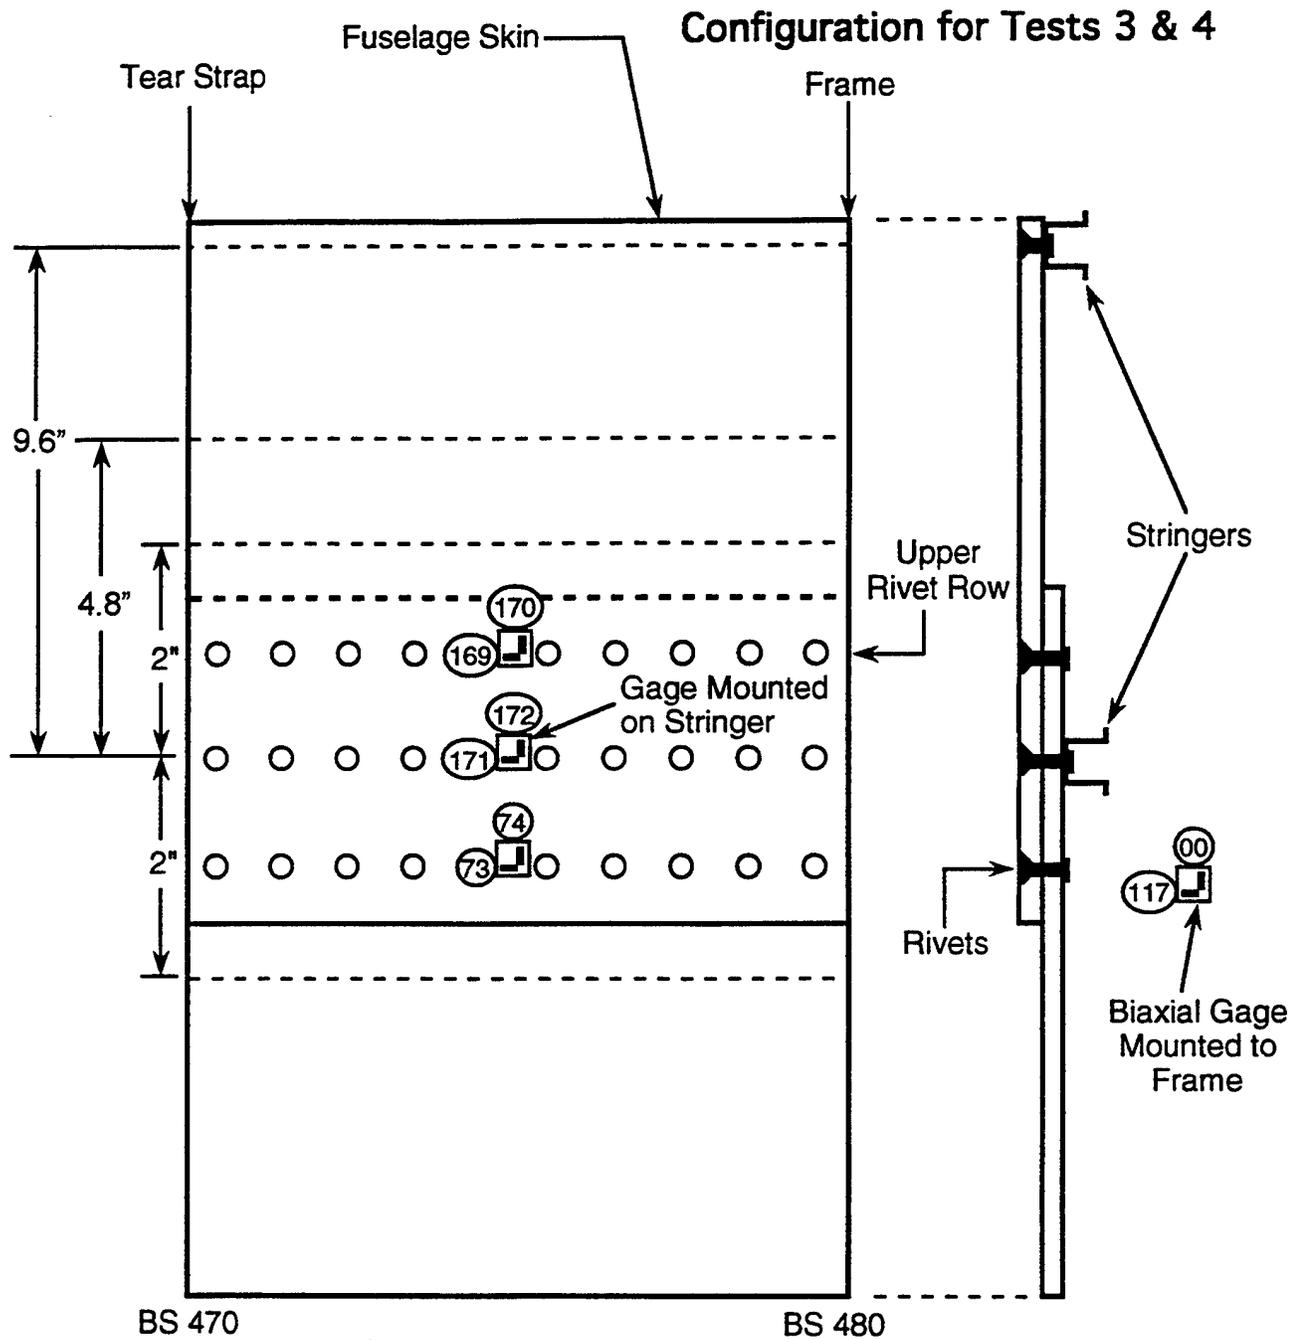
*Figure A.14. Strain Gage Numbers for Lap Joint Around Stringer S-4L; Body Stations 470-480; Internal (6 Gages).*
