Technical note

Improved Marking of Taxiway Intersections for Instrument Flight Rules (IFR) Operations

February 1989
Interim Report
DOT/FAA/ CT-TN89/23

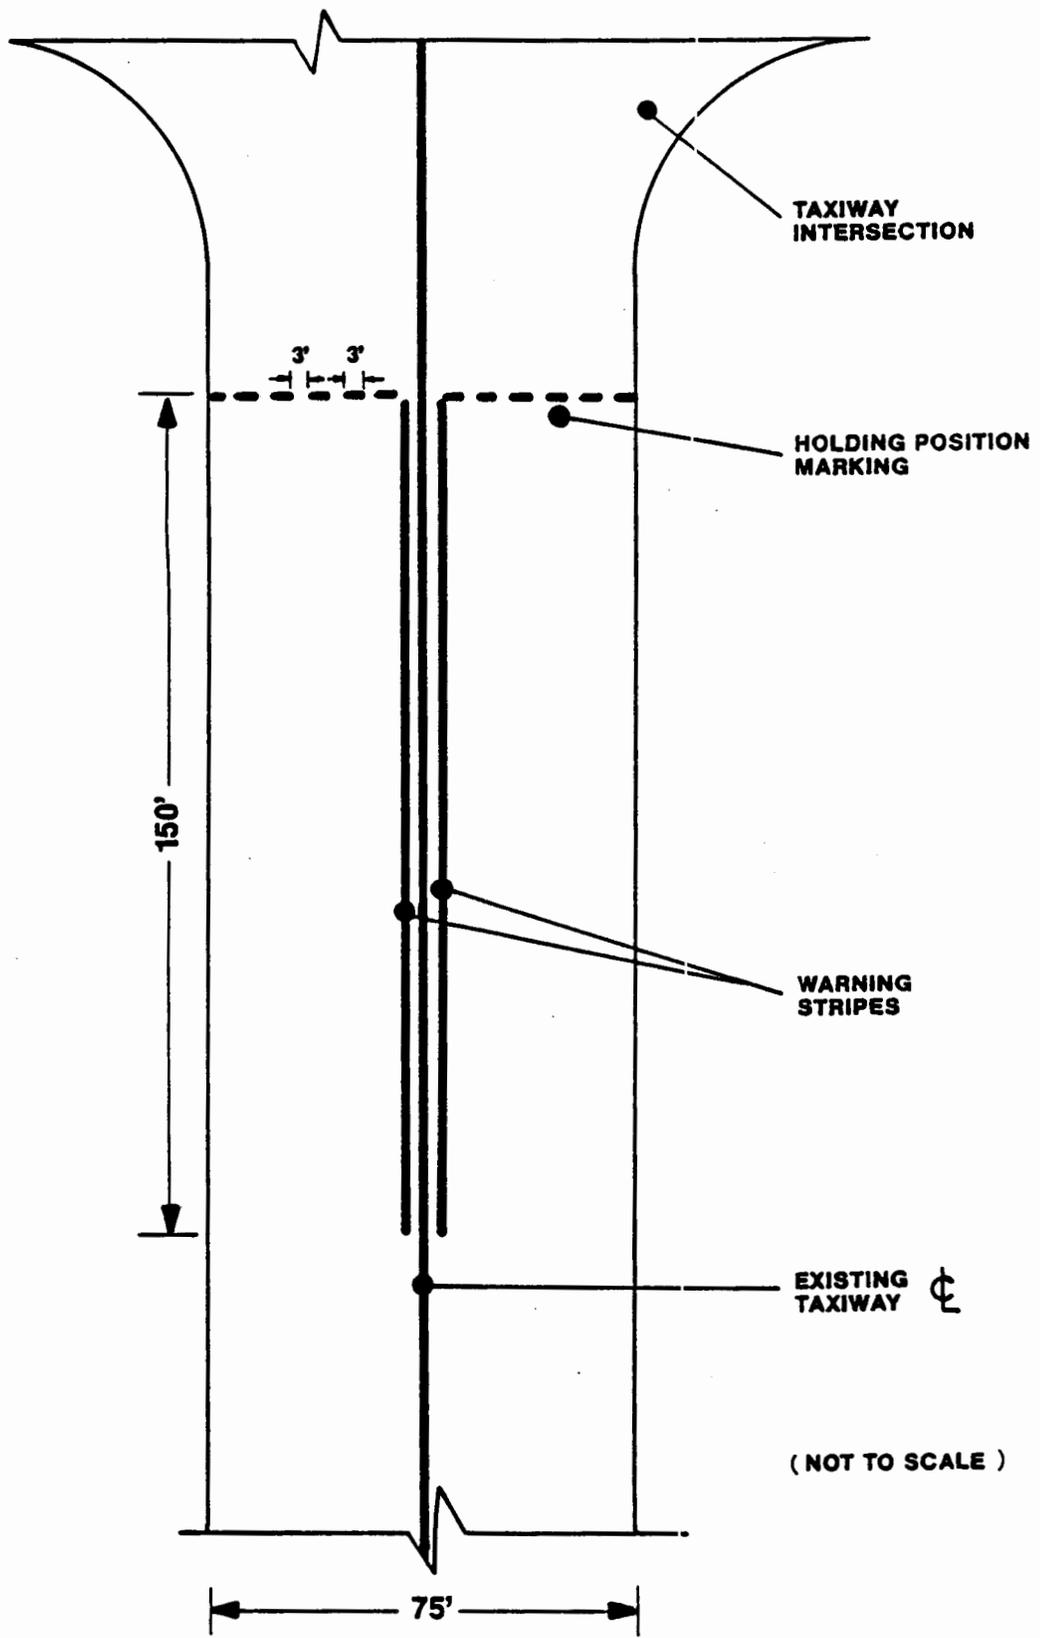
FIGURE 1. TAXIWAY INTERSECTION MARKINGS

The configuration selected for final evaluation was a 75- by 1-foot segmented holding position marking identical to the ICAO standard taxiway intersection marking, supplemented by two 150-foot by 6-inch warning stripes (figure 1).

1. The taxiway intersection markings evaluated (figure 1) will provide adequate advance warning of an approach to a taxiway intersection and the clearance location at which to stop, if required, under day and night low visibility conditions.
2. The configuration retains the standard International Civil Aviation Organization (ICAO) holding position marking supplemented by two easily applied advance warning stripes.
3. Additional lighting components may be necessary at locations where snow, water, or other contaminants may obscure surface markings.
4. Retroreflective tape or paint should be used to enhance the effectiveness of the taxiway intersection markings.
