86
12
DOT/FAA/PM-86/12
Program Engineering
and Maintenance Service
Washington, D.C. 20591

Performance of Recycled Asphalt Concrete Airport Pavement Surfaces

Naval Civil Engineering Laboratory
Port Hueneme, CA 93043

Final Report

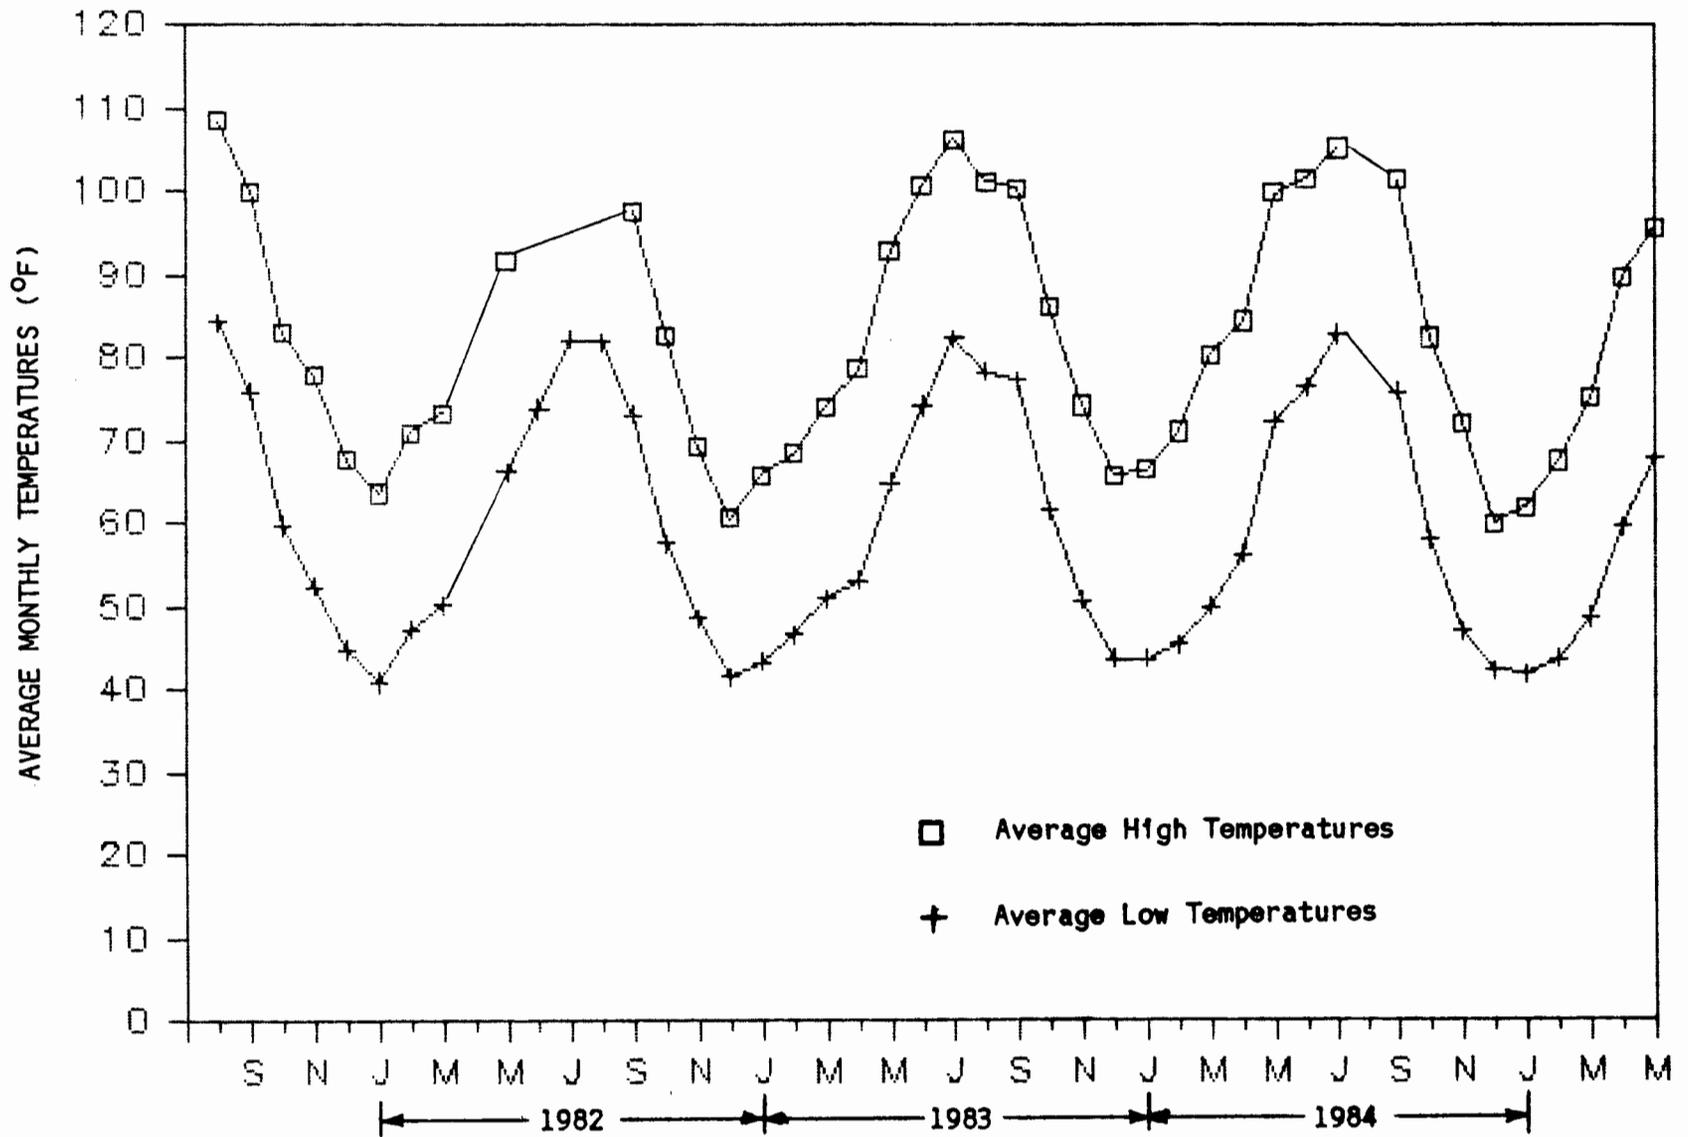
FIGURE 1. AVERAGE MONTHLY HIGH AND LOW TEMPERATURES SINCE RECYCLED SURFACE WAS PLACED AT NEEDLES AIRPORT, NEEDLES, CALIFORNIA.

The sites chosen were Runway 2-20 at Needles Airport in Needles, California and a Taxiway at Barnes County Municipal Airport in Valley City, North Dakota. Needles airport has a hot and dry climate. The recycled mix proportion on the runway was 50 percent recycled and 50 percent virgin material. The Valley City airport is in a cold and wet climate. The recycled surface mix proportion used on the taxiway was 70 percent recycled and 30 percent virgin material. Figures 1 through 4 show the average monthly high and low temperatures and total precipitation for both airports since reconstruction was completed. These figures show average temperature extremes of 40 to 110 °F at Needles and -20 to 90 °F at Valley City. Needles airport has recorded 26 inches of rain since completion of reconstruction in 1981 while Valley City has recorded 98 inches of rain since 1980 and 127 inches of snow since November 1981.

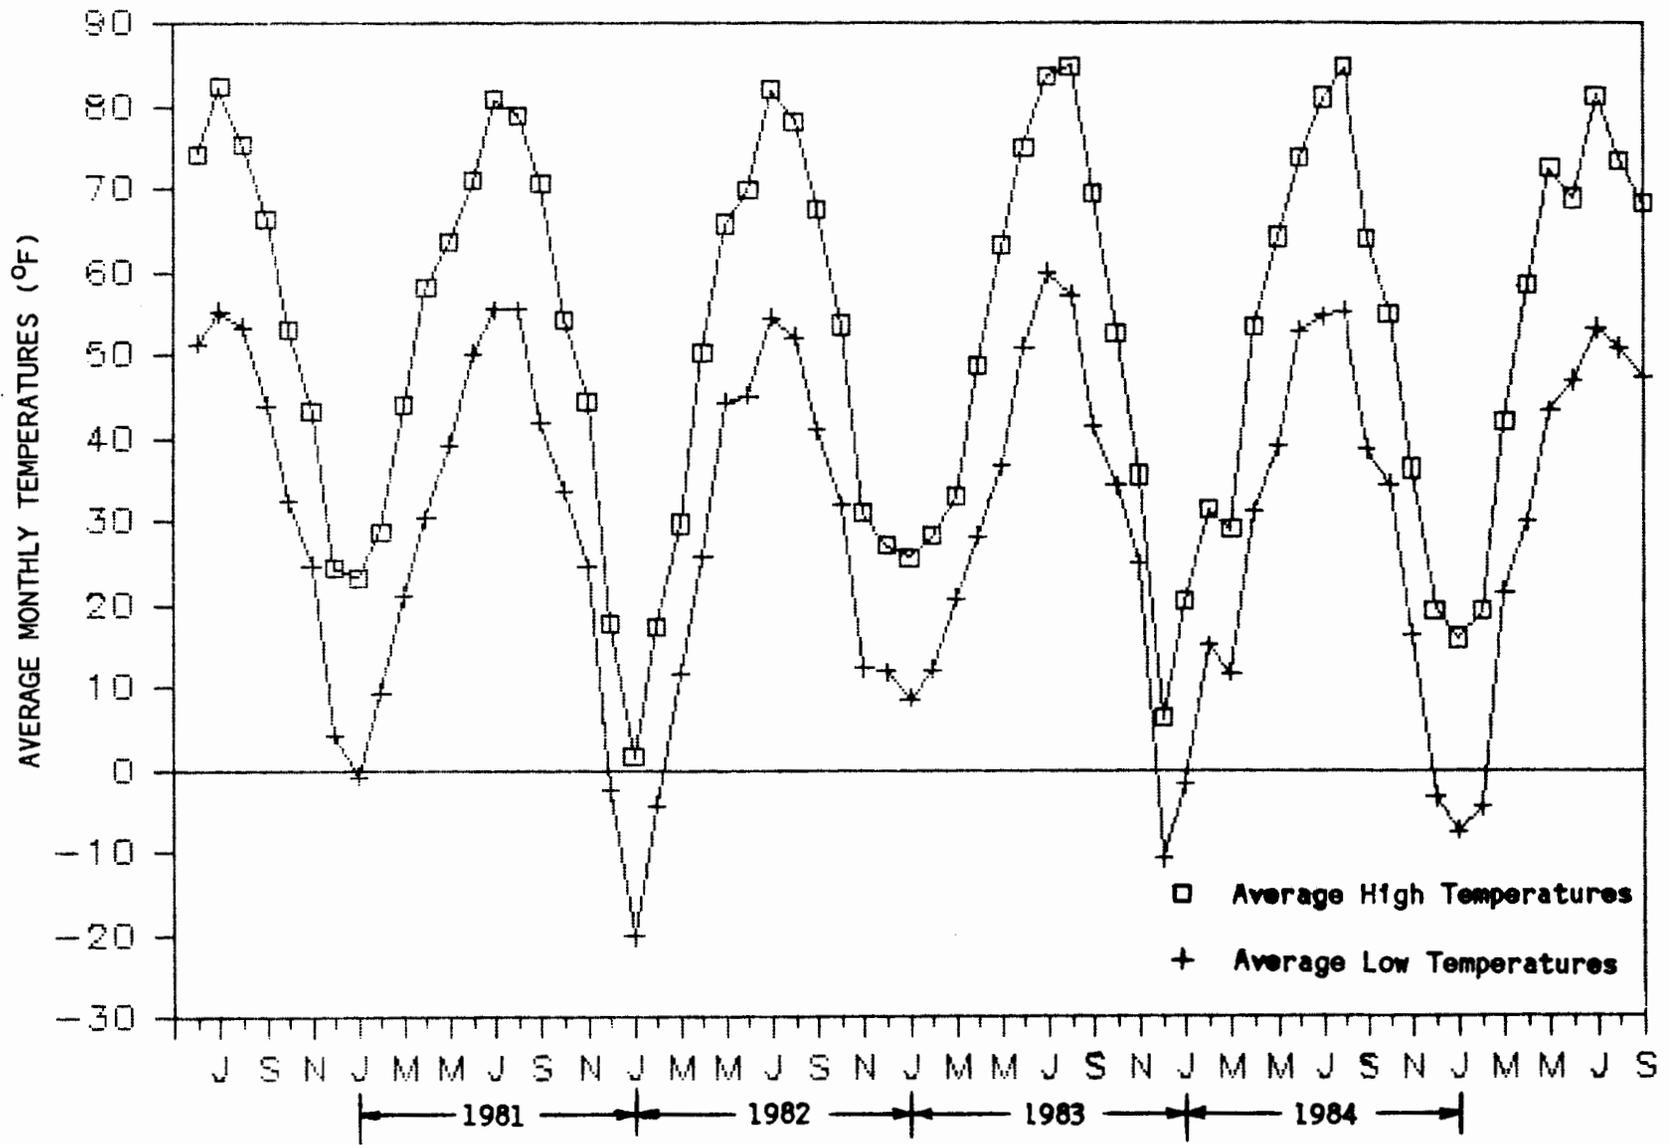
FIGURE 2. AVERAGE MONTHLY HIGH AND LOW TEMPERATURES SINCE RECYCLED SURFACE WAS PLACED AT BARNES COUNTY MUNICIPAL AIRPORT, VALLEY CITY, NORTH DAKOTA.

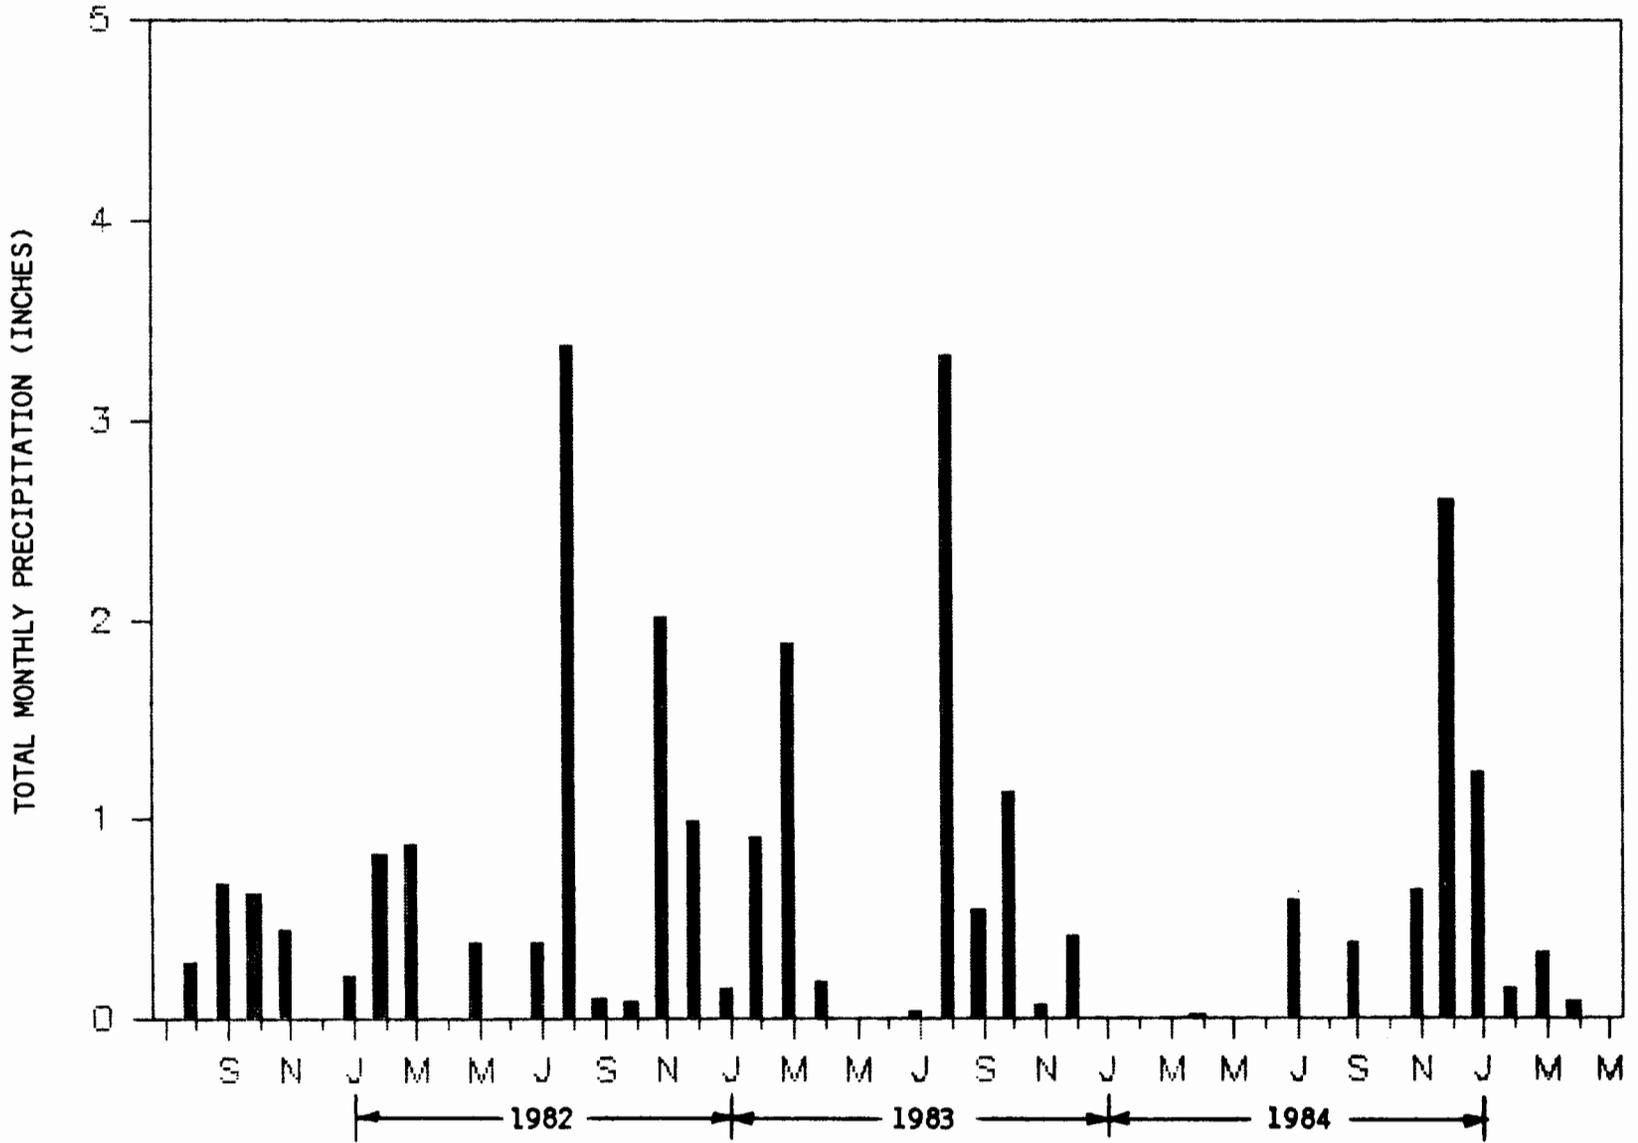
FIGURE 3. TOTAL MONTHLY PRECIPITATION SINCE RECYCLED SURFACE WAS PLACED AT NEEDLES AIRPORT, NEEDLES, CALIFORNIA.

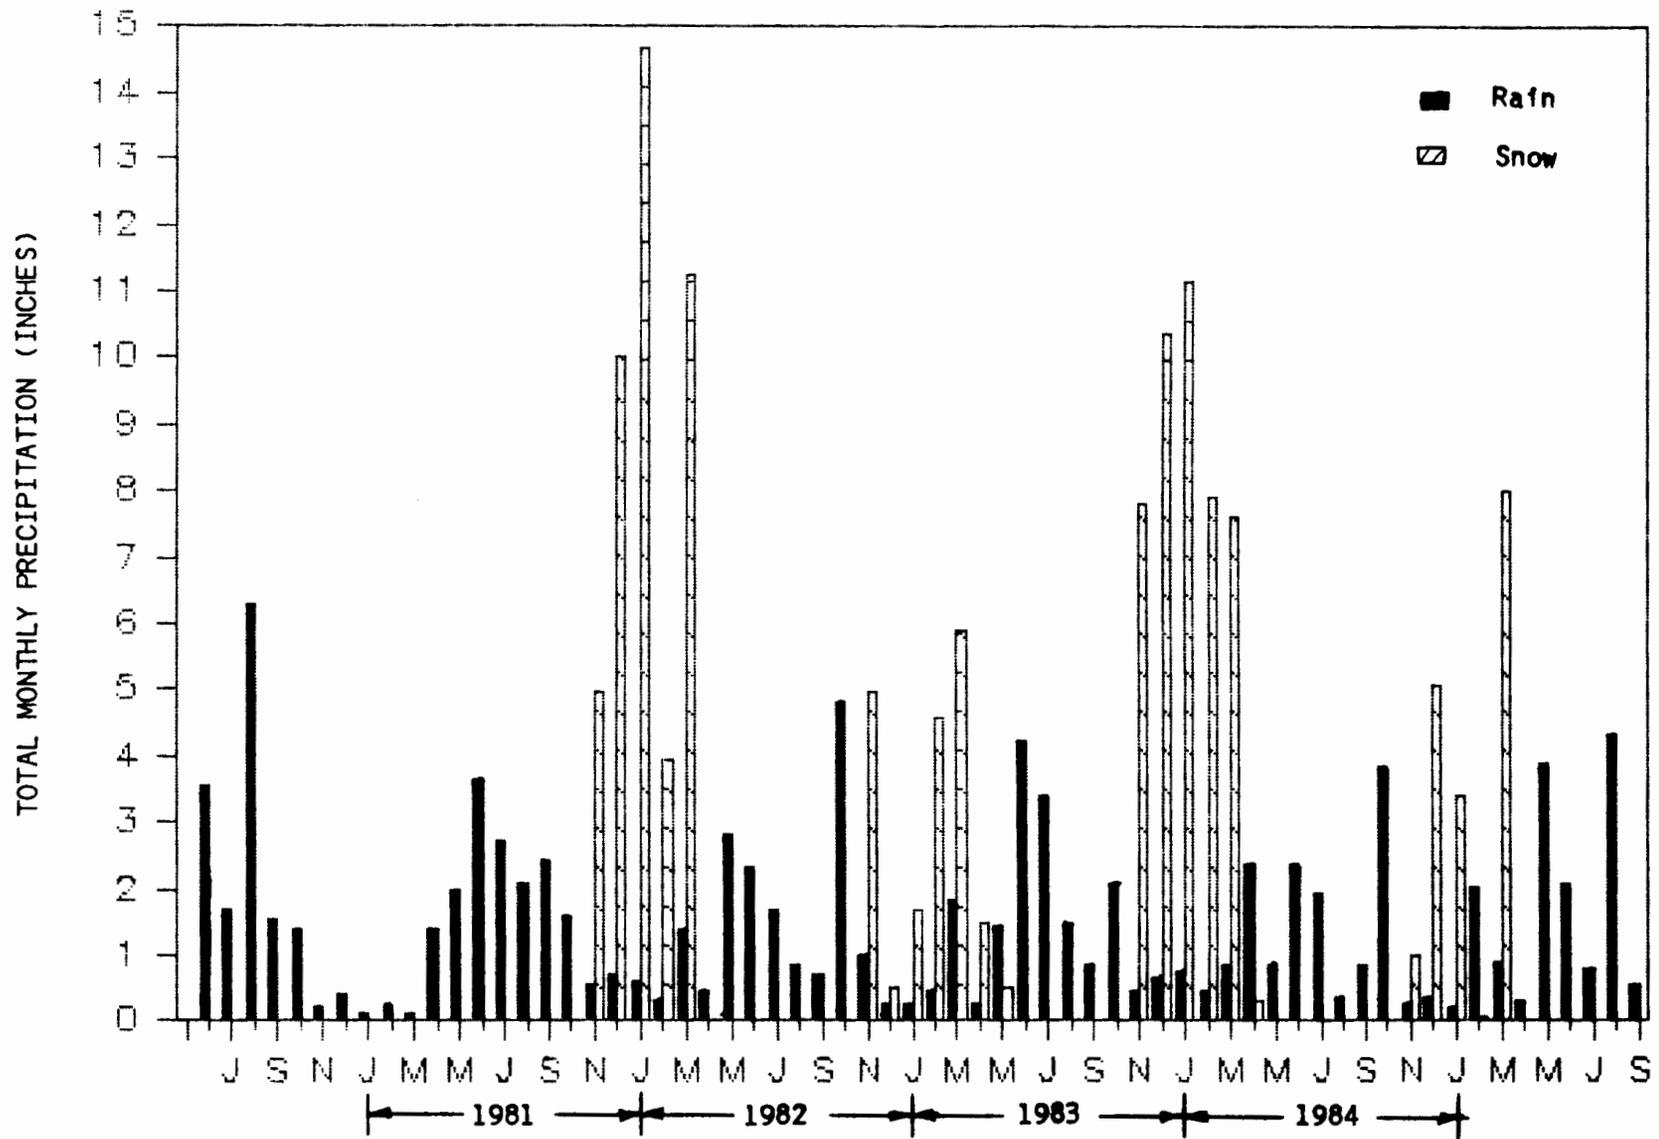
FIGURE 4. TOTAL MONTHLY PRECIPITATION SINCE RECYLCED SURFACE WAS PLACED AT BARNES COUNTY MUNICIPAL AIRPORT, VALLEY CITY, NORTH DAKOTA.

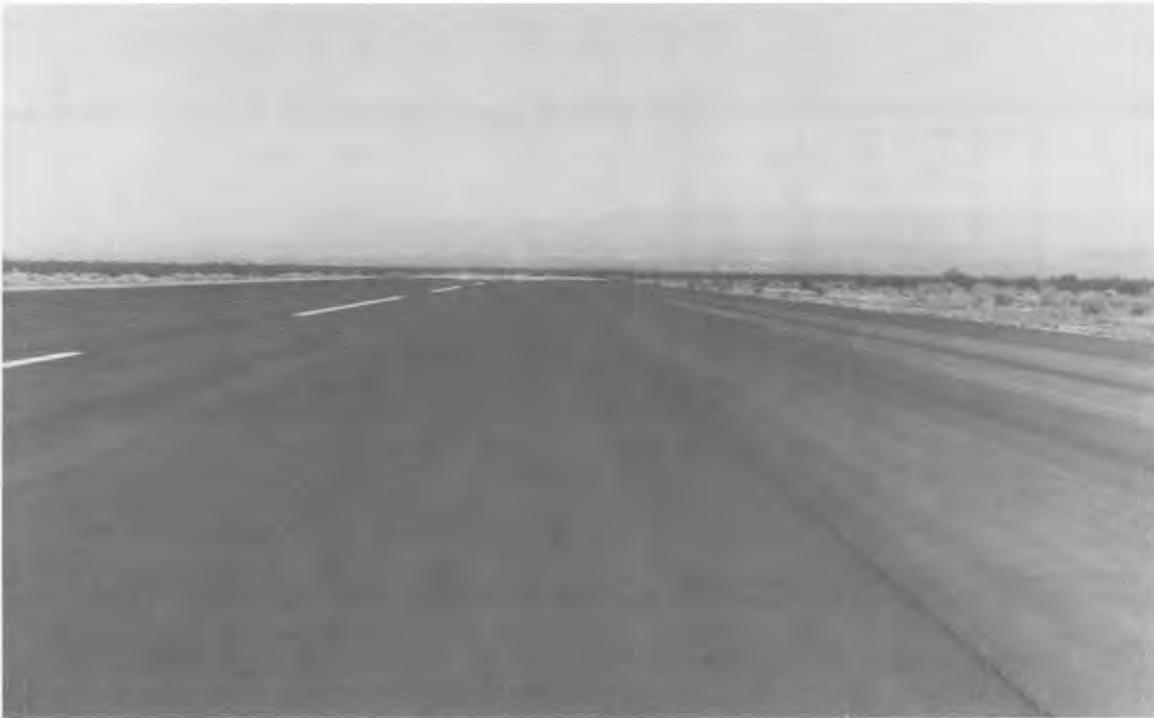
The Naval Civil Engineering Laboratory contracted with Harding Lawson Associates to perform PCI surveys of both Needles and Valley City airports⁷. Figures 5 and 6 show the overall view of Runway 2-20 at Needles Airport and the taxiway at the Valley City airport, respectively.

FIGURE 5. OVERALL VIEW OF RUNWAY 2-20 AT NEEDLES AIRPORT, NEEDLES, CALIFORNIA.

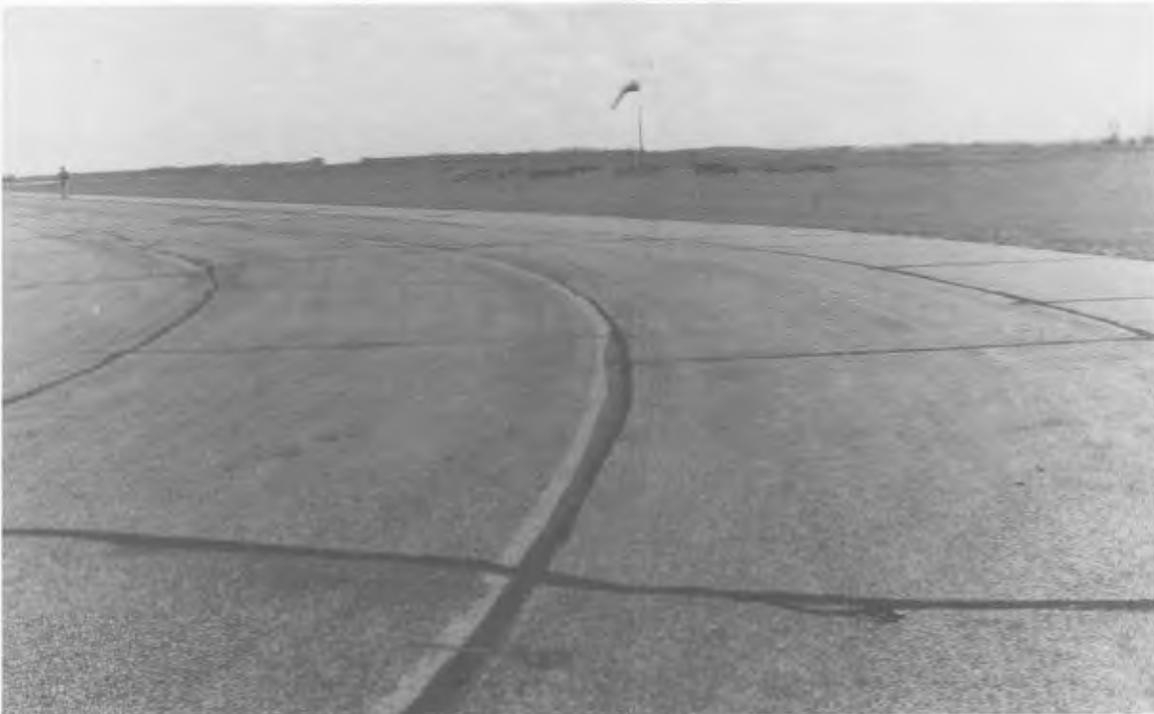
FIGURE 6. OVERALL VIEW OF THE TAXIWAY AT BARNES COUNTY MUNICIPAL AIRPORT, VALLEY CITY, NORTH DAKOTA.

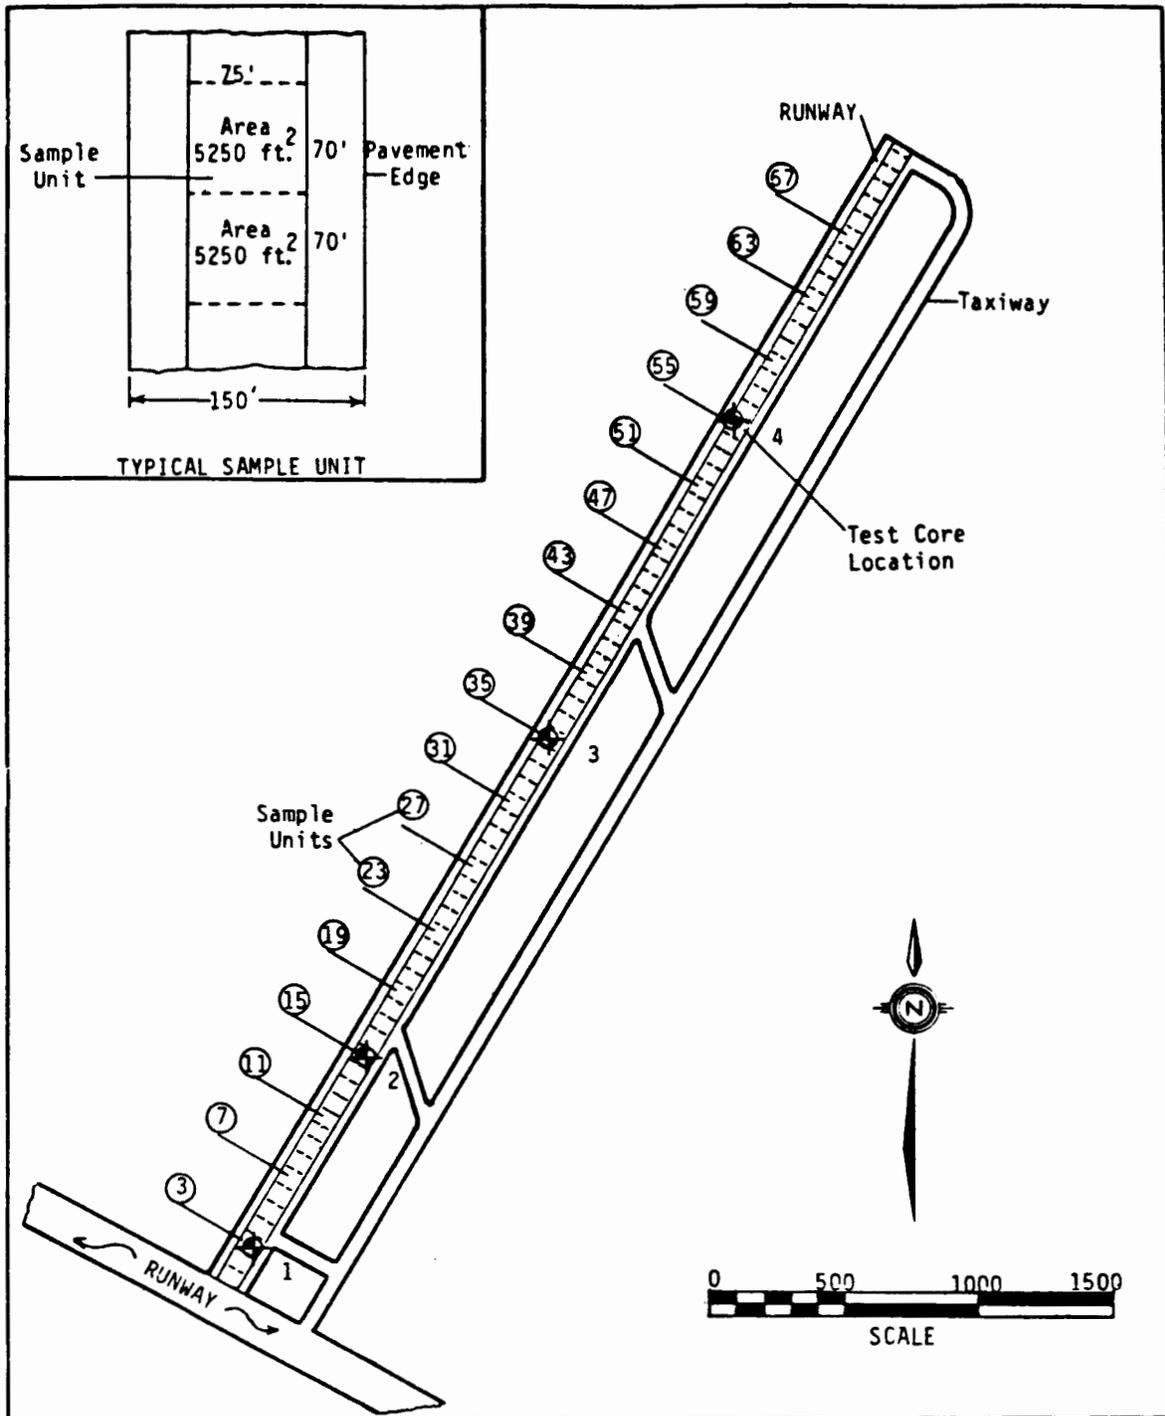
Figure 7 illustrates the layout of Runway 2-20 and location of condition survey sample units and test cores. Seventeen of the 72 sample units were surveyed. PCI values ranged from 80 to 88 with the average being 85 (see Table 2). The overall rating of the pavement is classified as very good in accordance with FAA Guidelines². The major distresses observed at Needles Airport were longitudinal and transverse cracking and raveling both of low severity. A typical view of the defects is shown in Figure 8. The primary distress mechanism is climatic effects on material durability.

FIGURE 7. SAMPLE UNIT LOCATION PLAN, NEEDLES AIRPORT, NEEDLES, CALIFORNIA.

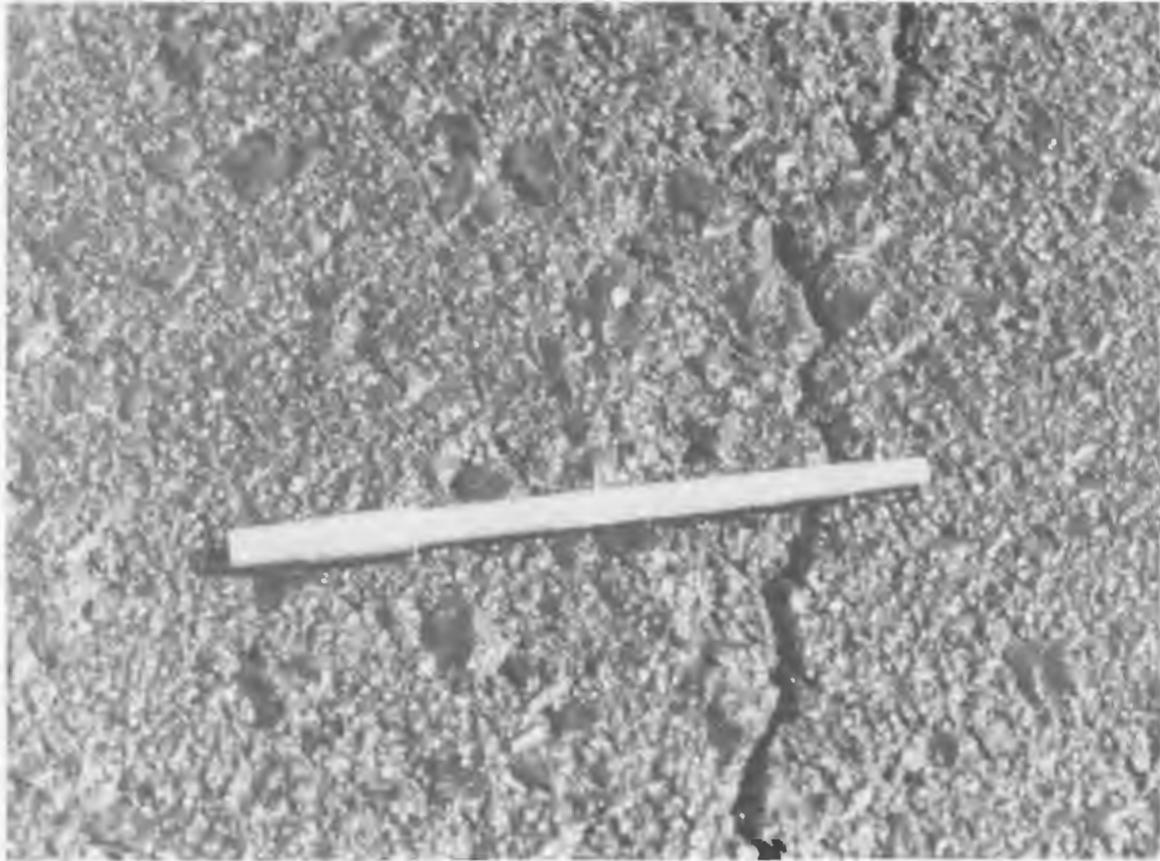
FIGURE 8. TYPICAL PAVEMENT DEFECTS (CRACKING AND RAVELING OF LOW SEVERITY) AT NEEDLES AIRPORT, NEEDLES, CALIFORNIA.

A fog seal was applied to the pavement surface in 1985. The fog seal was scheduled for 1 year after reconstruction to help keep raveling to a minimum but was postponed until raveling became evident.

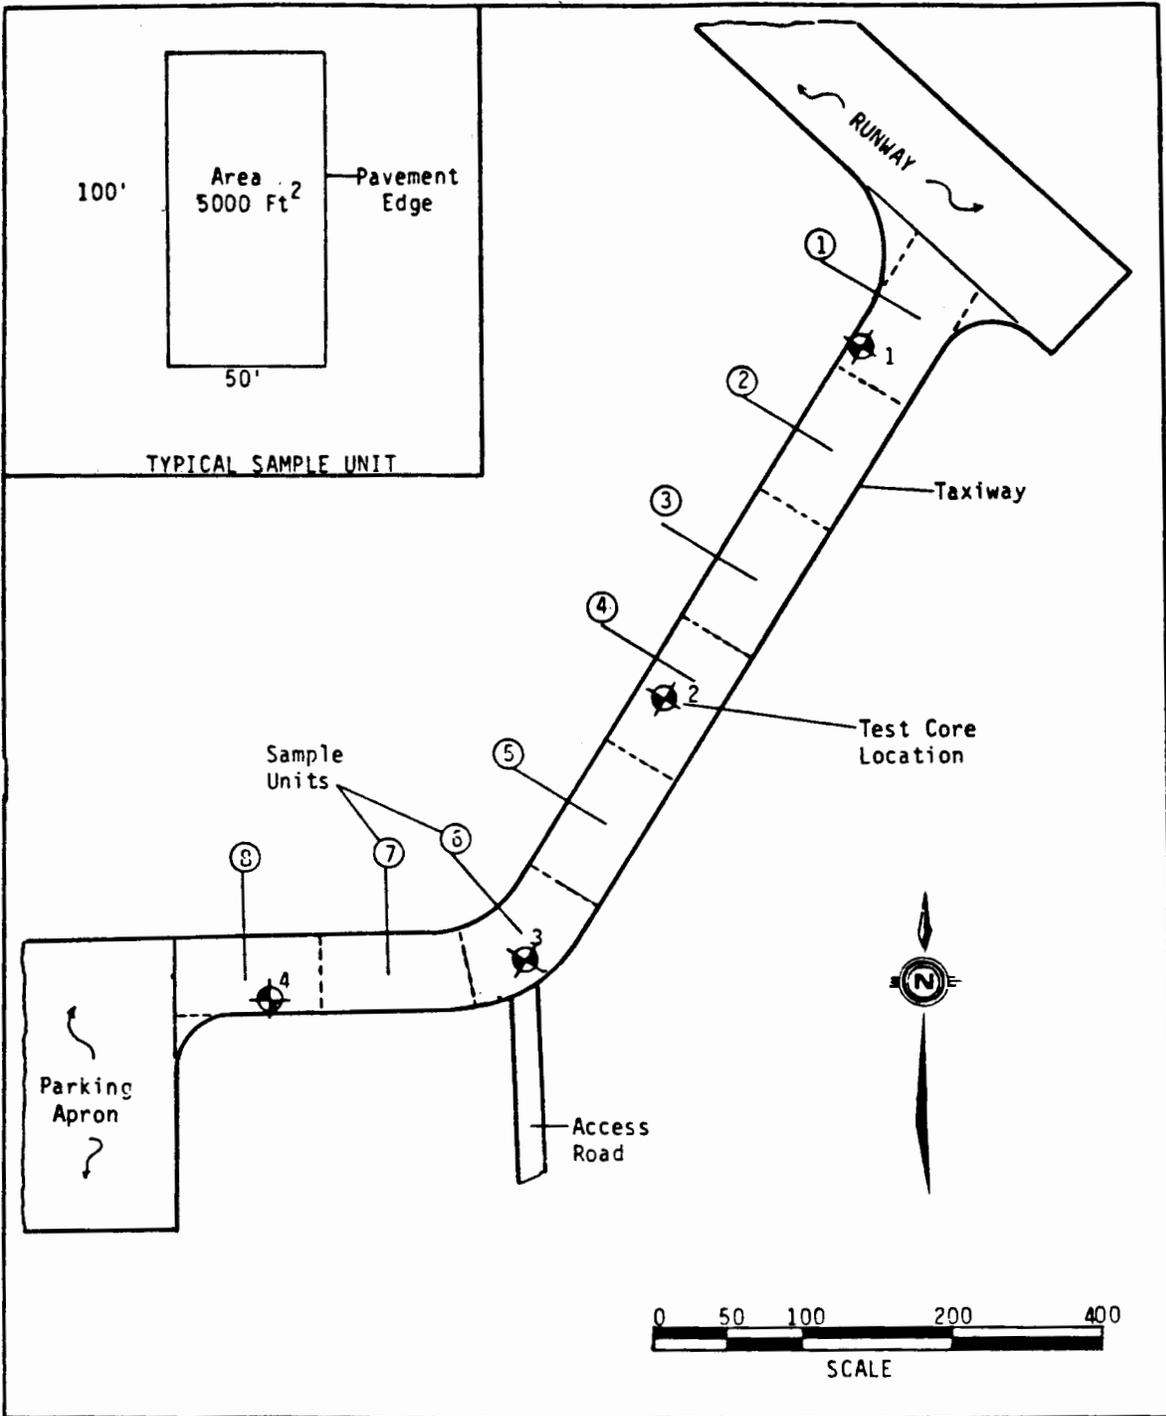
Figure 9 illustrates the layout of the Valley City taxiway and the location of sample units and test cores. All eight of the sample units representing the entire area of the taxiway were surveyed, and PCI values were calculated. PCI values ranged from 71 to 77 with an average of 75 (see Table 3). The overall rating of the pavement is classified as very good in accordance with FAA guidelines². Primary pavement distresses at the Valley City Airport were longitudinal and transverse cracking of the recycled AC and raveling of the aggregate seal. Both distress types are of low severity. A typical view of the defects is shown in Figure 10. The primary distress mechanism is climate and material durability.

FIGURE 9. SAMPLE UNIT LOCATION PLAN, BARNES COUNTY MUNICIPAL AIRPORT, VALLEY CITY, NORTH DAKOTA.

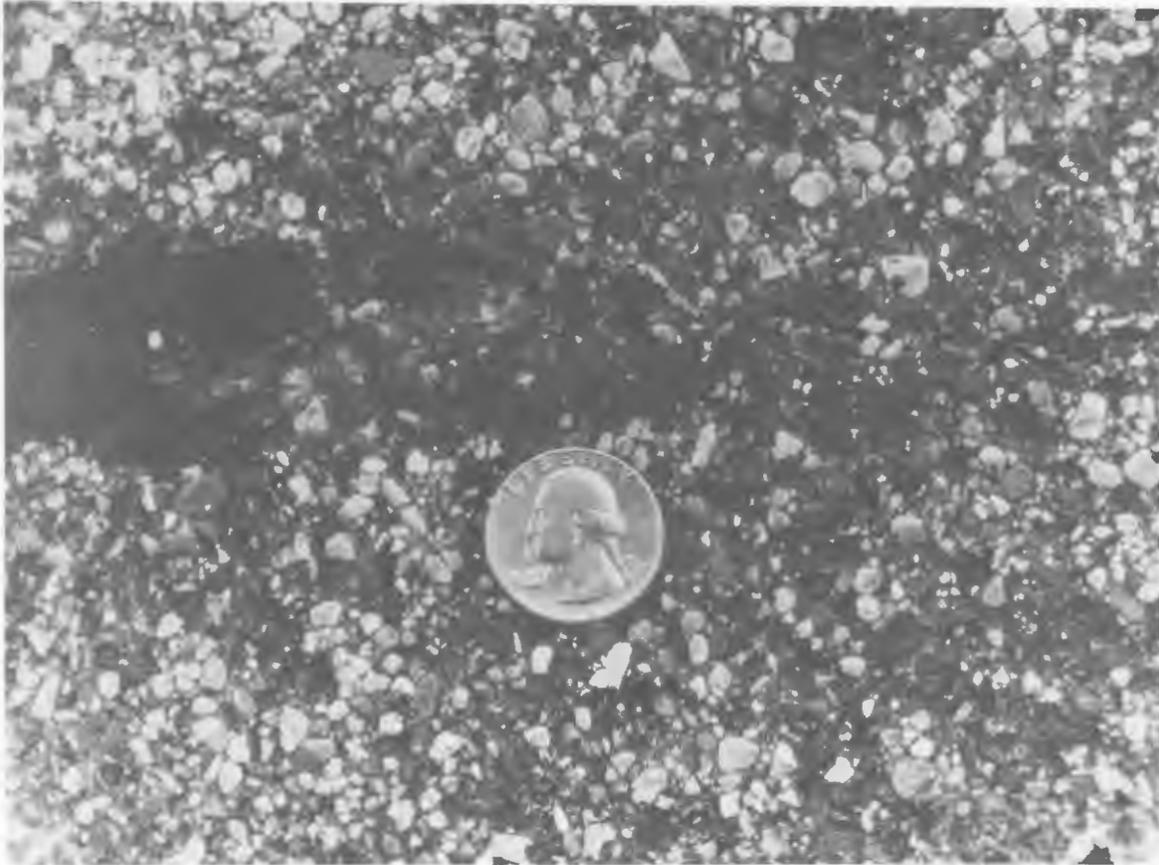
FIGURE 10. TYPICAL PAVEMENT DEFECTS (CRACKING AND RAVELING OF LOW SEVERITY) AT BARNES COUNTY MUNICIPAL AIRPORT, VALLEY CITY, NORTH DAKOTA.

Maintenance since reconstruction includes chip sealing, and crack routing and filling. A chip seal (3/8 minus aggregate) was placed immediately after reconstruction. Crack filling with asphalt cement was completed in 1981, 1982, and 1983. Crack routing and filling with rubberized asphalt was done in 1984 and 1985.

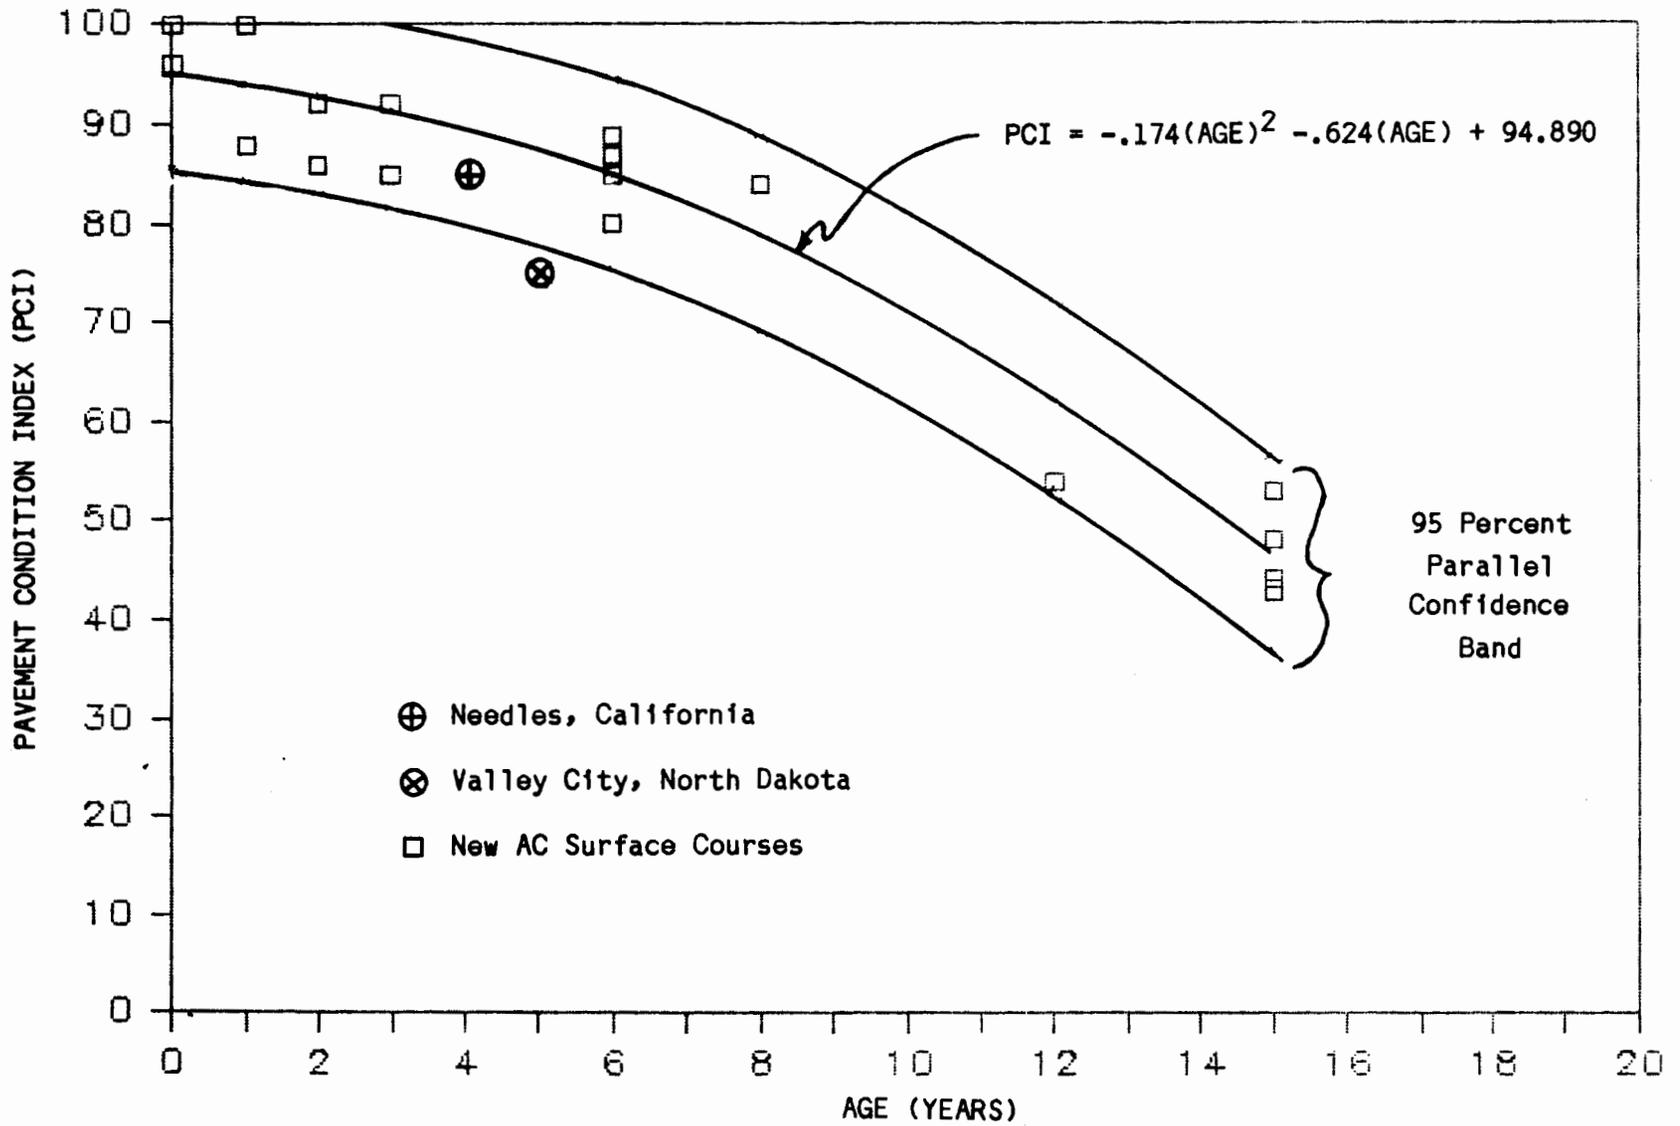
PCI values for virgin material AC pavement surfaces at Navy airfields were obtained from a report⁸ on the merits of the PCI procedure and numerous Navy airfield pavement condition survey reports. PCI values and age of surface were compared to each other and plotted. A regression analysis was then completed through the Statistical Package for the Social Sciences computer program using first, second, and third order equations. The evaluation of the results shows the second order regression equation is the most applicable to these data. Two parallel lines were developed by multiplying the standard error by 1.96, which is based on the 95 percent probability for normal distribution. These lines were then plotted on the graph, therefore creating a parallel confidence band of 95 percent. The 95 percent parallel confidence band indicates that 95 percent of any data collected from Navy airfields made of virgin material will fall within this band. Figure 11 represents the virgin AC pavement data. The two data points representing the condition of recycled surface material at the Needles and Valley City airports are also shown in Figure 11. Needles PCI value is well within the 95 percent confidence band while Valley City PCI is outside the band on the low side.

The recycled surfaces have low volume traffic and light aircraft while the virgin surface samples were used by heavier aircraft and subjected to higher volume. The kneading effect of traffic tends to keep an AC pavement "alive." Thus, assuming that heavier use is beneficial, PCI values at both Needles and Valley City airports should be lower than Navy airfields of the same age. This holds true for Valley City but generally in harsh climates, as is found in North Dakota, any surface materials do not perform as well as those in mild climates. The Needles airport recycled surface seems to be in the same condition as would be expected of a virgin surface.

FIGURE 11. PAVEMENT CONDITION INDEX VERSUS AGE OF RECYCLED AC SURFACE COURSES AT NEEDLES, CA AND VALLEY CITY, ND AIRPORTS COMPARED TO NEW AC SURFACE COURSES AT NAVY AIRFIELDS.

4. A regression analysis of PCI values versus age for Navy pavements constructed with virgin AC materials was made. The comparison of the results from this analysis with the values for the two recycled pavements surveyed showed that the performance of the pavement at Needles, California is within the 95 percent parallel confidence band and the pavement at Valley City, North Dakota is slightly outside this band on the low side. The performance of this latter pavement may be due more to the harsh environment rather than the pavement being constructed out of recycled material.
