# Field Performance of Fiber-Reinforced Concrete Airfield Pavements

Raymond S. Rollings

Geotechnical Laboratory  
DEPARTMENT OF THE ARMY  
Waterways Experiment Station  
Corps of Engineers  
Vicksburg, Mississippi 39180

July 1986  
Final Report

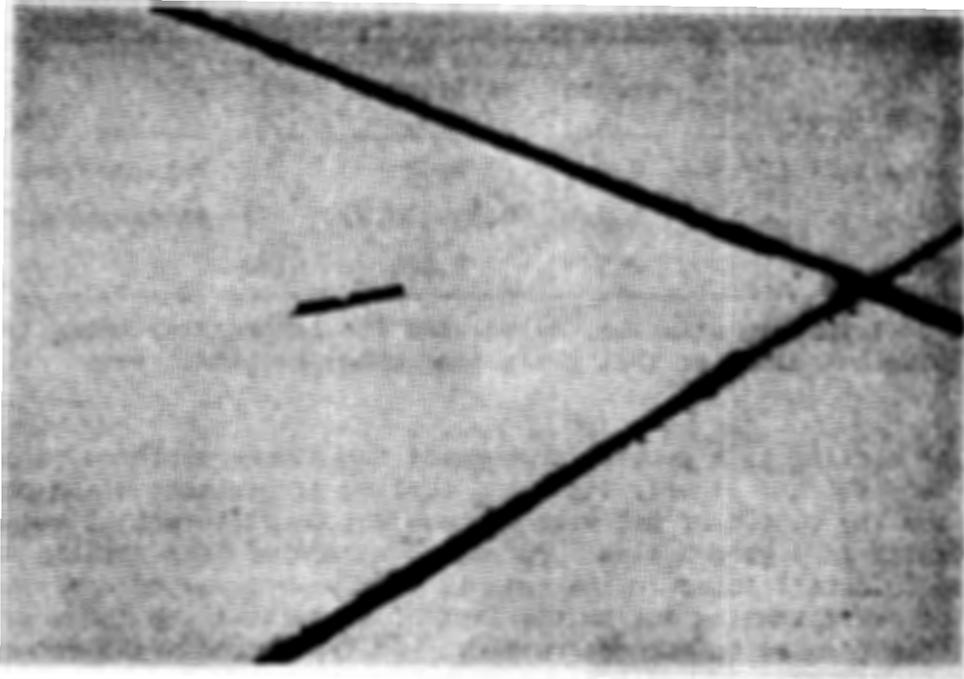
Figure 1. Typical corner crack in steel fiber-reinforced concrete

Slab curling is a problem throughout the fiber-reinforced concrete overlay and is sometimes clearly visible. Curling of pavement slabs occurs when the top and the bottom of the slab are subject to differential volume changes which results in a warped slab. Potential causes of this curling will be discussed in detail later in the report. The upward warped corners are vulnerable to overstressing due to the lack of support at the corners. Under traffic this results in corner cracking. In trafficked areas corner cracks are common, and sometimes all four corners at joint intersections have cracks. Typically, these consist of a crack 1 to 3 ft from the corner, such as that shown in Figure 1. The cracks are generally tight, without spalling. Occasionally, corner cracks have deteriorated, and in extreme cases, the corner has sheared off the slab and can be depressed as much as 1/2 in. below the upward warped slab. A typical deteriorated corner crack is shown in Figure 2, and a corner with two cracks is shown in Figure 3.

Figure 6 shows the original crack patterns in the base pavement and the progression of cracking in the overlay project through the next 12 years. Within 6 months cracks in the base pavement began to reflect through both overlays. Also, by this time, the lower transverse joint edge at sta 95+00 of the 4-in. overlay had begun failing badly with intersecting cracks and spalling. Reflective cracking continued in both the 4- and 6-in. overlays. Load-related intersecting cracks and spalling developed in the 4-in. overlay as early as 6 months and became extensive by 9-1/3 years. The 6-in. overlay has some load-related cracking at sta 102 at 9-1/3 years and this deteriorated into faulting, additional cracking, and spalling at 12-1/3 years. Load-related cracking appeared to begin at the transverse construction joints at the project ends where edge loading and high stresses would be expected. Figure 7 shows the extent of cracking at the edge of the fiber-reinforced pavement, and Figure 8 shows the development of additional cracking between older sealed cracks. Figure 9 shows the development of spalling along some cracks. Corner cracking such as that seen in Figures 1 through 3 was not observed in Tampa.

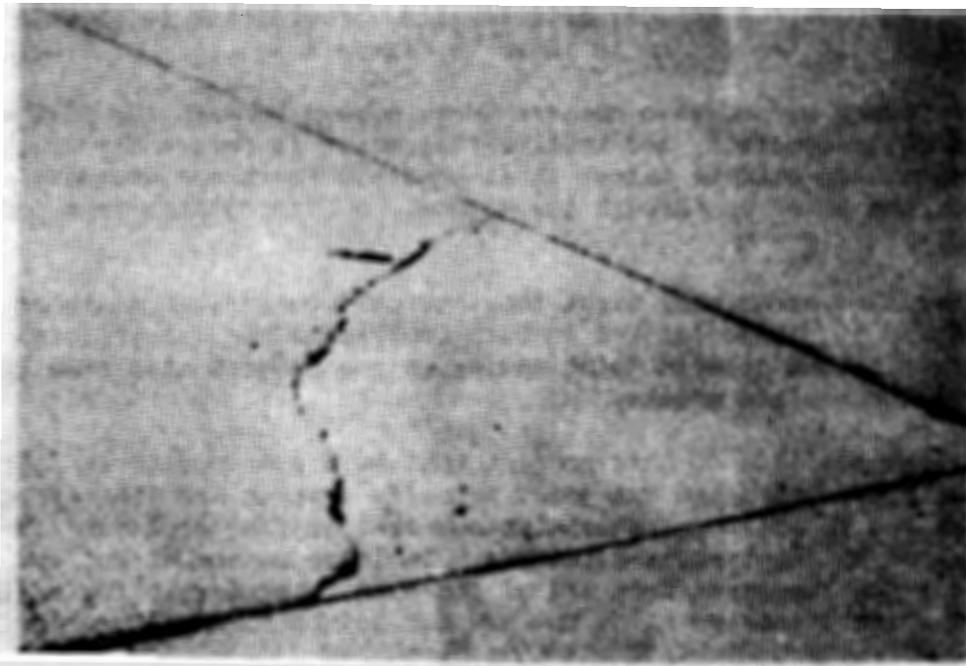
Figure 2. Deteriorated corner crack in steel fiber-reinforced concrete

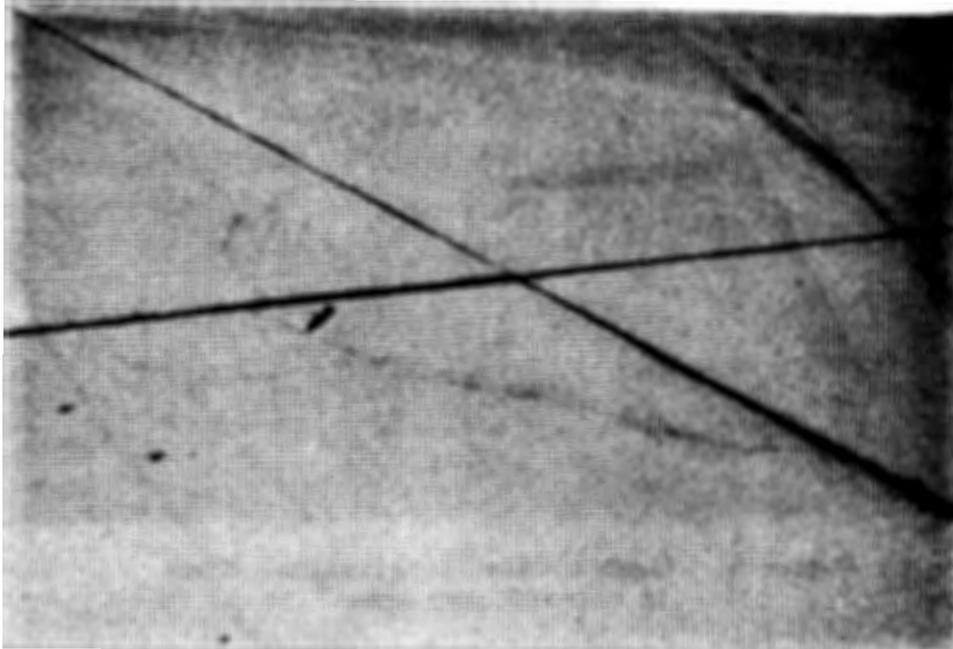
Figure 3. Multiple cracks in steel fiber-reinforced concrete

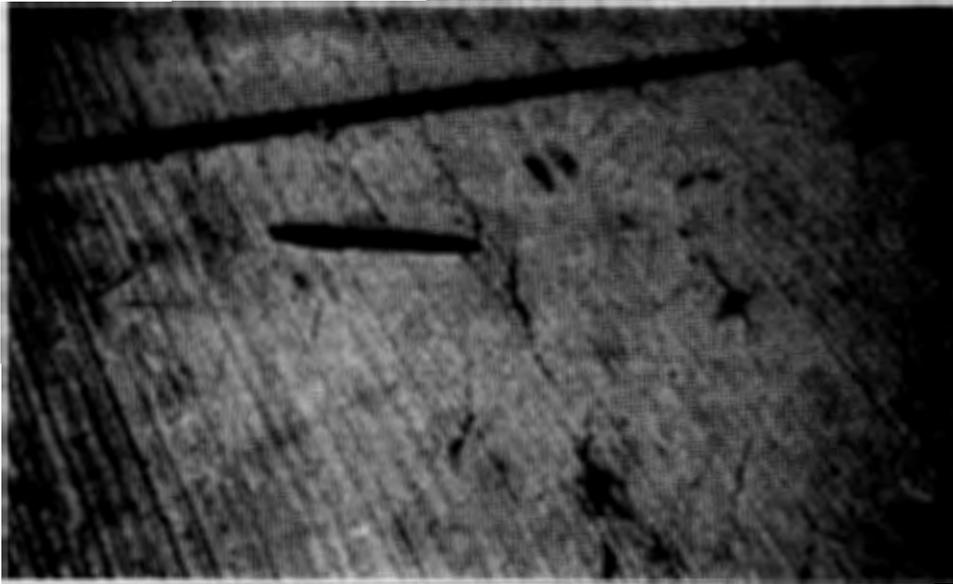
Figure 5. Tight midslab longitudinal crack  
in untrafficked area

There were occasional tight longitudinal cracks such as those seen in Figures 4 and 5. These existed in both trafficked and untrafficked portions of the apron. Some delayed joint sawing on one project also resulted in a few transverse contraction cracks.

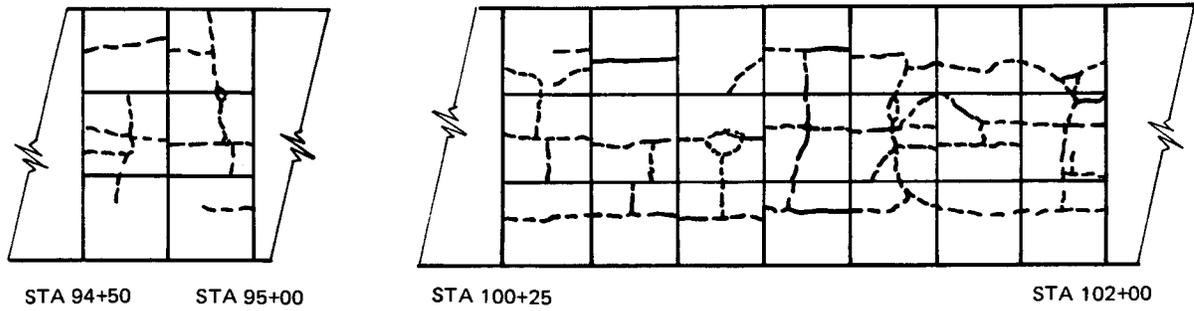
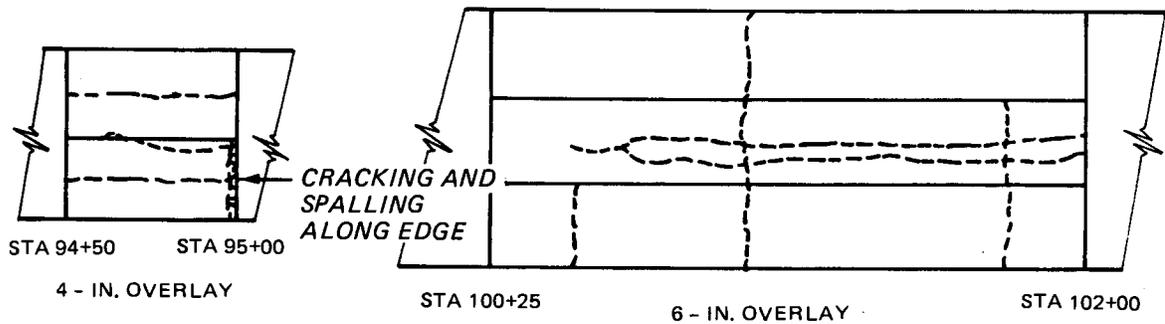
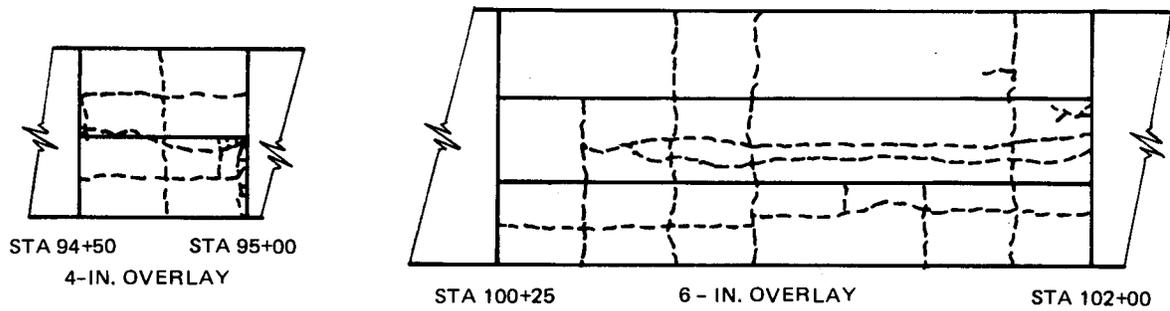
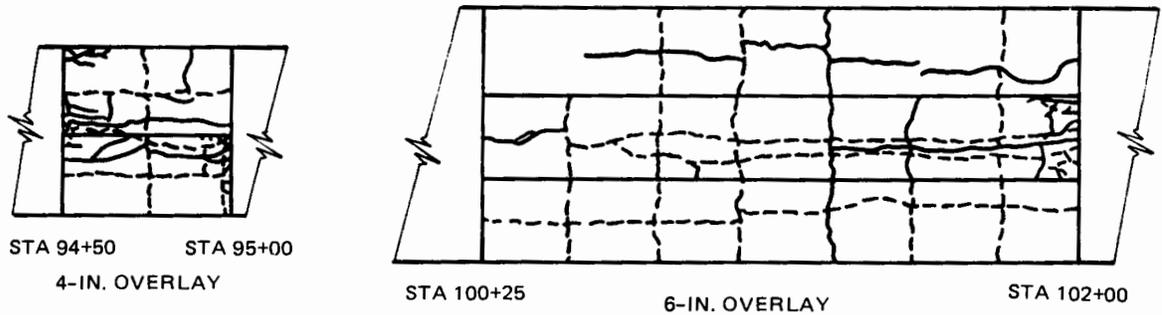
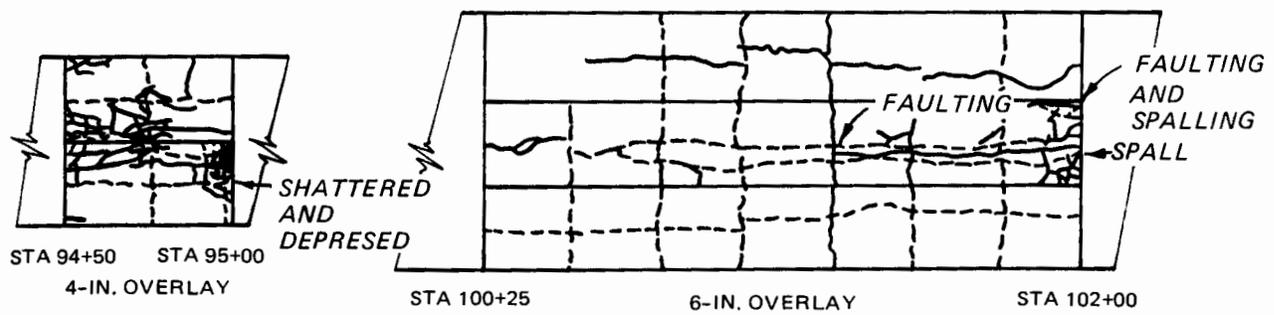
a. Joint and crack pattern in base pavement, 2/72

b. Crack pattern in overlays--6 months, 8/72

c. Crack pattern in overlays--28 days, 6/74

Figure 6. Crack pattern development, Tampa airfield pavement (Continued)

d. Crack pattern in overlays--112 months (9-1/3 years), 6/81

e. Additional damage observed--148 months (12-1/3 years), 6/84

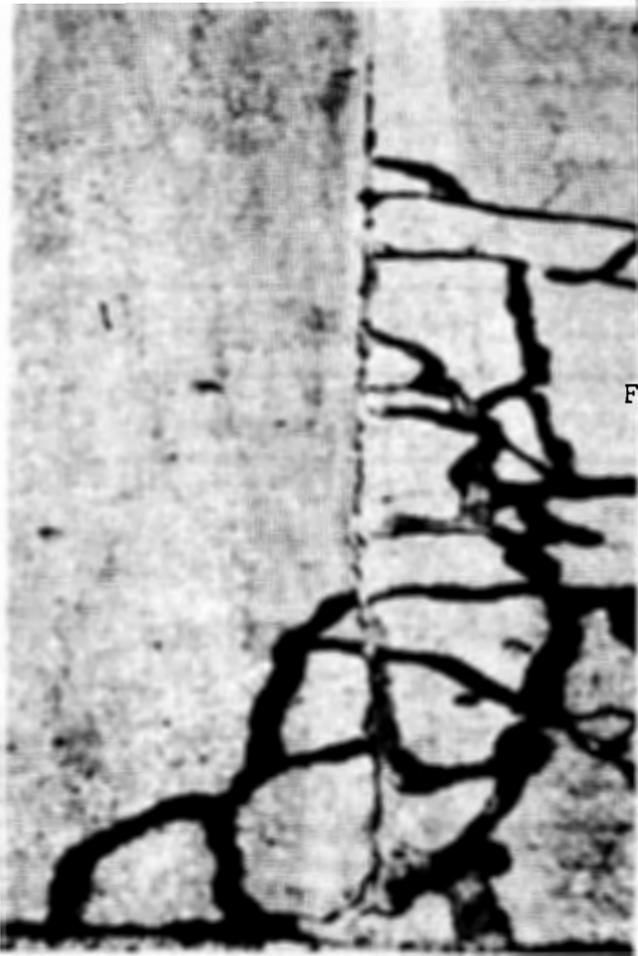
Figure 7. Edge cracking, Tampa airport pavements

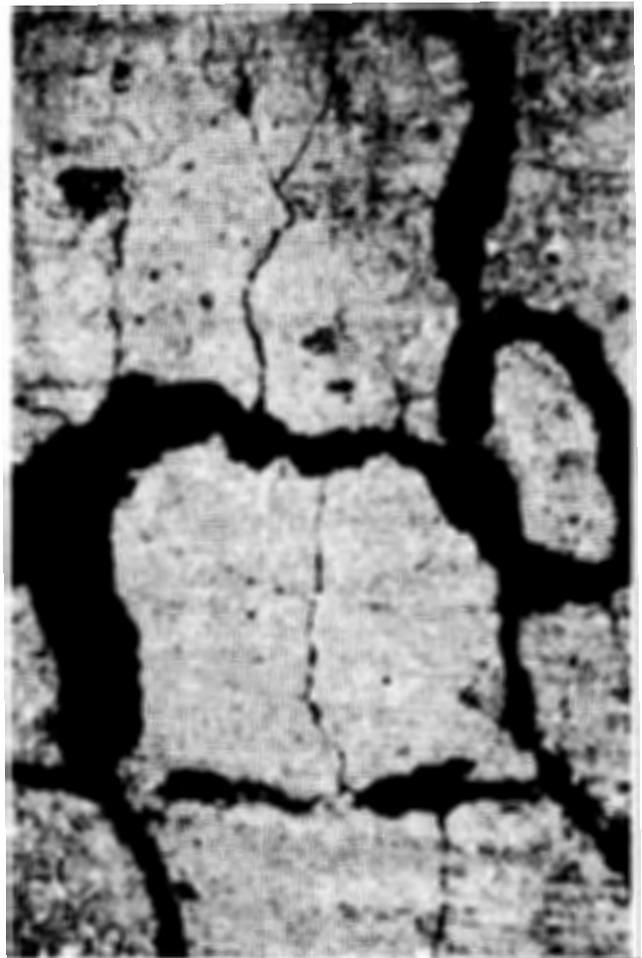
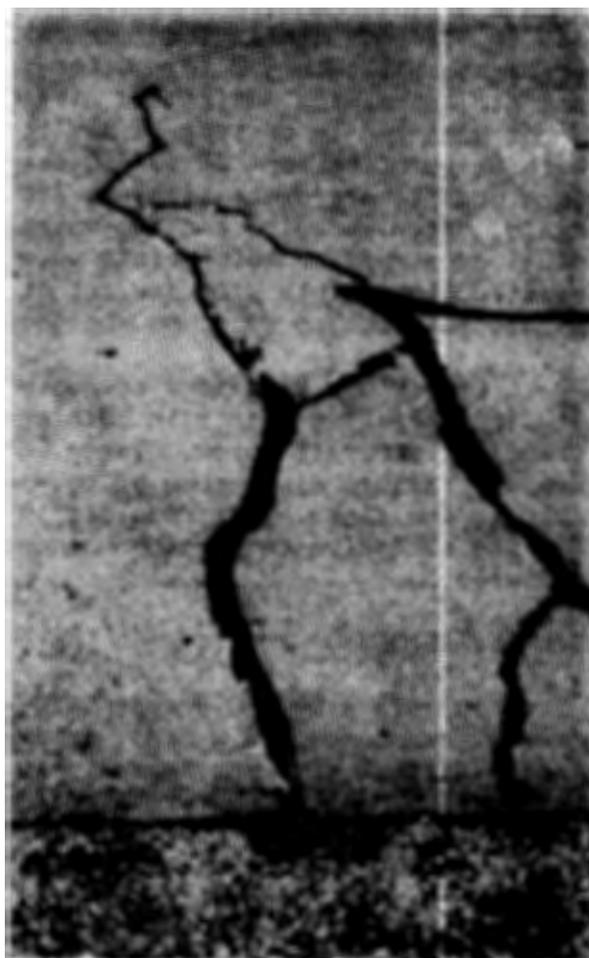
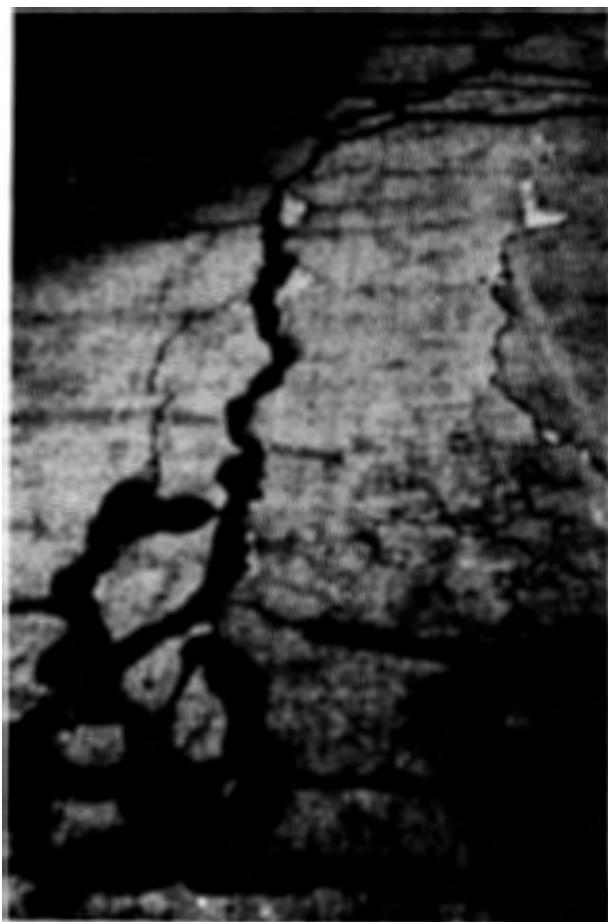
a. Cracking with development of spalling

b. Cracking with more severe spalling

Figure 9. Development of crack and spalling, Tampa airport pavement

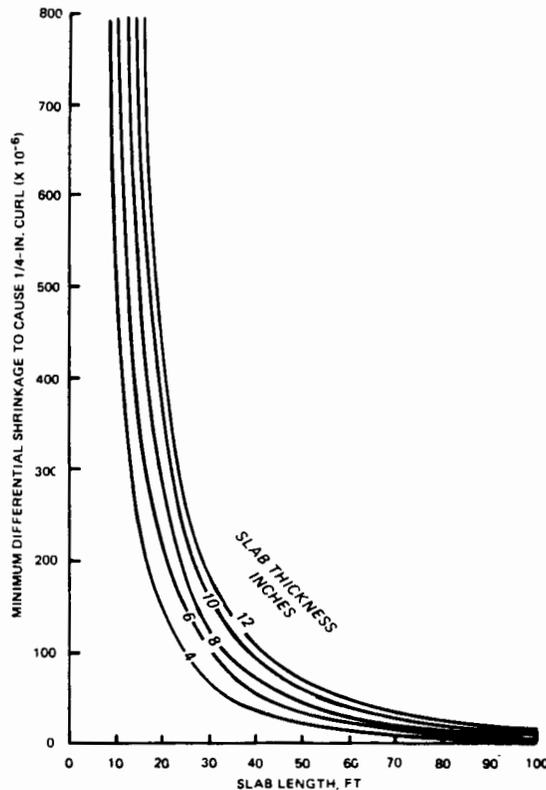
Figure 10 shows the minimum differential shrinkage that would cause a 1/4-in. curl as calculated by the above equation for different slab thicknesses and lengths. Using the maximum slab lengths and the thicknesses shown in Table 3, Tampa would curl for differential shrinkages of  $10 \times 10^{-6}$  or more,

Figure 10. Shrinkage required to cause 1/4-in. curl

Autogenous Shrinkage. Autogenous shrinkage resisted by frictional forces between the bottom of the slab and the underlying layers offers the most promising explanation of the curling problem in fiber-reinforced concrete pavements. This explanation agrees with the early age at which curl is observed, and autogenous shrinkage is large enough to cause curl for the slab lengths and thicknesses used in fiber-reinforced airfield pavements. This is further supported when consideration is given to the facts that Figure 10

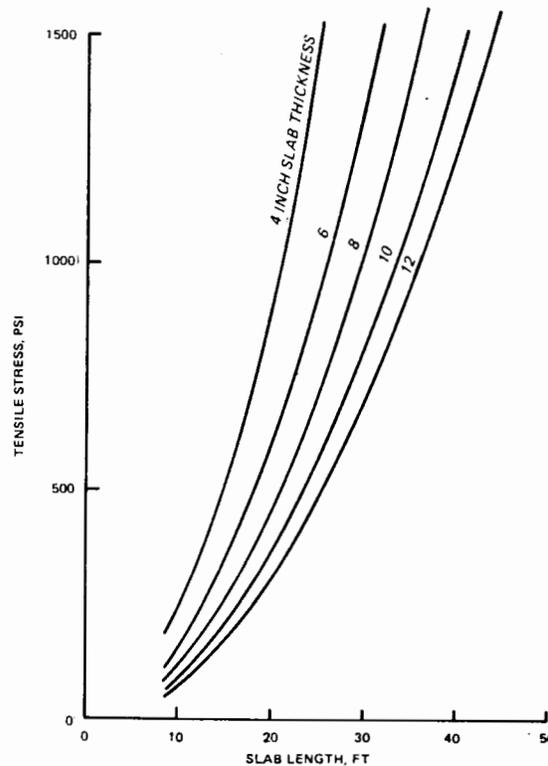
Figure 11 shows the tensile stress calculated from the above equation that will develop cracking for slabs of various thicknesses and lengths. The midslab longitudinal cracking seemed to be most prevalent at Norfolk, Las Vegas, and Denver, and the tensile stresses for these locations are shown in Figure 12. These stresses range from 705 to 1,150 psi. Steel fiber-reinforced concrete commonly develops 900- to 1,100-psi flexural strength for paving mixes which would appear to be adequate to resist the tensile stresses encountered in Denver and Las Vegas. However, these stresses develop as volume change occurs, so the development of cracking requires that the volume change must produce these critical cracking stresses before the concrete develops adequate strength to resist them.

Figure 11. Cracking tensile stress for slabs subject to volume change with discontinuous base shear restraint

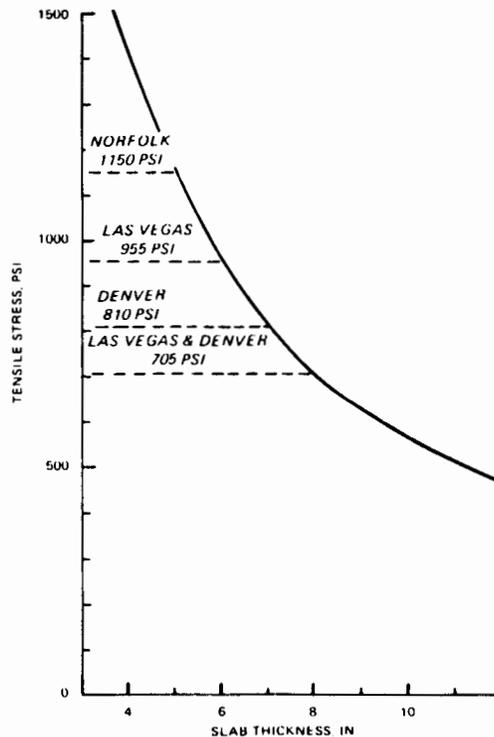
Figure 12. Tensile stress developed for 25-ft-wide placement lanes at several airports

This type of cracking appears to be due to the same volume change and large, thin slabs that caused the problems with slab curling. Use of the recommended slab dimensions shown in Table 4 will maintain the cracking tensile stress in Figure 11 between 340 and 480 psi which is considerably below that found in Figure 12.

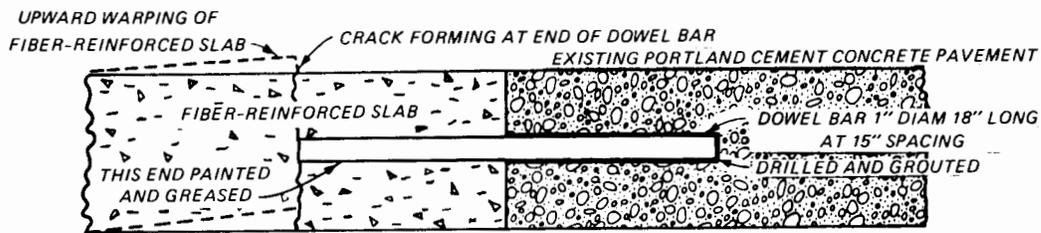
This cracking adjacent to doweled longitudinal joints at Denver is probably due to the upward curl of the fiber-reinforced concrete slabs. As the fiber-reinforced concrete slab shown in Figure 13 tries to curl upward, it is restrained by the dowels in the adjacent uncurled conventional concrete. This curl is occurring at an early age when the fiber-reinforced concrete is still gaining strength, and a crack forms at the end of the dowel bars to allow the remainder of the slab to curl.

Figure 13. Cracking at doweled longitudinal joint, Denver Airport

Several mechanisms may occur to help avoid this kind of cracking parallel to a doweled longitudinal construction joint between lanes of fiber-reinforced concrete and to explain its relative infrequency at Denver.

Concrete placement usually proceeds by skipping lanes. Dowels are then inserted in holes drilled in the slab edges, and finally concrete is placed in the fill-in lanes. The slab lanes which are first placed and drilled for dowels may have already curled by the time the fill-in lanes are placed. The passage of the equipment placing and finishing the fill-in lanes may deflect the upward curled adjacent slabs downward. After passage of the concrete placement equipment, these slab edges will curl up again and lift the fill-in slab edges or deform the freshly placed concrete sufficiently to allow later upward movement of the dowel bars when the newly placed slab cures. The newly placed concrete of both lanes may also allow sufficient deformation of the concrete around the dowel bars because of low bearing strength at early ages to tolerate some curling. Therefore, curling in adjacent slabs can usually be tolerated without cracks forming over the bar ends.

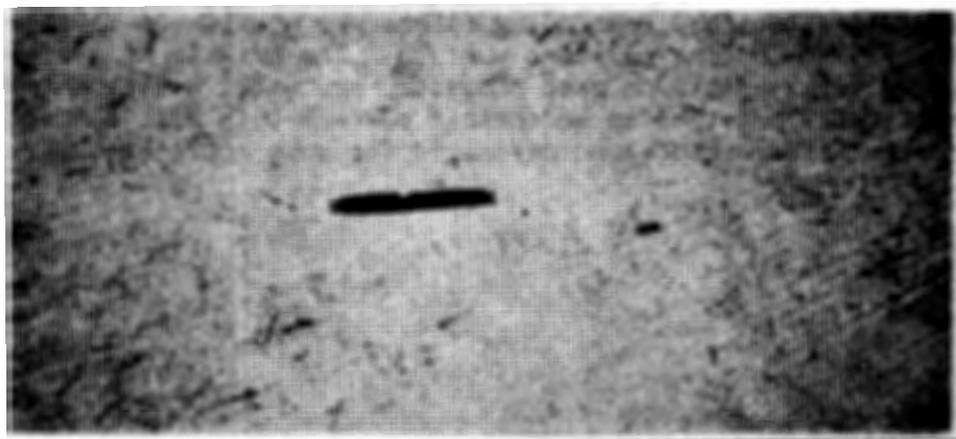
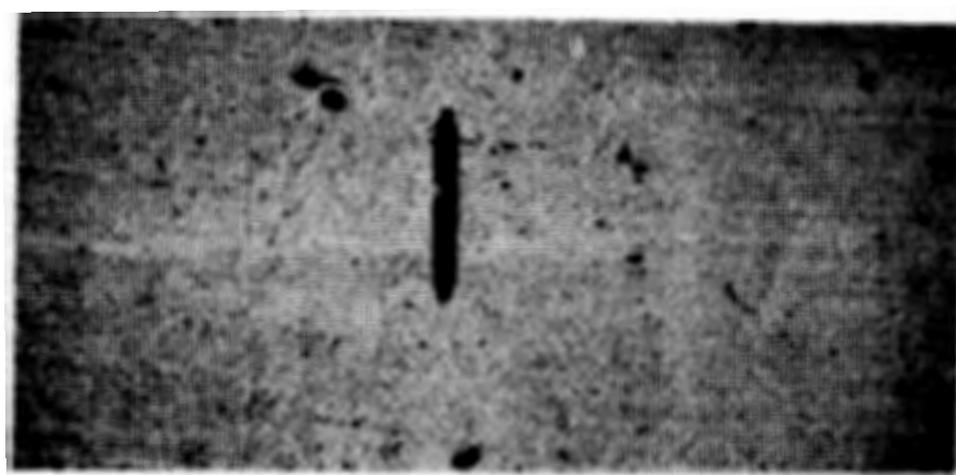
a. Rough texture with excessive exposed fibers

b. Fairly smooth surface with fewer exposed fibers

c. Smooth texture with minimal exposed fibers

Figure. 14. Examples of variable final finish of fiber-reinforced concrete

An improved method to consistently provide a finished surface free of loose and protruding fibers must be developed. Loose fibers are perceived as a hazard to certain aircraft. Protruding fibers are a nuisance to maintenance personnel who must work on the pavement surface. The quality of surface finishing has varied considerably on past projects, and until a method is developed that consistently provides an acceptable surface this will be detrimental to the use of steel fiber-reinforced pavements for some applications.

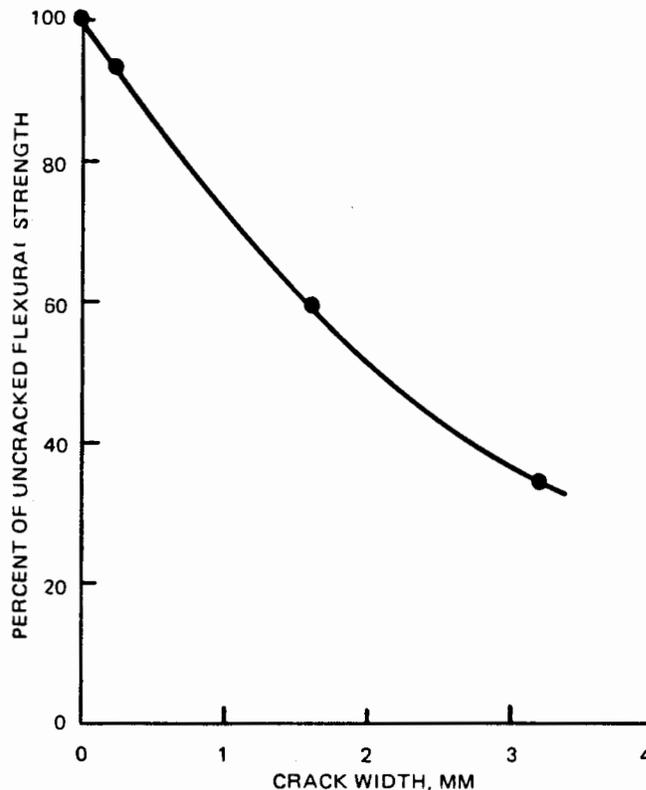
Figure 15. Average reduction in flexural strength for cracked beams after 1.5 years exposure to seawater (after Morse and Williamson<sup>13</sup>)

These results led Morse and Williamson<sup>13</sup> to define a critical crack width to be 0.25 mm. Additional laboratory tests found that 40 applications of a wet-dry saltwater environment to specimens with crack widths greater than this critical value resulted in sufficient corrosion to destroy the ability of these fibers to bridge the crack. At this point 90 percent of the steel fibers bridging the crack contributed little or no benefit to maintaining the specimen's integrity. This work supports Parker's<sup>16</sup> definition of failure for steel fiber-reinforced concrete pavements. Tight hairline cracks 0.25 mm wide or less do not lead to corrosion of fibers bridging the crack and do not represent failure of the pavement. Once the crack opens to a width greater

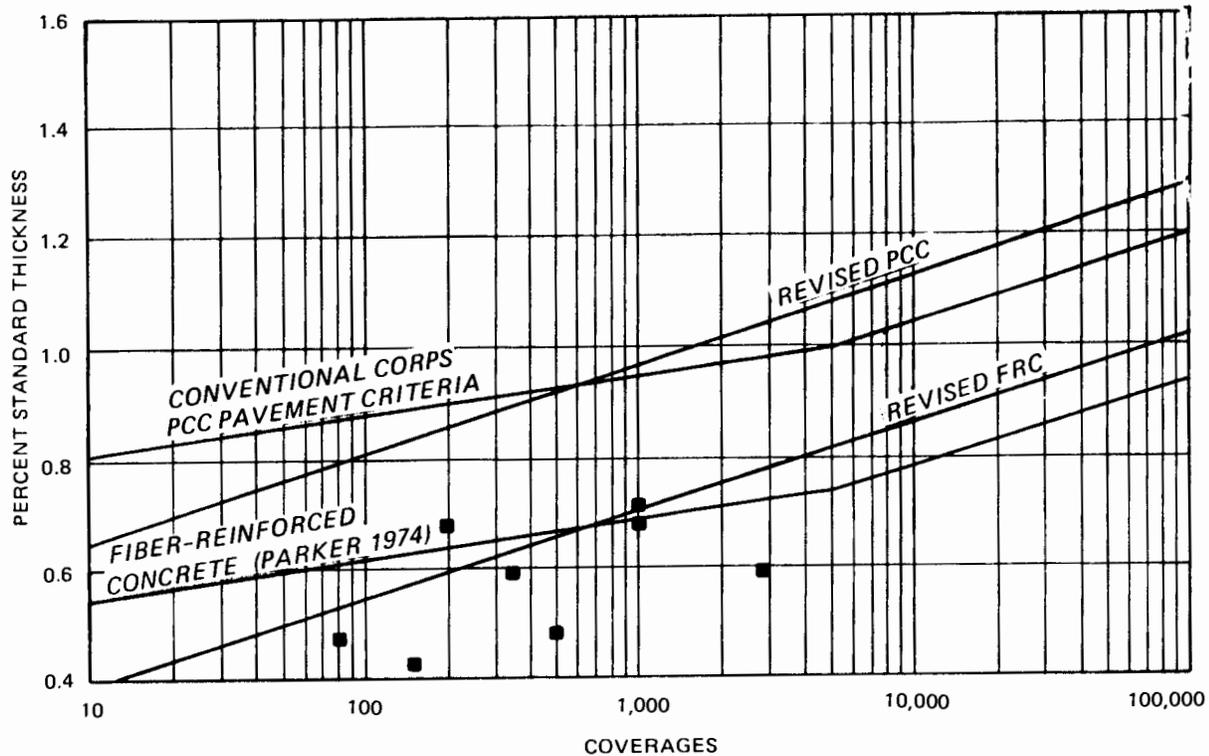
Figure 16. Steel fiber-reinforced concrete performance criteria using percent standard thickness

the time saving advantages of using the percent standard thickness have largely disappeared. The Corps of Engineers concrete pavement performance criteria are now calculated in terms of design factor versus coverages.

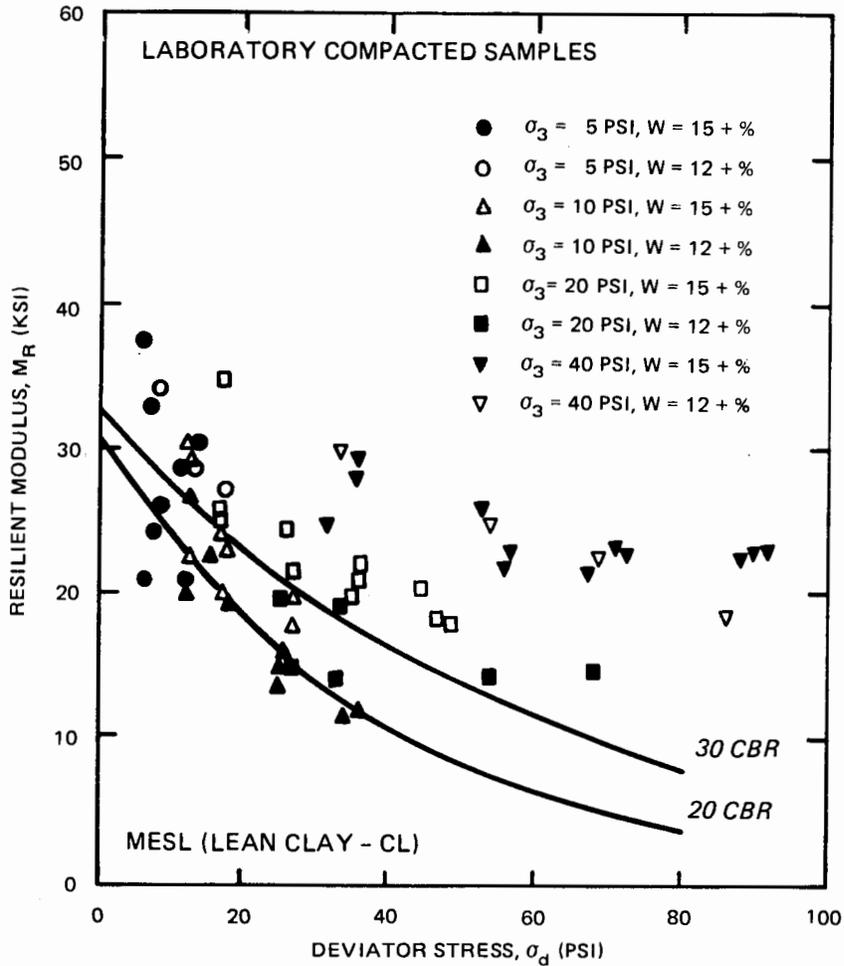
Figure 17. Resilient modulus data for lean clay used in MESL construction

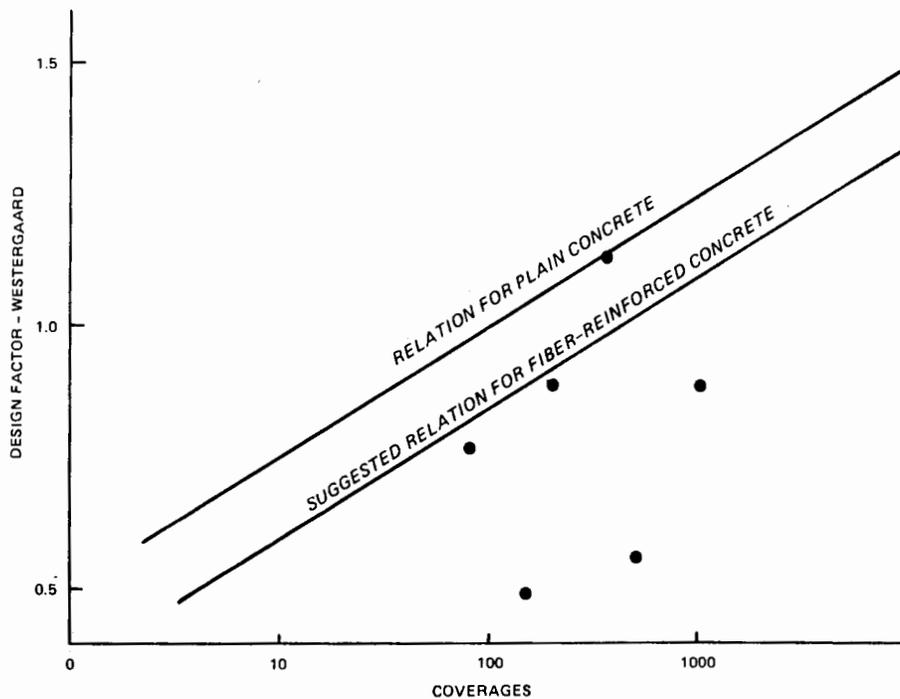
Figure 18. Steel fiber-reinforced concrete performance criteria using Westergaard based design factor

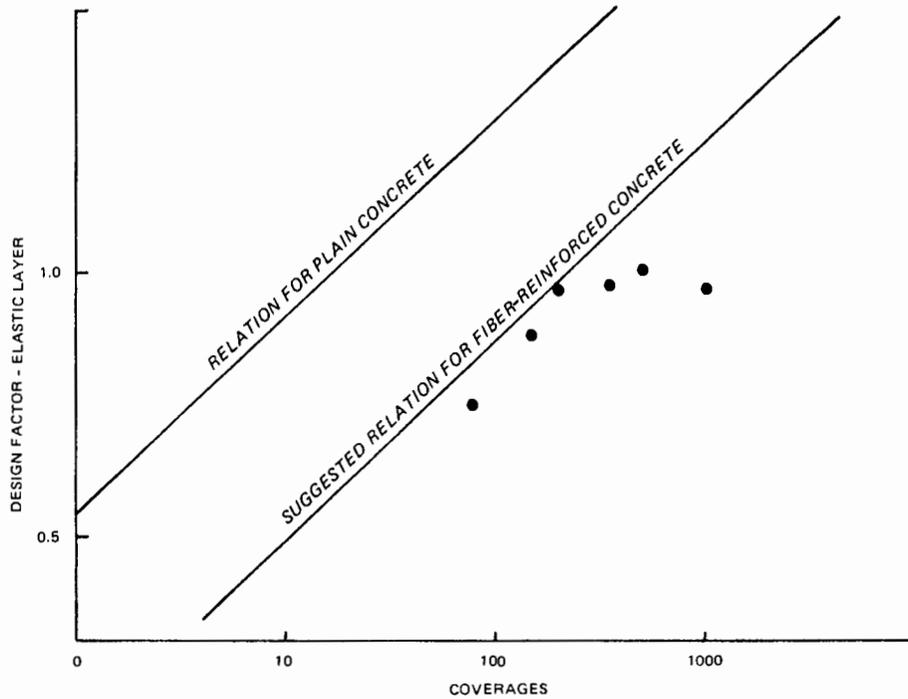
Figure 19. Steel fiber-reinforced concrete performance criteria using elastic layer based design factor
