DOT/FAA/RD-82/38
DOT/FAA/CT-82/21

Coast Terminal Radar Approach Control Facility (TRACON) Refurbishment

August 1982

Final Report

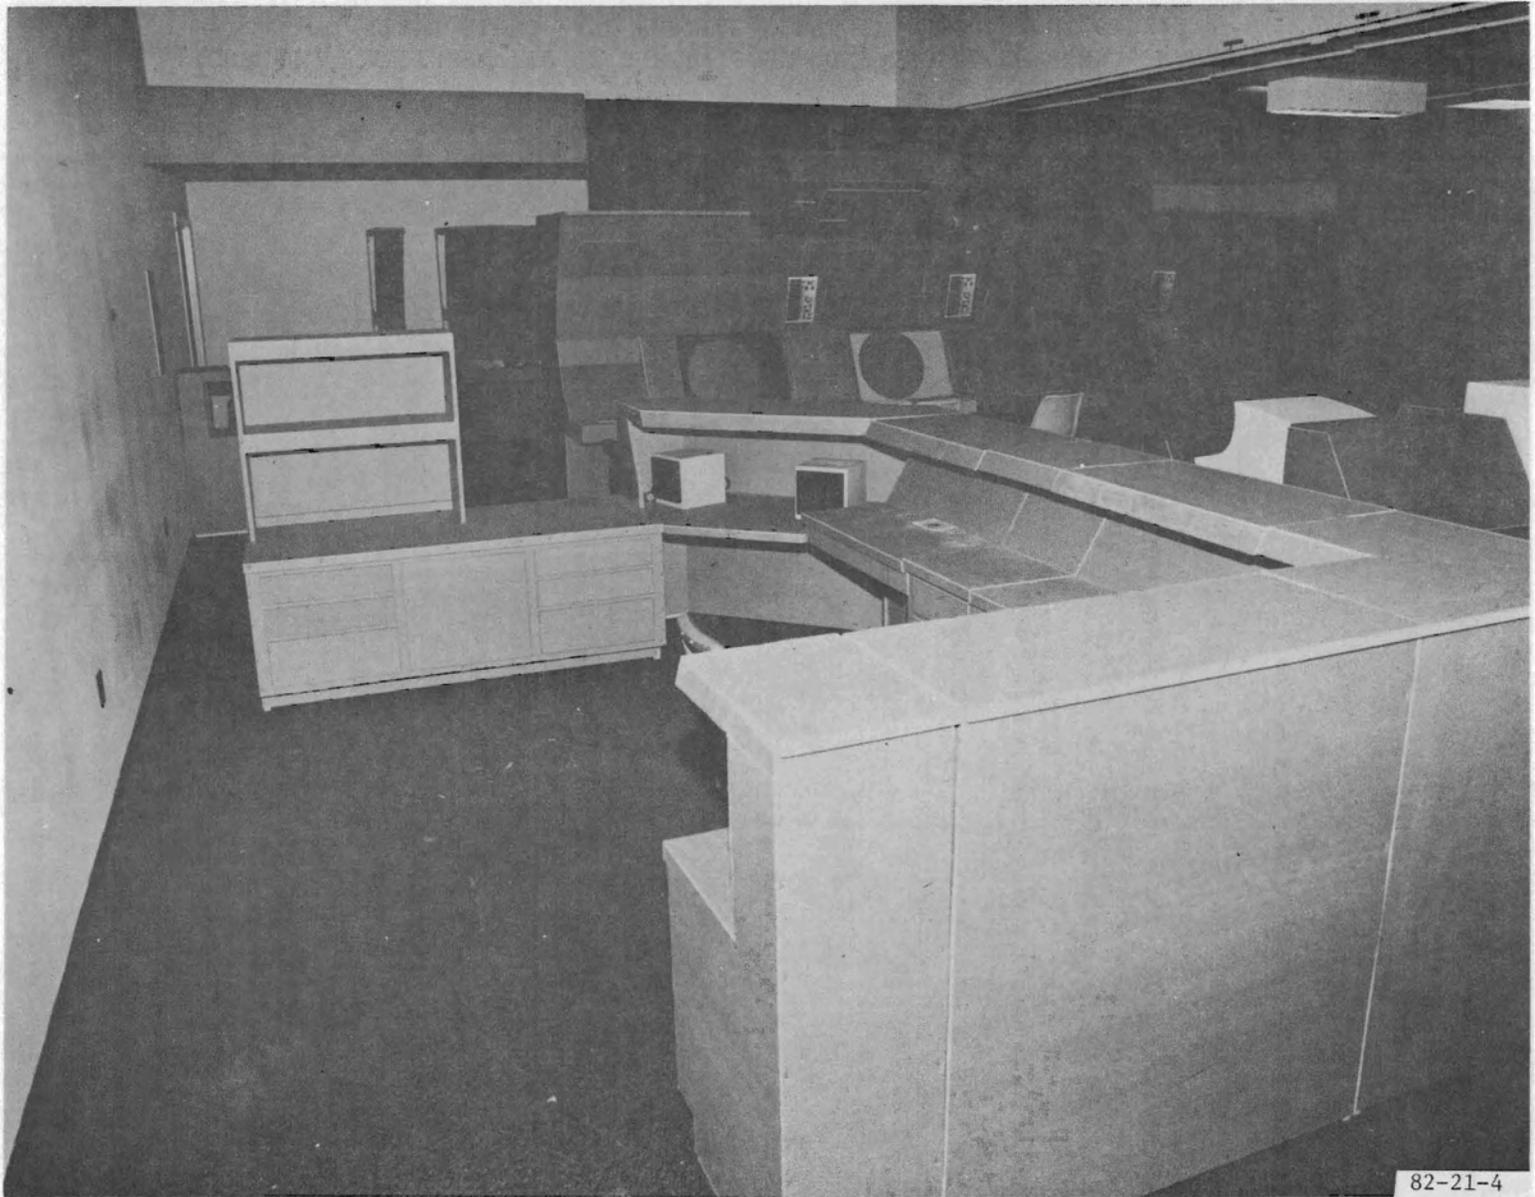
FIGURE 4. SUPERVISORY CONSOLE (FOREGROUND); DUKE, ORANGE, AND TUSTIN DISPLAYS (BACKGROUND) PLUS ASSOCIATED HANDOFF POSITIONS

A full-scale mockup which contained all of the positions and equipment presently found in the Coast TRACON was fabricated at the Air Traffic Control Facilities Configuration Laboratory. (See figures 2 through 7.) In consonance with this, the present day instrumentation, as used with the Coast TRACON horizontal displays, was located in the vertical console shrouds. Measurements were taken which made it apparent that the overhead frames or shrouds that contain various equipment and controls which can accommodate present day equipment would not be able to meet the requirements for planned, futuristic instrumentation. A divider was used to mark the limits of the floor space associated with the El Toro PAR equipment which was not depicted.
