DOT/FAA/RD-93/40,1

**Synthetic Vision
Technology Demonstration**

**Volume 1 of 4
Executive Summary**

**Synthetic Vision Program Office
Federal Aviation Administration**

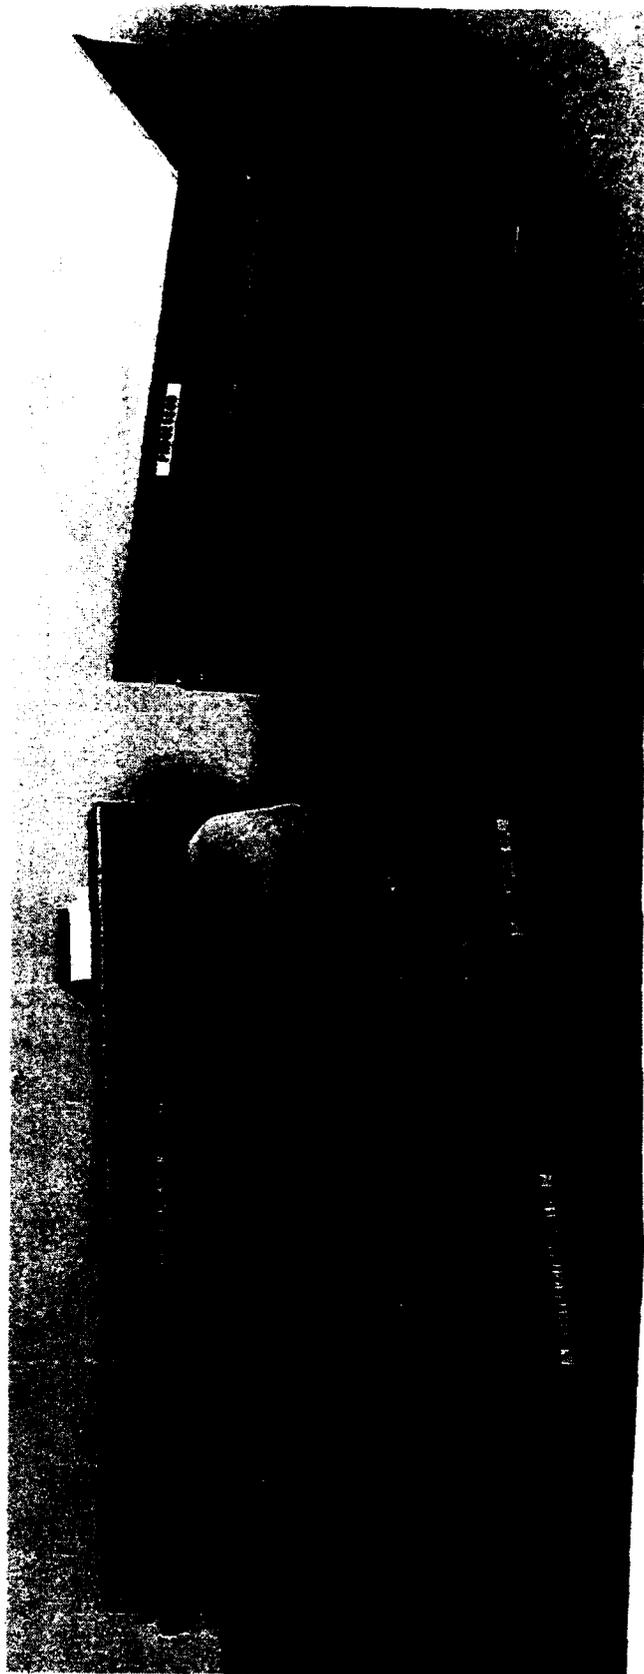
Figure 5. Honeywell 35 GHz SVS Imaging Radar Components

In June 1991, Honeywell was awarded a delivery order by the Microelectronics Technology Support Program at the Air Force Sacramento Air Logistics Center, to provide an integrated sensor system for tower testing. The delivery order was modified in December 1991, after it became clear that the primary flight test sensor would not be ready in time. The modification entailed sensor system upgrades for flightworthiness, engineering support for aircraft integration, and flight test support. The 35 GHz sensor was delivered in February 1992, hot bench integration testing was successfully completed, and the sensor was sent to the Air Force tower in March. The components of the sensor are shown in Figure 5.

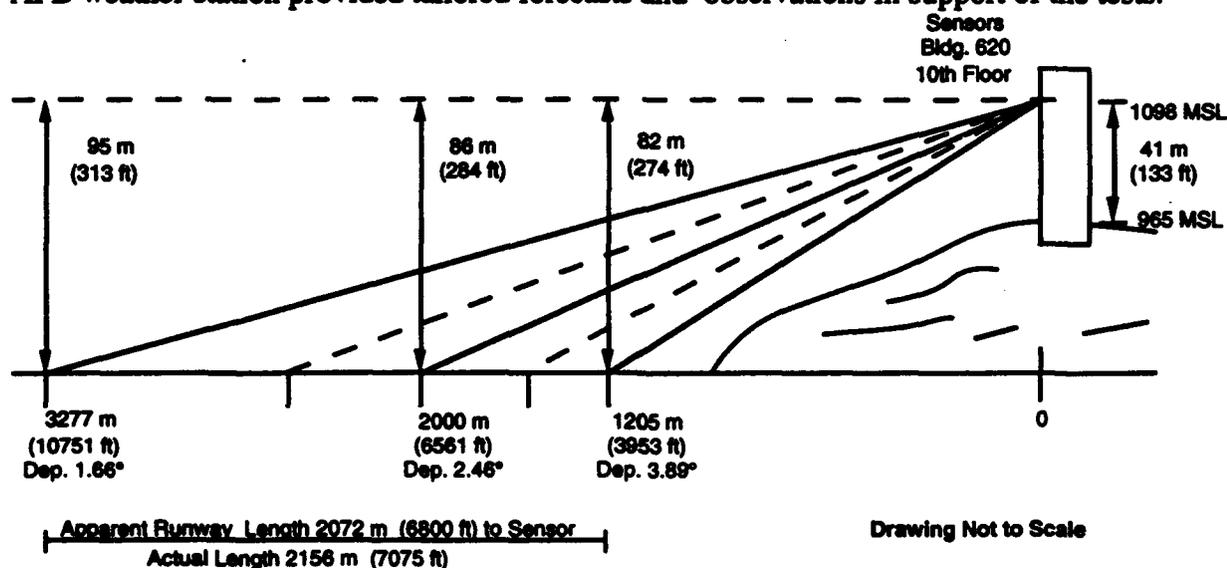
Figure 6. Elevation drawing of test area.

The scene dimensions, feature locations, and surface materials were surveyed to provide precise ground truth for comparison with sensor performance.

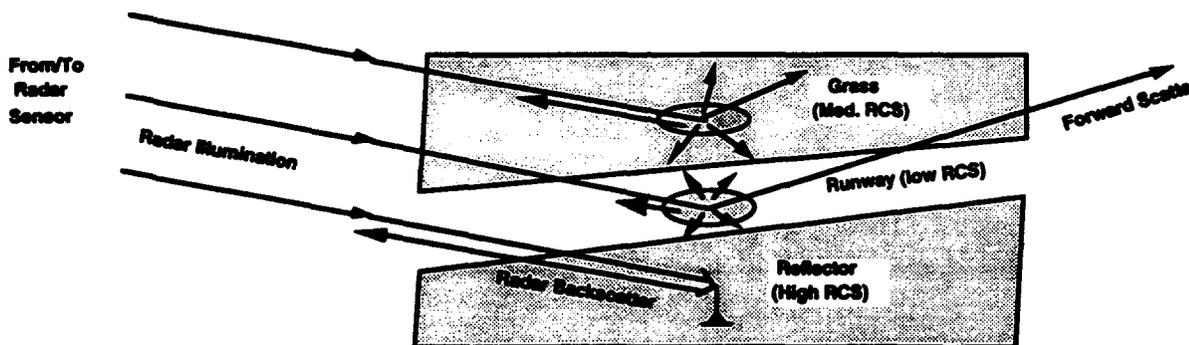
Figure 9. MMW radar detection of a runway.

A millimeter-wave (MMW) radar sensor exploits the differences in radar cross section between paved runway and bordering grass surface areas to image a runway scene, as shown in Figure 9. Radar cross section (RCS) is a measure of a target's ability to reflect radar waves. At the low incident angles encountered by an synthetic vision (SV) radar, most of the radar illumination energy is forward scattered from the smooth, low-RCS runway, and very little is backscattered to the radar receiver. The "rougher" grass areas have medium RCS and return a higher portion of the incident radar energy. A radar reflector is designed specifically to have high RCS and backscatters a large portion of the incident radar energy.

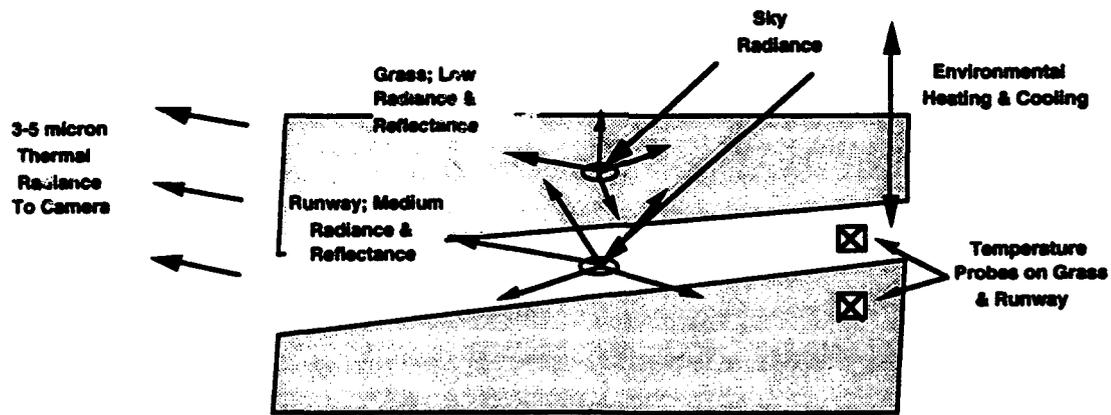
Figure 10. IR detection of a runway.

wavelength range accepted by an IR camera is based on the type of sensitive detector element used. Image contrast is developed by the differences in radiance received from the typically warmer pavement and the typically cooler grass areas within an airport scene. The actual radiance difference is a function of environmental heating and cooling during the daily cycle, grass moisture, and meteorological events.

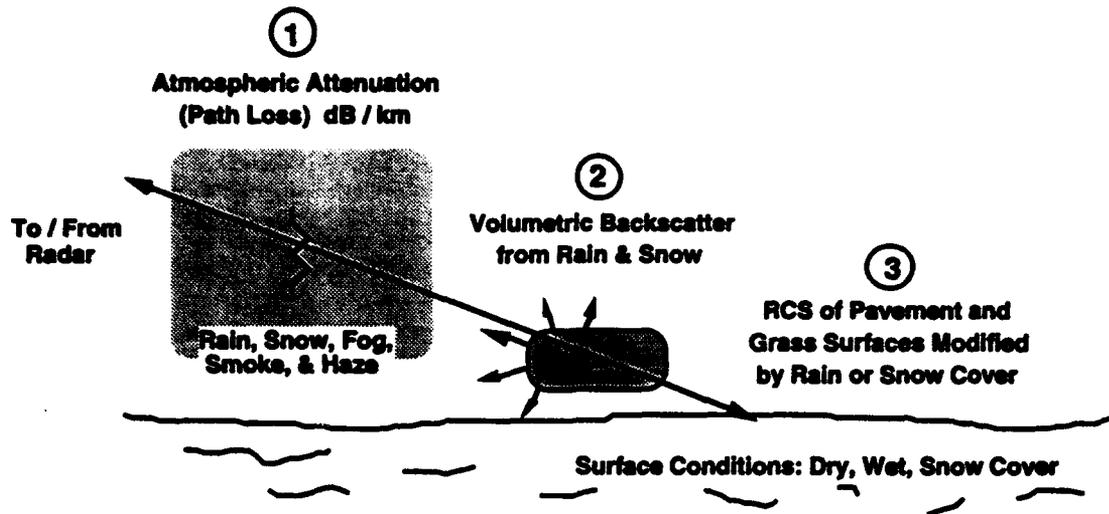
Figure 12. Meteorological effects on MMW radar sensors.

Conditions in the intervening atmosphere between a MMW radar and a target can degrade the radar's ability to detect and image that target, as shown in Figure 12. Airborne moisture due to fog and precipitation (rain, sleet, or snow) causes scattering and diffusion of the radar's electromagnetic waves. Atmospheric effects are separated into attenuation and volumetric backscatter.

Attenuation is the loss of apparent target RCS due to the intervening atmosphere. Atmospheric attenuation applies over the entire radar propagation path, from the radar to the target and back to the radar, or twice the target slant range for a monostatic radar (i.e., one with the transmitter and receiver collocated). Attenuation reduces the range at which a radar can resolve runways from bordering grass areas, due to a reduction in apparent grass clutter RCS and runway clutter RCS.

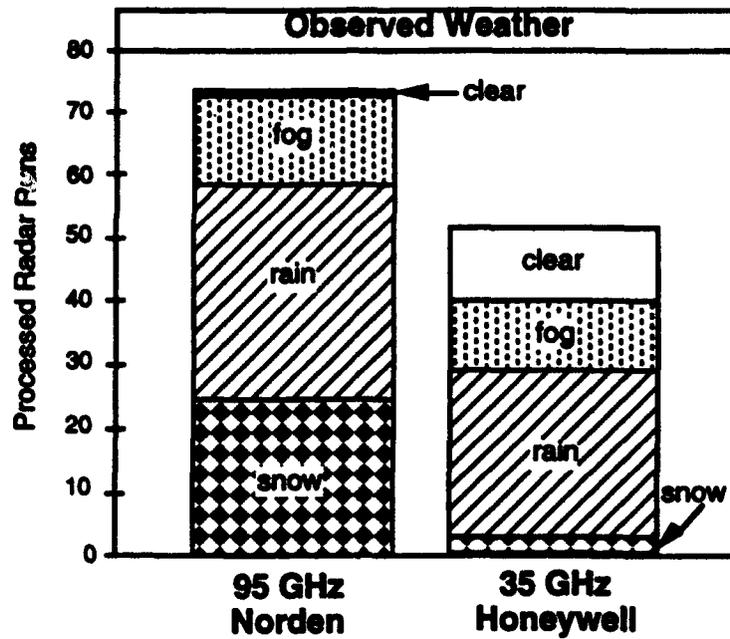
Figure 13a. MMW Test Data Matrix Sorted by Observed Weather.

The tower test data matrix for the Honeywell 35 GHz (HI2) and Norden 95 GHz (NS1) radar sensors is presented in Figure 13a, grouped by observed weather conditions, and in Figure 13b, sorted by along-path visibility (LPV) in feet. Although there were several runs with weather conditions of fog, the visibility was usually greater than 1,700 feet (520 m). Conditions of low-visibility fog did not occur at the tower during the sensor test periods. Note that the numbers of measurement runs listed are those that were processed by GTRI from among a larger set that were collected. Table 5 presents a more detailed MMW data matrix for all six sensor configurations tested. The total numbers of runs collected and processed for each sensor configuration are shown, along with the numbers of processed runs sorted by meteorological conditions.

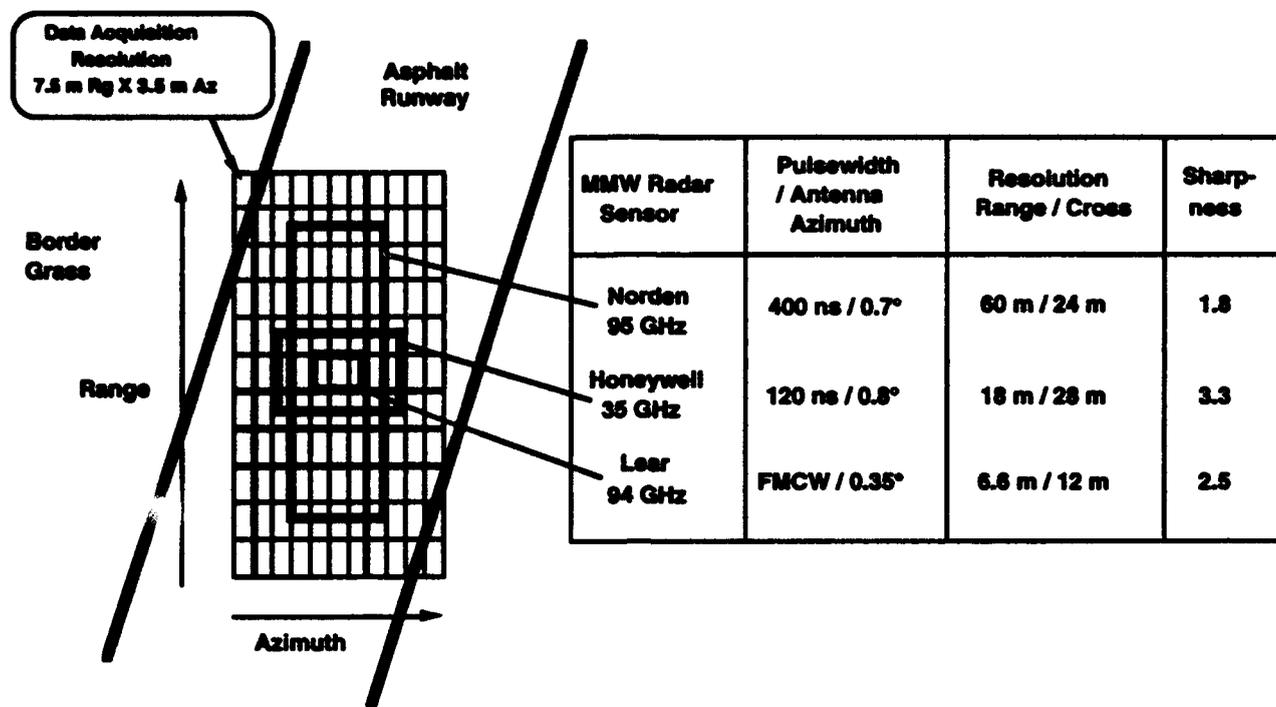
Figure 14. MMW sensor resolution of runway at 2 km range.

Analysis of the performance of the MMW sensors in clear weather established a performance baseline against which the effects of weather could be determined. Baseline measurements also allow comparisons of perceived image quality to the operating parameters of these particular radar sensors. Figure 14 shows how the radar resolution cell sizes at 2 km range compare with the width of the runway at the tower test scene. The radar resolution cell dimensions, downrange and cross-range, are defined by the range and azimuth resolution of the radar sensor, respectively. The fine grid overlay represents the sampling resolution of the data acquisition system (DAS), which in every case exceeded the sensor resolution. DAS oversampling gave a constant data set resolution independent of the MMW sensor under test and provided additional sample points for averaging.

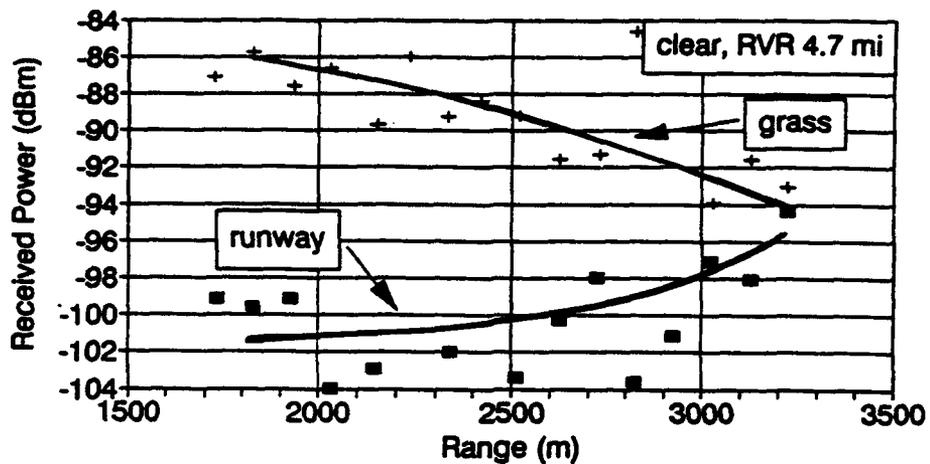
Figure 15a. 35 GHz Downrange Power Profile

Downrange profiles of equivalent received power are a good method of rating a MMW radar sensor's ability to discriminate the runway from the bordering grass areas. As described in Volume 2 (Sensor Tower Testing) of this report, a series of patch areas were defined along the runway and grass for data processing purposes. A downrange power profile plot presents the equivalent received power values from the patches spaced along the grass and runway between 1,700 m and 3,300 m range. Figure 15a is a downrange power profile for the 35 GHz radar, and Figure 15b is the same profile for the Norden 95 GHz radar sensor. Figure 16 is a similar profile for the Lear Astronics 94 GHz radar sensor. Curves have been fit to the points from the grass patches (plus signs) and the runway patches (solid squares). The difference in received power between the grass patches and the runway patches provided by the radar sensor is converted by the signal processor into image contrast. This power difference decreases with range and in weather, reducing the resulting image contrast and the detectability of the runway.

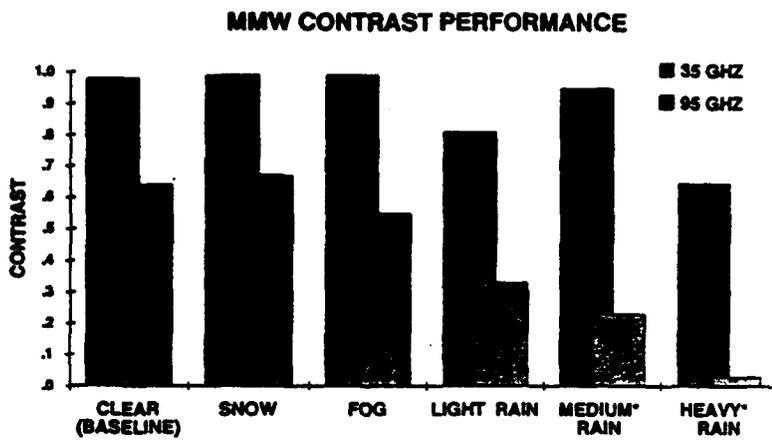
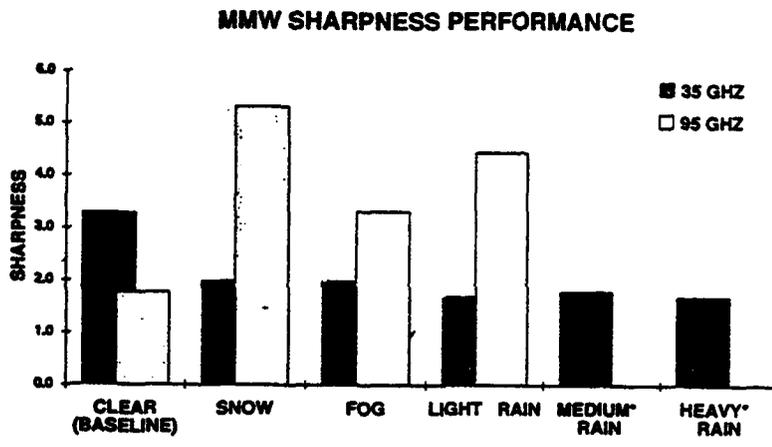
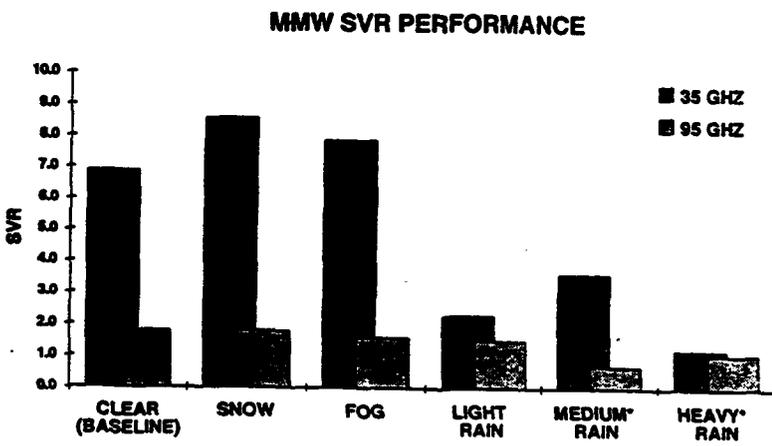
Figure 17. MMW Sensor Performance at 2 km in Clear Air, Fog, Snow, and Rain

Results for the Honeywell 35 GHz and Norden 95 GHz radar sensors are summarized in Figure 17 for the three performance categories of contrast, signal-to-variability ratio (SVR), and sharpness. 35 GHz and 95 GHz performance categories are graphed side-by-side for the six weather conditions of clear, medium snow, light fog, very light rain, light rain, and medium rain. These performance values are for runway and grass at 2 km range. The heights of the bars, or relative performance factors, have been normalized to the maximum value measured by these two sensors. No sharpness values could be extracted from the 95 GHz data for the higher rain rates.

The relative performance advantage of this 35 GHz sensor over the 95 GHz sensor in clear weather is due to the design parameters of these particular radars and not due to any fundamental limitations of the 95 GHz frequency band for runway imaging. The degradation in performance with increasing precipitation for each MMW sensor, relative to its own clear weather performance, does reflect the greater impact of precipitation at 95 GHz.

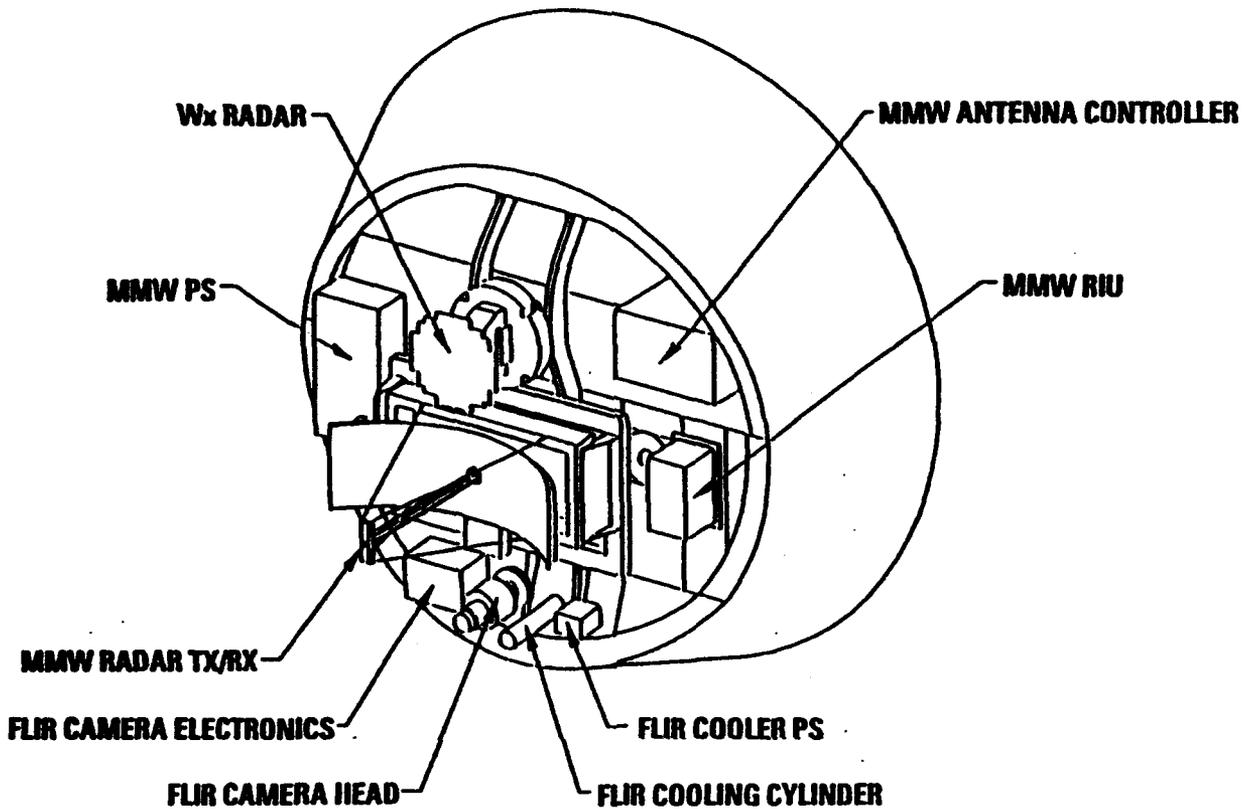
Figure 20. 94 GHz Sensor Installation in Test Aircraft

An image processor performed the trigonometric conversion from range-azimuth to elevation-azimuth to produce the conformal image. Conformality was also maintained during platform motion. Platform altitude, pitch, and roll were required by the processor to perform the conversion and stabilization.

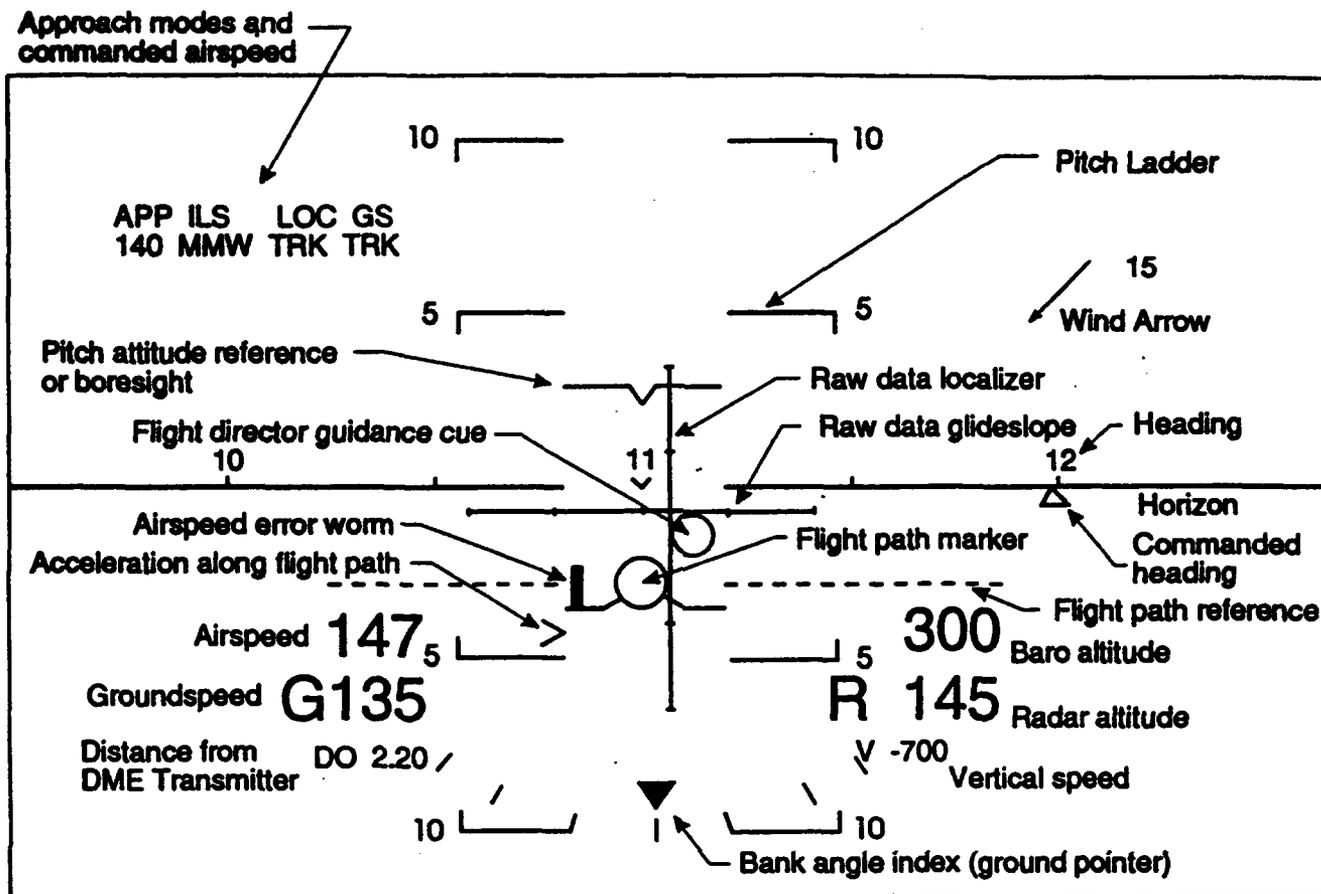
Figure 22. Head-Up Display Symbology Used in SVS Test Aircraft

An illustration of the stroke symbology used on the GEC head-up display (HUD) is shown in Figure 22. The symbol layout was patterned after that used on a HUD manufactured by Flight Dynamics, Inc. (FDI). That HUD is currently certified for Cat IIIa approaches in a Boeing 727 aircraft to runways with Cat IIIa equipment (3 transmissometers, a Type II ILS, and an ALSF approach lighting system with touchdown zone and centerline lights). The FDI HUD has been successfully used in Cat IIIa conditions by Alaska Airlines for several years. The symbology layout was used in this program because it was a known reference . The concept was to start from this reference and add the synthetic vision image, varying from the established layout only as required for the SIED Task. The symbols in Figure 22 depart from the certified symbol set

based on recommendations from an SAE subcommittee on HUD symbology, and on opinions of engineers at GEC.

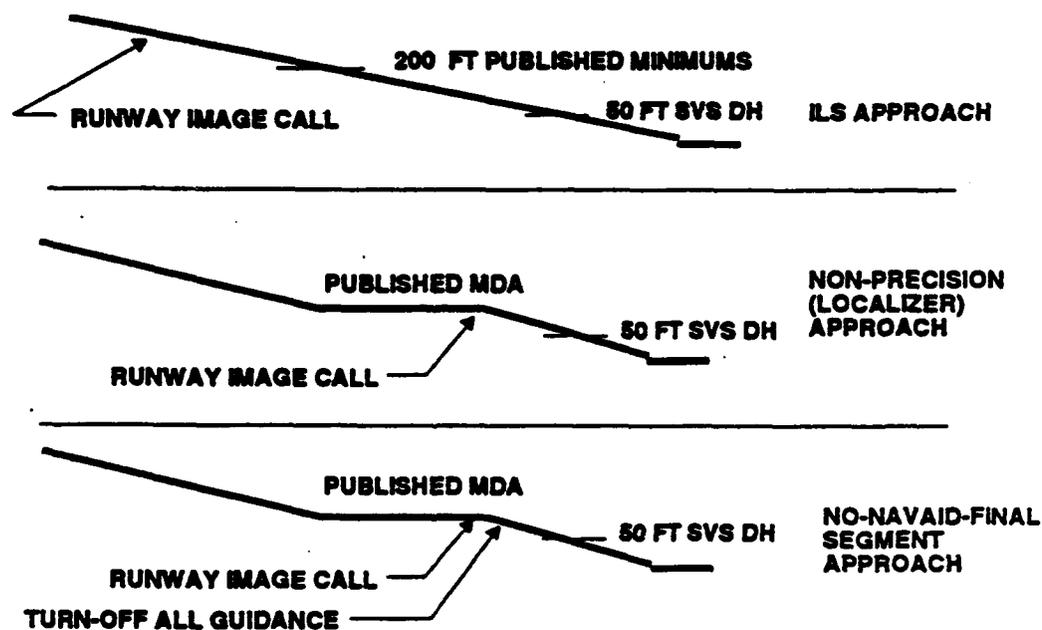
Figure 25. Approach Procedures Used in Flight Test Program

vertical speed hold for non-precision approaches, and the raw-data glideslope information was not displayed on the HUD. The no-navaid-final-segment approach was conducted in an identical fashion to the localizer approach except that the test director detuned the ILS localizer frequency after hearing the pilot call "runway image". This required the evaluation pilot to rely only on the HUD image and symbology (without flight director or ILS guidance) for guidance. The safety pilot always had full ILS glideslope and localizer information on his displays. For most simulated IMC approaches the cardboard shield was in place in front of the HUD down to an altitude of 50 feet. A few ILS approaches were conducted to Cat IIIc (0/0) minimums, and a few were conducted to Cat II (100 ft DH) minimums.

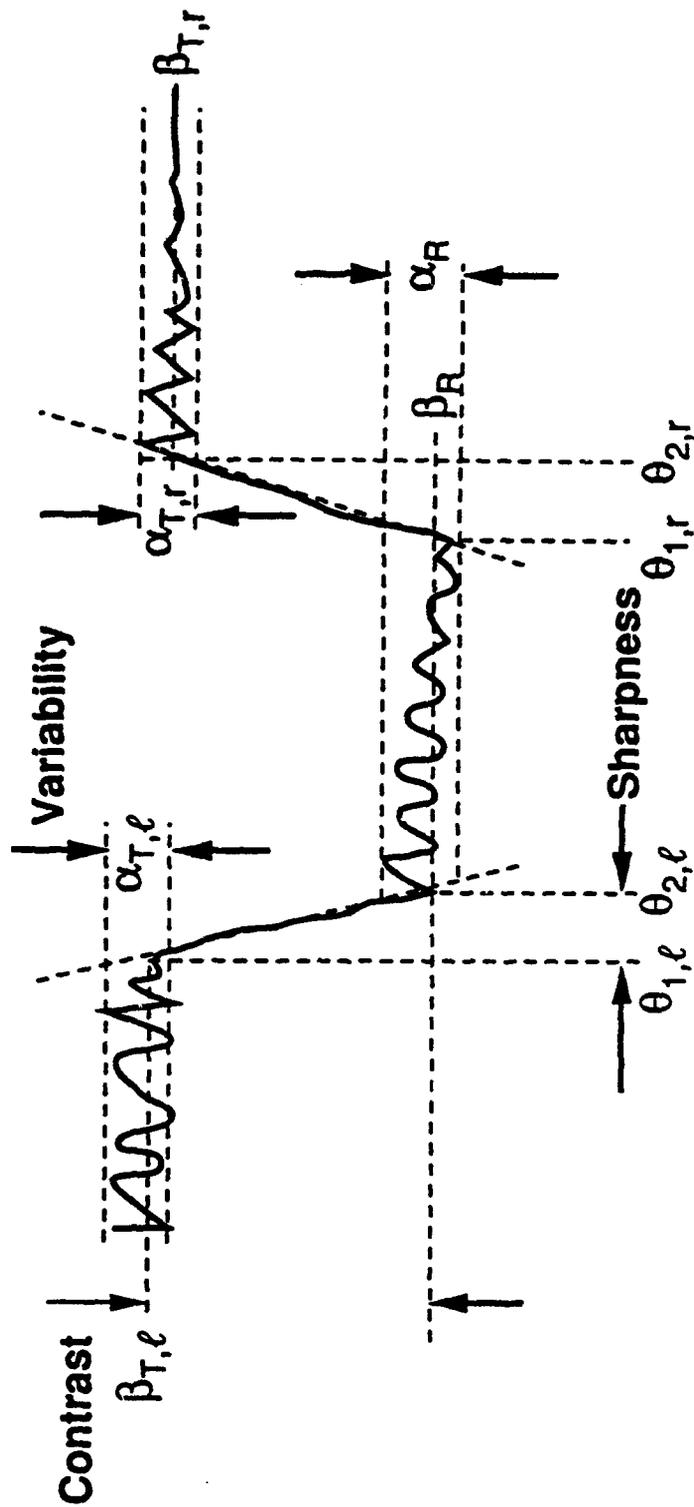
Figure 28. Illustration of Simple Gutter Plot with Basic Image Quality Metrics Indicated

Three parameters can be defined using the gutter plot which it was felt might be useful in characterizing how well the runway can be distinguished from the surrounding terrain. Contrast is a function of the average signal level received from the runway relative to that received from the surrounding terrain.

Intuitively from Figure 28, the contrast improves as the terrain brightness becomes increasingly larger than the runway brightness.

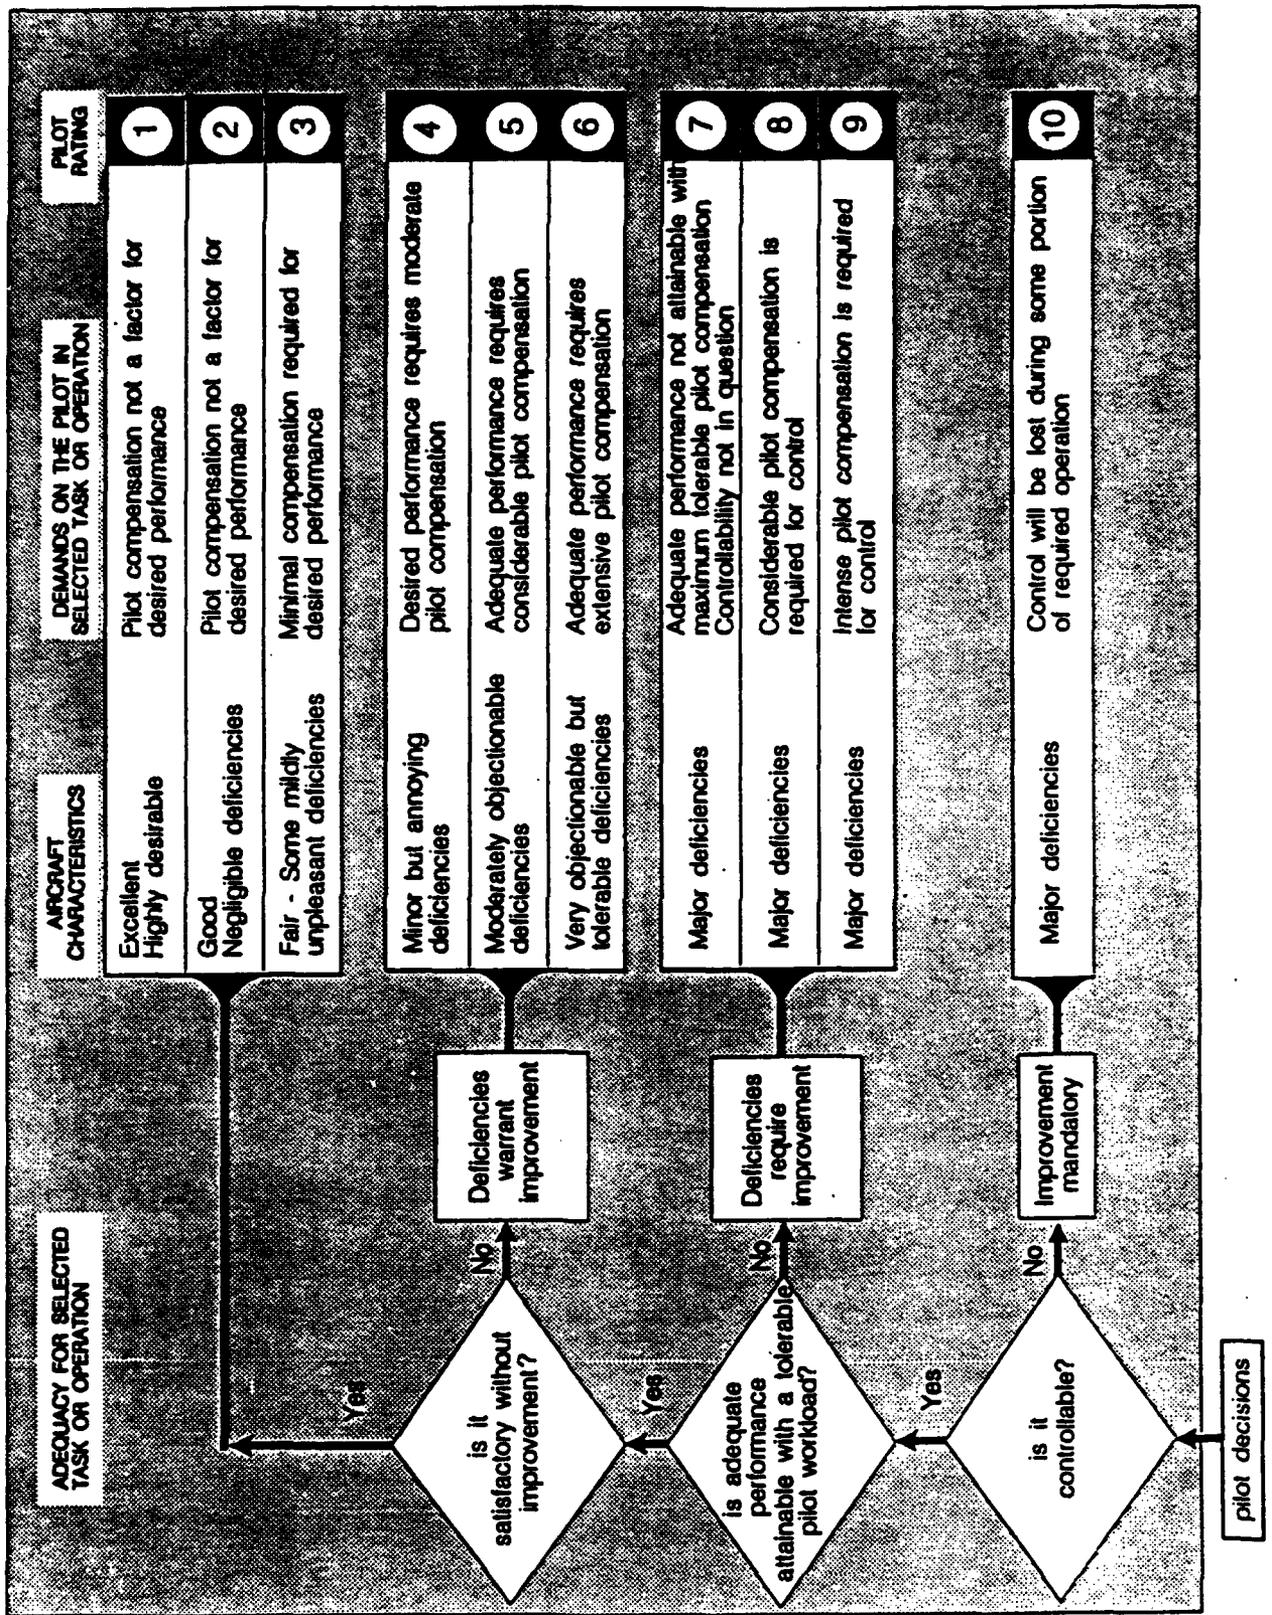
Figure 33. Cooper Harper Handling Qualities Rating (HQR) Scale

Separate ratings were assigned for the approach, the landing flare, and the rollout. The approach rating pertained only to the portion of the approach from 200 feet above the runway to the 50 foot flare point. All subjective pilot ratings must be referenced to some defined level of aggressiveness, hence performance standards must be established. The performance standards used in this program are summarized in Table 14.

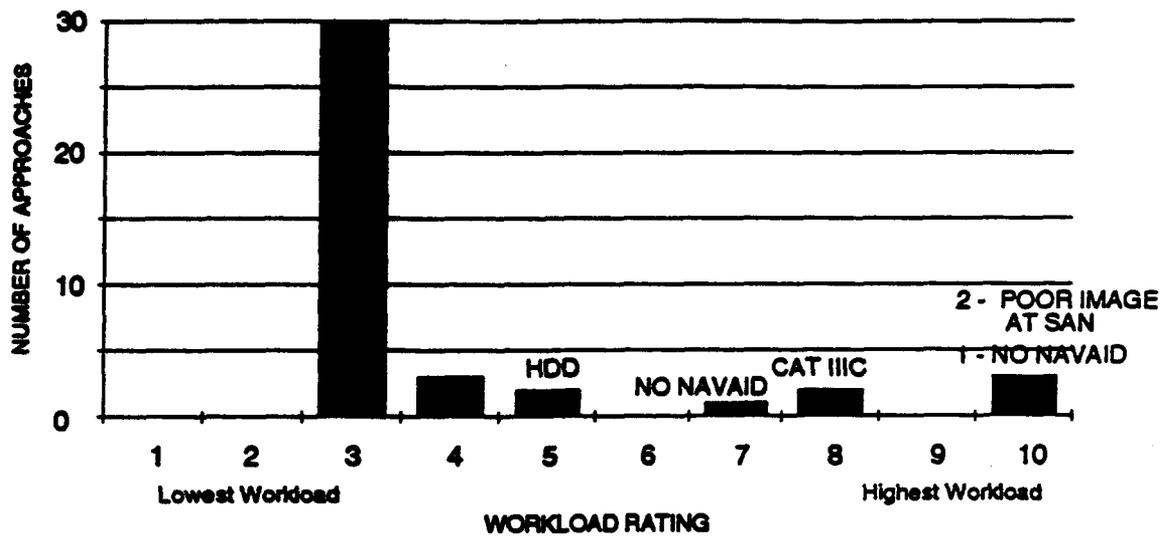
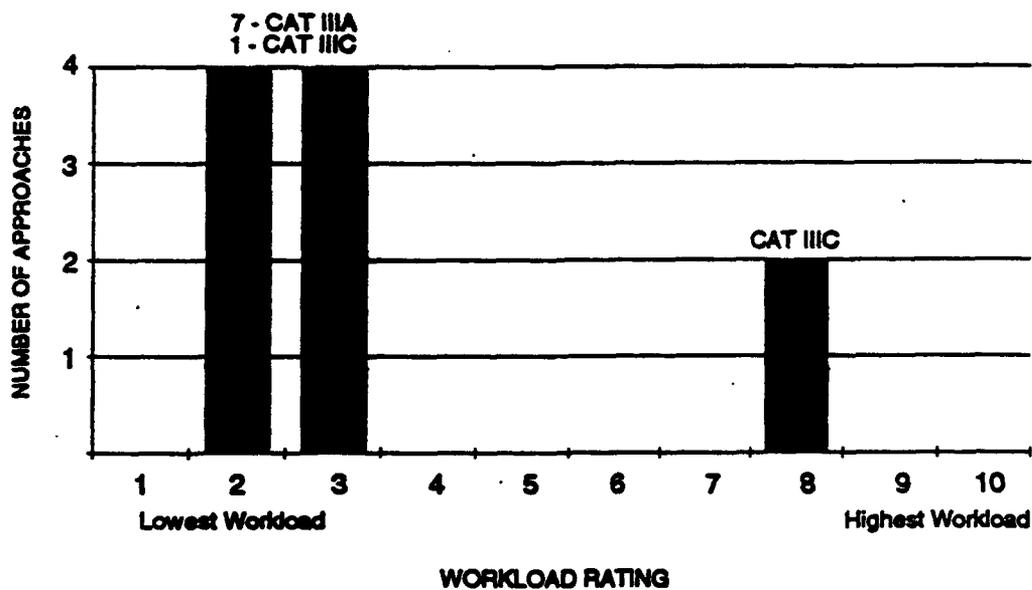
Figure 35. Frequency Distribution of Pilot Workload Rating Data for Simulated CAT IIIa and CAT IIIc Approaches

The frequency distributions of the subjective workload ratings for approaches and landing flares to simulated Cat IIIa and Cat IIIc conditions are shown in Figure 35. This data indicates that the majority of the ratings were 3 (ie., satisfactory without improvement). This should not be construed to imply that the experimental SVS was acceptable as a certified system, but rather that it was acceptable for specific approaches under the specified test conditions; in this case simulated IMC. IMC was simulated by placing a cardboard shield in front of the HUD, and removing the shield at the appropriate time, e.g., 50 feet for simulated Cat IIIa. The cases rated as 4 or worse provide valuable insight into potential problems with an operational SVS and were investigated to the extent that resources permitted.

a) Workload Ratings for Approach Segment From an Altitude of 250 ft to 50 ft

b) Workload Ratings for Flare

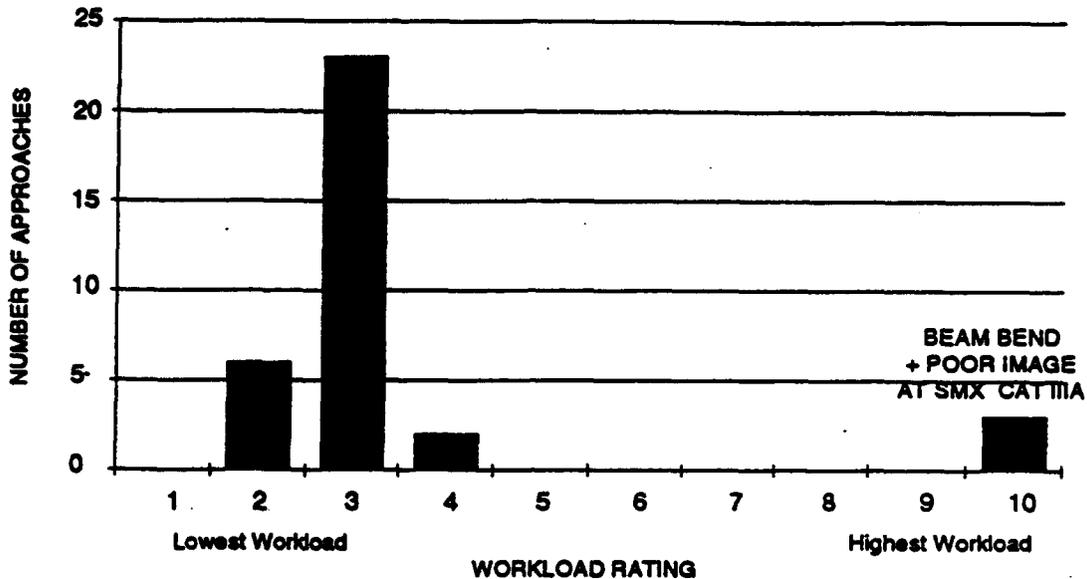
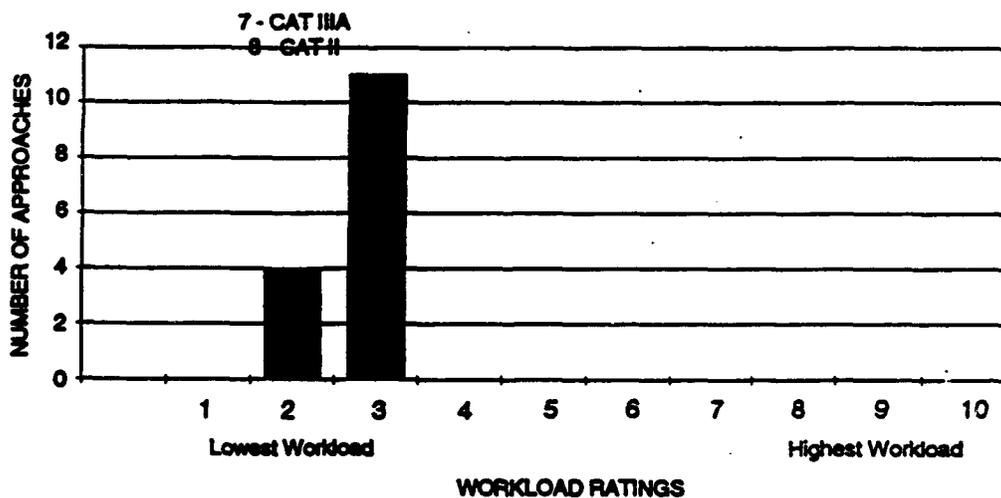
Figure 36. Frequency Distribution of Pilot Workload Rating Data for Actual Cat II and Cat IIIa Approaches

A frequency distribution of the pilot subjective workload ratings for approaches and landing flares in conditions below Cat I minimums is shown in Figure 36. Twenty-nine of the approaches received ratings of 2 and 3, two approaches were assigned a 4, and three approaches were rated 10.

a) Workload Ratings for Approach Segment From an Altitude of 250 ft to 50 ft

b) Workload Ratings for Flare
