**Airport and Aircraft Safety R&D
AAR-400
William J. Hughes Technical Center**

Highlights 1997

Federal Aviation Administration

Airport and Aircraft Safety R&D Division

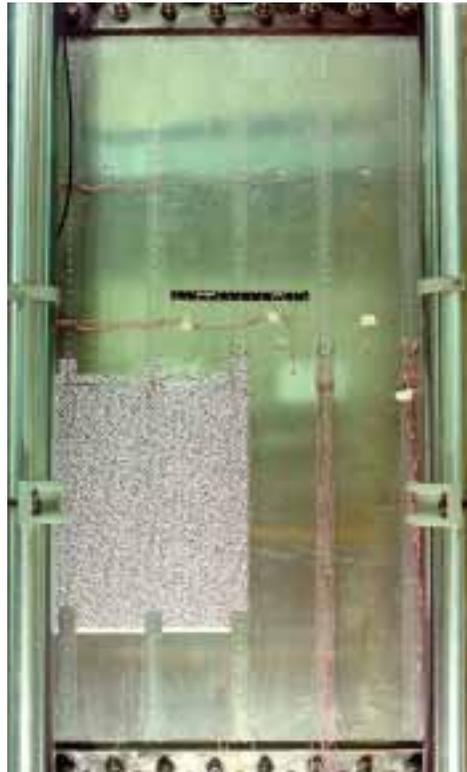
The following figure is a photograph of a 40-inch-wide, flat, stiffened panel. The five vertical riveted tear straps are clearly visible. In the center of the panel is a single 8-inch-long crack that runs perpendicular to the tear straps. Also visible in the photograph are some of the 60 gages used for strain measurements and a black and white speckled region used for the large area x, y, and z displacement measurements.

The objective of this joint FAA-NASA experimental program was to conduct fracture tests to evaluate and quantify the effect of MSD cracking on stiffened panels. Ten, 40-inch-wide panels of 0.063-inch-thick 2024-T3 aluminum alloy were tested. Five of the panels had riveted stiffeners to simulate tear straps of an aircraft fuselage; the other five panels were unstiffened. The crack configurations tested were (1) a single 8-inch lead crack, (2) a single 8-inch lead crack in line with 24 open holes, (3) a single 8-inch lead crack with 24 open holes with a 0.01-inch-long crack on both sides of each hole, (4) a single 8-inch lead crack with 24 open holes with a 0.03-inch-long crack on both sides of each hole, and (5) a single 8-inch lead crack with 24 open holes with a 0.05-inch-long crack on both sides of each hole. During each test, applied load, crack growth, strain at 60 locations, and large area x, y, and z displacements were measured. The results indicate that the presence of the small

MSD cracks reduced the load required to fail the stiffened and unstiffened panels by more than 25%. The results of this study will provide experimental data to show that MSD cracking sharply reduces the critical load for stiffened structures and will be used to verify analytical fracture models. Once verified, these analytical fracture models can be used to predict when an aircraft would develop MSD cracking, determine inspection intervals to maintain safety in the presence of MSD, and evaluate repairs suggested to eliminate MSD problems.

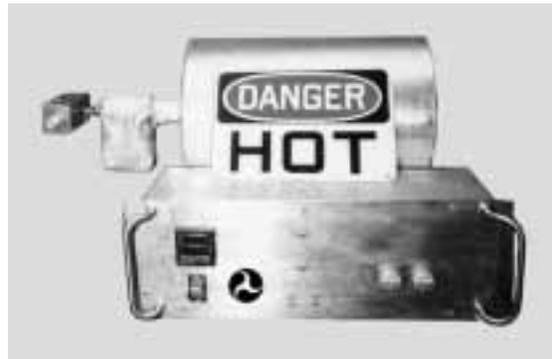
Figure 1. Microscale Combustion Calorimeter.

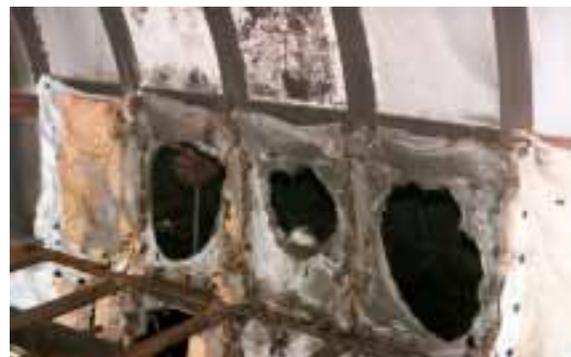
Burn Test with Ineffective Insulation

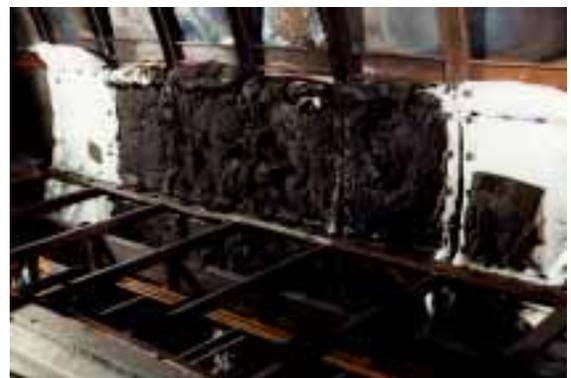
Burn Test with Effective Insulation

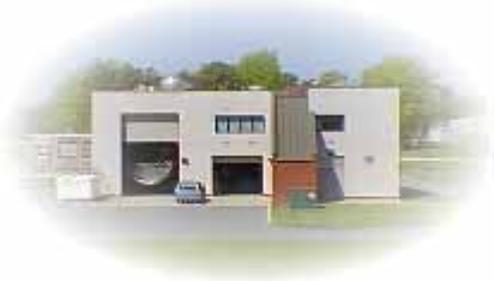
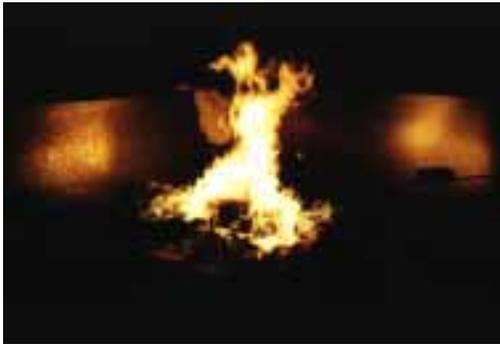
Recent testing in the building has included the development of new fire test standards for flight data recorders. The testing included propane burner tests, shown on the left, as well as long-term elevated temperature tests, using a high-temperature programmable oven. The results were used in the development of a new Technical Standard Order (TSO) for flight recorders.
