DOT/FAA/TC-15/4

Federal Aviation Administration
William J. Hughes Technical Center
Aviation Research Division
Atlantic City International Airport
New Jersey 08405

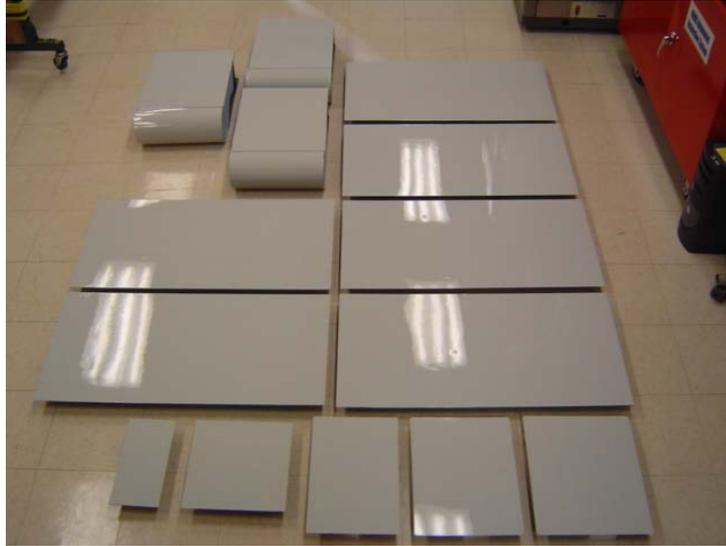
Figure 1. Subset of the 15 painted solid laminate test specimens and 5 feedback specimens

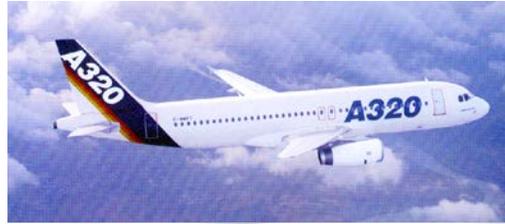
A320/A319 composite structures

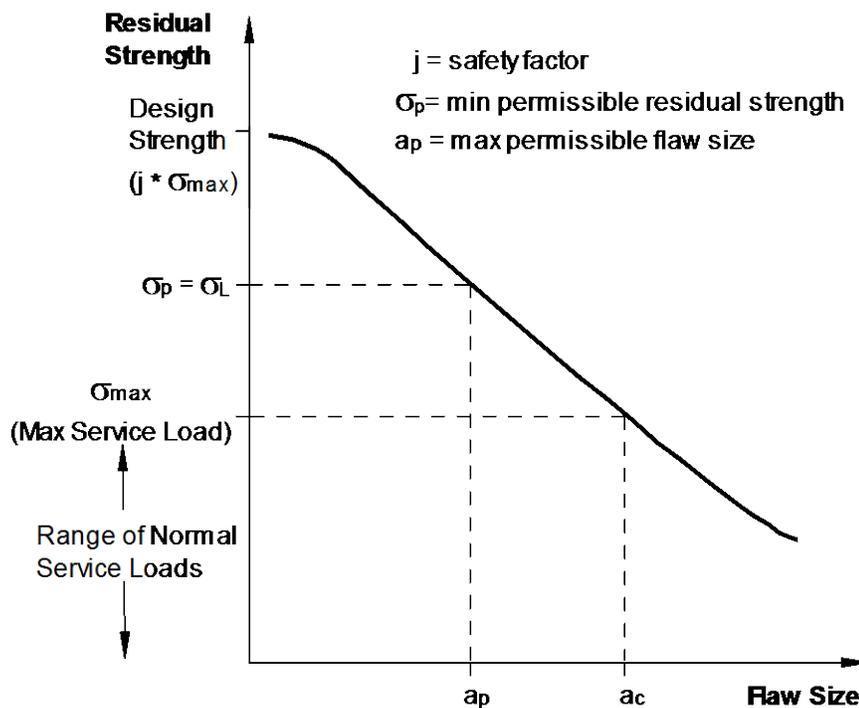
Figure 8. Residual strength curve

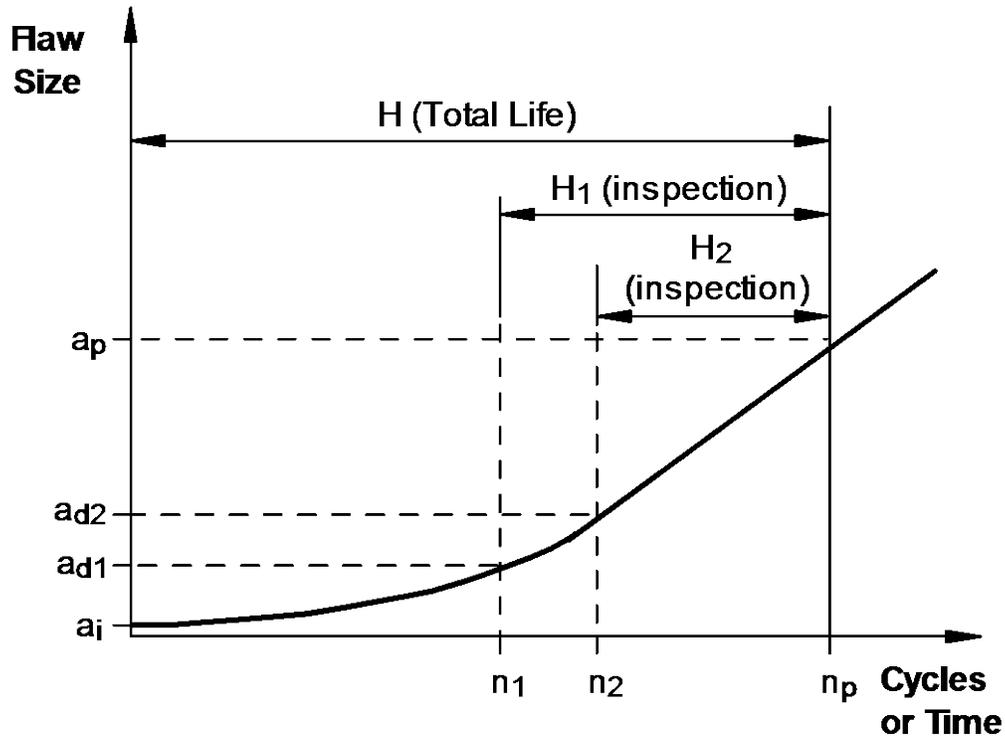
Figure 9. Crack growth curve showing time available for damage control

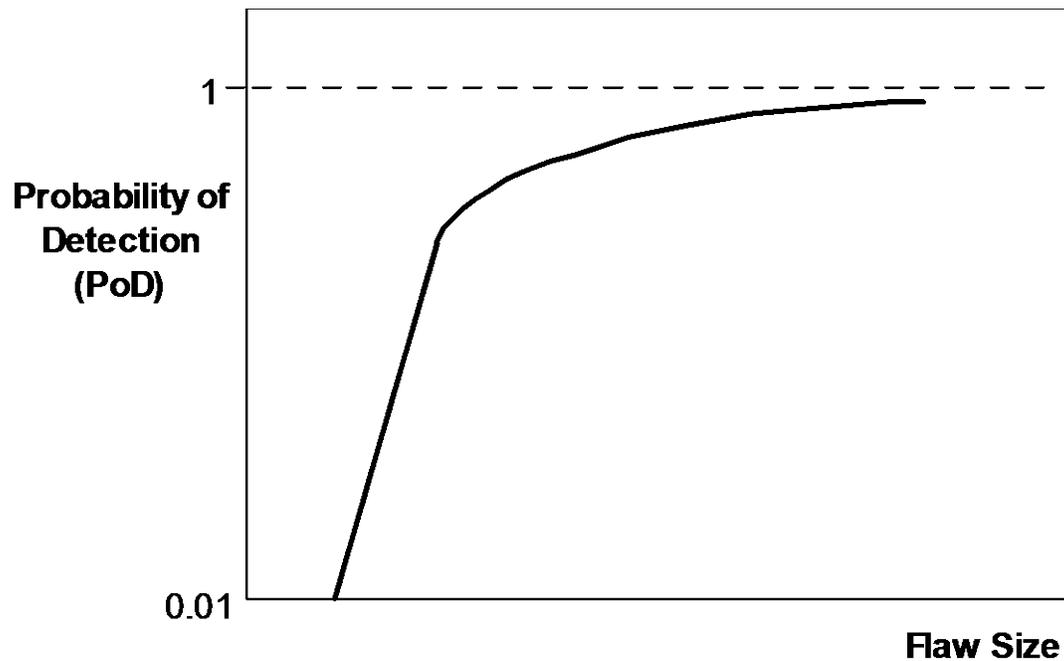
Figure 10. The POD vs. flaw size

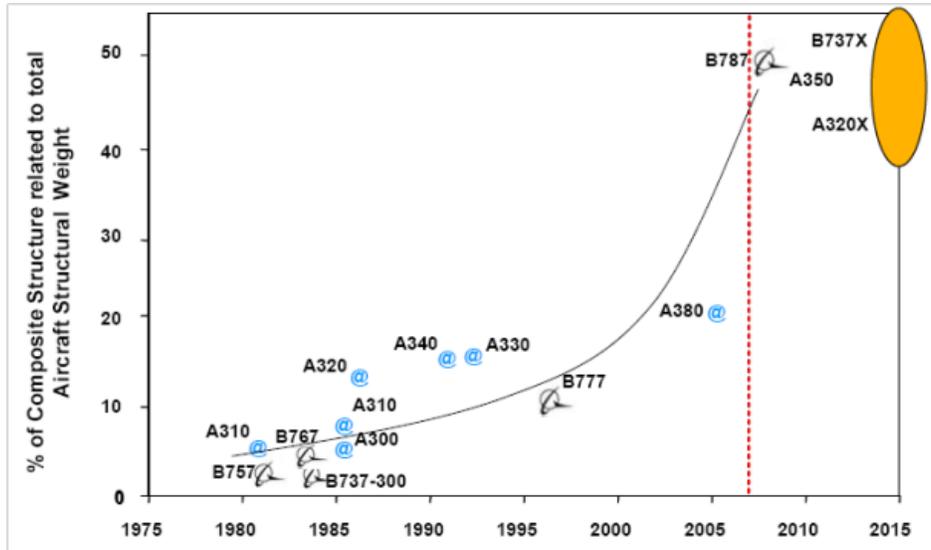
Figure 12. Expansion in the use of composite materials in aircraft construction

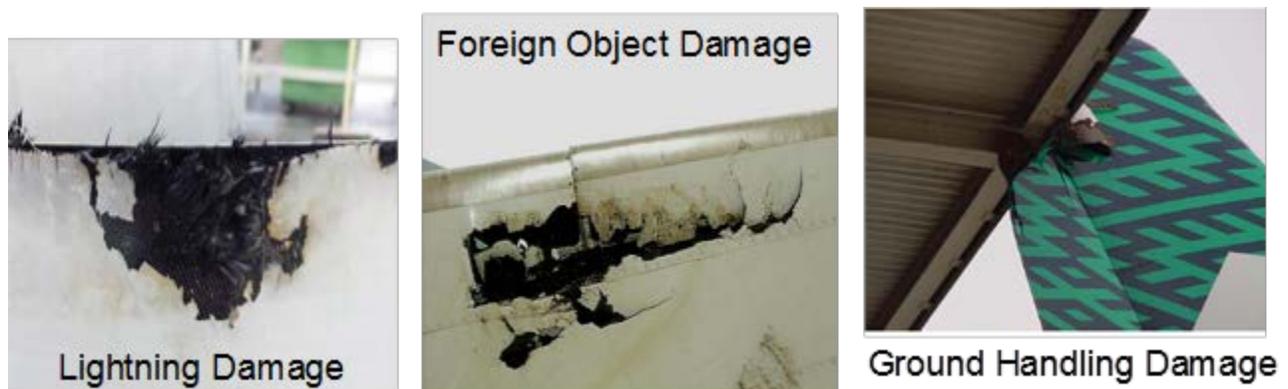
Figure 13. Sample sources of damage to composite structures

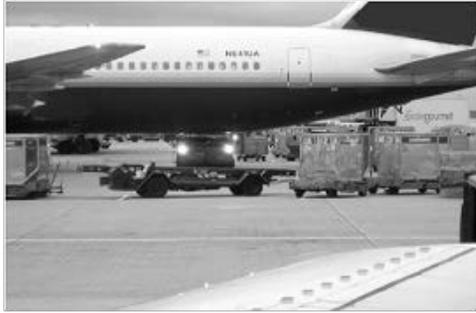
Ground Service Vehicles

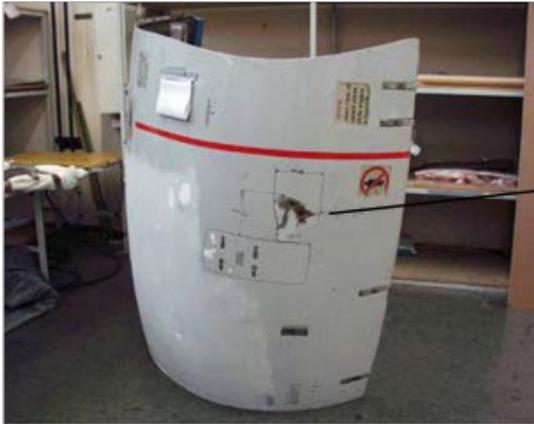
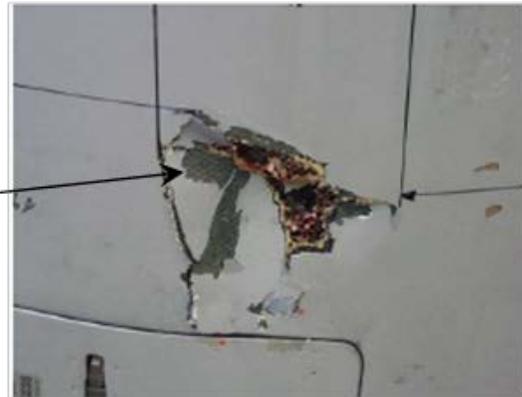
Figure 14. Sample damage from ground service vehicle impact

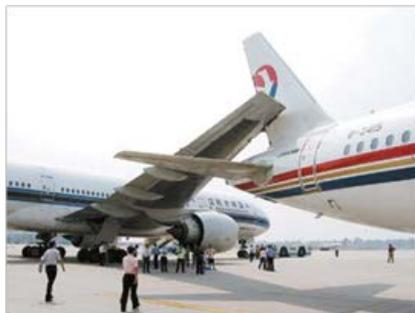
Towing and Docking Damage

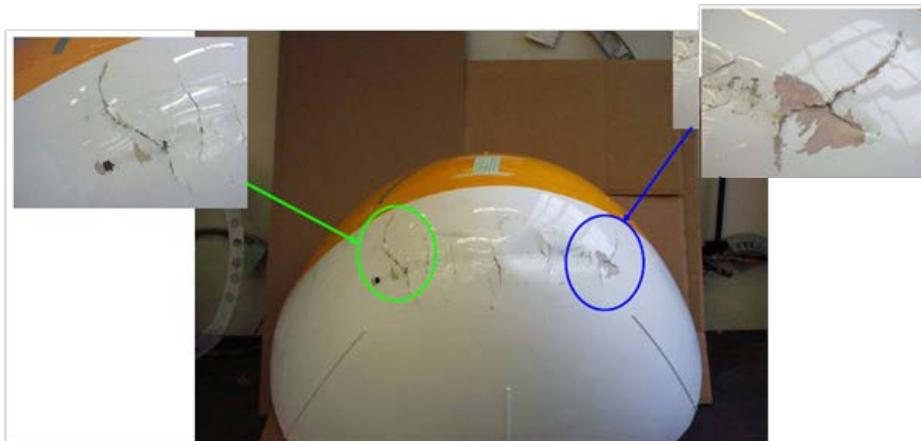
Figure 15. Sample damage from ground operations

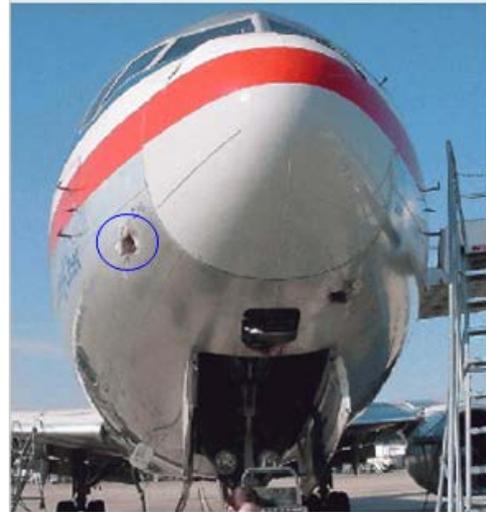
Figure 16. Sample damage from impacts during flight

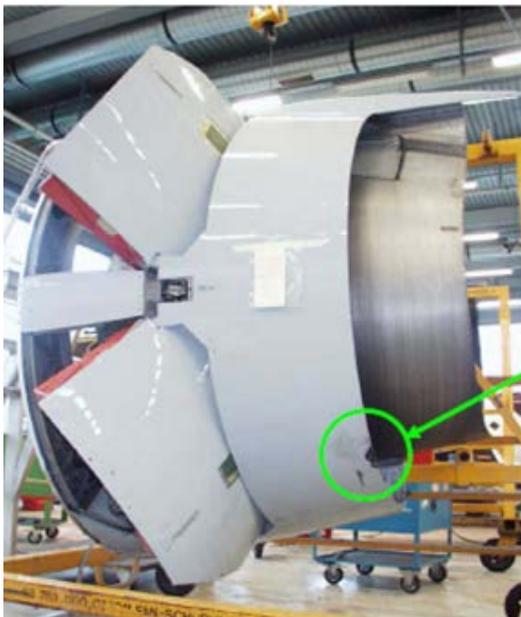
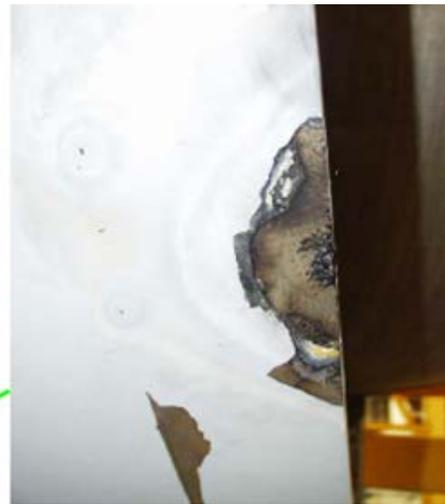
Lightning Strike on Thrust Reverser

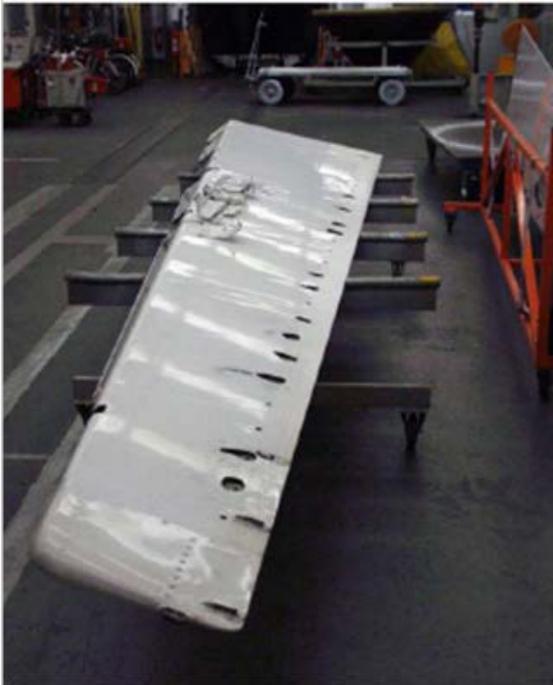
Water Ingress in Elevator

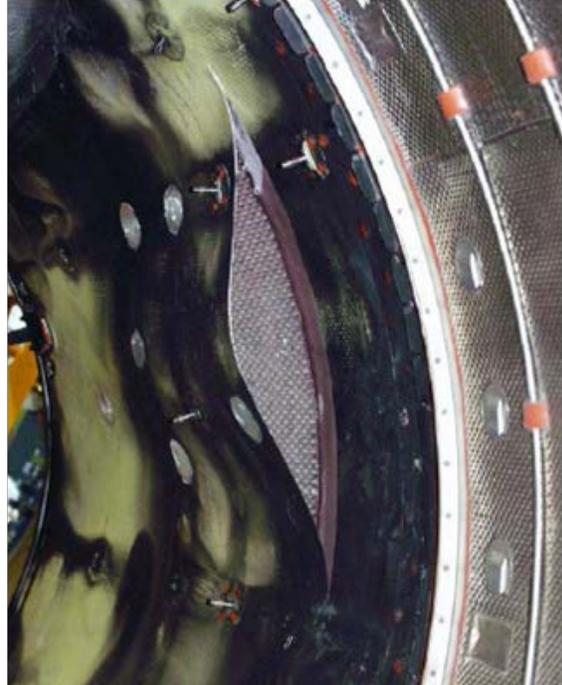
Disbonding at Skin-to-Honeycomb Interface

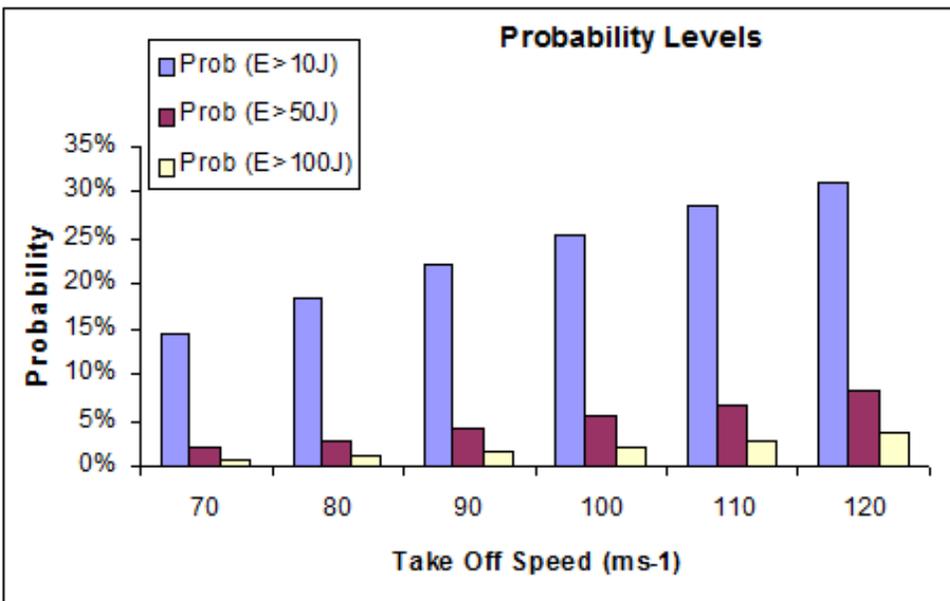
Typical Runway Debris

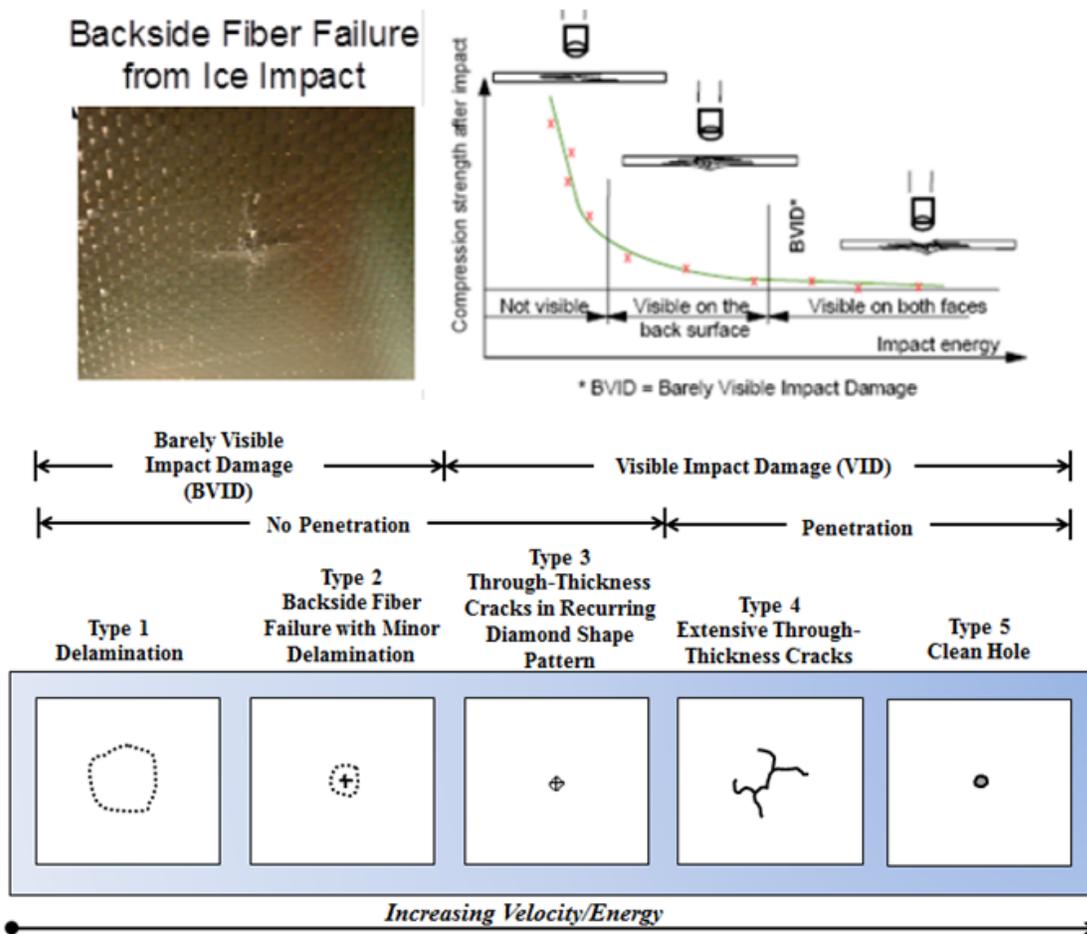
Figure 20. Effects of impact on composite structures

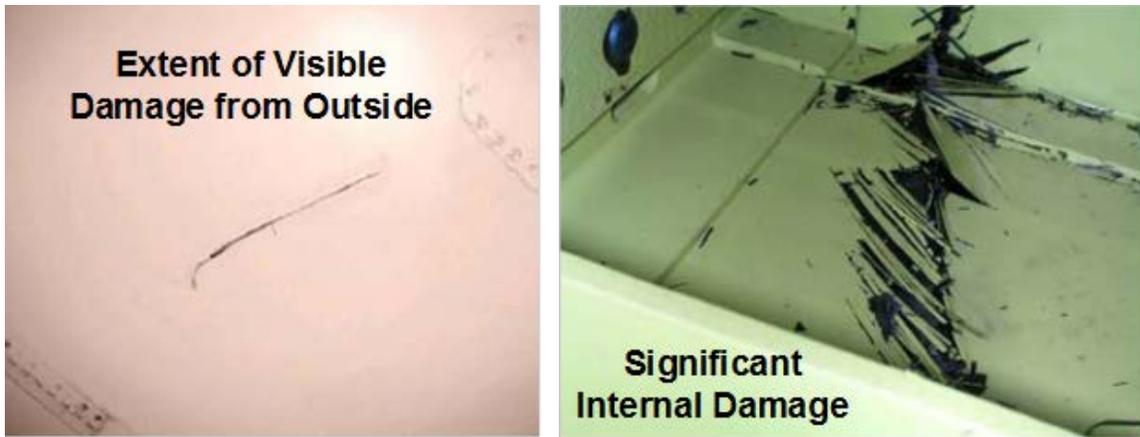
Source: Carlos Bloom (Lufthansa) & S. Waite (EASA)

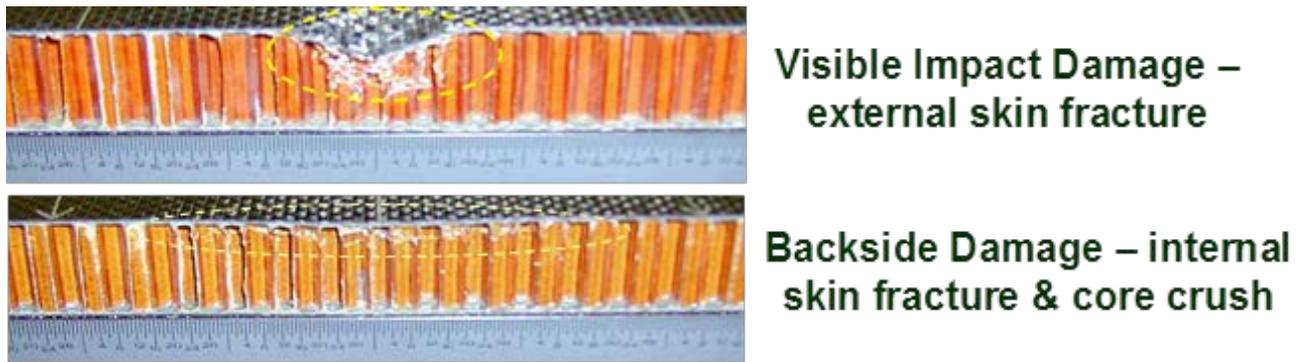
Figure 22. Comparison of visible and backside damage (crushed core and backside fiber fracture) in honeycomb structures

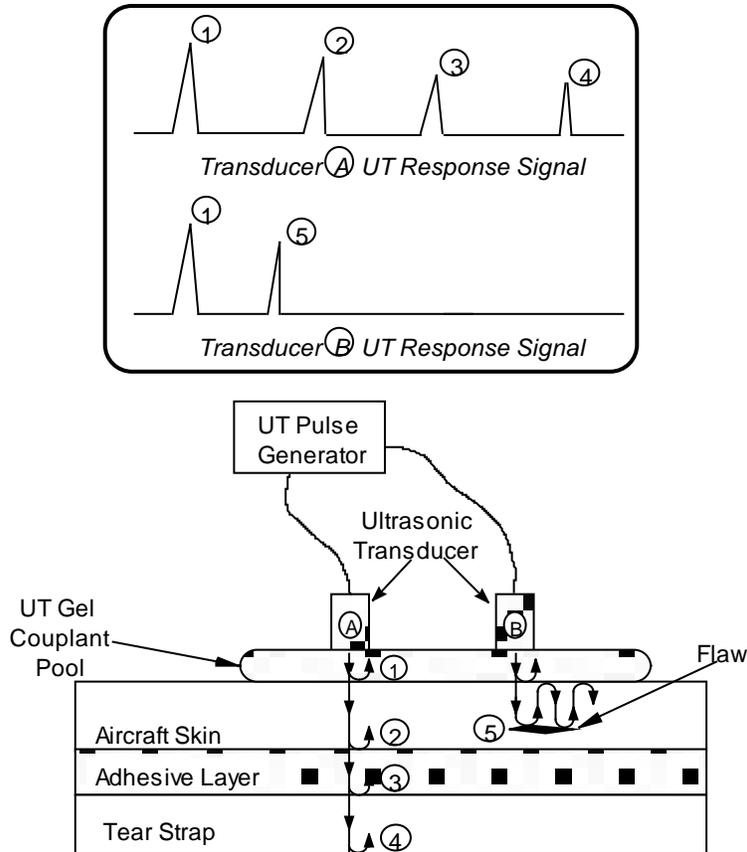
Figure 23. Schematic of PE-UT inspection and A-scan signal showing reflection of UT waves at assorted interfaces

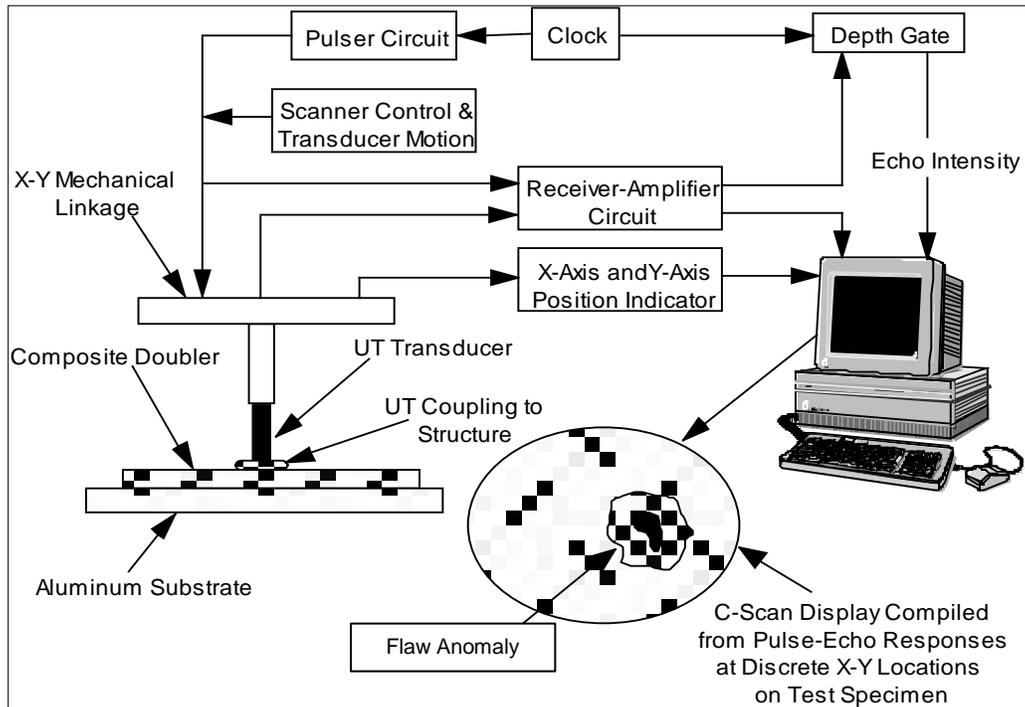
Figure 24. Schematic of C-scan setup for PE-UT inspection

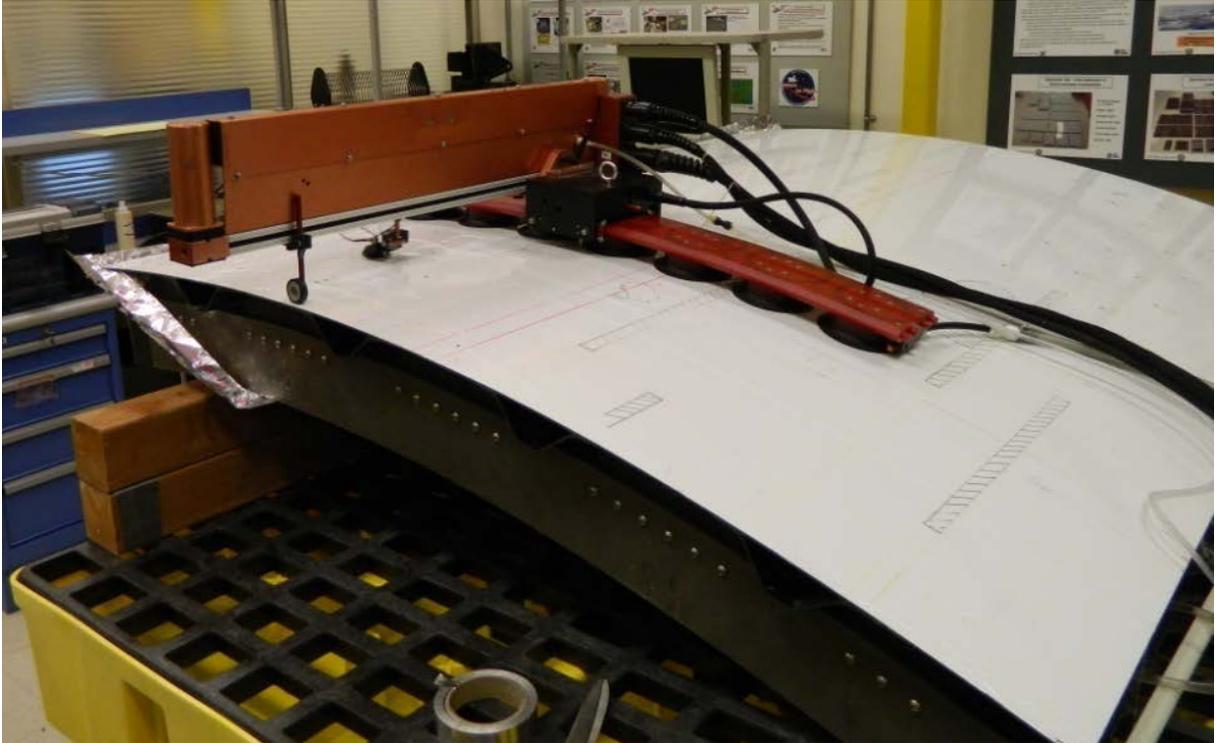
Figure 25. The MAUS automated UT scanning system

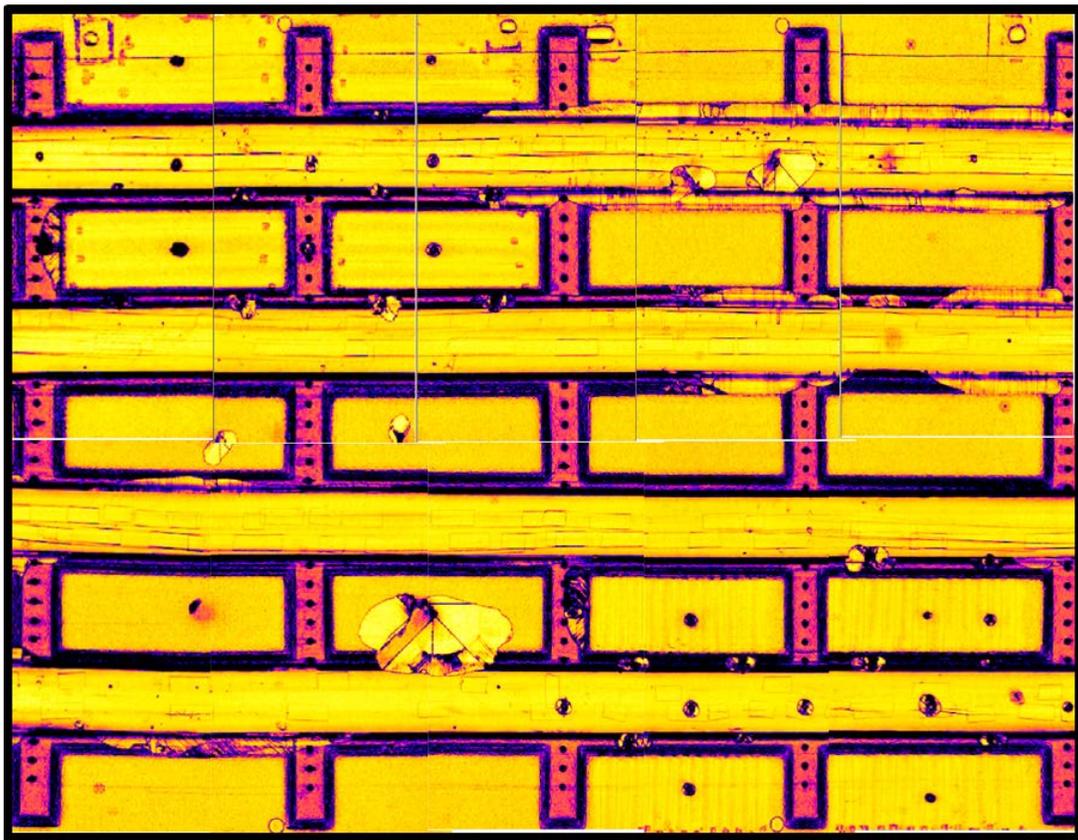
Figure 27. Sample C-scan produced by an automated UT scanning device

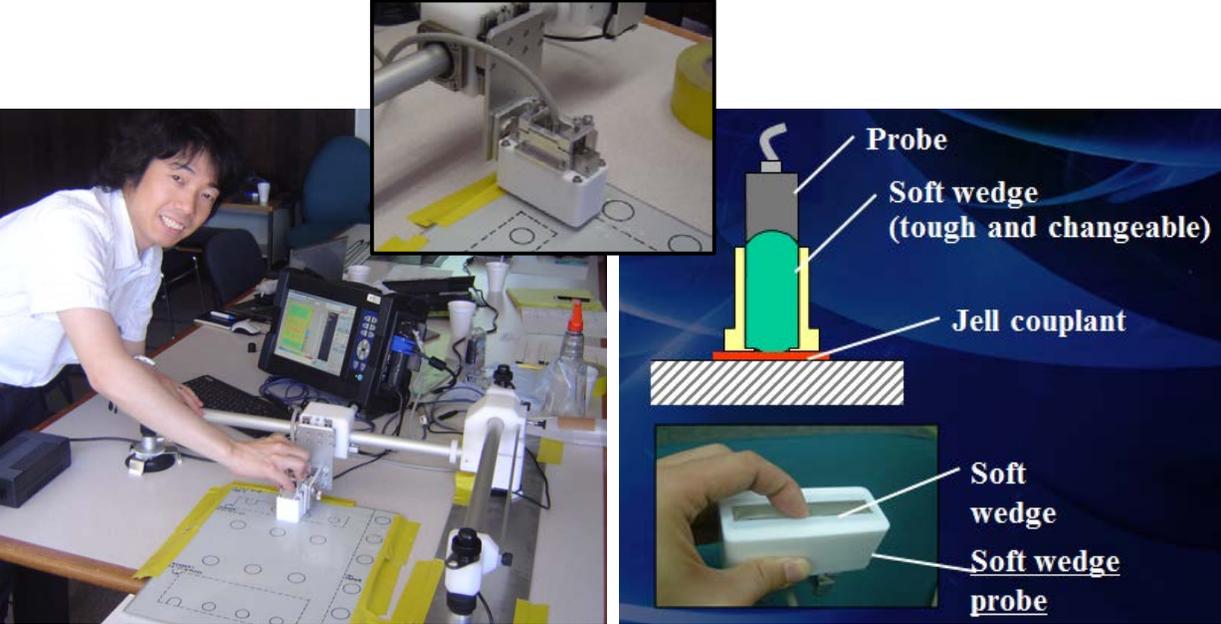
Figure 34. Matrixeye equipment deployed with an X-Y scanner and phased array probe incorporated into a soft wedge scanning shoe

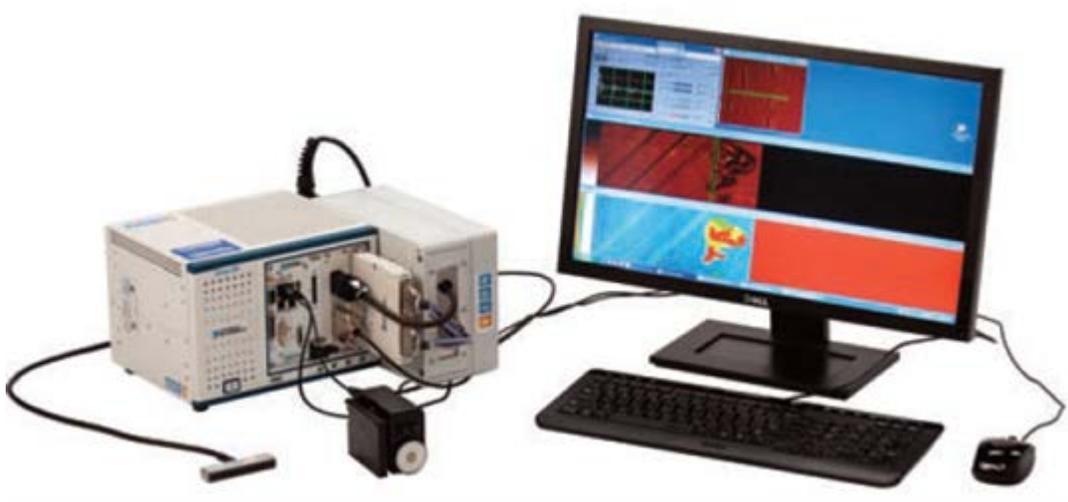
Figure 37. Diagnostic sonar FlawInspecta PA-UT inspection system

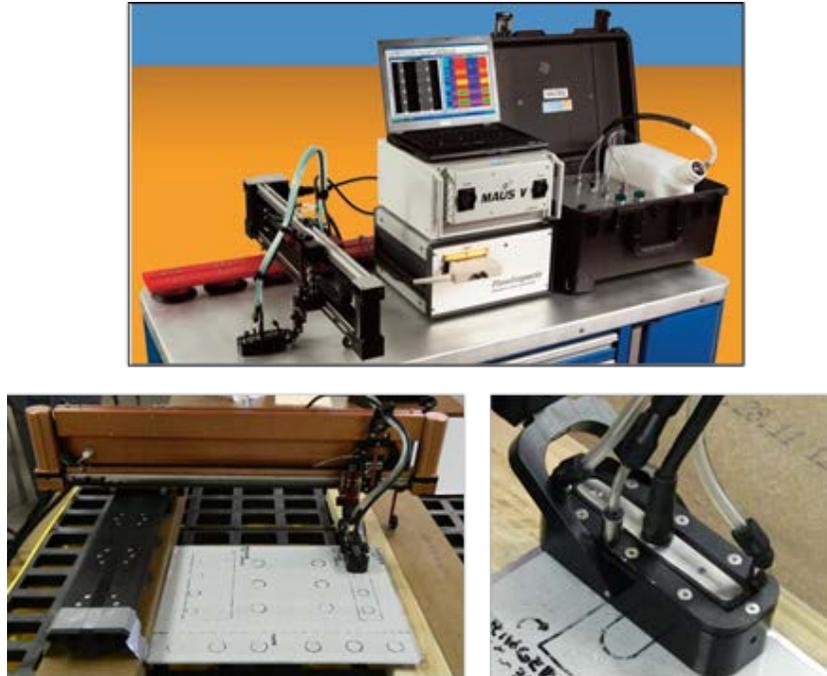
Figure 38. FlawInspecta linear array UT system deployed on MAUS V scanner platform (linear array UT probe includes a delay line shoe)

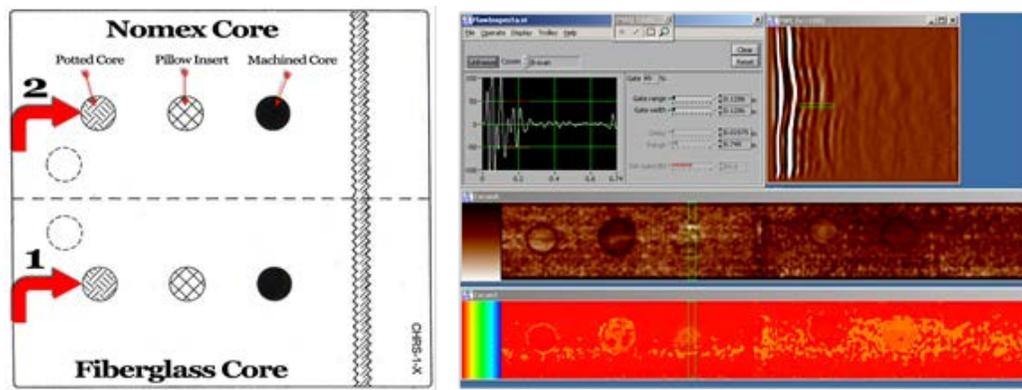
Figure 39. Composite honeycomb reference standard and sample FlawInspecta results (3-ply carbon skin with 1" thick core)

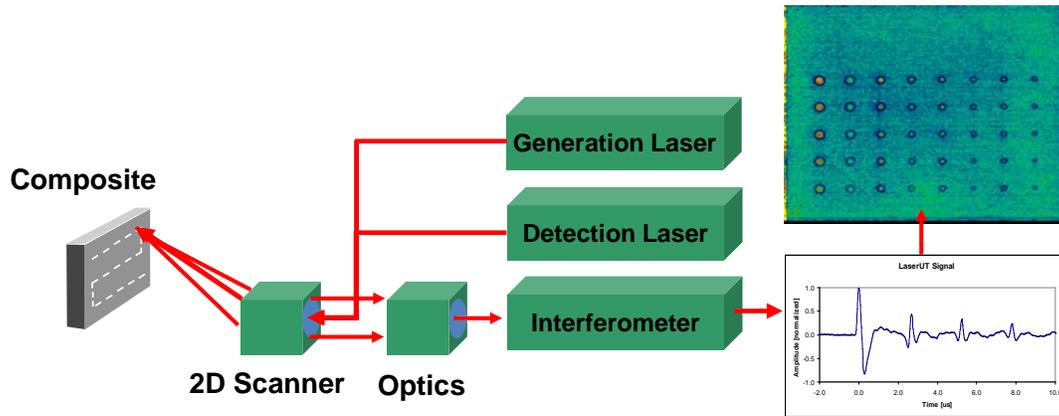
Figure 50. Schematic of LUS system operation

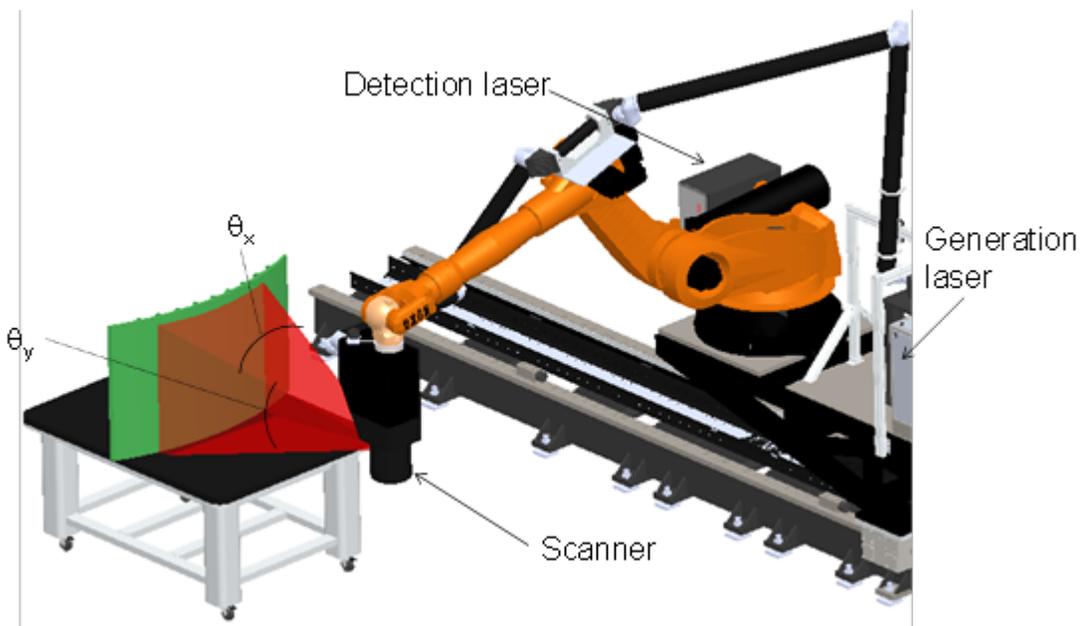
Figure 53. Inspection of a part using the iPLUS scan head and articulating robot

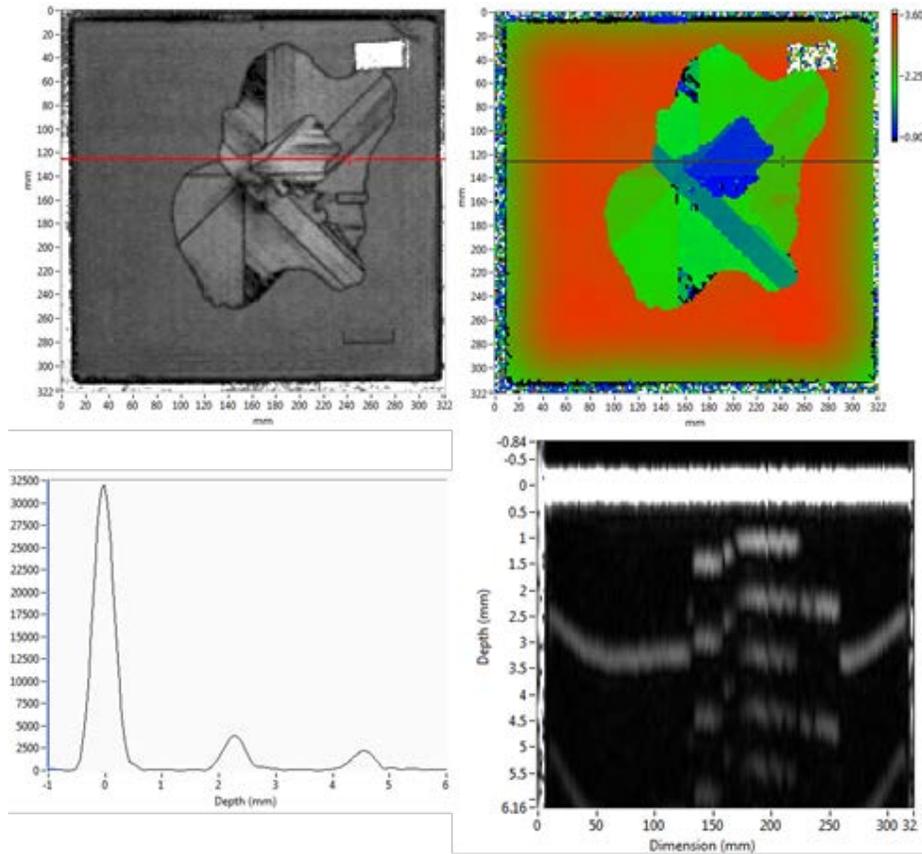
Figure 54. An iPLUS LUS scan of a 16-ply composite laminate with impact damage

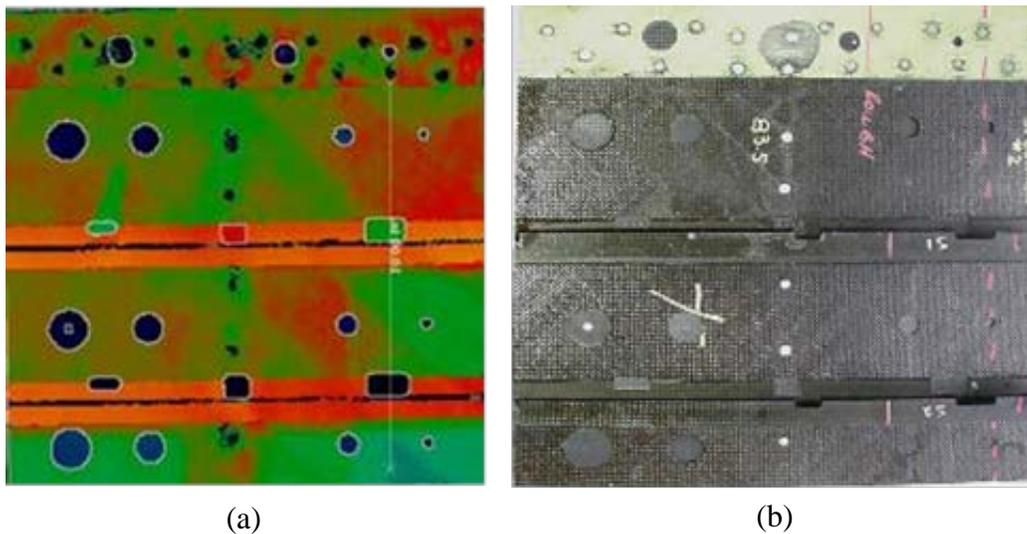
Figure 55. An (a) iPLUS LUS inspection of 0.111" thick composite laminate test specimen and (b) photograph of the layout of the engineered flaws

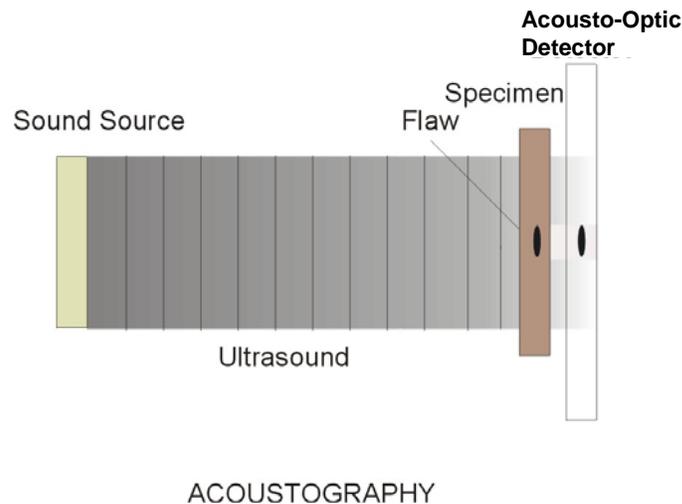
Figure 59. Acoustography through-transmission mode allows instant full-field inspection of an area

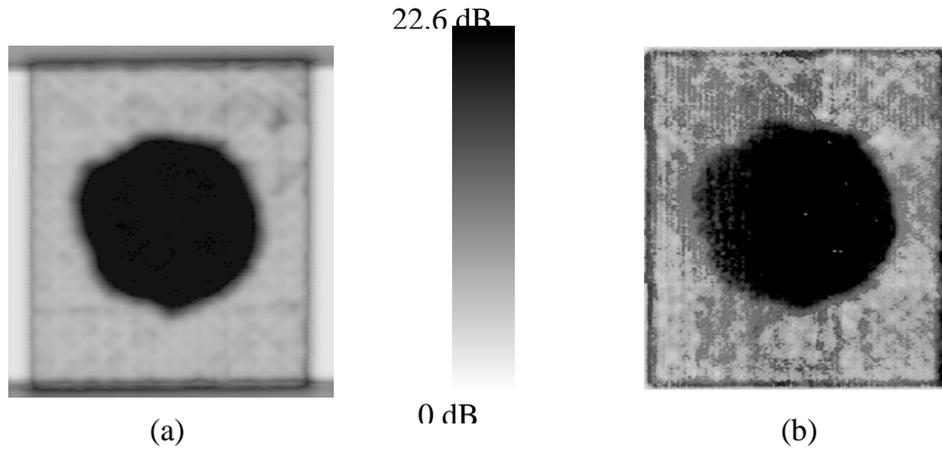
Figure 60. Through-transmission (a) C-scan and (b) acoustography inspection of impact damage in a graphite/epoxy composite specimen

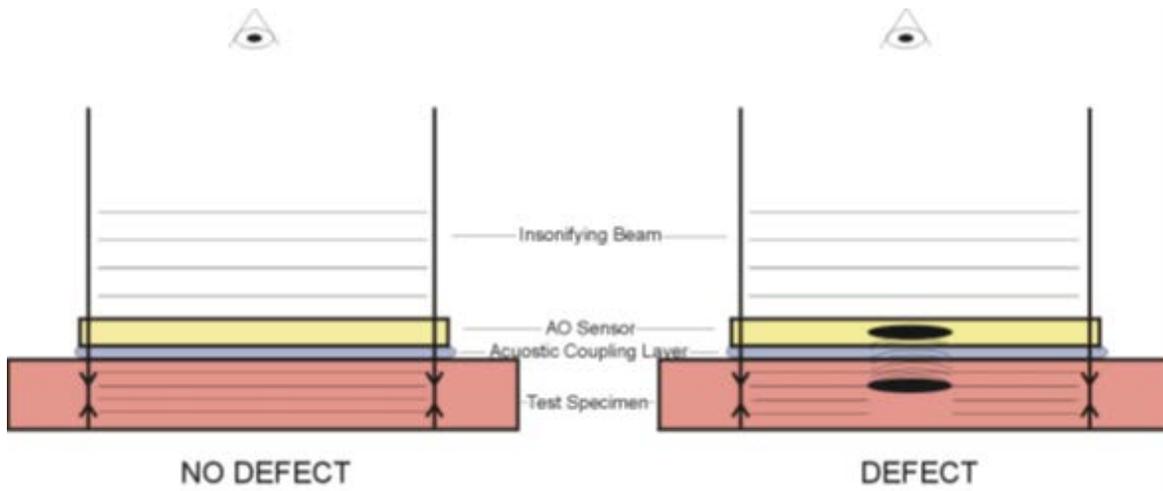
Figure 61. Reflection mode acoustography allows for single-sided UT inspection

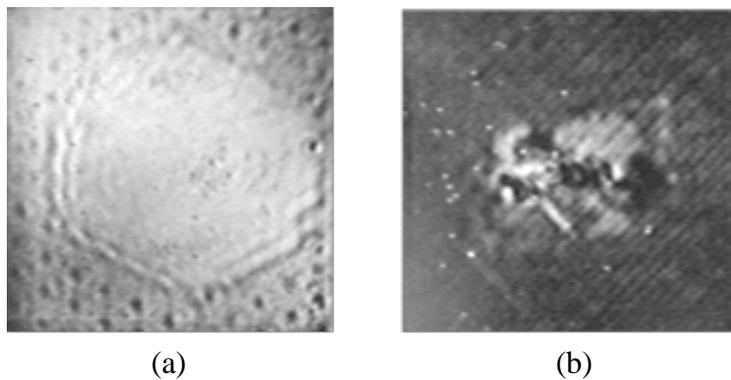
Figure 62. Preliminary results with reflection mode acoustography (a) image of disbond at aluminum skin/honeycomb interface, and (b) image of impact damage in graphite/epoxy composite laminate AcoustoCam (Imperium)

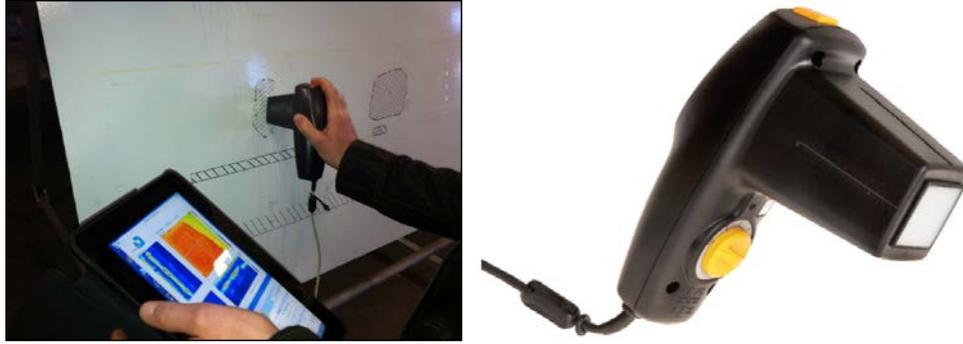
Figure 65. DolphiCam handheld portable ultrasound video camera

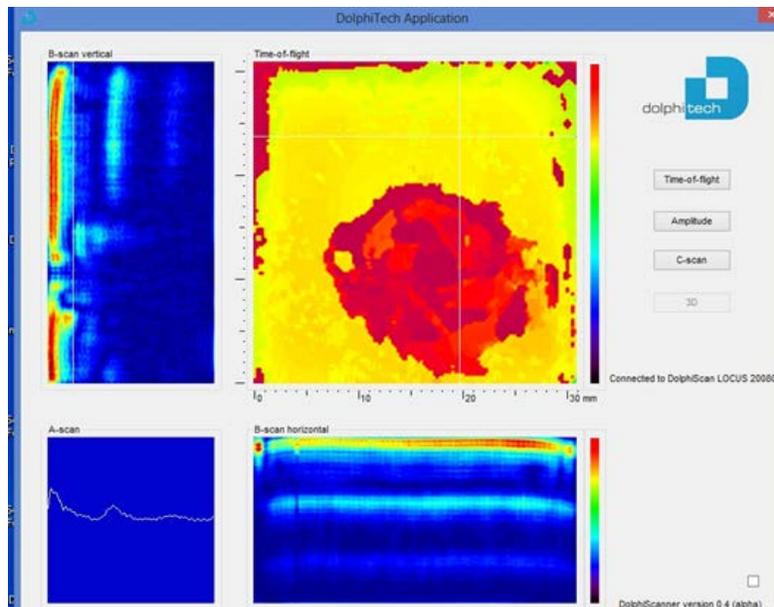
Figure 66. Dolphicam A-scan, B-scan, C-scan (time-of-flight or amplitude image) and 3D visualizer display showing interactive flaw sizing and depth measurements

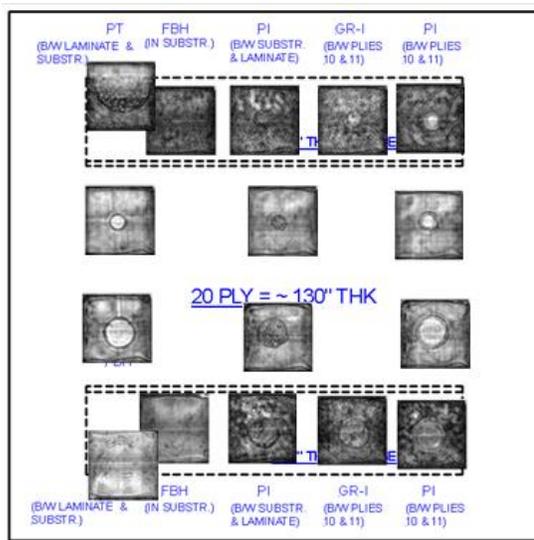
Figure 67. DolphiCam inspection results showing (a) amplitude images of impact damage, (b) interply delamination, and (c) impact damage in composite laminate structures

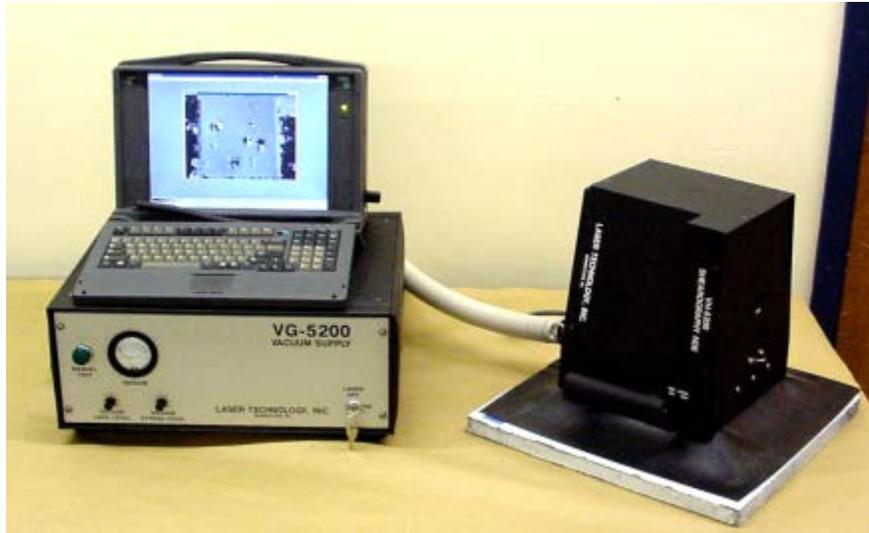
Figure 73. The LTI-5200 portable shearography system with camera on a test specimen

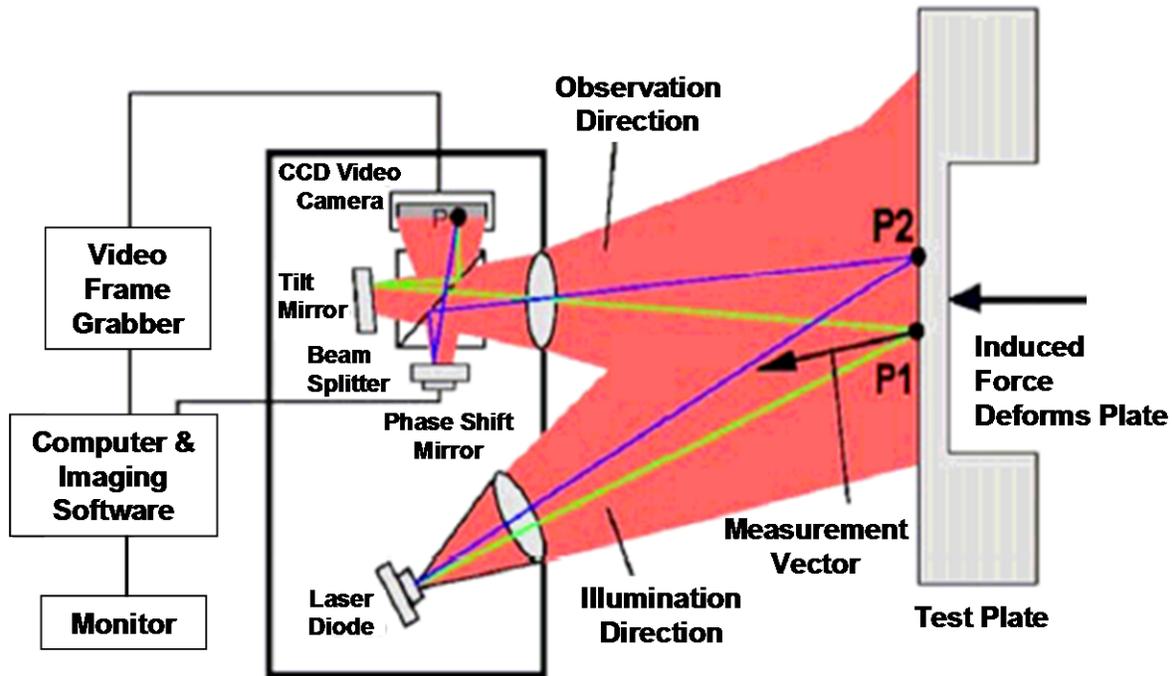
Figure 74. Basic principles of shearography

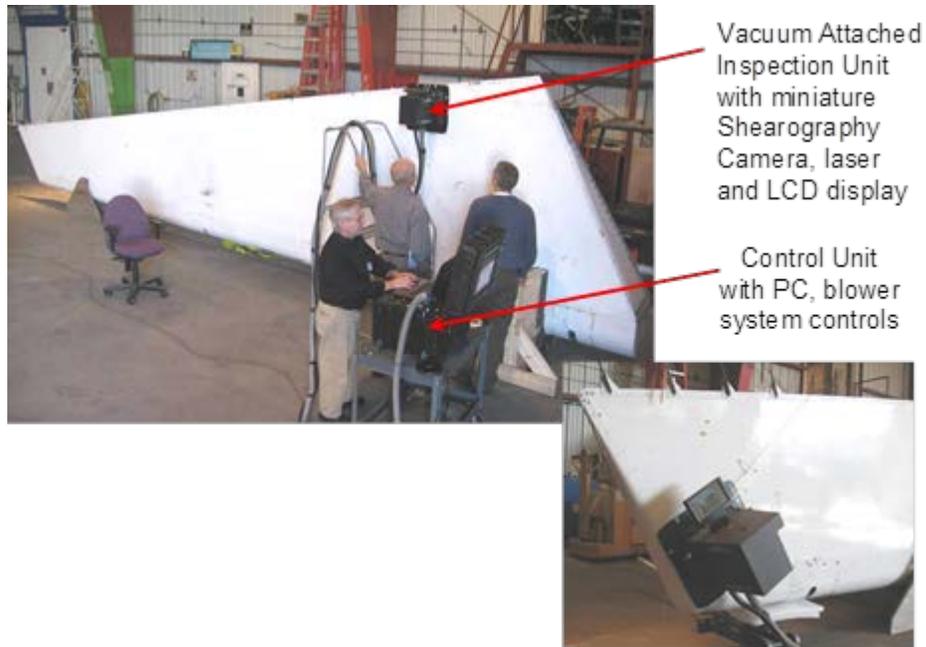
Figure 75. Composite rudder inspection using LTI-5200 portable vacuum shearography system

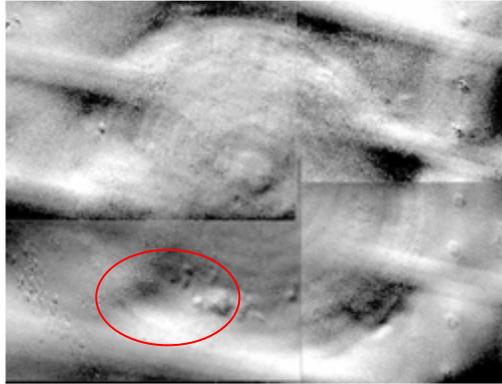
Figure 79. An LTI-5200 shearographic inspection image of a scarfed repair to a honeycomb structure with anomaly indications in the repair plies

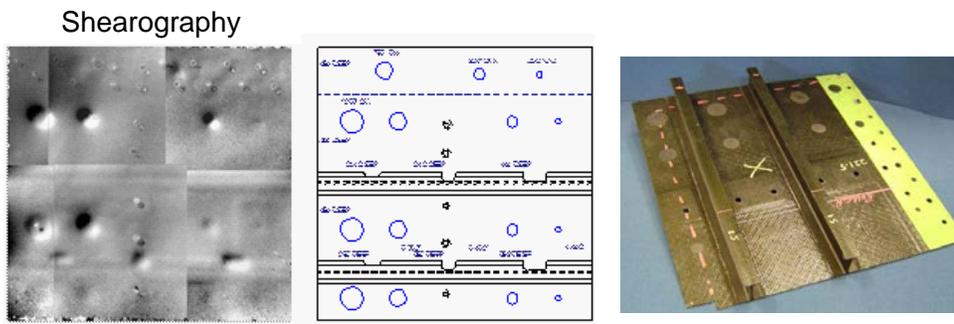
Figure 80. Shearography image produced from inspection of composite laminate panel (0.11" thick skin; the flaw profile is shown in the middle drawing)

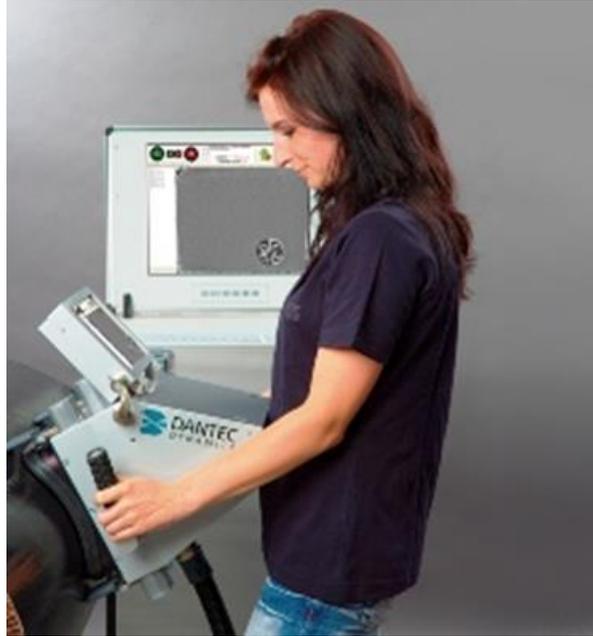
Figure 81. The Q-810 laser shearography system
