DOT/FAA/TC-15/4

Federal Aviation Administration
William J. Hughes Technical Center
Aviation Research Division
Atlantic City International Airport
New Jersey 08405

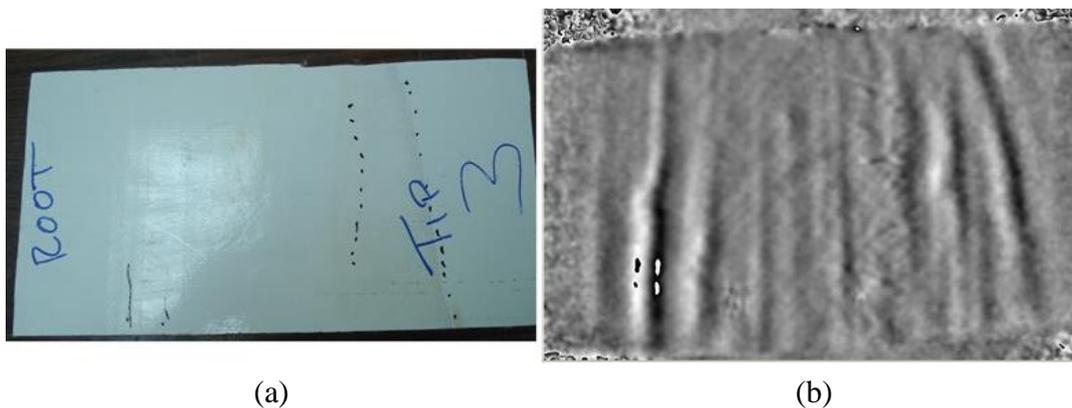
Figure 82. The (a) test specimen and (b) Q-810 shearography image of wrinkles in a composite laminate

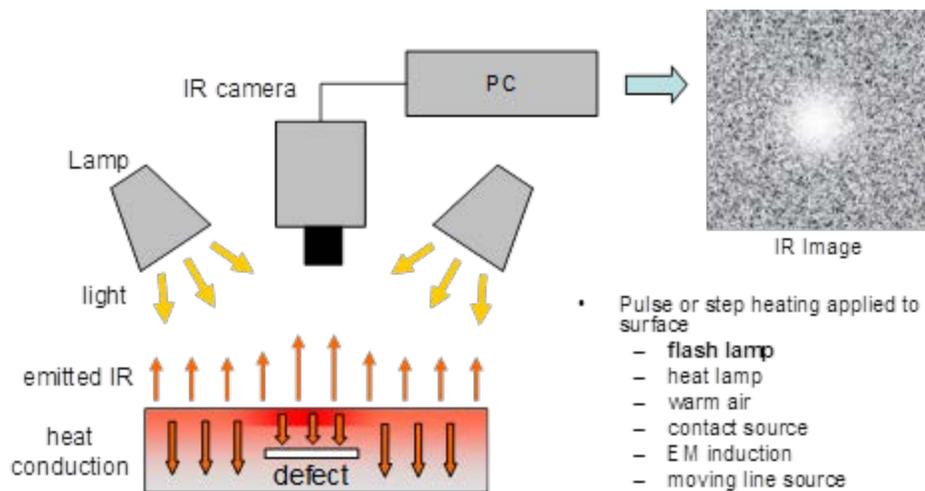
Figure 83. Principle of active pulsed thermography

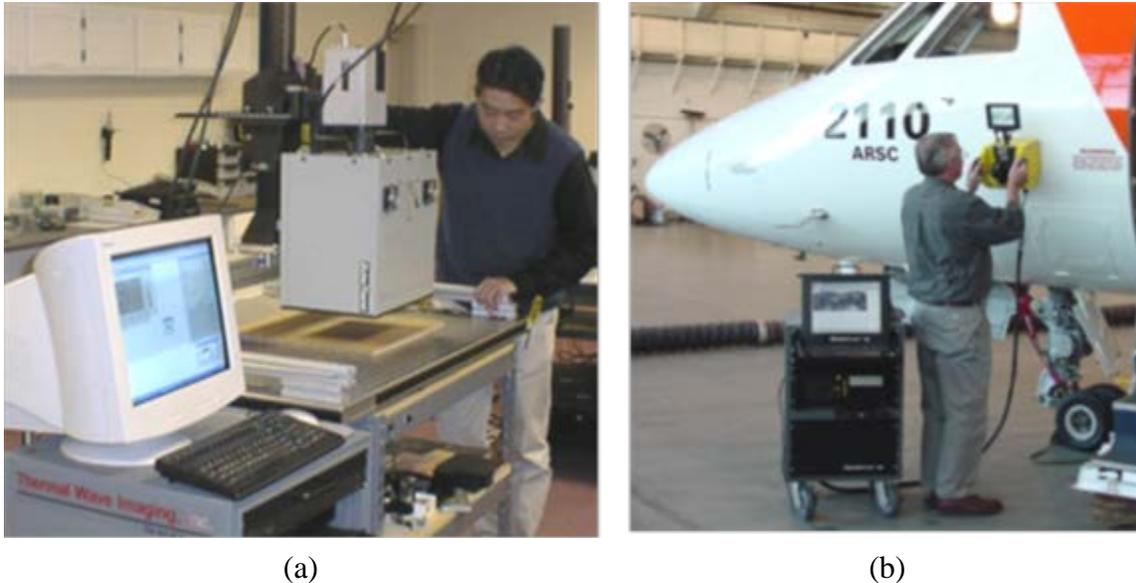
Figure 84. Laboratory (a) Thermal Wave Imaging system inspecting composite flow detection panels and (b) portable field system inspecting an aircraft fuselage

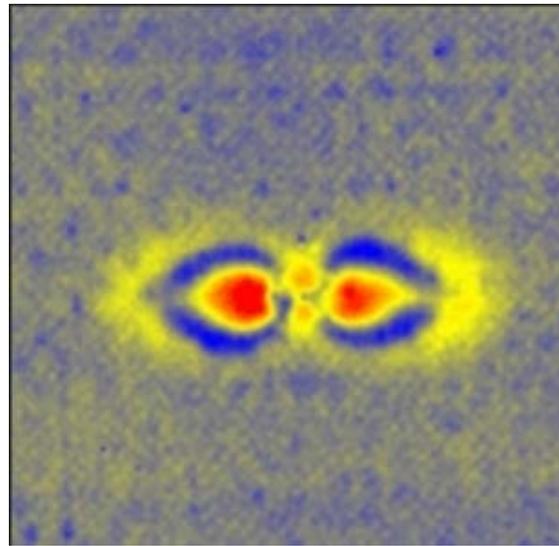
Impact Damage in a Solid Laminate Composite Structure

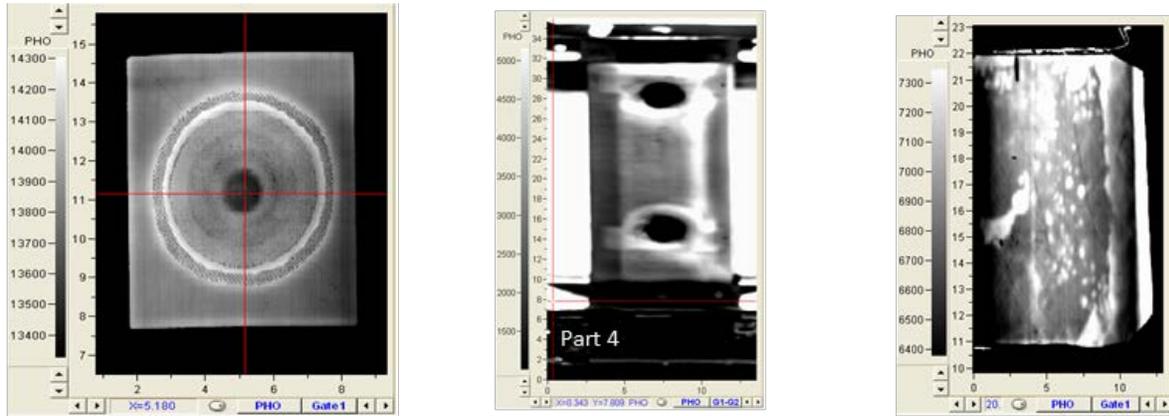
Image of a scarf composite repair in a sandwich composite panel.

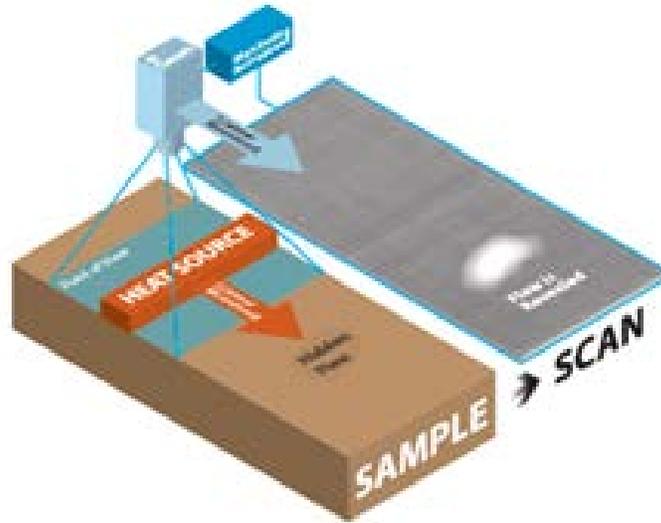
Figure 93. Setup of LST in which IR camera and heat source move in tandem over the surface to be inspected

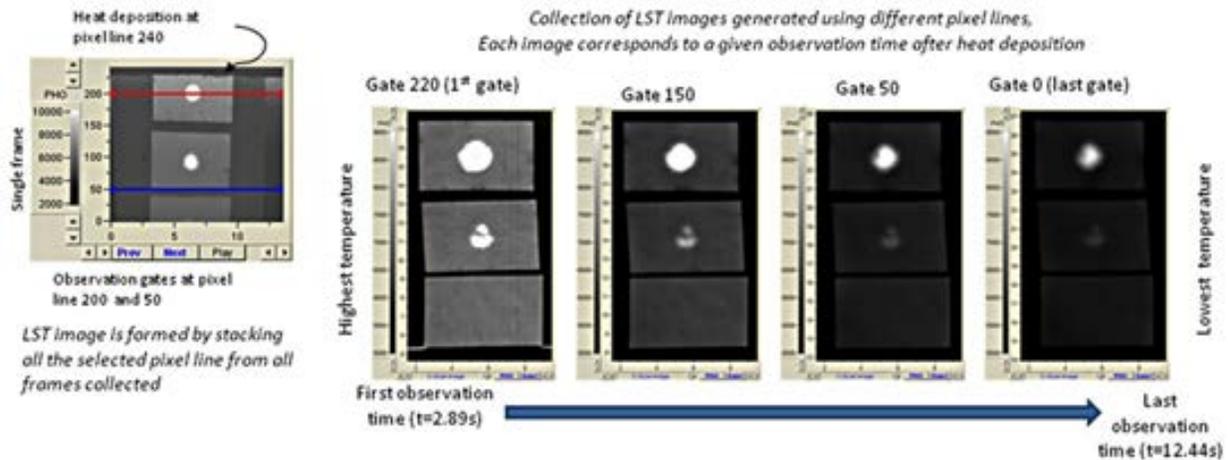
Figure 94. Panel showing the observation gate selection with respect to the heat deposition location

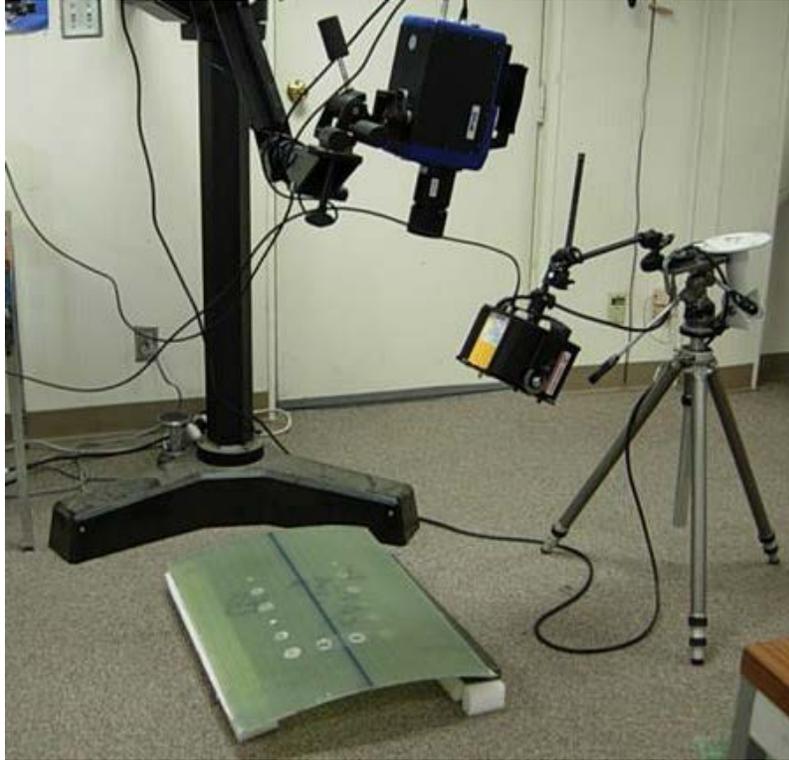
Figure 99. MoviTHERM lock-in thermography with halogen heat lamp being used as the excitation source

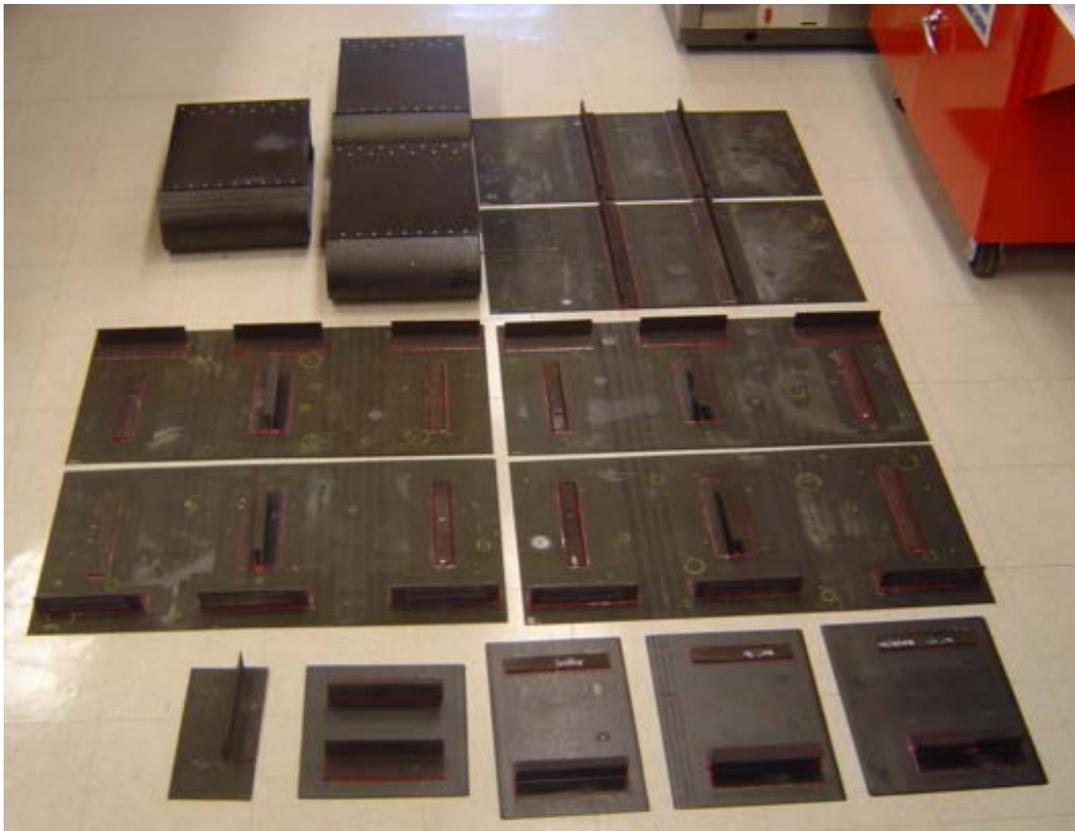
Figure 101. Subset of the 15 solid laminate test specimens and five NDI feedback specimens

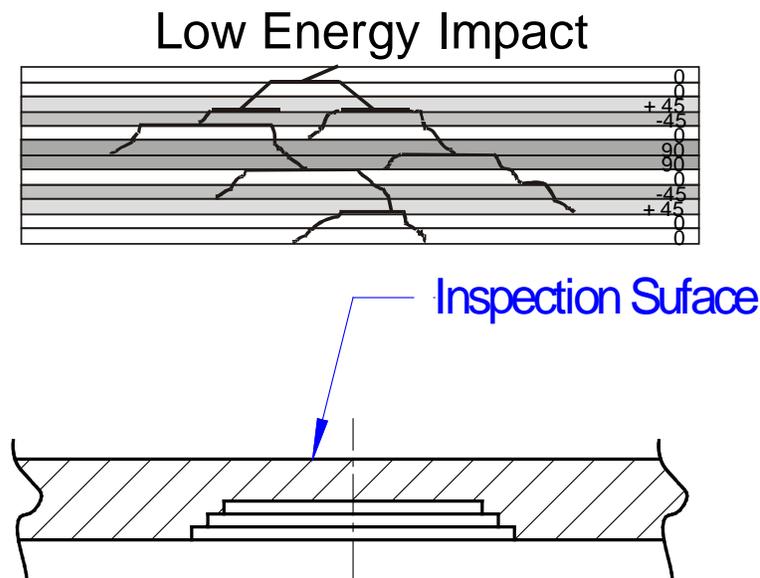
Figure 103. Simulated impact damage (laminates cross-section)

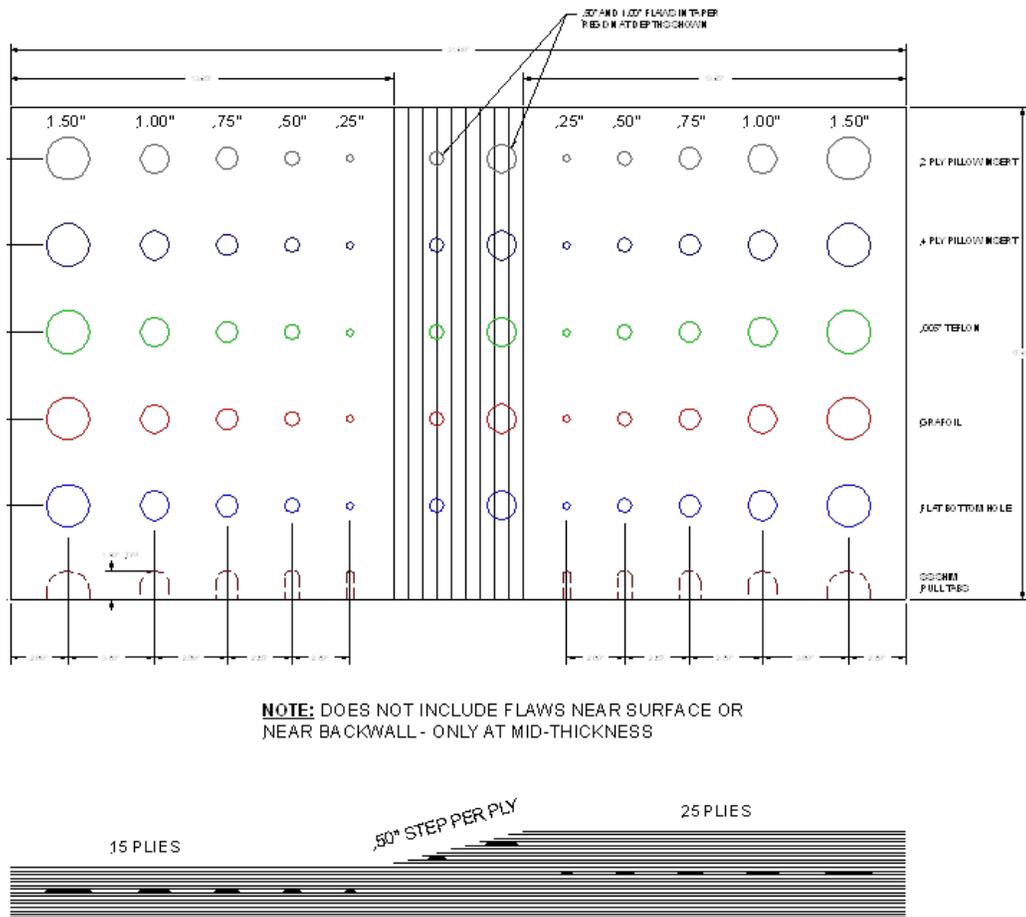
Figure 117. Trial S/N solid laminate specimen for preliminary testing of methods for producing engineered flaws

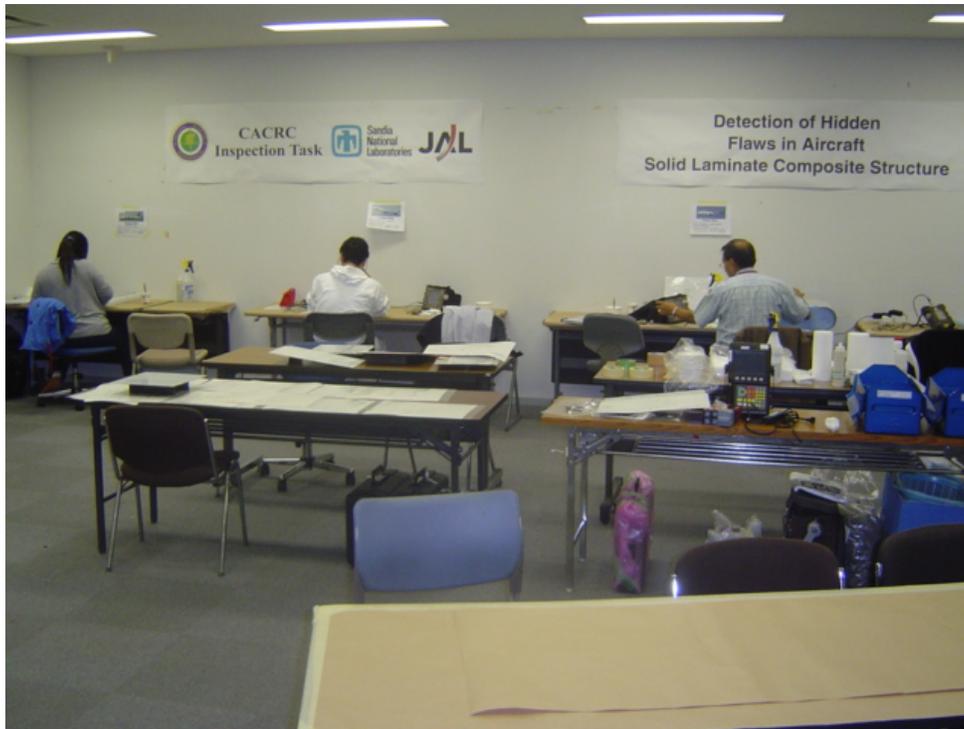
Figure 128. Typical experiment setup with separate inspector workstations

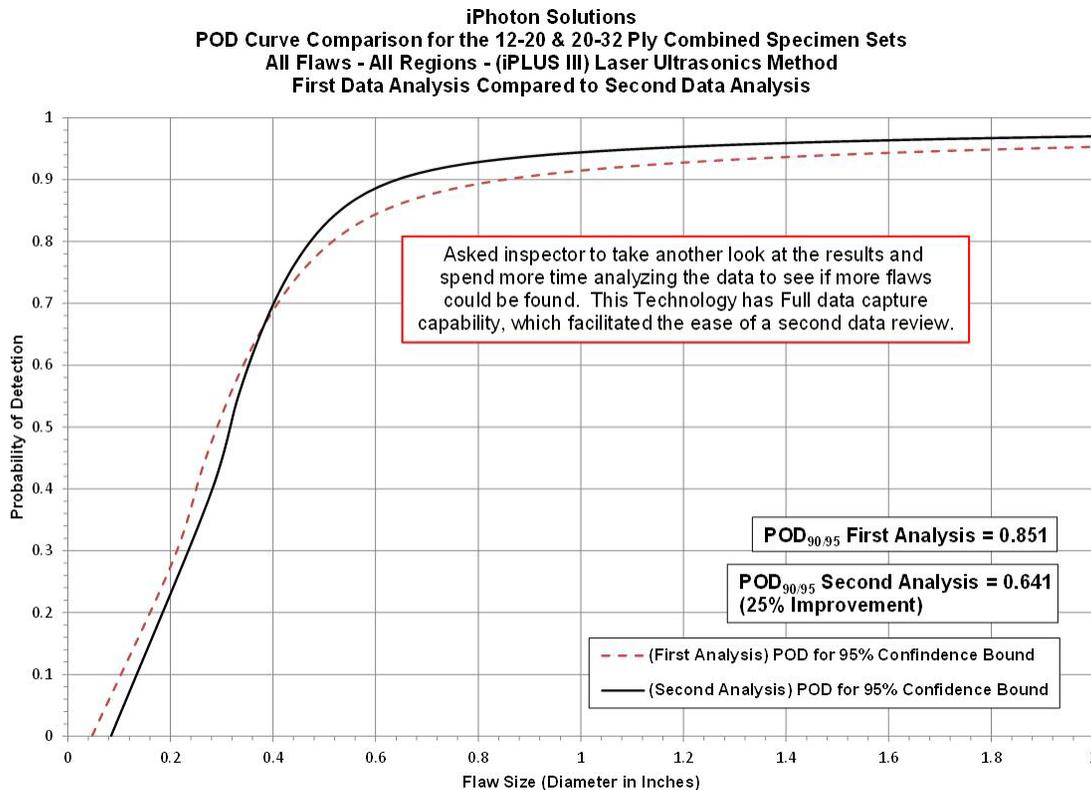
Figure 184. The POD improvements stemming from a second analysis of iPLUS LUS data

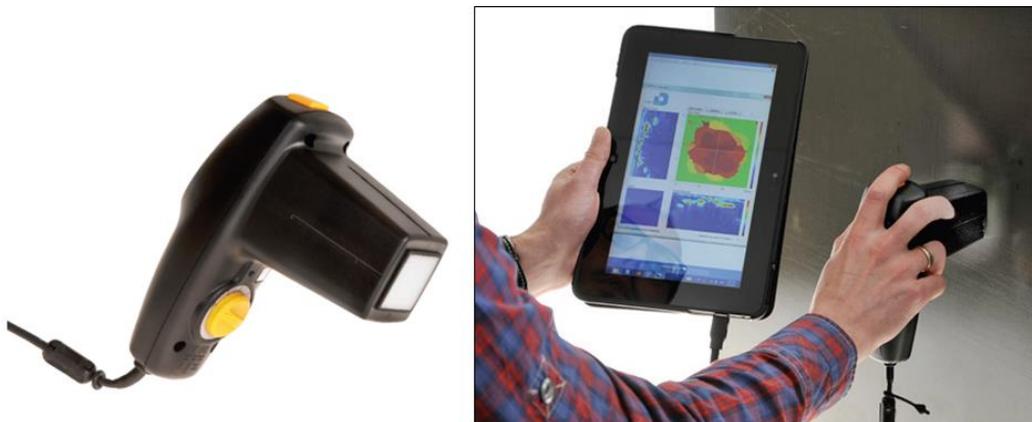
Figure 192. DolphiTech DolphiCam video-based UT device

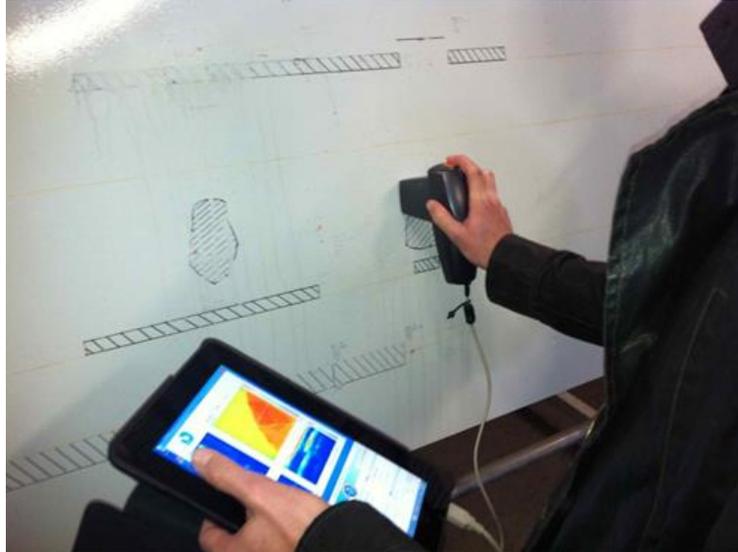
Figure 193. Deployment of DolphiCam video-based UT system on full-scale composite panel (image of impact damage on screen)

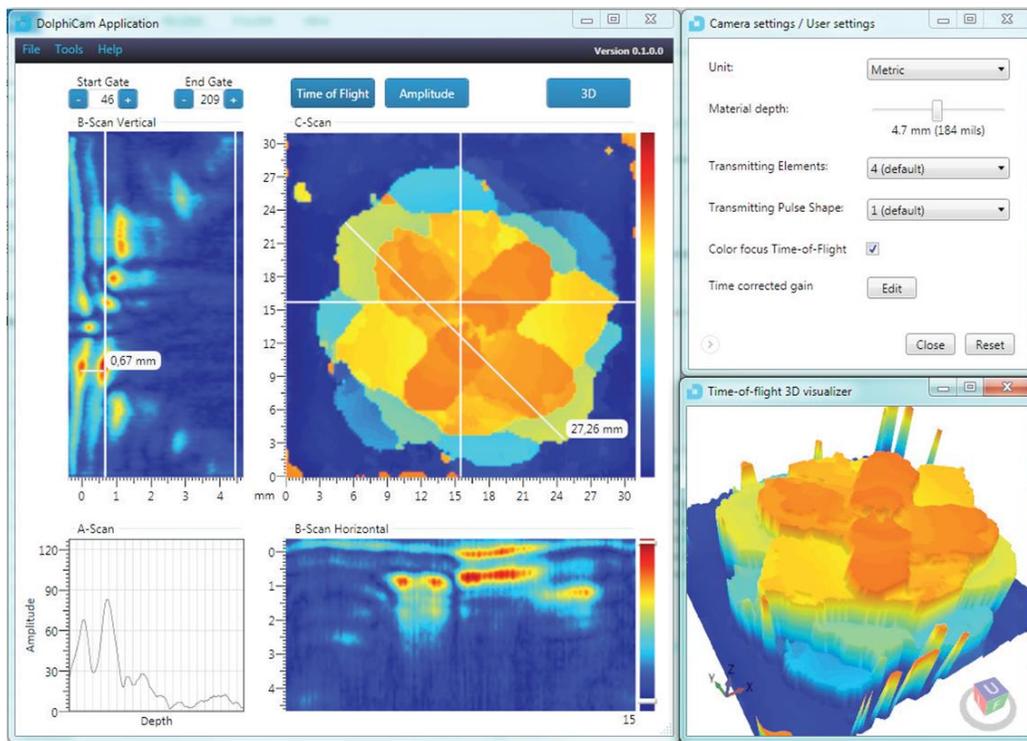
Figure 194. Typical UT image and A-scan display produced by DolphiCam showing an individual flaw

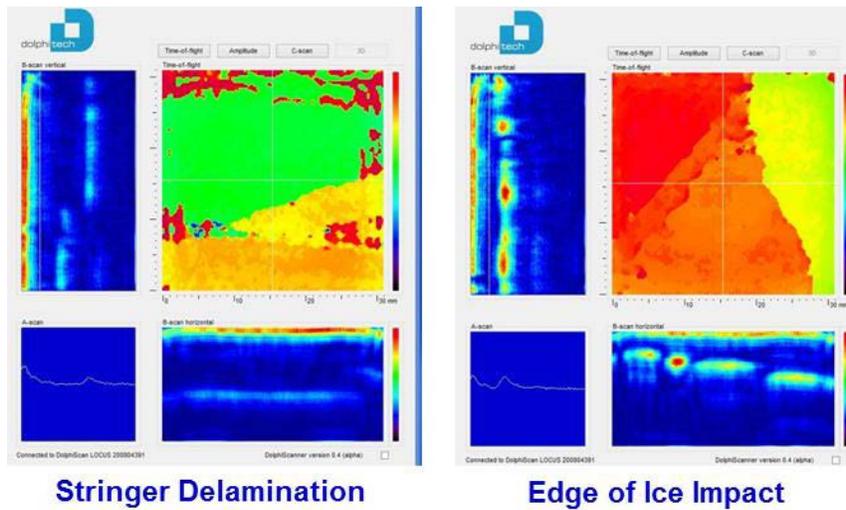
Figure 196. Image displays produced by DolphiCam UT system for delamination and impact damage

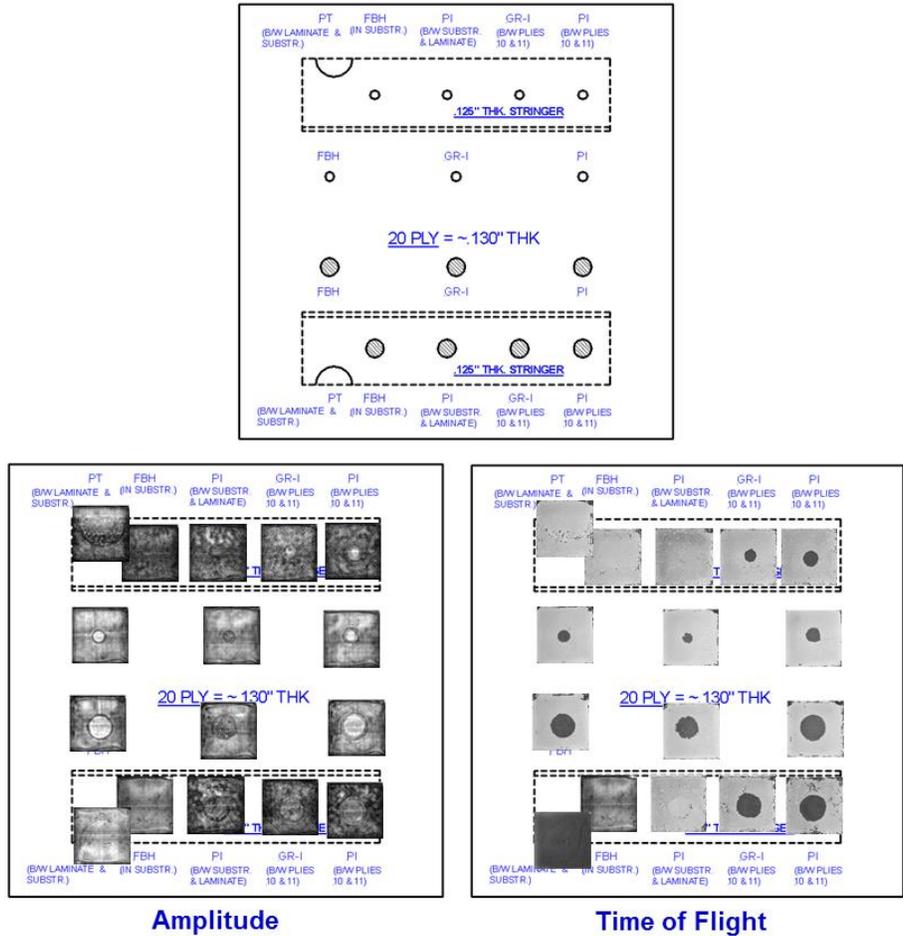
Figure 197. Flaw images produced by DolphiCam video-based UT system inspection of SLE 20-ply reference panel

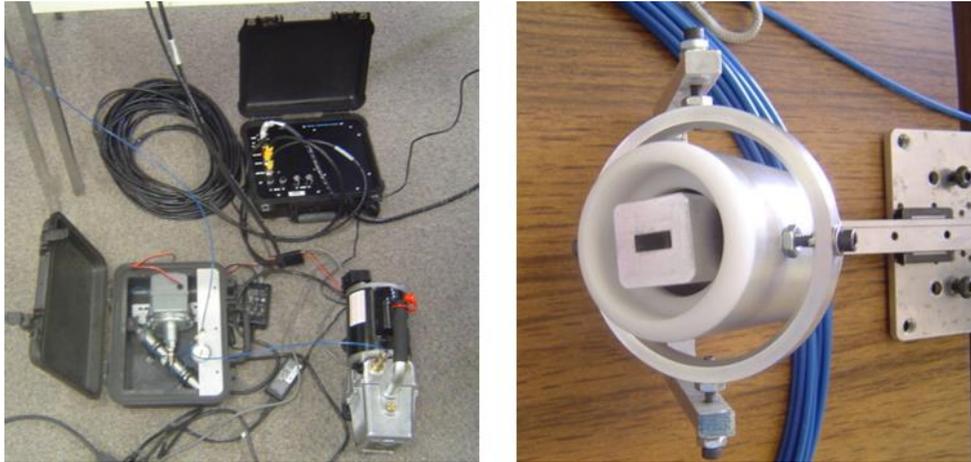
Figure 198. Evisive MW device

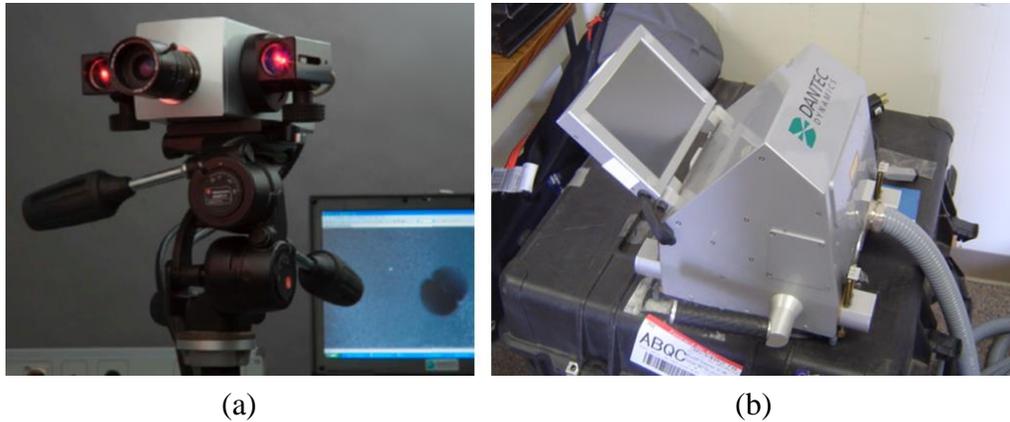
Figure 205. Dantec Dynamics shearography devices: the (a) Q800 and (b) Q810

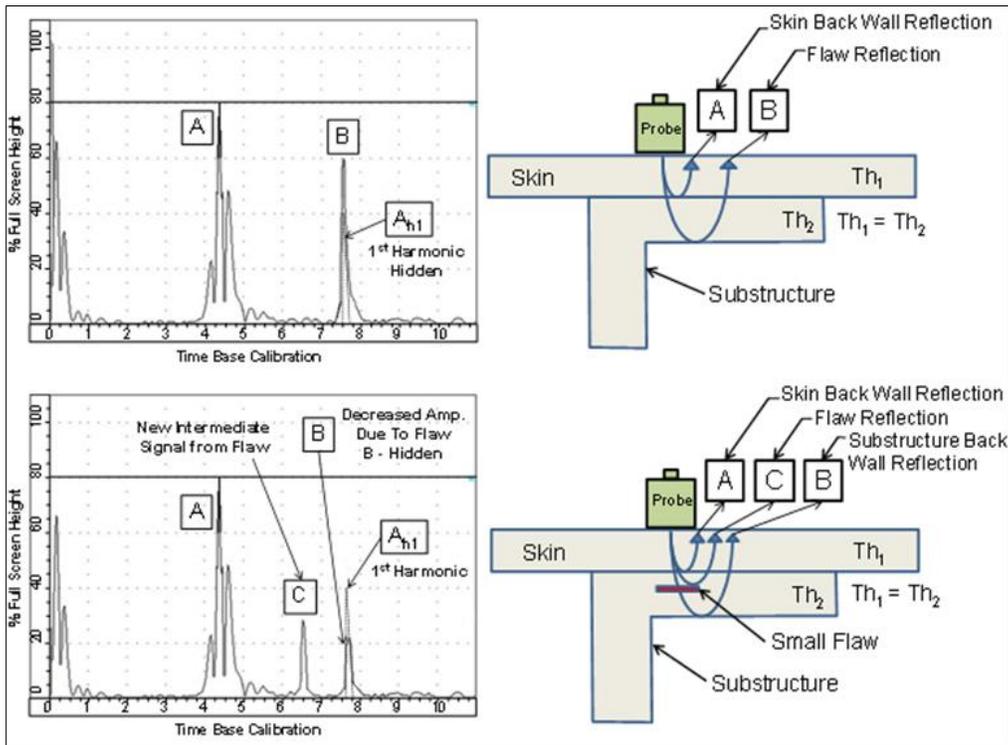
Figure 227. Inspection impediment in which signal harmonics occur in the same time frame as the signals of interest

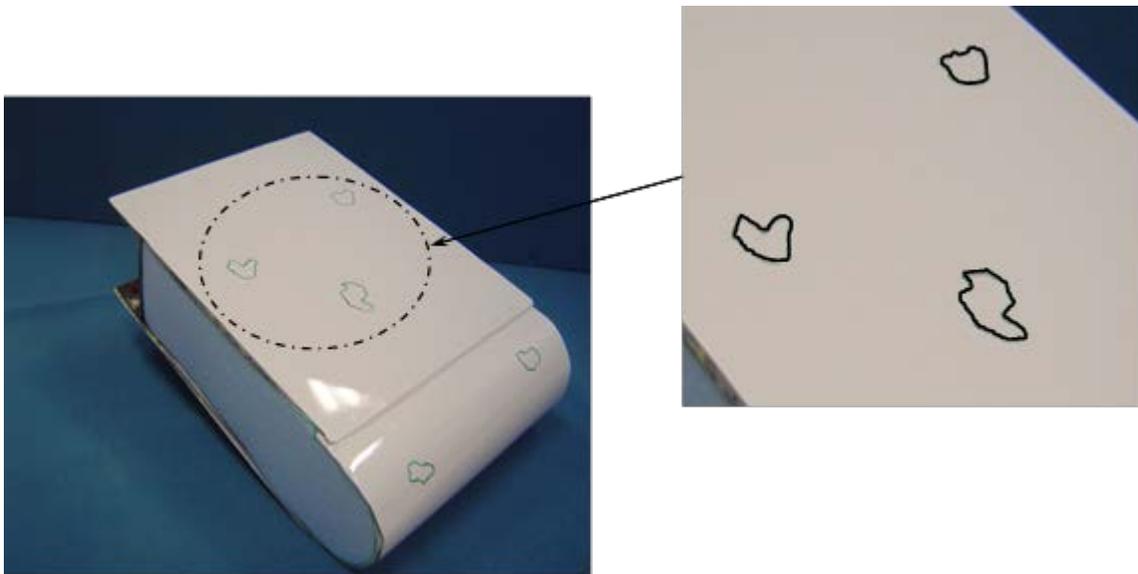
Figure A-7. Sample set of inspector's flaw marks on a solid laminate test specimen

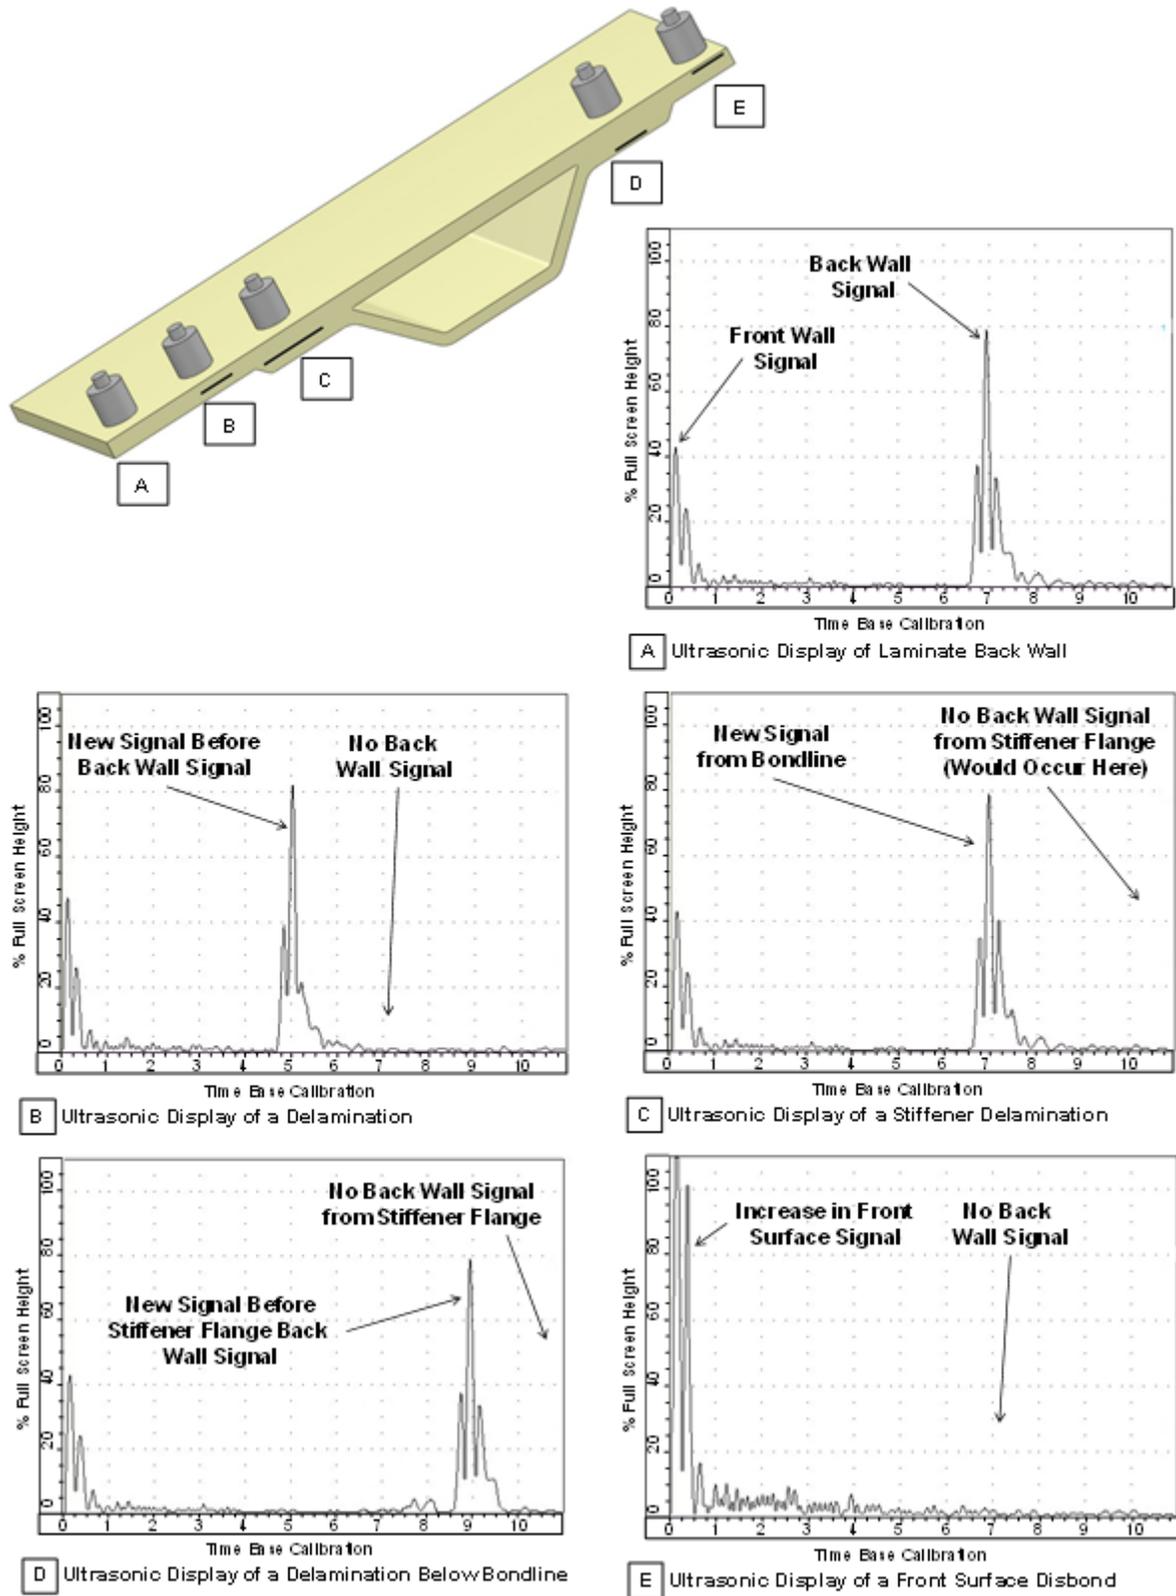
Figure A-8. Delamination indications at different structure thicknesses for co-cured substructures

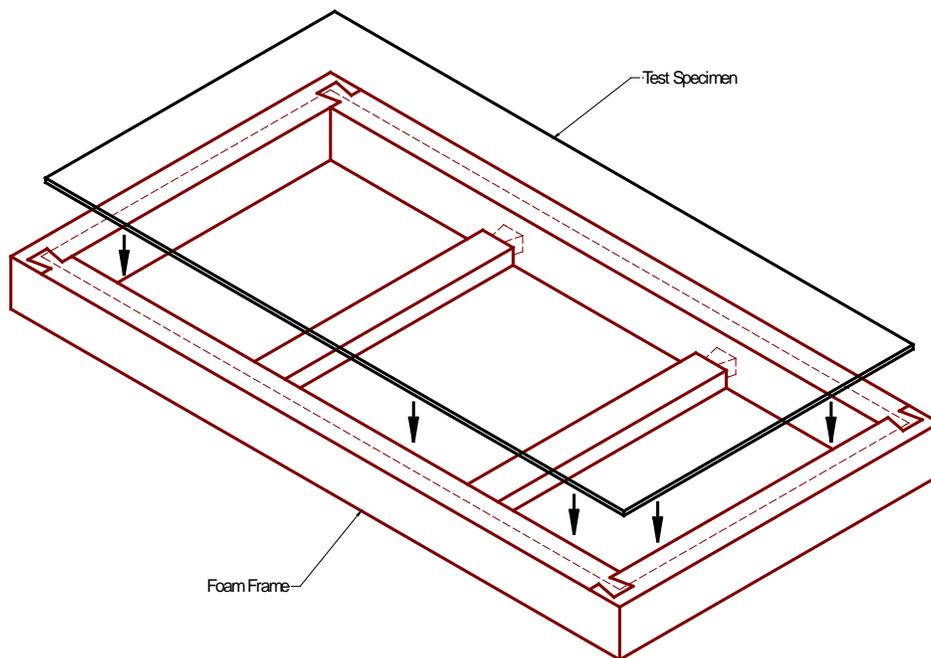
Figure A-13. During inspections, place each panel such that it is supported around its perimeter by a foam frame. This will provide uniform boundary conditions.
