Evaluation of Structured Methyl Methacrylate Marking to Increase Paint Conspicuity

October 2015

DOT/FAA/TC-TN15/50

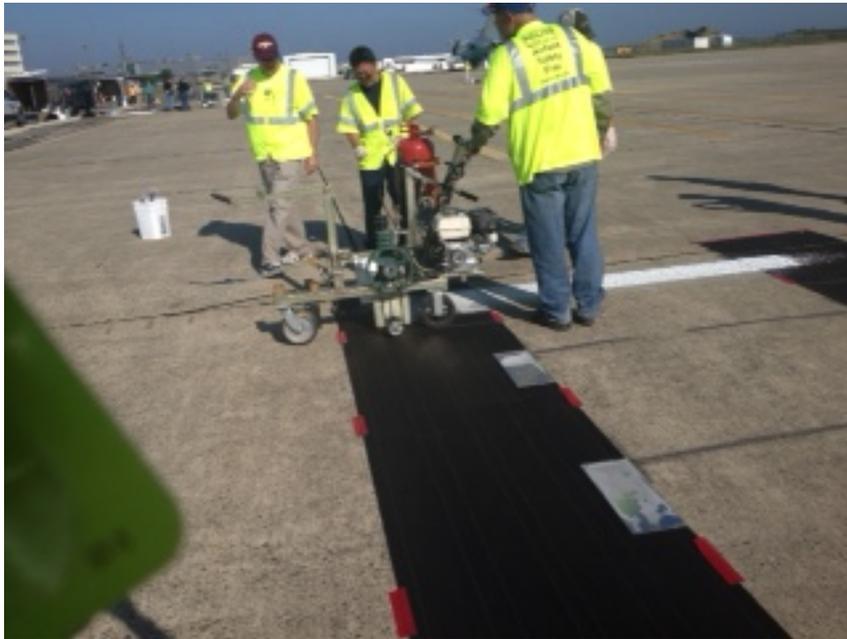
Figure 1. Hi-Lite SMMA Application

It is important to note that each manufacturer had a different approach to creating the structured format. In some cases, the paint was splattered on the surface; in other cases, the paint was laid down in a thicker, ribbon-like fashion. Although approached in different ways, the results were a thicker, three-dimensional marking.

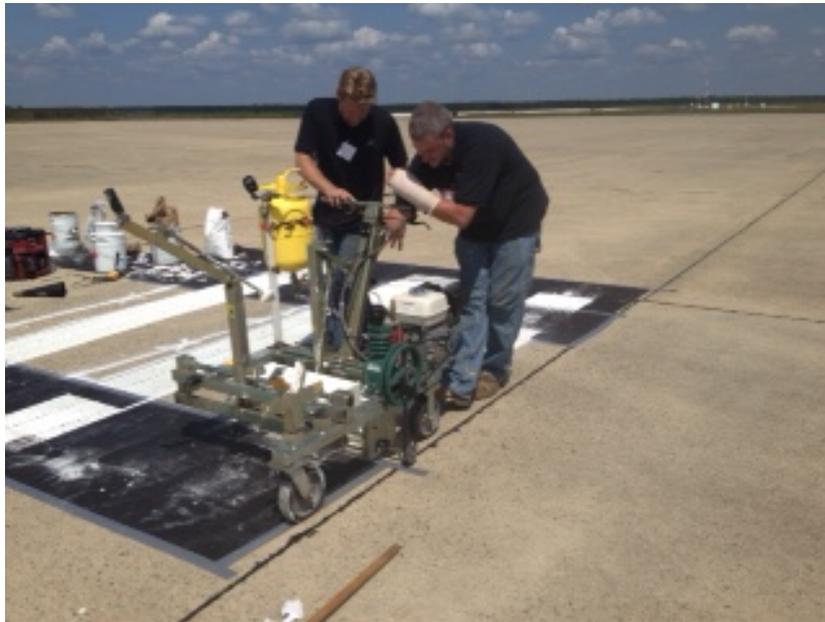
Figure 2. Ennis/Flint SMMA Application

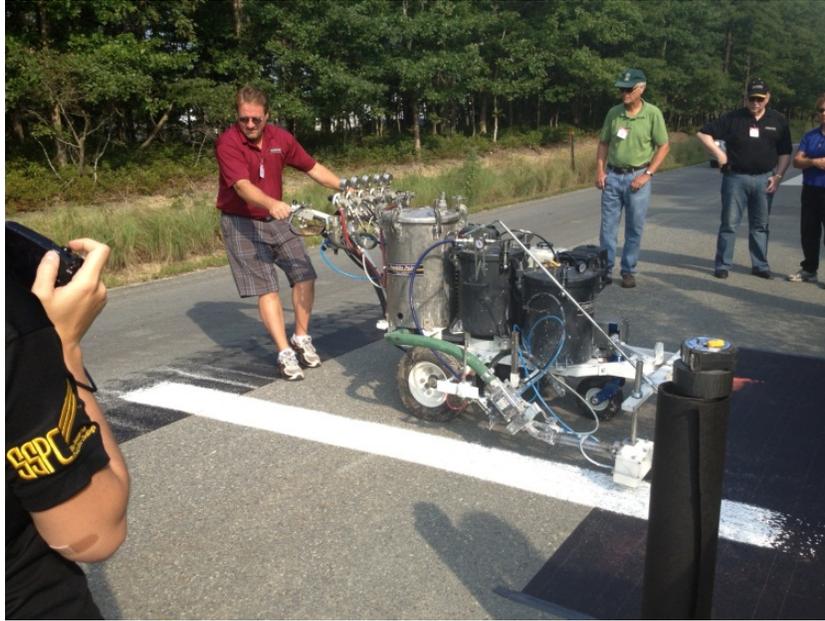
Figure 3. Franklin Paint SMMA Application

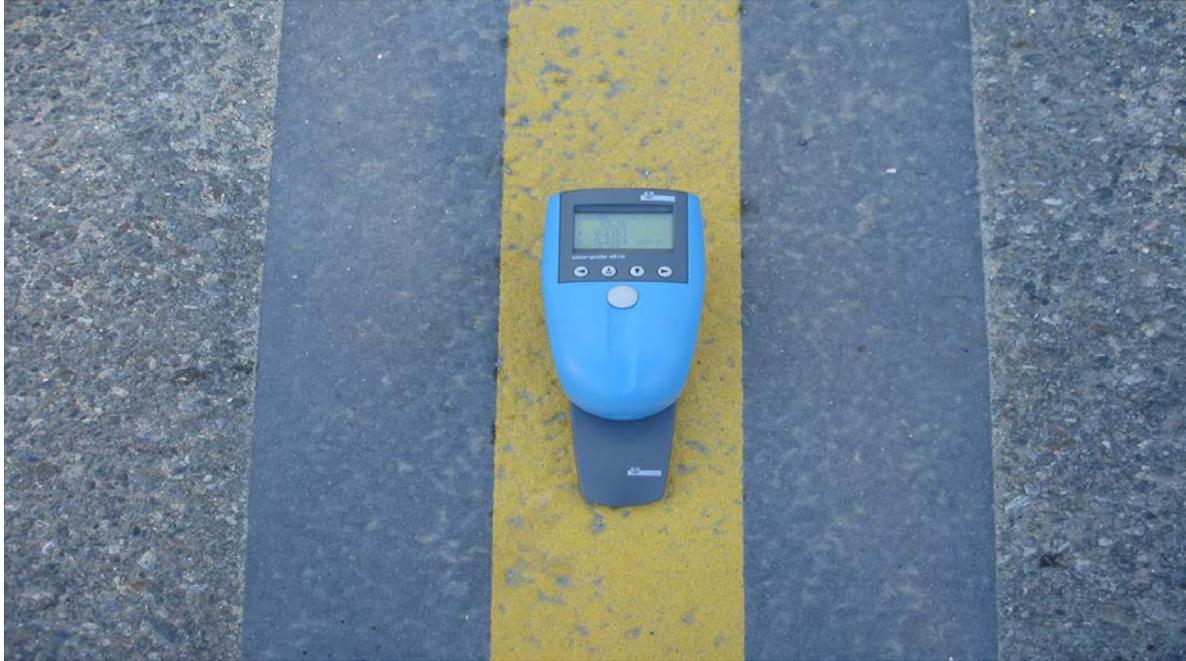
Figure 4. The BYK-Gardner Spectrophotometer

- Chromaticity tester—A Color-Guide 45/0, 20-mm, 6801-Gloss spectrophotometer manufactured by BYK-Gardner of Germany (S/N 1042342) was used to measure the chromaticity (color) of the paint markings (figure 4).
- Retroreflectometer tester—An Ennis/Flint, 30-meter geometry LTL-X built by Delta Lights and Optics of Denmark (S/N 540) was used to measure the paint markings' retro-reflectivity (figure 5).
- Pull-off tester—A Dyna Z16 pull-off tester was used to measure the tensile strength of the bond between the pavement and paint. The tester was also used to determine if the bond fails cohesively or adhesively (figure 6).
- Friction tester—A Saab Sarsys Runway Friction Tester, with tire pressure at 30 psi, was used to test the friction (figure 7).
- Heavy Vehicle Simulator—A custom-designed HVS (airfield version HVS-A) is a Mark VI Airport model built by Dynatest (figure 8).

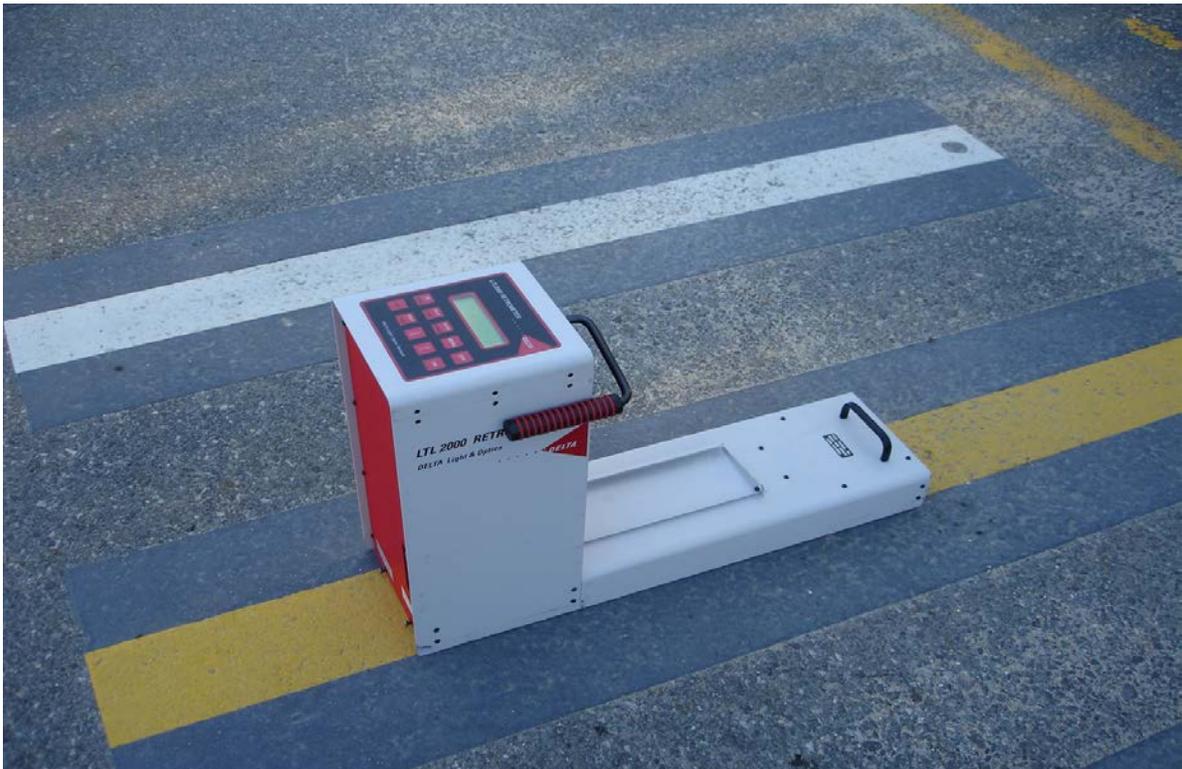
Figure 5. Delta Light and Optics LTL-X Retroreflectometer

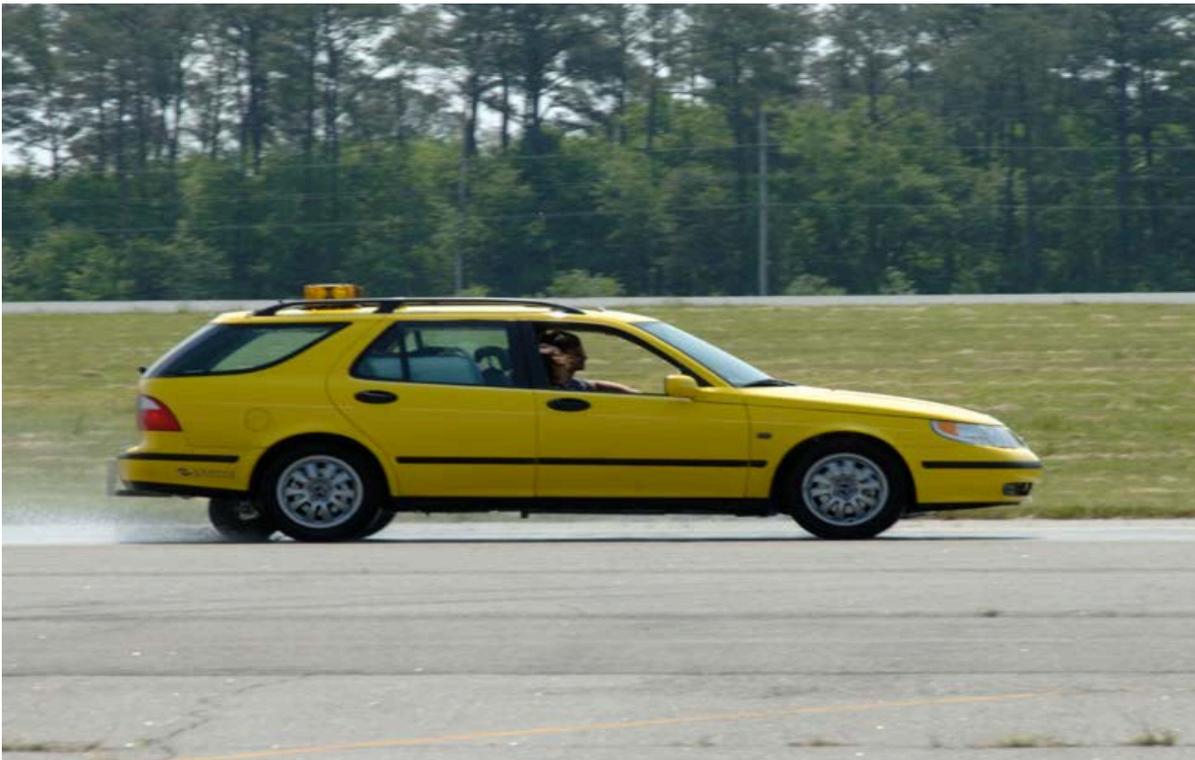
Figure 7. Saab Sarsys Runway Friction Tester

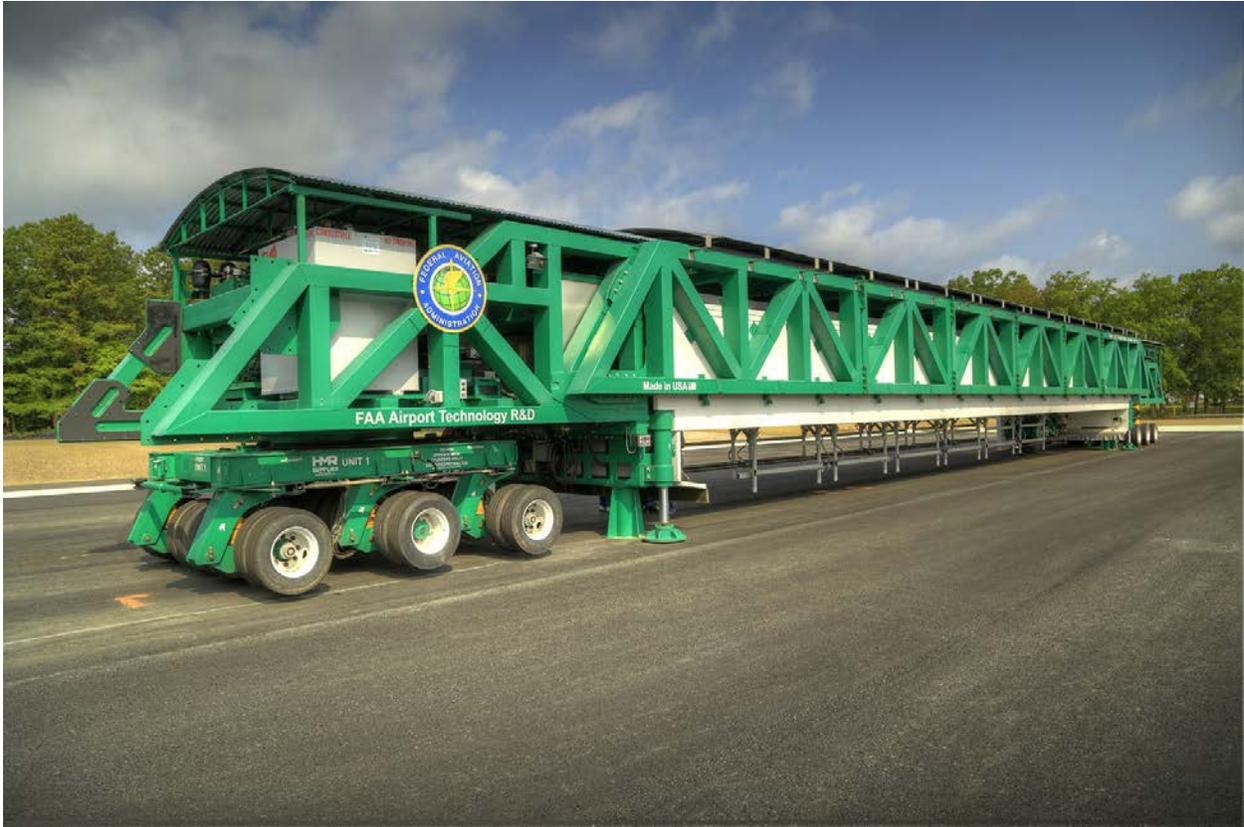
Figure 8. Heavy Vehicle Simulator (Airport Version)

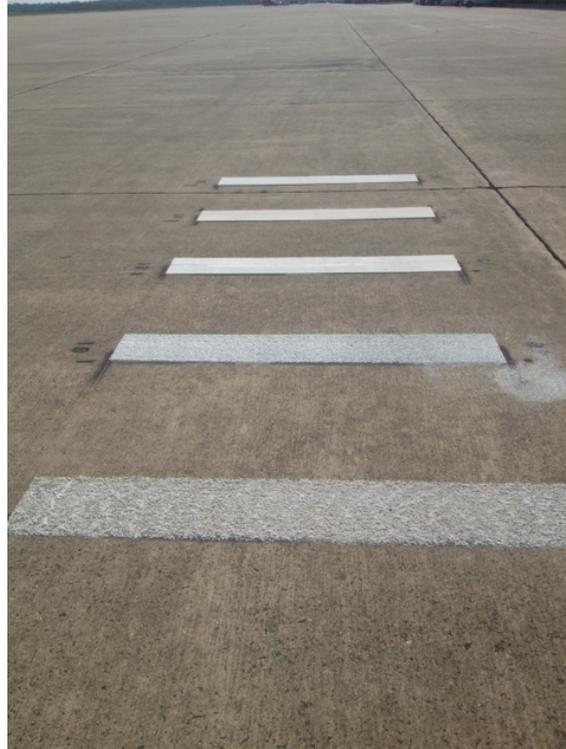
Figure 10. Initial Installation of Edge Lines on the FAA Ramp (Concrete)

Figures 10 and 11 show samples of the edge lines and the friction lines installed on the FAA Ramp (concrete). Table A-1 shows a matrix of data for the MMA and SMMA stripes that were applied on the FAA Ramp (concrete).

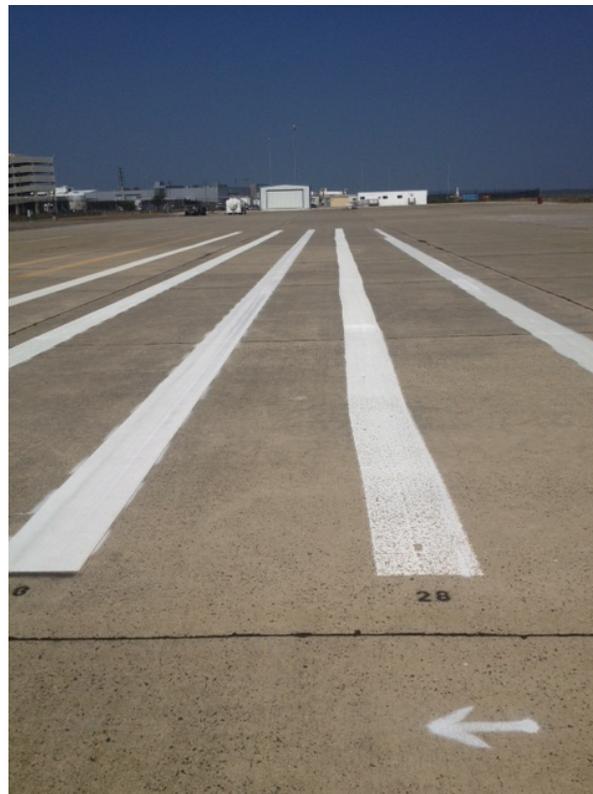
Figure 11. Initial Installation of Friction Lines on the FAA Ramp (Concrete)

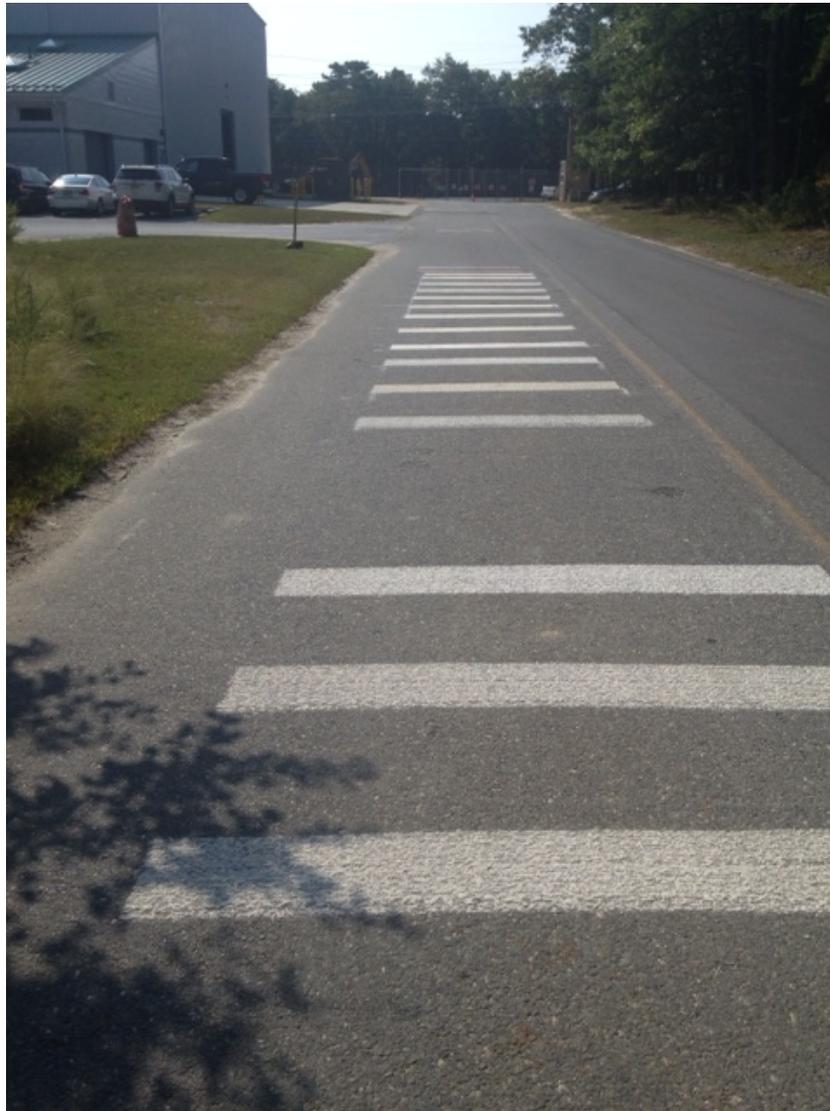
Figure 13. Initial Installation of the Edge Lines on Pangborn Road (Asphalt)

Figures 13 and 14 show samples of the edge lines and the friction lines installed on Pangborn Road (asphalt). Table A-2 shows a matrix of data for the MMA and SMMA stripes that were applied on Pangborn Road (asphalt).

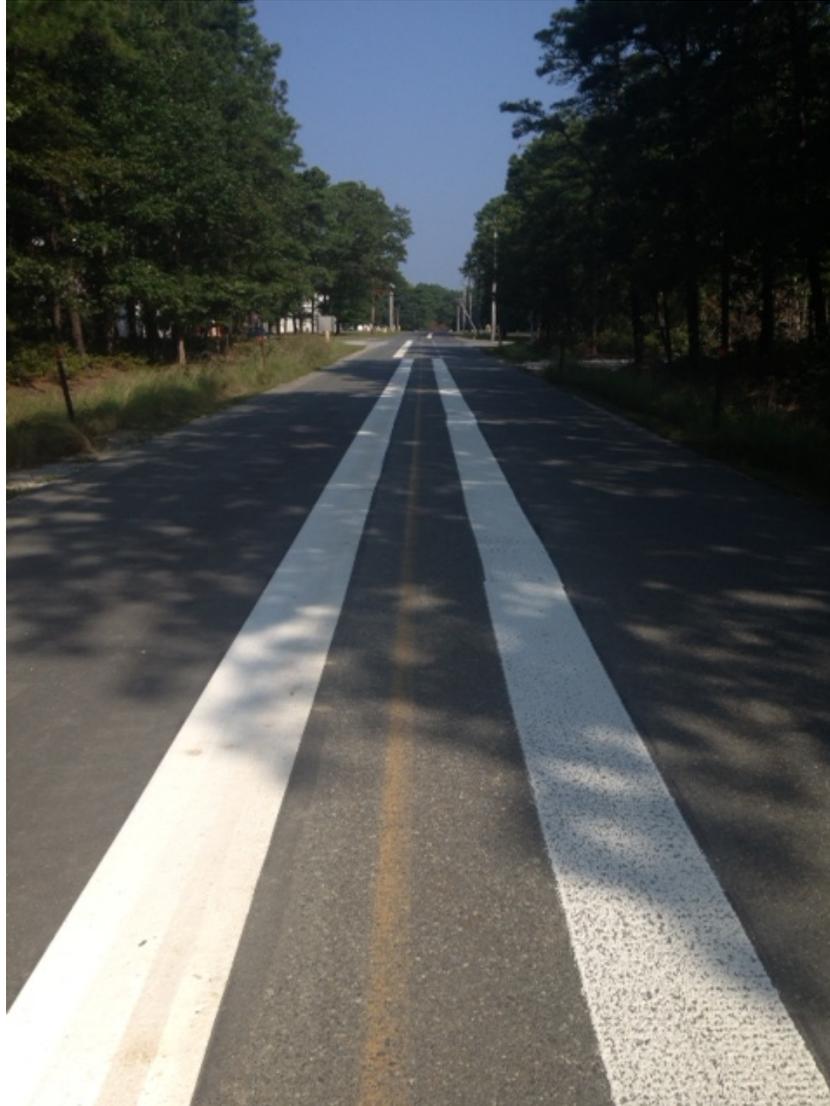
Figure 14. Initial Installation of the Friction Lines on Pangborn Road (Asphalt)

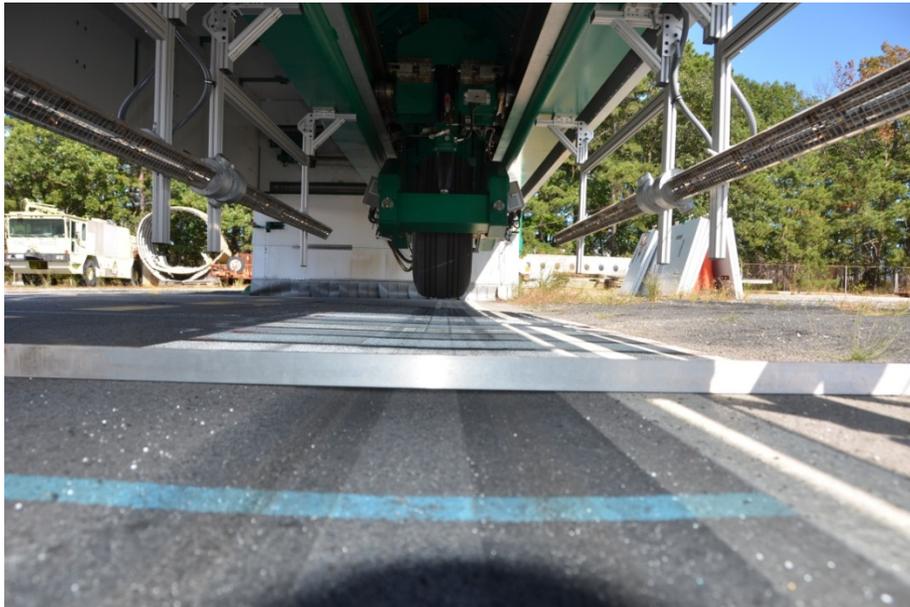
Figure 15. Edge Line Installation Under the HVS Test Machine (new hot mix asphalt)

Figure 15 shows samples of the edge lines installed underneath the aircraft tire of the HVS. Table A-3 shows a matrix of data for the MMA and SMMA stripes that were applied at the HVS test facility.

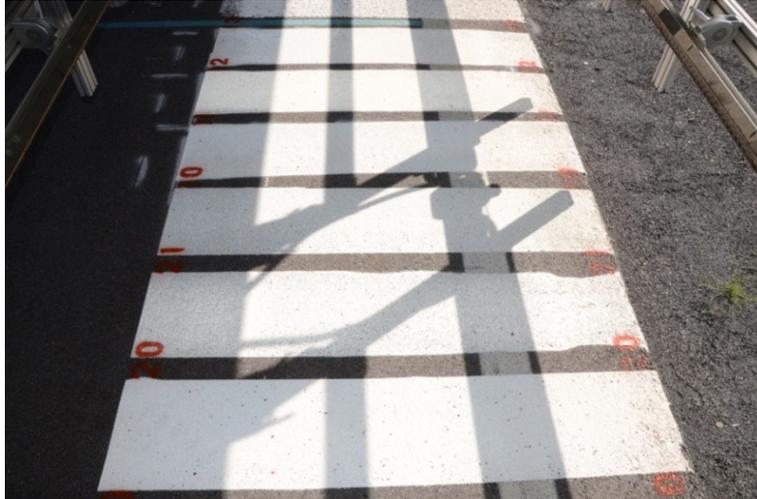
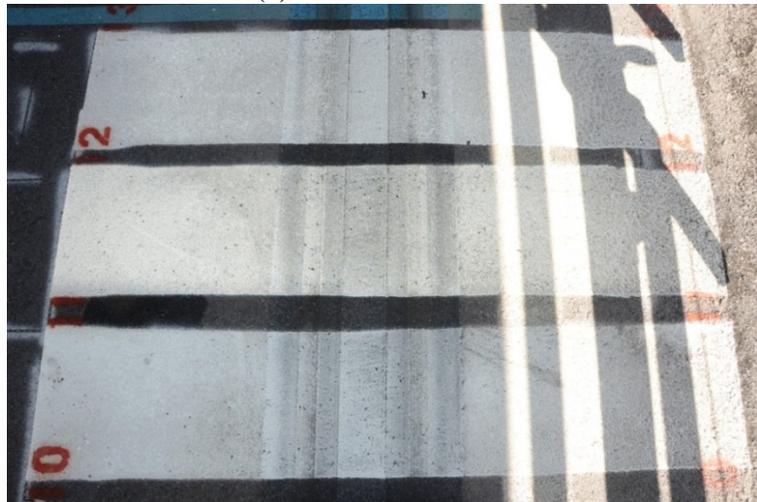
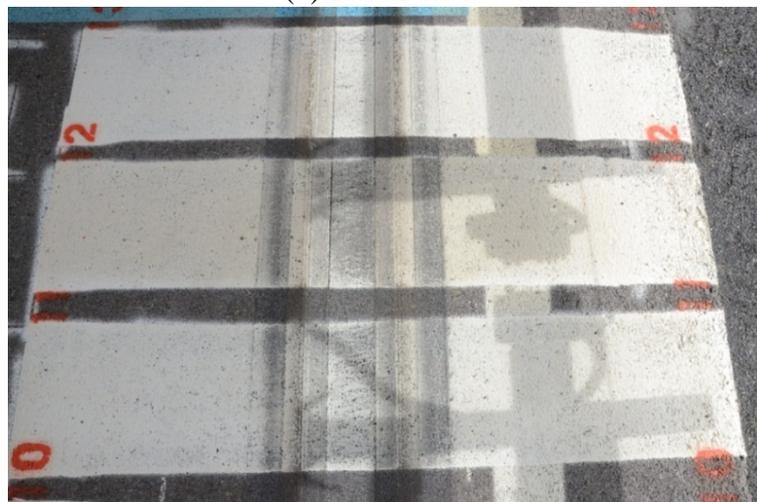
Figure 16. The HVS Test Stripes, 0-2000 Passes, Ambient Temperature, Hi-Lite MMA (Lines 10-12)

- The SMMA test stripes appeared to collect rubber deposits at a higher rate than the MMA test stripes, as shown in figures 16 through 20.
- Minor grooving caused by the aircraft tire appeared on both the SMMA and MMA markings.
- The softer Franklin Paint formula did not appear to be any better or worse than the standard MMA formulas.
- There was no major disfiguring, cracking, breakage, or transfer of either the MMA or the SMMA paint after enduring 2000 passes by the HVS test machine.

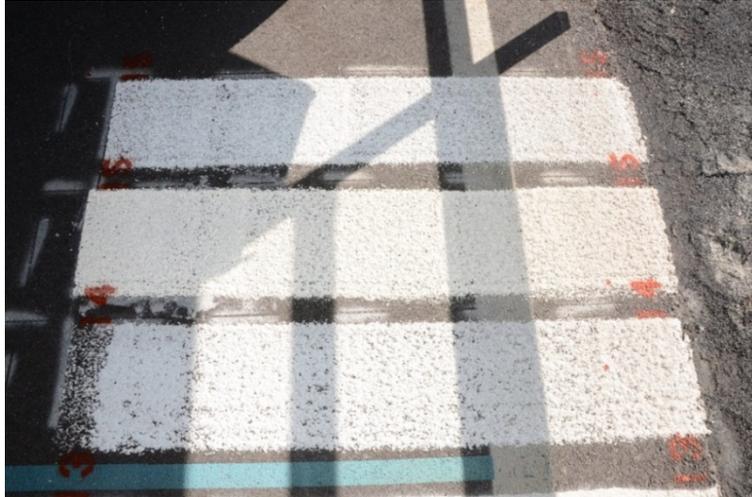
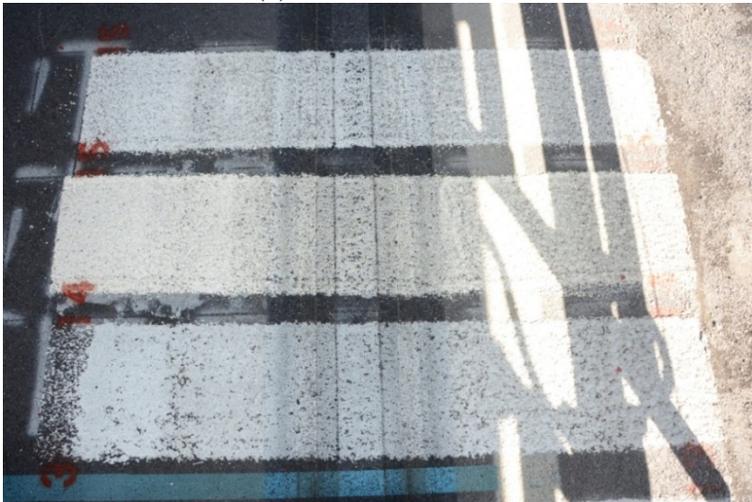
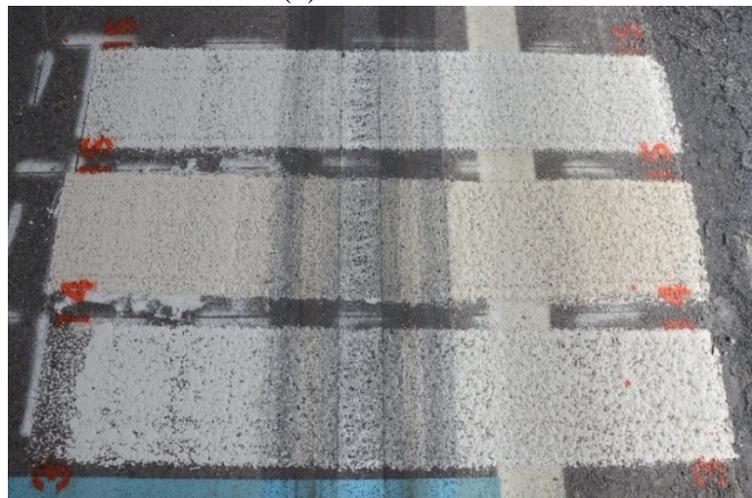
Figure 17. The HVS Test Stripes, 0-2000 Passes, Ambient Temperature, Hi-Lite SMMA (Lines 13-15)

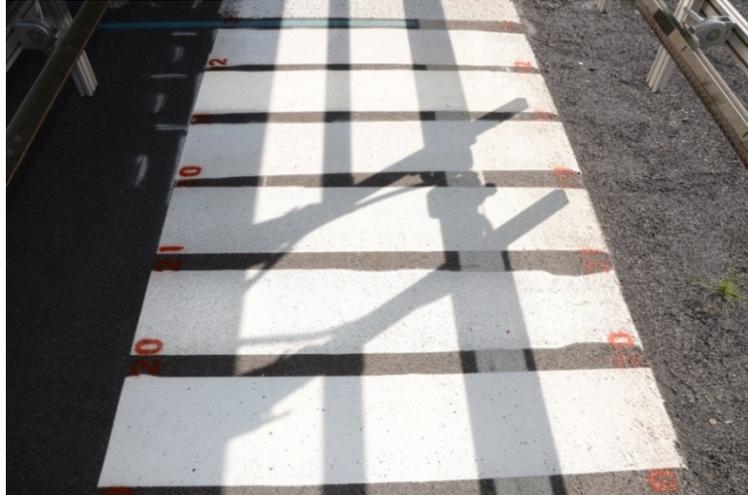
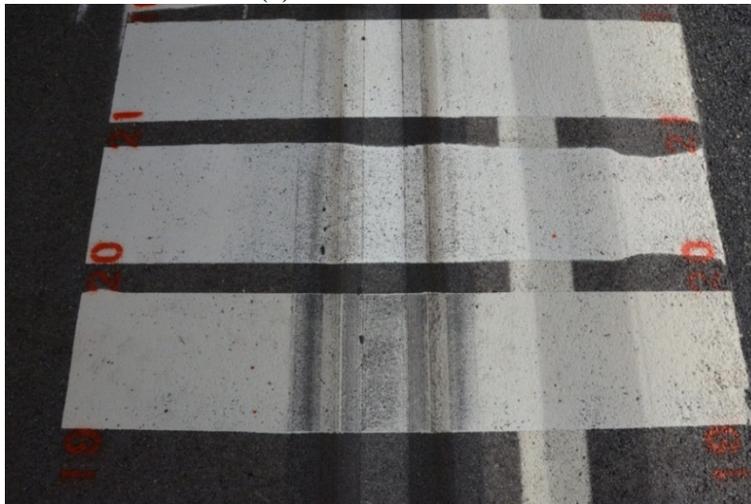
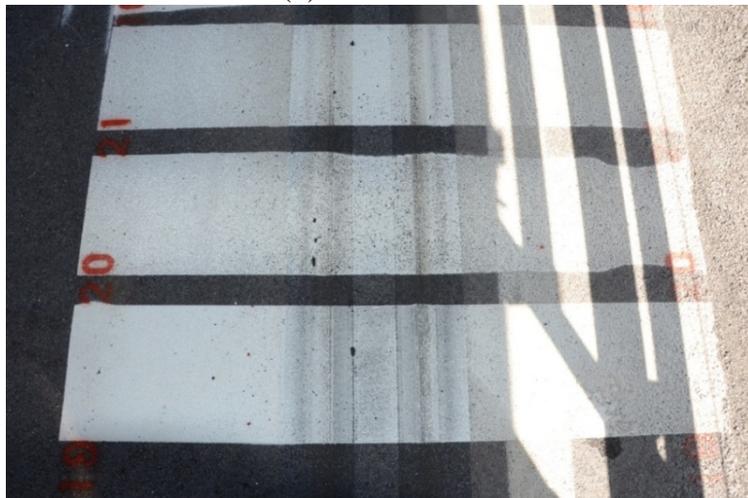
Figure 18. The HVS Test Stripes, 0-2000 Passes, Ambient Temperature, Ennis/Flint MMA (Lines 19-21)

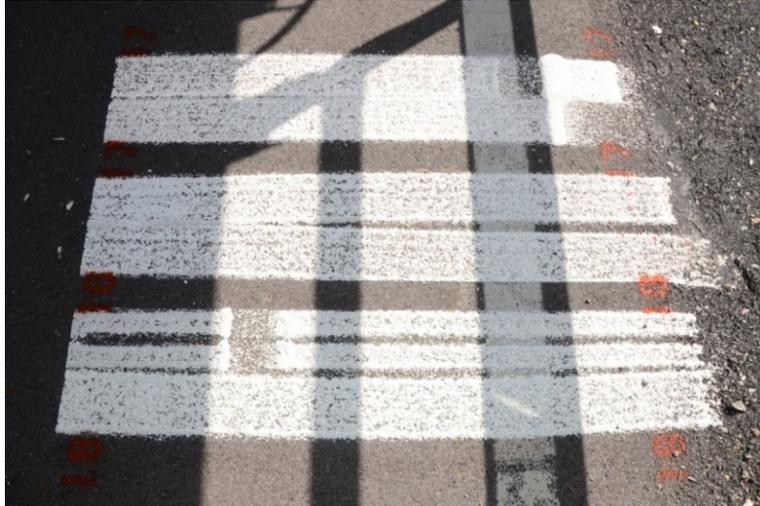
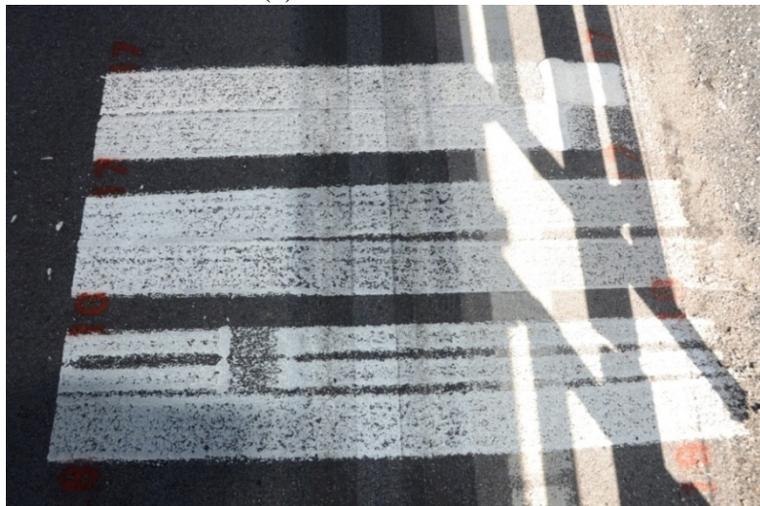
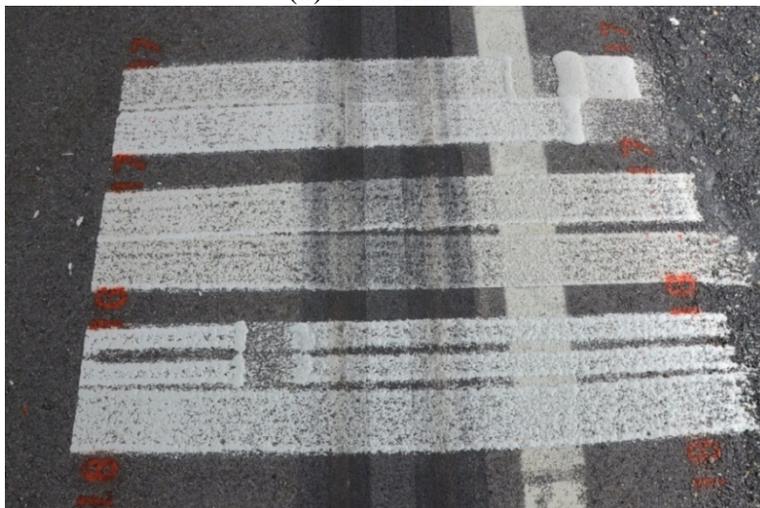
Figure 19. The HVS Test Stripes, 0-2000 Passes, Ambient Temperature, Ennis/Flint SMMA (Lines 16-18)

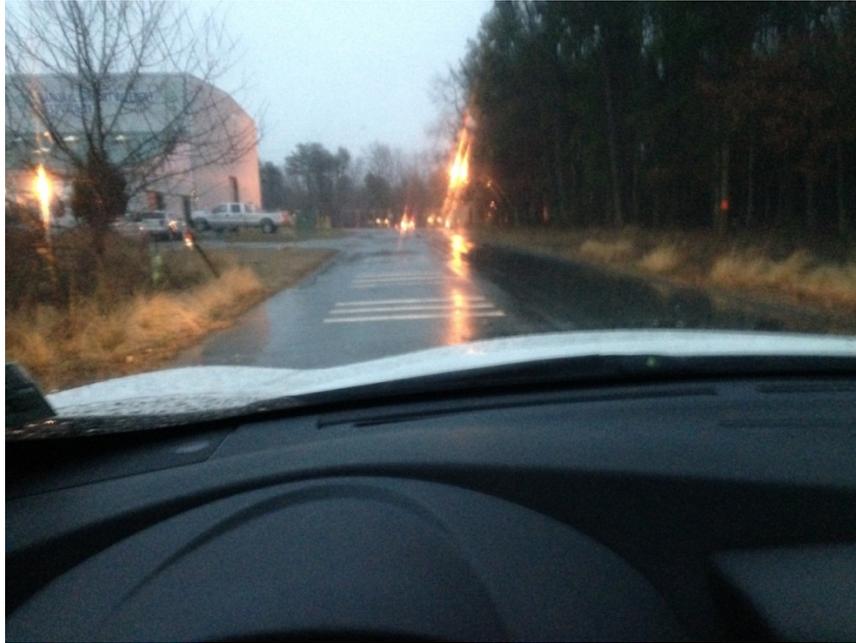
Figure 21. Wet-Weather Photograph of Old Hot Mix Asphalt on Pangborn Road

Occasionally, the research team conducted visual inspections of the MMA and SMMA paint markings on the FAA Ramp (concrete) and Pangborn Road (asphalt) throughout the evaluation period. Observers saw a noticeable difference in the markings because of the type of glass beads that were used, but they were not able to differentiate between the MMA and SMMA markings. Photographs of the observations are shown in figures 21 through 23.

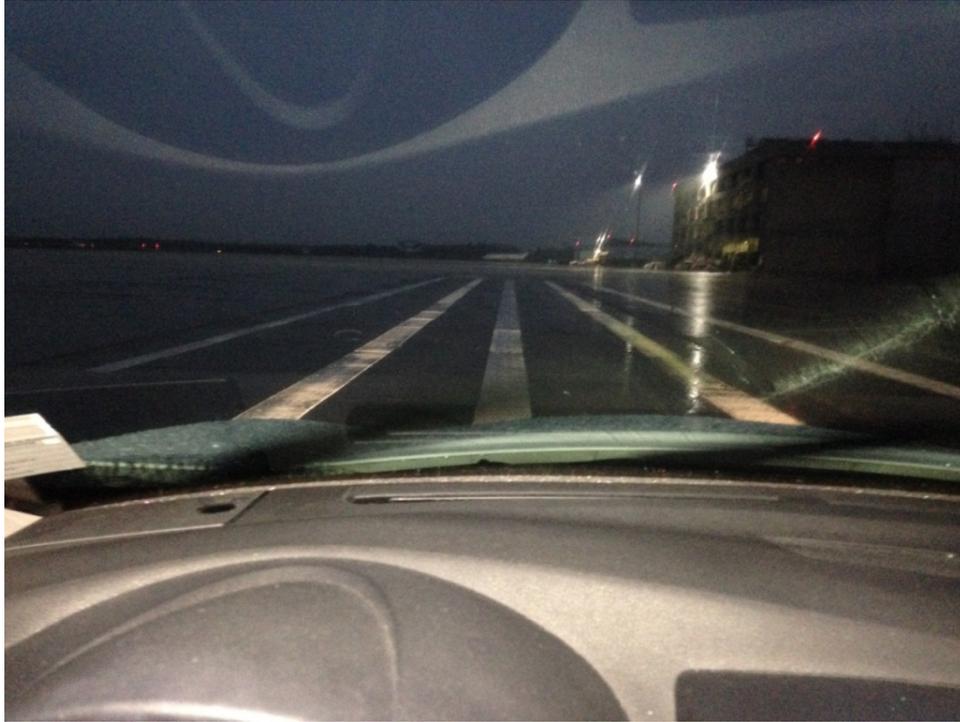
Figure 23. Wet-Weather Photograph of Old PCC With Friction Lines on the FAA Ramp
