Long-term Implications of Ethanol-based Fuel on an Aviation Aircraft Fuel System

A thesis submitted

South Dakota State University

Long Term Effects of Aviation Grade Ethanol on a TCM Fuel System

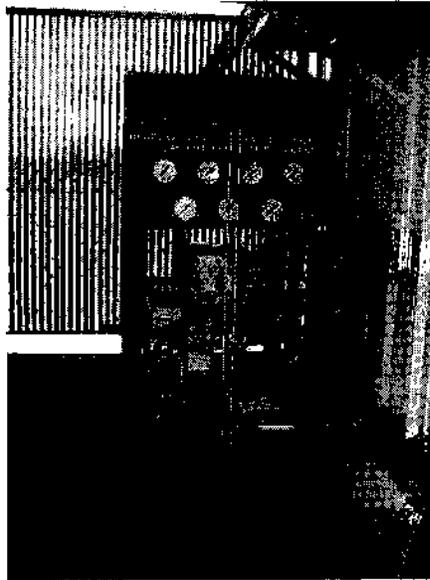
and flow controller, as an operator adjusts the pump speed and settings of the fuel servo, and records the corresponding data, revealing the status of the components.

Figure 1.1. Cessna Rig Test Set-Up. (photo courtesy Cessna Aircraft).

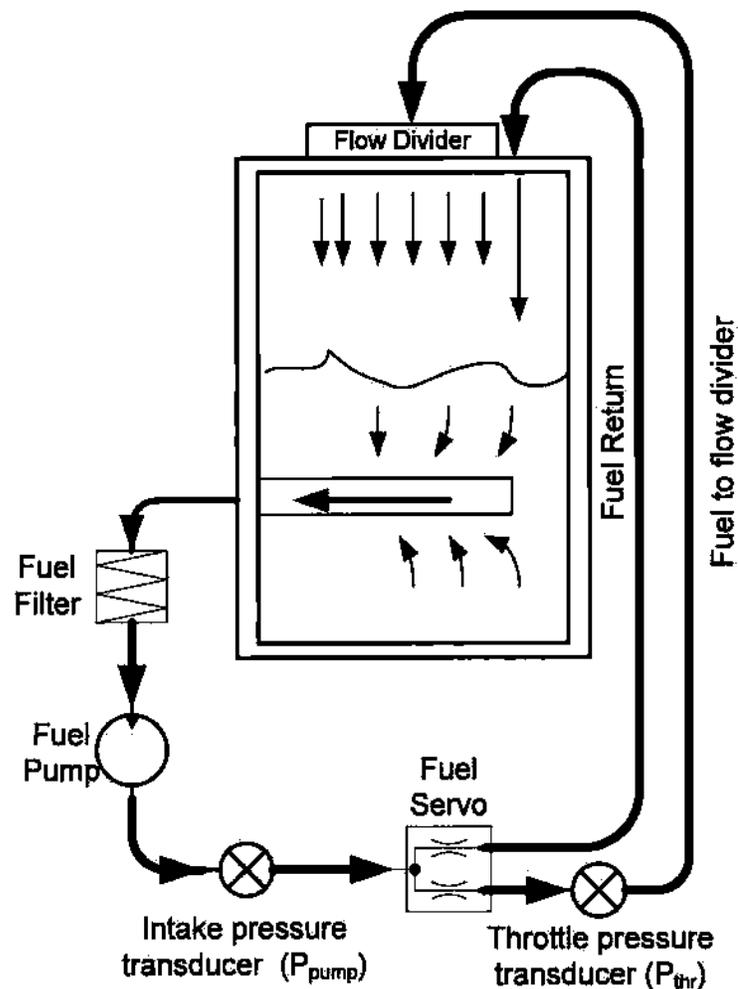
This project was intended to simulate the performance of a TCM manufactured fuel pump and servo. The simulation required isolation of the fuel pump and servo from the rest of an aircraft and subjection of these parts to an emulated aircraft lifetime of pumping fuel and adjusting the mixture and throttle settings. A closed system was required in which AGE fuel was circulated from a stationary tank through a fuel filter by the fuel pump. The fuel then flowed into the fuel servo where it was returned to the fuel tank either through a flow divider (emulating fuel flow to the engine), or straight back to the tank via a return hose. Figure 2.1 gives a pictorial explanation of the circulation paths.

Figure 2.1 Basic Fuel Flow Diagram.

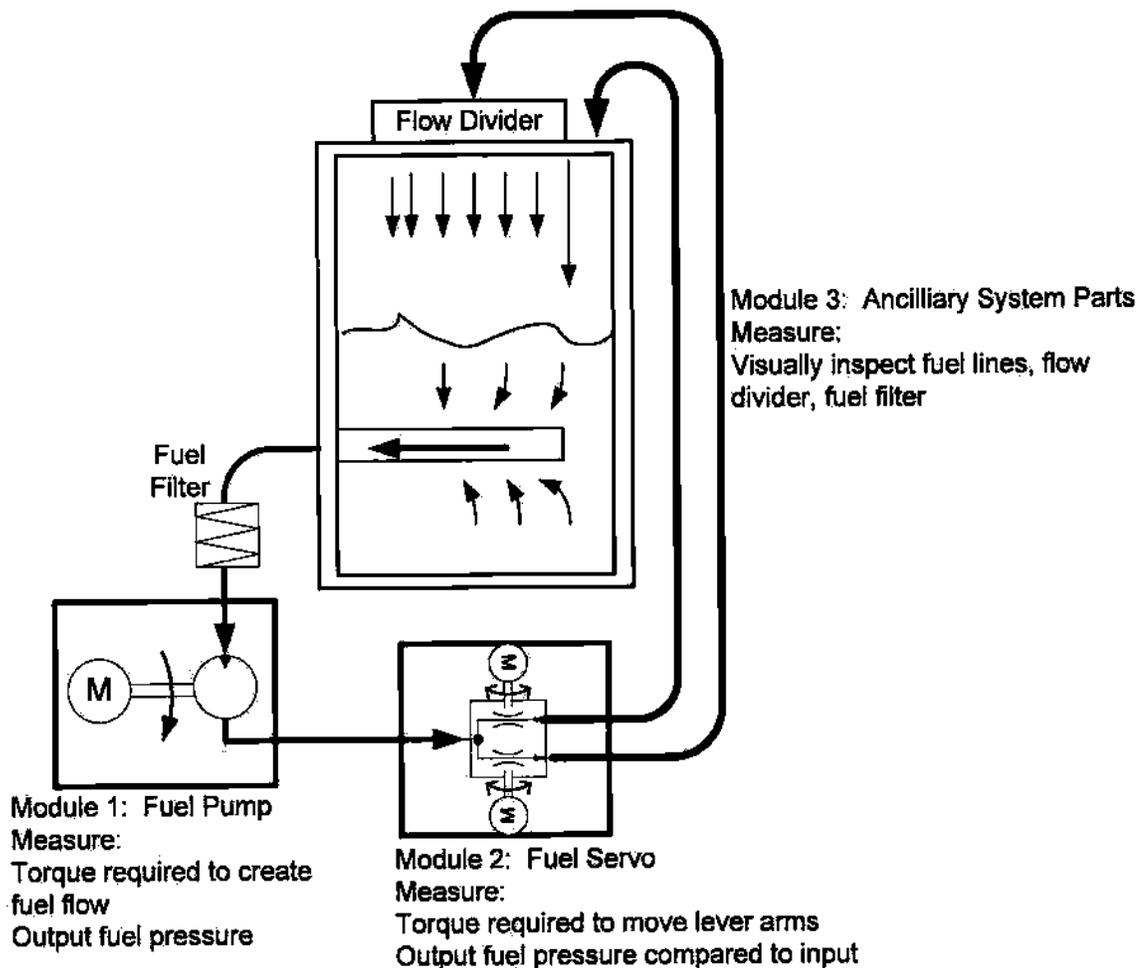
The mechanical system can be divided into three modules each having specific functions and external requirements. The module definitions are shown in Fig. 2.2. The first module included the fuel pump, the second included the fuel servo, and the final consisted of the auxiliary parts and flow divider. Two pressure transducers were introduced into the system at significant points within the circulation path.

Figure 2.2. Module Definitions.

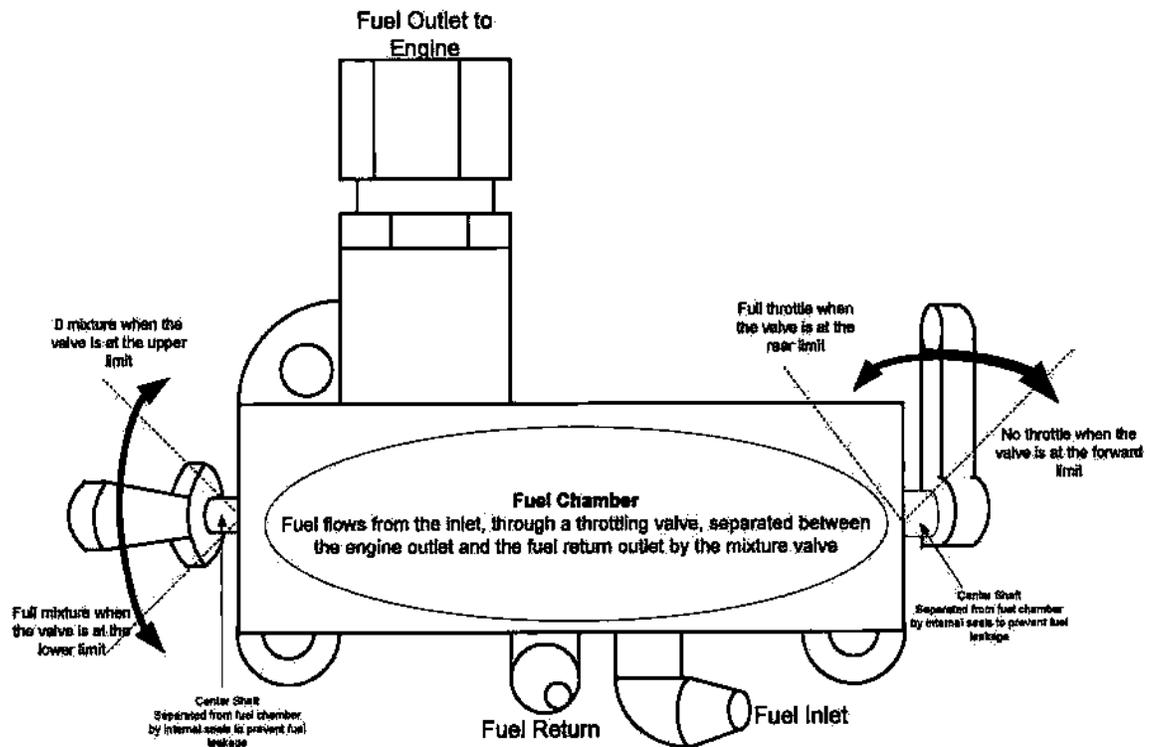
When installed in an aircraft, the pilot rotates a pair of control levers which are linked through several meters of a stiff cable/housing line to the servo installed near the engine. A motion of the pilot's entire arm is required within the cockpit to position the control levers, and far exceeds the torque required to position the lever arm at the servo. Doubling or even tripling the torque required to position the lever arms at the servo would likely be imperceptible to the pilot. The lever arms must remain mobile, however, changes of 100% are not considered alarming over unit's lifetime.

Fig. 2.4. Simplified TCM Fuel Servo Diagram.

Possible degradations within the fuel servo resulting from ethanol fuel include corrosion or buildup on the seals around the lever arm's center shaft, resulting in a change in the torque required to adjust the lever arms, or corrosion/buildup within the fuel chamber and flow separation paths themselves, resulting in a change in the output fuel pressure. The test was required to measure these parameters.

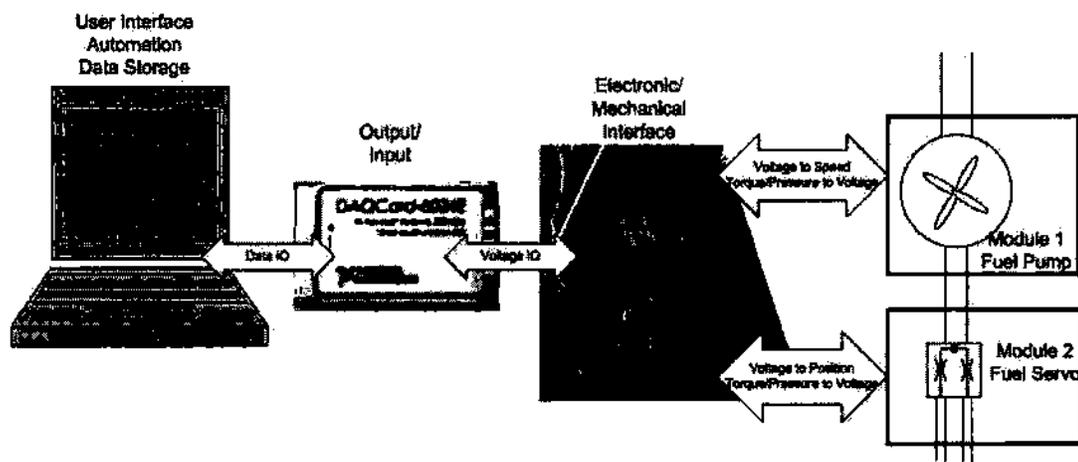
A commercial-off-the-shelf (COTS) data acquisition card (DAQ) provided a means of input/output communication between the computer and the external electronics shown in the interface board. The DAQ card transformed the PC's binary numbers to

Figure 3.2. System Interface Flowchart.

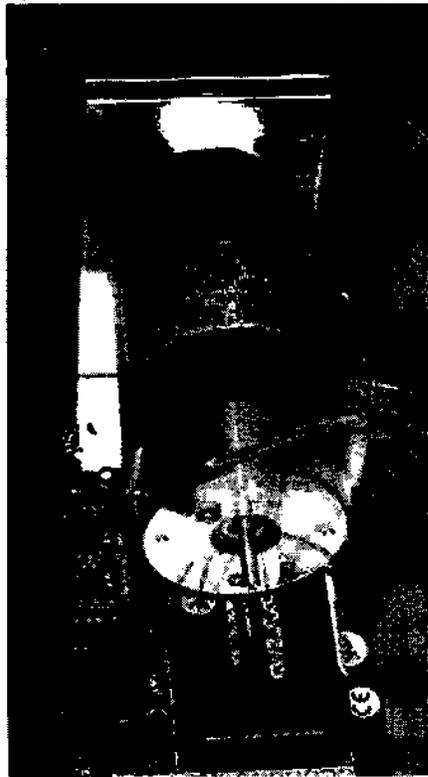
Module 1 revolved around the TCM fuel pump described in Section 2.2.2. A 48 V, 8.1 A permanent magnet DC (PMDC) motor and motor drive was chosen to provide power needed to circulate the fuel. Figure 3.3 shows the motor used, coupled to the rear of the pump. For a complete description of the motor refer to Section 3.5. The coupling itself was custom designed and built by SD Tool and Die, operating in Brookings, SD.

Figure 3.3. Fuel Pump Motor, Motor Drive and Coupling.

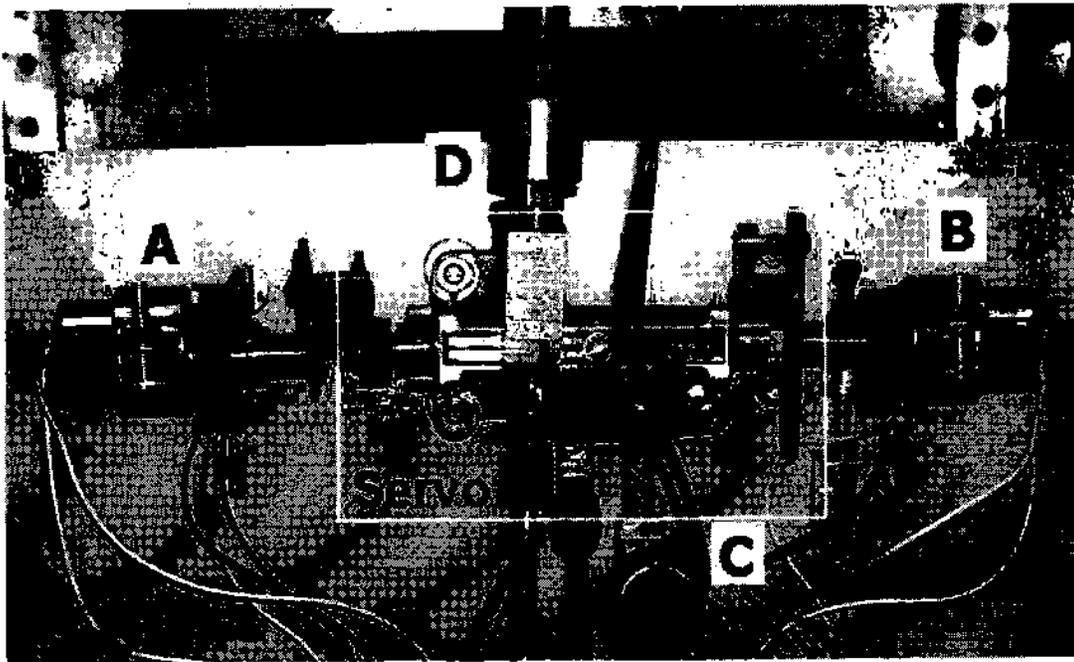
Figure 3.4. Fuel Servo Setup.

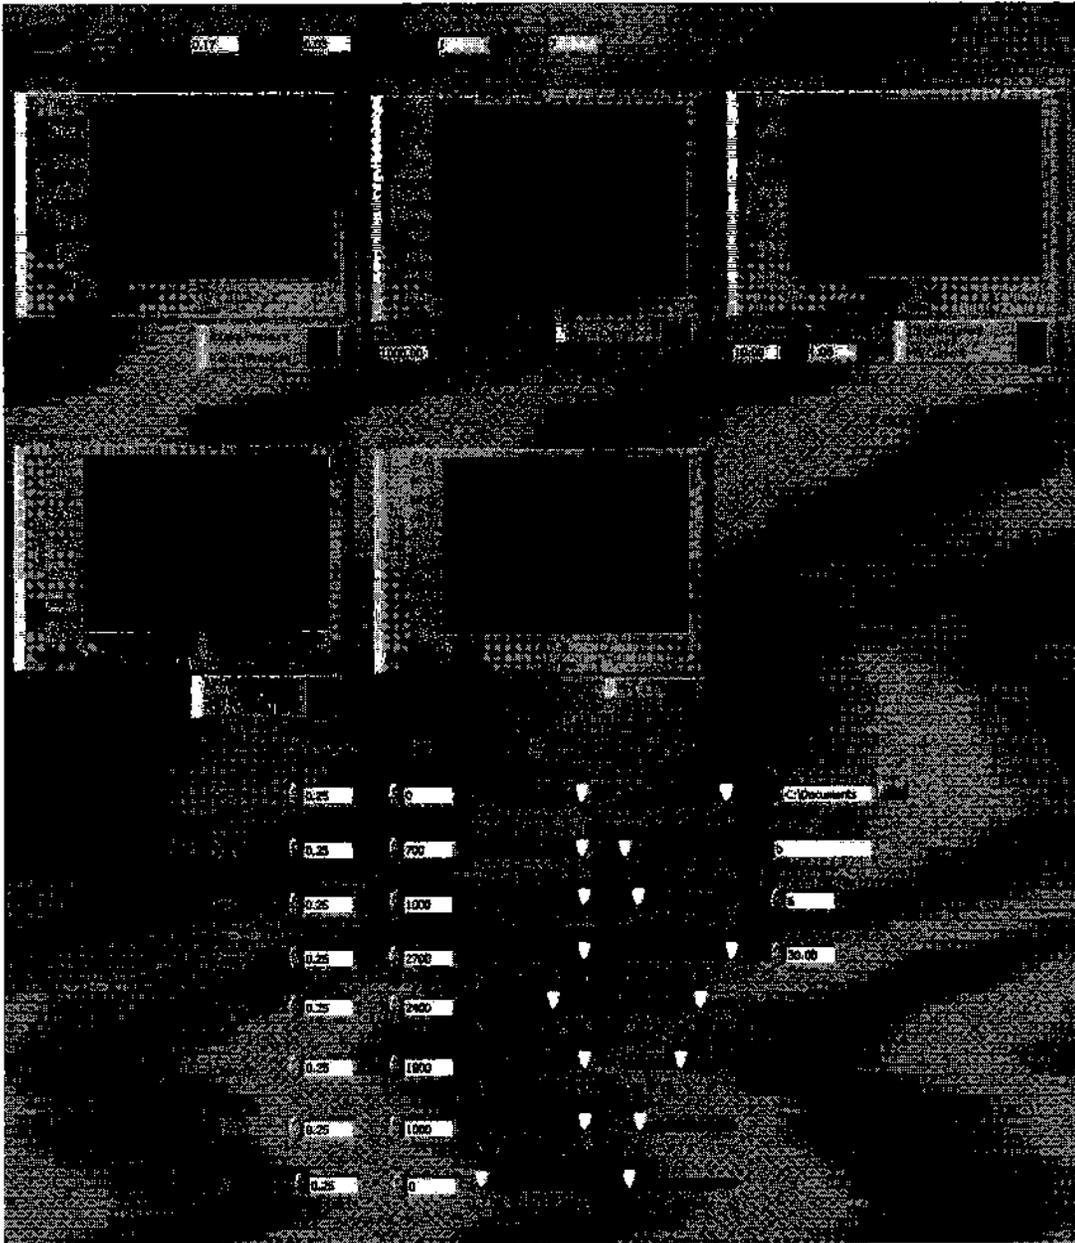
Running graphs of the measured data were displayed in the top portion of the interface. In reading order, the upper left graph displayed the pump and throttle pressure, the adjacent graph displayed the motor current, then the right graph showed the servo actuation currents. Below, the air and fuel temperatures were displayed, and finally, the ambient humidity.

As the test ran, the data were stored into Excel spreadsheet files for evaluation. Data were saved every three seconds during the first 30 seconds of an event, and stored every 30 s until the onset of the next event. Each file contained six cycles (approximately 32 hours) worth of data, with each sample time stamped in the first column, with following columns listing air temperature, humidity, fuel temperature, throttle pressure, pump pressure, motor current, peak throttle current, peak mixture current, mixture setting, throttle setting, and motor speed.

Figure 3.5. User Interface.

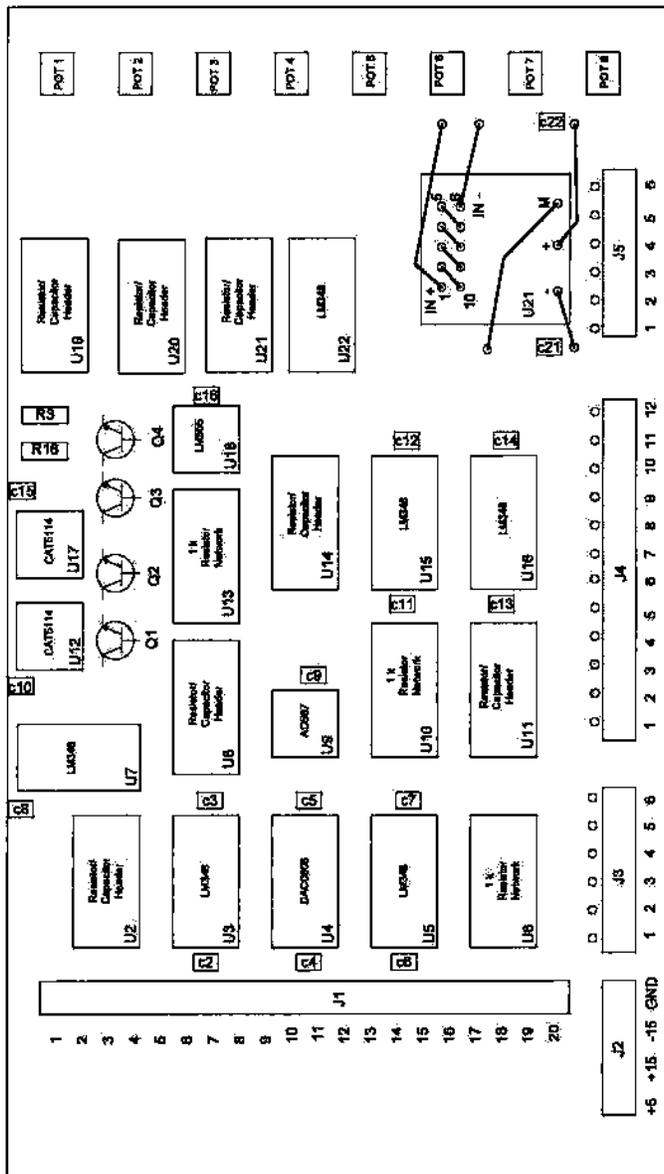
The DAQ card was interfaced to the other modules via an electronic interface mounted on an interface board, designed and assembled primarily by myself, with assistance and advice provided by Dr. Stephen Hietpas. The board component layout is shown in Fig. 3.6. Connector J1, located at the left of the figure, interfaced the DAQ card to the board through a series of 24 AWG wires. The board was powered using an AC to DC power supply, having supply voltages of +24, +15, +5 and -15 V. The 24 V supply was separated from the other voltages and was used to power the humidity sensor. Electrical grounding and the remaining supply voltages were connected through J2. External connections between the electronics and mechanical system were grouped in connectors J3 through J5. Individual electronic components within the board are discussed in Sections 3.5 and 3.6, as they relate to their respective modules.

Figure 3.6. DAQ/Electronic Interface.

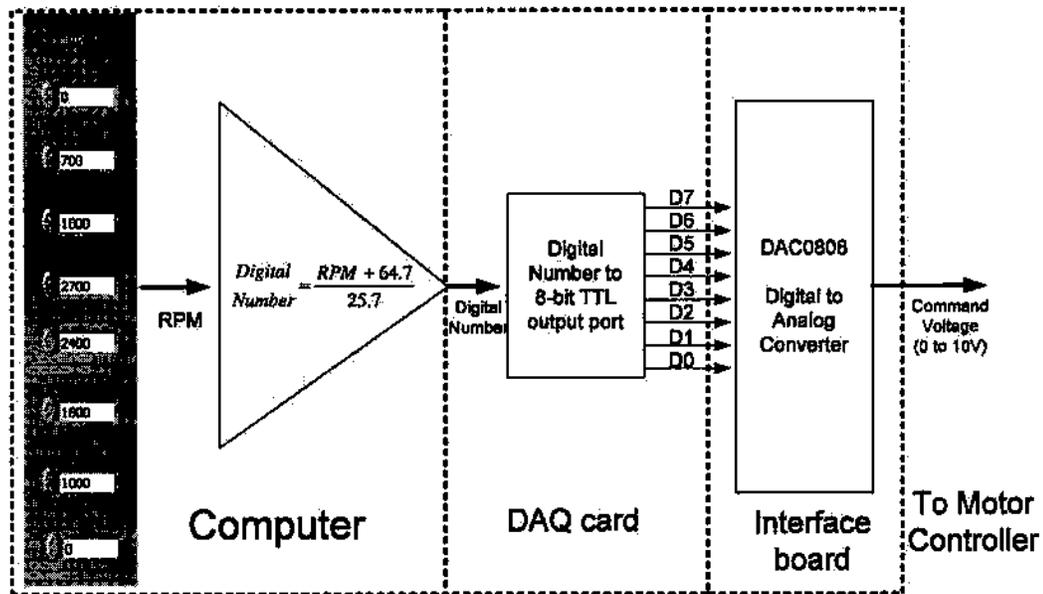
The equation shown within the triangle of Fig. 3.7, relating the desired RPM to a digital number was determined through empirical testing. The speed of the motor was measured as the command voltage was increased from 0 to 10 V. The speed/voltage measurements were then transformed back to a digital number with a range of 0 to 255.

Figure 3.7. Motor control command signal block diagram.

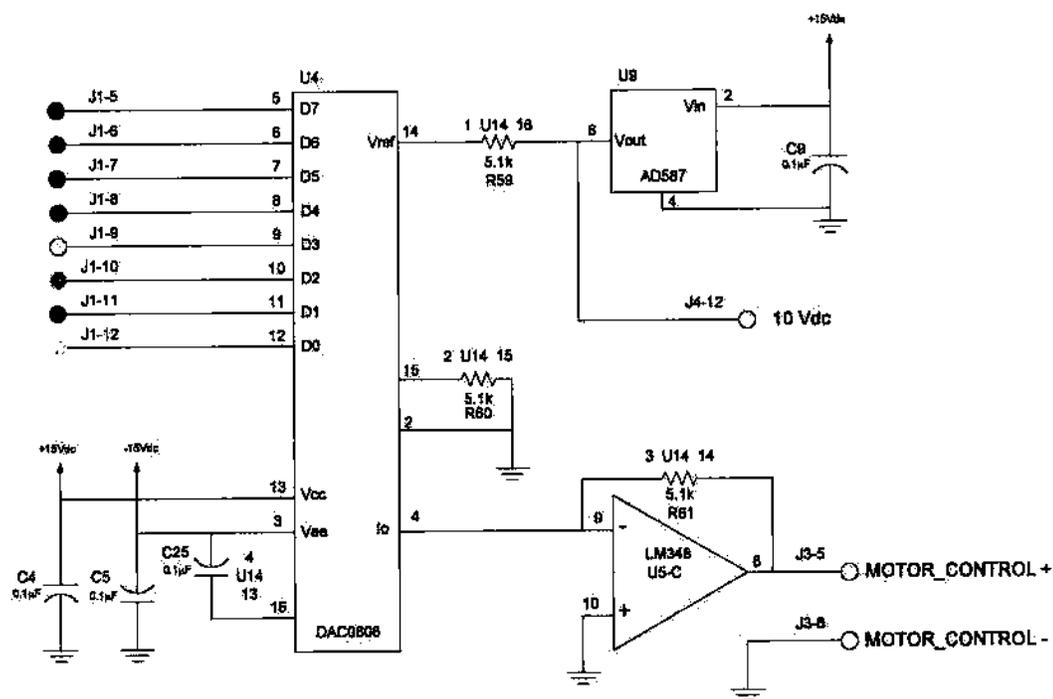
The corresponding circuit design is shown in Fig. 3.8. An AD587 precision voltage regulator provided a 10 V reference voltage. This voltage was the upper rail for the DAC0808 D/A converter. The DAQ card set the digital output lines D0 through D7. When designed as shown in Fig. 3.8, the voltage at pin 8 of the LM348 corresponded to the analog voltage represented by the binary code in pins D0 through D7. The circuit comprised of the LM348, R59, R60 and R61 operates as an amplifier with unity gain. The control signal, referenced to ground, was wired to the motor drive through interface board interconnects J3-5 and 6.

Figure 3.8. Motor Control Signal Detailed Design.

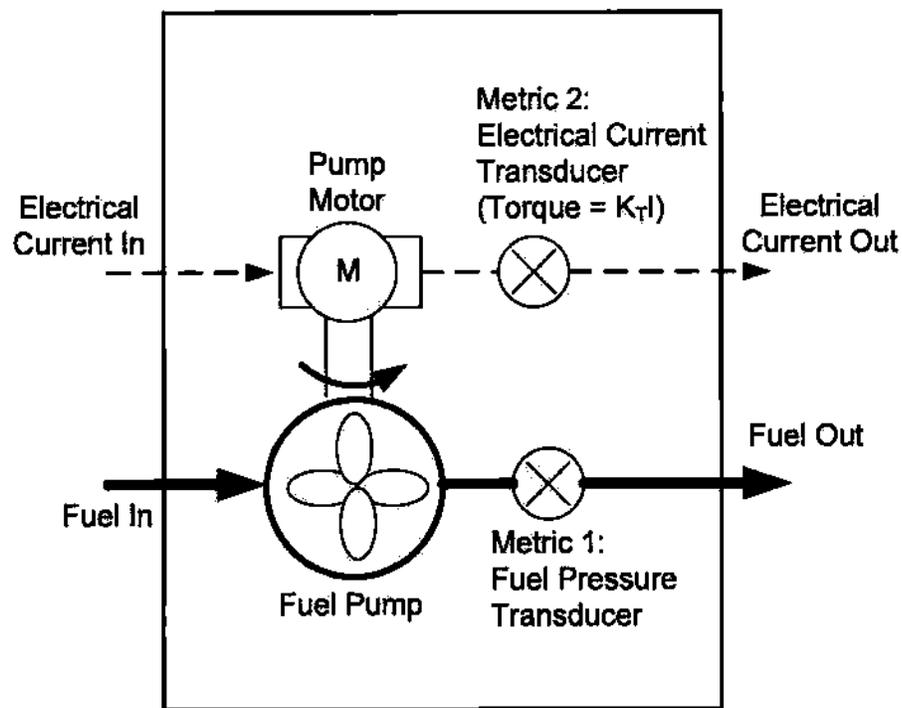
The electronic design revolving around the fuel pump provided the measurement of two parameters: the current required by the pump motor (I_{mot}) and the output fuel pressure (P_{pump}). Figure 3.9 provides a detailed schematic of the measurements regarding Module 1.

Figure 3.9. Module 1 Detailed Diagram.

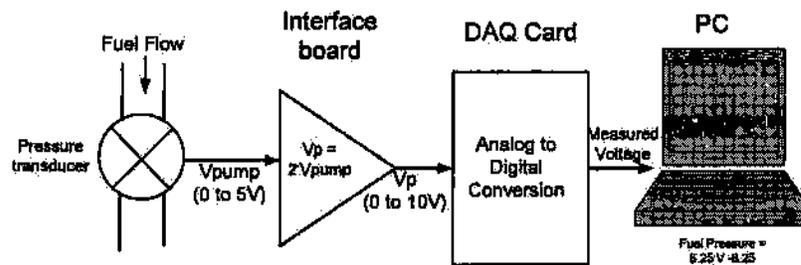
Figure 3.10. Pressure Sensor Flow Chart.

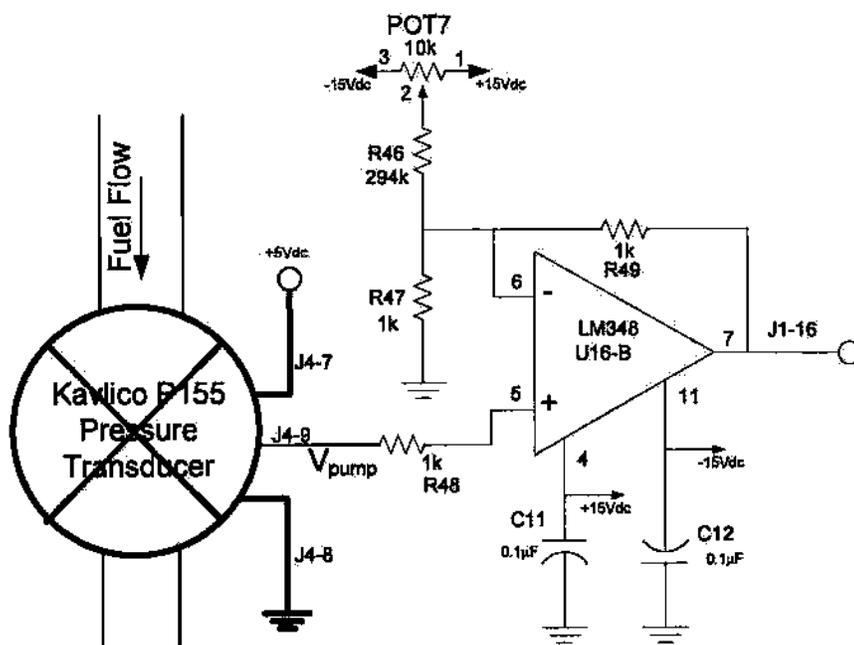
A fuel pressure transducer was placed at the inlet port of the fuel servo. The circuit schematic is shown in Fig. 3.11. A Kavlico P155 fuel pressure transducer was chosen to monitor the fuel pressure. This particular sensor was chosen, as it had an appropriate range of fuel pressure (0 to 50 PSD), and was donated. Full specifications are found at [6]. By supplying the sensor with a 5 V potential, the sensor was designed by the manufacturer to produce an output voltage with a range of 0.5 to 4.5 V. The

specifications for this particular sensor, supplied by the manufacturer, state that the output voltage is linear, and given by (3.1). The design shown in Fig. 3.11 supplies the sensor through J4-7, and grounds through J4-5. The output voltage, V_{pump} , is applied to a non-inverting amplifier with a gain of 2, stepping V_{pump} up to 9 V at full scale. The DAQ recorded this voltage at pin 16 of J1.

Figure 3.11. Pump pressure sensor schematic.

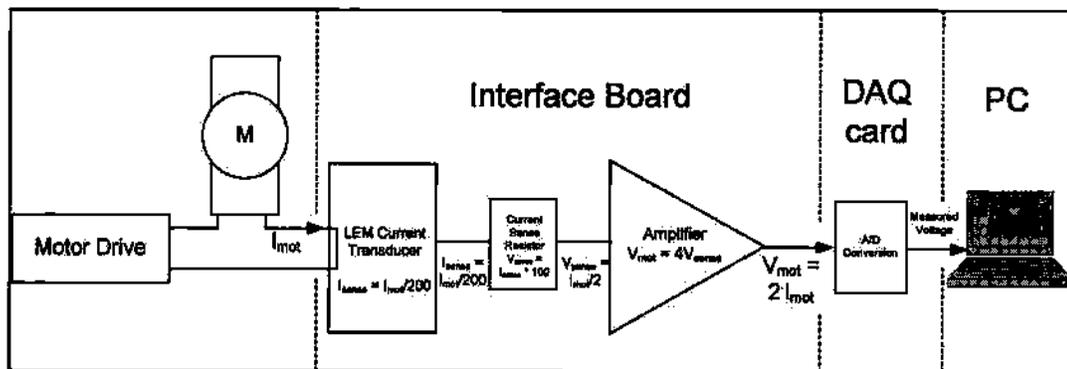
Figure 3.12 presents a pictorial diagram outlining the process used to monitor the motor current throughout the test. A current transducer/sense resistor converted the motor current into a measurable voltage, which went through an amplifier to scale the voltage to a level more accurately sampled by the DAQ card.

Figure 3.12. Motor Current Measurement Flowchart.

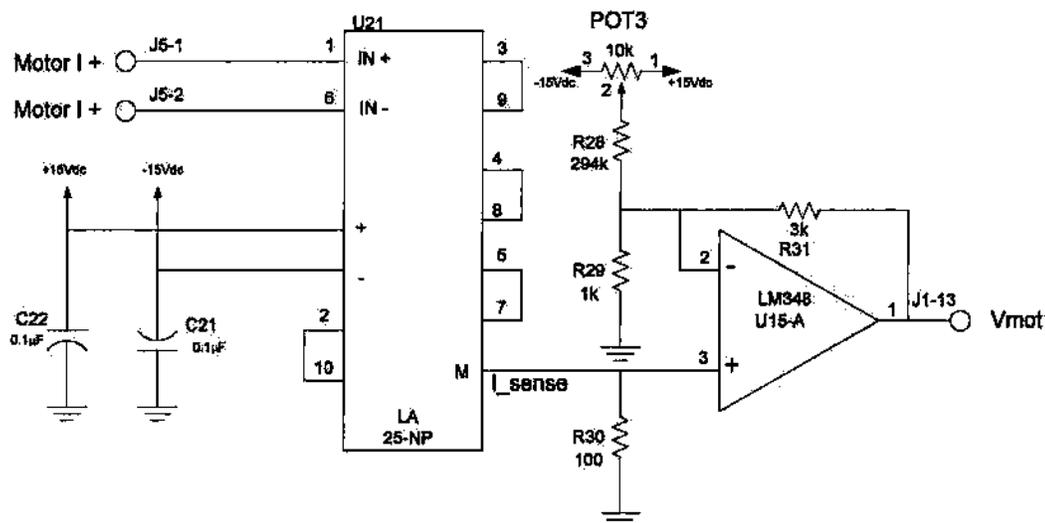
The detailed circuit design is shown in Fig. 3.13. The motor current entered the interface board via interconnect J5 pin 1, which is tied to an LEM LA25-NP current transducer. The motor current then exits the current transducer and returned to the motor drive via J5-2.

Figure 3.13. Motor Current Measurement Circuit.

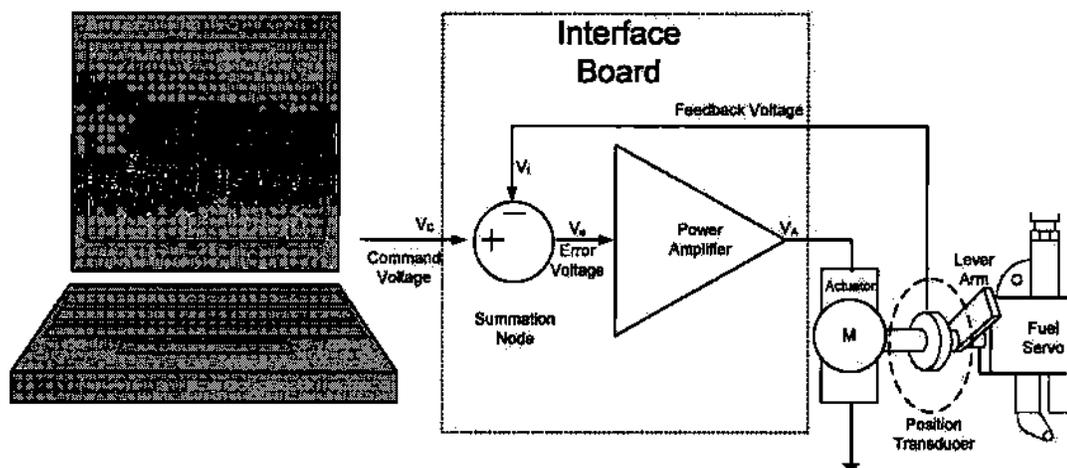
Honeywell/Clarostat, a pair of hollow-shaft rotary potentiometers, TH100 series with a 90° range of motion, and total impedance of $10\text{ k}\Omega$ (see Appendix B for manufacturer specifications). These allowed the appropriate range of motion, as well as related the angle of the lever to a corresponding voltage, as explained next.

Figure 3.14. Position Control Scheme Flowchart.

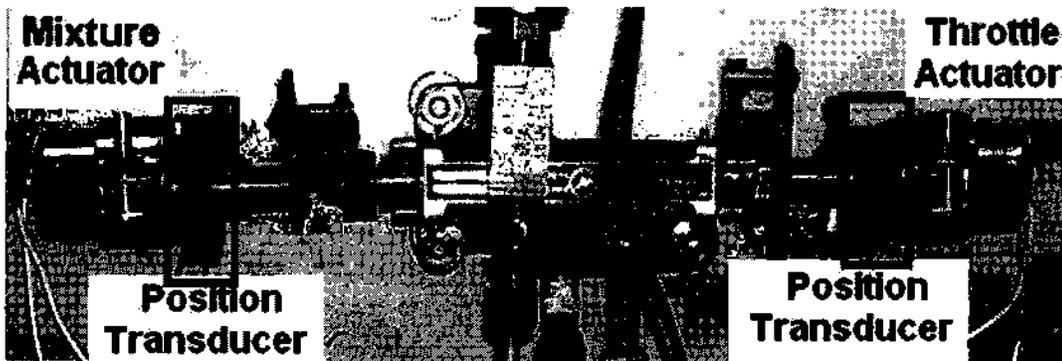
Figure 3.15. Servo Mechanical Setup.

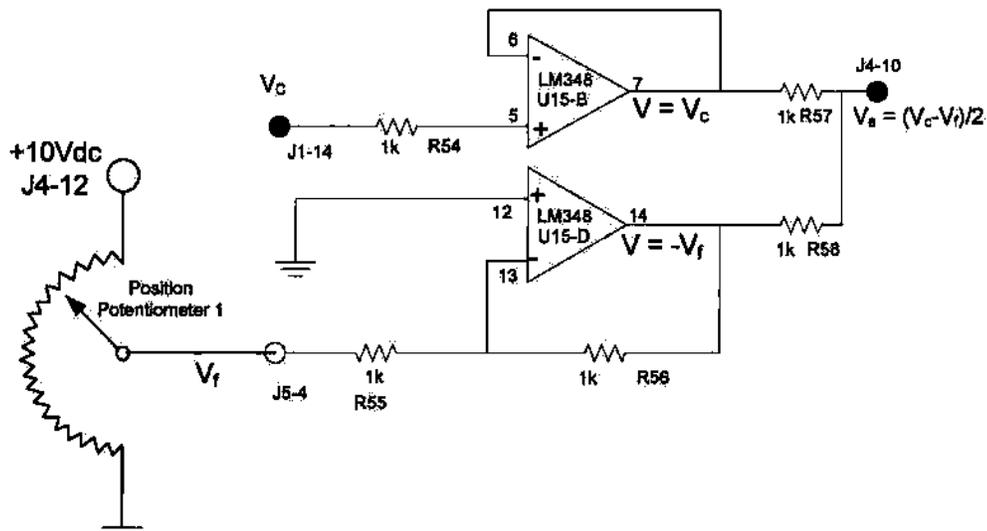
with a gain of -1. The control signal, V_C , enters the circuit from the DAQ via J1-14. U15-B is designed as a buffer; the voltage at pin 7 is equal to V_C . By joining the voltages of pin 7 and pin 14 through resistors R57 and R58 as shown, the voltage at J4-10 corresponds to half the summation of V_C and $-V_f$, effectively subtracting V_f from V_C to produce V_e as shown in Fig. 3.14.

Figure 3.16. Summation Node Detailed Design.

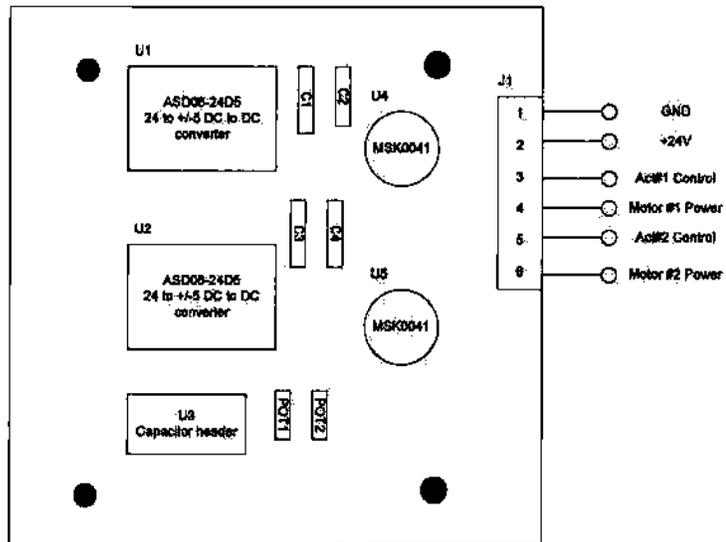
The error voltage was applied to the power amplifier. The power amplifier was placed on a separate board to allow independent power supplies. Figure 3.17 shows the layout of the second board, and Fig. 3.18 shows the detailed design of the power amplifier. The actuation of the lever arms required more current than LM348 op-amps are capable of sourcing/sinking. Therefore, a pair of amplifiers designed to operate with higher output currents were needed. Such a design may allow a potentially damaging scenario. If the lever arm reached a physical limit, yet the error voltage had not reached 0, a motor stall would result. Under this condition, the motor may draw excessive current, overheat and burn out. Therefore, it was expedient to provide some means of limiting the amount of current the motors can draw. The amplifiers chosen were a pair of MS Kennedy 0041 medium power op-amps, having a maximum output current of 0.5 A. This limit was sufficient to prevent damaging current being supplied to the motors. See [11] for manufacturer specifications. To provide some isolation between the actuators (having higher power requirements) and the other electronics (designed for small signals), the amplifiers were given individual power supplies. A pair of 5 V bi-polar DC to DC converters, manufactured by Astrodyne Technologies, part number ASD06-24D5 were used. These stepped the 24 V power source down to dual output voltages of +/- 5 V.

Figure 3.17. Power Amplifier Circuit Board.

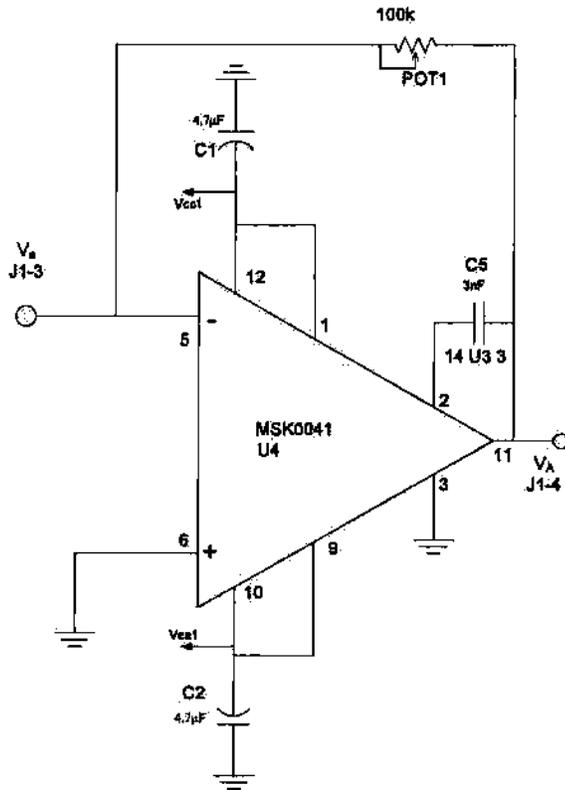
Figure 3.18. Power Amplifier.

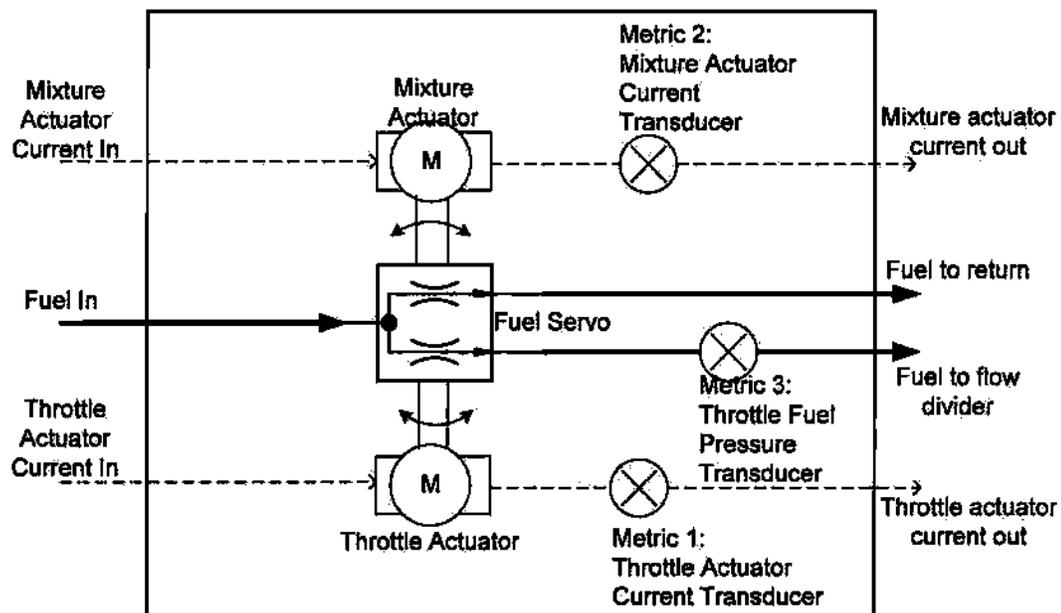
Figure 3.19 gives a pictorial summary of the instrumentation method used to monitor the fuel servo.

Figure 3.19. Detailed Diagram of Module 2 Measurements.

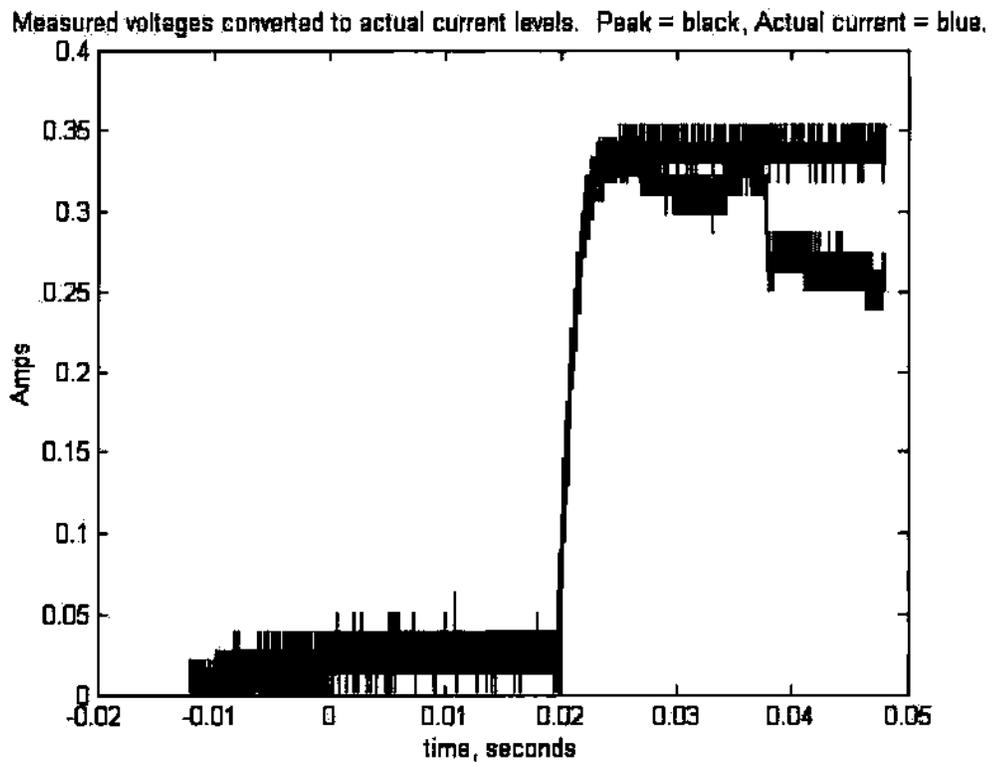
At the onset, before the motor began to move the lever, the motor current was near 0, and no torque was being applied to the lever arm. When the transition began at 0.02 seconds, the applied torque increased to a maximum, as the motor overcame stiction and rotated the lever arm. Then, as the lever arm inertia reduced the needed torque, and finally as the lever neared its desired position and the speed of rotation slowed, the applied torque reduced, and the electrical current returned to 0.

Figure 3.20. Example Actuation Current during an Event Transition.

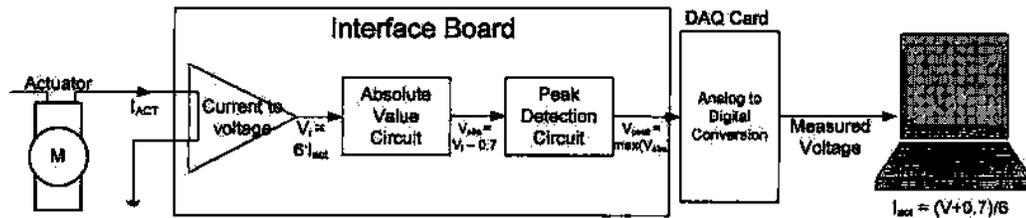
the mixture. Figure 3.21 gives a pictorial explanation of the design approach. The electrical current of the actuator is first converted to a measurable voltage, V_i . Then, considering that the rotation may be either forward or reverse, V_i is passed through an absolute value circuit, such that V_{abs} is positive, regardless of the rotation of the actuator. Finally, the peak of V_{abs} is latched, and this voltage (V_{peak}) is sampled and stored in the computer by the DAQ.

Figure 3.21. Actuator Peak Current Measurement Scheme.

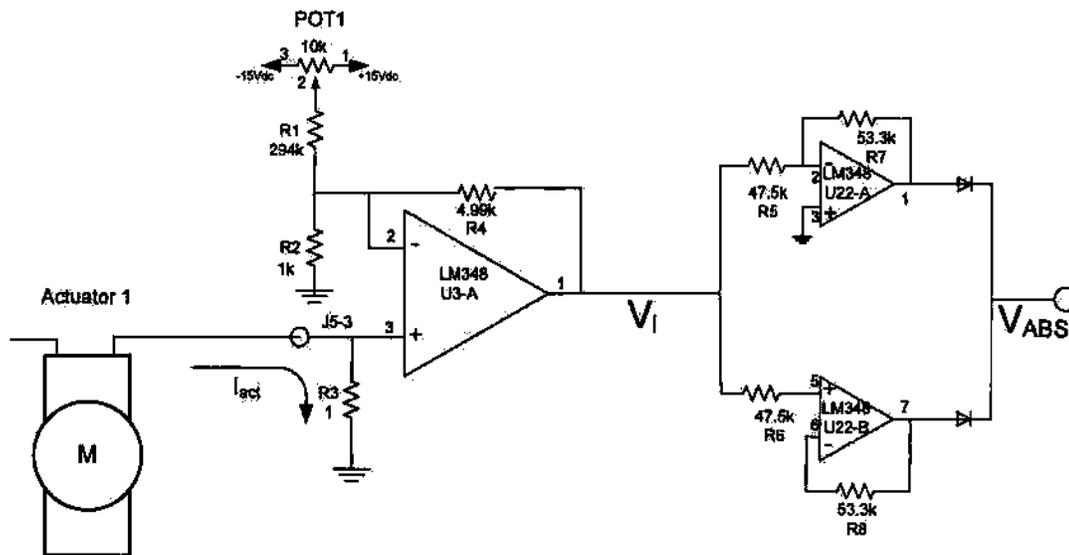
A detailed design of the current-to-voltage stage (blue) and the absolute value stage (red) is shown in Fig. 3.22. Beginning at the actuator, the current enters the interface board via J5-3, where it is shunted to ground through a 1Ω current-sense resistor, resulting in a voltage at pin 3 of the LM348 op-amp of equal magnitude to the actuator current. The LM348 op-amp is designed as a non-inverting amplifier with a gain of 6, producing V_i at pin 1 of the amplifier. With a gain of 6, and assuming the maximum actuation current possible was 0.5 A, V_i was limited to 3 V. This was chosen for circuit stability. The peak detection circuit was found to give erroneous results when the input voltage exceeded approximately 3.2 V.

Figure 3.22. Current to Voltage and Absolute Value Circuit.

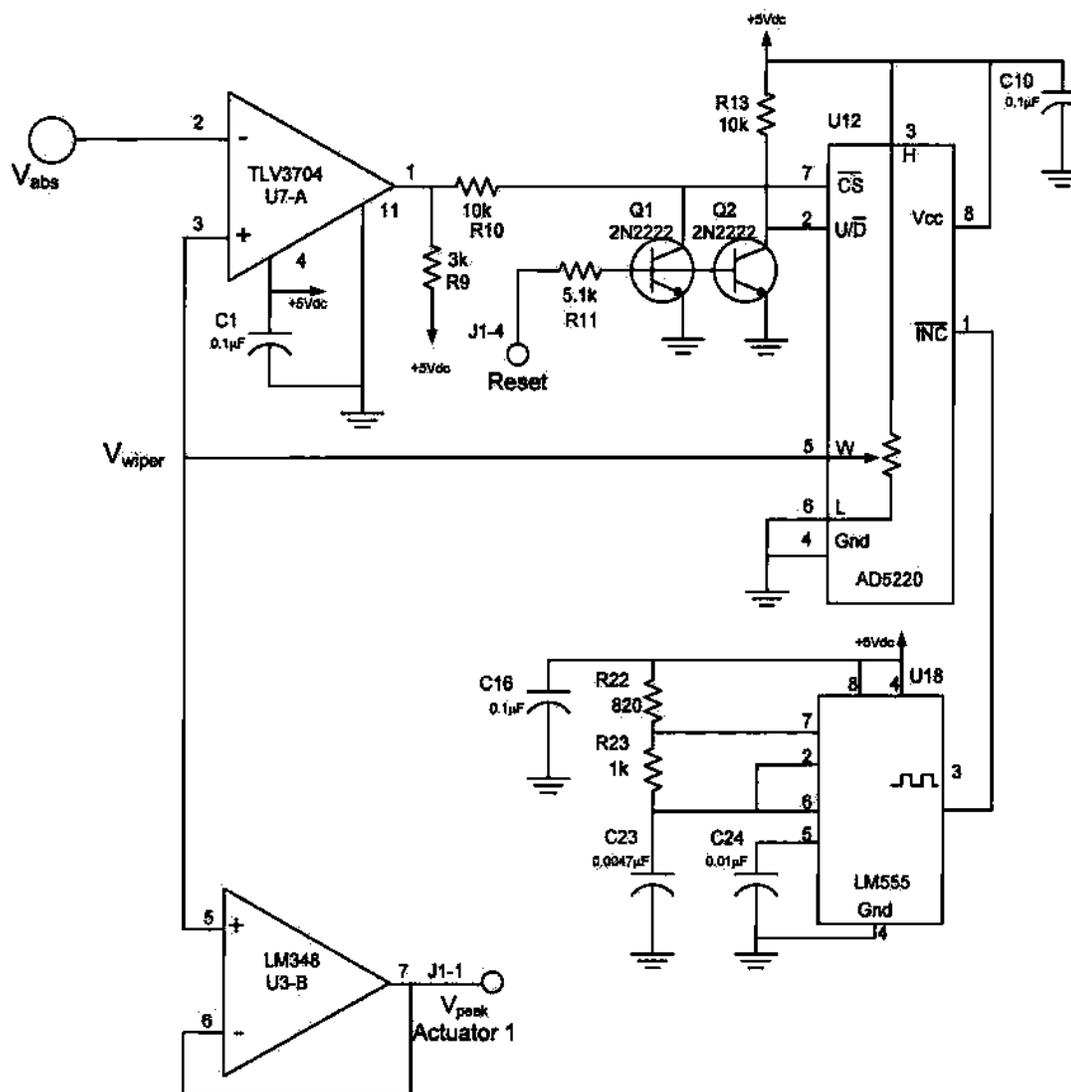
The peak detection circuit is shown in Fig. 3.23. The design revolves around an AD5220 digital potentiometer. This particular chip, manufactured by Analog Devices, was chosen as it is a standard IC, therefore easily obtainable, and other manufacturers produce similar chips, but packaged inappropriately. The full specifications can be downloaded by [13]. This device has a 10 k Ω internal resistor with 128 taps between pin 6 and pin 3. The resistance at the wiper (pin 5) increments when the following three conditions are met: i) the direction is set to “up” by applying a TTL-high voltage (+5 V) to pin 2; ii) the chip is enabled (TTL-low voltage (0 V) at pin 7); and iii) the voltage at INC (pin 1) transitions from TTL-high to TTL-low. The resistance at the wiper decrements under the same conditions, except the direction must be set to “down” by applying a TTL-low voltage to pin 2.

100 000 taps per second. At a clock frequency of 100 kHz, the potentiometer required 1.28 ms for the wiper to travel from 0 to 10 k Ω , and vice versa.

Figure 3.23. Peak Detection Circuit.

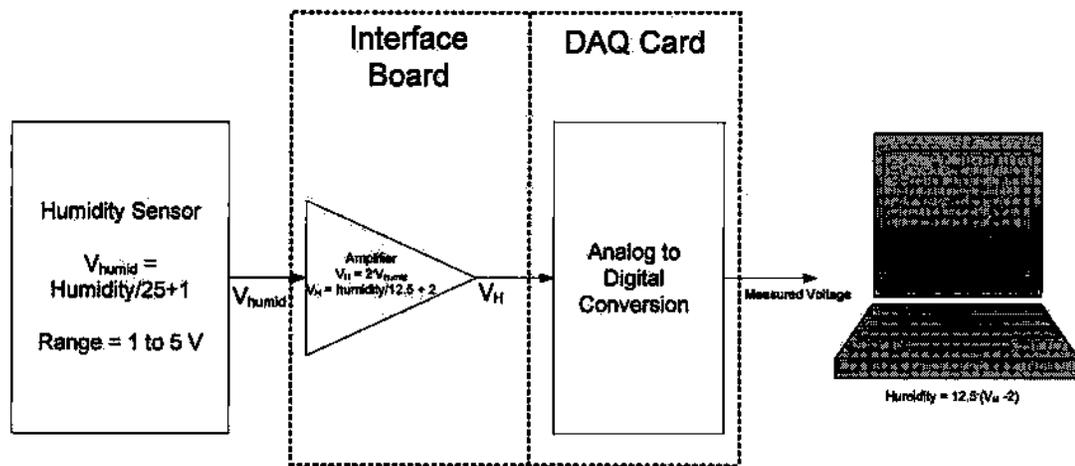
Figure 3.24 presents a pictorial diagram illustrating the implementation of the humidity sensor scheme. The humidity sensor produces a humidity dependent voltage, V_{humid} , amplified by a set of components on the interface board, creating V_H . Then the DAQ card samples V_H and the computer converts the sampled voltage back to the corresponding humidity.

Figure 3.24. Humidity Sensor Flow Chart.

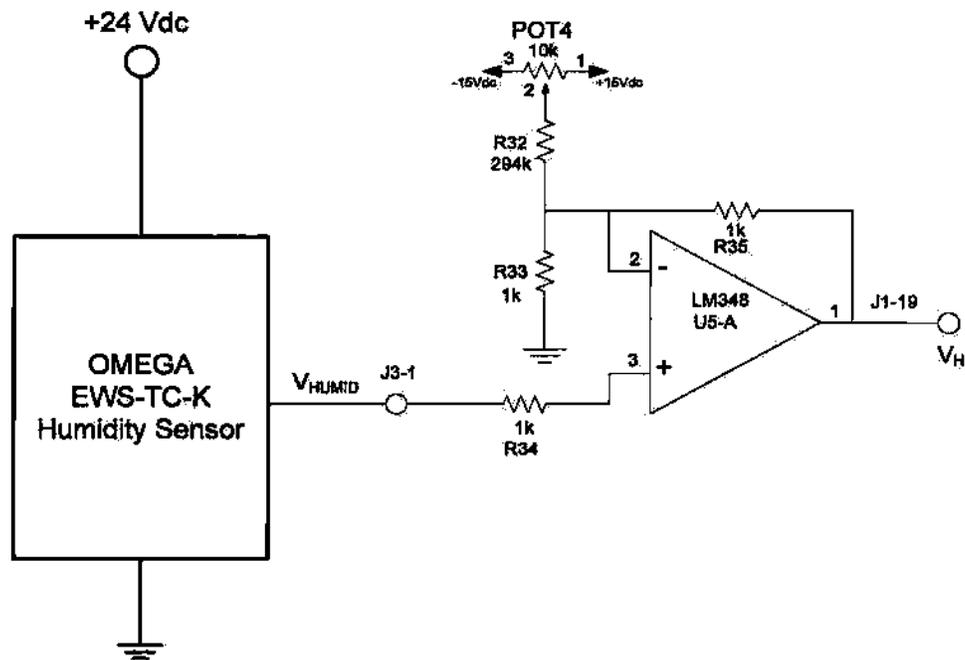
The circuit design is shown in Fig. 3.25. The humidity sensor applies V_{humid} to the input of a non-inverting amplifier with a gain of 2, designed similar to the pressure sensor discussed in section 3.5.3, producing V_H with a magnitude twice that of V_{humid} , boosting V_H to range from two to 10 V, allowing the DAQ to use its full voltage range for measurement. The DAQ then measures this voltage at J1-19, and the computer translates this voltage measurement back to the corresponding humidity.

Figure 3.25. Humidity Sensor Design.

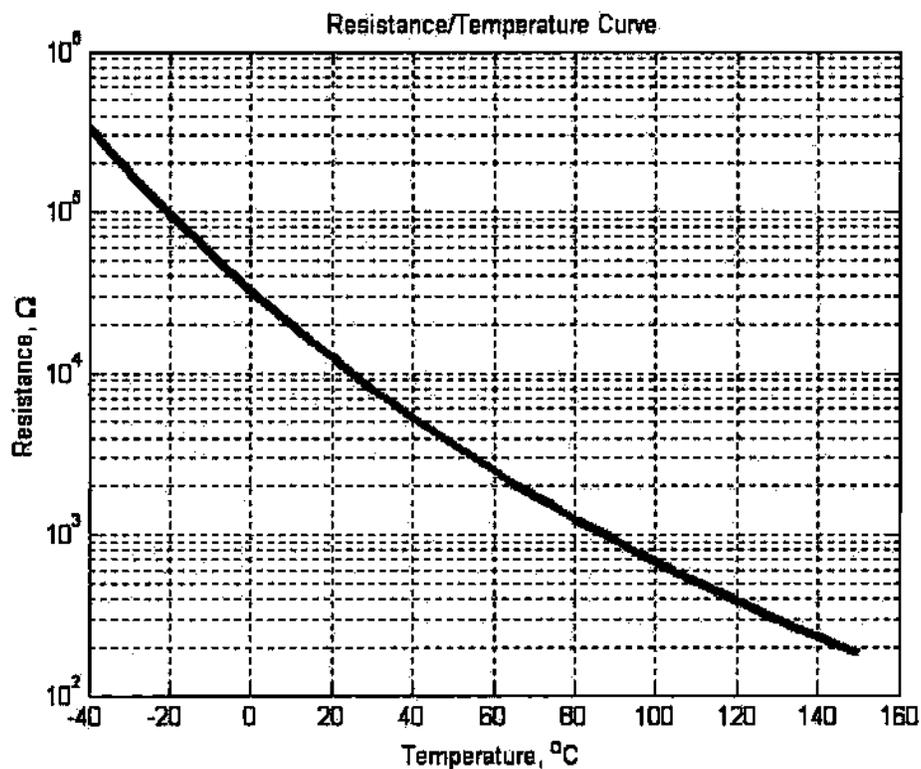
Figure 3.26. Fuel Temperature Sensor R/T curve (Source: Delphi Specifications).

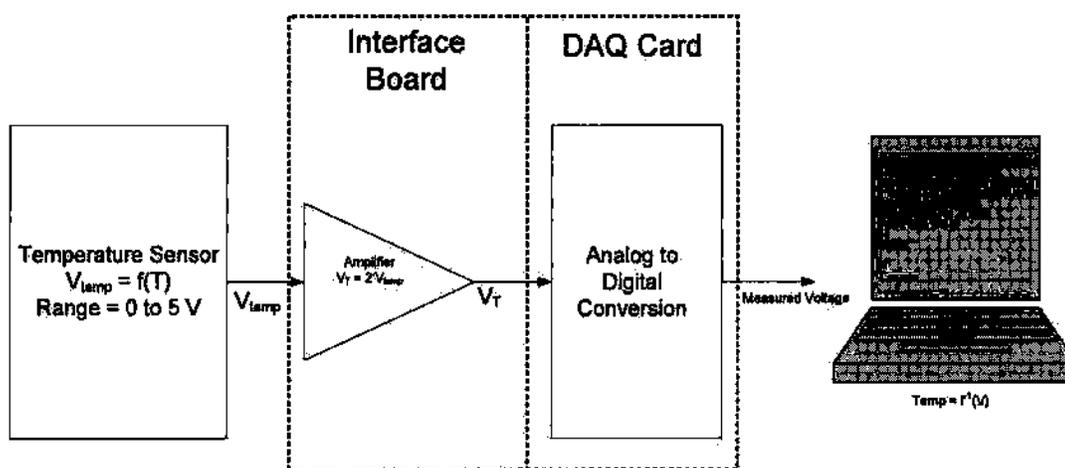
range, resulting in V_T , which the DAQ samples. Finally, the PC calculates the corresponding temperature based on the measured voltage.

Figure 3.27. Temperature Sensor Flow Chart.
