Long-term Implications of Ethanol-based Fuel on an Aviation Aircraft Fuel System

A thesis submitted

South Dakota State University

Long Term Effects of Aviation Grade Ethanol on a TCM Fuel System

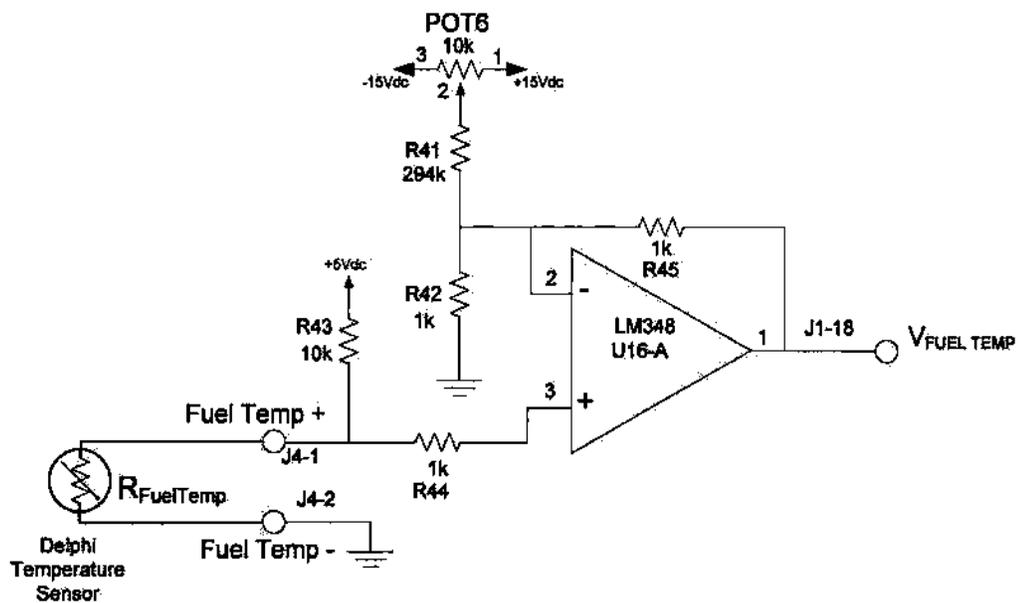
Figure 3.28. Fuel Temperature Sense Circuit.

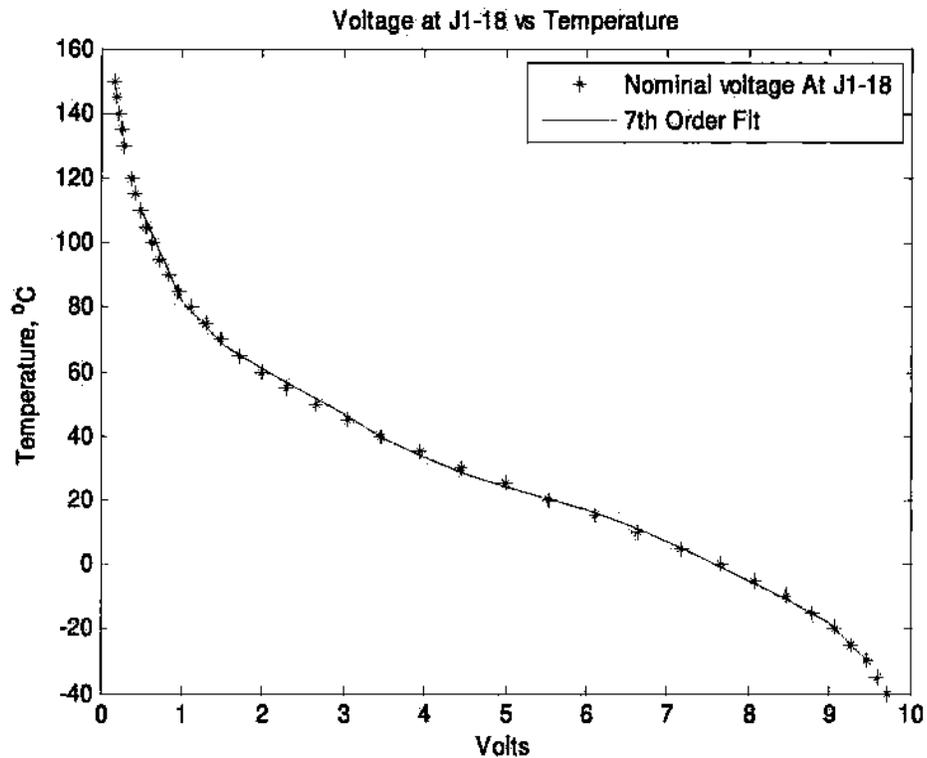
Figure 3.29 graphs the voltage at J1-18 versus temperature, with a 7th order polynomial fit superimposed. First, the red asterisks correspond to the voltage measured by the DAQ, based on the manufacturer data and nominal component values within the circuit shown in Fig. 3.28. The continuous blue line corresponds to the voltage/temperature curve derived from (3.4).

At first glance, a 7th order fit appears excessively complex. This is deceptive, as a region of great error between a 7th order fit and a 4th order fit is very near our operating temperature region (about 20 °C). In this area, the difference between the 7th order fit and the 4th order fit is approximately 1 °C versus 4 °C. Thus, it was justified to implement a 7th order fit.

Figure 3.29. Temperature versus Voltage at J1-18, with a 7th order fit superimposed.

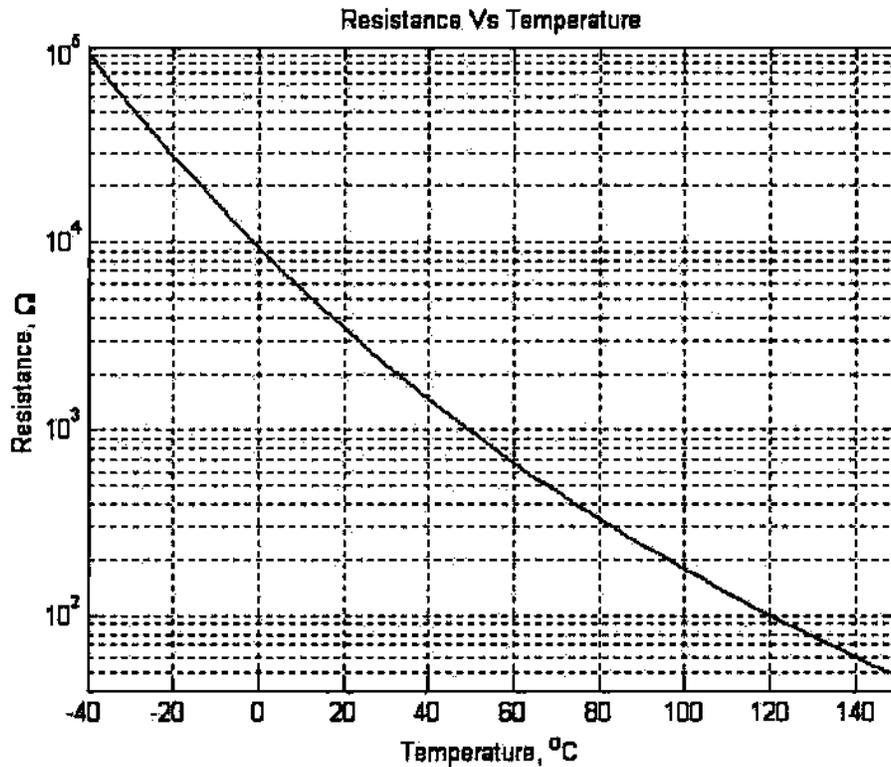
resistance/temperature curve is shown in Fig. 3.30, based on the manufacturer supplied specifications.

Figure 3.30. Air Temperature Thermistor R/T Curve (Source: Delphi Specifications).

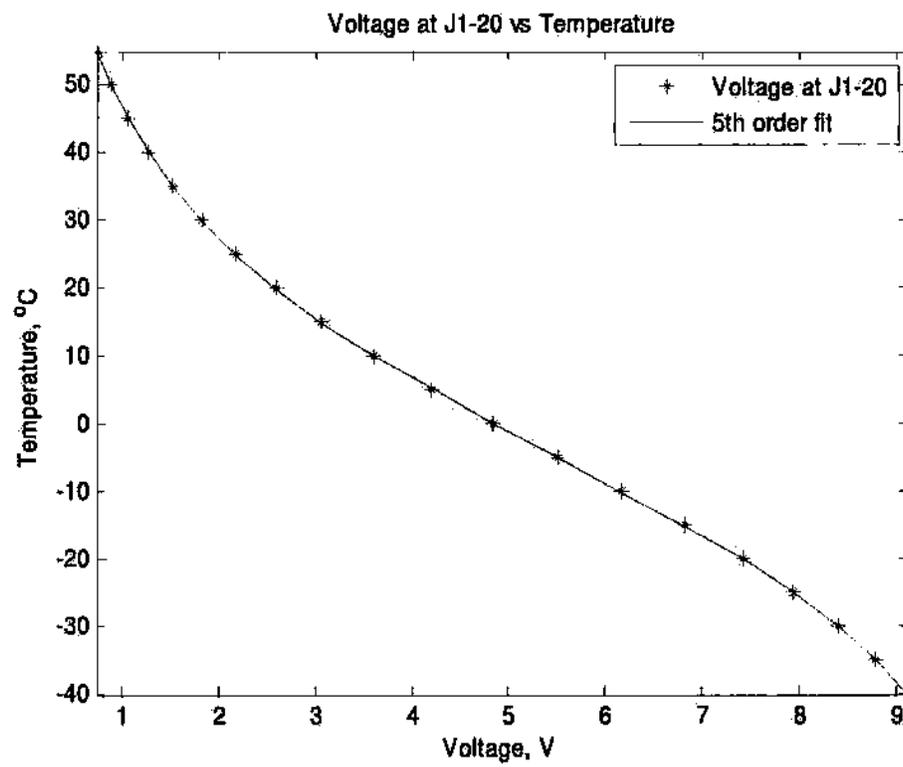
Figure 3.31. Air Temperature versus Voltage Curve.

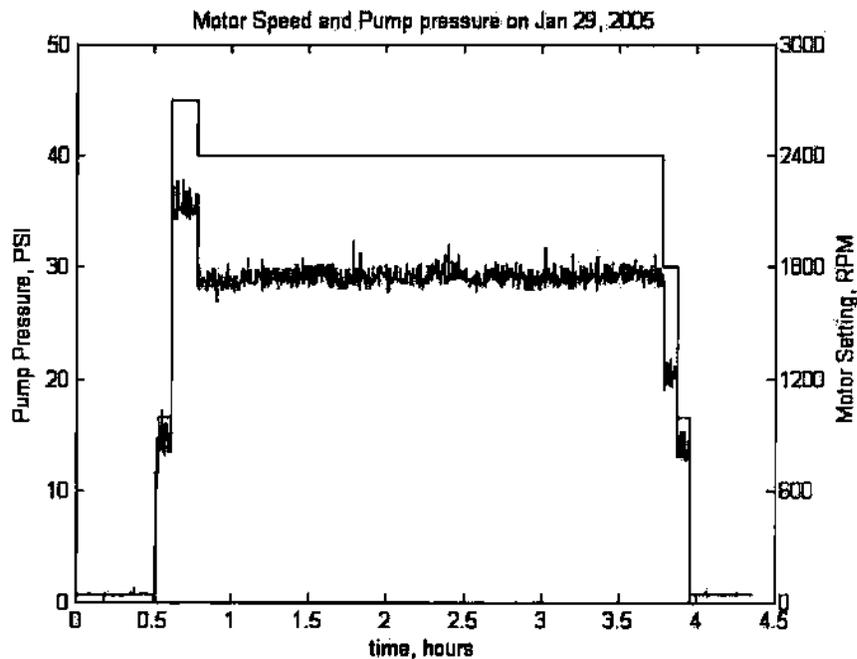
Figures 4.1 through 4.3 present example data graphically; in these instances the plots show the pump pressure for three separate cycles, the first on January 29th, the second on April 20th, and the final on September 14th. The red curve shows the motor setting, in RPM, and the blue curve shows the pump pressure in PSI. By following the motor setting curve, the corresponding event can be deduced, from idle (motor setting = 700 RPM) to taxi (motor setting = 1000 RPM), to takeoff (motor setting = 2700 RPM), as determined by the timing scheme of Table 2.1.

Figure 4.1. Fuel Pump Pressure and RPM, January 29, 2005.

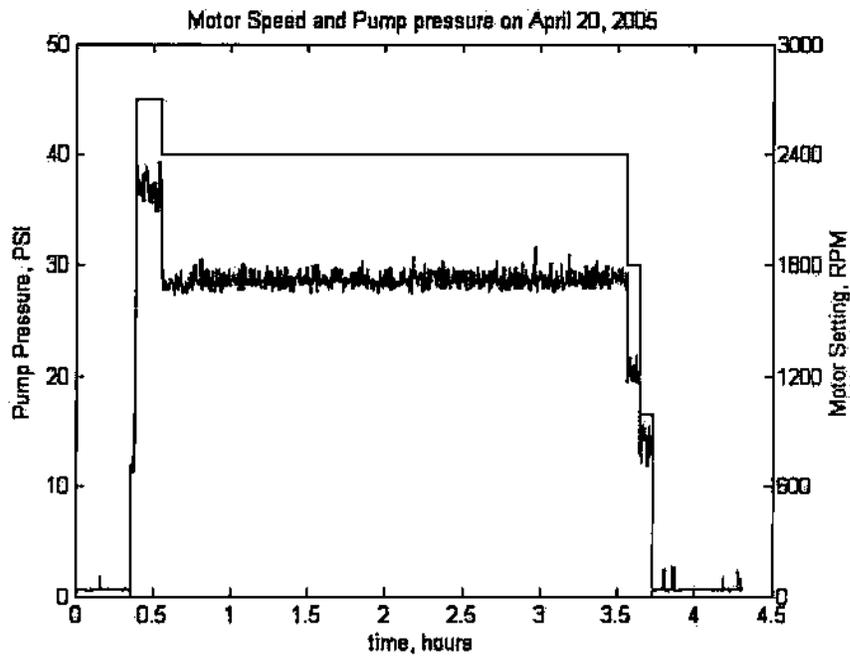
Figure 4.2. Fuel Pump Pressure and RPM, April 20, 2005.

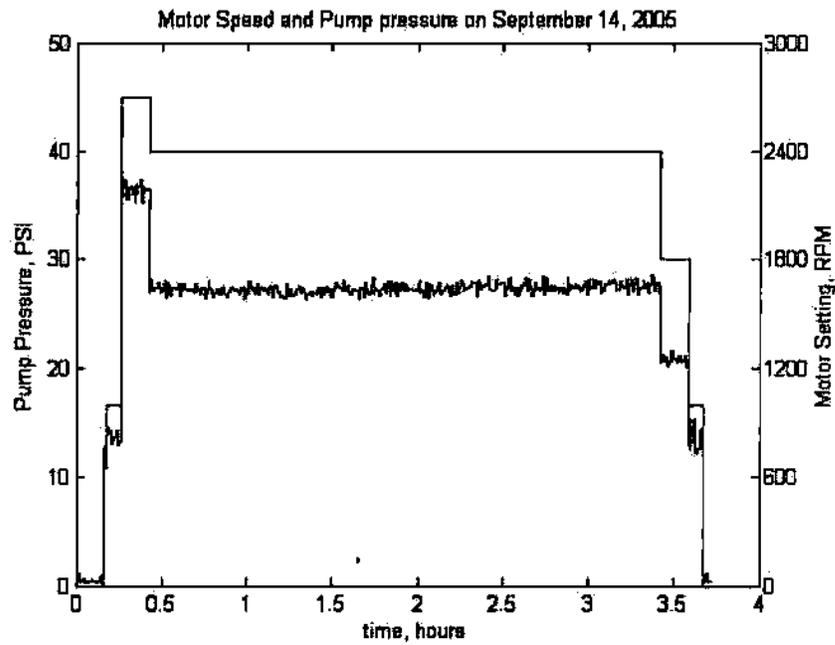
Figure 4.3. Fuel Pump Pressure and RPM, September 14, 2005.

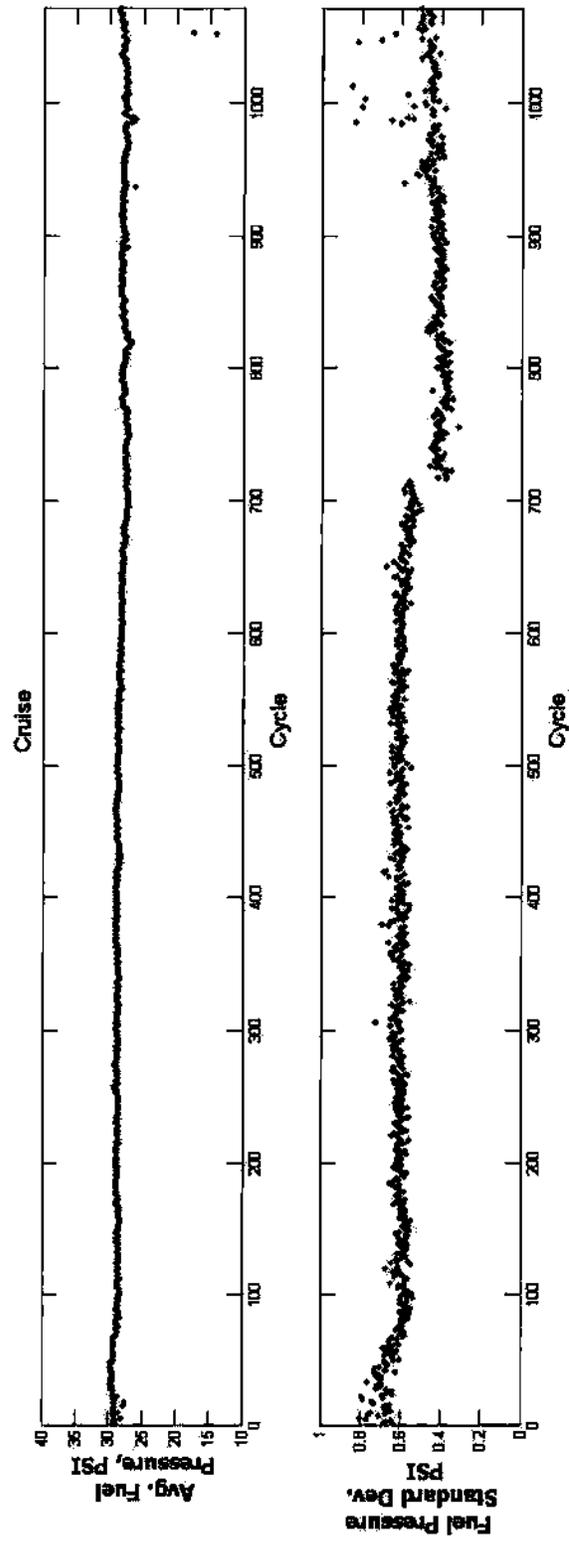
Figure 4.4. Average Fuel Pump Pressure and Standard Deviation.

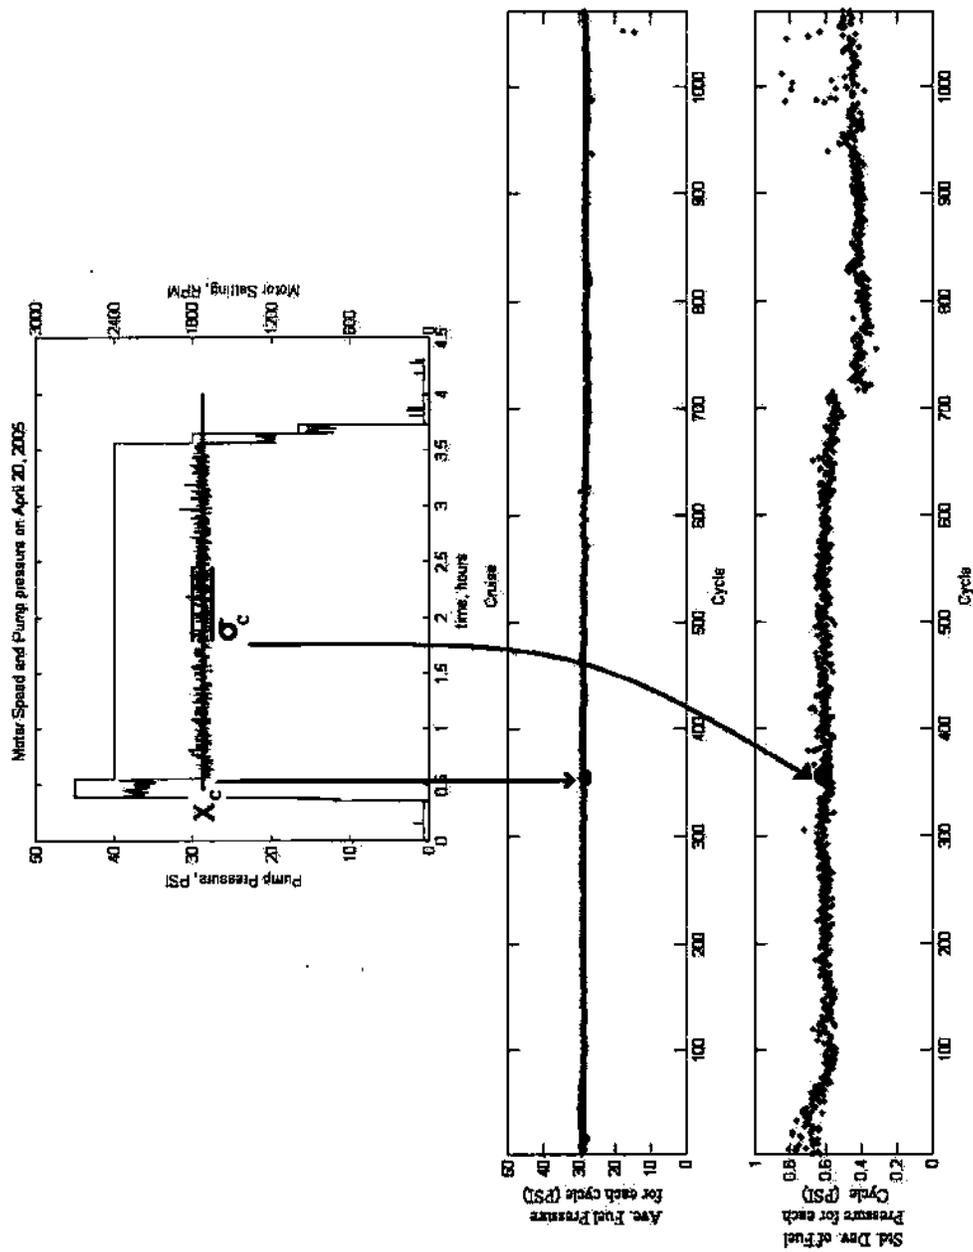
Figure 4.5. Explanation of Sample Data within a Cycle, and Cumulative Data.

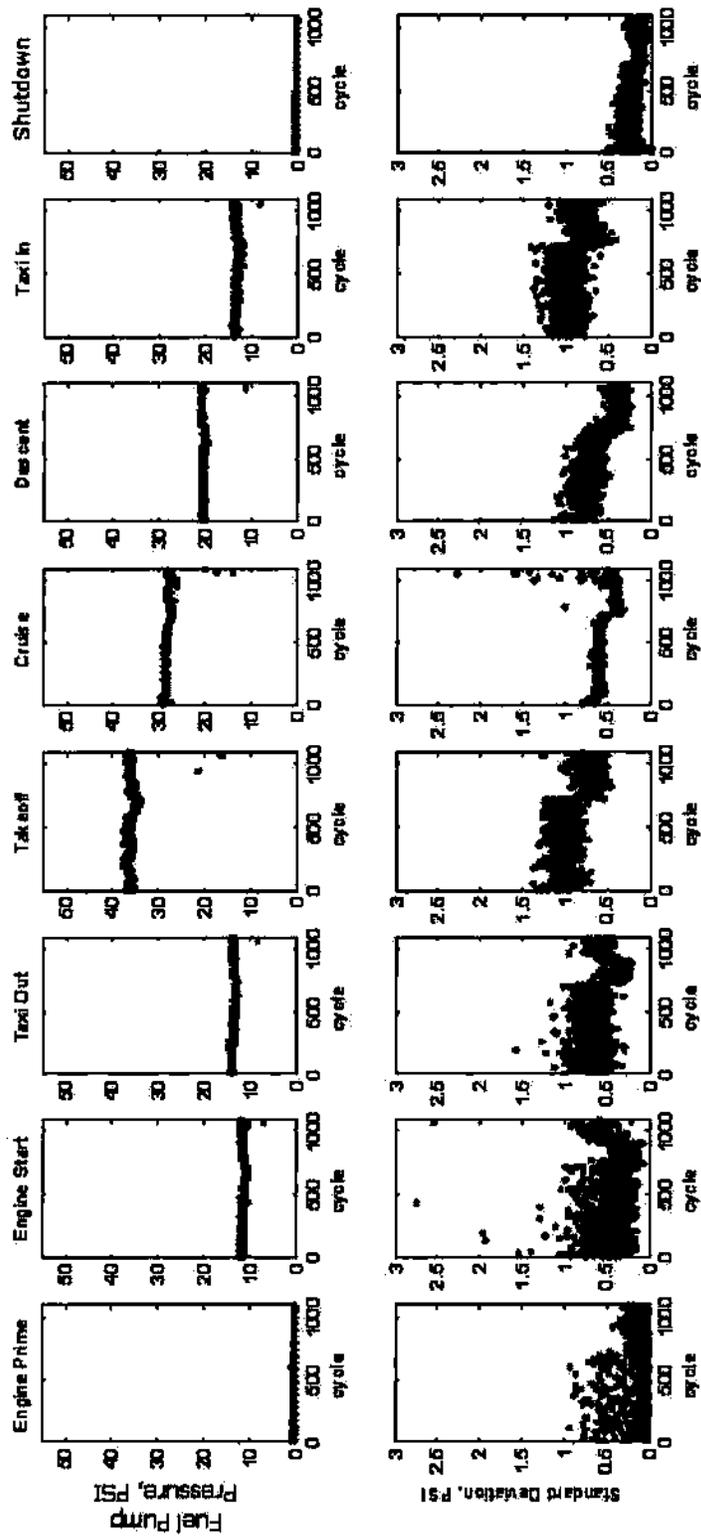
Figure 4.6. Fuel Pump Pressure Data, summarized per event.

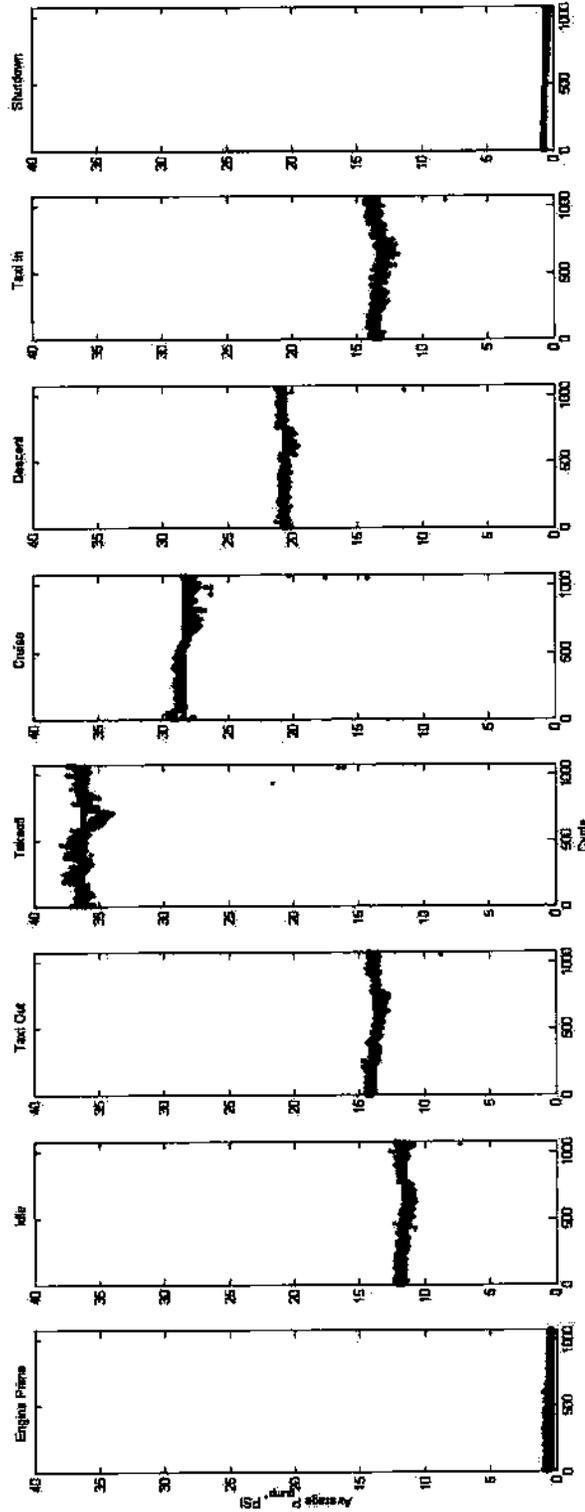
Figure 4.7. Summarized data for P_{pump} (red) with regression analysis (black) and the test average (green).

With regard to the performance of the pump, the data revealed little change in fuel pressure throughout the test (5.8 % decline, worst-case); though the torque required to circulate the fuel had fallen 6% after an initial break-in period. When the data were considered together, these changes likely revealed the deteriorating condition of the motor, not deterioration within the fuel pump.

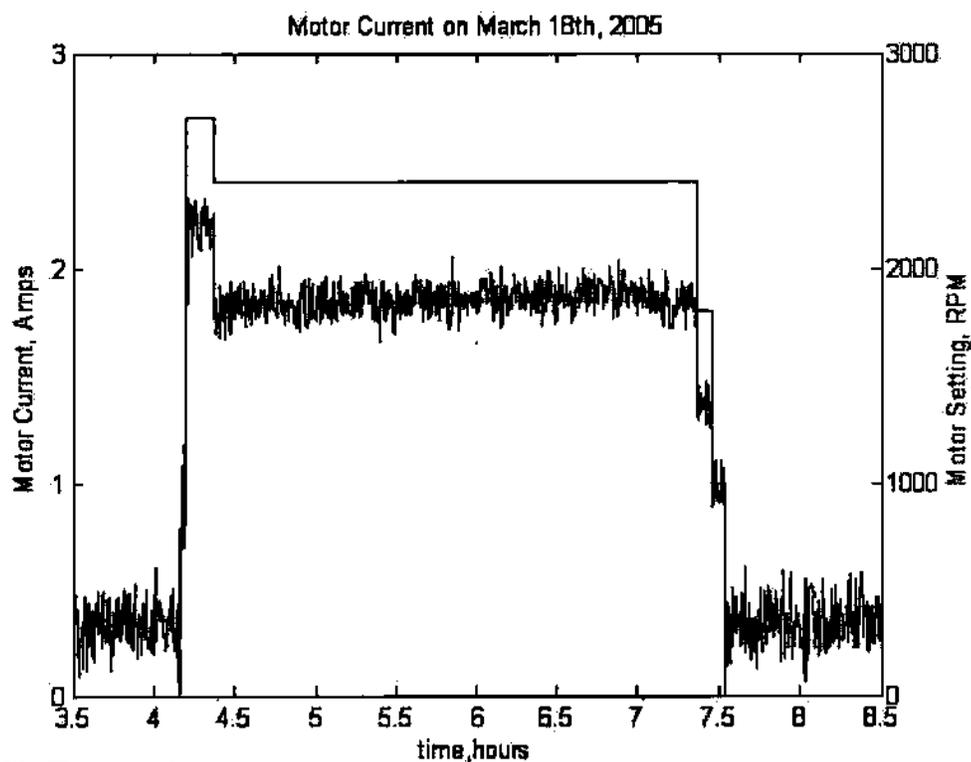
Figure 4.8. Example motor current data on March 18th 2005.

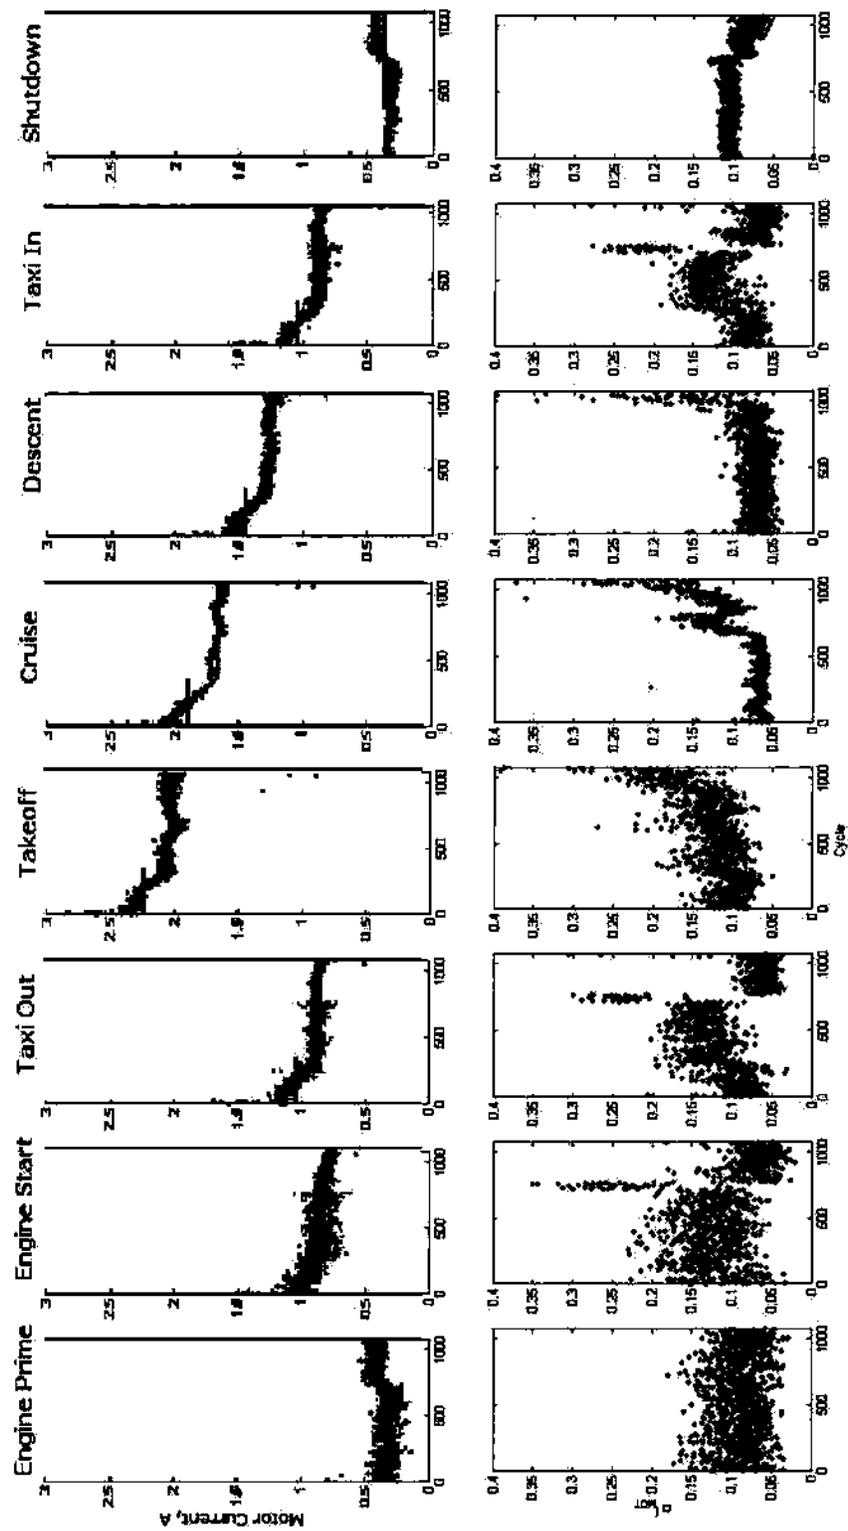
Figure 4.9. Average Motor Current (top) and Standard Deviation (bottom) per Event for the Lifetime of the Test.

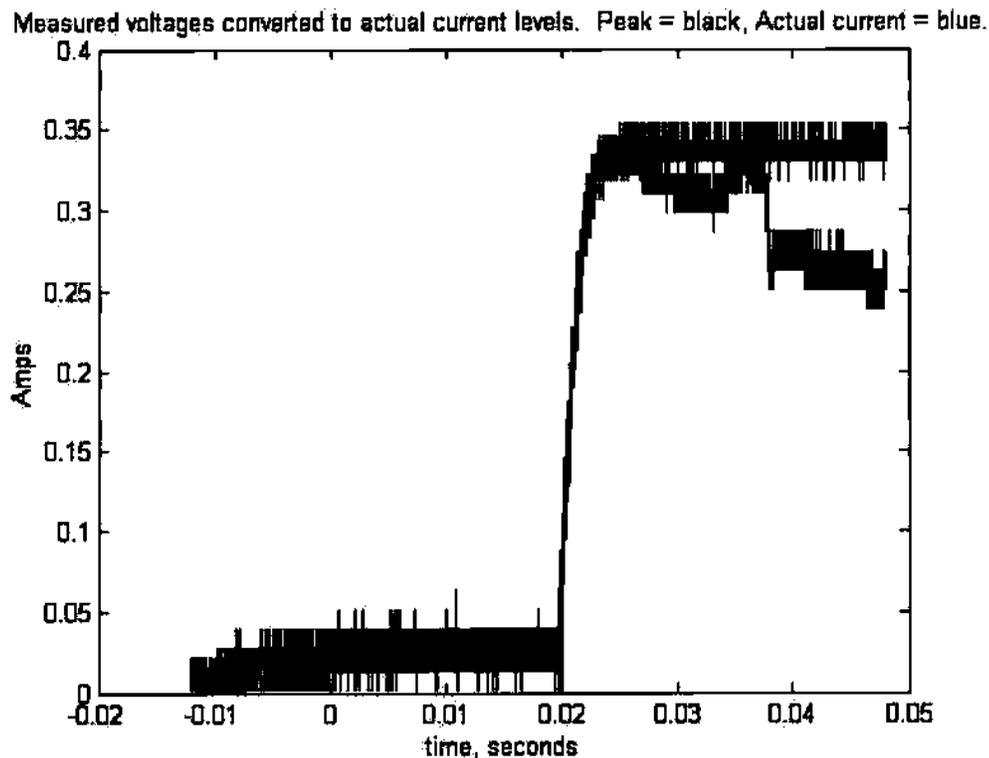
Figure 4.10. Example I_{thr} During an Event Transition.

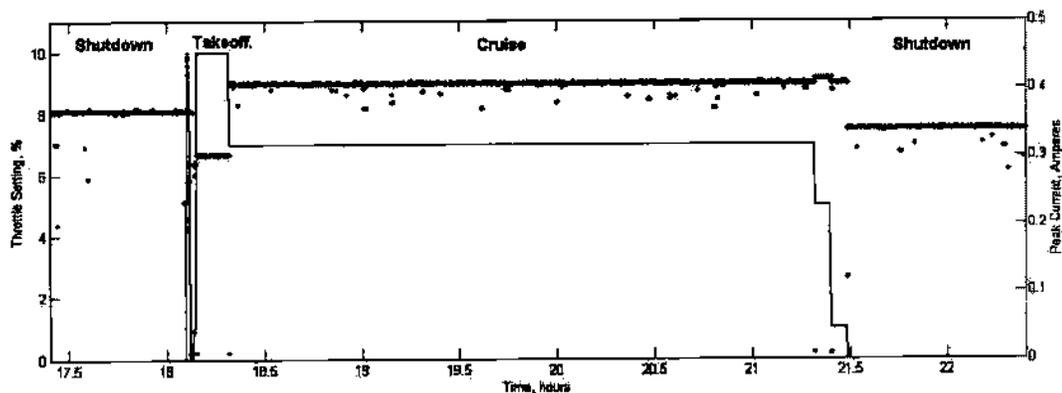
Figure 4.11. Example I_{thr} Data over a Single Cycle.

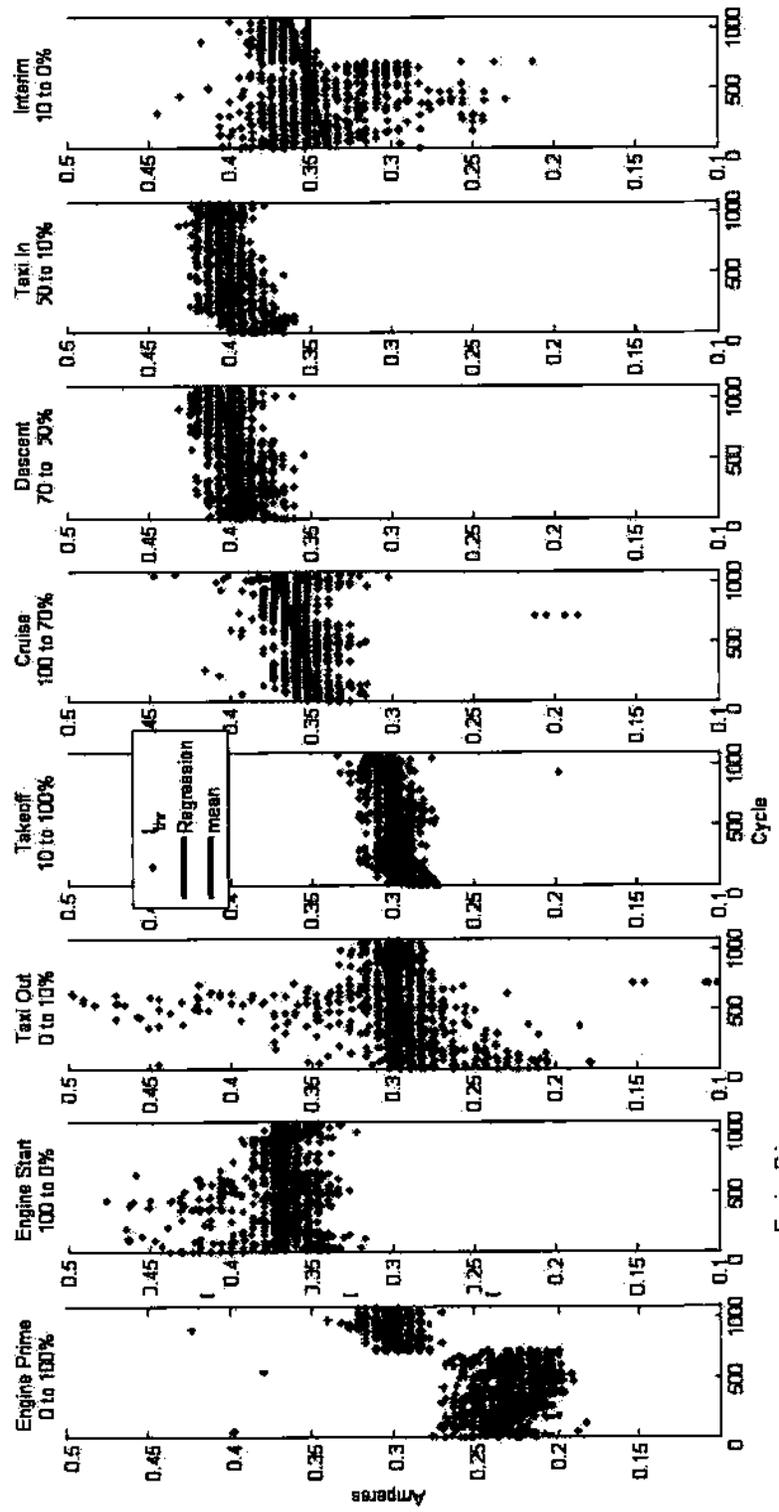
Figure 4.12. I_{br} throughout the Test, with Regression Analysis.

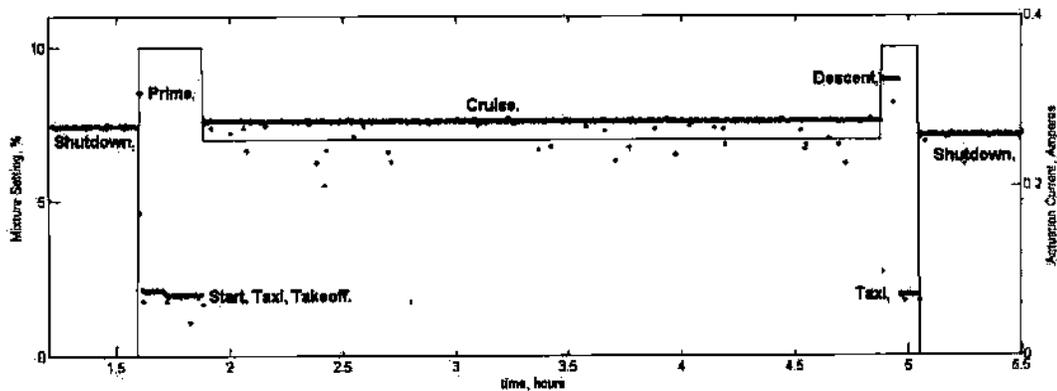
Figure 4.13. Mixture Current Measurements on Jan 30th 2005.

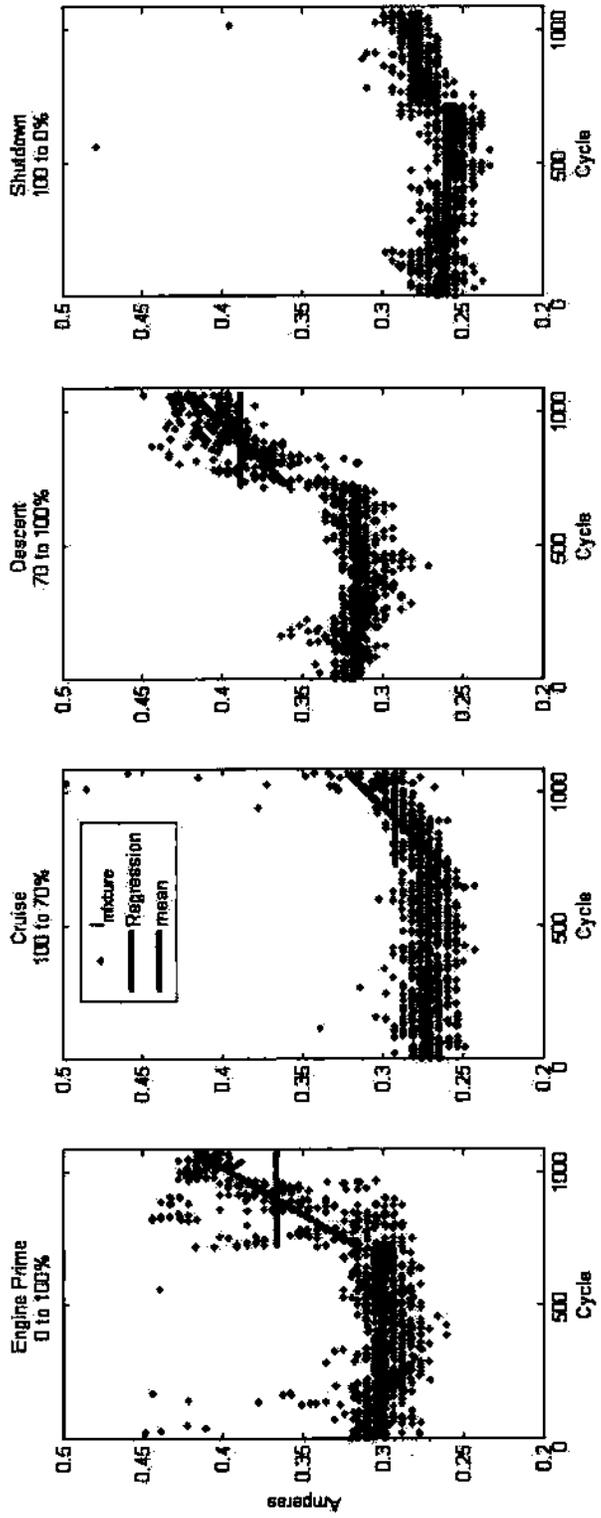
Figure 4.14. Summarized Mixture Actuation Current.

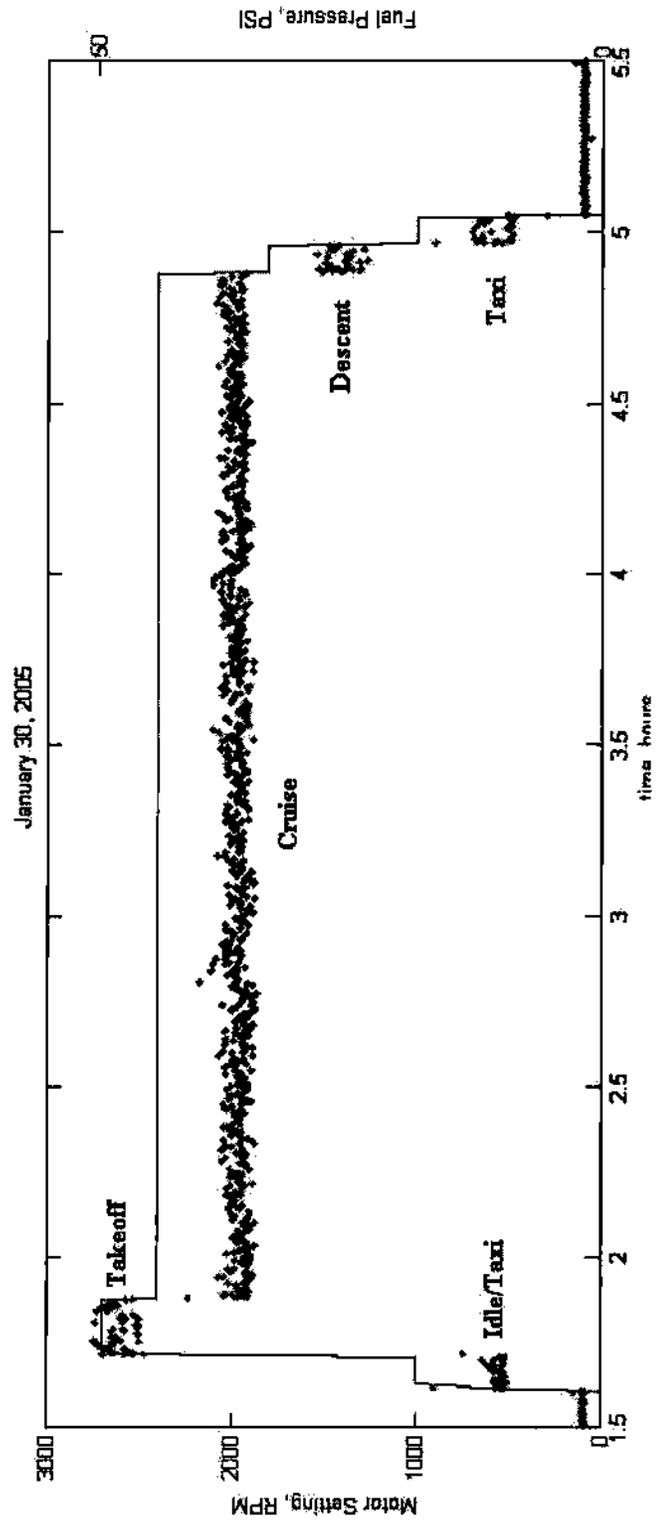
Figure 4.15. Fuel Pressure from the Fuel Servo to the Flow Divider, on January 30th, 2005.

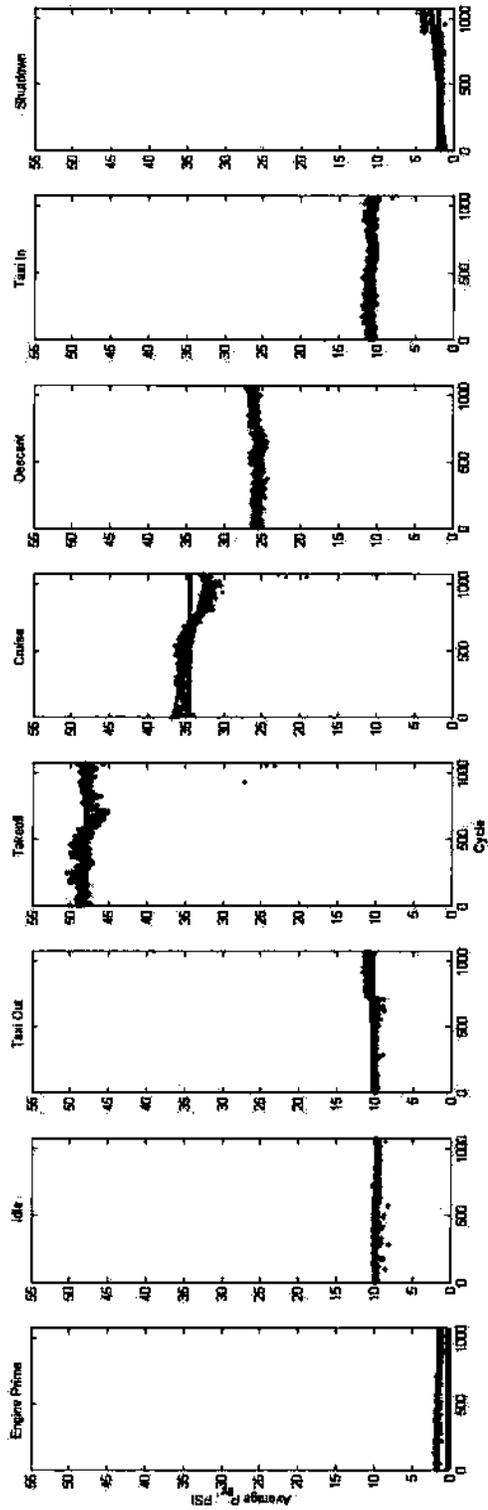
Figure 4.16 Fuel Pressure from the Servo to the Flow Divider.

Regarding the fuel servo, the data indicated the fuel pressure exiting the servo for the fuel flow divider had fallen approximately 12%. However, since the inlet pressure (pump pressure) had fallen 5.8% over the same period, the majority of this change most likely reflected the condition of the fuel pump and motor drive, not deterioration within the servo. Also, data indicated the torque required to adjust the mixture and throttle settings had increased approximately 7 and 27% respectively. Though these results may indicate some deterioration of the seals within the fuel servo, the results were not alarming, since neither leakage was observed nor did external testing indicate similar changes.

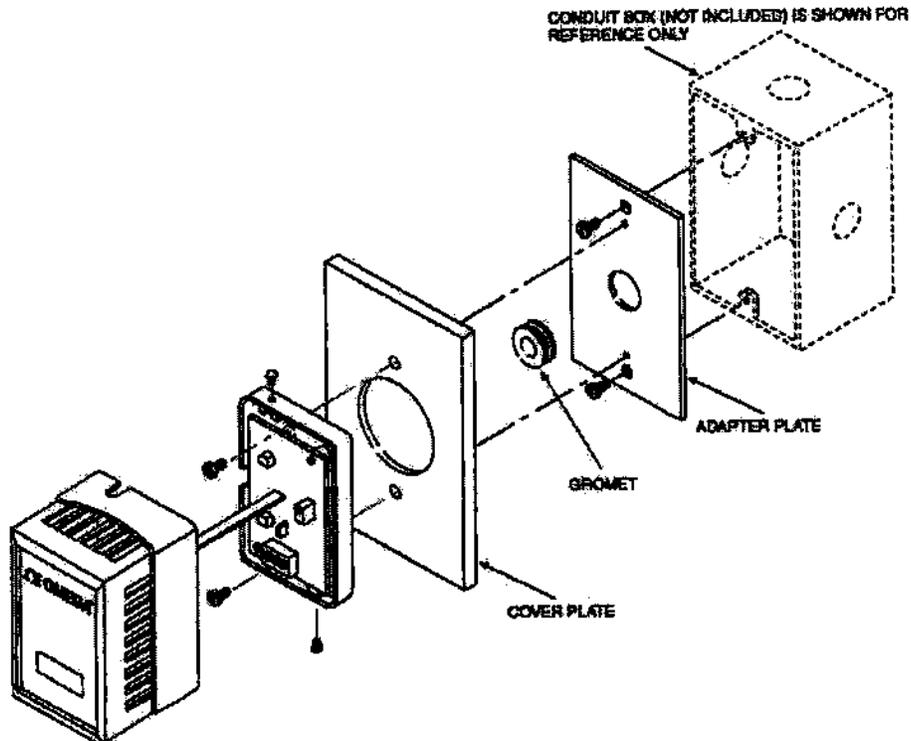
Figure 1: Mounting Diagram

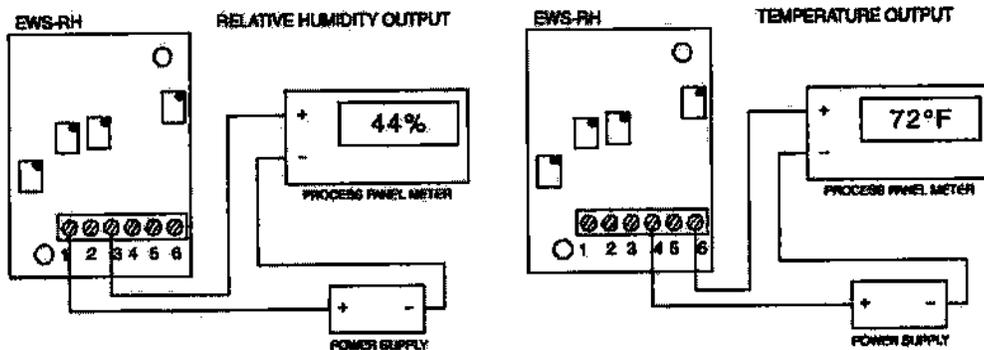
**Figure 2: Transmitter Wiring Examples
 For Current Output (4-20 mA)**

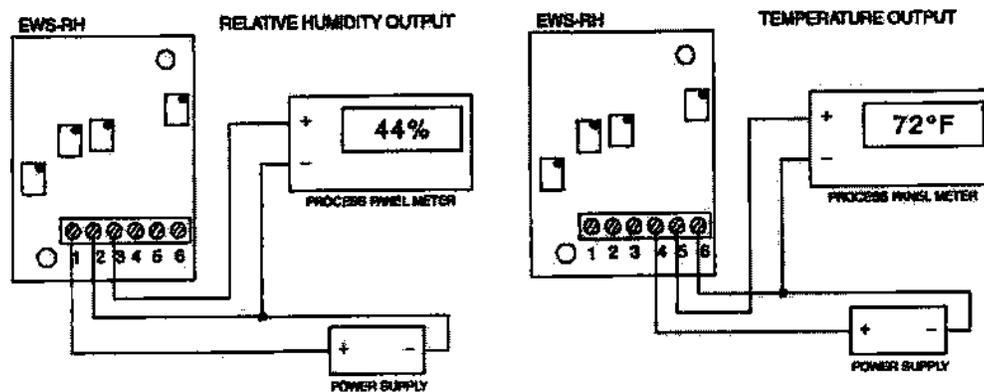
**Figure 3: Transmitter Wiring Examples
 For Voltage Output (1-5 Vdc)**

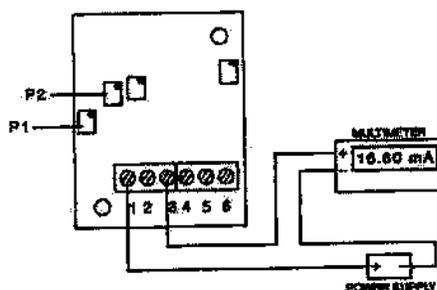
Figure 4: Relative Humidity Calibration Procedure

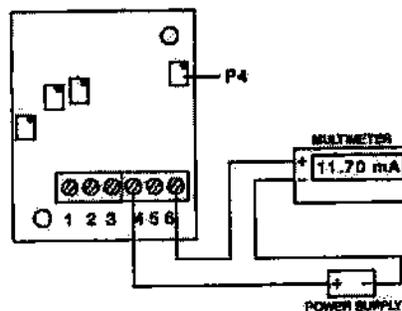
Figure 5: Temperature Calibration Procedure
